FULL-SCALE PERFORMANCE STUDY OF A PROTOTYPE CRASH-
FIRE PROTECTION SYSTEM FOR RECIPROCATING-
ENGINE-POWERED AIRPLANES

By Dugald O. Black and Jacob C. Moser

NATIONAL ADVISORY COMMITTEE
FOR AERONAUTICS

November 15, 1955

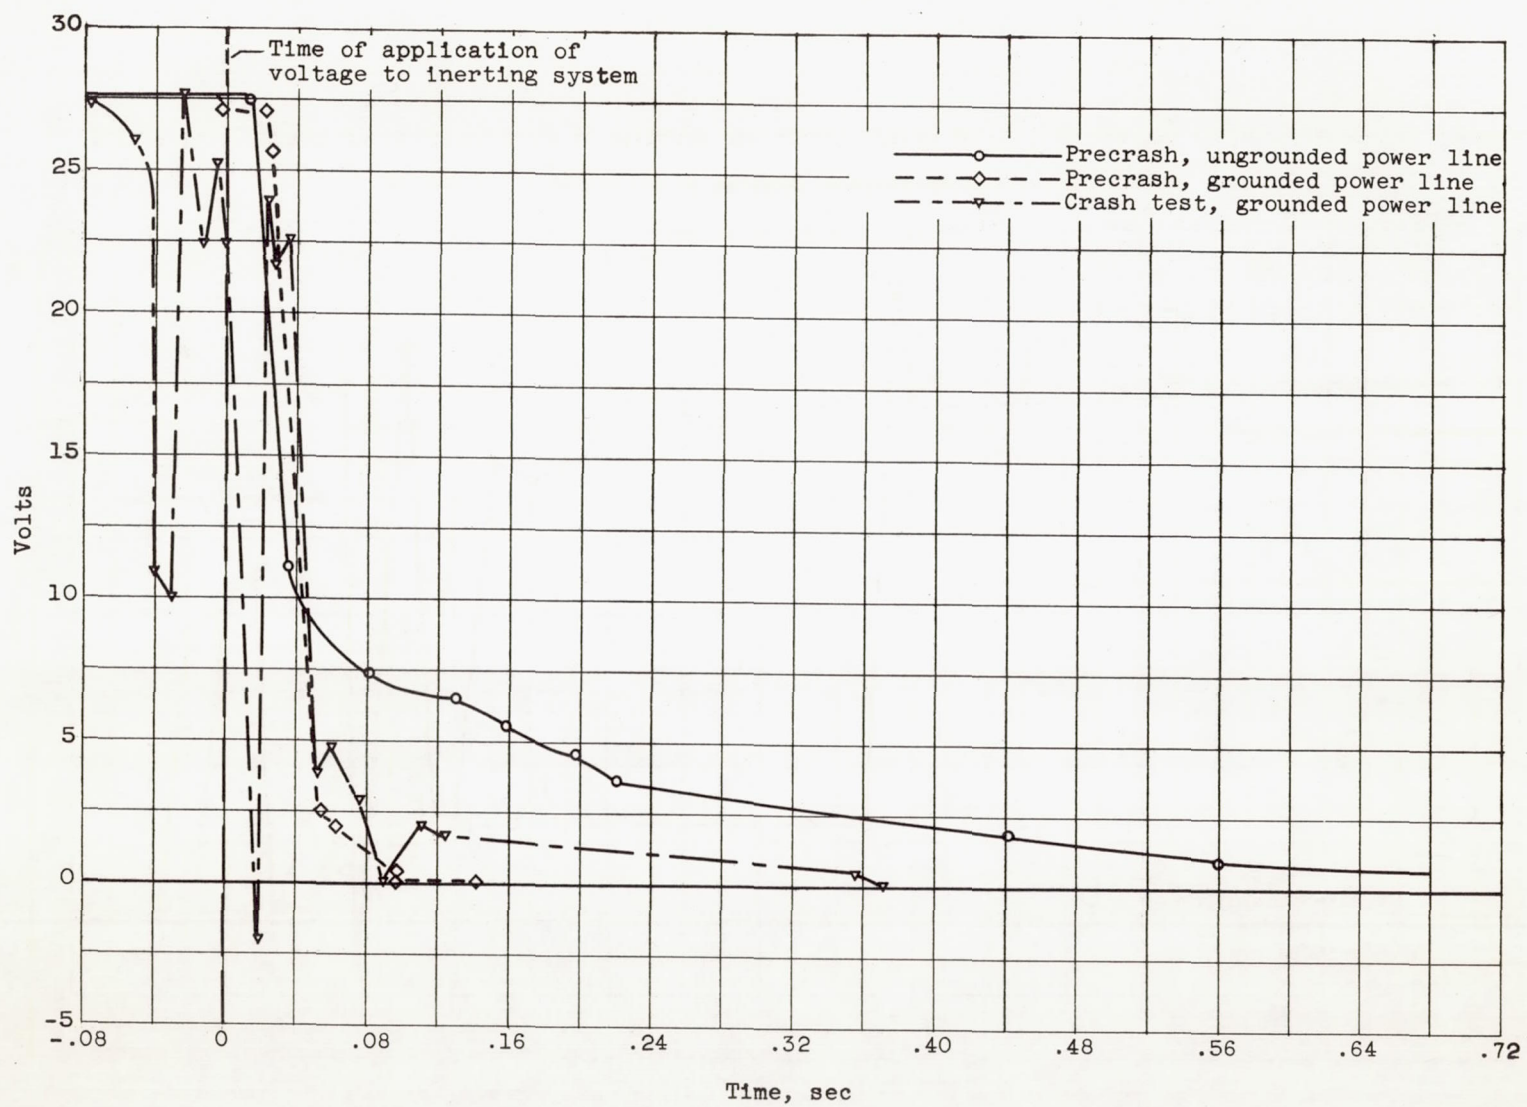
The effect of the grounding relay in the fire-prevention system on the airplane electrical system voltage is shown in figure 13. The voltage variations recorded during this crash are compared with those obtained in precrash trials of the electrical inerting system with and without a grounding relay. It can be seen from this figure that zero potential is obtained in a much shorter time with a grounding relay. The grounding relay used in the crash study had smaller contacts and lighter contact pressure than the relay used in the precrash studies. Because of these differences, the voltages in the precrash studies reached zero 0.25 second sooner than in the crash. In figure 13 "zero" on the time coordinate is defined as the moment at which voltage was applied to the inerting system.

Figure 13. - Effect of grounding on airplane electrical system voltage.

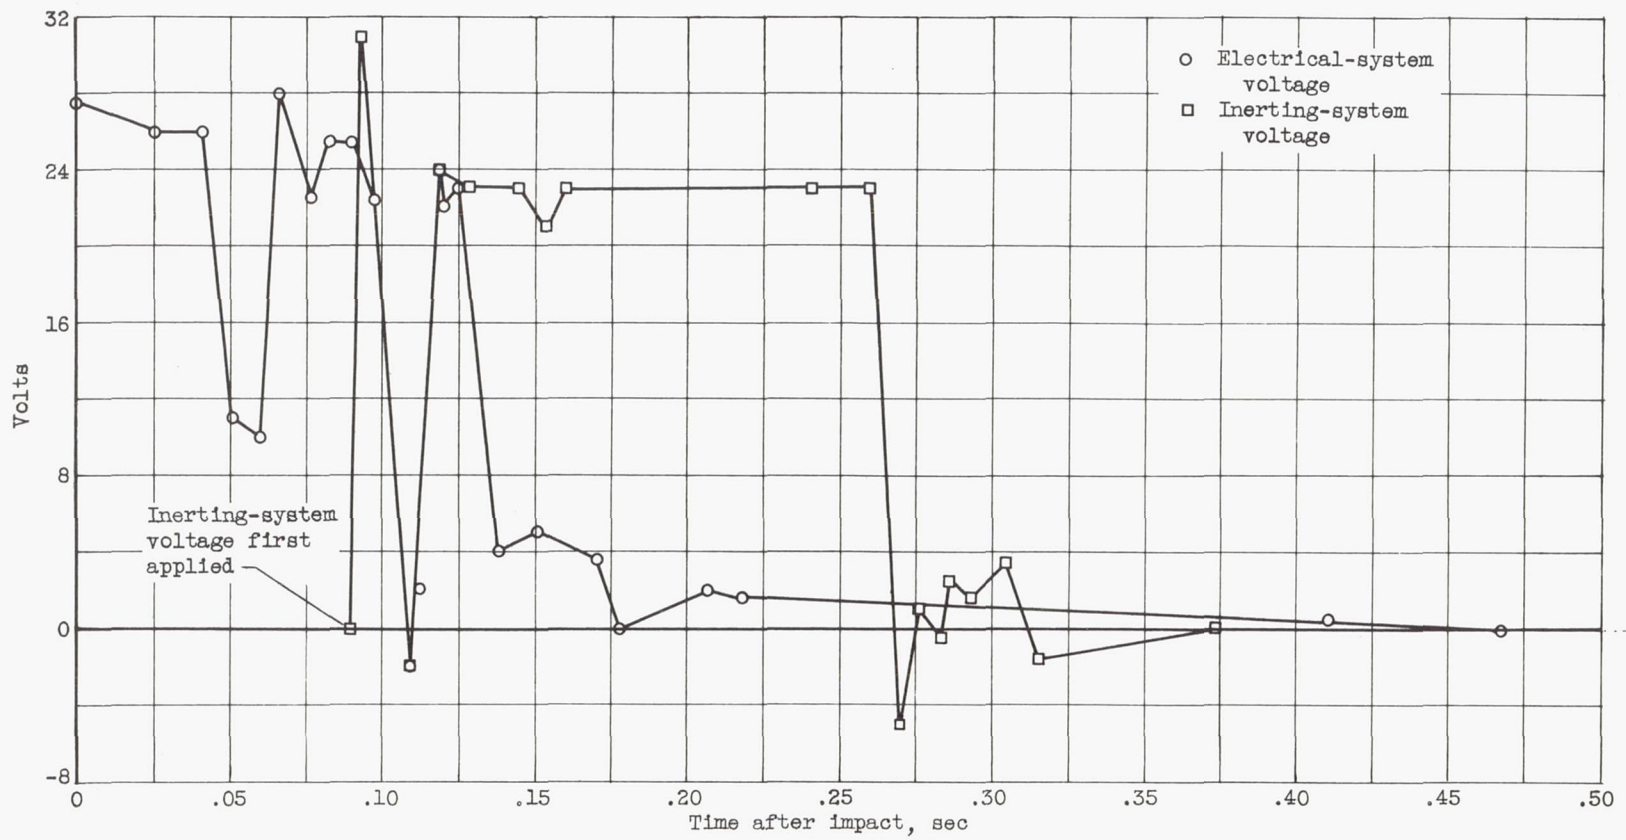
Inerting-system voltage. - The effect of the short circuits in the airplane electrical system on the voltage applied to the inerting-system components is presented in figure 14. The initiating system first applied voltage to the inerting-system components 0.09 second after impact. The second short circuit in the airplane electrical system occurred immediately thereafter and reduced the inerting voltage to zero, which delayed

the action of part of the inerting system. However, this short circuit quickly disappeared and both the airplane-electrical-system and the inerting-system voltage increased to battery potential (23 volts). The inerting-system voltage then remained at 23 volts from approximately 0.12 to 0.26 second after impact. At 0.26 second after impact the time-delay switch opened the circuit from the battery to the inerting system. The inerting voltage reached zero 0.27 second after impact and the inerting system wiring could then no longer act as a potential ignition source. The varying voltage after 0.27 second was due to inductive effects in valve and relay coils.

Figure 14. - Effect of short circuits in airplane electrical system on voltage applied to inerting-system components.

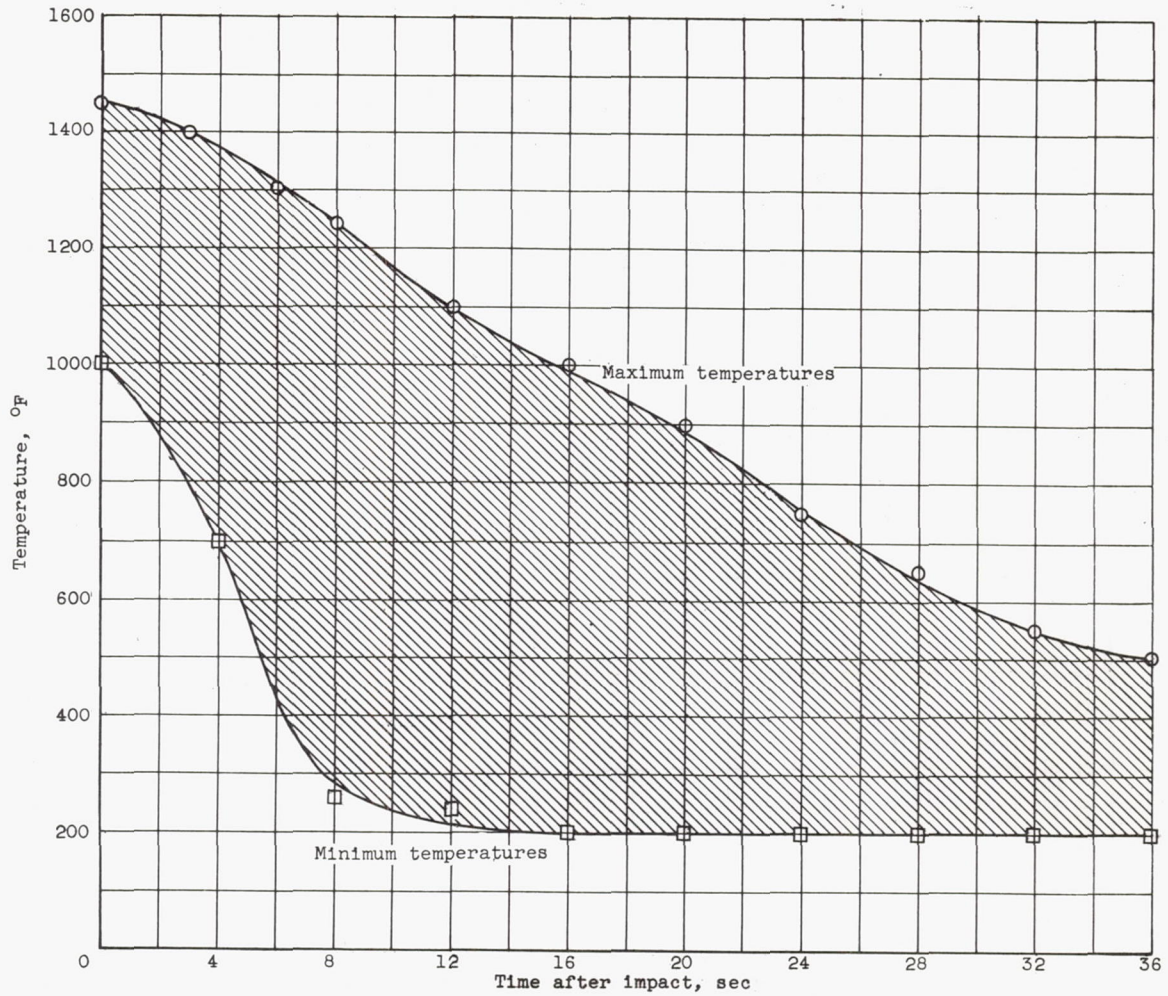
The temperature history of the right-engine exhaust collector ring (fig. 16) indicates that it took 17.5 seconds for the hottest portion of the exhaust collector ring to cool to 950° F, the lowest temperature at which gasoline will ignite readily on the external surfaces of the exhaust system, and 24 seconds to cool to 760° F, the lowest temperature at which lubricating oil was observed to ignite readily. The temperatures continued to fall well below these critical values, indicating that the cooling system cooled the exhaust collector ring enough so that it was no longer an ignition source.

Figure 16. - Temperature history of right-engine exhaust collector ring.

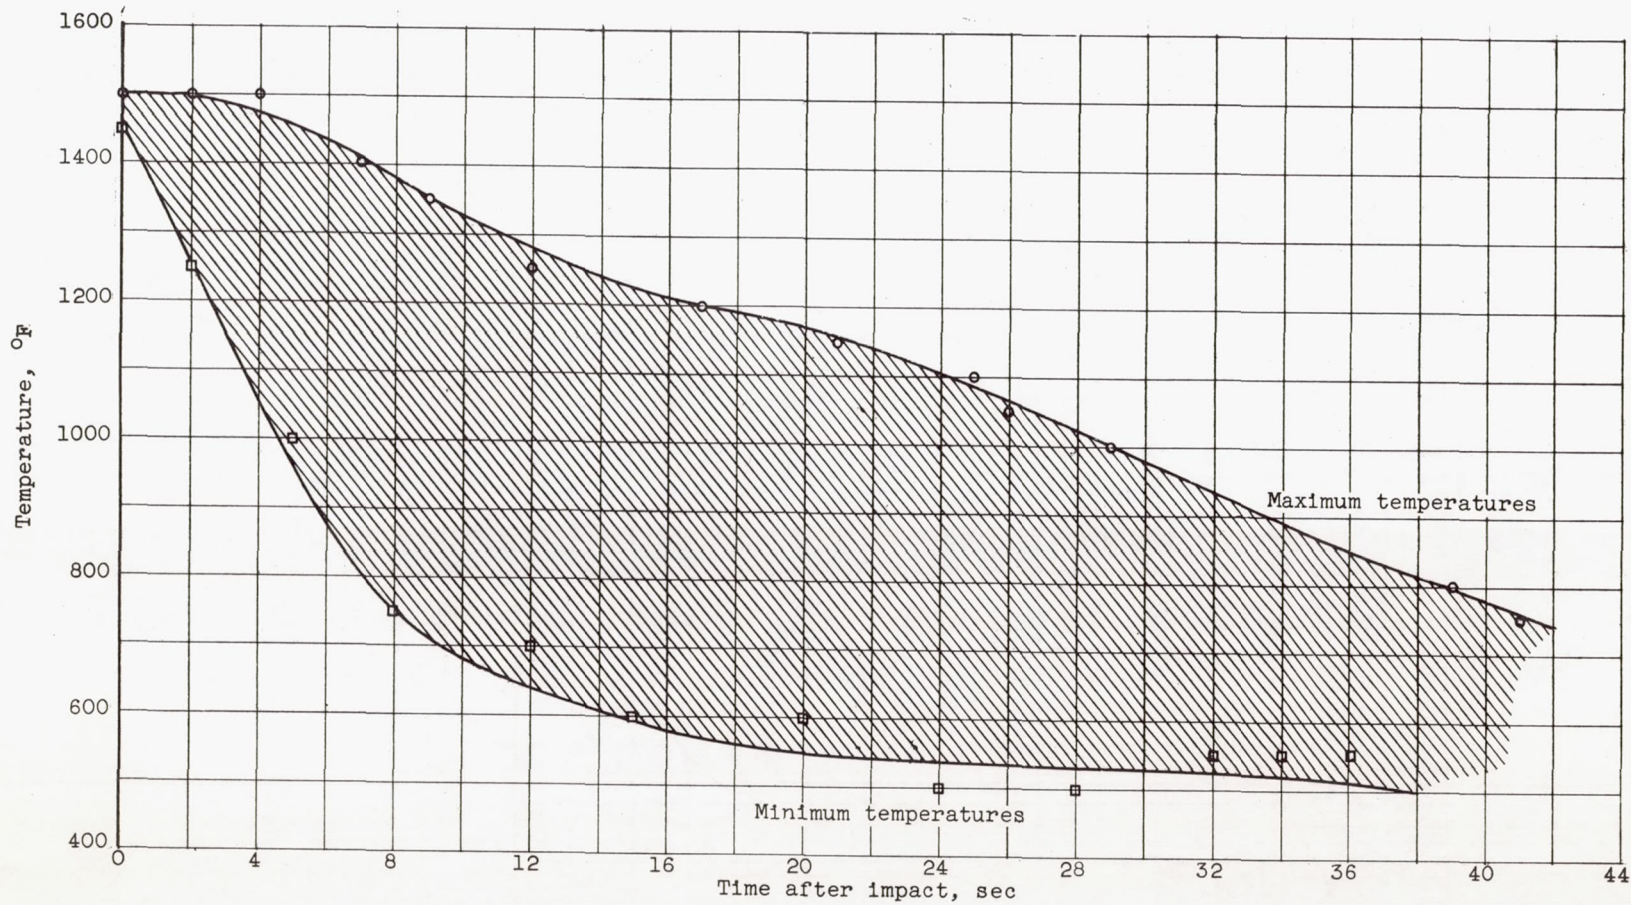
The temperature history of an exhaust heat exchanger (fig. 17) shows that the hottest part of the heat exchanger had been cooled to 850° F by the time the flow of coolant and driving gas stopped. Precrash studies showed that neither gasoline nor oil would ignite on these heat-exchanger surfaces at this temperature. The relatively stagnant atmosphere of inert gases within the heat exchanger evidently continued to protect this zone while the heat exchanger continued to cool by radiation and conduction. The data presented in figure 16 were taken from the right engine; the data from the left engine are essentially similar.

Figure 17. - Temperature history of right-engine exhaust heat exchanger.

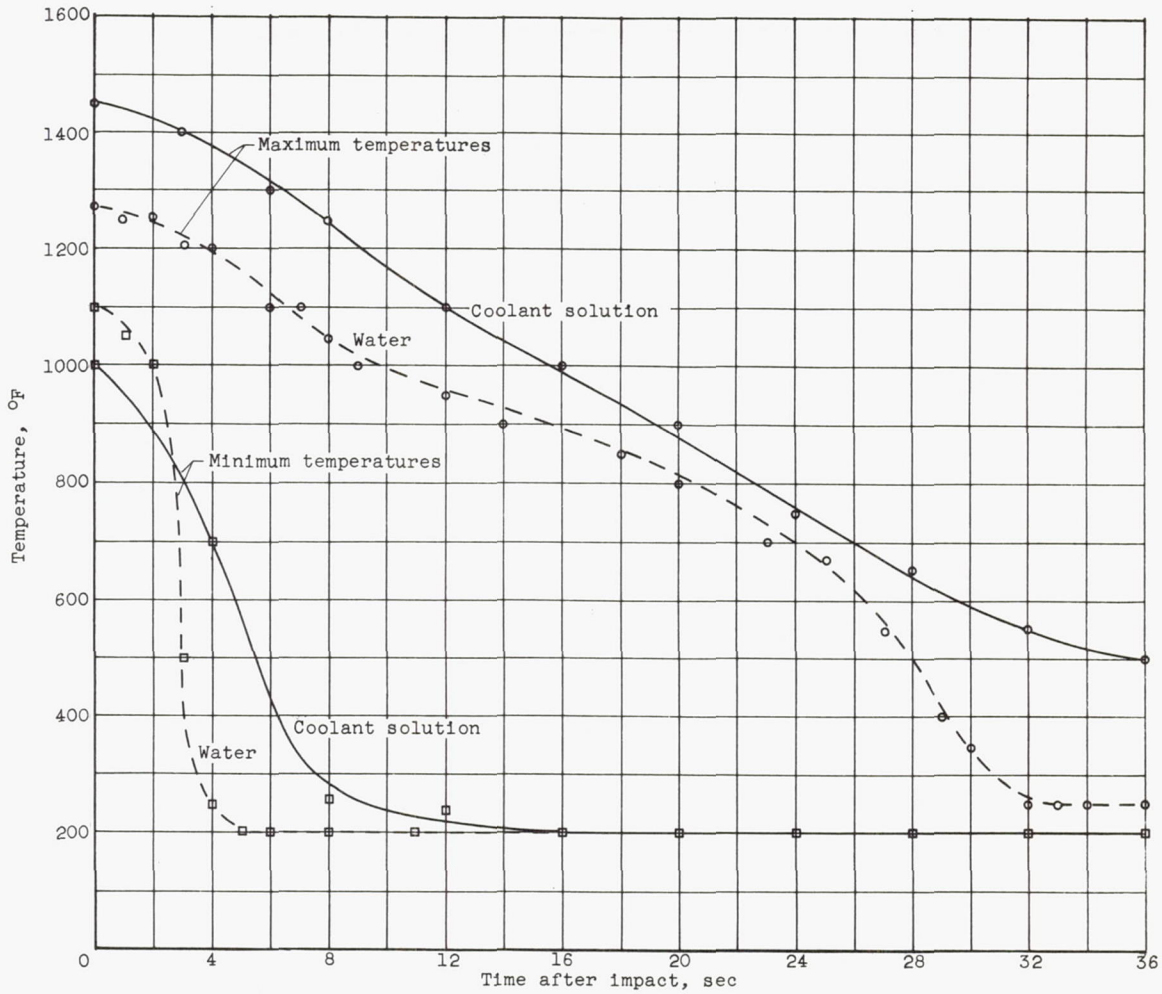
The coolant used in the earlier experimental inerting systems (ref. 1) was water, whereas in this prototype system the coolant was a mixture of water and chemicals. Figure 18 compares the cooling effectiveness of water and the coolant solution for the exhaust collector ring. These data were obtained from a preliminary study made before the airplane was crashed. The results indicate that the rate of temperature decrease was approximately the same for water and the coolant solution.

Figure 18. - Cooling effectiveness of water and coolant solution as indicated by temperature of exhaust collector ring.
