NACA RM E53L17

AN EXPERIMENTAL INVESTIGATION OF HOLLOW TURBINE BLADES

FOR EXPENDABLE JET ENGINES

By W. C. Morgan and C. R. Morse

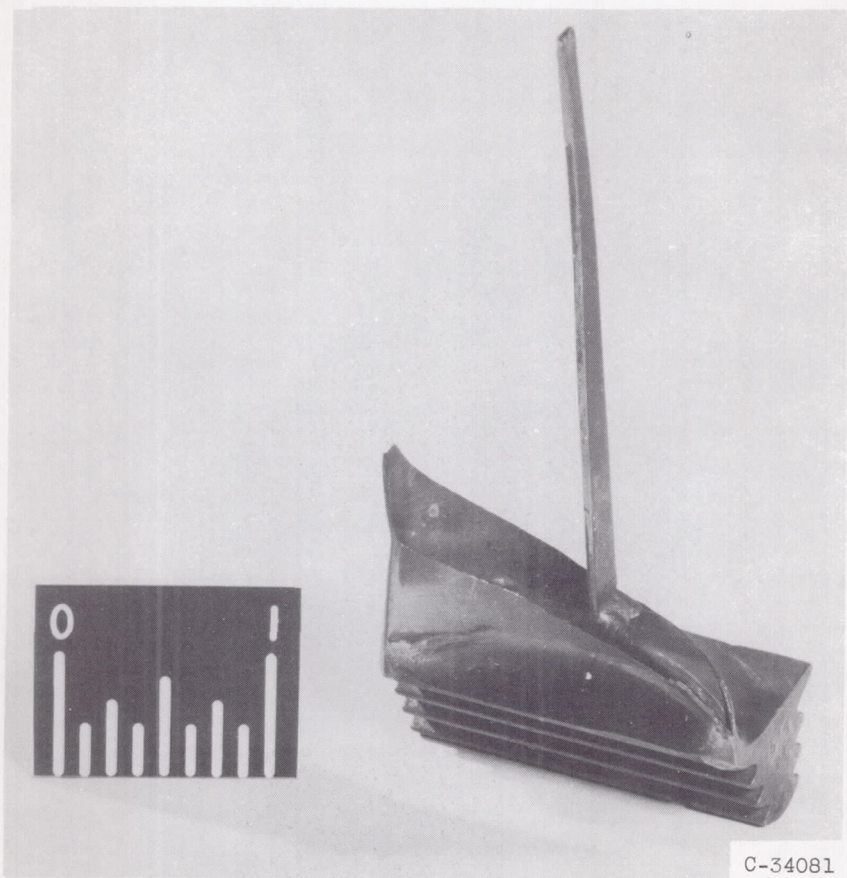
Tests of N-155 and Inconel X. - The initial engine operation of N-155 blades with wall thickness of 0.020 inch was terminated by a blade failure after 23 minutes at rated speed and temperature. The failure originated in the trailing edge at the welded juncture between airfoil and base, as shown in figure 2.

Figure 2. - Failure of N-155 airfoil (0.020-in. wall thickness).

There were fatigue cracks at the tips of the other blades of 0.020-inch wall thickness, and in the subsequent N-155 test blades, the wall thickness was made 0.030 inch. These blades withstood operation for 6 minutes. Failure was attributable to weld failure at the base.

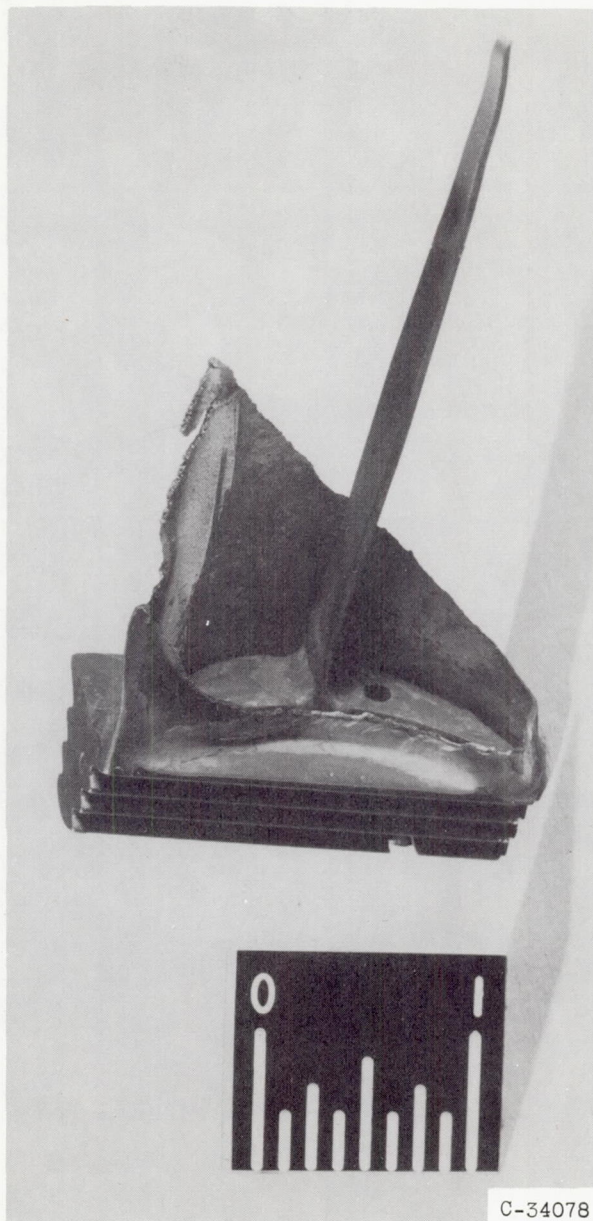
(a) 0.030-Inch wall thickness

Service-operation history was similar in the case of the blades formed from Inconel X. A blade with 0.030-inch wall thickness failed after 31 minutes (fig. 3(a)); another blade formed from material of 0.040-inch thickness was destroyed after 1 hour and 31 minutes (fig. 3(b)). An attempt to alleviate stress failure by the use of tapered stock was unsuccessful; failure occurred after 1 hour and 45 minutes. Figure 4 shows an undamaged blade together with the one that failed. The failures were attributed to a lack of strength in the weld between the airfoil and base.

Figure 3. - Failure of Inconel X airfoil.

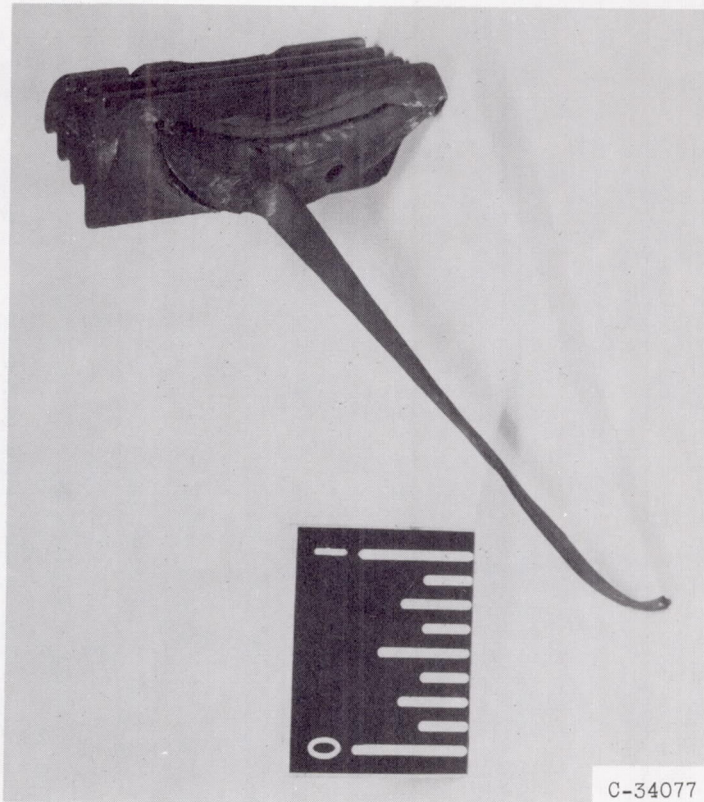
(b) 0.040-Inch wall thickness.

Figure 3. - Failure of Inconel X airfoil.

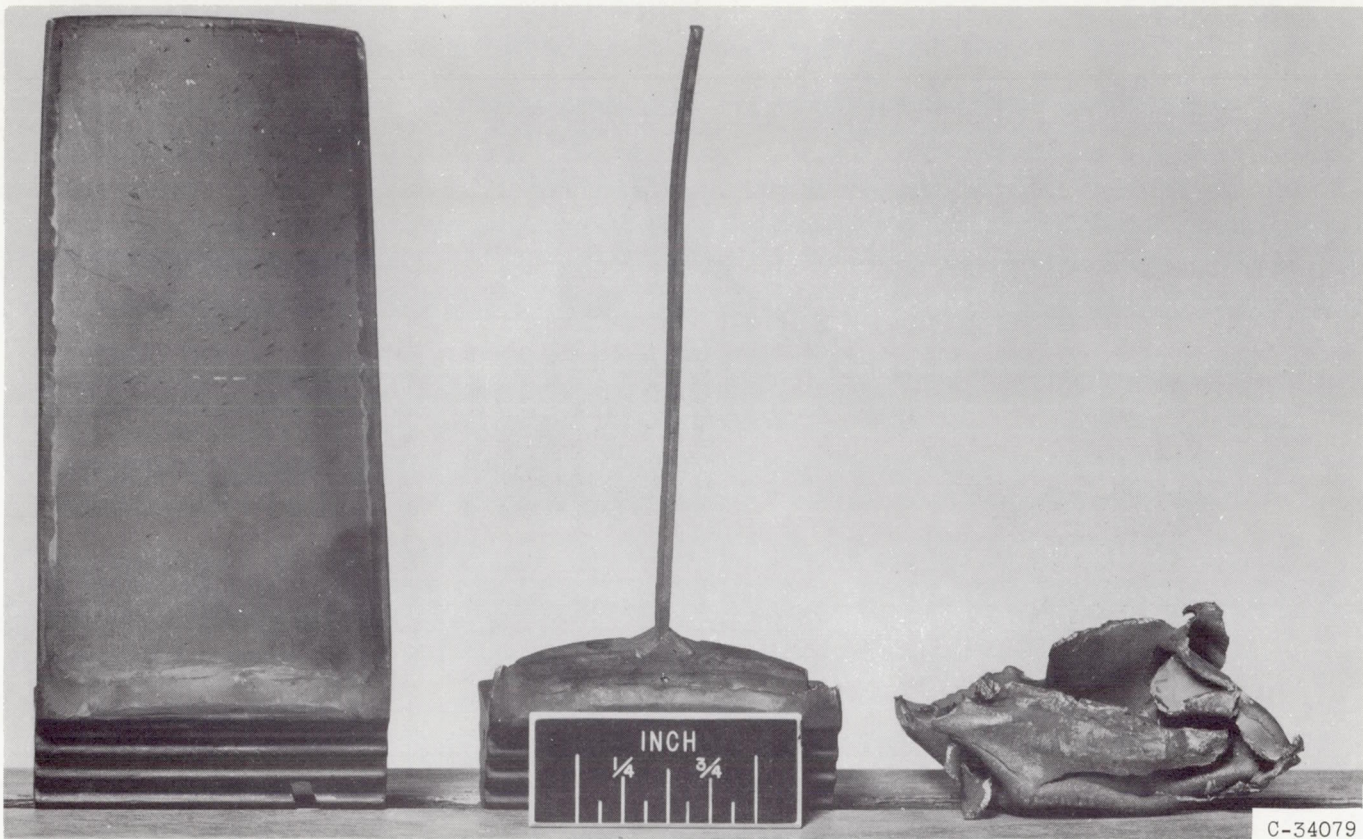
On the basis of the results obtained from the investigation, it appeared that L-605 proved to be more satisfactory than either N-155 or Inconel X. The use of tapered blade walls did not afford sufficient reduction in centrifugal stress to overcome the problem of weld-attachment failure. Tack-welding of airfoils to bases prior to brazing appeared to be a satisfactory method of holding base and airfoil in correct position during the process.

Figure 4. - Inconel X blade (0.040 - 0.020 in. tapered wall) before and after failure due to operation.

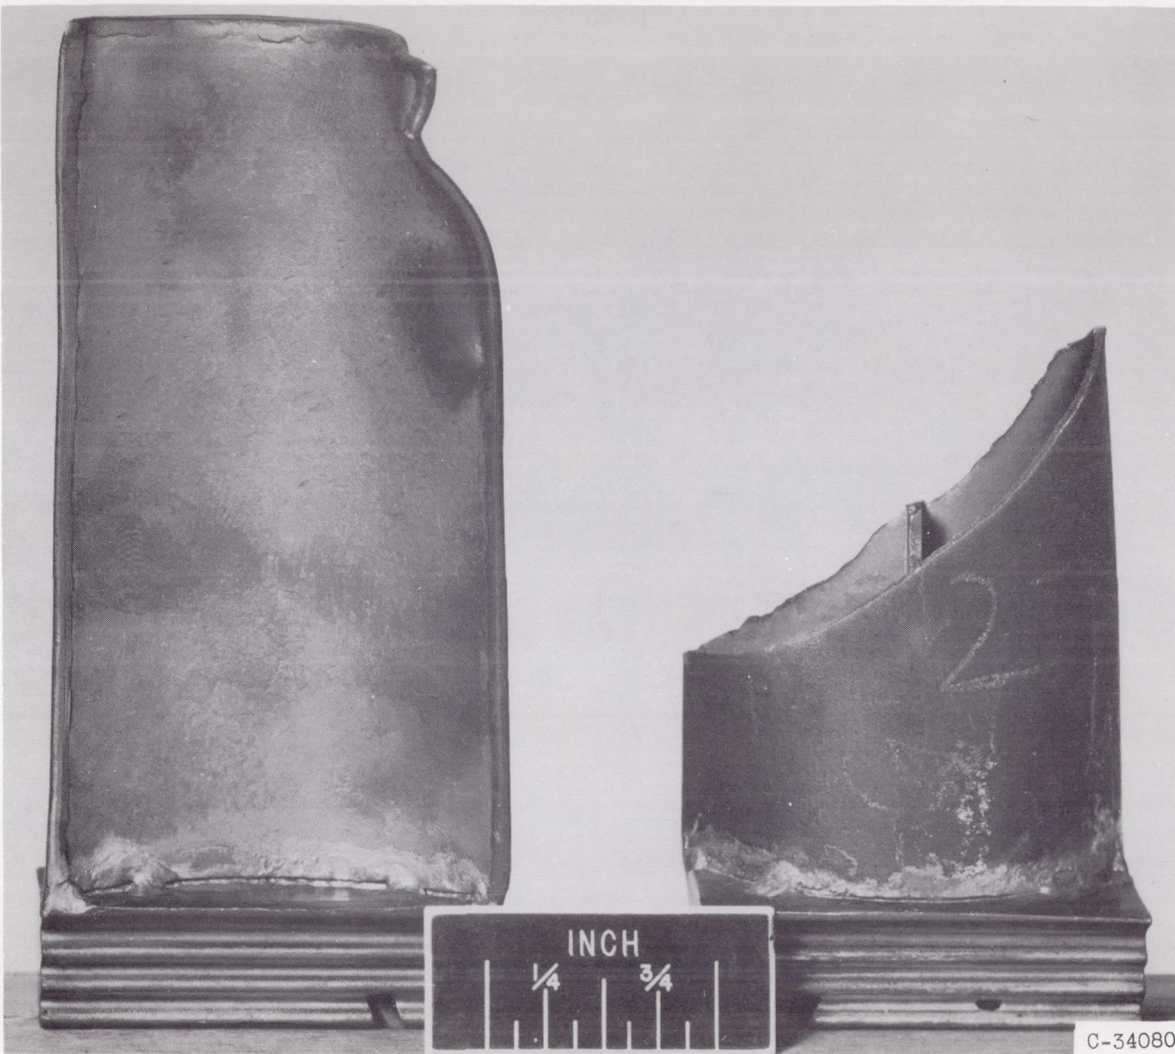
In the initial engine operation of L-605 blades brazed to stub bases, a service life was obtained of 15 hours and 39 minutes. The failure occurred in the central region of the airfoil. Figure 5 shows this blade together with one that had received impact damage.

Figure 5. - Failure of L-605 airfoil (0.030-in. wall thickness) and similar blade with impact damage.

The construction of the blades was altered slightly for the remainder of the investigation. The stub bases were reduced to 0.13 inch in height, and the vibration damper was abandoned. Examination of previous failures indicated that the damper was not operating effectively.
