RESEARCH MEMORANDUM

ADHESIVE AND PROTECTIVE CHARACTERISTICS OF CERAMIC
COATING A-417 AND ITS EFFECT ON ENGINE LIFE OF FORGED
REFRACTALOY-26 (AMS 5760) AND CAST STELLITE 21

(AMS 5385) TURBINE BLADES

By Floyd B. Garrett and Charles A. Gyorgak

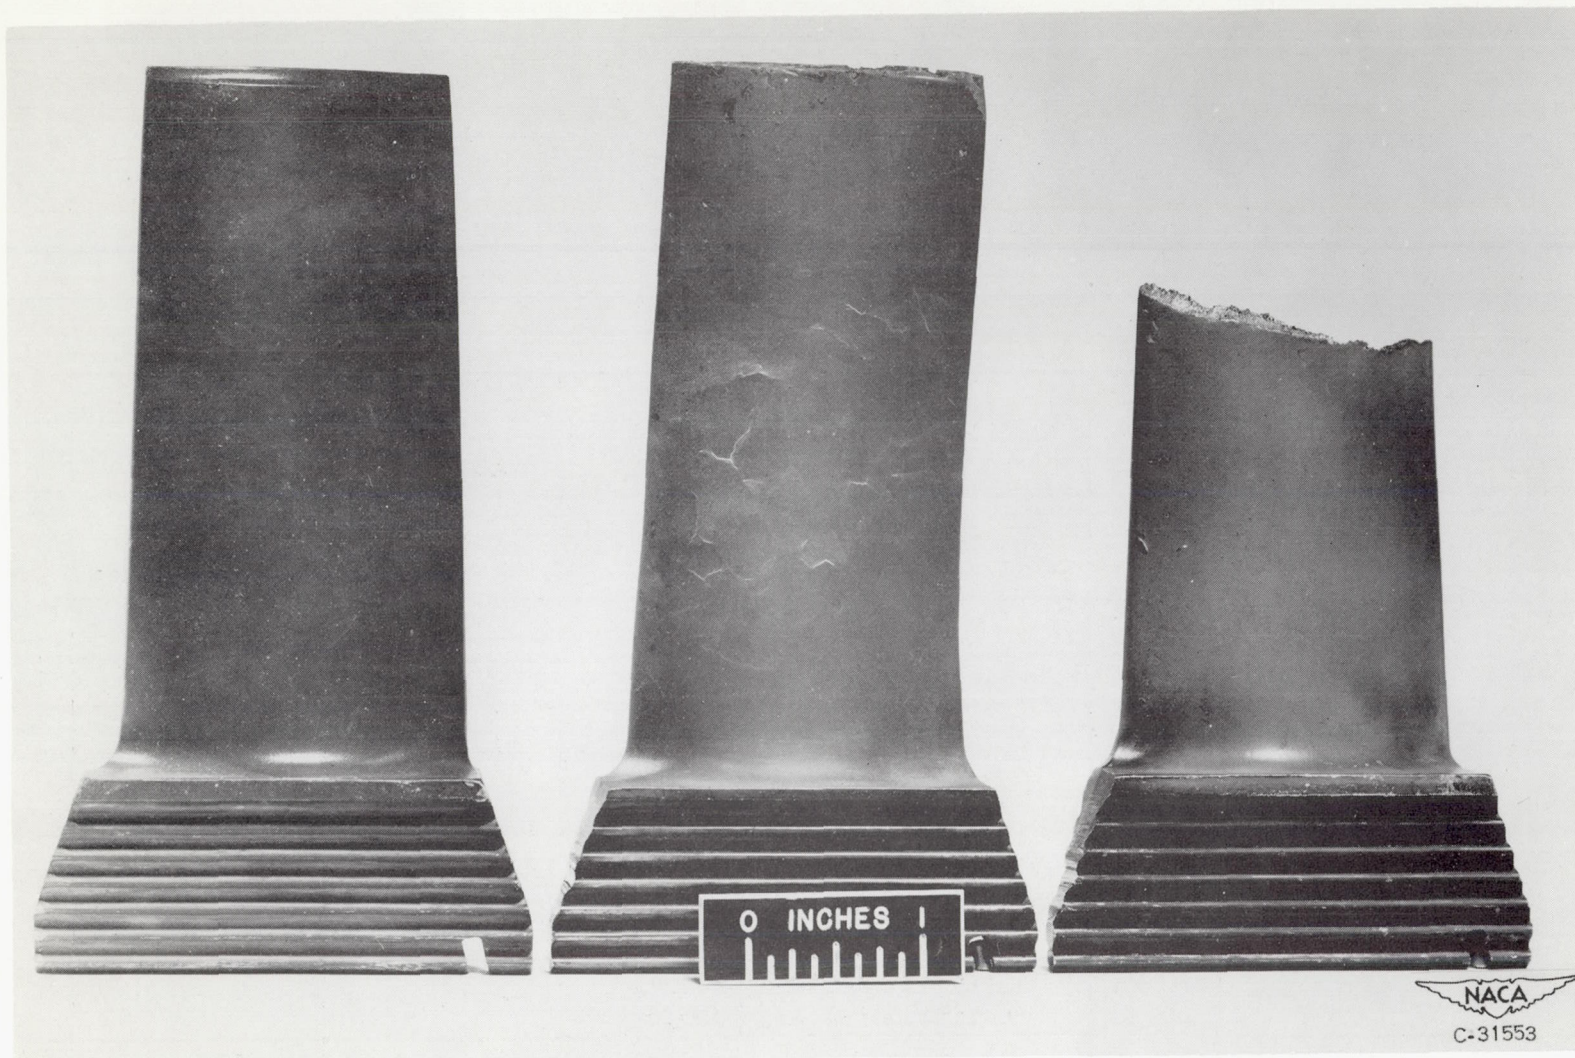
Figure 1. - Comparison of ceramic coated blades.

Appearance of blades. - Appearances of typical coated blades before and after operation are shown in figure 1. The blade in figure 1(a) is representative of as-coated blades. The coating is continuous over the airfoil surface and has a characteristic chromic oxide green color with a vitreous sheen. During operation, the sheen is removed and the color is lightened by the action of the hot gases. The blade of figure 1(b), Stellite 21, and the blade of figure 1(c), Refractaloy 26, are typical blade failures. Stress-rupture cracking of the Stellite 21 blades was not localized to the critical stress and temperature zone (2 in. above the root flat form) but became general over a wide area, giving an "orange peel" effect. Numerous grain boundaries were opened with a consequent shifting of some grains. This mass movement of metal broke the continuity of the coating, as would be expected, but the ceramic-to-metal bond remained intact. The Refractaloy 26 blade failed completely by stress rupture. The spalling of the ceramic coat noted in the center and right-hand blades was caused by fragments of prior failures impinging

on these blades. Macroscopic examination of the coated blades showed that the damage to the ceramic coating by impinging fragments was slight.

(a) As coated; unoperated.

(b) Coated Stellite 21; failed by cracking after 99.7 hours.

(c) Coated Refractaloy 26; failed by rupturing after 99.7 hours.

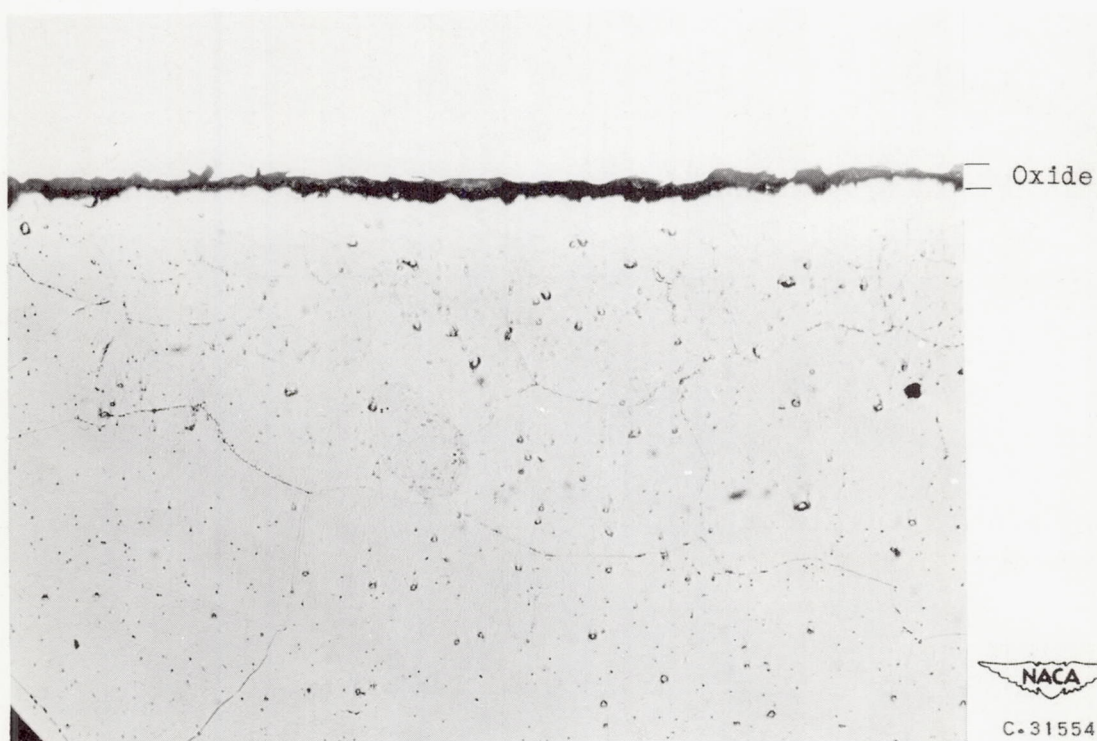
Examination of uncoated blades. - A typical oxide coating produced by solution treating and aging Refractaloy 26 is shown in the photomicrograph of figure 3. The oxide layer was approximately 0.00025 inch thick, and penetration of the grain boundaries of the recrystallized zone was observed although it is not apparent in the photomicrograph. Excessive grain-boundary corrosion of uncoated Refractaloy 26 blades operated for 106 and 143 hours is shown in figure 4. Severe corrosion of this type would be expected to lead to short operational life. However, as has been noted, failure times of coated and uncoated blades are practically the same.

Figure 3. - Oxidation of Refractaloy 26 during heat treatment. Electrolytically etched in 50-percent hydrochloric acid. X250.

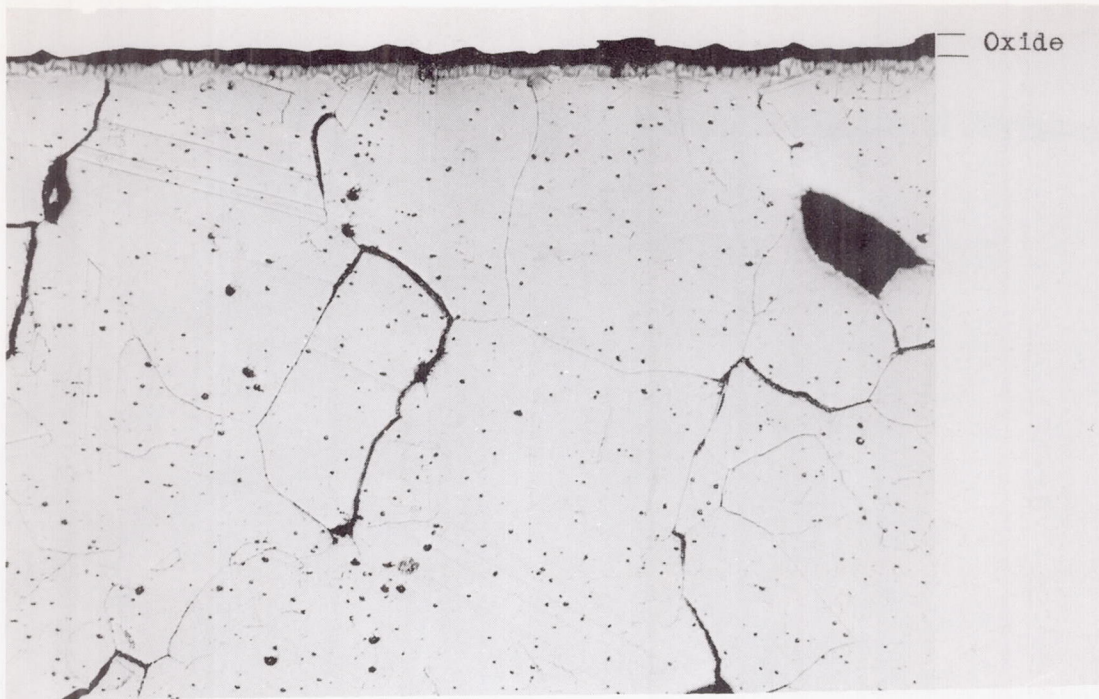
(a) Fired twice; operated 106.4 hours. Electrolytically etched in 50-percent hydrochloric acid. X100.

Figure 4. - Extensive grain boundary corrosion of uncoated Refractaloy 26 operated in a turbojet engine.

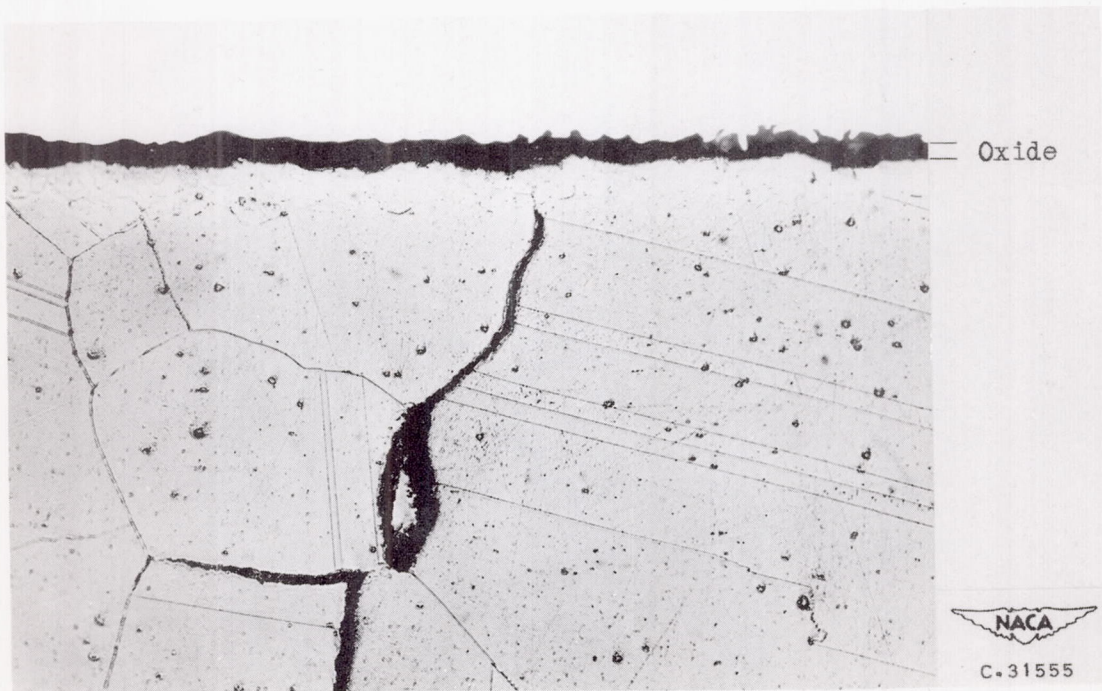
(b) Same specimen as in figure 4(a) at X250.

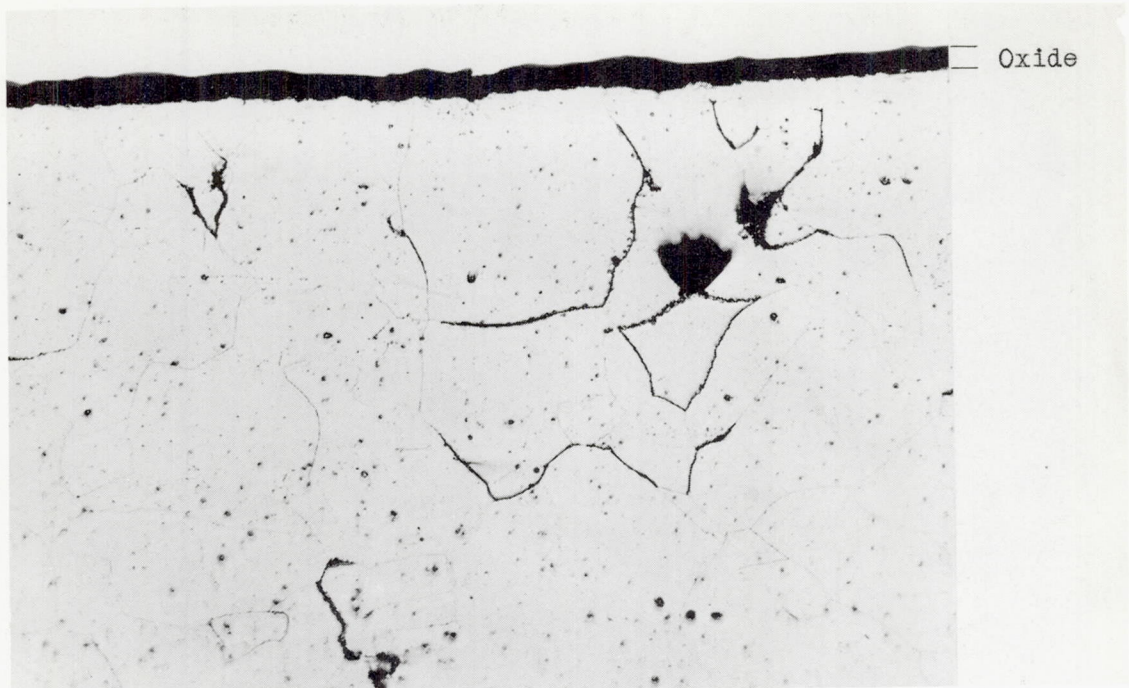
(c) Fired once; operated 142.9 hours. Electrolytically etched in 50 percent hydrochloric acid. X100.

Figure 4. - Concluded. Extensive grain boundary corrosion of uncoated Refractaloy 26 operated in a turbojet engine.

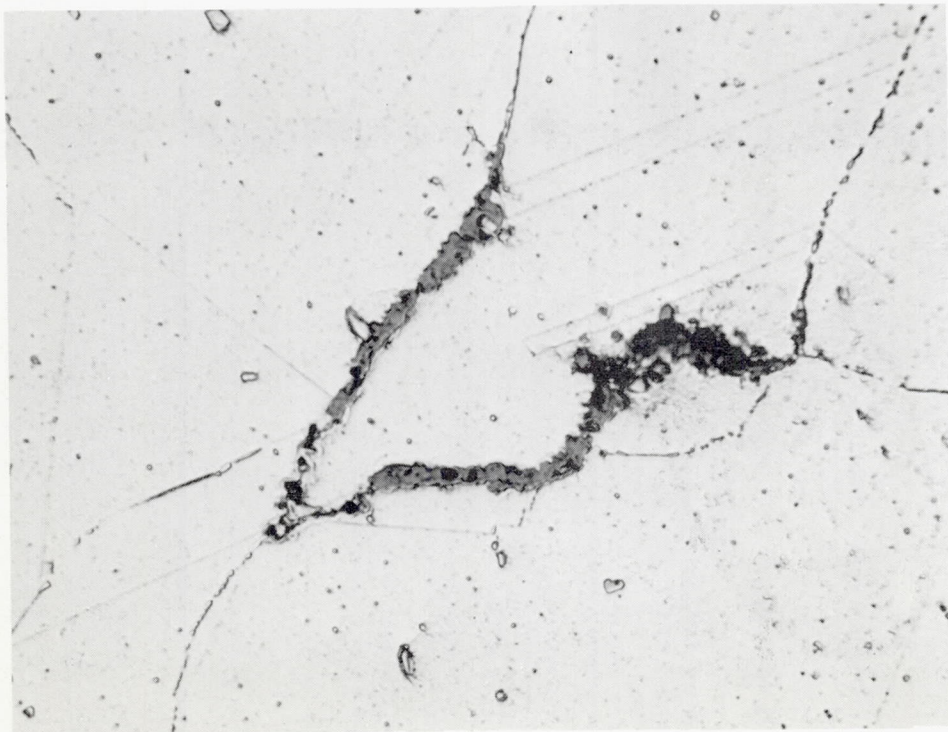
(d) Same specimen as in figure 4(c) at X750.

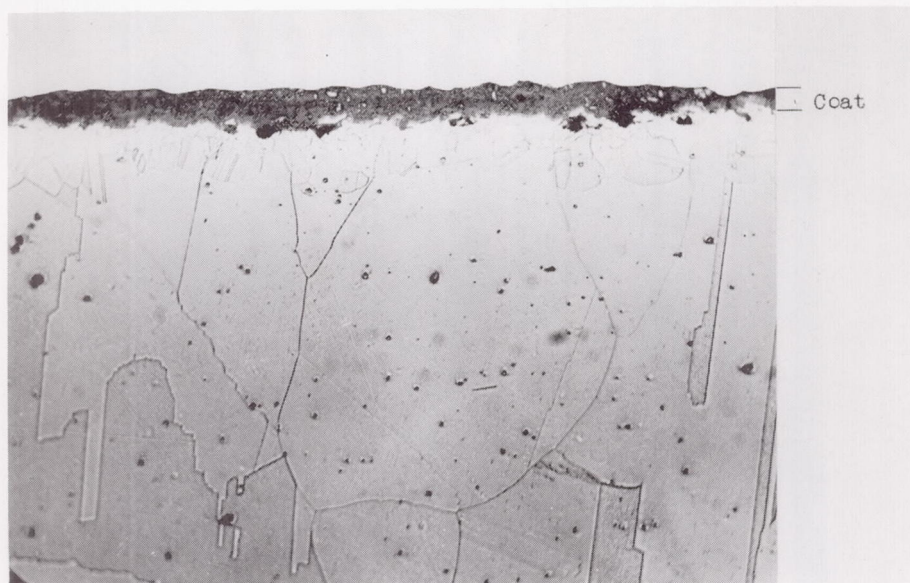
Examination of coated blades. - Metallographic examinations of specimens cut from portions of operated blades that did not elongate severely showed that the ceramic coating prevented corrosion and adhered well to the surfaces of the metal (fig. 5). Some of these sections, which were protected from corrosion, were obtained from the immediate vicinity of the fractures, in the hottest, most critically stressed zones of the blades. In other specimens, in areas near the fractures, corrosion was observed, but the fracturing of the ceramic that permitted this corrosion almost certainly occurred after the blade alloy entered third-stage creep.

(a) Fired once; unoperated. Electrolytically etched in 50-percent hydrochloric acid.

Figure 5. - Ceramic-metal interfaces of coated Refractaloy 26 before and after operation in a turbojet engine. Photographed at X250; reduced 23 percent in reproduction.

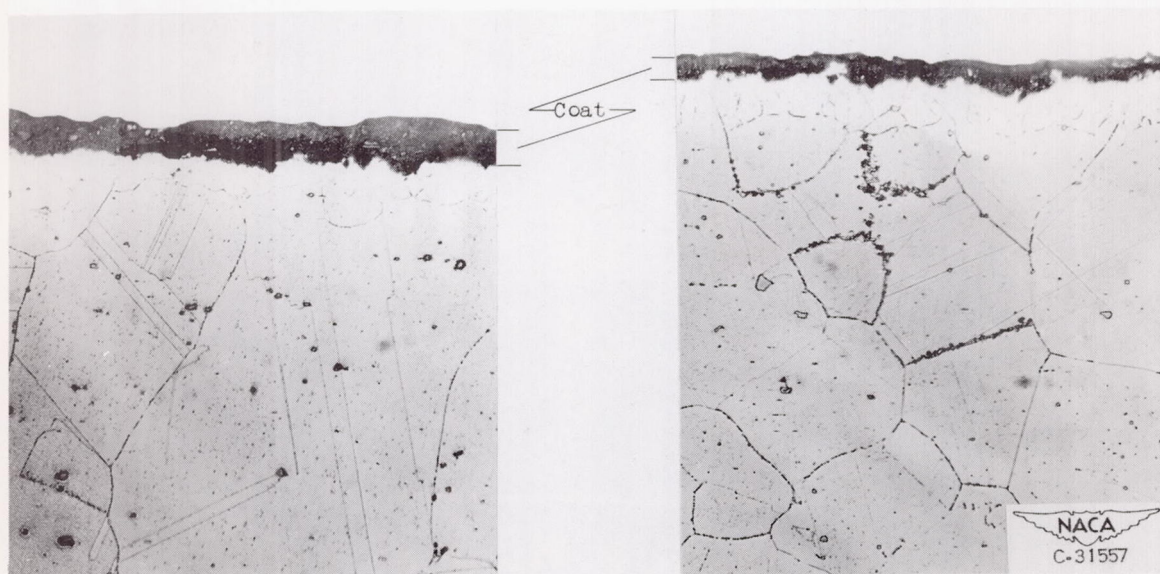
(b) Fired once; operated 99.2 hours. Electrolytically etched in 50 percent hydrochloric acid.

(c) Fired twice; operated 149.5 hours. Extensive precipitation in grain boundaries. Electrolytically etched in 50-percent hydrochloric acid.

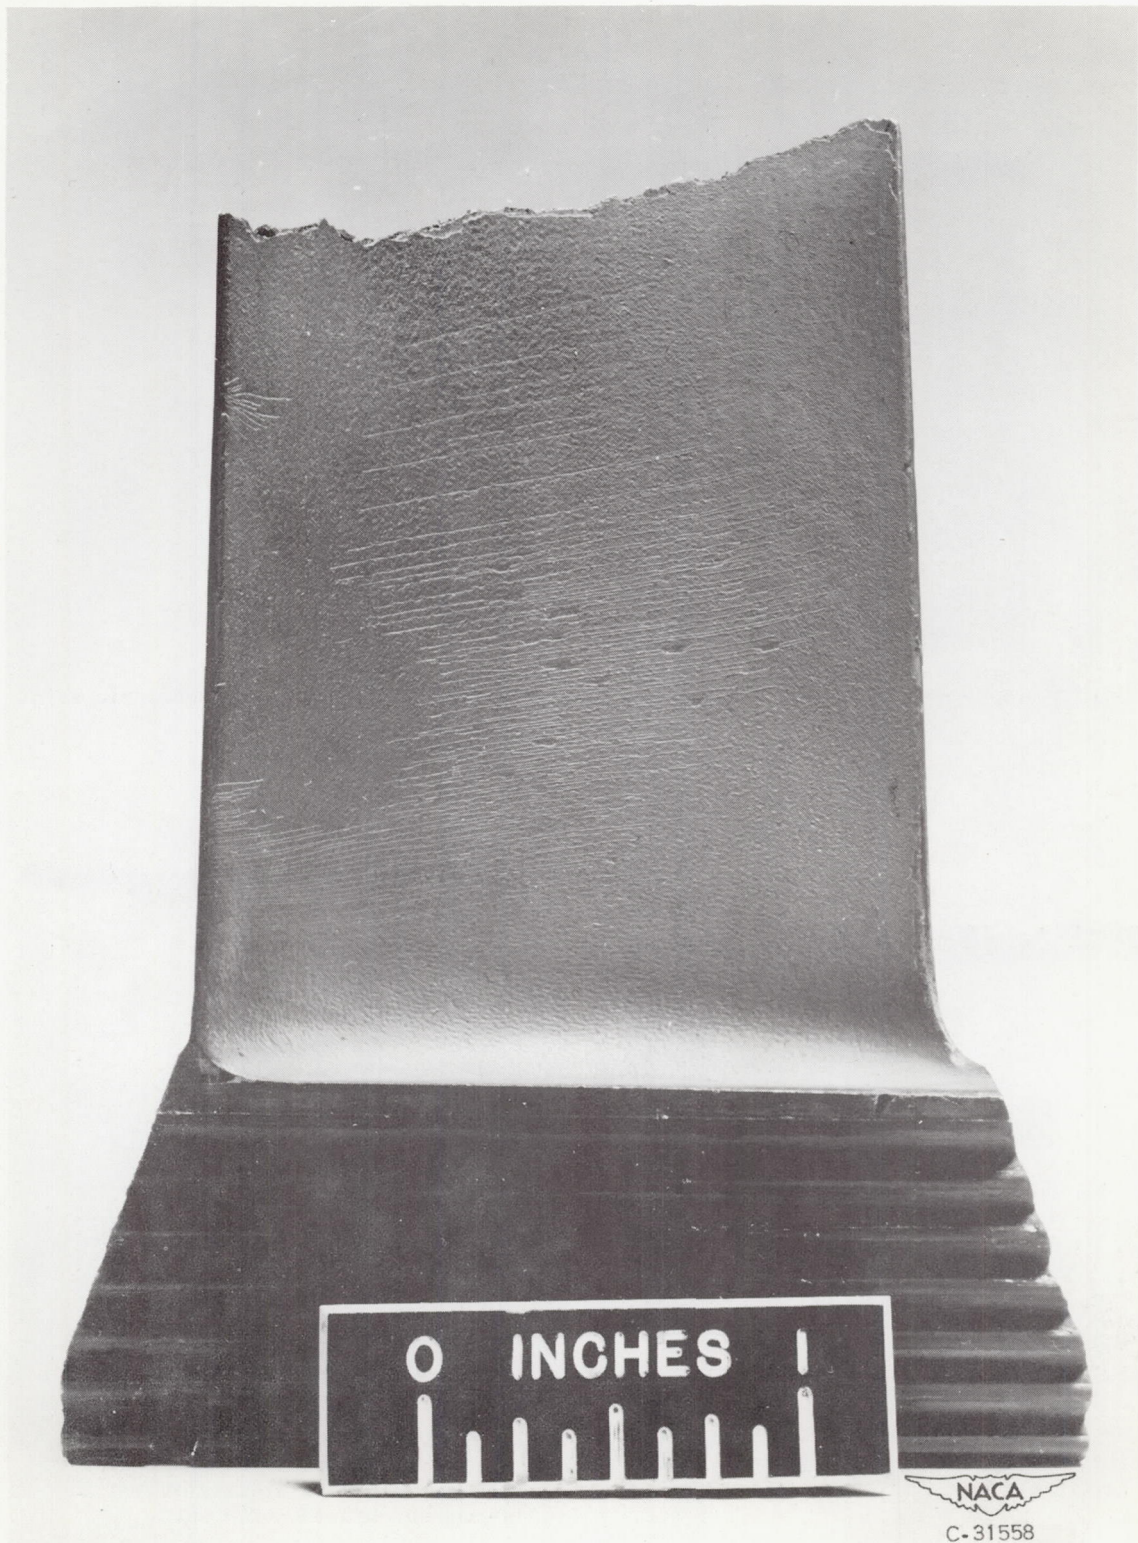
Three of the four blades which had a coat thickness of 1.0 to 2.0 mils developed striations on the concave face during operation (see fig. 6). The striae probably formed in these thick coatings during cooling at shut downs of the engine, which produced an elastic recovery of the base metal.

The ceramic is believed to have flowed plastically as the metal elongated both plastically and elastically during heating. On cooling, the metal recovers by a greater amount than the ceramic. To relieve the compressive stresses, ridges are built up on the outer surface by plastic movement of the coating. This analysis is substantiated by an examination of a cross section of the striae. Photomicrographs of this section (fig. 7) show a ridge and valley on the coat surface, but no visible change occurs to the ceramic-metal interface.

Figure 6. - Striations present in thick coating (1.0 to 2.0 mil) on Refractaloy 26 after 153.6 hours of engine operation.

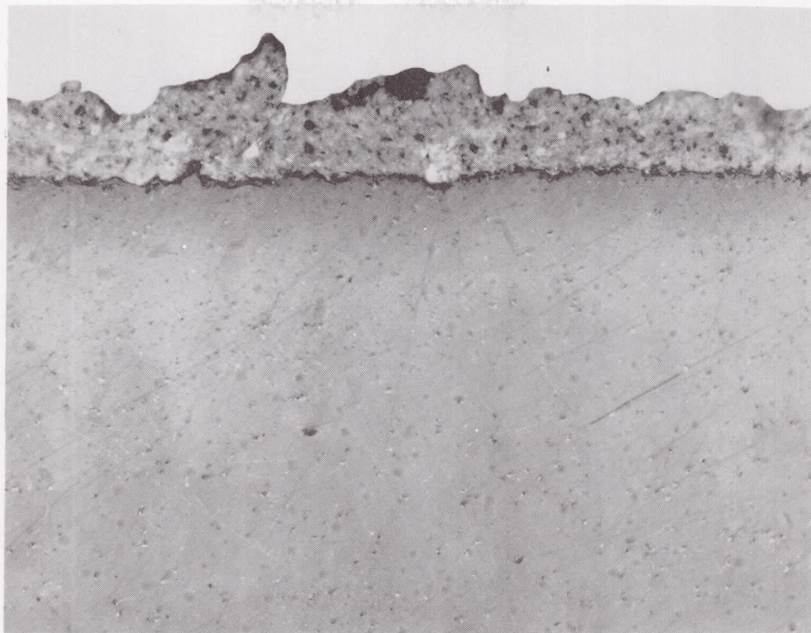
(a) Unetched. X100. Polarized light.

Figure 7. - Ridges produced in thick ceramic coating on Refractaloy 26 during engine operation.

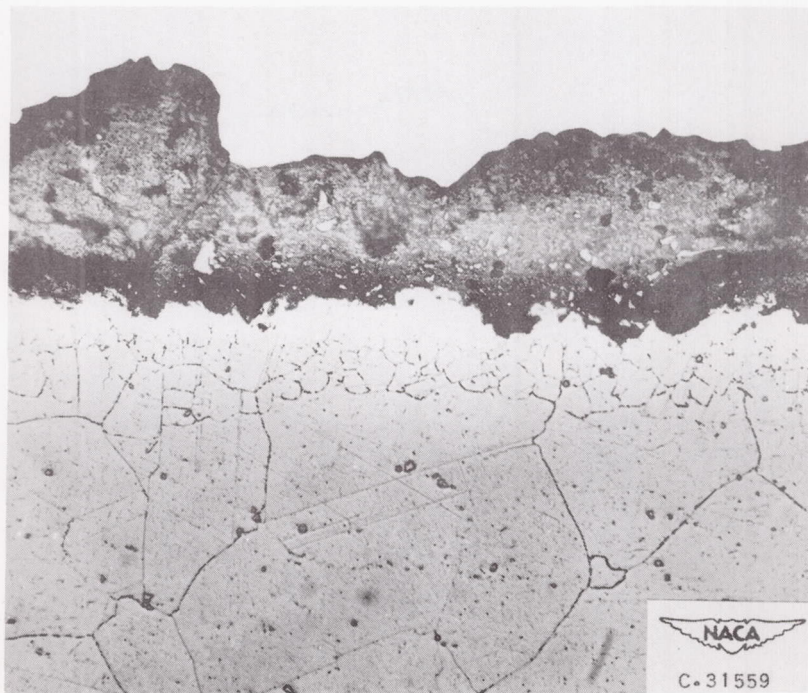
A layer of recrystallized grains was observed at the surfaces of the Refractaloy 26 blade airfoils and is believed to have resulted from surface working followed by heat treatment.

(b) Same specimens above electrolytically etched in 50-percent hydrochloric acid. X250.
Recrystallization zone produced during heat treatments.

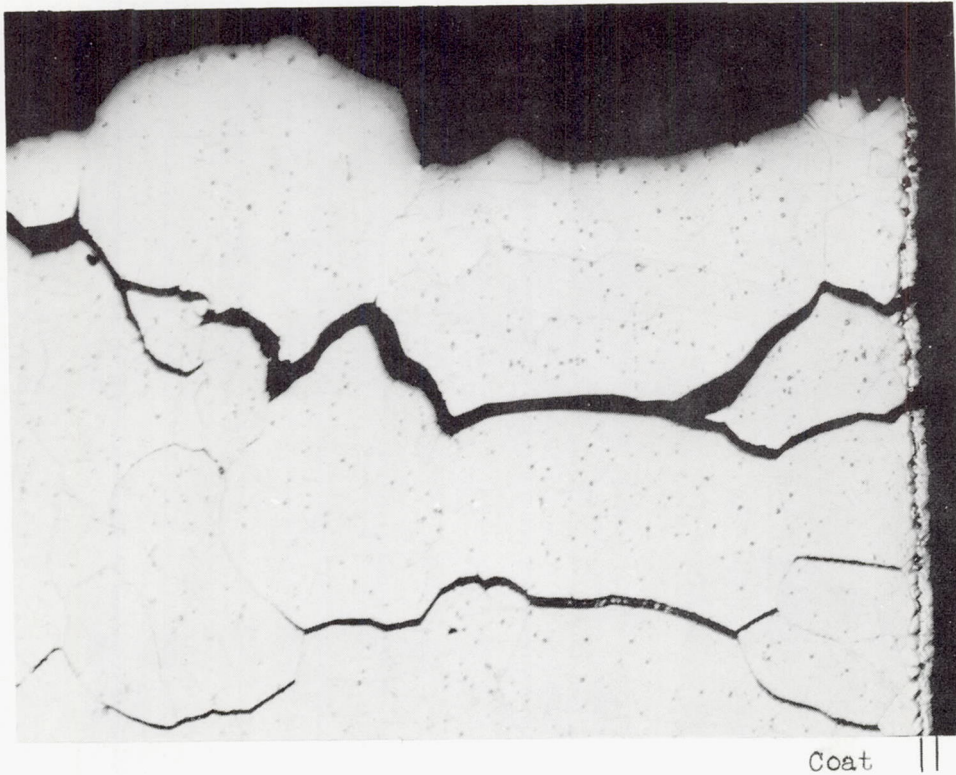
The failure zone shown in figure 8 (coated Refractaloy 26) is typical of all failures in this alloy. The mode of failure is stress-rupture which propagates intergranularly. Oxidation of the grain boundaries occurs only after the coating is broken by excessive elongation (stress-rupture).

Figure 8. - Typical intercrystalline failure in coated Refractaloy 26 occurring during operation in a turbojet engine. Electrolytically etched 50-percent hydrochloric acid. X100.

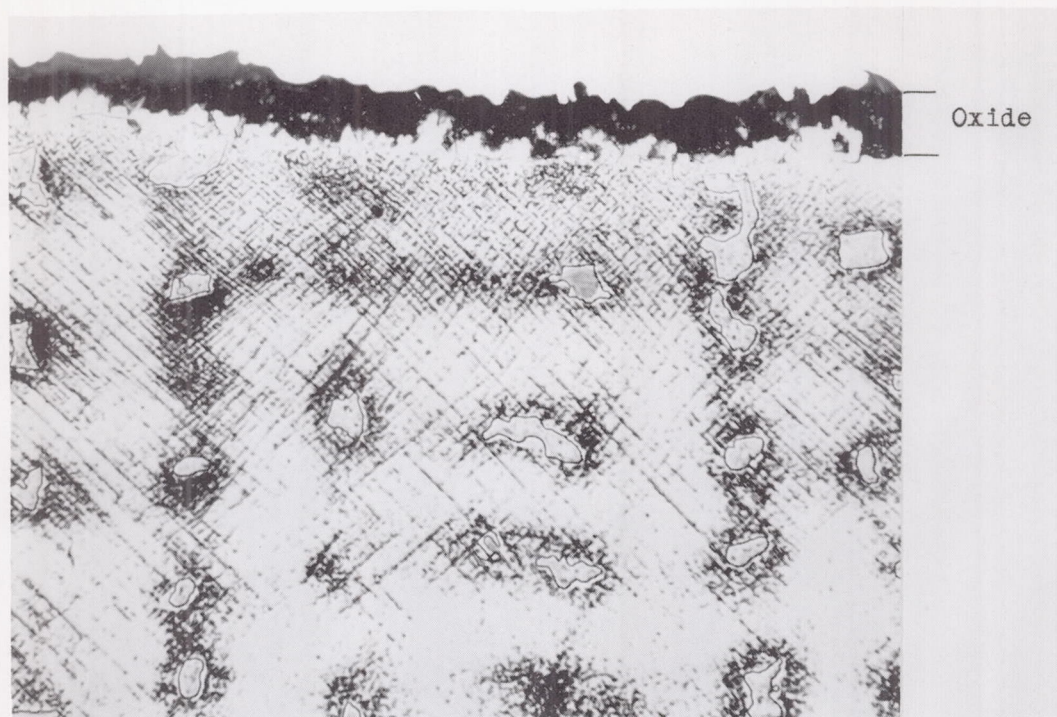
Examination of uncoated and as-cast Stellite 21 blades. - A thin oxide layer (approximately 0.0003 in.) was produced on all unprotected Stellite 21 blades by the hot gases (fig. 9(a)) and slight oxide penetration of the grain boundaries occurred (although infrequently) during engine operation.

(a) Uncoated; fired once; operated 66.5 hours. Electrolytically etched in 5-percent aqua regia. X750.

Figure 9. - Comparison of uncoated and coated Stellite 21 after engine operation.

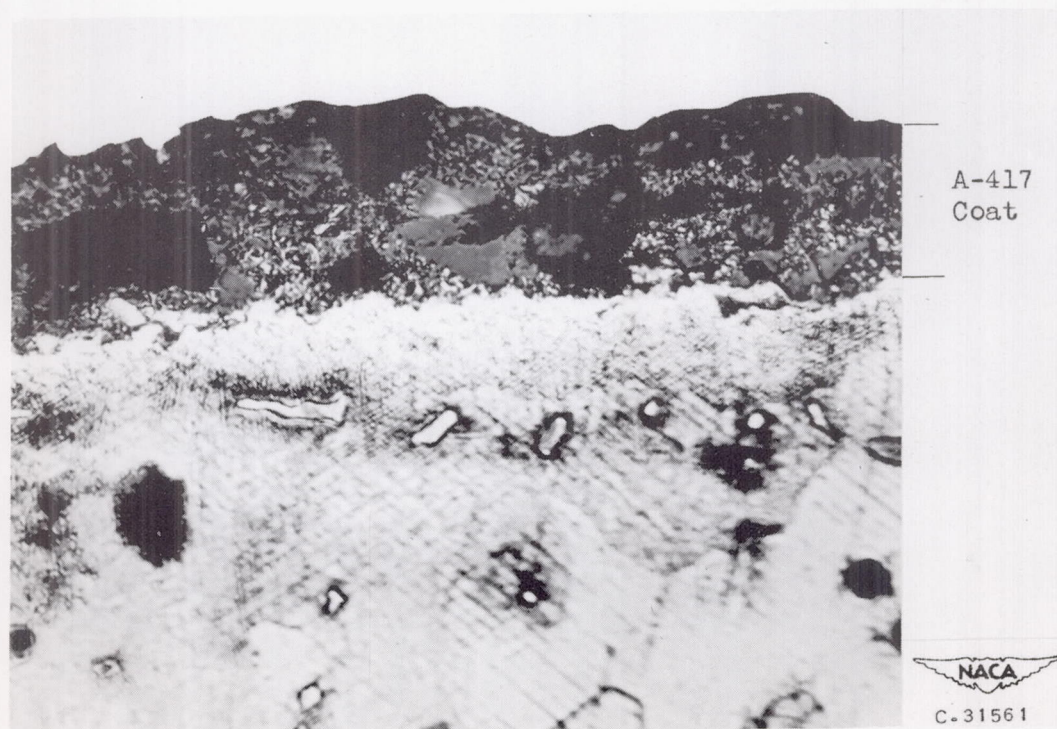
Examination of coated Stellite 21 blades. - Metallographic examinations of operated blades showed that the adherence of the A-417 coating to Stellite 21 was excellent. No oxide penetration of the coating was detected on any of the coated blades. A typical coating-to-metal interface is shown in figure 9(b).

(b) Coated; fired once; operated 73.6 hours. Electrolytically etched in 5-percent aqua regia. X750.
