RESEARCH MEMORANDUM

RESULTS OF TURBOJET ENGINE OPERATION TESTS USING
A 50-50 MIXTURE OF JP-4 AND TRIBUTYL BORATE
AS THE FUEL

Lewis Flight Propulsion Laboratory
Cleveland, Ohio

January 16, 1957
Declassified October 31, 1958

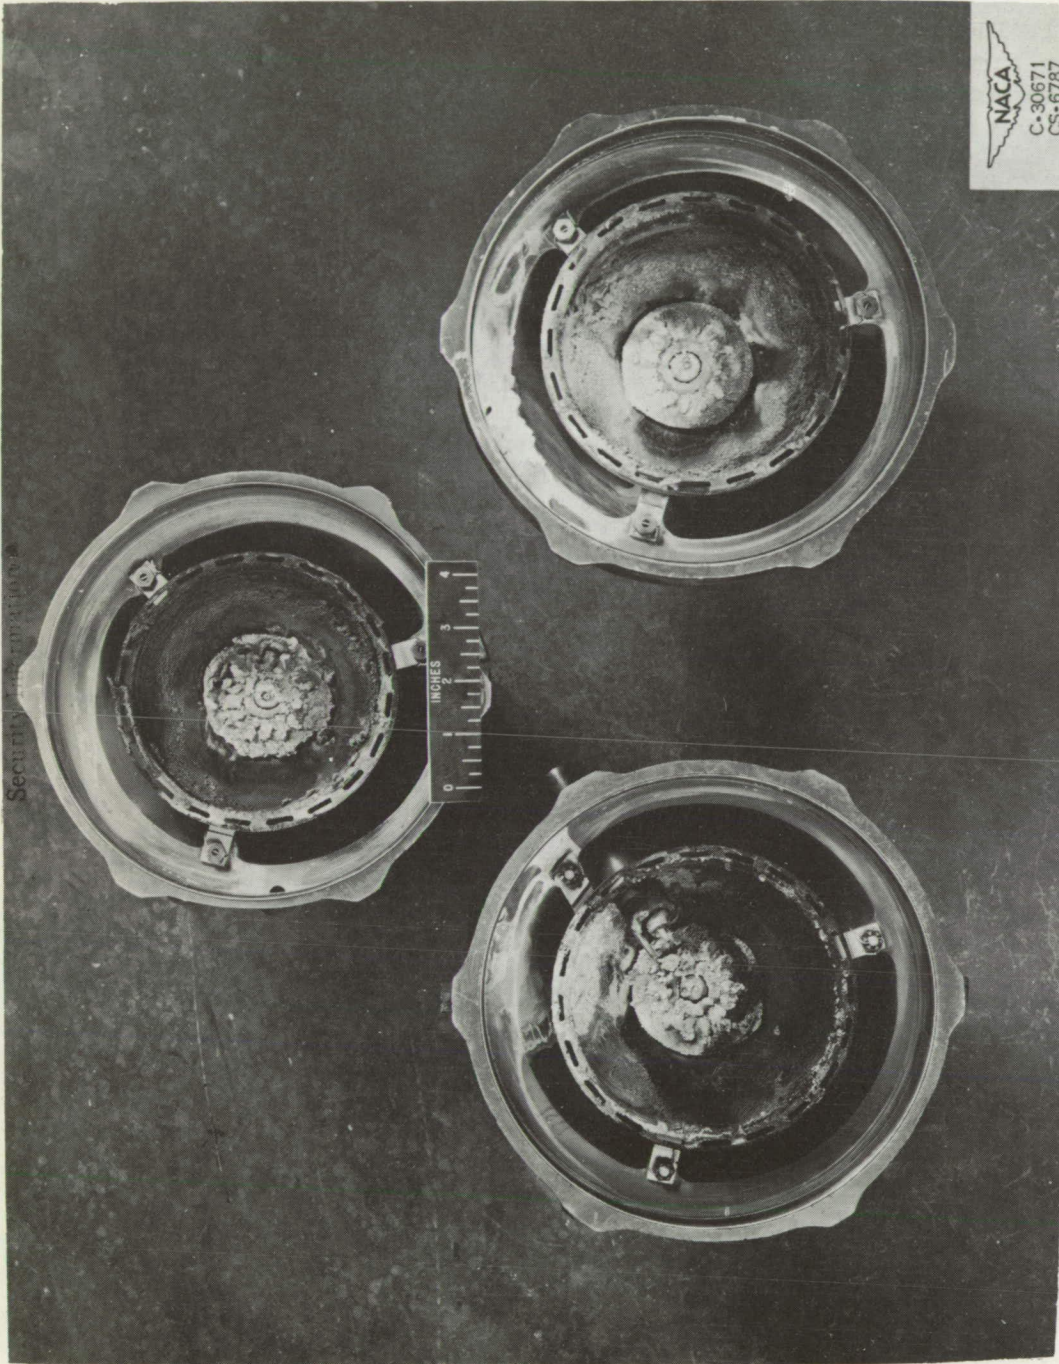
Three fuel nozzles assembled in their burner domes are shown in figure 1. The deposits in these parts were thicker than in any others. The deposits were heaviest on the fuel nozzles and on the air spinner disk which fits around the fuel nozzles. It is conceivable that the deposit on the fuel nozzles could build up to such a degree that it would alter the shape of the cone of the fuel spray and thus reduce the combustion efficiency. Besides having the boric oxide deposit on the outside, several of the fuel nozzles were completely plugged. This was probably a result of the fuel left in the nozzles hydrolyzing after the engine was shut down. This is a characteristic of the high-energy fuels also, and is a disadvantage that must be considered. The build-up of boric oxide on the air spinner disk was very heavy also. The vanes in the spinner were almost completely plugged. This condition did not seem to have any effect on the engine operation. The air adapter containing the spark plug is shown at the lower left corner of figure 1. Some evidence of the deposits was observed on the spark plug electrodes, but they did not close the gap. The spark plug still operated satisfactorily. The coating on the burner dome was not as thick as it was on the other parts shown in figure 1.

1. The greatest accumulation of boric oxide in the engine was found in the burner domes where the air spinners were almost completely plugged and the boric oxide deposits on the fuel nozzles was such as to possibly alter the shape of the fuel spray and decrease the combustion efficiency.

Figure 1. - Build-up of boric oxide deposits on fuel nozzles and burner dome.

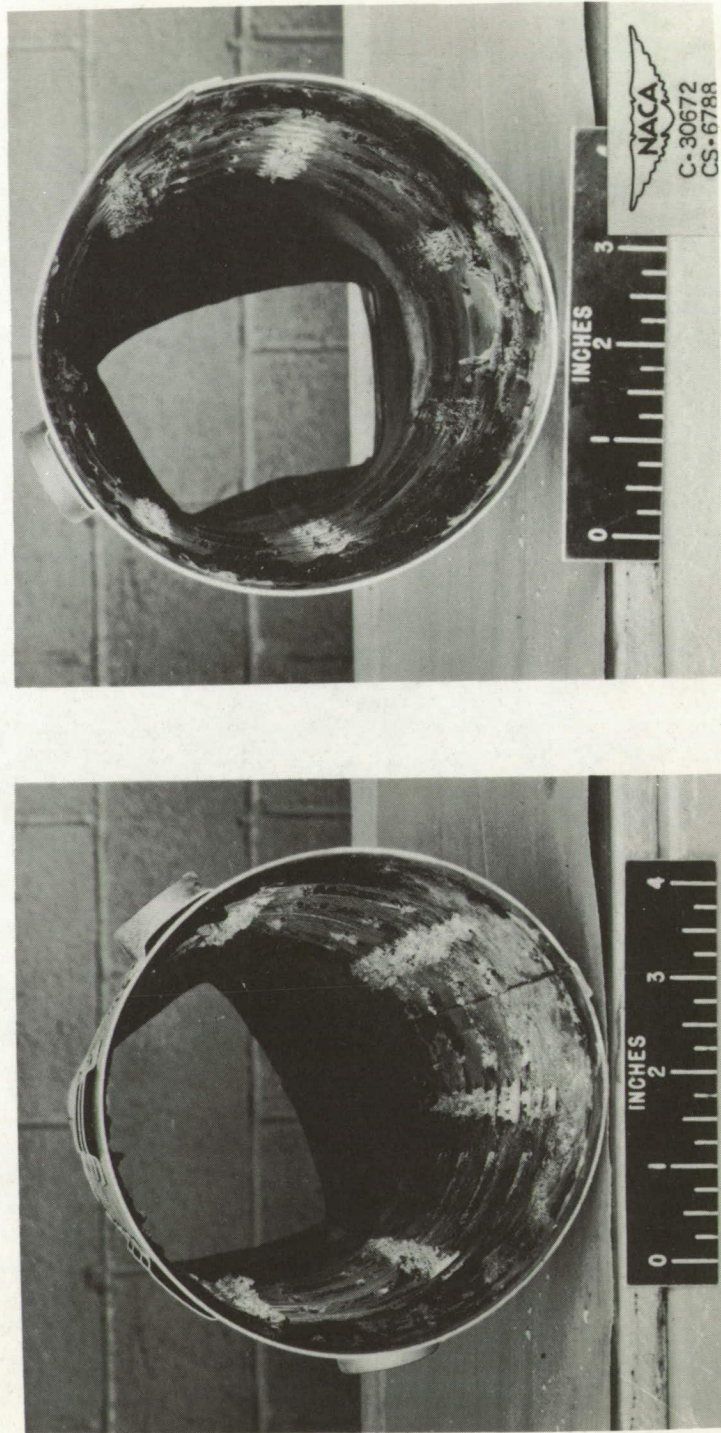
Two of the burner liners are shown in figure 2. These showed a buildup of deposits over small areas just downstream of the air holes in the liners. These deposits were the same type as those that were found in the burner domes and around the fuel nozzles. The rest of the surface of the burner liners had a thin rippled coating of boric oxide. The boric oxide was obviously molten on these surfaces of the liners and was flowing toward the nozzle diaphragm where it built up in clumps at the exit of the burner liners as is shown in figure 3. There was also evidence of molten boric oxide between the outer ring of the nozzle diaphragm and the engine casing shown in figure 3.

Figure 2. - Build-up of deposits on burner liners.

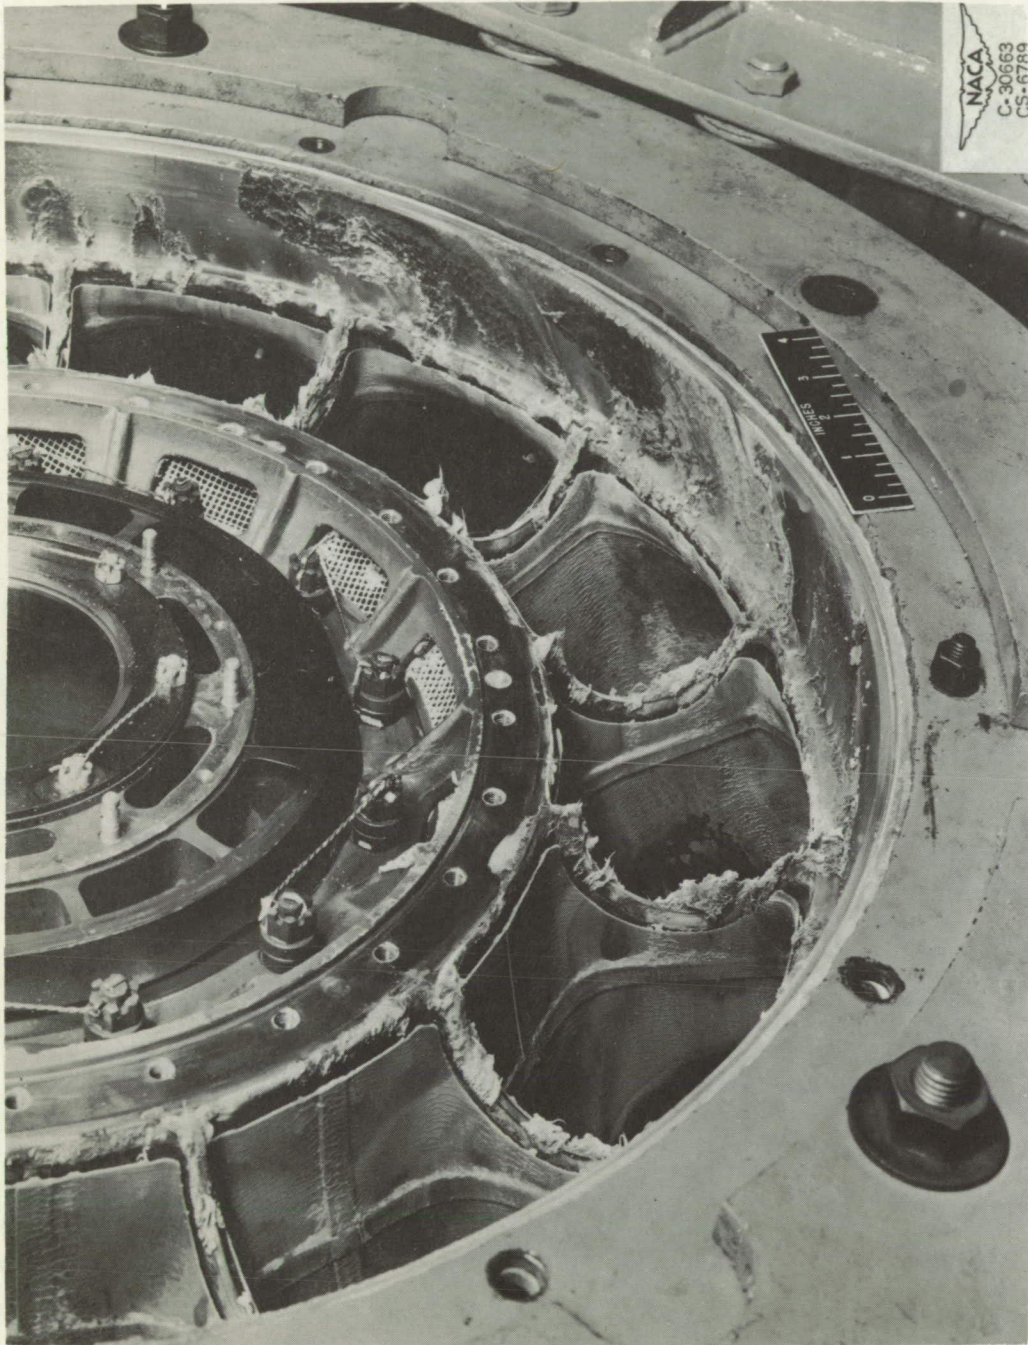
A more serious location of the deposit of a rather powdery formation of boric oxide was on the exit screens for the turbine-disk cooling air. This deposit is also shown in figure 3. There was a partial plugging of some of these screens. If these screens become plugged completely, the cooling air that is supplied to cool the rear engine bearing would be blocked off, and this would result in excessive temperatures of this bearing.

Figure 3. - Build-up of deposits at exit of burners.

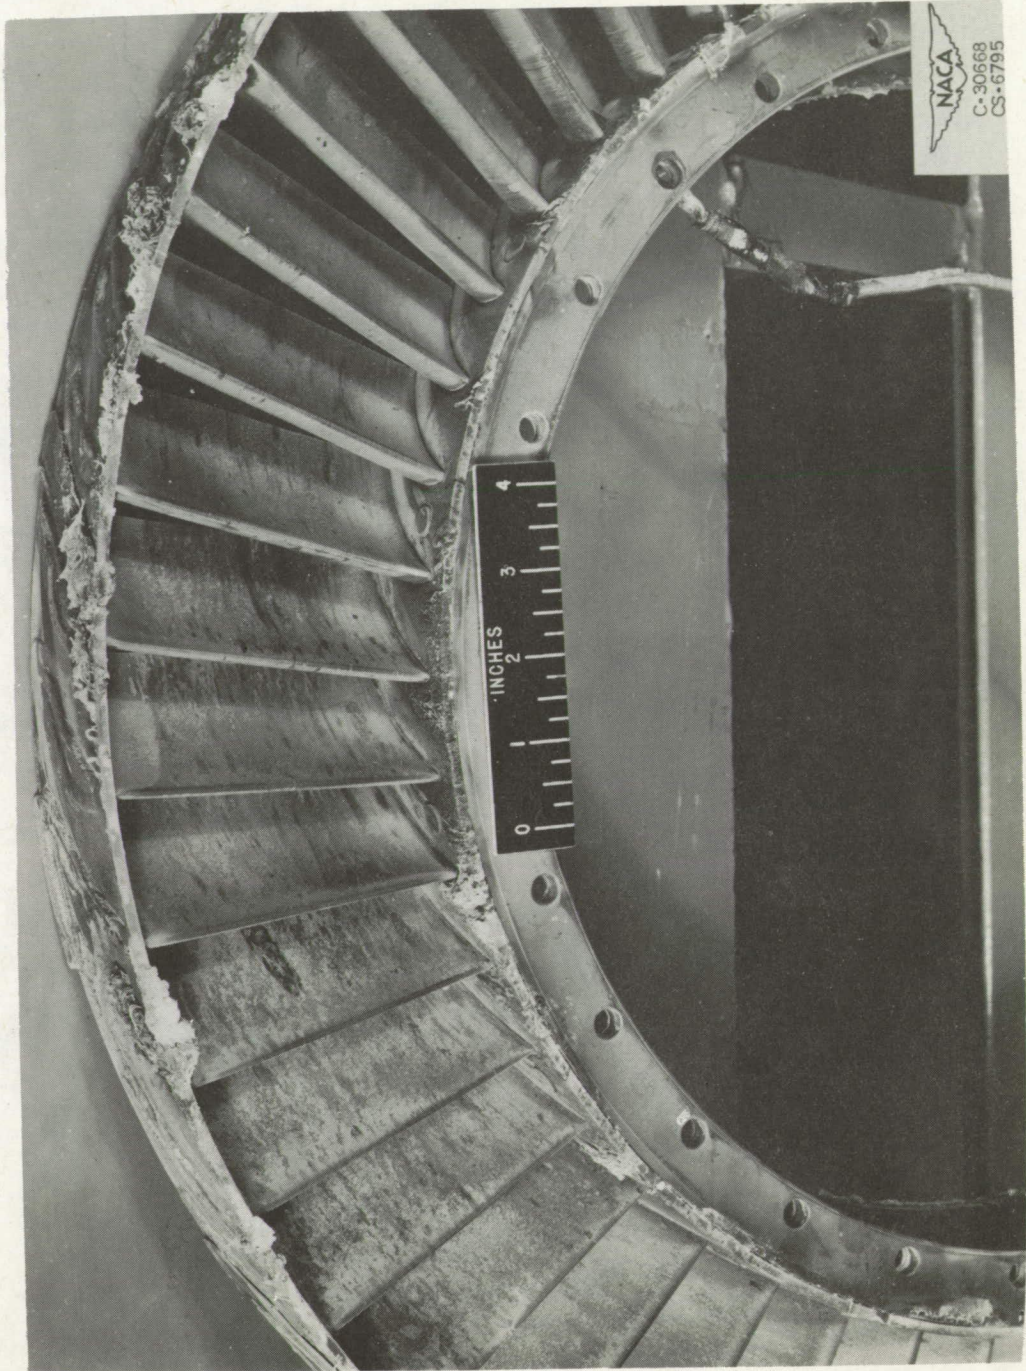
The deposit formations on the upstream and the downstream sides of the nozzle diaphragm are shown in figure 4. The deposits on this part are the molten type of deposit. The deposits on the nozzle blades were insignificant. Most of the deposit was found around the outside of the outer diaphragm ring where it would have no effect on the aerodynamic performance of the nozzles. There was also a coating of the deposit on the gas seal rings between the nozzle diaphragm and the turbine rotor.

(a) Upstream side of diaphragm.

Figure 4. - Build-up of deposits on nozzle diaphragm.

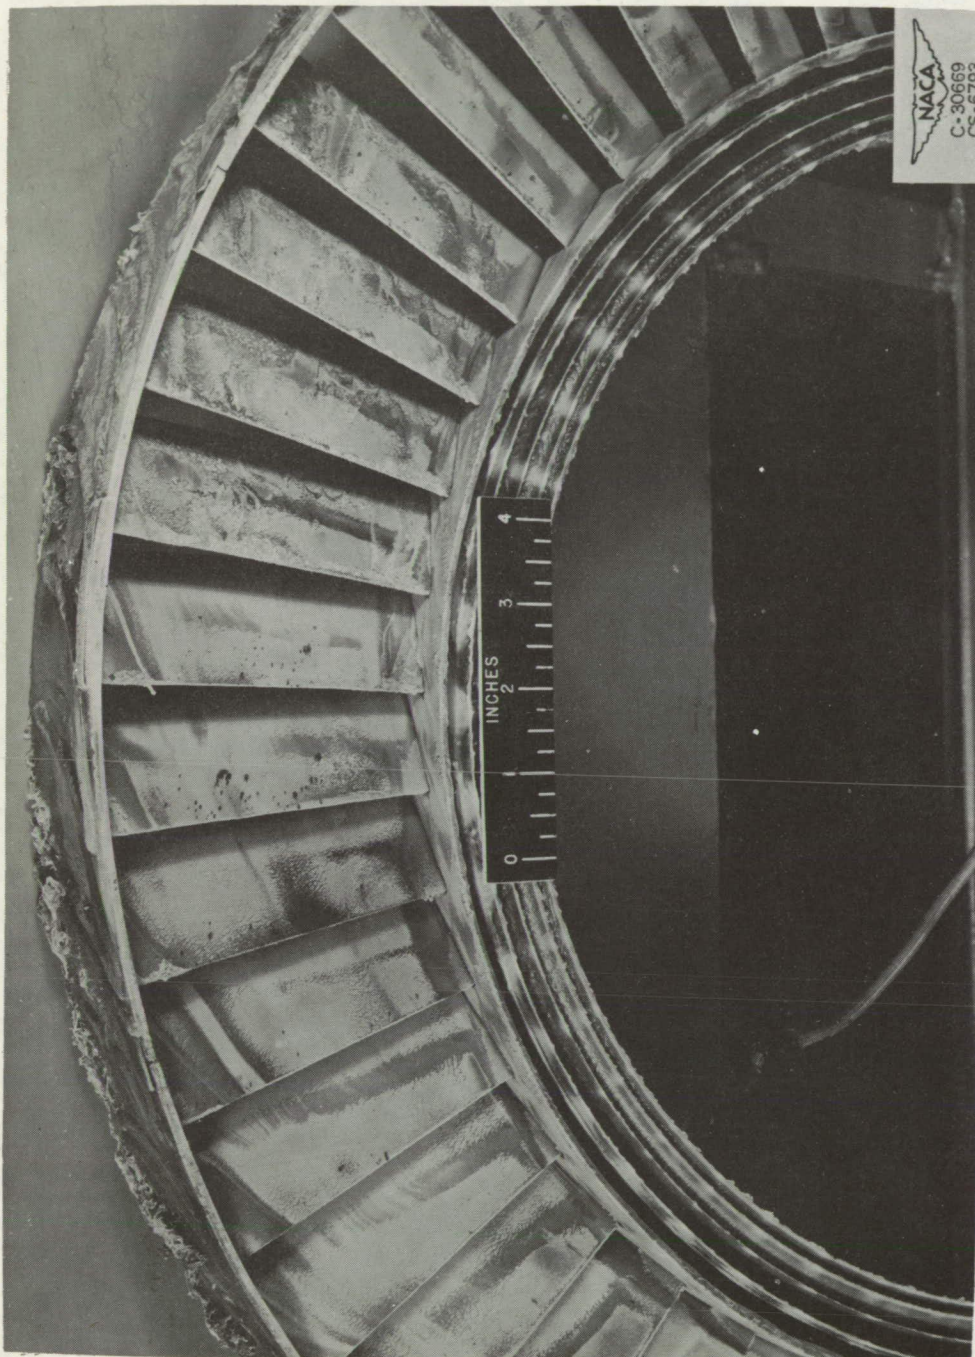
(b) Downstream side of diaphragm.

Figure 4. - Concluded. Build-up of deposits on nozzle diaphragm.

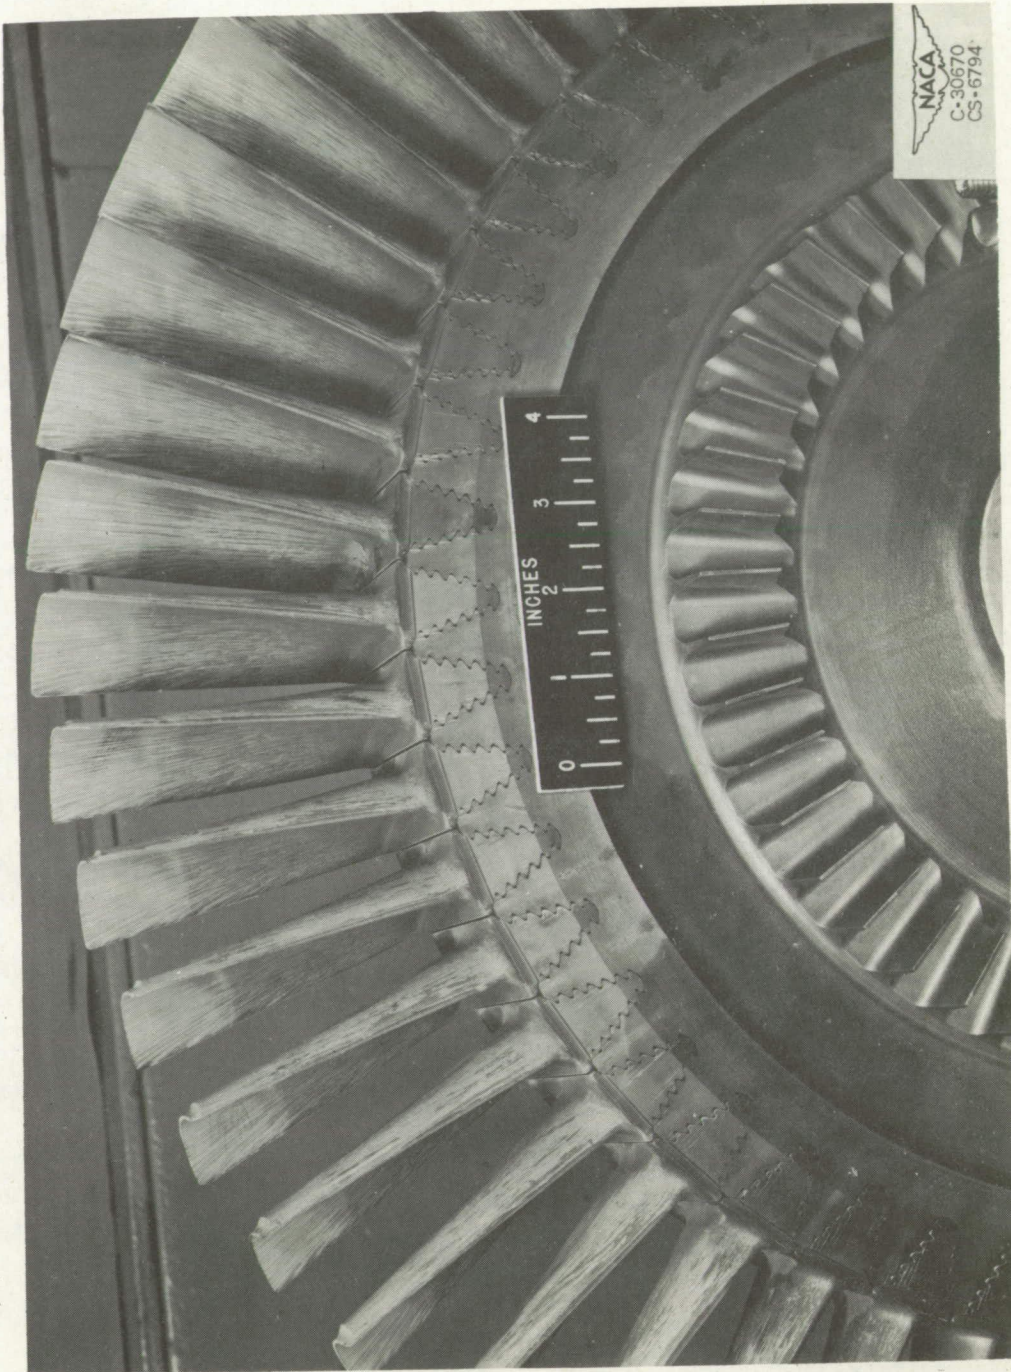
Photographs of the upstream and the downstream side of the turbine rotor are shown in figure 5. The deposits on this part were very thin.

The boric oxide that formed on the blades evidently was thrown off the blade tips. This flow of the deposits along the blade span is borne out by the nearly radial flow lines that can be seen on the blades in figure 5(a). The pressure surface of the rotor blades was covered with the deposits more completely than the suction surface. Only the tip half of the suction surface (fig. 5(b)) showed evidence of any coating. The turbine rotor disk had no coating of boric oxide on the upstream side but the downstream side showed a very thin, uniform coating.

(a) Upstream side of rotor.

Figure 5. - Build-up of deposits on turbine rotor.

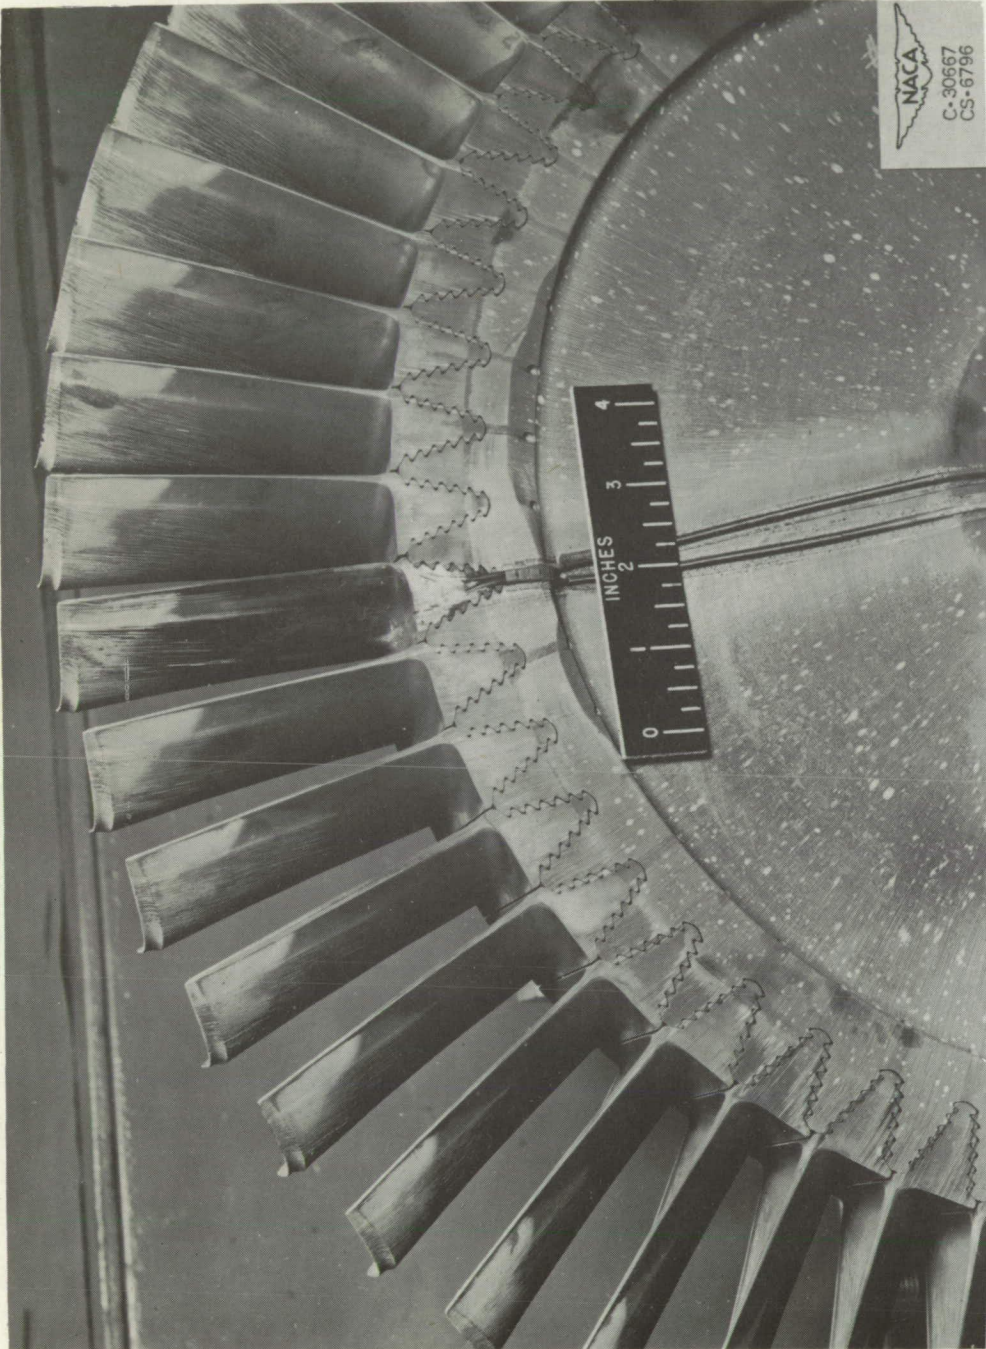
(b) Downstream side of rotor.
Figure 5. - Concluded. Build-up of deposits on turbine rotor.

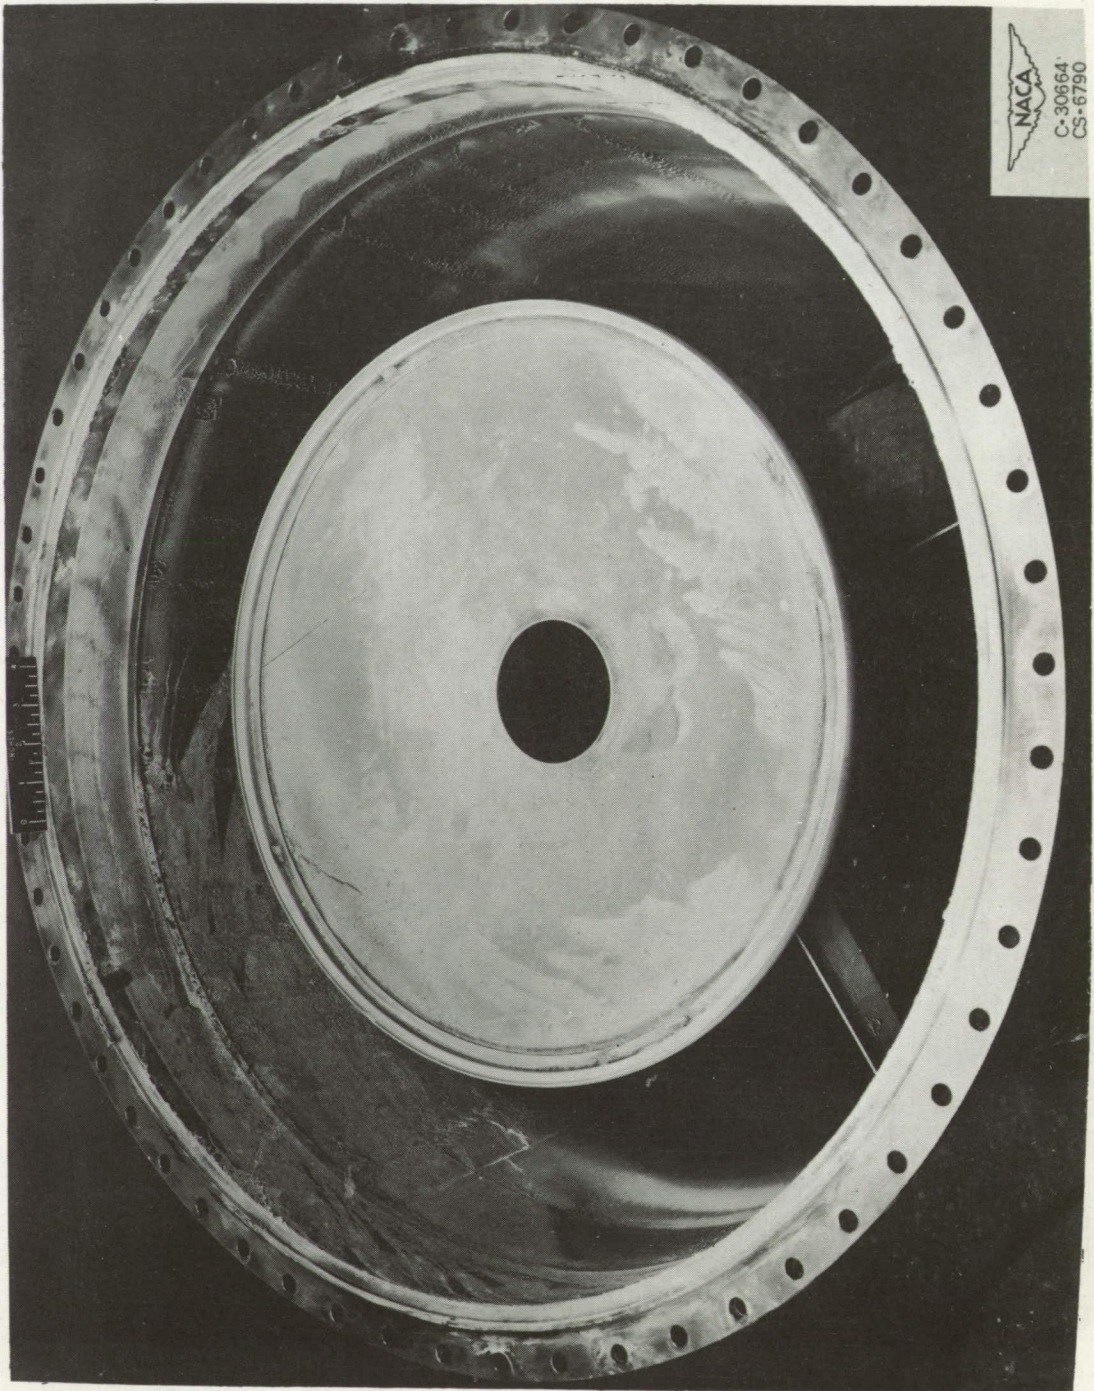
The tail cone (fig. 6) had a thin coating of boric oxide that had been thrown from the tips of the turbine rotor blades and flowed along the inside surface of the outer exhaust cone. Besides these streams of boric oxide there was a uniform thin coating over the entire inner surface of the tail cone.

Figure 6. - Build-up of deposits in exhaust tail cone.

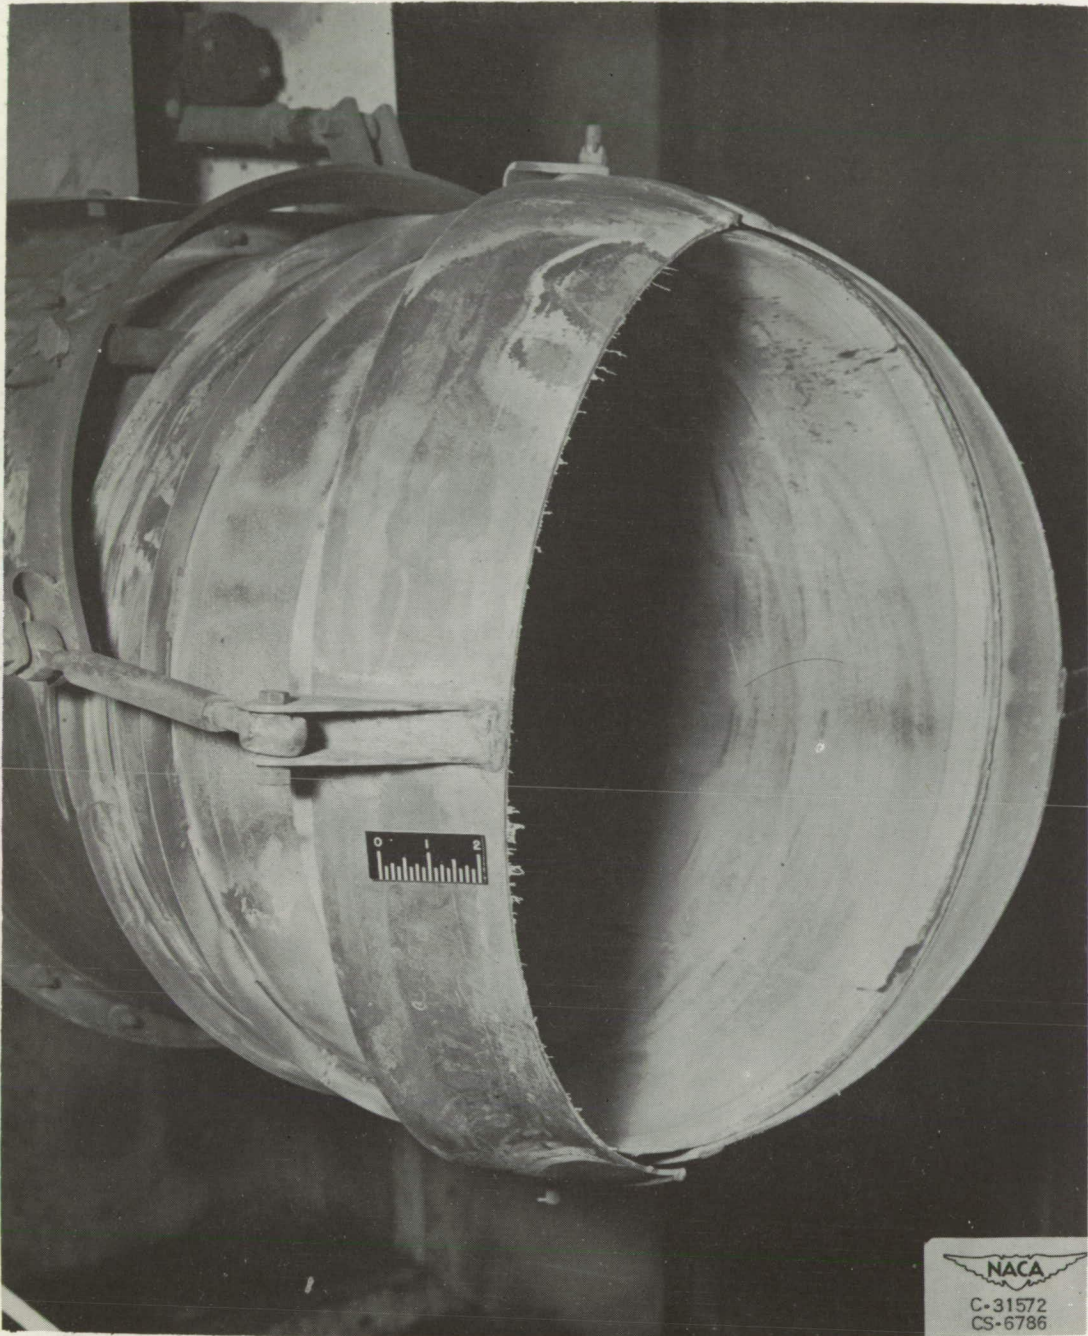
There was a thin coating over the inside surface of the tail pipe and a light fringe of the deposit at the exit of the tail pipe nozzle as shown in figure 7. The exhaust-gas thermocouples that were located in the tail pipe had a thick coating on their downstream side, but the coating did not affect the temperature measurements that were made with them.

Figure 7. - Build-up of deposits on exhaust tail pipe nozzle.
