NACA RM E50C15

EFFECTS OF INLET ICING ON PERFORMANCE OF AXIAL-FLOW
TURBOJET ENGINE IN NATURAL ICING CONDITIONS

By Loren W. Acker and Kenneth S. Kleinknecht

Lewis Flight Propulsion Laboratory
Cleveland, Ohio

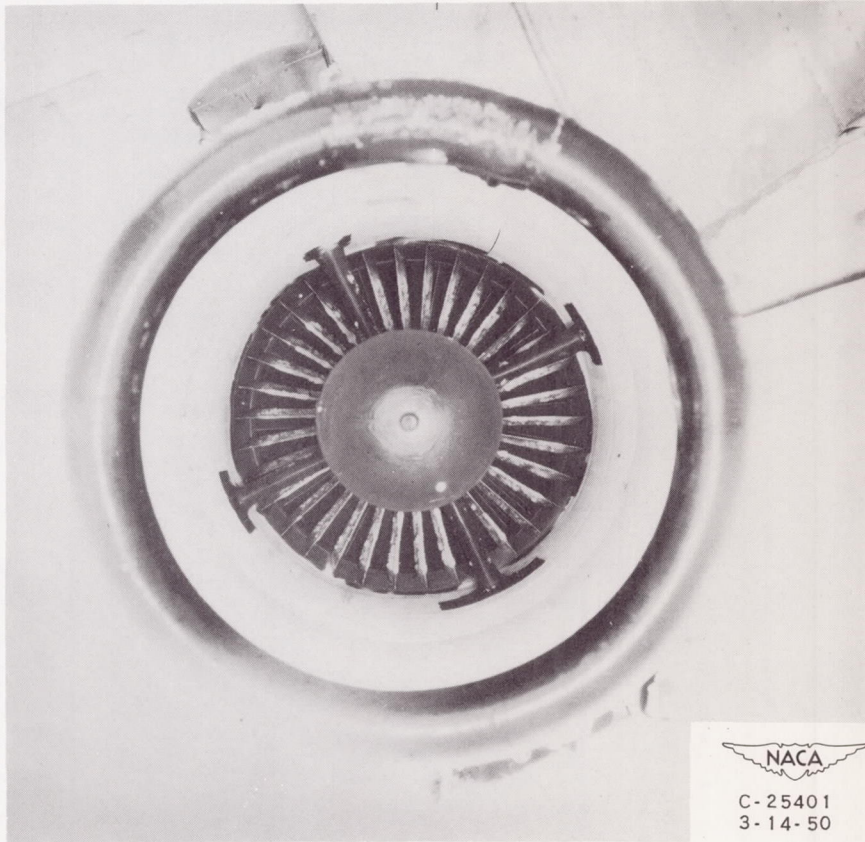
A photograph of the engine inlet, taken approximately 25 minutes after encountering icing during flight 1, is shown in figure 5. A very light ice formation is shown on the guide vanes and no ice is visible on the first stages of the compressor stator blades. Other parts of the engine inlet contained practically no ice because of the electric heating applied to these components.

Figure 5. - Ice formation on compressor-inlet guide vanes during flight 1. Time in icing, 25 minutes; liquid-water content, 0.1 to 0.2 gram per cubic meter; droplet size, 12 to 7 microns; ambient-air temperature, 13° to 16° F; loss in thrust, 6 percent.

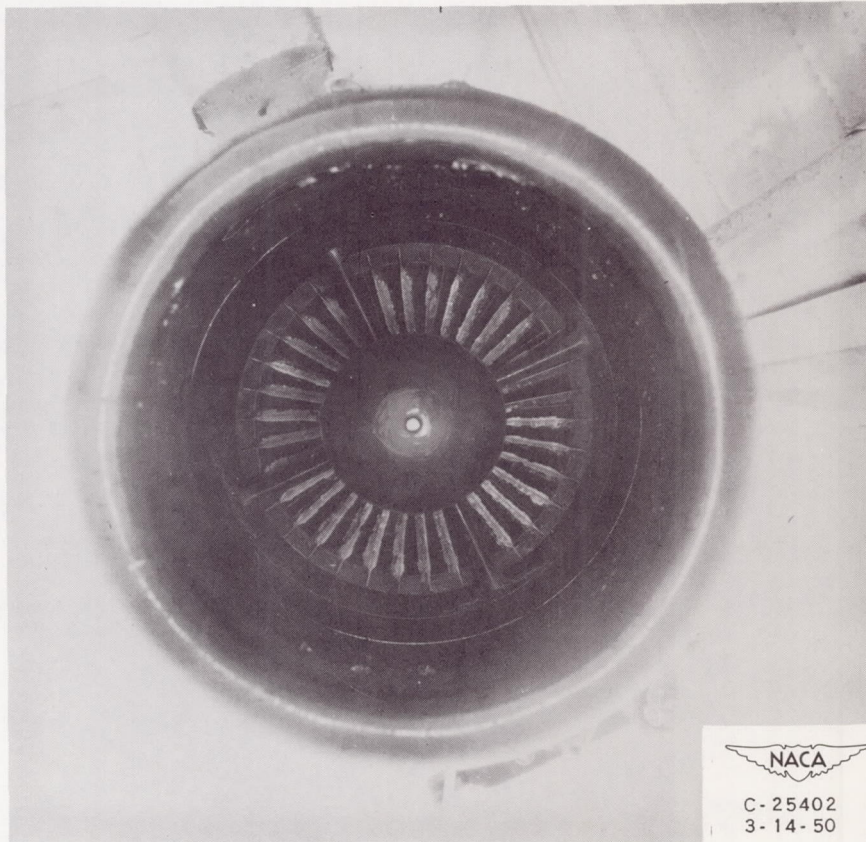
(a) Elapsed time in icing conditions, 11 minutes.

The series of photographs taken during the two parts of flight 2 are shown in figures 7 and 8, respectively. The time intervals at which the photographs were taken are indicated for convenience in figure 6. Photographs from the first part of the flight (fig. 7) show the progress of the guide-vane ice formations from 11 to 35 minutes after the icing condition was encountered.

Figure 7. - Ice formation on compressor-inlet guide vanes during flight 2, with anti-icing. Liquid-water content, 0.3 to 0.5 gram per cubic meter; droplet size, 11 to 17 microns; ambient-air temperature, 22° to 25° F; thrust loss, 8 percent.

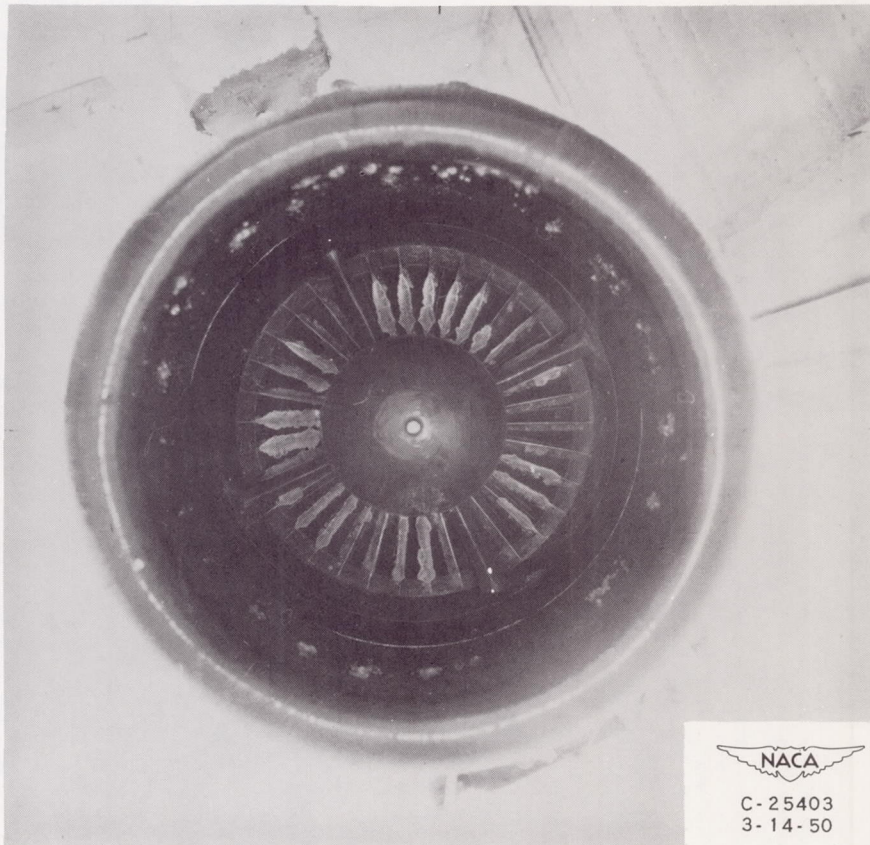
(b) Elapsed time in icing conditions, 17 minutes.

Figure 7. - Continued. Ice formation on compressor-inlet guide vanes during flight 2, with anti-icing. Liquid-water content, 0.3 to 0.5 gram per cubic meter; droplet size, 11 to 17 microns; ambient-air temperature, 22° to 25° F; thrust loss, 8 percent.

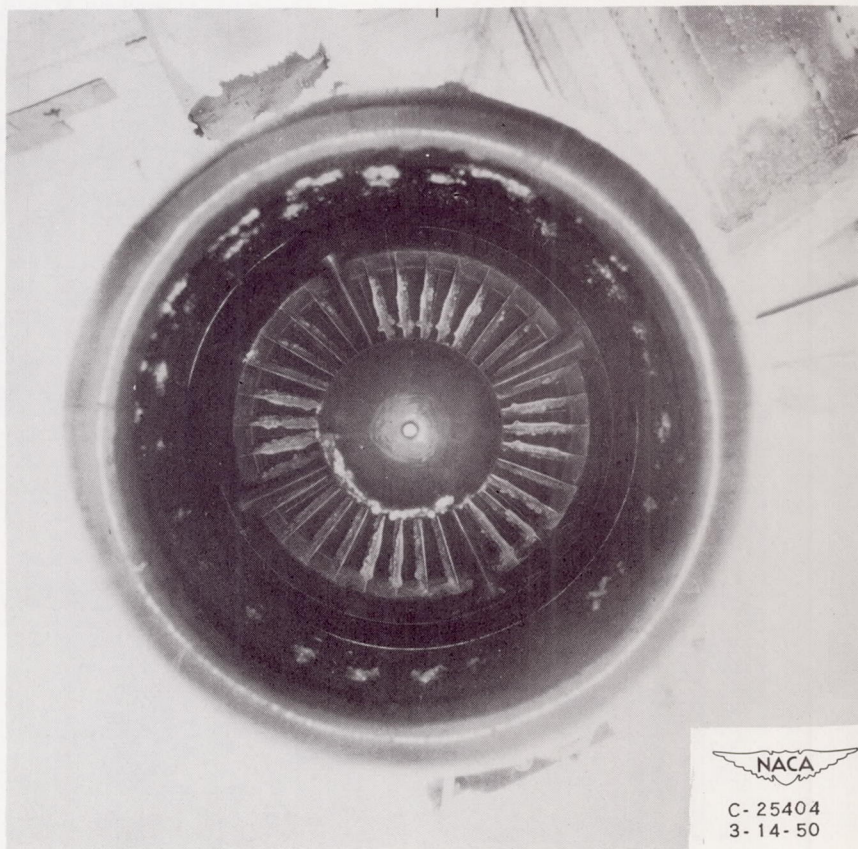
(c) Elapsed time in icing conditions, 24 minutes.

Figure 7. - Continued. Ice formation on compressor-inlet guide vanes during flight 2, with anti-icing. Liquid-water content, 0.3 to 0.5 gram per cubic meter; droplet size, 11 to 17 microns; ambient-air temperature, 22° to 25° F; thrust loss, 8 percent.

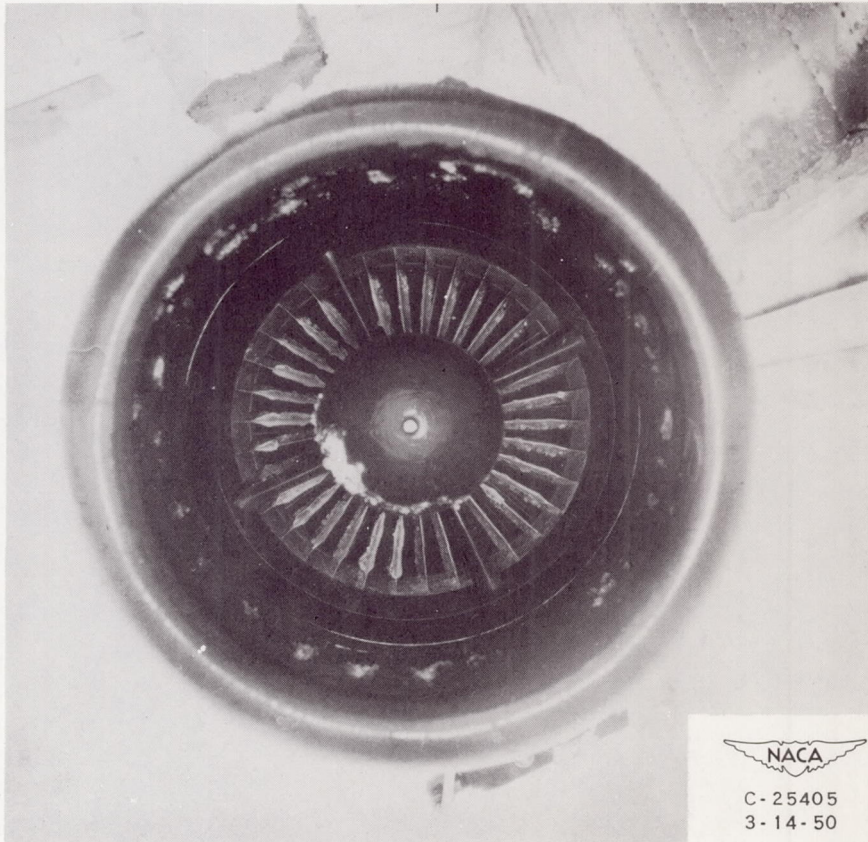
(d) Elapsed time in icing conditions, 35 minutes.

Figure 7. - Concluded. Ice formation on compressor-inlet guide vanes during flight 2, with anti-icing. Liquid-water content, 0.3 to 0.5 gram per cubic meter; droplet size, 11 to 17 microns; ambient-air temperature, 22° to 25° F; thrust loss, 8 percent.

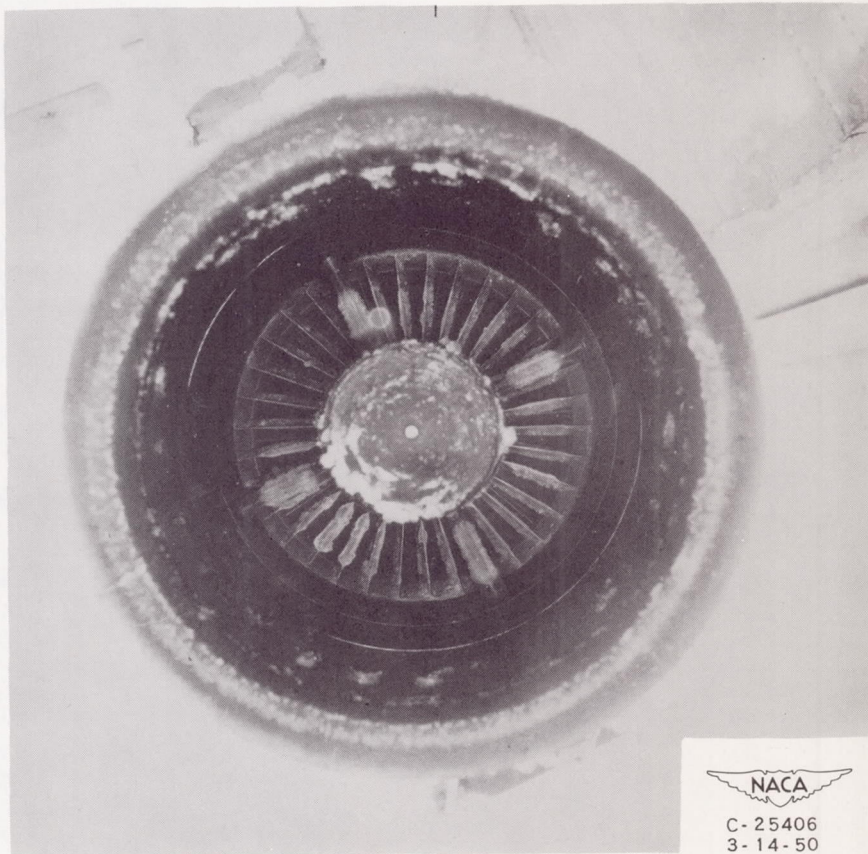
(a) Elapsed time in icing conditions, 5 minutes.

Photographs taken during the second part of the flight (fig. 8) show the progress of the ice formations on the entire engine inlet, when no heating was applied to any of the components. The guide-vane ice formations were similar to those of the first part of the flight. These formations, which appeared to be clear ice built-up, became unstable and broke off in a continuing cycle. This cycle of forming and shedding occurred several times during both parts of flight 2, and was characteristic of all flights in the investigation. After 15 minutes of the second part of the flight had elapsed, however, the formations on the inlet lip and the starter dome became large and the guide-vane formations appeared to stabilize. A large quantity of the water droplets was probably separated out of the air stream by the large crater-like formations on the inlet lip and the starter dome and collected on these formations ahead of the guide vanes.

Figure 8. - Ice formation on turbojet-engine inlet during flight 2, without anti-icing. Liquid-water content, 0.1 to 0.5 gram per cubic meter; droplet size, 11 to 20 microns; ambient-air temperature, 22° to 26° F; thrust loss, 13 to 16 percent.

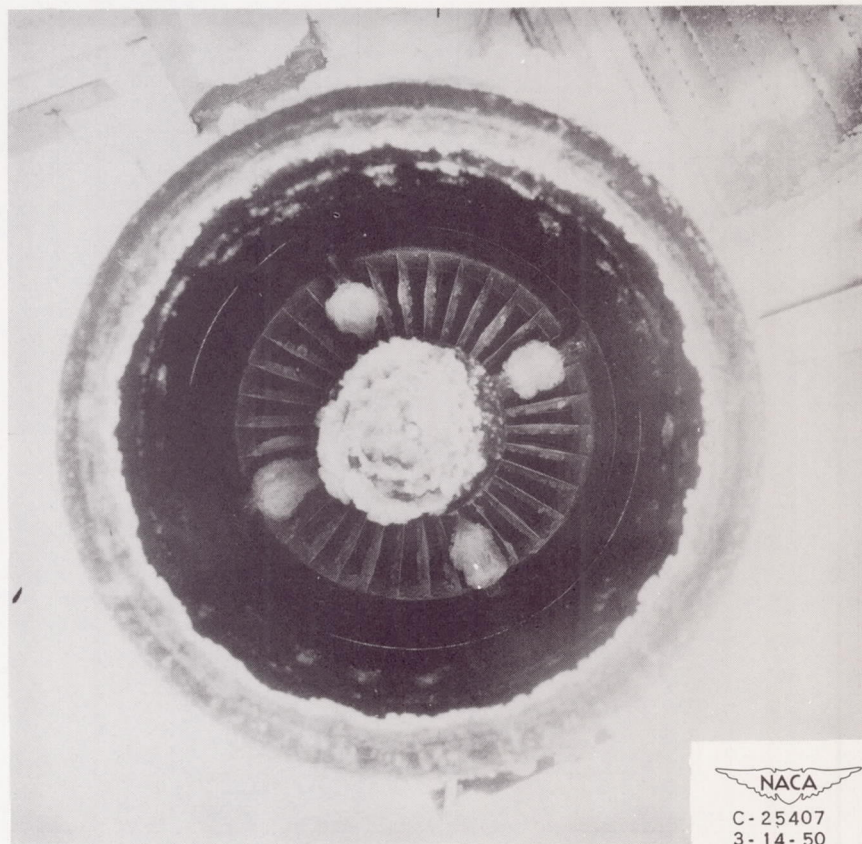
(b) Elapsed time in icing conditions, 9 minutes.

Figure 8. - Continued. Ice formation on turbojet-engine inlet during flight 2, without anti-icing. Liquid-water content, 0.1 to 0.5 gram per cubic meter; droplet size, 11 to 20 microns; ambient-air temperature, 22° to 26° F; thrust loss, 13 to 16 percent.

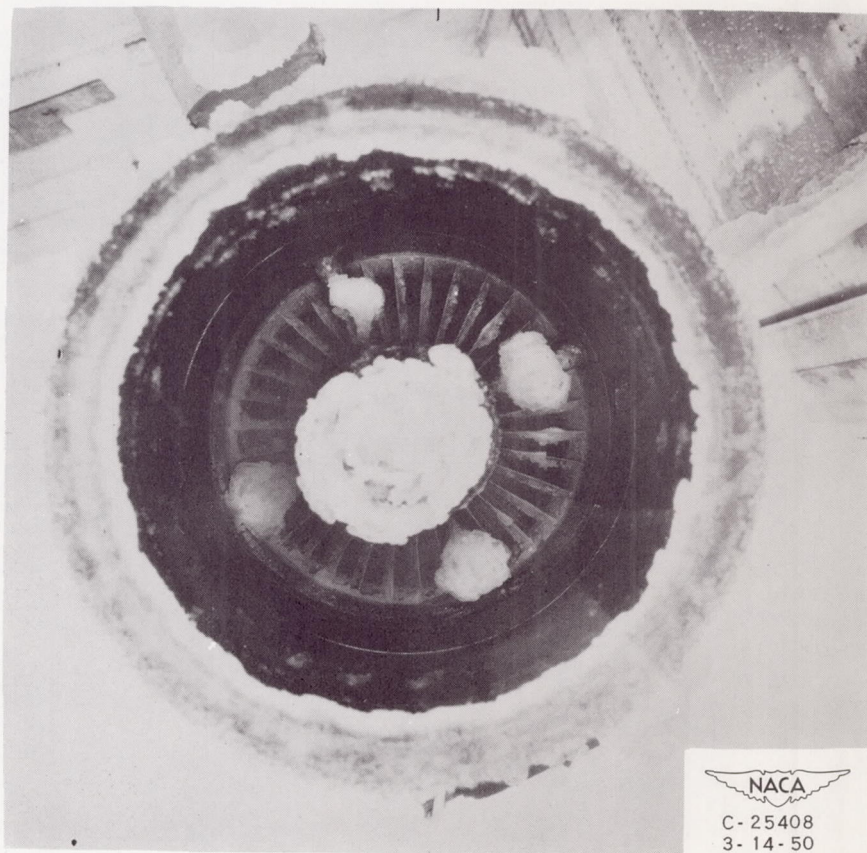
(c) Elapsed time in icing conditions, 15 minutes.

Figure 8. - Continued. Ice formation on turbojet-engine inlet during flight 2, without anti-icing. Liquid-water content, 0.1 to 0.5 gram per cubic meter; droplet size, 11 to 20 microns; ambient-air temperature, 22° to 26° F; thrust loss, 13 to 16 percent.

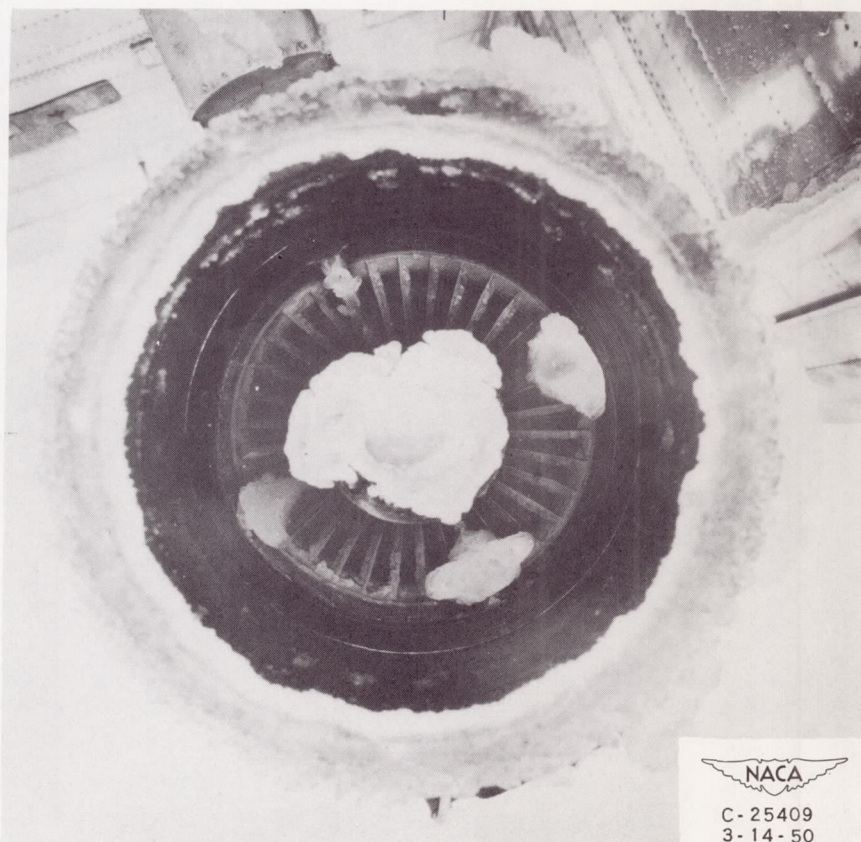
(d) Elapsed time in icing conditions, 28 minutes.

Figure 8. - Continued. Ice formation on turbojet-engine inlet during flight 2, without anti-icing. Liquid-water content, 0.1 to 0.5 gram per cubic meter; droplet size, 11 to 20 microns; ambient-air temperature, 22° to 26° F; thrust loss, 13 to 16 percent.

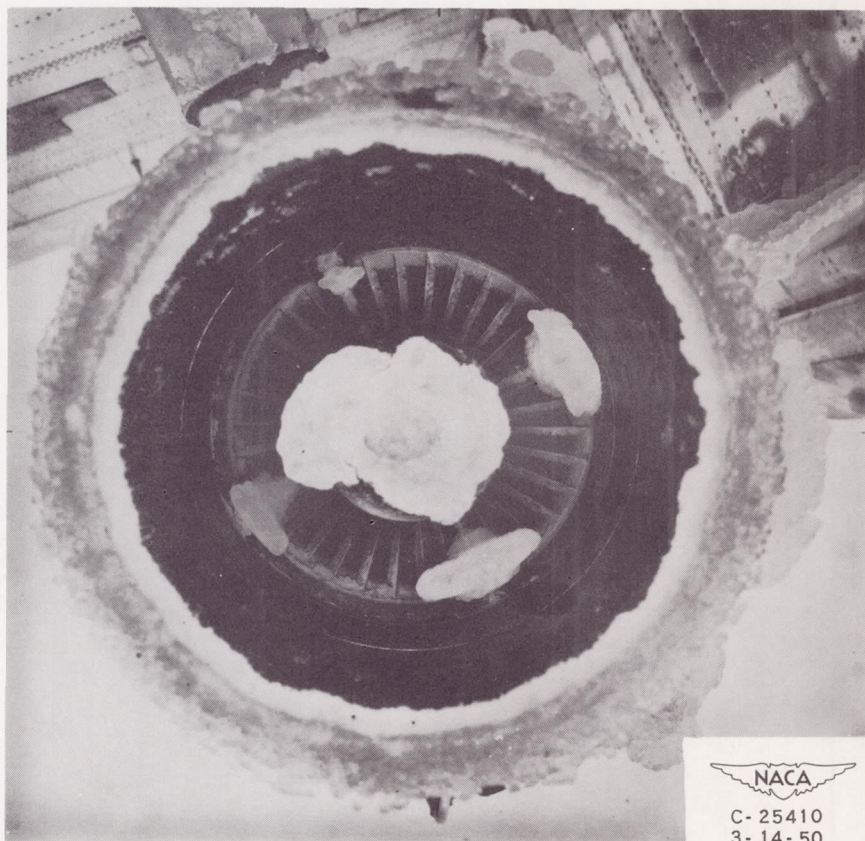
(e) Elapsed time in icing conditions, 39 minutes.

Figure 8. - Continued. Ice formation on turbojet-engine inlet during flight 2, without anti-icing. Liquid-water content, 0.1 to 0.5 gram per cubic meter; droplet size, 11 to 20 microns; ambient-air temperature, 22° to 26° F; thrust loss, 13 to 16 percent.

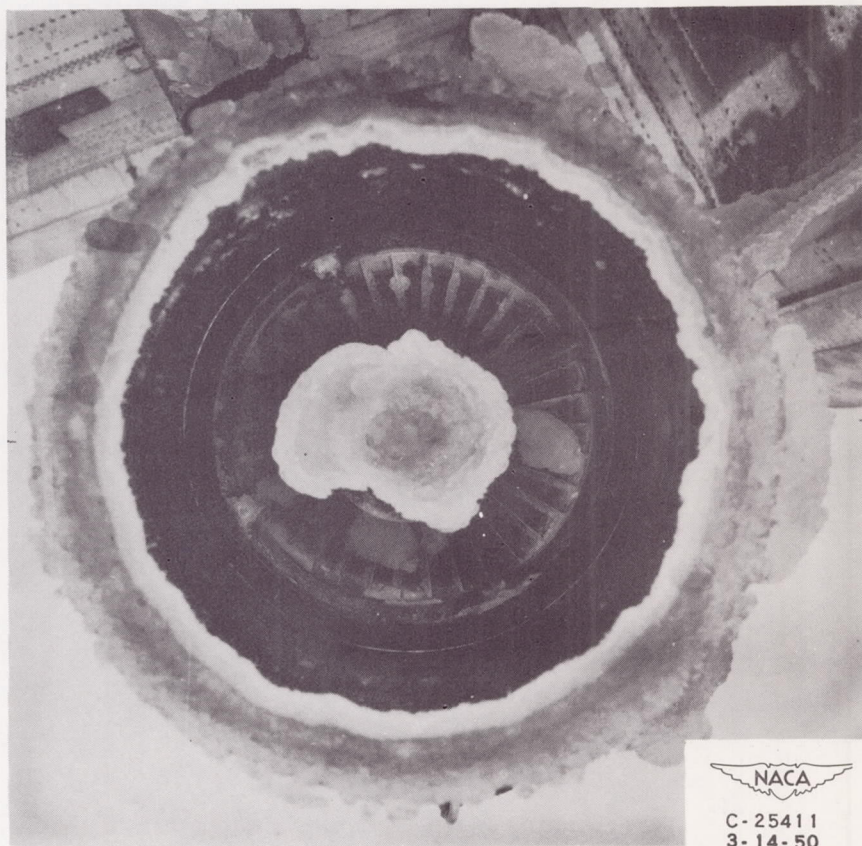
(f) Elapsed time in icing conditions, 47 minutes.

Figure 8. - Concluded. Ice formation on turbojet-engine inlet during flight 2, without anti-icing. Liquid-water content, 0.1 to 0.5 gram per cubic meter; droplet size, 11 to 20 microns; ambient-air temperature, 22° to 26° F; thrust loss, 13 to 16 percent.

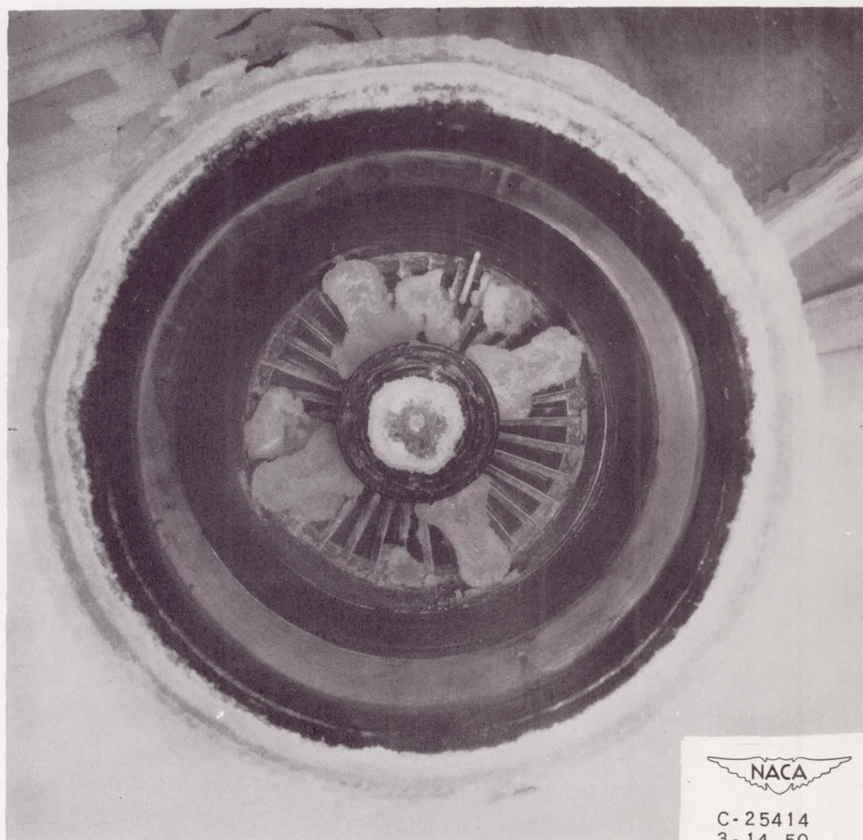
(a) Elapsed time in icing conditions, 70 minutes.

The reduction in engine thrust and the increase in tail-pipe temperature that occurred during flight 3 are understandable from examination of the large ice accretions on the front-bearing support struts and the large loose pieces lodged on the inlet guide vanes, as shown in figure 10(a). Ice formations can be observed on the first-stage stator blades of the compressor. Further penetration of ice formations in the compressor are not detectable. Soon after the photograph in figure 10(a) was taken, the large ice formations shown began to break up and pass through the engine. A photograph taken 6 minutes later (fig. 10(b)) shows that a large portion of the ice formation had disappeared. The result was an increase in engine thrust and a decrease in tail-pipe temperature of approximately 50° F (fig. 9).

Figure 10. - Ice formation on turbojet-engine inlet during flight 3 at 92-percent rated speed. Liquid-water content, 0.4 to 0.9 gram per cubic meter; droplet size, 12 to 14 microns; ambient-air temperature, 17° to 22° F; thrust loss, 26 percent.

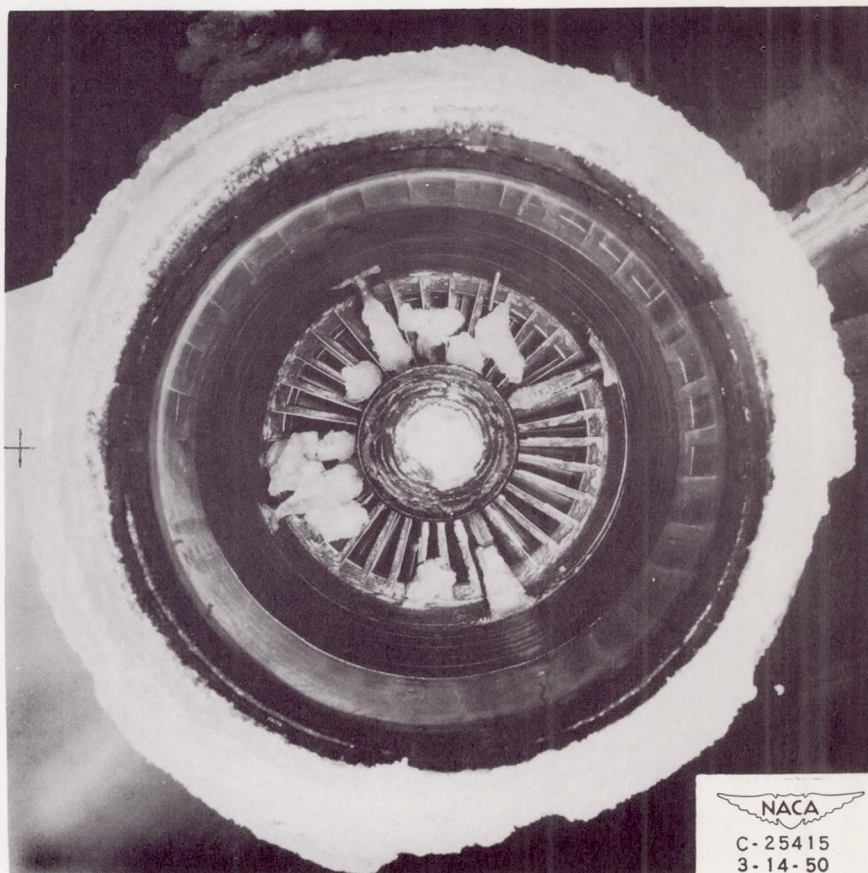
(b) Elapsed time in icing conditions, 76 minutes.

Figure 10. - Concluded. Ice formation on turbojet-engine inlet during flight 3 at 92-percent rated engine speed. Liquid-water content, 0.4 to 0.9 gram per cubic meter; droplet size, 12 to 14 microns; ambient-air temperature, 17° to 22° F; thrust loss, 26 percent.

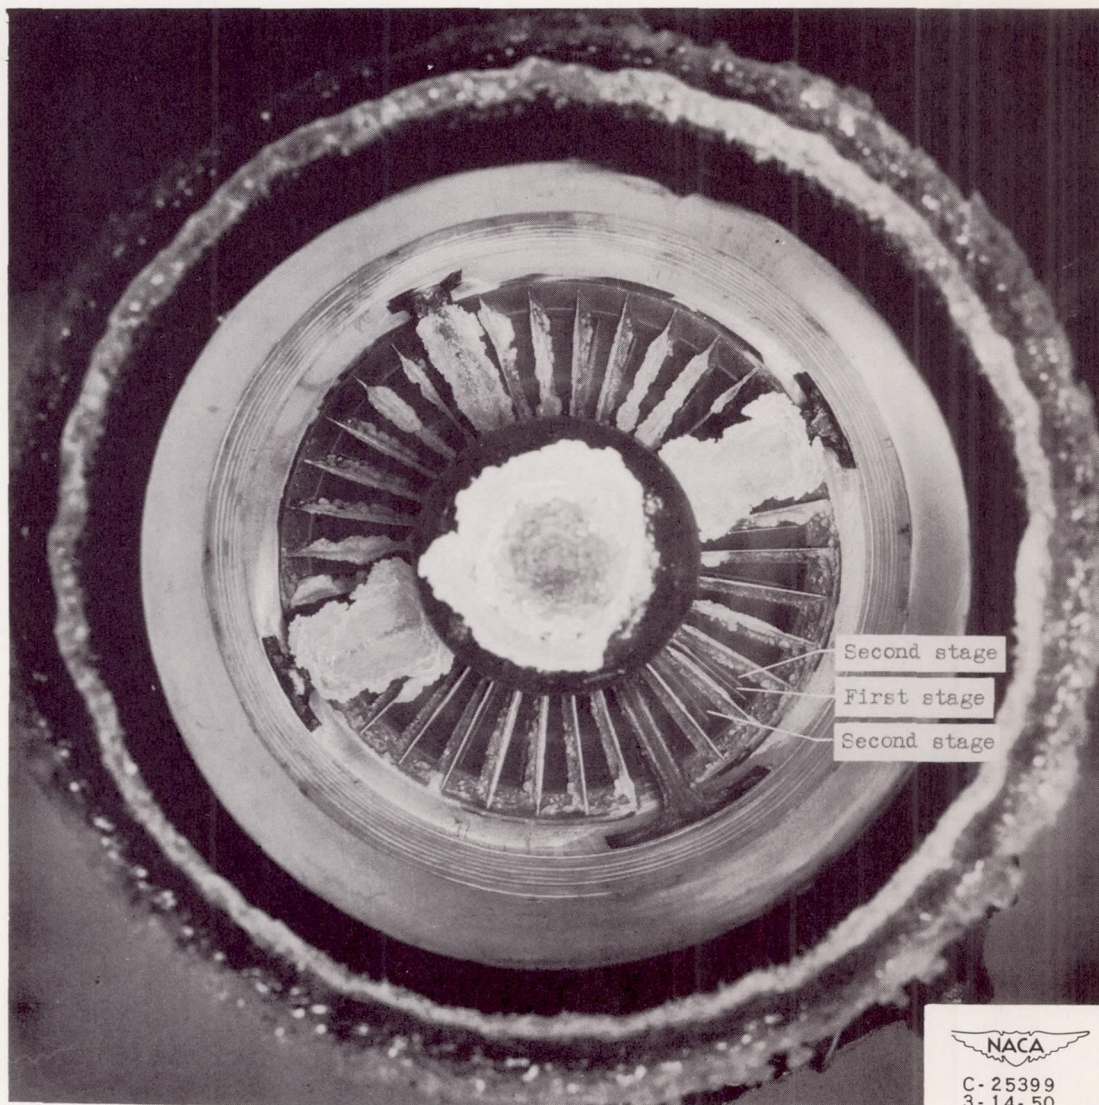
The ice formations on the engine inlet after 22 minutes of operation in the icing condition of flight 4 is shown in figure 12. The first-stage stator blades of the compressor had a light formation of ice and one second-stage stator blade evidently had an ice accretion at the blade root. Further penetration of ice formations into the compressor is not visible.

Figure 12. - Ice formations on turbojet-engine inlet at rated speed during flight 4. Time in icing, 22 minutes; liquid-water content, 0.4 to 0.6 gram per cubic meter; drop size, 11 to 16 microns; ambient-air temperature, 25° F; loss in thrust, 18 percent.

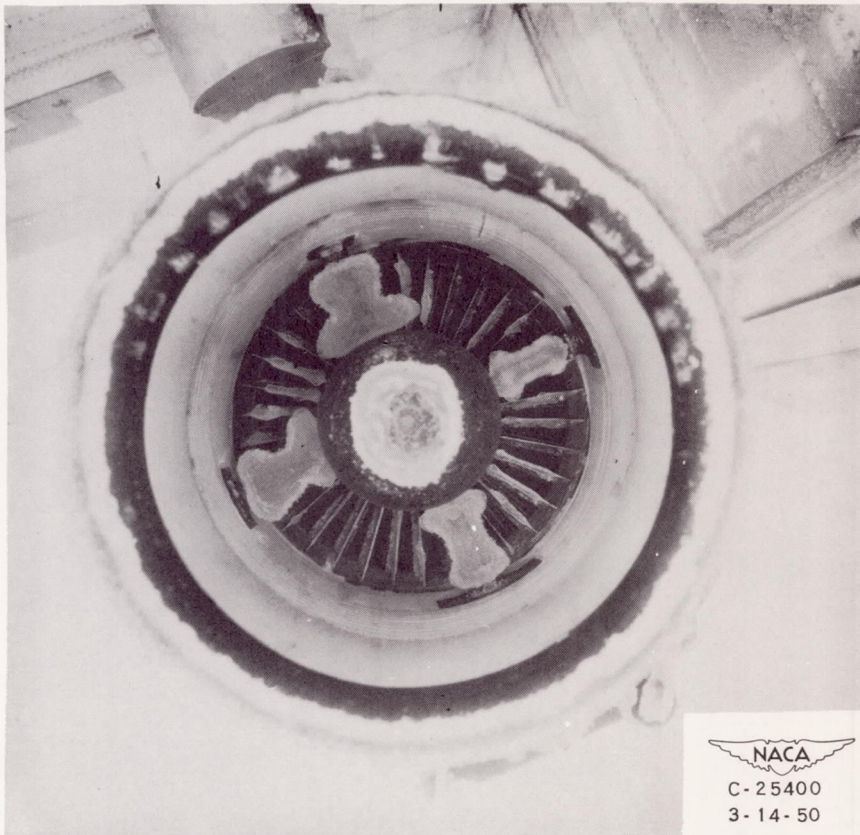
During flight 5, the engine was operated at 100- and 92-percent rated speed for 70 minutes in an icing condition in which the liquid-water content varied from 0.1 to 0.5 gram per cubic meter, with water-droplet sizes of 10 to 18 microns and an ambient-air temperature of 20° to 24° F. Operation in this icing condition resulted in a maximum reduction of 12 and 9 percent in engine thrust, 7 and 5 percent in air flow, 9 and 5 percent in compressor efficiency, and tail-pipe temperature was increased a maximum of 40° and 10° F at 100- and 92-percent rated speed, respectively, (fig. 13). Within the first minute in the icing encounter, the engine thrust at rated speed was reduced approximately 10 percent and the tail-pipe temperature increased 40° F. The initial losses were equivalent to the maximum losses reached during the entire 70-minute flight, thus illustrating again that the steady growth of the ice formation during the first few minutes of exposure to icing caused the greatest rate of reduction in engine performance. A photograph taken after approximately 23 minutes of operation in this icing condition (fig. 14) shows the typical ice formations obtained during the encounter.

Figure 14. - Ice formation on turbojet-engine inlet during flight 5. Time in icing, 23 minutes; liquid-water content, 0.1 to 0.5 gram per cubic meter; droplet size, 10 to 8 microns; ambient-air temperature, 20° to 24° F; thrust loss, 9 to 12 percent.

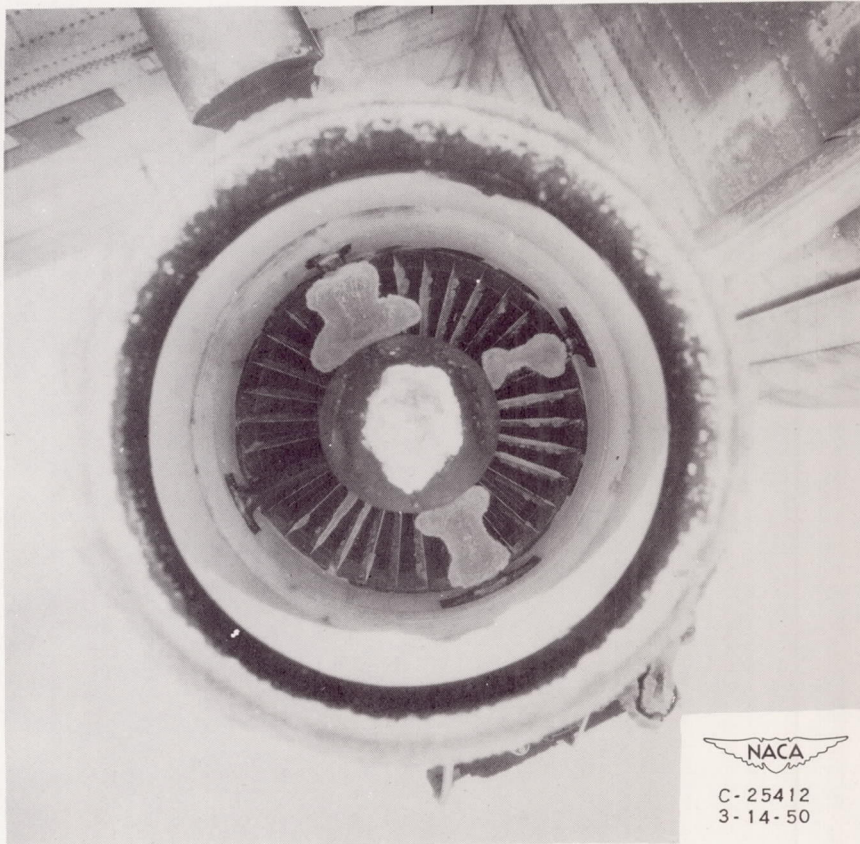
(a) 1 minute before ice formations passed into engine.

After approximately 30 minutes of operation in the icing encounter of flight 5, the engine instantly swallowed about two-thirds of the inlet-lip ice formation and almost all the formations on the other inlet components. A sudden but momentary drop of approximately 1000 rpm in engine speed occurred. The quantity of ice that passed through the engine is indicated by a comparison of the two inlet photographs in figure 15, which were taken 1 minute before and 1 minute after the incident. Immediately after the ice formations passed into the engine, the jet thrust and the air flow partly recovered and the tail-pipe temperature was decreased 35° F. A close inspection of the engine after the flight revealed no damage to the compressor or stator blades. On several other occasions, large quantities of ice were observed to pass into the engine with approximately the same results.

Figure 15. - Ice formations on turbojet-engine inlet after approximately 30 minutes of operation in icing condition of flight 5.

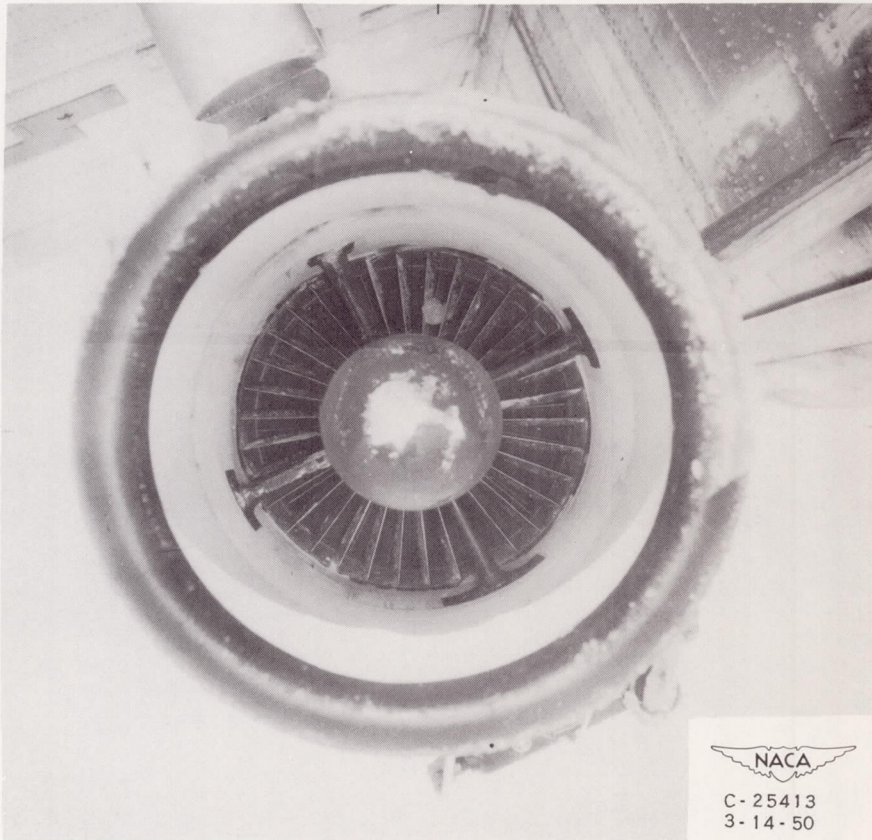
(b) 1 minute after ice formations passed into engine.

Figure 15. - Concluded. Ice formations on turbojet-engine inlet after approximately 30 minutes of operation in icing condition of flight 5.
