NACA RM E9G13

CYCLIC ENGINE OPERATION OF CAST VITALLIUM TURBINE BLADES
AT AN EXHAUST-CONE GAS TEMPERATURE OF $1440 \pm 20^{\circ}$ F

By Charles Yaker and Floyd B. Garrett

Lewis Flight Propulsion Laboratory
Cleveland, Ohio

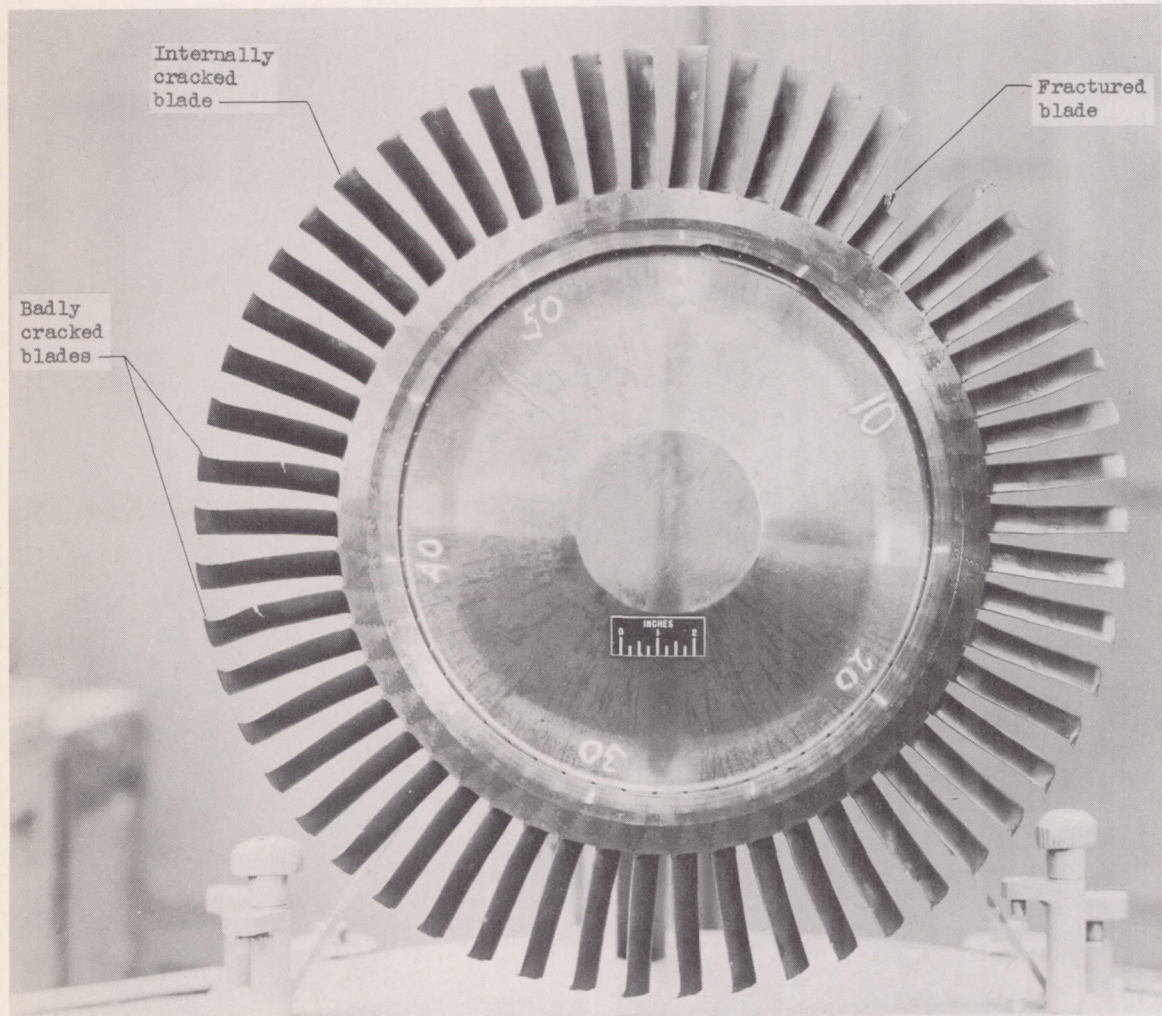
The condition of the four blades that were considered broken because they showed large cracks through the thickness of the airfoil section is presented in table I. The turbine rotor at the conclusion of the run is shown in figure 2; the fractured and cracked blades are shown in figures 3 and 4, respectively.

Figure 2. - Turbine rotor after $7\frac{1}{2}$ cycles (2 hr, 30 min) of operation.

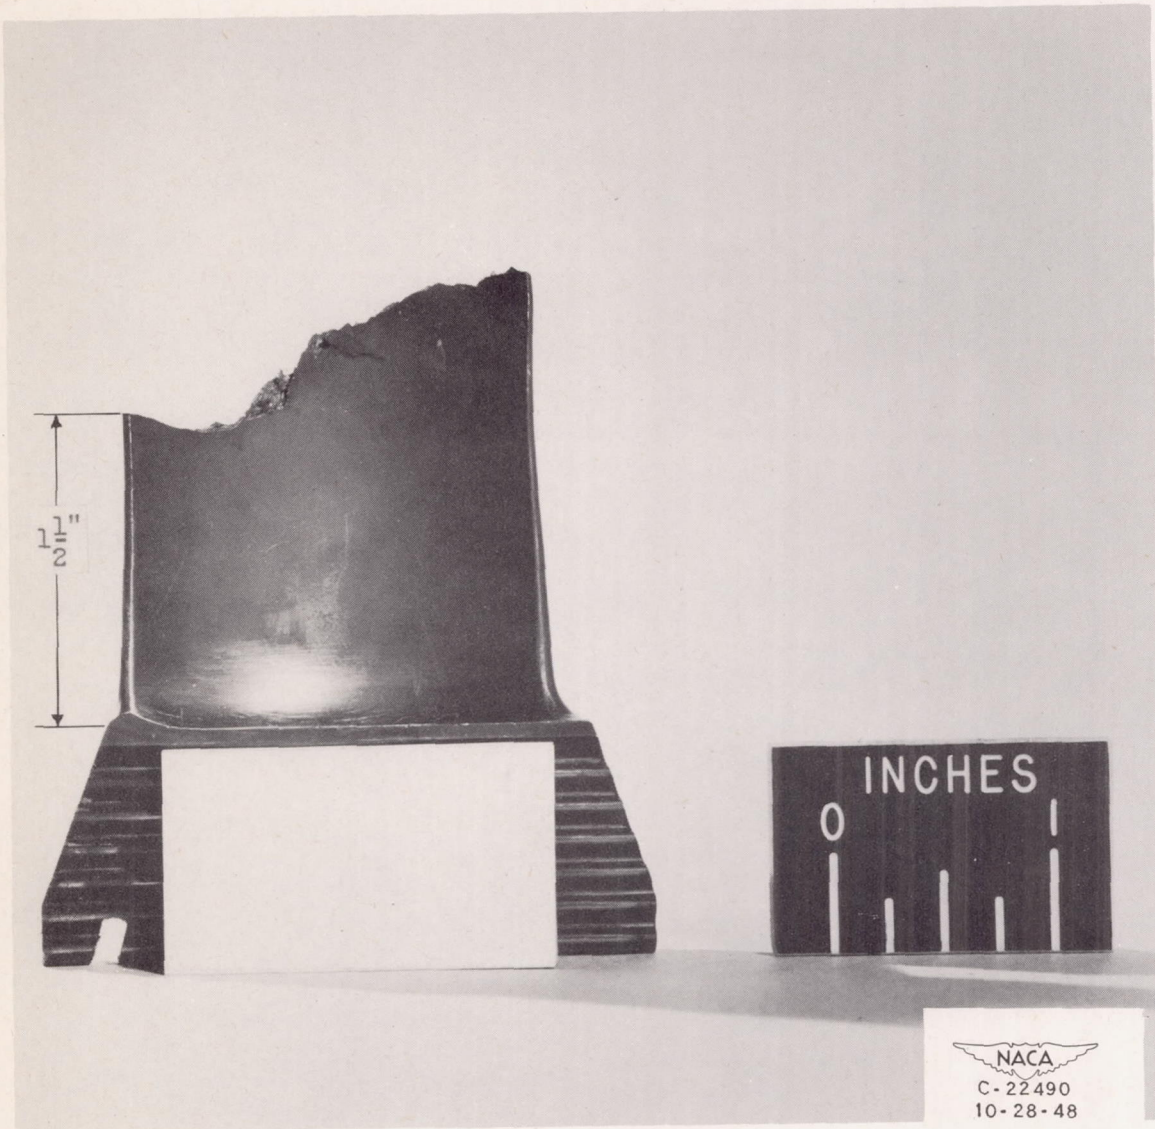
Blade	Condition	Chord position of failure	Distance from root (in.)	Length of crack (in.)
6	Fractured	Entire blade	$\frac{1}{2}$	-----
39	Cracked	Trailing edge	$2\frac{7}{16}$	0.72
42	Cracked	Trailing edge	$1\frac{9}{16}$.60
48	Cracked	1/4 inch from trailing edge	$2\frac{1}{4}$.58

Figure 3. - Failure path across fractured blade.

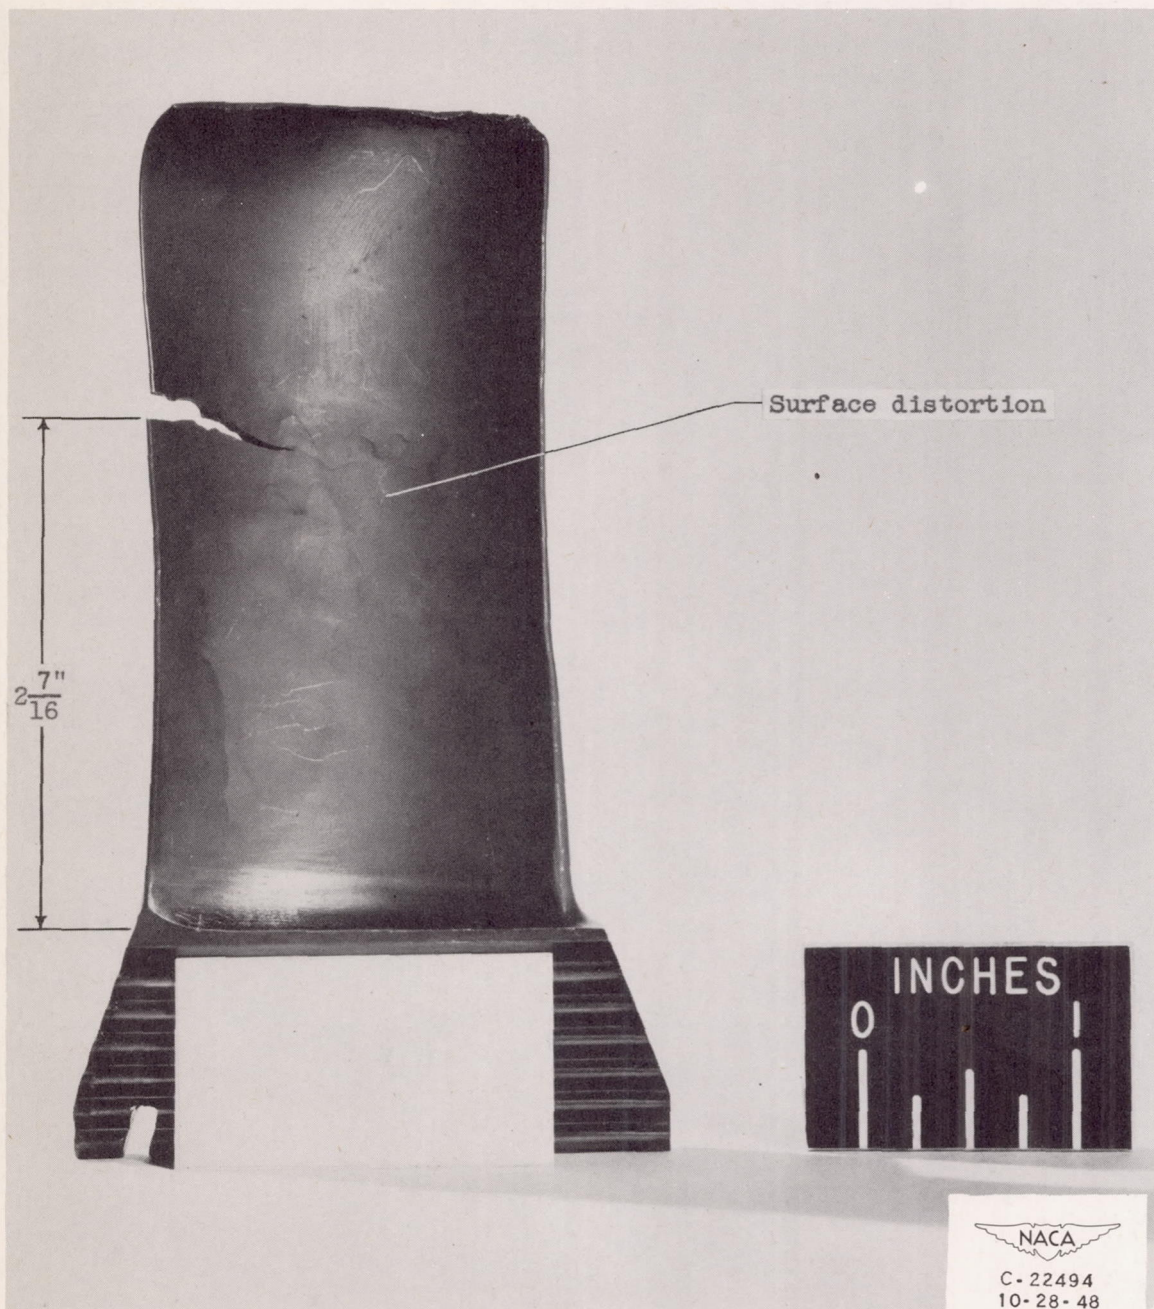
Results of the microexamination of the two blades having large transcrystalline cracks in their trailing edge indicate that they apparently failed by some different mechanism.

Figure 4. - Blade with large crack in trailing edge. Note surface distortion.

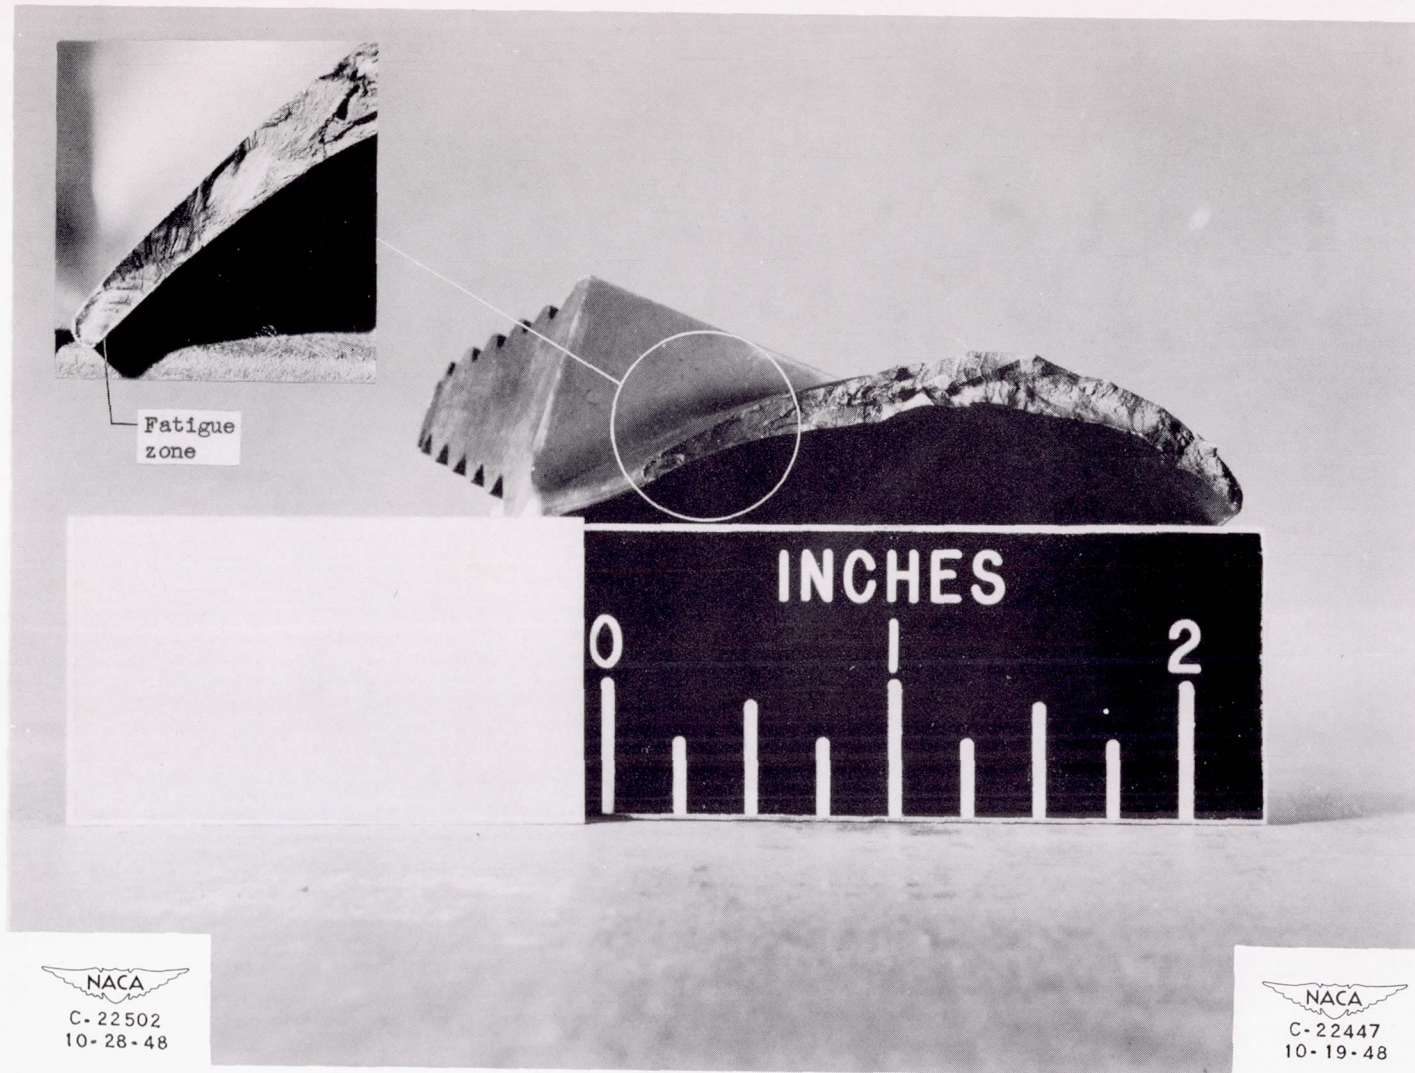
Visual examination. The blade surfaces were coated with a dark gray oxide and showed surface irregularities, which appeared to have been caused by a relative shifting of grains. Small cracks were visible in many of the blades away from the leading and trailing edges. The failure surface of the fractured blade (fig. 6) exhibited three distinct zones. The zone at the trailing edge was covered with a dark gray oxide and had the smooth surface typical of fatigue fracture, that is, concentric markings through the metal about a nucleus indicating that this failure originated by a fatigue mechanism. The zone at the leading edge, covered with a blue oxide, had a coarse crystalline appearance, characteristic of stress-rupture-test failures of cast Vitallium. The central zone is one of transition between the other two zones. The fracture surface of the large internal crack in another blade was similar to the leading-edge zone in the fractured blade except that it was covered with a dark gray oxide. Large cracks in the trailing edges of two blades were coated with a dark gray oxide and were similar in texture to the transition zone of the fractured blade. No evidence of a fatigue-type failure appeared in these cracks.

the largest number of failures of cast Vitallium blades have been caused by fatigue. The results of this investigation indicate that fatigue is a cause of blade failure at a higher temperature of operation as well.

Figure 6. - Fracture surface of fractured blade, X2. Insert shows trailing-edge section, X4. Note fatigue-type fracture starting at edge of blade.

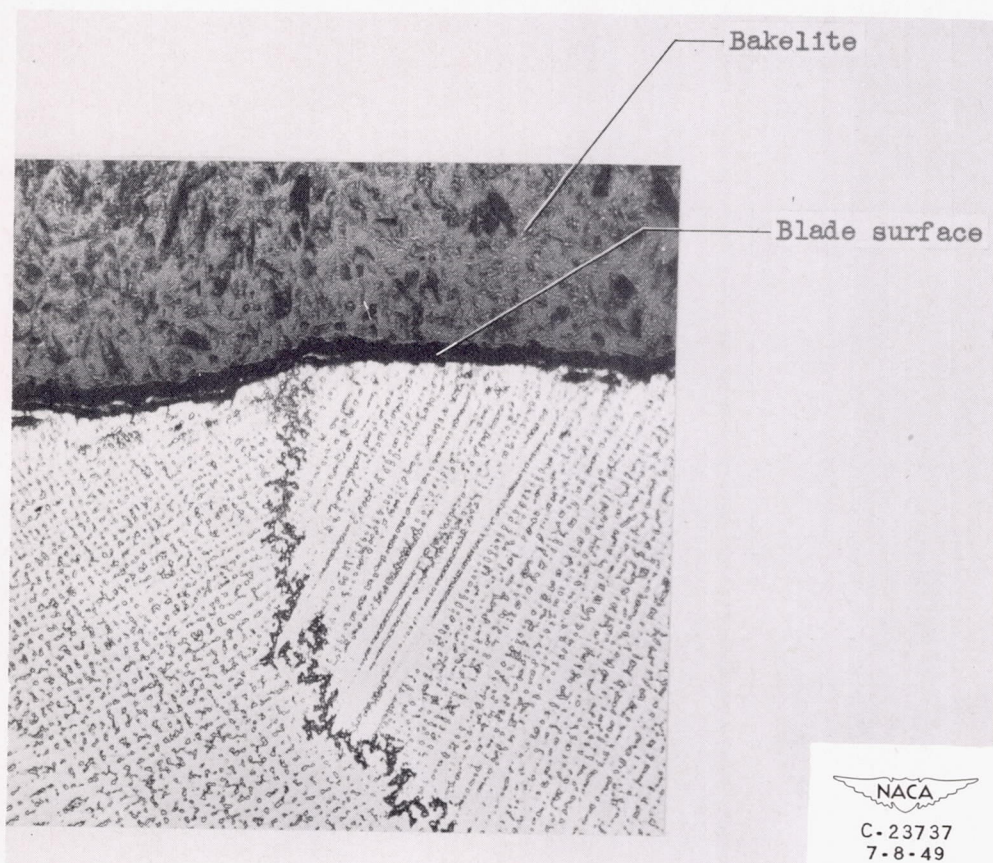
Microexamination. The microstructures of distorted grains and areas of intercrystalline cracking are shown in figures 8 and 9, respectively. These photomicrographs reveal the presence of what appears to be small grains within the large primary grains of the structure. Examination of an unused cast Vitallium blade disclosed no evidence of these secondary grains except for a few scattered traces in the very thin trailing edge (fig. 10). The microstructure in the zone of the fatigue nucleus in the fractured blade is shown in figure 11. Note that a very fine secondary-grain boundary occurs in the grain at the tip of the fracture. Microexamination of the failure zones in the two blades having transcrystalline cracks in their trailing edges revealed no evidence of secondary grains. A comparison of the amount of aging that occurs along the blade during operation, as shown in figure 12, revealed that the amount of aging at the base and the tip of the airfoil section was the same with a greater amount of aging occurring in the center zone of the section.

The results of the metallurgical examination indicate that the grain distortion of the blades is due to orientation differences between grains. These differences result in different magnitudes of grain slip, depending on the variation of the orientation from the preferred slip orientation (fig. 8). The blade-surface distortion is the same as the "orange-peel" or "alligator-skin" surface found in coarse-grained low-carbon steels after deep-drawing (reference 5). The orange-peel effect in steels is also due to orientation differences in coarse-grained areas. After the grains have elongated to the point where they become strain-hardened, they resist further elongation. Further stress then induces failure in the grain boundaries.

Figure 8. - Distorted grains. Structure at blade surface indicates grain movement, X25.

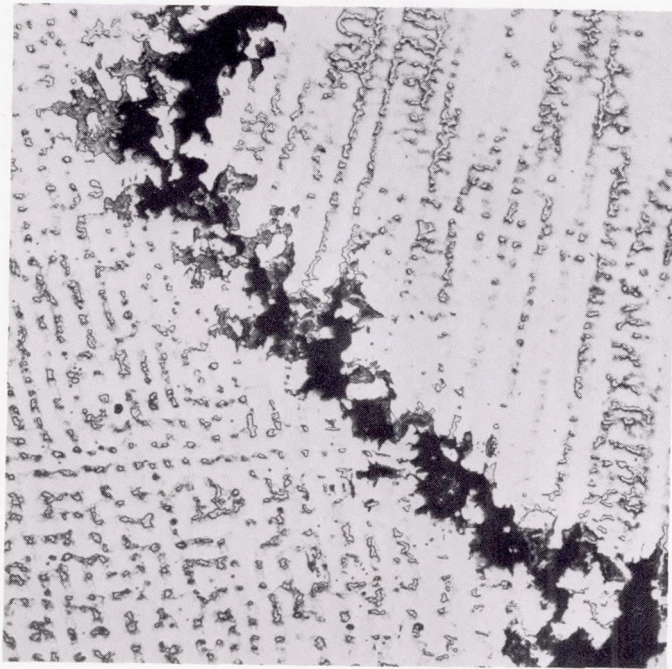
Macroexamination. Examination of the macroetched blades under a low-power microscope showed that the cracks in the fractured blade and in the two blades with large cracks in their trailing edges were transcrystalline. The large internal crack and all small internal cracks were found to be intercrystalline. The results of the grain-size measurements are presented in table III.

(a) Large intercrystalline crack in blade 48, X50.

Figure 9. - Intercrystalline cracks.

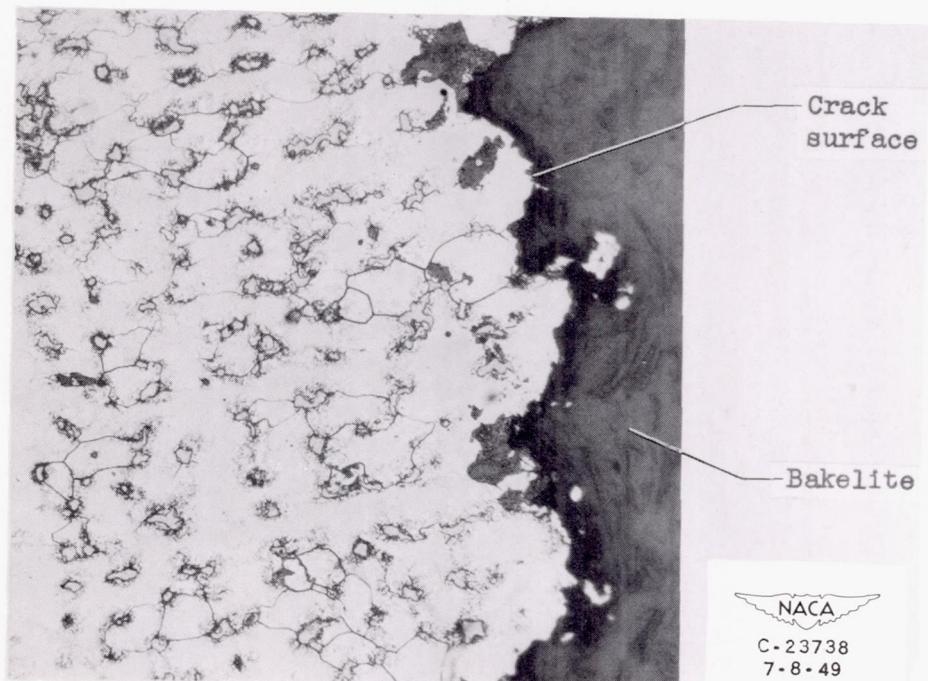
(b) Area alongside crack containing secondary grains, X250.

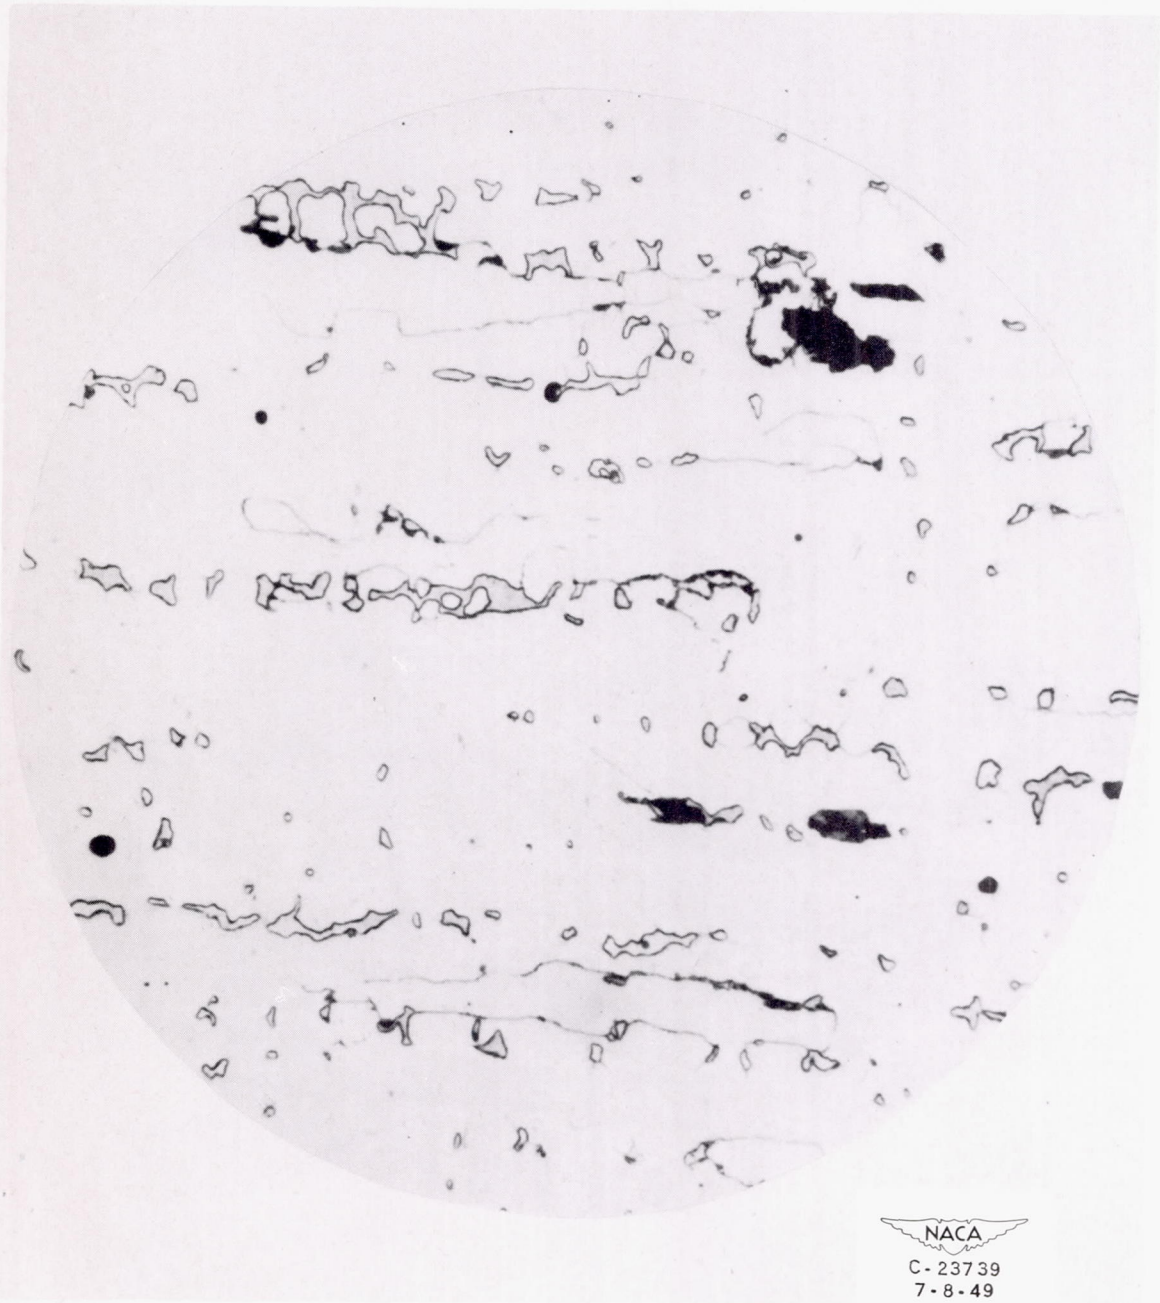
The presence of the secondary-grain boundary in the fatigue-fractured blade (fig. 11) suggests the possibility that the secondary grains and their boundaries, when present in the original unused blades (fig. 10) or formed during operation, might serve as the stress raisers that nucleate a fatigue failure. The intercrystalline cracks might also serve as fatigue nuclei. The presence of secondary grains and intercrystalline cracks suggests that, although cast Vitallium blades have a certain rupture life, they are only suitable for use to a point in the rupture life where the stress raisers within the alloy make it susceptible to fatigue failure.

Figure 10. - Microstructure near trailing edge of unused Vitalium blade showing traces of secondary grains, X500.

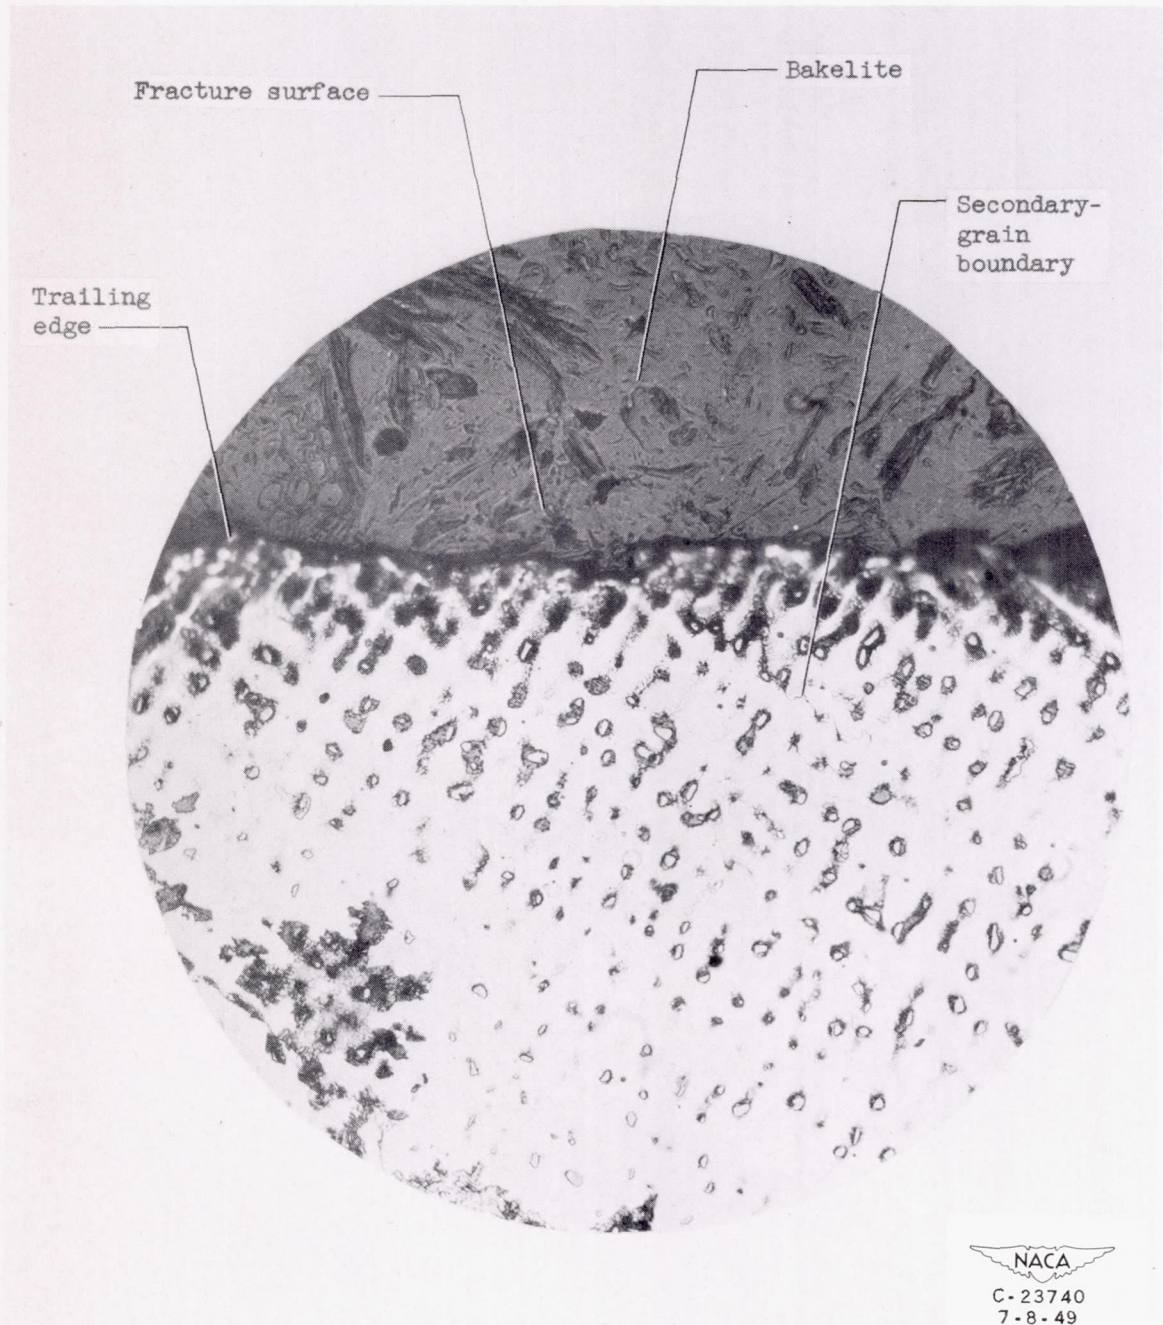
Figure 11. - Microstructure in zone of fatigue nucleus of blade 6. Note secondary grain boundary, X250.

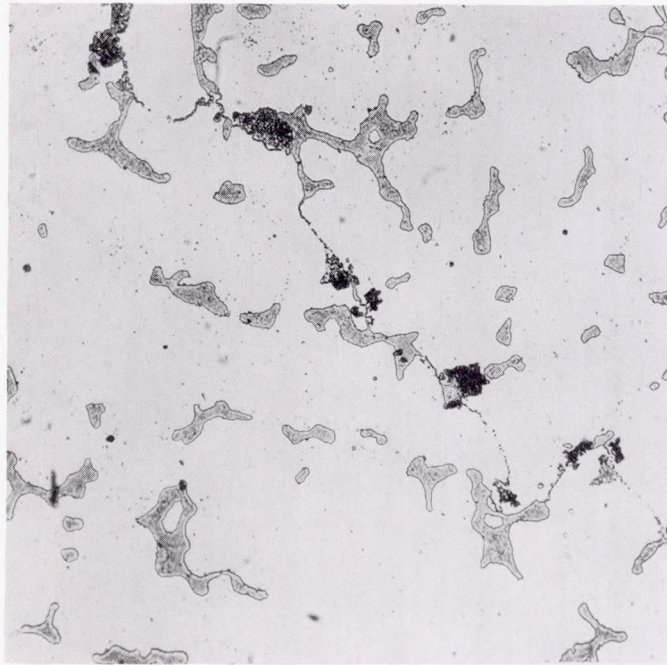
(a) Vitallium before operation. Rockwell C hardness, 30.

Figure 12. - Amount of aging occurring during blade operation, X250.

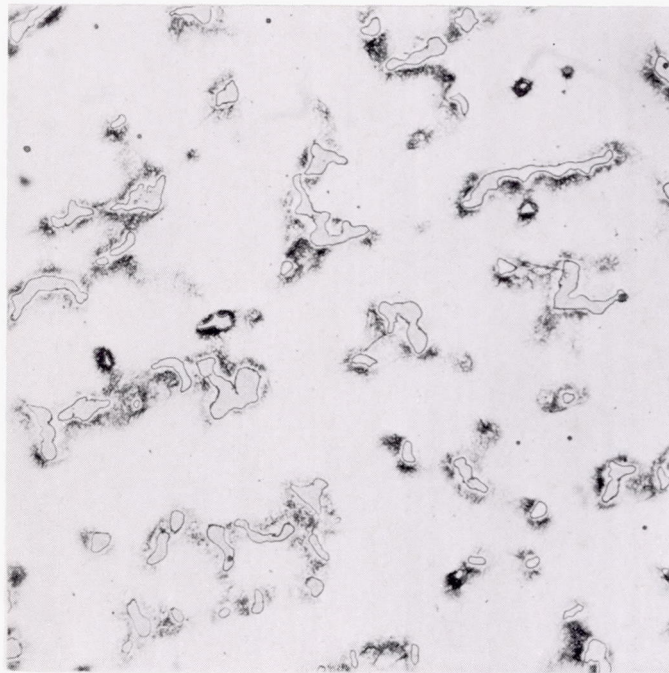
(b) Base of airfoil section. Blade 48; Rockwell C hardness, 34.

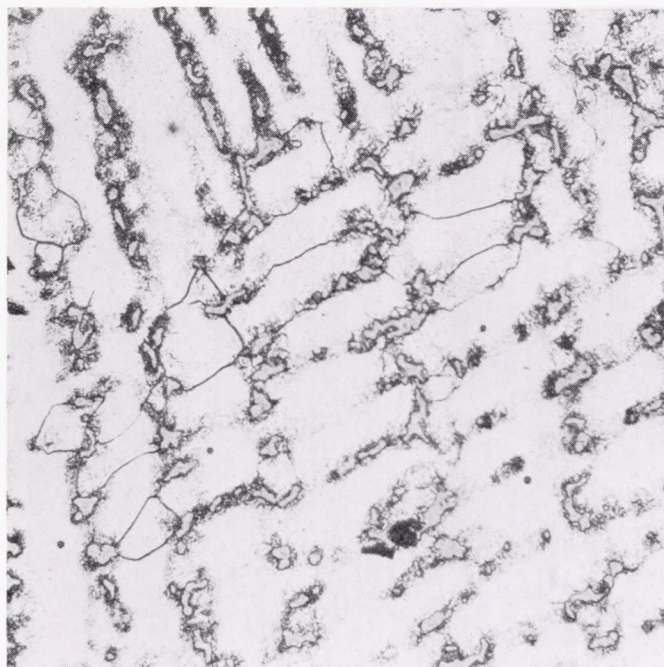
(c) Center of airfoil section. Blade 48; Rockwell C hardness, 40.

Figure 12. - Concluded. Amount of aging occurring during blade operation, X250.

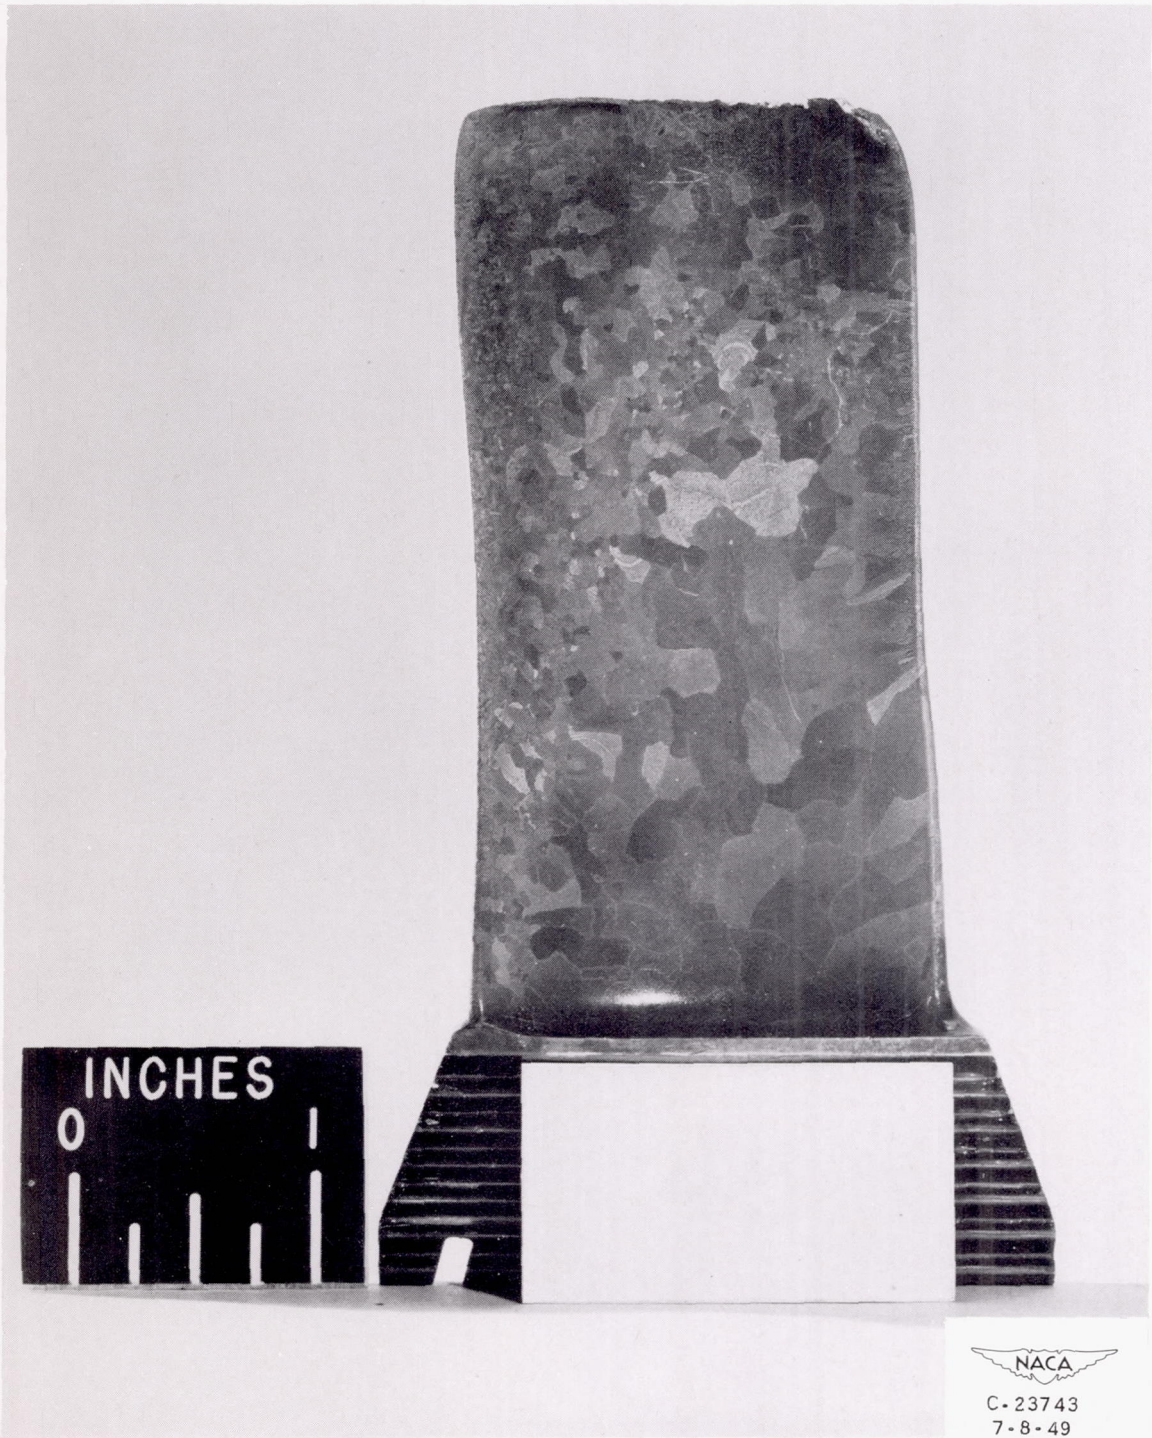
The results of the grain-size measurements failed to produce any relation between blade failure or elongation and grain size, probably because of the wide variation of grain size and orientation within the individual blades. These variations are very likely due to differences in casting variables during blade fabrication. An example of the grain-size variation within a blade is shown in figure 15.

Figure 15. - Grain structure within blade with grain-size range from 4 to 128 grains per square inch. Electrolytically etched in 10-percent hydrochloric acid.
