RESEARCH MEMORANDUM

OPERATING TEMPERATURES OF I-40-5 TURBOJET ENGINE
BURNER LINERS AND THE EFFECT OF TEMPERATURE
VARIATION ON BURNER-LINER SERVICE LIFE

By H. D. Wilsted, Robert T. Duffy
and Ralph E. Grey

Flight Propulsion Research Laboratory
Cleveland, Ohio

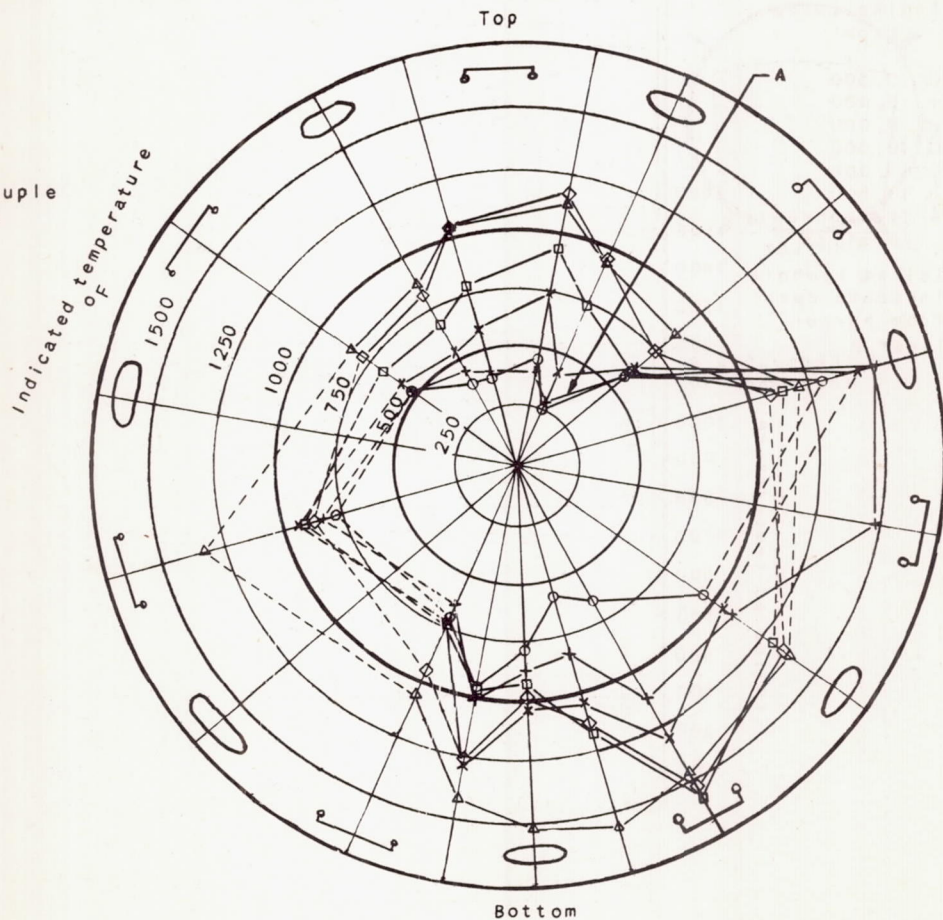
sections containing the louvers and air-intake holes, respectively. An examination of the data shows that the highest indicated burner-liner temperature recorded in these investigations was 1590° F, as shown in figure 9 at an engine speed of 11,500 rpm. This peak temperature occurred in the thermocouple belt $9\frac{1}{2}$ inches from the inlet end of the liner near the critical section.

Temperature gradients as great as 700° F per inch of circumference are shown in figure 9 (point A). The high-temperature gradients from point to point in the burner liner are probably the cause of failure, the principal factor at the present time limiting the service life of the gas-turbine engine. Any process or method that will remove heat from the hot spots or give a more even temperature distribution such as the use of heavier gage metal for the liners to more rapidly conduct heat away from the hot spots or the use of cooling fins to remove heat from the high temperature areas should add materially to the burner-liner service life.

Figure 9. - Circumferential burner-liner temperature distribution near hottest temperature belt on burner liner A at various engine speeds. Average diameter of liner, 5.5 inches. (Dashed lines indicate missing temperature readings as a result of thermocouple failure.)

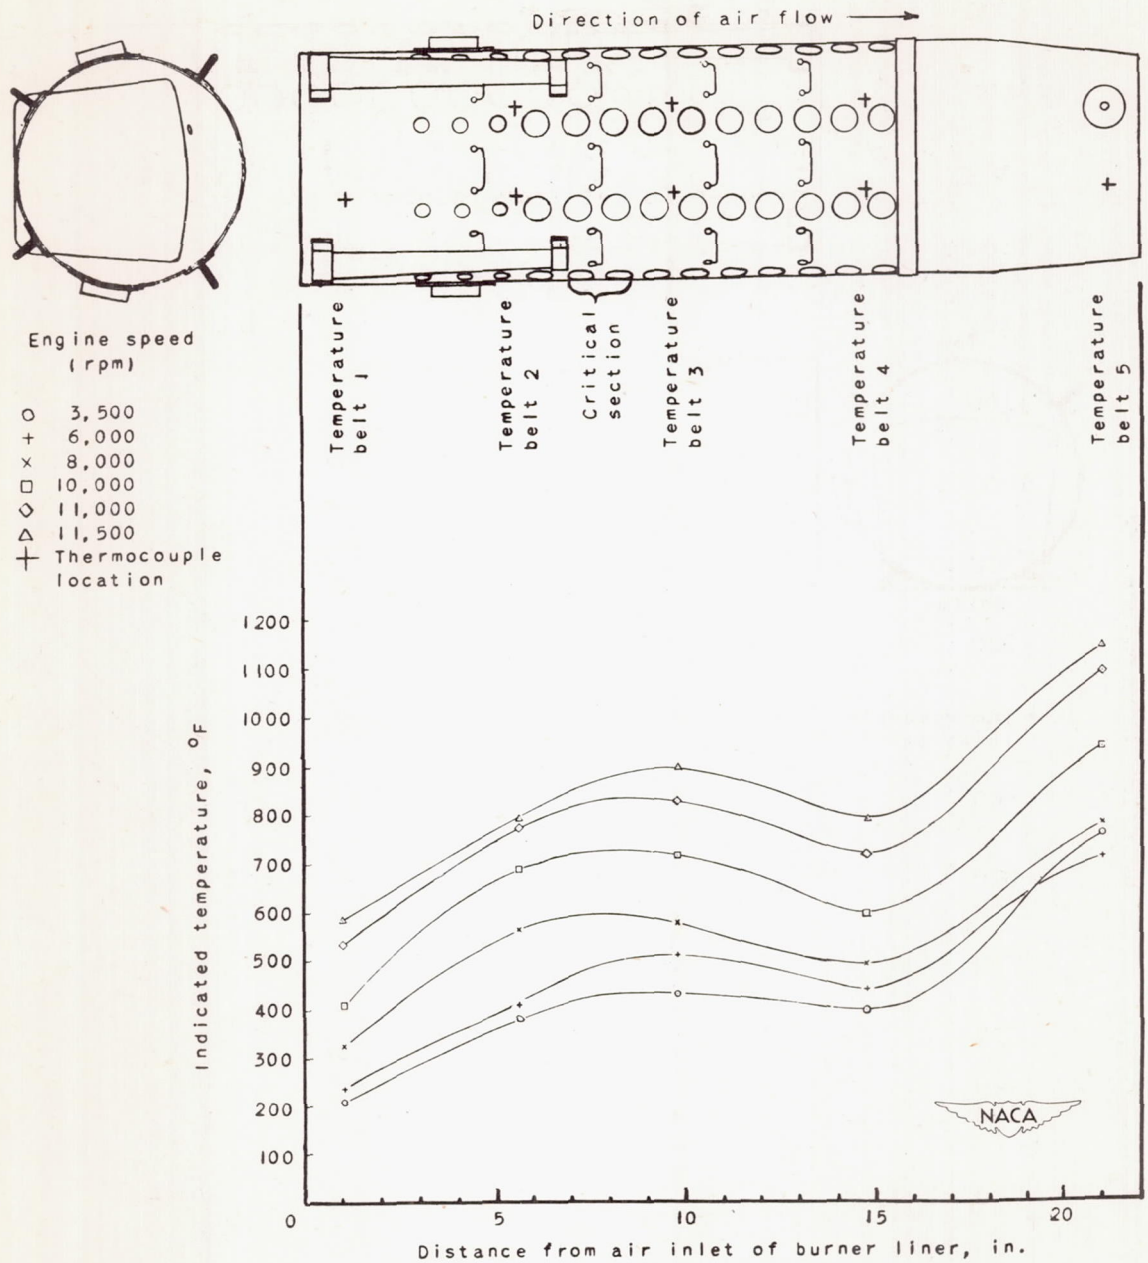
The thermocouples on burner liner B are located in circumferential belts; therefore the average circumferential temperature for each position along the length of the liner can be plotted as in

figure 11. The average values show the following trend: a peak in temperature about one-third the length downstream on the liner with a greater peak occurring at the liner exit. It is in the region of the first-mentioned peak temperature that liners have failed in NACA investigations. These failures occur in the form of fractures and severe warping extending from the louvers to the air-intake holes at a section approximately 8 inches from the inlet end of the liner. This failure belt will hereinafter be referred to as the "critical section." Inspection of service liners has also shown failures at other locations between air-intake holes and louvers but in every case of this type there was a more serious failure at the critical section.

Figure 11. - Temperature variation along length of burner liner B. All points are average of belt temperatures.

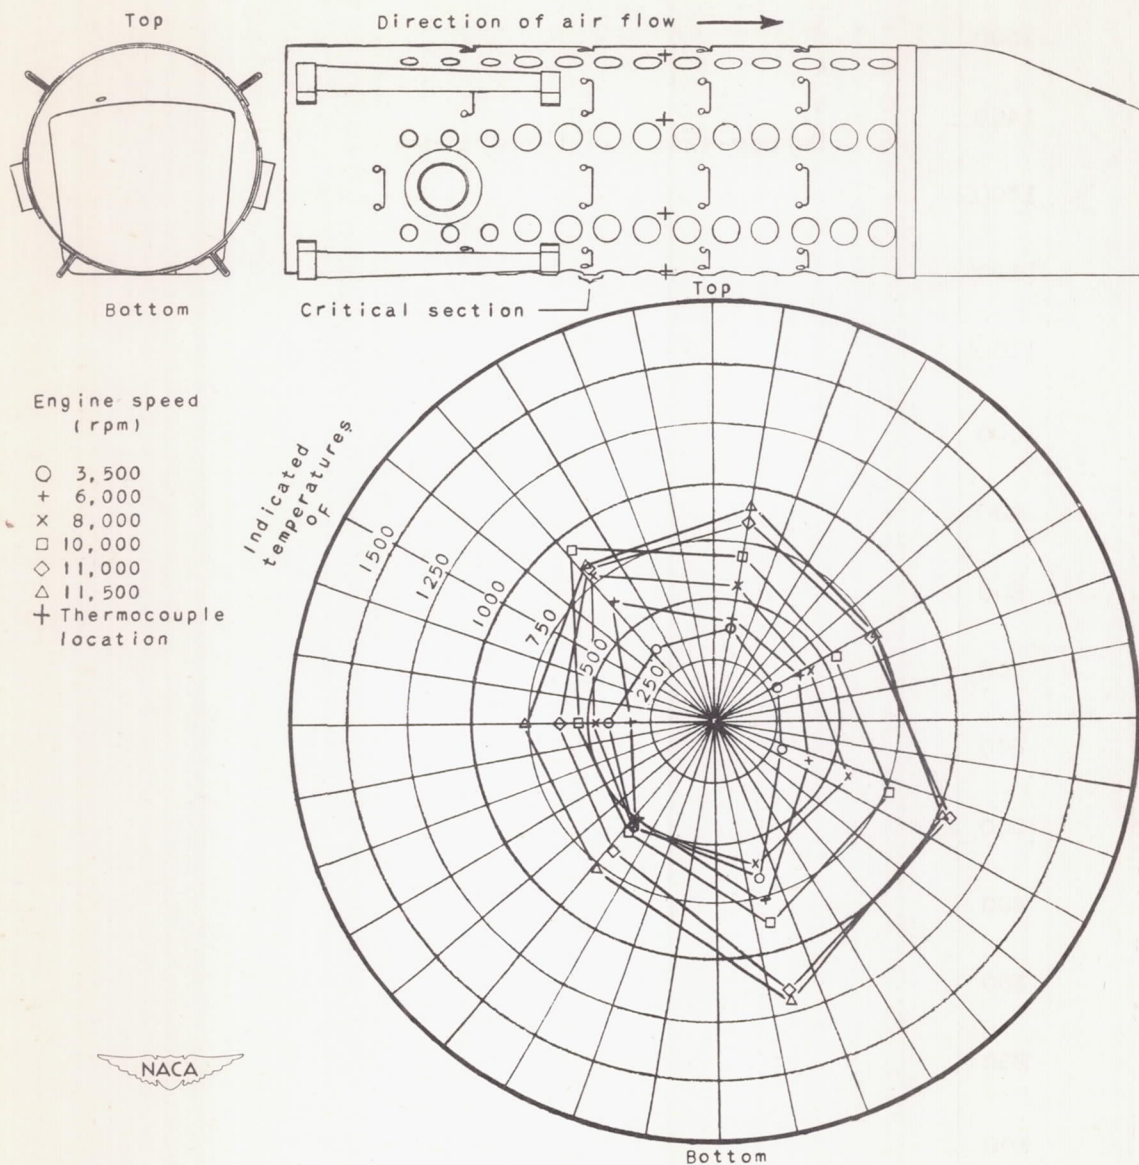
The circumferential temperature variation nearest the critical section is presented in figure 13. An appreciable temperature variation occurs with a decidedly high-temperature region located at the lowest portion of the burner liner as installed in burner 12. This peak agrees with that of figure 9. The high-temperature region is behind the right-hand interconnector fitting. The axial temperature distribution along this section is shown in figure 14 and the temperature behind the left-hand interconnector fitting in figure 15. These figures also show the maldistribution indicated in figure 13. The peak temperatures behind the right-hand interconnector fitting at the higher speeds are of the order of 500° F greater than the corresponding section behind the left-hand interconnector fitting. Inasmuch as air-flow patterns approaching the burner have not yet been obtained, it is not known whether this shift is a result of air-flow variations or maldistribution of fuel.

Figure 13. - Circumferential temperature distribution near-critical section of burner liner B at various engine speeds.

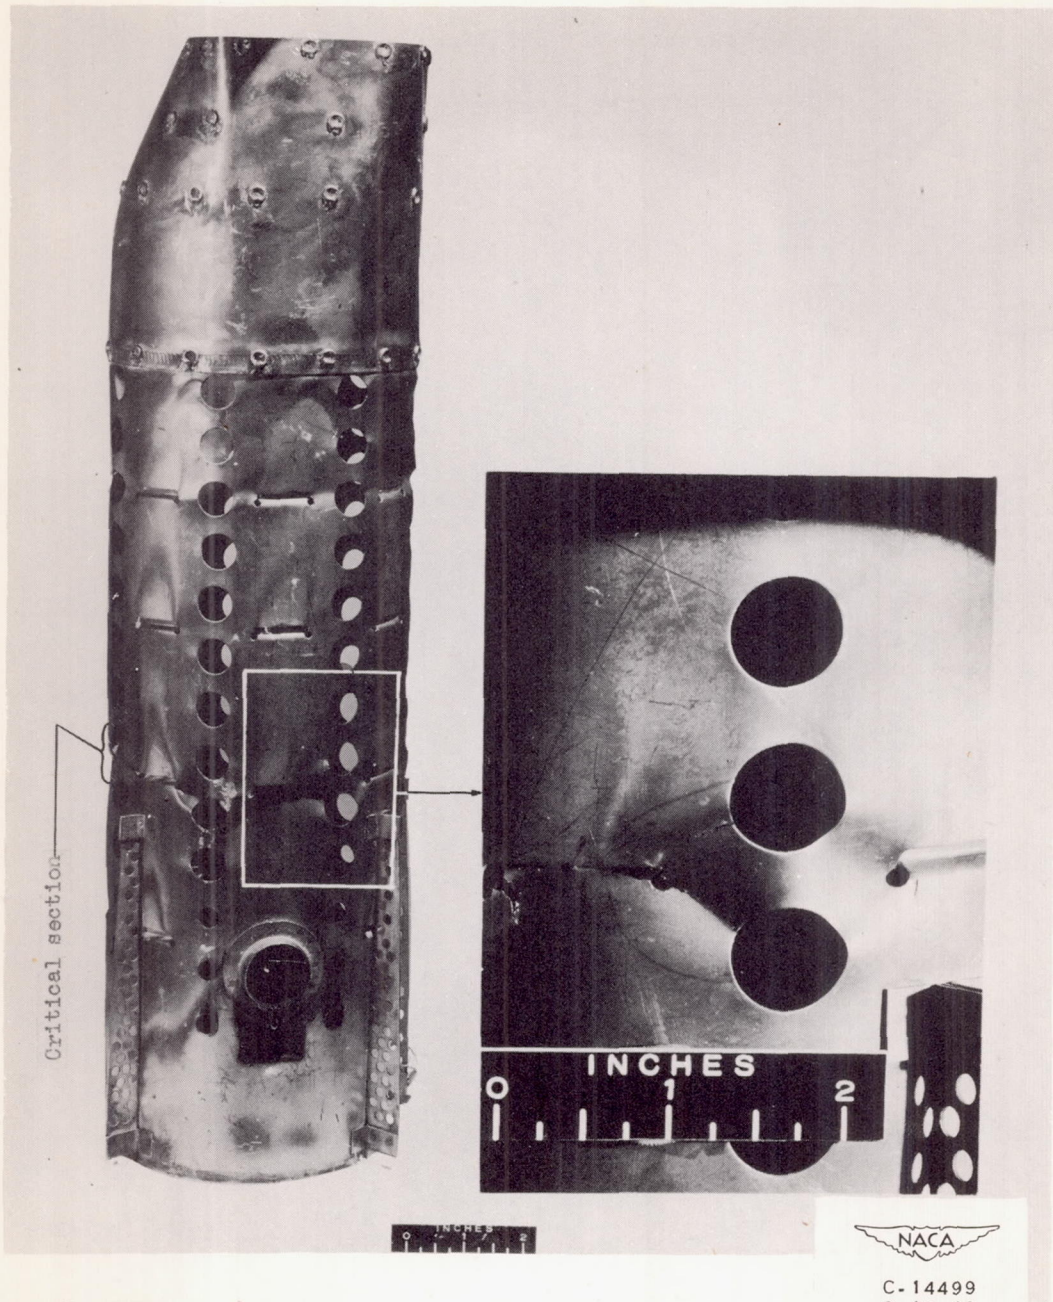
A liner failure typical of 14 liners removed from a service engine after 36 hours and 10 minutes operation is shown in figure 17. The severe warping and fractures are clearly shown in the photograph. The most severe warping and fractures occur in the belt of louvers marked "critical section."

This thermocouple was one of the belt nearest the critical section, which is located about 8 inches downstream of the burner-liner inlet. Most of the buckling and fracturing of burner liners investigated occurred in the critical section.

Figure 17. - Typical burner-liner failure. Total operating time, 36 hours and 10 minutes.
