NACA TN 4030

TECHNICAL NOTE 4030

EXPERIMENTAL INVESTIGATION OF CERMET TURBINE BLADES  
IN AN AXIAL-FLOW TURBOJET ENGINE

By William C. Morgan and George C. Deutsch

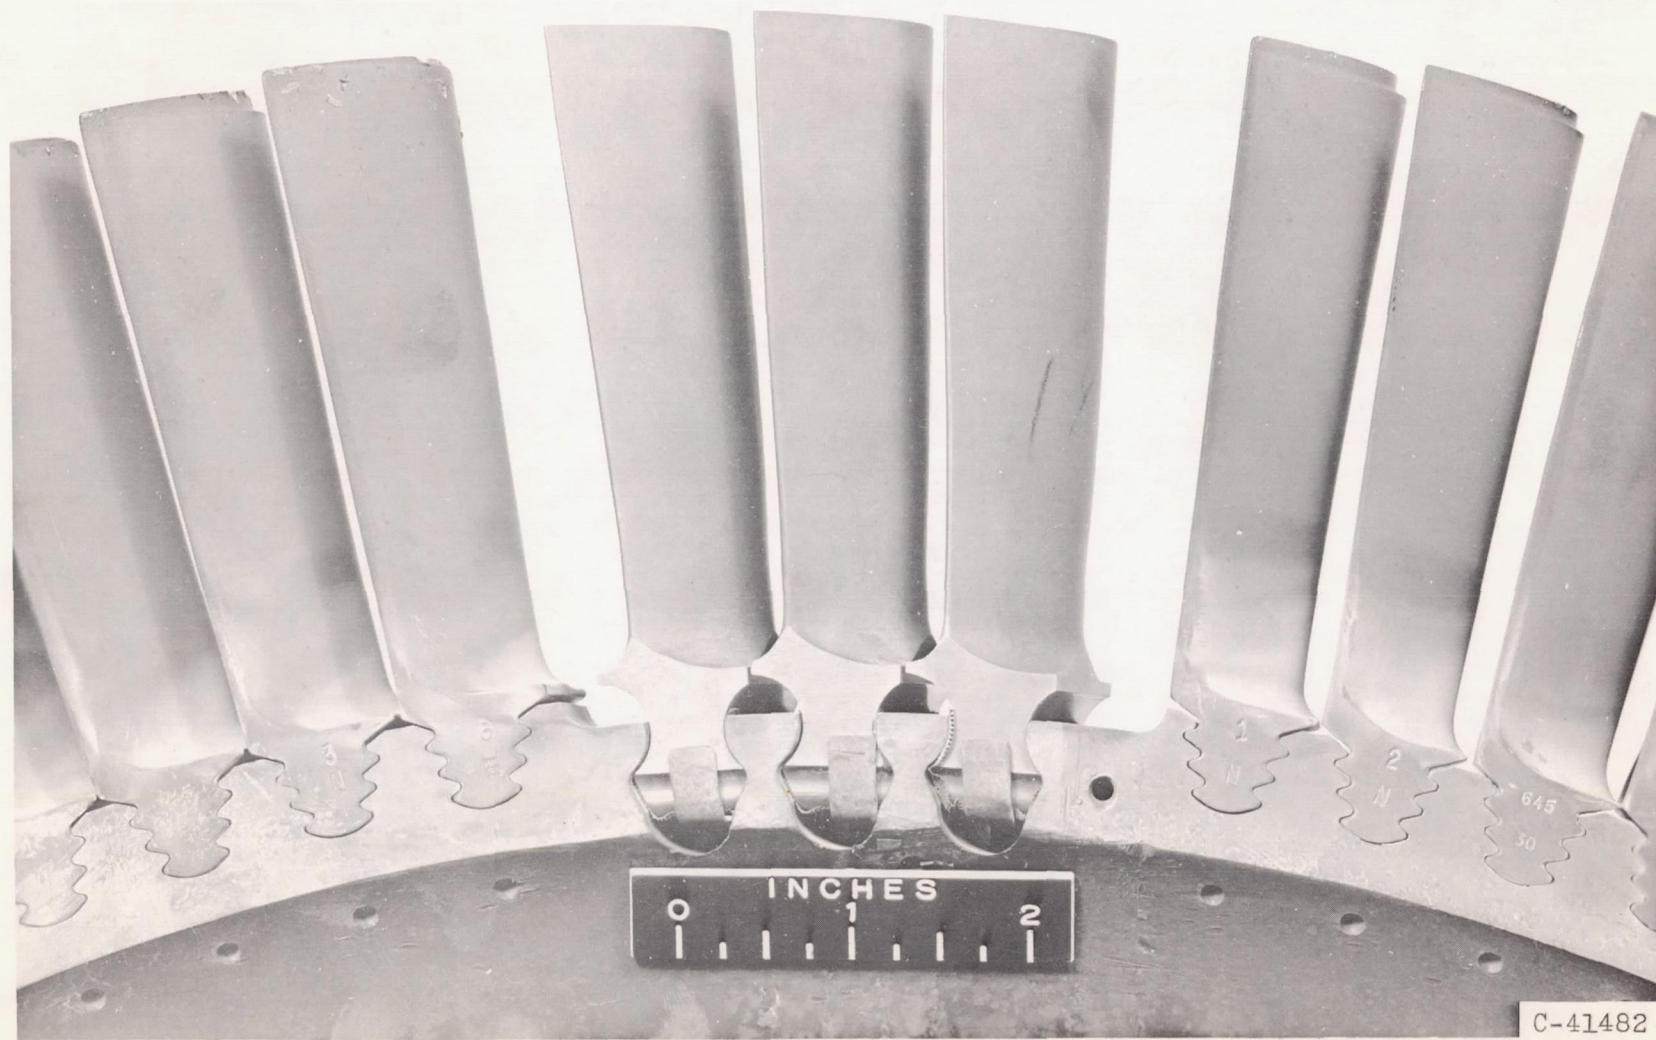
(c) Vibration may have been more serious in the six-blade tests. The spacing between the outer blades of a cluster of three and the adjacent metal blades was not a normal condition (fig. 2). In the course of a concurrent program on light-weight metal blades one test blade was placed in the space normally occupied by two blades. This metal test blade failed because of fatigue in the tip after a short time; blade life was less than 2 percent of the time for similar test blades in standard spacing.

Figure 2. - Three cermet turbine blades mounted in space normally provided for four standard metal blades.

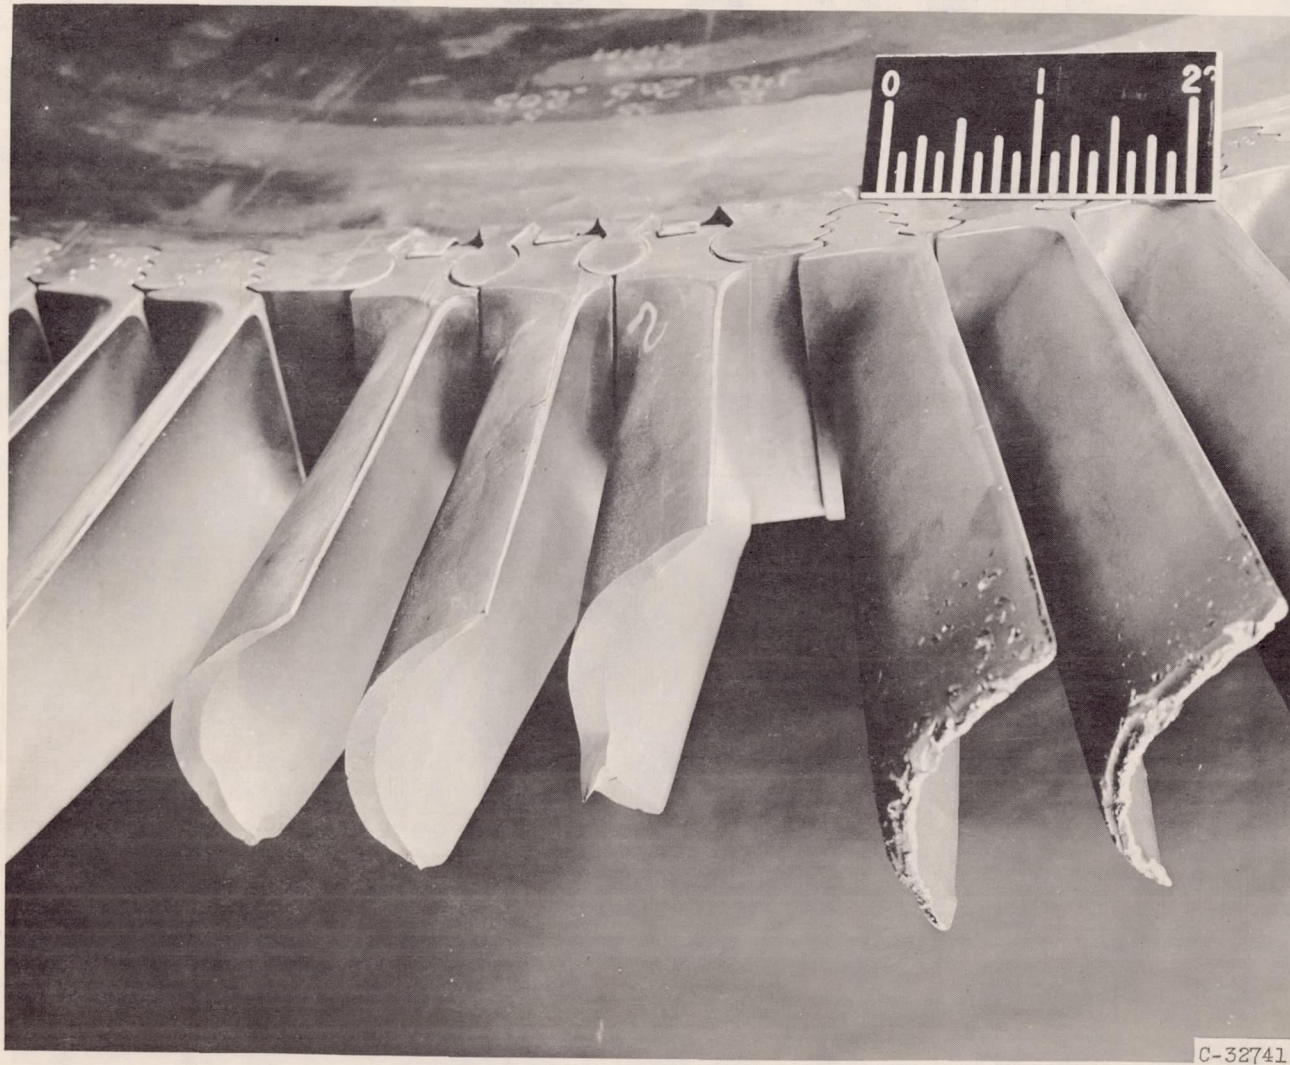
Table I gives operating time, number of starts, test conditions, and brief description of failure. In most of the early tests the blades were damaged in the tip region (tests 1 to 4 and 7). Figure 5 shows a typical failure. There are two possible causes for these failures, impact and fatigue.

Damage may have been caused by the impact of carbon fragments passing through the turbine. For example, hard carbon deposits were found in the combustion chambers in amounts considered excessive. This was a condition peculiar to the individual test engine. Figure 6 shows a piece of carbon removed during inspection. The deposits were not homogeneous, varying from a soft and amorphous material to a silver-gray substance comparable to industrial limestone slag. Spectroscopic analysis did not indicate the presence of material other than carbon.

Fatigue was considered as the other possible cause of blade failure. Damage occurred principally as tip failure. Metal turbine blades fail in this area as a result of excessive vibration, and this lends credence to the possibility of fatigue damage to cermet blades.

Figure 5. - Blade failures in test 1 after 1 hour and 25 minutes at maximum turbine speed, typical of runs 1 to 4 and 7.

The substitution of gasoline for standard fuel made some improvement in maximum blade life. It was used in tests 5, 6, 9, 9a, 12, 13, and 14. Test operation of 43 hours and 57 minutes was obtained in test 14 before occurrence of failure. Periodic inspection showed that carbon formation was low. In tests where standard fuel was used, with the exception of tests 15 and 16 where test conditions were radically different, the maximum blade life was 19 hours and 27 minutes (test 8).

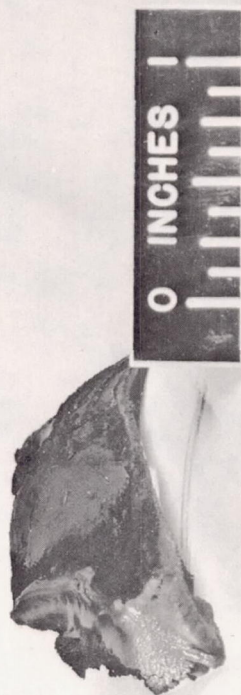
Figure 6. - Carbon deposit removed from combustion chamber.

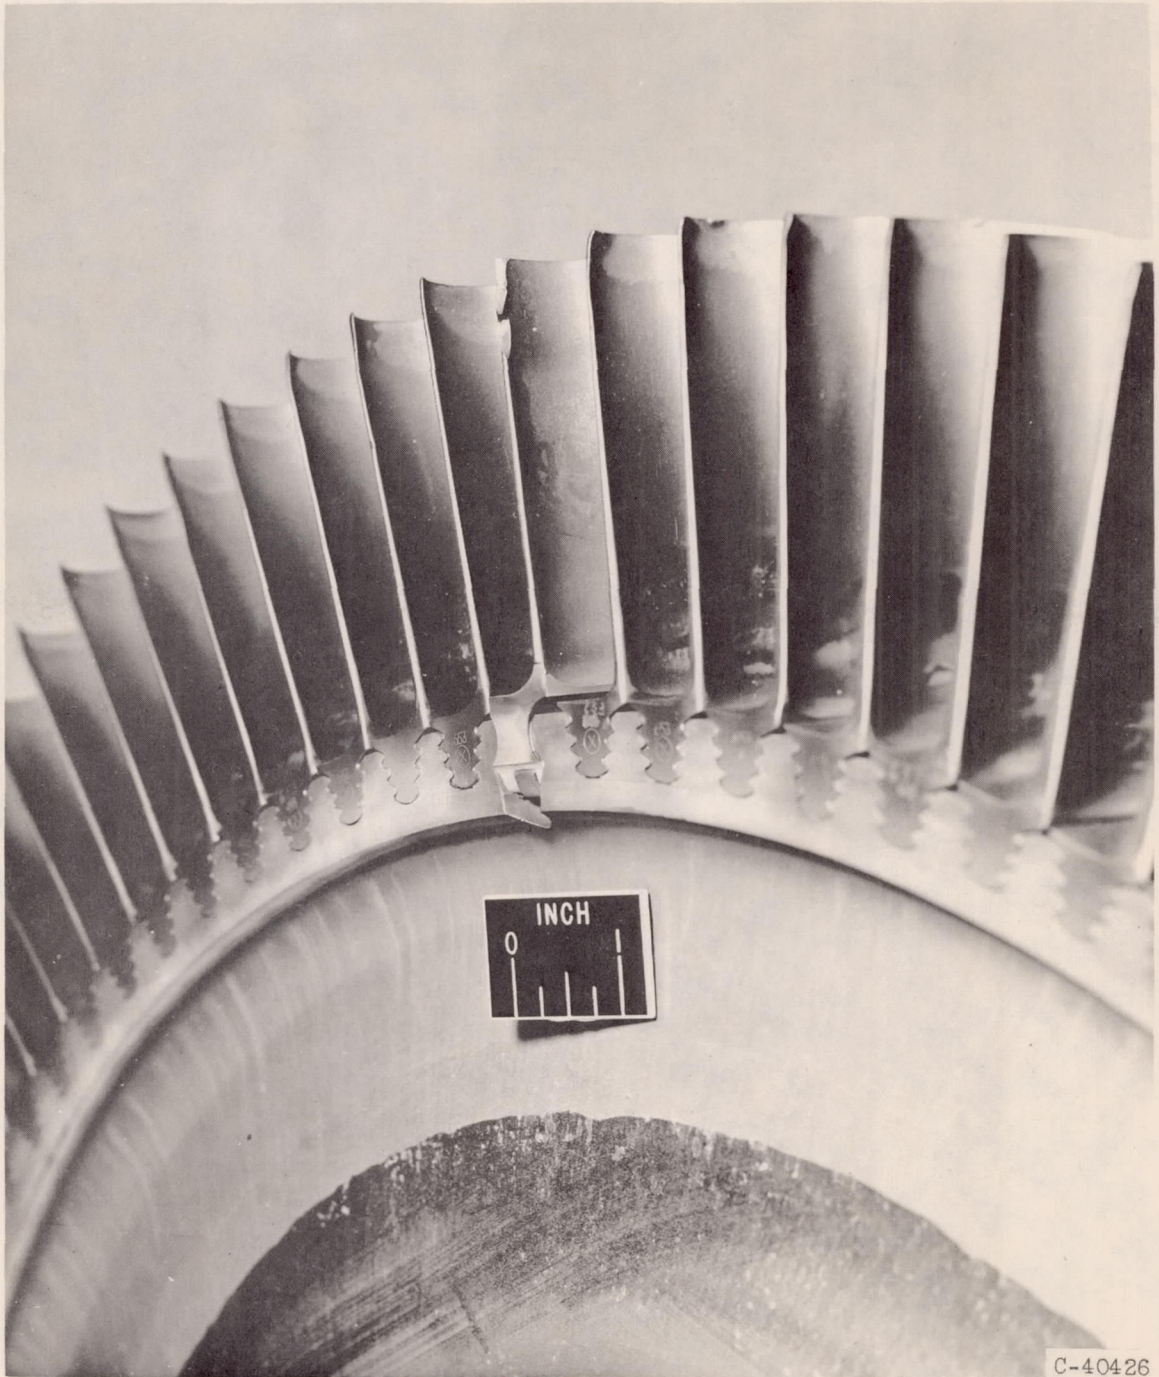
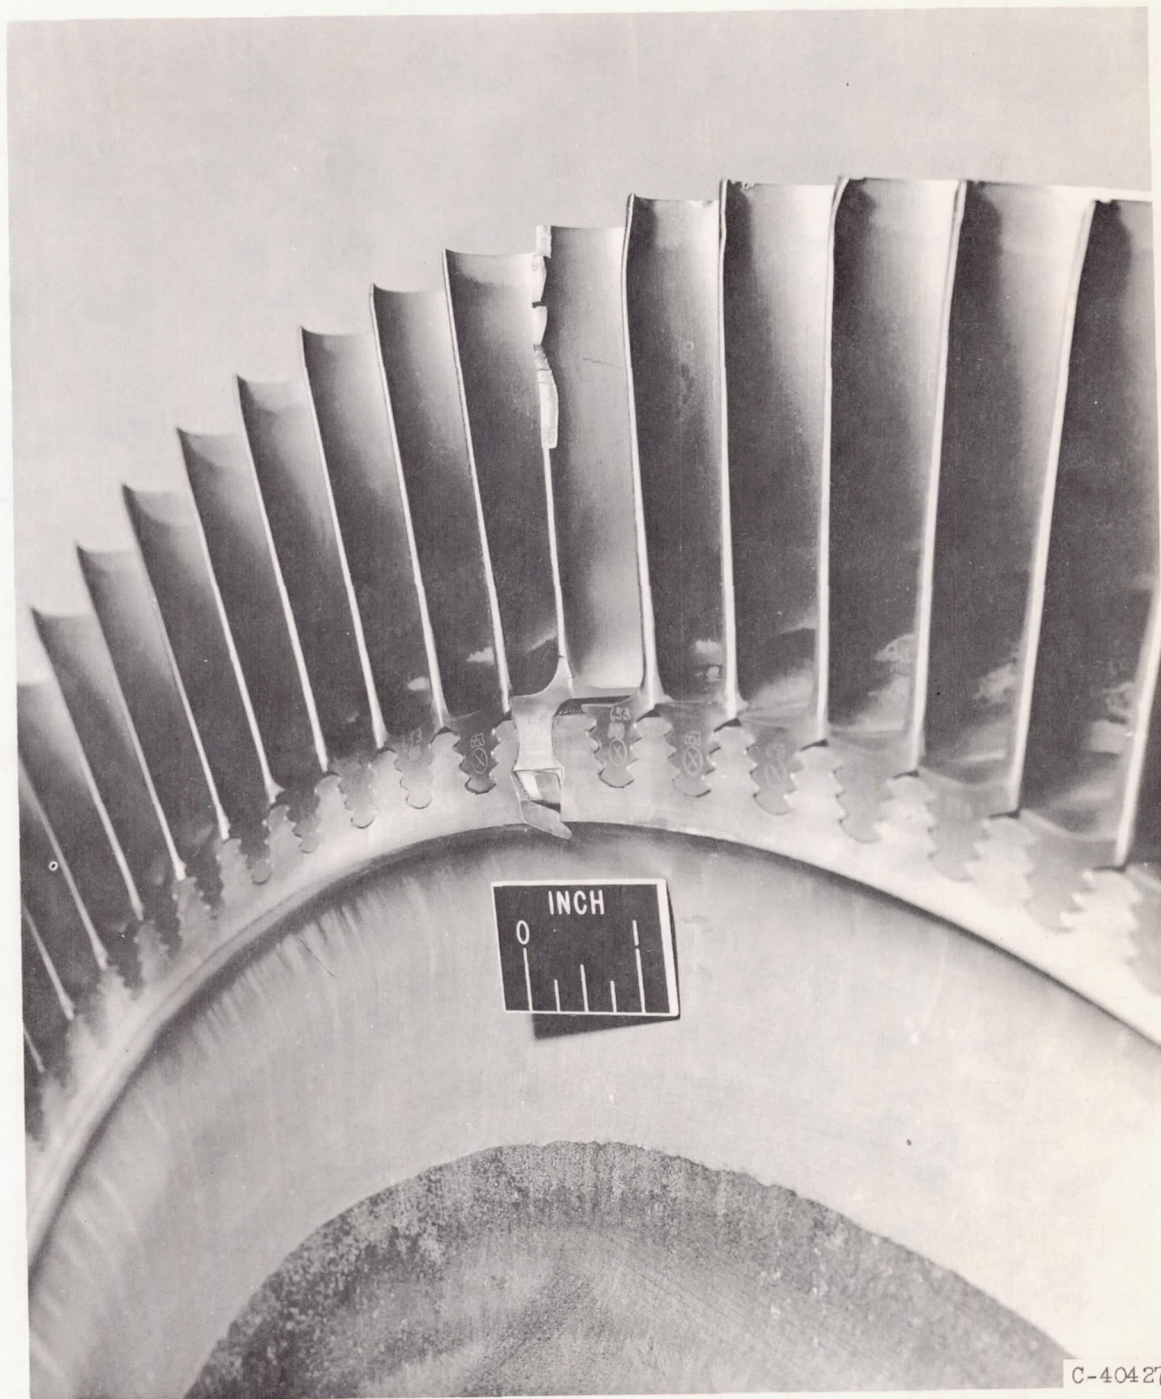
The best performances of cermet blades were obtained in tests 15 and 16, using the rotor modified for two test blades in standard spacing. The blades in test 15 had 1/4-inch radii at the tips. This test was discontinued after 150 hours at a turbine speed of 7950 rpm and exhaust temperature of 1260° F. One blade from test 15 lost a small chip from the tip (leading edge) after 84 hours and 34 minutes; the other blade was chipped in the same location after 97 hours and 38 minutes. Chipping continued during the remainder of the test. The extent of damage at the end of 150 hours is shown in figure 7,

Figure 7. - Cermet blades from test 15 after 150 hours at maximum turbine speed.

Figure 7. - Concluded. Cermet blades from test 15 after 150 hours at maximum turbine speed.

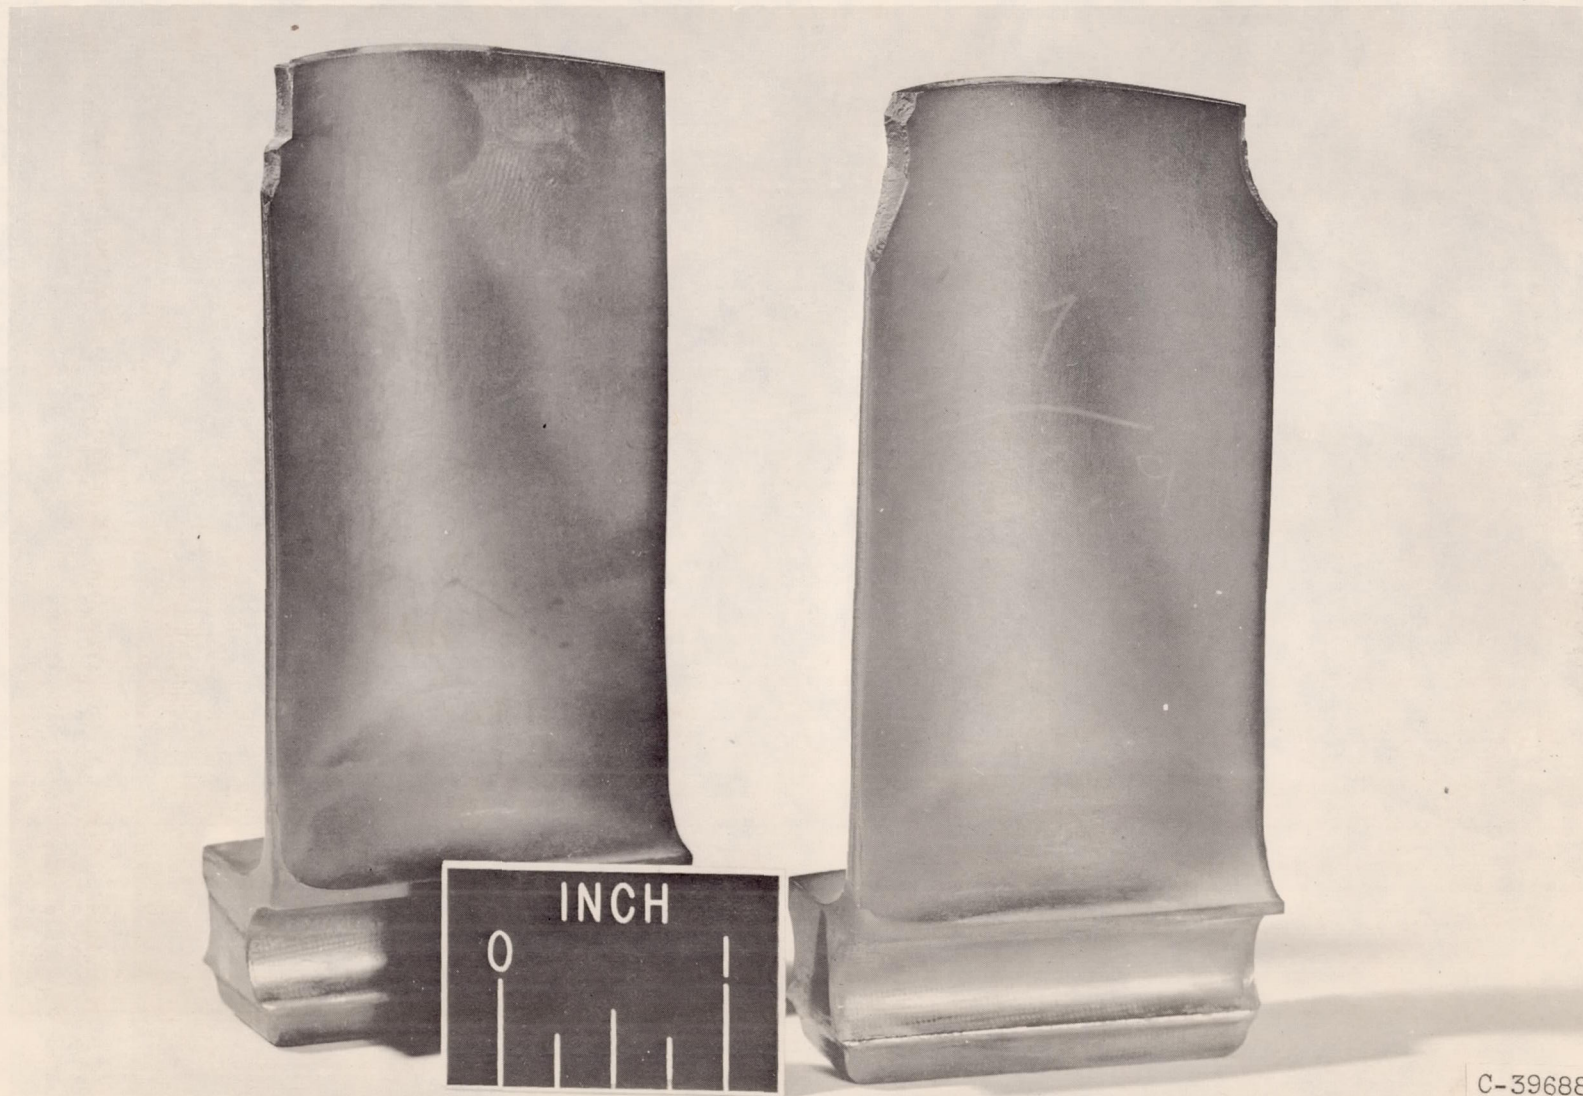
The two blades of test 16 were not modified. The test was ended after 150 hours and 30 minutes at the maximum conditions of operation. Initial chipping was observed in the leading edges of both blades and the trailing edge of one after 41 hours and 50 minutes. Damage was confined to the tip region. Figure 8 shows the total extent of damage at the end of the test.

16	2	None	0.03-In. short	Standard	JP-4	21	158	33	150	30				On conclusion of this test both blades had sustained minor tip damage. Chipping of the blade tips was observed after 41 hr 50 min of operation at maximum turbine speed. Chipping continued to occur during the remainder of the test operation. The blades were operated as received, with no rounding of the tips or honing of the airfoils.

Figure 8. - Cermet blades from test 16 after 150 hours 30 minutes at maximum turbine speed.
