TECHNICAL NOTE 3190

FATIGUE INVESTIGATION OF FULL-SCALE
TRANSPORT-AIRPLANE WINGS

SUMMARY OF CONSTANT-AMPLITUDE TESTS THROUGH 1953

By M. J. McGuigan, Jr., D. F. Bryan, and R. E. Whaley

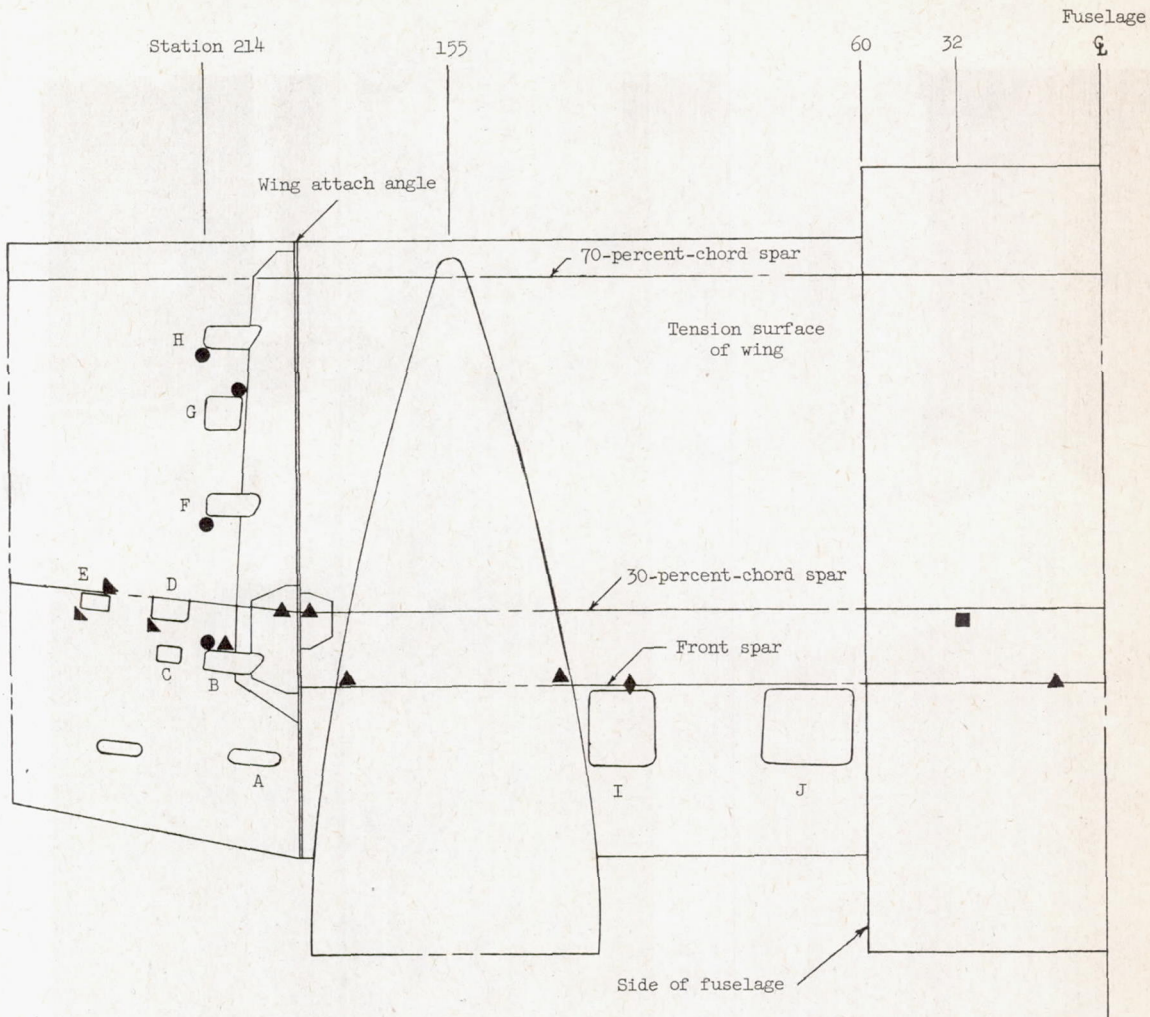
The five types and their locations are shown in the plan view of the tension surface in figure 5, and are illustrated in figures 6 and 7. Most of these types of failures occurred in stress raisers which would be present in similar form on almost any metal aircraft structure.

Figure 5.- Locations and types of fatigue failures.

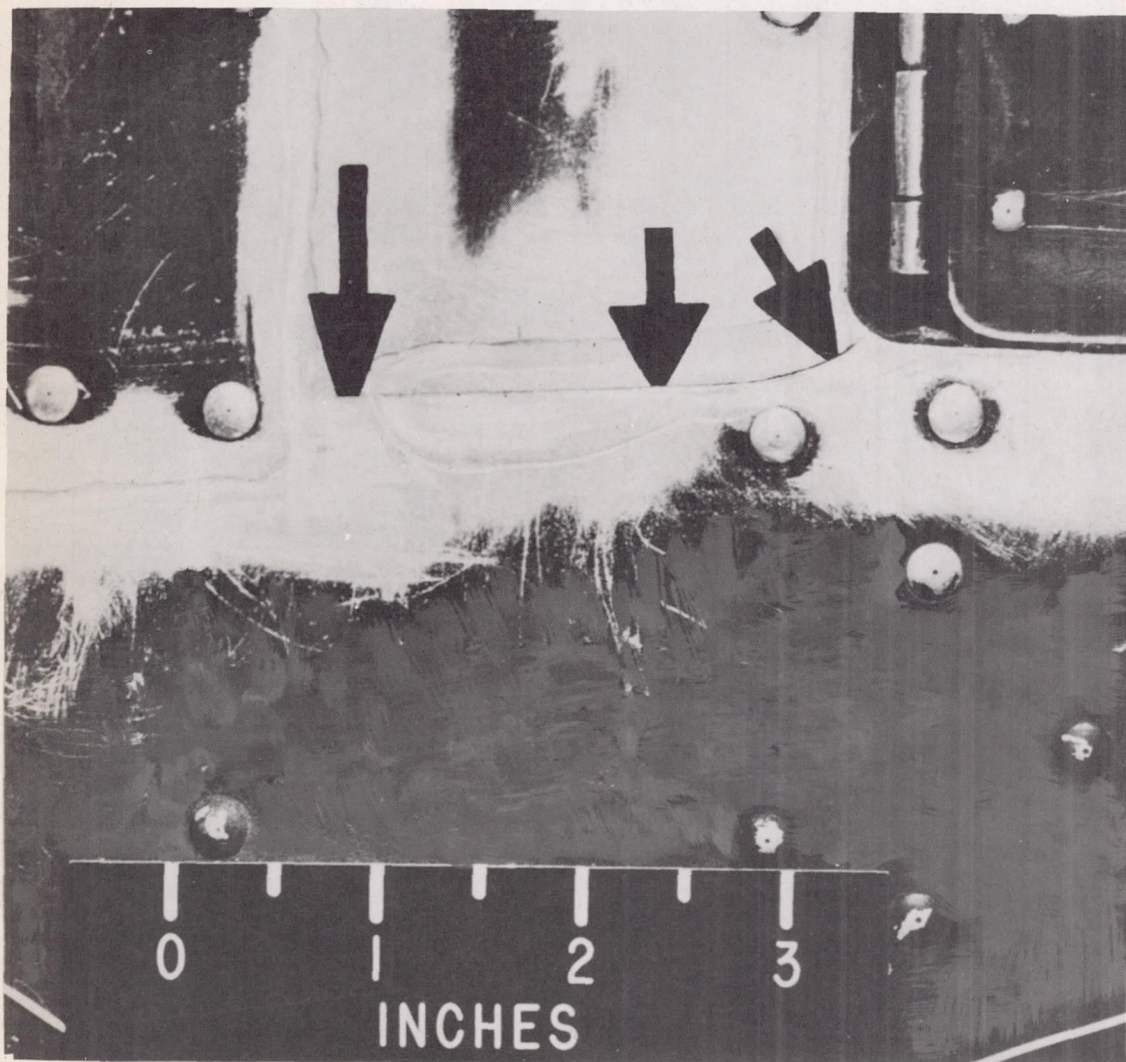
L-77922.4

The type I failures originated in the corners of inspection cutouts B, F, G, and H, and examples are shown in figures 6(a) and 6(b). These cutouts had non-load-carrying covers and were all at span station 214. Most of the failures occurred in the vicinity of the spar at the 30-percent-chord position, which was the most highly stressed region as indicated by the chordwise stress-distribution survey at this station. Since span station 214 contained numerous cutouts, doublers, and other discontinuities and therefore yielded an irregular stress distribution, another chordwise survey was made at span station 235, which was the nearest station that was free of these discontinuities. The gages used in these surveys were oriented so as to measure the strain in a spanwise direction. The results of these surveys are presented in figure 8, along with a cross section of the tension surface at span station 214. This figure indicates that for both of these stations the highest stress occurs in the vicinity of the 30-percent spar.

(a) Type I failure at forward outboard corner of inspection cutout F.

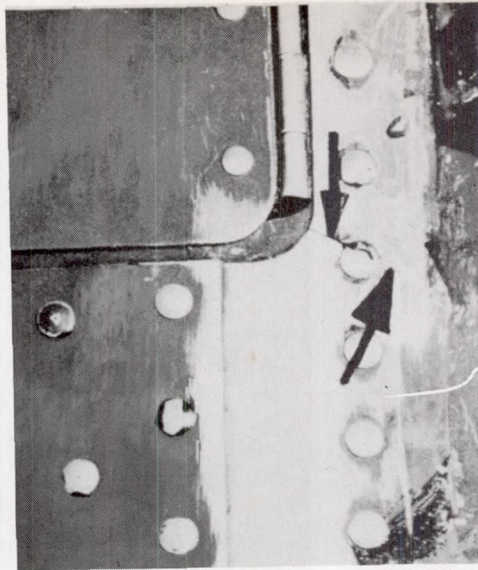
L-77923.1

(b) Type I failure at forward outboard corner of inspection cutout H.

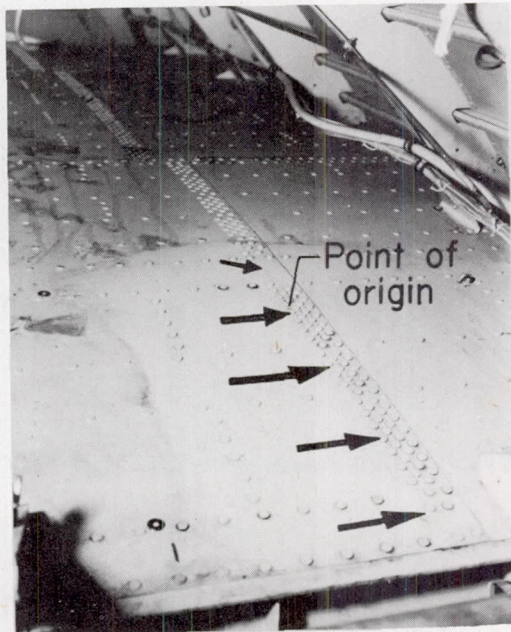
L-65799.2

The type II failures, which originated in riveted tension joints, all occurred at span station 32 inside the fuselage in the vicinity of the 30-percent spar. A photograph of this type of failure is shown as figure 6(c). A chordwise distribution of stress at span station 32 was included in reference 1 and indicated that the higher stresses again occurred in the vicinity of the 30-percent spar. These failures were consistent during the earlier tests but did not occur during the later tests because of the reinforcing strip previously described.

(c) Type II failure in riveted tension joint.

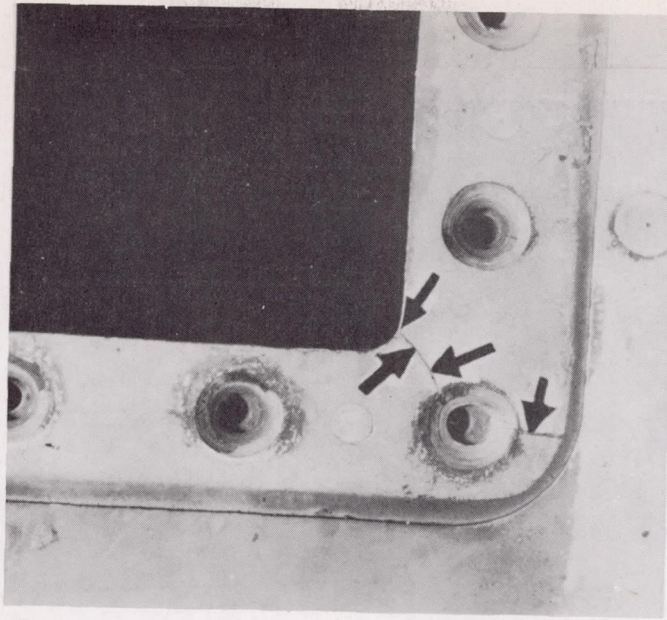
The type IV failures occurred in internal reinforcing doubler plates around cutouts D and E, located outboard of span station 214 and immediately forward of the 30-percent spar. A photograph of this type of failure is presented as figure 6(d). These cutouts had cover plates that were fastened to the reinforcing doubler plate with machine screws and channel nuts. The failures originated in the screw holes on some wings and in the smaller-radius corner of the internal doubler plate on others, frequently occurring very early in a test. These failures spread into the skin on only two occasions but in no case did they grow to more than a few inches in length.

(d) Type IV failure in reinforcing doubler plate at inspection cutout D. L-77924

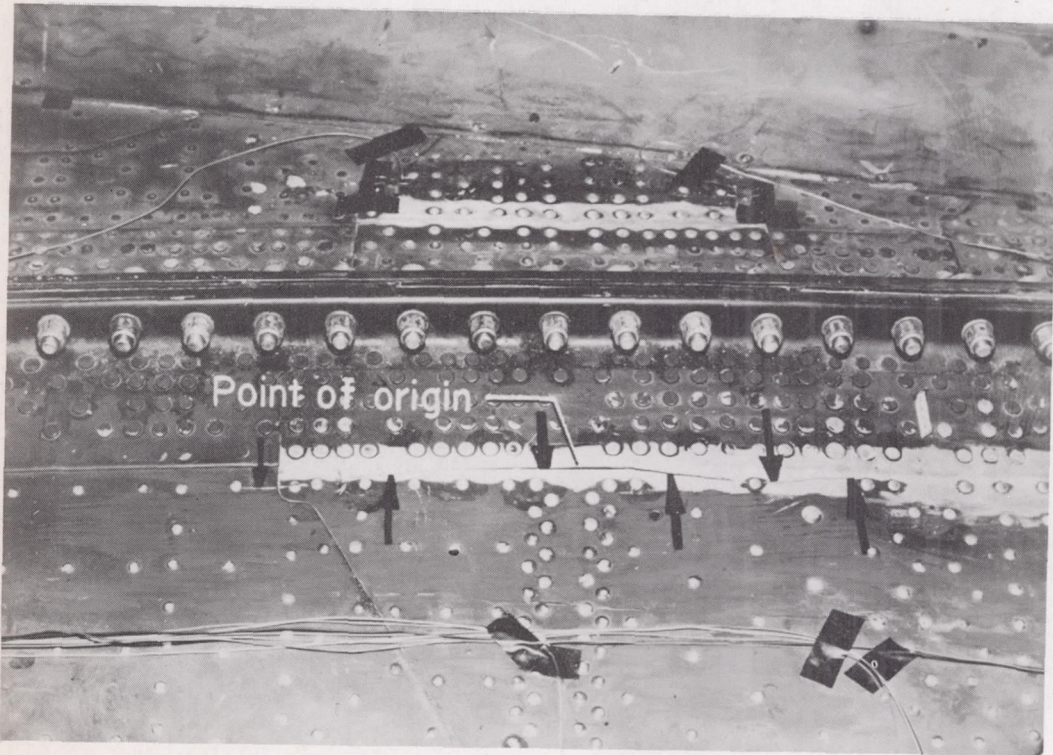
(e) Type V failure in joggle in external reinforcing doubler plate. L-67351.1

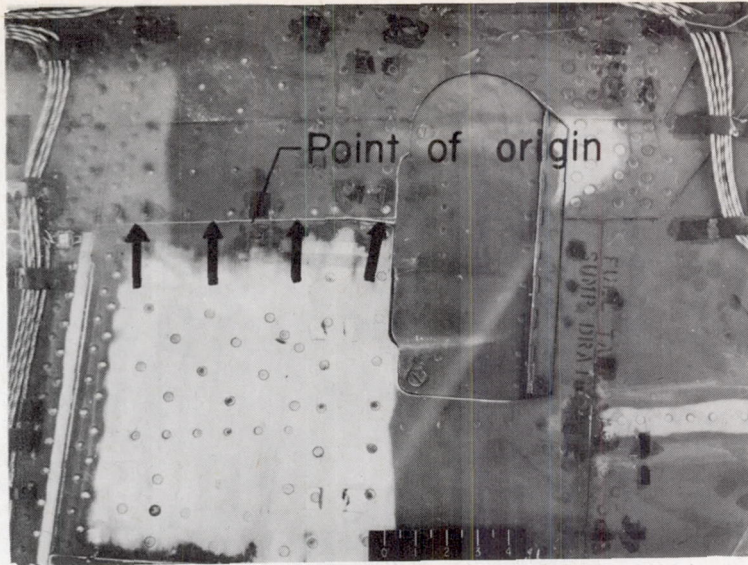
L-81785.2

(f) Type V failure at edge of external reinforcing doubler plate between cutout B and 30-percent-chord spar.

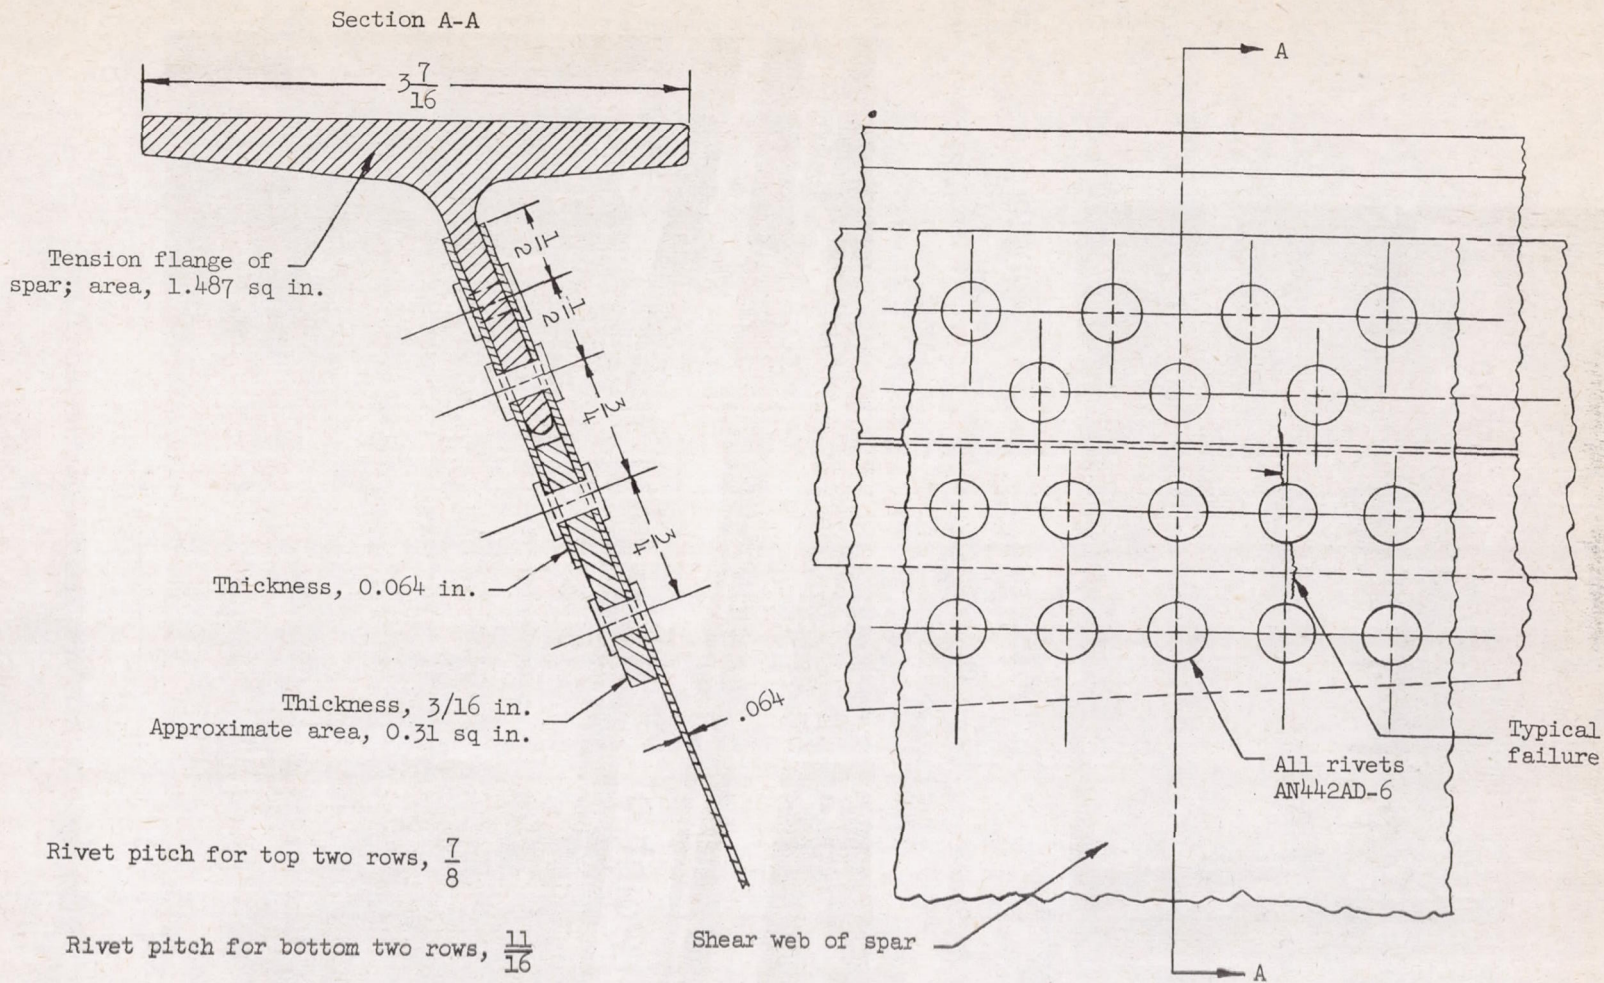
The type III failures occurred at span station 120 in the riveted joint connecting the shear web to the tension flange of the front spar. Since this location was very difficult to photograph, a drawing of the details of this joint is shown in figure 7. The cracks usually progressed vertically through the shear web and were accompanied by a crack in a small piece of skin over the spar cap.

Figure 7.- Details of riveted shear joint at span station 120 in which type III failures occurred.

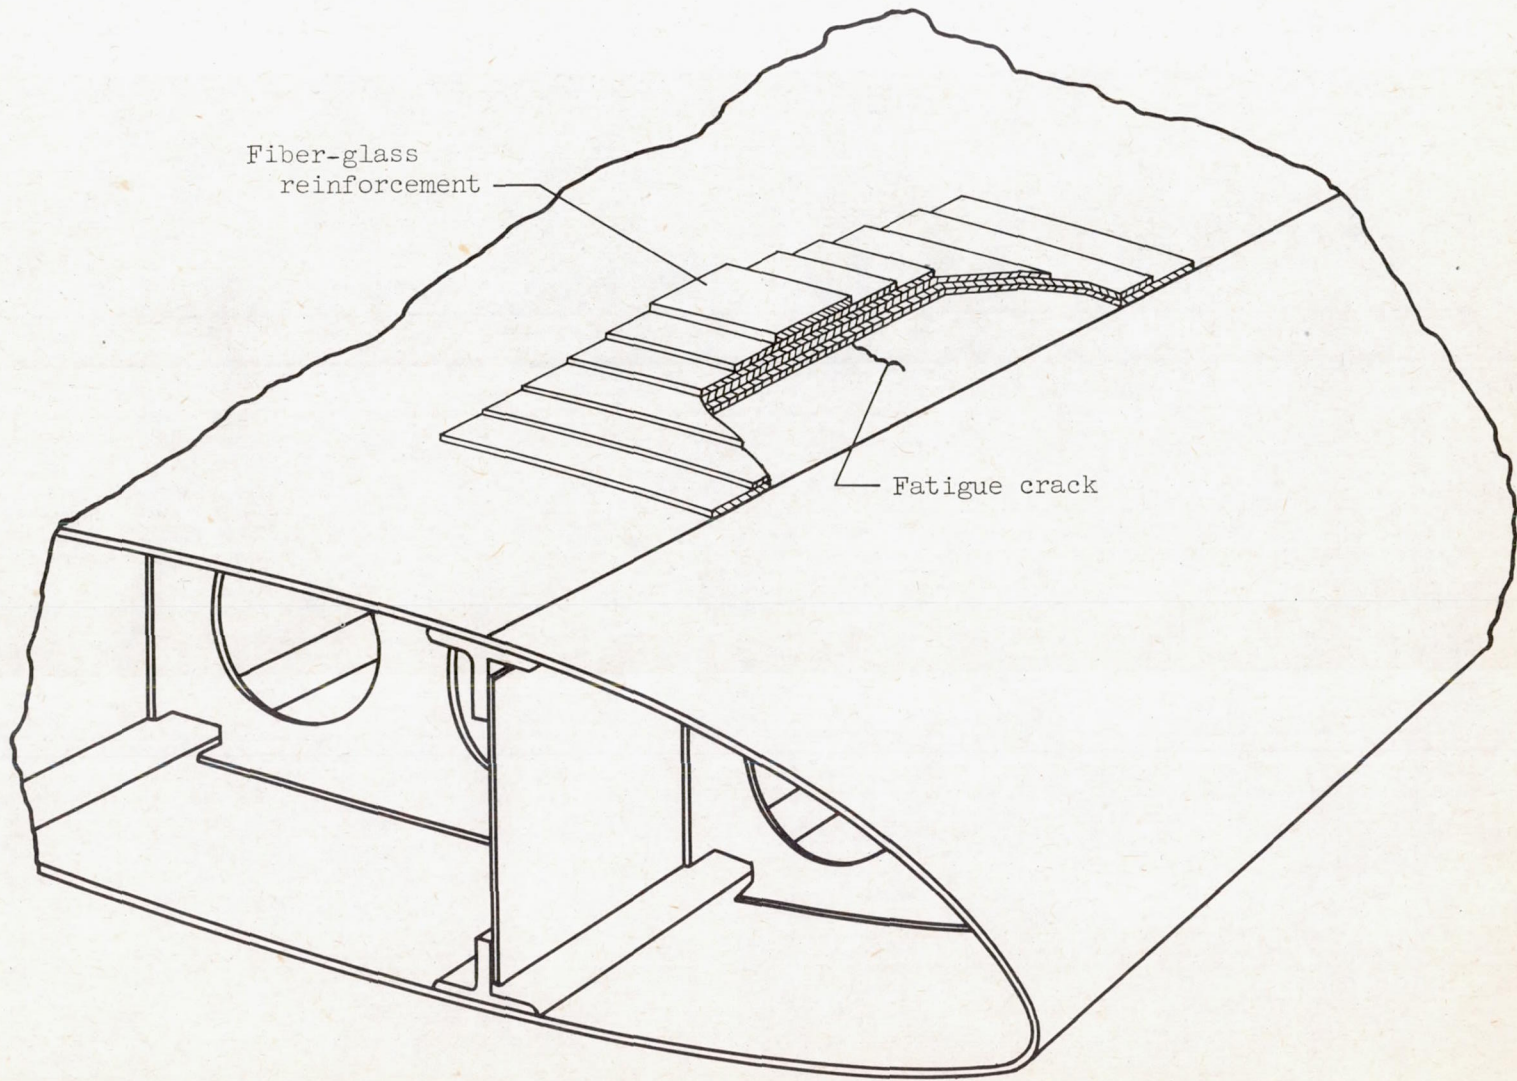
Figure 16.- Typical arrangement of fiber-glass reinforcement.

All fatigue cracks which were repaired by this method extended in essentially a chordwise direction on the tension surface of the wing. The patches were therefore designed principally to carry tension loads in a spanwise direction. For these fatigue tests the tension surface of the wing was the upper surface since the wing was mounted in the inverted position. The size of the patch required for satisfactory reinforcement naturally depended to some extent on the size of the fatigue crack to be repaired. The length and width of the reinforcement were determined by a generous estimation of the bond area necessary to secure adequate transfer of load from the wing structure to the fiber-glass reinforcement. Since the modulus of elasticity of the reinforcing material was considerably less than that of the aluminum wing structure, the thickness of reinforcement used was about five times the thickness of the structure to be repaired, so that both had about the same stiffness. All reinforcements were laminated from 10 to 16 layers of fiber-glass cloth arranged in a tapering stack which reached its maximum or design thickness over the fatigue crack. This arrangement is shown schematically in figure 16.

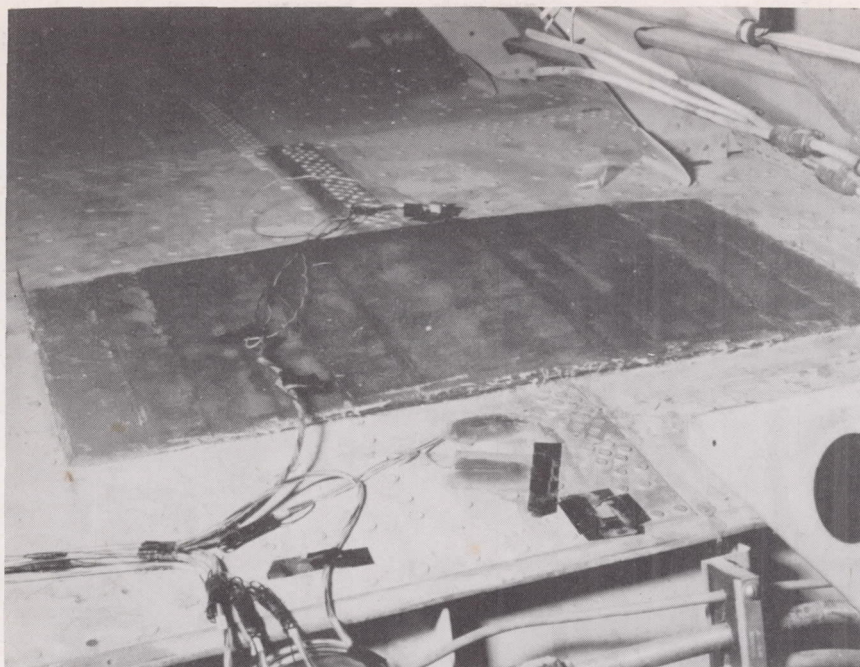
L-71724

(a) Inside fuselage at span station 32.

A number of these fiber-glass reinforcements have been used in the fatigue tests of the C-46 wings to repair structural damage resulting from fatigue cracks of several different types ranging in length from 1/4 inch to 12 inches. Two typical repairs are shown in figure 17. Part (a) of this figure shows the repair of a failure in a riveted tension joint at span station 32 similar to the failure shown in figure 6(c). Part (b) of figure 17 shows the repair of a failure inside the engine nacelle similar to the failure shown in figure 6(g). The latter location illustrates how these fiber-glass reinforcements may be cut to conform to various structural discontinuities. Repairs have also been made to the shear web of the front spar in the wing center section at station 120. In this case the fiber-glass reinforcement was applied to a vertical surface without great difficulty.

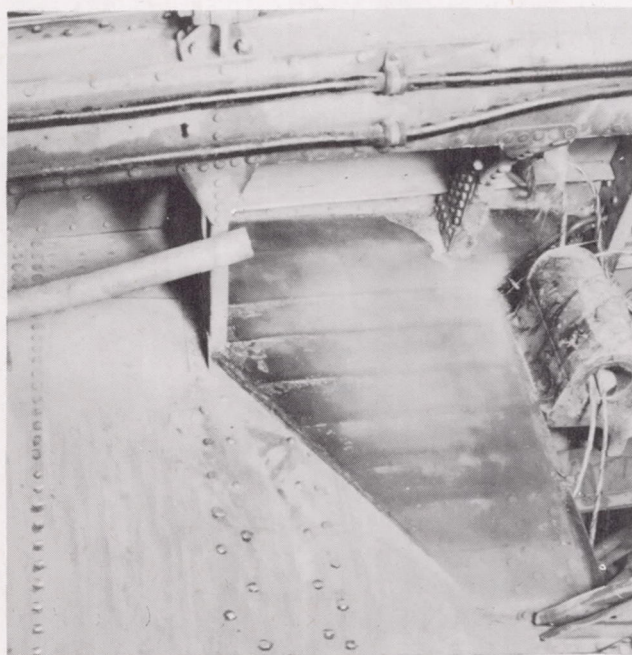
L-83859.1

(b) Inside engine nacelle.
