TECHNICAL NOTE 2920

INTERIM REPORT ON A FATIGUE INVESTIGATION OF A
FULL-SCALE TRANSPORT AIRCRAFT WING STRUCTURE

By M. James McGuigan, Jr.

Langley Aeronautical Laboratory
Langley Field, Va.

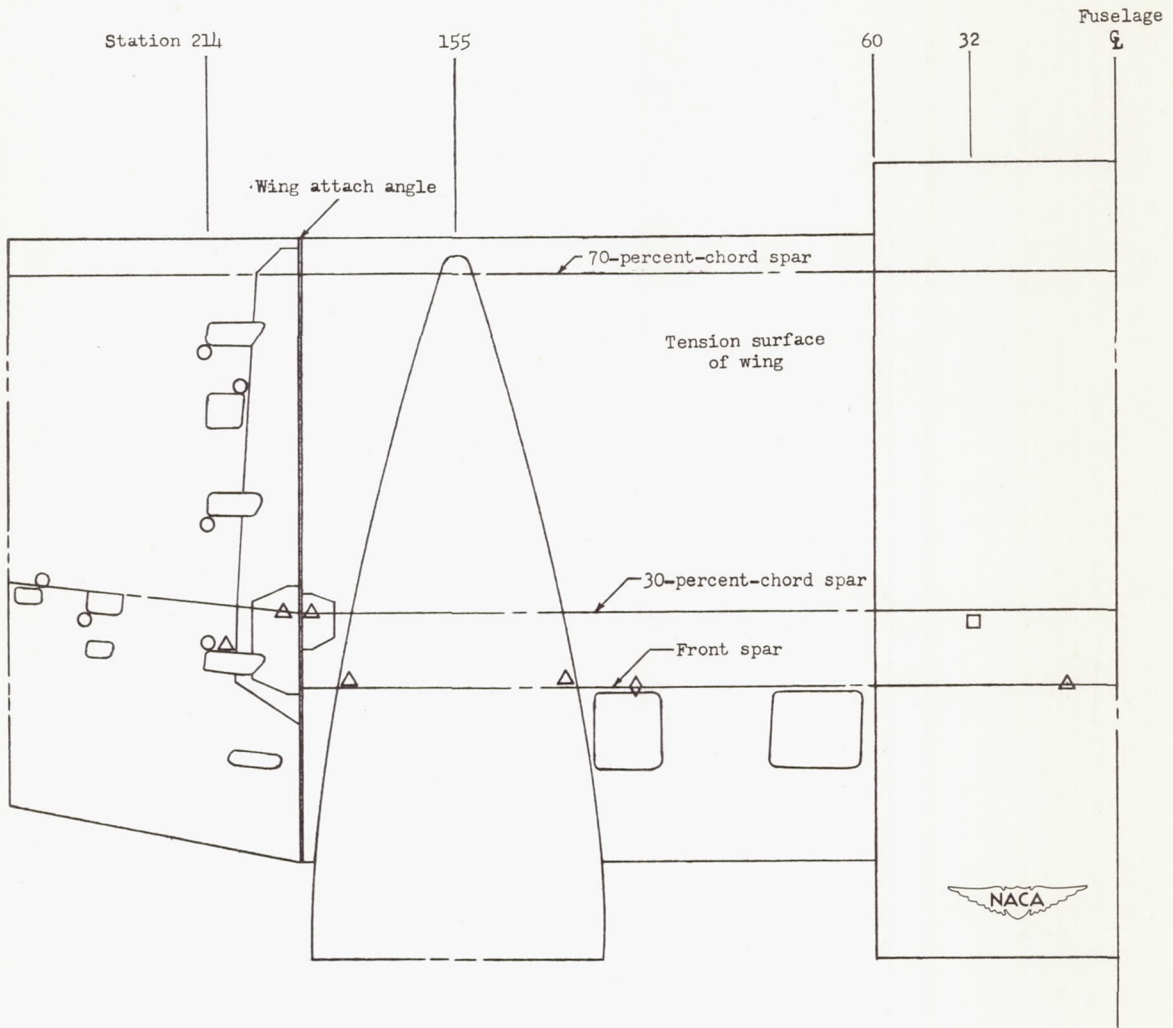
The fatigue failures that occurred in the specimens tested appeared to be concentrated in three principal localities. One locality was in the vicinity of the station designated as critical - span station 214 on the outer panel - in which 15, or almost half, of the failures took place. Another locality was in the vicinity of the engine nacelle where 12 failures appeared, and the third locality was a region in the center section of the wing near the center line of the aircraft where 7 failures appeared.

The first type included the 10 failures which originated at the corners of inspection cutouts. The second type included the 6 failures which occurred in a riveted tension joint near the center line of the aircraft. The third type included the 6 failures which occurred in a riveted shear joint where the shear web of the front spar was riveted to the tension flange of that spar. The fourth type included 12 failures which originated at abrupt changes or discontinuities in section or shape, such as the edge of a reinforcing doubler plate. The points of initiation for these four types of failure are shown in figure 7 which is a plan view of the tension surface of the wing. For convenience, failures that occurred on both wings are shown on a portion of one semispan.

Figure 7.- Location and types of fatigue failures.

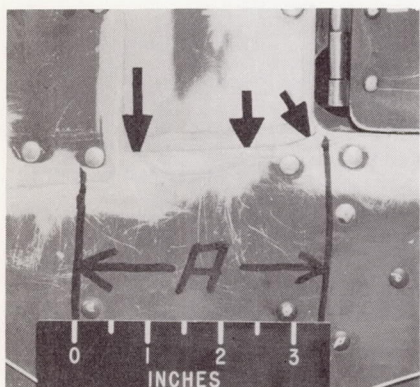
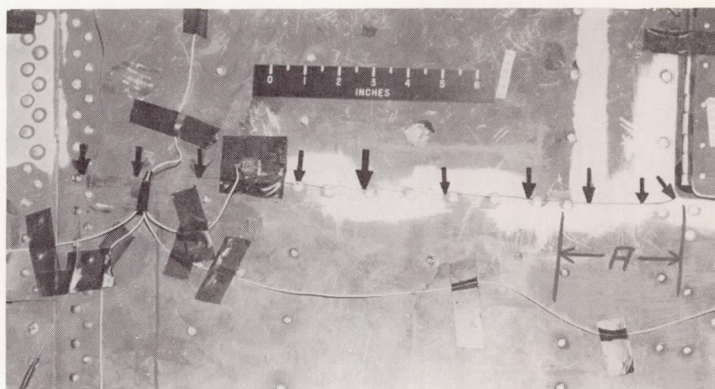
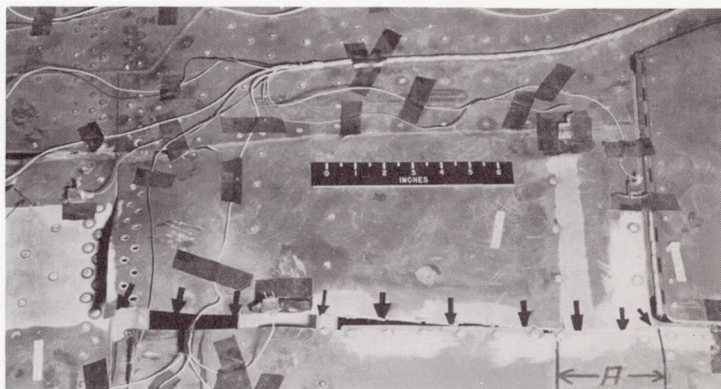
(a) Start of failure.

(b) Intermediate stage of failure.

(c) Final stage showing failure of 30-percent-chord spar.

Figure 9.- Three stages of typical failure that originated at corner of inspection cutout.

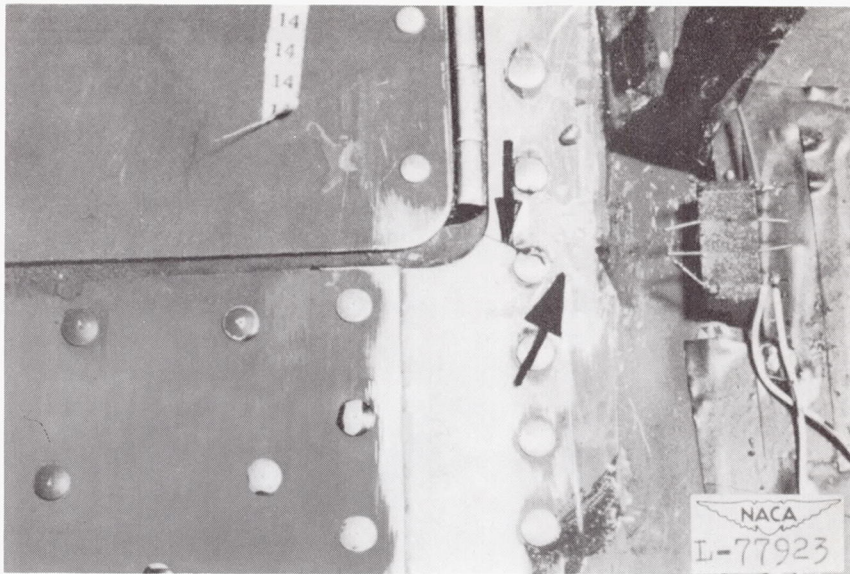
Figure 10.- Typical example of consistent failure that originated at corner of inspection cutout.

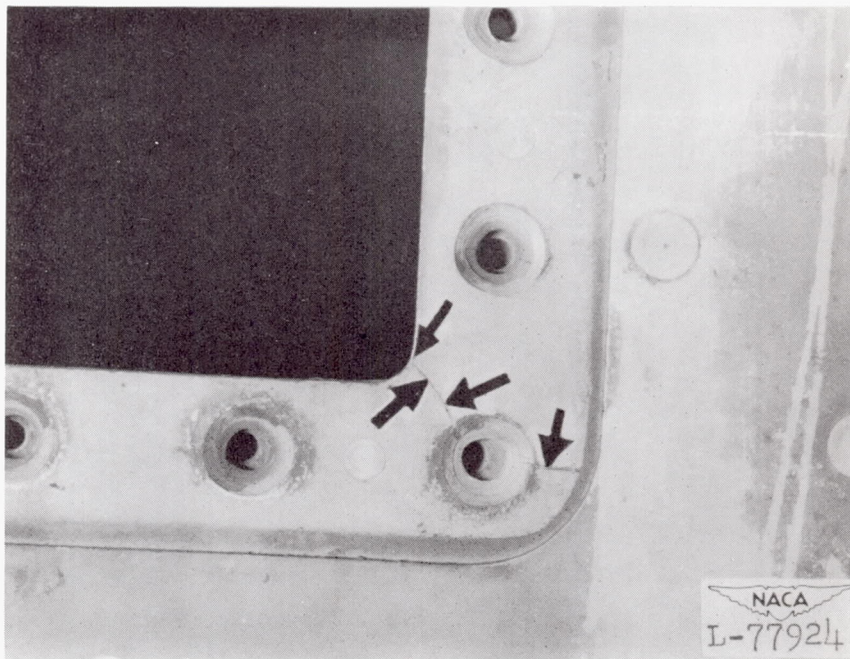
Although the corners of most of the inspection cutouts have fairly large radii, the corners of some of the reinforcing doubler plates underneath the cutouts have much smaller radii. This situation caused the initiation of some failures in the doubler plates which in one case progressed into the wing skin. An example of the start of one of these failures is shown in figure 11.

Figure 11.- Failure that originated in sharp corner radius of an internal reinforcing doubler plate.

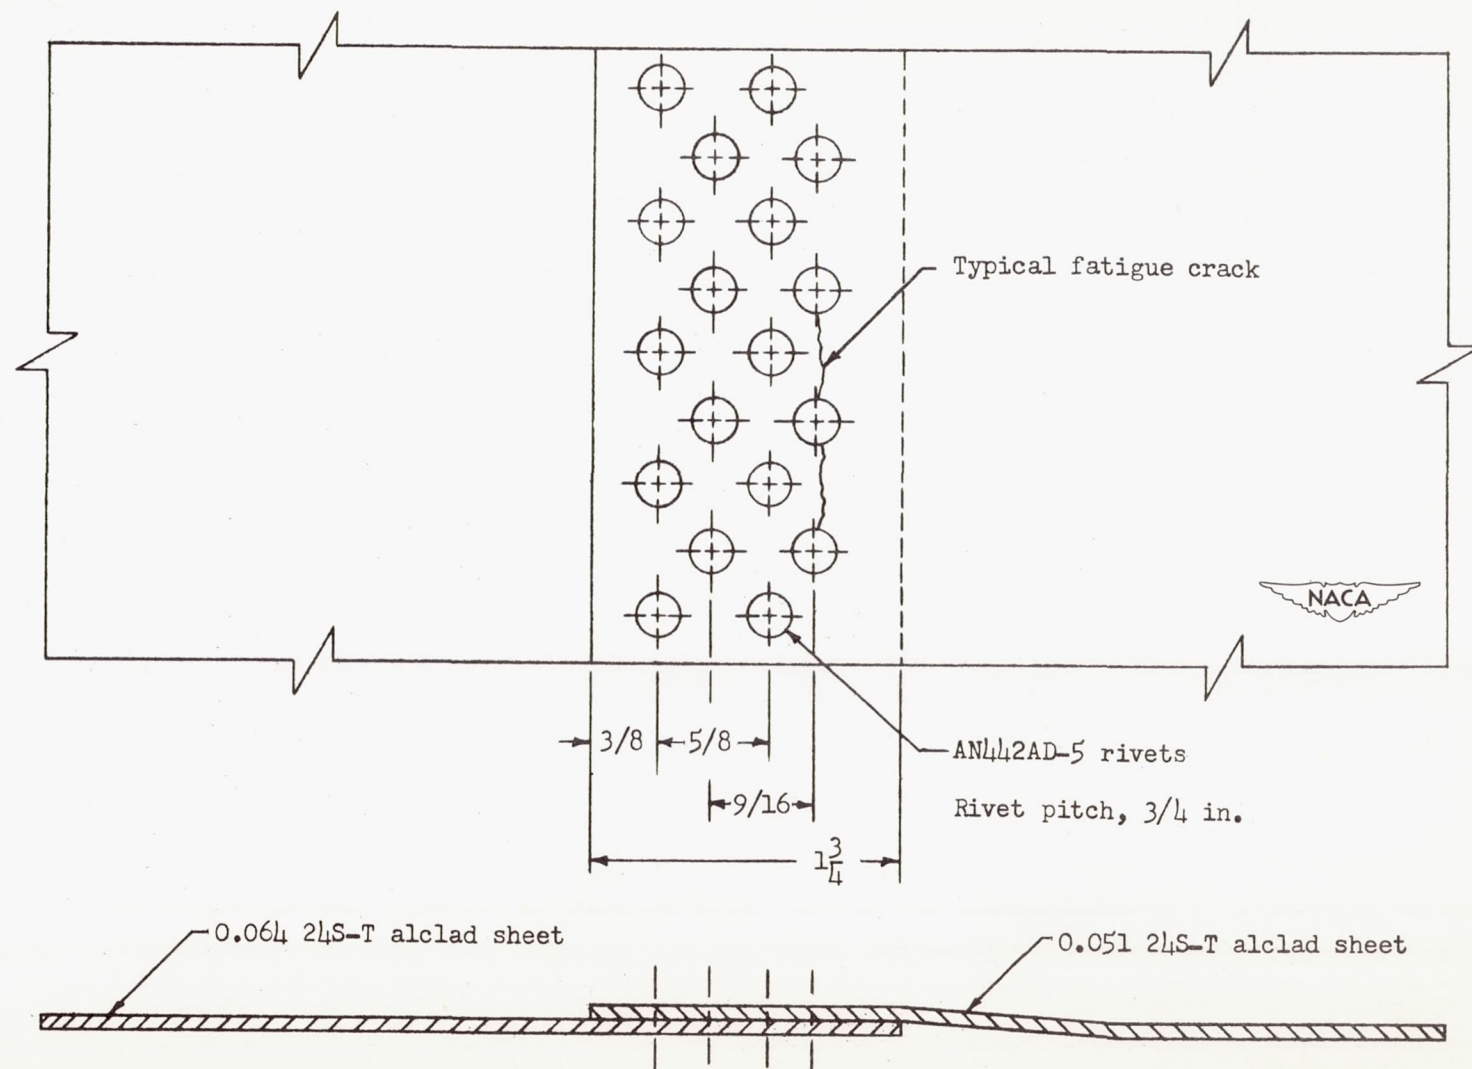
The second type of failure occurred in a riveted tension joint 32 inches from the aircraft center line. The joint extended chordwise at this wing station from the front spar to the rear spar. Failures of this type appeared on the left and right wing of the first three wing center sections in the same chordwise location and are listed as failures 1, 2, 11, 14, 22, and 23. The details of this joint and the manner of failure are shown in figure 12. The measured chordwise stress distribution through this section is shown in figure 13, from which it may be seen that the highest stress occurs at the point where all the failures originated.

Figure 12.- Details of riveted tension joint at span station 32. All dimensions are in inches.

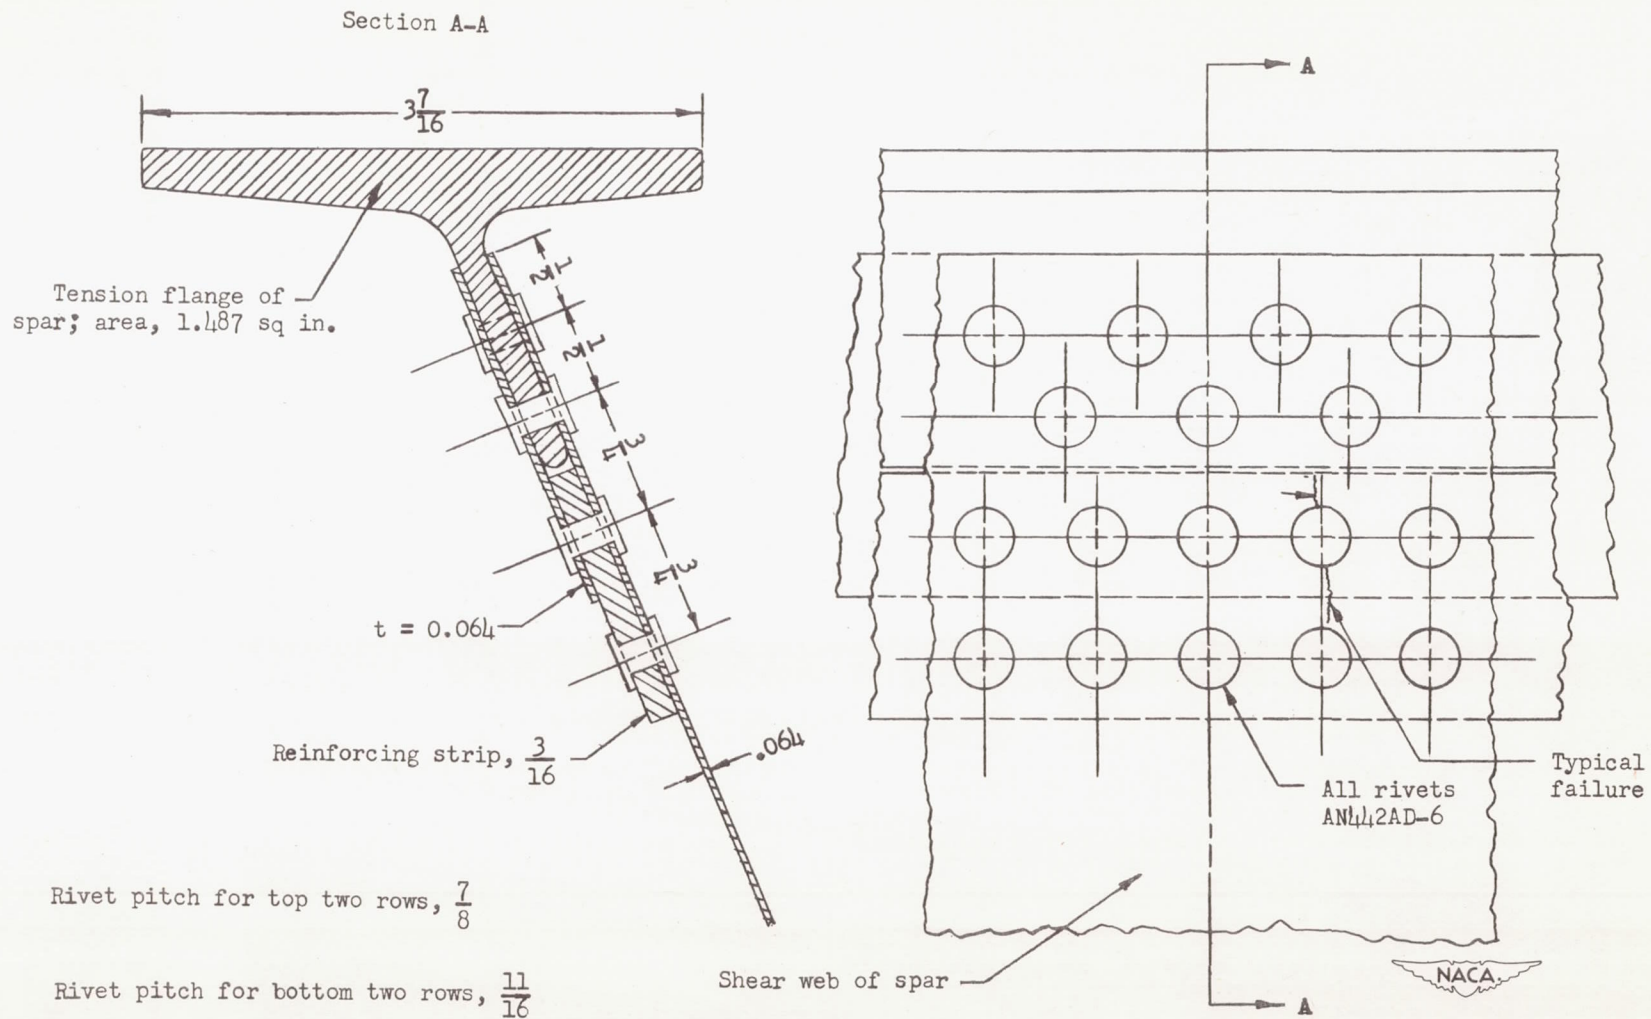
The third type of failure occurred in a riveted shear joint at span station 120 where the shear web of the front spar was riveted to the tension flange of that spar. There were four horizontal rows of rivets in the shear web and the fatigue failures originated in a rivet in the third row away from the tension surface of the wing as can be seen in figure 14. These failures are numbered 8, 9, 20, 21, 28, and 32. Although this joint is designed primarily for shear, strain-gage rosette measurements near the point of failure showed the principal stress to be approximately parallel to the tension flange of the spar. This condition would indicate that the failures were probably primarily due to tension stresses. The shear at this point in the spar was probably small since the spar ends a short distance outboard of this point as can be seen in figure 7.

Figure 14.- Details of riveted shear joint at span station 120. All dimensions are in inches.

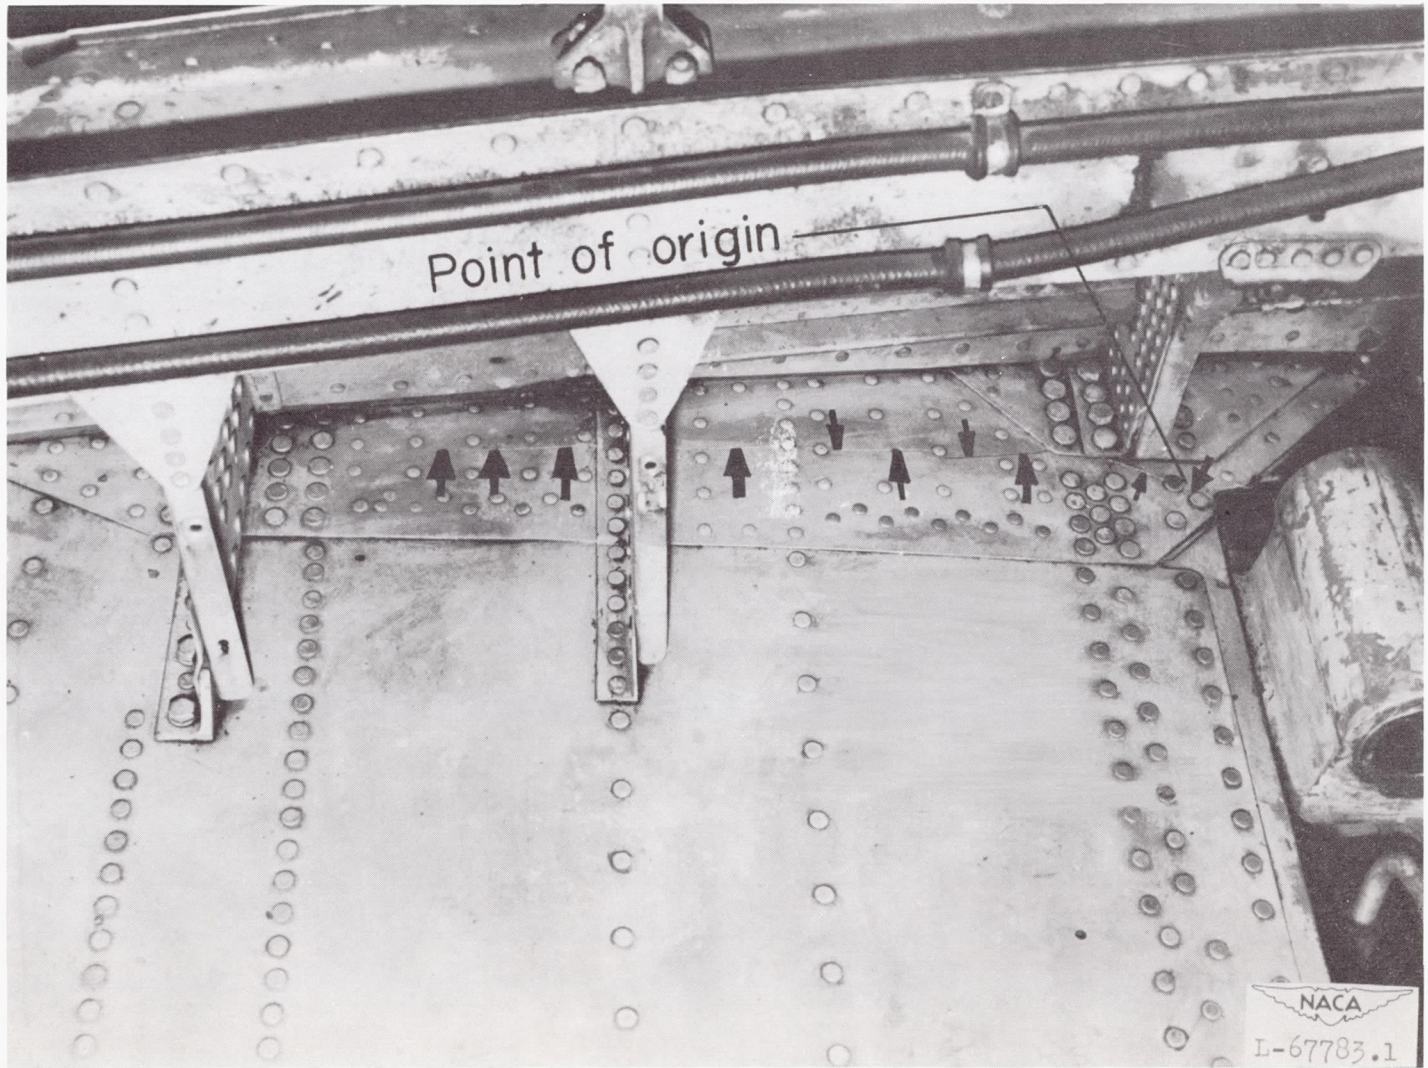
A typical example of those cracks which occurred at the junction of the engine nacelle and the wing spar and which are grouped in the fourth type is shown in figure 15. The failure shown is similar to failures 6, 7, 18, 19, and 30 and originated in a rivet hole near a half-round notch cut in the edge of the skin to eliminate interference of the landing-gear retracting strut with the wing skin during operation of the landing gear. Another failure of the fourth type which was repeated often occurred in a chordwise joggle in an external doubler plate near the wing attach angle. These failures appeared in three left wings and one right and are numbered 4, 10, 16, and 29. Failures were expected to occur at this point since the brittle-lacquer static test had indicated a high stress in this region. An example of this failure is shown in figure 16 after it had progressed to a considerable length.

Figure 15.- Failure inside right nacelle, span station 170.

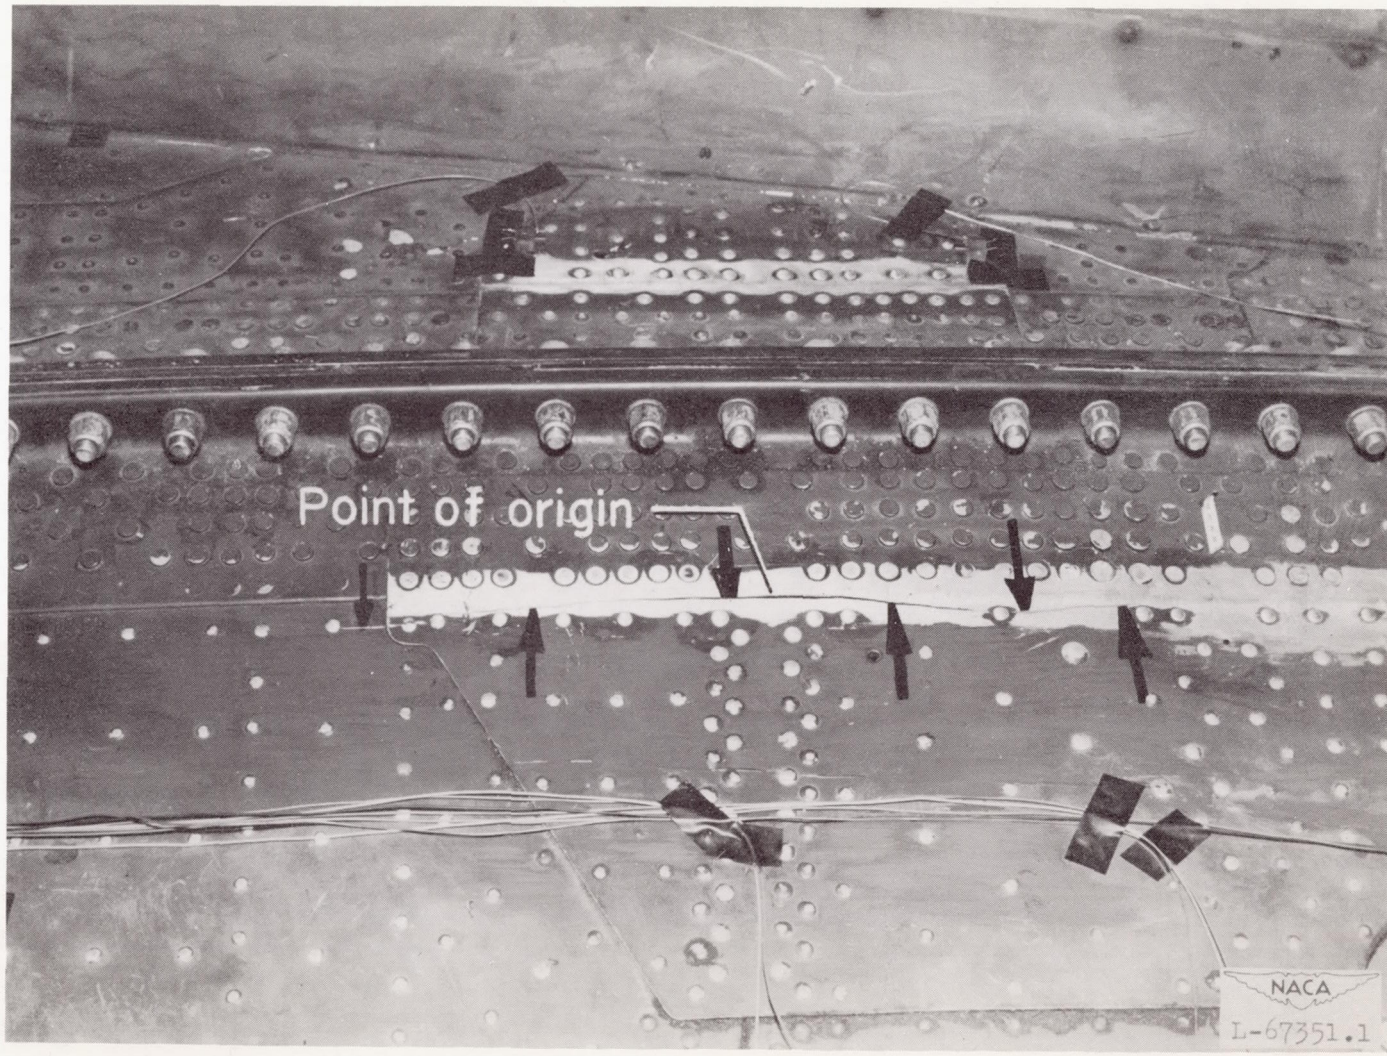
Figure 16.- Failure that initiated in a joggle of an external reinforcing doubler plate.
