TECHNICAL NOTE 2538

MECHANICAL AND CORROSION TESTS OF SPOT-WELDED ALUMINUM ALLOYS

Fred M. Reinhart
National Bureau of Standards

Washington
December 1951

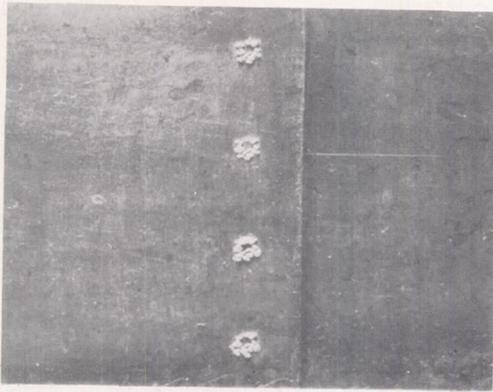
- A no corrosion products
- B ring of corrosion products just inside circumference of weld as illustrated in figure 2

Figure 2.- Type B. Typical ring of corrosion products just inside circumference of welds, $\times \frac{1}{2}$.

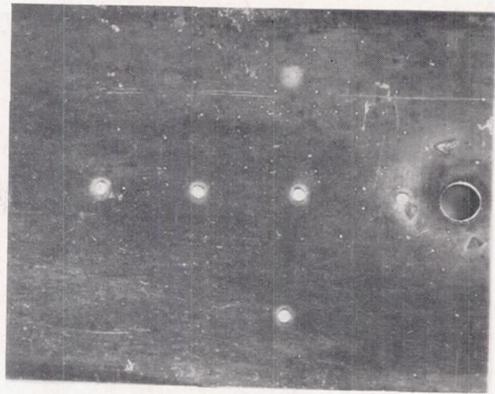
- C area of corrosion products in center of weld as illustrated in figure 3
- D corrosion products on circumference (rim of depressed area) of weld, a typical example of which is shown in figure 4

The alclad 24S-T3 panels were uncorroded after 2 days of exposure in the tidewater, except for the welds. Sound welds having 50-percent or less penetration (series 3) and welds made with dirty electrode tips (series 7) were unattacked. Corrosion products were found at the centers of some welds on panels welded so as to leave high residual stresses (series 4); panels with cracks visible on the surface of the welds (series 5); and panels with fins of weld metal expelled between the sheets (series 6), a typical example of which is shown in figure 3.

Figure 3.- Type C. Typical area of corrosion products in center of welds, $\times \frac{1}{2}$.

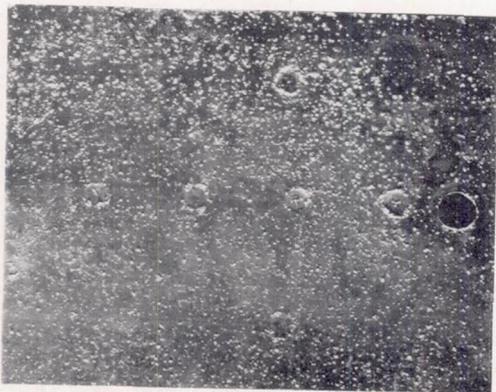
Figure 4.- Type D. Typical circumferential ring of corrosion products on rim of depressed area of weld, $\times \frac{1}{2}$.

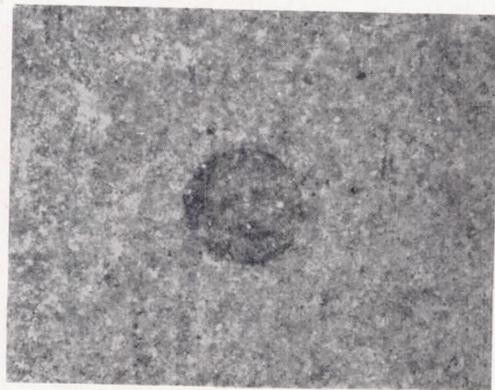
Figure 5.- Type E. Rough discolored ring inside weld, darker than main portion of panel, $\times 3$.

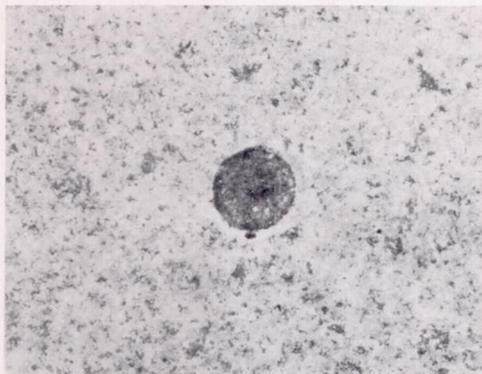
Figure 6.- Type F. Dark gray colored area in center of weld, darker than main portion of panel, X3.

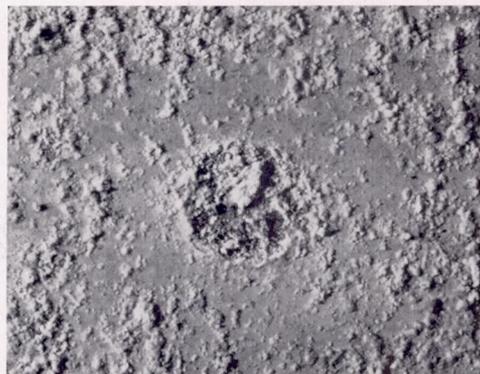
- G corrosion products general, that is, about equally distributed on the welds and the rest of the panel (This is illustrated in fig. 7, which is the earthward surface of a panel after 36 months of exposure in marine atmosphere. Skyward surfaces of panels, panels exposed in tidewater, and panels exposed for shorter periods of time (less than 36 months) were not necessarily as severely corroded as that shown in fig. 7, but uniformity of corrosive attack was about the same in each case.)

Figure 7.- Type G. Corrosion products are approximately as heavy on panel as they are on weld, X3.

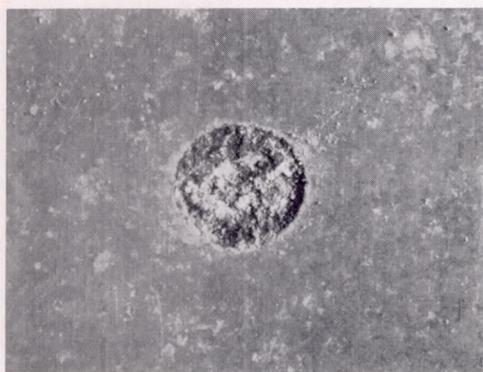
- J general severe corrosion on spot welds as illustrated in figure 8
- K corrosive attack in form of patterned ring on spot weld as shown in figure 9
- L welds separated at faying surfaces as shown in figure 10

Figure 8.- Type J. General, severe corrosive attack on spot welds, X3.

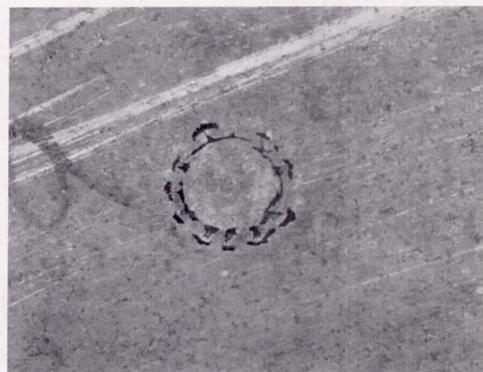
Figure 9.- Type K. "Pattern" corrosion on welds made with "poor" technique, X3.

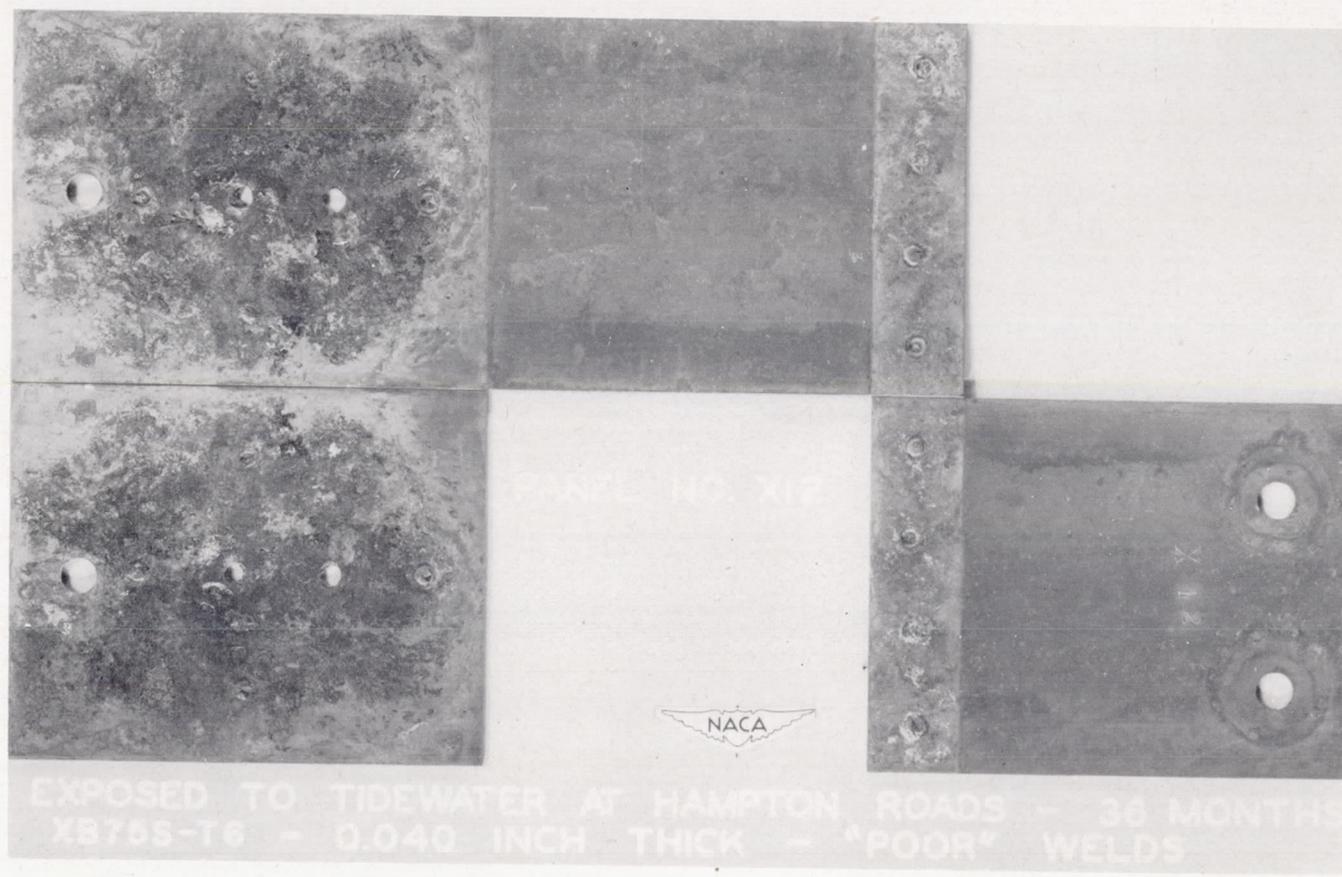
Figure 10.- Type L. Welds separated at faying surfaces by corrosive attack, $\times \frac{1}{2}$.

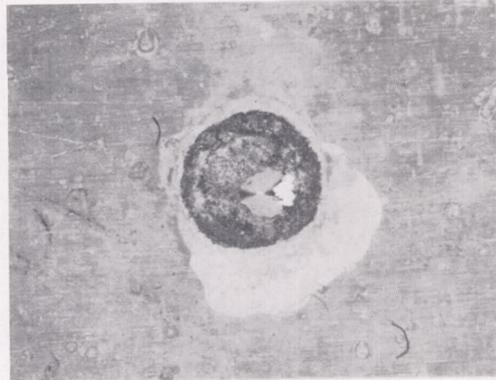
Figure 12.- Type P. Weld completely penetrated at one place and through one thickness of sheet in balance of weld, X3.

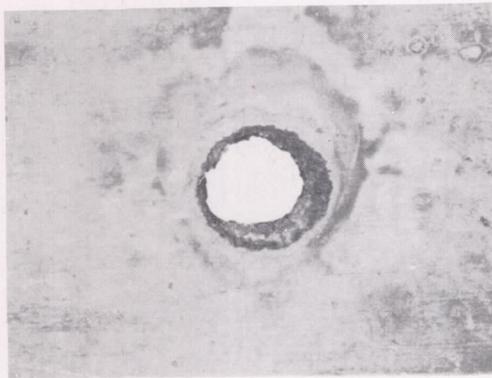
Figure 13.- Type P. Weld completely penetrated by corrosive attack, X3.

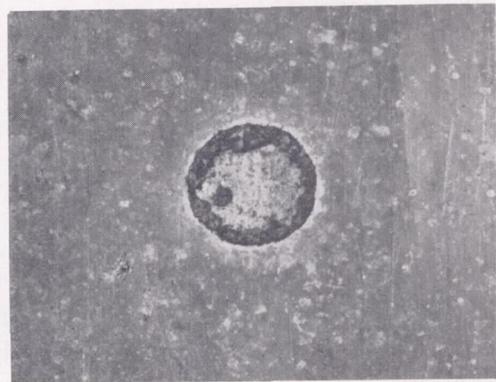
- R deeply pitted dark ring on circumference of weld as illustrated in figure 14
- S corrosive attack penetrated sheet from faying surface to outer surface

Figure 14.- Type R. Deeply pitted dark ring on circumference of weld, X3.

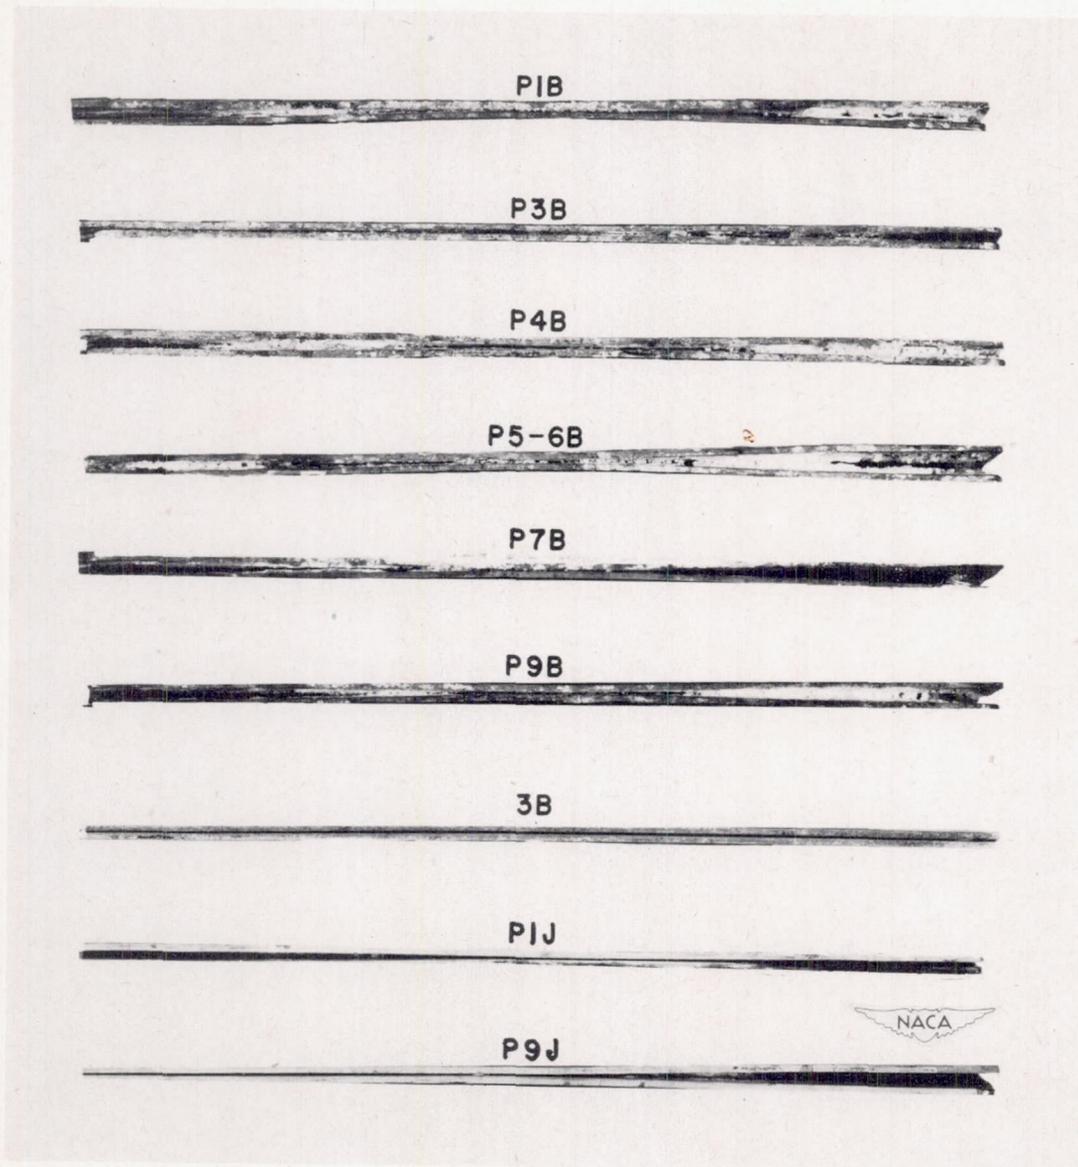
- 1 corrosion products between faying surfaces forced sheets apart a maximum distance of 1/16 inch (Illustrations of separations of faying surfaces are shown in figs. 15 and 16.)
- 2 corrosion products between faying surfaces forced sheets apart a distance of 2/16 inch
- 3 corrosion products between faying surfaces forced sheets apart a distance of 3/16 inch

Figure 15.- Separation of sheets resulting from accumulation of corrosion products between faying surfaces, XI. Exposed in tidewater for 6 months. Panel 3B, alclad 24S-T3, was inserted for comparison purposes; no accumulation of corrosion products at faying surfaces.

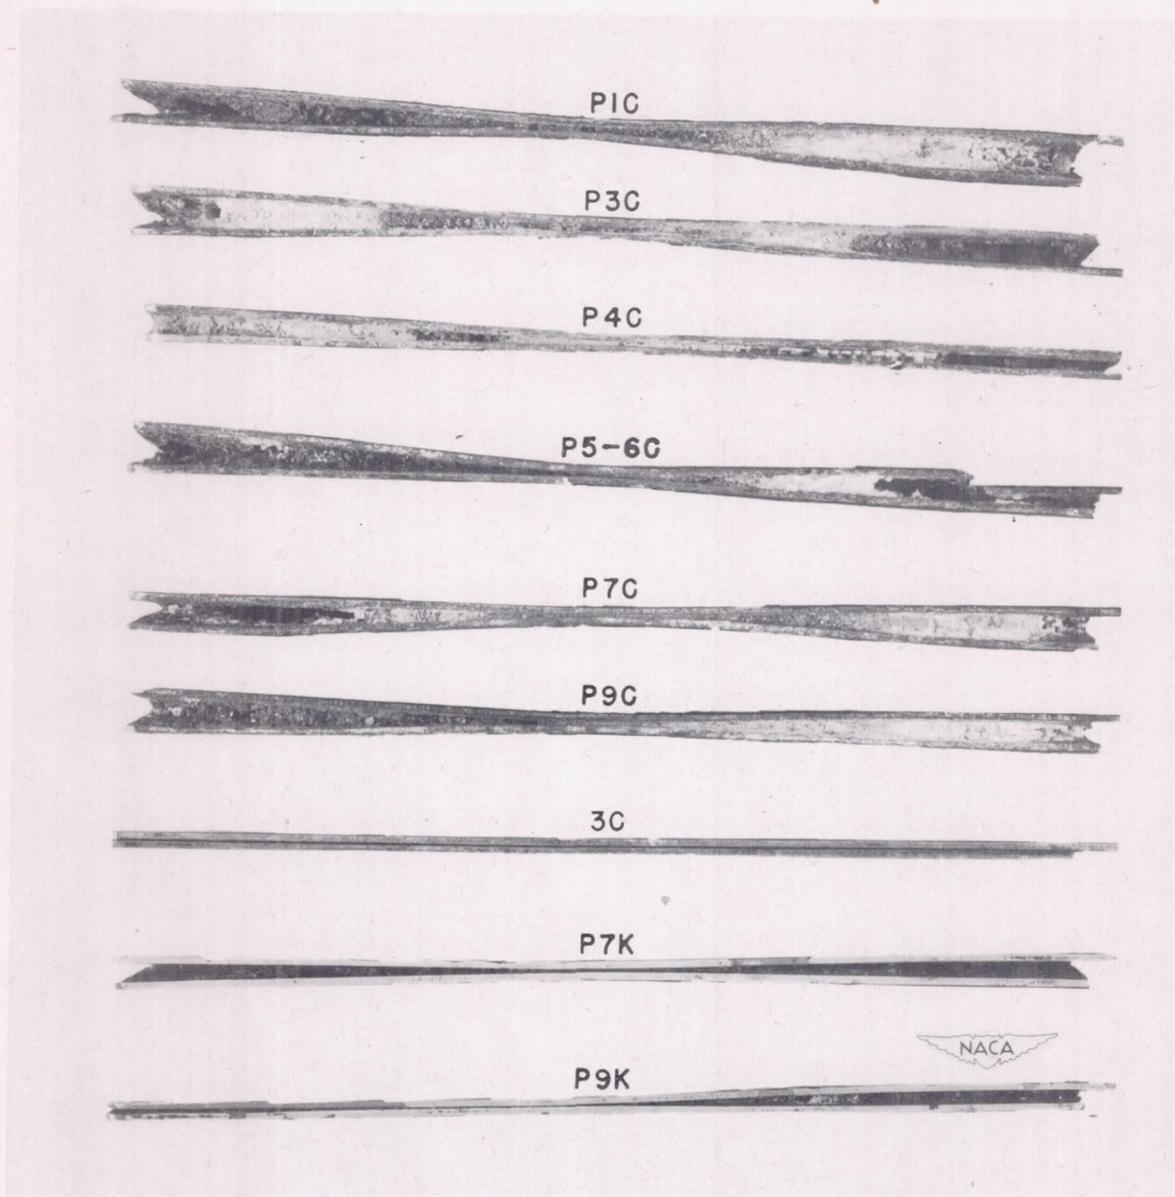
Figure 16.- Separation of sheets resulting from accumulation of corrosion products between faying surfaces, X1. Exposed in tidewater for 12 months. Panel 3C, alclad 24S-T3, was inserted for comparison purposes; no accumulation of corrosion products at faying surfaces.

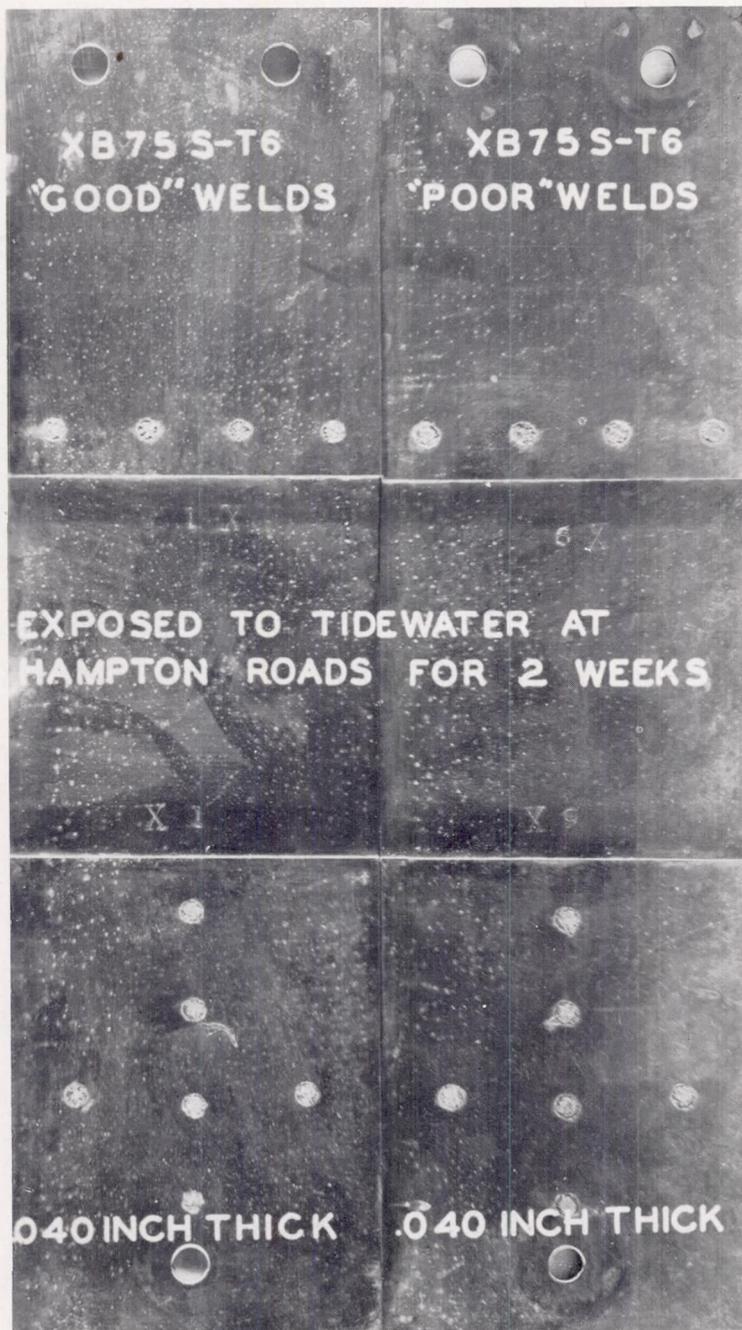
Figure 17.- Localized corrosion on spot welds made with both "good" and "poor" techniques, $X\frac{1}{2}$. Attack was almost as severe as shown here after 2 days of exposure to tidewater.

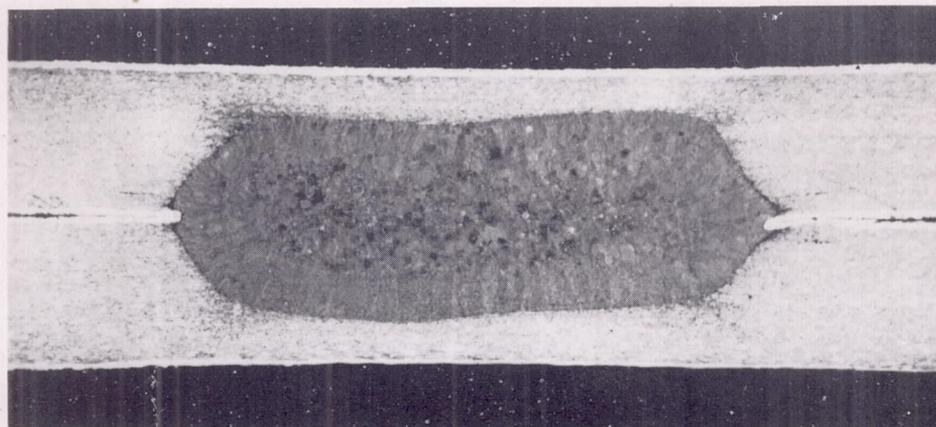
Figure 18.- Macrostructure of weld zone of sample 1C, alclad 24S-T3, exposed to tidewater for 1 year, X20. Keller's etch, 20 seconds. Weld structure was sound and uniformly distributed between two sheets. Structure was characteristic of group 1 samples which were welded under conditions to produce sound welds after chemical preparation of sheet surfaces.

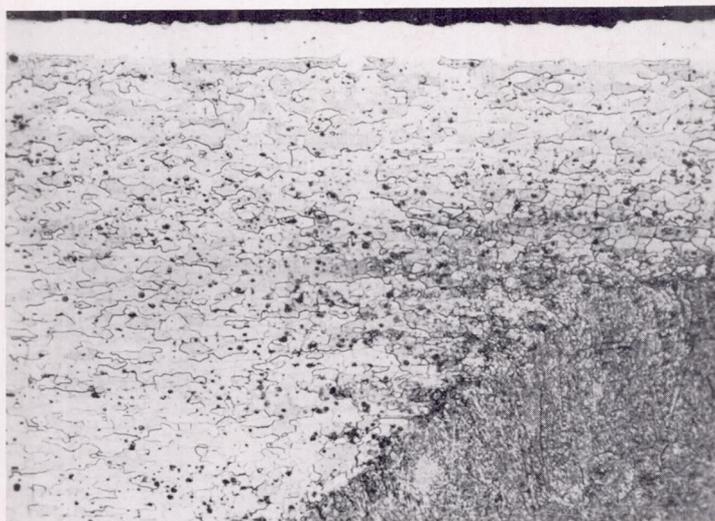
Figure 19.- Area from upper left corner of nugget shown in figure 18, X100. Keller's etch, 20 seconds. No significant extent of corrosion attack was observed on this sample.

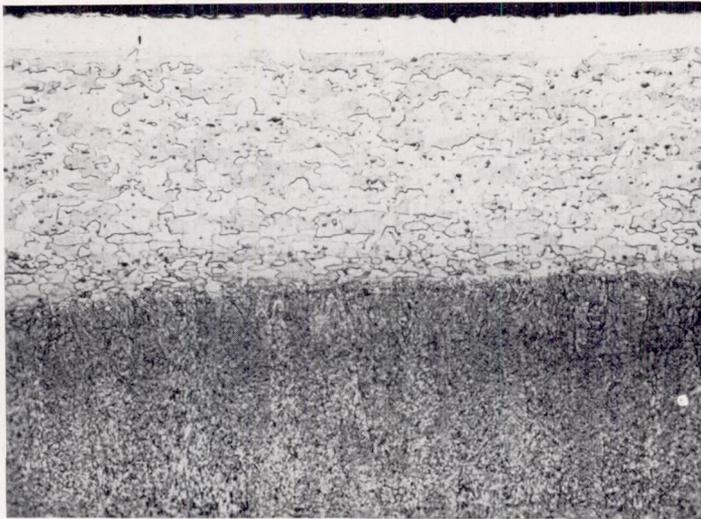
Figure 20.- Typical appearance of portion of nugget, core, and clad regions in sample 1G, alclad 24S-T3 sheet, exposed 3 years to laboratory atmosphere, X100. Keller's etch, 20 seconds. No evidence of corrosion attack on this sample.

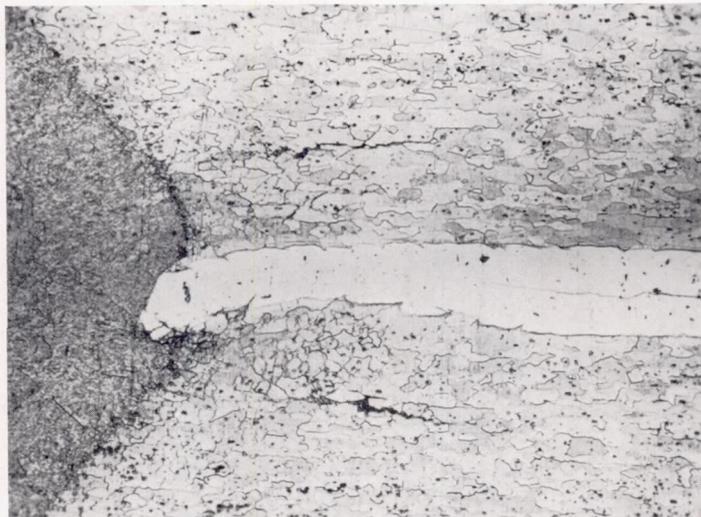
Figure 21.- Nugget-faying surface interface of sample shown in figure 20, X100. Keller's etch, 20 seconds. Structure was typical of appearance of alclad 24S-T3 samples examined in this study. Note continuation of higher-melting 2S clad into nugget zone and intrusion of eutectic into core structure above and below cladding.

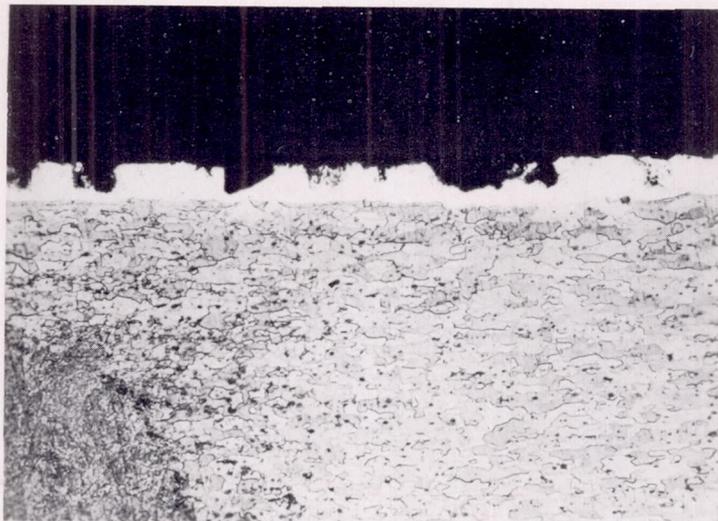
Figure 22.- Most severe degree of pitting type of corrosion attack on sample IE, alclad 24S-T3, exposed 3 years to a sea coast atmosphere, X100. Keller's etch, 20 seconds. Attack was concentrated near weld zone and did not penetrate cladding.

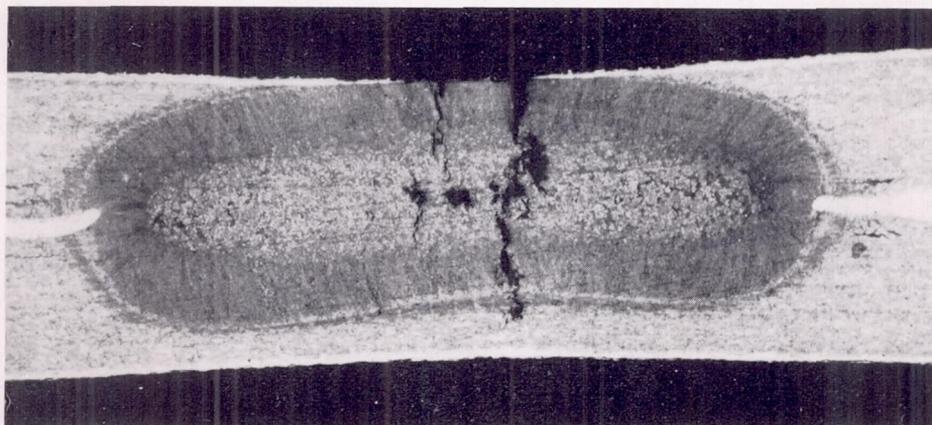
Figure 23.- Macrostructure of sample 5C, alclad 24S-T3, welded under conditions to produce cracking to surface and exposed 1 year to tidewater, X20. Keller's etch, 20 seconds. Nugget has absorbed portion of cladding on one surface. See figure 24.

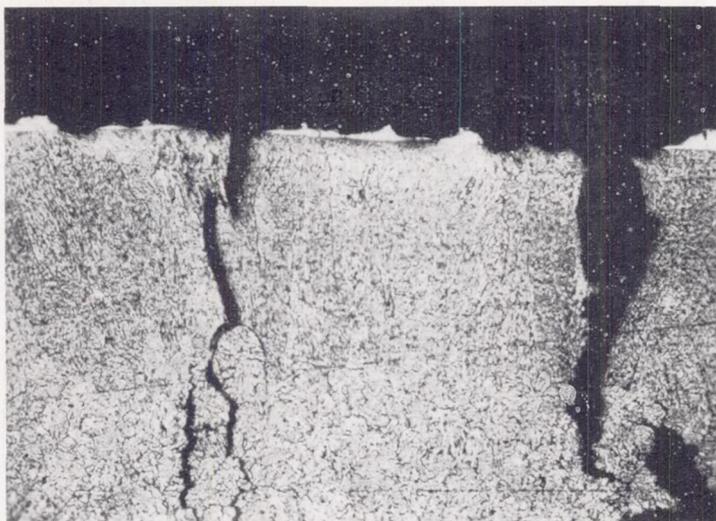
Figure 24.- Area from the top-center surface of weld shown in figure 23, X100. Keller's etch, 20 seconds. Note that tiny fragments of cladding have remained to provide effective cathodic protection for underlying core.

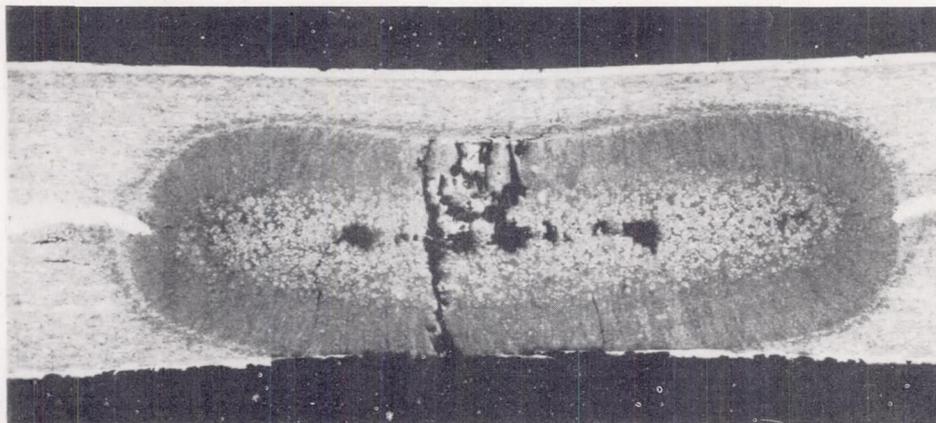
Figure 25.- Macrostructure of sample 5F, alclad 24S-T3, exposed 3 years to sea coast atmosphere after welding to produce cracks to surface, X20. Keller's etch, 20 seconds. Compare with figure 23. Note corrosion attack in cladding in vicinity of weld along bottom.

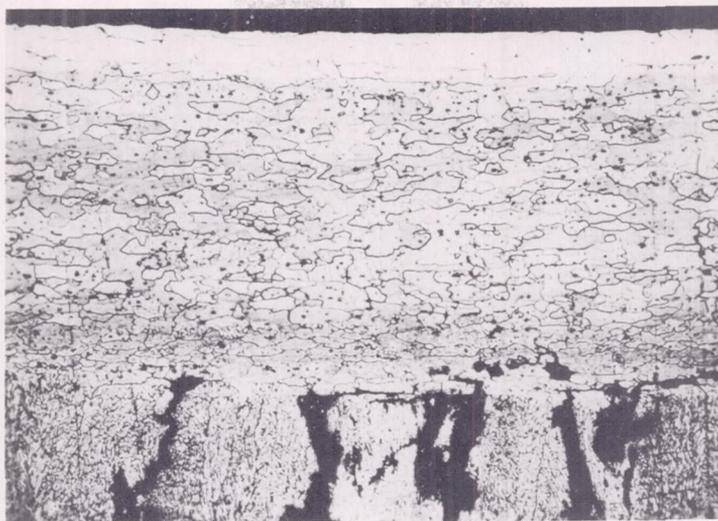
Figure 26.- Area from top center of figure 25 showing no significant extent of corrosion attack on surface, X100. Keller's etch, 20 seconds. Lower side of weld in figure 25 was similar in appearance to figure 24.

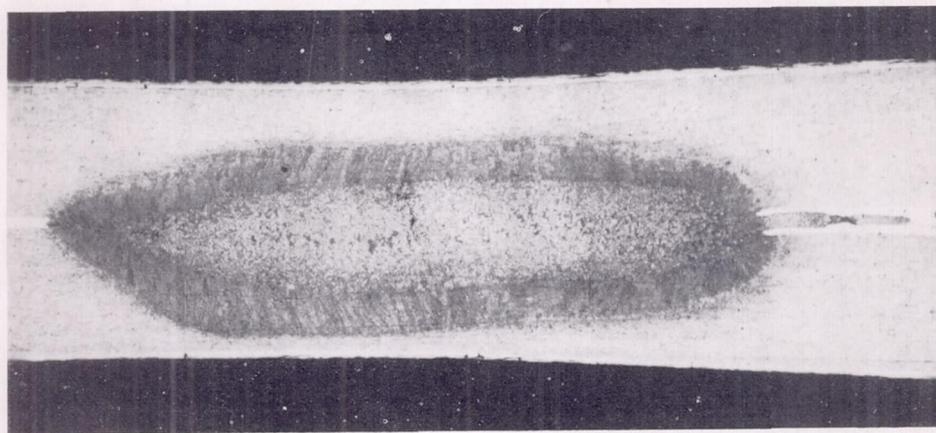
Figure 27.- Example of expulsion between faying surfaces of sample 6C, alclad 24S-T3, welded under conditions to induce expulsion and exposed 1 year to tidewater, X20. Keller's etch, 20 seconds.

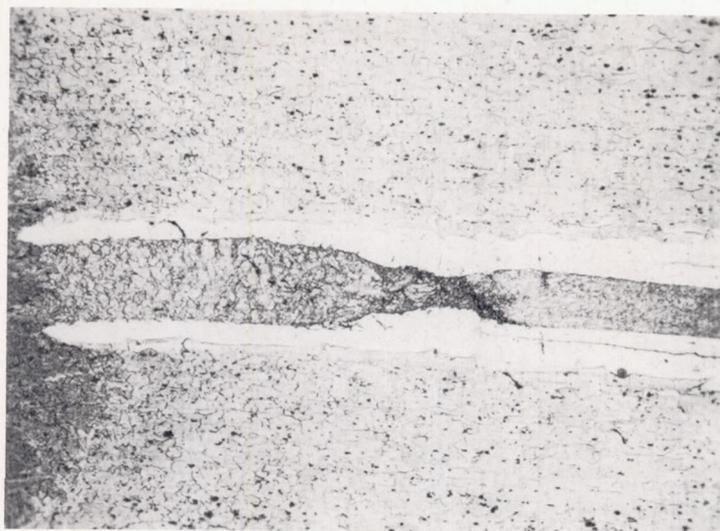
Figure 28.- Area of expelled metal showing retention of layer of cladding on either side, X100. Keller's etch, 20 seconds. No evidence of corrosion attack associated with this condition.

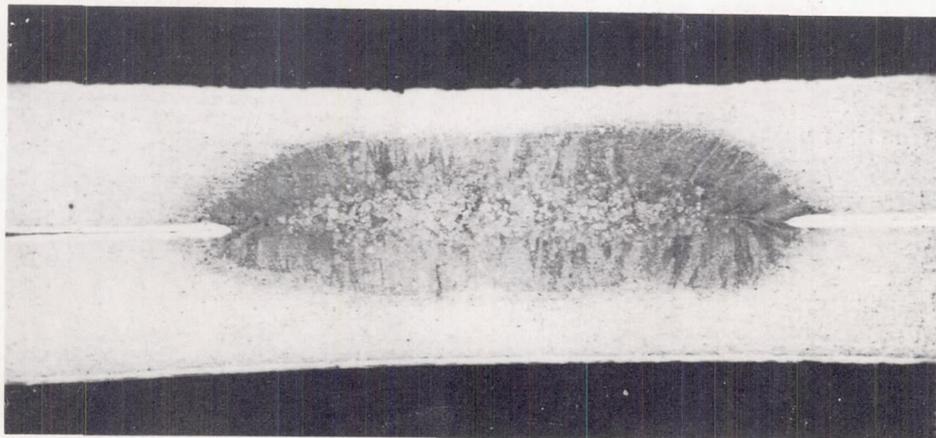
Figure 29.- Macrostructure of sample 6F, alclad 24S-T3, welded under conditions to produce expulsion and exposed 3 years in sea coast weather, X20. Keller's etch, 20 seconds.

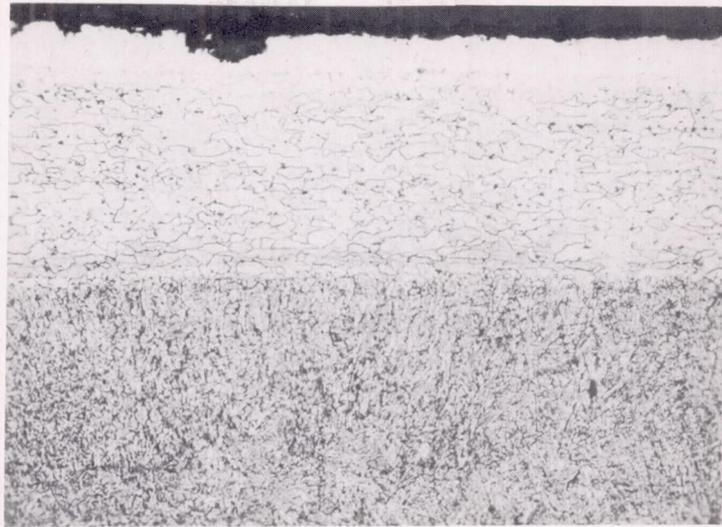
Figure 30.- Most severe degree of corrosion attack found in this specimen did not penetrate cladding. Area is from top center of figure 29, X100. Keller's etch, 20 seconds. No significant extent of attack on sheet away from weld zone. Note fine cracks in lower left corner in nugget structure.

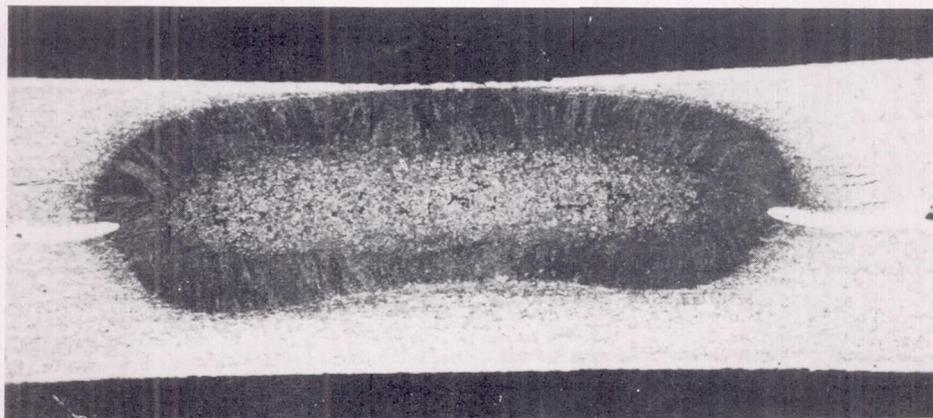
Figure 31.- Sample 9C, alclad 24S-T3, welded under conditions to produce a sound weld after wire-brush preparation. Nugget penetrated entirely to the cladding, X20. Keller's etch, .20 seconds.

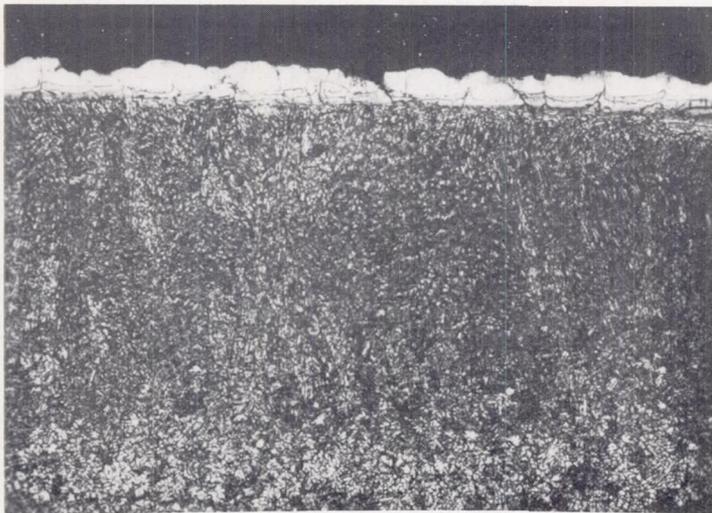
Figure 32.- Region from top center of figure 31 showing pronounced extent of diffusion of copper into cladding and evidence of corrosion attack, X100. Keller's etch, 20 seconds. As shown in figure 31, attack was confined to small area where nugget approached sheet surface.

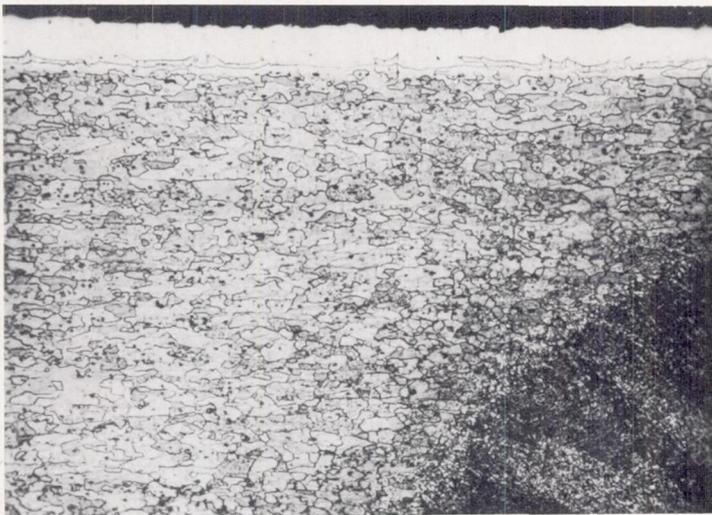
Figure 33.- General condition of diffusion of copper into cladding, typical of appearance in all parts of sheet. Area is from upper left corner of nugget in figure 31, X100. Keller's etch, 20 seconds. No significant extent of corrosion was observed.

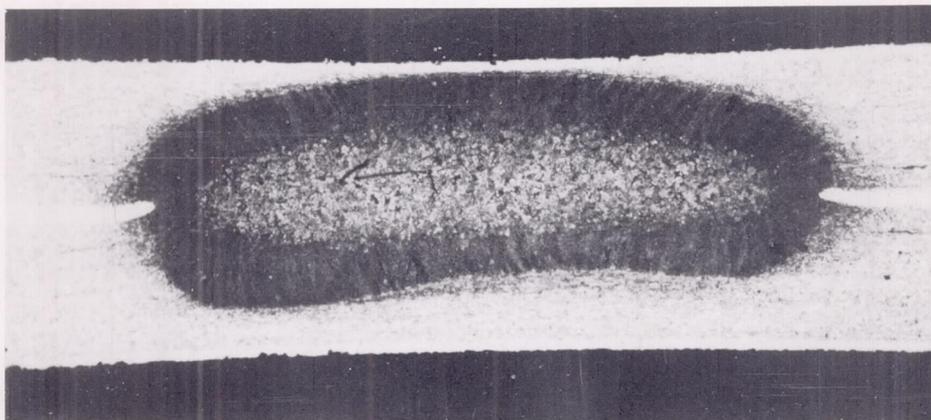
Figure 34.- Macrograph showing weld nugget slightly below clad surface in sample 9F, alclad 24S-T3, welded under conditions to produce a sound weld after wire-brush preparation and exposed 3 years to sea coast atmosphere, X20. Keller's etch, 20 seconds. Compare with figure 31.

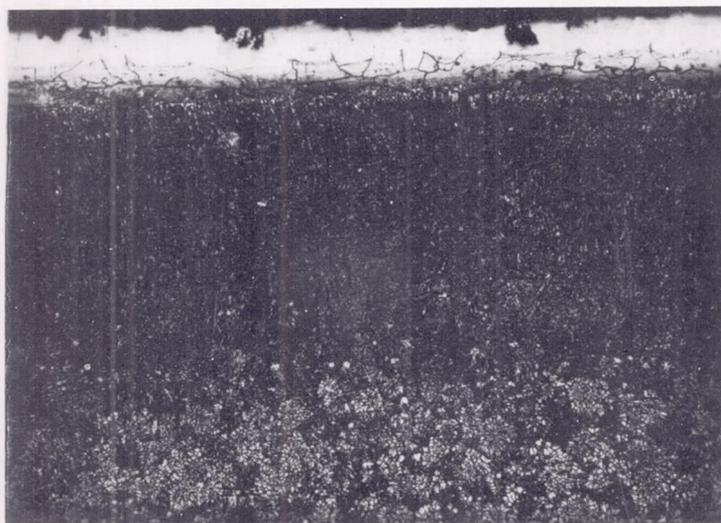
Figure 35.- Area from top center of figure 34 showing some evidence of diffusion of copper into cladding but less pronounced than in figure 32, X100. Keller's etch, 20 seconds. General condition of surface attack throughout sample, not accelerated in vicinity of weld.

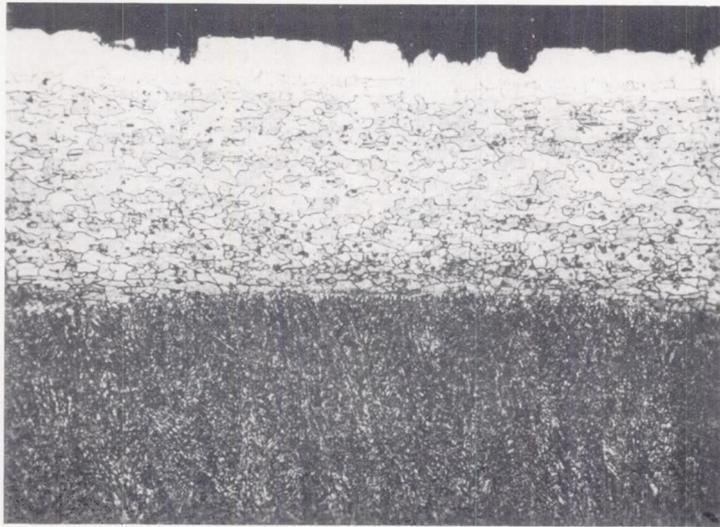
Figure 36.- Extent of surface attack on opposite side of sheet from region in figure 35, X100. Keller's etch, 20 seconds. Attack penetrated over half of cladding thickness, but was not greater in extent than in other parts of sheet surface away from weld.

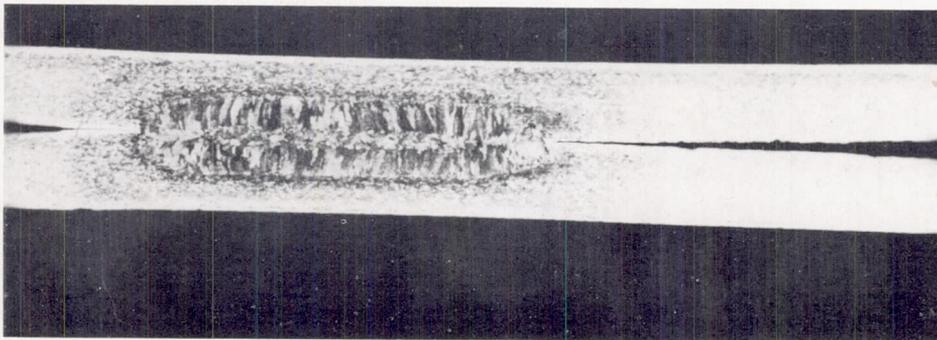
Figure 37.- Macrostructure of sample 2R₄, R-301-T6, welded to produce a sound structure after chemical preparation of sheet and exposed 3 years in tidewater, X20. Keller's etch, 20 seconds.

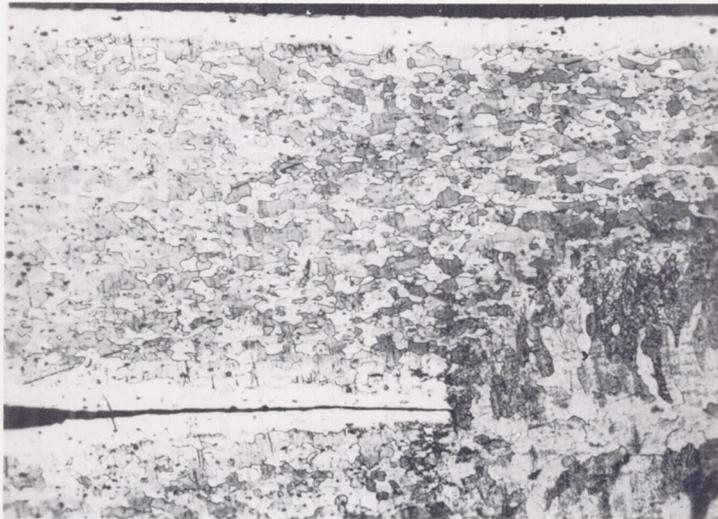
Figure 38.- No significant extent of attack was observed on outer or faying surfaces of sample 2R₄. Dark areas in cladding alloy are constituent particles, X100. Keller's etch, 20 seconds.

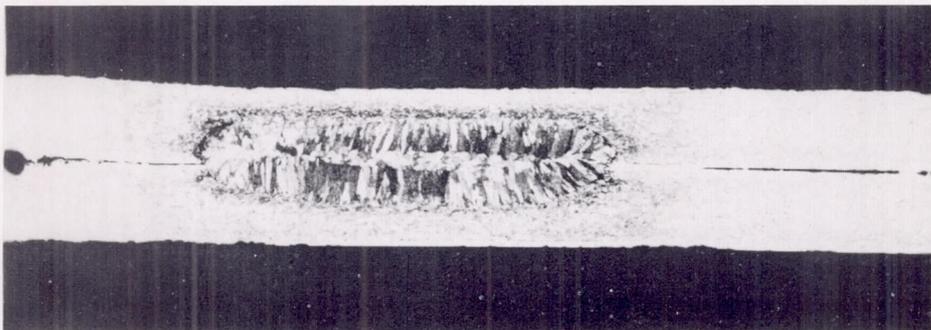
Figure 39.- Macrostructure of sample 2R₆, R-301-T₆, welded to produce a sound structure after chemical preparation and exposed 3 years to sea coast atmosphere, X20. Keller's etch, 30 seconds.

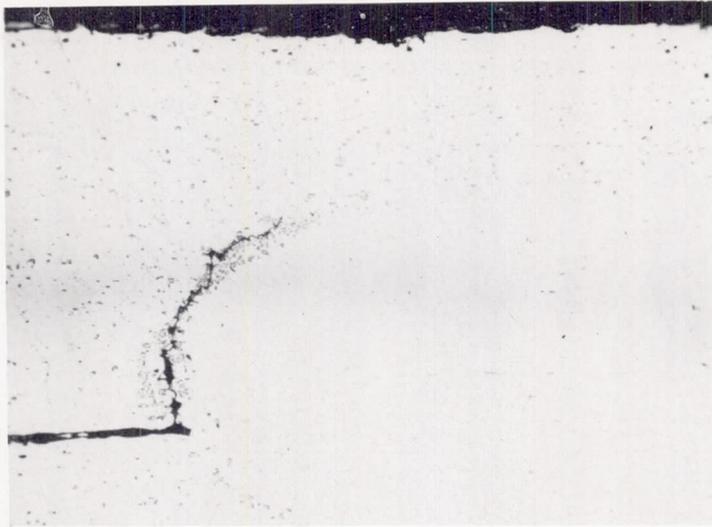
Figure 40.- Typical appearance of envelope of constituent particles segregated along periphery of weld nugget, X100. Unetched. This condition was characteristic of R-301-T6 sheet welds, was observed in XB75S-T6 welds, but not apparent in alclad 24S-T3 welds. Identity of constituents was not established completely but from etching characteristics it was believed that they were of the insoluble aluminum-copper-iron-manganese phase. The crack, possibly formed during specimen preparation, illustrated susceptibility of the condition to propagation of fracture.

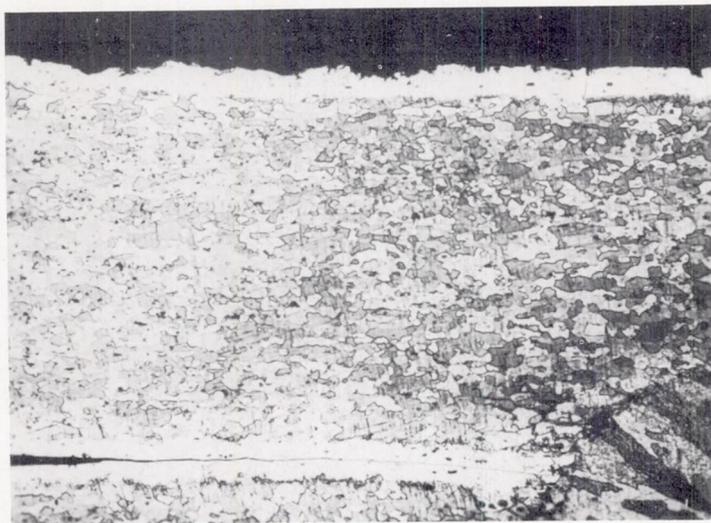
Figure 41.- Example of general type of corrosion observed on outer and inner surfaces of sample 2R6 in all parts of sample, X100. Keller's etch, 30 seconds.

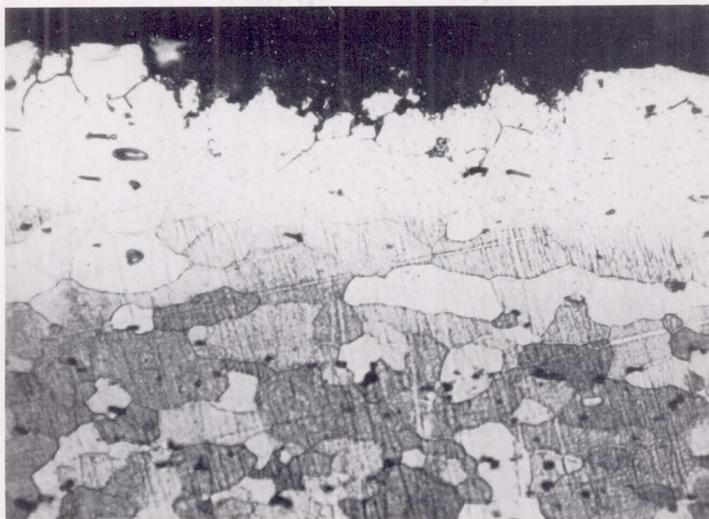
Figure 42.- Example of general type of corrosion observed on outer and inner surfaces of sample 2R6 in all parts of sample, X500. Keller's etch, 30 seconds. Attack appeared to be predominantly intergranular but had not penetrated coating.

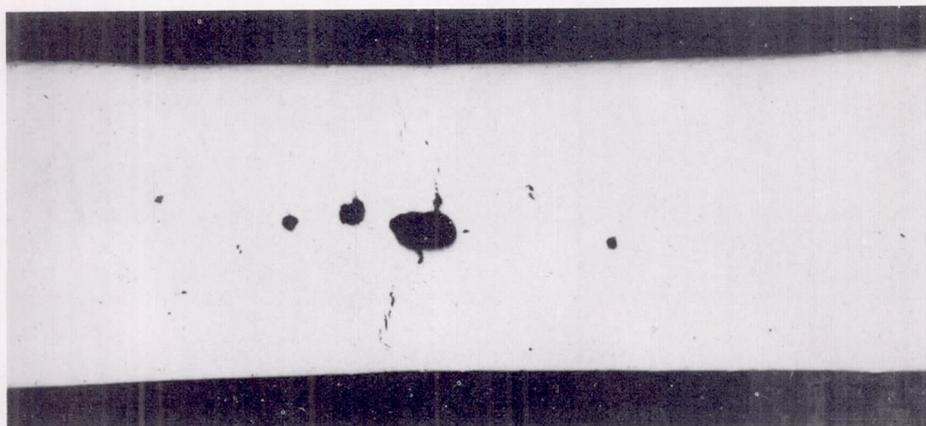
Figure 43.- Cracks to surface and general unsound weld structure of sample X-15, XB75S-T6, welded with dirty electrodes and exposed 3 years to laboratory atmosphere, X20. Unetched.

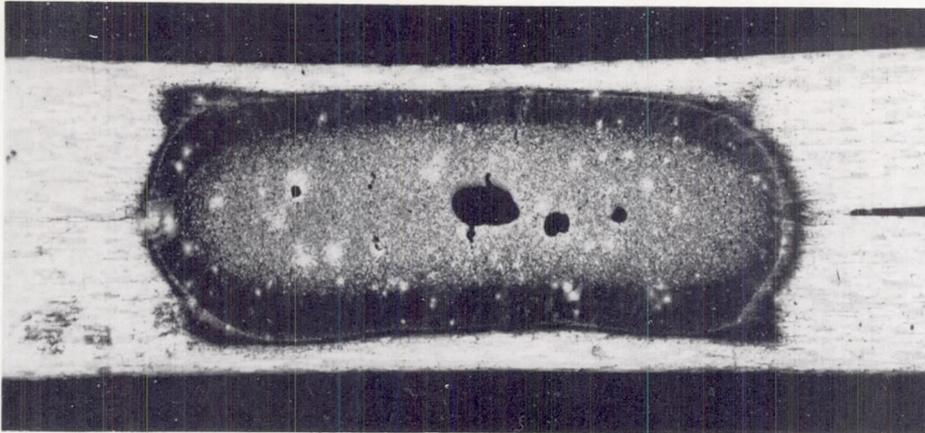
Figure 44.- Etched appearance of sample X-15, X20. Keller's etch, 30 seconds. No distinct evidence of corrosion attack was observed.

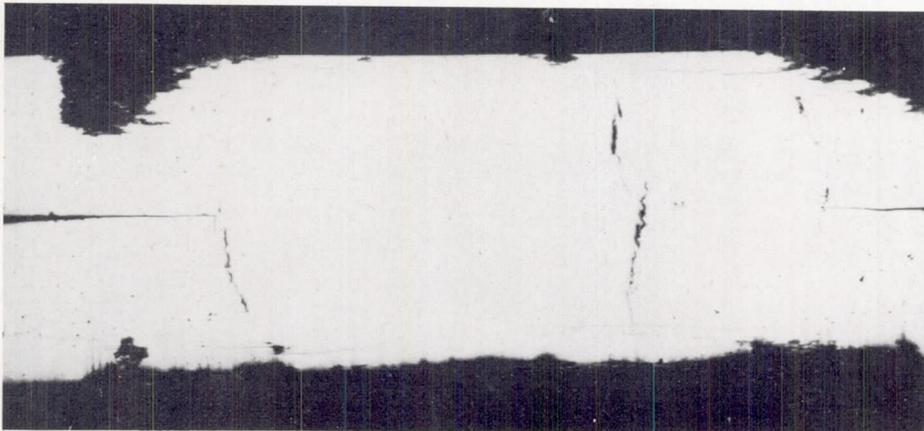
Figure 45.- Extremely severe intergranular corrosion attack accelerated at periphery of electrode indentation of sample X-9, XB75S-T6, welded with dirty electrodes after chemical preparation of surfaces and exposed 12 days in tidewater, X20. Unetched. Note thin envelope of constituent particles along periphery of nugget, shown more distinctly in figure 47.

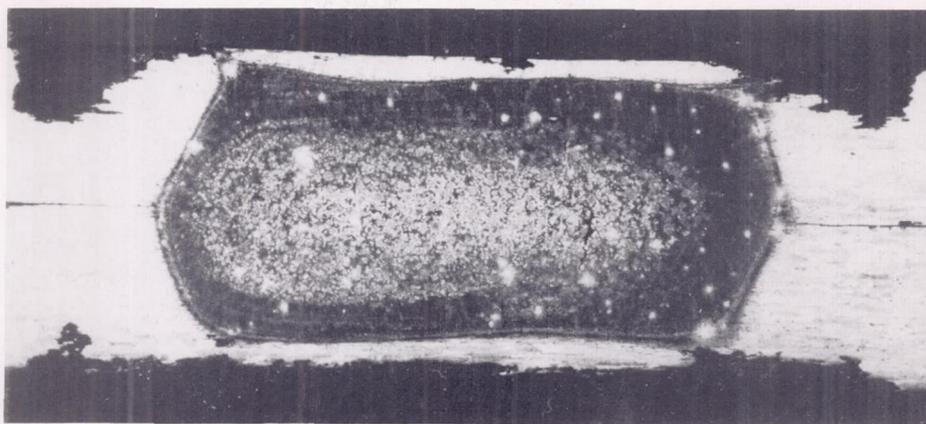
Figure 46.- Etched appearance of sample X-9, X20. Keller's etch, 20 seconds. Note intergranular attack along inner surface at extreme right.

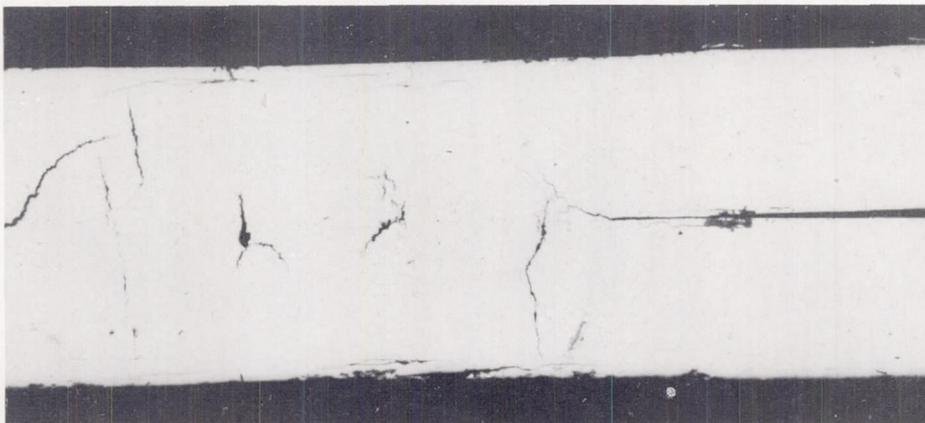
Figure 49.- Severe weld fracturing and intergranular corrosion attack on inner and outer surfaces of sample X-13, XB75S-T6, welded with dirty electrodes and exposed 1 year to sea coast atmosphere, X20. Unetched.

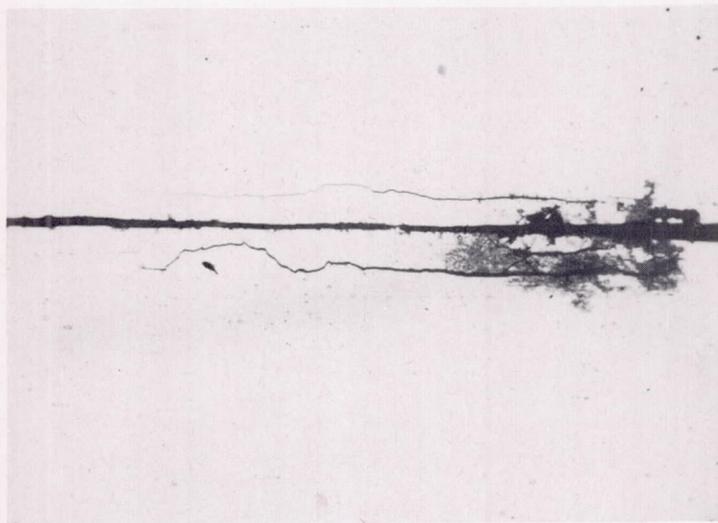
Figure 51.- Intergranular attack along faying surfaces in region at extreme right in figures 49 and 50, X100. Unetched.

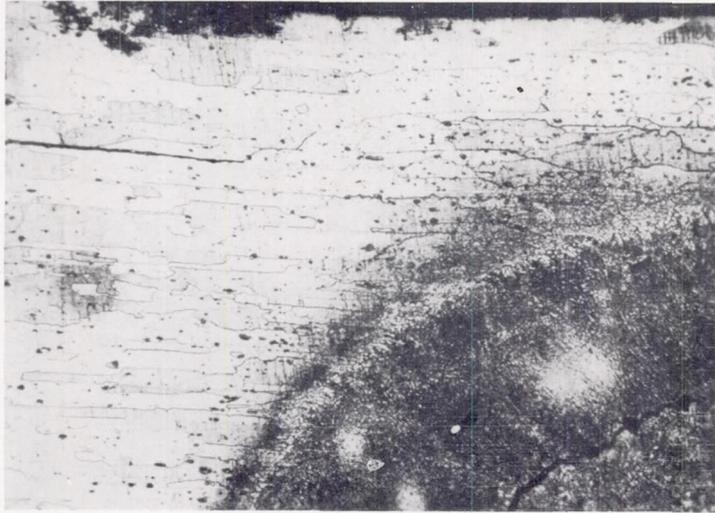
Figure 52.- Region from upper left corner of nugget (fig. 50) showing intergranular attack, X100. Keller's etch, 30 seconds. Note grain-boundary precipitate, visible at this low magnification, along which attack is proceeding from left to right.
