NATIONAL ADVISORY COMMITTEE  
FOR AERONAUTICS

TECHNICAL NOTE 1938

MECHANISMS OF FAILURE OF HIGH NICKEL-ALLOY  
TURBOJET COMBUSTION LINERS

By John W. Weeton

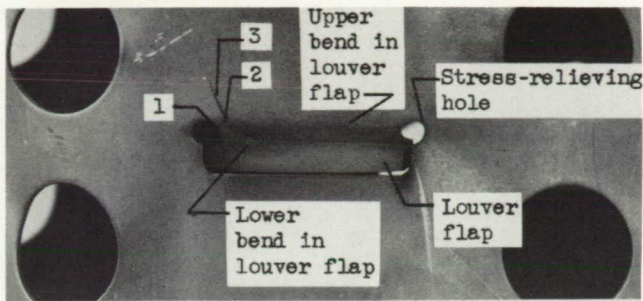
These cracks originated in the upper bend of the louver flap at the inner edges of the stress-relieving holes (fig. 3(a), point 1). They proceed in a direction approximately perpendicular to the holes for a distance of  $1/32$  to  $1/16$  inch. The cracks deviate from their

straight paths at this point and turn either away from the center line of the louver or parallel to the center line, as shown in figure 3(a), point 2. The cracks proceed in a slightly crooked path but continue in the same general direction, away from or parallel to the center line, (fig. 3(a), point 3). In extreme cases, cracks extended as far as the air-intake holes. Warping or buckling takes place at or near almost every crack. In many cases, the warpage forms either a ridge or a groove between the stress-relieving holes of the louvers and the nearest air-intake holes (fig. 3(c)). Buckling is most serious in the second row of louvers from the intake end (figs. 1 and 4). The louver flaps (fig. 3(a)) do not warp.

(a) Most common type of crack.

Figure 3. - Typical cracks and buckle at louver.

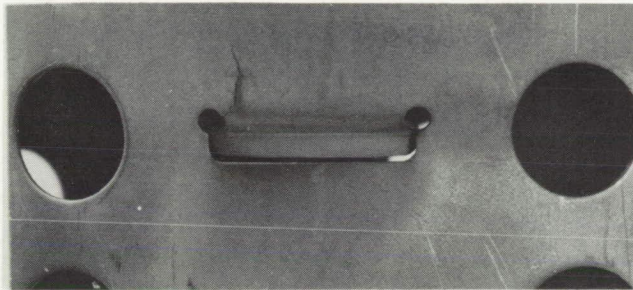
(b) Second most common type of crack.

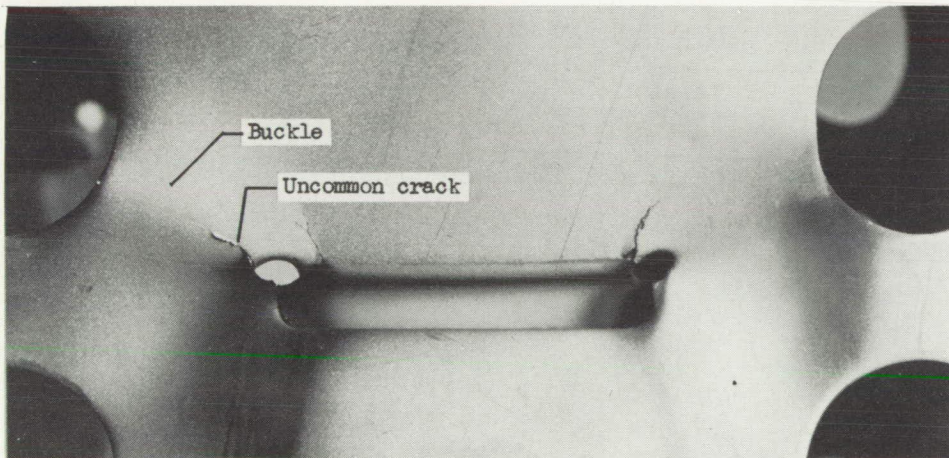
Buckling occurs between the stress-relieving holes of the louvers and the air-intake holes because of the geometry of the holes and louvers and the large temperature gradients (fig. 16). Operational conditions such as starting, stopping, and power surging, which produce thermal changes in the liner, are believed to raise and lower the buckle to some extent. The fluctuating thermal stresses thereby produced are believed to fatigue the metal thermally and to produce a crack in the buckle of the type shown in figure 3(c).

(c) Large buckle and typical cracks enlarged from figure 4.

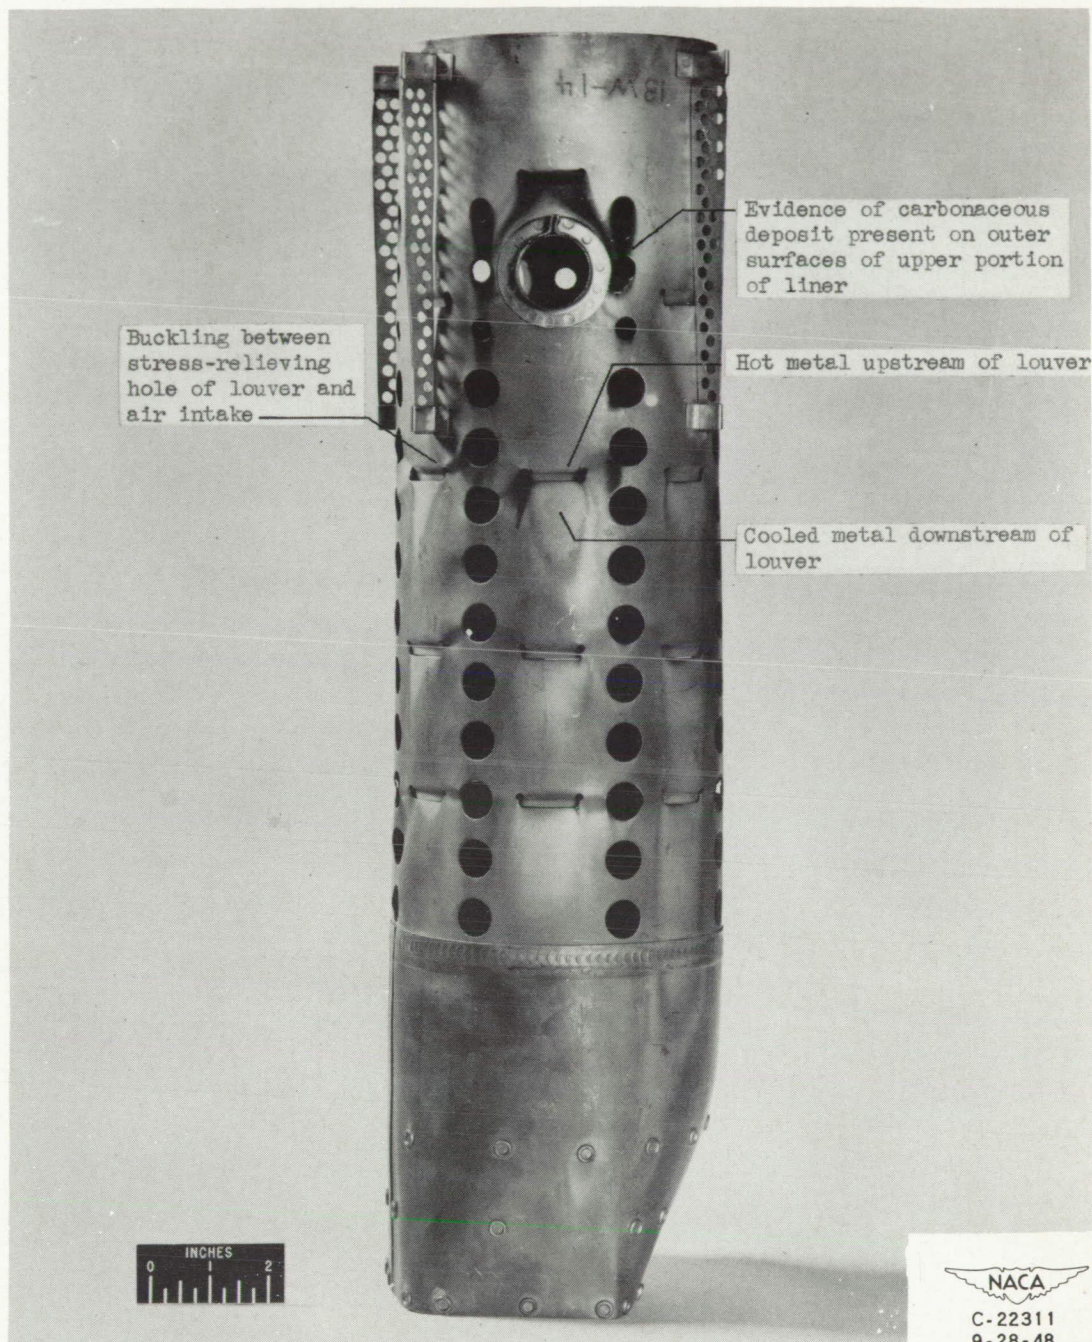
Some of the cracks were jagged and widely separated and looked like tears whereas others were minute. The smaller cracks were usually much more crooked than the larger ones. Most of the cracks were located in the second and the third row of louvers from the intake end (figs. 1 and 4).

Figure 4. - Combustion-chamber liner showing cracks extending from louver holes.

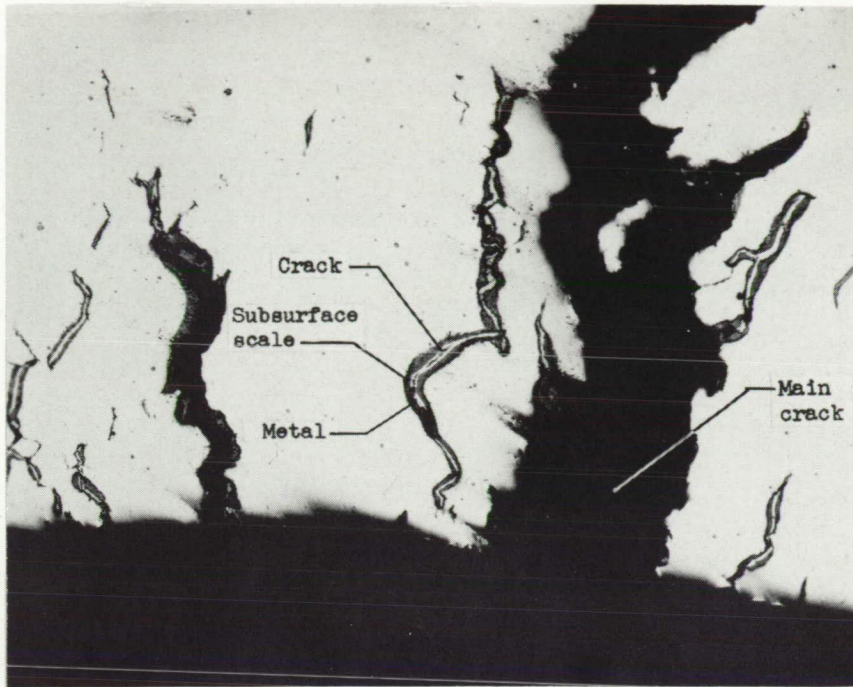
Figure 5. - Cracks at edge of air-intake hole. Type-A liner; etchant, none; condition, failed in service; magnification, X100. Largest crack is approximately 1/4 inch long.

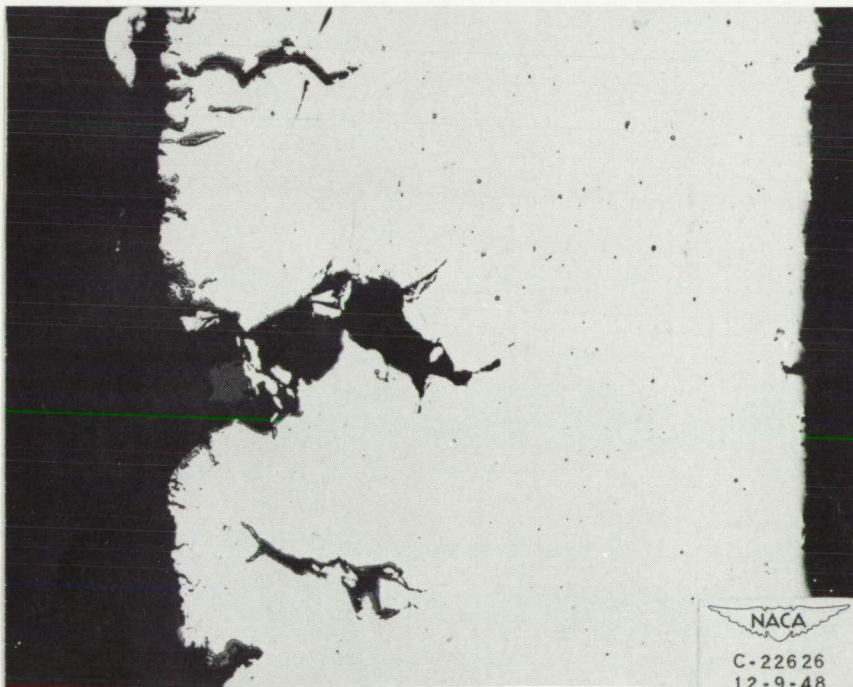
Figure 6. - Cross section showing cracks extending into metal from liner surfaces. Type-A liner; etchant, none; condition, failed in service; magnification, X100. Cracks shown were located near large crack.

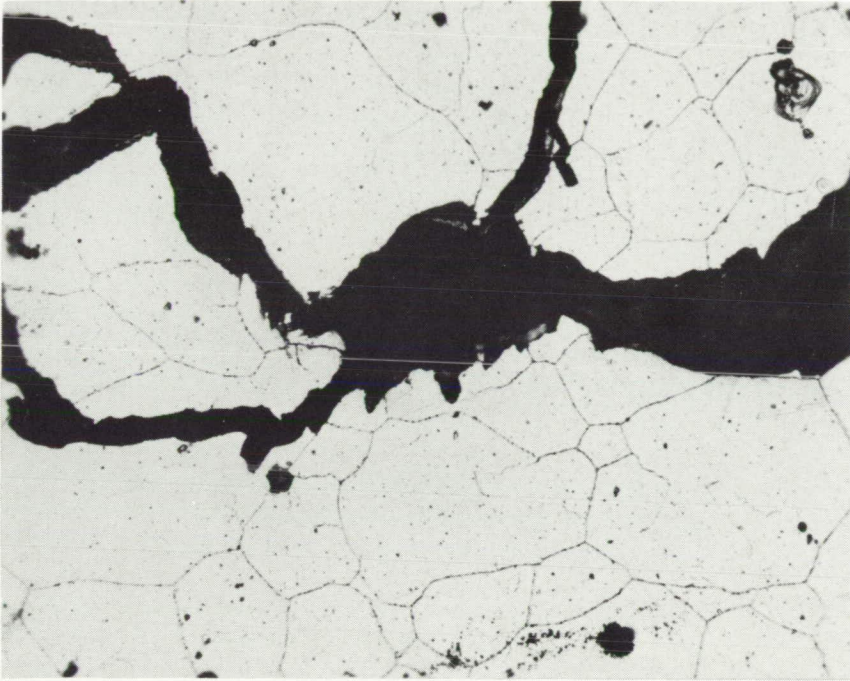
Figure 7. - Transcrystalline cracking in liner run for 66 hours and 57 minutes. Type-B liner; etchant, 5-percent aqua regia in water, electrolytic; magnification, X350.

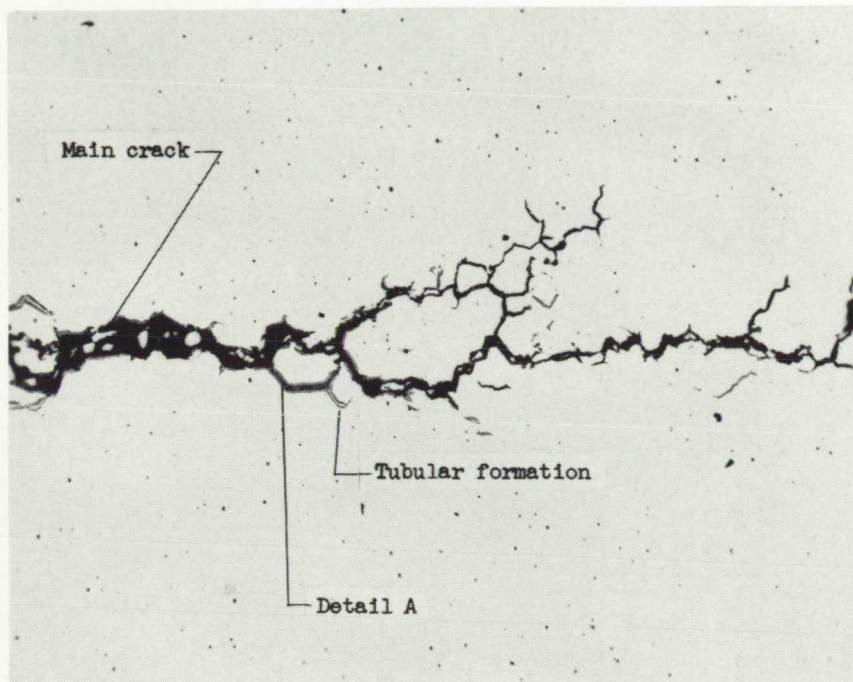
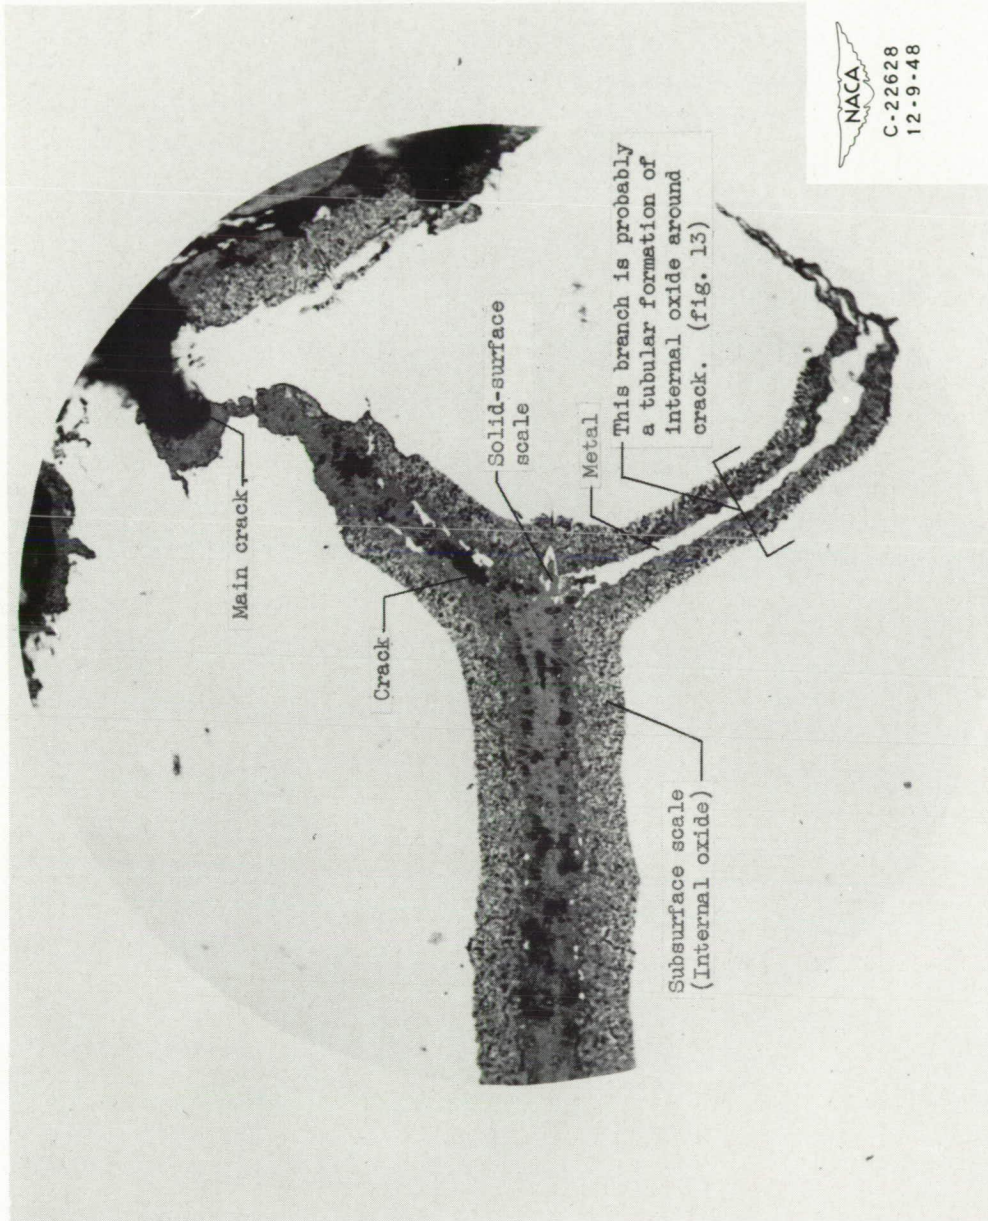
Both surface and subsurface scales were present at most of the edges of larger cracks (figs. 8 to 10). In a few cases, branches from these main cracks appeared to be lined with nothing but surface scale (fig. 11); whereas in many cases branches seemed to be entirely of the subsurface type, (figs. 5 and 9(b)). The separation of layers of scale by metal rather than a crack in some cases leads to the observation that a tubular formation of oxides existed about some of the cracks or branches. Evidence of this type of formation may be seen in figures 5, 8, and 9(b) and a pictorial explanation of what is believed to occur is shown in figure 12. Etching sometimes changes the appearance of the scale until it appears to be a two-phase structure (fig. 10). The innermost oxidized zone turns purple and the outer portion remains a dull gray.

(a) Magnification, X60.

(b) Detail A; magnification, X1500.

Figure 8. - Concluded. Portion of large crack showing surface and subsurface scale. Type-A liner; etchant, none; condition, failed in service.

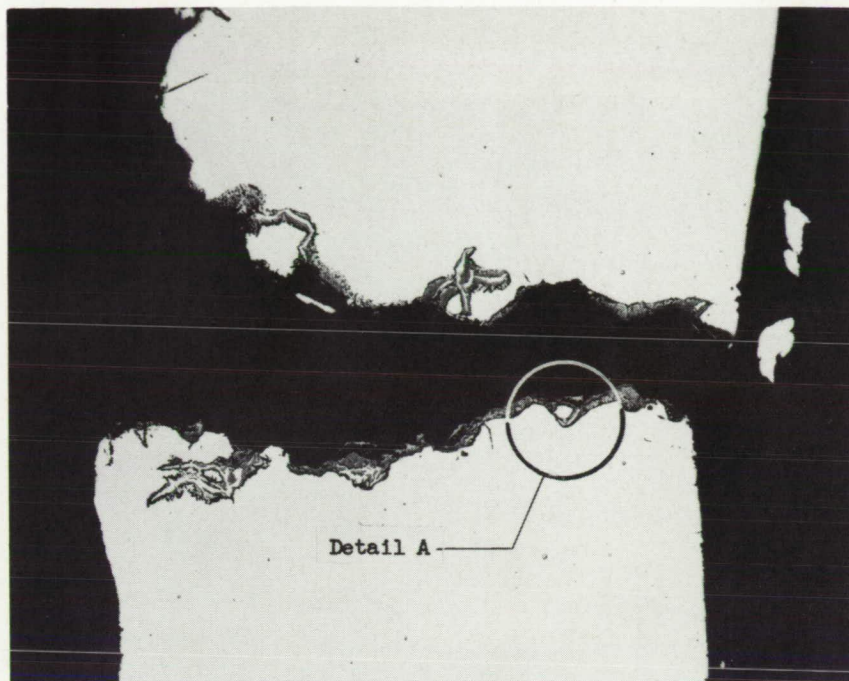
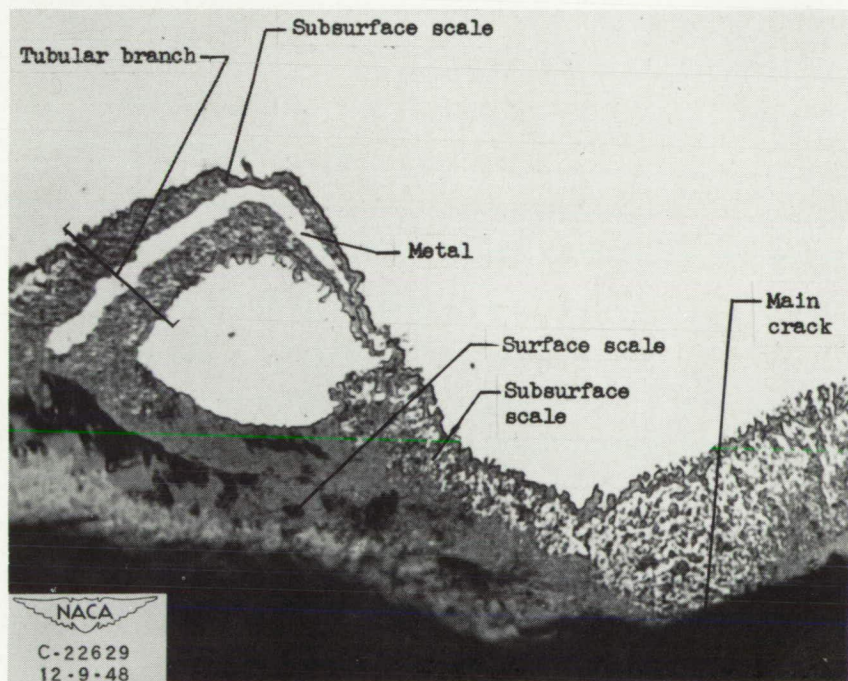
(a) Cross-sectional view; magnification, X100.

(b) Detail A showing surface scale at edge of crack; magnification, X1500.

Figure 9. - Crack extending from punched edge. Type-A liner; etchant, none; condition, failed in service.

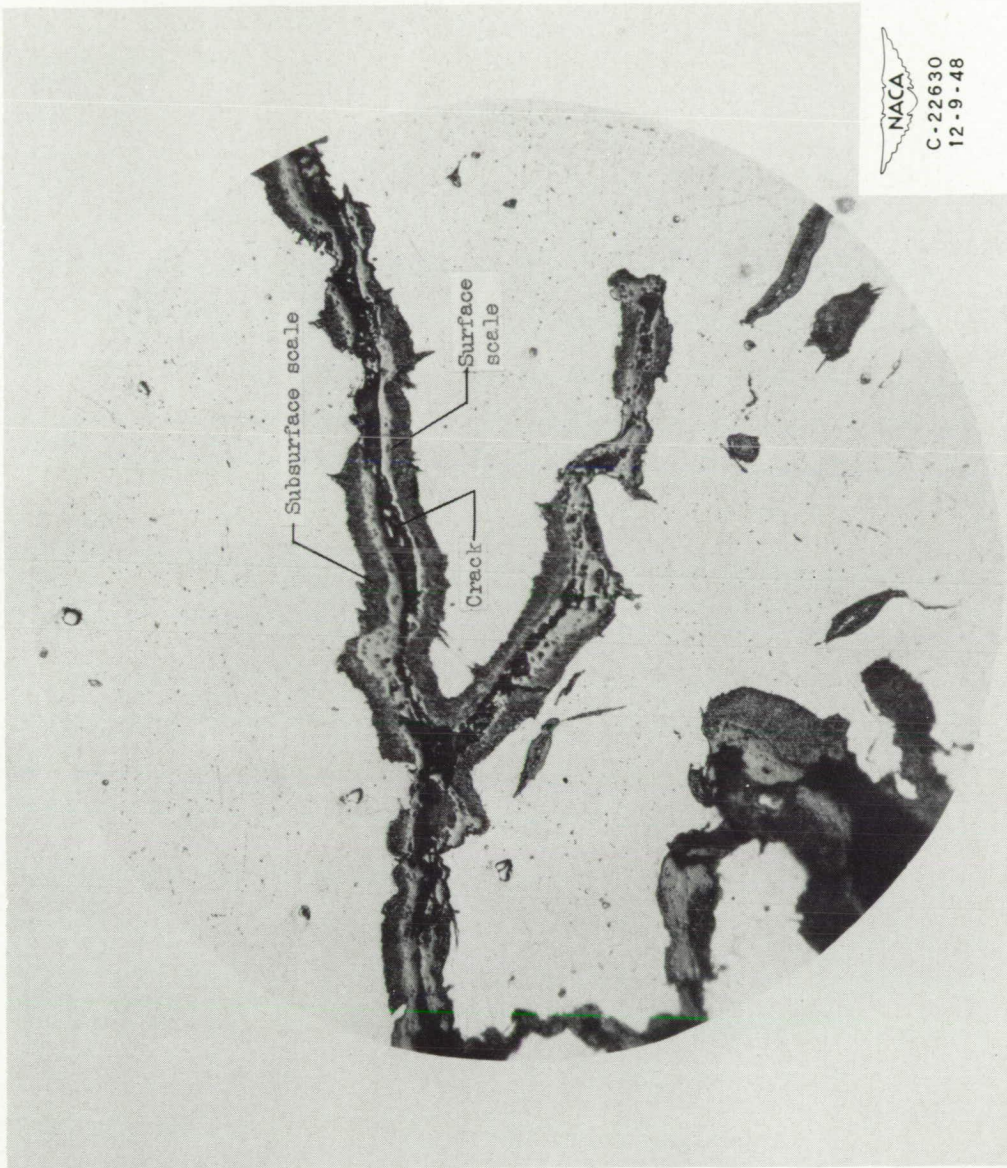
Figure 10. - Scale formations at crack. Type-B liner; etchant, 5-percent aqua regia in water, electrolytic; condition, cracked during accelerated-life determination; magnification, X500. Etchant has darkened subsurface scale zone. Scale almost appears to be two-phased because dark zone is dull purple and surface scale is gray.

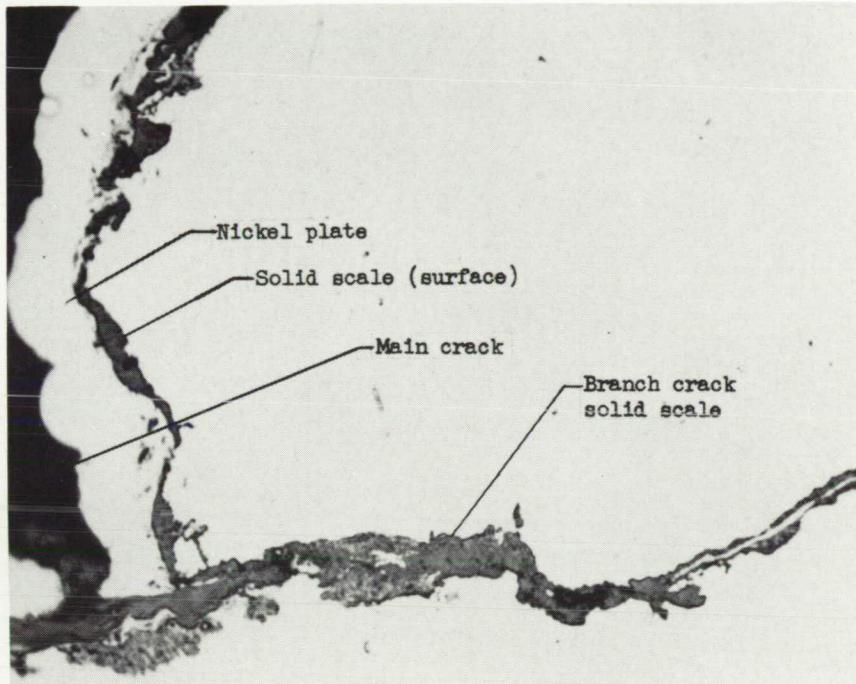
Figure 11. - Branch of main crack. Type-B liner; etchant, none; condition, cracked during accelerated-life determination; magnification, X1500. Scale appears to be solid, similar to surface scale. Edge of main crack is plated with nickel.

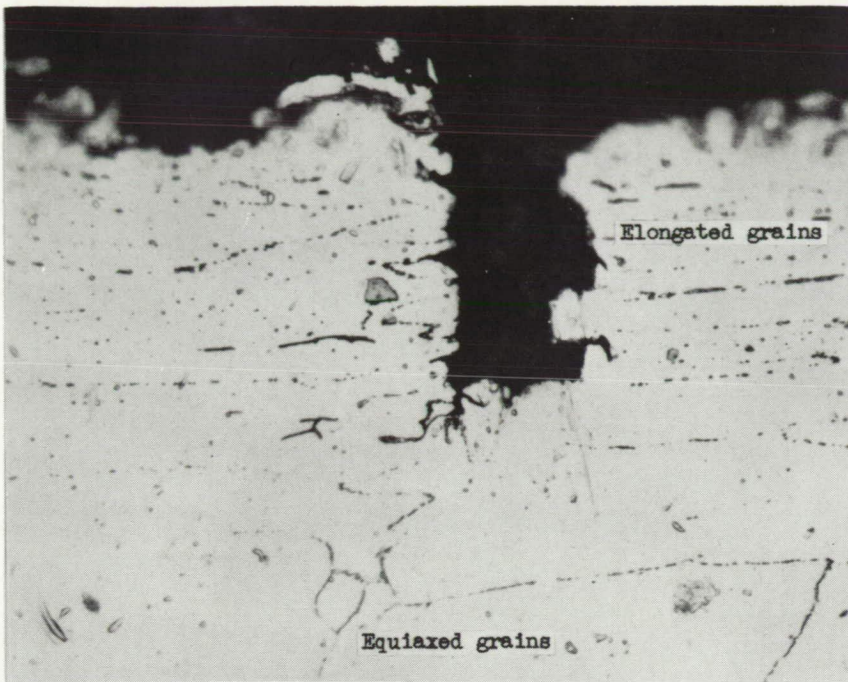
The punched edges of an as-fabricated type-A liner were bordered by a layer of disturbed and elongated grains and were torn in several places (table I and fig. 13). The fissures produced by tearing were large enough to act as stress raisers or potential sources of cracking, the largest being 0.0019 inch long.

Figure 13. - Edge of stress-relieving hole of louver. Type-A liner; etchant, 10-percent sodium cyanide, electrolytic; condition, as fabricated; magnification X750. Note fissure and elongated grains. Fissure is 0.0019 inch deep.

4. Cracking may be retarded and liner life prolonged by removing stress raisers produced during punching operations by reaming, sanding, and vapor blasting the edges of the punched holes. Some cracks probably originated from small fissures produced by the punching operation.

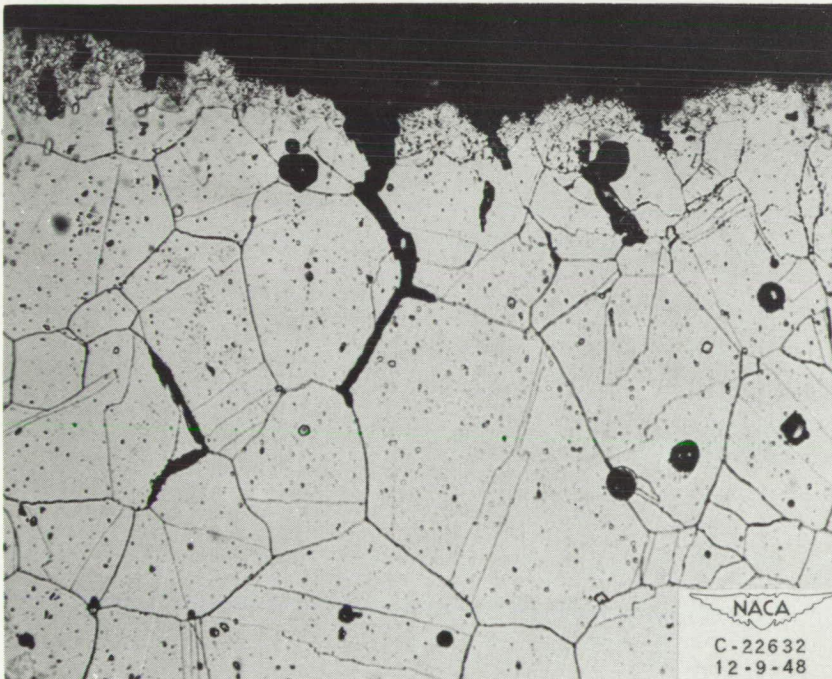
Figure 14. - Intercrystalline cracks in liner run for 16 hours and 40 minutes. Type-B liner; etchant, aqua regia and glycerine; condition, cracked during accelerated-life runs; magnification, X250. Incipient intergranular cracks formed at punched edge. Note small grains at edge. Cracks are lined with oxide scale, which does not show.

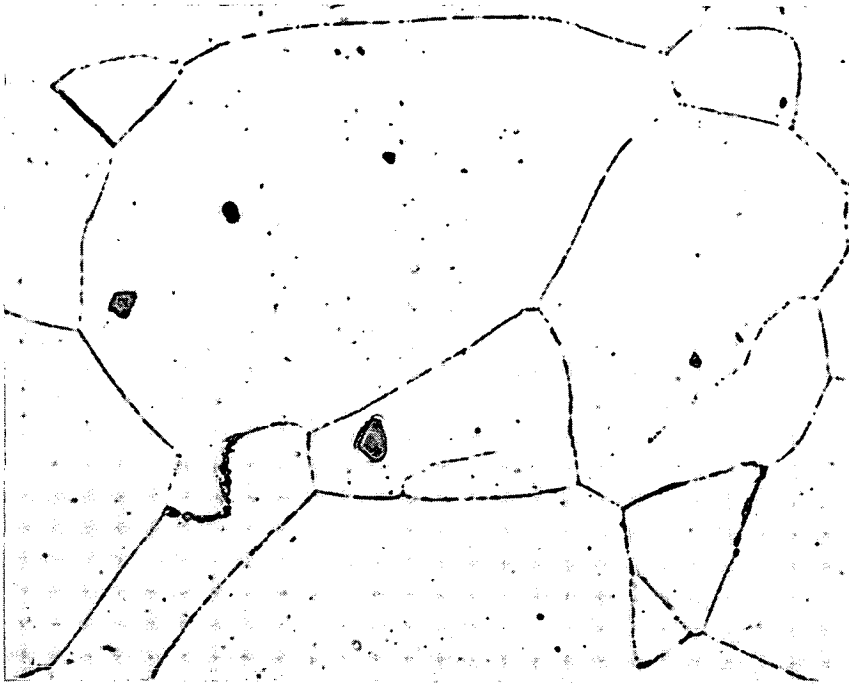
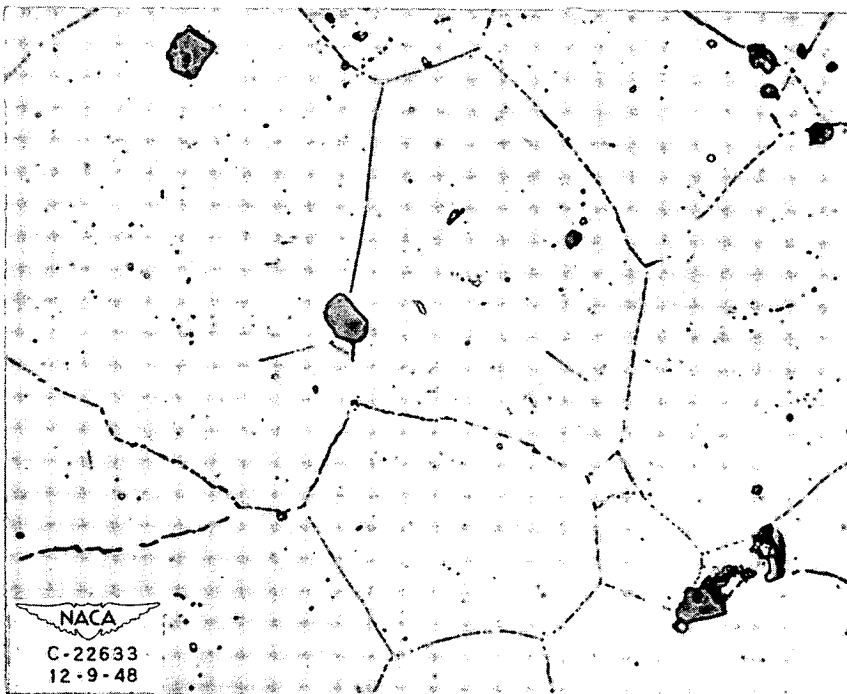
Trial heat treatments. - Heat treatment at 900° F produced no significant difference from the as-fabricated sample (figs. 15(a) and 15(b)). Heating at 1600° F caused precipitation of microconstituents, whereas heating at 2200° F dissolved most of these microconstituents (figs. 15(c) and 15(d)). In addition, heating at 2200° F softened the metal, caused grain growth, and aided recrystallization. No significant differences were observed between samples that were quenched in air or in water (table II).

(a) Not treated (dead soft).

(b) After heating at 900° F for 1 hour and air-cooling.

Figure 15. - Microstructure of dead-soft Inconel. Etchant, 10-percent sodium cyanide, electrolytic; magnification, X750.

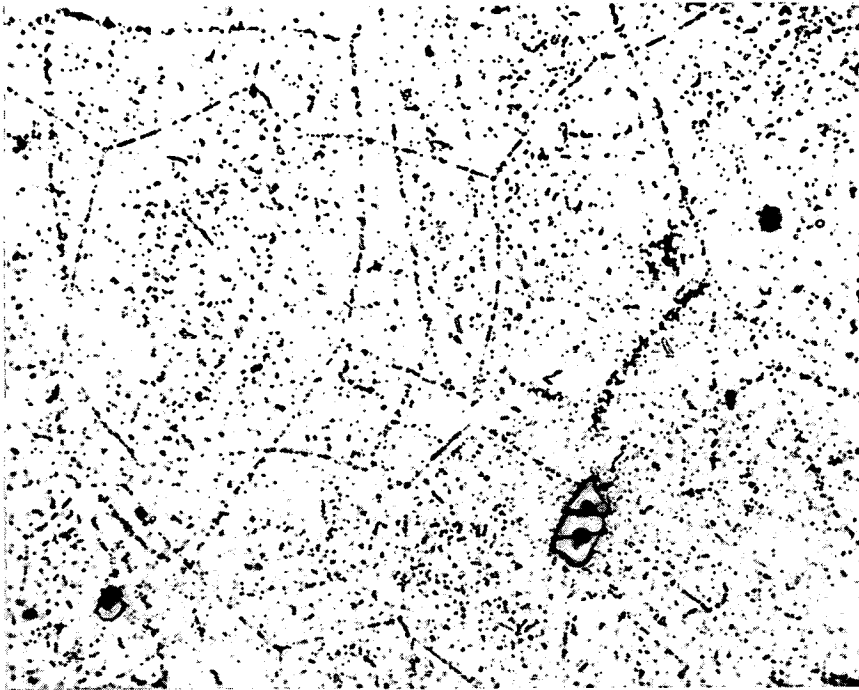
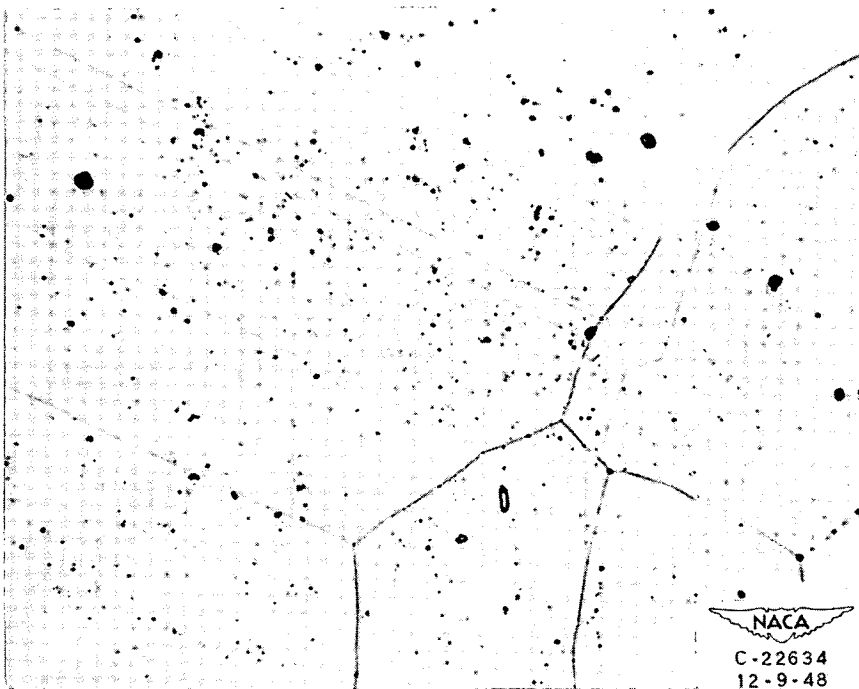
(c) After annealing at 1600° F for 2 hours and air-cooling.

(d) After annealing at 2200° F for 2 hours and air-cooling.

Figure 15. - Concluded. Microstructure of dead-soft Inconel. Etchant, 10-percent sodium cyanide, electrolytic; magnification, X750.

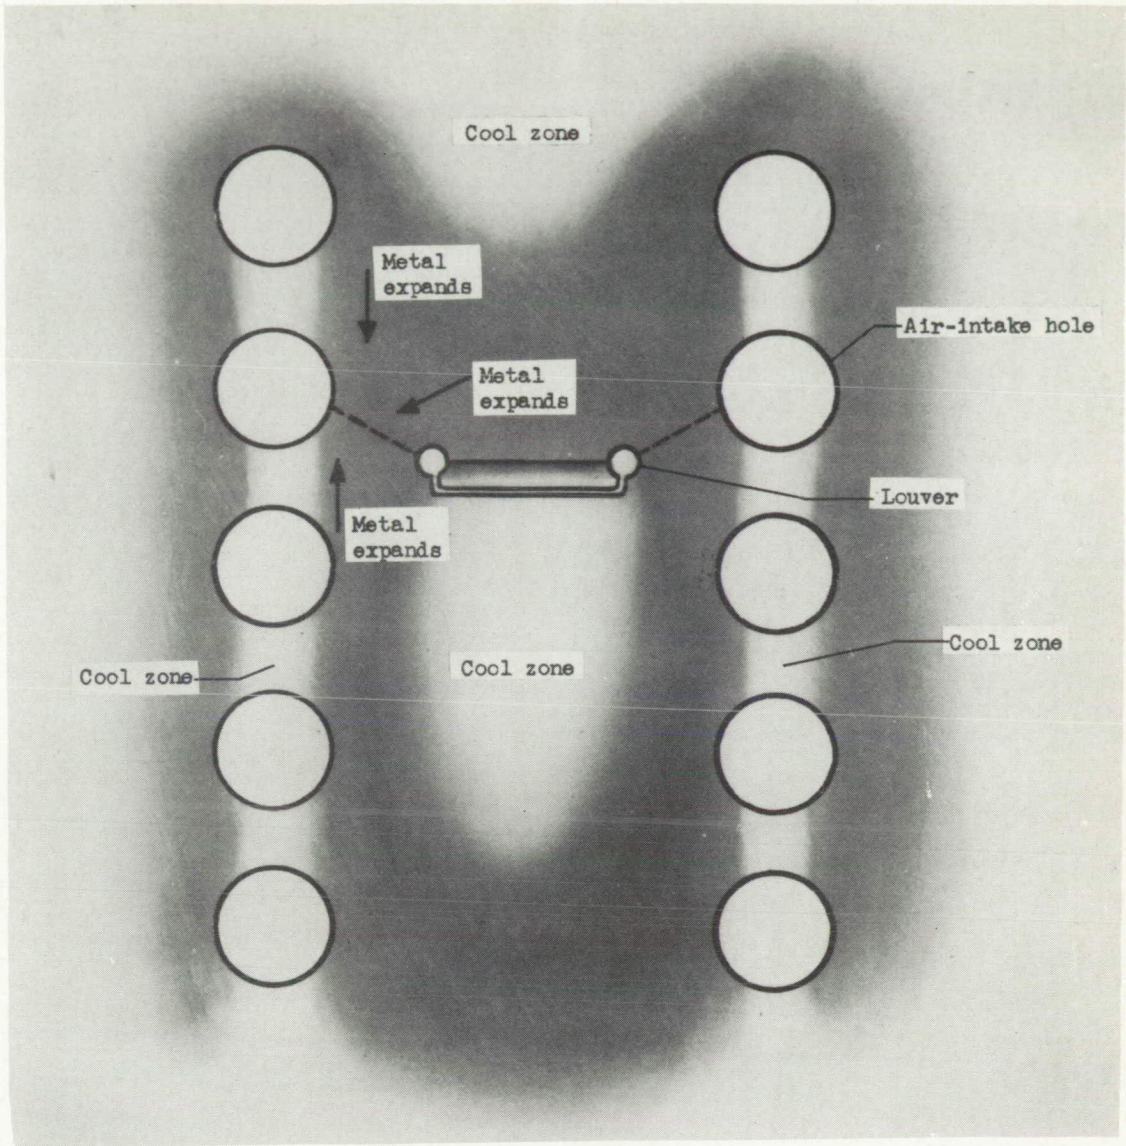
Figure 16. - Hot and cool zones about louver. Dashed lines indicate approximate location of buckles.

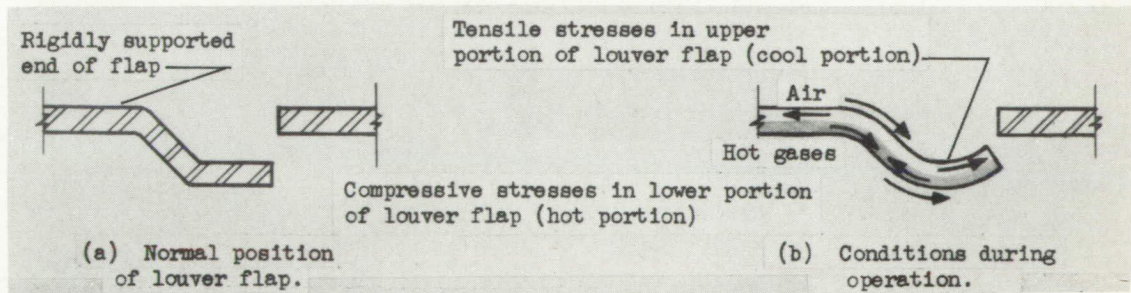
By alternately heating and cooling the louver flap, an outward and inward movement of the flap was produced. The operational conditions previously described therefore probably caused a similar motion of the flaps producing a thermal fatigue. Any bending of the louver flap would apply maximum bending stresses at the inner edge of the stress-relieving holes (fig. 3(a), point 1). Because the lower side of a flap projects into the path of the combustion gases and thus becomes hot and the upper side is cooled by the flow of secondary combustion air, tensile and compressive stresses are produced in upper and lower portions, respectively, as a result of differences in thermal expansion (fig. 17). These stresses produce the upward bending upon heating.

Figure 17. - Conditions in louver flaps.
