NATIONAL ADVISORY COMMITTEE FOR AERONAUTICS

TECHNICAL NOTE

No. 1637

EFFECT OF PREIGNITION ON CYLINDER TEMPERATURES
PRESSURES, POWER OUTPUT, AND PISTON FAILURES

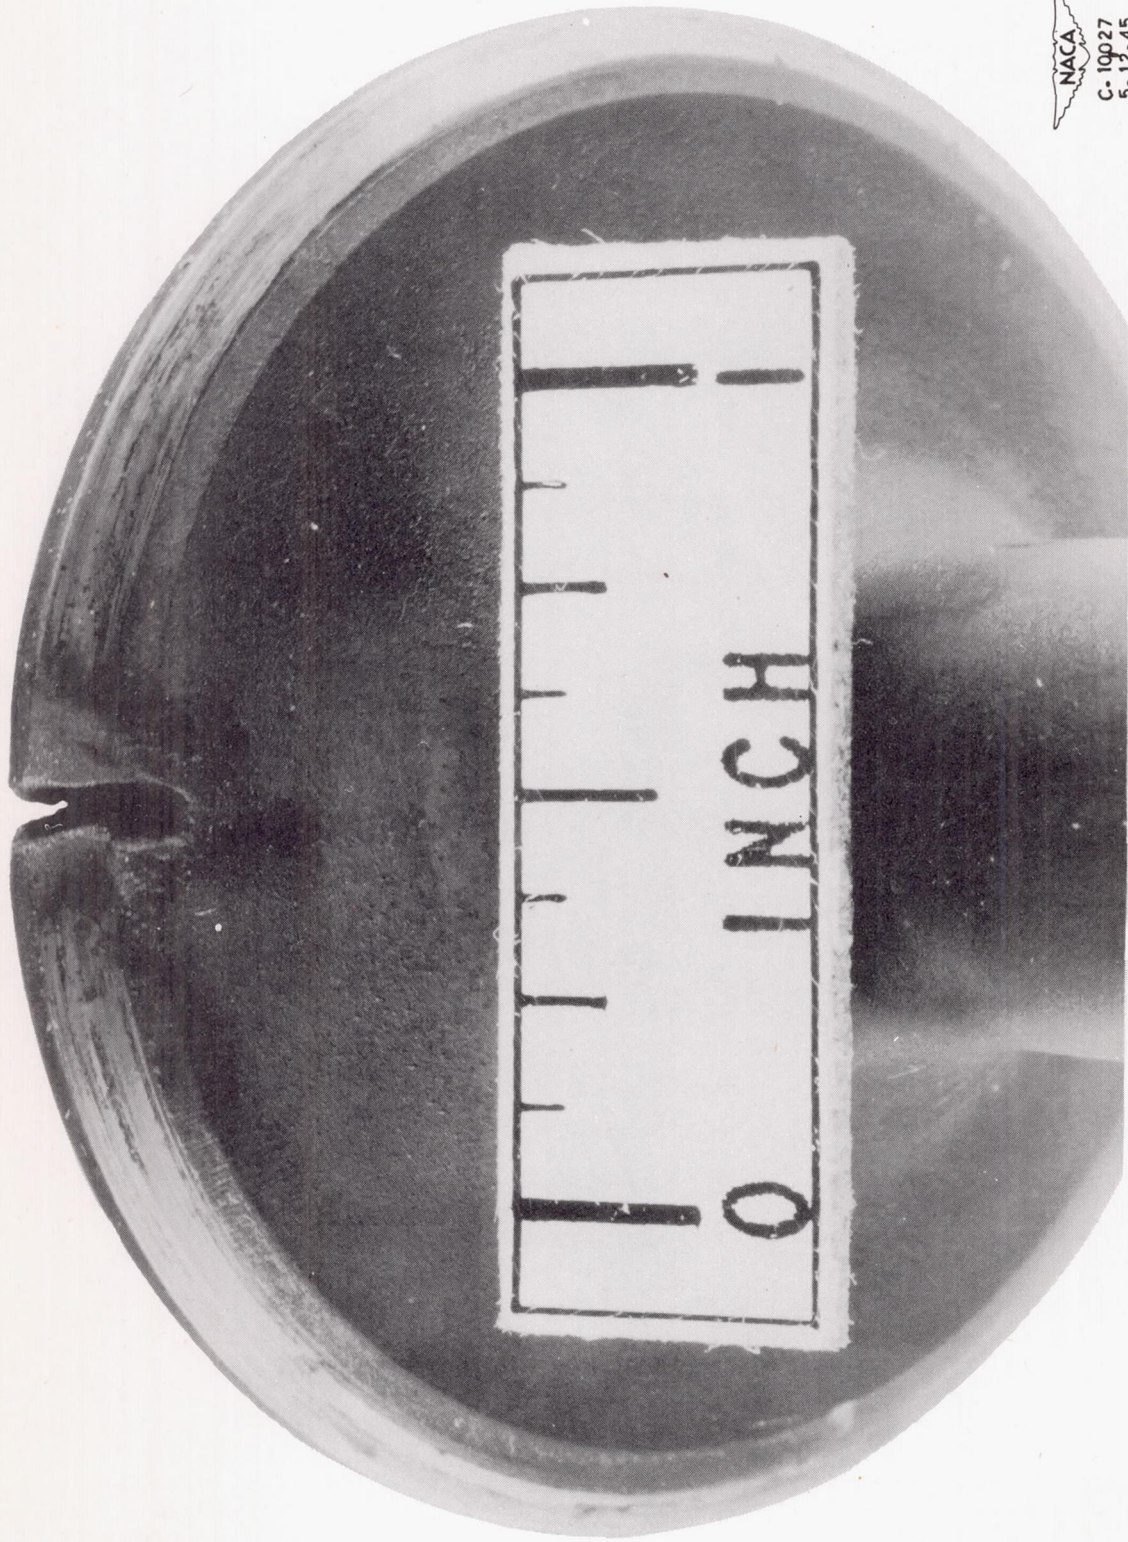
Engine difficulties experienced. - The previously mentioned runs were made with a stock piston, the diameter of which had been reduced 0.005 inch. With this added piston clearance, the only part failures encountered involved the spark plugs and the intake valves. After engine operation under some of the preignition conditions, the center electrode of the exhaust spark plug was found to be burned or melted. On two occasions one of the intake valves was found to be burned (fig. 11). Although piston-ring wear was more rapid than normal, no other failures were experienced in more than 500 preignition runs of the type discussed.

Figure 11. - Intake valve burned during preignition runs.

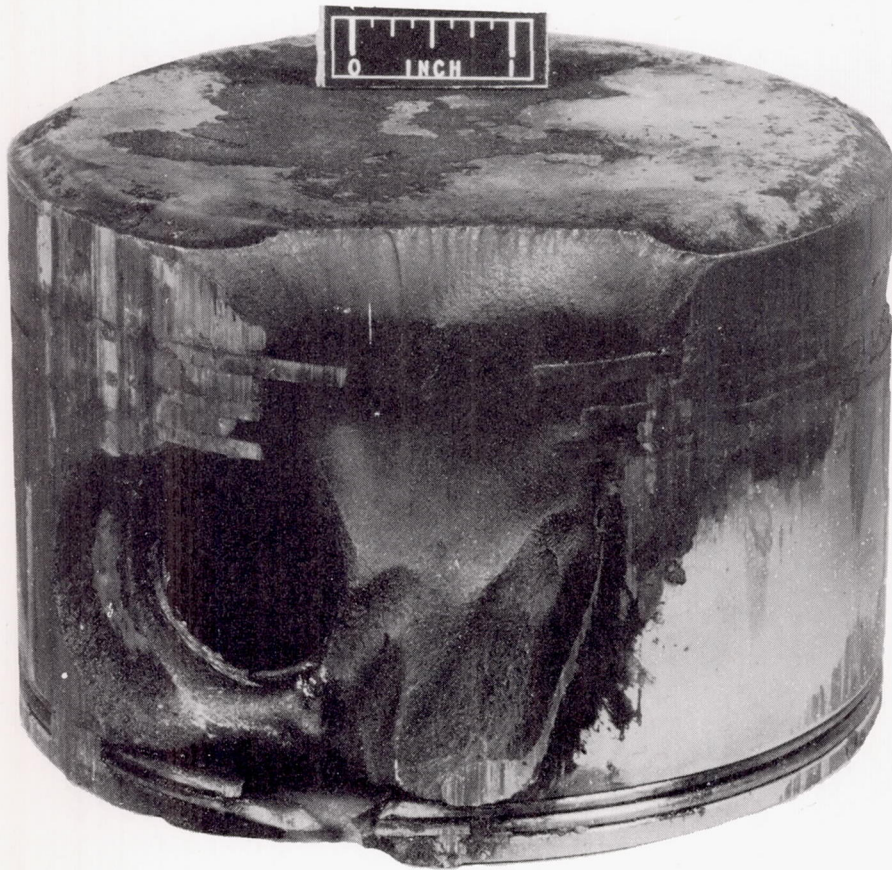
The clearance for the first run was about 0.004 inch less than the normal value (0.021 in.) for the engine. In this run, preignition caused overheating that resulted in piston seizure and consequent melting of the side (fig. 12(a)). With the normal clearance, a higher power level was necessary to cause failure but the failure was of the same nature (fig. 12(b)). The general temperature level of the piston at the time of seizure was apparently higher, however, and a small amount of local melting took place in the center of the crown. When the clearance was increased to 0.005 inch greater than normal, the failure was still a seizure with consequent melting of the side (fig. 12(c)) but more local melting took place in the center of the crown than with normal clearance. A further increase of the clearance to 0.013 inch greater than normal eliminated the seizure (fig. 12(d)) and complete failure was not experienced at the power level investigated. Slightly more severe local melting, however, took place in the center of the crown. On the basis of these runs and a number of unreported preignition investigations, when piston failure is caused by preignition the type of failure depends mainly on the clearance between the piston and the cylinder. With small clearances, the failure occurs through seizure and consequent melting of the side; whereas if the clearances are large enough, melting will probably occur wherever the piston is hottest, in the center of the crown in this instance.

(a) Clearance, 0.004-inch less than normal; imep, 271 pounds per square inch; fuel-air ratio, 0.098.

Figure 12. - Exhaust-side view of piston failures caused by preignition with various clearances between top of skirt and cylinder barrel.

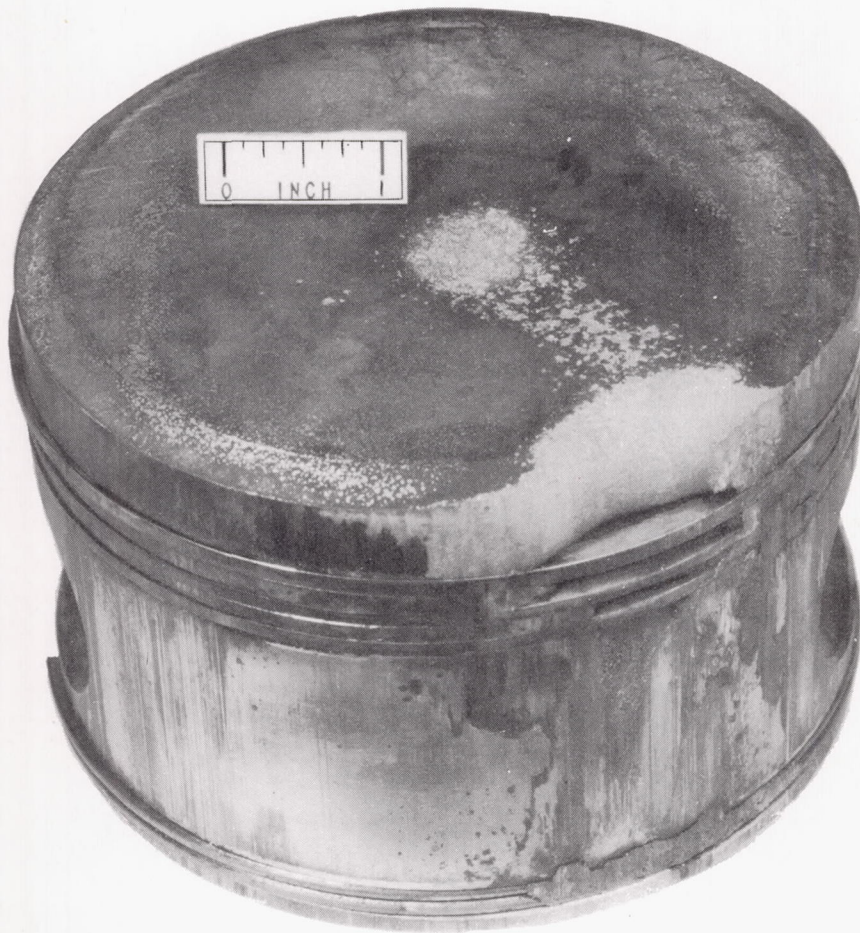
(b) Clearance, normal; imep, 364 pounds per square inch;
fuel-air ratio, 0.094.

Figure 12. - Continued. Exhaust-side view of piston failures
caused by preignition with various clearances between top
of skirt and cylinder barrel.

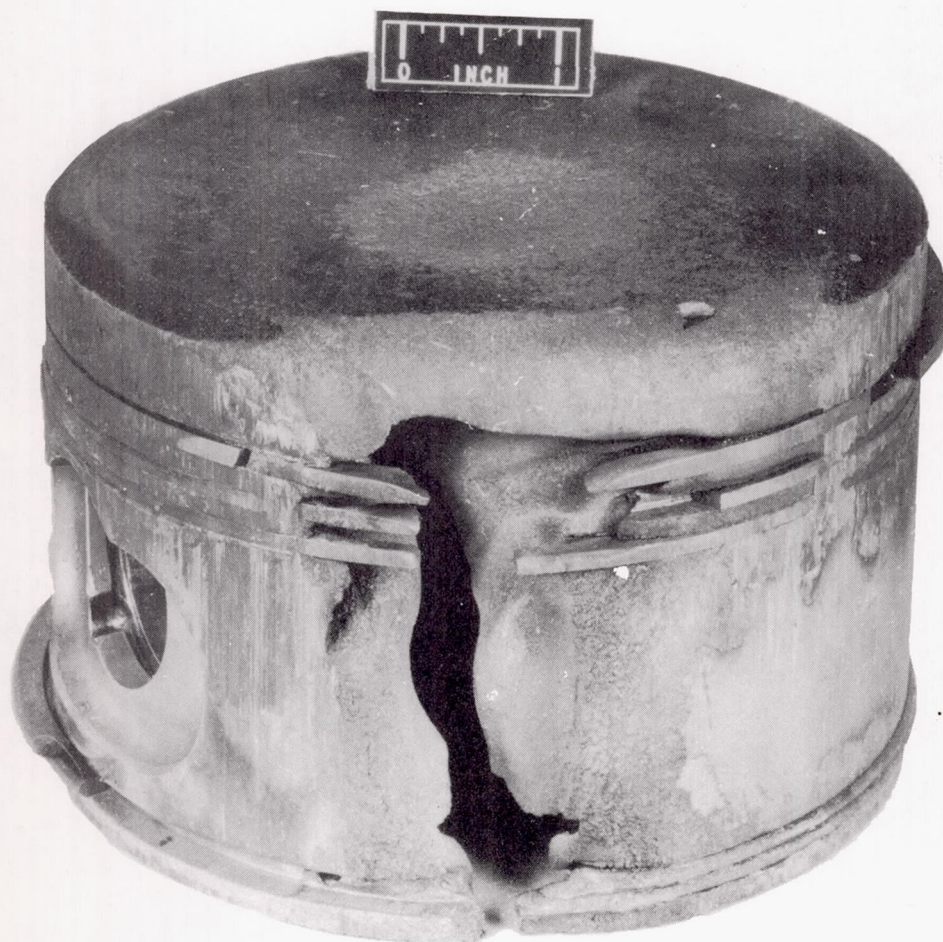
(c) Clearance, 0.005-inch greater than normal; imep, 364 pounds per square inch; fuel-air ratio, 0.094.

Figure 12. - Continued. Exhaust-side view of piston failures caused by preignition with various clearances between top of skirt and cylinder barrel.

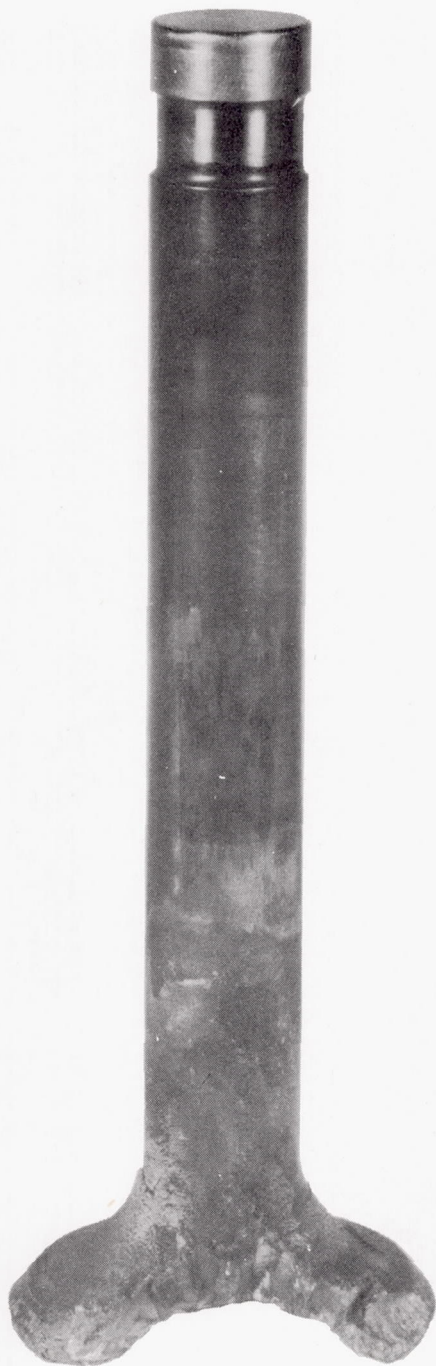
Photographs of damage to other cylinder parts that accompanied the piston failures in two of the runs are also presented. Figure 14 shows an exhaust valve that burned at the time of the piston failure shown in figure 12(b). Inasmuch as two other runs were made at more severe operating conditions without valve failure, it is felt that this failure was brought about by particles of aluminum or other substance lodging between the valve and its seat. Figure 15 shows the damage to the cylinder barrel that accompanied the piston failure shown in figure 12(c). The torching action of the hot gases burned through the barrel into the coolant passage.

Figure 14. - Damage to exhaust valve accompanying piston failure of figure 12(b).

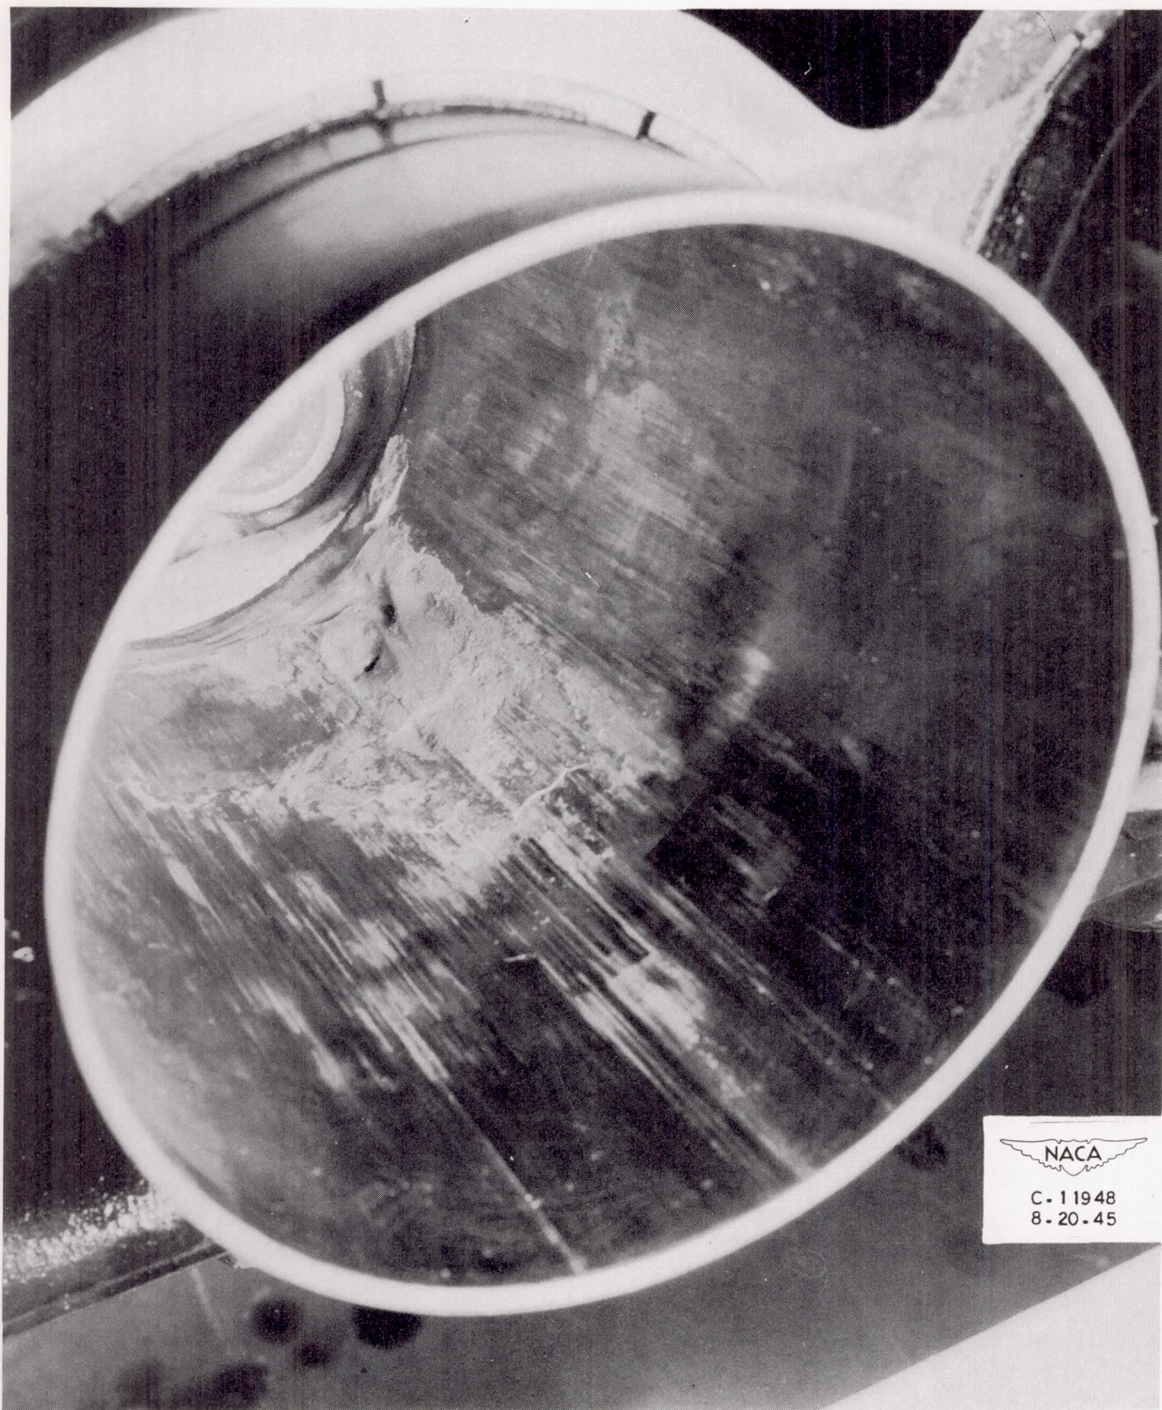
Figure 15. - Damage to cylinder barrel caused by piston failure of figure 12(c).
