TIDEWATER AND WEATHER-EXPOSURE TESTS ON METALS

USED IN AIRCRAFT - II

By Willard Mutchler and W. G. Galvin
National Bureau of Standards

Washington
February 1942

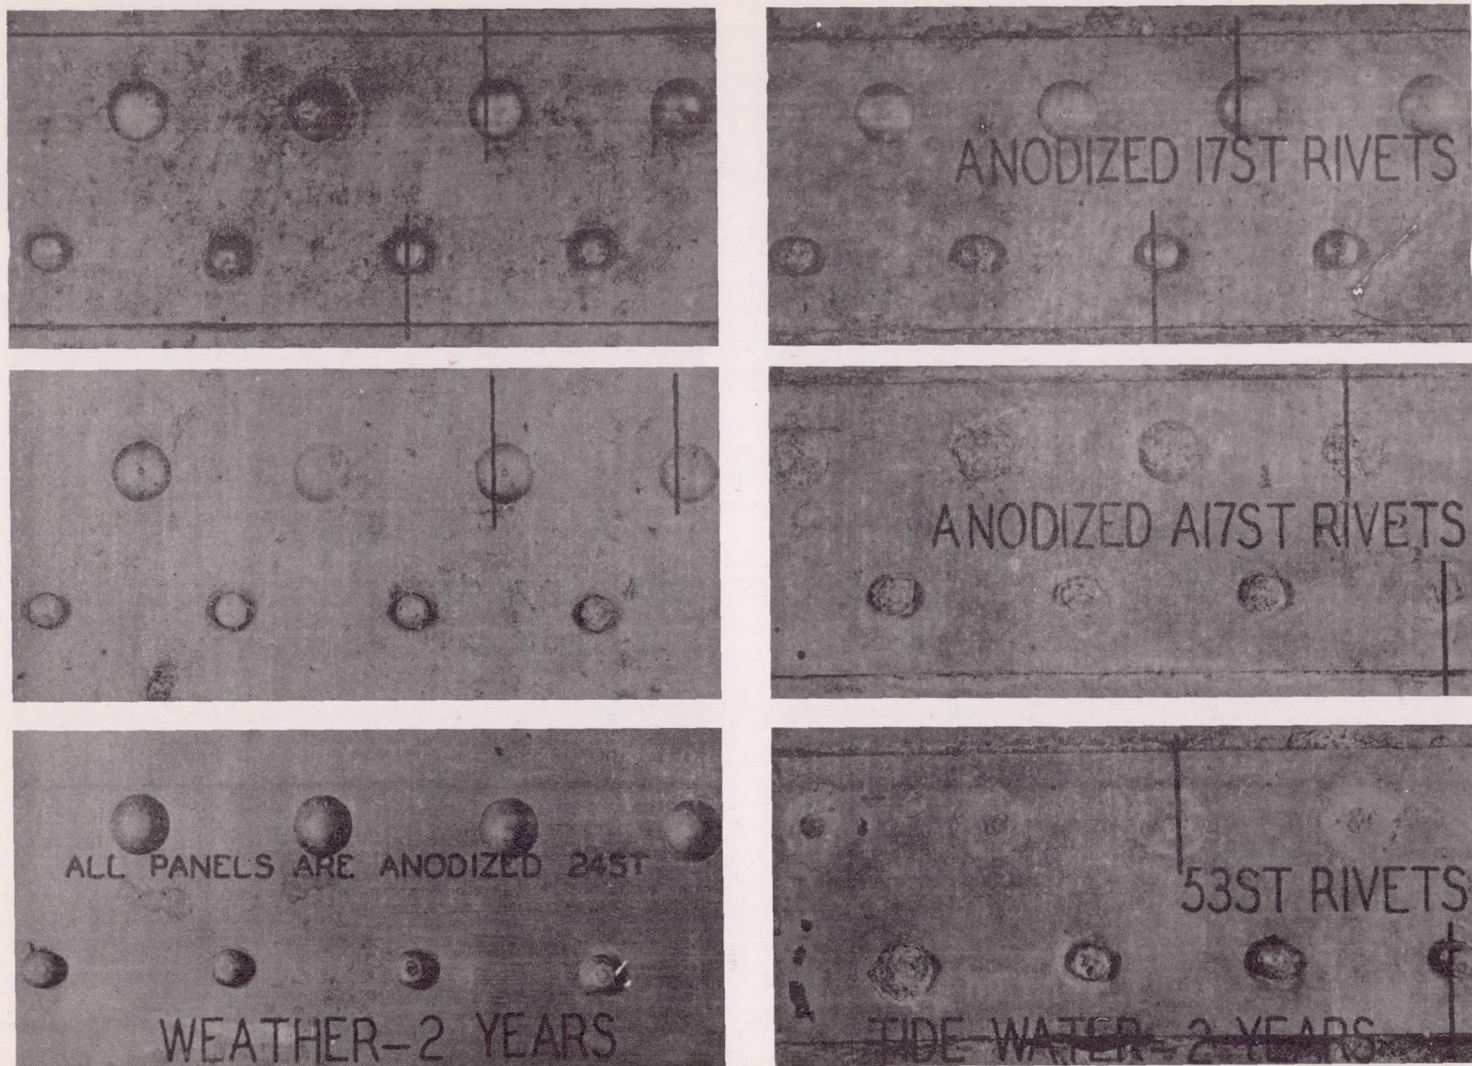
The attack on the 53ST and the anodized Al7ST rivets on 24ST sheet was but little worse after the second than after the first year of exposure. The corrosion on rivets treated with sealed Alumilite coatings was almost as severe as that on rivets anodized in the chromic-acid electrolyte. Sufficient disintegration had occurred during the first year to make it evident that both alloys were anodic with respect to 24ST. The photomicrographs (fig. 4) disclose the severity of the attack on the rivet heads and reveal no corrosion on portions of the 24ST sheet adjacent to, or in contact with, the rivets. The attack on the 53ST rivets was in part intercrystalline, and corrosion was occasionally noted on the shanks of both 53ST and anodized Al7ST rivets.

Figure 2.- Rivets used on 24ST alloy panels exposed for 2 years. Note the advanced disintegration of the 53ST and the anodized A17ST rivets exposed to the tidewater as compared with those exposed to the weather, and the relative absence of attack on the anodized 17ST rivets. In this, and all similar photographs that follow, the large letters at the right apply to the entire horizontal rows, while those at the tops or bottoms apply to the entire vertical rows. x 1 (4 and 6).

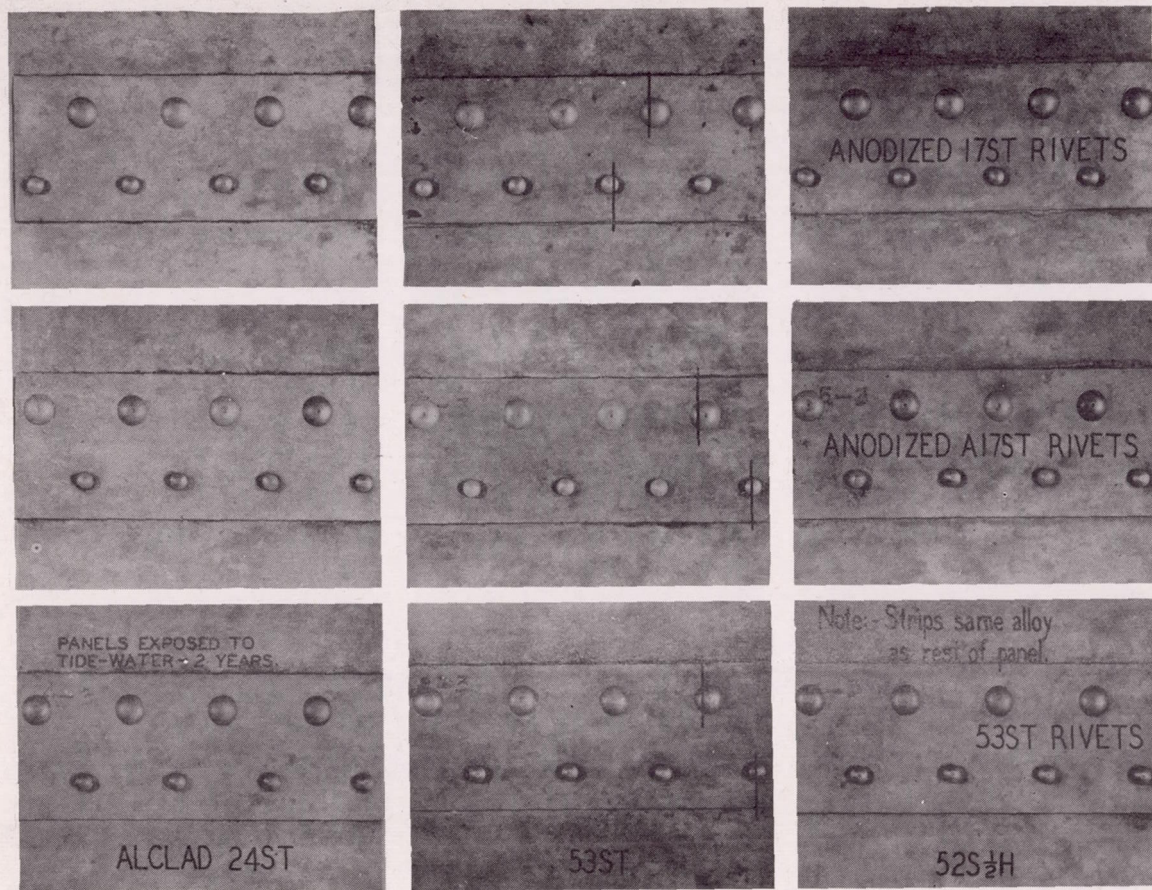
Figure 3.- Rivets used on panels of Alclad 24ST, 53ST, and 52S- $\frac{1}{2}$ H alloys exposed to tidewater. Neither the rivets nor the sheets are corroded. x 1/2 (5).

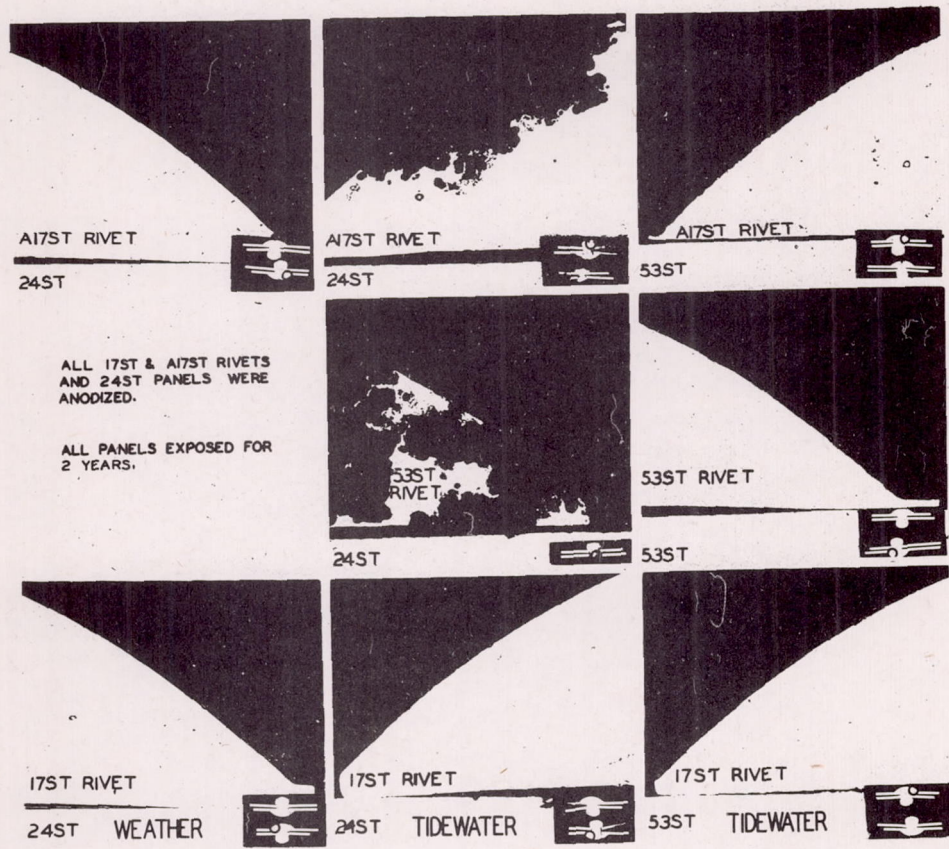
The microscopic examinations confirmed the practical absence of corrosive attack on either the rivets or the sheets where any of the three kinds of rivet were used to join Alclad 24ST, 52S- $\frac{1}{2}$ H, or 53ST (fig. 4) sheet. Such corrosion as occurred seldom exceeded 0.002 inch in depth and was of the pitting type on all the alloys.

Figure 4.- Corrosion on rivet heads and 53ST and anodized 24ST sheets. Attack was especially severe on 53ST and anodized A17ST rivets joined to 24ST sheet and exposed to tidewater. Photomicrographs, x 25; cross sections (in black rectangles), x 1/2.

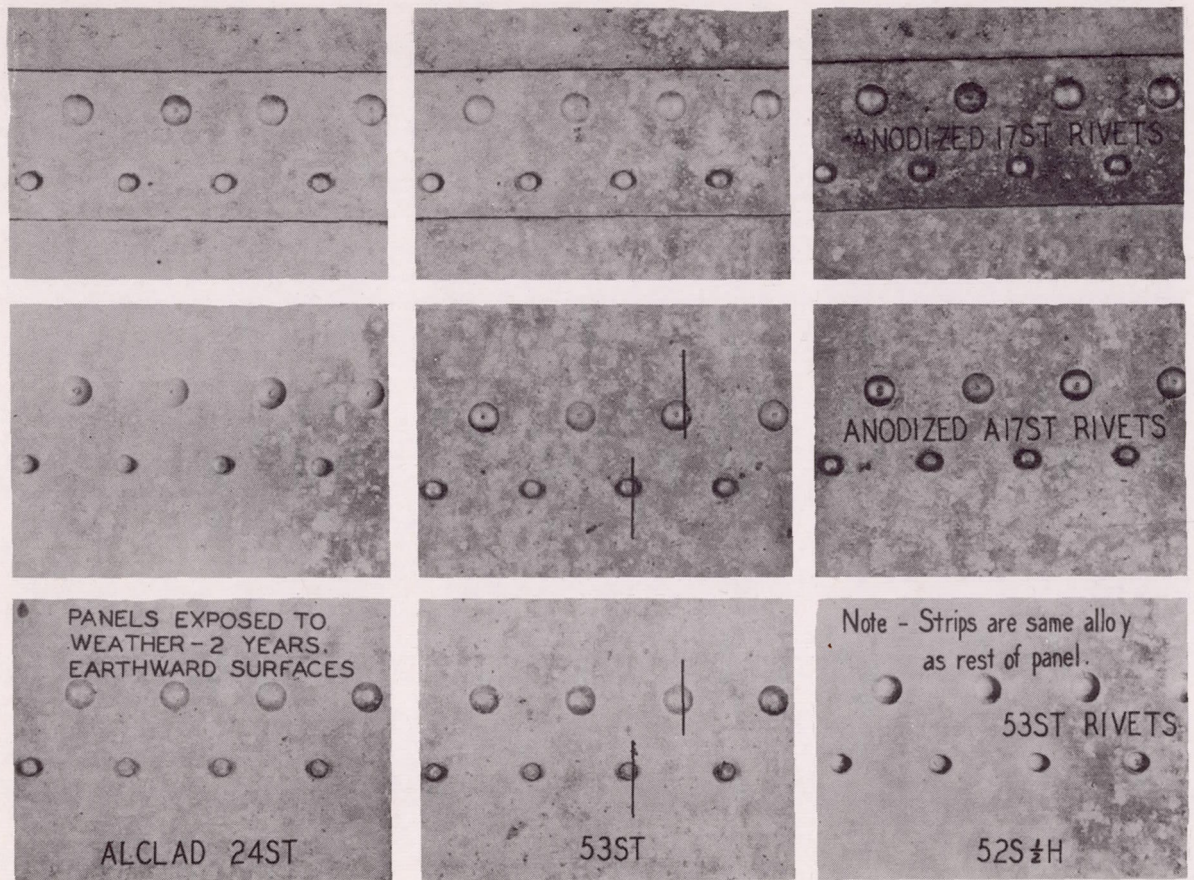
Figure 5.- Rivets used on panels of Alclad 24ST, 53ST, and 52S- $\frac{1}{2}$ H alloys exposed to the weather. Attack on both rivets and sheet was, in general more severe than in the tidewater tests. x 1/2 (6).

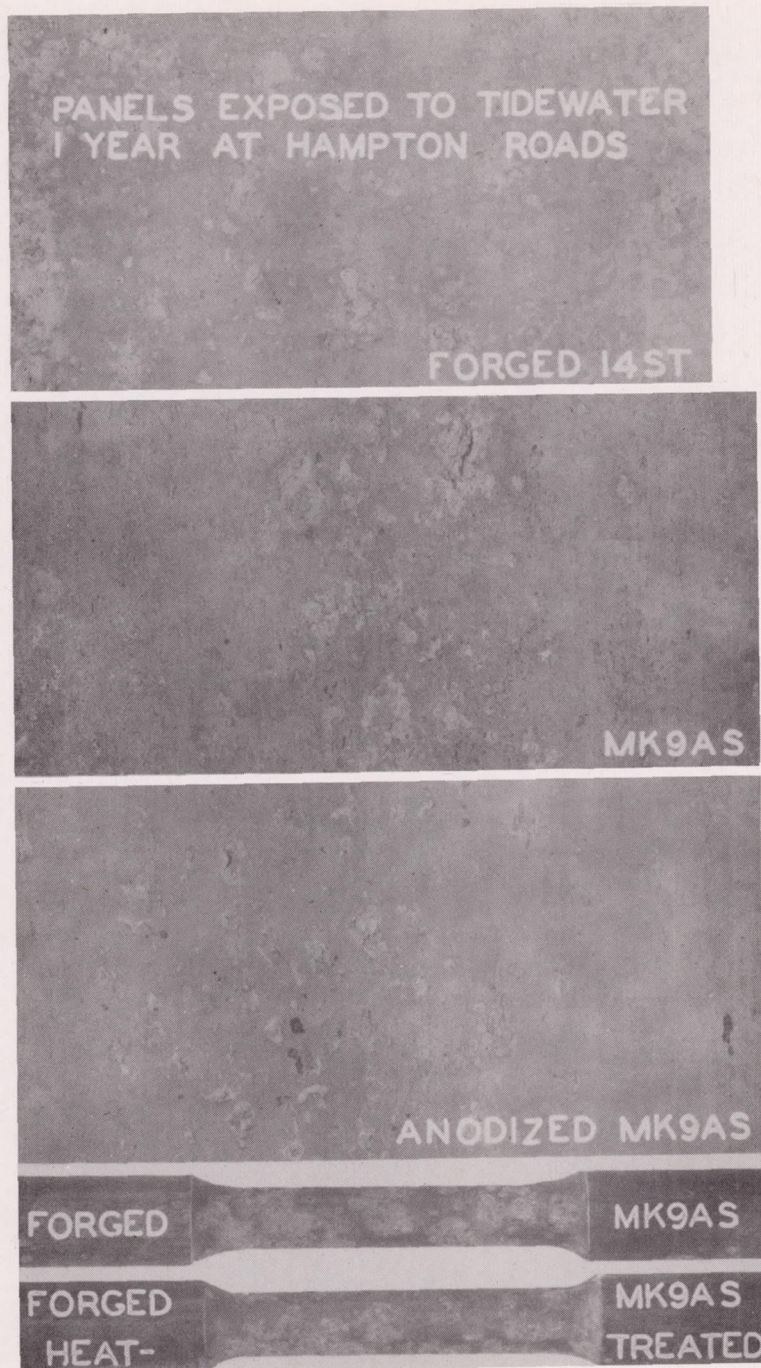
Unriveted aluminum-alloy panels.— The forged 14ST panels, not anodically treated, were the most severely attacked of all the aluminum alloys, both in the tidewater and weather-exposure tests (fig. 6). The corrosion was predominantly intercrystalline and attained a depth of 0.015 inch in tidewater and of 0.01 inch in the weather after 2 years. These panels were solution heat-treated in air at approximately 940° F, given a quench in an aqueous solution (not in air, as erroneously stated in table II of reference 1), and aged 10 hours at 340° F.

The Major metal sheets (fig. 6), anodized and unanodized, corroded in a fashion quite similar to the 14ST alloy. The attack was largely intercrystalline and the unanodized sheet panels 0.060 inch thick were penetrated in spots after 6 months in the tidewater. The specimens exposed as forged and heat-treated bars, 0.575 inch diameter, had an initial (uncorroded) ultimate tensile strength

Figure 6.- Forged 14ST and Major metal (MK9AS) panels exposed to tide-water. These alloys were the most susceptible to corrosion of all the aluminum alloys included in the test. x 1.

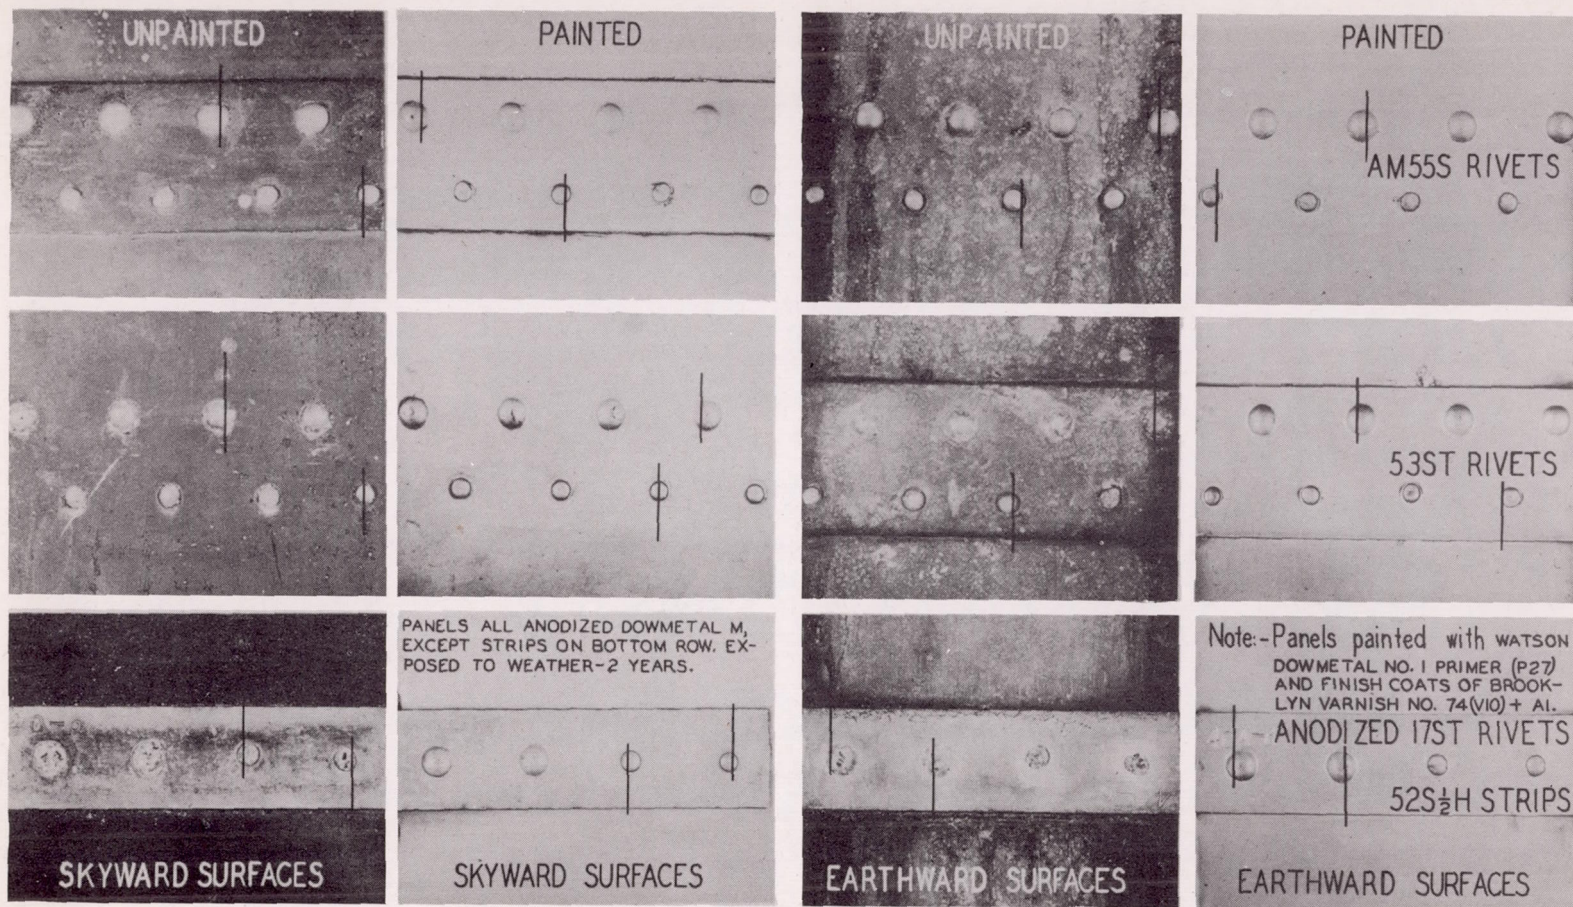
The anodized 17ST rivets on unpainted panels, after 2 years of exposure to the weather, were in advanced stages of disintegration (fig. 7), while the 53ST rivets were also severely attacked. Both were much worse attacked than after 1 year of exposure. The AM55S rivets, however, continued to exhibit relatively little attack. The Dowmetal M sheets were discolored brown on the skyward surfaces and were partly covered with a thin nonuniform grayish-white film of corrosion product on the earthward surfaces. Microscopic examinations (fig. 8) revealed a few pits 0.001 inch deep on the AM55S rivets, but the 53ST rivets had several pits 0.003 inch deep. Numerous pits from 0.002 to 0.008 inch deep were found on the Dowmetal M sheet, and its edges were rounded off by corrosion. Relatively little corrosion occurred on the Dowmetal M surfaces which were in contact with the Neoprene tape.

Figure 7.- Rivets on Dowmetal M panels exposed to the weather. The AM 55S rivets were very much less attacked than the 53ST or anodized 17ST rivets. The paint coating, however, protected both the rivets and the sheet from attack. x 1/2 (8).

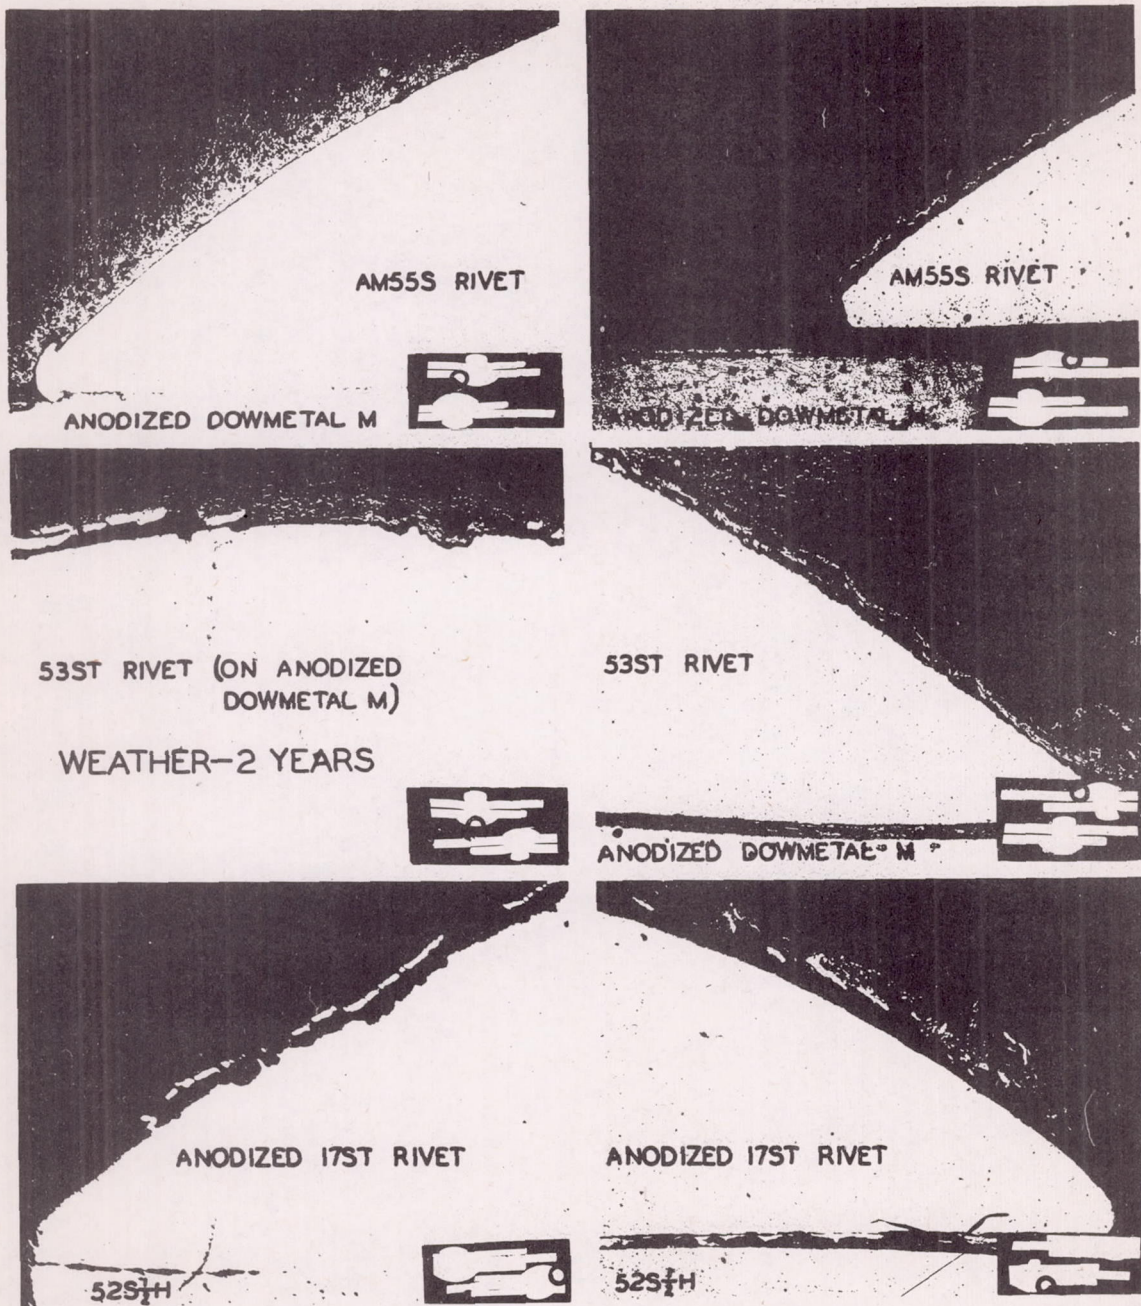
Figure 8.- Corrosion on rivets used for joining Dowmetal M sheets. Attack was least on the unanodized AM55S, intermediate on the 53ST, and most on the anodized 17ST rivets on unpainted panels. None of the rivets on painted panels were corroded. Micrographs, x 40; cross-sections, x 1.

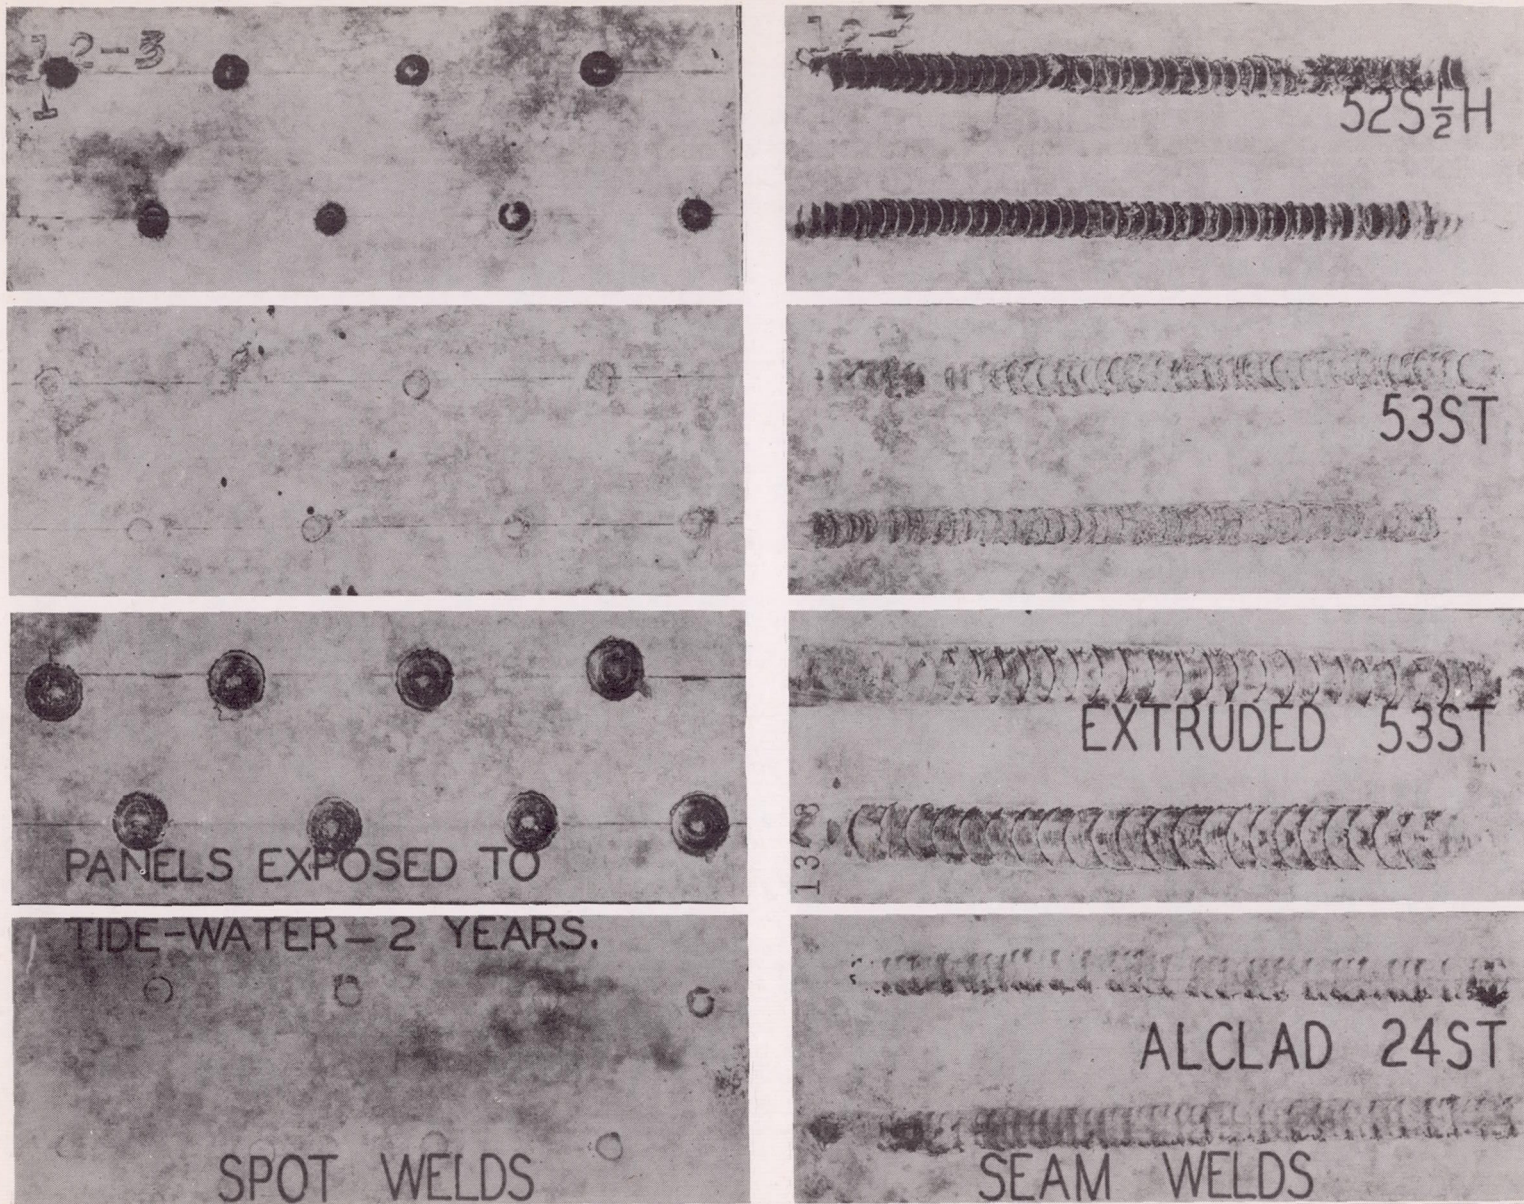
None of the welded panels exhibited much corrosion after 2 years of exposure to tidewater (fig. 9). This result indicates that either the metal on the surfaces of the welds had potentials approximately equivalent to that of the remainder of their respective panels or else were somewhat cathodic thereto. The microscopic examinations (fig. 10) revealed that corrosion on the welded or unwelded parts of the panels was largely confined to a relatively few small pits, nearly all being less than 0.001 inch deep. On the 53ST and the 52S- $\frac{1}{2}$ H panels a few small areas of intercrystalline corrosion occasionally appeared; a very few had depths of 0.004 inch. The 53ST panels exhibited more attack, however, than the 52S- $\frac{1}{2}$ H panels. The surfaces of welds joining dissimilar alloys were corroded similarly to those joining alloys of the same compositions. The faying surfaces, which were in metallic contact, were relatively free from corrosion.

Figure 9.- Welded aluminum alloy panels remained practically unattacked after 2 years of exposure to tidewater. The dark colorations on some of the welds were caused by the copper electrodes used for welding. x 1 (10).

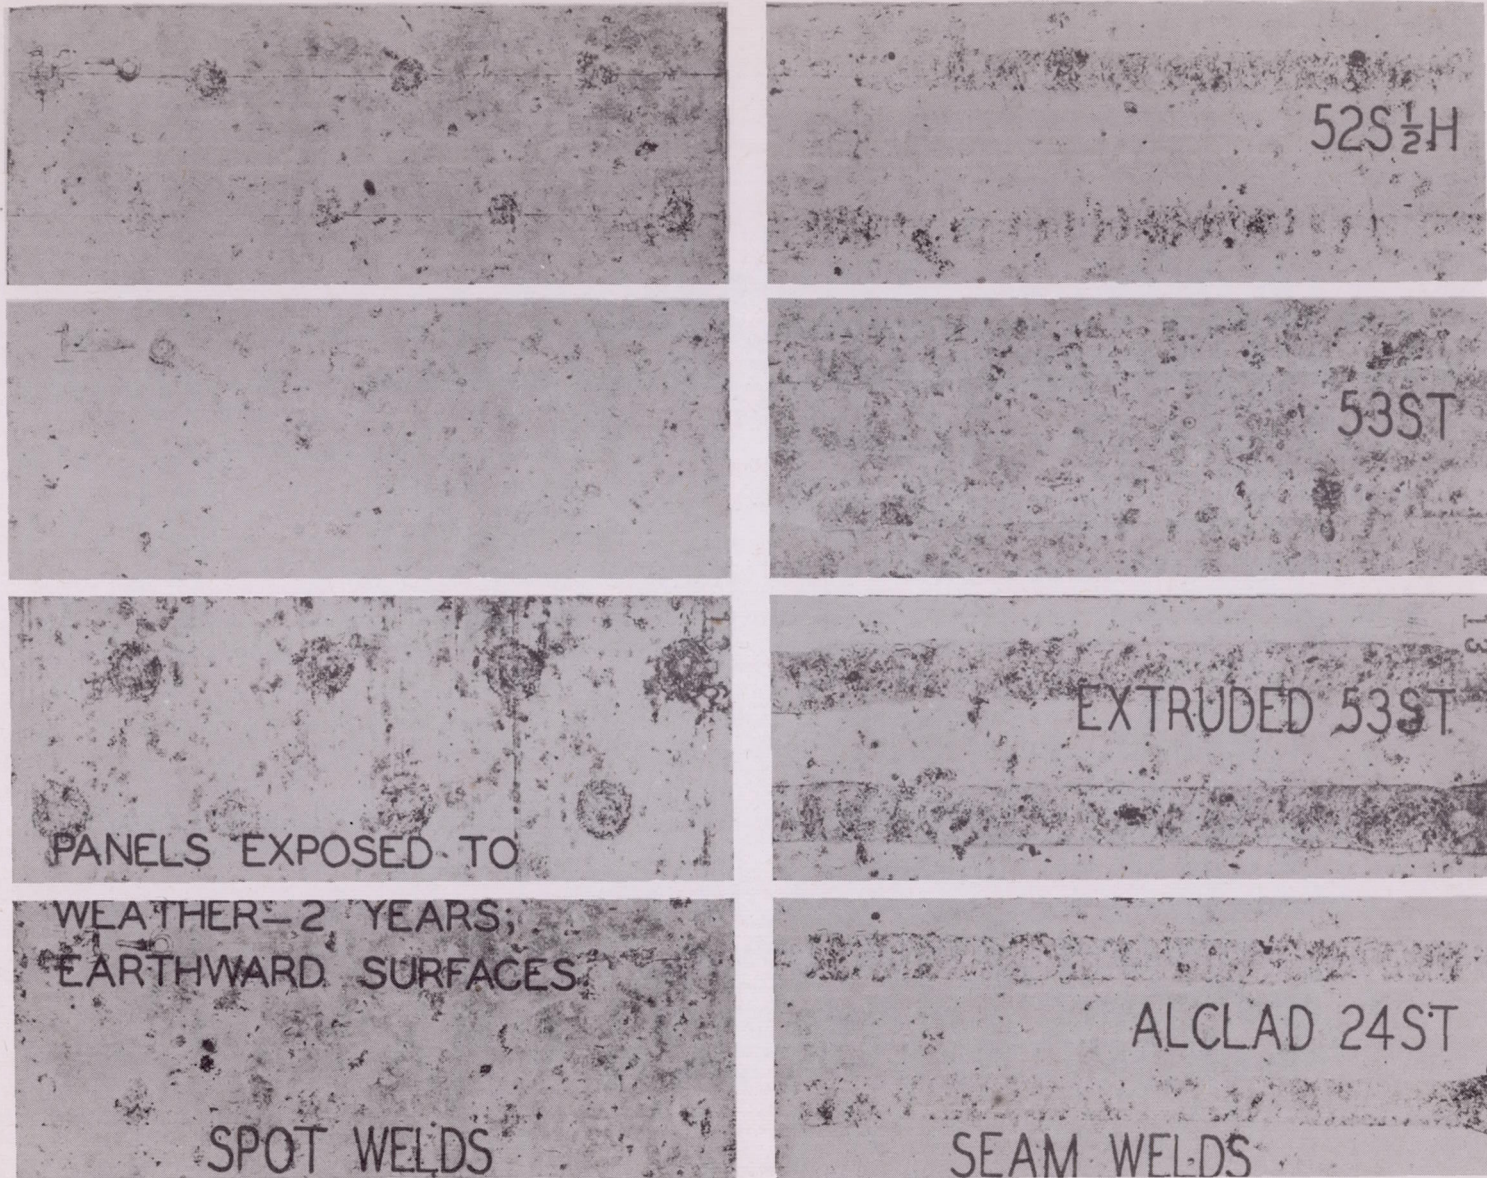
The panels exposed to the weather for 2 years (fig. 11) were much more corroded, especially on the welds, than those in tidewater. In general, the attack was somewhat worse on the earthward surfaces than on the skyward surfaces. The seam welds were more corroded than the spot welds, while the gas welds exhibited but little attack.

Figure 11.- Welded aluminum-alloy panels exposed to the weather were more corroded than those exposed to tidewater, especially at the welds. x 1 (11).

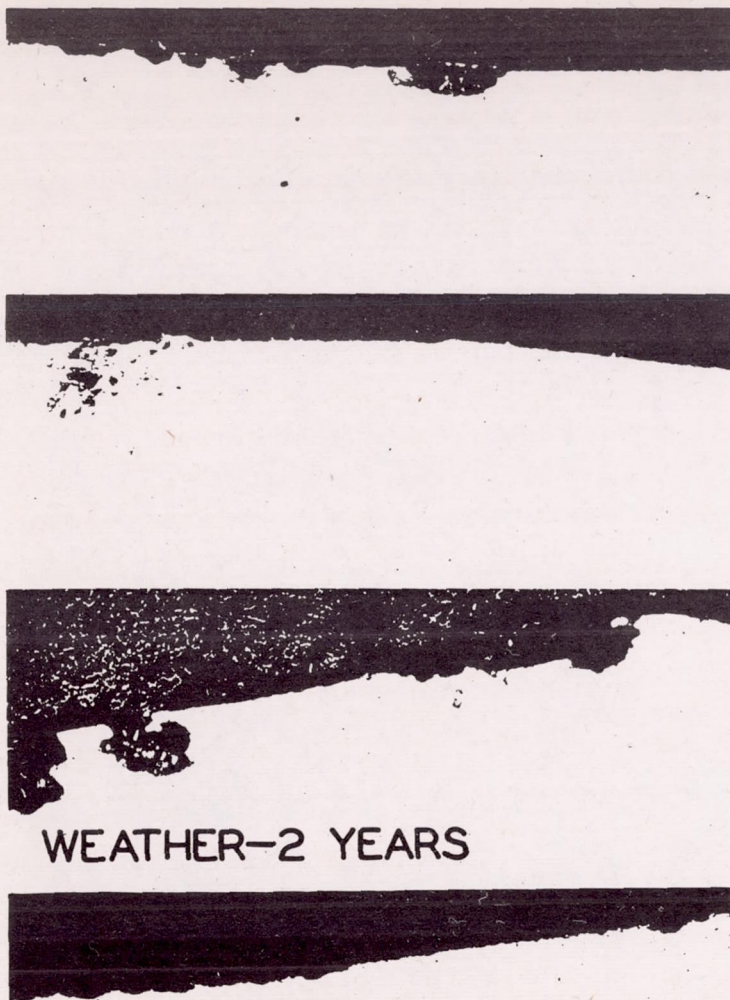
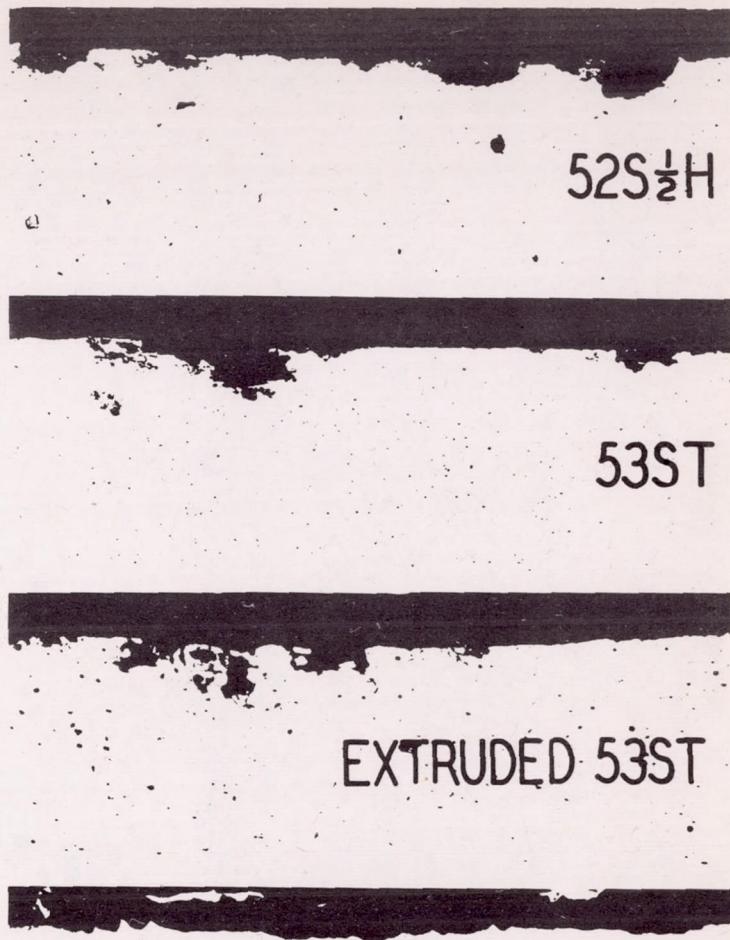
The microscopic examinations (figs. 12 and 13) of the spot welds disclosed many pits (0.001 and 0.002 in.) on the Alclad 24ST panels, but in no case was penetration of the aluminum protective coating found. On 52S- $\frac{1}{2}$ H welds numerous pits were found associated with some intercrystalline attack, generally 0.002 inch deep, but occasionally 0.006 inch. The welds on the sheet and extrusions of 53ST alloy were attacked similarly to those on 52S- $\frac{1}{2}$ H but intercrystalline attack was more in evidence; and occasionally pit depths of 0.010 inch were noted. Little attack occurred at the faying surfaces, but some pits 0.005 inch deep were detected on the 53ST materials.

Figure 12.- Microscopic examination of welds on aluminum-alloy panels exposed to the weather revealed considerable corrosion of greater depth than occurred on unwelded portions. Seam welds were the most severely attacked. Corrosion on welds on Alclad 24ST was shallower than on the other alloys but penetrated the protective aluminum coating in some instances. x 50.

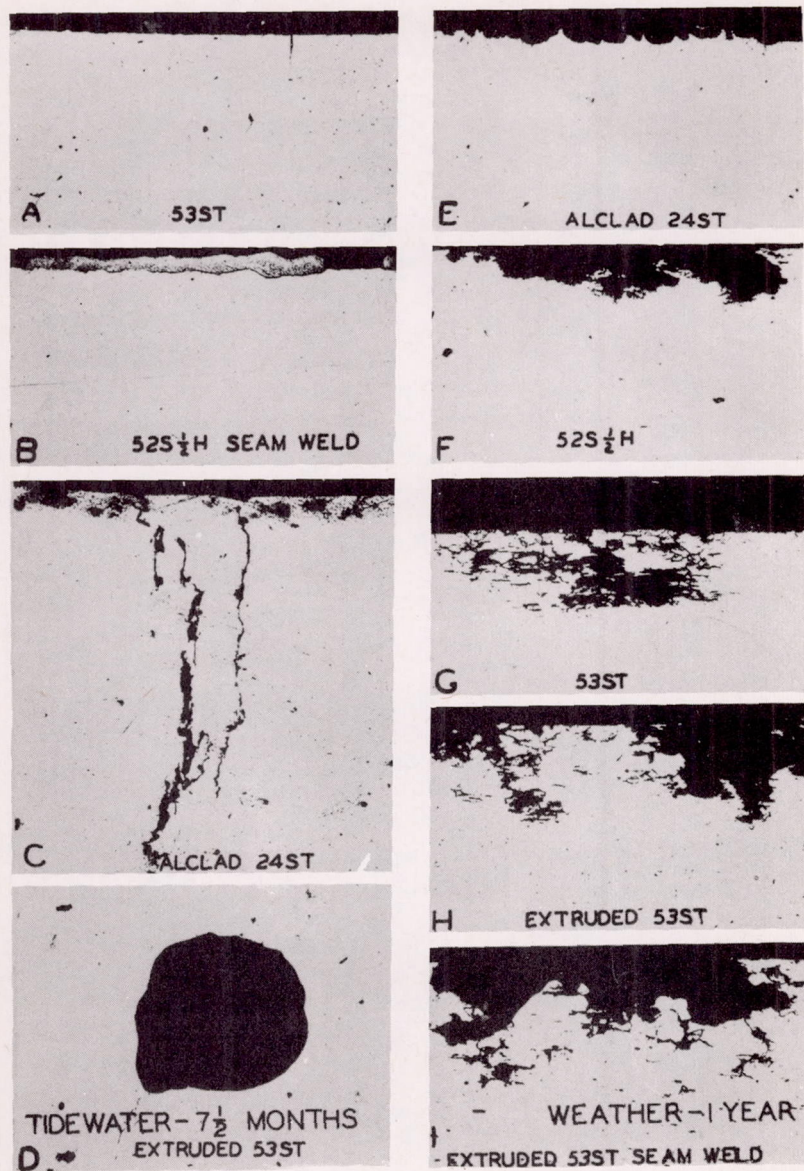
The seam welds were uniformly sound, but cracks occurred on some of the Alclad 24ST spot welds (fig. 13); whereas very small cavities, 0.001 inch in diameter, were present on a few of the 52S- $\frac{1}{2}$ H welds and cavities as wide as 0.010 inch were found in several of the welds on extruded 53ST panels. Numerous cavities, ranging from 0.005 to 0.010 inch in diameter, were found in the gas welds.

Figure 13.- Photomicrographs of welds on aluminum-alloy panels exposed to weather or to tidewater. Spot welds are pictured, unless otherwise noted. A - Formative stage of intercrystalline corrosion. B - Coating on weld, perhaps resulting from reaction with the electrode. C - Cracks present in some of the spot welds in this alloy. D - Cavity, representative of those of average size found in some spot or gas welds. E - Pitting, though general, had not penetrated the aluminum protective coating during the first year. F - Traces of intercrystalline attack were occasionally associated with pits on the 52S- $\frac{1}{2}$ H alloy. G - Intercrystalline corrosion on an area of the sheet remote from a weld. H and I - Intercrystalline corrosion on welds. x 60.

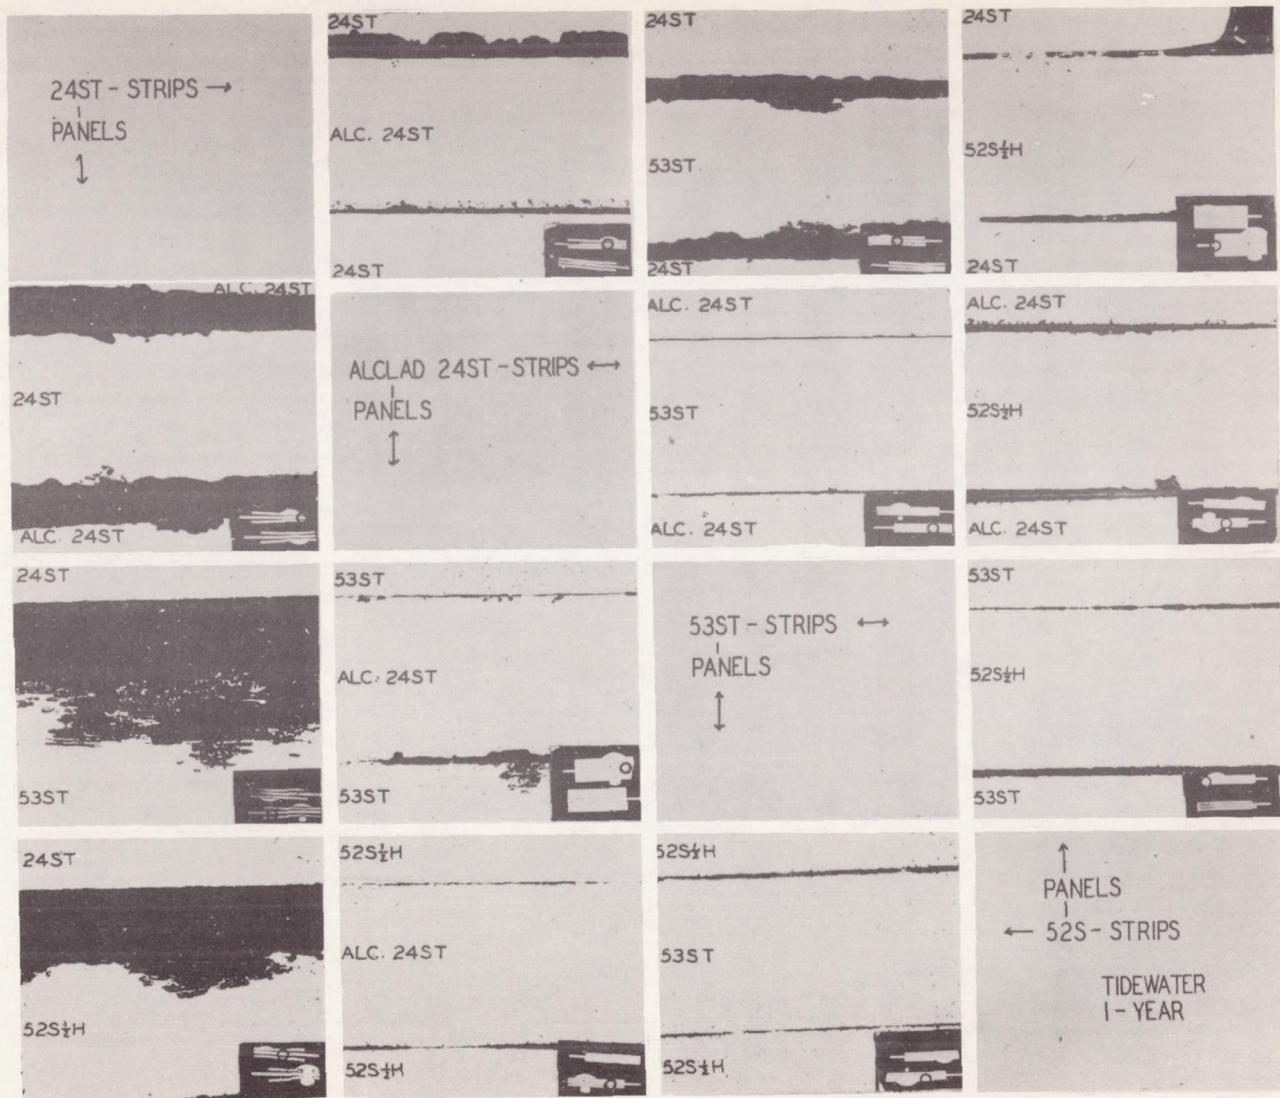
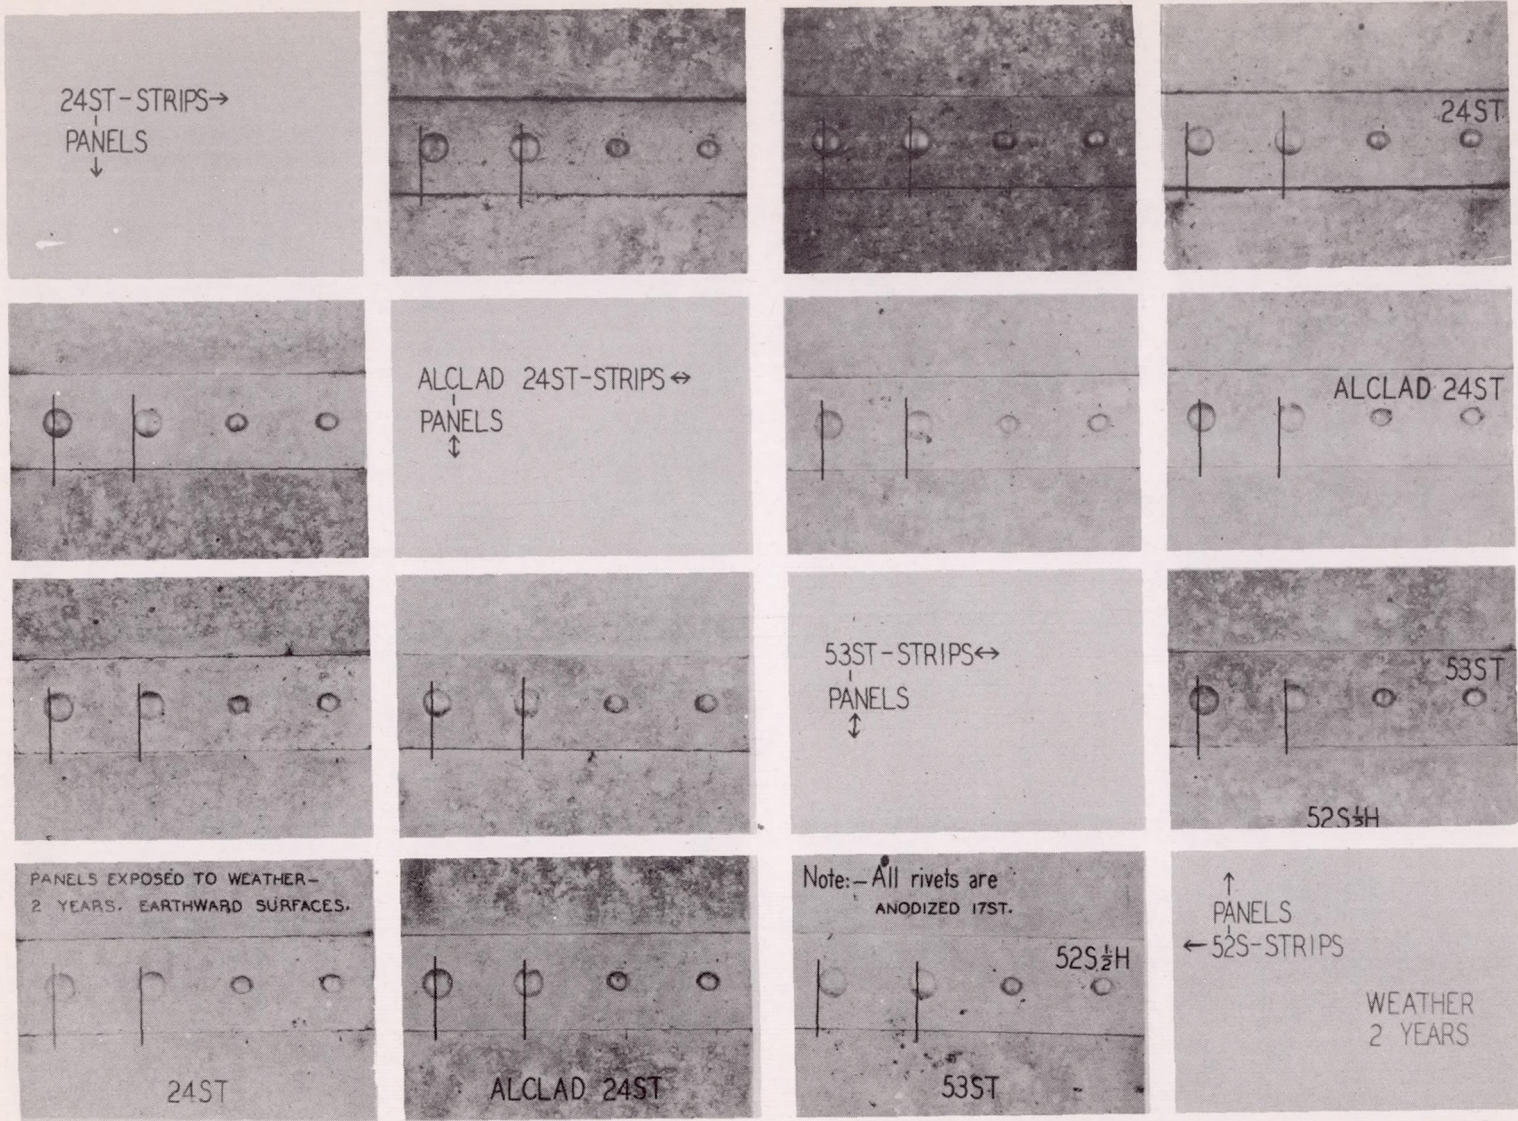
The surface appearance of the panels exposed for 2 years to the weather (fig. 16) indicates that, though corrosion products in some instances accumulated along the edges of and under the 1- by 4-inch strips, the quantities of such products were usually less than the quantities on the panels exposed to tidewater. The results of the microscopic examinations (fig. 17 and table II) are included for comparison with the panels exposed to tidewater.

Figure 16.- Surface appearance of aluminum alloys exposed to the weather in contact with each other. Accumulations of corrosion products at the faying surfaces were usually much less than when the same alloys were exposed to tidewater or were in contact with more dissimilar metals. x 1/2 (13 & 14)

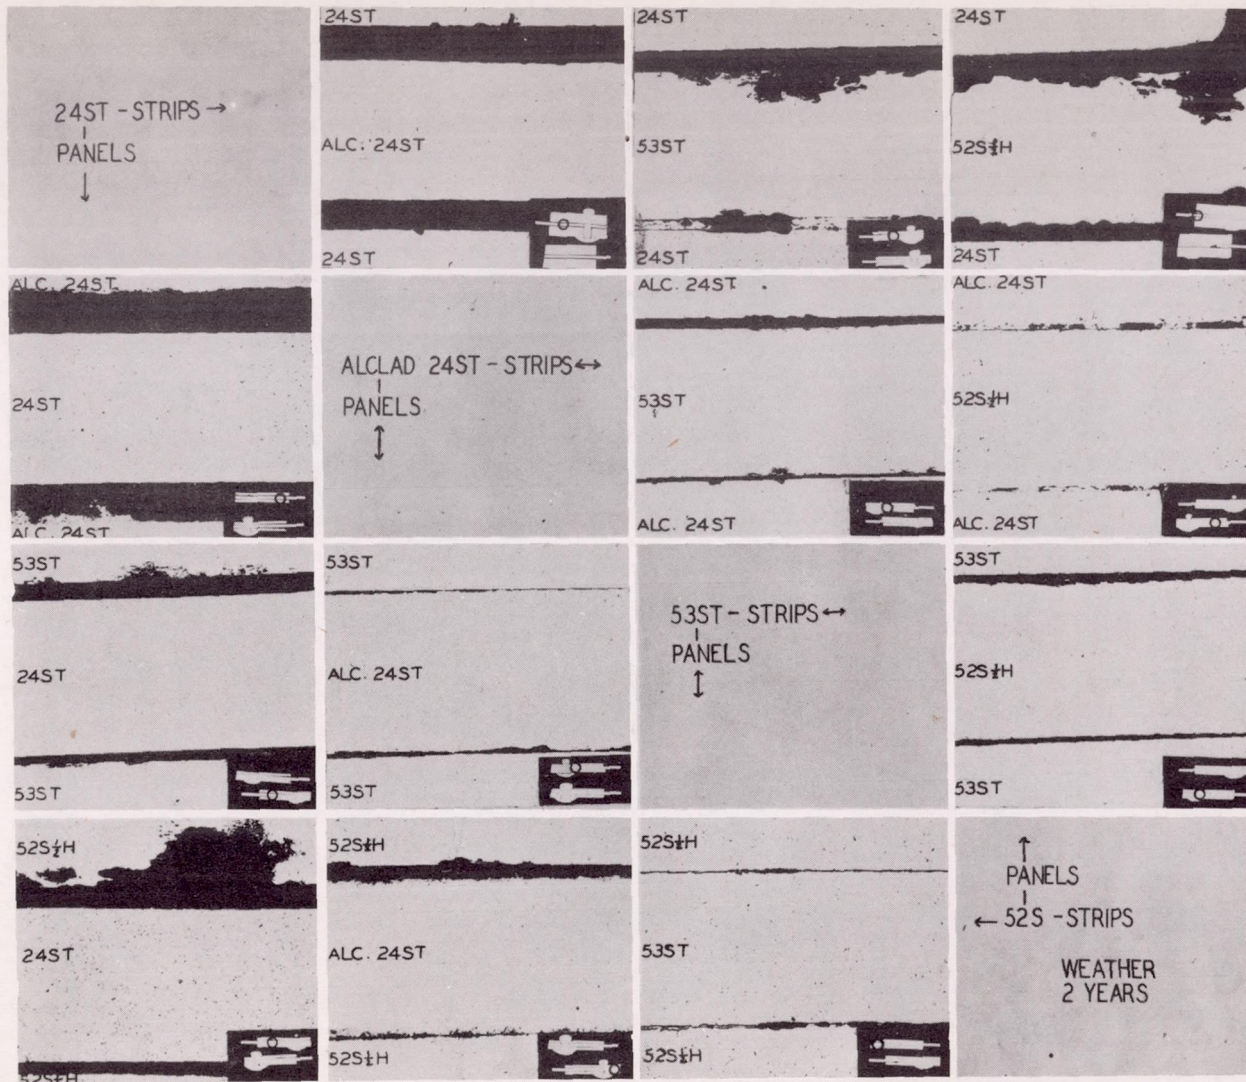
Figure 17.- Cross sections showing aluminum alloys exposed to the weather in contact with each other. Corrosion owing to electrolytic effects were similar to those observed in the tidewater tests but were usually less severe. Photomicrographs, x 25; smaller cross sections, x 1/2.
