TIDEWATER AND WEATHER-EXPOSURE TESTS ON METALS

USED IN AIRCRAFT - II

By Willard Mutchler and W. G. Galvin
National Bureau of Standards

Washington
February 1942

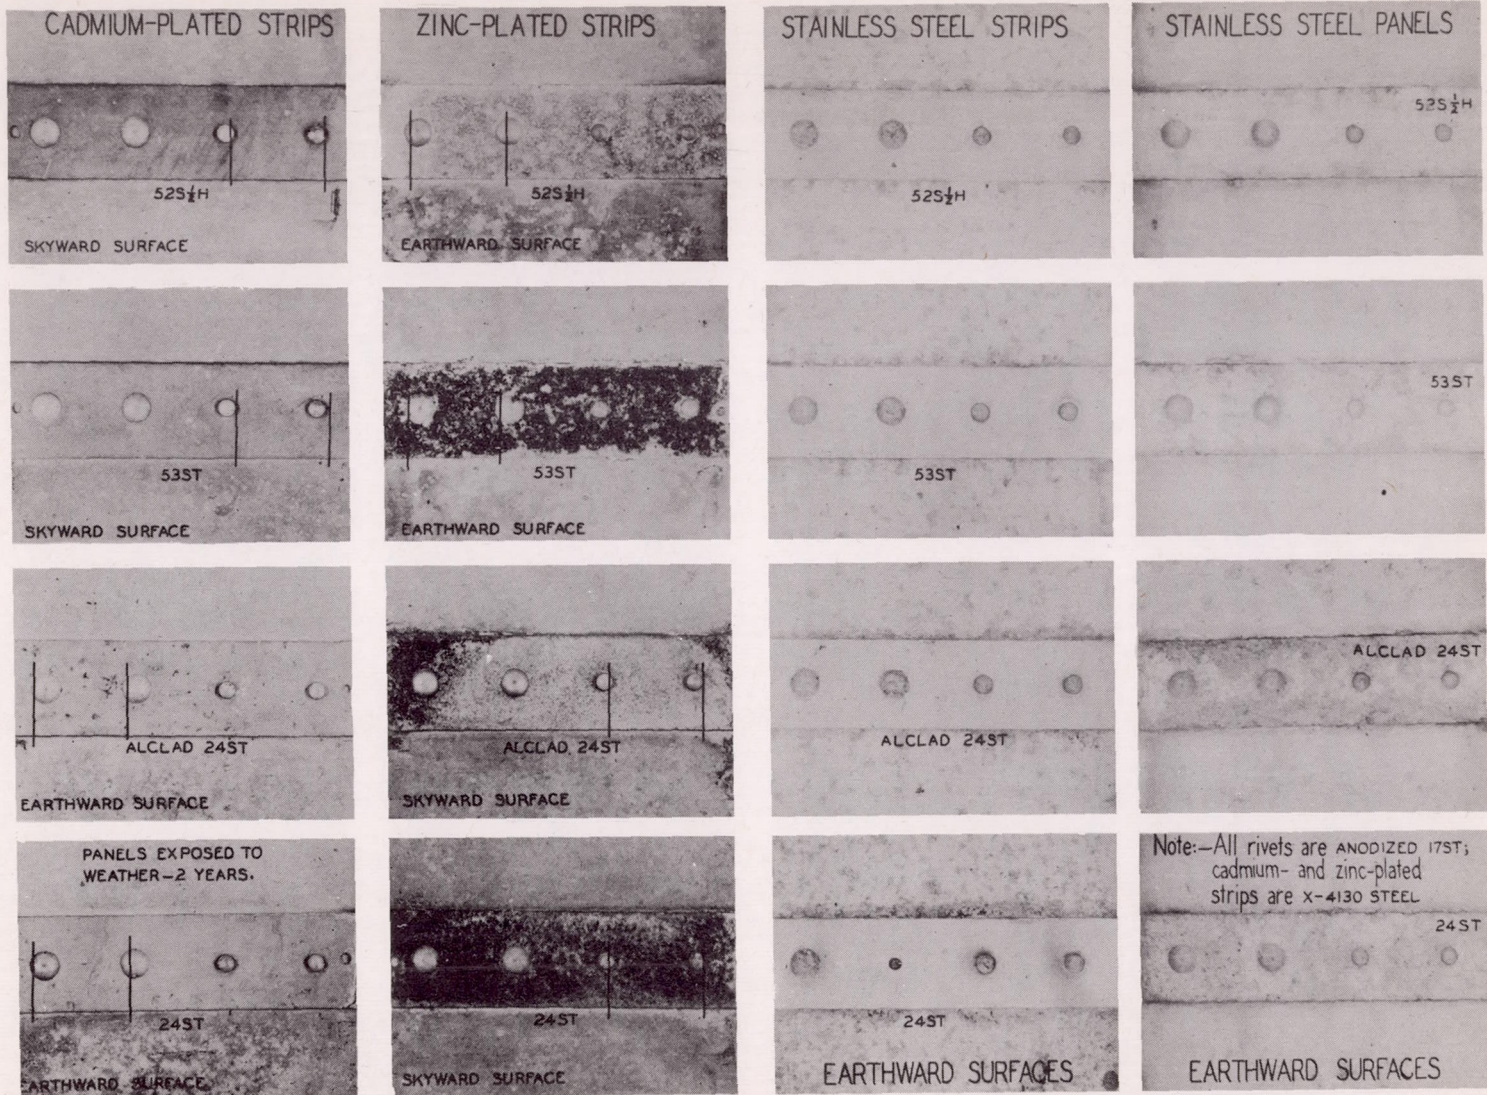
The cadmium-plated strips exposed for 2 years to the weather were all in excellent condition (fig. 18) although faint traces of rust were visible on the strip in contact with Alclad 24ST. The zinc coatings were entirely corroded off strips in contact with Alclad 24ST, were mostly off when in contact with 53ST, but were fairly intact when joined to 24ST and 52S- $\frac{1}{2}$ H sheets. Microscopic examinations revealed little corrosion at the faying surfaces of either coating with the aluminum-alloy sheets except near the edges of the strips, where the attack on the aluminum alloys was usually very severe (fig. 19 and table II). The results at the end of the second year, in general, demonstrate that zinc is anodic to all the aluminum alloys tested and that cadmium is either slightly cathodic or has a potential equivalent to that of these alloys. The tests show that zinc sheets attached to aluminum alloys may be sacrificially attacked and prevent corrosion of the aluminum where cell action can be maintained more or less continuously.

Figure 18.- Aluminum-alloy panels in contact with SAE X4130 steel having electro-deposited coatings of zinc and cadmium, and with stainless steel. Cadmium-plated strips remained in relatively excellent condition,

but the zinc coatings were in either partial or complete stages of disintegration. Corrosion products at the faying surfaces of one of the 24ST-stainless steel combinations separated the metals enough to cause one of the rivet heads to break off. x 1/2 (15-16).

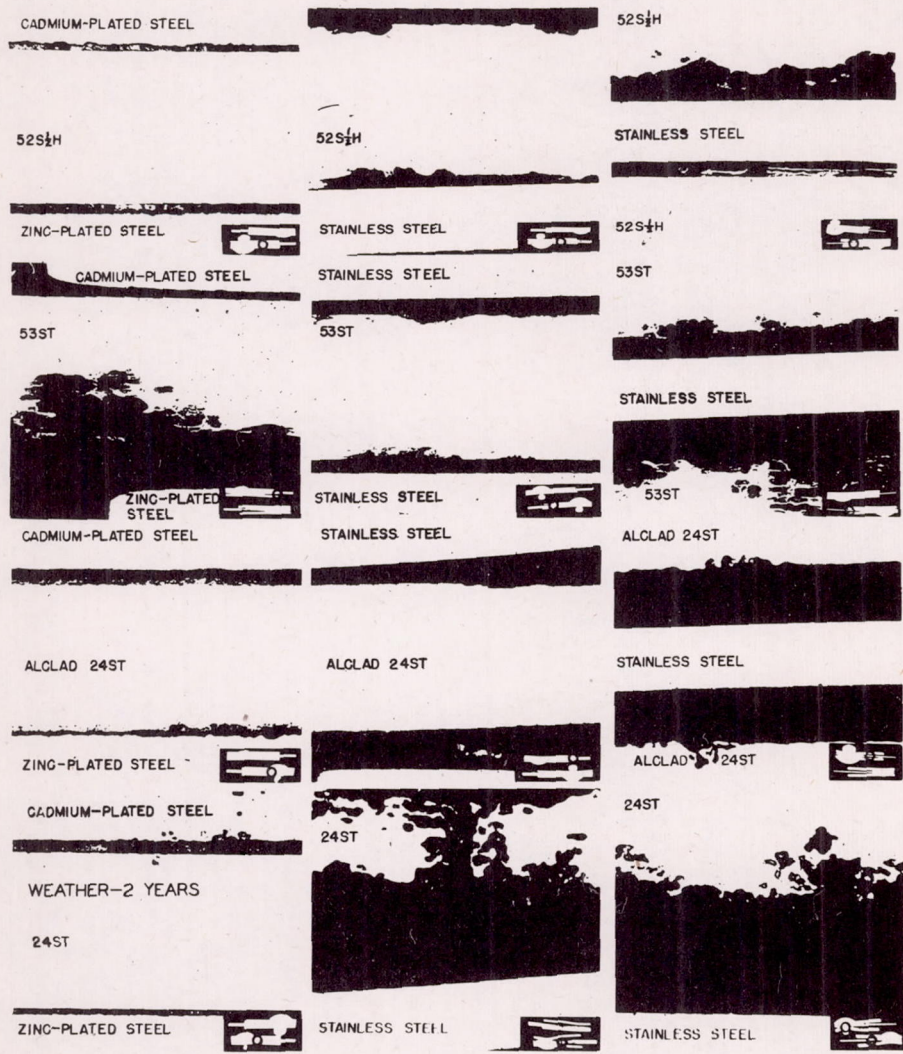
Figure 19.- Cross section showing aluminum alloys exposed to the weather in contact with electrodeposited coatings of cadmium and zinc or with stainless steel. Attack at the faying surfaces was usually deepest on the main panel at areas near the edges of the strips, especially when corrosion products were present in quantity. Photomicrographs, x 25; smaller cross sections, x 1/2.

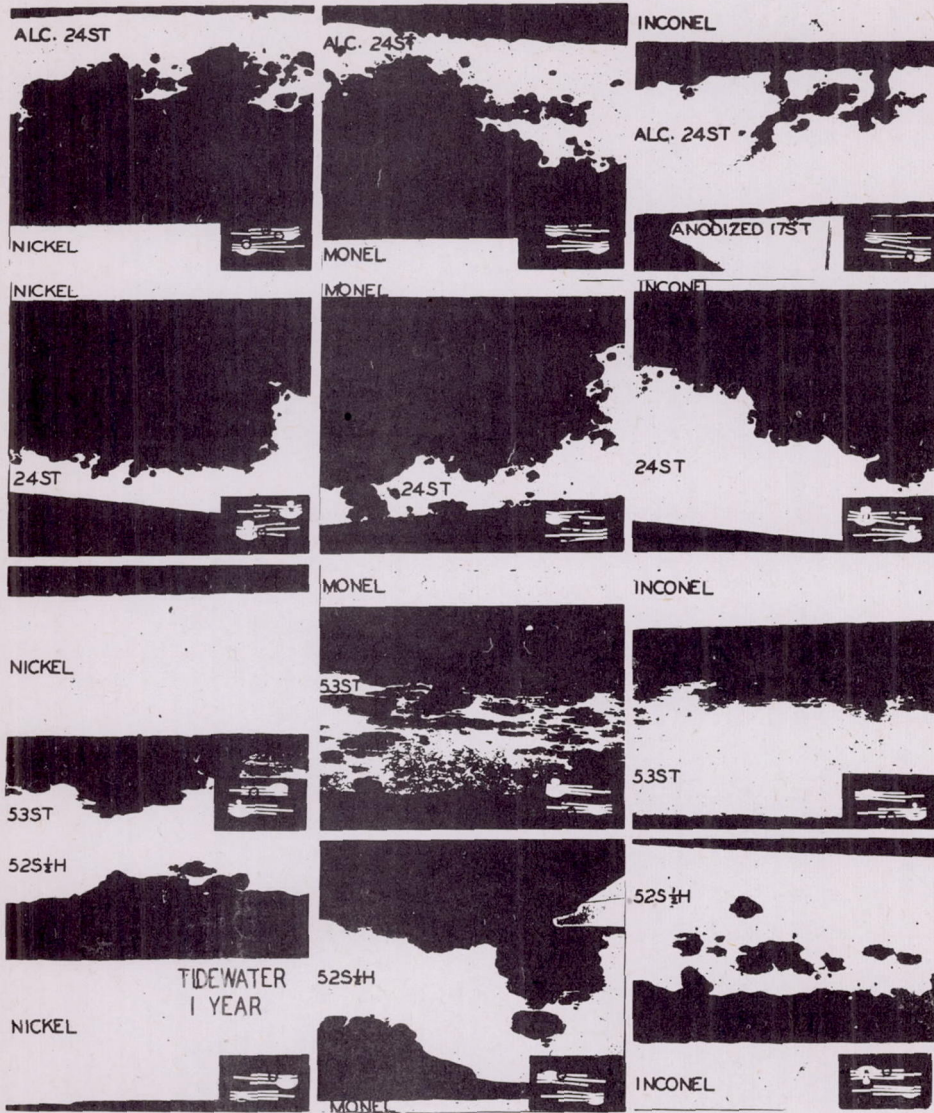
Contacts of aluminum alloys with nickel alloys.— The aluminum alloys formed the 1- by 4-inch strips attached to main panels of nickel, monel metal, or Inconel. Microscopic examinations of the panels exposed for 1 year to tidewater (fig. 20 and table II) indicated that the aluminum alloys were probably more anodic to the nickel alloys than to the stainless steels. Monel-aluminum alloy couples resulted in the worst corrosion on aluminum, but the corrosion was sufficiently severe with all these combinations to indicate that coupling with these nickel alloys should be avoided. Cracks resulting from the combined action of stresses and corrosion were found on all strips of 24ST and Alclad 24ST in contact with these alloys.

Figure 20.- Cross sections showing nickel alloy panels exposed to tide-water in contact with aluminum alloys. Attack on the aluminum alloys was very severe in every instance. Note the stress-corrosion cracking on the Alclad 24ST strips joined to Inconel (upper right corner). Photomicrographs, x 25; smaller cross sections, x 1/2 (17).

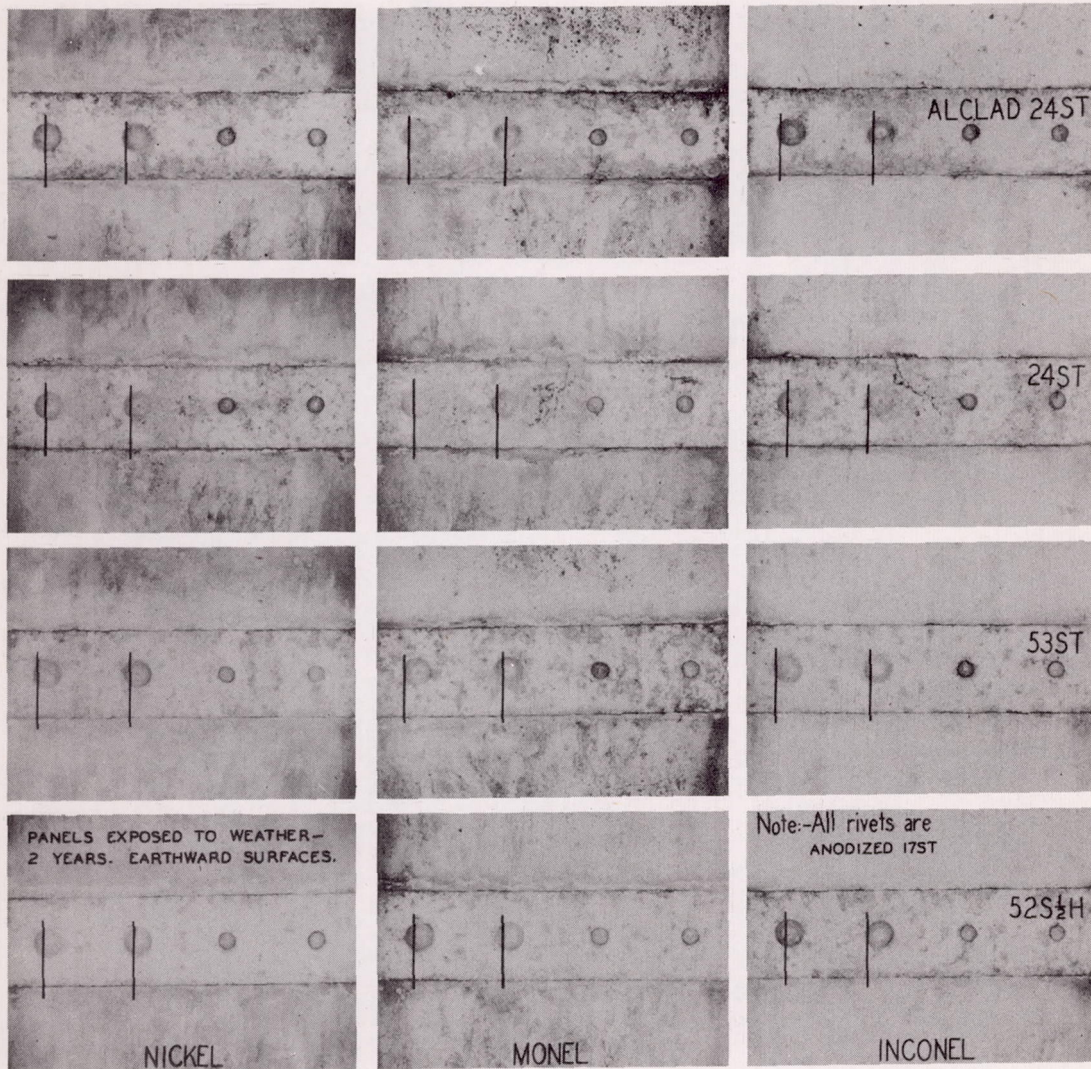
The panels exposed to the weather for 2 years were almost as severely attacked as those in tidewater for 1 year (figs. 21 and 22 and table II) as evidenced by the quantity of corrosion products at faying surfaces of the strips and the main panels. Cracks due to stress corrosion were present only on 24ST strips.

Figure 21.- Nickel alloy panels exposed to the weather in contact with aluminum alloy strips. The presence of considerable corrosion products along the edges of the strips indicates severe attack owing to electrolytic effects. x 1/2 (17).

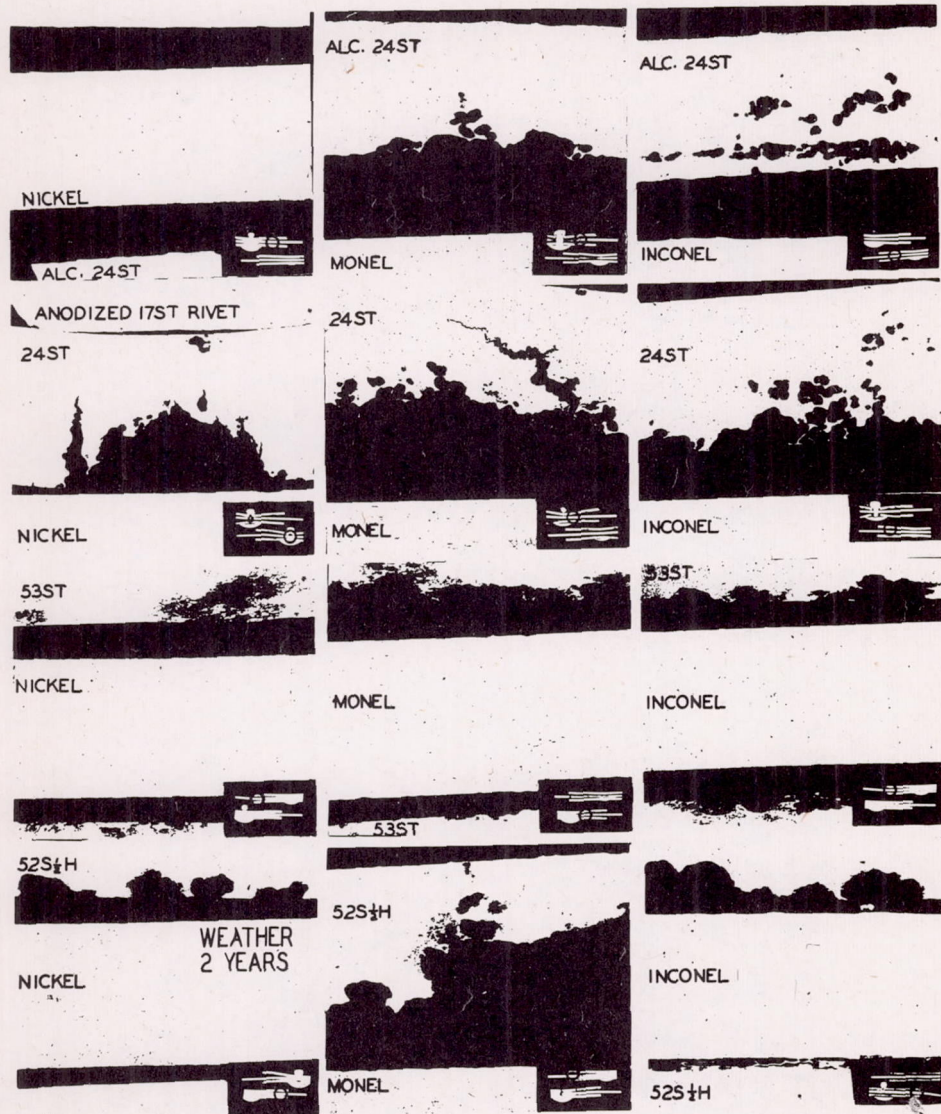
Figure 22.- Cross section showing nickel alloy panels exposed to the weather in contact with aluminum alloys. Compare with Figure 20. Note cracks on 24ST strips in contact with nickel and monel metal. Photomicrographs, x 25; small cross section, x 1/2.

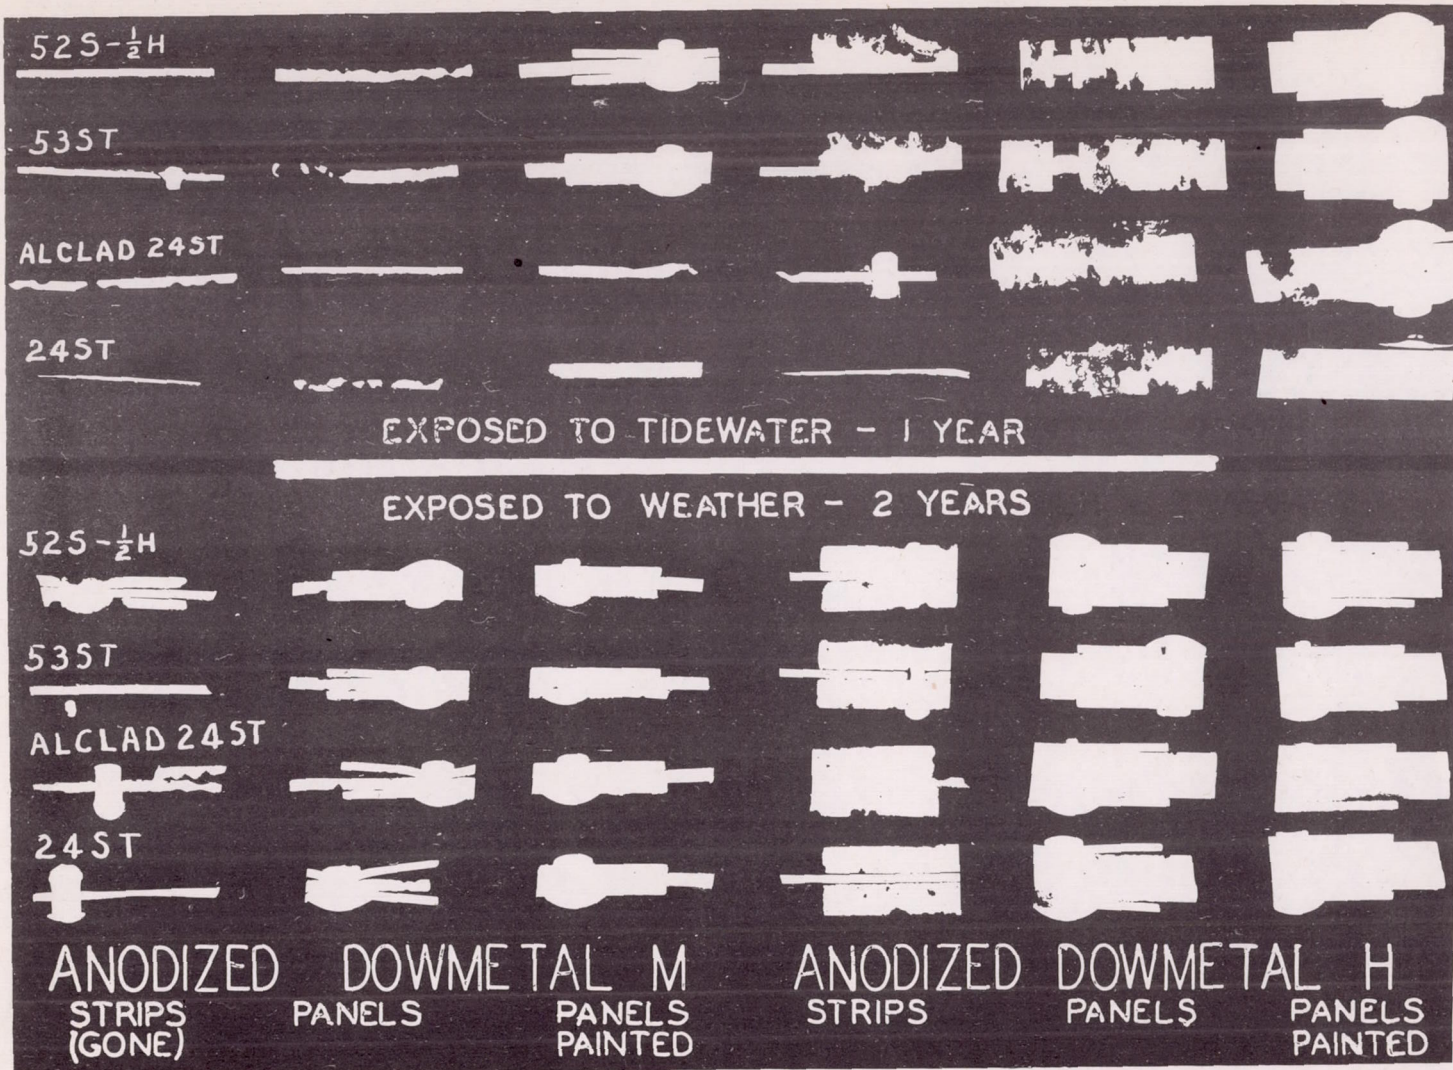
posed to the weather (fig. 23), but the painted panels were in relatively good condition after 2 years (figs. 23, 24, and 25). The panels were painted with 1 coat of Watson Standard Dowmetal Primer No. 1 plus 3 coats of Brooklyn Varnish No. 74 pigmented with $1\frac{1}{2}$ pounds of aluminum paste per gallon. The photographs illustrate that corrosion was much less severe where Dowmetal H, instead of Dowmetal M, was coupled with the aluminum alloys.

Figure 23.- Cross sections showing aluminum alloys exposed to tidewater and to the weather in contact with magnesium alloys. The magnesium alloys were the strips attached to larger areas of aluminum alloys in the first and fourth vertical columns; in the other vertical columns the aluminum alloys were the strips. Panels in the tidewater tests were in advanced stages of disintegration, except when painted. Unpainted panels with Dowmetal M strips were also severely attacked in the weather. x 1 (18).

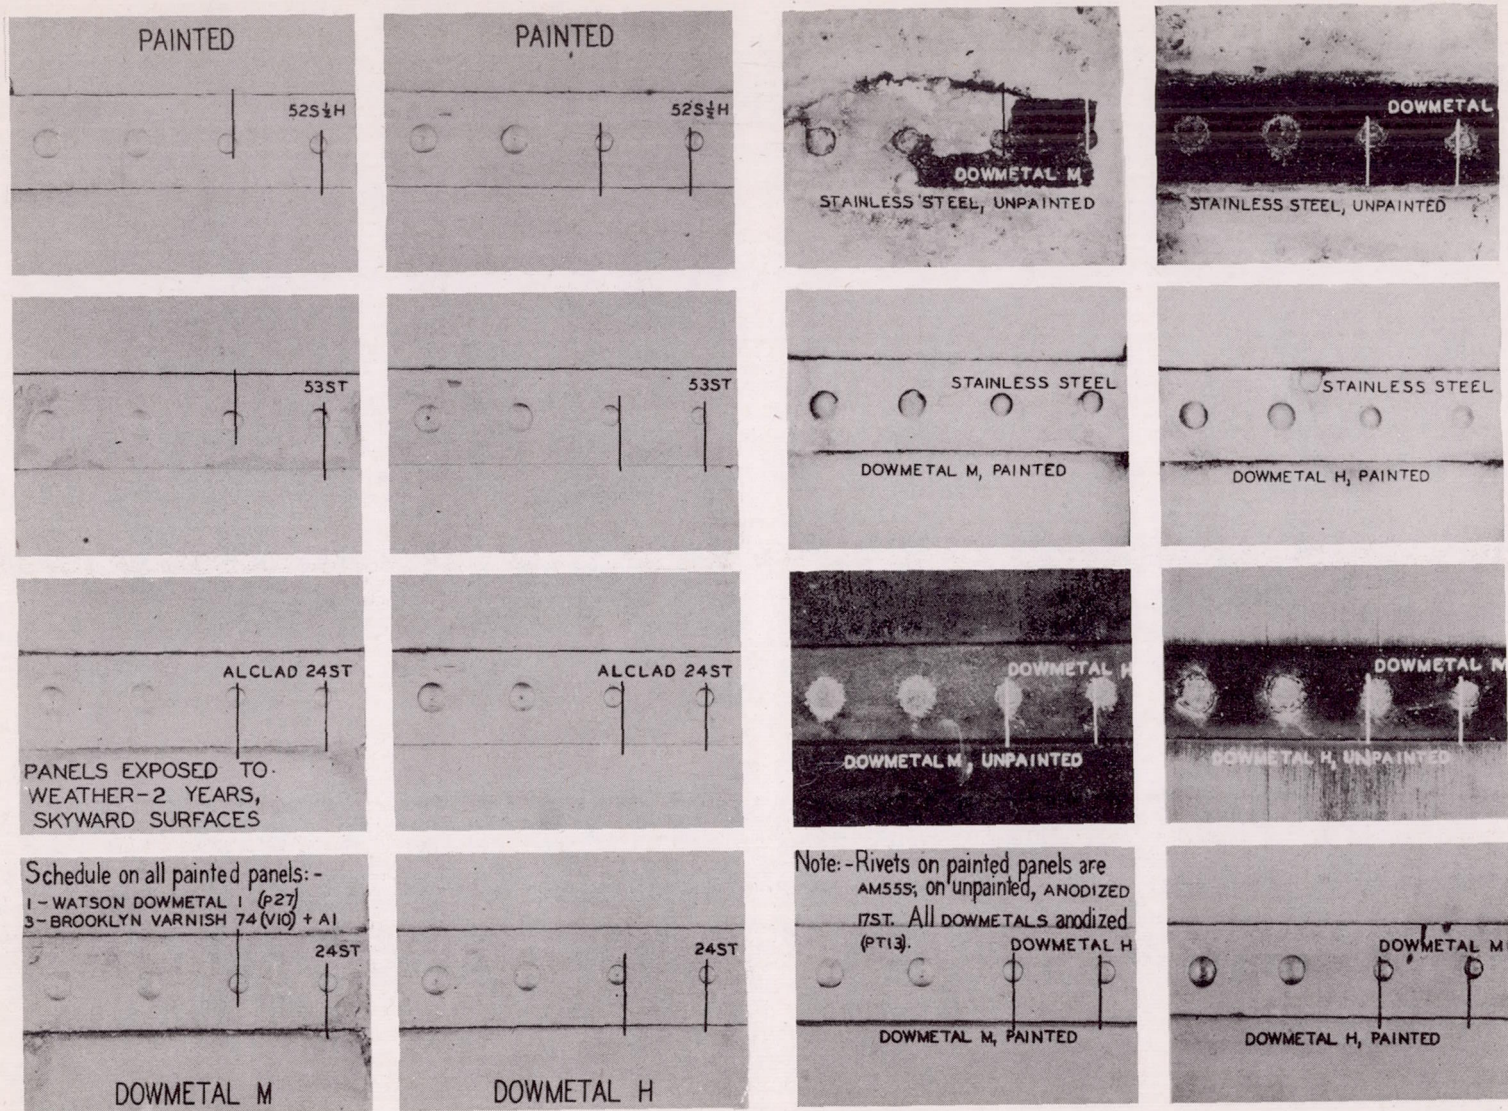
Figure 24.- Surface appearance of panels exposed to the weather with magnesium alloys in contact with each other, with aluminum alloys, or with stainless steel. The painted panels remained in relatively good condition. x 1/2 (19-20).

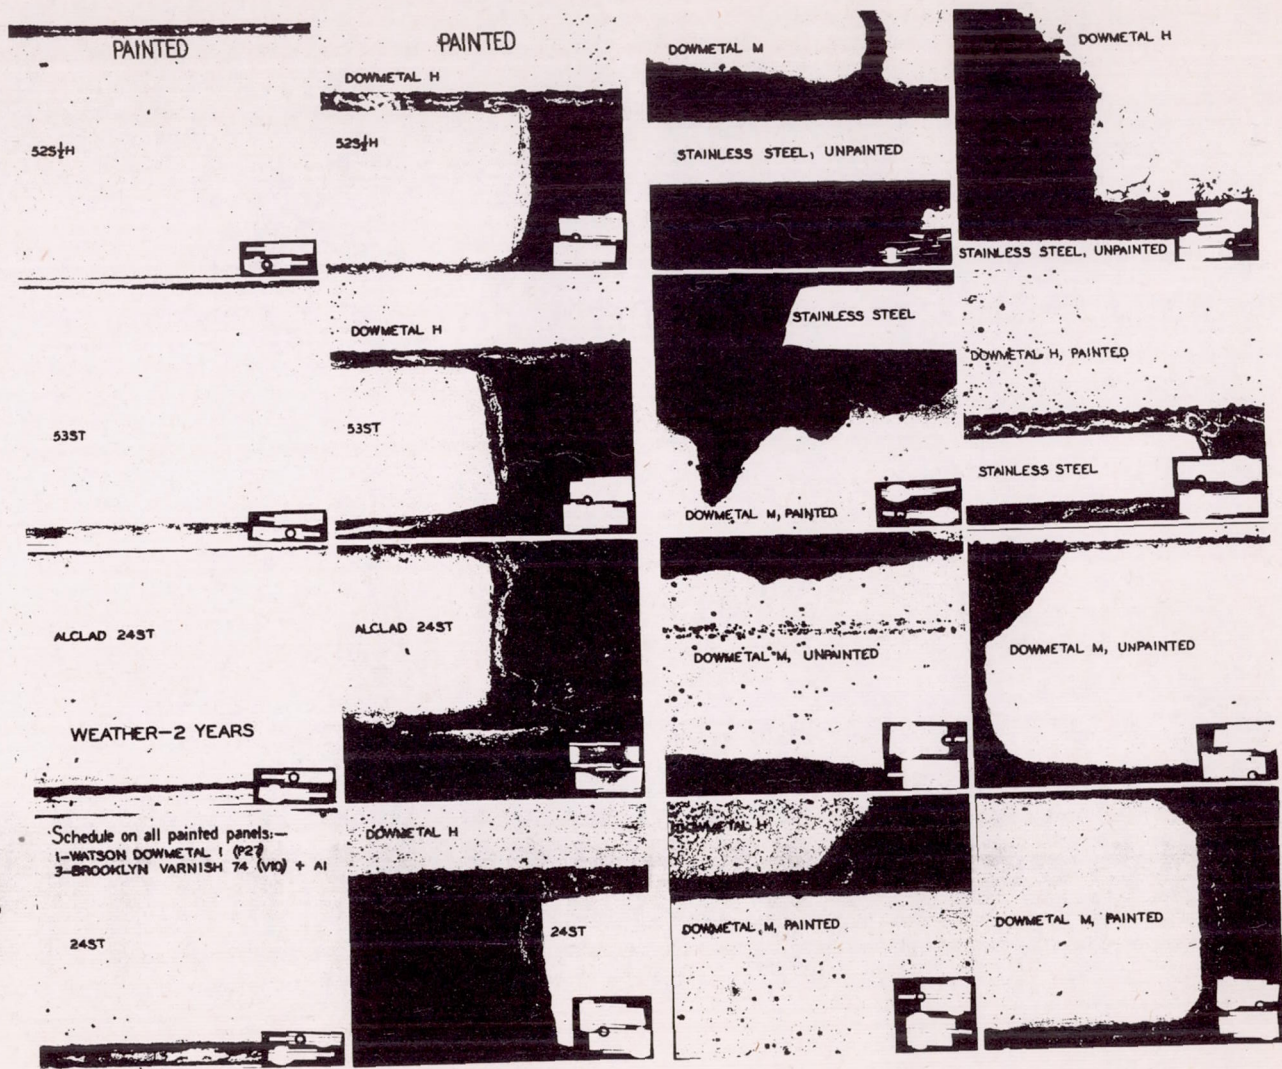
Figure 25.- Cross sections of panels exposed to the weather with magnesium alloys in contact with each other, with aluminum alloys, or with stainless steel. Painting was effective in preventing electrolytic reactions at the flying surfaces except near the edges of Alclad 24ST, 24ST, and stainless-steel strips. Severe corrosion was present on corresponding unpainted panels. Photomicrographs, x 25; smaller cross sections, x 1/2.

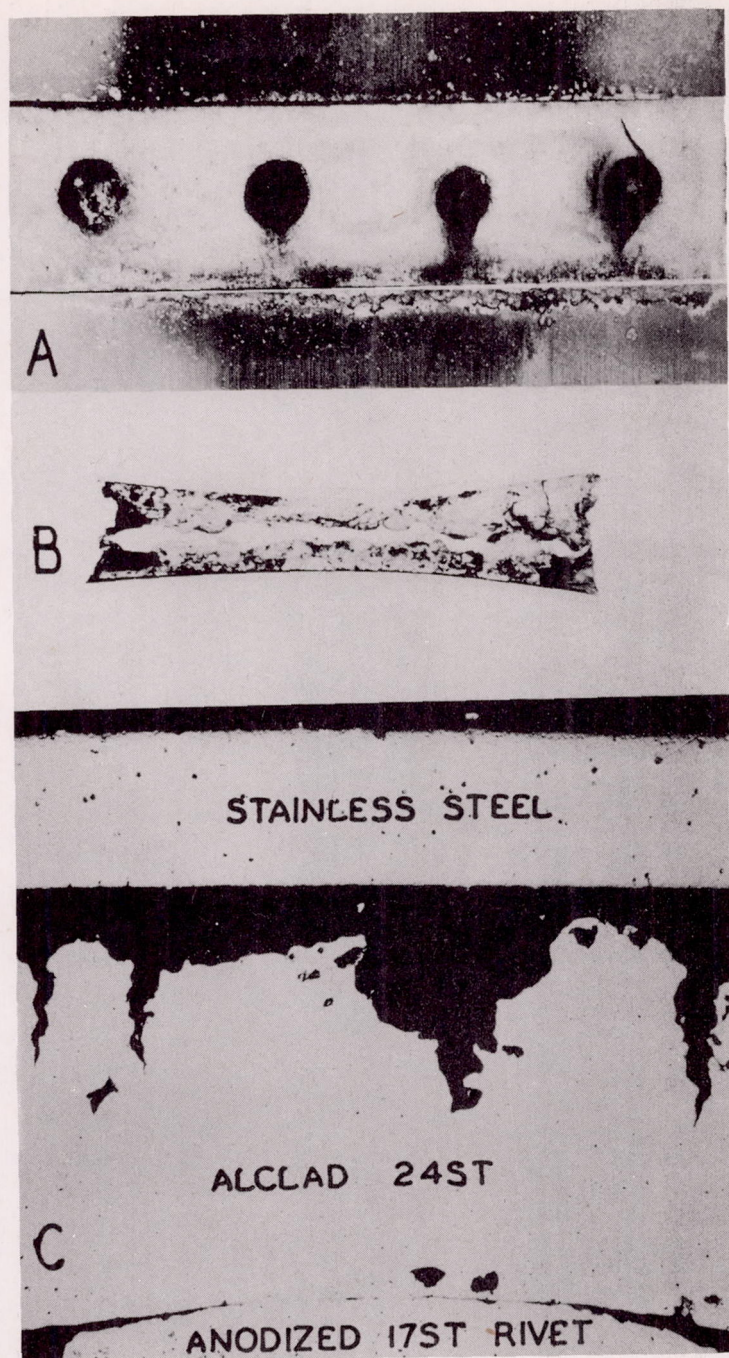
Stress corrosion.— The presence of cracks, which tended to follow intercrystalline boundaries, was noted on the following: (1) 24ST strips coupled with the nickel alloys or stainless steel, in both the tidewater and weather tests; (2) Alclad 24ST strips coupled with the nickel alloys or stainless steel (fig. 26) in the tide-water tests only; (3) Dowmetal H strips joined to 24ST and 52S- $\frac{1}{2}$ H alloys, after 2 years of exposure to the weather; (4) stainless-steel strips joined to Dowmetal H (fig. 26), after 2 years of exposure to the weather.

The cracks were undoubtedly caused by the combined action of corrosion and stress. The stresses were markedly increased by the accumulation of corrosion products

Figure 26.- Examples of stress-corrosion. A - Crack on stainless steel strip joined to Dowmetal M panel. x 1. B - Cross section showing large amount of corrosion product present on couple of (A). x $2\frac{1}{2}$. C - Cracks in Alclad 24ST strip attached to a stainless steel panel. x 50.

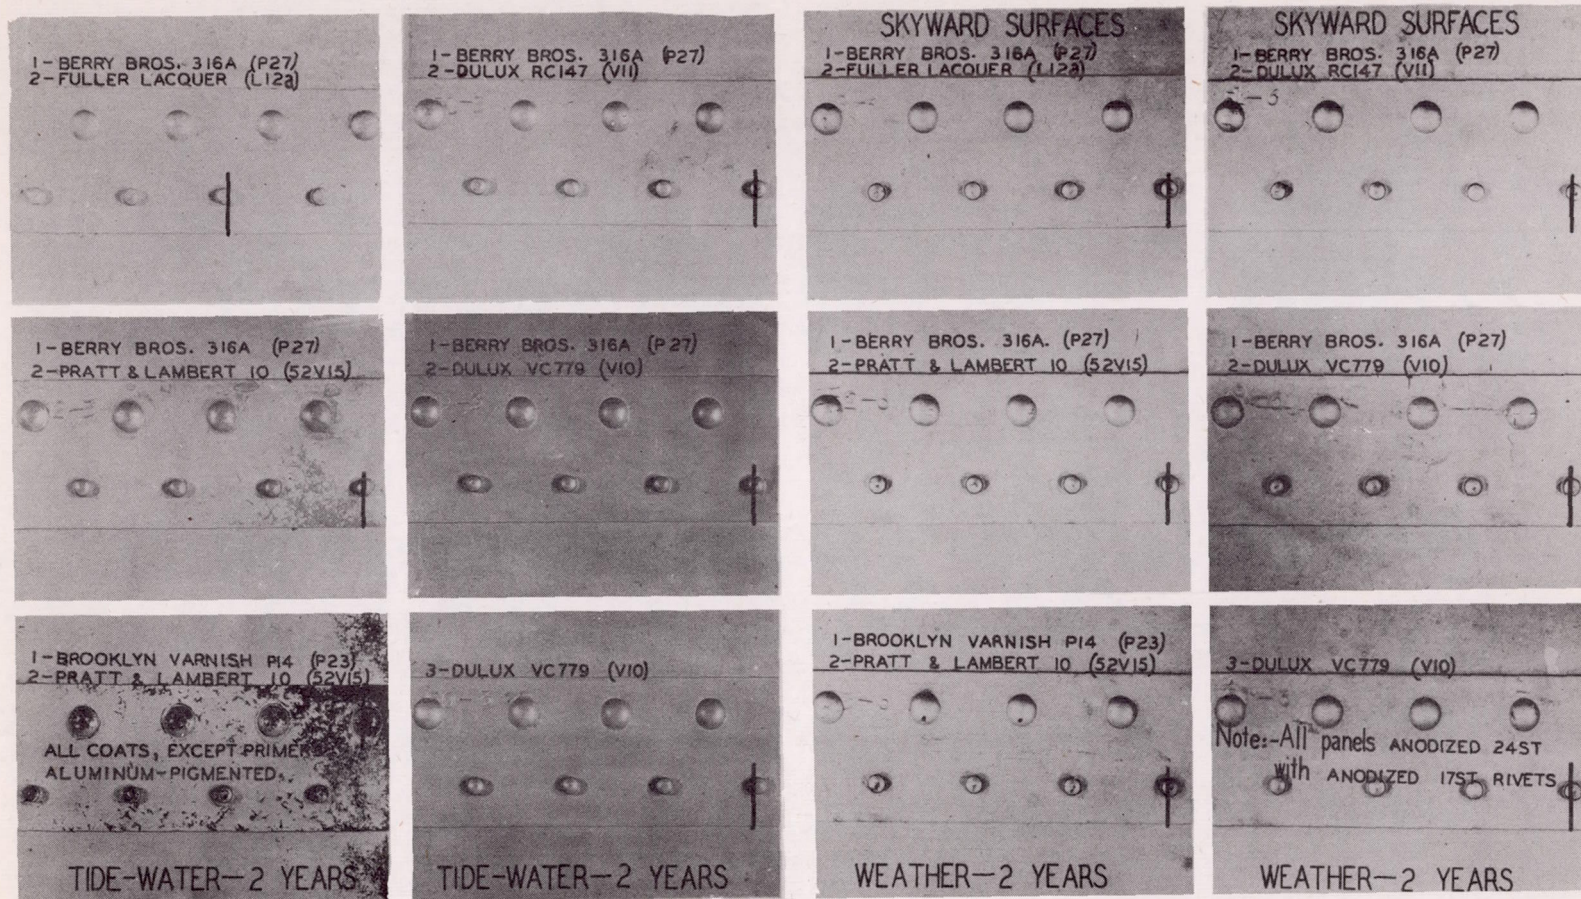
Paints on anodized 24ST aluminum alloy.- The paint schedules (fig. 27) applied to 24ST aluminum alloy were generally in excellent condition in both the tidewater and the weather-exposure tests at the end of 2 years. In the tidewater tests aluminum-pigmented finish coats of Fuller lacquer (Navy specification L12a) and of Pratt and Lambert Number 10 aluminum mixing varnish (Navy specification 52V15b) failed to adhere in some areas when applied, respectively, over Berry Brothers 316A Primer (Navy specification P27) and Brooklyn Varnish P-14 Primer (Navy specification P23). Microscopic examinations, however, revealed no corrosive attack on any of the painted panels.

Figure 27.- Skyward surfaces of anodically treated 24ST panels exposed to tidewater or to the weather with various protective paint coatings. The finish coats on panels at the top and the bottom of the first vertical column at the left failed, in some areas, to adhere to the primers. This condition was somewhat more pronounced than at the end of the first year. The rest of the coatings were in excellent condition. x 1/2 (21).

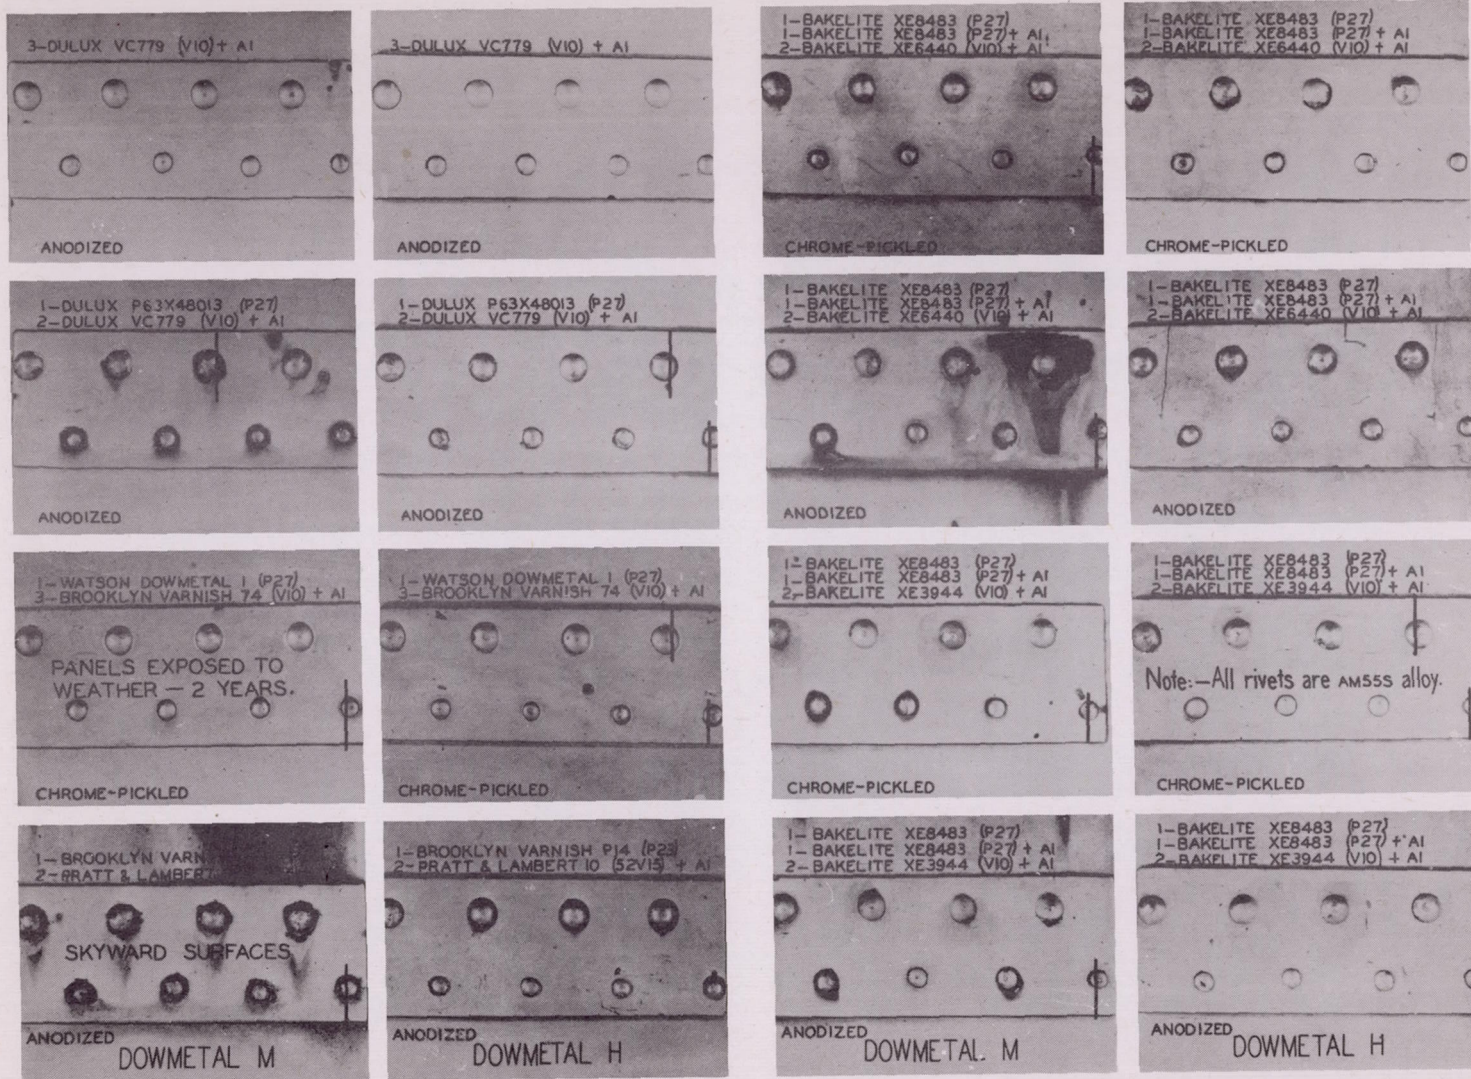
In the weather-exposure tests, at the end of the second year, most of the paints were in good condition (fig. 28). Failures were generally confined to the unanodized AM55S rivet heads and to the edges of the panels. Microscopic examinations (fig. 29) revealed occasional deep pits at areas adjacent to rivet heads.

Figure 28.— Surface appearance of magnesium alloys exposed to the weather with various protective paint coatings. Most of the paints remained in good condition, except at the rivet heads and at the edges of the strips of the main panel. x 1/2 (22).

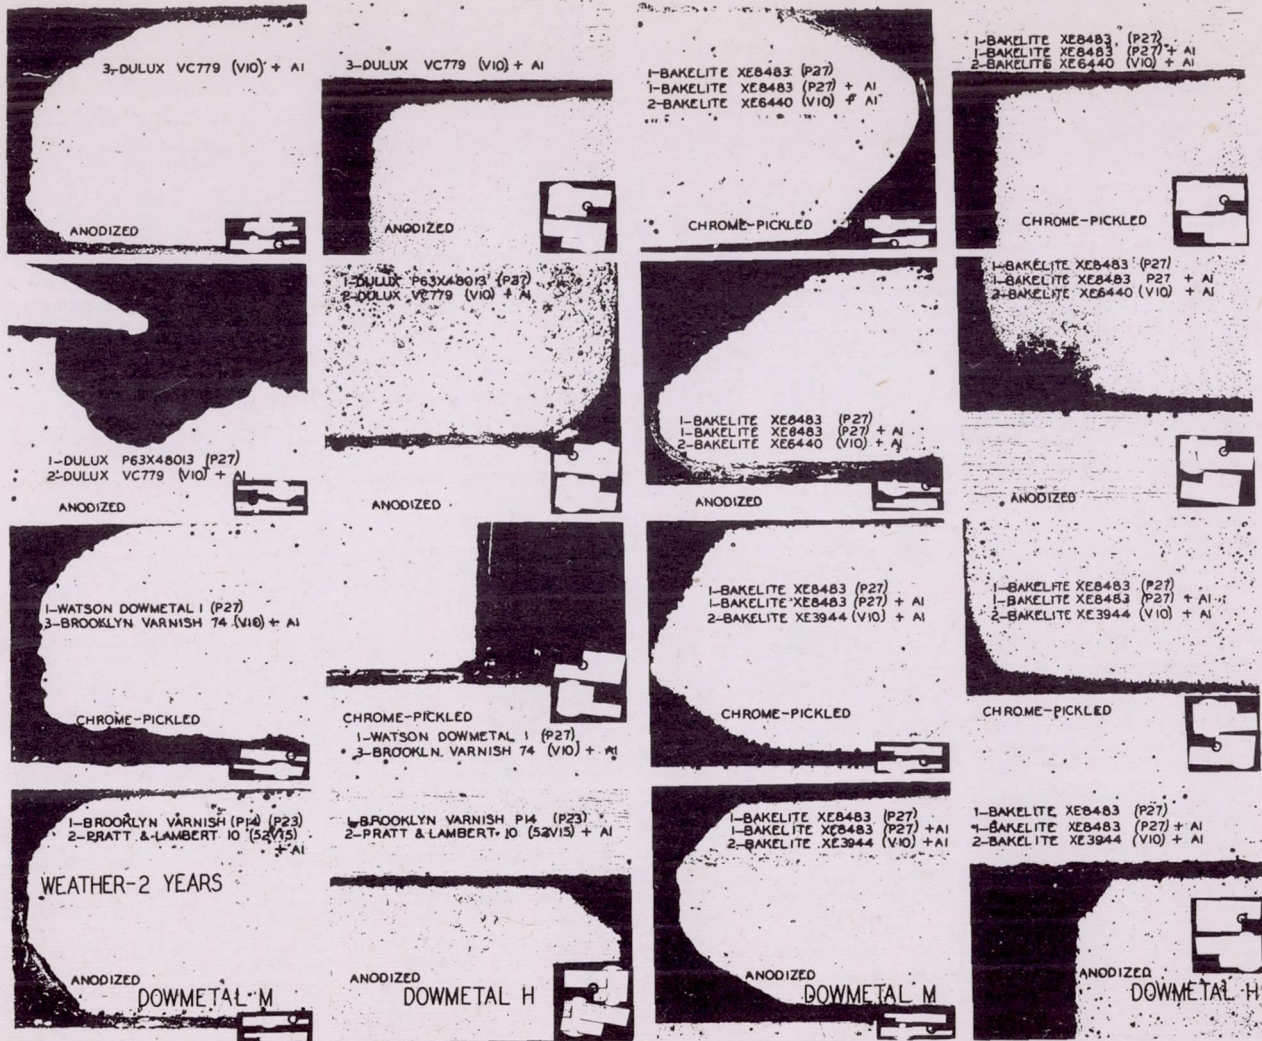
Figure 29.- Cross sections of magnesium alloys exposed to the weather with various protective paint coatings. Edges of strips were purposely rounded prior to painting. Much of the corrosion present occurred on these edges or at areas of paint failure adjacent to the AM55S rivet heads. Photo-micrographs, x 25; smaller cross sections, x 1/2.

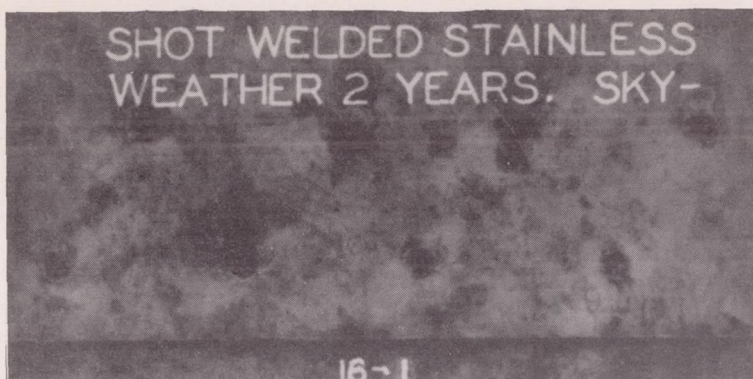
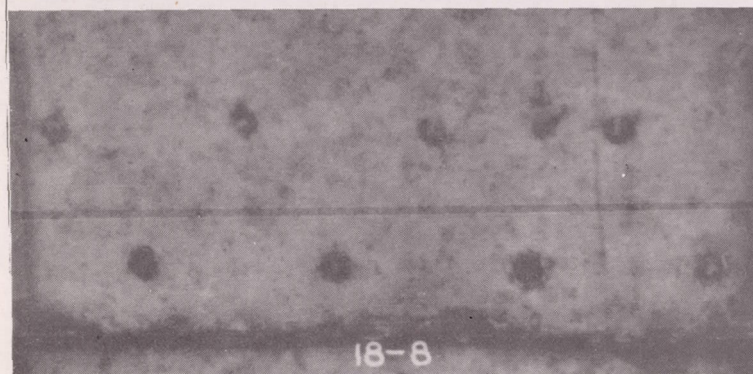
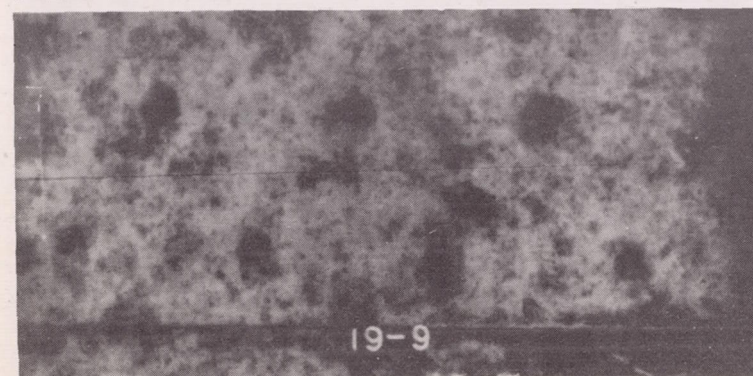
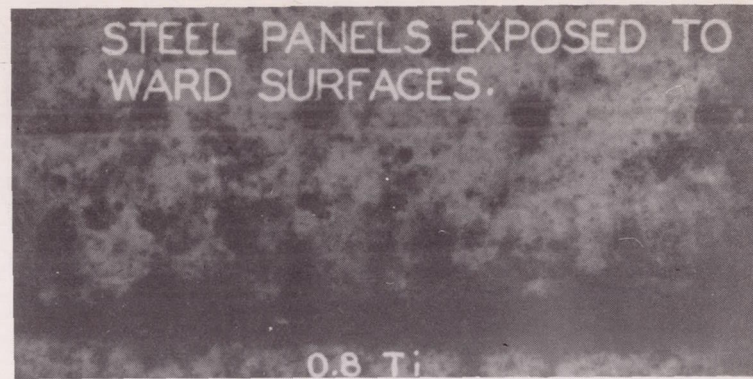
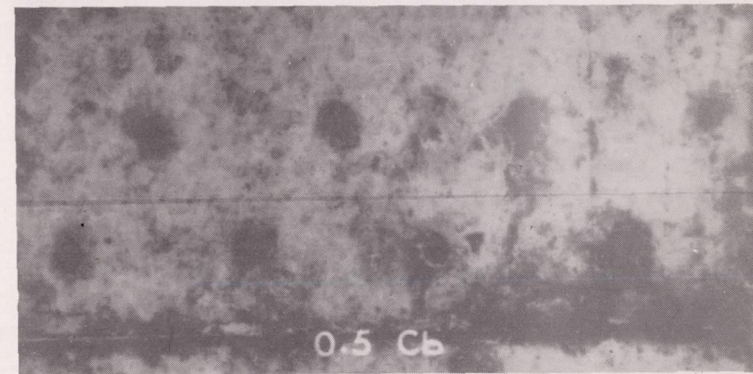
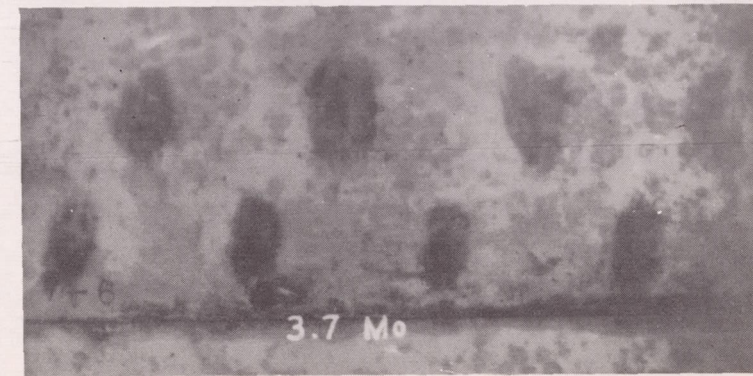
The panels exposed to tidewater at the end of the second year still exhibited practically no rust except for a number of localized areas on the 16:1 chromium-nickel alloys. Rust on the panels exposed to the weather was greater in extent and somewhat more heavily deposited at the end of the second year than at the end of the first year (fig. 31). Rusting continued to be worse on the 16:1 alloy, and notably much less on the steel containing

Figure 31.- Stainless steel panels of various compositions, exposed to the weather. Rust deposits were considerably heavier at the end of the second than the first year. Figures in the left column indicate percentages of chromium and nickel, respectively. Figures in the right column give the percentage of the addition element shown. Rust on the welds was generally worse than on the rest of the panels. Deposits on the steel containing molybdenum were very much lighter than on the other steels. x 1 (26).
