AN OVERVIEW OF THE CRASH DYNAMICS FAILURE BEHAVIOR OF METAL AND COMPOSITE AIRCRAFT STRUCTURES

Huey D. Carden
NASA Langley Research Center
Hampton, VA

SUMMARY

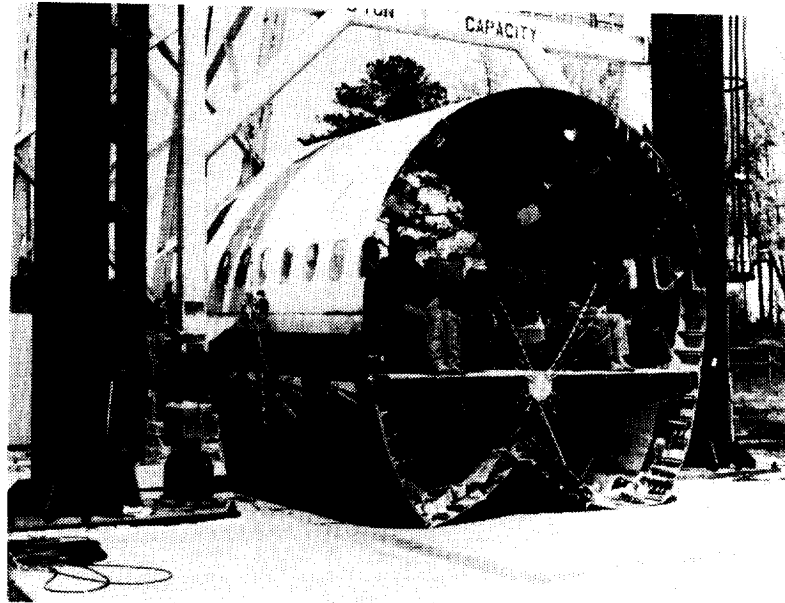
Dynamic tests.- Structural damage and behavior of the transport aircraft structures resulting from the 20 ft/s drop tests is shown in figure 9(a) and (b). The damage to the transport sections was confined to the lower fuselage below the floor level. Under the vertical impact of 20 ft/s, all seven of the frames ruptured near the bottom impact point. Plastic hinges formed in each frame along both sides of the fuselage at about 50° up the circumference from the bottom contact point (See figure 9(c)). The upward movement of the lower fuselage was approximately 22-23 inches at the forward end and 18-19 inches at the rear for the section taken from forward of the wing location (figure 9(a)) whereas in the section from aft of the wing location (figure 9(b)), the crushing was about 14 inches forward and 18 inches in the rear. Although the aircraft structures are metal and the failures discussed above involve plastic deformations with some tearing of the metal rather than brittle fractures, the general observed failure pattern and locations for the transport fuselage sections will be shown to be quite similar to the results of the composite frames and subfloors discussed later.

(a) Section from forward of wing.

Figure 9.- Structural damage to metal aircraft structures.

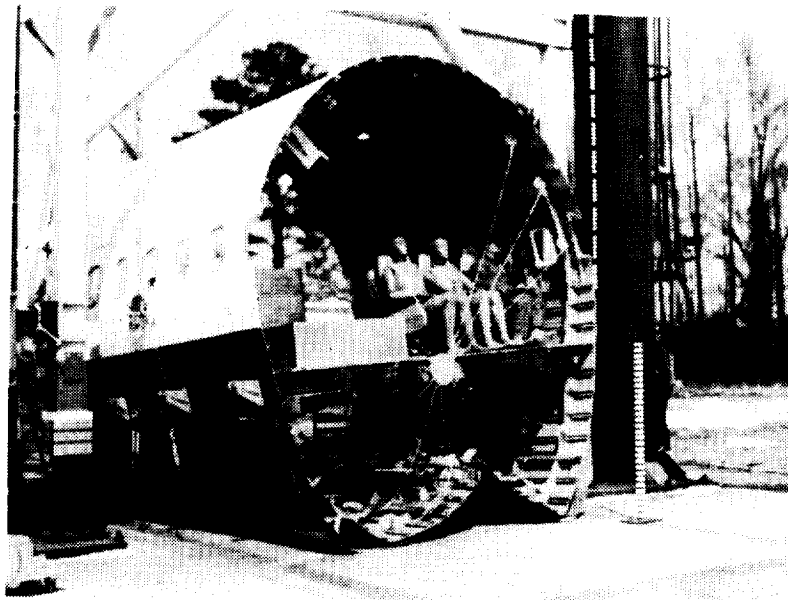
(b) Section from aft of wing.

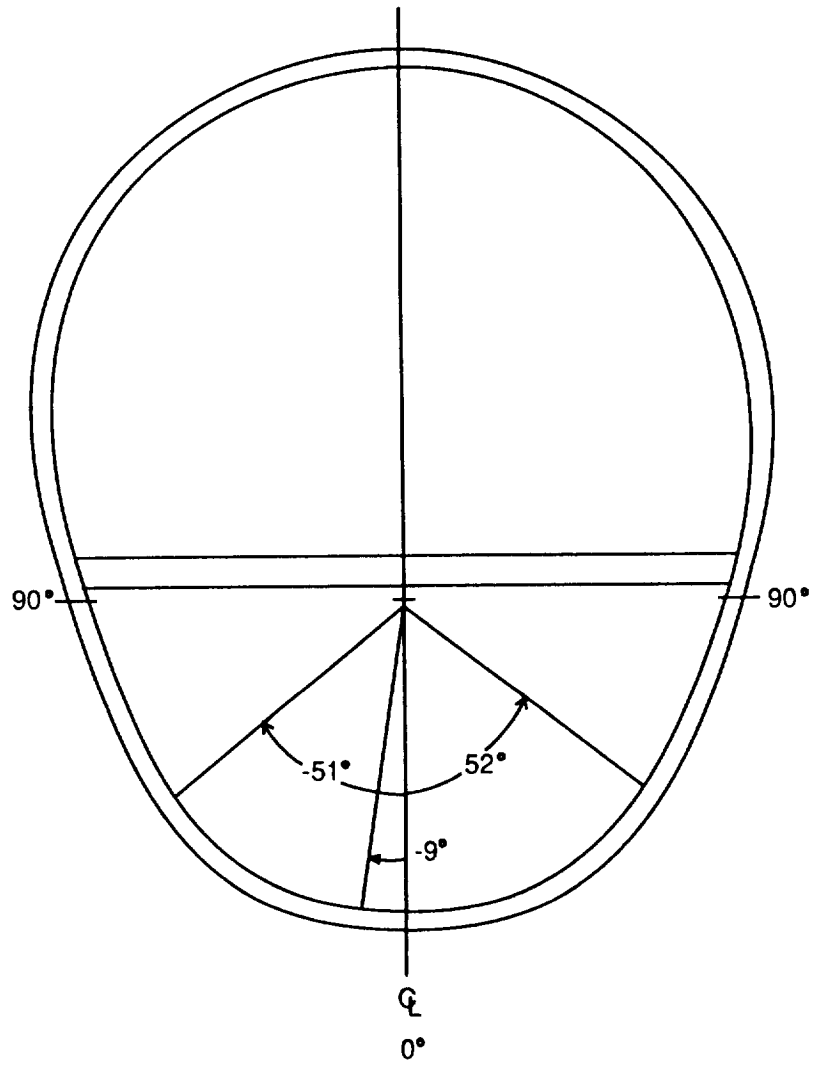
(c) Angular location of failures.

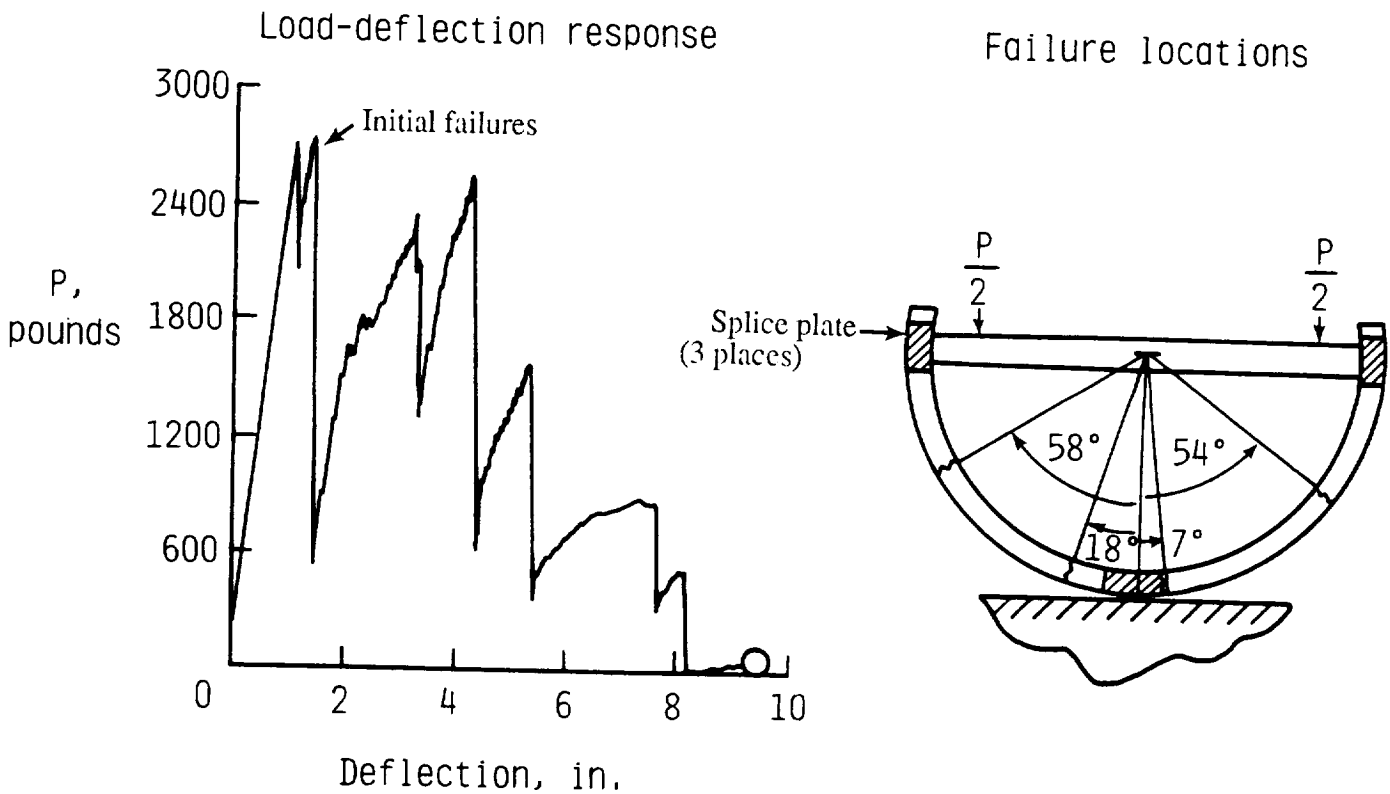
Static tests.- Figure 13 presents static results from tests of single composite Z-frames discussed in reference 26. A photograph of the static test apparatus in figure 13(a) shows that the splice plate was at the load point. The frame failed just outside the doubler splice plate area by a complete fracture across the Z-section. Load-deflection data and the location of failures of the frame are shown in figure 13(b). The load-deflection data show a saw-toothed behavior beginning with the essentially linear behavior of the frame up to initial failure with subsequent loading of the frame after failure being at a new, reduced stiffness for the damaged frame. Photographic data in figure 13(c) show that the initial failure was induced by a local buckling of the frame which occurred at about 18° from the bottom loading point outside the splice plate area. Second and third fractures occurred up the side at about 54° and 58° under continued loading as may be noted in the sketch at the right of figure 13(b). The sequence of events was local buckling near the splice plate induced out of plane deformations which led to a fracture of the section; the ends then remained in contact (jammed together under the compressive loads in the frame), the initial point of fracture moved vertically, essentially in a guided manner until two additional fractures occurred farther up the frame.

A comparison of the analytical cases (figure 14(a)) with the actual static load-deflection of the Z-section (figure 13(b)) indicates very similar load-deflection behavior patterns as discussed above. Although the Z-frame had no skin, if the ends jam together (as they did in several cases), the boundary is effectively between the skin stiffened case and a guided boundary. Thus, the predicted failure location in the simple beam-frame model at about 50° (See figure 14(b)) agrees well with the 54° and 58° failure locations in the experiment with the Z-section frame.

(b) Load-displacement and failure locations.

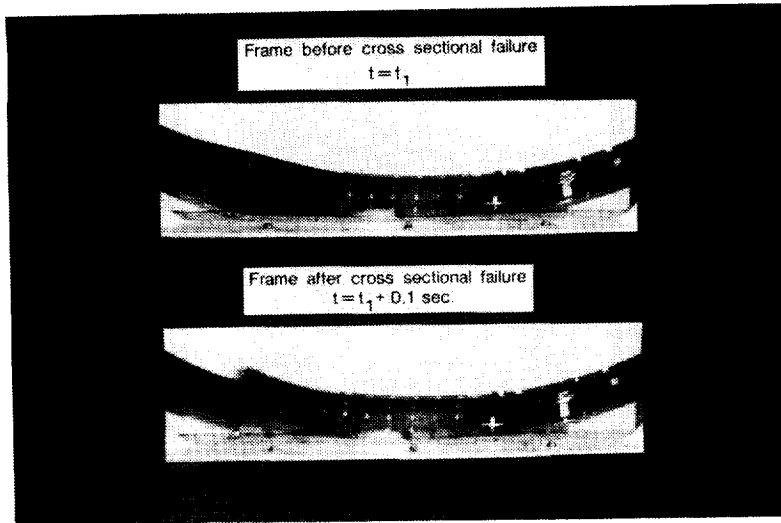
(c) Frame local instability.

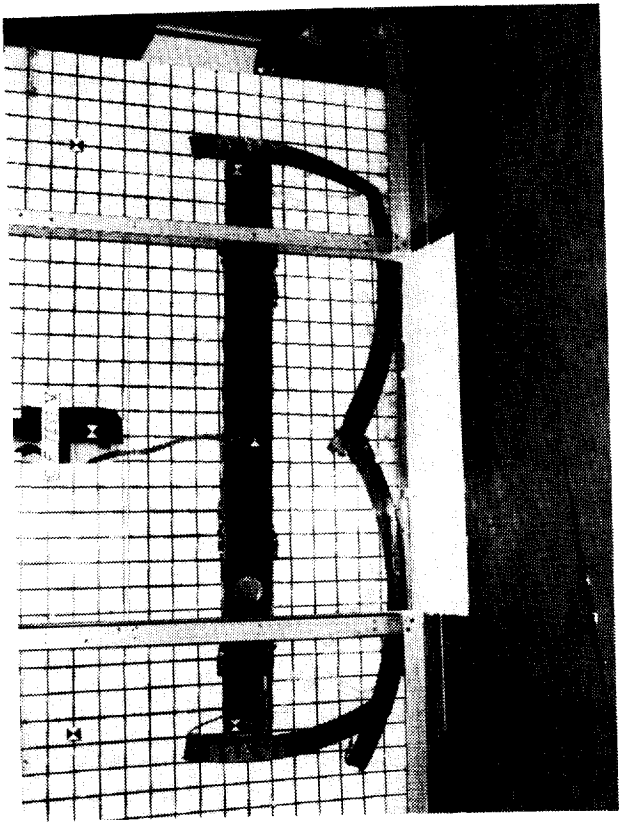
Dynamic tests.- Figure 15 presents results from the dynamic studies of the response of composite frames (Reference 27). As noted in figure 15(a) or (b), the splice plates joining the segments of the frame are $\pm 45^\circ$ up the circumference from the point of impact. As shown in figure 15(b) complete failures (fractures) of the Z-section frames occurred at the bottom and approximately $\pm 60^\circ$ from the bottom. Potentially, it appears that the presence of the splice plates may have influenced the locations by moving the top failure points up a few degrees to about the $\pm 60^\circ$ locations.

(a) Photographs of failed frames.

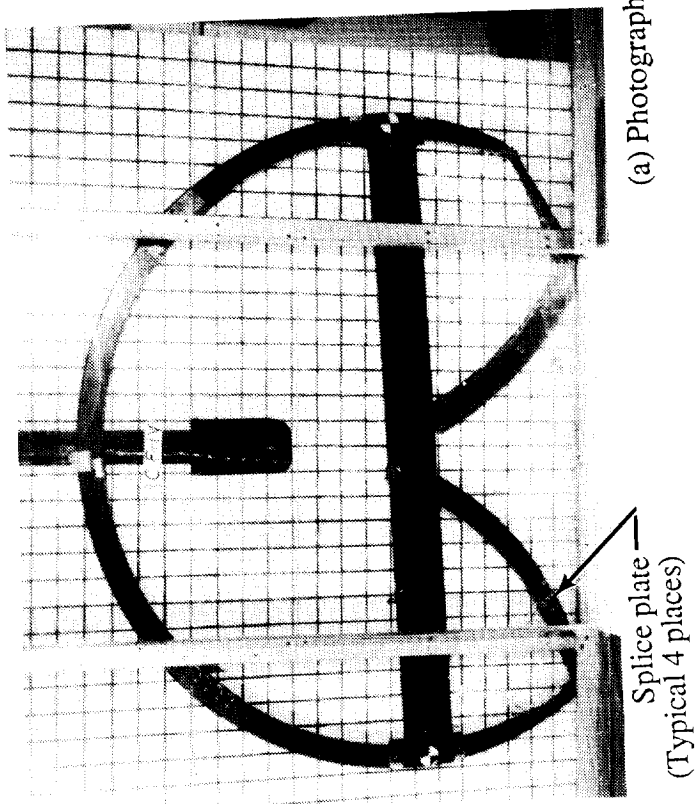
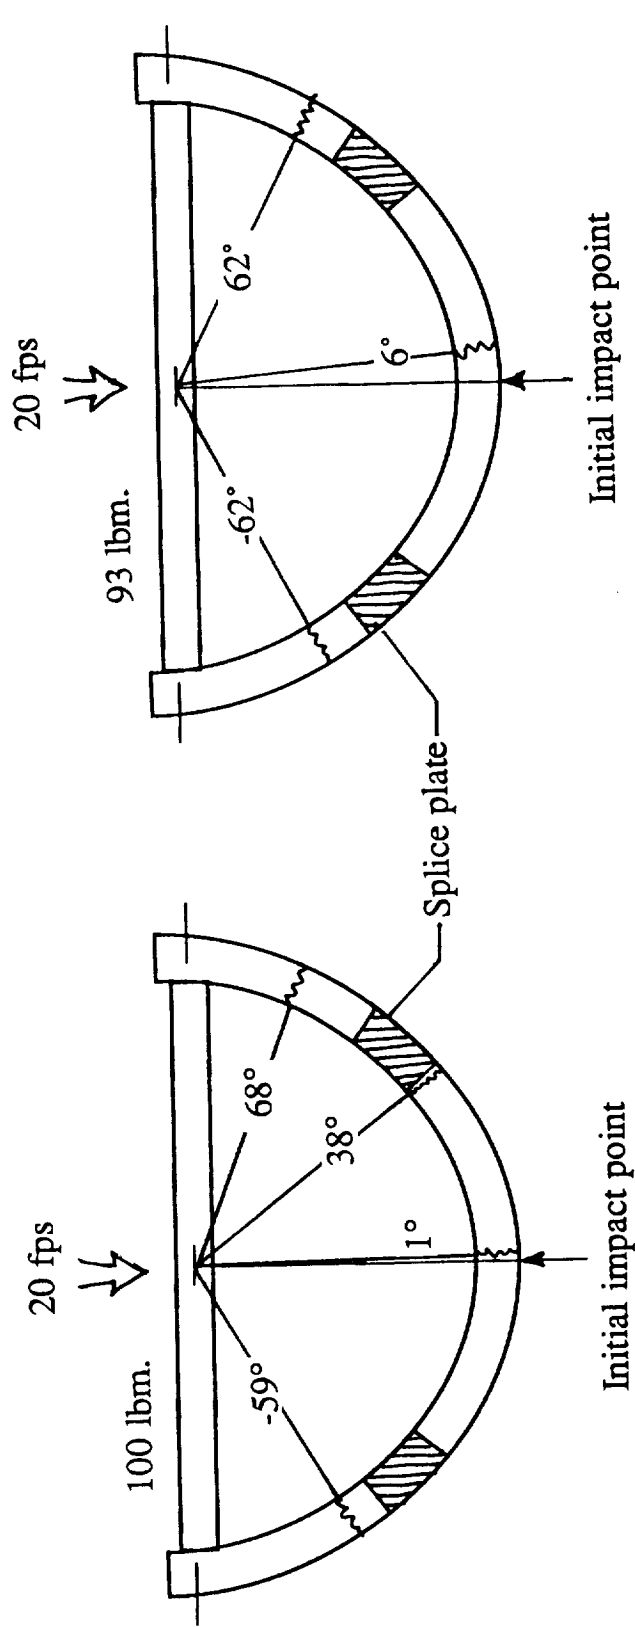
(b) Location of failures in frames.

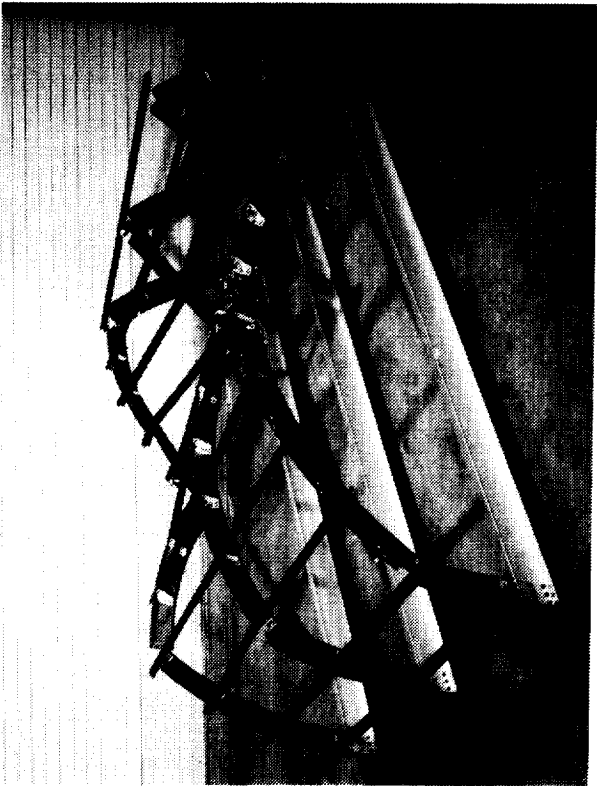
Static tests.- Figure 16 presents experimental results (Reference 28) of the skeleton subfloor specimen following a static test. As noted in figure 16(a) and (b), failures on the three Z-section frames occurred at 13 discrete locations. Unlike the unnotched single Z-frame, the failures in this specimen occurred at notches (which served as stress risers) in the frame through which the stringer passed. However, as shown in figure 16(b) the failures were still near the point of load application (approximately 11°) and at other circumferential

locations of approximately 45-68°. In the absence of skin material, twisting and bending out-of-plane occurred with the frames. The stringers had minimal effect on the subfloor response with the exception of maintaining the lateral spacing of the three Z-frames.

(a) Failed skeleton subfloor.

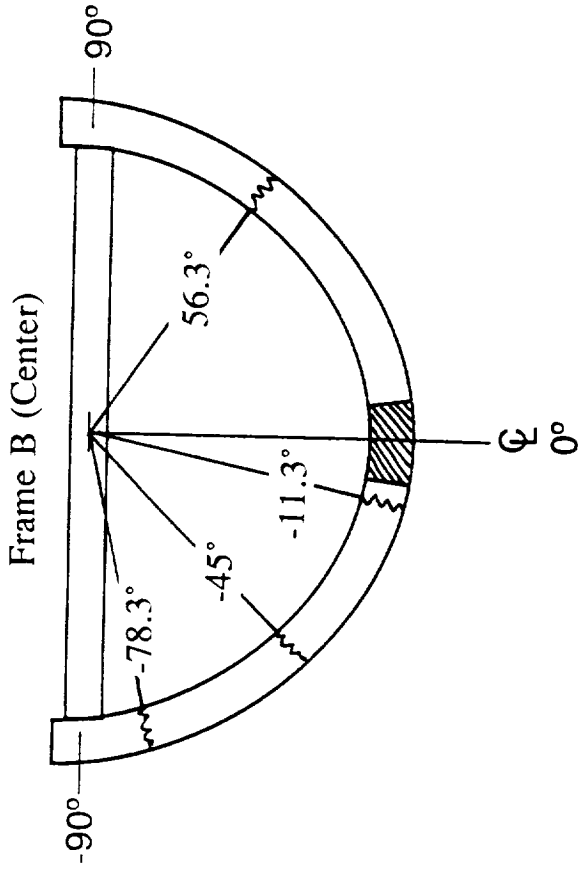
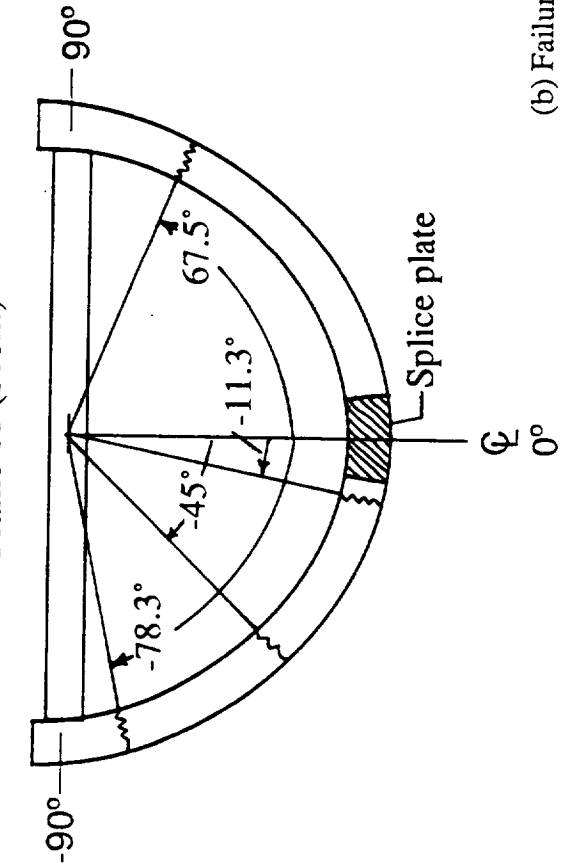
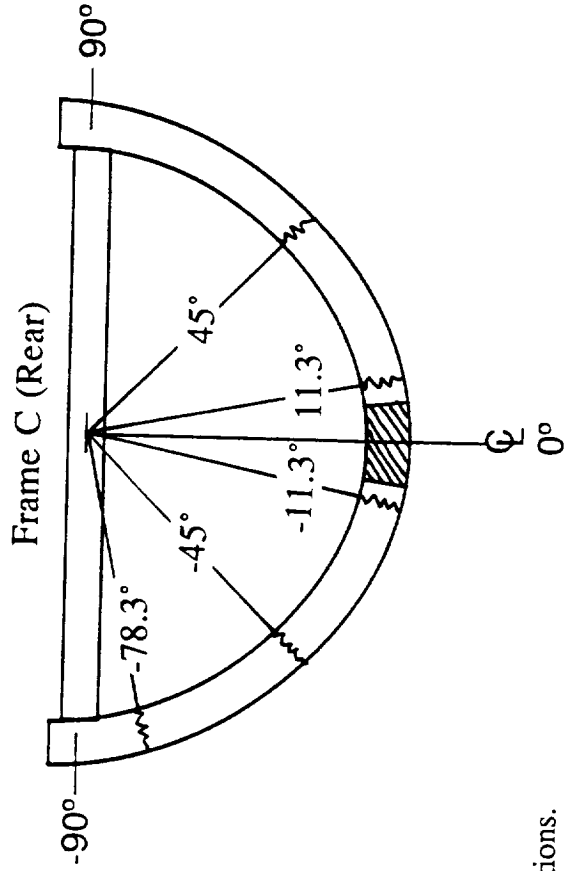
(b) Failure locations.

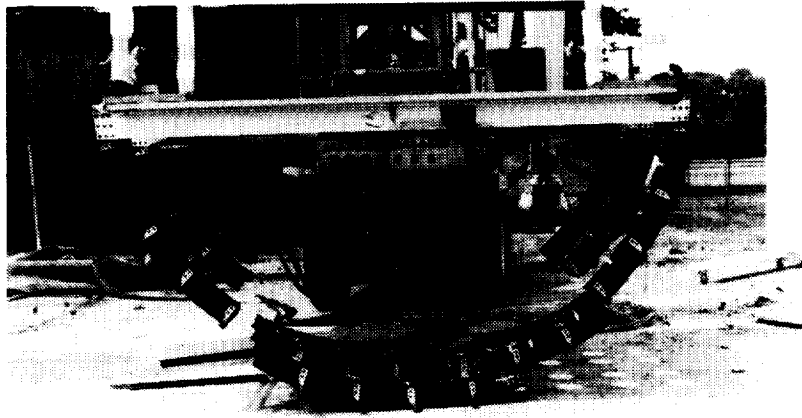
Dynamic tests.- Figure 17 shows the skeleton subfloor after an impact test onto a concrete surface at 20 feet per second. In the dynamic test of the skeleton subfloor, fractures were produced at notches in the frames (Figure 17(a)). The locations, shown in figure 17(b), were also near the point of impact (about 11° because of the splice plate) and at two other locations up the circumference of the frames ($\pm 45^\circ$ and $\pm 78^\circ$) and involve all three frames for a total of 15 fractures. The impact energy exceeded the energy absorbed by the local fractures and the floor bottomed out in the impact. Figure 17(c) is a normalized strain distribution measured on the first (end) frame during the dynamic test just before first failure. A comparison of the distribution to the moment distribution of Figure 14(b) and (c) shows essentially identical shape between the single frame and skeleton frame distributions. Maximums at 0° and at approximately $\pm 50^\circ$ to 55° agree well with the analytically predicted locations on the frame.

(a) Failed skeleton subfloor.

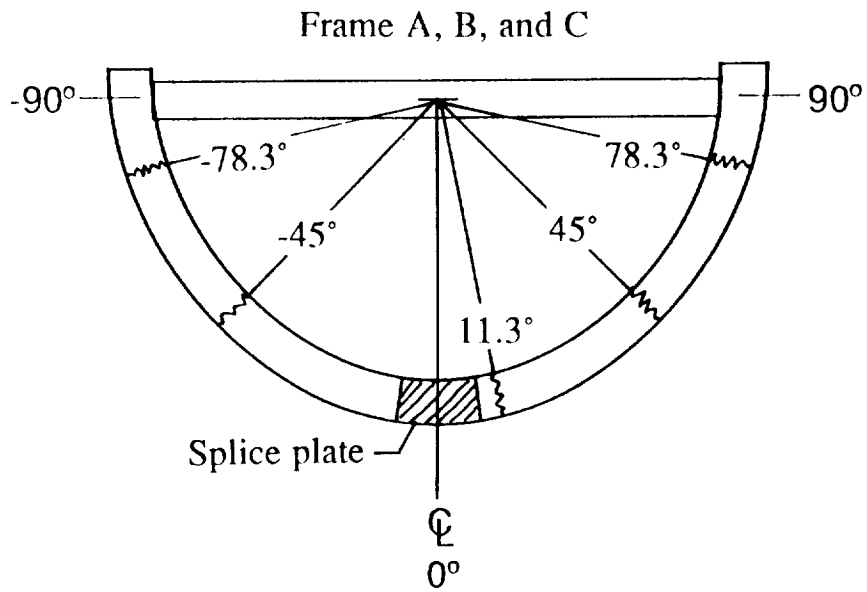
(b) Failure locations.

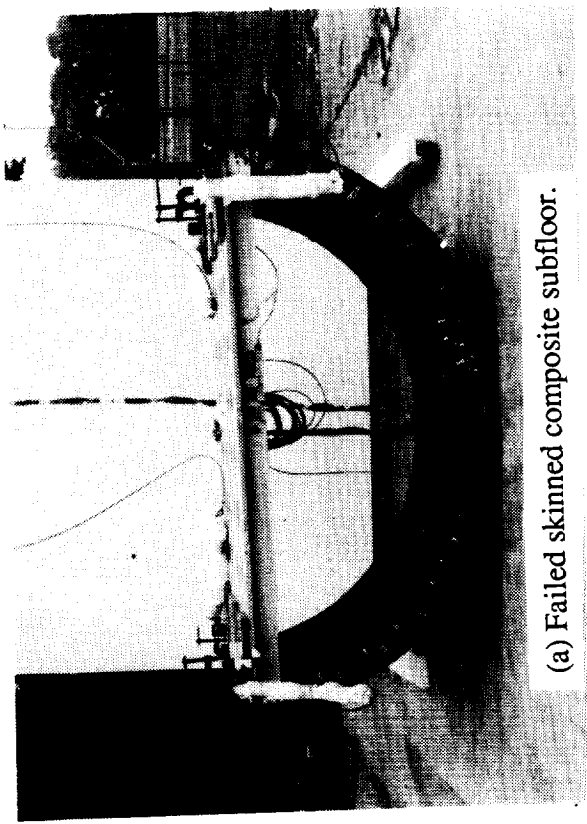
Figure 18 presents impact results for the subfloor with skin after an impact of 20 feet per second. Figure 18(a) is the subfloor specimen after the test. Points of failure of the frames in this specimen are indicated in figure 18(b). Again the points of failure are at/near the impact point (within 12°) and on the circumference at about $\pm 56^\circ$ up both sides of the frame on the middle and back frame and 11°, 22.5° and 45° on the front frame. It was observed that the subfloor impacted first on the front area which possibly explains the 11° and 22.5° fractures being different from the other locations. Again all three frames were involved in the failures. Some delamination of the frames from the skin was evident but the skin remained intact. Figure 18(c) is a normalized strain distribution (just prior to first failure) measured on the first (end) frame during the dynamic test. A comparison of the distribution to the moment distribution of Figure 14(b) and (c) and the strain distribution in Figure 18(c) shows essentially identical shape as the single frame and skeleton frame distributions. As was the case for the skeleton subfloor maximums at 0° and at approximately $\pm 50^\circ$ to 55° agree well with the analytically predicted locations on the frame.

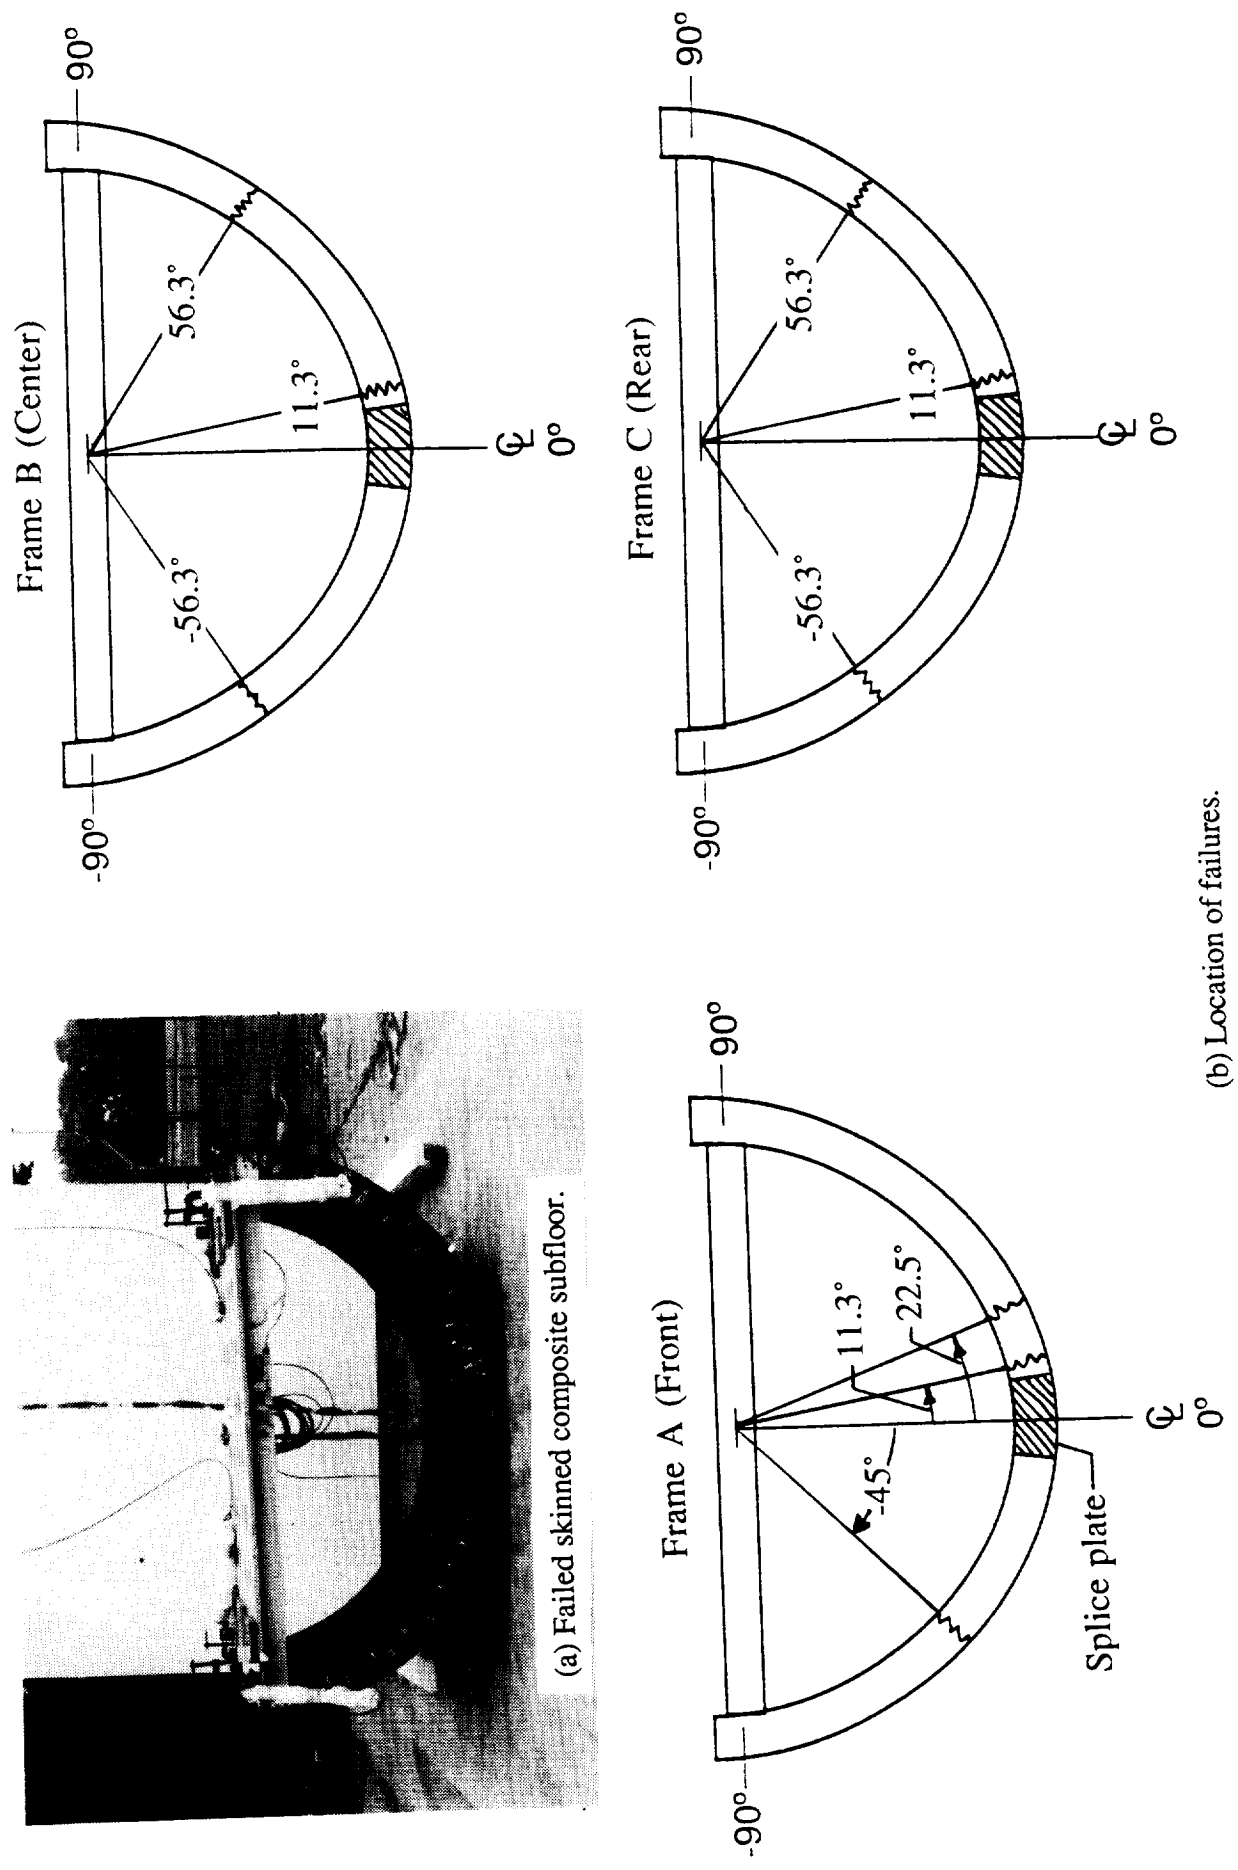
(b) Location of failures.

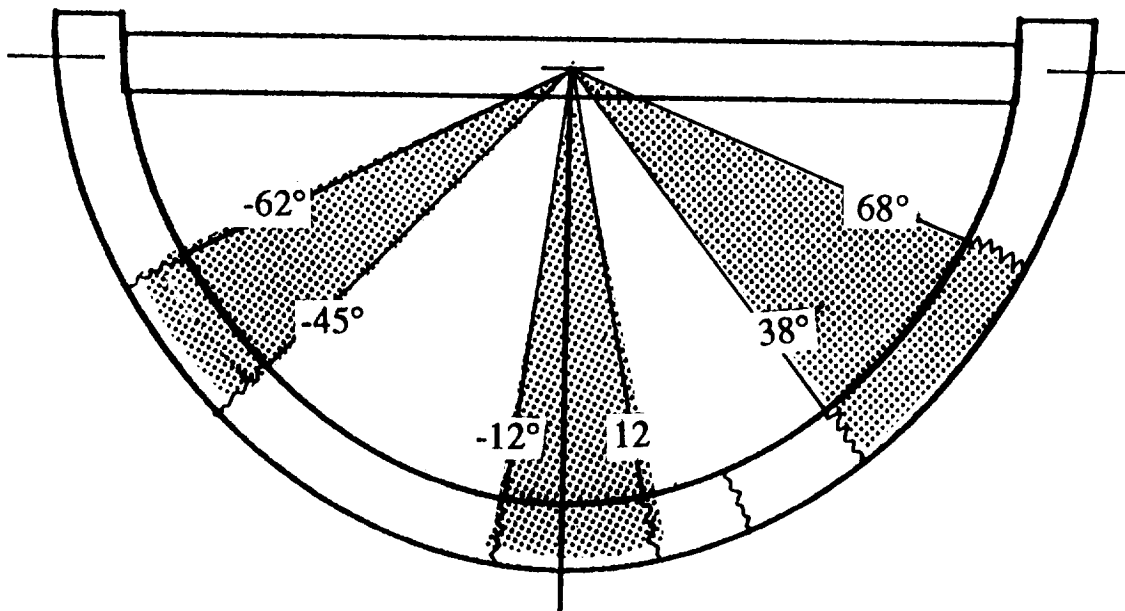
The response behavior determined during the studies of full-scale aircraft sections, fuselage panels, fuselage frames, and subfloors are summarized in figure 20. Figure 20(a) shows normalized moment distribution on a representative frame of the various specimens and Figure 20(b) shows the failure locations which were noted from static or dynamic tests. The visual impression is quite striking among the various specimens. It is suggested that from the results of simpler frames to the more complex subfloors and full-scale sections, a strong similarity is evident in the failure behavior of the structures. The structures share in

(b) Failure locations.
