NASA Technical Memorandum 104771

Hypervelocity Impact Testing of the Space Station Utility Distribution System Carrier

Scott Lazaroff

July 1993

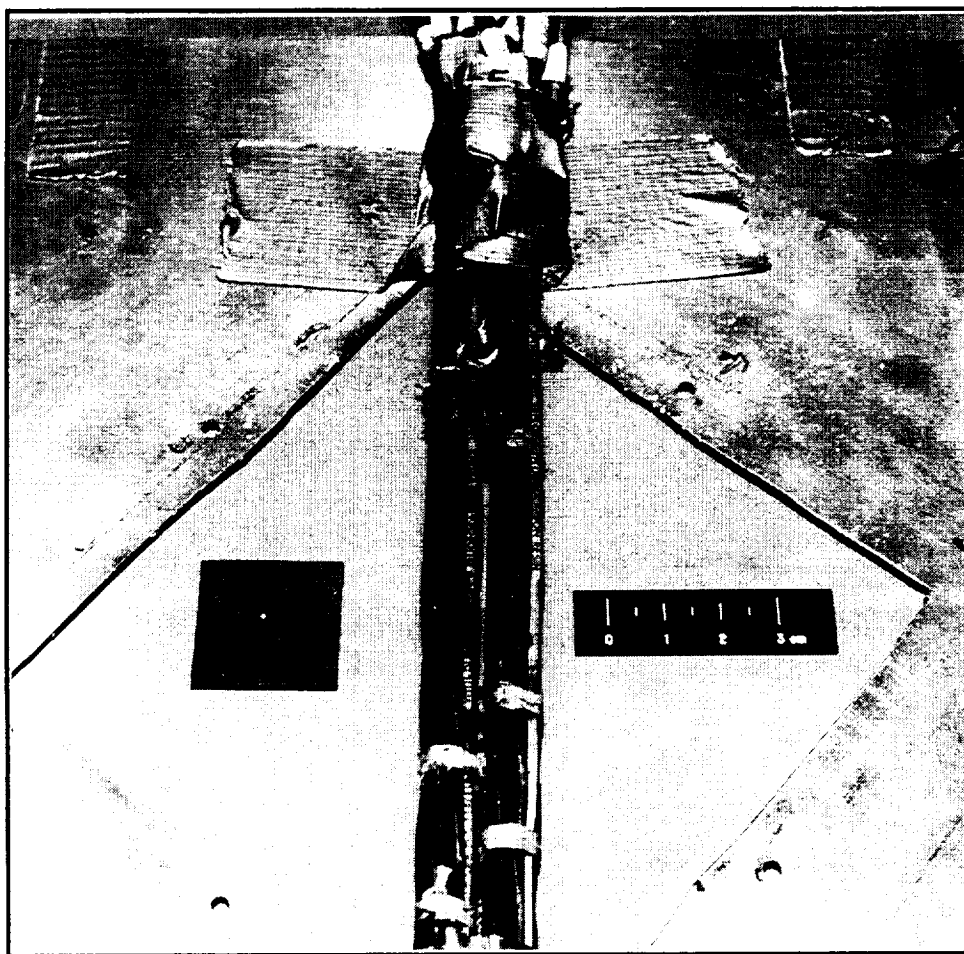
A precise ballistic limit was not determined for secondary power lines. A 2.4 mm (3/32 in.) diameter Al sphere striking the simulated carrier cover at 45° (HIRL shot no. A1494) was the biggest particle fired at the secondary power lines. It caused a large amount of physical damage (figures 10, 11, and 12), and a few of the test article lines indicated some slight increases in resistance during the post-HVI checkout. There was no dielectric breakdown of the insulation on any of the secondary power lines. For this part of the HVI test program, the parameters of A1494 are on the borderline of the ballistic limit curve, and the WSTF active line testing will better establish this limit.

Figure 10. Physical Damage to Secondary Power Lines from HIRL Shot No. A1494

Figure 11. Physical Damage to Secondary Power Line Bundle A2A from HIRL Shot No. A1494 at Magnifications of 10x, 10x, 10x, and 16x (starting upper left, going clockwise)

Figure 12. Physical Damage to Secondary Power Line Bundle A2C from HIRL Shot No. A1494 at Magnifications of 16x, 16x, 10x, and 10x (starting upper left, going clockwise)

Secondary Power Lines: The initial shot should be with a 2.4 mm or even a 1.6 mm diameter Al sphere striking at 45°. These lines will operate at 120 volts, and under full load conditions they will carry 58 A. Because of the potential of a high current fault, the smaller particle is suggested.

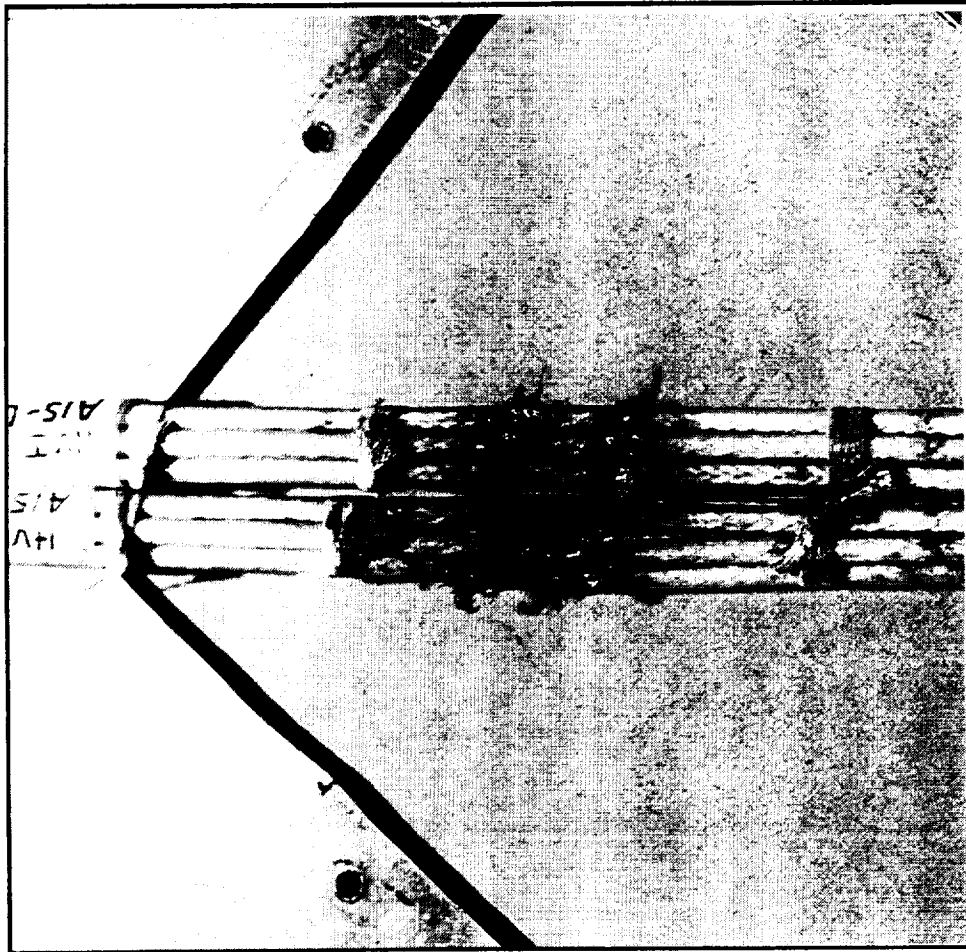
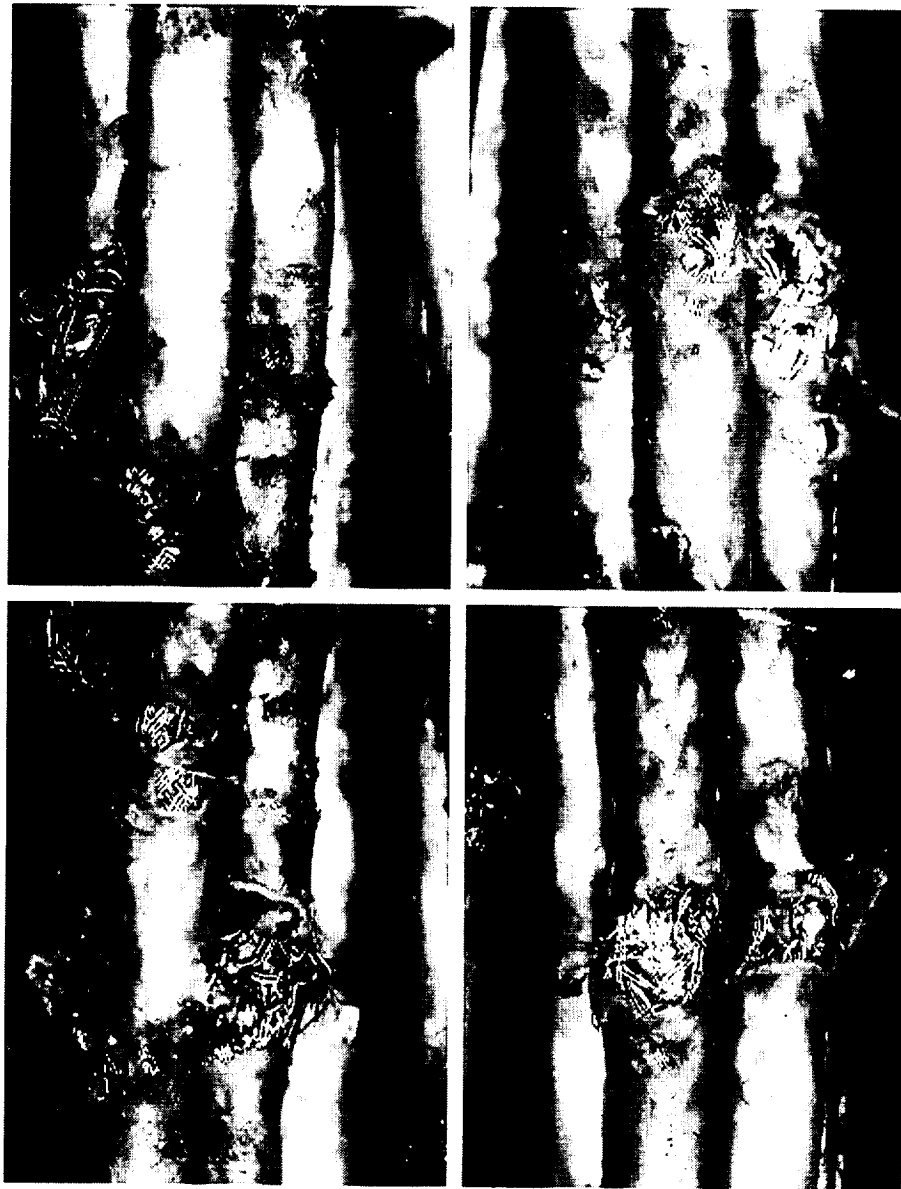
HIRL shot no. A1532 used a 2.4 mm diameter Al sphere striking at 45° and caused significant dielectric breakdown (> 5mA of current leakage = failure assumption) in several lines of both test article bundles. The physical damage to the data bus lines from this shot is depicted in figures 16 and 17. The results of this test indicate that the parameters are well within the ballistic limit since many lines failed. A smaller particle was not shot at these lines, but it will be included as part of the recommendations for the active avionic HVI tests at WSTF.

Figure 16. Physical Damage to 1553 Data Bus Lines from HIRL Shot No. A1532

Figure 17. Physical Damage to 1553 Data Bus Lines from HIRL Shot No. A1532 at Magnifications of 6x and 6x for Line A15A and 6x and 6x for Line A15B (starting upper left, going clockwise)

1553 Data Bus Lines: It is recommended that the initial shot should be with a 1.6 mm diameter Al sphere striking at 45°. This is because several lines were found to be functionally damaged with a 2.4 mm diameter particle striking the bumper (HIRL shot no. A1532). A smaller particle might have enough kinetic energy to cause functional damage to a single 1553 data bus line. Thus, the parameters of A1532 could be past the ballistic limit.

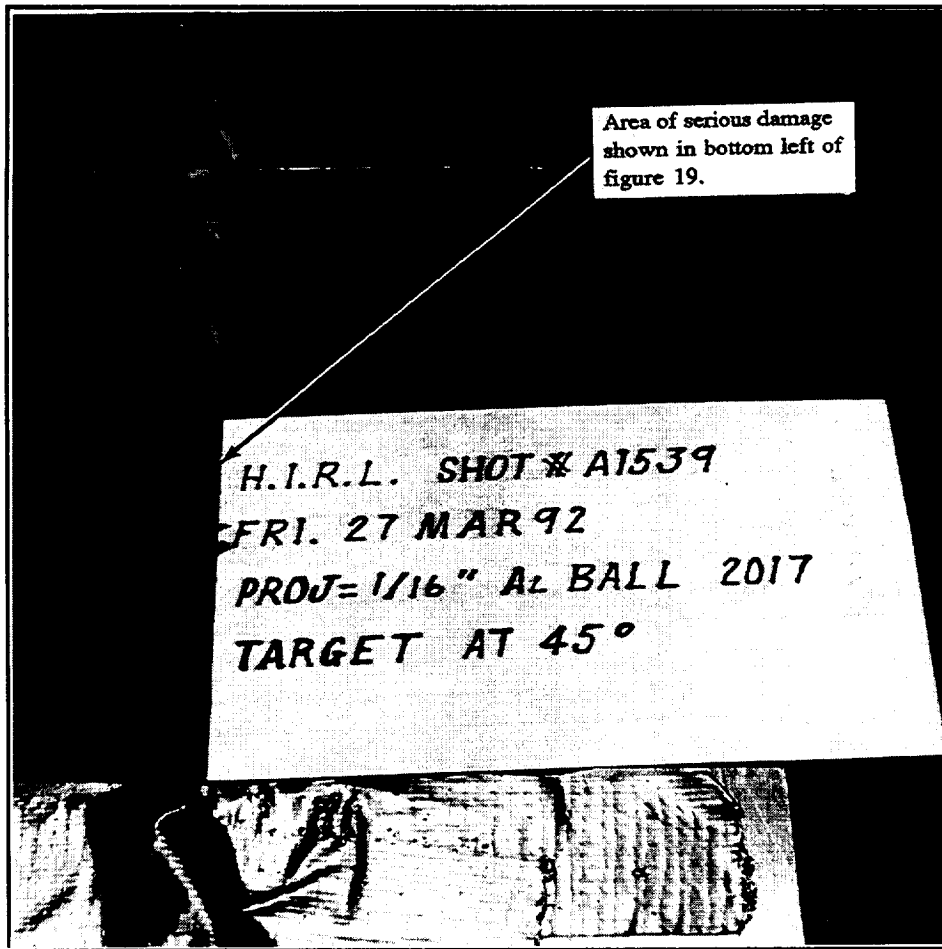
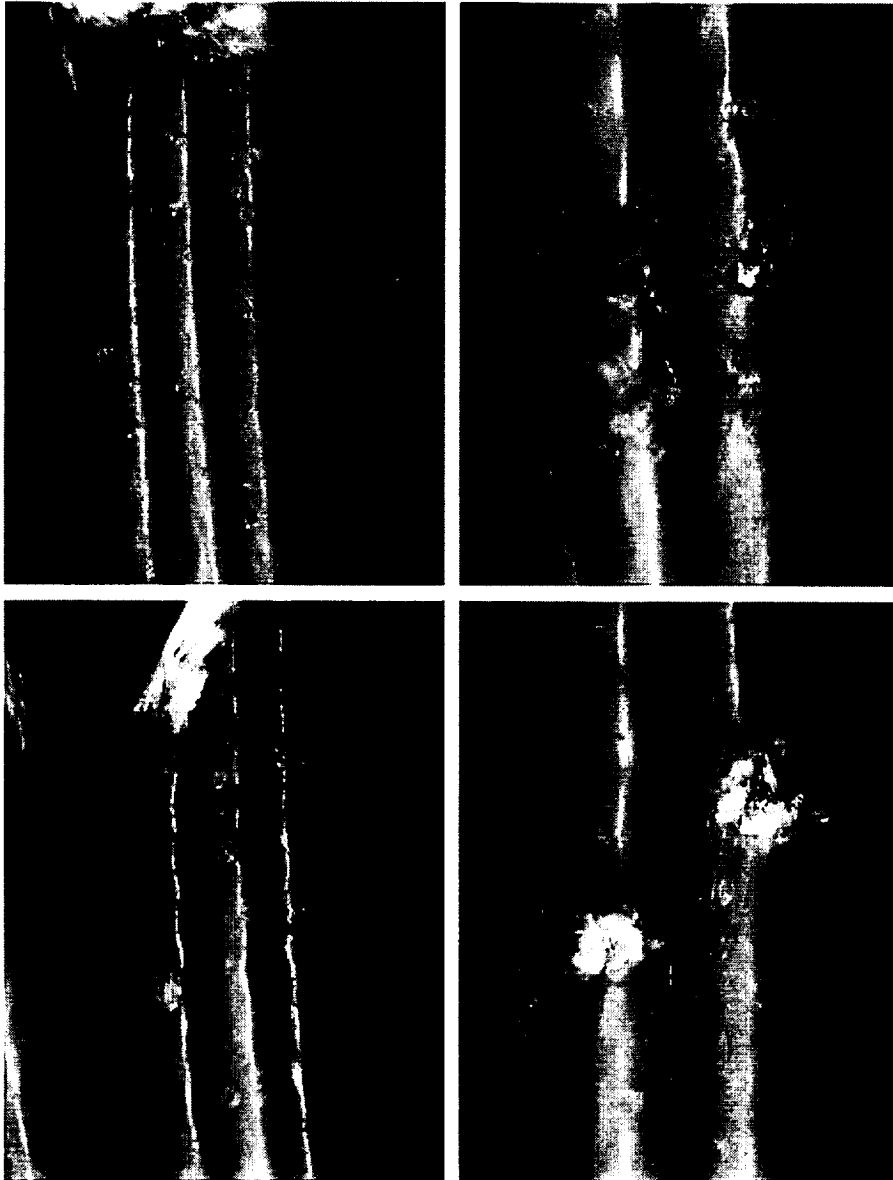
The ballistic limit for the fiber optic lines is found from the HIRL shot no. A1539, in which a 1.6 mm diameter Al sphere impacted the bumper at 45°. The signal losses in the two severely damaged fiber optic lines of shot A1539 were 35.4 and 36.3 dB. Based on the failure criteria, this is significant enough for a functional failure of the line. The physical line degradation associated with shot A1539 can be seen in figures 18 and 19.

Figure 18. Physical Damage to Fiber Optic Lines from HIRL Shot No. A1539

Figure 19. Physical Damage to Fiber Optic Line Bundles from HIRL Shot No. A1539 at Magnifications of 6x, 6x, 10x, and 10x (starting upper left, going clockwise)

Fiber Optic Lines: It is recommended that a shot with either a 1.6 mm or slightly smaller particle (such as a 1 mm) diameter Al sphere striking at 45° should be used as a starting point.

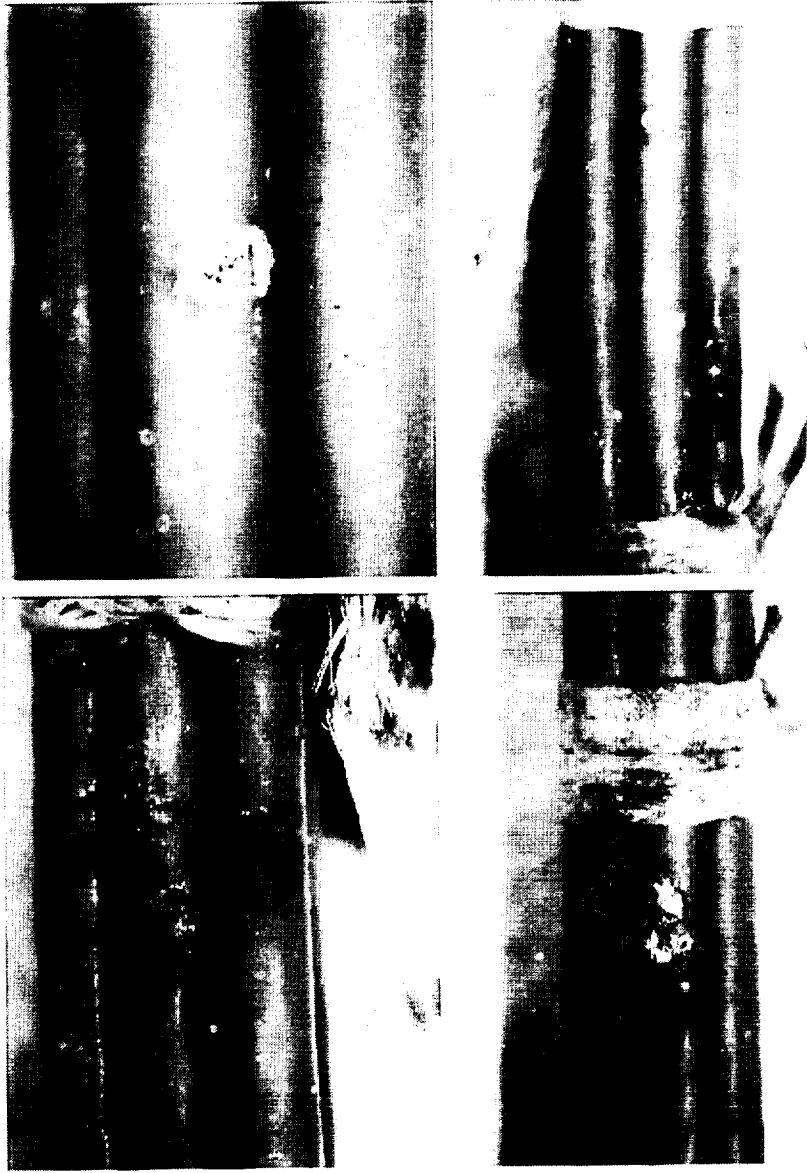
The ballistic limit conclusion is reached because a repeat of the A1539 parameters was made (HIRL shot no. A1578), and the post-HVI check showed no loss of light signal through the line. As seen in figure 20, the physical damage is very similar to the damage to the lines from HIRL shot A1539. Thus in a worst case, the parameters of A1539 and A1578 *can* cause a failure in the fiber optic lines and therefore they lie on the border of the ballistic limit curve.

Figure 20. Physical Damage to Fiber Optic Line Bundles from HIRL Shot No. A1578 at Magnifications of 6x, 10x, 6x, and 6x (starting upper left, going clockwise)

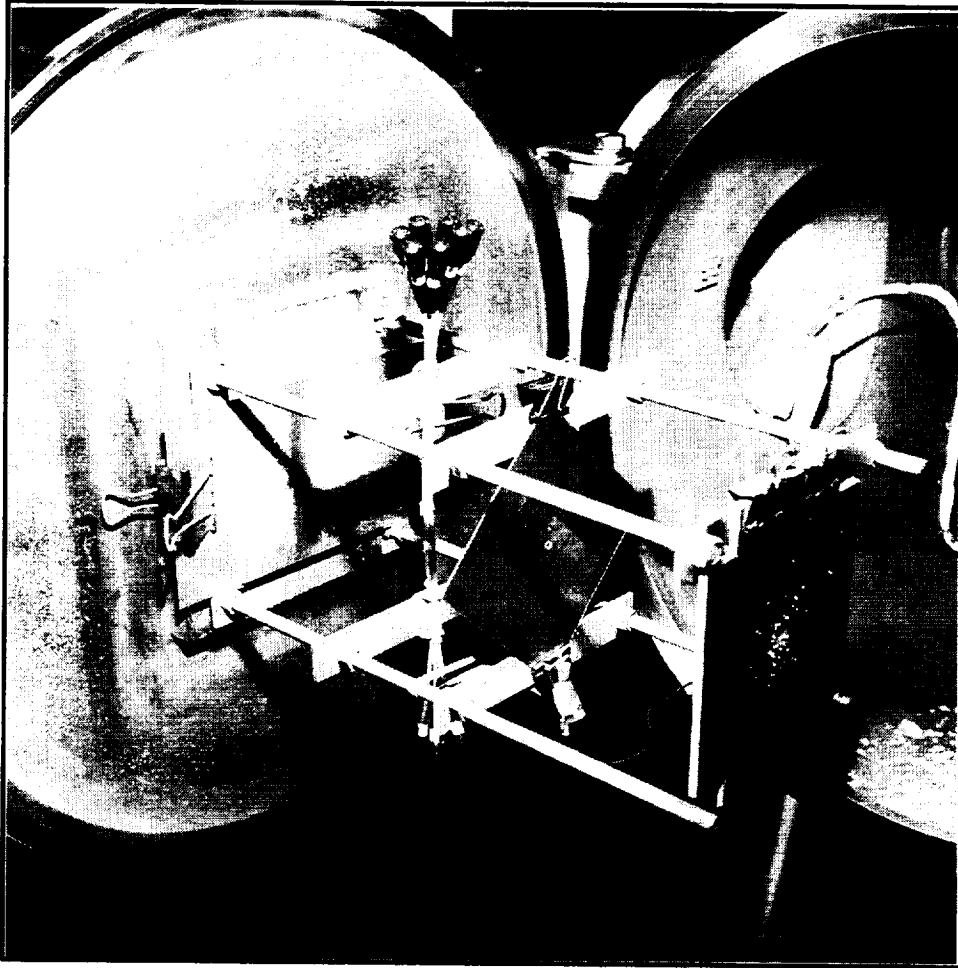
In addition, figures 21 and 22 indicate similar findings described in the secondary power lines summary of results. It can be seen that small particles (< 1.6 mm in diameter) penetrate the bumper, yet cause little physical damage and no functional damage.

Figure 21. Bumper, Fiber Optic Bundle and Witness Plate Mounted in 1.7 mm Light Gas Gun Test Cell from HIRL Shot No. 2020

Figure 22. Physical Damage to Fiber Optic Lines from HIRL Shot No. 2020

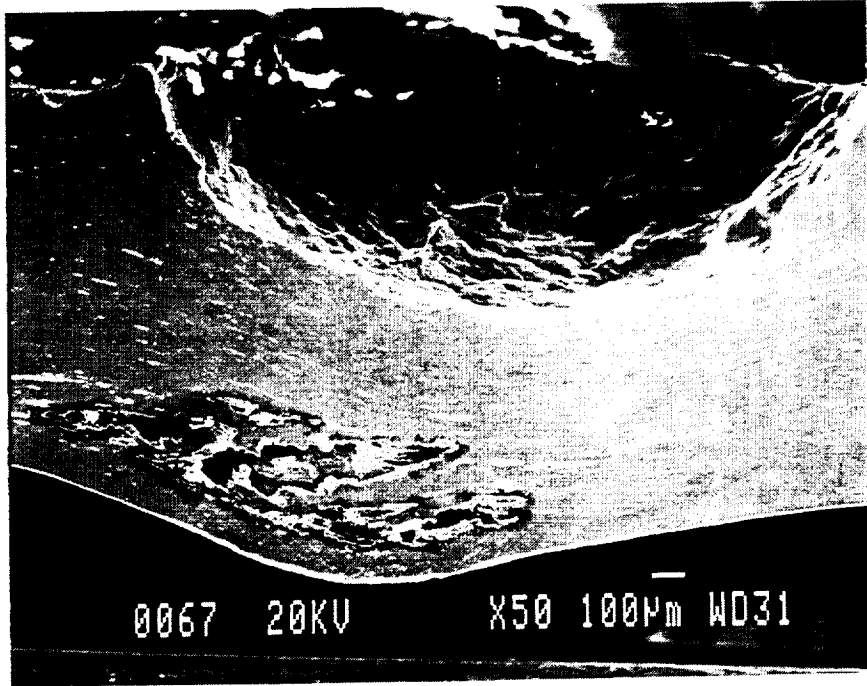
Figure 25. Scanning Electron Microscope Photo of the HIRL Shot No. A1688 Tube Wall, an Impact Crater, and Inner Wall Spalling at a Magnification of 50x

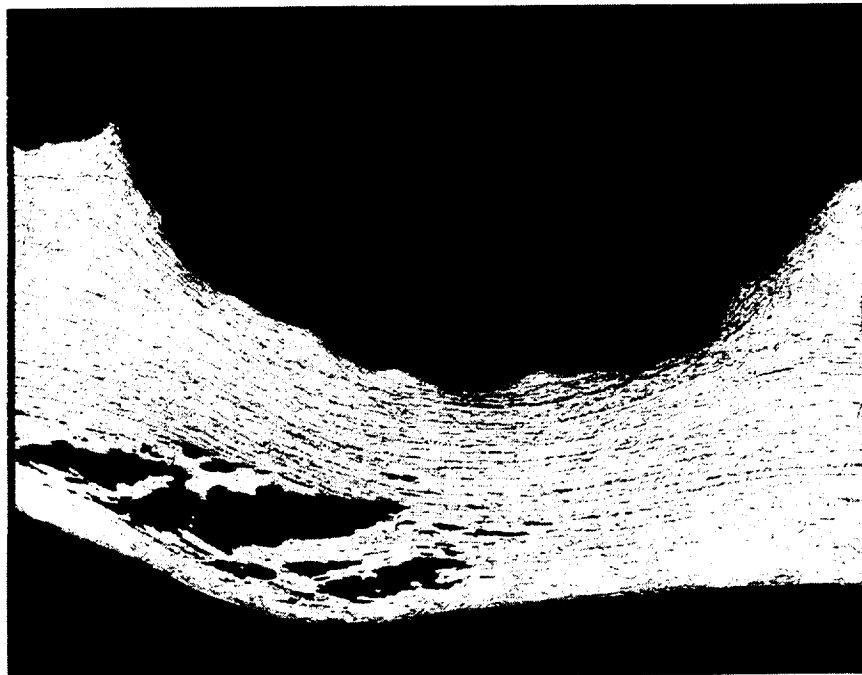
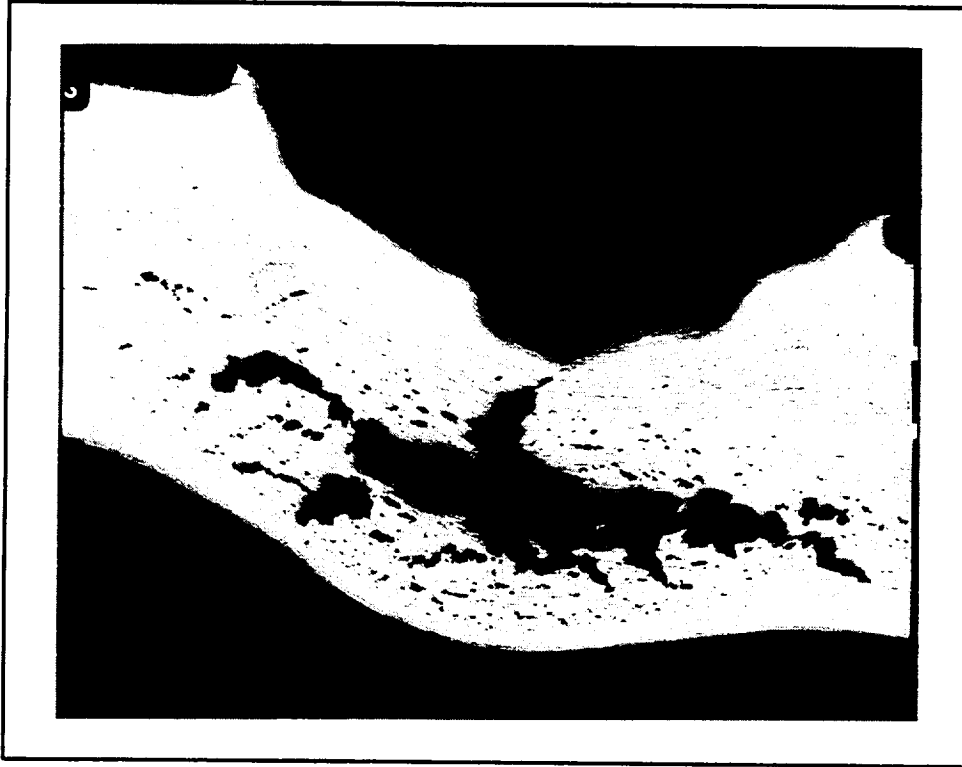
In addition, a cross section of the impact area was looked at using a Zeiss AX10MAT metallograph. These metallurgical cross sections further clarified the degree of spalling of the internal fluid line wall. As can be seen in figures 26 and 27, there is significant damage to the test article from HIRL shot nos. A1688 and A1690, respectively.

Figure 26. Metallurgical Cross Section of Fluid Line from HIRL Shot No. A1688

Figure 27. Metallurgical Cross Section of Fluid Line from HIRL Shot No. A1690

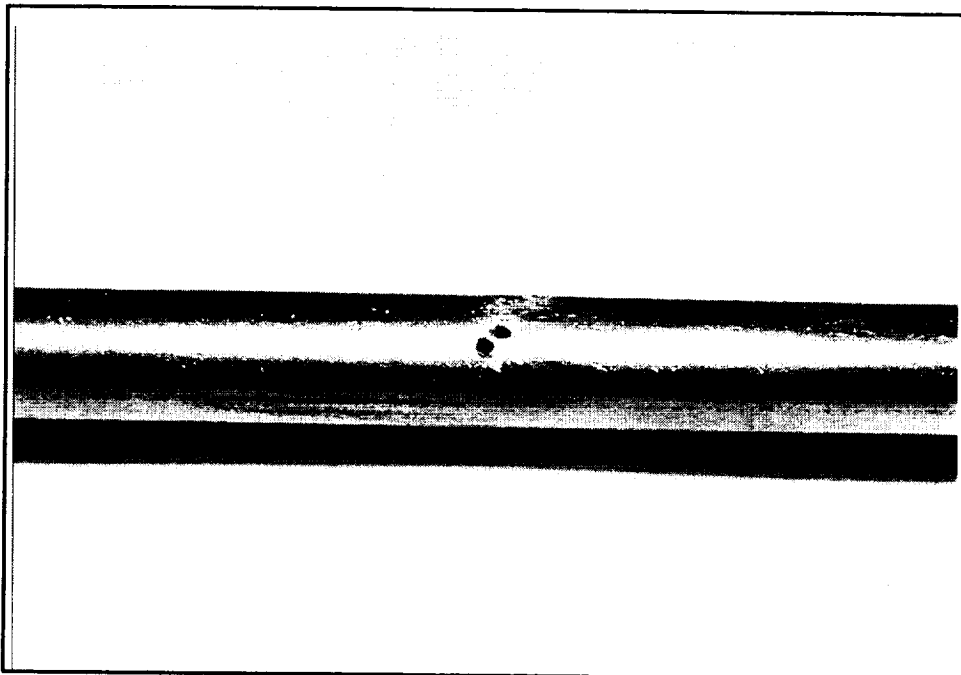
Figure 28. Physical Damage to Environmental Control and Life Support System Line from HIRL Shot No. A1631

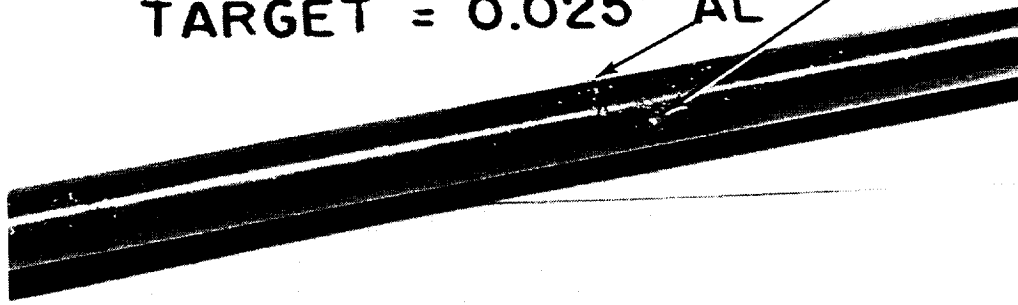
JSC H.I.R.L. SHOT # A1751

spall on the right internal dimple and the starting of some detached spall on the other (small crack/flaking of material). Further observation under the stereoscopic microscope substantiated the spalling that occurred on the internal surface of the tube. As a result, it is concluded that the parameters from HIRL shot A1751 lie on the borderline of the ballistic limit for these lines.

A slower moving piece of debris (relative to the particle) penetrated the bumper approximately 1.5 cm down and 1.1 cm to the right of the particle impact point. It is similar to the type of debris seen in the ATCS tests. Because of its speed and location and for the reasons discussed earlier for the ATCS lines, it is concluded that the particle and not the debris produced the serious damage to the SRS line described here in the results.

Two large craters
that caused internal
wall dimples shown
in figure 30

Figure 29. Physical Damage to Supplemental Reboost System Fluid Line from HIRL Shot No. A1751
