SPACE ENVIRONMENTAL EFFECTS ON LDEF COMPOSITES: A LEADING
EDGE COATED GRAPHITE EPOXY PANELPete E. GeorgeBoeing Defense and Space Group
Seattle, Washington 98124-2499 M/S 73-09
Phone: 206/234-2679, Fax: 206/237--0052

SUMMARY

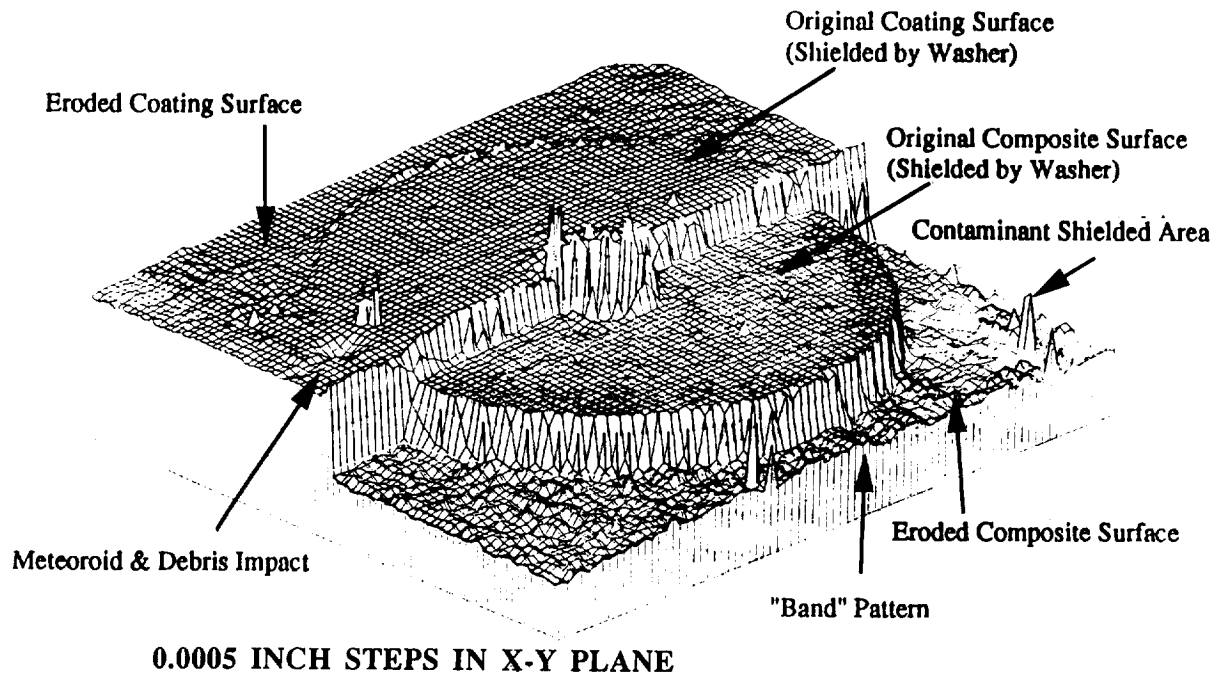
Figure 5 is a 3-D plot of the data collected during a laser profilometry raster scan of a partially coated T300 graphite/934 epoxy panel segment. Data is plotted as a 0.0005" grid for the x-y plane and 0.001" line segments of various thicknesses for the z-direction (depth). The approximately 1 inch square area contains a circular region shielded from AO attack by a mounting washer on the surface. An A276 white polyurethane coating covers the rear left half of the panel segment.

There are three distinct height levels in this plot representing (from highest to lowest) the coating surface, the original uncoated composite surface (semicircular disk), and the AO eroded composite surface. The outline of the mounting washer can be seen on the coating surface where approximately 0.002" of coating was eroded beyond the washer protected area. On the uncoated composite half of the segment the washer protected area is easily detectable as a 0.003" step between the AO eroded surface and the original bare composite surface. The original coating thickness of 0.002" can be seen between the original uncoated composite (semicircular disk) surface and the coating surface.

Other visible features include a micrometeoroid or debris impact on the coated surface just to the left of the washer protected area and vertical spikes rising from the AO eroded composite surface due to particulate contaminate AO shielding.

FIGURE V - LASER PROFILOMETRY RASTER SCAN OF WASHER REGION

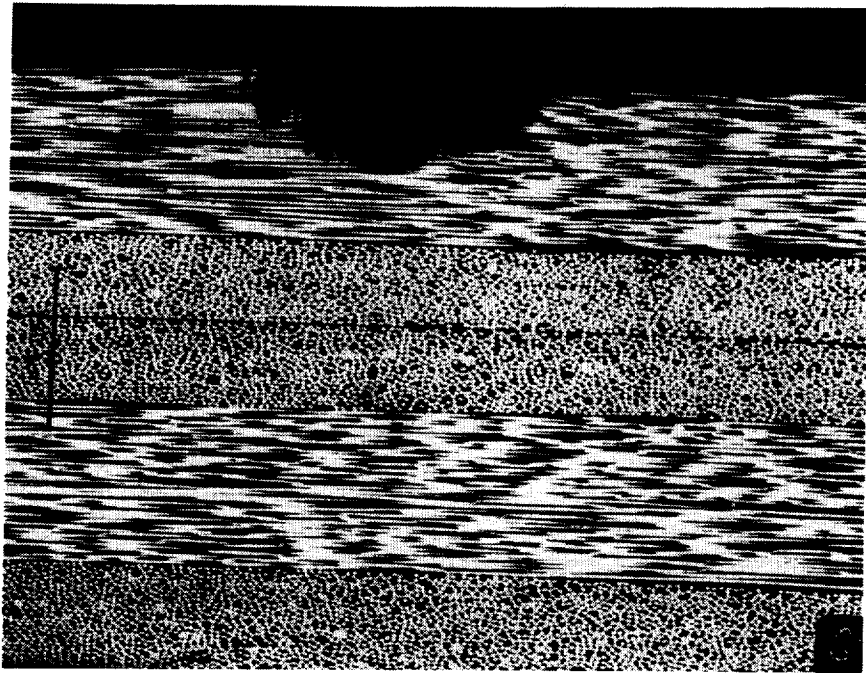
The polished cross sections were then examined at various magnifications using a Zeiss Axomat microscope with bright field illumination. Figures 7 through 11 are photomicrographs of the polished cross sections for impacts one through five respectively. These impacts have many of the same features along with some distinct dissimilarities. Four of the five impacts display an inverted hat shape (three very strongly). These four impacts (numbers 1,2,3 & 5) also display AO erosion features which are approximately 3 to 4 fiber diameters tall both on the "shoulders" and at the "base" of the hat (See Figure 12). Impact number four, which does not have the inverted hat shape, displays extensive crushing and displacement of material. Also, its erosion features are only one fiber diameter tall.

FIGURE IX - CROSS SECTIONAL PHOTOMICROGRAPH OF IMPACT #3 IN A-276
COATED T300/934

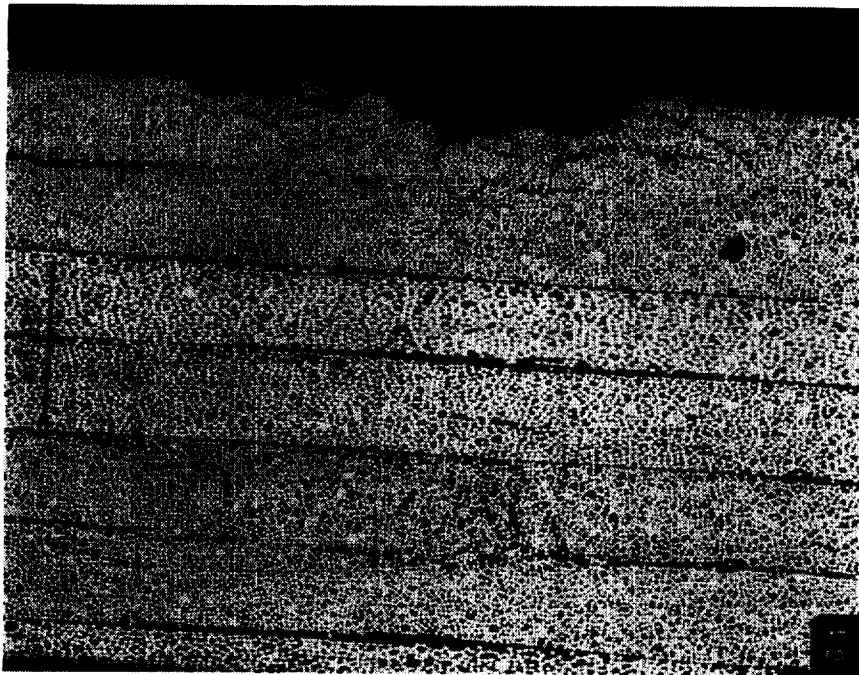
FIGURE X - CROSS SECTIONAL PHOTOMICROGRAPH OF IMPACT #4 IN A-276
COATED T300/934

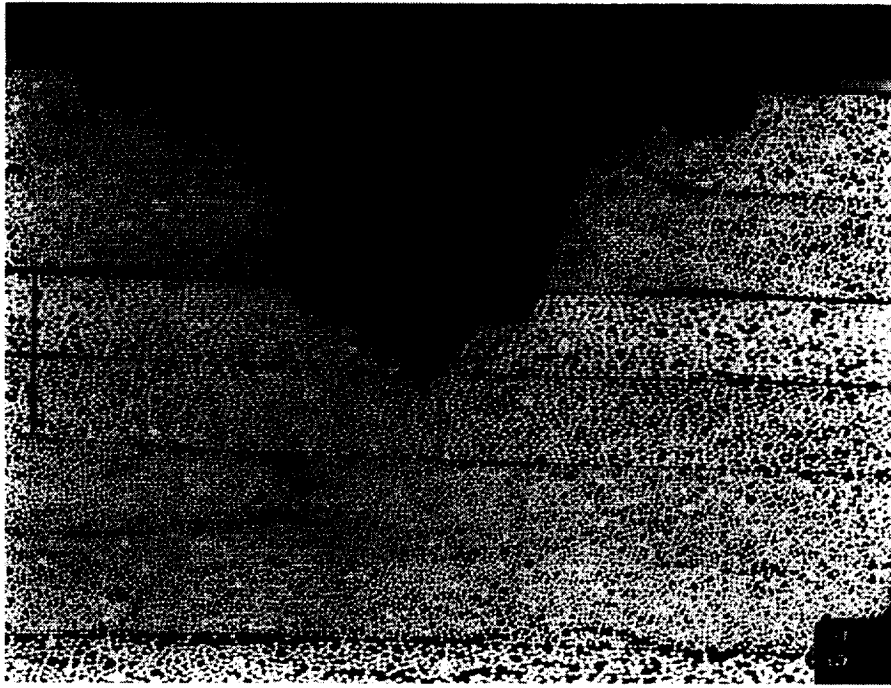
All impact sites displayed delaminations at the first ply orientation transition interface. Only the largest impact, #5, displayed deeper delaminations. Impact #5 also contains what appear to be fiber fractures below the base of the impact. These were initially thought to be polishing artifacts. However, after repolishing and observing using a differential interference contrast technique the fractures were still present and an indication of depth to the fractures visible (see Figure 13). No indications of coating undercutting by AO were visible.

FIGURE XI - CROSS SECTIONAL PHOTOMICROGRAPH OF IMPACT #5 IN A-276
COATED T300/934

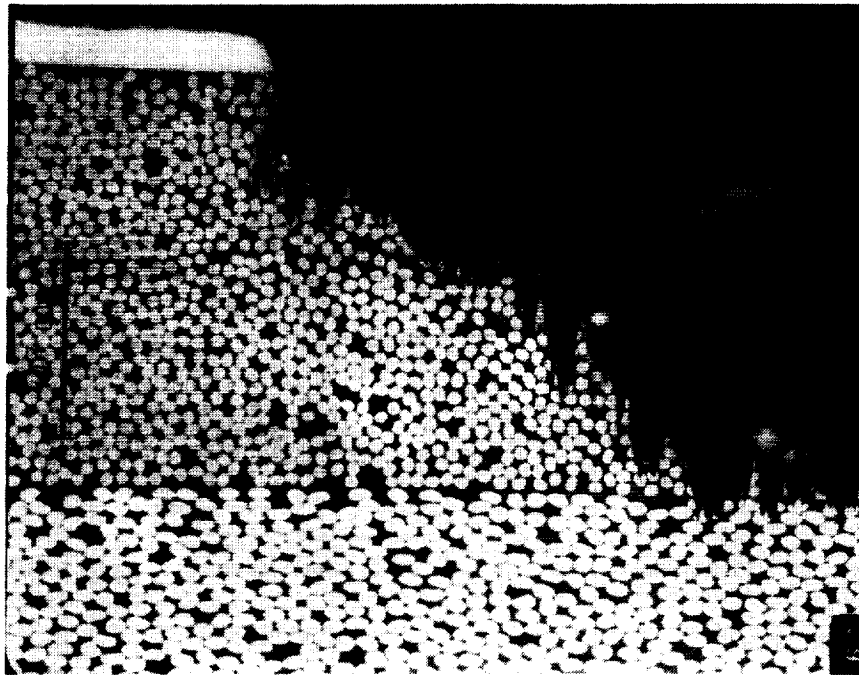
FIGURE XII - ATOMIC OXYGEN EROSION FEATURES OF IMPACT #2

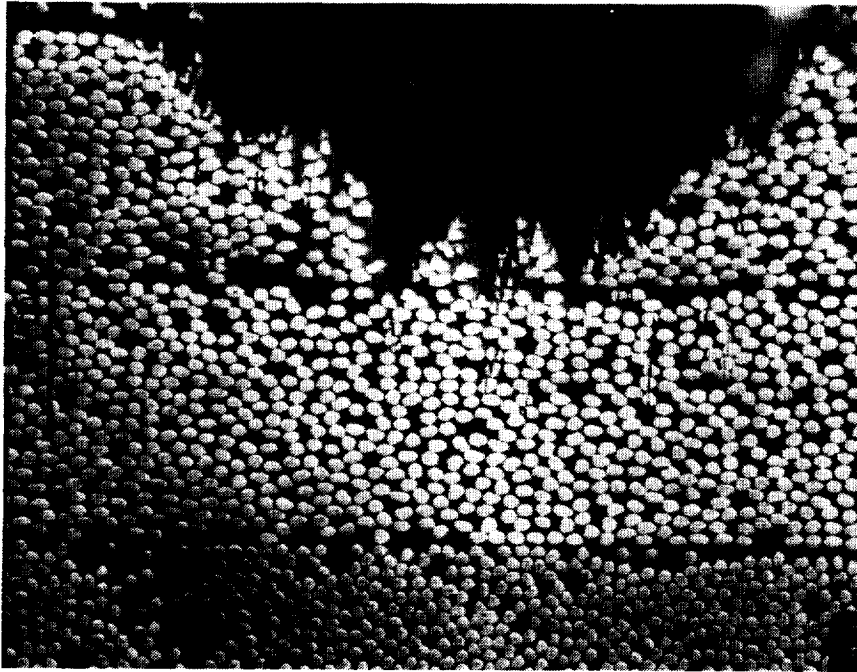
FIGURE XIII - DIFFERENTIAL INTERFERENCE CONTRAST
PHOTOMICROGRAPH OF FIBER CRACKS IN IMPACT #5

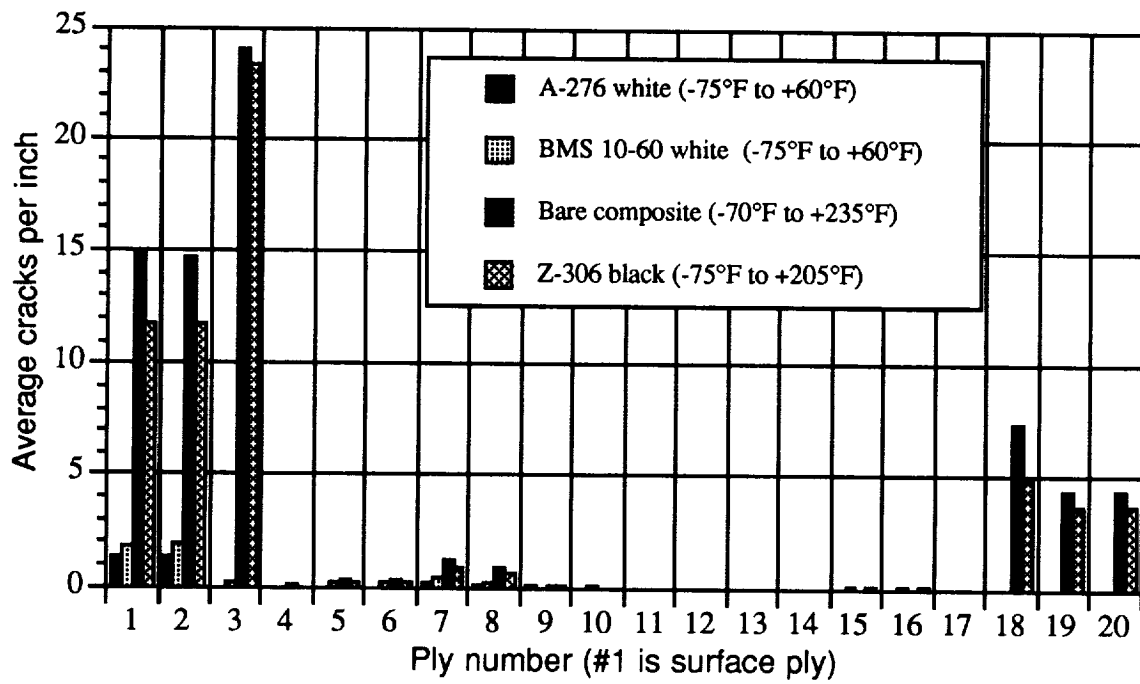
quadrant, were examined by optical microscopy at 200x magnification for microcrack location and density. A summary of the results is presented in Figure 15. The black coated and bare quadrants contained significant levels of microcracking while the white coated quadrants were relatively crack free. Most of the cracks that were found in the white coated specimens were located within close proximity to the black or bare area boundaries. The more extreme thermal environment experienced by the black coated and bare quadrants appears to have created thermal stress induced microcracking in those areas as well as in adjacent regions of the white coated quadrants.

FIGURE XV - MICROCRACK DENSITY VS. PLY NUMBER FOR THE COATED AND UNCOATED COMPOSITE SUBSTRATES

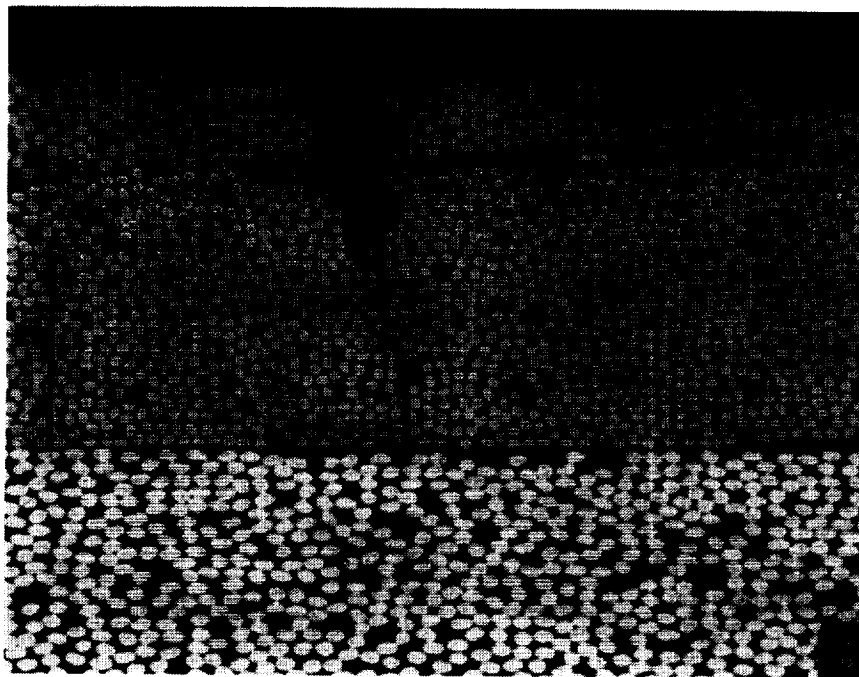
AO interaction with microcracks was observed in both bare and coated areas. Figure 16 shows a microcrack in the surface ply of the bare composite quadrant. The upper portion of the crack has been enlarged by AO attack. This interaction was found in two thirds of the observed surface ply cracks for the bare quadrant. Figure 17 shows similar interaction for a crack in the black coated quadrant. Note that AO attack has begun in the composite substrate in some regions where the coating has been completely eroded. As mentioned above the AO erosion may have also created crack initiation sites. The AO created sharp erosion troughs running parallel to the fiber direction.

FIGURE XVI - CROSS SECTIONAL PHOTOMICROGRAPH OF MICROCRACK IN SURFACE PLY OF EXPOSED UNCOATED T300/934 PANEL QUADRANT

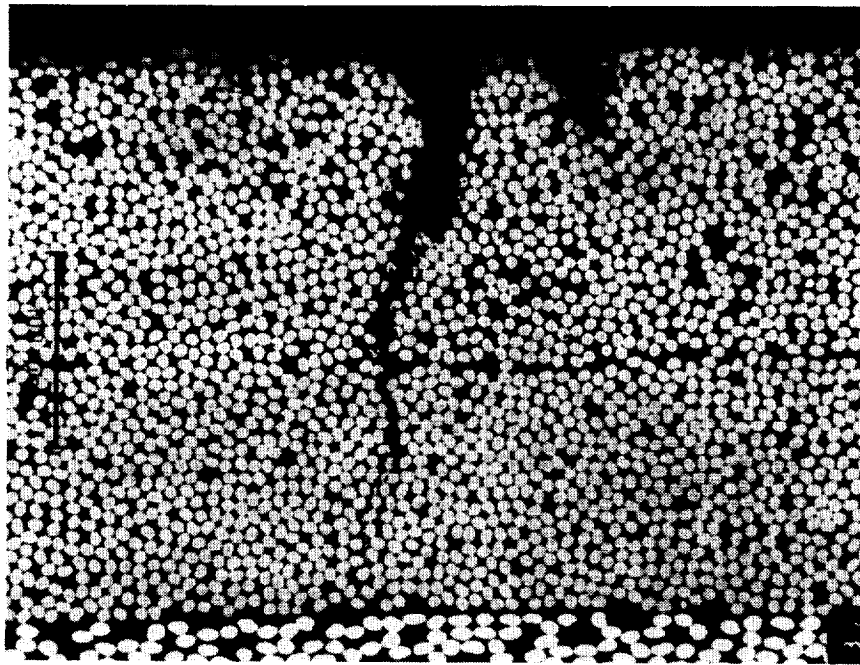
FIGURE XVII - CROSS SECTIONAL PHOTOMICROGRAPH OF MICROCRACK IN SURFACE PLY OF EXPOSED Z306 COATED T300/934 PANEL QUADRANT

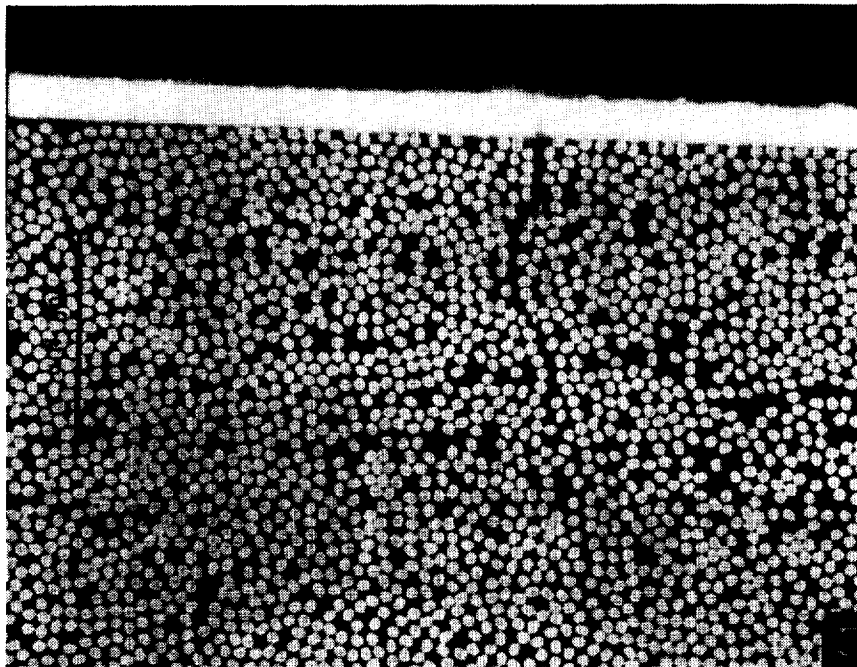
AO-microcrack interaction was also observed for a crack in the A276 white coated region. Figure 18 shows a thermal cycle induced microcrack in the surface ply of the A276 coated quadrant. Careful observation reveals that the crack has propagated through the coating allowing limited AO attack of the substrate. The coating breach, which is visible with the unaided eye on the panel surface, was present during flight as evidenced by the signs of AO erosion in the crack. Crack propagation through the A276 coating was unexpected as the coating has a strain to failure of 30-50%. The limited AO erosion in the substrate microcrack suggests that propagation through the coating occurred later in the mission. The substrate crack which would have developed before most of the AO exposure may have created stresses in the coating which accelerated AO attack of the coating over the crack.

FIGURE XVIII - CROSS SECTIONAL PHOTOMICROGRAPH OF MICROCRACK IN SURFACE PLY OF EXPOSED A276 COATED T300/934 PANEL QUADRANT
