NASA Technical Memorandum 106169  
AIAA-93-2534

# Brush Seal Low Surface Speed Hard-Rub Characteristics

Robert C. Hendricks, Julie A. Carlile, and Anita D. Liang  
*Lewis Research Center*  
*Cleveland, Ohio*

Prepared for the  
29th AIAA Joint Propulsion Conference and Exhibit  
cosponsored by the AIAA, SAE, ASME, and ASEE  
Monterey, California, June 28-30, 1993

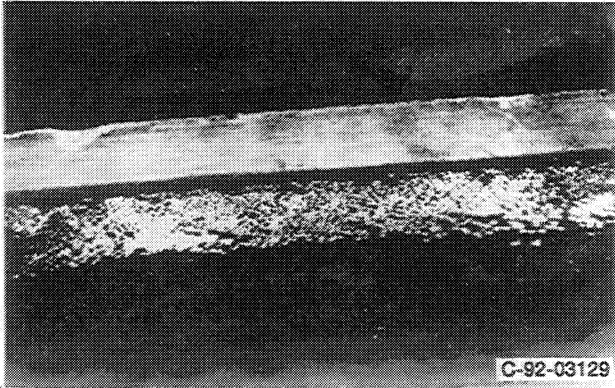
Figure 3.—Brush seal prior to tests (270° mark).

The 38.1-mm (1.5-in.) diameter brush seal (Fig. 3) was damaged in a previous series of tests related to Ref. 2. The damaged section, although quite small and having a "chewed" appearance, increased seal leakage. The seal could no longer be used for leakage tests but was adequate for the tests herein.

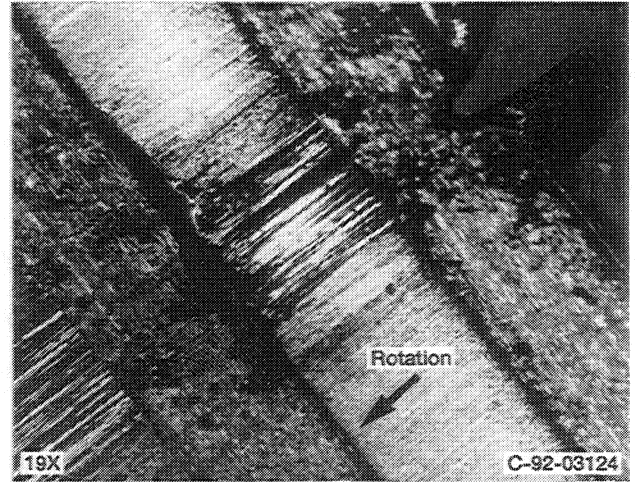
Optical inspection of the grooves cut by the brush into the stainless steel rotor (test 1) showed that the cut converged from the leading edge to the trailing edge of the land as the wires (bristles) crossed the rotor (Fig. 4). Wire grooves were clear cut and debris was evident, as is better shown in the enlargement (Fig. 5).

The following groove extents in millimeters (inches) were measured in test 1:

Width at inlet	1.52 (0.06)
Width at center	1.3 (0.051)
Width at outlet	1.27 (0.05)

Figure 4.—Rotor surface after test 1. (Arrow shows direction of rotation.)

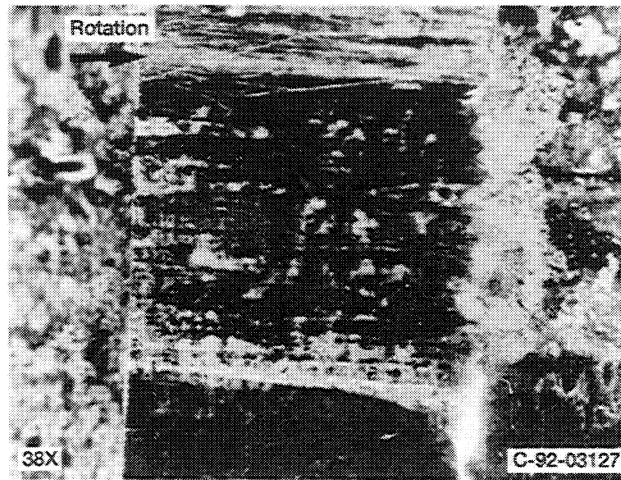
Figure 5.—Rotor land and groove after test 1.

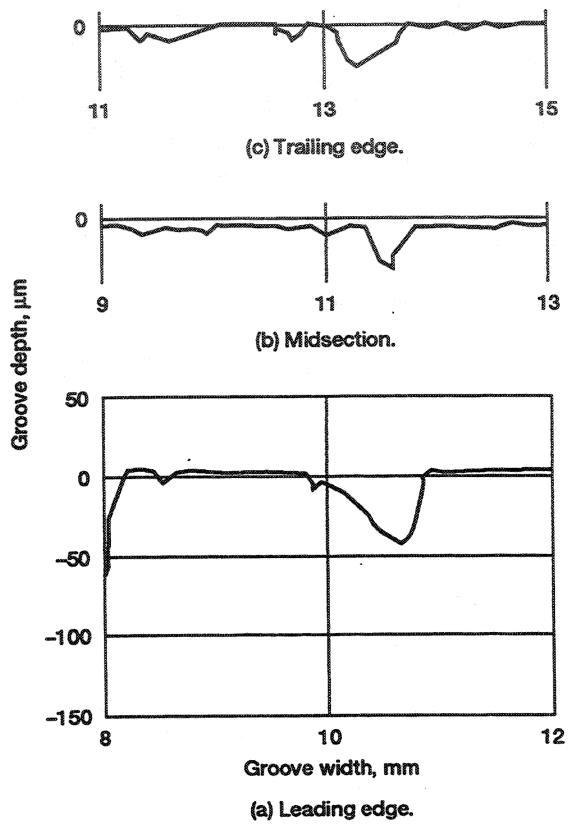
The first profile, labeled "leading edge," was taken within 0.10 mm (0.004 in.) of the leading edge and shows a broad damage region with deep grooving for test 2 (Fig. 7(a)) and test 3 (Fig. 8(a)) but a minor amount of material damage for test 1 (Fig. 6(a)). The material buildup adjacent to the groove of test 3 probably occurred during rotor-fence rub. The second profile, labeled "mid section," was taken midway between the tooth leading and trailing edges. The damage of test 2 (Fig. 7(b)) and test 3 (Fig. 8(b)) was severe, and a twofold cut has developed in the rotor during test 2. Again moderate damage was noted for test 1 (Fig. 6(b)). The third profile, labeled "trailing edge," was taken within 5 percent of the trailing edge. The grooving seen in the midsection profile carried through with perhaps some sharpness of the features near the trailing edge (Figs. 6(c), 7(c), and 8(c) for tests 1, 2, and 3, respectively).

The trailing edge of the land was "cut" clean by the brush in all three tests in stark contrast to the erratic leading-edge surface, which was whipped by the bristles. Of interest is the contrast between the land surface cuts. Test 1 surface cuts were a simple wear scar; those of tests 2 and 3 were multiple grooves with complex surfaces and burnishing. The most rotor damage appeared from test 2 and the most brush damage from test 3, where the rotor was set eccentric.

Figure 6.—Profilometer traces for 40-tooth rotor (test 1).

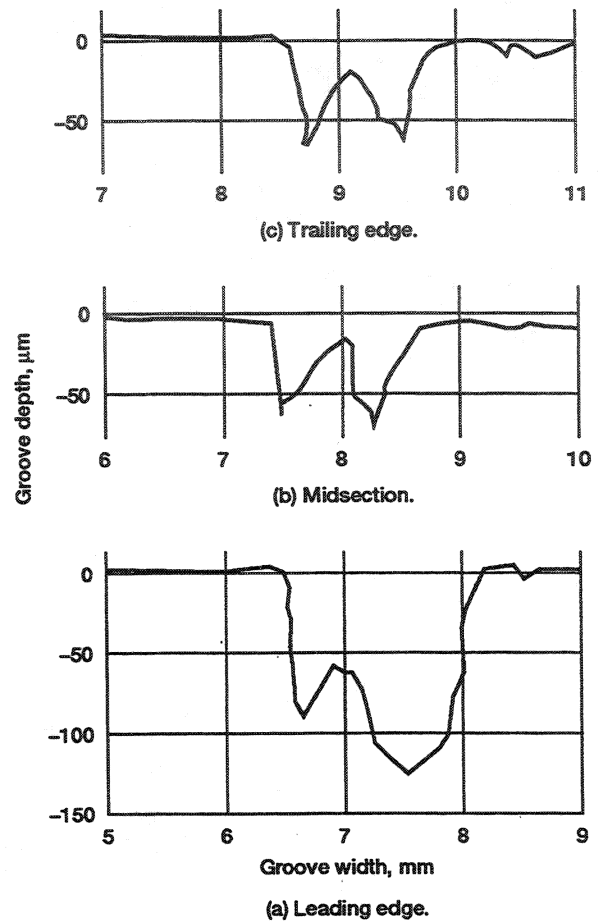
Figure 7.—Profilometer traces for 40-tooth rotor (test 2).

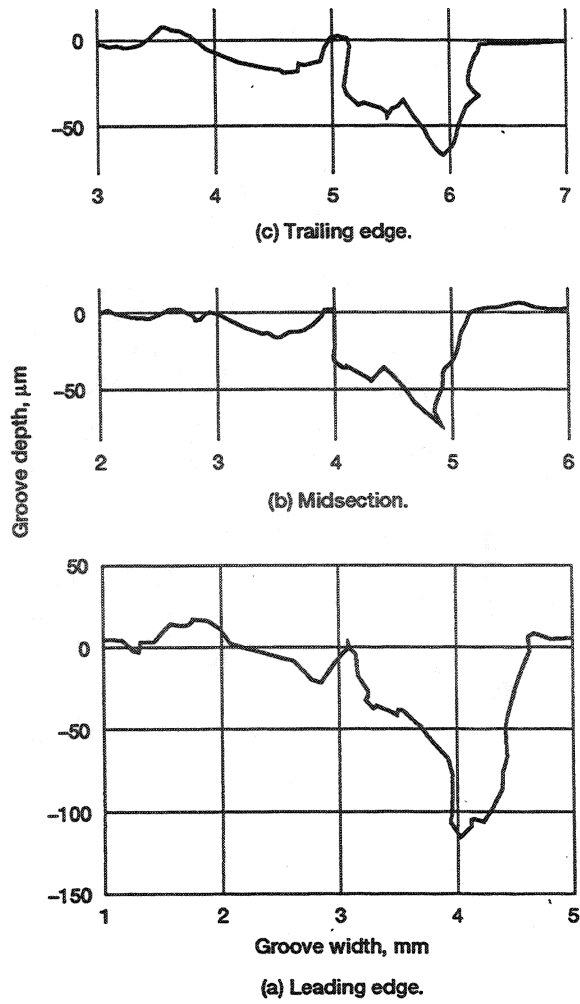
Figure 8.—Profilometer traces for 40-tooth rotor (test 3).

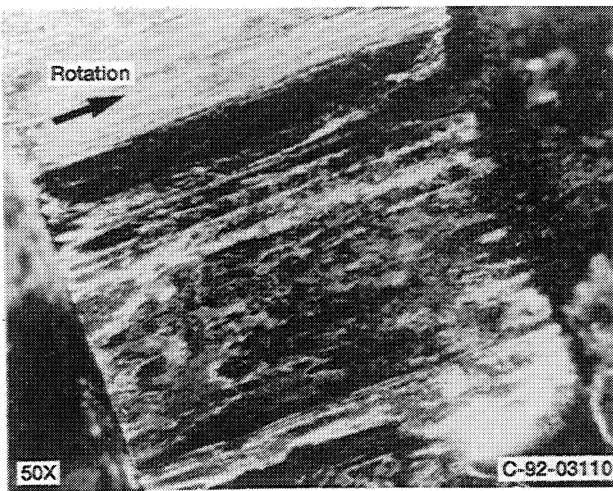
The brush bristle impact at the leading edge left material deposits that were magnetic (i.e., from the

rotor) and rust color (probably  $Fe_3O_4$ ) with a spongelike (or cauliflower) appearance (Fig. 9); these deposits are readily seen at higher magnification (80X) in Fig. 10. Debris was generated by surface machining grooves, "whipping" of the leading edge, burnishing, and sharp trailing edges. The deposited materials were fine, porous, "greasy" to the fingers, and readily removed from the rotor; removal from the bristles was not straightforward. Standard degreasing cleaned but not thoroughly, and ultrasonic cleaning was not attempted. The reasoning was to see if these deposits would inhibit the responsive character of the bristles. The debris can affect both the response and the leakage, but neither effect was observed in these tests. Further work here is warranted.

Figure 9.—Rotor land with debris and rub scars (test 2).

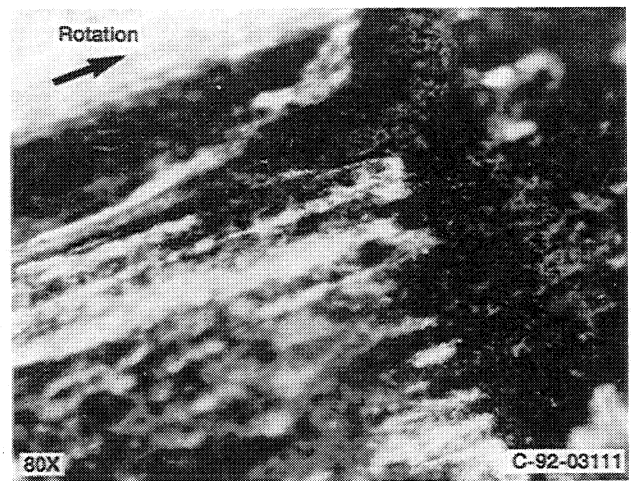
These deposits also indicate rapid wear-in with a long oxidation period for the "machined out" material. The materials deposited on the groove wall at the land leading edge (Fig. 10) and on the groove wall at the land trailing edge (Fig. 11) had little or no structure; the defraction spectra were peakless.

It is speculated that the bristles were dragged across the land, with "machined" material adhering to the bristle and then "impacted" off the bristle at the leading edge of the next tooth. Some of the materials were deposited within the groove. Black nodule-like debris tended to adhere to the groove wall at the land trailing edge. This black material and rust-colored materials formed in the groove at the land leading edge.

Figure 10.—Rotor leading-edge debris formation (test 2).

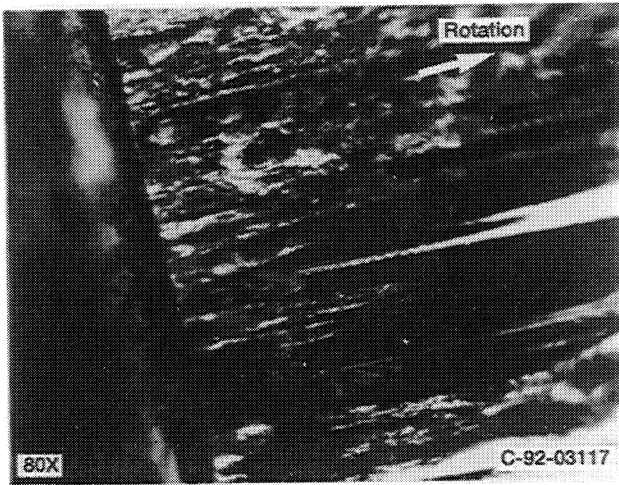
Figure 11.—Rotor trailing-edge surface grooving and debris (test 3).

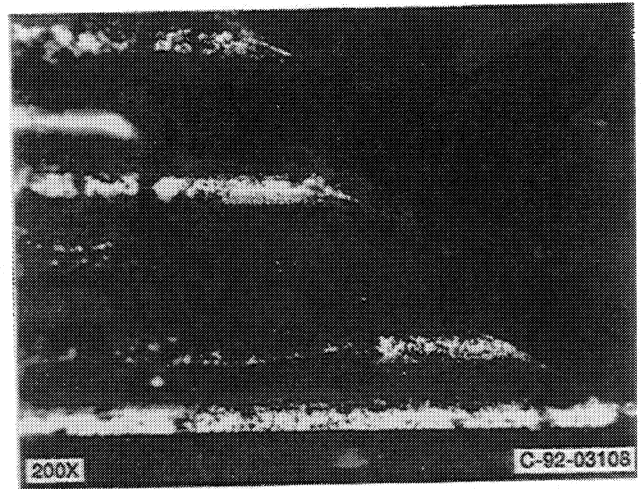
Stainless steel work hardens so that the cut grooves were probably harder than the parent stainless steel and would wear the annealed Haynes 25 bristles. The smooth grooves, the hot spots, and the hot streaking may indicate that a thin layer of stainless steel flowed plastically as it was machined out. Because of the incursive impact of the toothed rotor and the heated interface, the Haynes 25 bristles could lose strength, erode, fracture, or pull out as massive debris. But no pullouts or massive debris was found after any of the three tests. At higher magnification (200X) the tips still appear intact without fracture, but wear is evident and oxidation debris appears to be well adhered to the surface (Fig. 12). As further evidence of the bristle wear an examination of the bristle tip surface revealed tip grooving, and the severe impacting on the bristles is shown by erratic wear notches on the bristle surface.

Figure 12.—Brush bristle tips with debris (test 1).

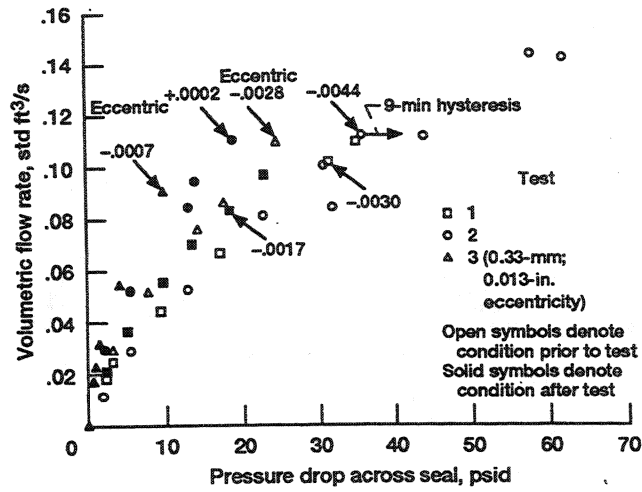
Leakage is characterized in Fig. 13 in terms of volumetric flow rate as a function of pressure drop across the brush seal before and after each of the three tests. Both pretest and post-test results are provided in the same figure. Because this brush seal was damaged (see Apparatus section), absolute leakage measurements would require weighing, but the relative leakage should be accurate. The interference fits for the brush seal leakage data for pretests 1 and 2 were nearly the same, resulting in corresponding leakages. While taking data it was found that the brush would stiffen and the pressure drops would increase. Data points illustrating hysteresis (typical in brush seals) are shown. After correcting the post-test 2 data for clearance, these test results agreed with those of post-test 1.

Setting the rotor eccentric in test 3 proved a major problem in cross correlating the leakage results. The estimated initial static eccentricity for the smooth rotor was less than 0.15 mm (0.006 in.), and the smooth rotor and the 40-tooth rotor were assumed to be interchangeable at the same spindle loading. However, the rotor rubbed the fence (backing washer) slightly, requiring an initial static eccentricity of 0.36 mm (0.014 in.) and implying a difference in spindle loading. The rotor was reset to an estimated eccentricity of less than 0.025 mm (0.010 in.). Post-test examination indicated that the dynamic eccentricity was <0.10 mm (<0.004 in.).

From the data of Ref. 19 a relation was found for the change in pressure as a function of eccentricity at a fixed volumetric flow rate. Using this relation and corrections for clearance and assuming a pretest static eccentricity of 0.15 mm (0.006 in.) and a post-test static eccentricity of 0.25 mm (0.010 in.) show that the results of test 3 were overcorrected by 20 percent with respect to the results of tests 1 and 2. Future testing requires instrumentation to overcome these positioning errors. Nevertheless, these leakage data indicate that under conditions of severe brush and rotor wear the brush seal leakage increased 30 percent. And, although brush seal performance degraded, the brush seal did not fail.

Figure 13.—Pre- and posttest leakage results for smooth rotor.
