NASA Technical Memorandum 104580

Automated Inspection of Solder Joints for Surface Mount Technology

Robert M. Savage
Hyun Soo Park
Dr. Mark S. Fan

March 1993

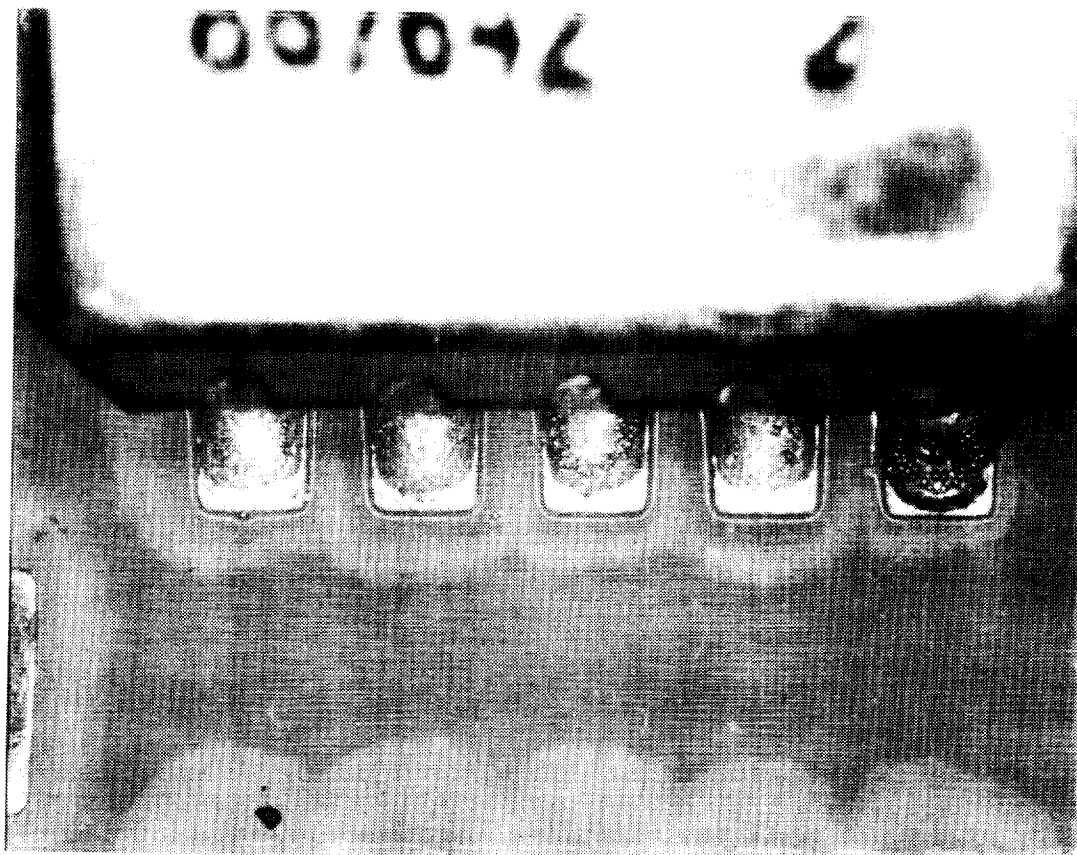
DEVICE TYPE:	20 Pin LCC
DEVICE NUMBER:	U16 - LCC array
PIN NUMBER:	8 thru 12
MAGNIFICATION:	16 X
ACTUAL DEFECT:	Non-wetting on pins 8 thru 12
AIS DEFECT:	No defects detected on pins 8 thru 12
COMMENT:	The automated inspection system failed to detect the presence of non-wetting and solder balls.

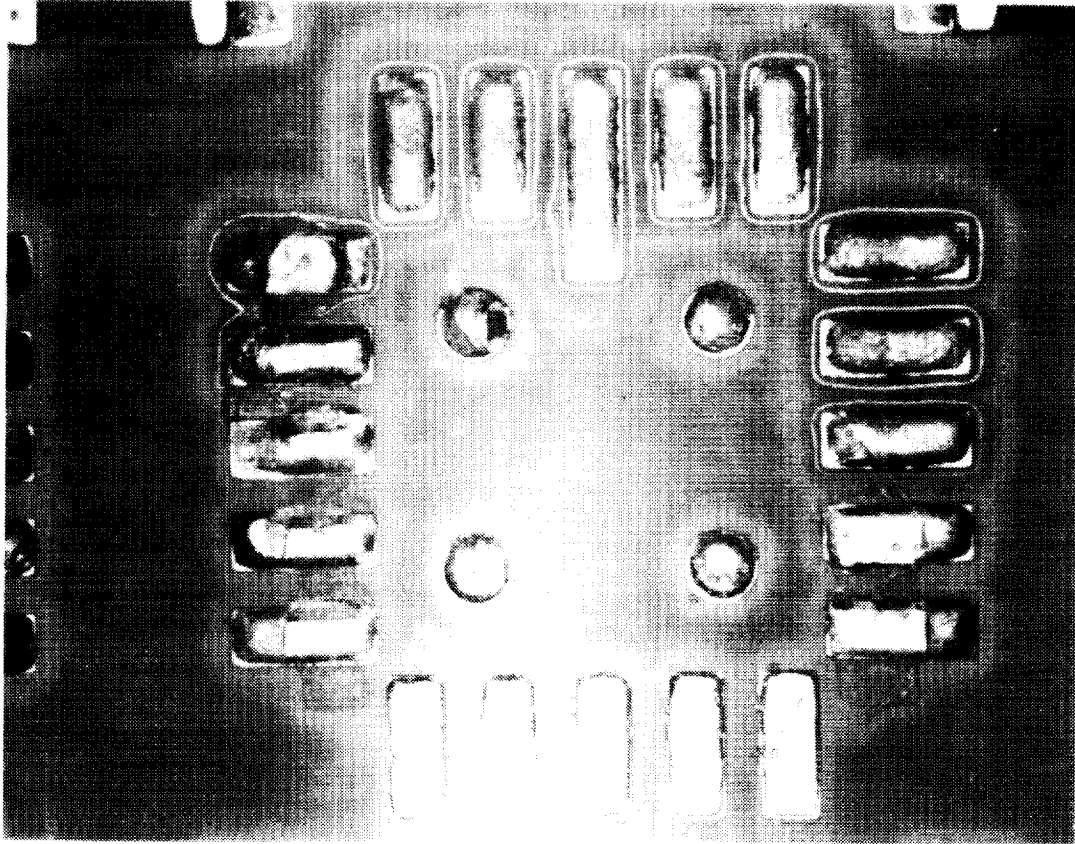
DEVICE TYPE:	20 Pin LCC
DEVICE NUMBER:	U93 - LCC array
PIN NUMBER:	N/A
MAGNIFICATION:	7.5 X
ACTUAL DEFECT:	Missing component
AIS DEFECT:	Numerous
COMMENT:	The AIS machine identified numerous soldering defects when no component was present.

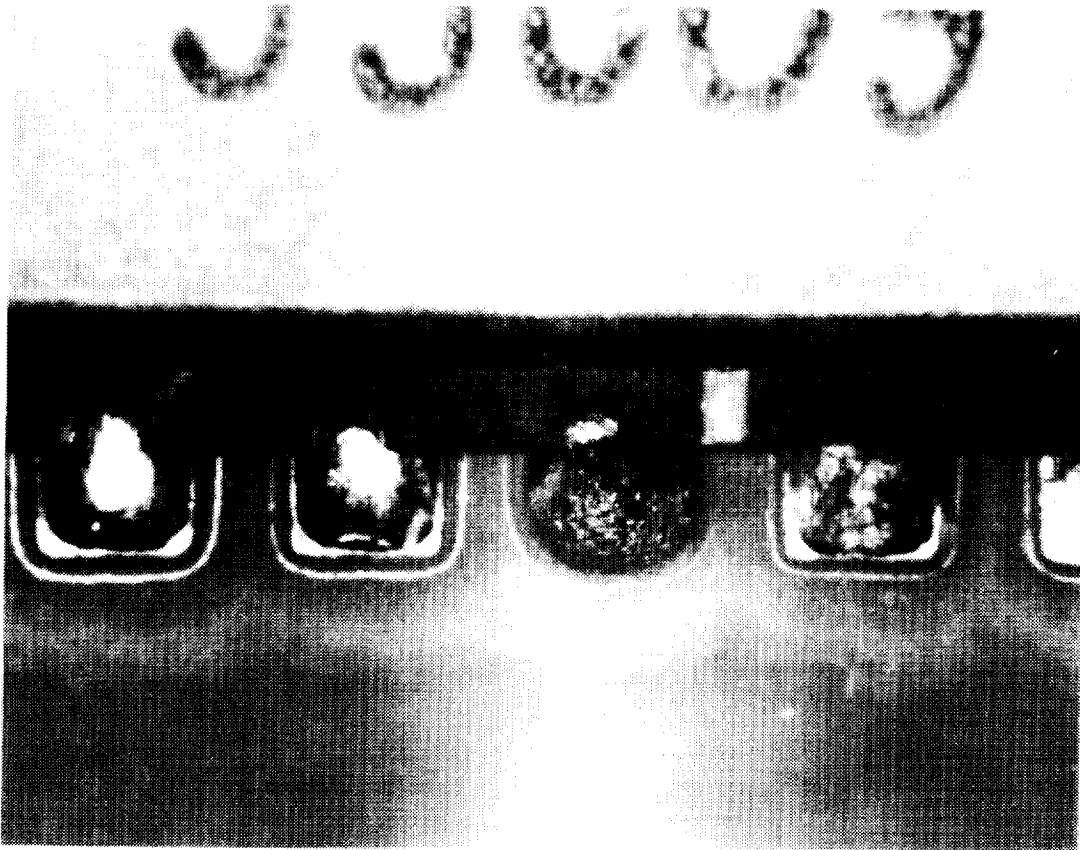
DEVICE TYPE:	20 Pin LCC
DEVICE NUMBER:	U98 - LCC array
PIN NUMBER:	11 and 12
MAGNIFICATION:	20 X
ACTUAL DEFECT:	Excess solder on pin 11, Non-wetting on pin 12
AIS DEFECT:	Excess cast on pin 11
COMMENT:	The AIS machine correctly identified excess solder condition almost every time but failed to identify non-wetting.

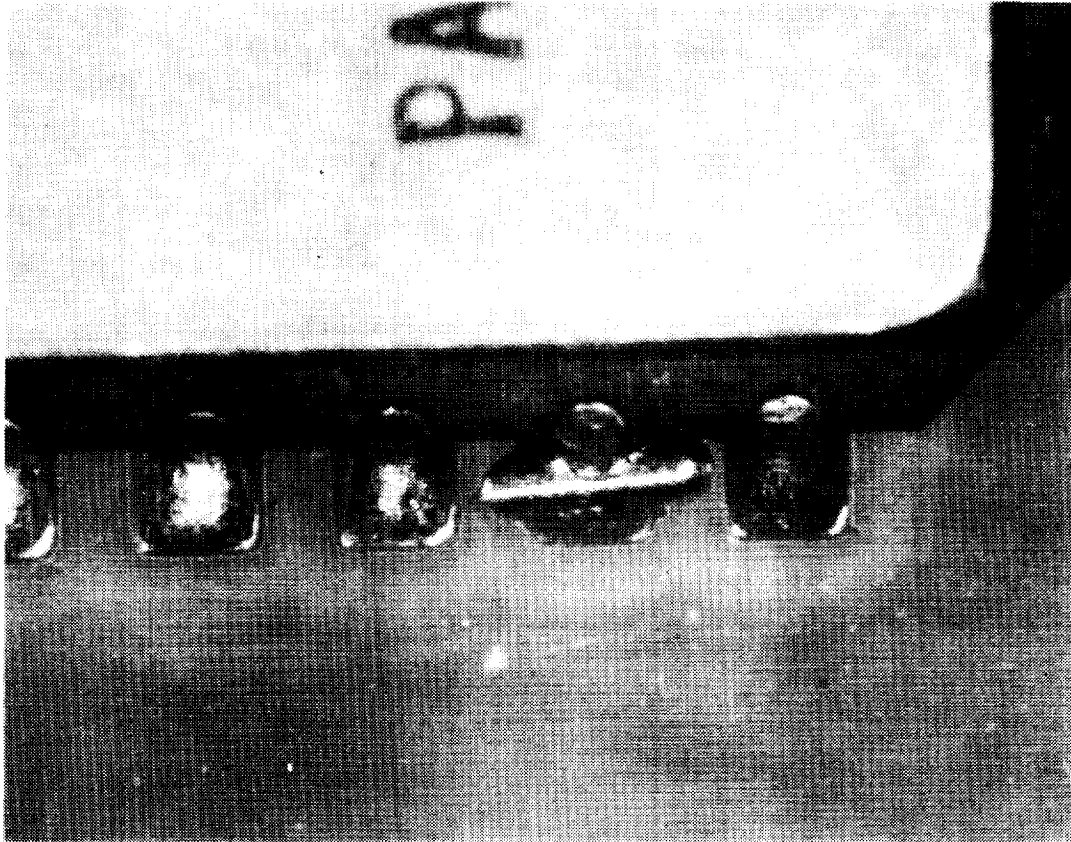
DEVICE TYPE:	20 Pin LCC
DEVICE NUMBER:	U16 - Serial No. 9110-1
PIN NUMBER:	7
MAGNIFICATION:	16 X
ACTUAL DEFECT:	Gold wire in solder joint
AIS DEFECT:	Excess cast
COMMENT:	The AIS could not identify contaminated solder joint.

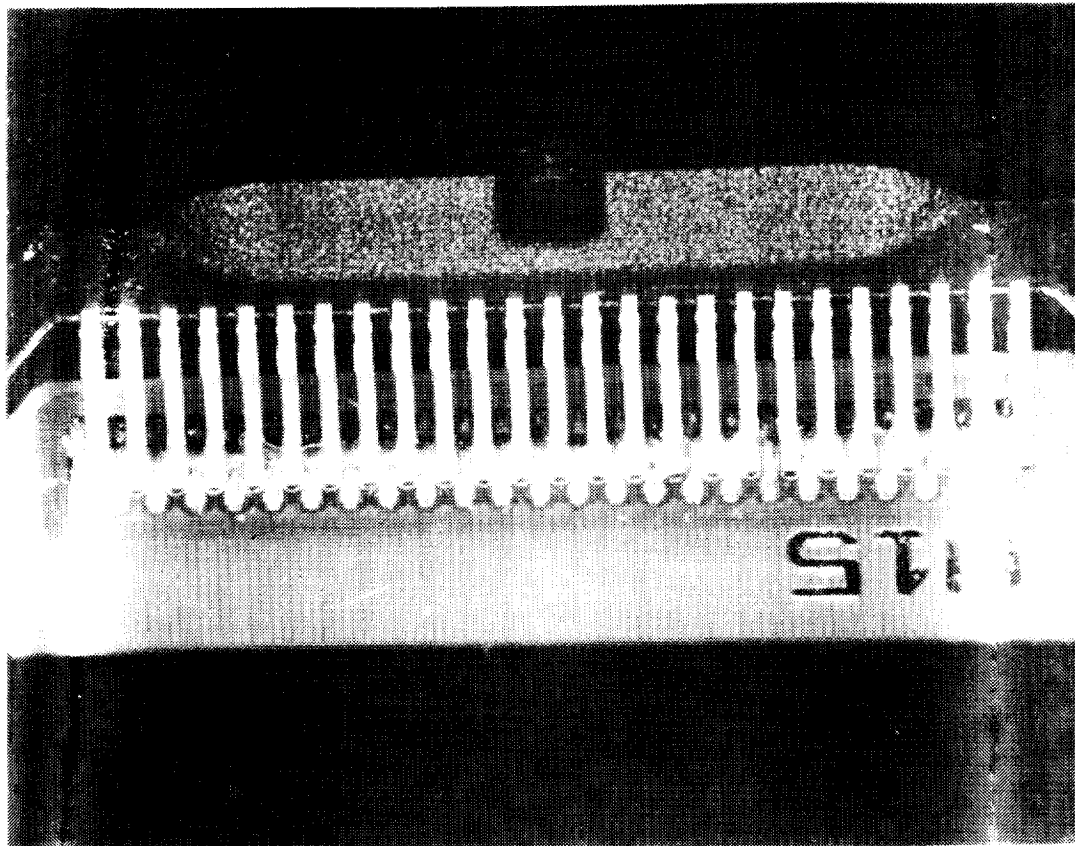
DEVICE TYPE:	100 Pin BQFP
DEVICE NUMBER:	U15 - Serial No. 105
PIN NUMBER:	1 thru 13, 89 thru 105
MAGNIFICATION:	6.3 X
ACTUAL DEFECT:	Misalignment and bridging on almost every pin.
AIS DEFECT:	Various
COMMENT:	The AIS machine incorrectly identified totally lifted lead, it identified some bridging, but not all, and it identified some bridging. The machine did not identify any defects on pin 13 even though it was misaligned and bridged.

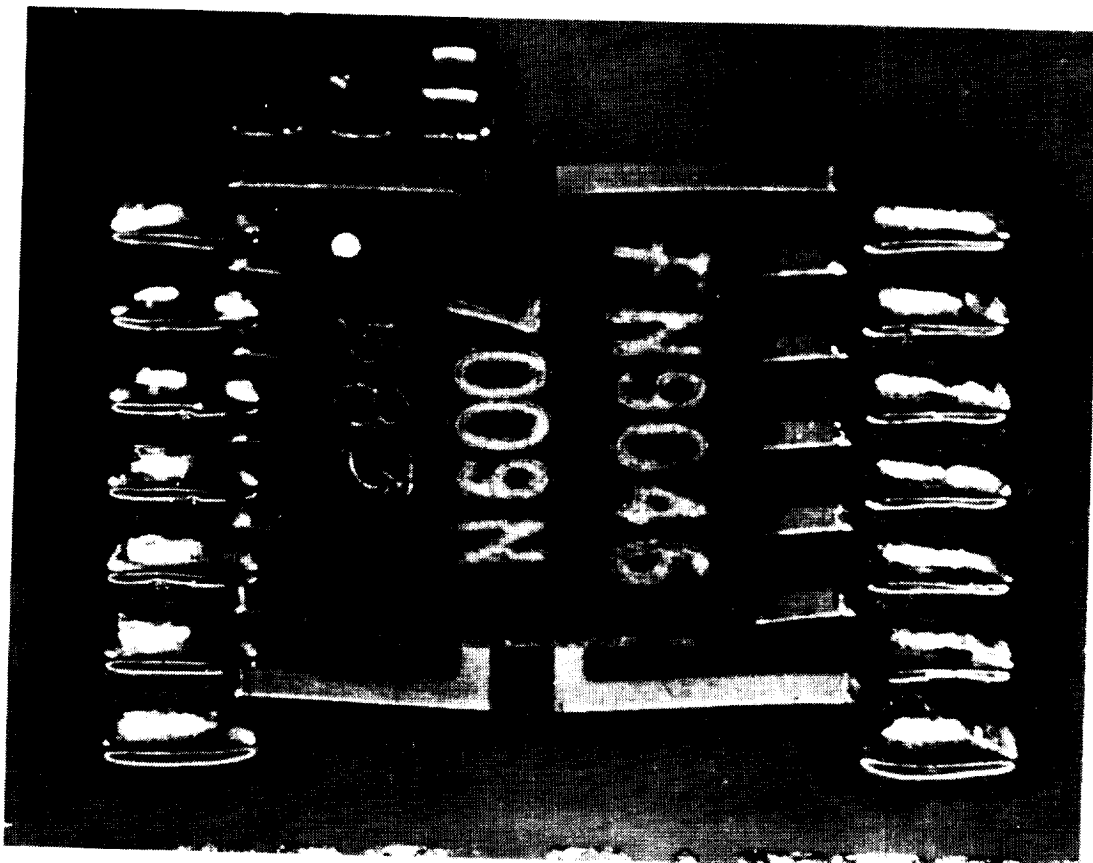
DEVICE TYPE:	14 Pin flat pack
DEVICE NUMBER:	U19 - Serial No. 105
PIN NUMBER:	All
MAGNIFICATION:	7.5X
ACTUAL DEFECT:	Excess solder on all the leads
AIS DEFECT:	Identified almost every lead as totally lifted
COMMENT:	None of the leads on the flat pack were lifted off the pad.

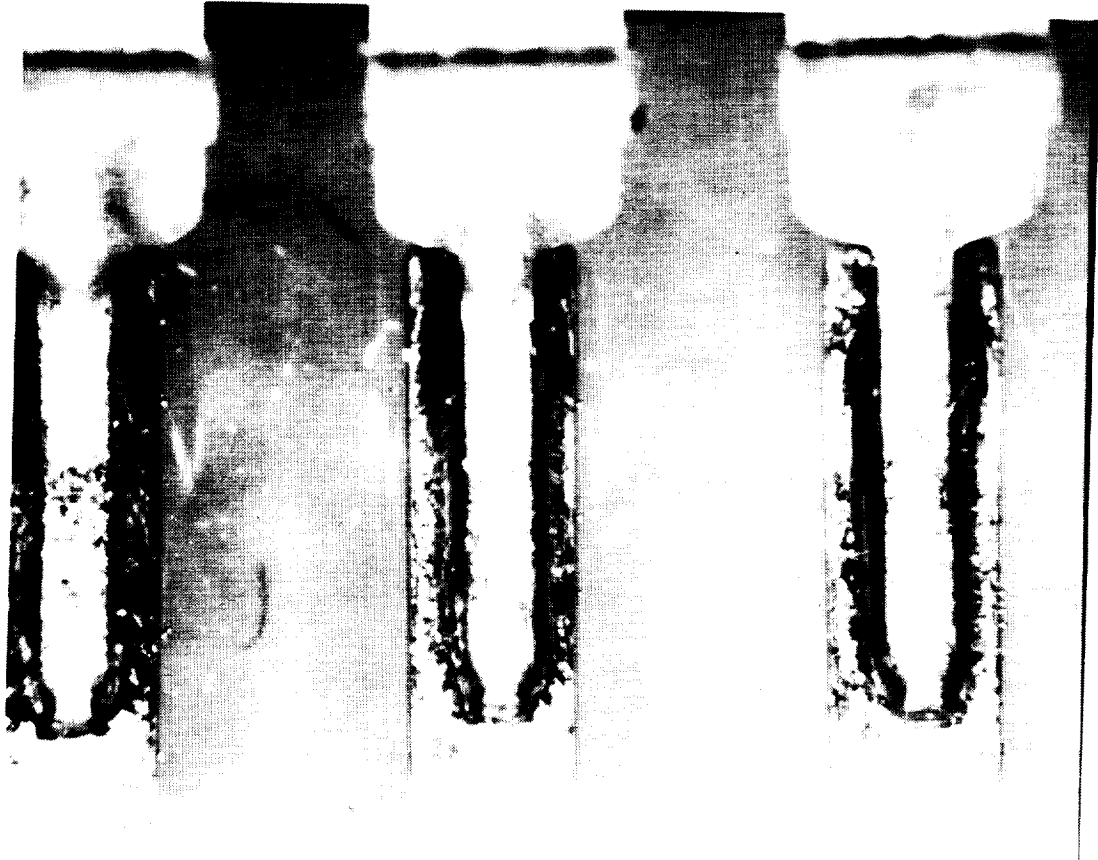
DEVICE TYPE:	20 Pin DIP
DEVICE NUMBER:	U1 - Serial No. 105
PIN NUMBER:	6,7,8
MAGNIFICATION:	17 X
ACTUAL DEFECT:	None
AIS DEFECT:	Misaligned Y and Totally lifted for pins 6,7 and 8.
COMMENT:	The AIS machine incorrectly identified misalignment and lifted leads. The 3 pins in the photo did not have any defects.
