NASA Technical Memorandum TM 107556

Debris/Ice/TPS Assessment And Integrated Photographic Analysis For Shuttle Mission STS-53

DEBRIS/ICE/TPS ASSESSMENT
AND
PHOTOGRAPHIC ANALYSIS
OF
SHUTTLE MISSION STS-53

December 2, 1992

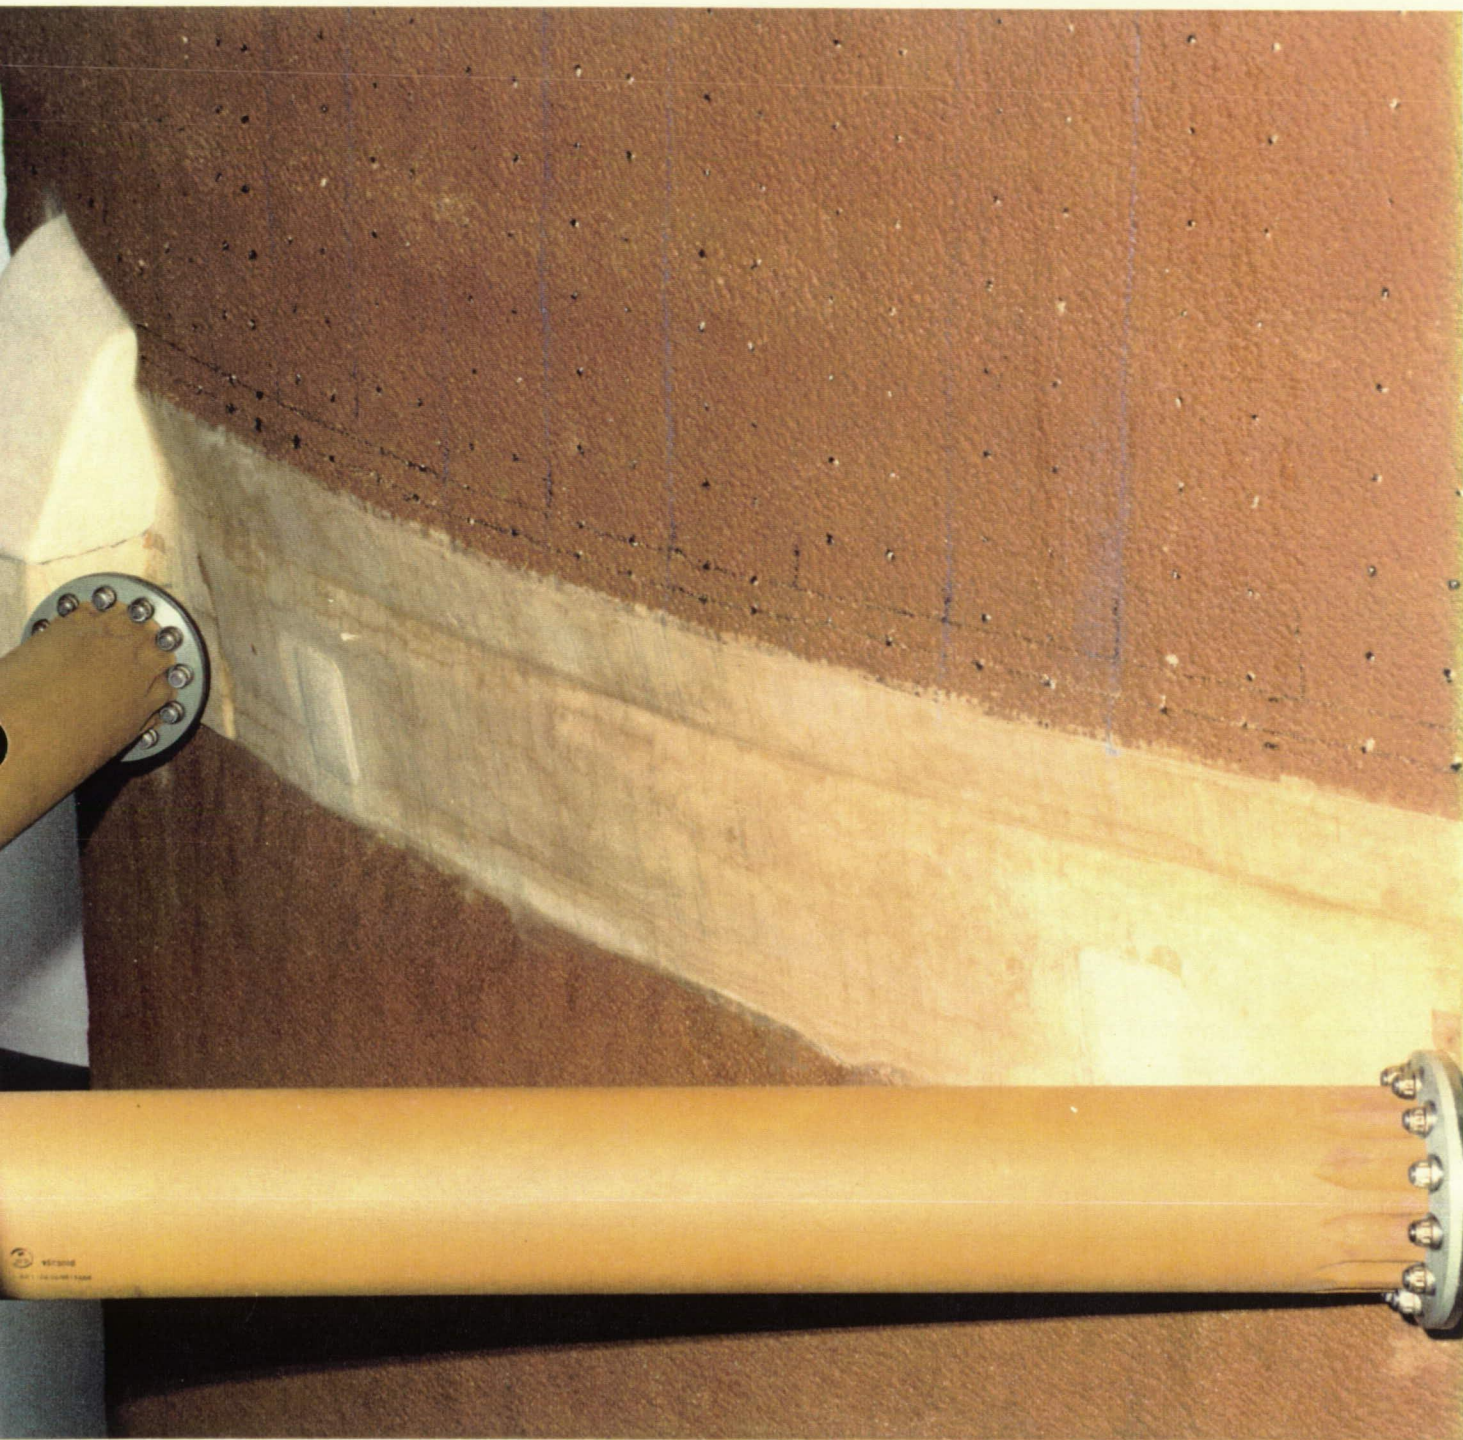
Pre-flight configuration of the bipod jack pad closeouts, the intertank TPS acreage, and the LH2 tank flange closeout.

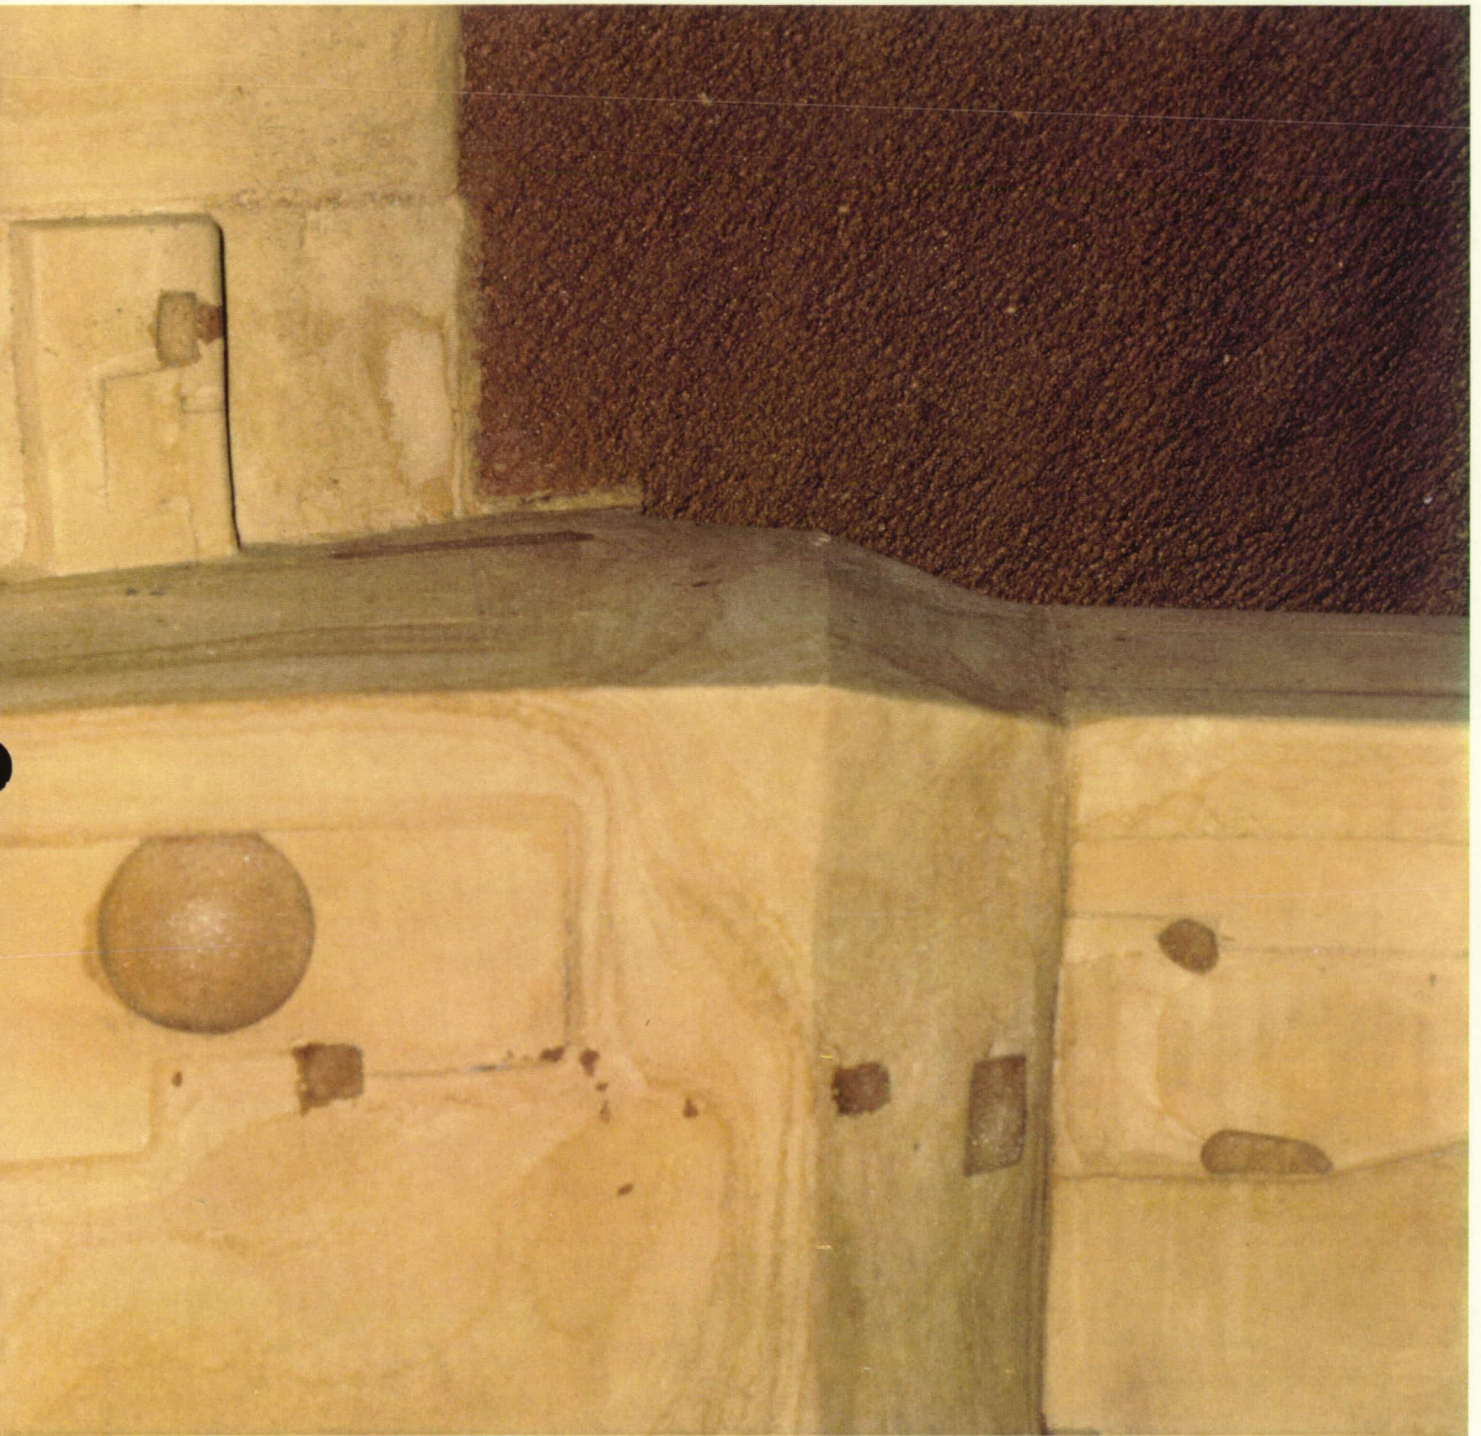
LH (-Y) vertical strut/cable tray TPS forward surface prior to cryogenic fuel loading. Cracks have appeared in this general area after cryoload due to the elimination of a stress relief gap as part of a manufacturing process enhancement change.

A crack that extended 2/3 the width of the -Y vertical strut cable tray was present in the forward surface TPS near the longeron closeout interface. Although jagged in appearance, the crack exhibited no offset and was not filled with ice or frost. The appearance of the crack was expected due to the elimination of the stress relief gap at the factory.

Anomaly 001 documented a crack in the forward surface TPS covering of the -Y vertical strut cable tray at the intersection to the ET/SRB cable tray transition fairing. The crack exhibited no offset and was not filled with ice or frost. The condition was acceptable for launch per NSTS-08303 and CR S041254C.

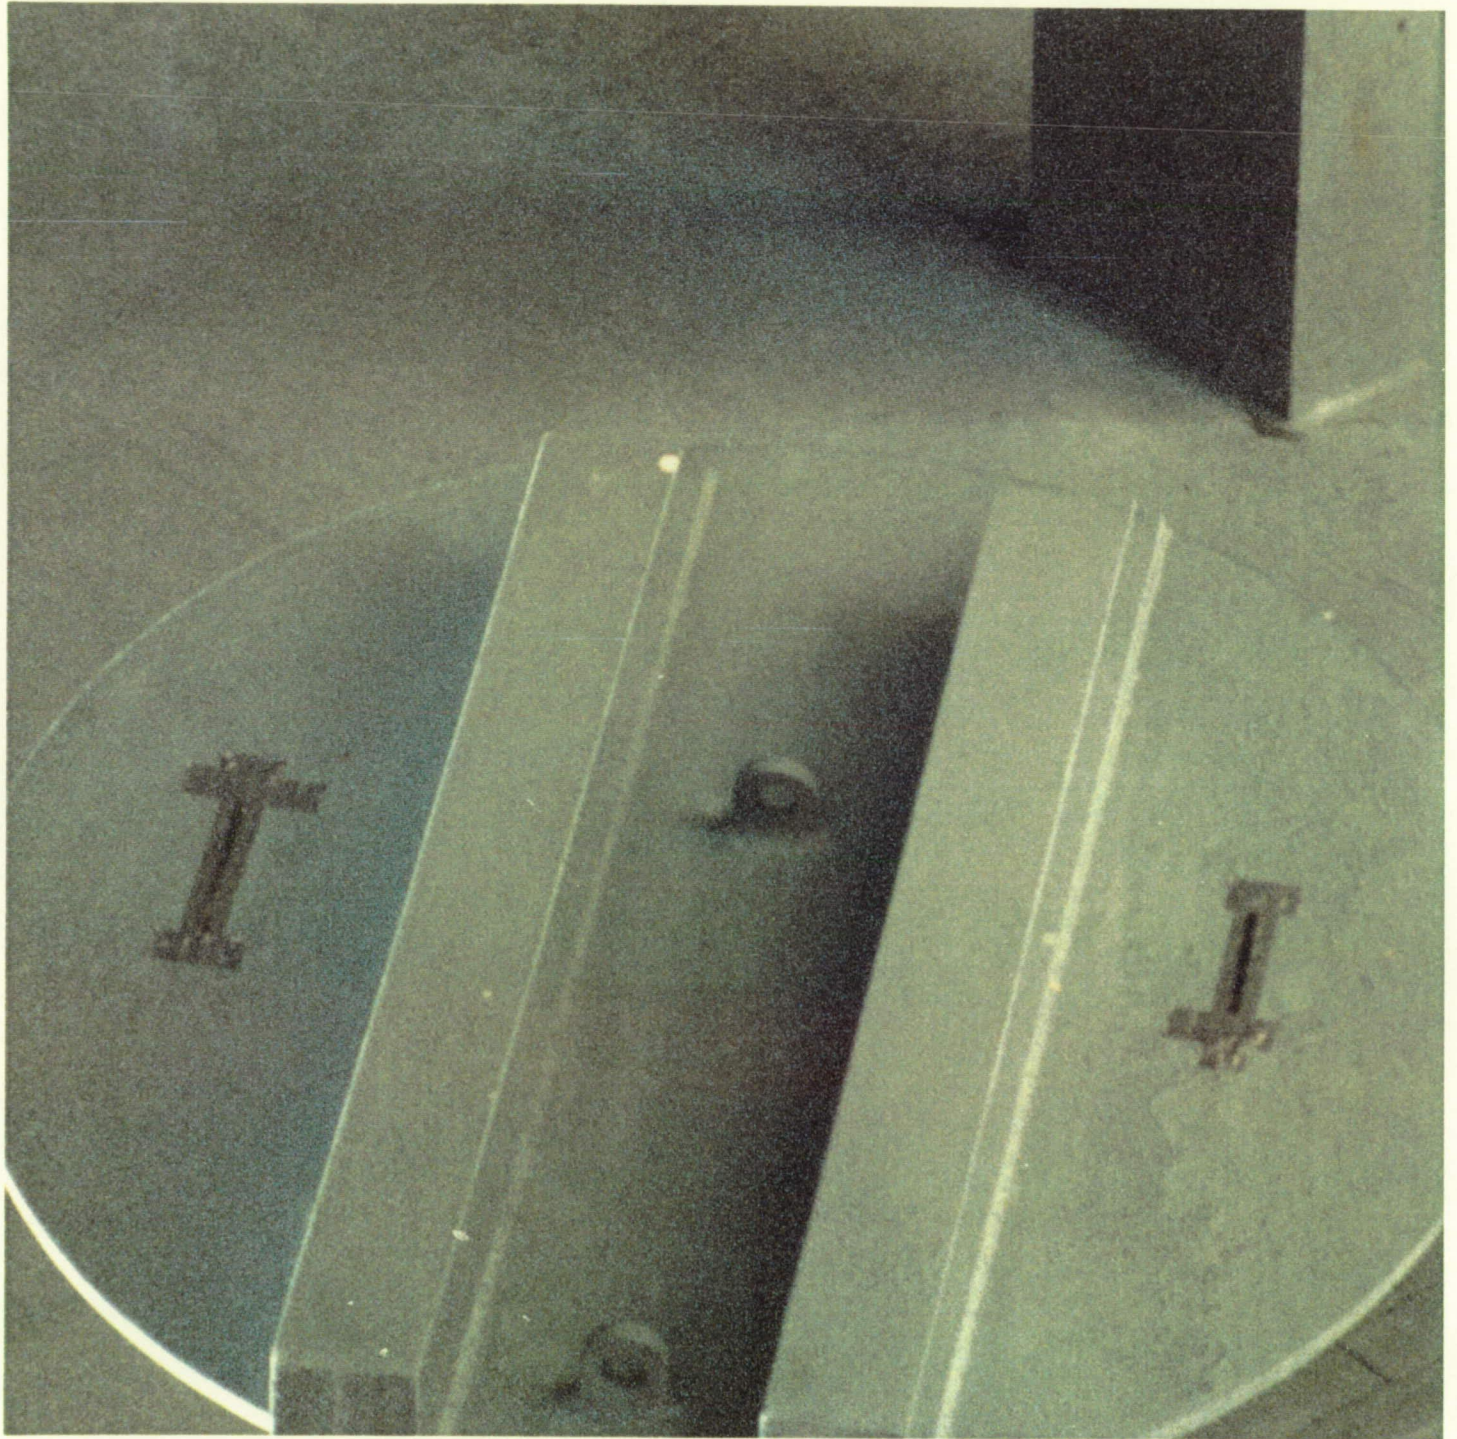
Flat, foil-like, particulate collectors had been taped to the top of each rainbird water deflector as part of an SRB plume study. The foil/tape was not a debris threat to the vehicle.

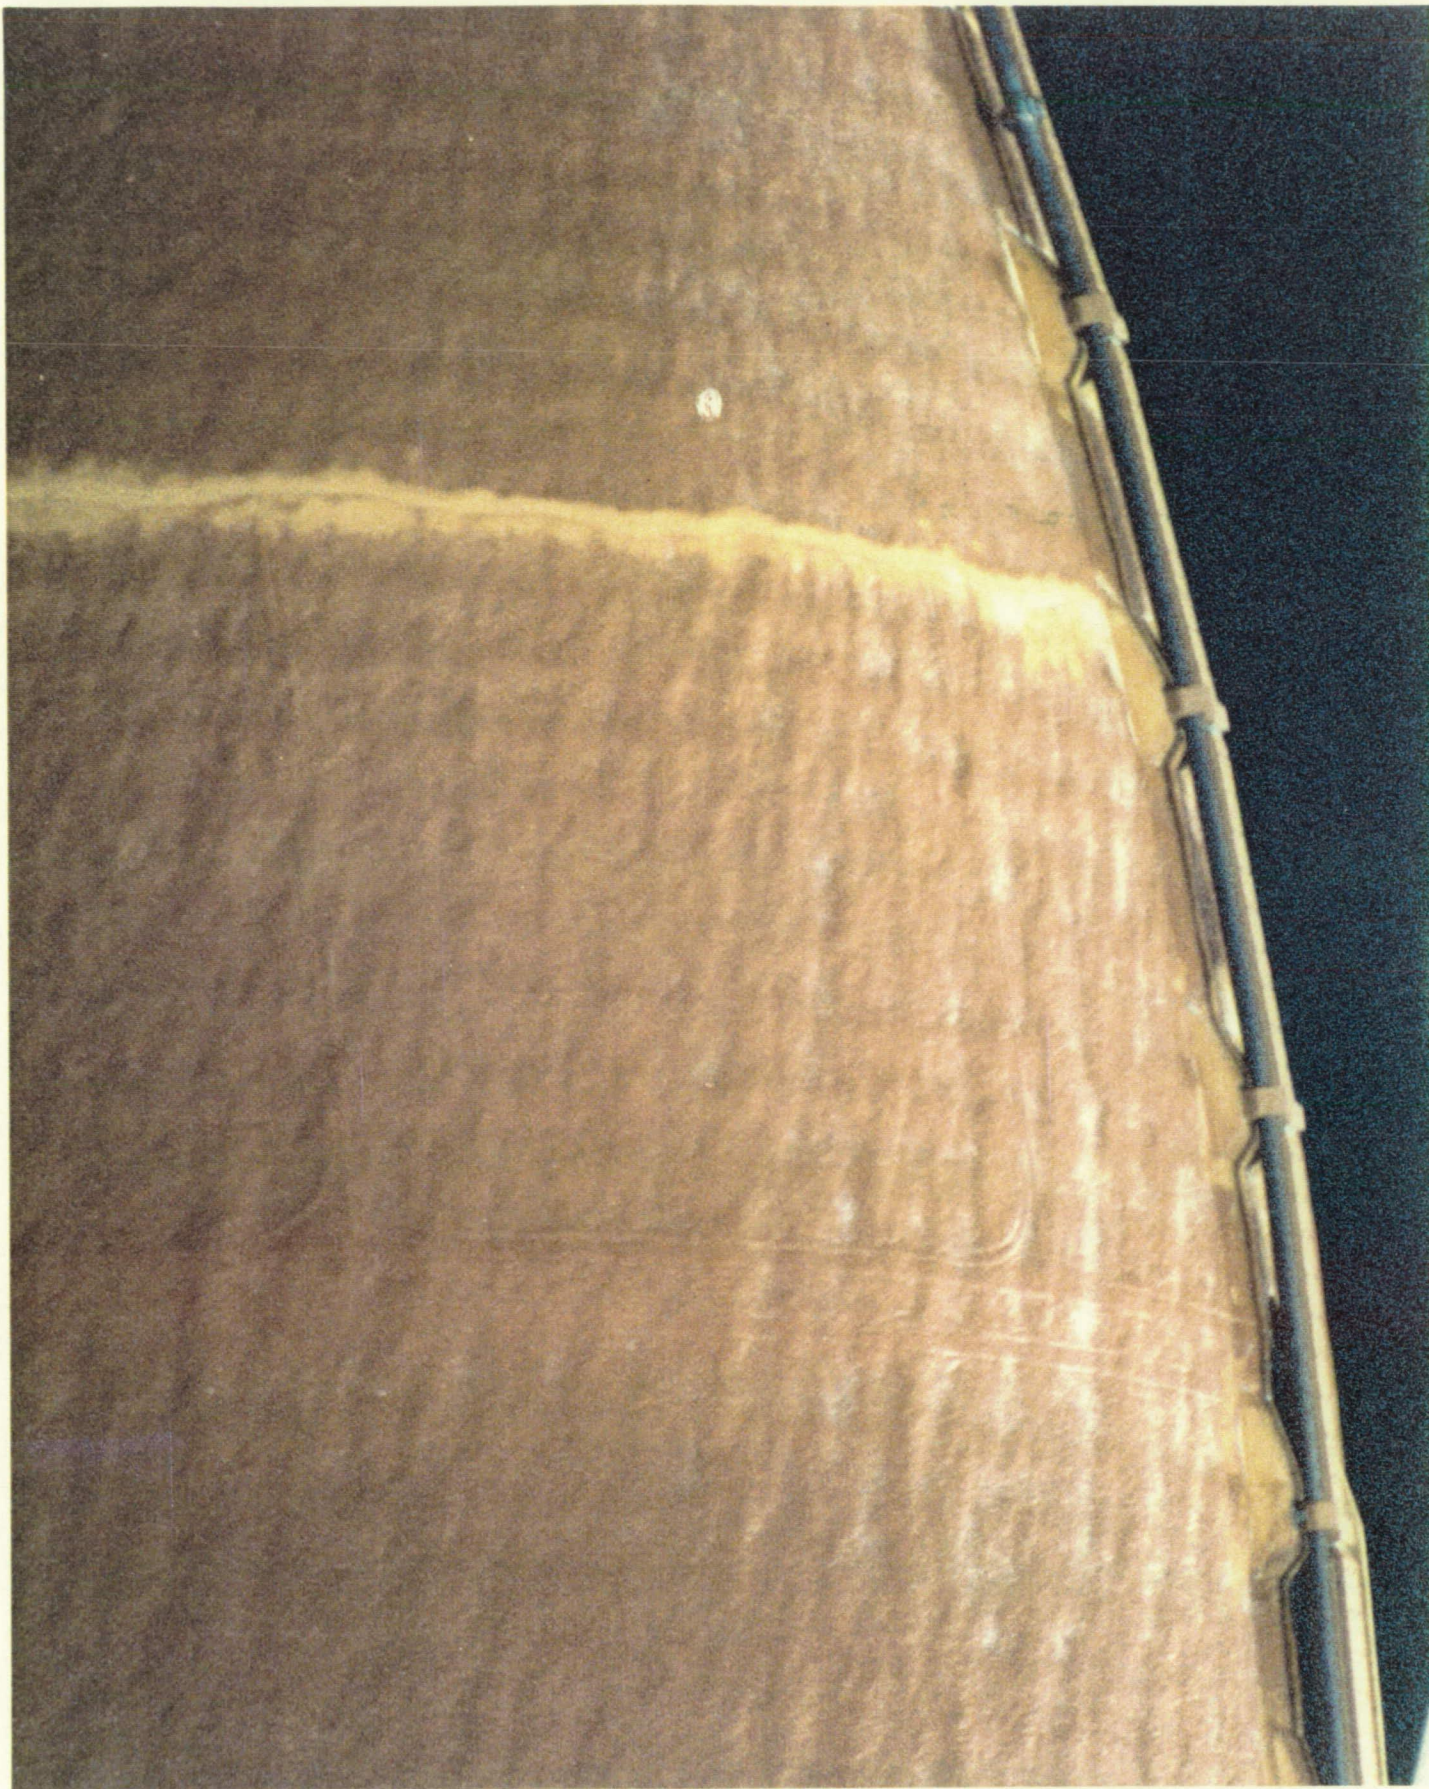
At the time of the Ice Inspection, condensate on the LO2 tank barrel section +Y+Z quadrant was freezing and changing to ice with a frost covering. Visually, the ice thickness appeared to exceed the 1/16 inch allowed in the LCC. There was no ice or frost in the "no ice" region. There were no TPS anomalies. The tumble valve cover was intact. The pressurization line and support ramps were in nominal configuration. SURFICE predicted temperatures of 33 degrees F on the ogive and 30 degrees F on the barrel.

Anomaly 002 recorded ice accumulation on the +Y+Z quadrant acreage of both LO2 and LH2 tanks. Ice Team observations determined the ice thickness exceeded 0.0625 inches, which was an LCC violation. Launch was delayed until ambient warming melted the ice/frost formations. A second on-pad visual inspection at 0730 hours revealed ice/frost conditions were acceptable for launch.

At the time of the Ice Inspection, condensate on the LO2 tank barrel section +Y+Z quadrant was freezing and changing to ice with a frost covering. The ice thickness exceeded the 1/16 inch allowed in the LCC.

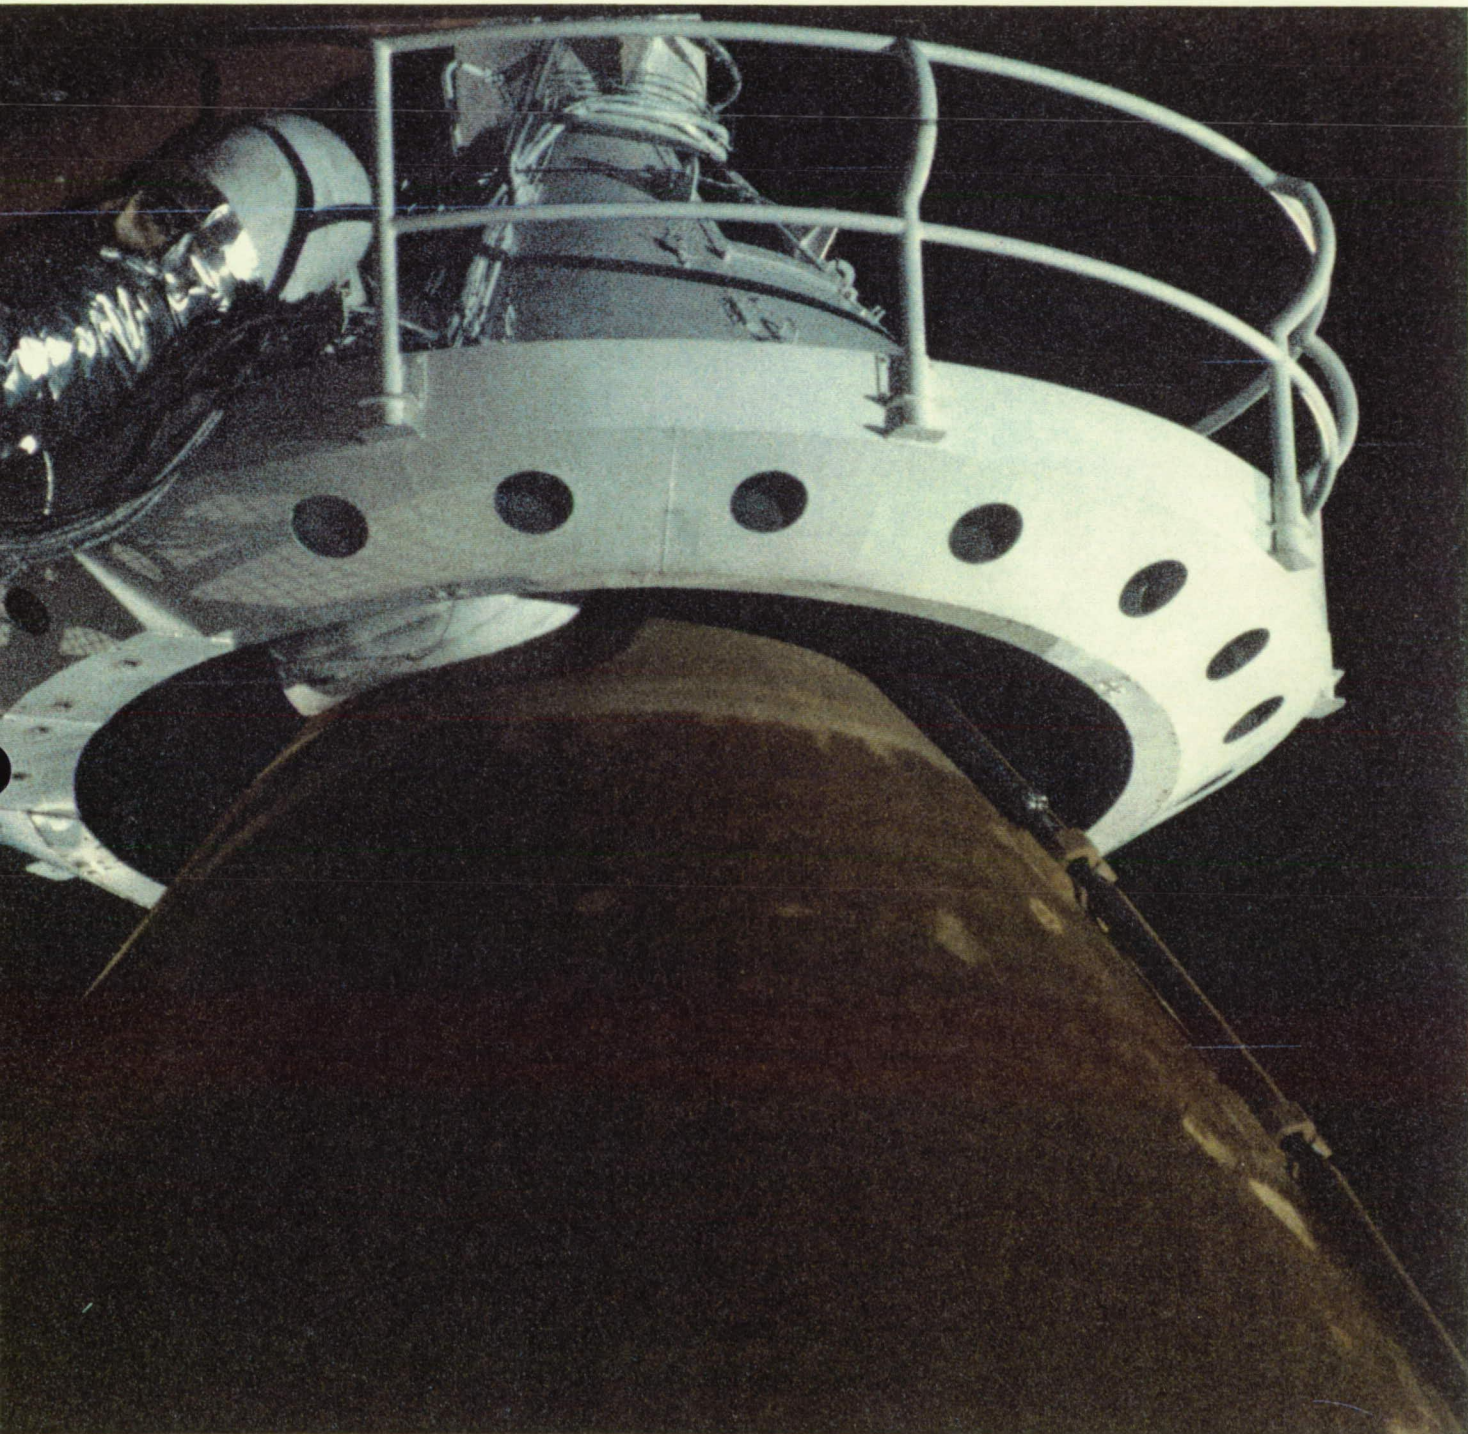
The thicker TPS on the LO2 tank ogive prevented ice or frost from forming in the "no ice" region. There were no anomalies on the LO2 tank TPS.

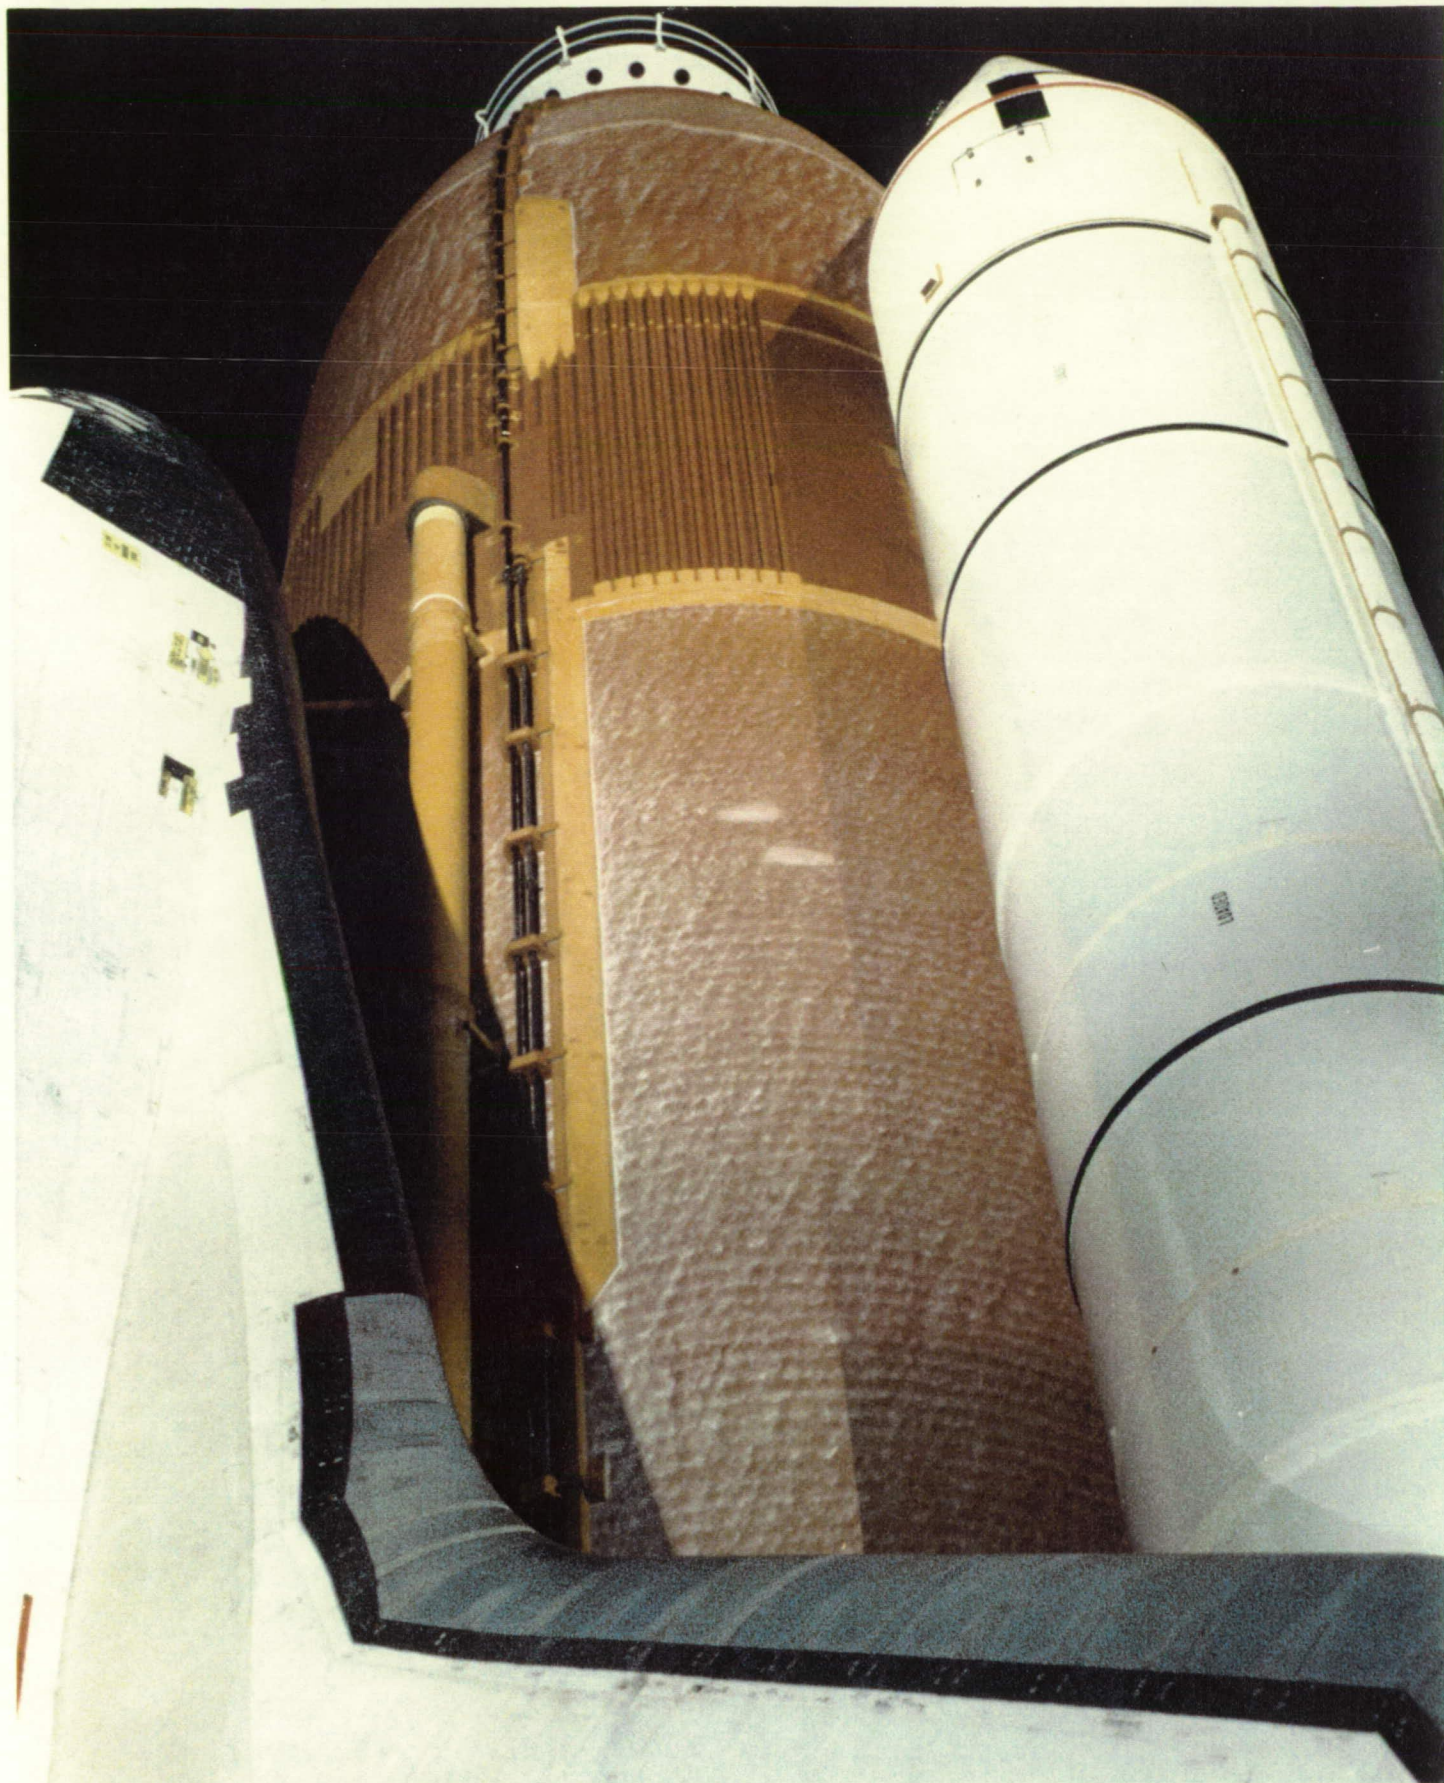
There were no LH2 tank TPS acreage anomalies. At the time of the Ice Inspection, condensate on the LH2 tank +Y+Z quadrant was freezing and changing to ice with a frost covering. Visually, the ice thickness appeared to exceed the 1/16 inch allowed in the LCC. Two sanded areas at XT-1250 and XT-1500 had a heavier coating of ice/frost due to the somewhat thinner TPS. Early in the inspection, the portable STI measured surface temperatures as low as 32 degrees F on the upper LH2 tank and 24 degrees F on the lower LH2 tank. SURFICE predicted temperatures of 25 degrees F on the upper LH2 tank and 32 degrees F on the lower LH2 tank.

At the time of the Ice Inspection, condensate on the LH2 tank +Y+Z quadrant was freezing and changing to ice with a frost covering. The ice thickness exceeded the 1/16-inch allowed in the LCC.

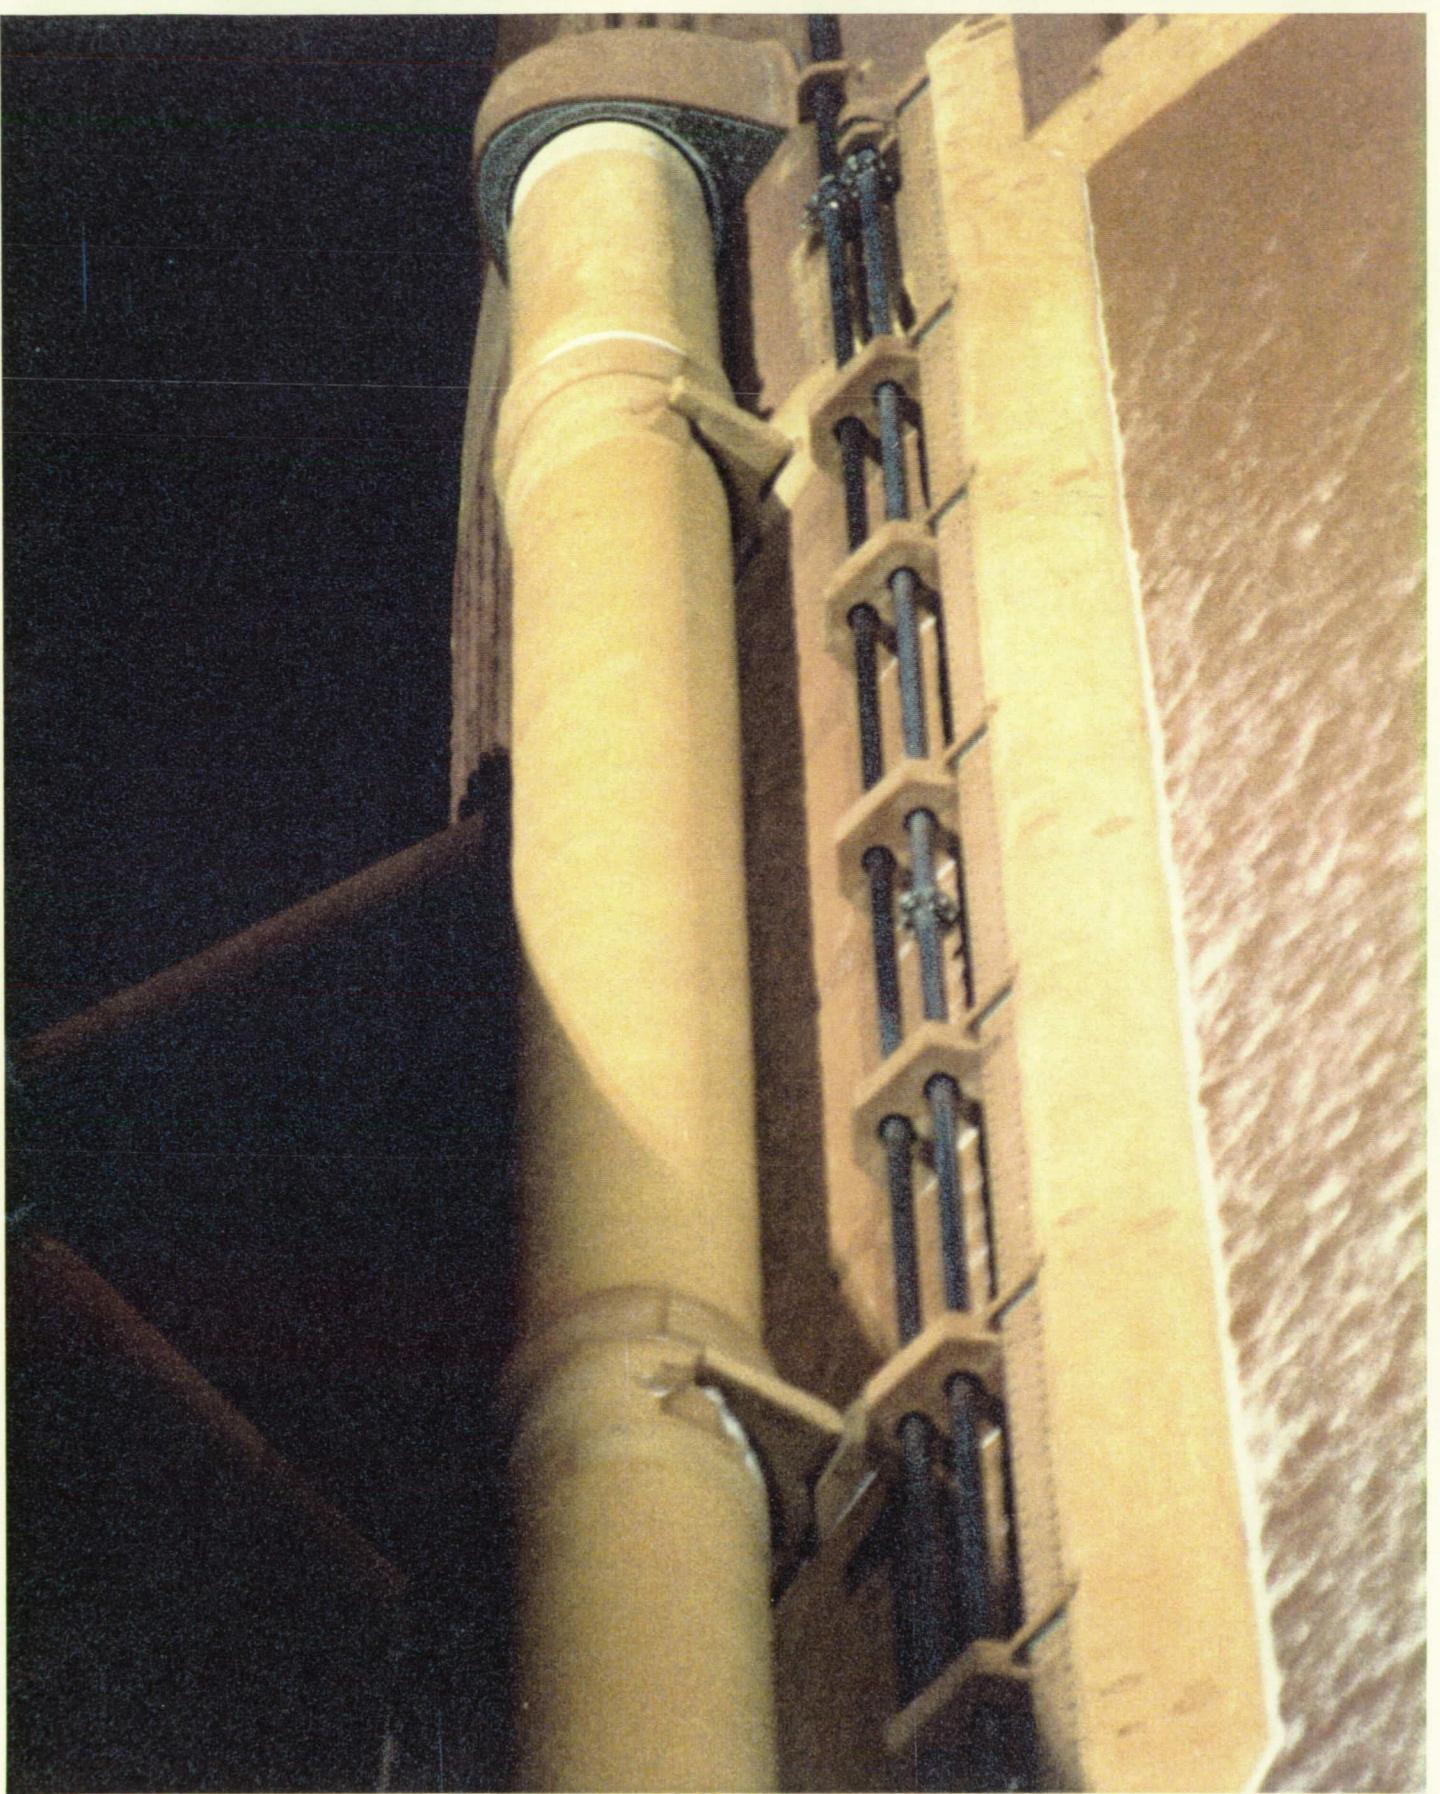
Ice/frost formed along the bondlines of the PAL ramp and some of the pressurization line/cable tray ramps. Ice/frost was also present in the L02 feedline upper bellows and support brackets.

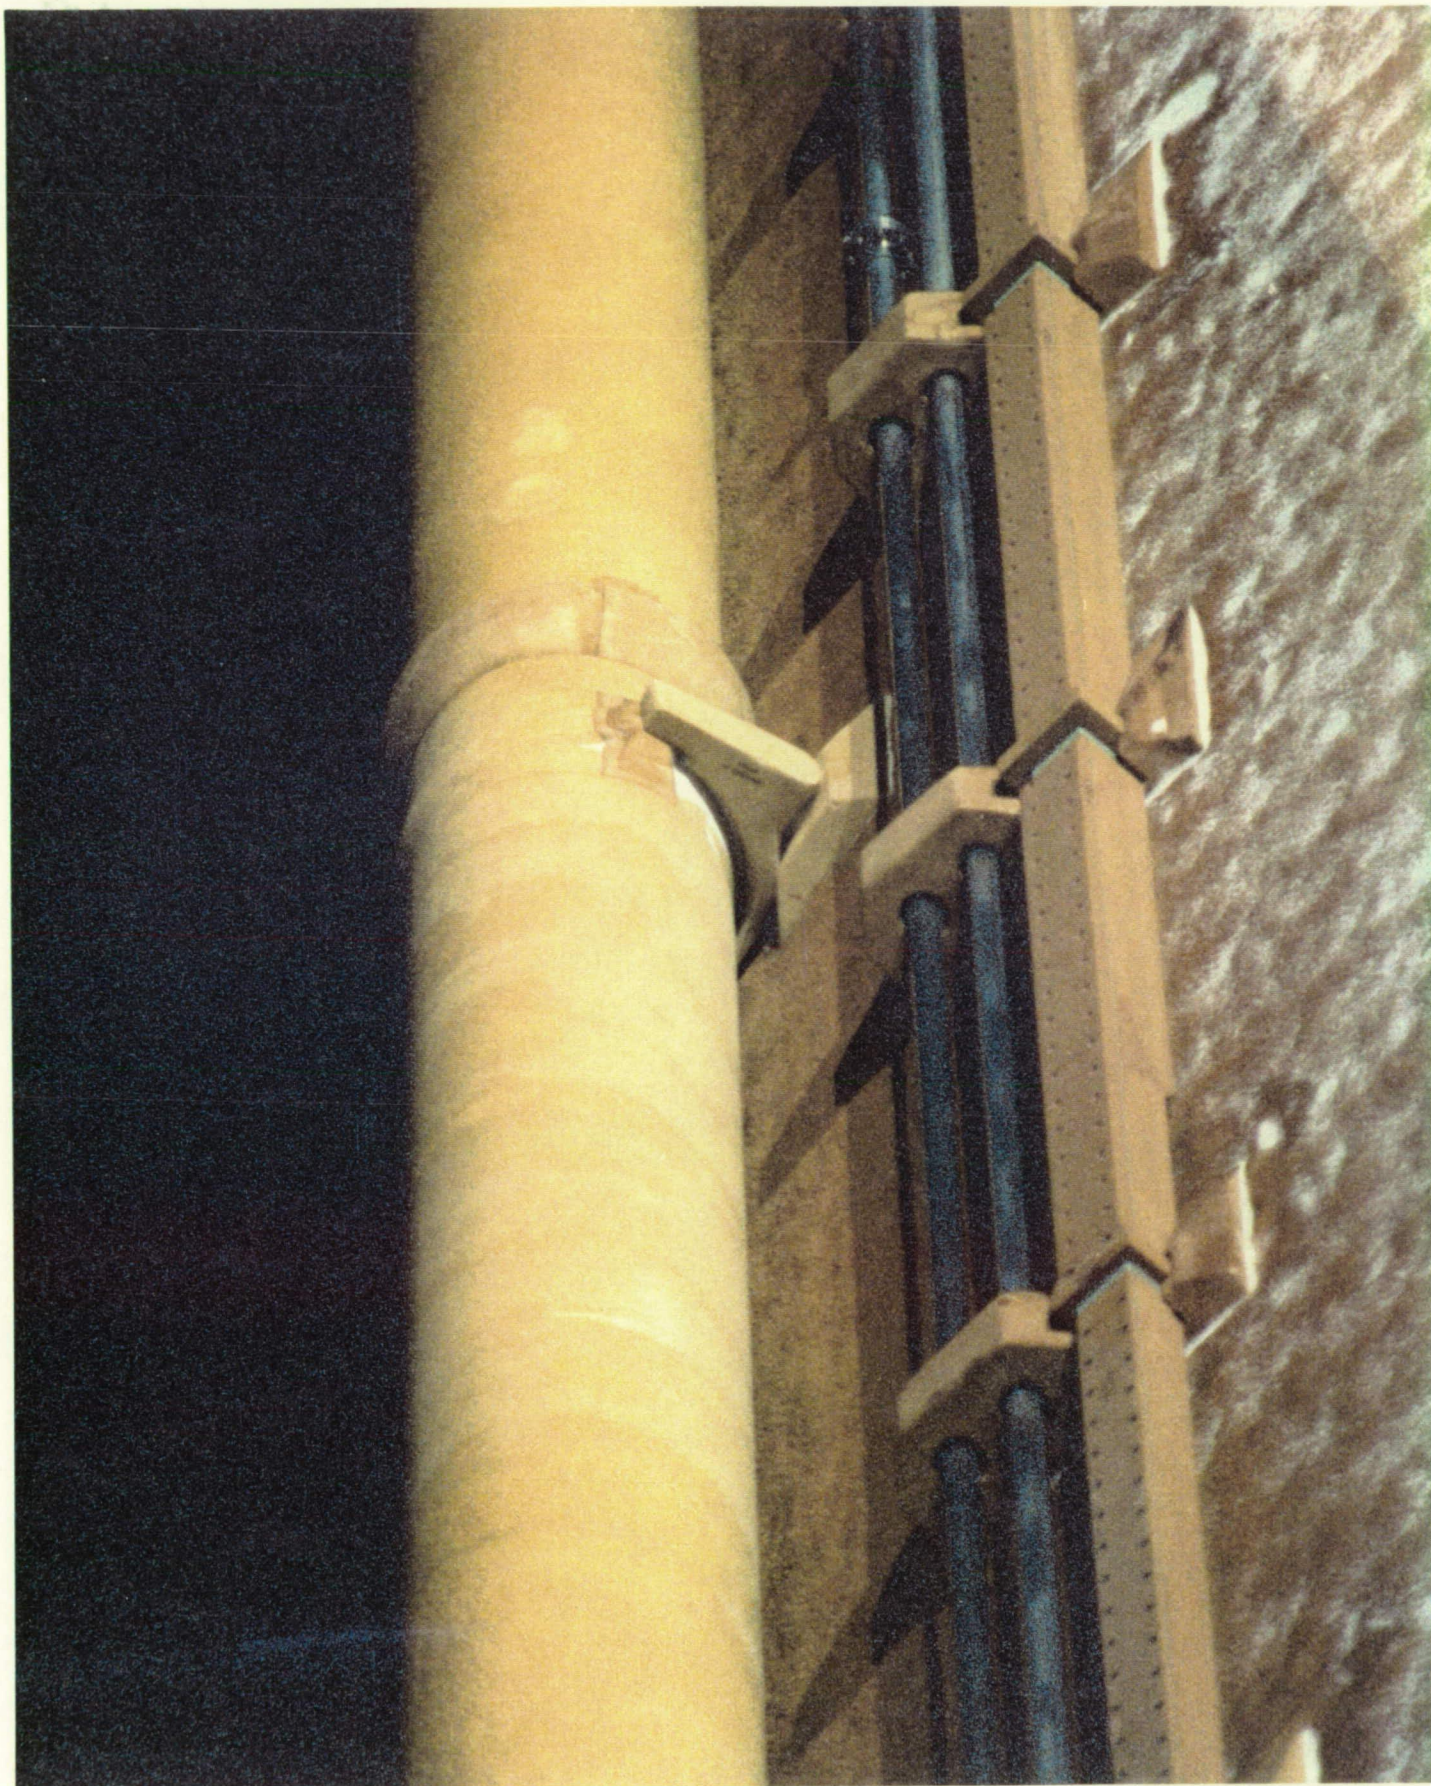
Ice/frost had formed on the LH2 tank acreage, in the L02 feed line support brackets, and along the cable tray ramps

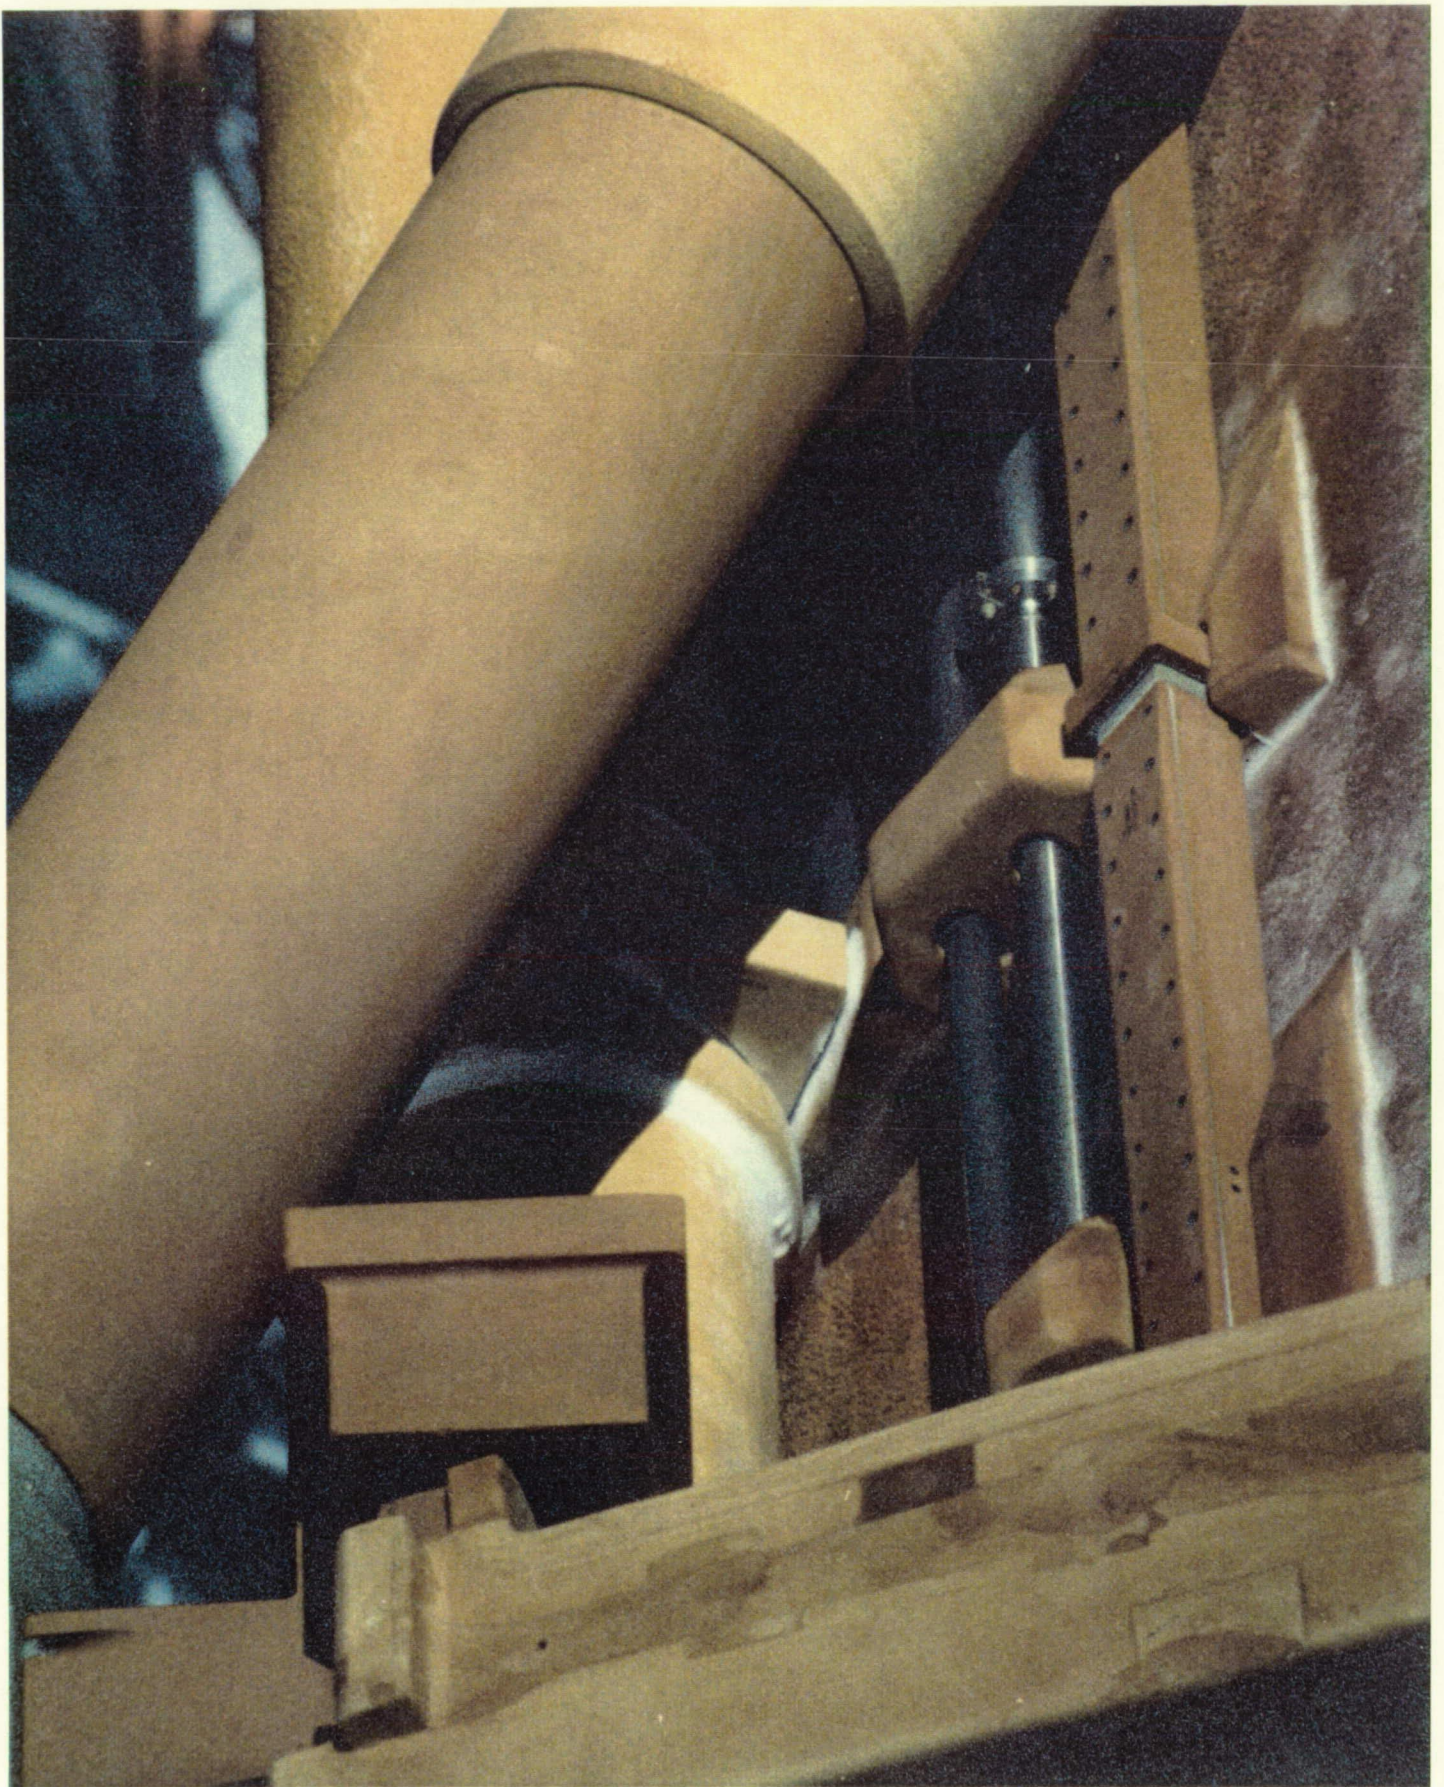
Ice/frost had formed on the lower LH2 tank TPS acreage, in the L02 feedline lower bellows and support brackets, and on some of the L02 feedline acreage areas.
