NASA Technical Memorandum TM 107556

Debris/Ice/TPS Assessment And Integrated Photographic Analysis For Shuttle Mission STS-53

DEBRIS/ICE/TPS ASSESSMENT
AND
PHOTOGRAPHIC ANALYSIS
OF
SHUTTLE MISSION STS-53

December 2, 1992

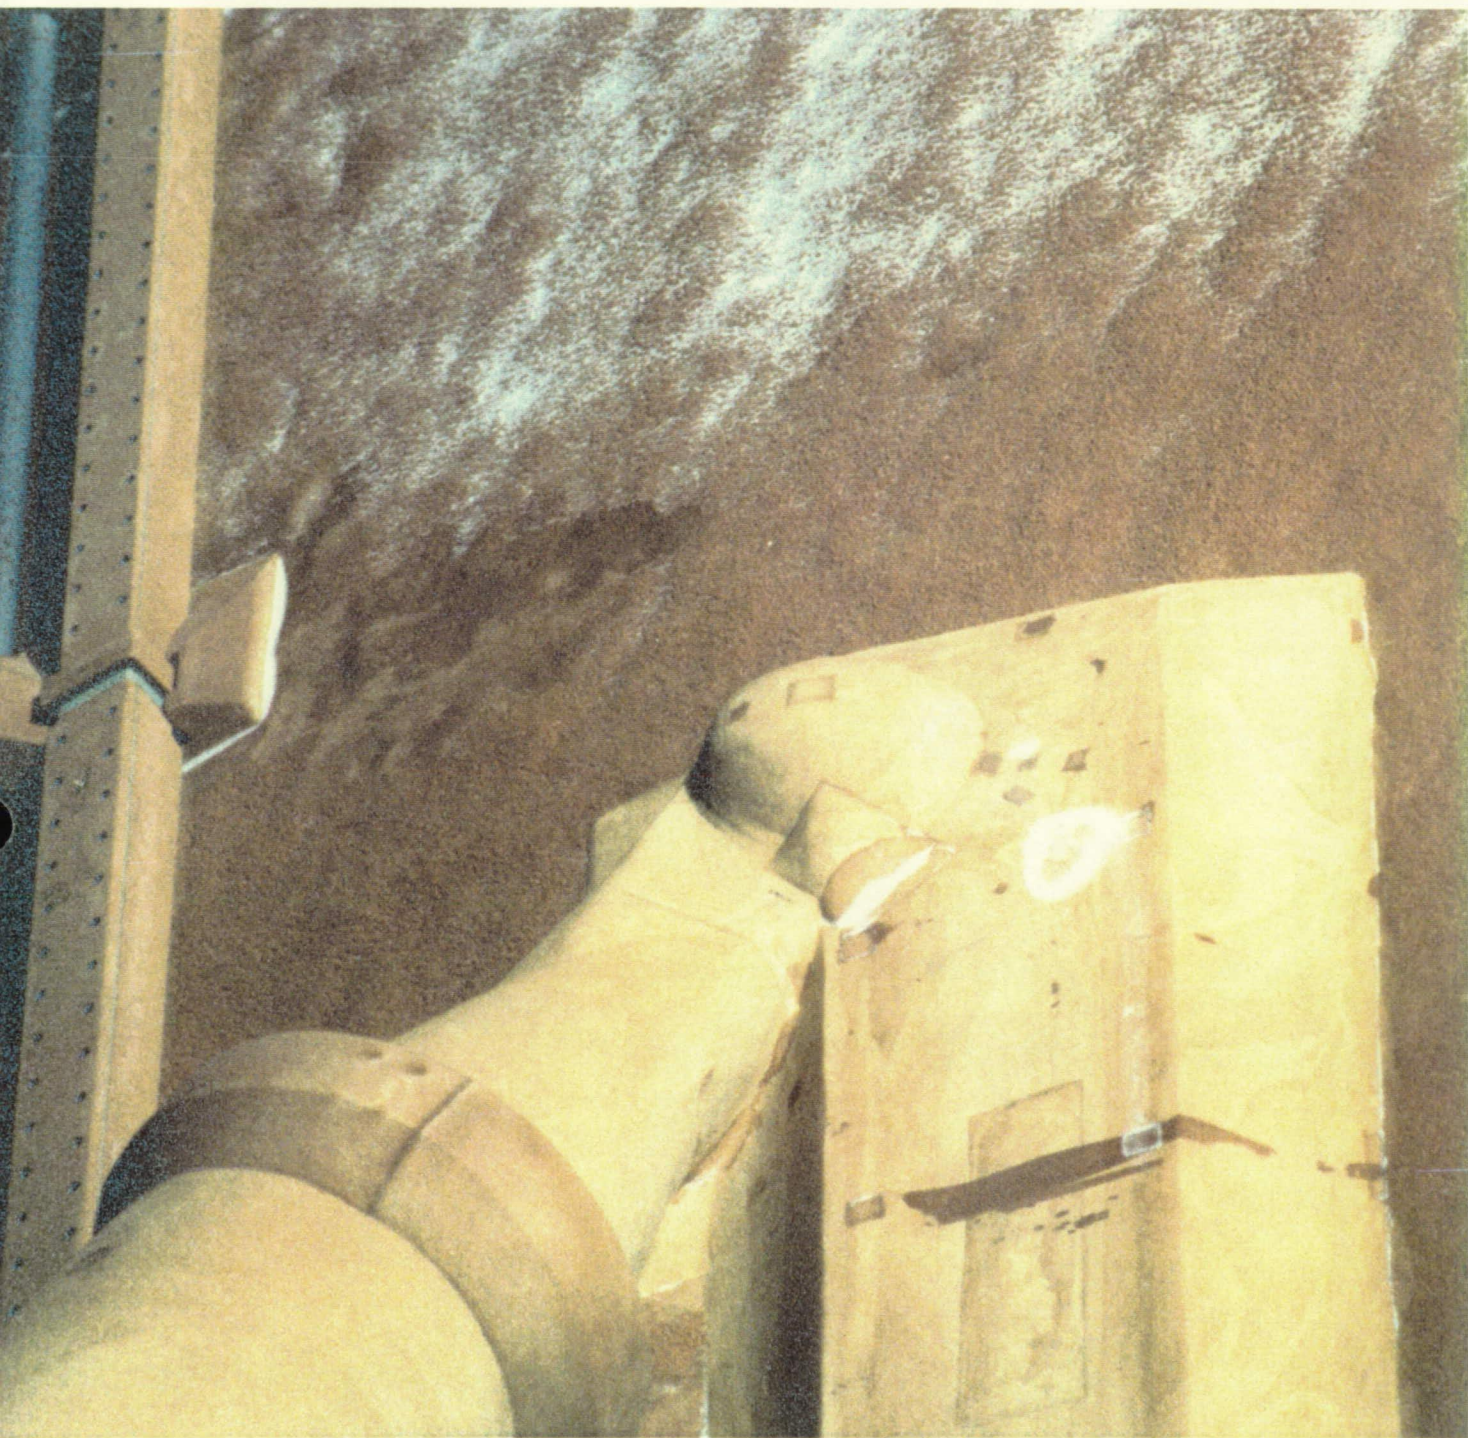
Ice/frost had formed on the lower LH2 tank TPS acreage and along the cable tray ramp bondline closeouts. An ice/frost formation on the +Y longeron closeout was emitting vapors, but exhibited no offset.

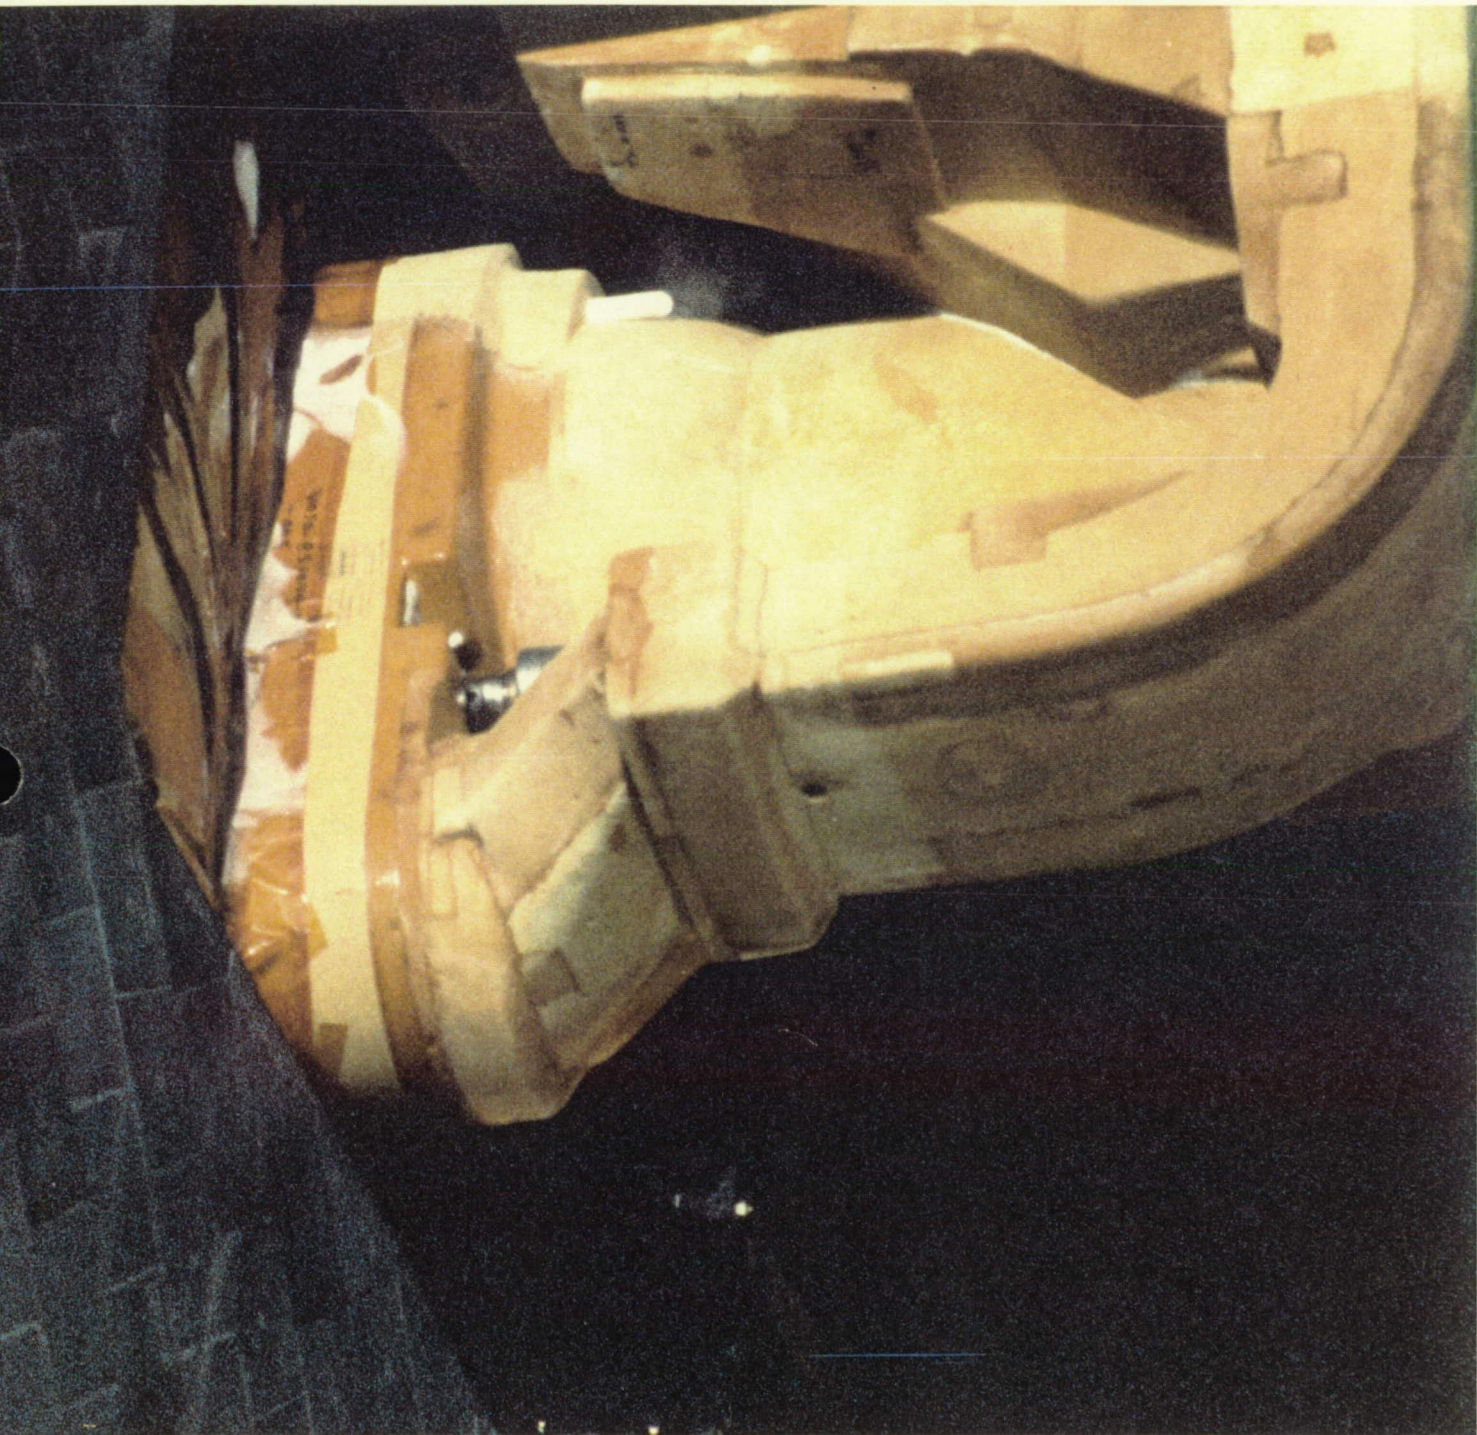
There were no TPS anomalies on the L02 ET/ORB umbilical. The purge barrier (baggie) was configured properly and was holding positive purge pressure. There were light accumulations of ice/frost on the acreage areas of the umbilical. Formation of ice/frost on the separation bolt pyrotechnic canister purge vents was typical. Normal venting of nitrogen purge gas had occurred during tanking, stable replenish, and launch.

There were no TPS anomalies on the LO2 ET/ORB umbilical. There were light accumulations of ice/frost on the TPS acreage areas and on the purge barrier (baggie).

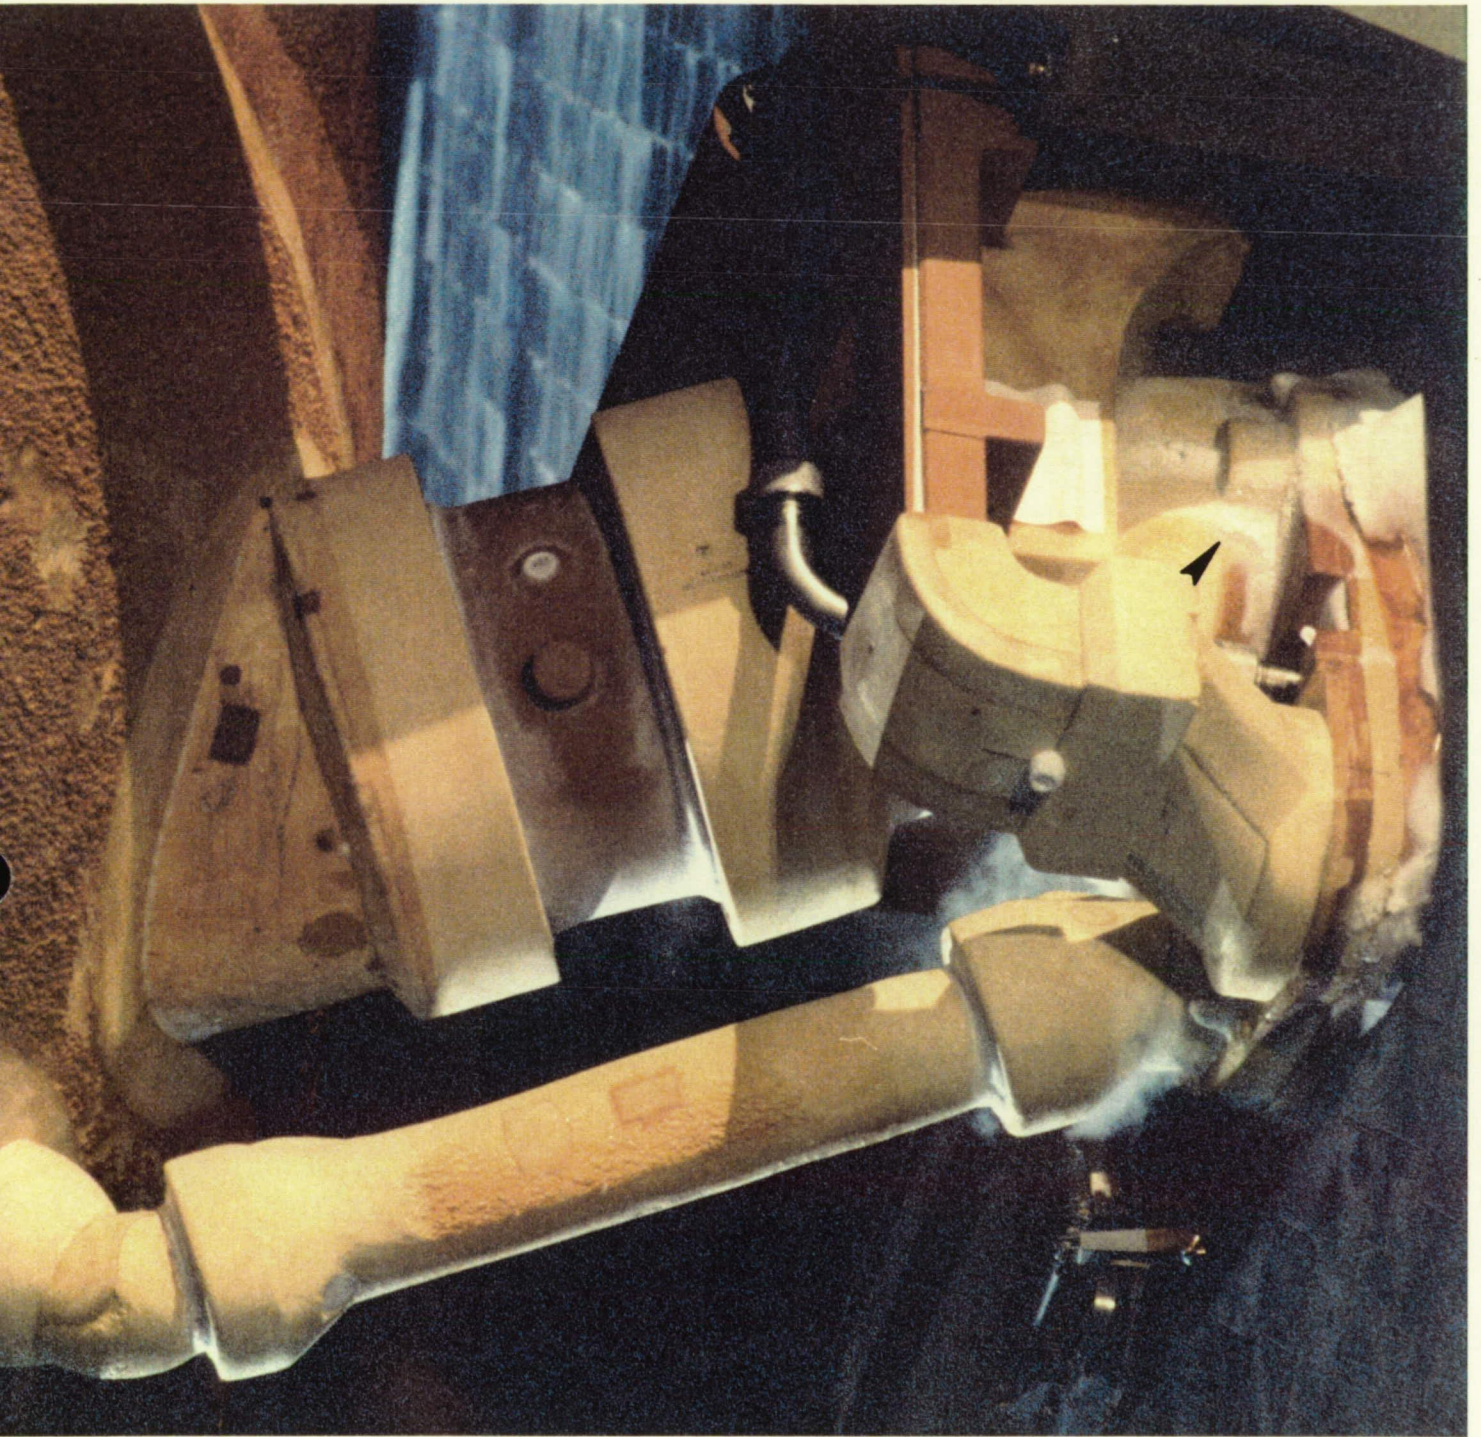
Somewhat greater than usual amounts of ice/frost had accumulated on the top, aft, and outboard sides of the LH2 ET/ORB umbilical/purge barrier. Typical ice/frost fingers had formed on the pyro canister and plate gap purge vents. Ice/frost was present on both the aft and forward outboard pyrotechnic canister closeout bondlines indicating thermal shorts. Some venting was occurring at the forward outboard location. The amount and location of the ice/frost was acceptable for launch per the NSTS-08303 criteria. A 2-inch ice/frost finger had formed on the cable tray vent hole. The 17-inch flapper valve actuator access port foam plug closeout exhibited a slight leak at the forward corner and was covered by ice/frost. No unusual vapors or cryogenic drips had appeared during tanking, stable replenish, and launch.

Somewhat greater than usual amounts of ice/frost had formed on the top, aft, and outboard sides of the LH2 ET/ORB umbilical/purge barrier. Normal amounts of ice/frost had accumulated on the plate gap and pyrotechnic canister purge vents, and the LH2 recirculation line bellows/burst disks. Ice was present on the forward outboard pyrotechnic canister closeout bondline indicating a thermal short (arrow). Frost was beginning to form on the LH2 feedline straight section (spool).

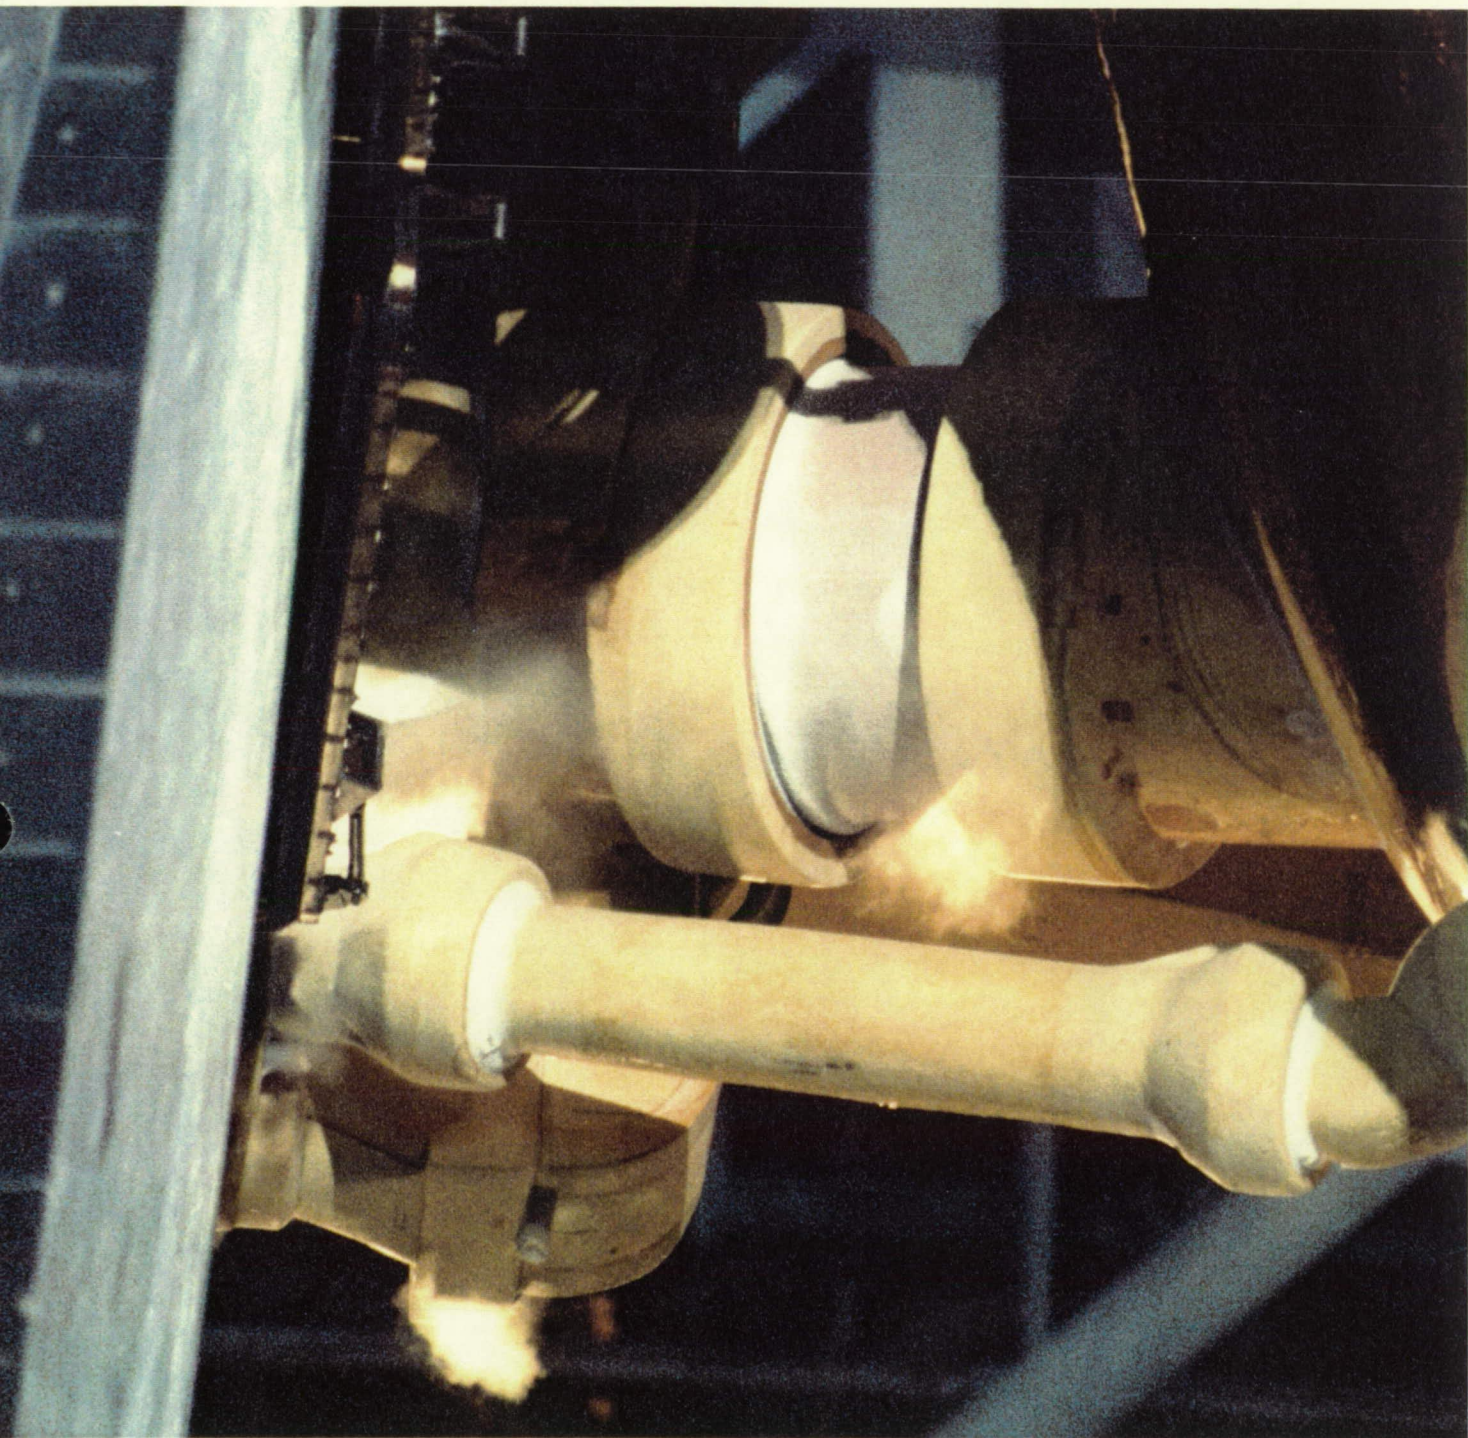
Ice/frost in the LH2 recirculation line bellows and on both burst disks, and in the LH2 feedline bellows, was typical. The LH2 feedline straight section (spool) was also covered by ice/frost - a condition that is not expected unless the ambient temperature falls below 32 degrees F.

Ice/frost continued to form and accumulate in the LH2 recirculation line bellows. By the end of the Ice Inspection, the LH2 feedline straight section (spool) was almost completely covered by ice/frost, a condition that should not occur until the ambient temperature falls below 32 degrees F.

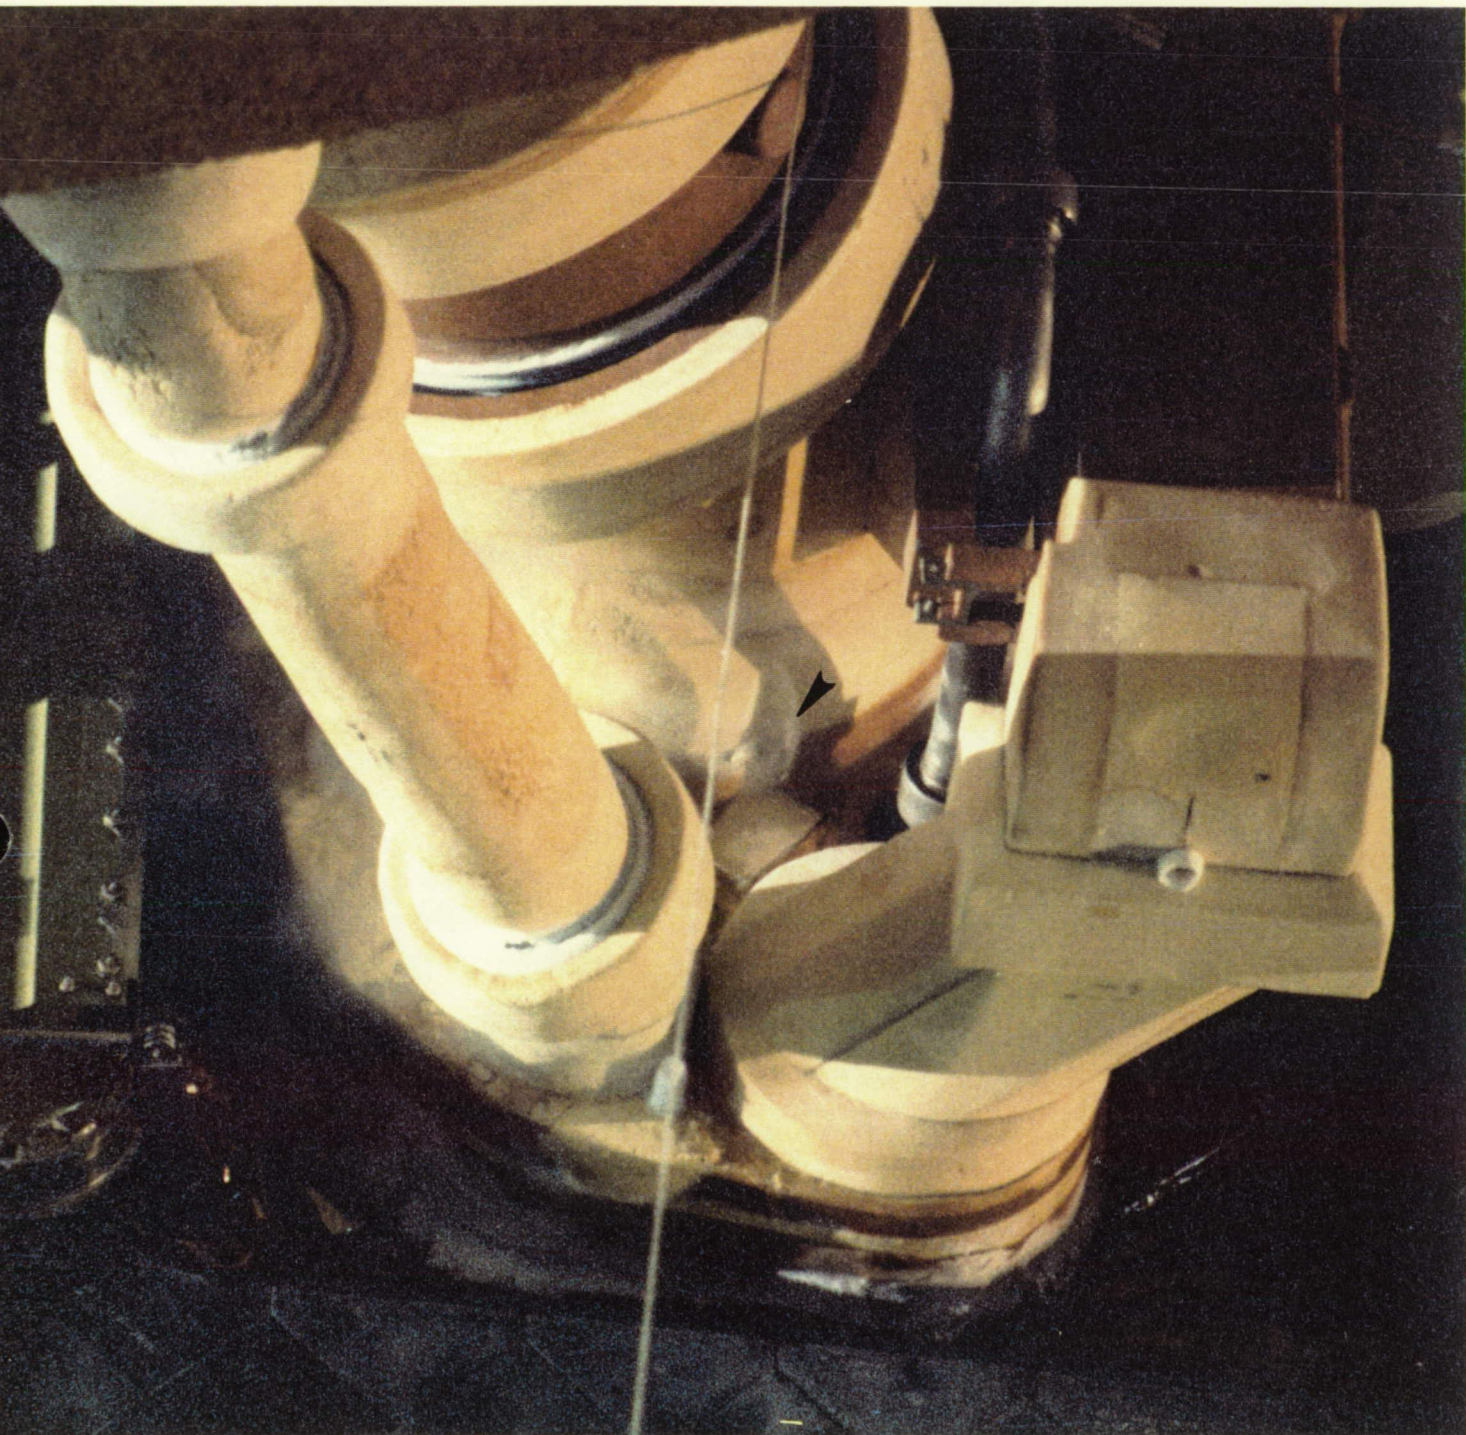
Typical in size, ice/frost fingers had formed on the aft plate gap purge vent and LH2 umbilical cable tray vent hole. Some ice and frost had formed at the forward corner of the 17-inch flapper valve actuator access port TPS plug closeout indicating a small purge gas leak at the bondline.

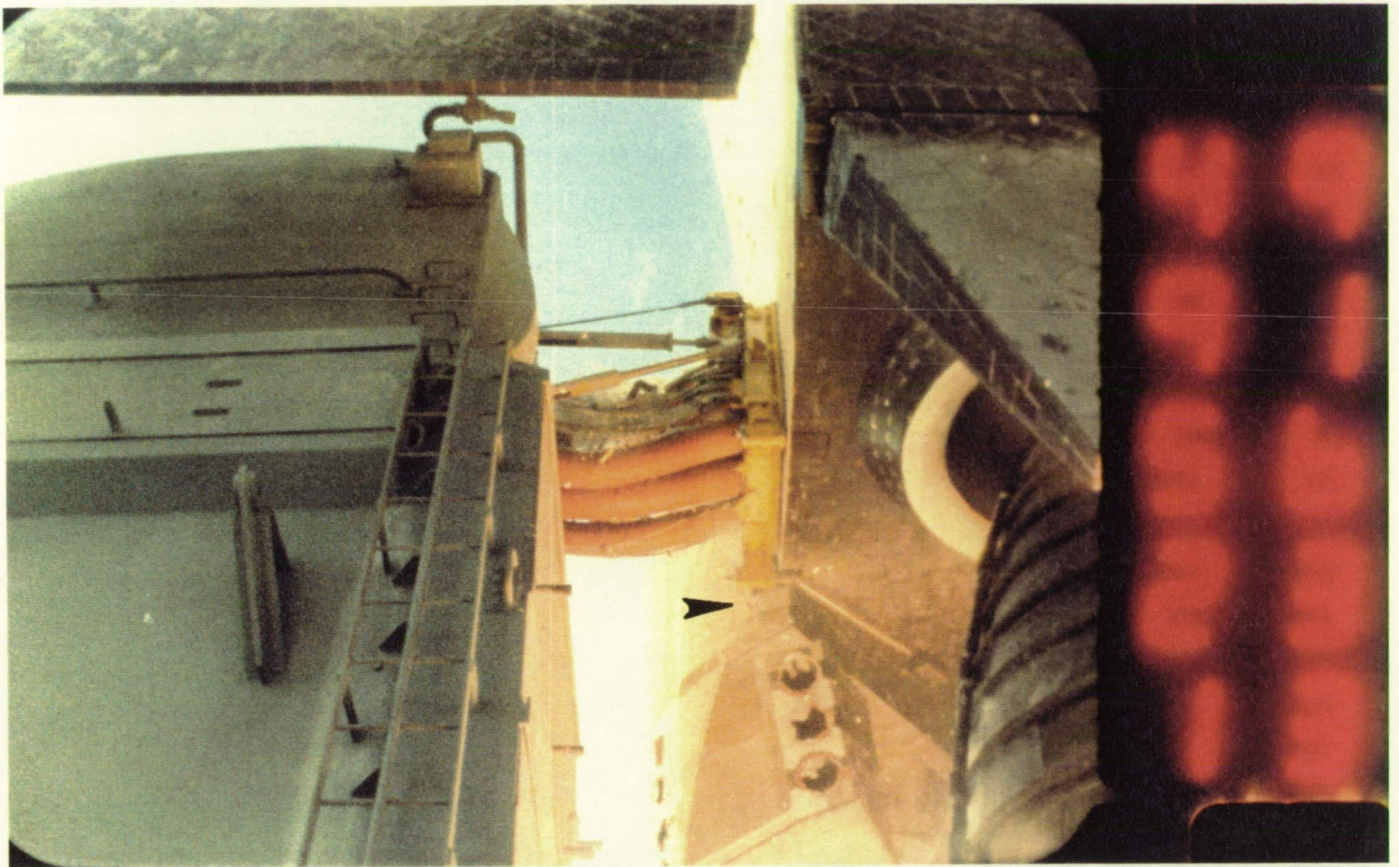
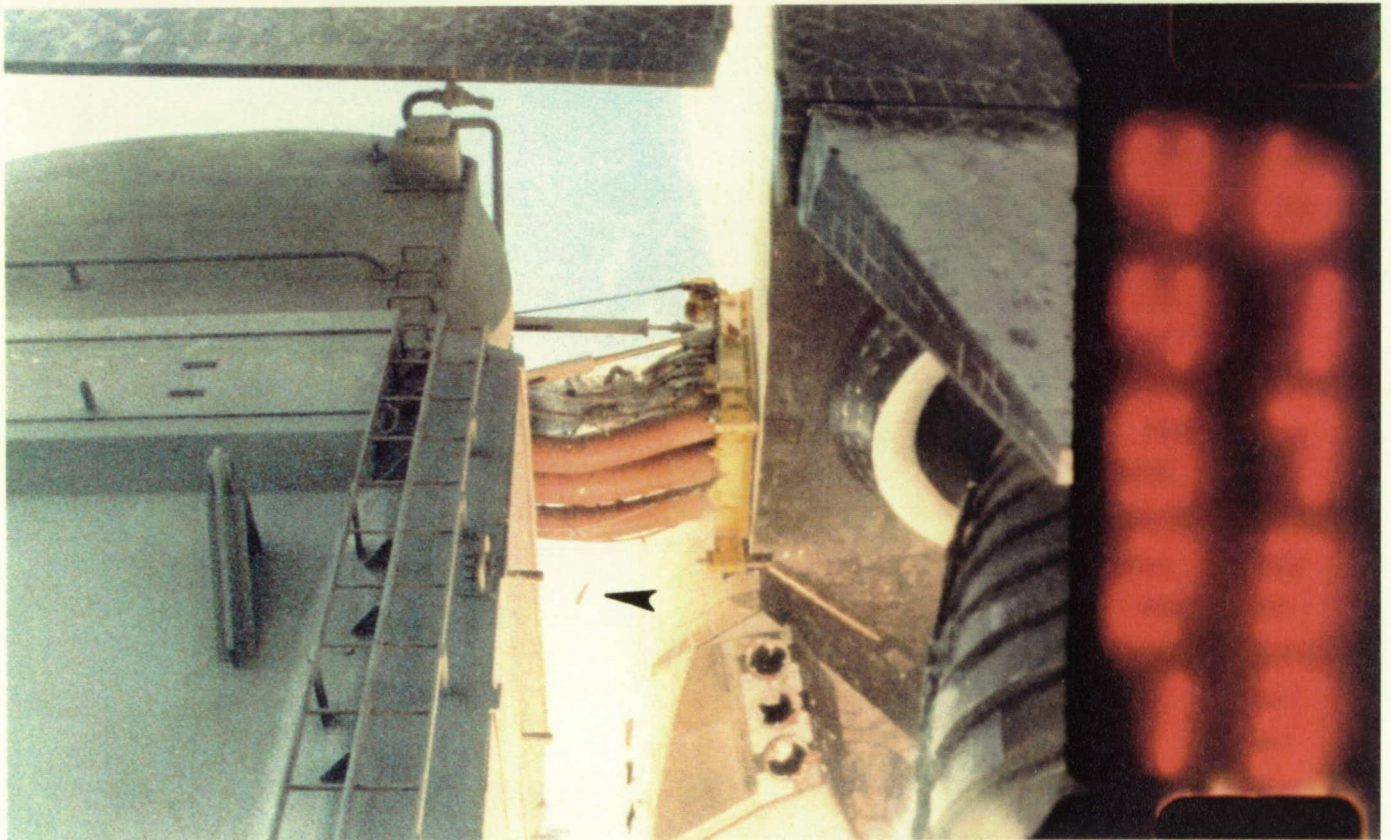
Orange vapor (burning hydrogen) was visible between the exit plane and the #9 hatband near the steer horn, or the coolant manifold, on the SSME #2 nozzle -Z side. This event may be indicative of a cold wall hydrogen leak.

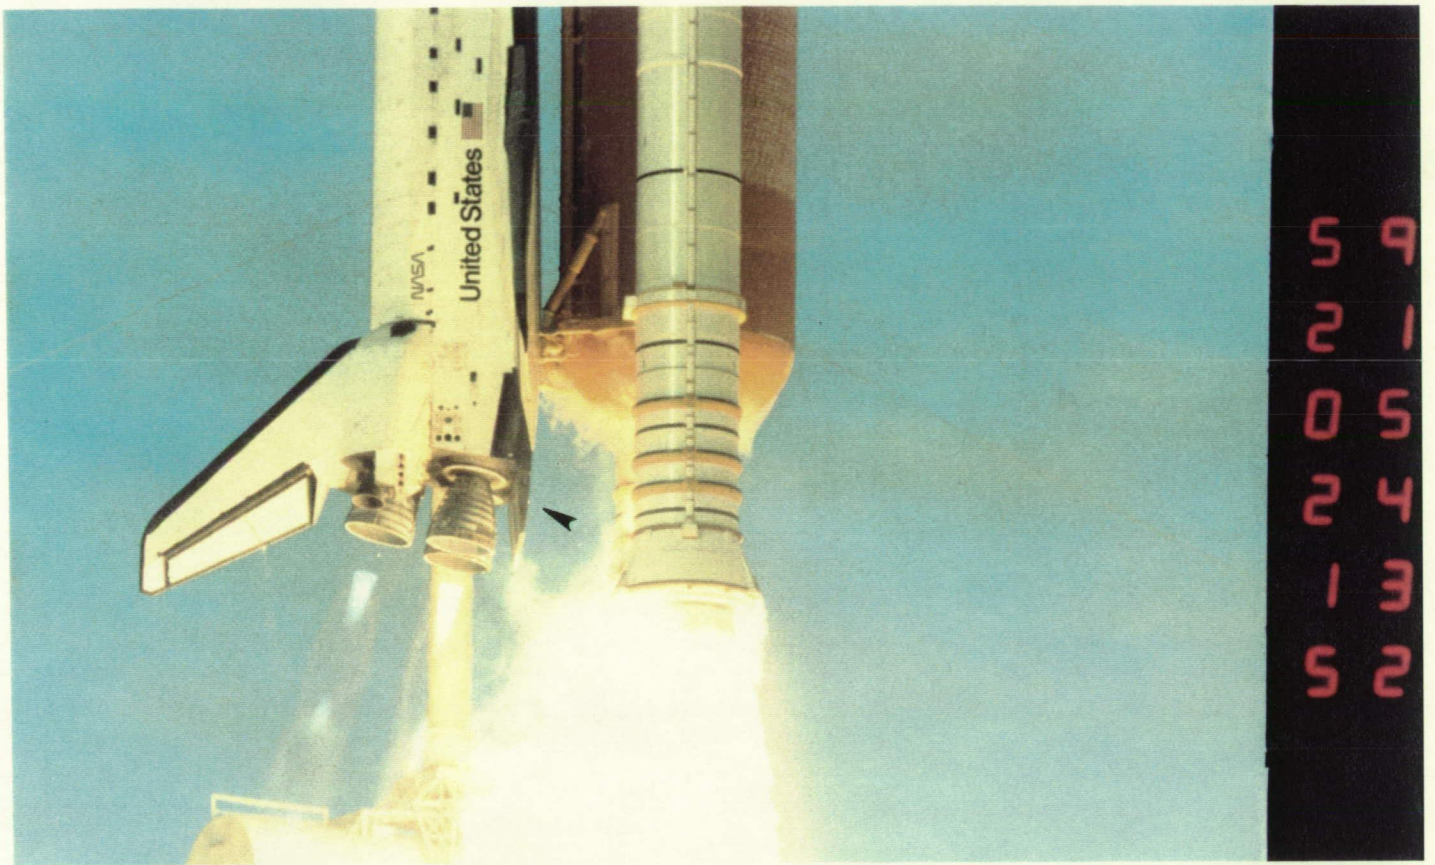
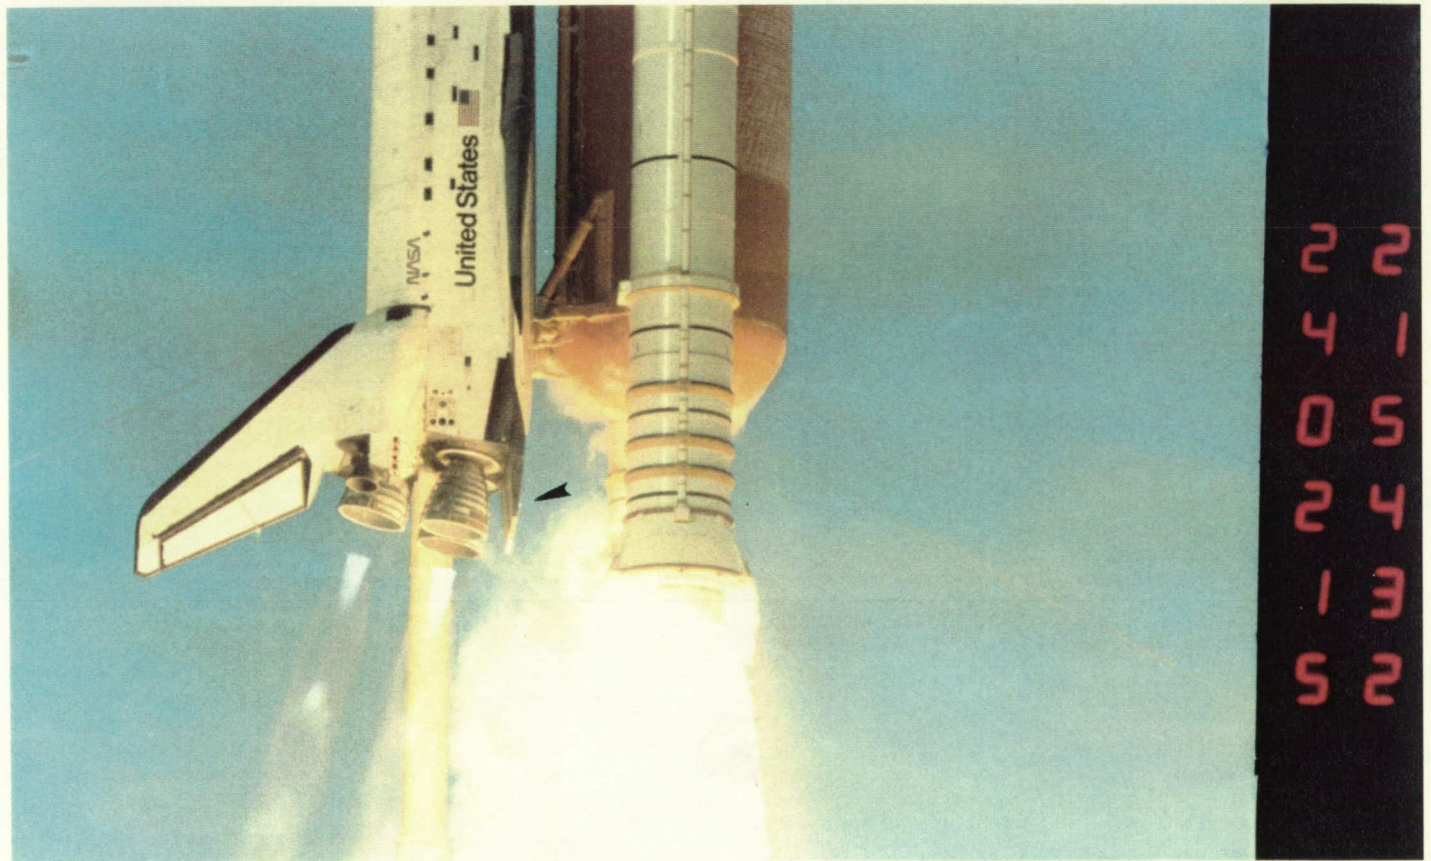
Ice continued to fall aft from the ET/ORB umbilicals as the vehicle cleared the tower. One piece impacted the Orbiter body flap (arrows), but no tile damage was visible.

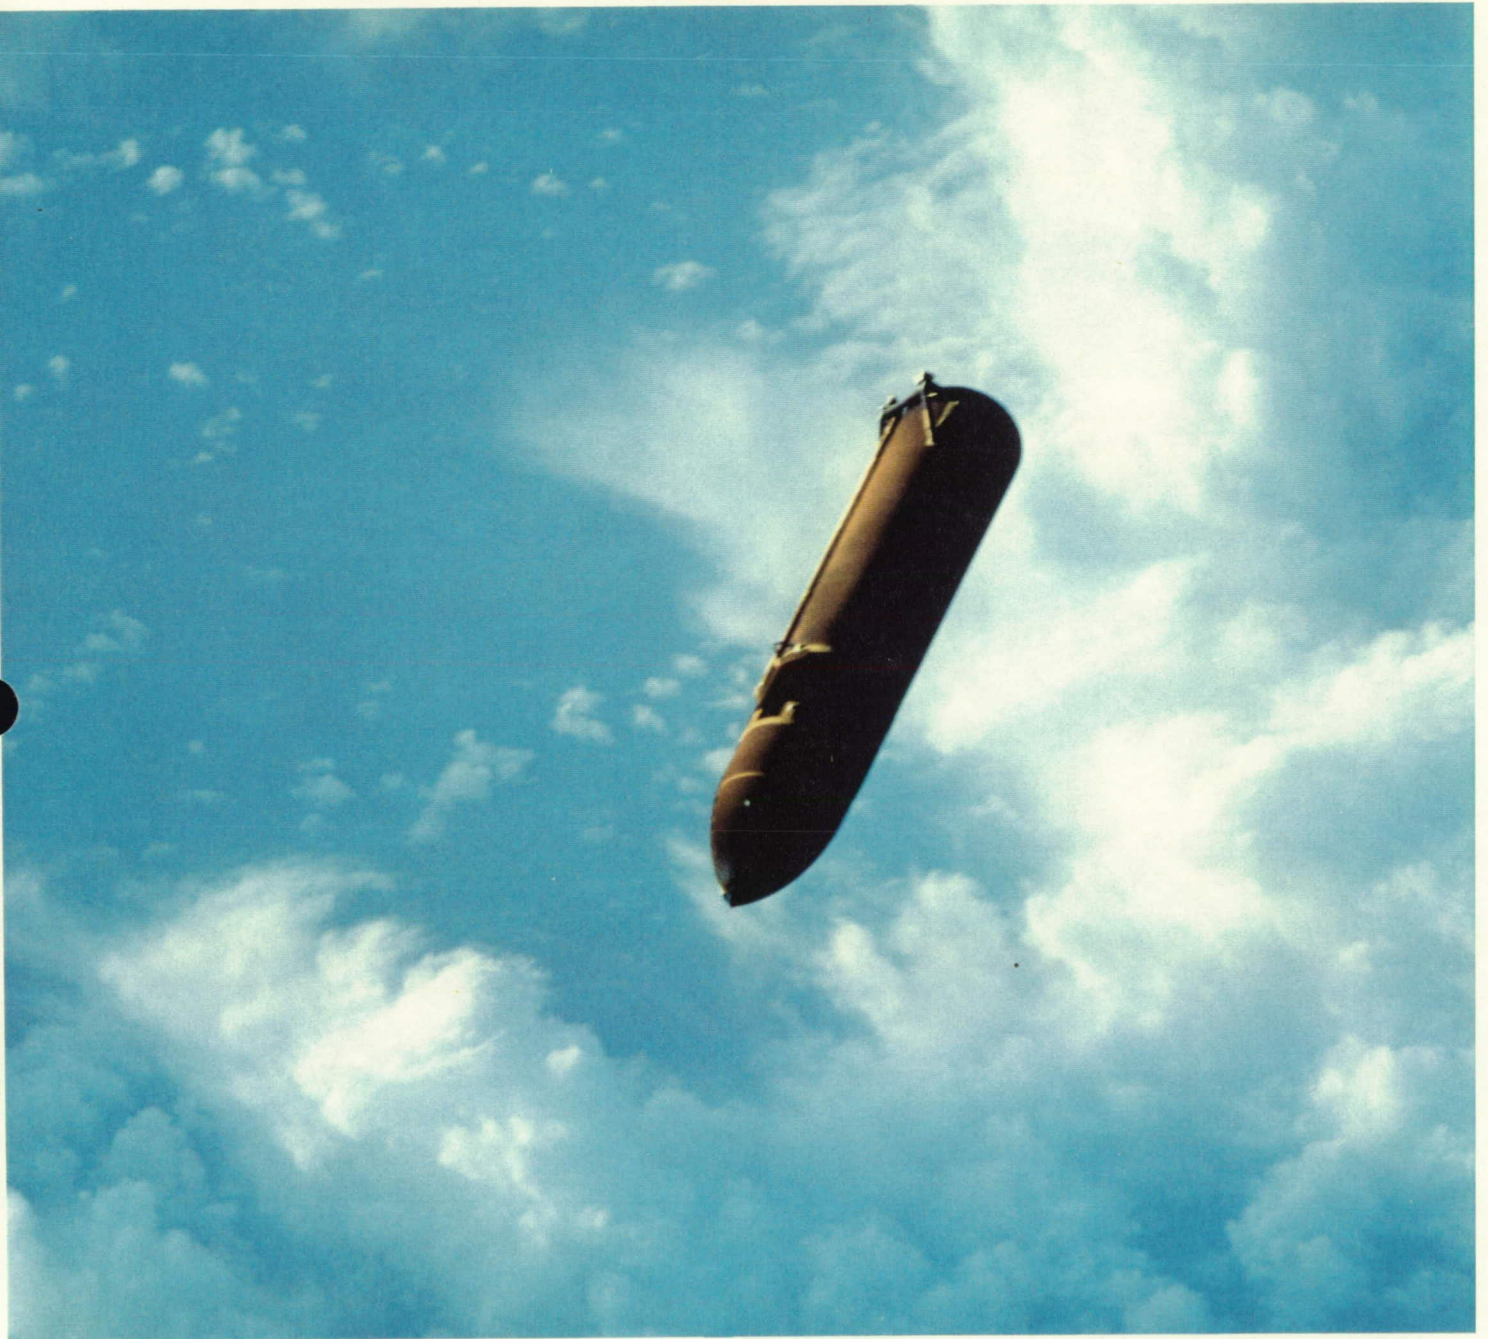
ET structural separation from the Orbiter appeared nominal. No anomalies were observed on the nosecone, L02 tank acreage, and LH2 tank TPS acreage. Four divots were present in the LH2 tank-to-intertank flange closeout.

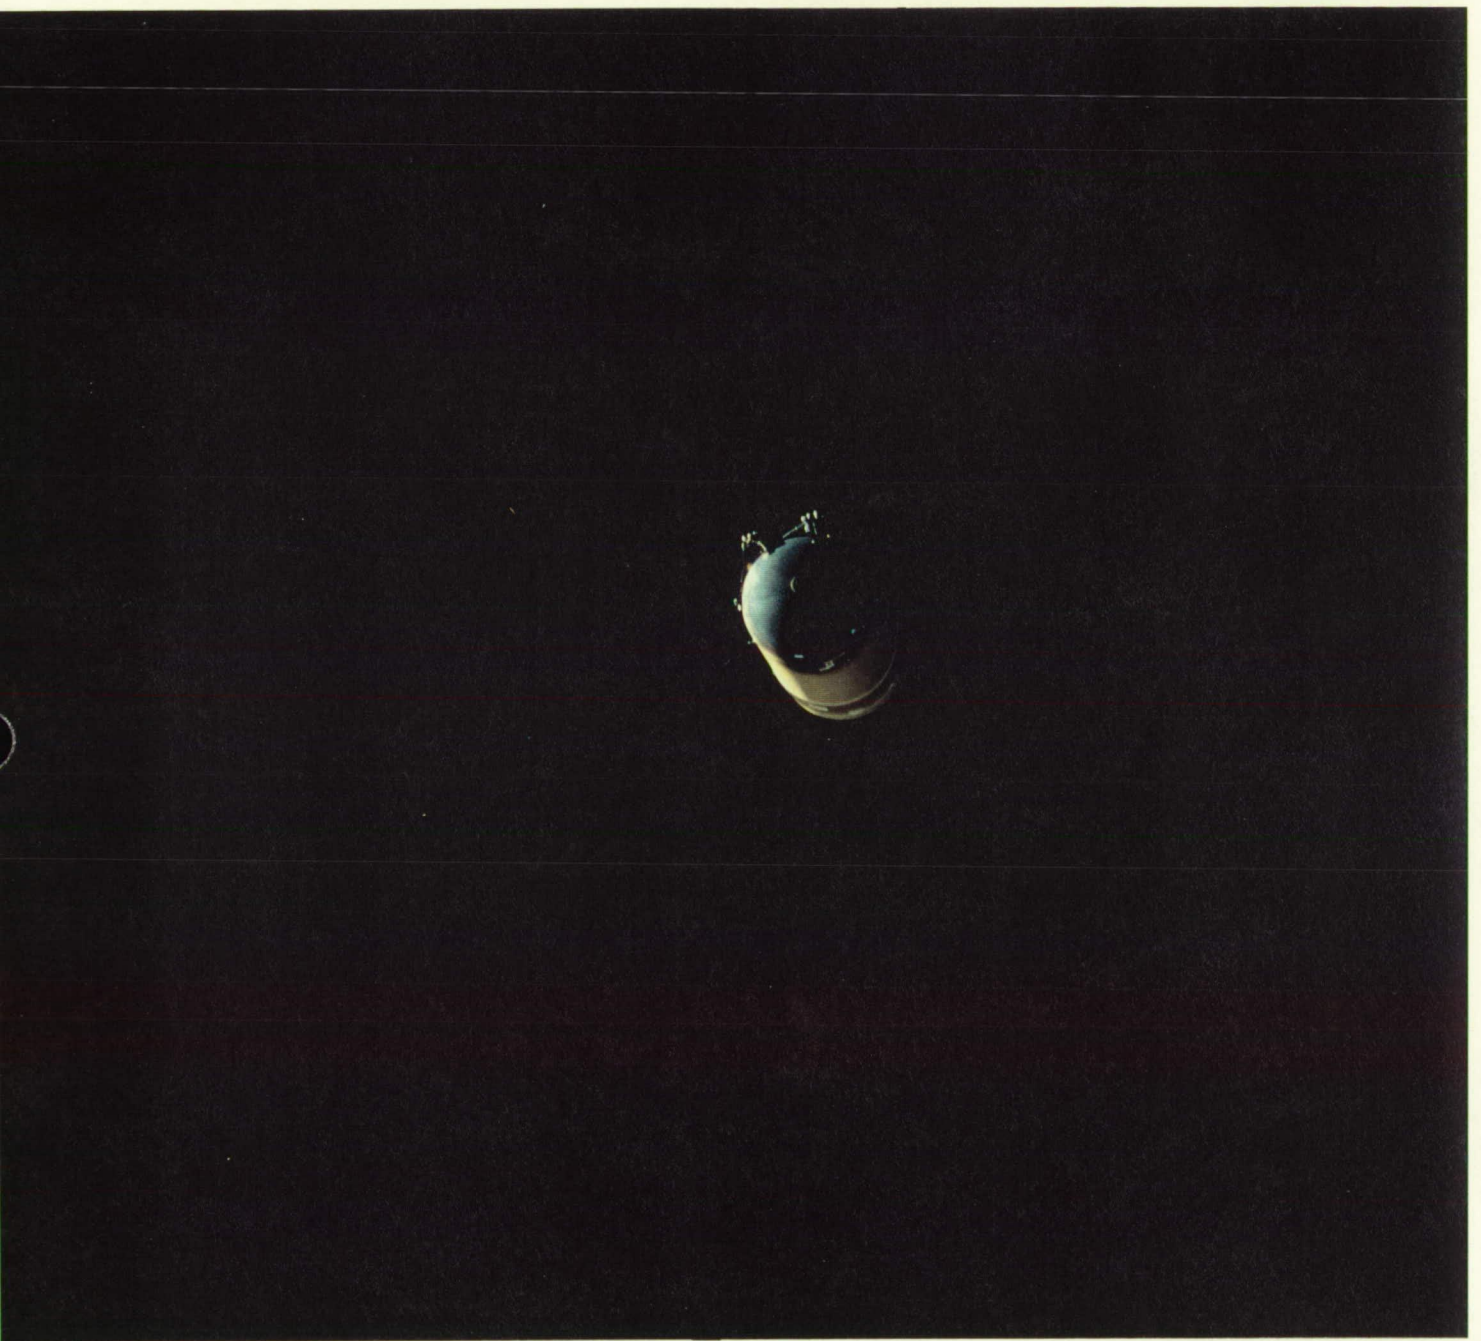
Four large and two small divots occurred in the aft dome spray abort. Plume recirculation and aft dome heating caused the usual charring of the NCFI. Residual hydrogen was venting from the LH2 ET/ORB umbilical - a phenomenon that has been observed on previous tanks.

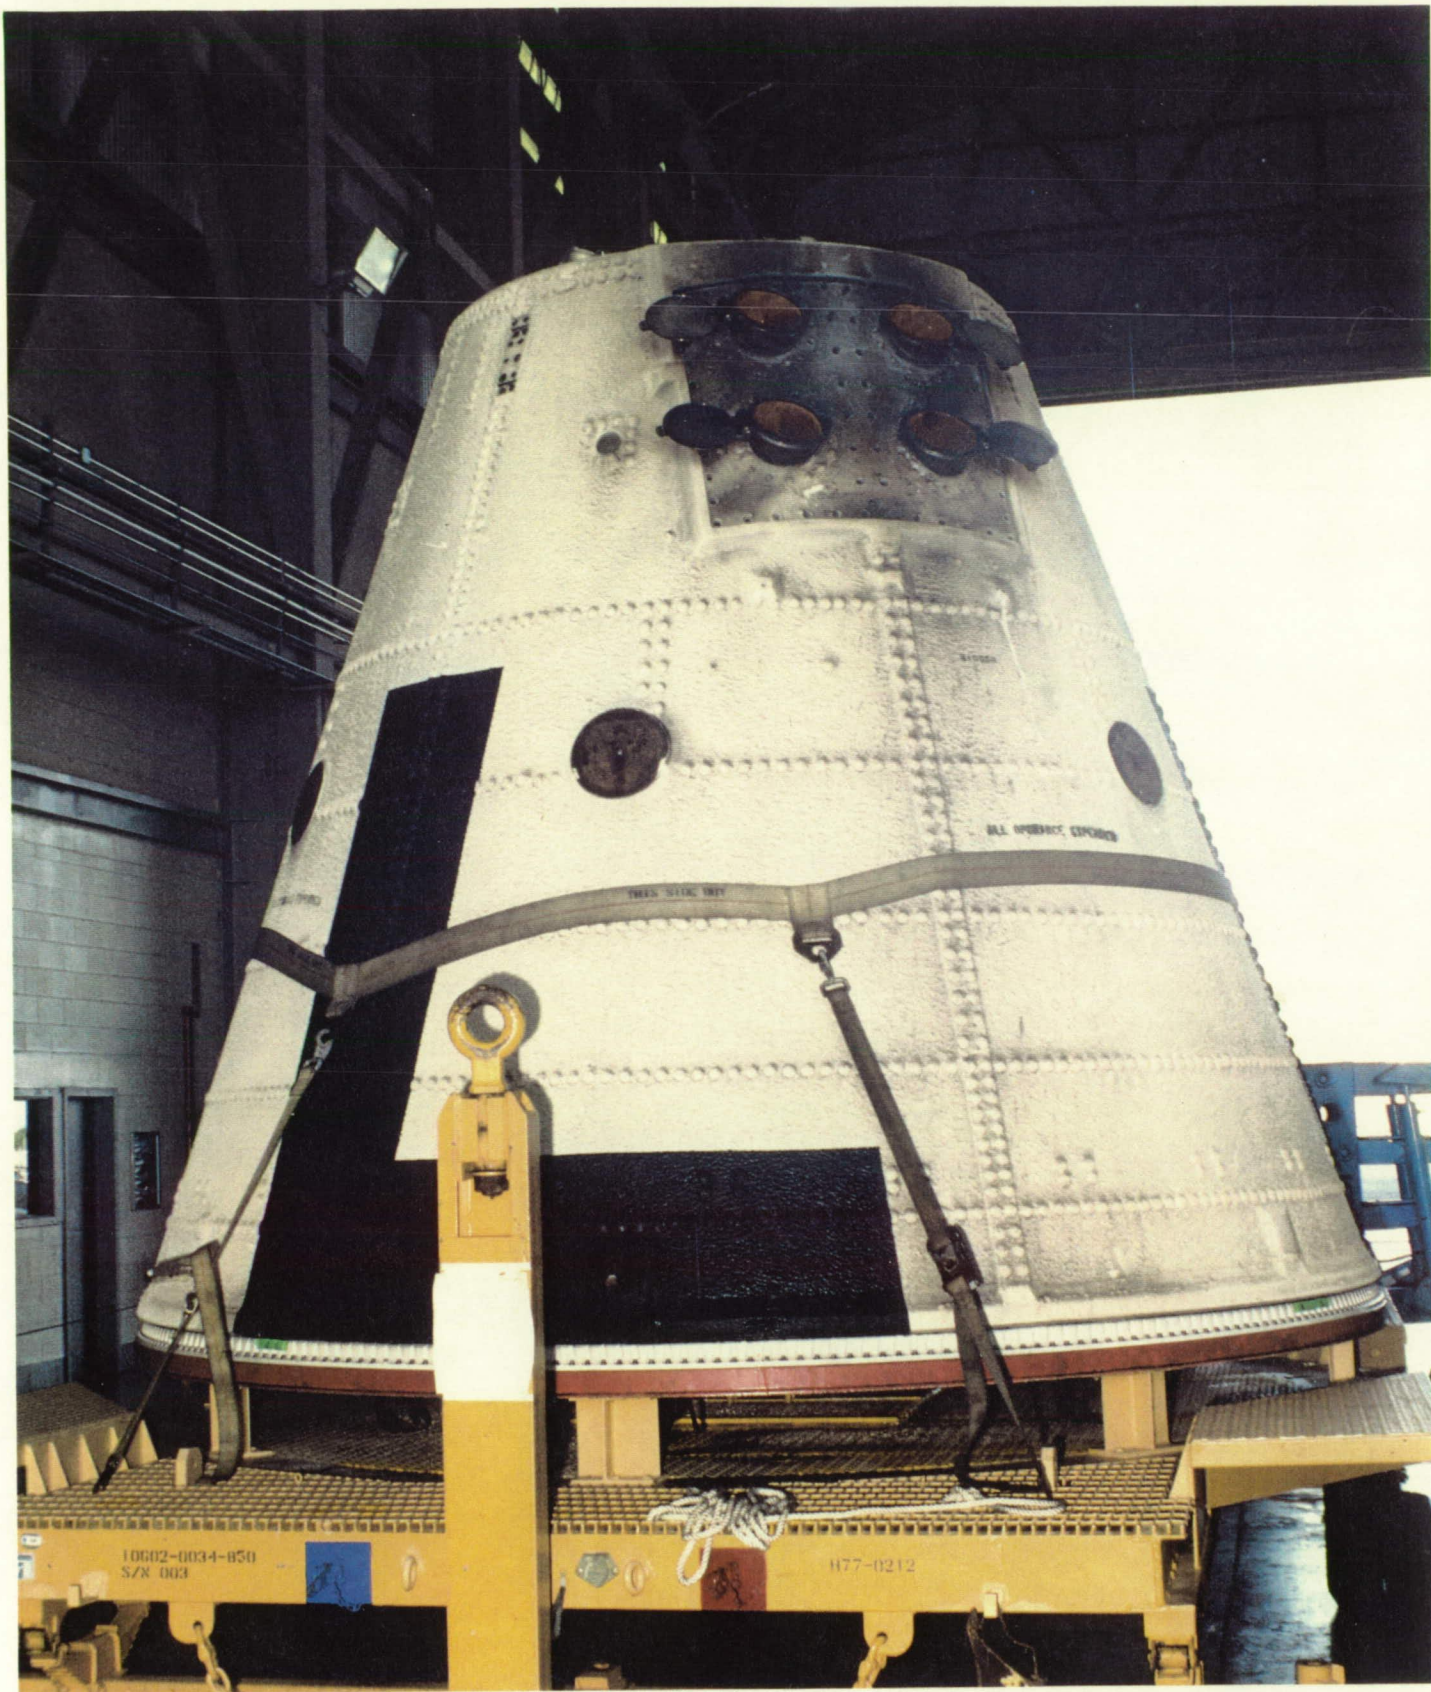
The RH frustum had 16 MSA-2 debonds over fasteners and one 1-inch diameter area of missing TPS between the +Y and -Z axes at the 381 ring frame. All BSM aero heat shield covers were locked in the fully opened position.
