NASA Technical Memorandum TM 107556

Debris/Ice/TPS Assessment And Integrated Photographic Analysis For Shuttle Mission STS-53

DEBRIS/ICE/TPS ASSESSMENT
AND
PHOTOGRAPHIC ANALYSIS
OF
SHUTTLE MISSION STS-53

December 2, 1992

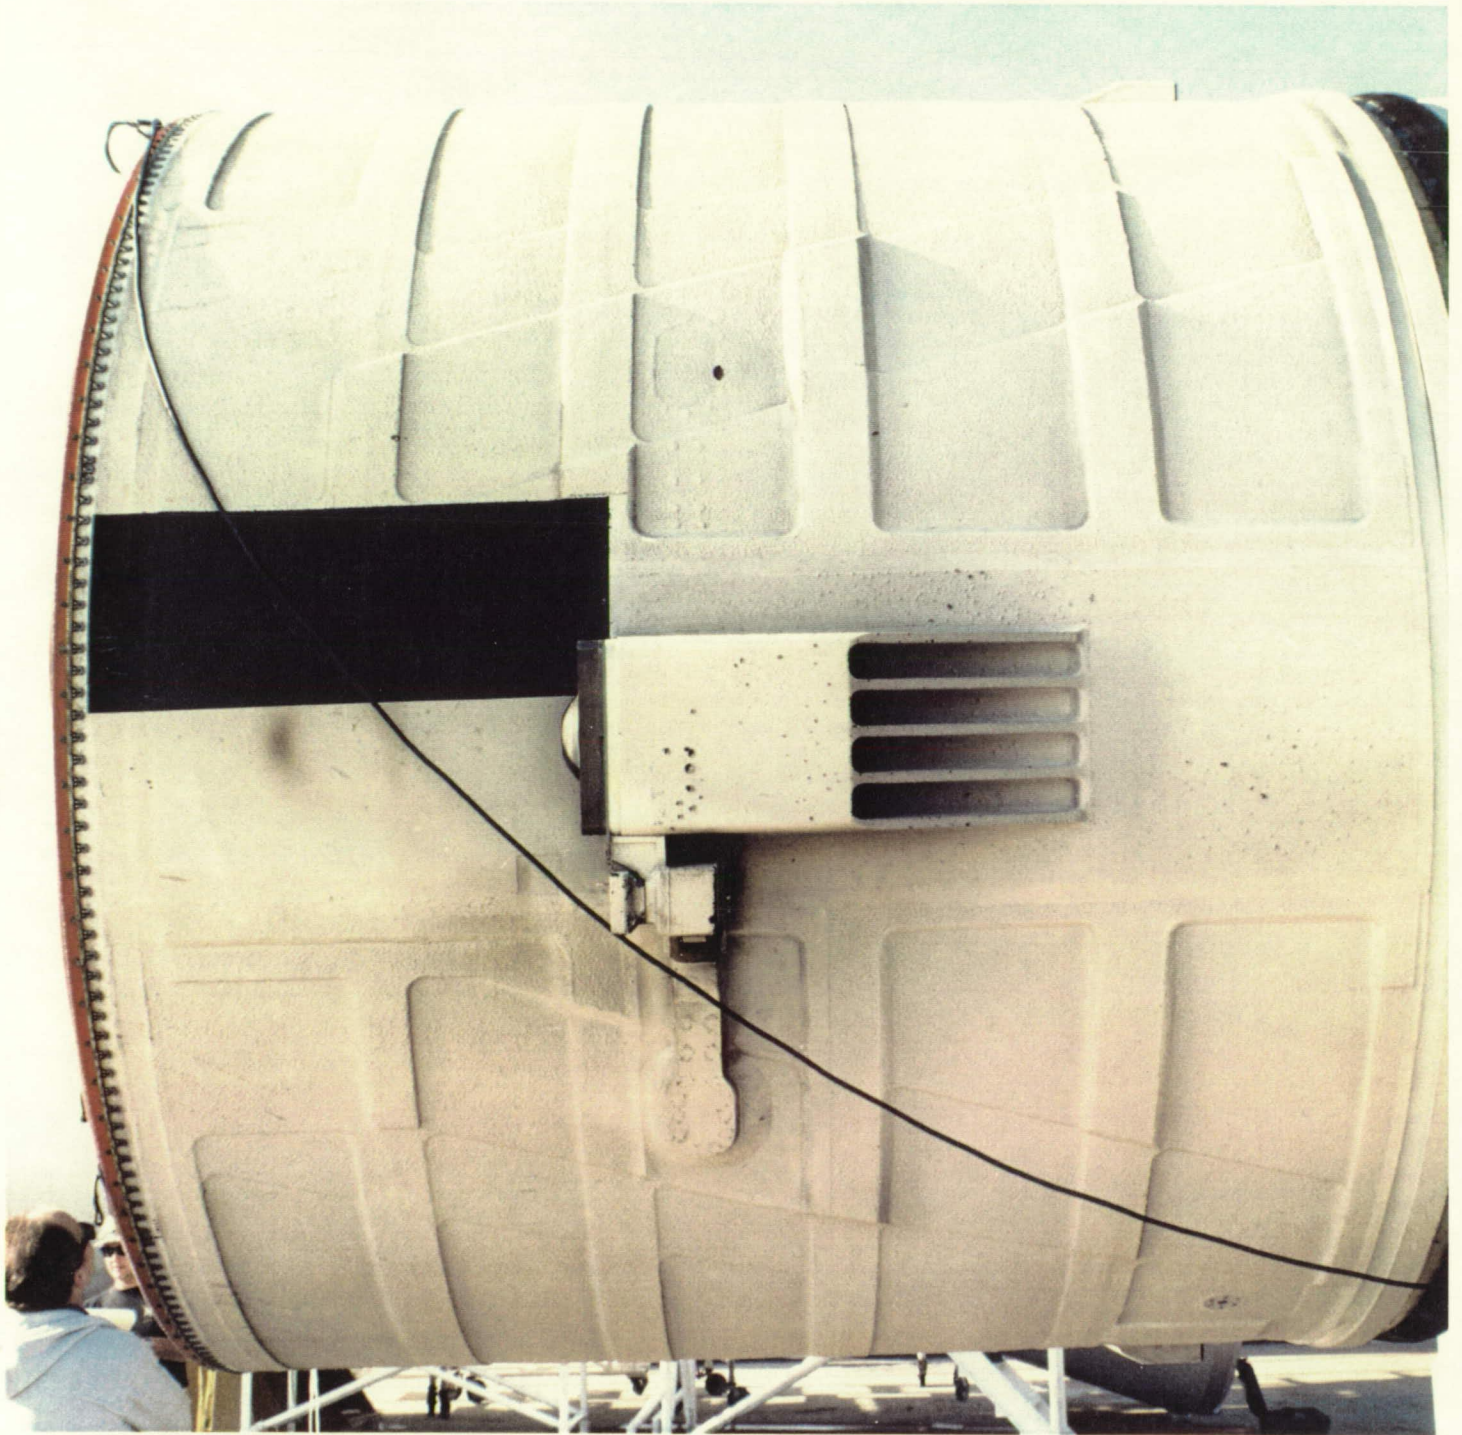
The RH forward skirt exhibited no debonds or missing TPS. Minor blistering of the Hypalon paint occurred on the forward ET/SRB attach point. Both RSS antenna covers/TPS were intact and undamaged.

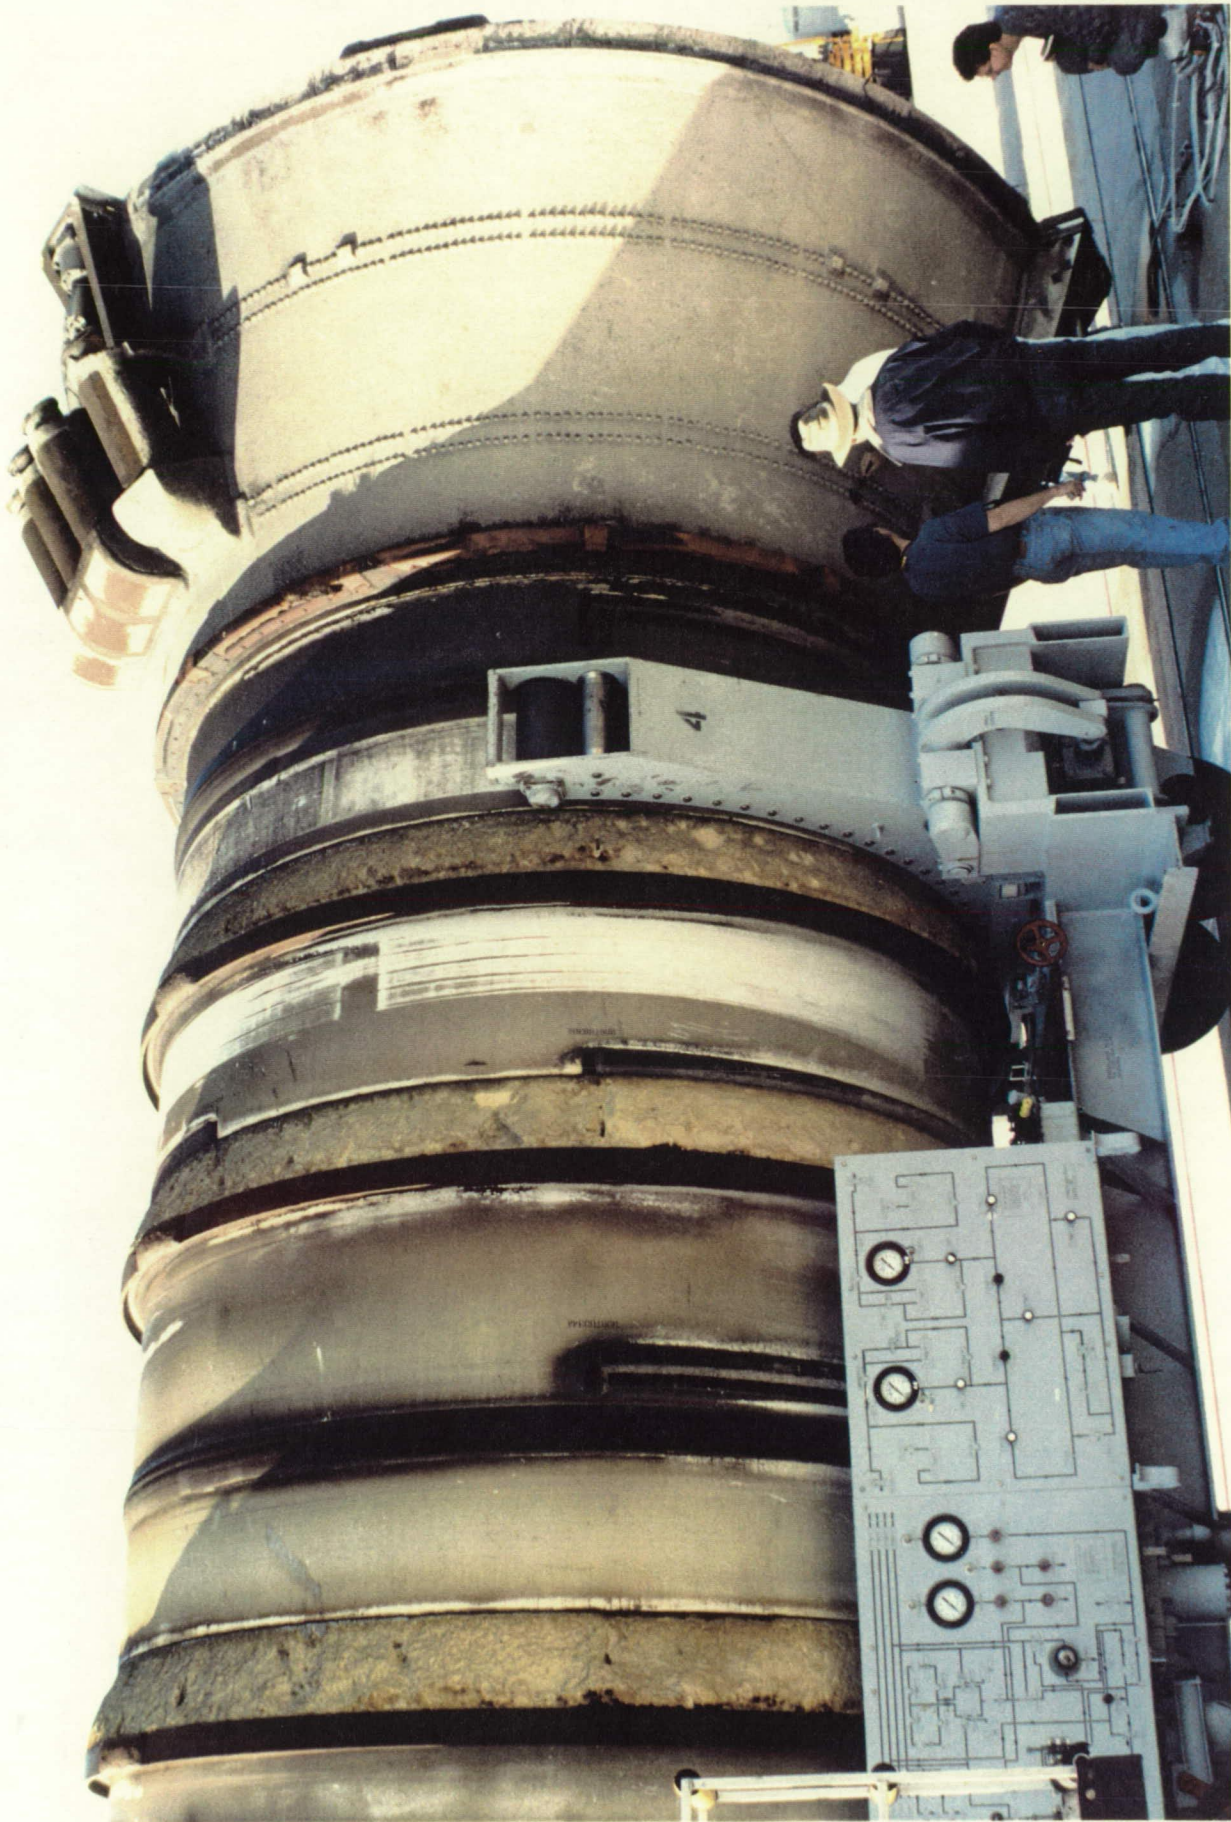
Post flight condition of the RH aft booster. Separation of the aft ET/SRB struts appeared normal. One divot, measuring 4 inches in diameter, had occurred over fasteners on the aft skirt TPS near holddown post #3.

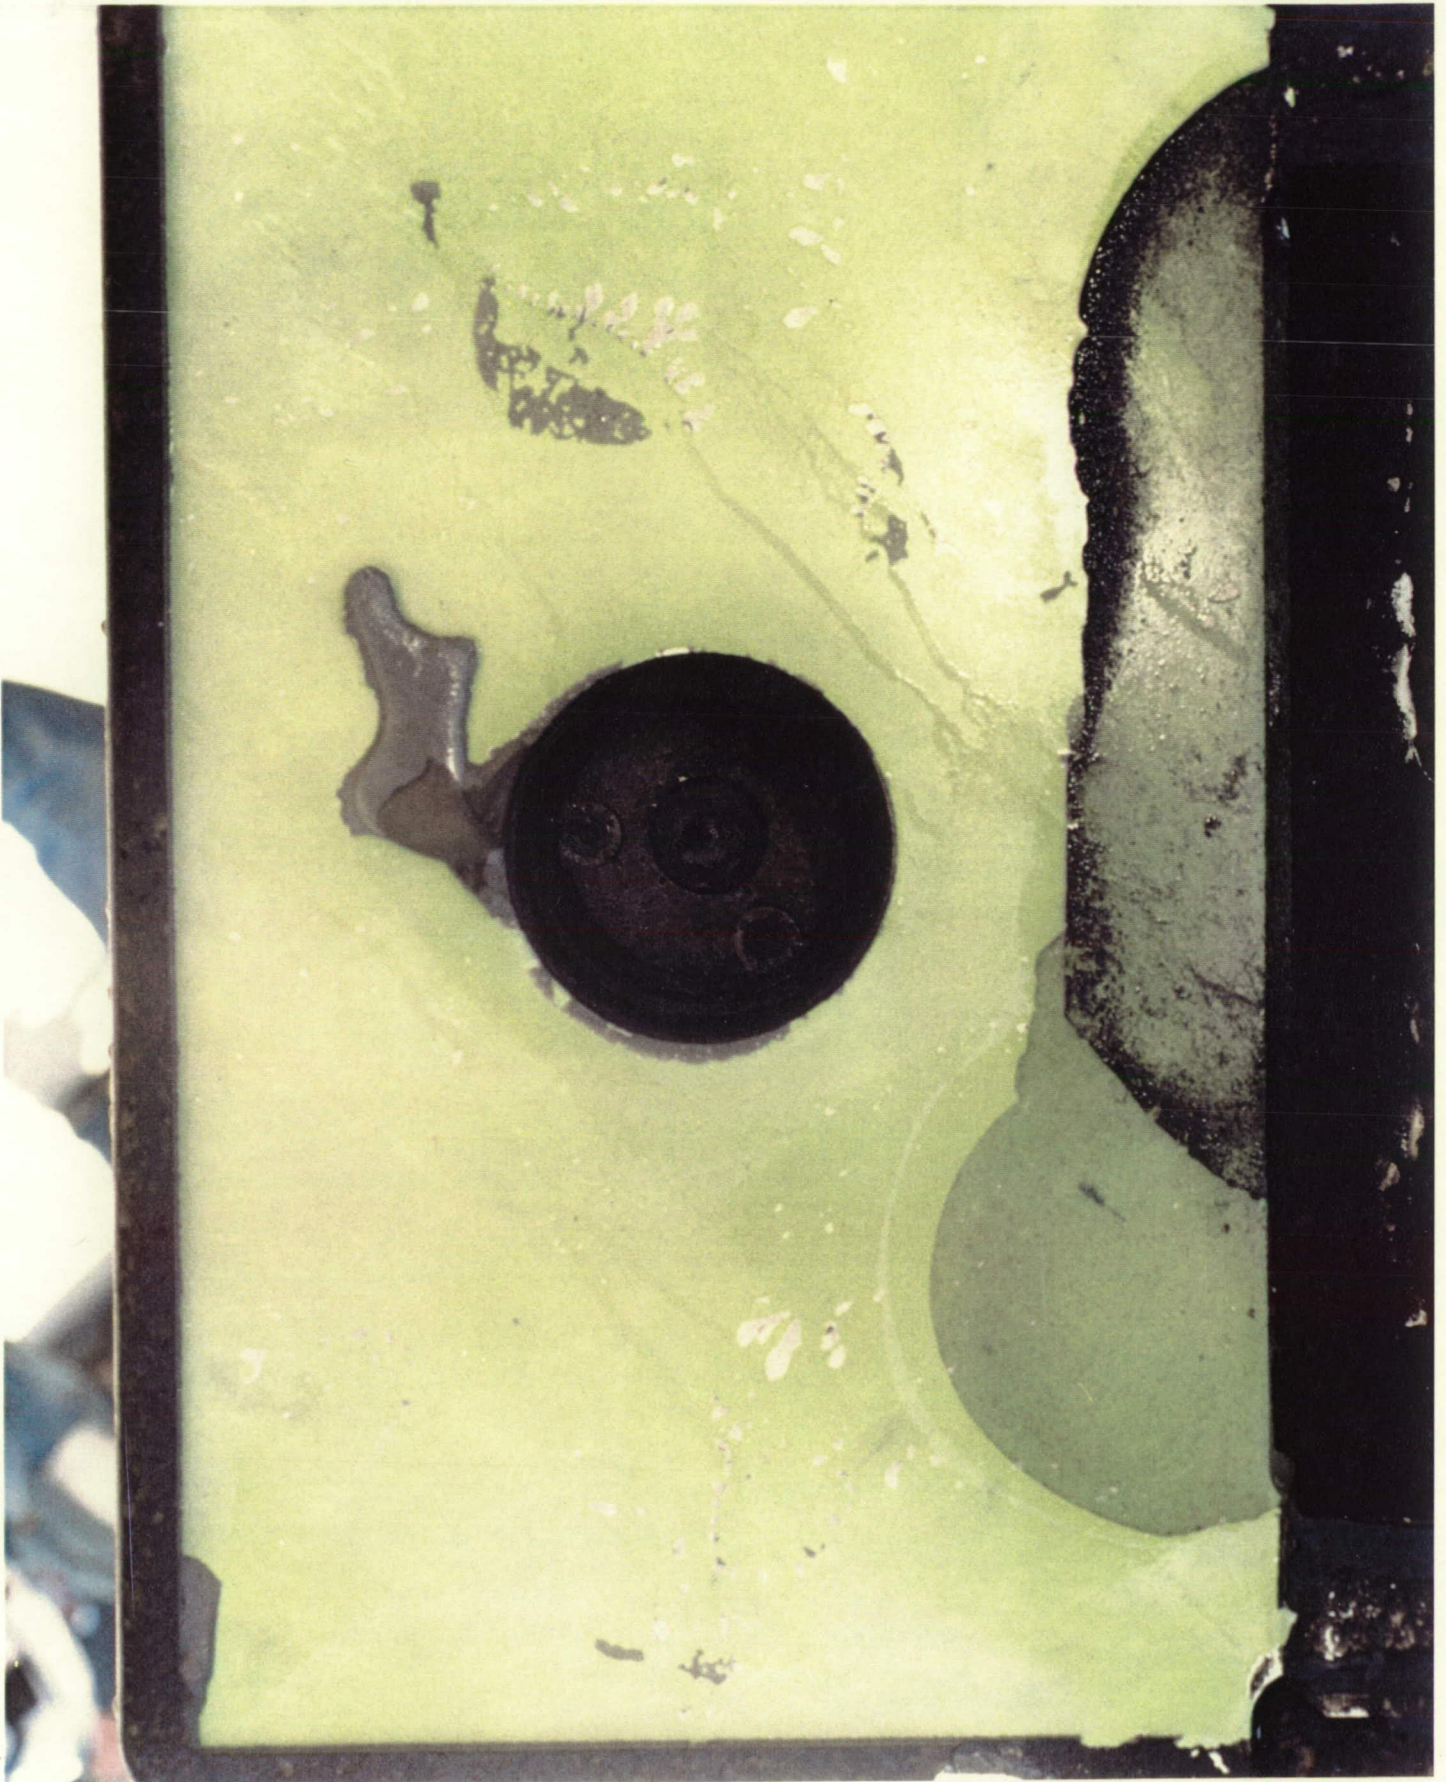
A 10"x3" area of EPON shim was missing from HDP #3. The material was lost prior to water impact (sooted substrate).

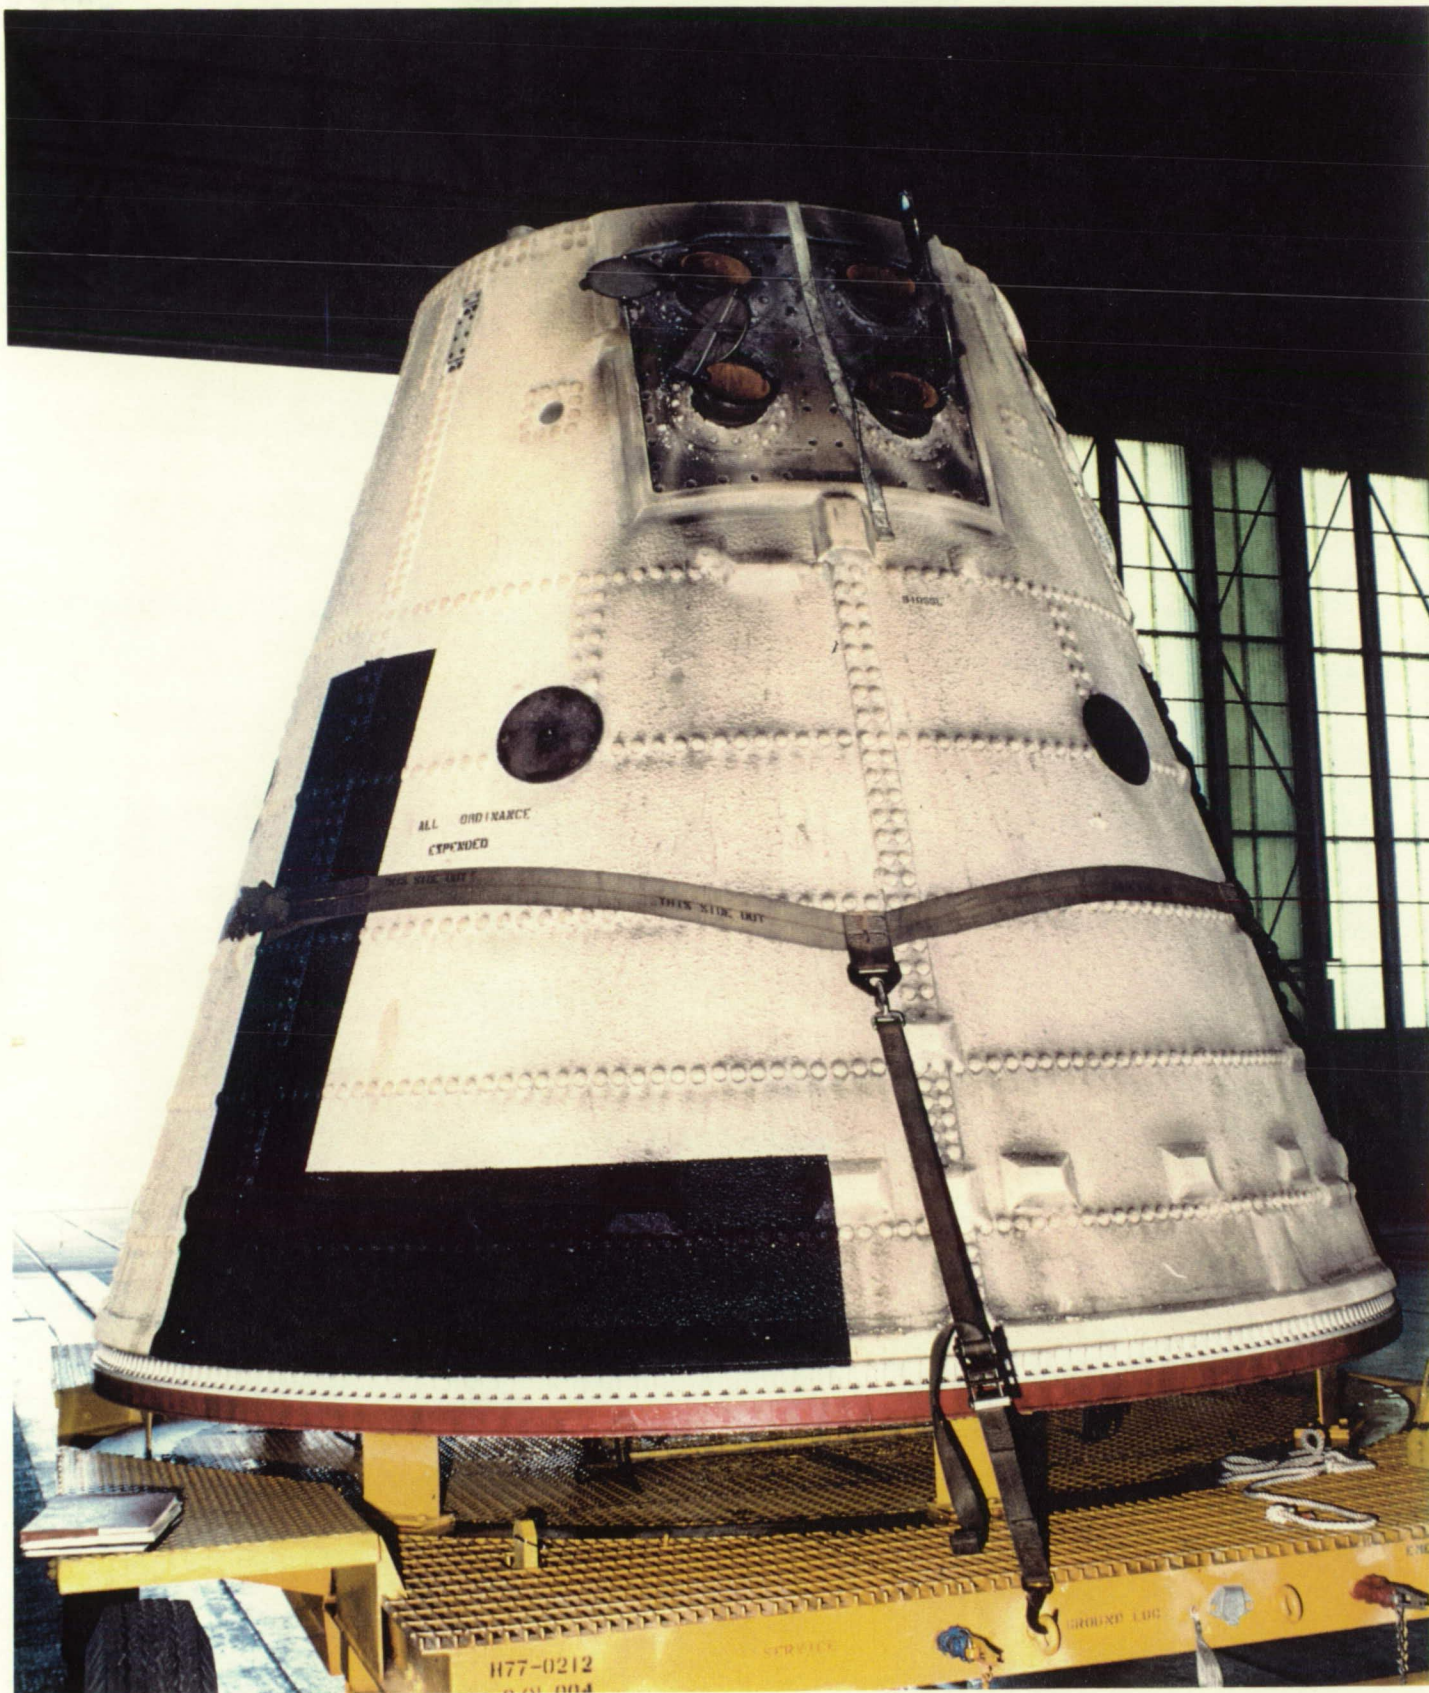
The LH frustum had 28 MSA-2 debonds over fasteners. The BSM aero heat shield covers were locked in the fully opened position, though three of the four cover attach rings had been bent by parachute riser entanglement.

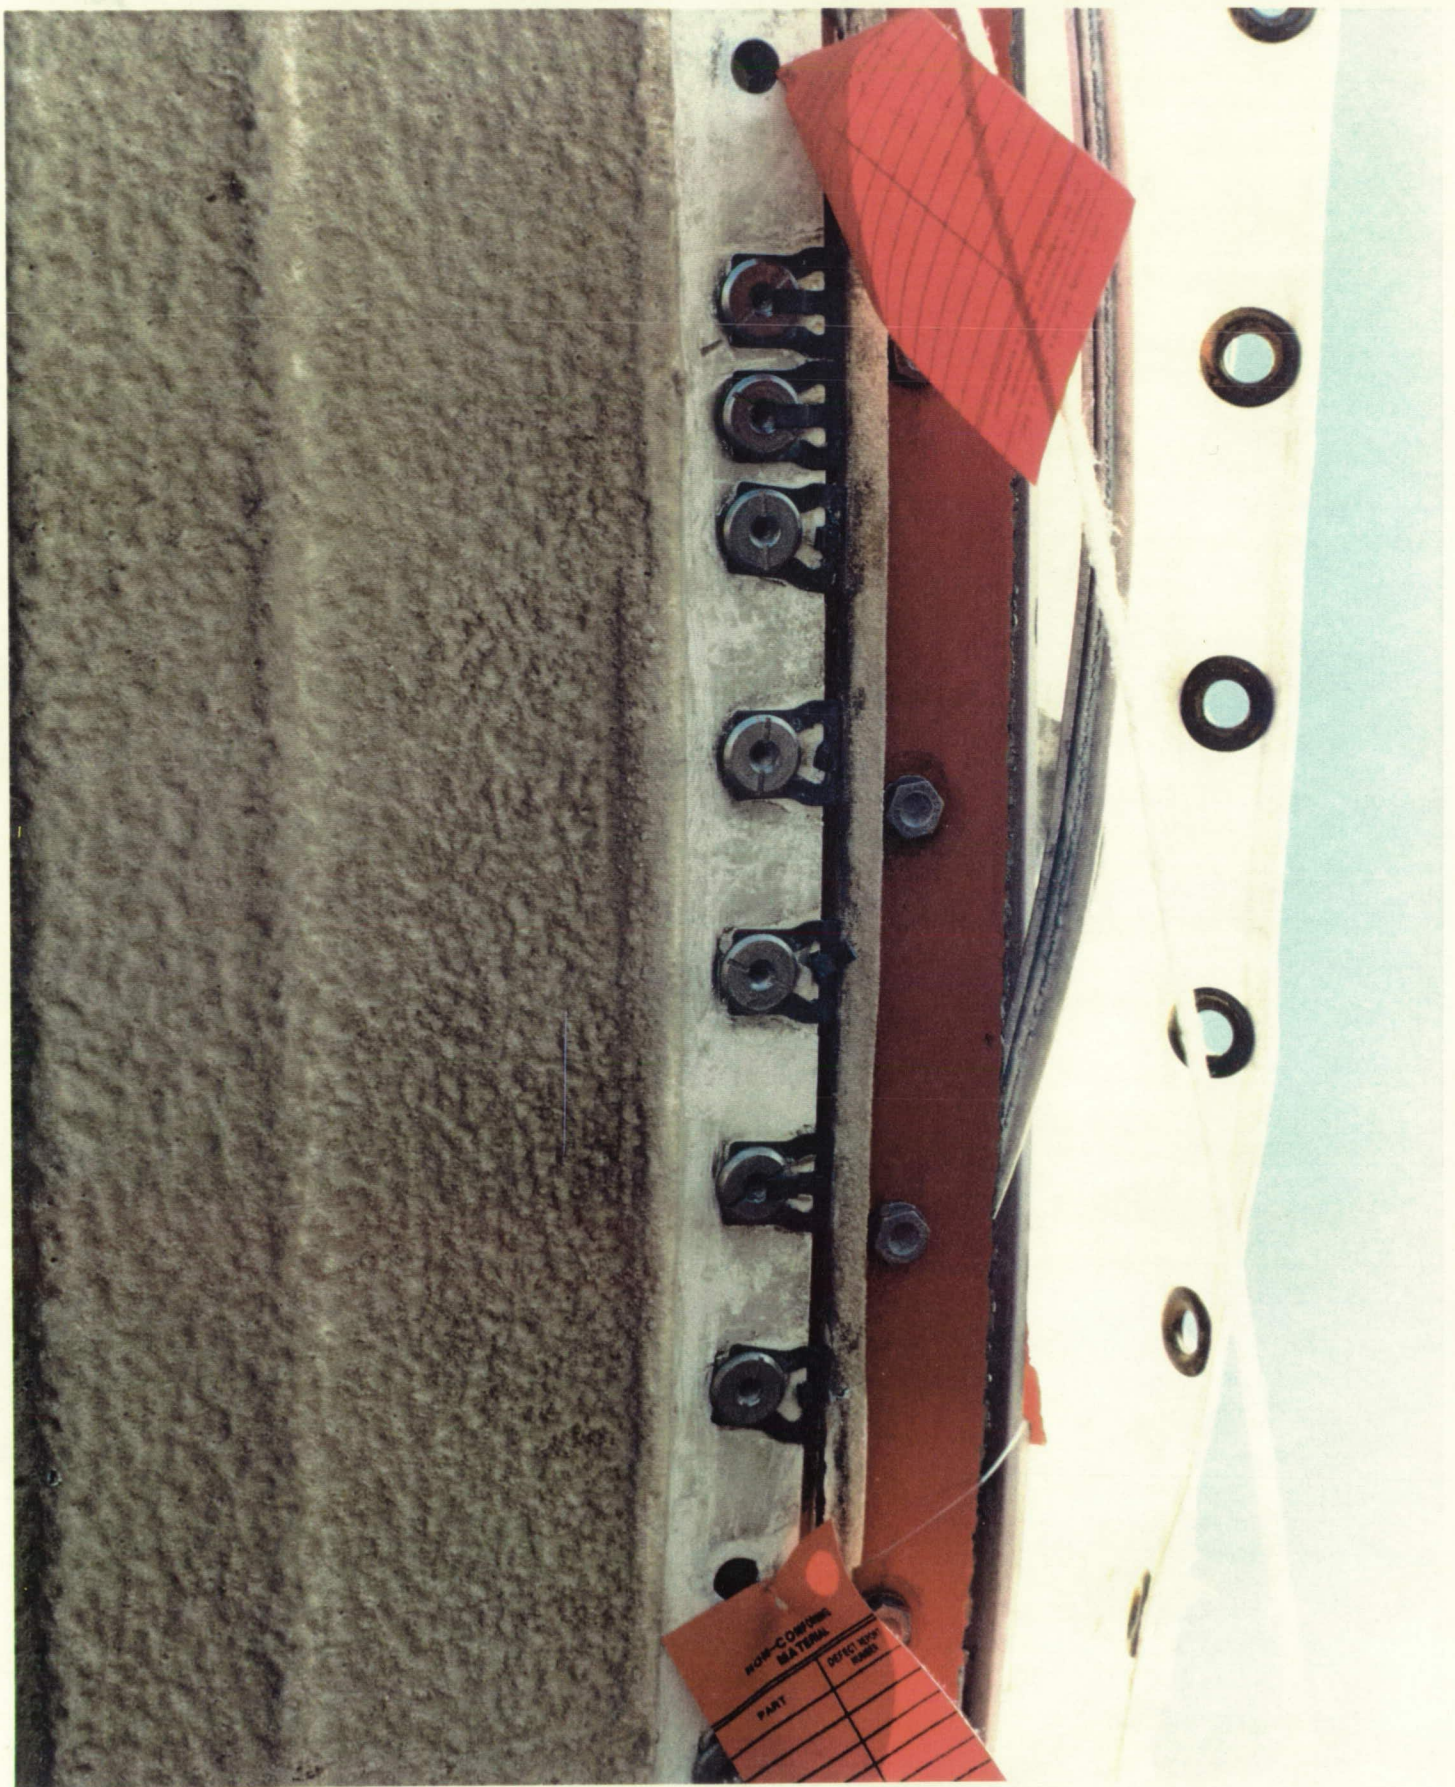
Three pins were missing from the frustum severance ring, a condition that reportedly was the result of parachute entanglement

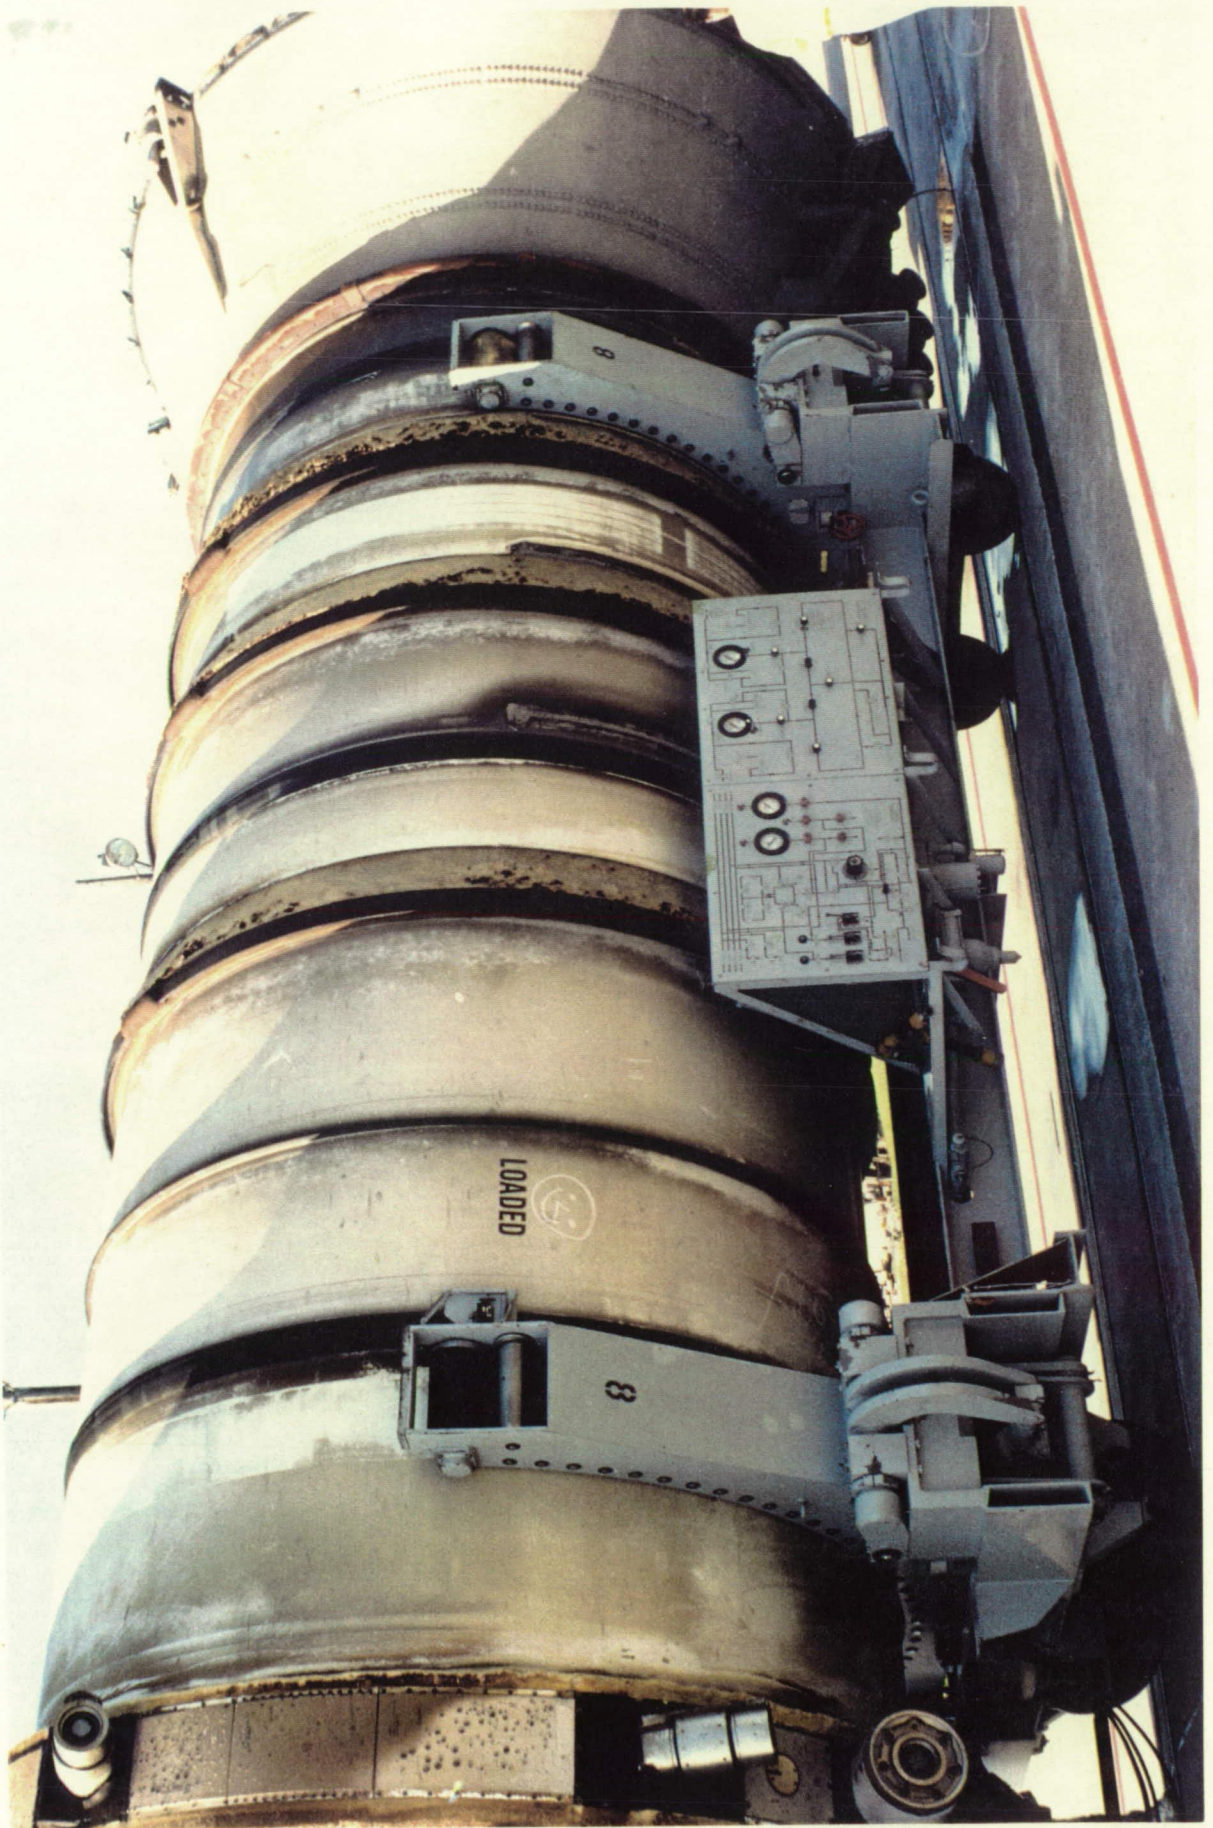
Post flight condition of the LH aft booster. The ET/SRB aft struts, ETA ring, IEA, and IEA covers appeared undamaged. Two aft booster stiffener rings sustained water impact damage.

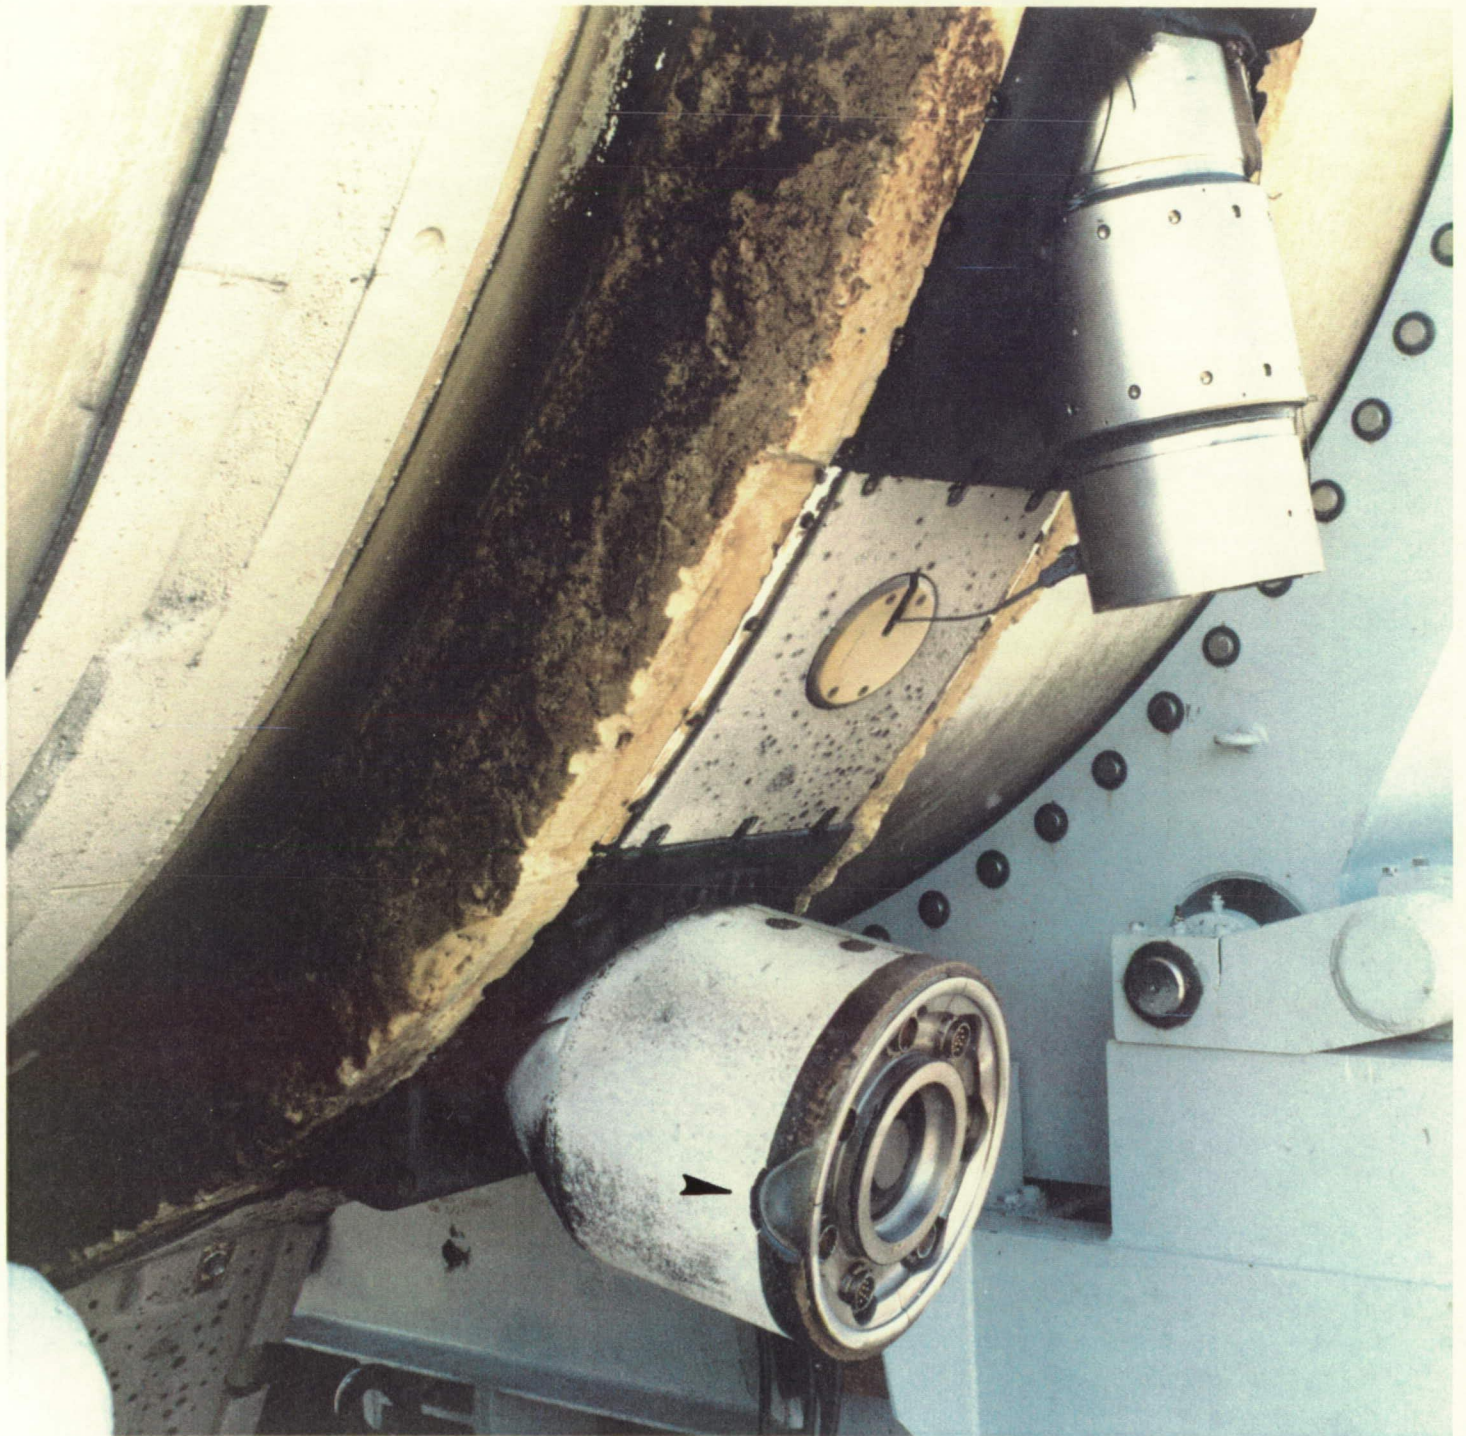
Separation of the aft ET/SRB struts appeared normal. The upper strut fairing was missing two areas of K5NA (5"x3" and 4"x1") along the separation edge. The substrate was charred/sooted.

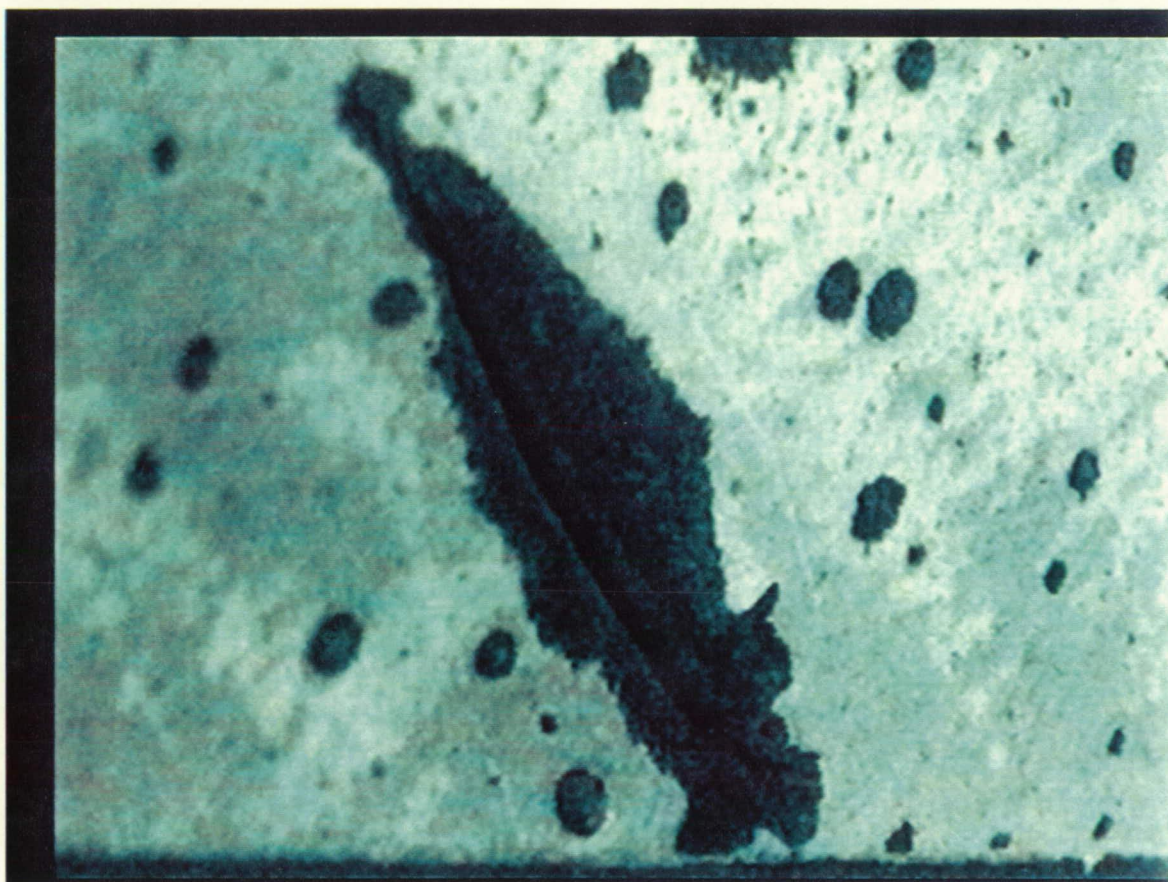
A 2.75 inch long (mild radius) by 0.125 inch wide fracture was discovered in the RH SRB aft skirt center BSM mounting base cover TPS. The fracture/incision occurred at an angle of approximately 30 degrees to the SRB centerline and extended through the 0.5 inch thick cork closeout to the substrate. Soot deposits, erosion, heat effects, and discoloration were visible around the damage site. Twelve black and white particles, or flakes, were subsequently discovered inside the fracture/incision. Laboratory analysis determined the particles and flakes were high in silica content and are believed to be pieces of Orbiter lower surface tile. The analysis concluded the aft skirt cork damage was most likely caused by an impact from ascent debris containing Orbiter tile material.

A fracture/incision in the cork insulation on the RH SRB aft center BSM fairing contained black and white particles believed to be fragments from Orbiter lower surface tiles. The cork damage was most likely caused by an impact from ascent debris containing Orbiter tile material.

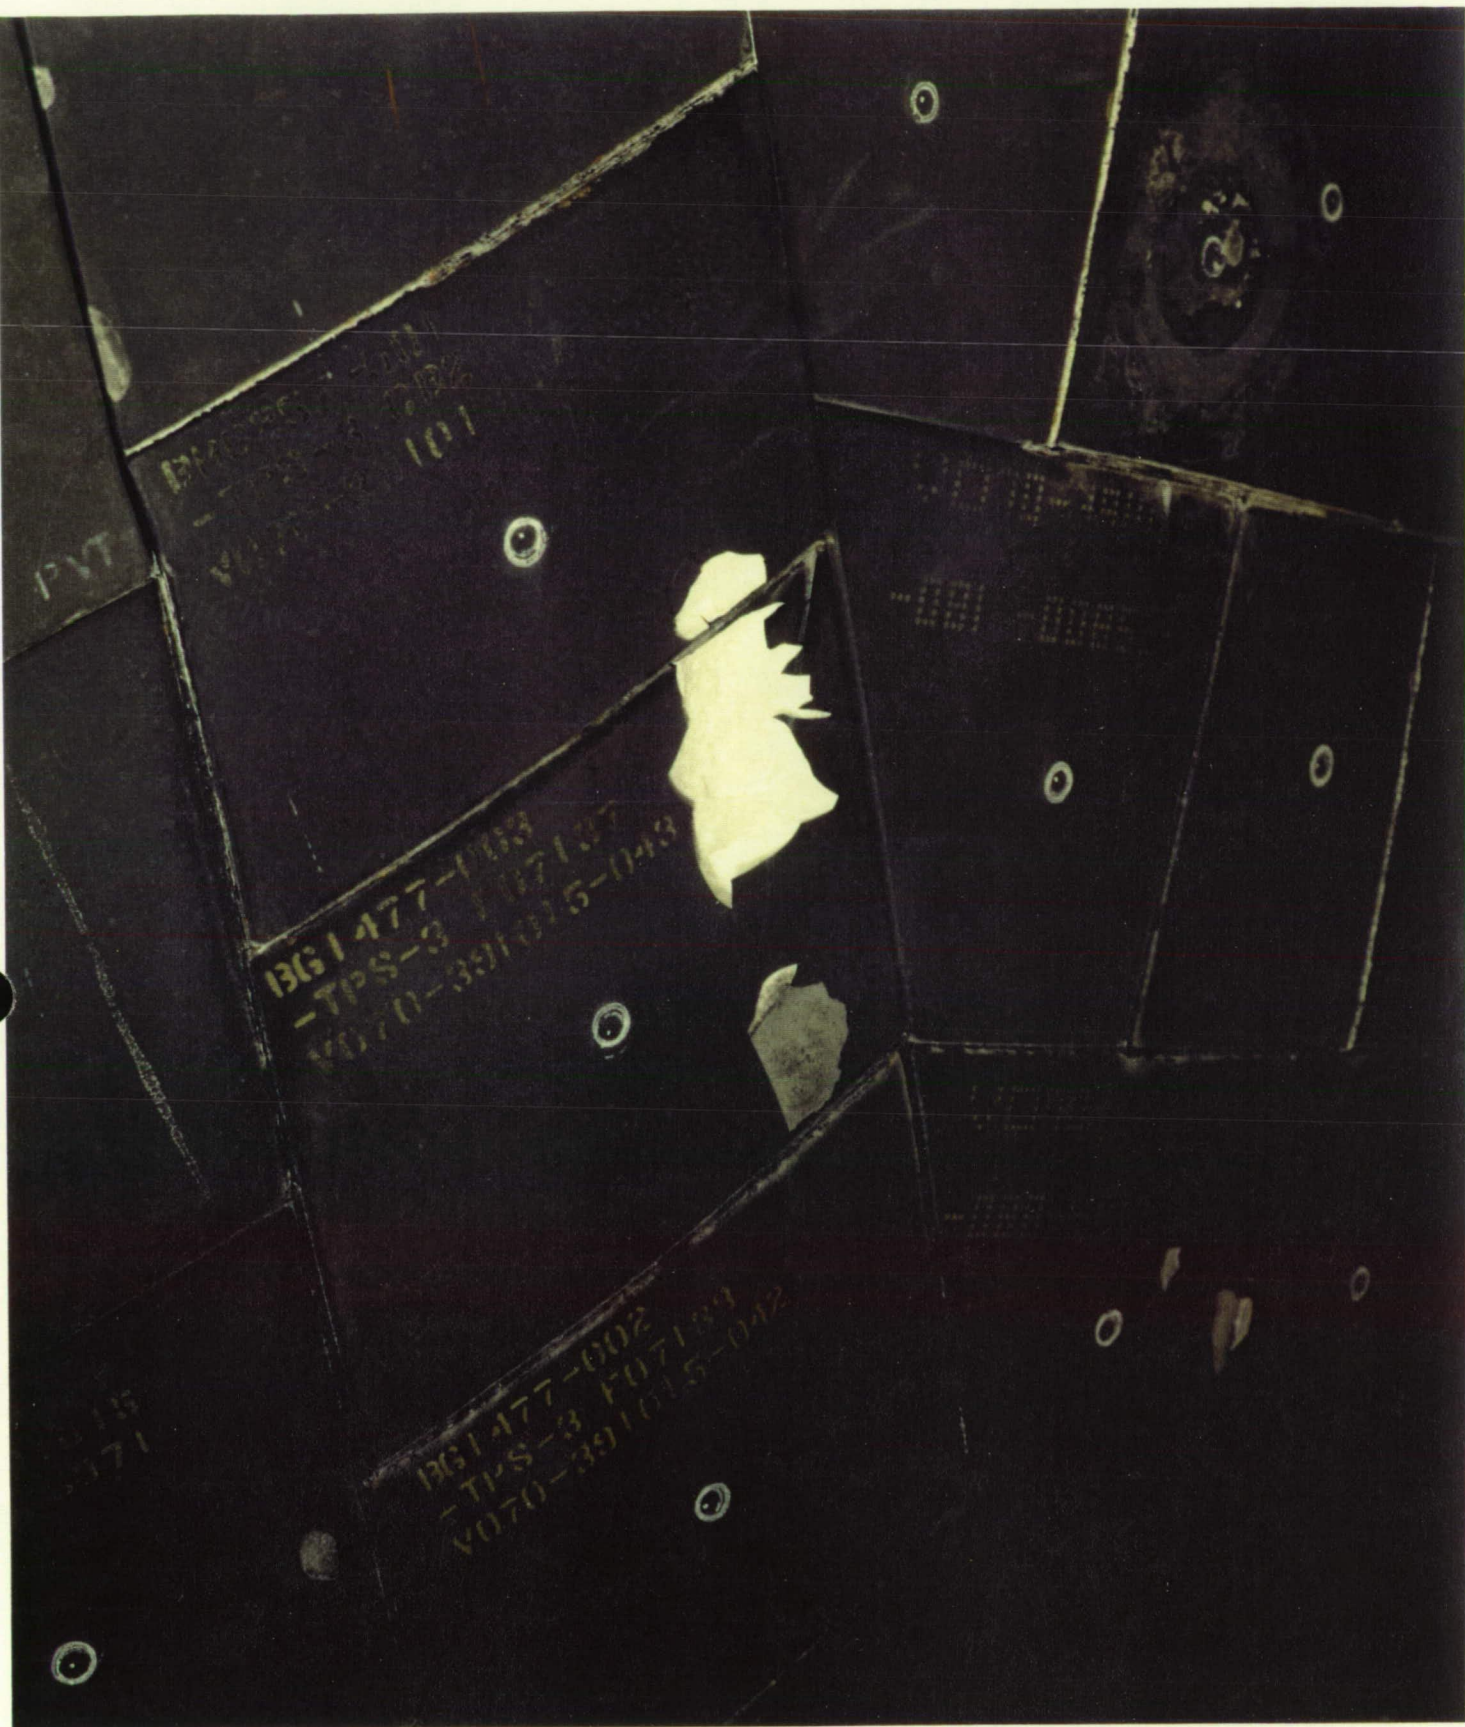
The Orbiter lower surface tiles sustained a total of 145 hits, of which 11 had a major dimension of 1-inch or greater. The majority of the tile damage occurred on the right side of the vehicle and was attributed to ice from the LO2 feedline.

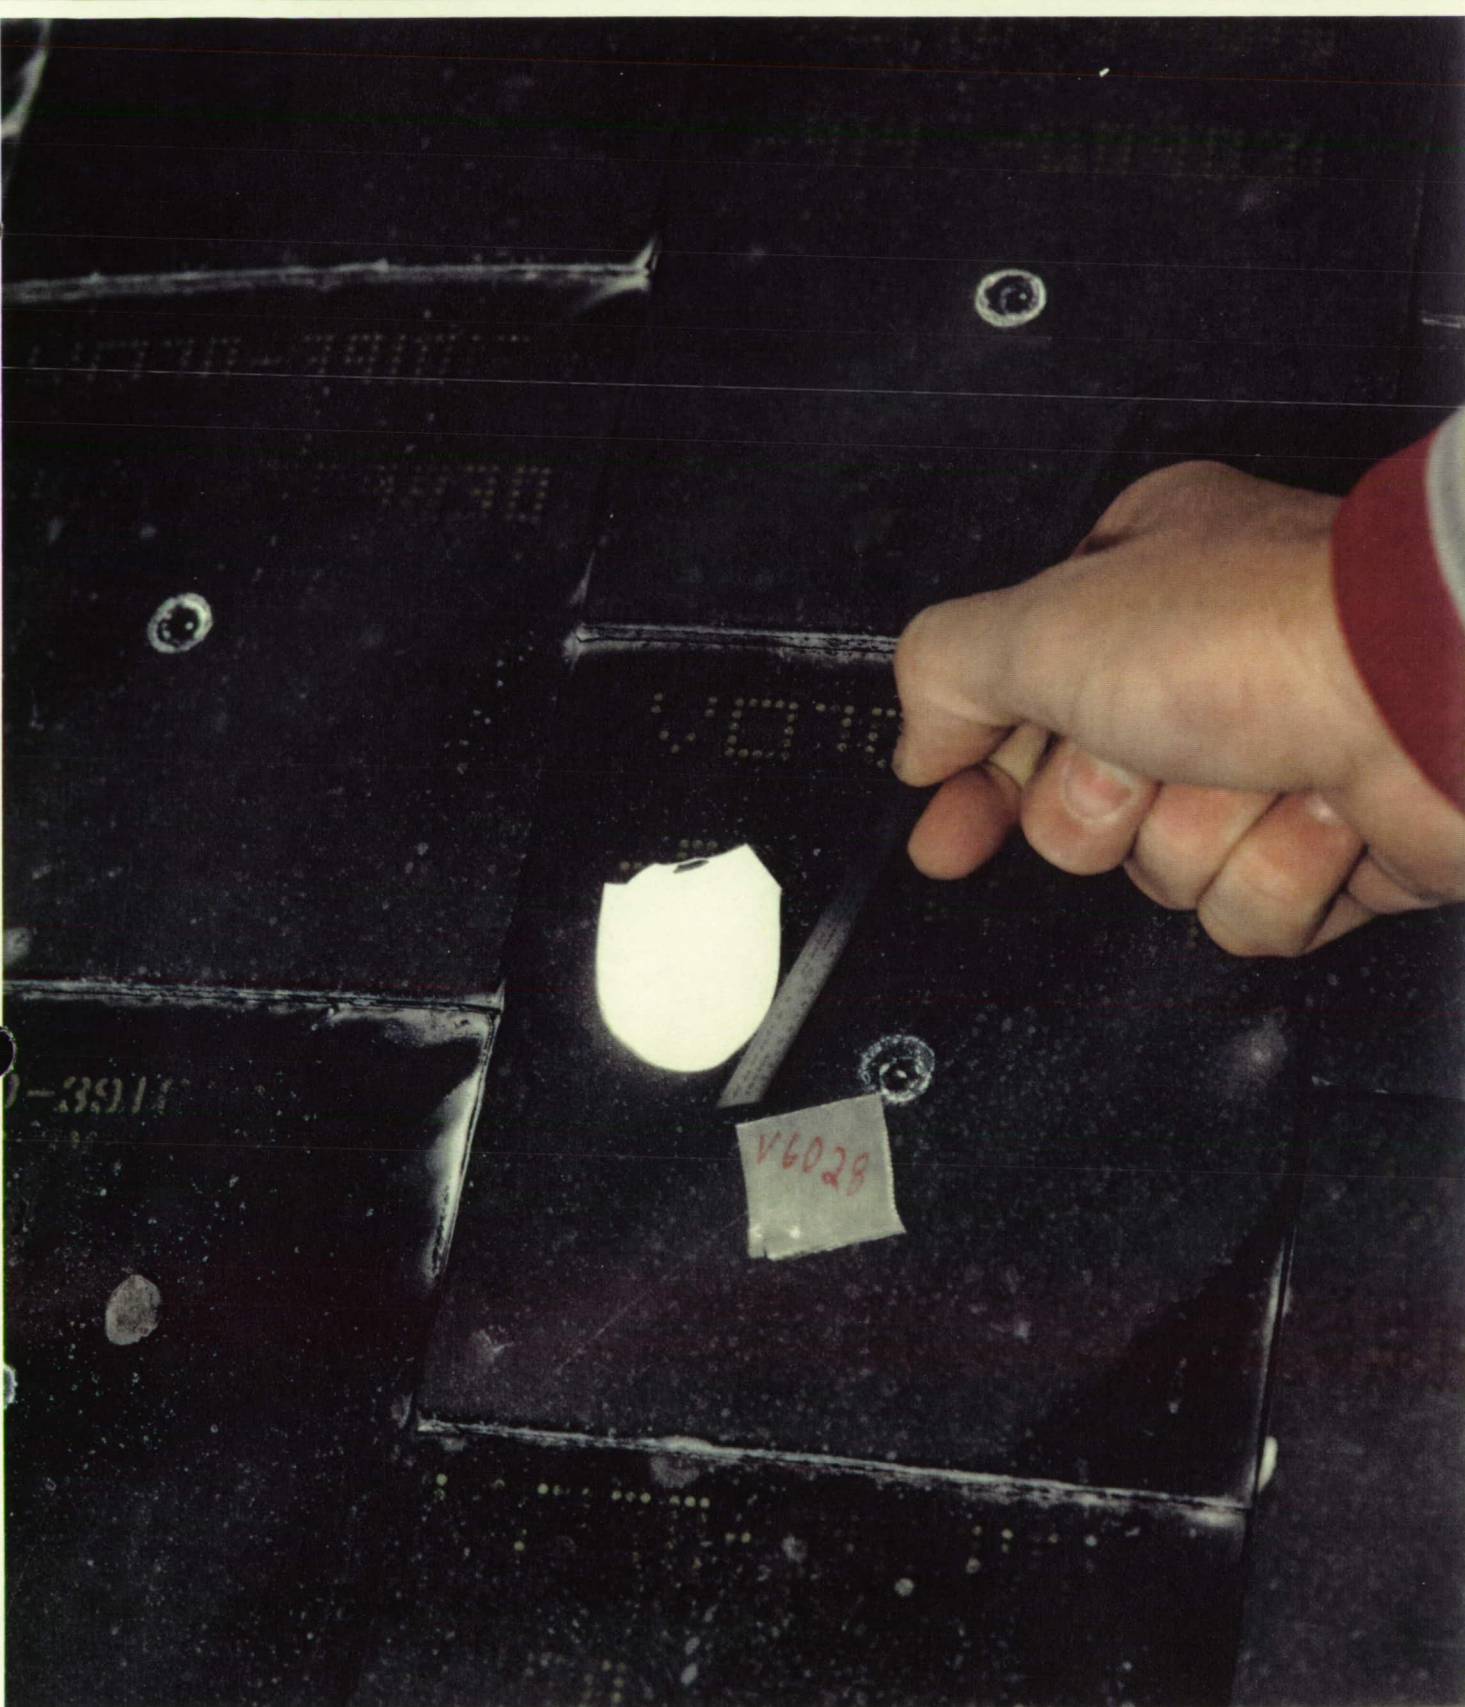
The tile material which was found embedded in the RH SRB aft skirt BSM fairing insulation may have originated from a tile on the Orbiter forward RH lower surface. The area of missing material from this tile included some OEM tile identification markings similar to that found on the particles embedded in the BSM TPS.
