NASA Technical Memorandum TM 107556

Debris/Ice/TPS Assessment And Integrated Photographic Analysis For Shuttle Mission STS-53

DEBRIS/ICE/TPS ASSESSMENT
AND
PHOTOGRAPHIC ANALYSIS
OF
SHUTTLE MISSION STS-53

December 2, 1992

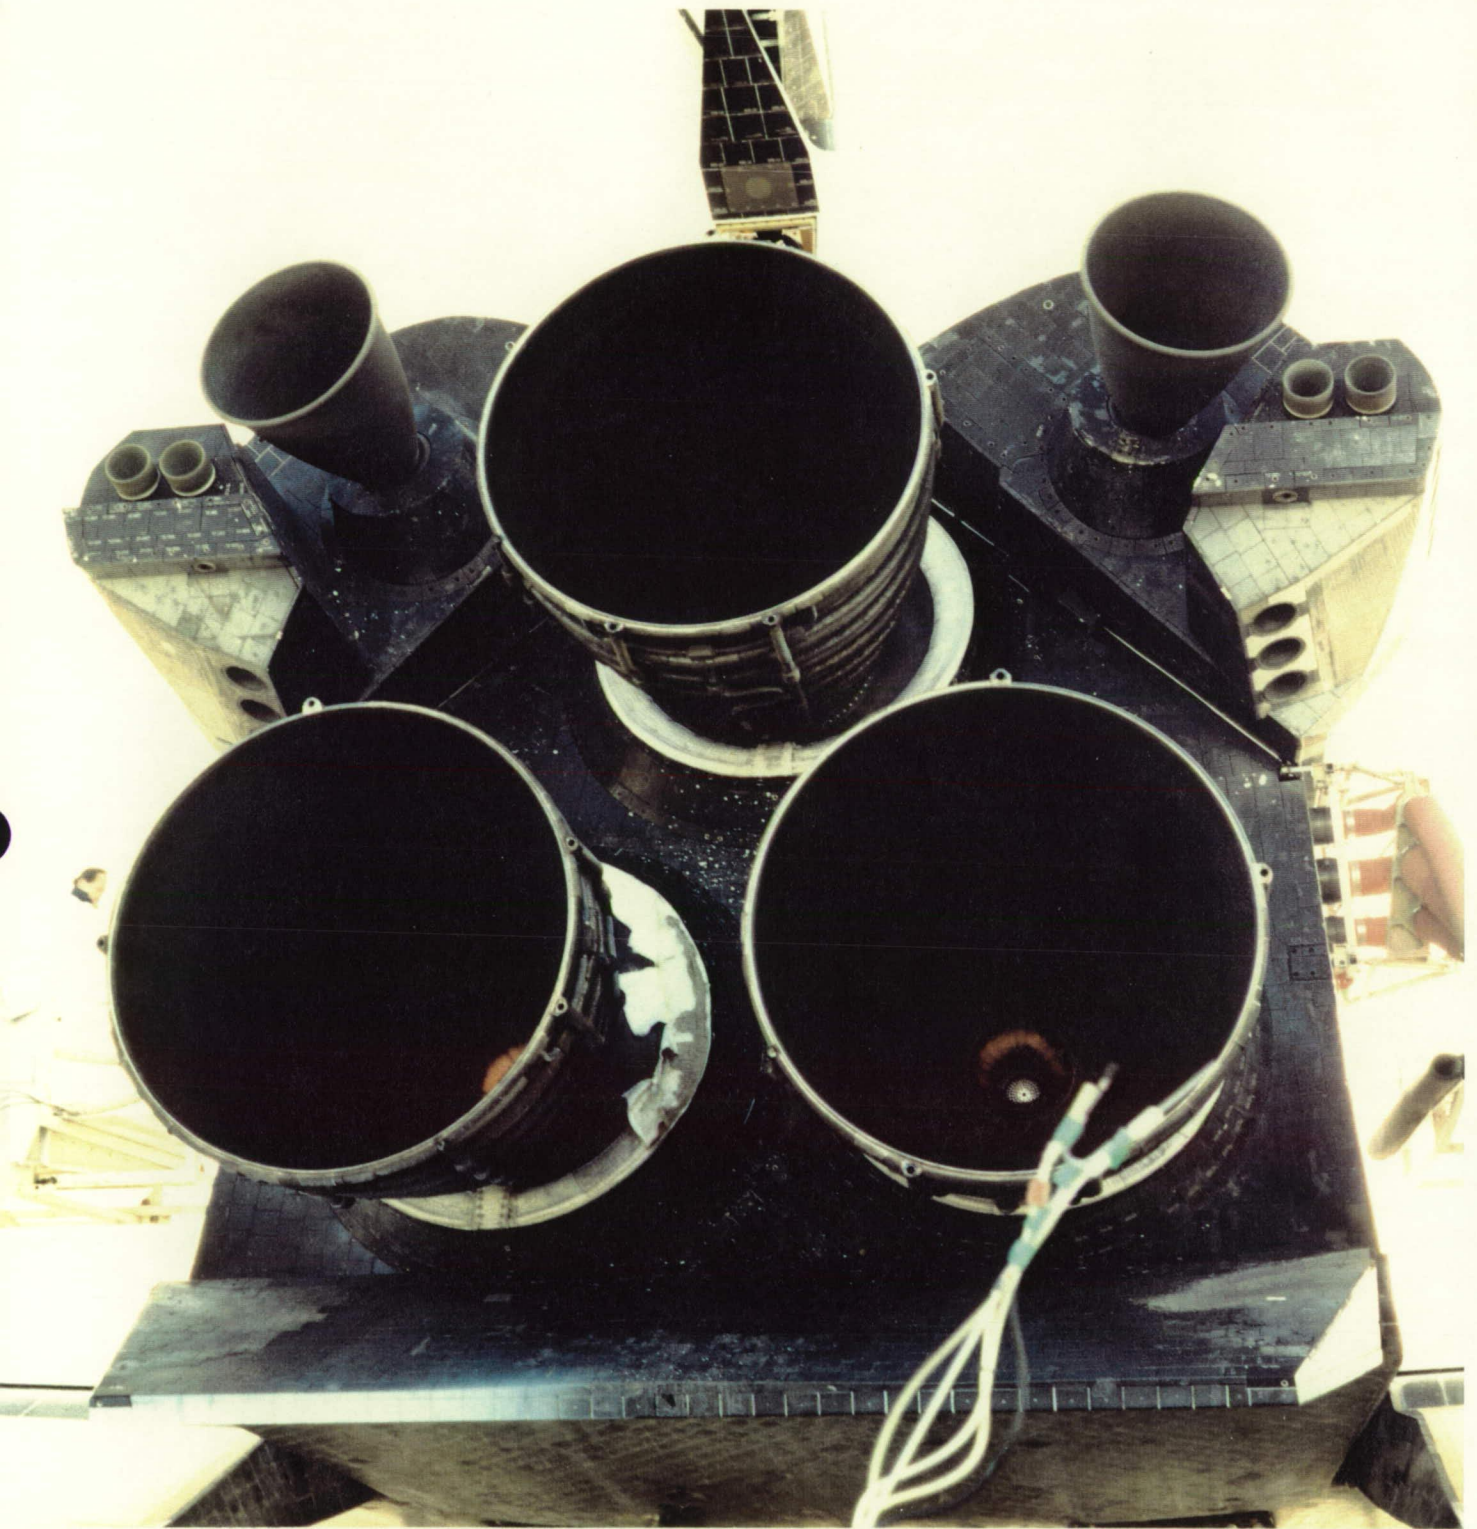
Tile damage on the base heat shield was typical. Four SSME #2 Dome Mounted Heat Shield closeout blanket sacrificial panels were nearly detached and the underlying batting material was exposed.

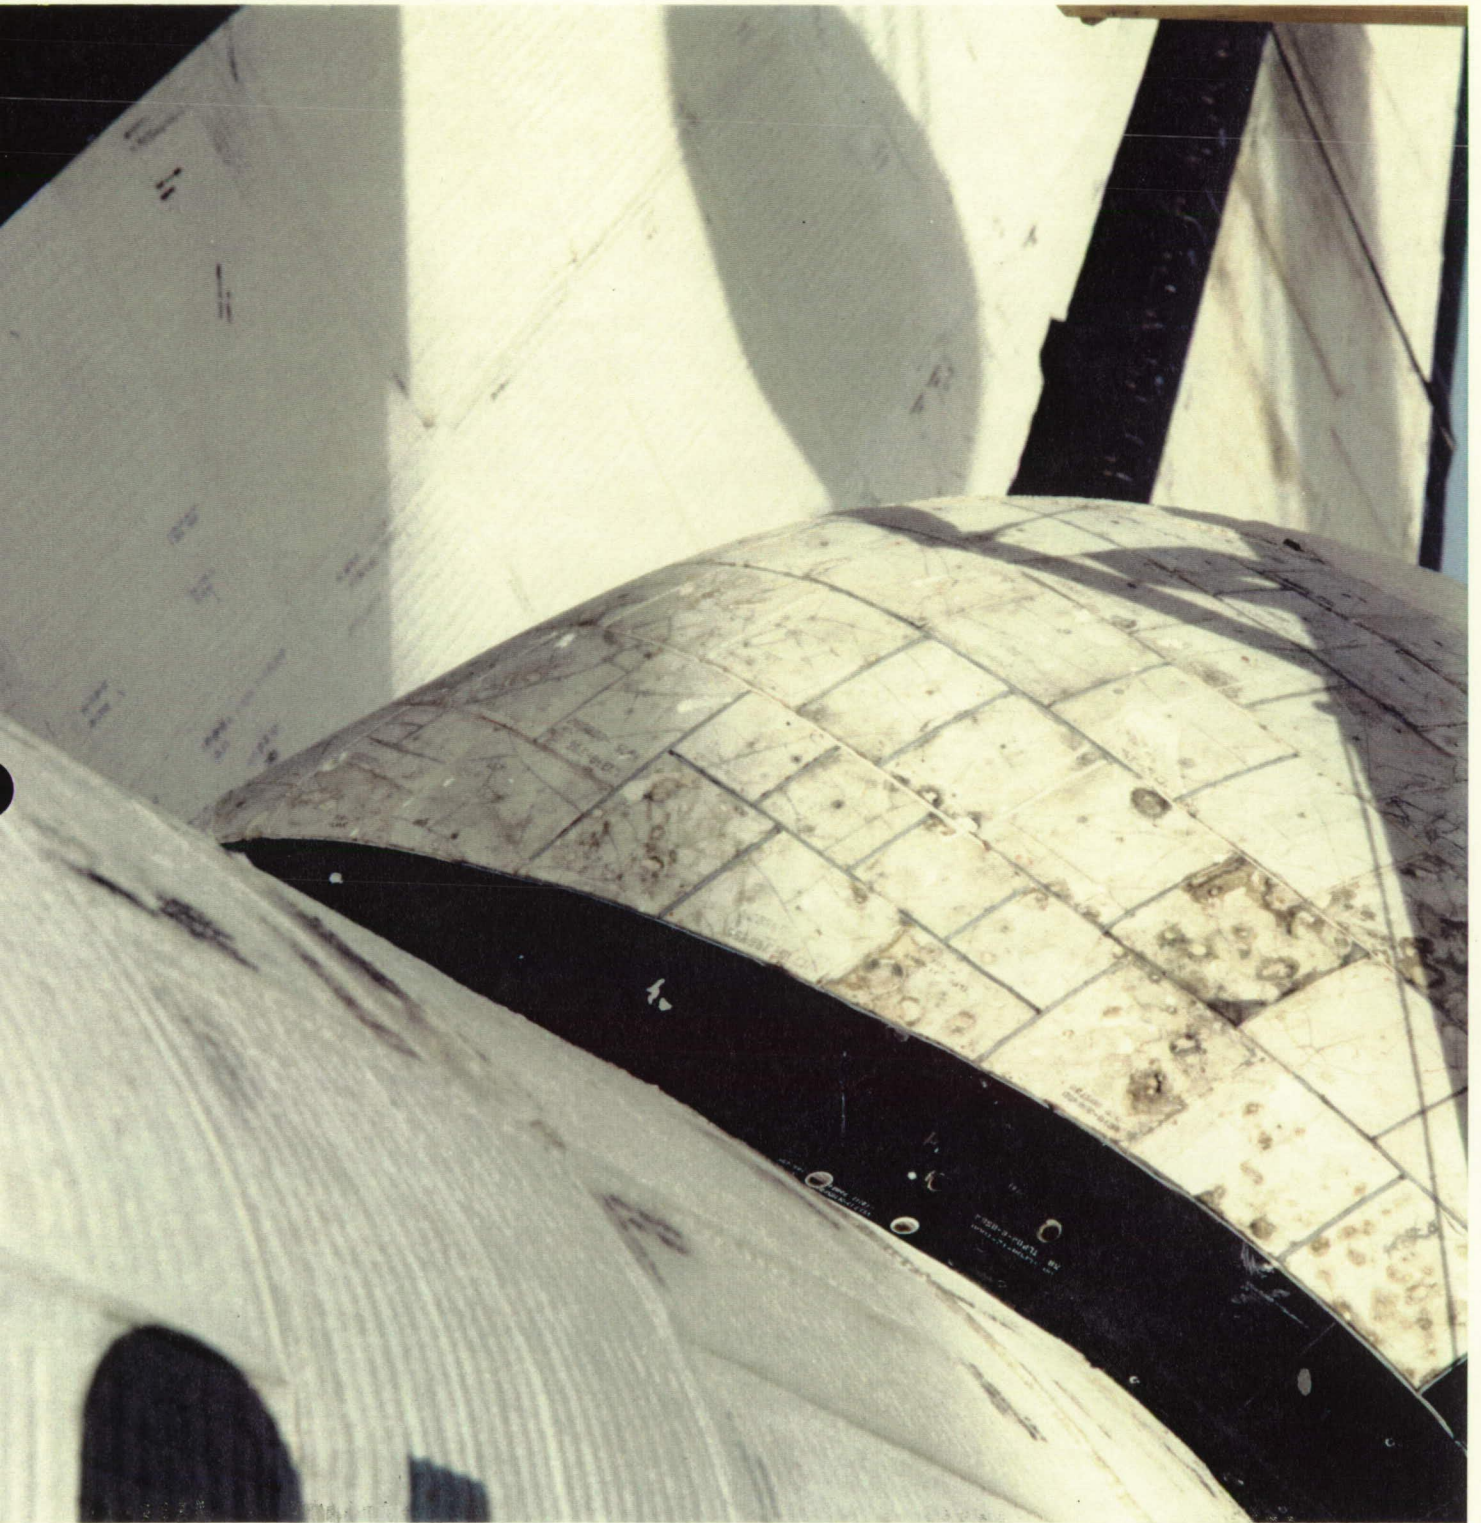
Tiles on the left OMS pod leading edge sustained more damage than usual. The cause of this damage is still undetermined.

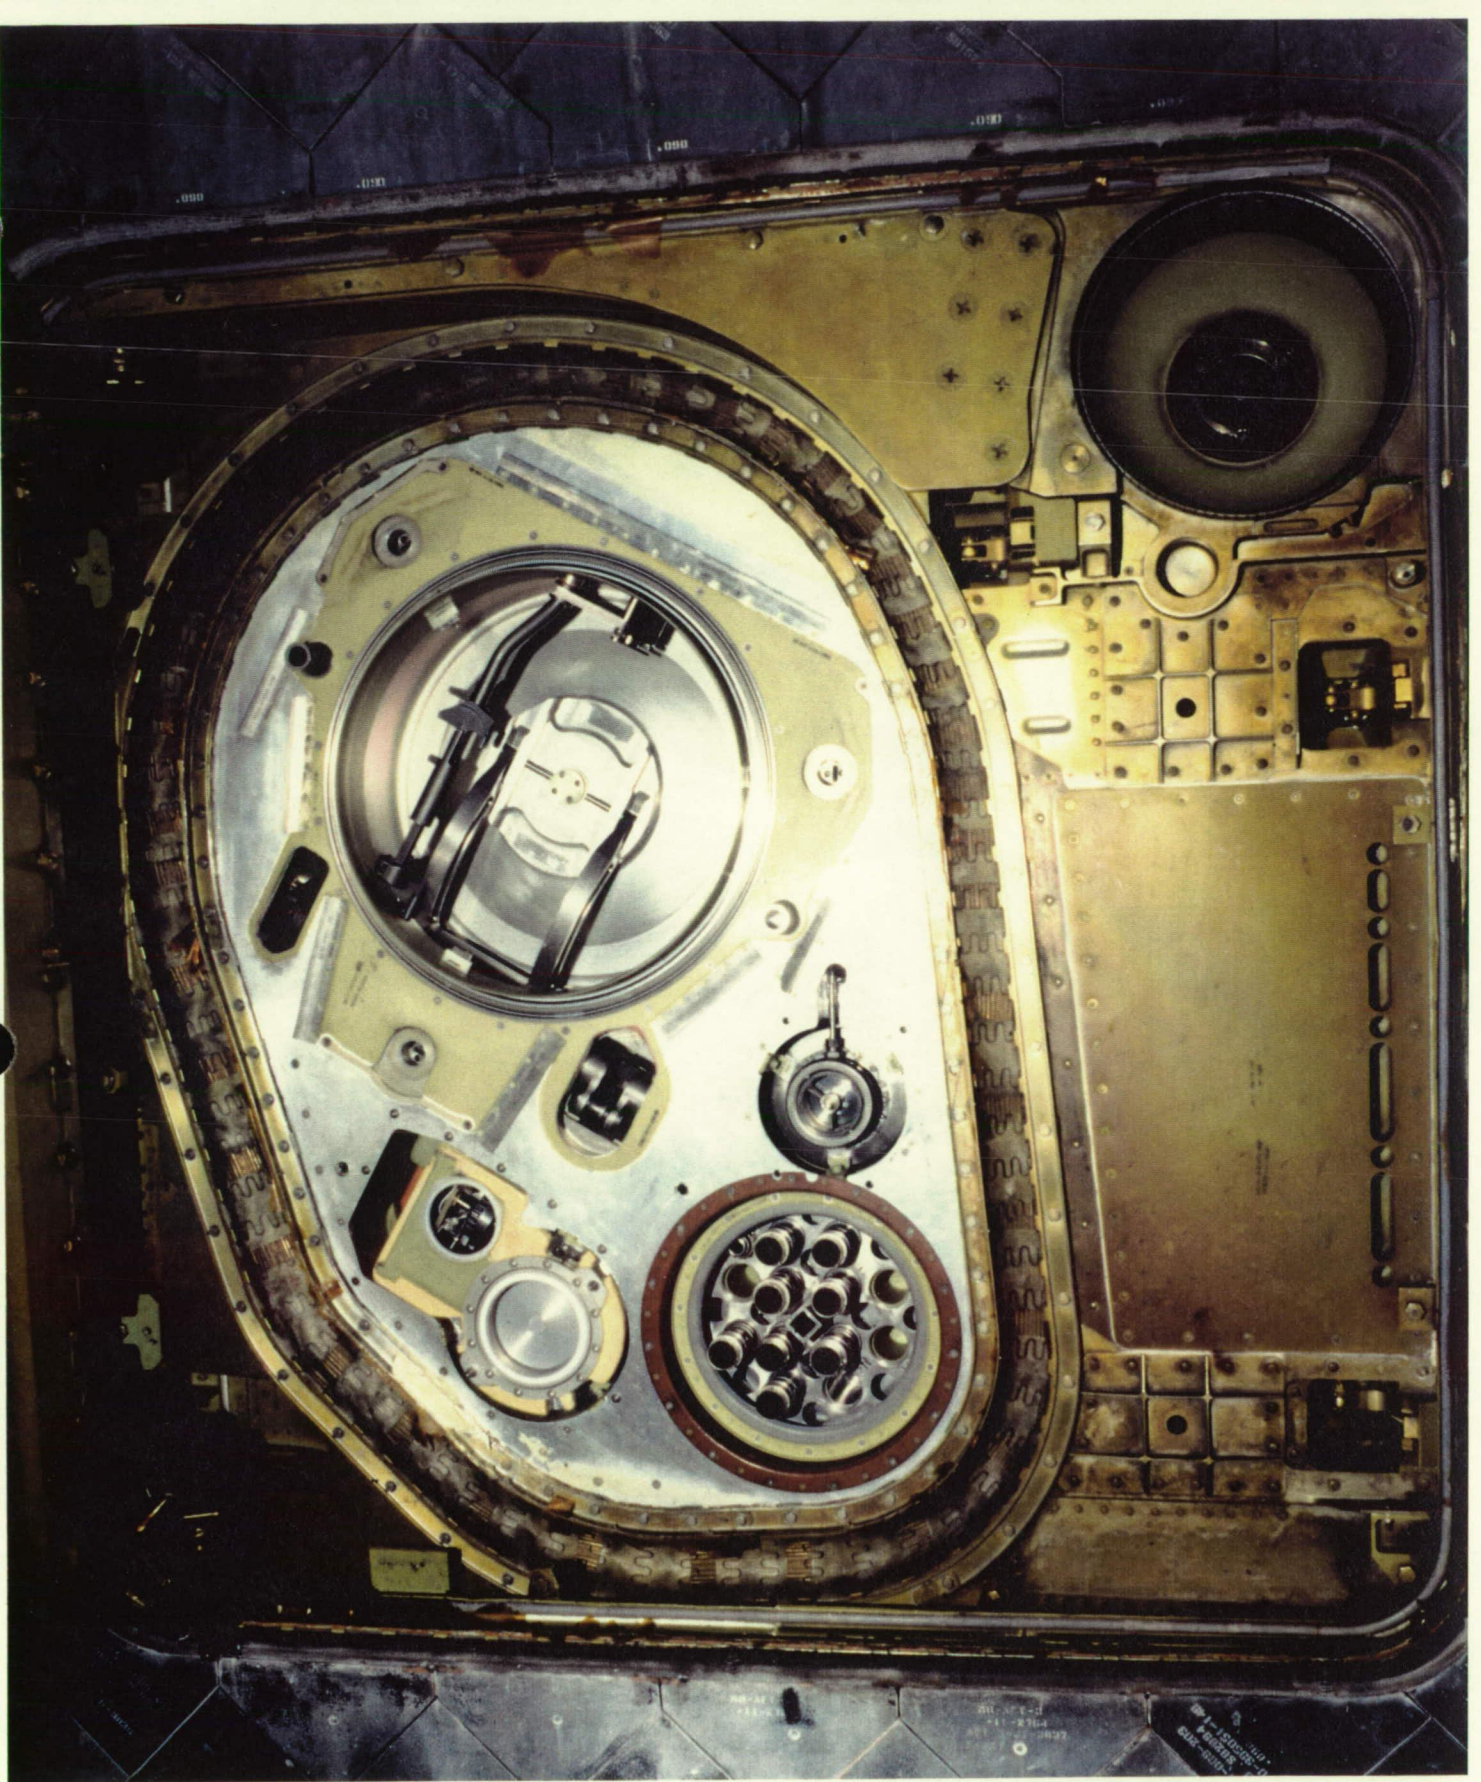
Overall view of the LH2 ET/ORB umbilical. All separation ordnance devices functioned properly. No flight hardware was found on the runway below the umbilical when the ET door was opened.

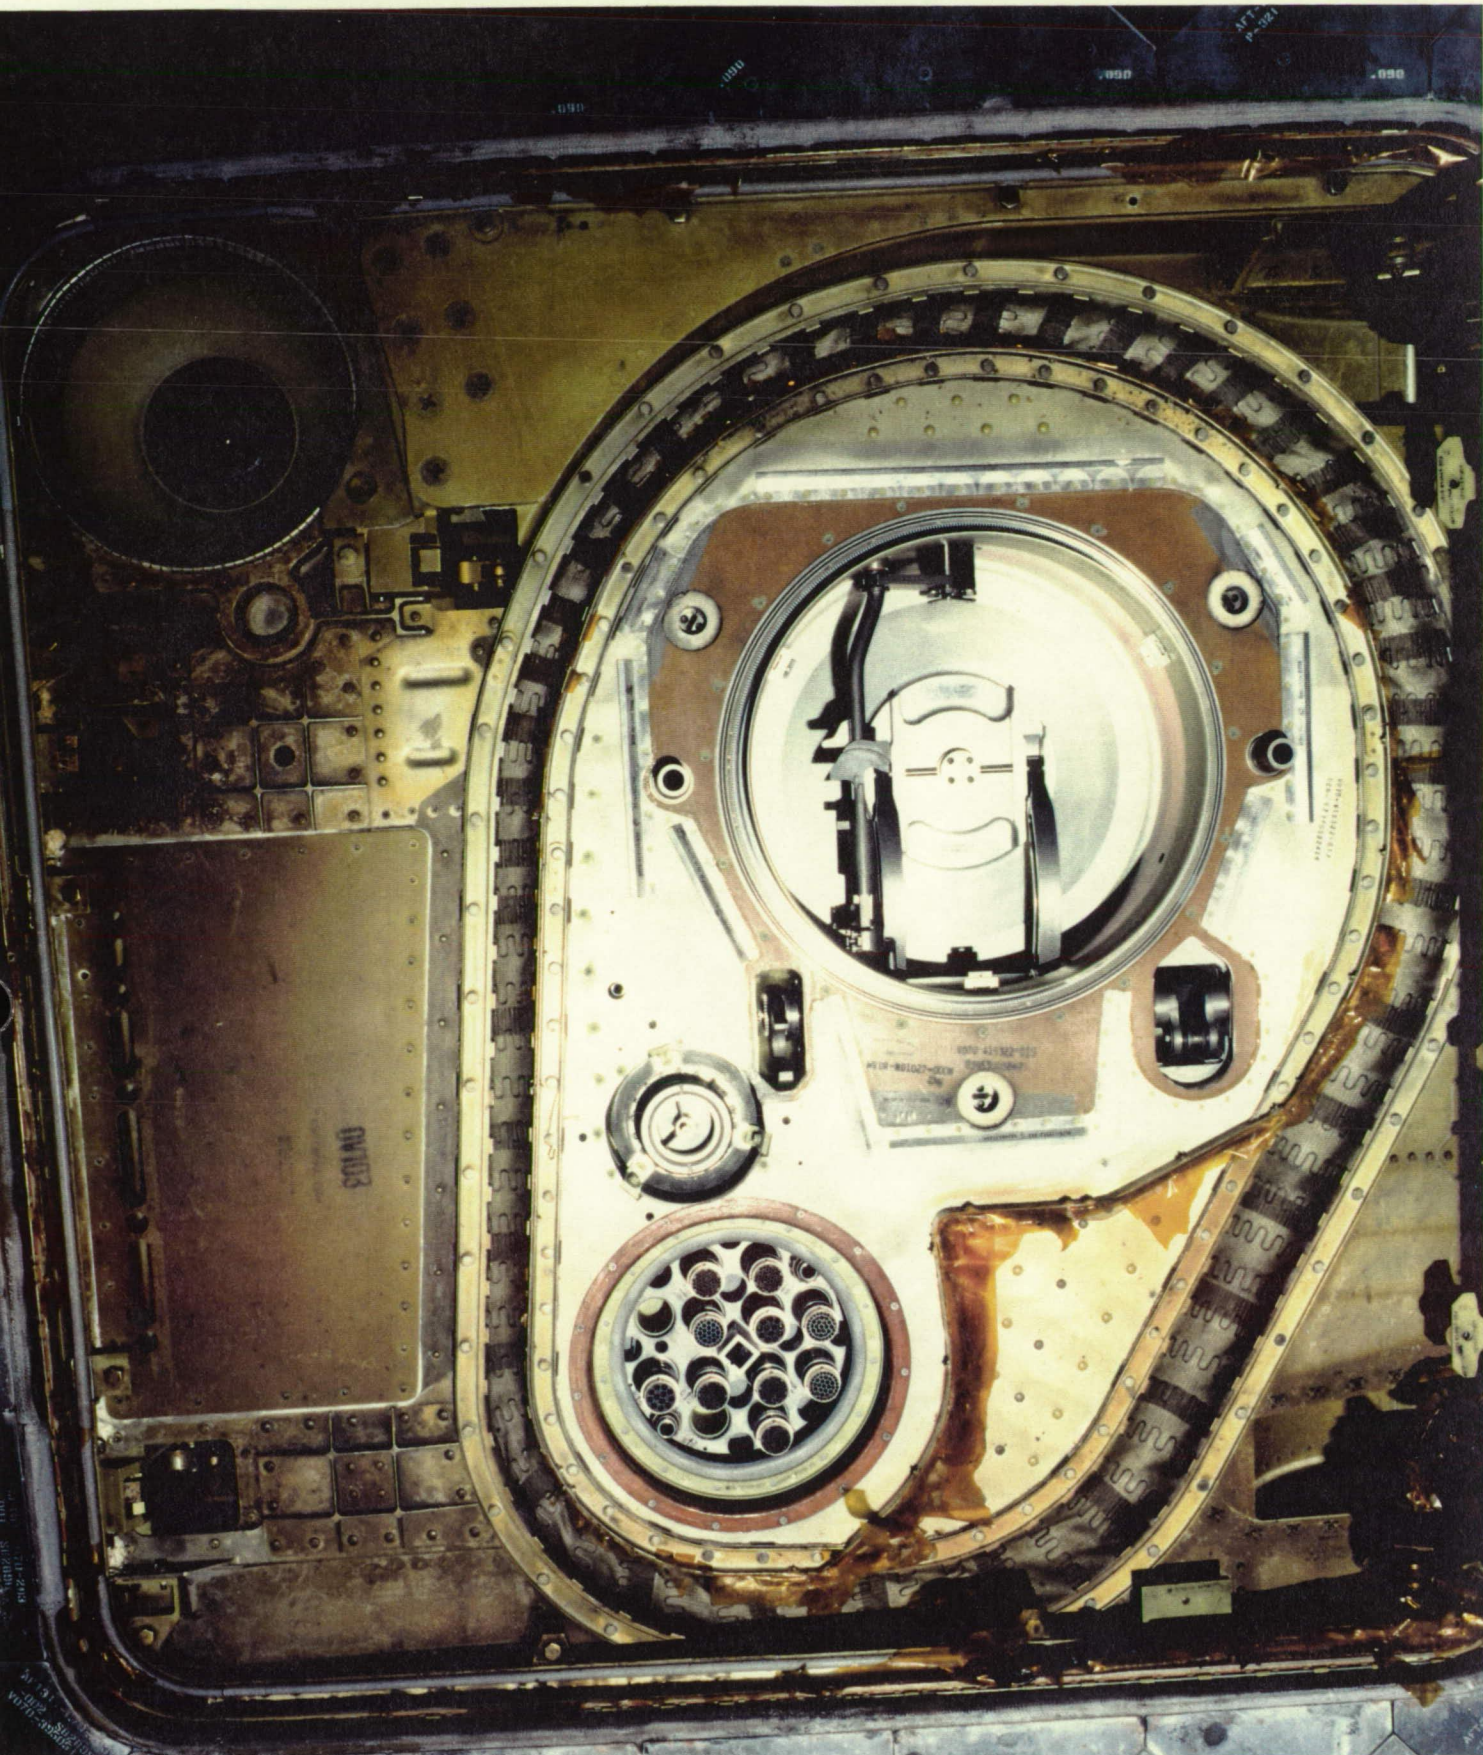
Overall view of the L02 ET/ORB umbilical. All separation ordnance devices functioned properly. No flight hardware was found on the runway below the umbilical when the ET door was opened.

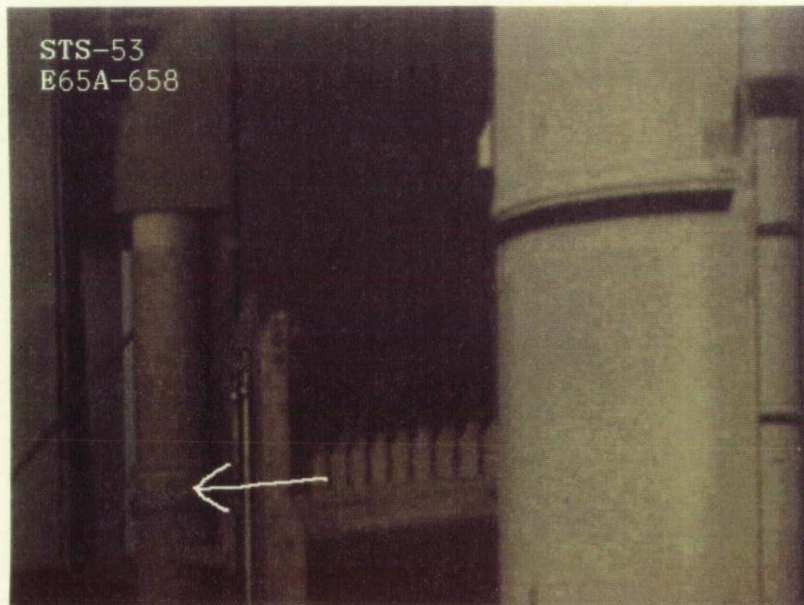
Figure 2.1.1.1 Light Colored Debris Falling Aft along South Side of ET

Multiple light colored pieces of debris, probably ice, were first noted above the ET/Orbiter umbilical disconnects and then fell aft along the vehicle prior to liftoff. The debris originated from the ET LO2 feedline upper bellows. Debris falling aft from above the ET/Orbiter umbilical disconnects has been observed on previous missions. None of the debris appeared to strike the vehicle.

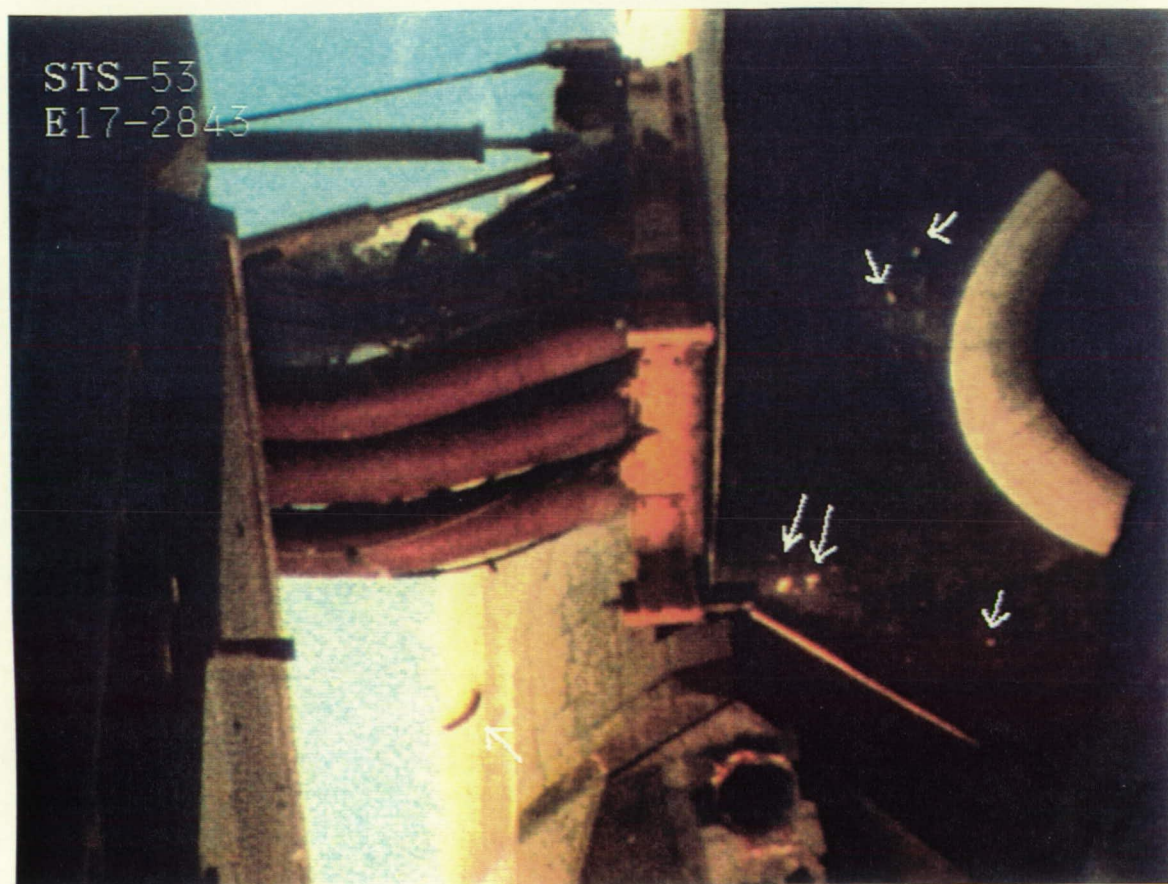
Figure 2.1.1.5 Debris from the LO2 TSM Carrier Plate

A single red rectangular shaped piece of debris fell aft from the LO2 TSM feed line area prior to liftoff. A single, light colored, rectangular piece of debris first noted in the LO2 TSM carrier plate area fell aft prior to liftoff. No further photographic analysis has been requested.

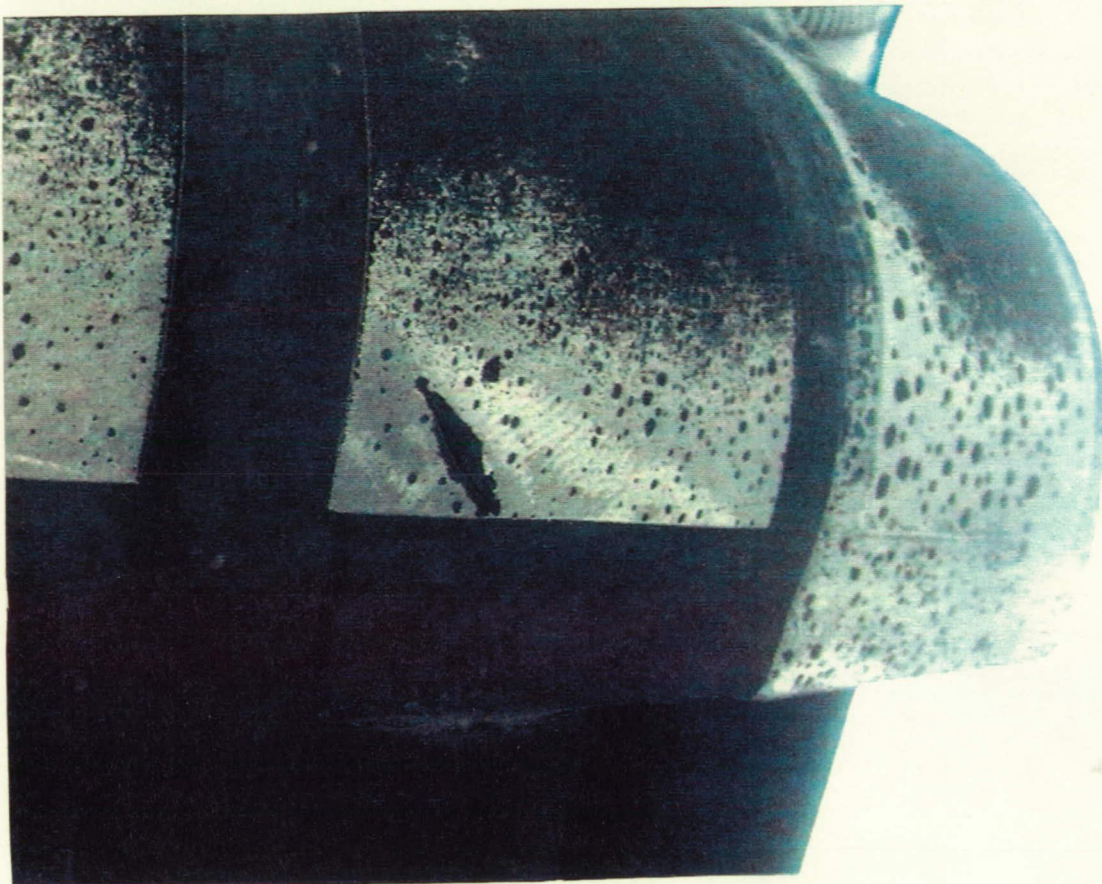
Figure 2.1.4a Elliptical Debris Strike on the RSRB Aft BSM Triple Motor Housing

An elliptical scar was noted on the RSRB aft BSM triple motor housing during post recovery inspection. The elliptical scar showed evidence of contact with a Thermal Protection System (TPS) tile. The damaged motor cover was over the center of the triple motors (separate from the fourth motor). The damage was 3" long x 0.5" deep and very narrow. The damaged area was sent to two separate laboratories for independent analysis (USBI and MSFC). Chemical analysis showed that the scar had a high silicon content. A quarter inch piece of debris was found imbedded in the crack. The recovered debris appeared to have original equipment manufacturer (OEM) tile identification markings. The only missing tile material from the Orbiter's lower surface with these markings was located on the Orbiter forward right hand lower surface. The Photo/TV Analysis Project was asked to review all of the STS-53 films in which the RSRB was visible. The results are given in Appendix D Task #11.

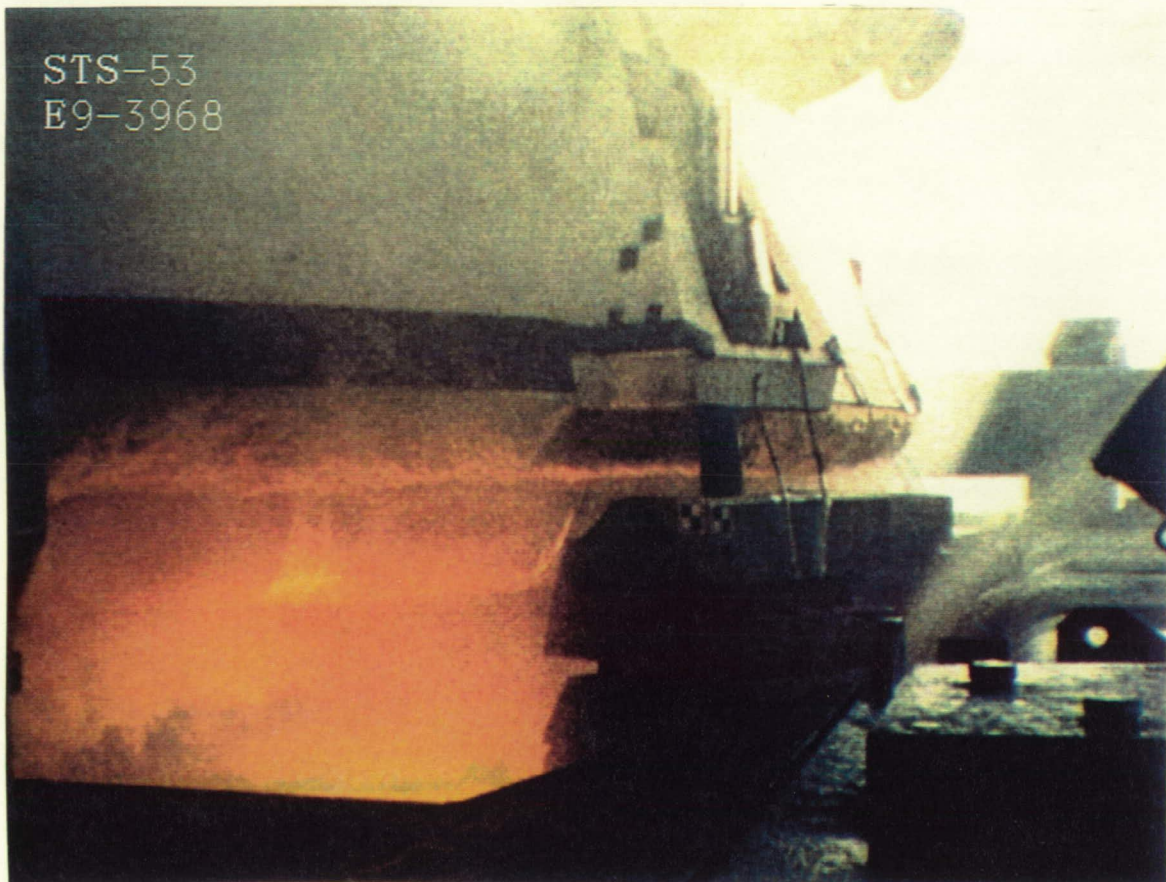
Figure 2.2.1 Holddown Post #M-1 Bolt Hangup

A holddown bolt hangup was noted at HDP #M-1. The bolt retracted after the vehicle cleared the length of the bolt. No further photographic analysis has been requested. The bolt released from the RSRB and retracted to its normal position after extending 9.4 inches above the shoe (Appendix D Task #12).

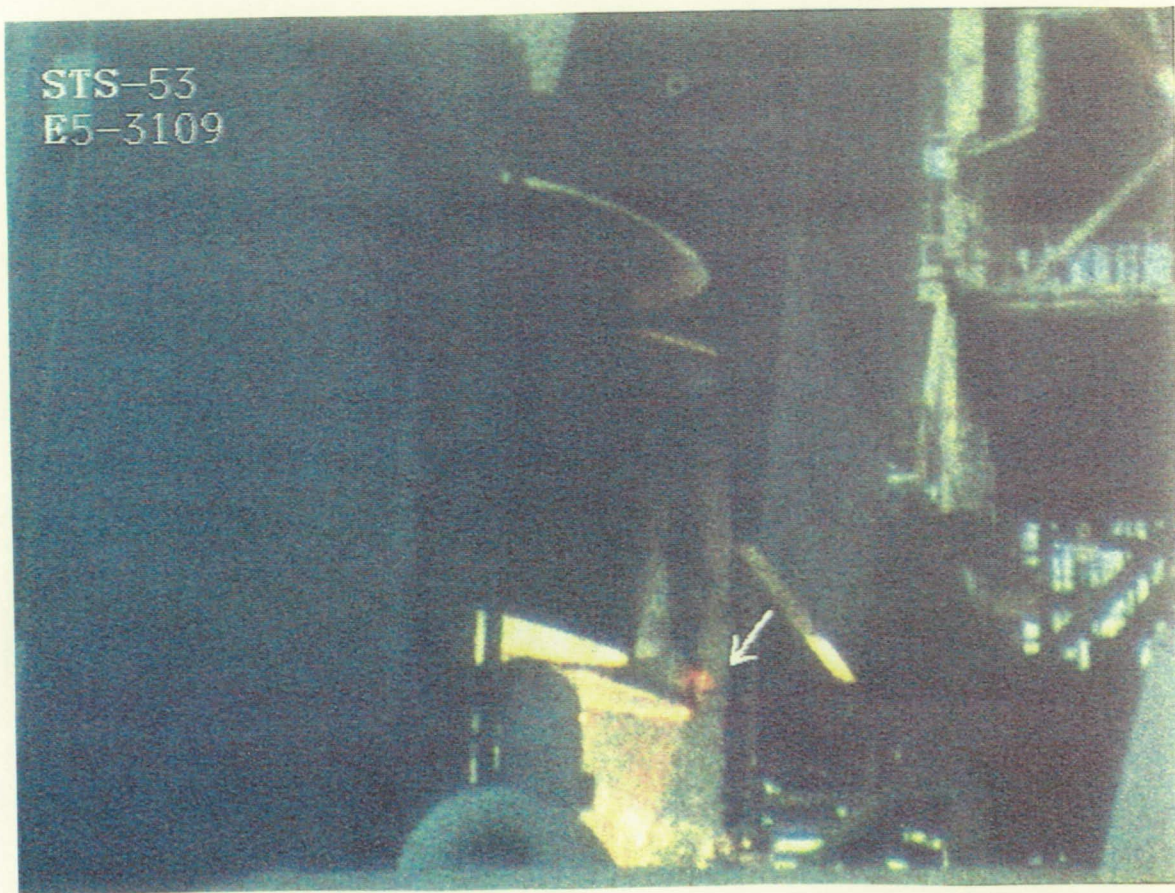
Figure 2.2.2 Vapor Above the Rim of SSME #2

Orange vapor (possibly free burning hydrogen) was first seen on the north side between the rim and the #9 hatband of SSME #2 at 13:23:56.181 UTC and continued through LOV after liftoff. The vapor appeared to originate from a point source rather than a large general area. Unlike the orange vapor observed on previous missions which lasts only a fraction of a second, this event occurred throughout SSME ignition and startup. Photographic still views of the orange vapor seen above the rim of SSME # 2 were reviewed with the MER manager. No follow up analysis has been requested.

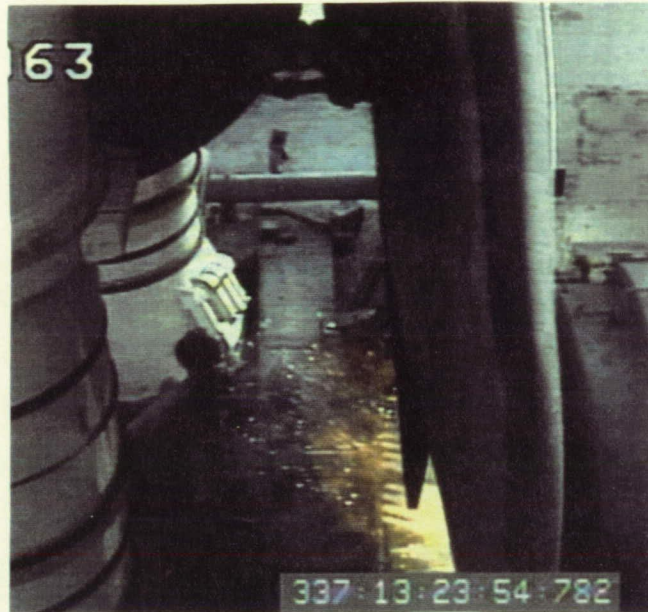
Figure 2.2.3 Orange Vapor Under the Body Flap at SSME Ignition

Orange vapor, possibly free burning hydrogen, was noted near the SSMEs just prior to SSME ignition. The view from OTV-063 showed this vapor moving north under the body flap (possibly due to winds from the southwest). Similar orange vapors have been observed on previous missions. No further photographic analysis has been requested.

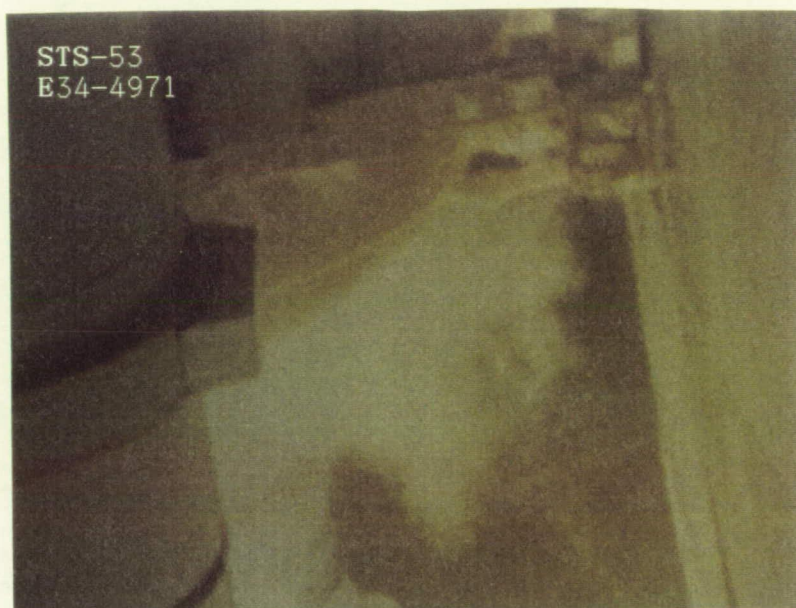
Figure 2.3.2 Vapor from ET/Orbiter Umbilical Areas After Liftoff

Vapor was noted near the LH2 17 inch line after liftoff. Normally, ice and vapor events originating from this area occur at SSME startup and conclude prior to liftoff. No further analysis has been requested.

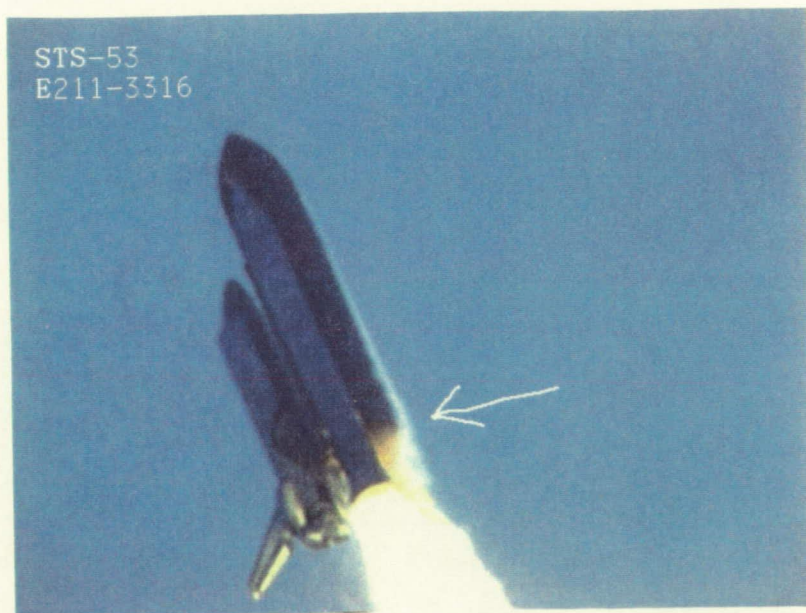
Figure 2.3.3 Vapor from -Z side of ET after Liftoff

Vapor was noted to drift from the bottom (-Z side) of the ET after the roll maneuver. The source of the vapor is probably the frost noted on the north side of the ET prior to liftoff. No further photographic analysis has been requested.

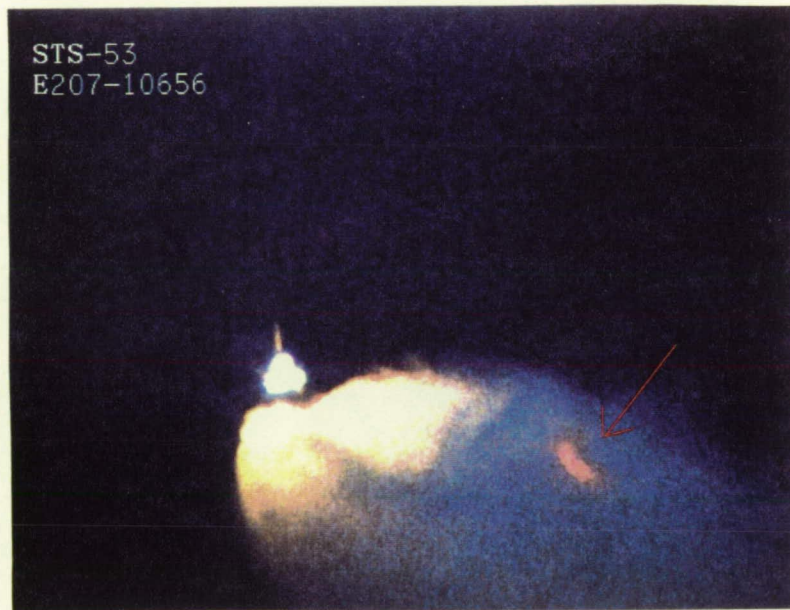
Figure 2.3.6 Flashes in Exhaust Plume Prior to SRB Separation

Multiple orange flashes were noted in the SRB exhaust plume aft of the vehicle during plume brightening prior to SRB separation. These flashes have occurred on previous Space Shuttle missions. No further photographic analysis has been requested.

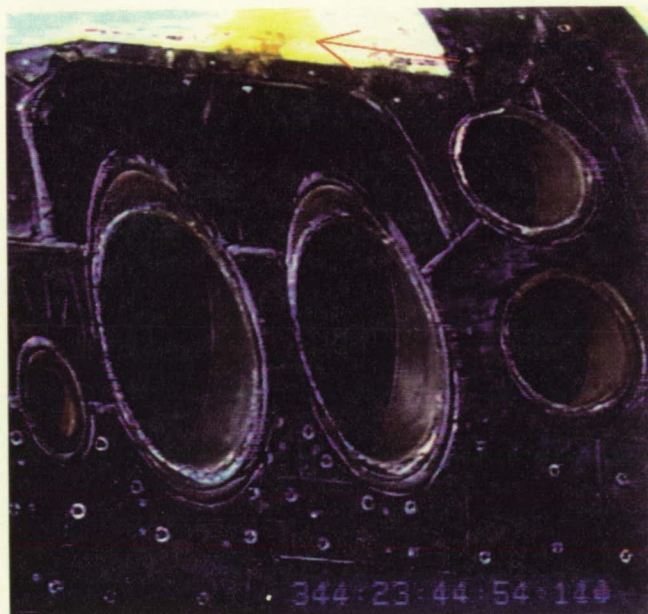
Figure 2.5.3.1 Nitrogen Tetroxide Leak Leaves Discoloration on Orbiter

A reddish brown stain was seen above the F1L forward thruster port. No further photographic analysis has been requested.
