NASA Technical Memorandum TM 107558

Debris/Ice/TPS Assessment and Integrated Photographic Analysis for Shuttle Mission STS-54

March 1993

John F. Kennedy Space Center

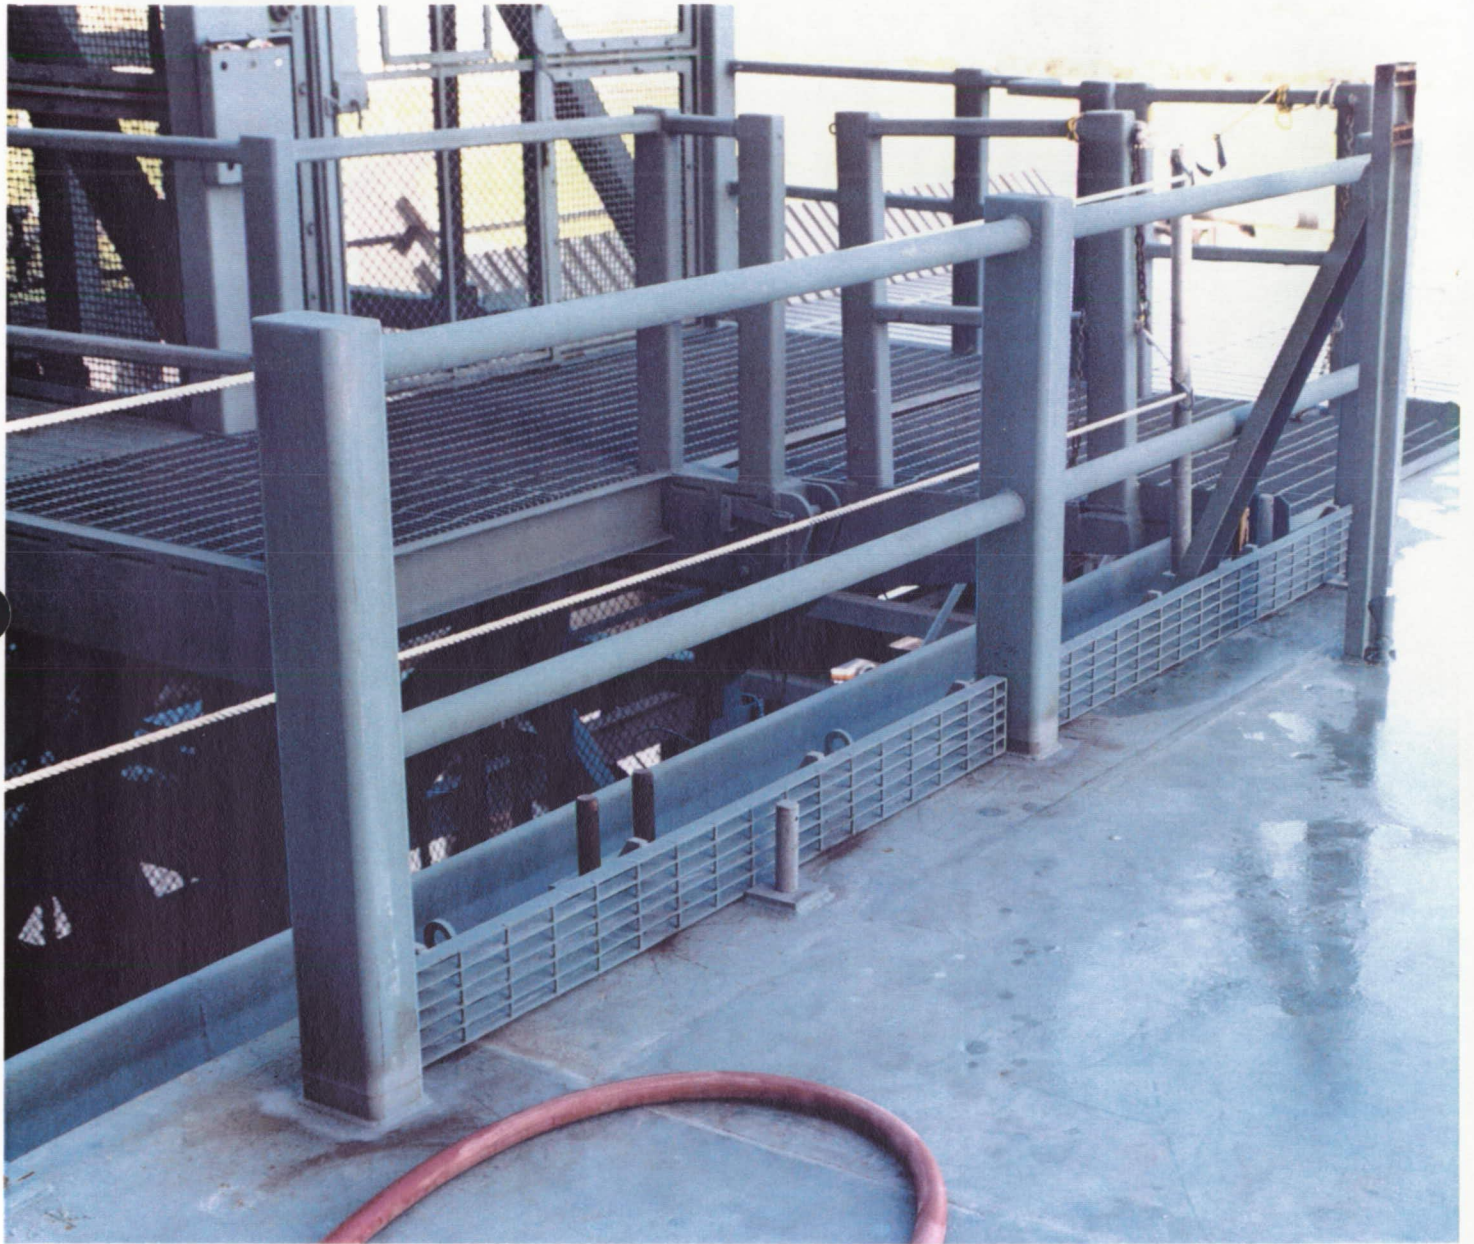
Seven test sections of a new handrail design for the MLP perimeter were bolted and/or welded in place

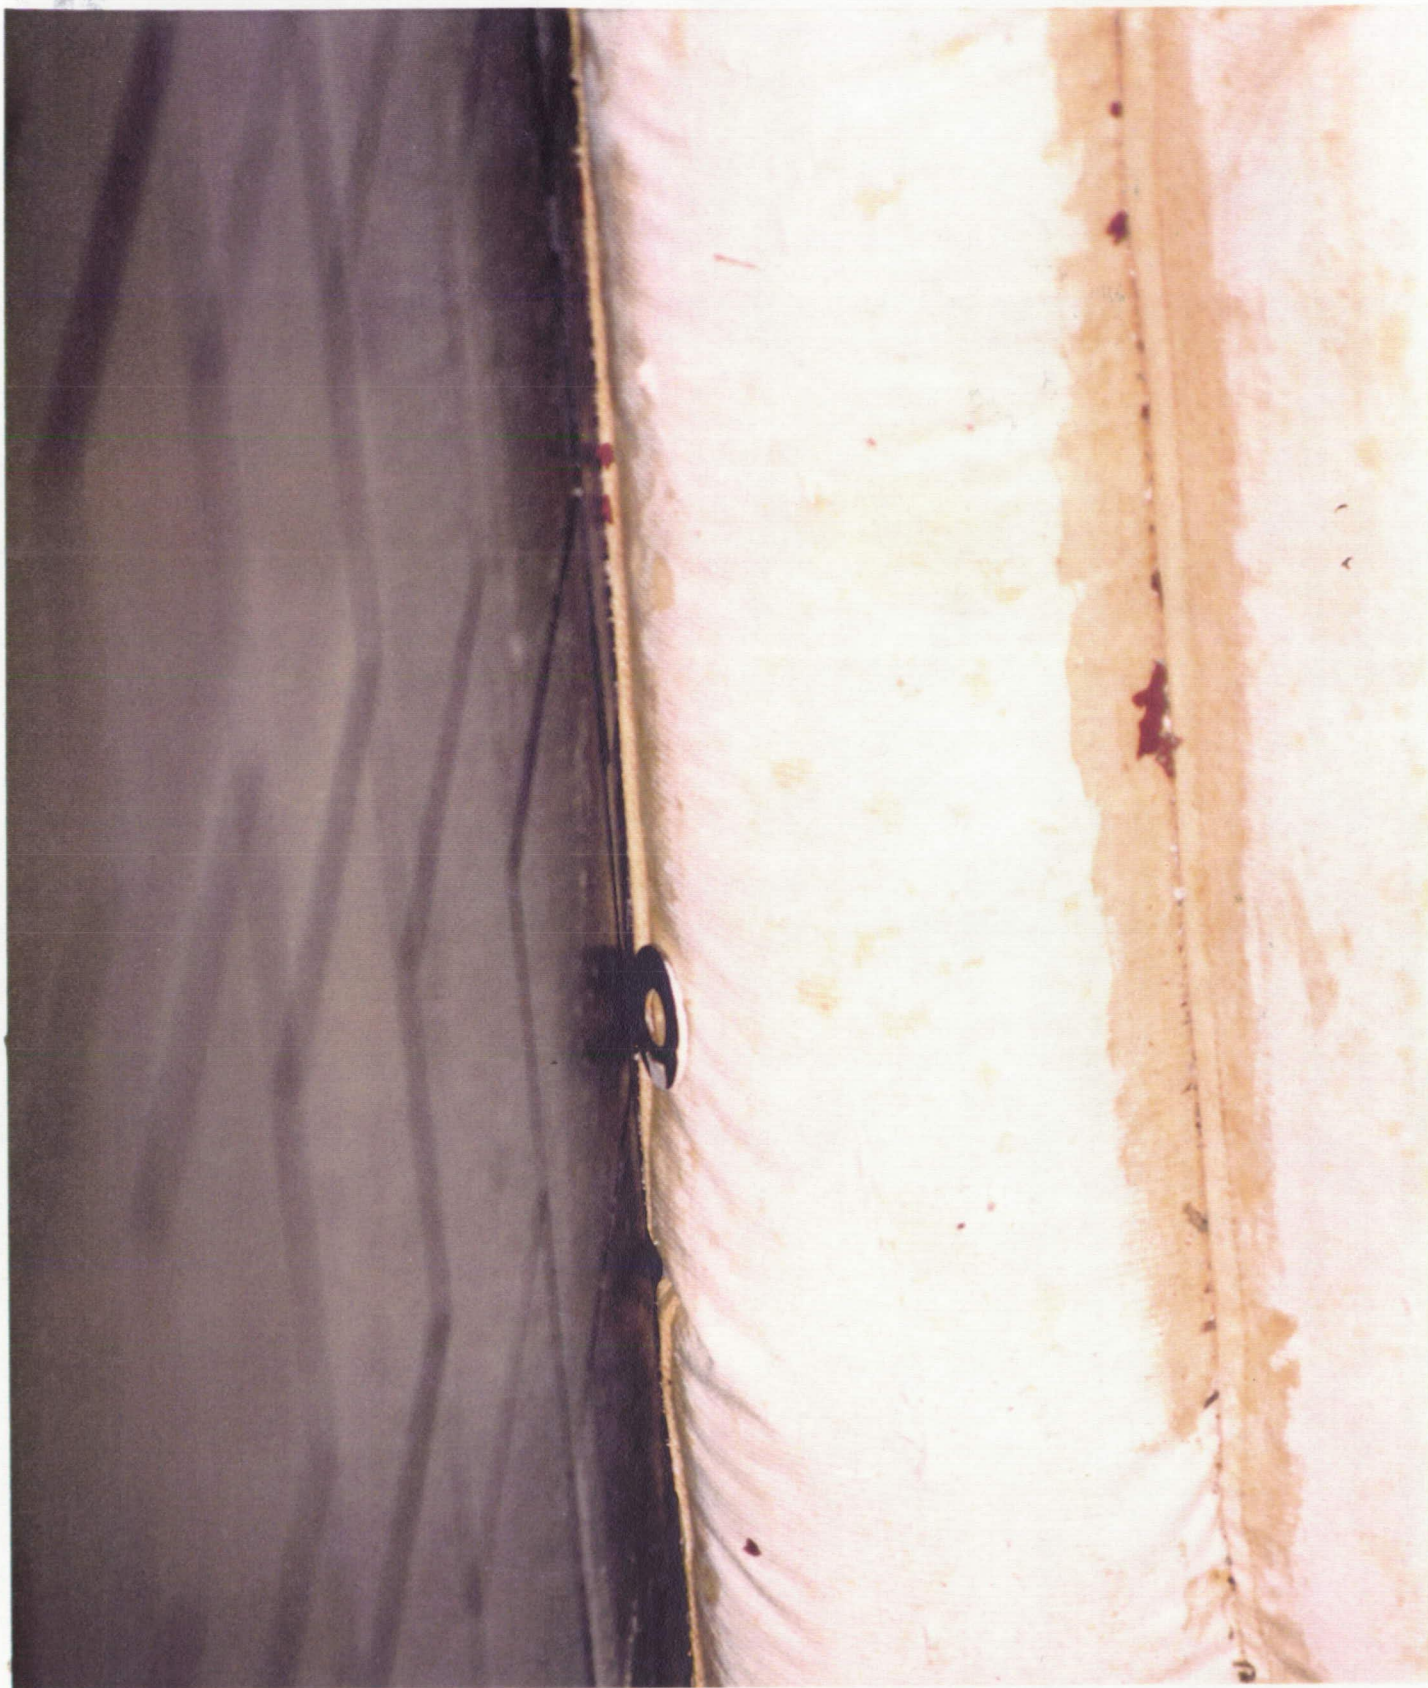
A metal washer lay against Orbiter tiles on top of the Orbiter Access Arm inflated seal. After removal, a partial coating of white paint was found on the washer similar to that covering the nearby hypergolic fuel system access platform. No damage to Orbiter tiles was detected.

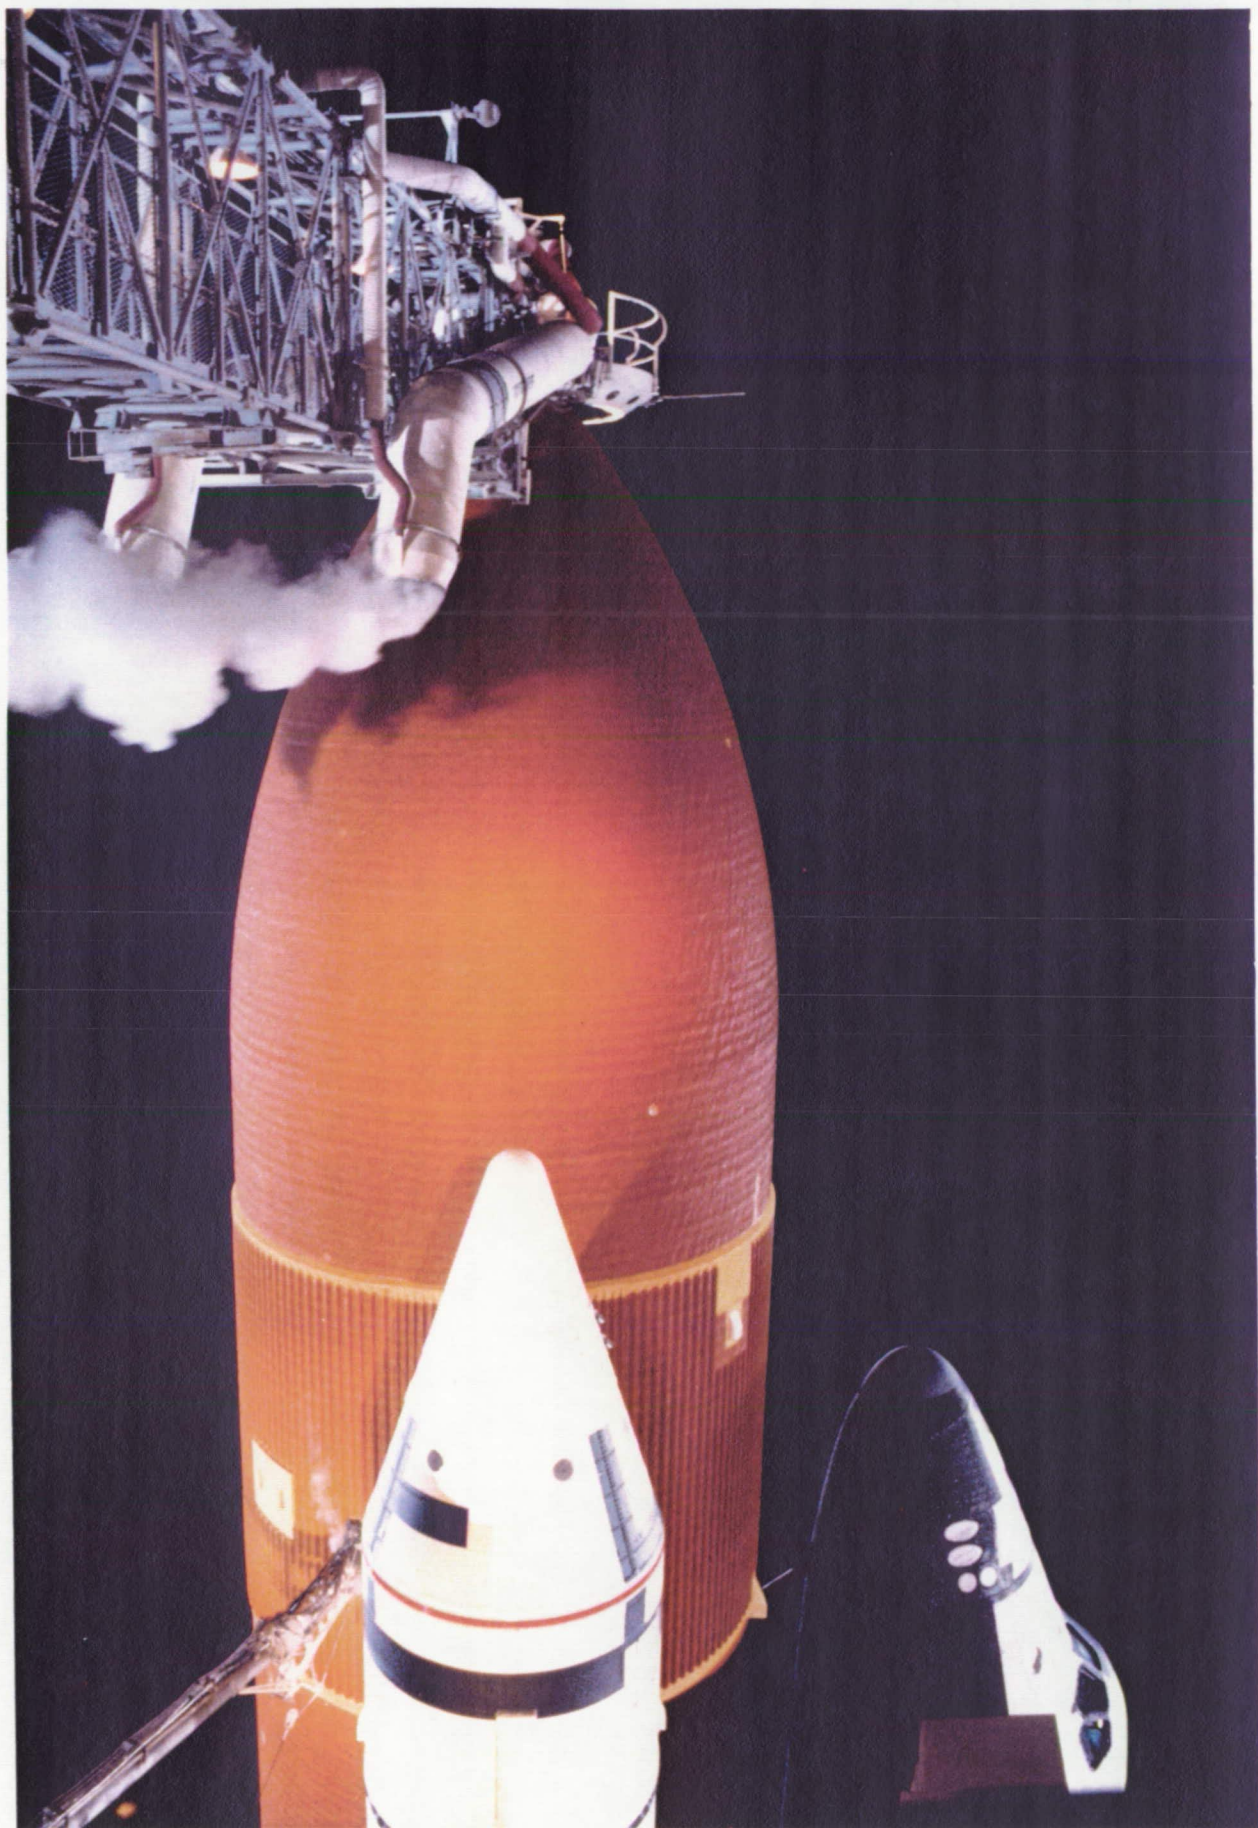
There were no TPS anomalies or ice/frost accumulations on the L02 tank. Some light condensate was present on the L02 tank barrel section.

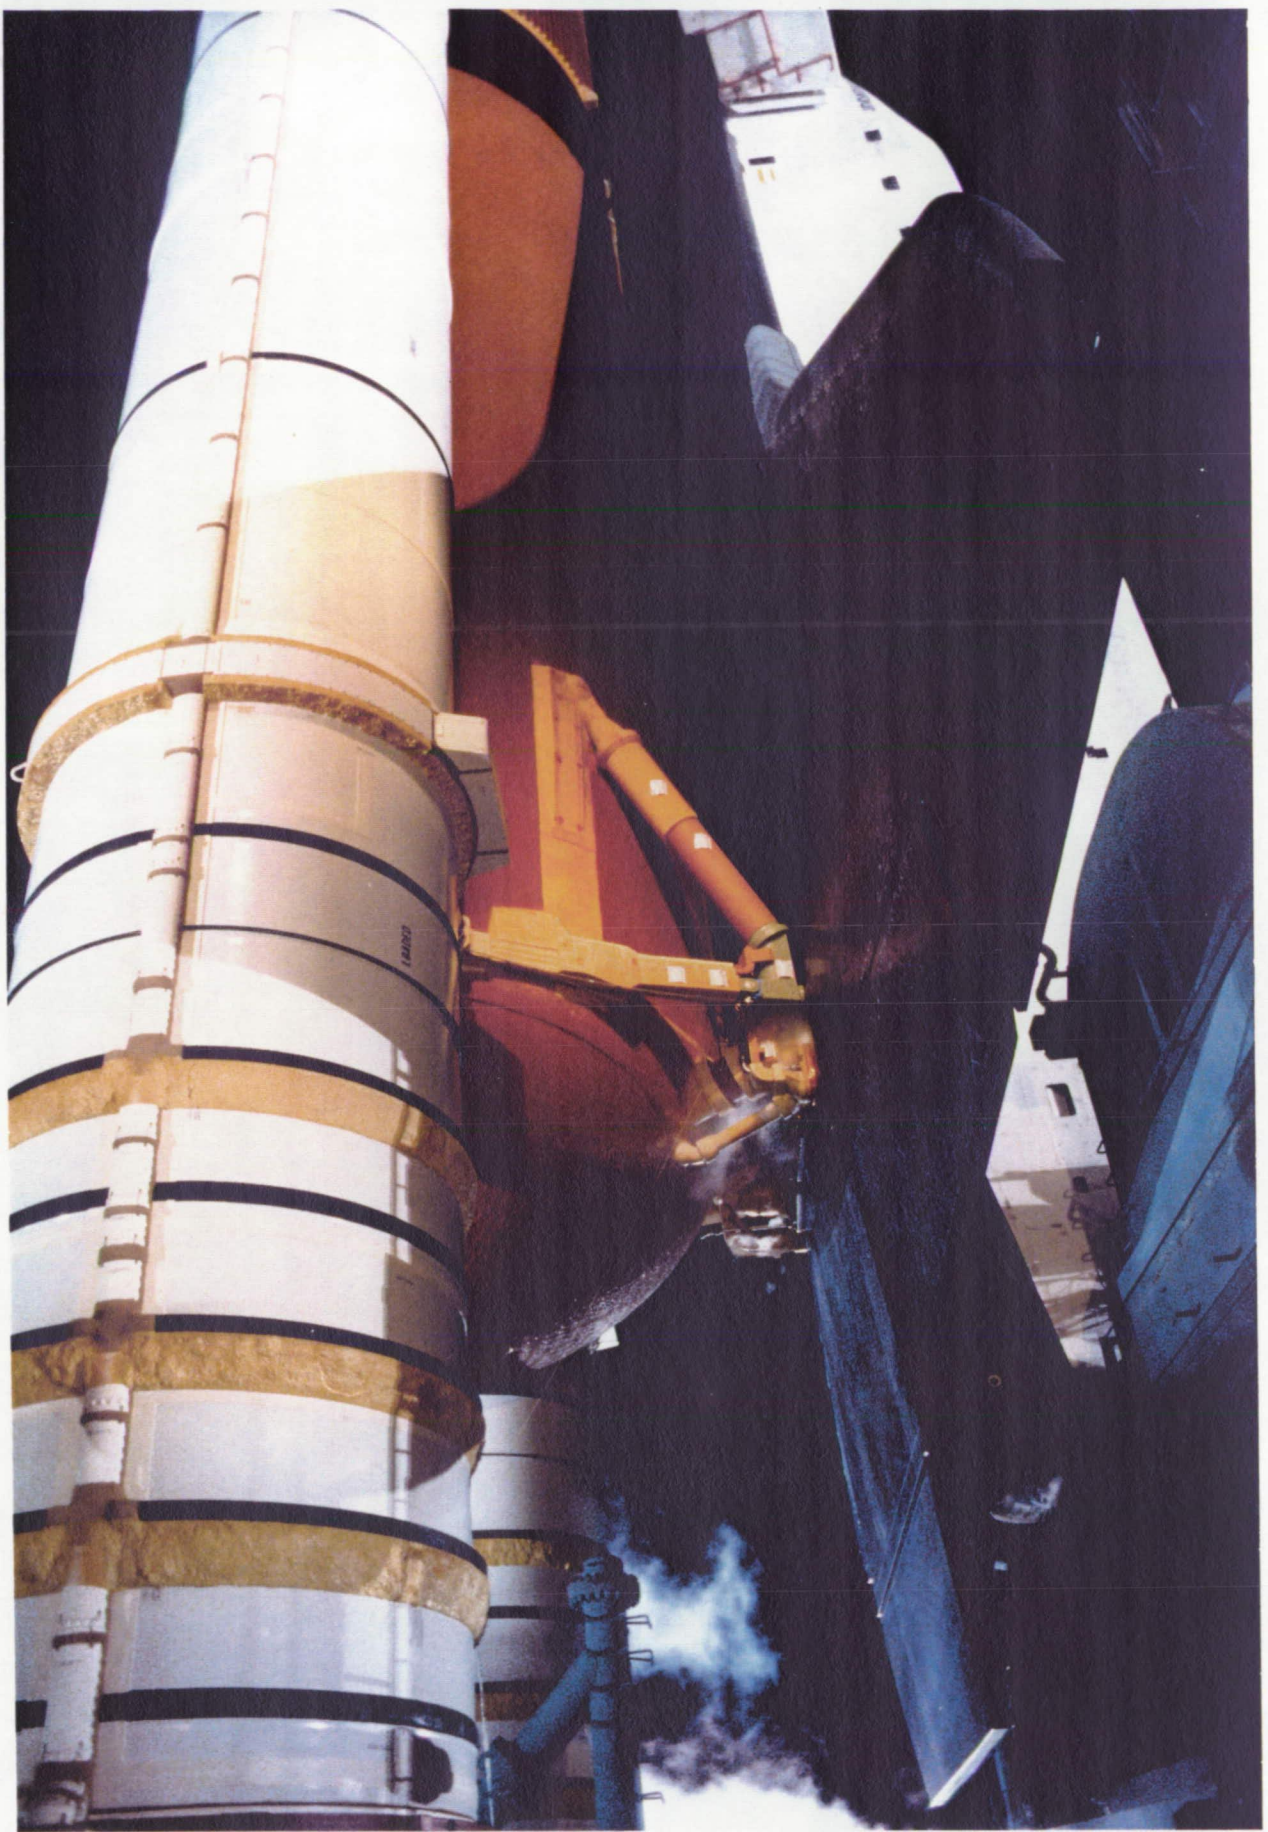
There were no LH2 tank TPS acreage anomalies. Light condensate, but no ice or frost, was present on the acreage and aft dome.

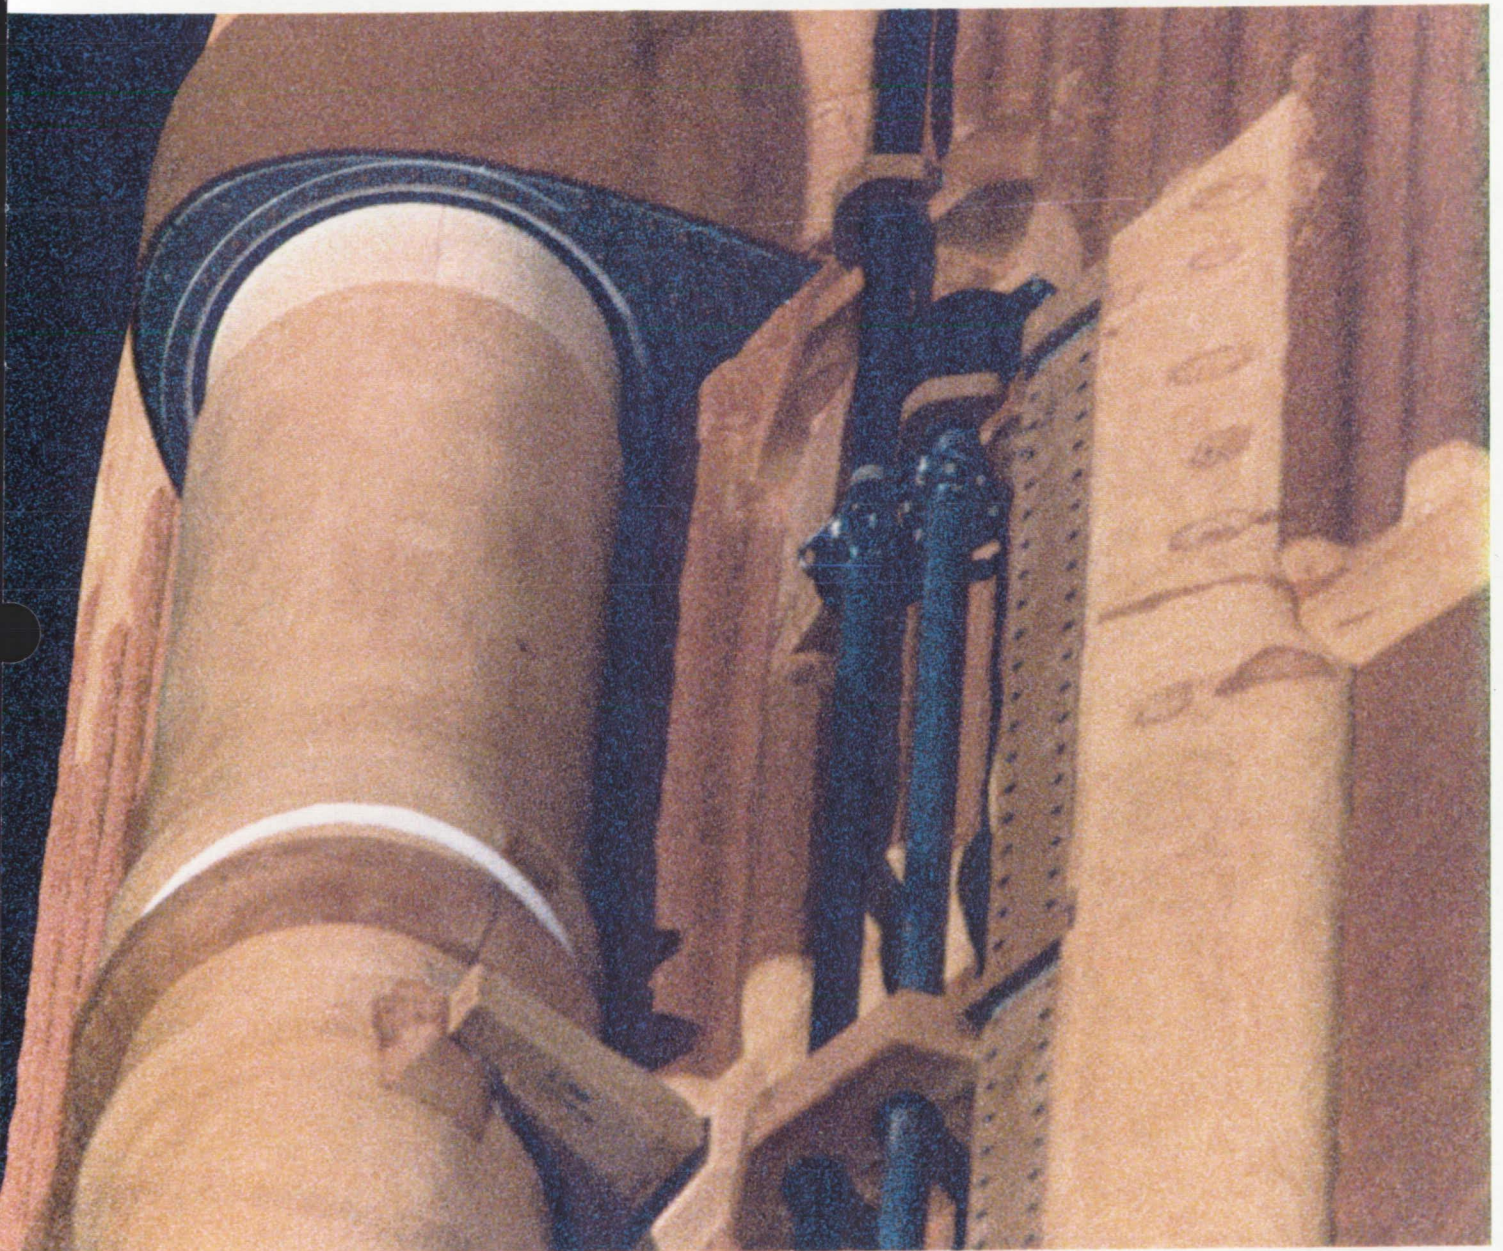
Typical amounts of ice/frost were present in the LO2 feedline
upper bellows and support brackets

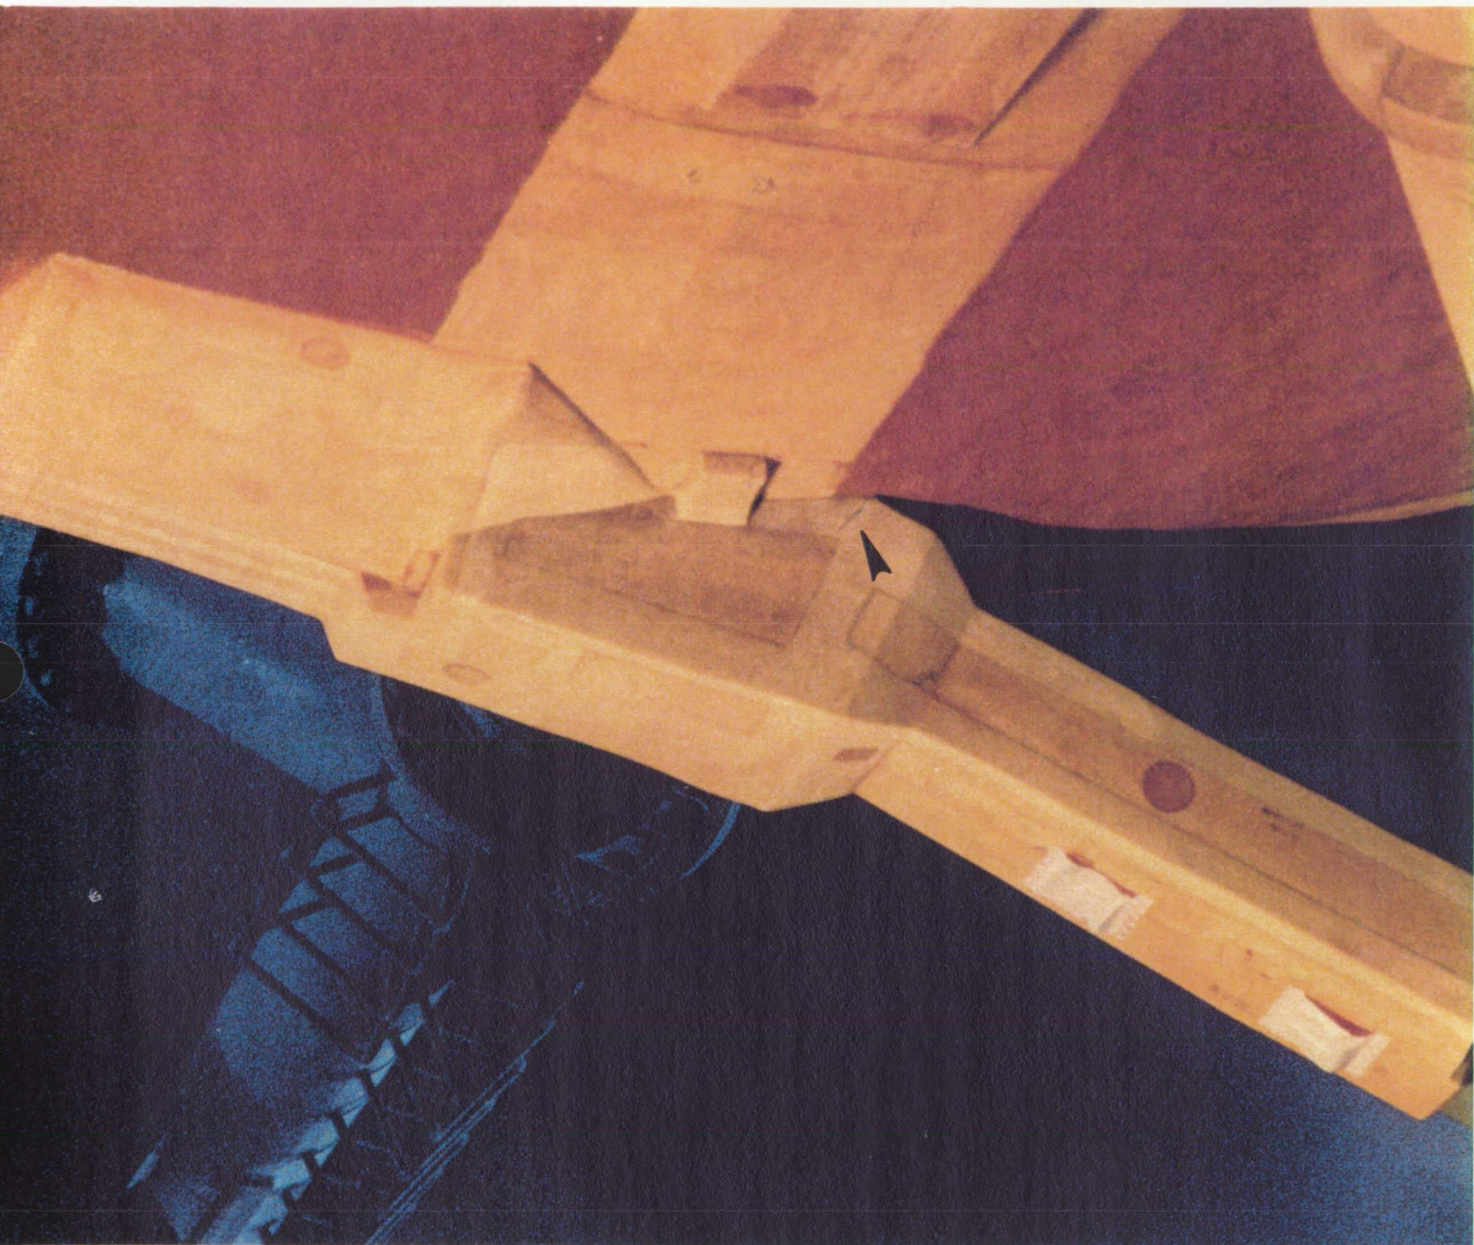
Anomaly 002 documented a 4-inch crack in the -Y vertical strut cable tray forward surface at the intersection to the ET/SRB cable tray transition fairing. The 1/4-inch wide crack exhibited no offset and was not filled with ice or frost. The condition was acceptable for launch per NSTS-08303 and CR S041254C.

A 4-inch long crack was present in the -Y vertical strut cable tray forward surface TPS near the longeron closeout interface. The 1/4-inch wide crack exhibited no offset and was not filled with ice or frost. The condition was acceptable for flight.

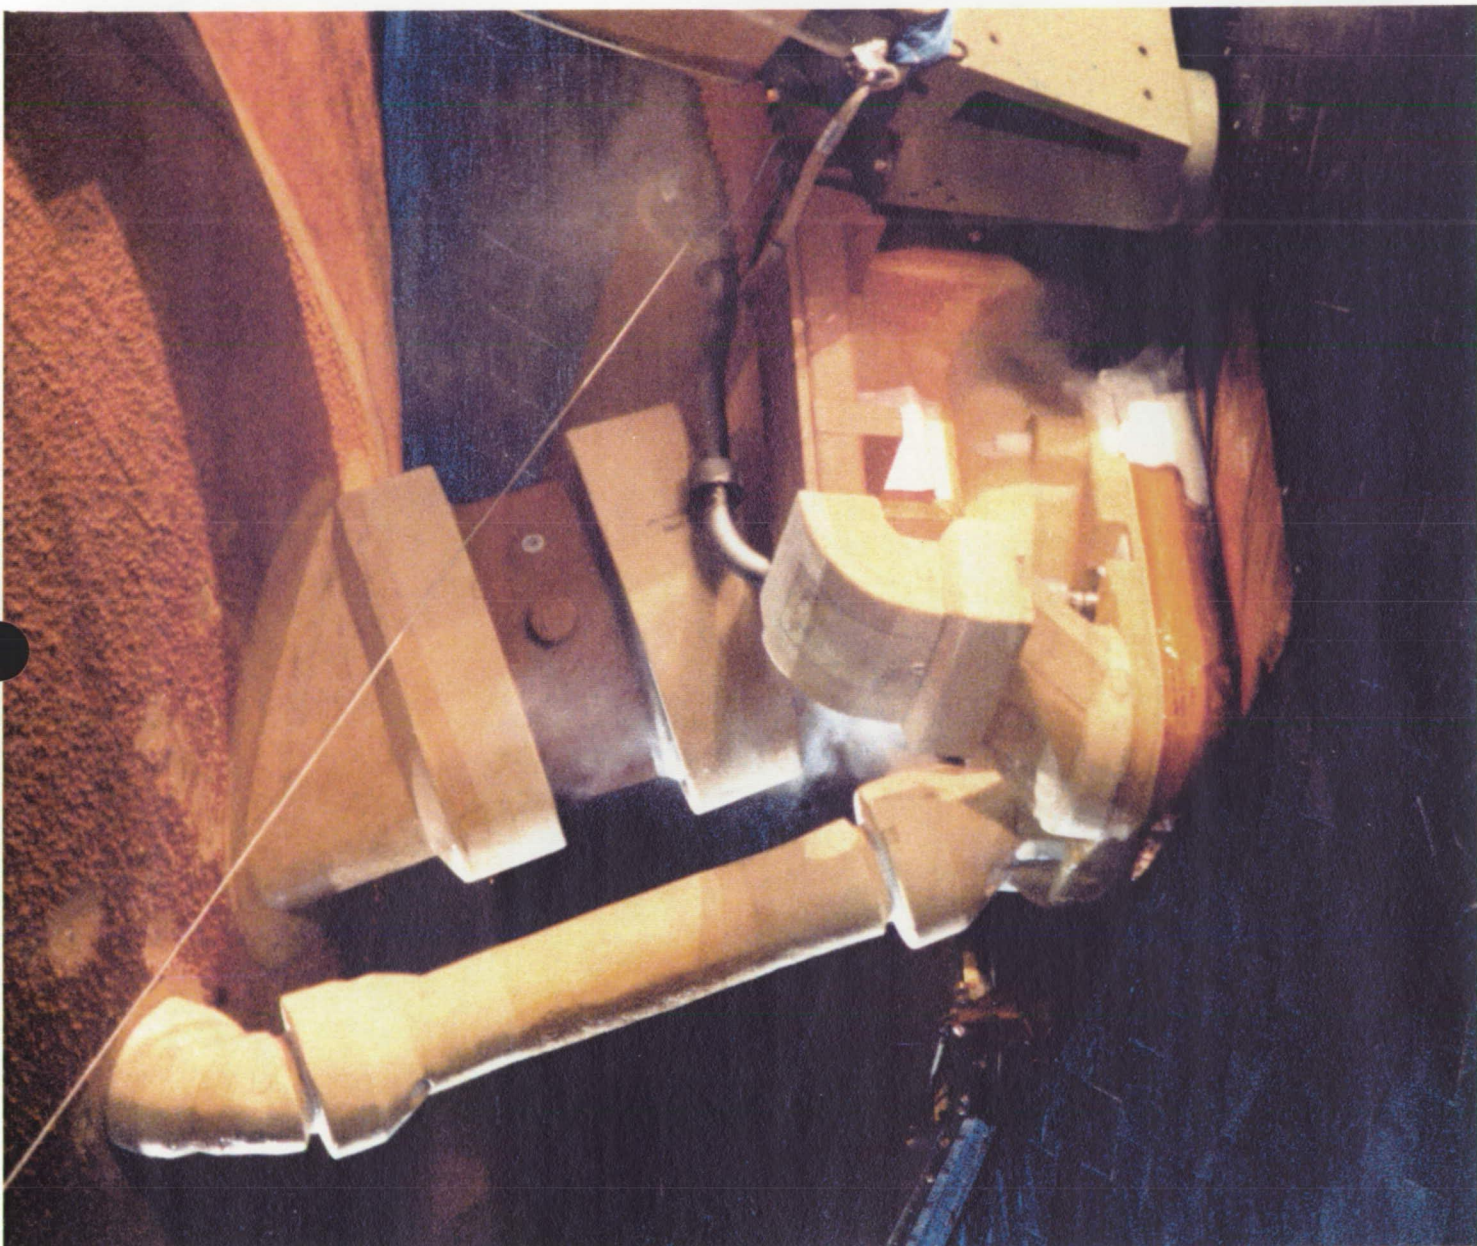
Ice/frost formations on the ET/ORB LH2 umbilical were typical. No unusual vapors or cryogenic drips had appeared during tanking, stable replenish, and launch.

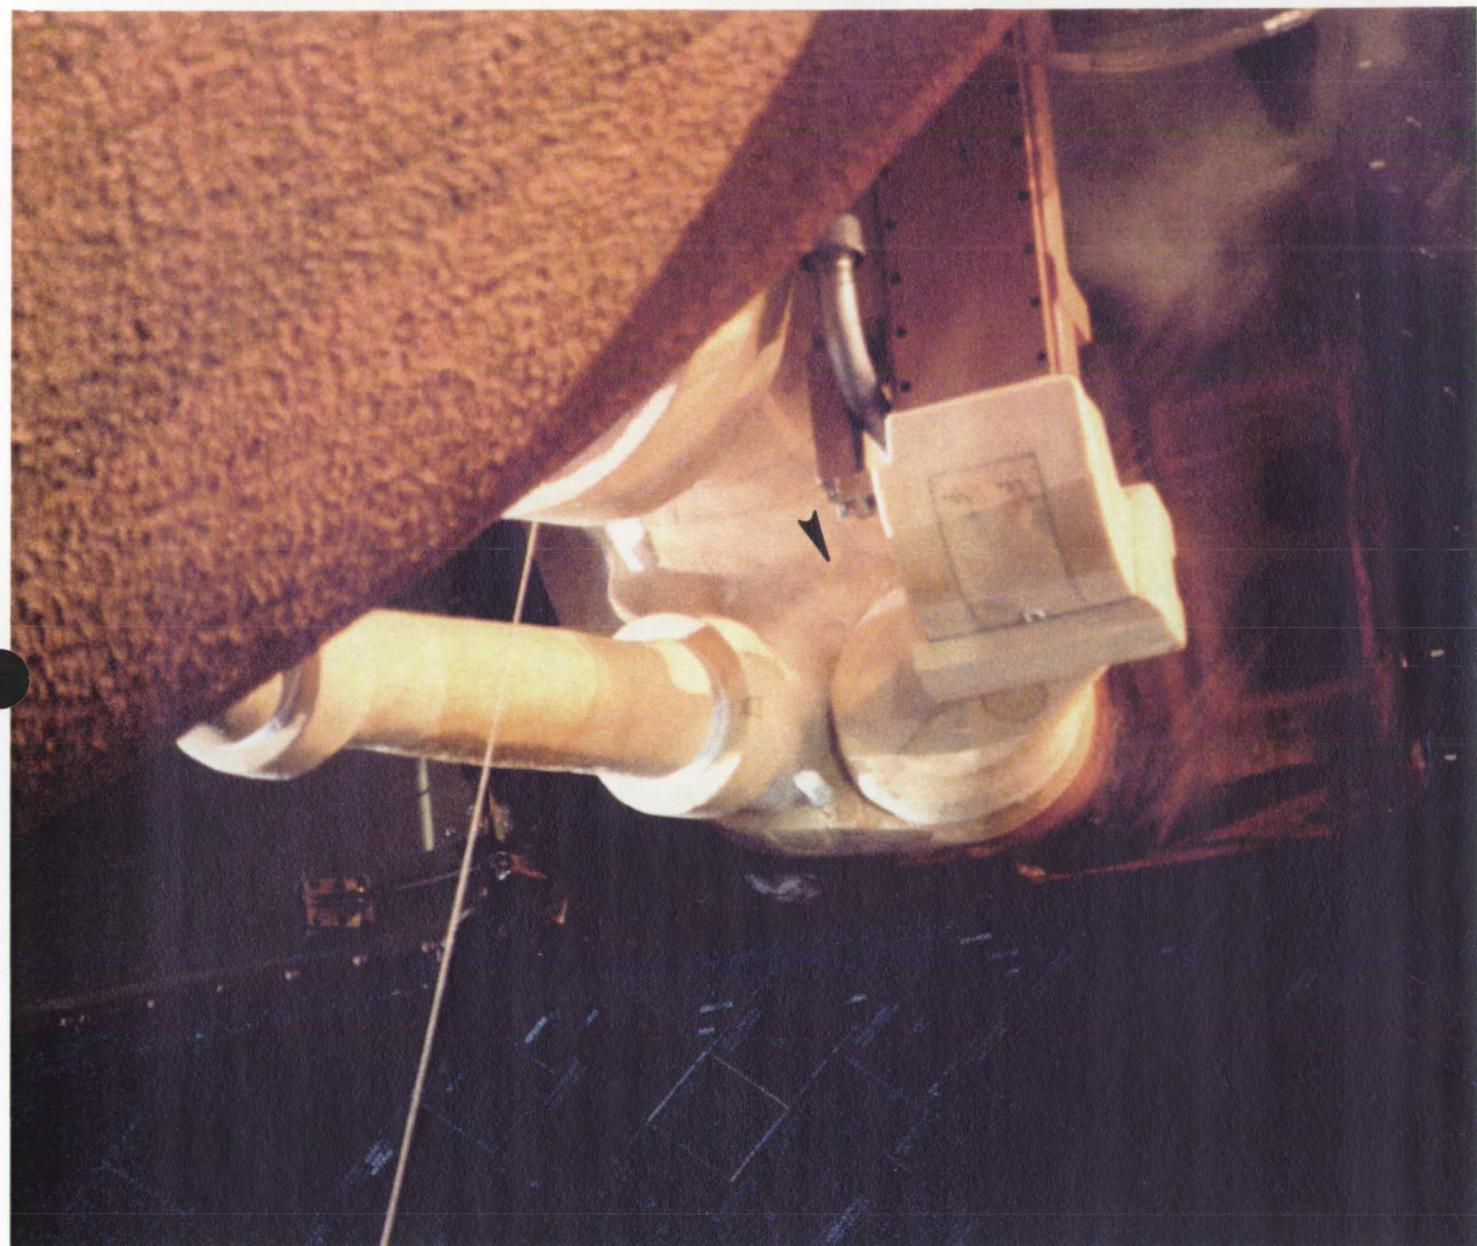
Typical in size, ice/frost fingers had formed on the aft plate gap purge vent and LH2 umbilical cable tray vent hole. No ice or frost had formed on the 17-inch flapper valve actuator access port TPS plug closeout indicating a proper closeout.

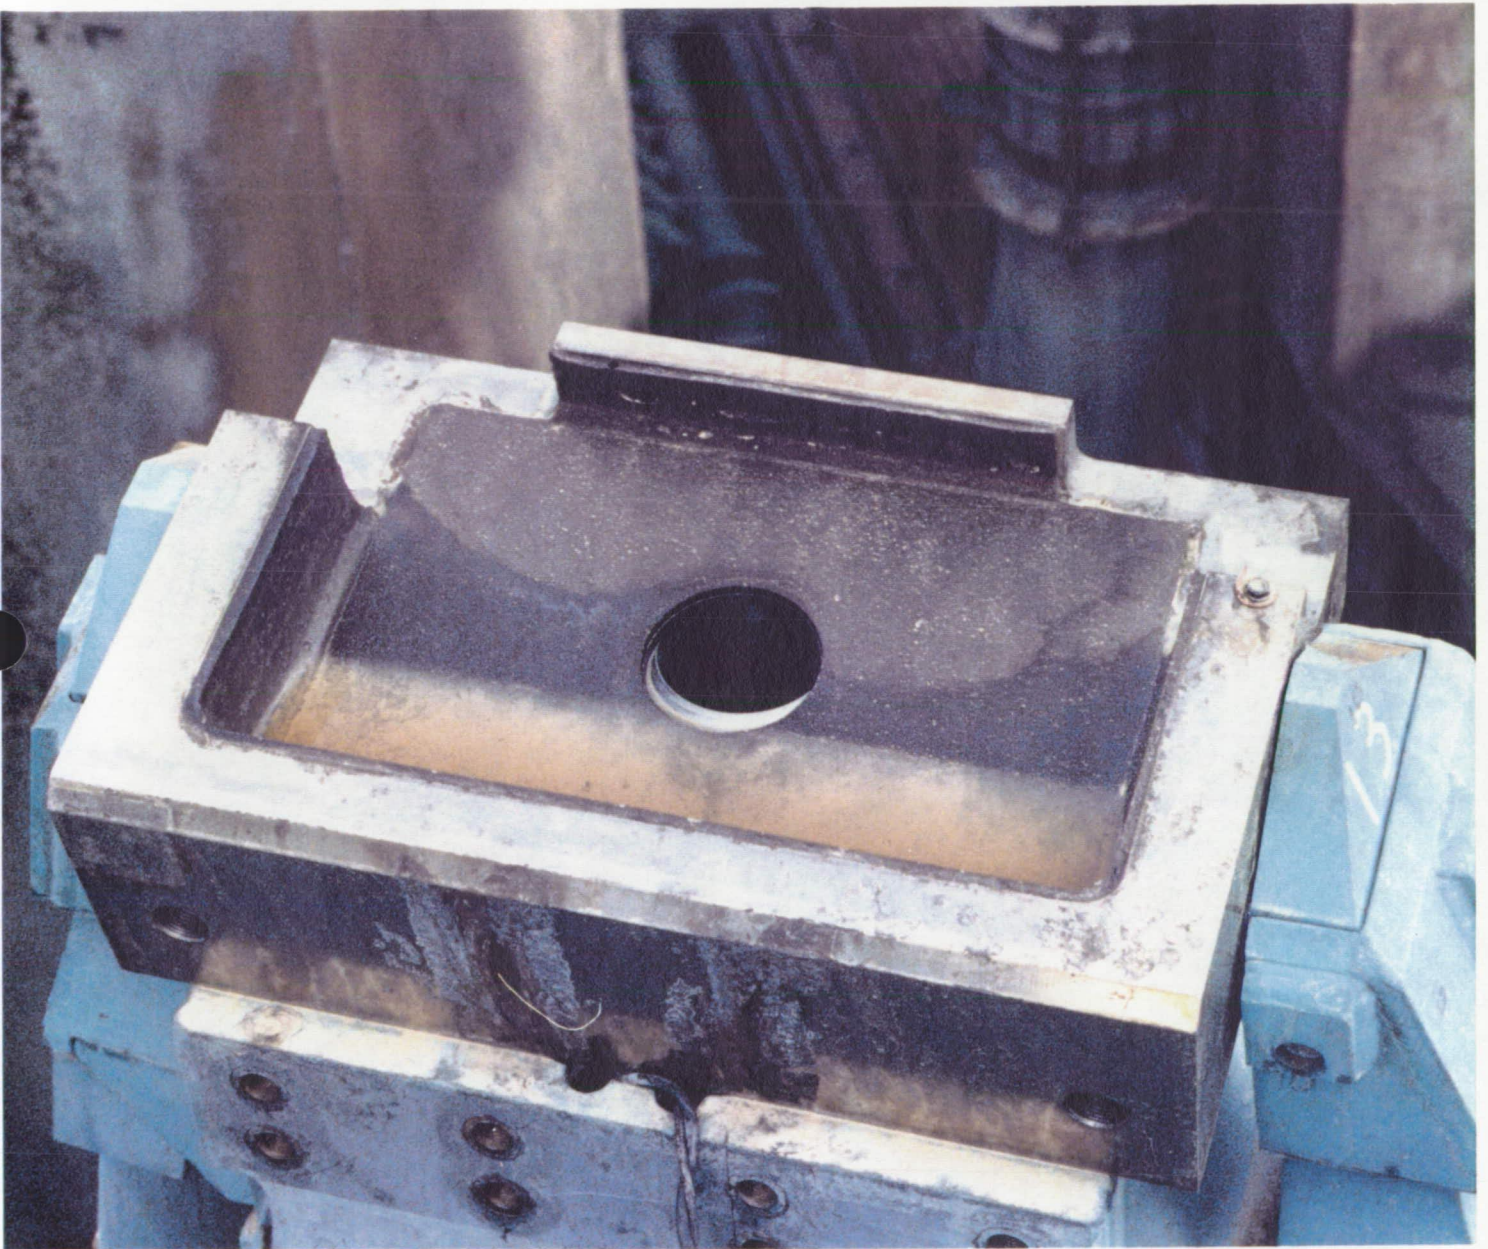
Plume erosion of the south SRB holddown posts was typical. EPON shim material was intact but slightly debonded from the sidewalls of the holddown post shoes.

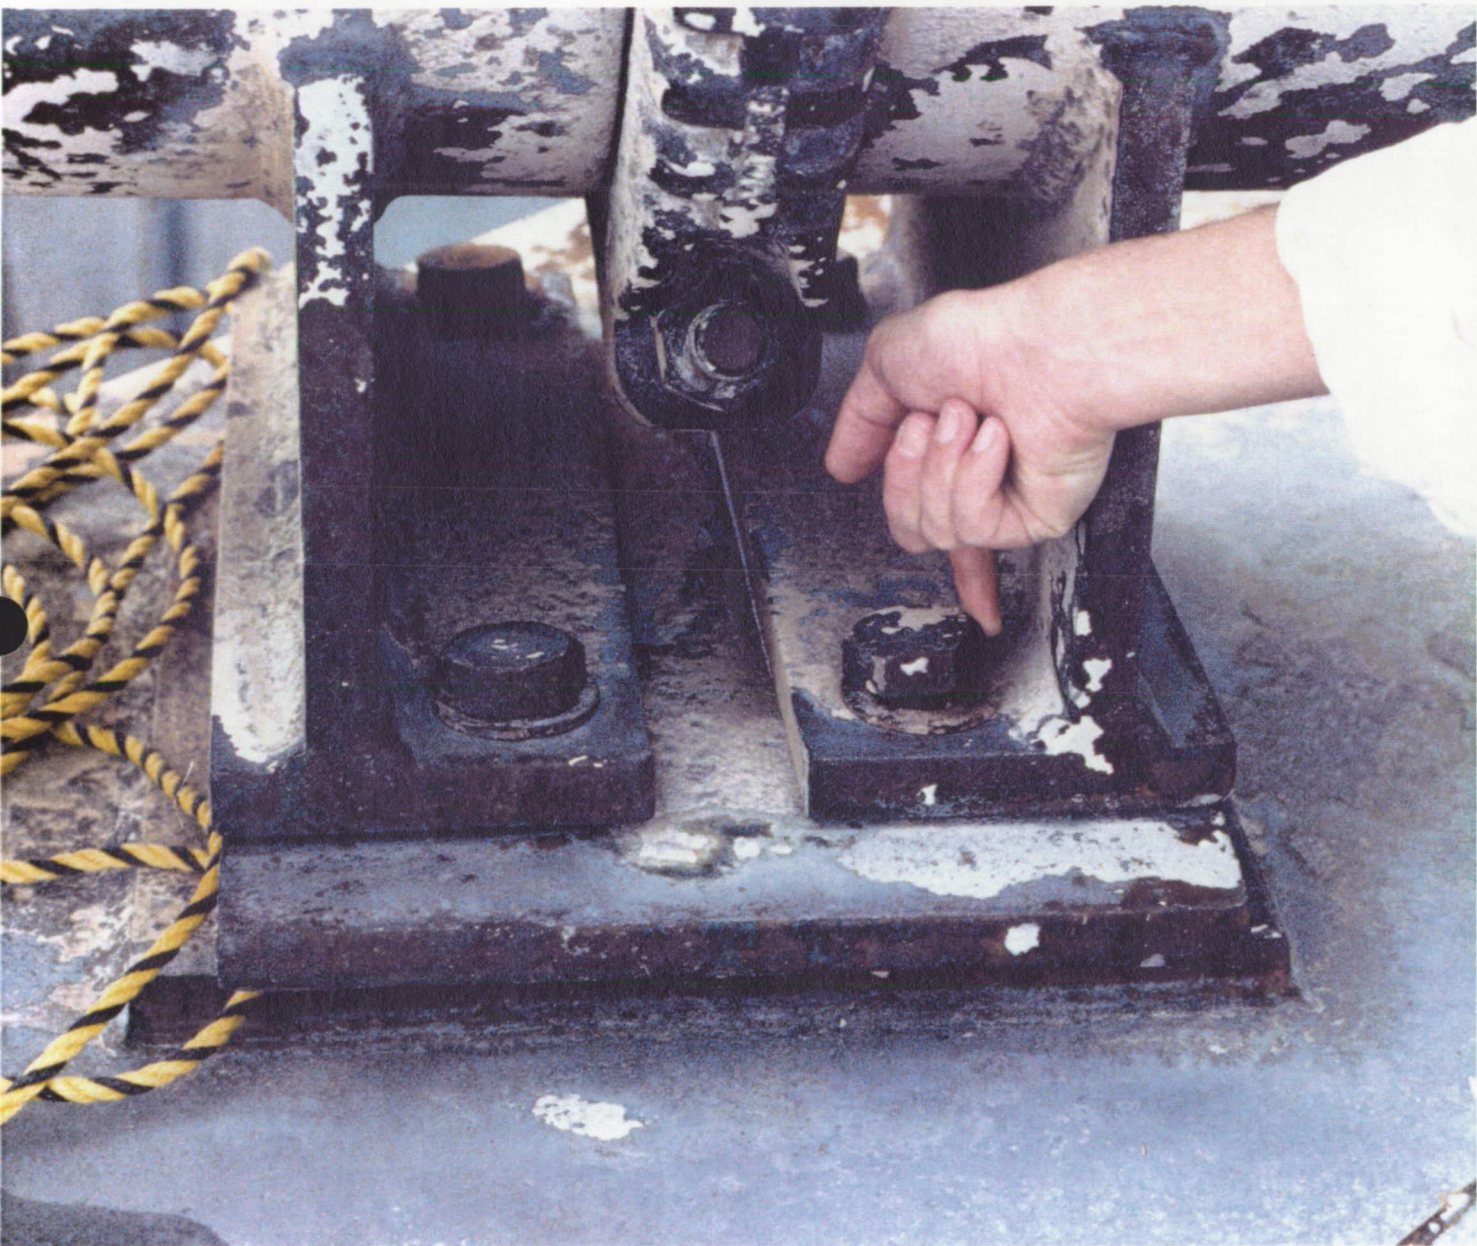
A sound suppression pipe base mounting plate bolt
north of the RH SRB exhaust hole was loose

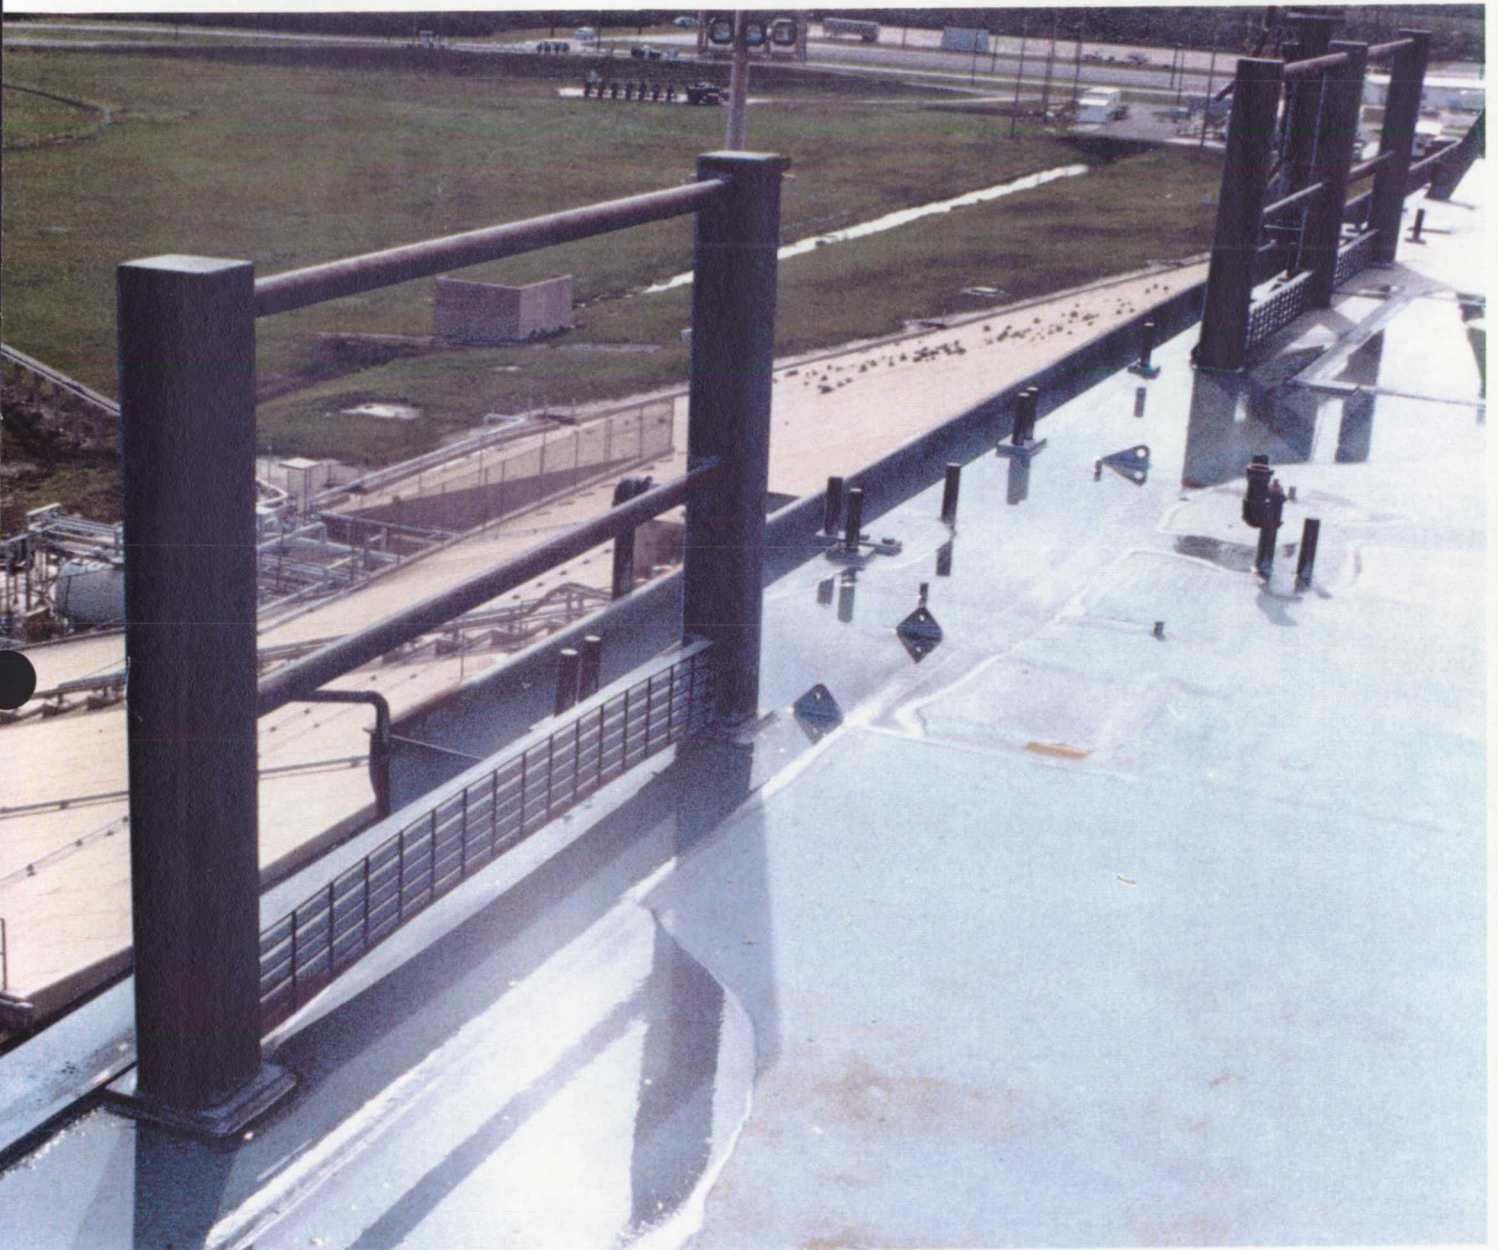
The seven test sections of the permanent MLP deck perimeter handrails were generally in good shape after launch except for the east and west side removable sections, which exhibited minor deformation of the kickplates.
