NASA Technical Memorandum TM 107558

Debris/Ice/TPS Assessment and Integrated Photographic Analysis for Shuttle Mission STS-54

March 1993

John F. Kennedy Space Center

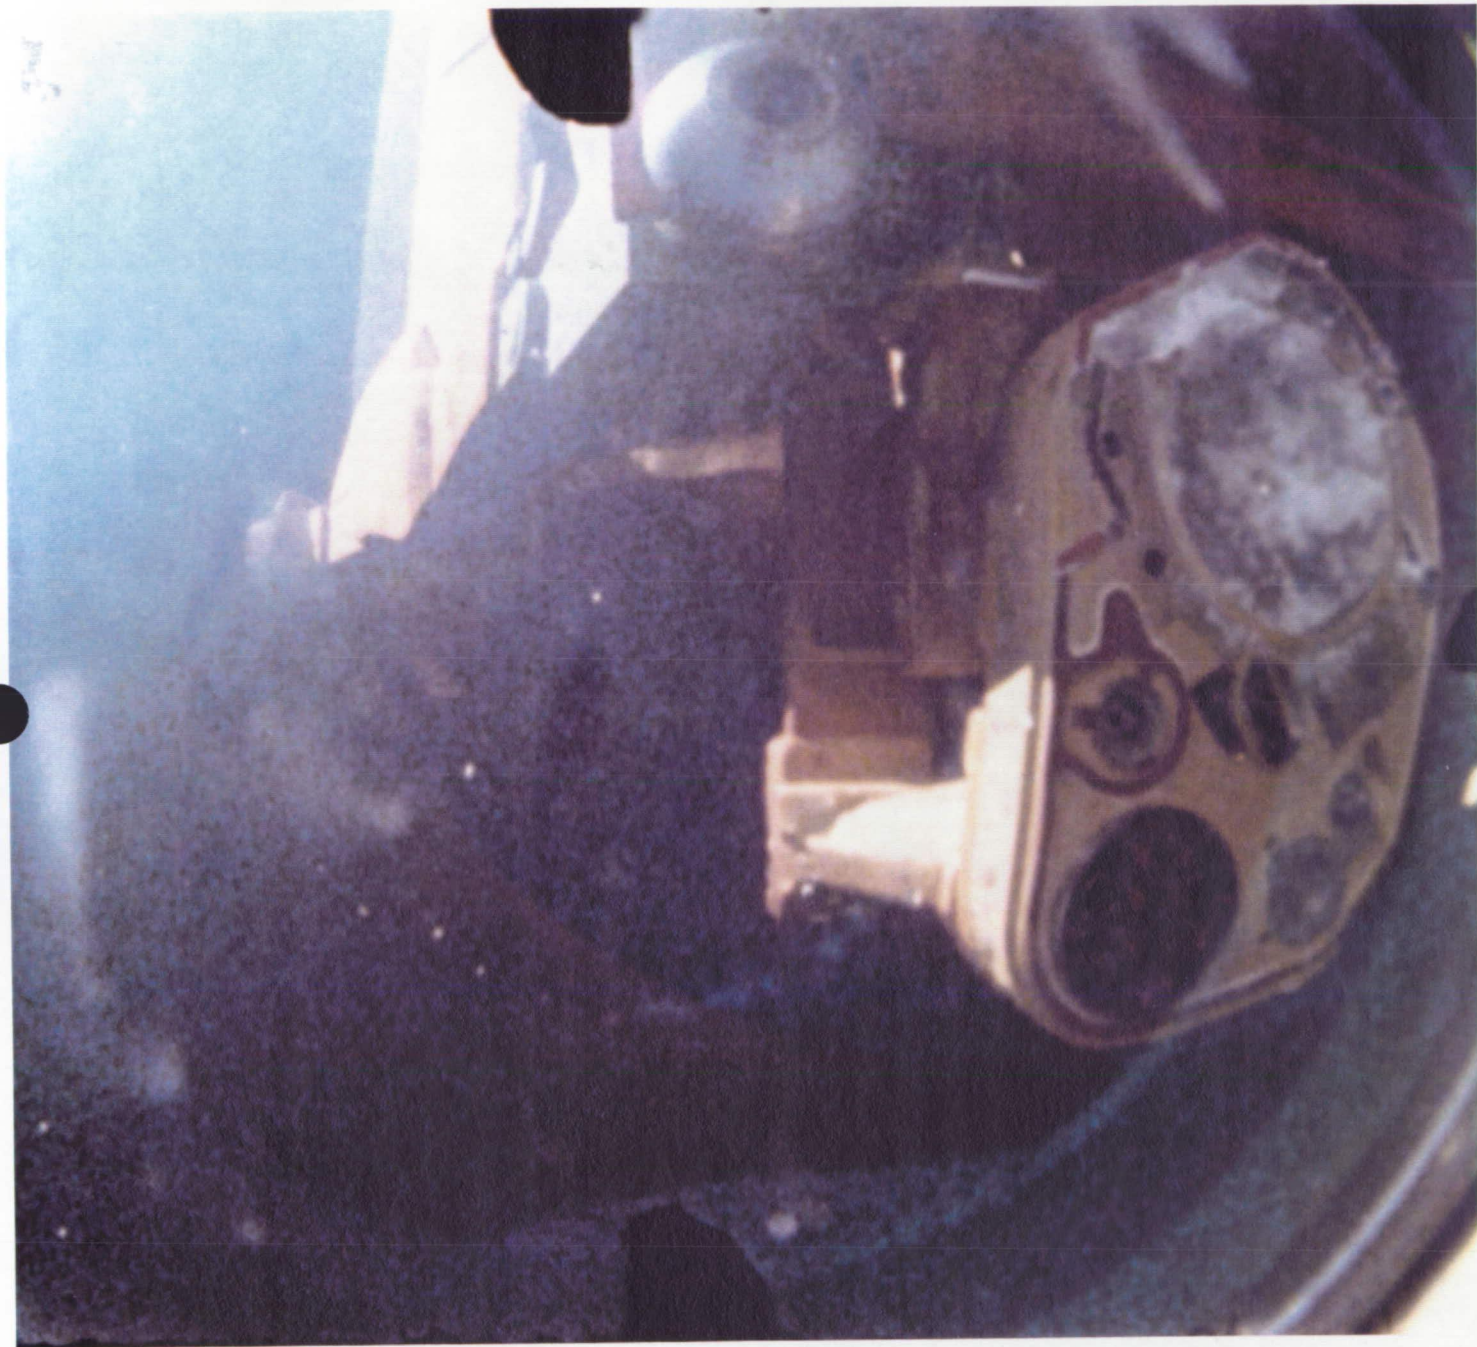
Frozen hydrogen, but no TPS or structural damage, was visible on the LH2 ET/ORB umbilical interface. Erosion and charring of TPS on the aft surfaces of the LH2 umbilical cable tray and the -Y vertical strut/cable tray was typical.

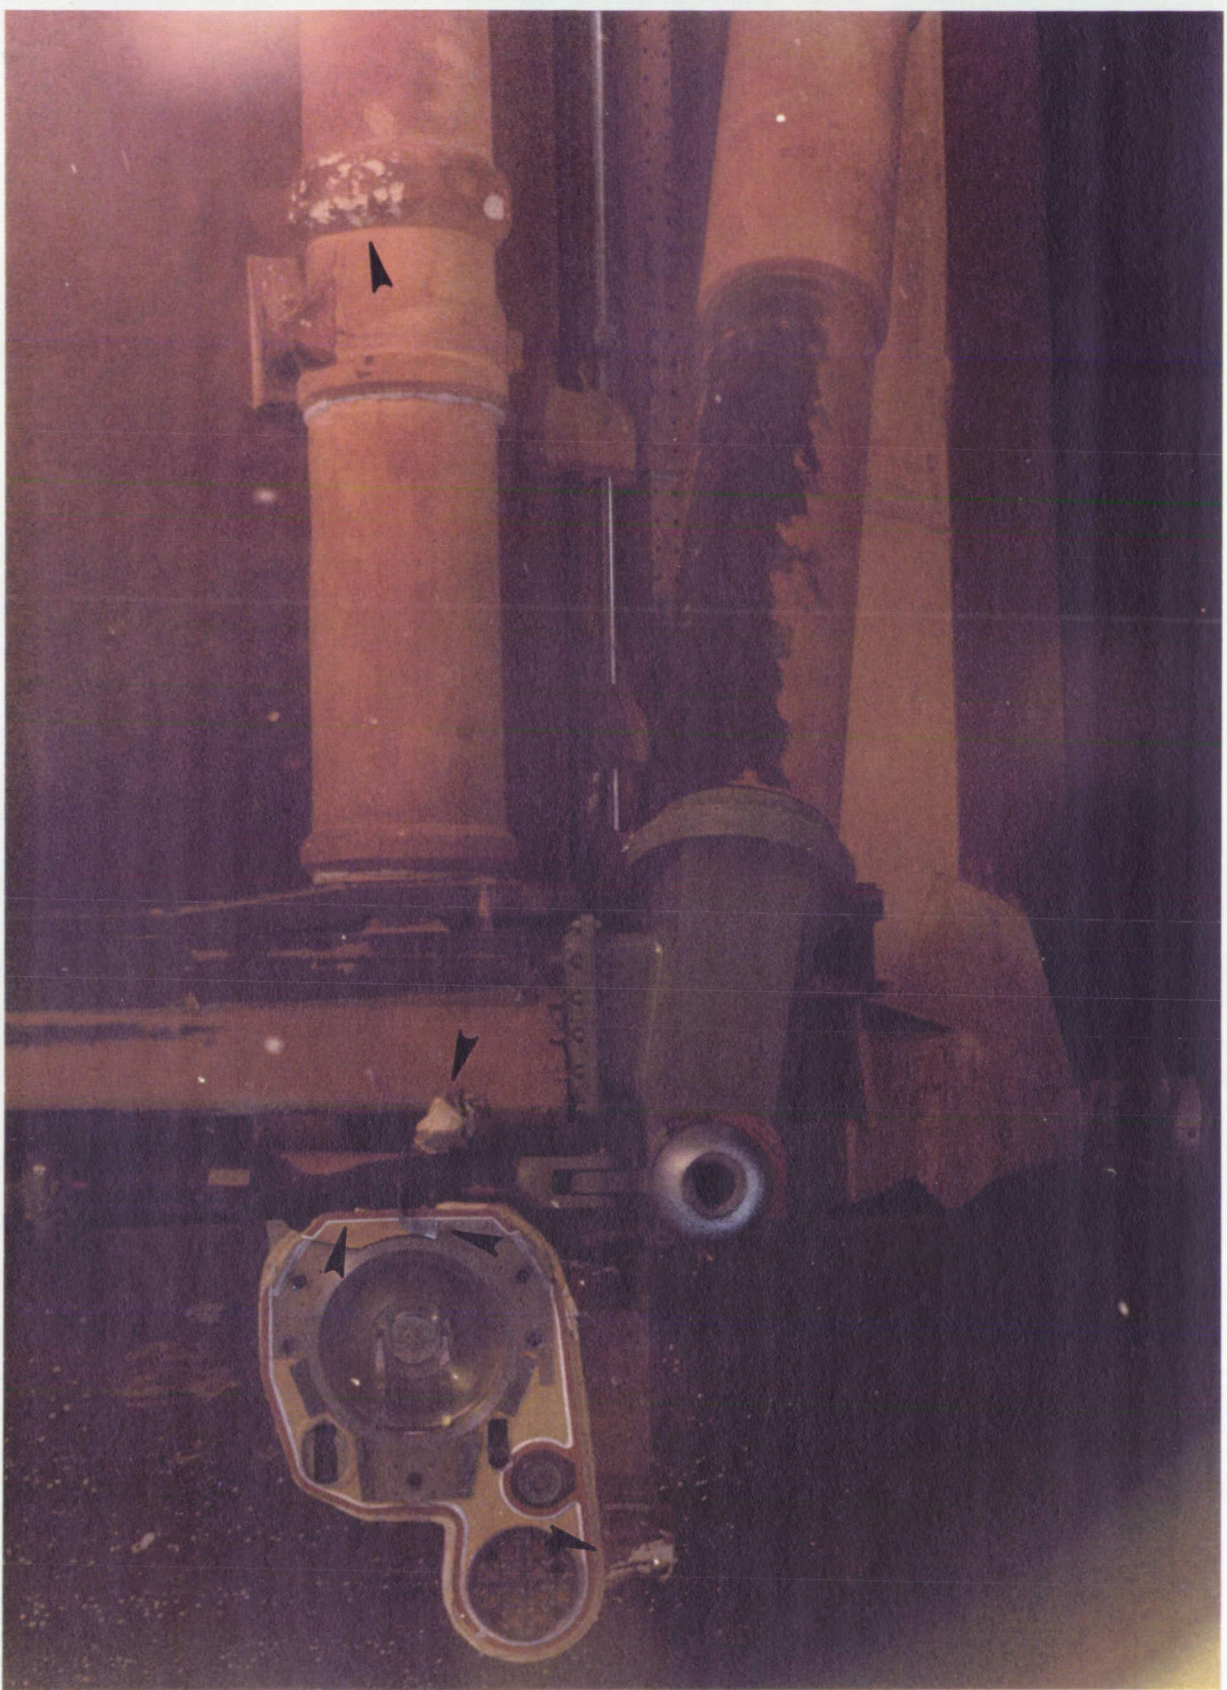
TPS damage was visible on the forward surface of the L02 ET/ORB umbilical. A 6-8 inch diameter piece of foam wedged between the diagonal strut and the crossbeam may have originated from this area. Sixty percent of the lightning contact strip was debonded and bent in the forward direction. TPS was missing from the cable tray horizontal section and the underlying SLA was exposed. Some TPS had eroded from the L02 feedline flange closeout.

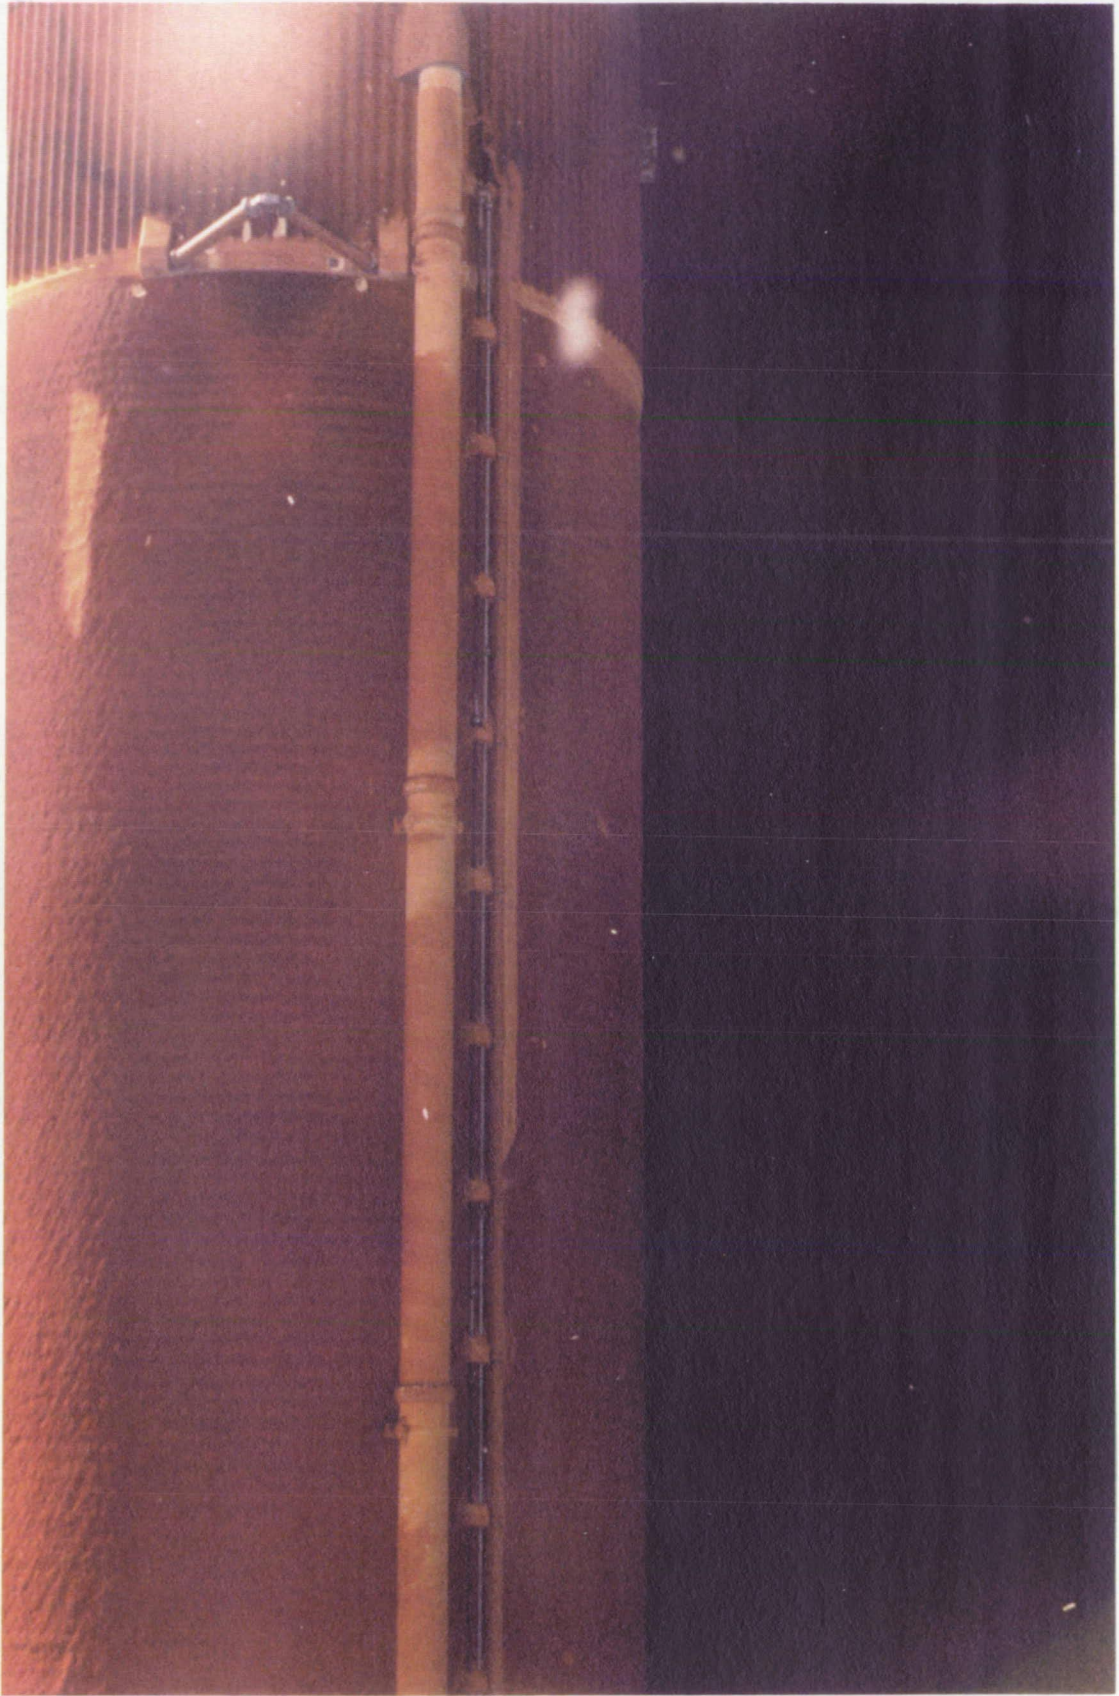
Loss of TPS on the +Z side of the ET near the Orbiter nose is a potential threat to lower surface tiles. Divots occurred on the intertank acreage, in the upper LH2 tank acreage, and in the LH2 tank-to-intertank flange closeout. The entire RH (+Y) bipod jack pad closeout was missing.

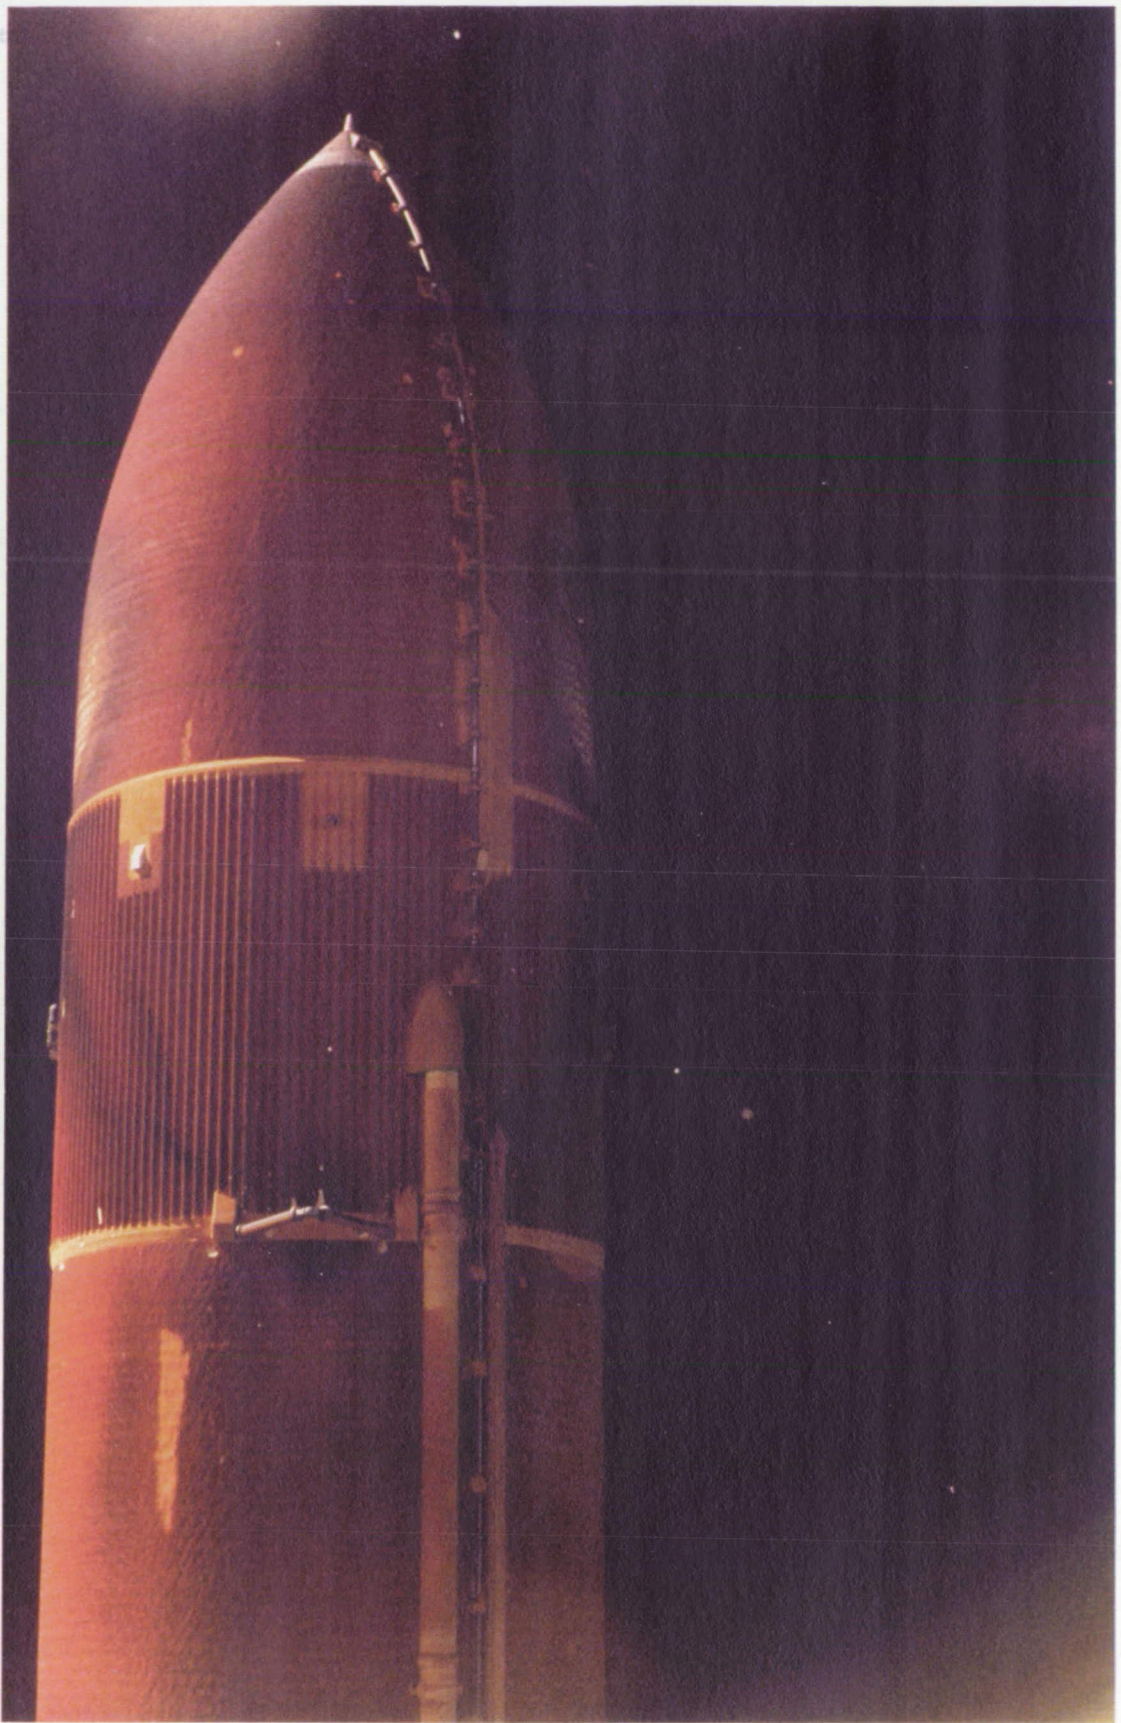
No anomalies were observed on the nosecone, LO2 tank acreage, PAL ramps, RSS antenna, or bipod ramps. PDL foam spill discoloration on the LH2 tank acreage below the left (-Y) bipod was present prior to launch.

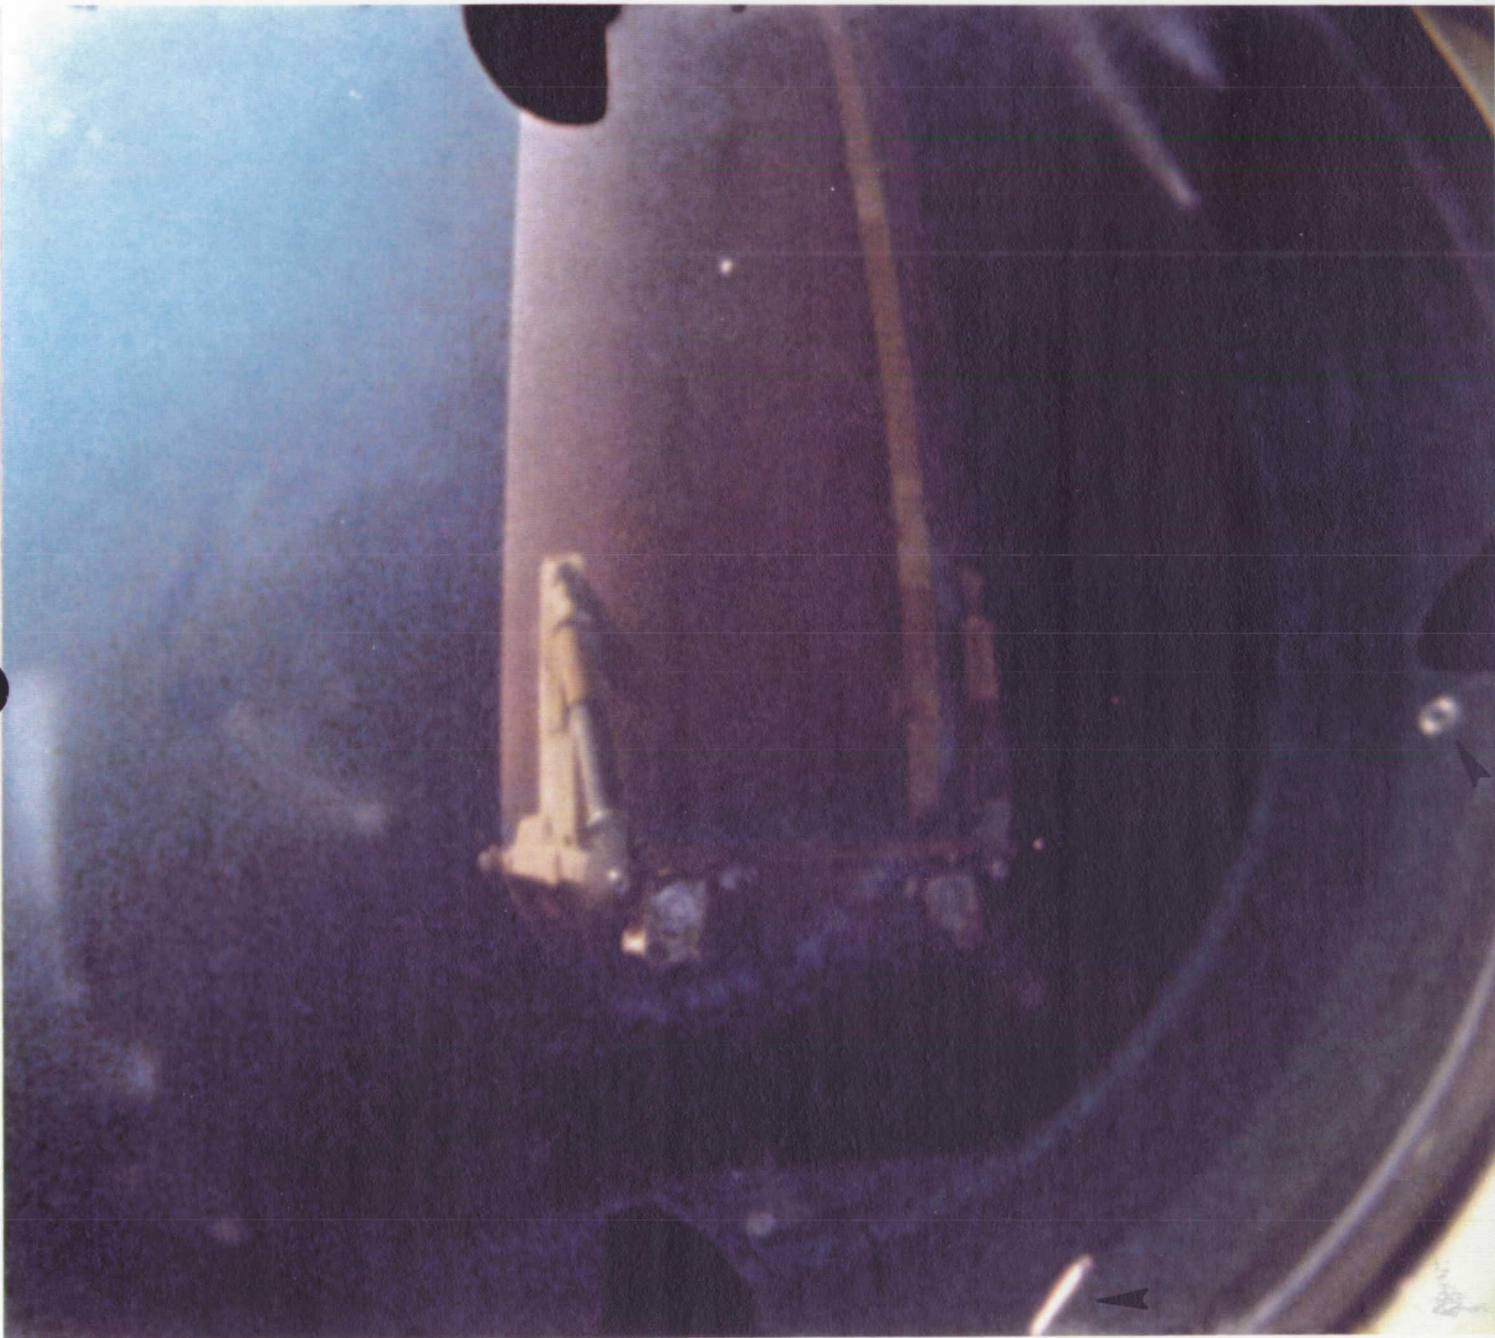
After ET separation from the Orbiter, two metallic objects (a thin washer and a cotter, or shear, pin) drifted into the field of view of the LH2 ET/ORB umbilical camera. The debris may have been entrapped in the numerous cavities of the umbilical prior to purge barrier closeout.

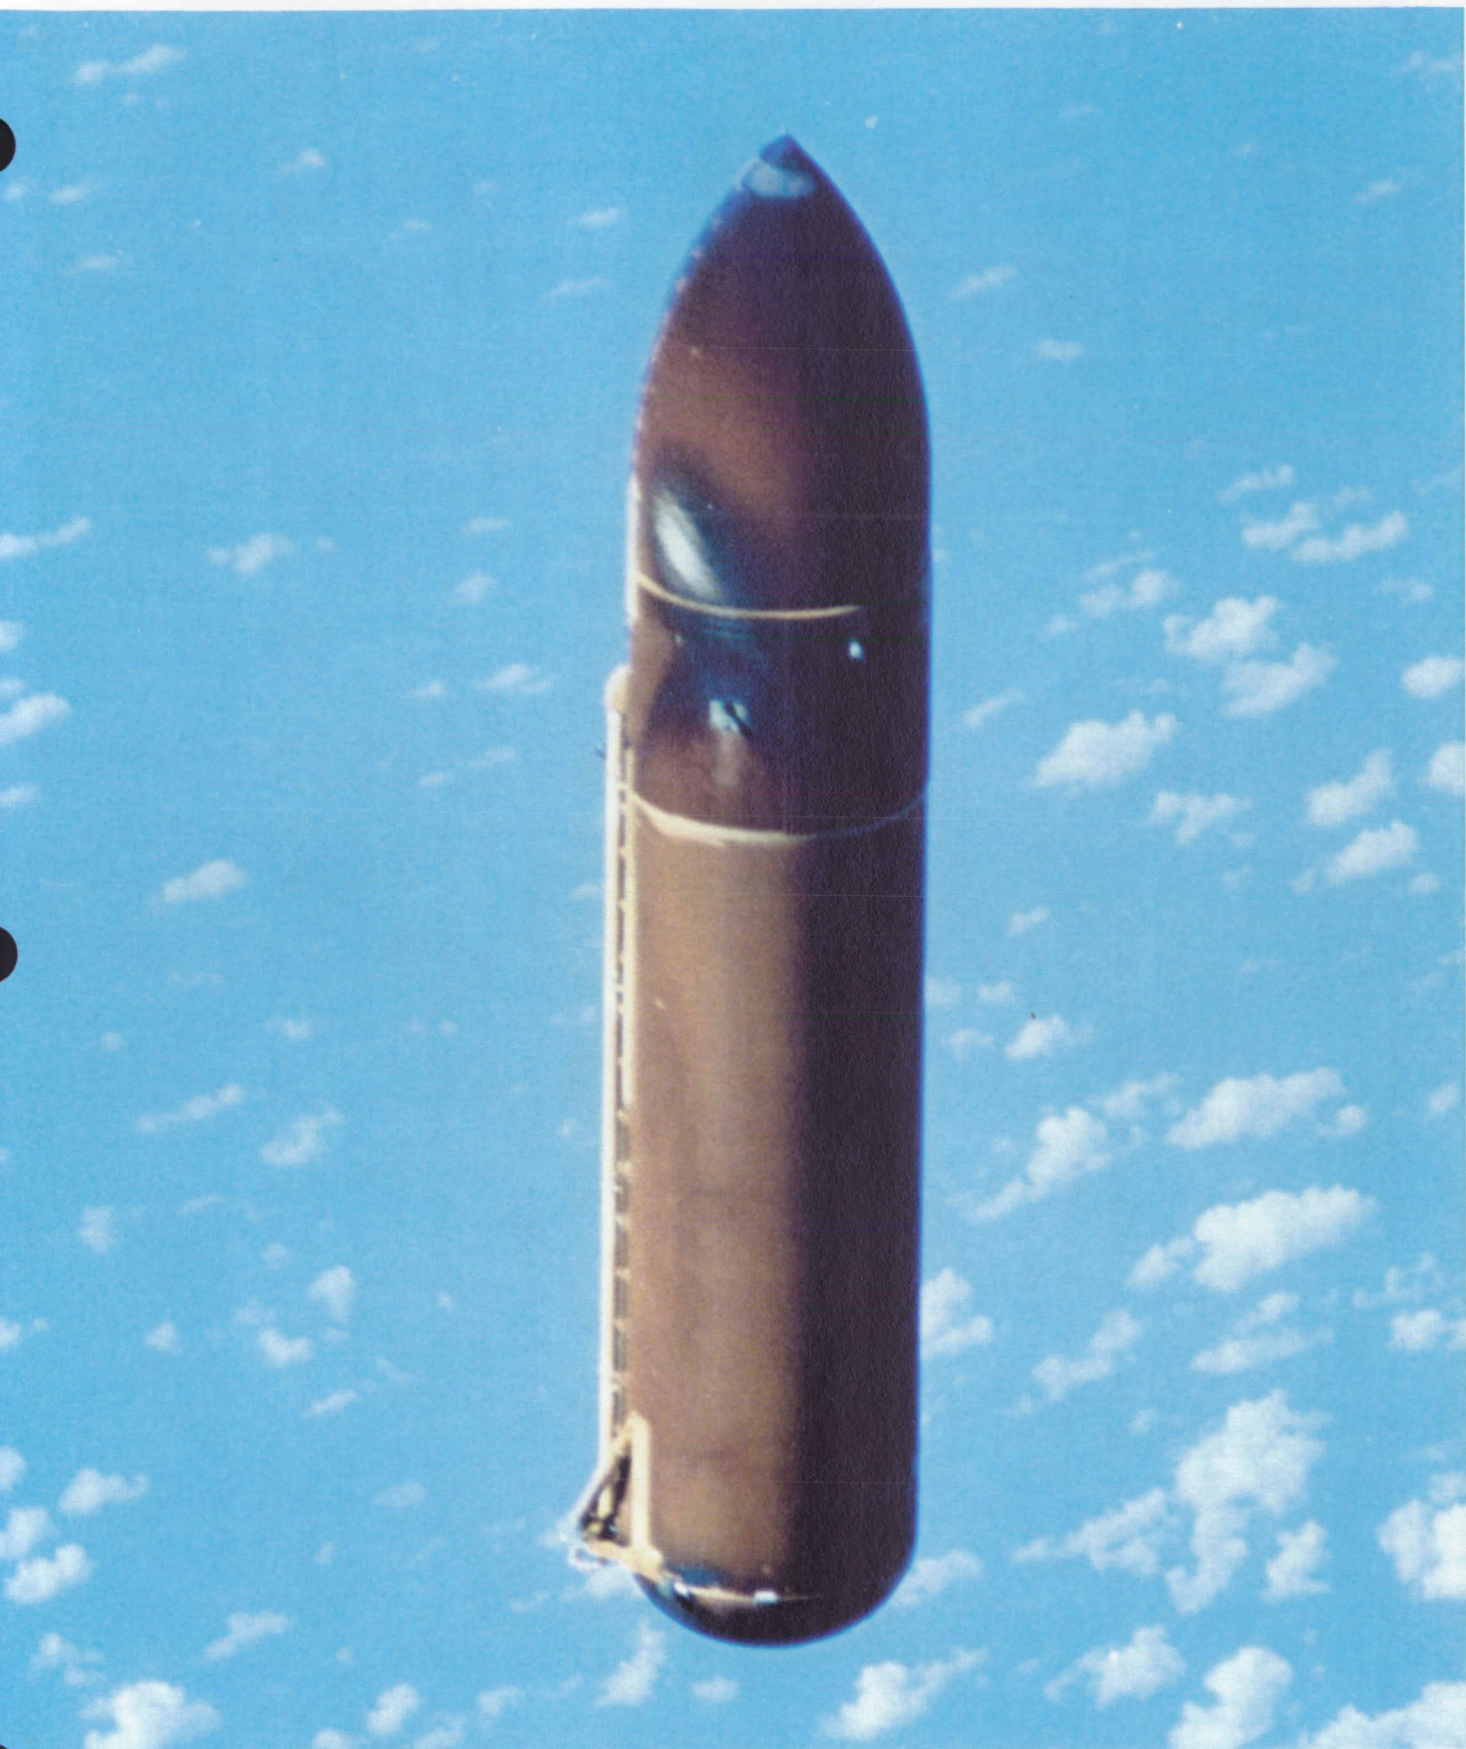
BSM burn scar on the LO2 tank was typical. No anomalies were observed on the +Y-Z side of the LO2 tank, intertank, LH2 tank, or aft hardpoint closeout.

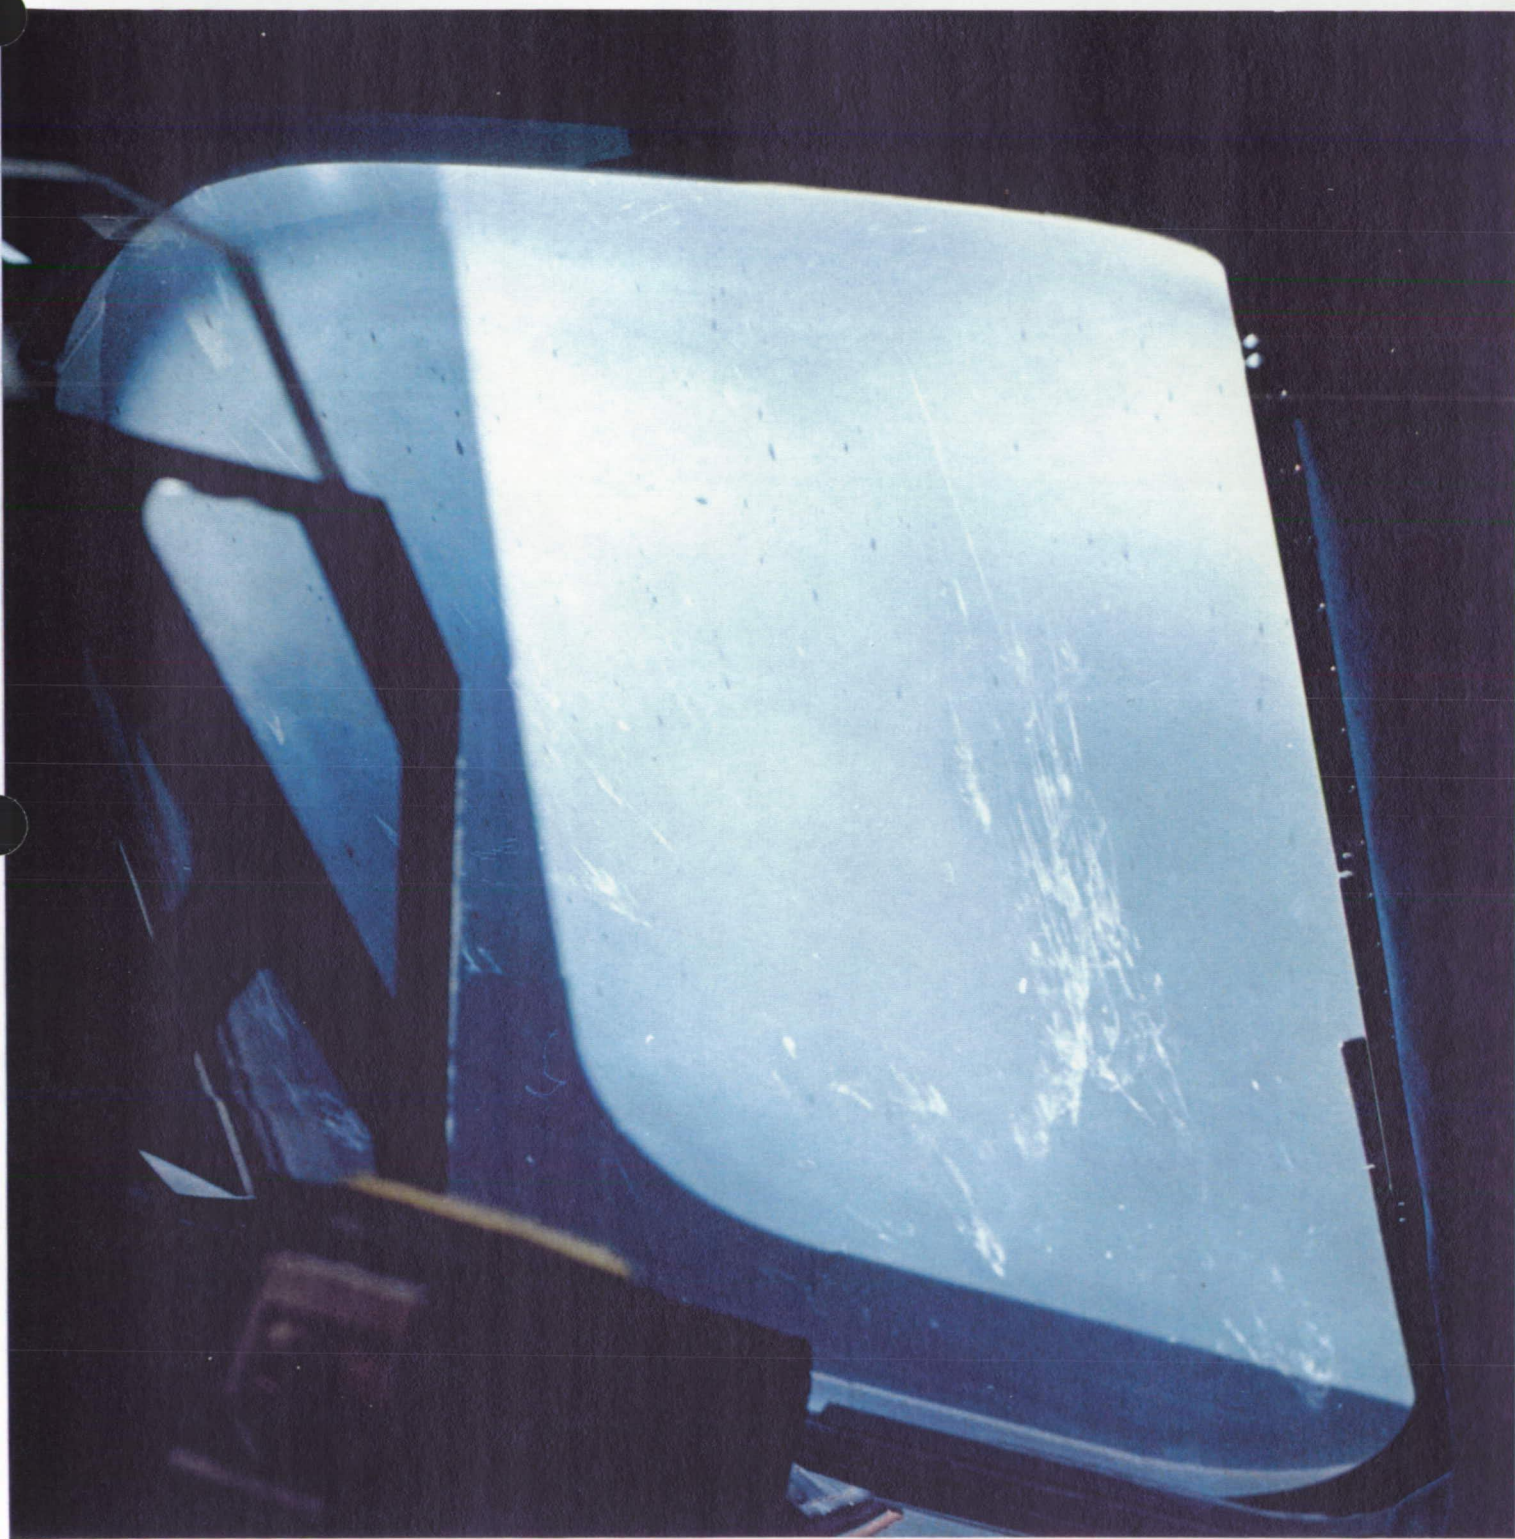
Samples of residue that appeared on the Orbiter windows during ascent revealed the presence of SRB BSM exhaust particles, Orbiter TPS fibers, and RTV from either the Orbiter TPS or the material used to bond paper covers to the forward RCS thrusters

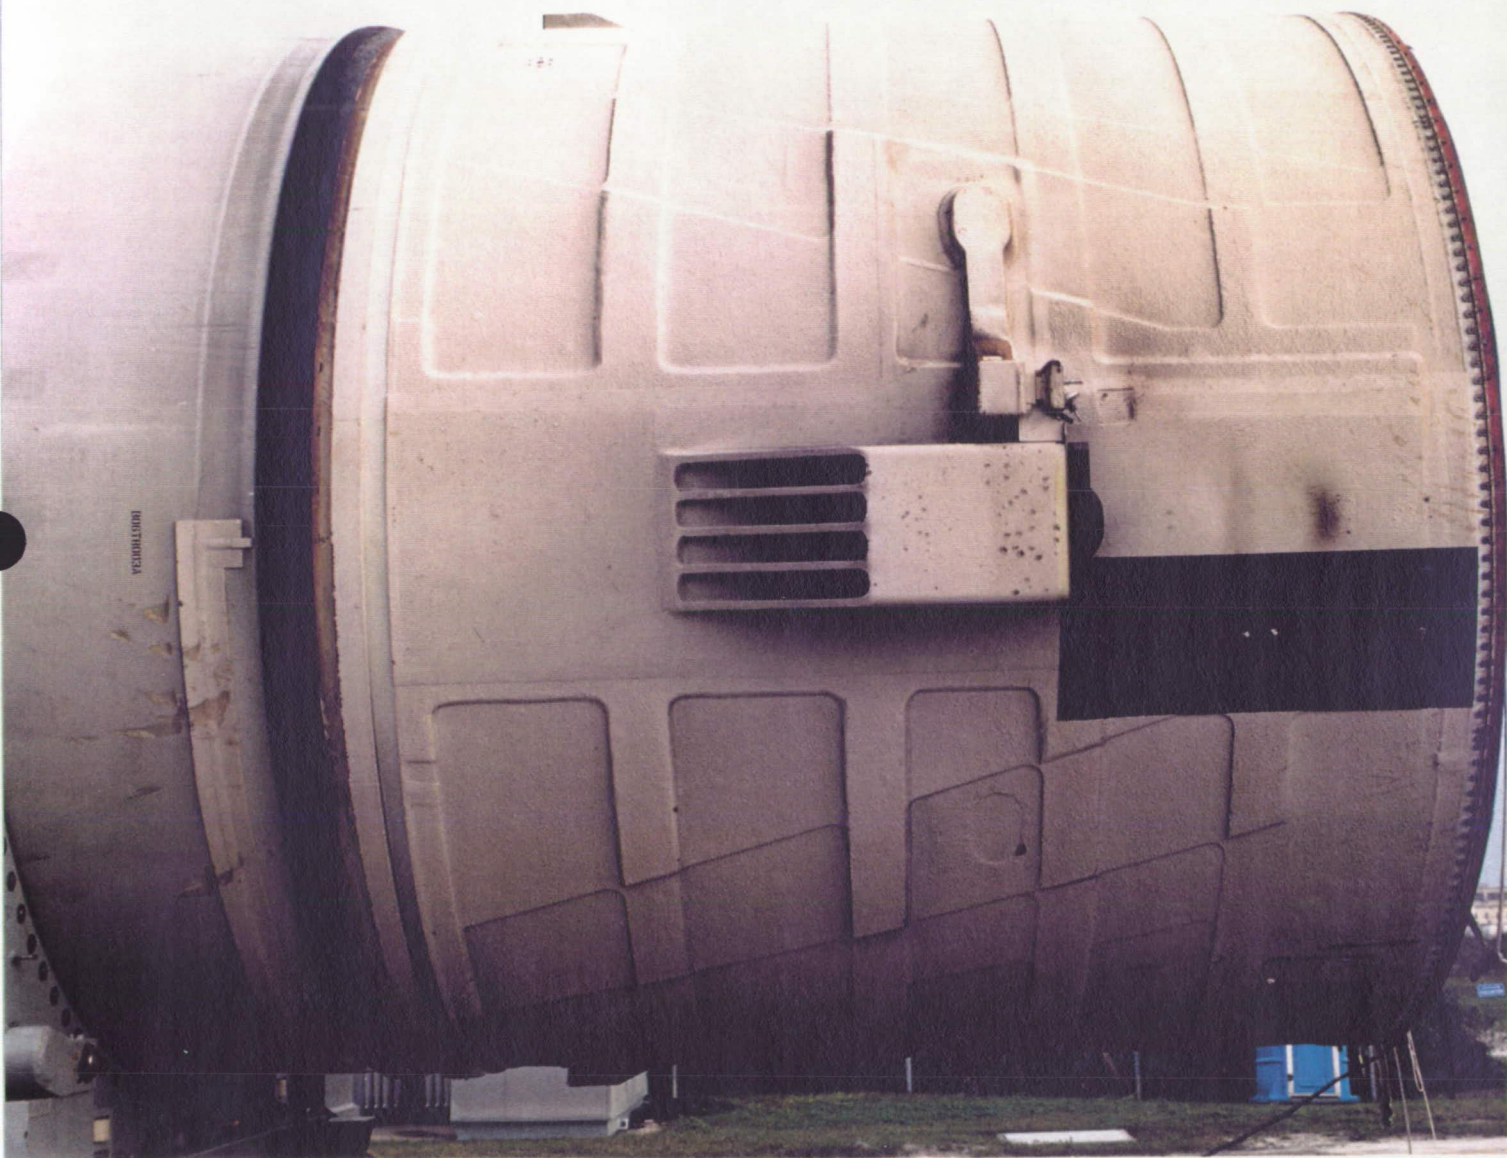
The RH frustum was missing no TPS, but had 31 MSA-2 debonds over fasteners. All BSM aero heat shield covers were locked in the fully opened position though the lower left cover attach ring had been bent by parachute riser entanglement.

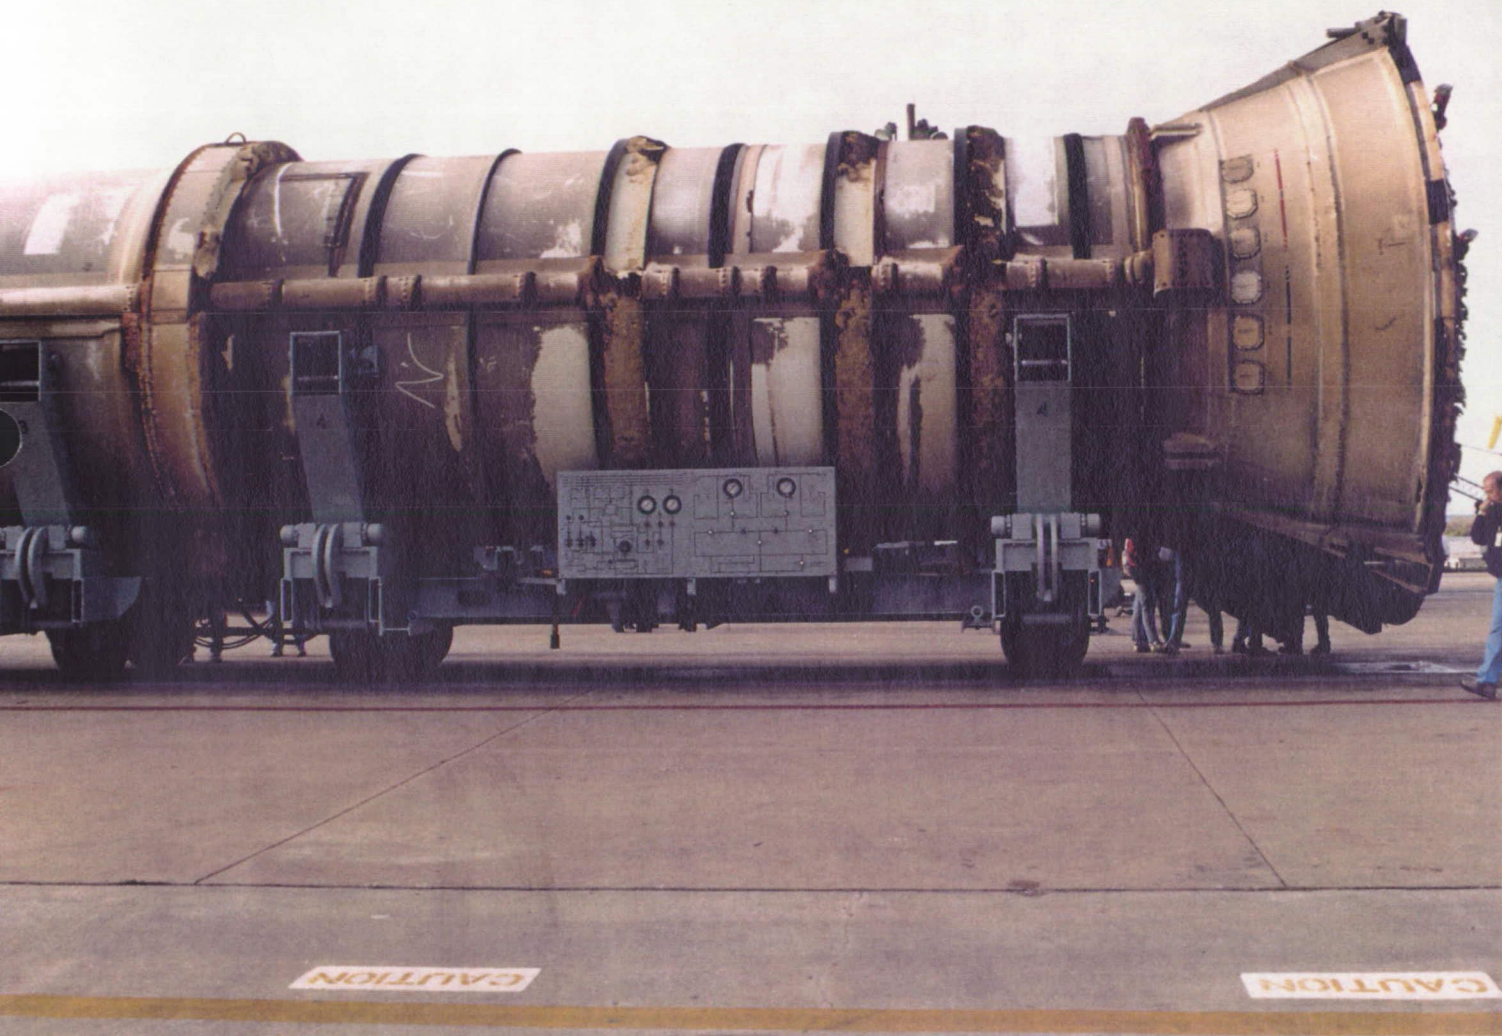
Several areas on the SRM segment cases exhibited missing paint and exposed metal substrate.

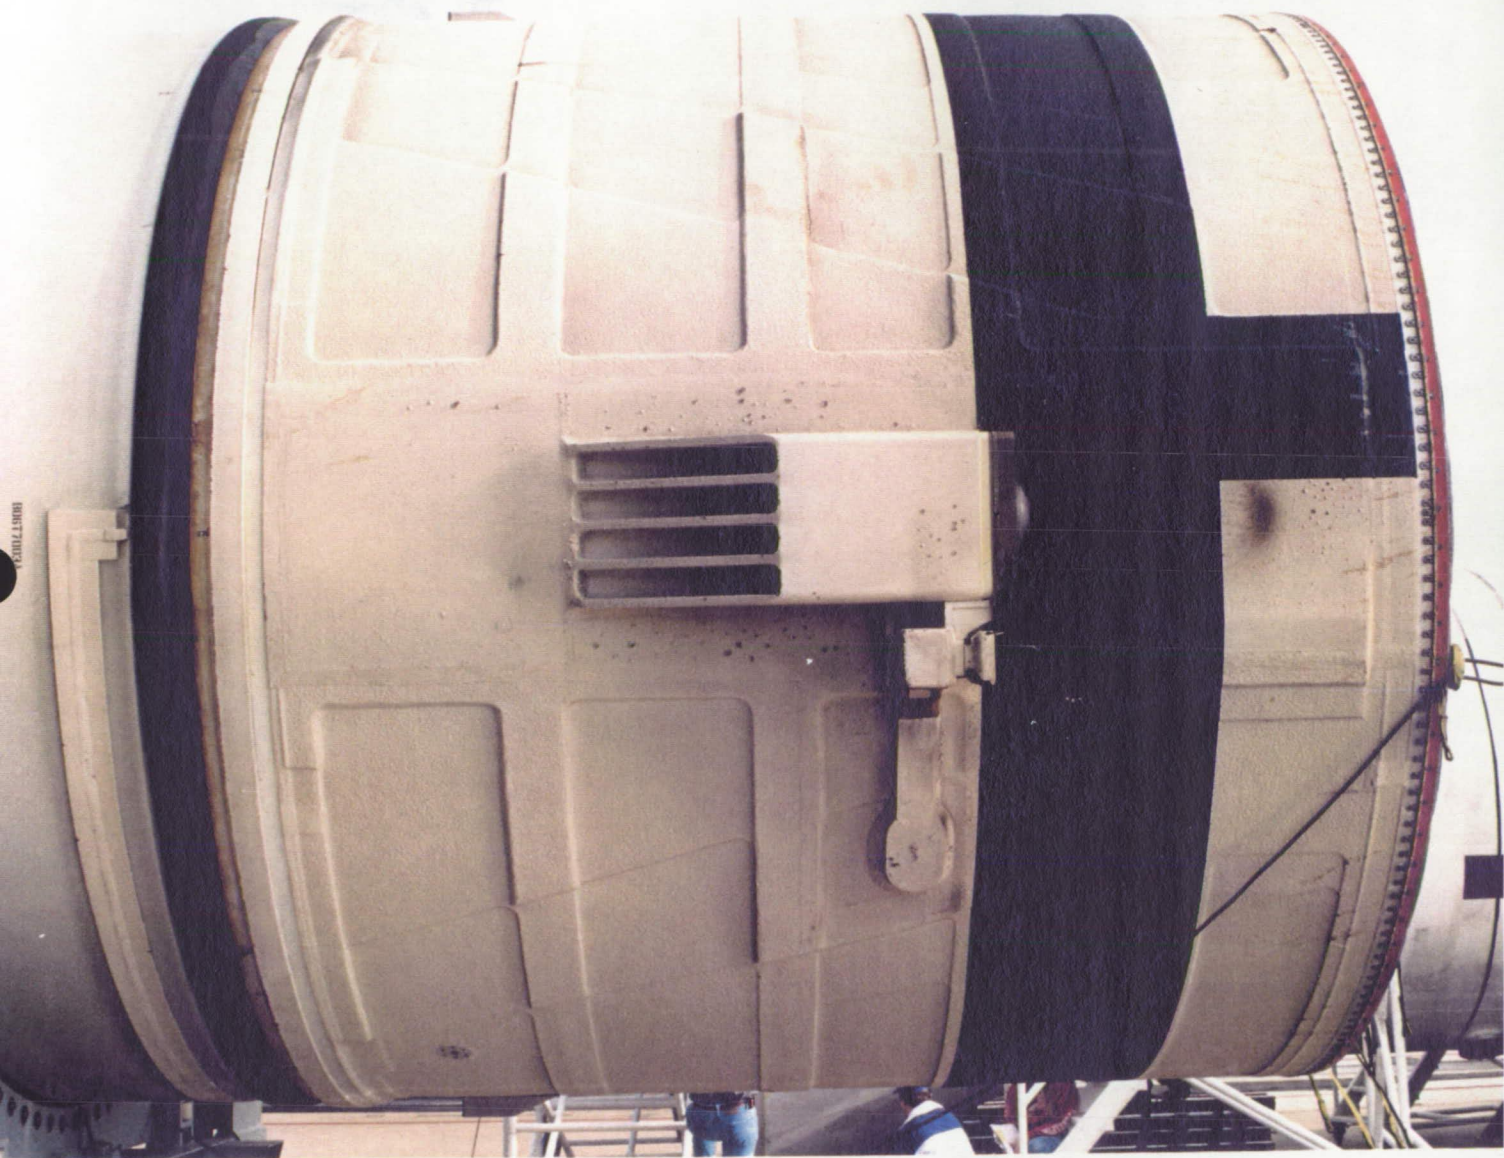
The LH frustum was missing no TPS, but had 18 MSA-2 debonds over fasteners. The BSM aero heat shield covers were locked in the fully opened position, though the lower left cover attach ring had been bent by parachute riser entanglement.

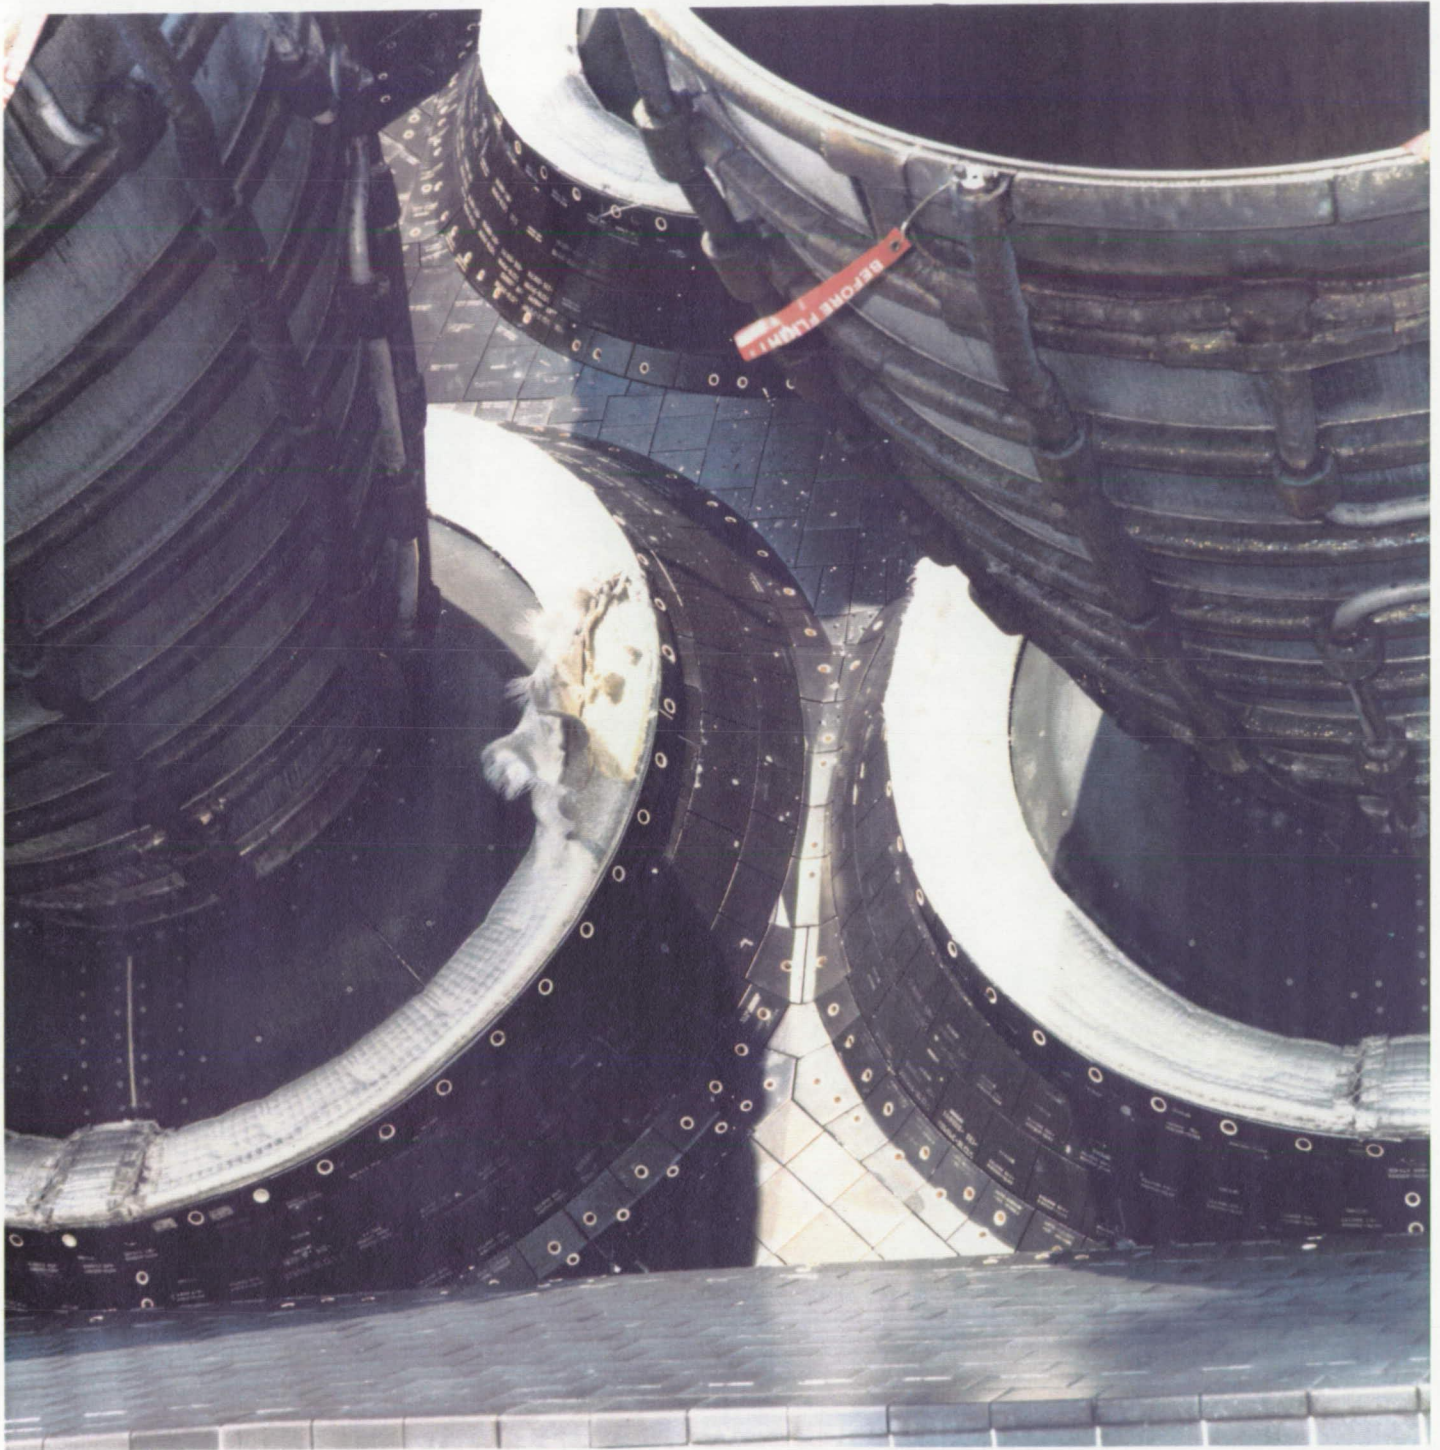
The Orbiter lower surface tiles sustained a total of 80 hits (less than average), of which 14 had a major dimension of 1-inch or greater (average).
