NASA Technical Memorandum TM 107558

Debris/Ice/TPS Assessment and Integrated Photographic Analysis for Shuttle Mission STS-54

March 1993

John F. Kennedy Space Center

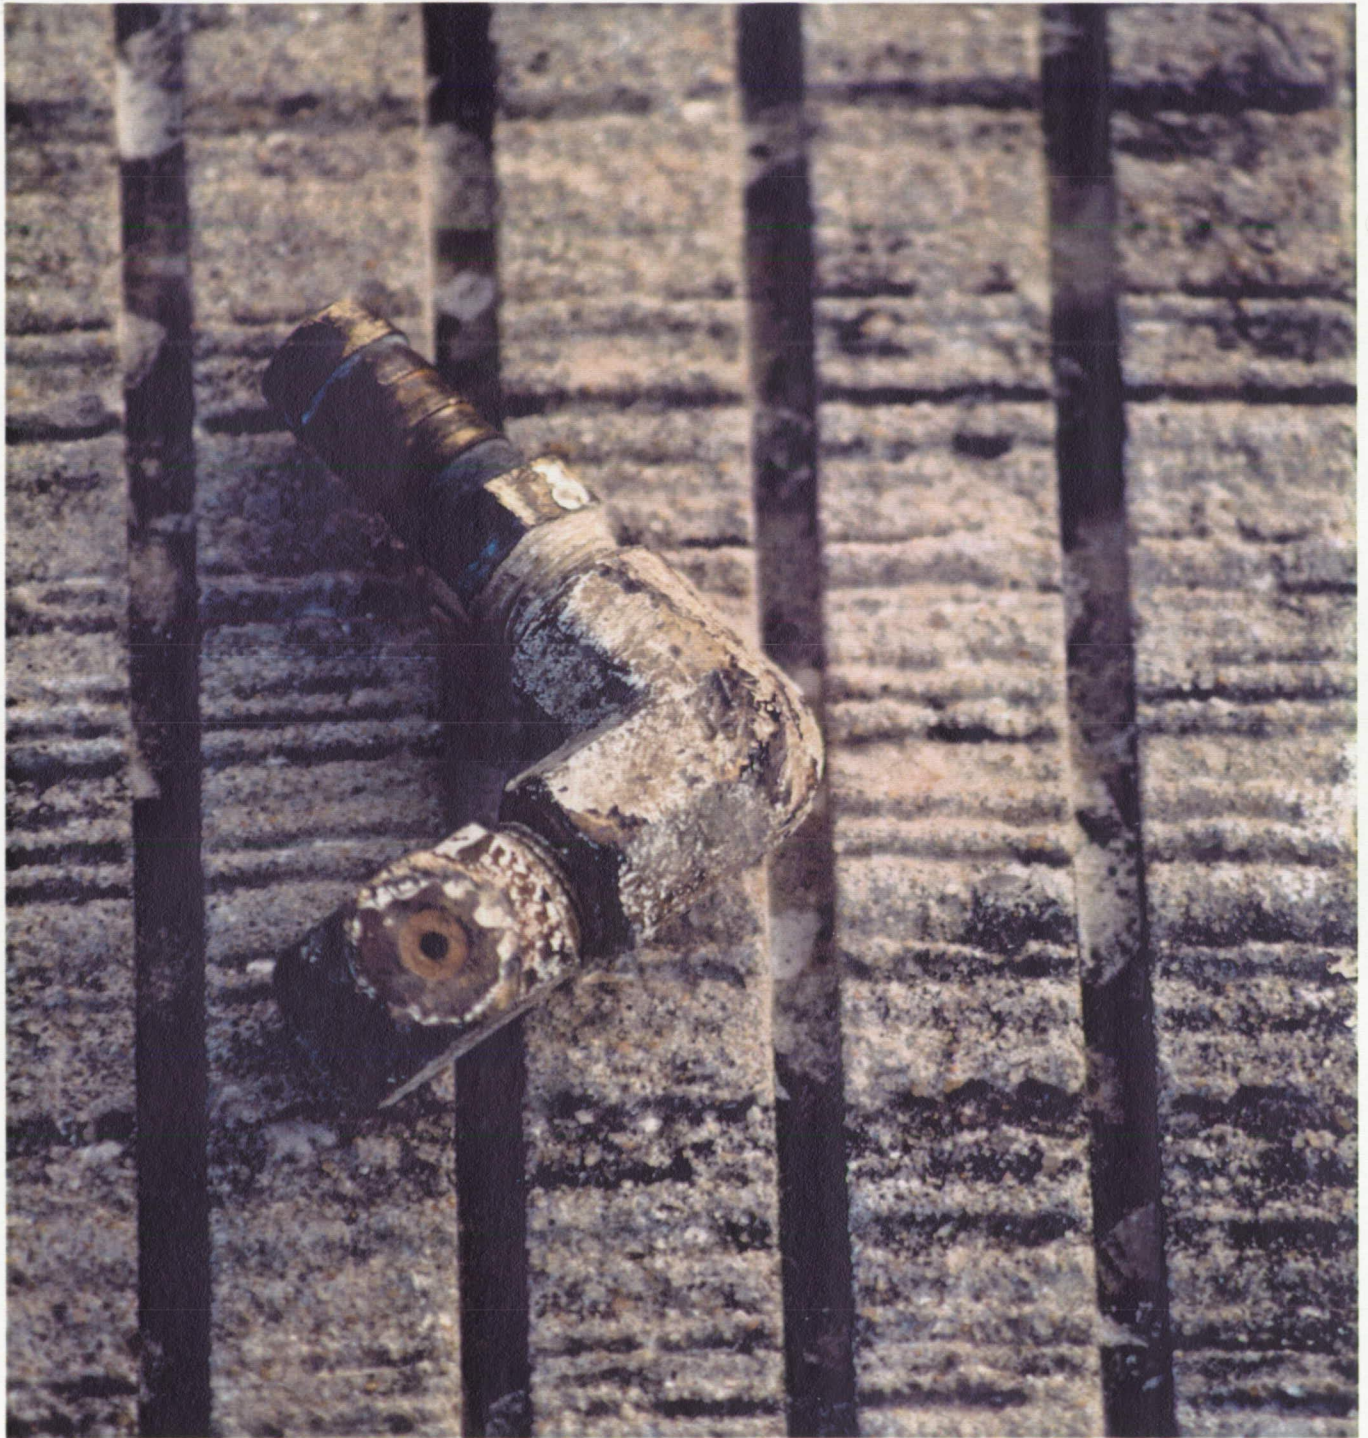
Five tile fragments found on the runway originated from the vertical stabilizer "stinger" and had been dislodged by contact with the drag chute riser lines during deployment.

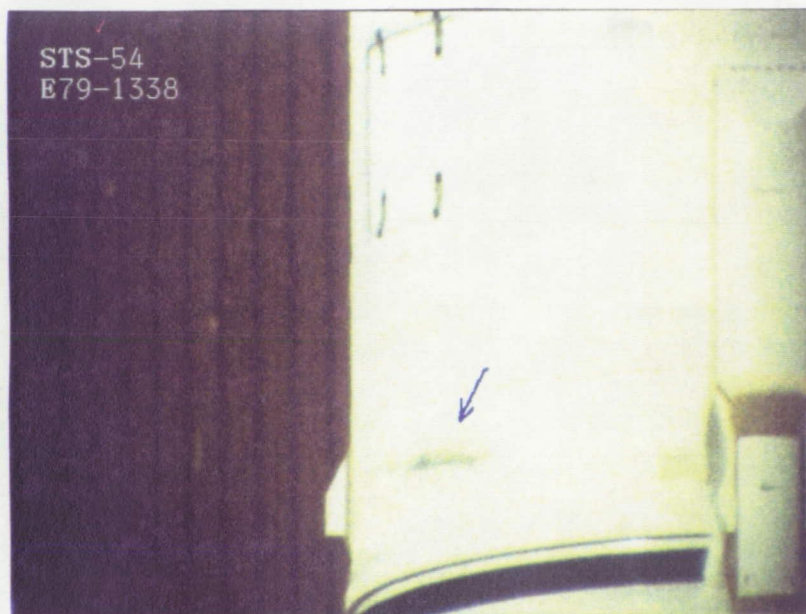
Figure 2.2.5 Dark Discoloration on Forward Segment of Right SRB

2.2.5 Discoloration on Forward Segment of Right SRB (Cameras E-65 and E-79)

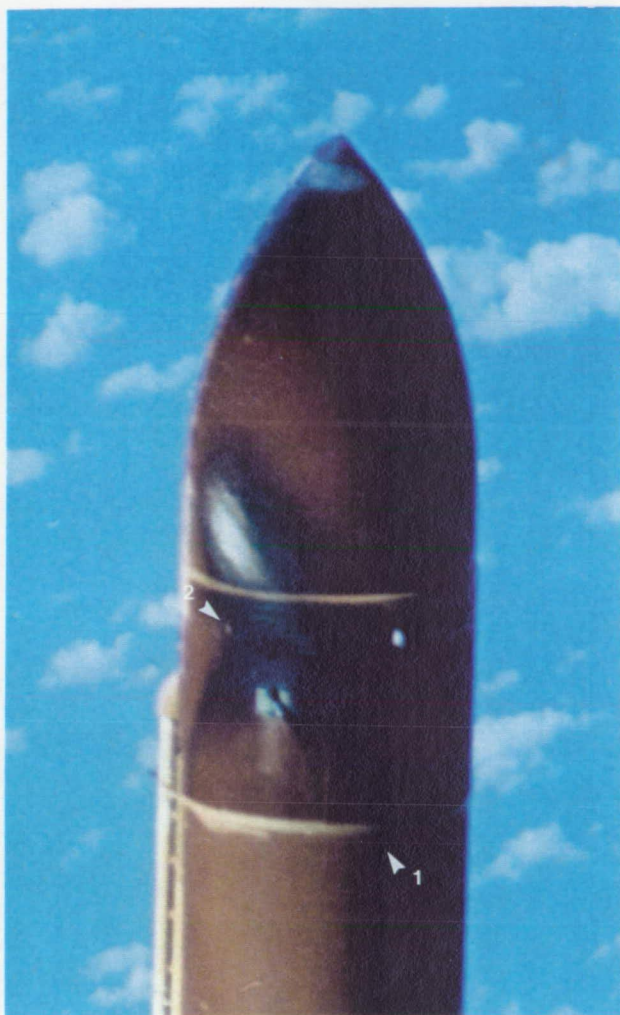
Figure 2.4.1 (A) **Handheld Camera View of the Right Side (+Y Axis) of ET**
(Frame STS-54-27-024)

Magazine 27 viewed the nose cone/O-Give and the right side (+Y axis) of the ET. From frame 13 through frame 24 a possible small divot was observed on the LH2 intertank interface (1). A second possible divot was noted in the intertank area below the right SRB burn separation motors (BSM) burn scar (2). The second divot could not be confirmed since a close-out photograph of this region was not available.

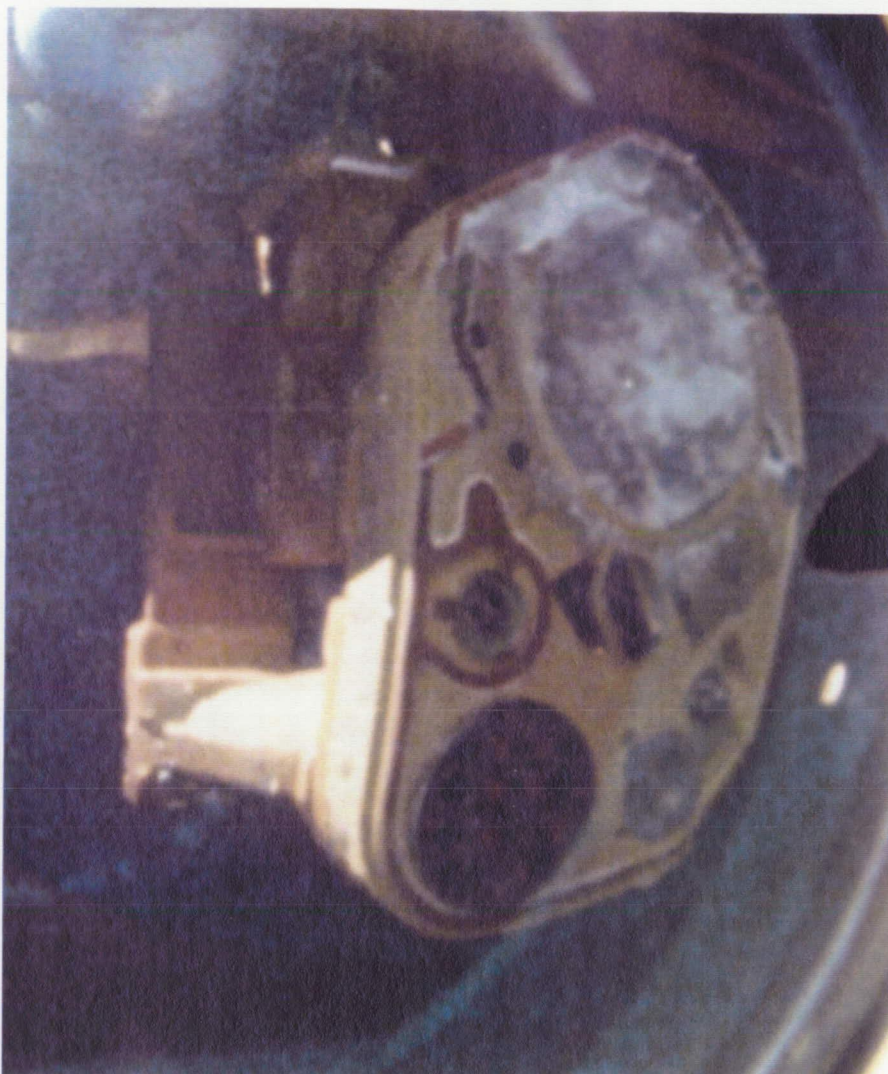
Figure 2.4.2.2.2 (C) ET LH2 Umbilical after ET Separation
(Frame STS-54-57-5228)

Multiple pieces of white debris (possibly ice from the umbilical vent purge) were seen throughout the ET separation sequence. White debris was seen to strike the ET electrical cable tray and break into smaller pieces just prior to ET separation.

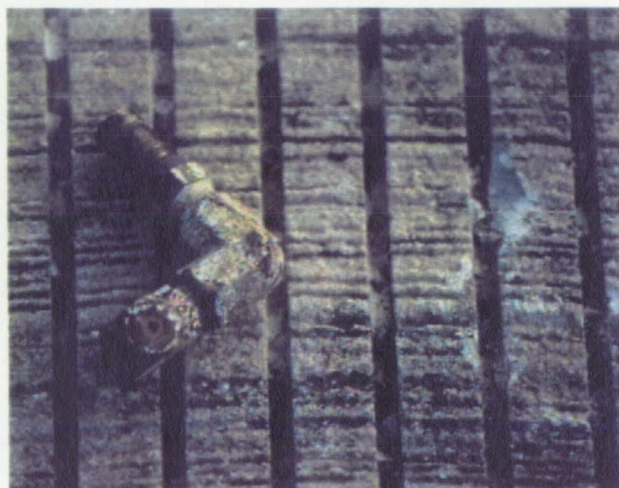
Figure 2.5.4 Nozzle from Sweeper Truck

An 8 ounce, 2.5" x 2.25" x 0.5" thick, brass spray nozzle/elbow was found at the 3800 foot marker 18 feet east of the runway centerline. The nozzle originated from the runway sweeper.
