**Thermal Protection System of the Space Shuttle's  
Orbiter**

**F. E. Jones  
KSC**

### ORBITER TPS DAMAGE REVIEW TEAM

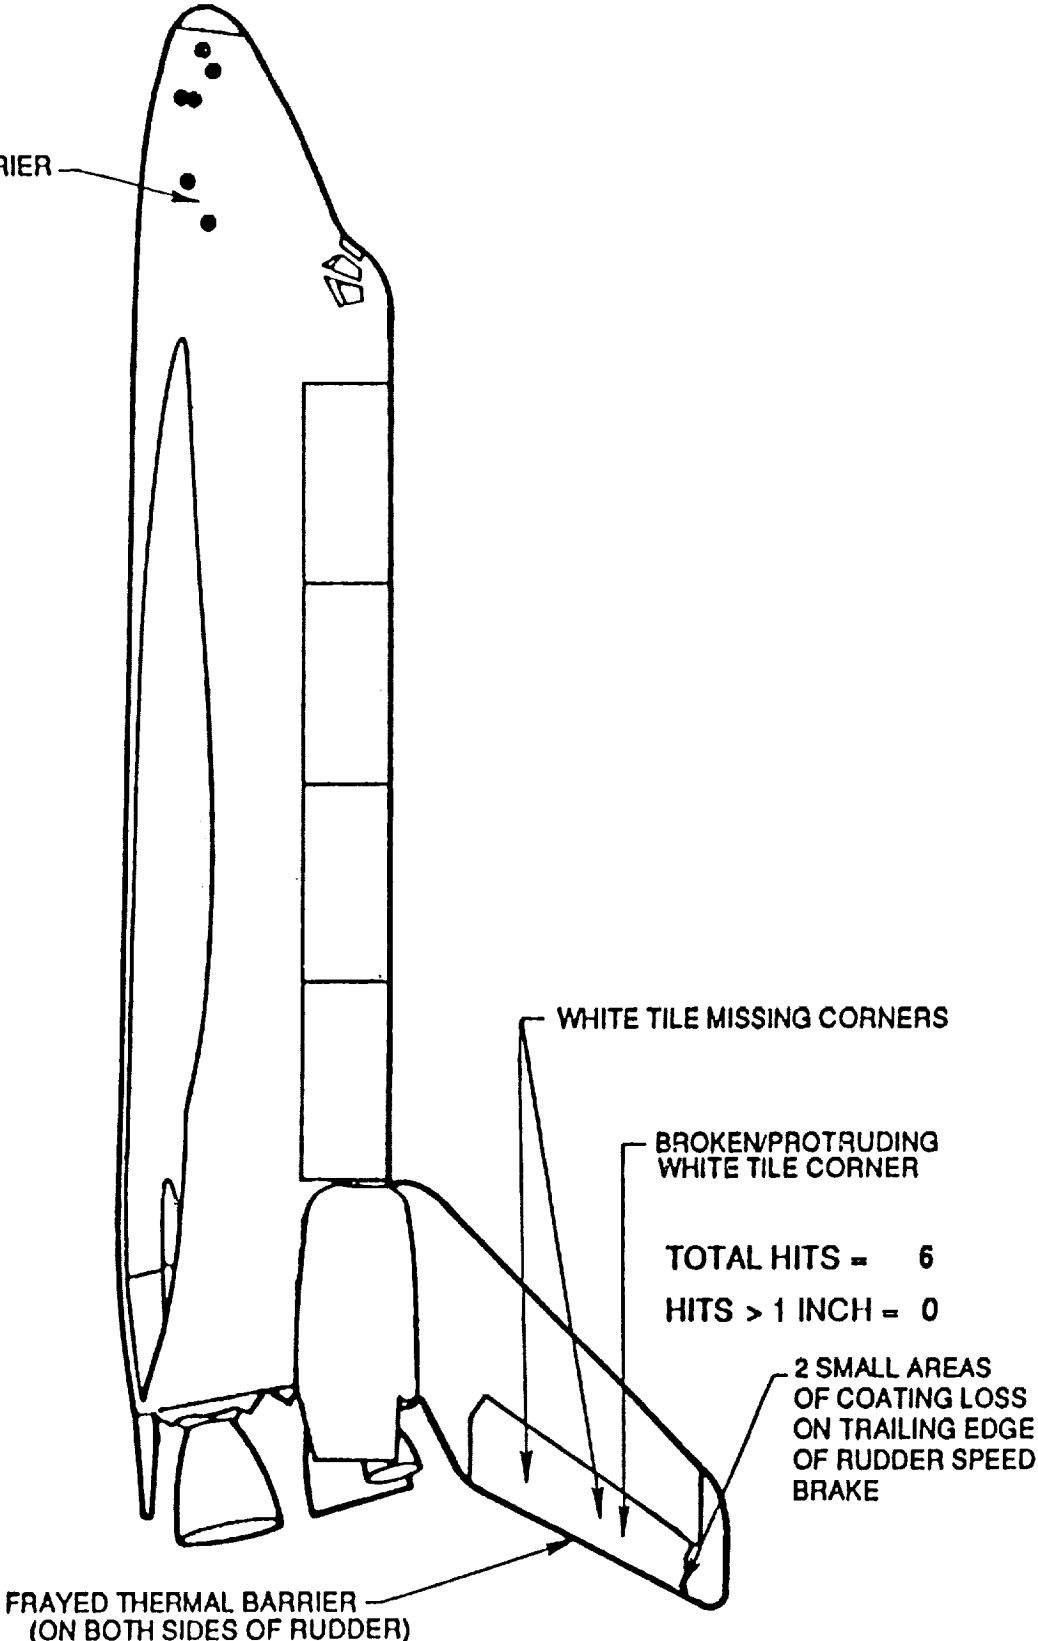
# STS-40 DEBRIS DAMAGE LOCATIONS

FRAYED THERMAL BARRIER  
(4 PLACES)
