NASA-CR-192522

Final Report on the SRB Frustrum "Smiley" Cracking Phenomenon Study

February 6, 1993

Thomas A. Cruse, Ph.D.
401 Bowling Ave. #6
Nashville, TN 37205
(615) 343-8727; (615) 343-8730 (fax)

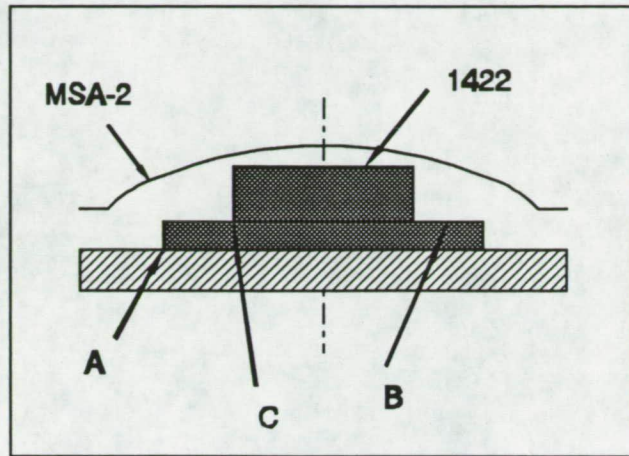
Figure 1: Representation of Material Configuration at Single Fastener

The figure indicates the essential features of the material arrangement in the area of a single fastener. Examination of all of the removed specimens containing various sizes, shapes, and orientations of cracks including the specimen with the divot indicated that each appeared to have common elements which are seen to be critical to understanding the "smiley" problem. Locations A, B, and C are all locations of an appearance of weak bonding between the MSA and substrate materials. Locations B and C have 1422 sealant as the substrate, while location A has base metal as the substrate material. Location C is the site of the undercut associated with the caps that are used for sealant application. The sealant between sites A and C is the overfill sealant from the application procedure and has variable thickness. In one case, the 1422 sealant was seen to extend beyond site A on the metal substrate but with very little apparent thickness. It would seem that the cleanup of the overfill resulted in a regularly-sized "smear" of 1422.

very low strength of the bond at site B in the figure, corresponding to the MSA-2 bond on the overfill bead of the 1422 sealant. The very low strength conclusion is based on the lack of adhesion of the MSA-2 to the 1422 indicated by MSA-2 "fuzz" which is clearly seen on other locations of the debond. Examination of the witness surface on the MSA-2 material I removed showed a consistent picture - the MSA-2 surface at location B was quite smooth and had the appearance of a mold of the 1422 sealant.

Examination of the six debonded regions also shows that the adherence of MSA-2 to the supporting material is weak at locations A and C. In no case did the weak bond of MSA-2 to base metal extend more than a few mils from the edge of the 1422, but the metal surface clearly showed a lack of retained MSA-2 over a significant arc length of the failed zone. The radial extent of the weak bond is consistent with the size of the "voids" noted in the report on STS-48 that I read. The MSA-2 fractures were all featured as conical failure surfaces at roughly 45° to the substrate. The small radial extent of the weak bonded surface indicated to me that this location was not primary, but secondary in the sequence of MSA-2 fracture.

The weak bond of MSA-2 and 1422 sealant is radially large compared to that at location A. The weakness may include both locations B and C. The undercut showed very little likelihood of good bonding between the two materials. However, the size of the weak region associated with the overfill surface (location B) appears to be large enough to allow fracture associated with the depressurization event near the point of separation, when the external pressure at the hypalon is at its lowest point. Such depressurization fractures of the MSA-2 material were shown in the USBI M&P test report, without the need for external heating. In removing the MSA-2 material from the selected sites, I qualitatively noted that the bond to the crown of the 1422 sealant in cases where the debond did not include this region, was quite strong in comparison to that strength I noted in peeling the material from location B.

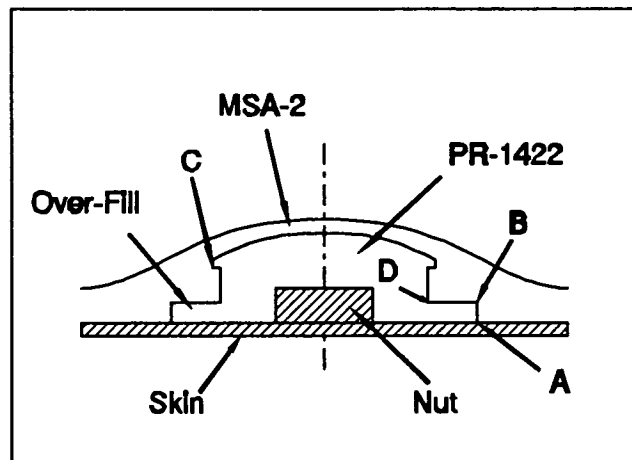
Figure 4: Schematic Showing Key Locations

The results of the stress analyses for all cases involving excess PR-1422 material show that the maximum effective stress occurs at location B, as indicated in Figure 4. The mechanical cause of the high stress at this location is the re-entrant corner formed by the MSA-2, and the fact that the MSA-2 material is much stiffer than the PR-1422 material. The load being carried by the MSA-2 material over the PR-1422 sealant must turn the corner at location B, and then flow to the substrate at location A. The high stress region focused at point B extends into the MSA-2 material, somewhat along the interface towards location A. Stress contour results for the various cases are given in the appendices to this report. The maximum stresses are not to be taken too literally, as they will increase as the size of the finite elements near location D is refined. All FEM model results are based on the same mesh refinement near the stress concentrations, in order to make the comparisons, at least, meaningful. The following table summarized the results for the FEM solutions involving geometries with excess PR-1422 material, shown above as the overfill region.

The FEM analysis therefore strongly suggests that the excess material should act to reduce the strength of the MSA-2/PR-1422 bond. Further, failure should occur from locations near the corner of the excess PR-1422 material (location B). The strength reduction due to the stress concentration is of the order of 30%, based on these results.

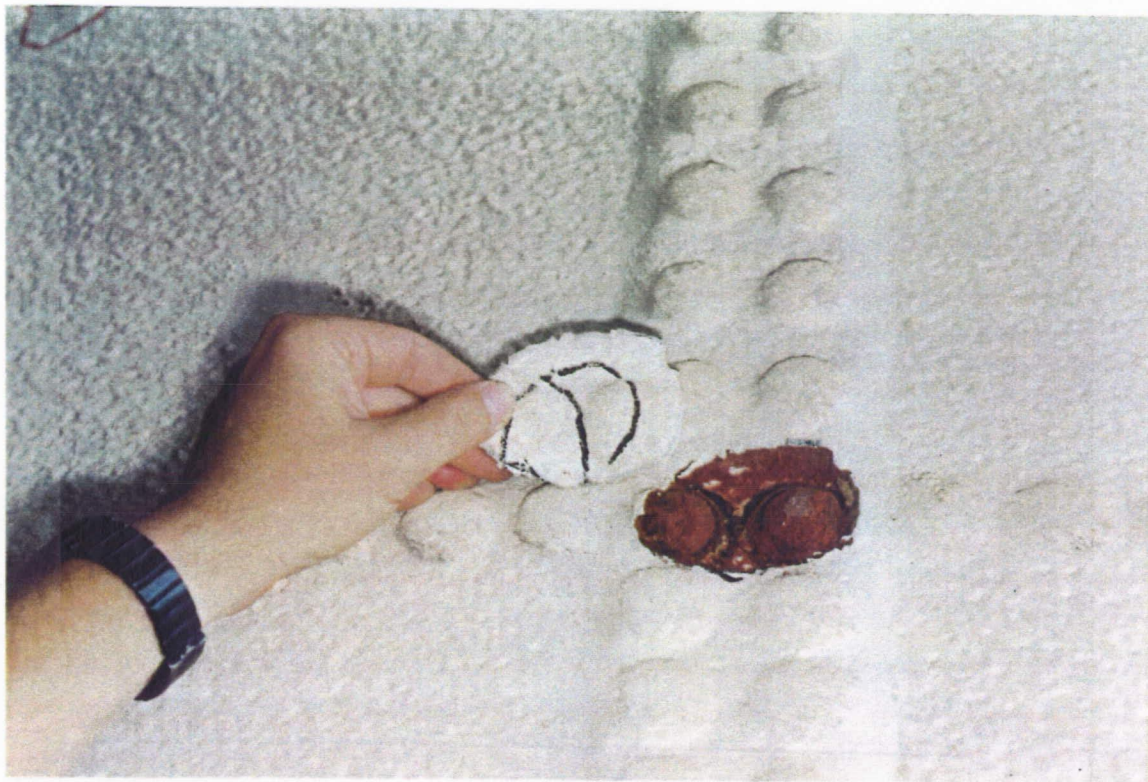
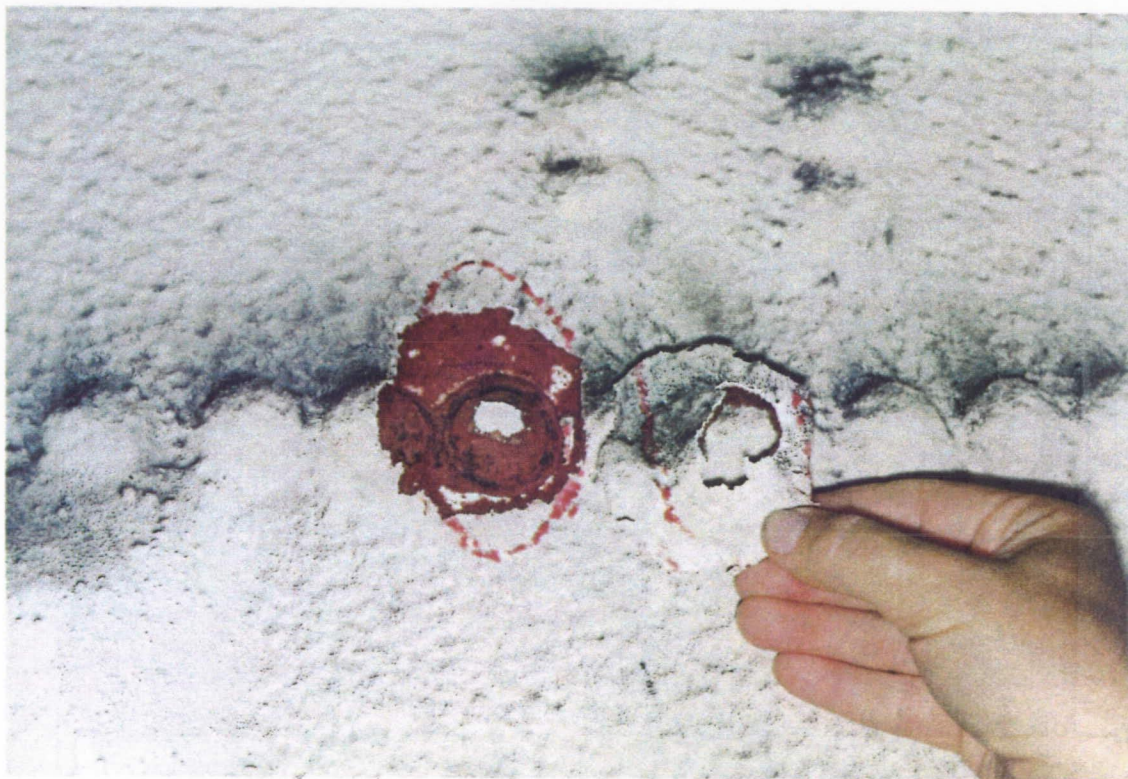
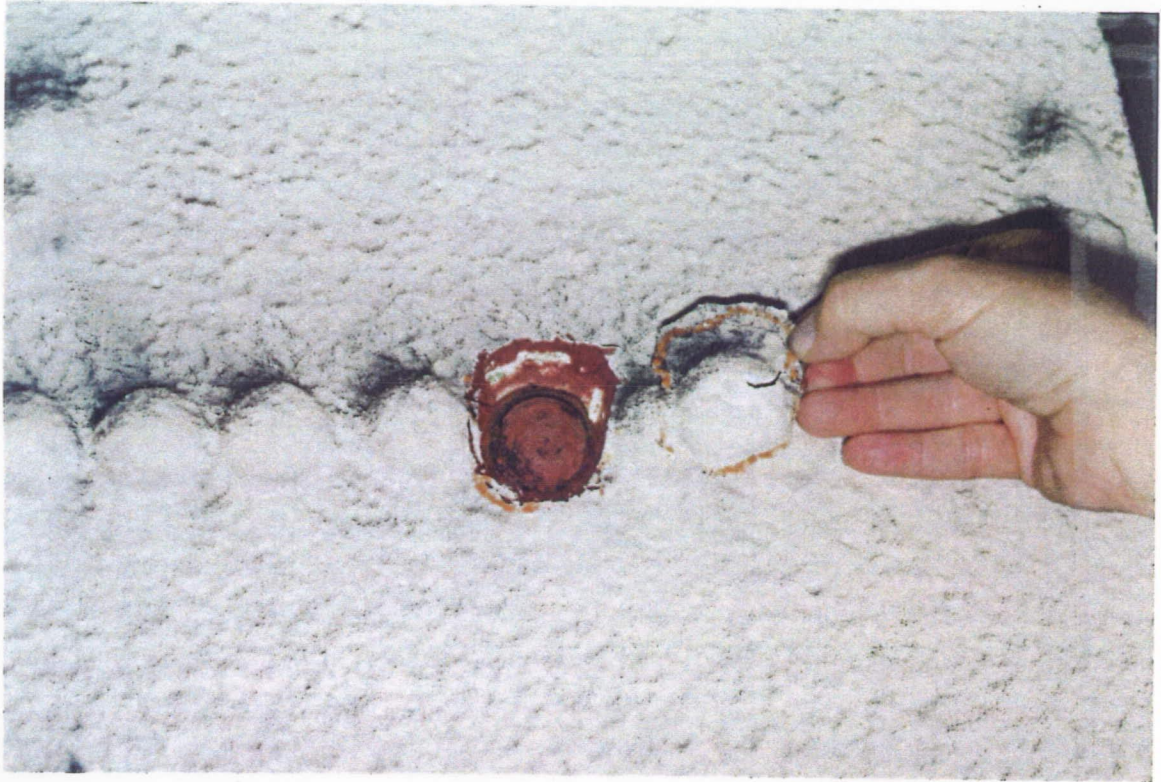
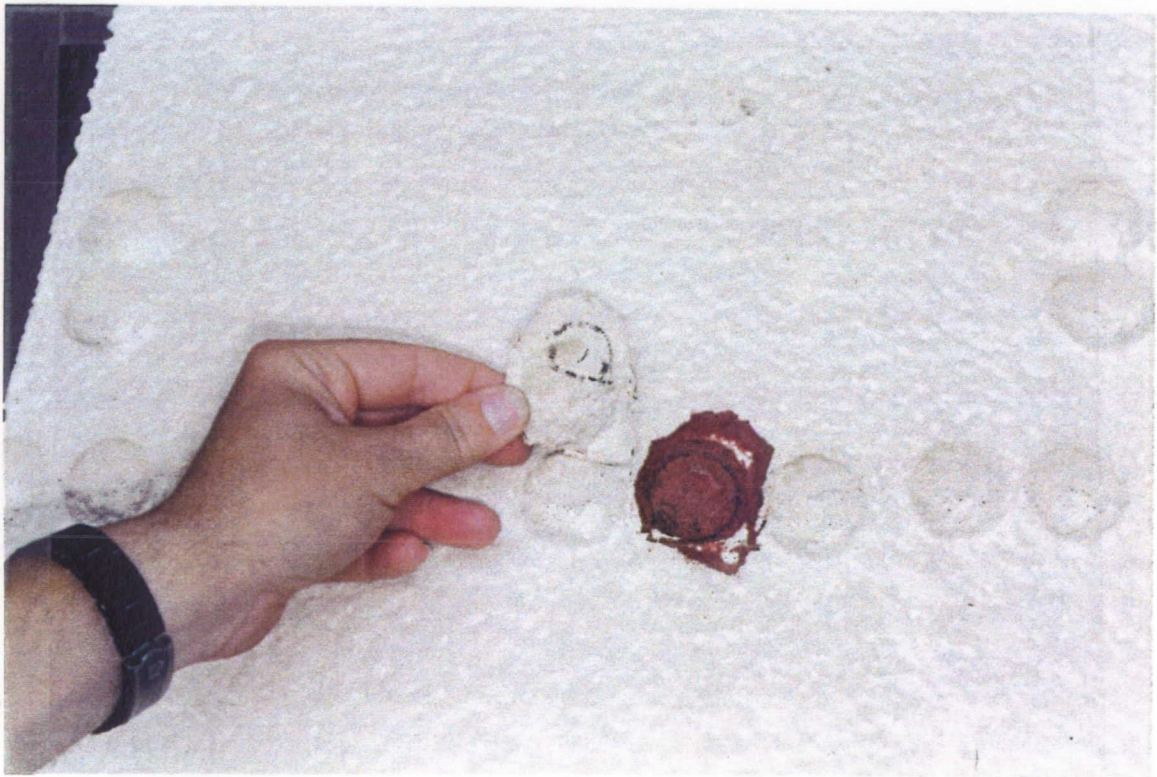
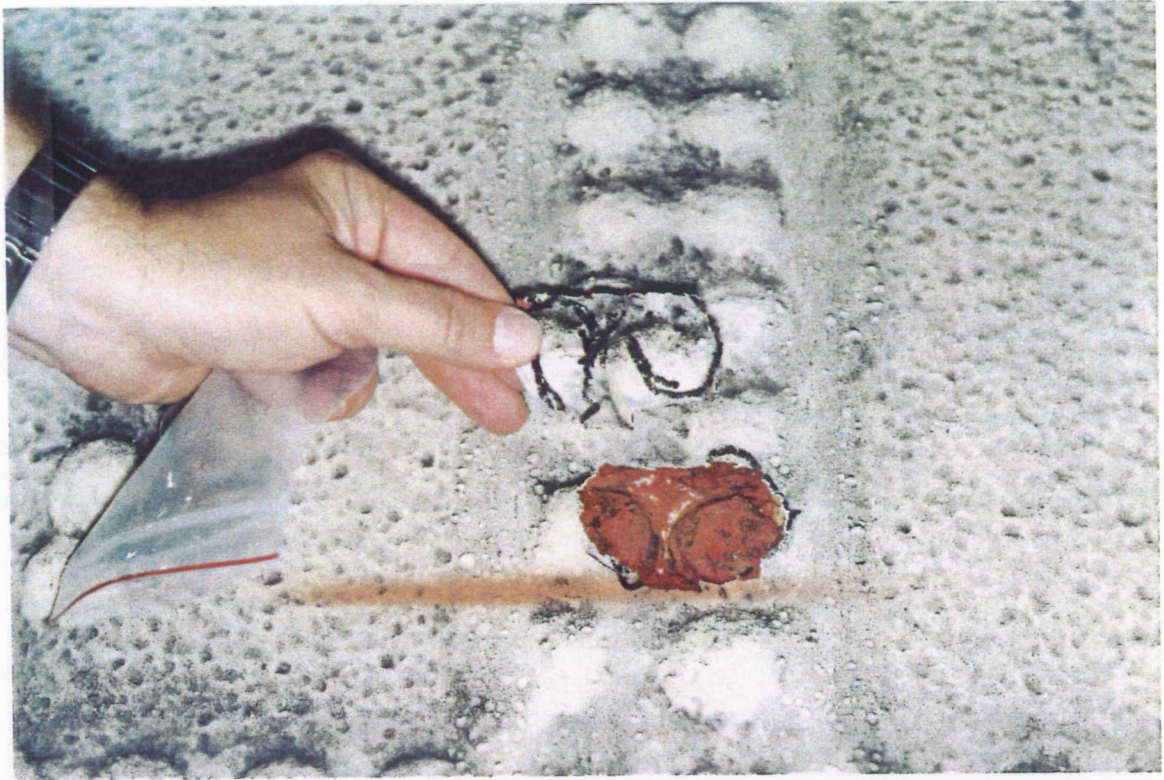
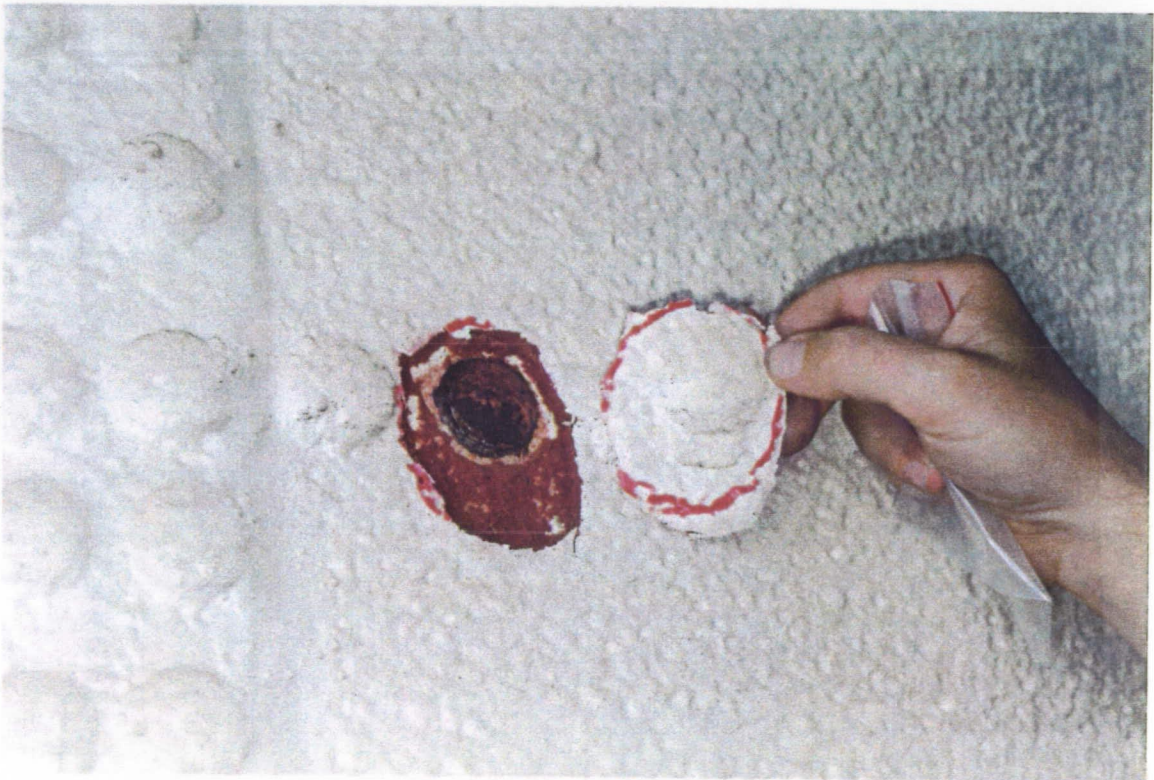
A. Photographs from post-flight inspection

I will begin with a summary of what I saw and what import I give to the observations. First, I think we need to generalize the definition of "smiley" cracks. There were numerous debonds of the MSA-2 over the fastener sealer. Many of these debonds had cracks of various sizes, orientations, and locations relative to the fasteners. According to those who report cracks, these are all "smileys" even though only some of them have the characteristic "smiley" shape and location. I observed a large number of these cracks and removed the MSA-2 material with crack at six locations. I have that material along with photos of the removed material and the frustrum site of the sample.

There was one divot on the frustrums, and I have the material from which the divot came. The debonds I observed were all over raised sealant material. Most debonds involved single fasteners, although there were some in the double row locations that involved two fasteners. One debond and "smiley" was located at an access panel, but again was over raised sealant. The USBI engineers fully documented the frustrum for "smiley" locations, and both video and still camera pictures were taken. My examination was sufficient for me to observe patterns and trends in the "smiley" types and locations, but did not constitute a full survey of the frustrums.

With only one major exception, all of the debond/cracking appeared to be on the up-wind side of the fastener (in the case of single-fastener row locations and some double-fastener row locations) or on the side of the double-fastener rows, or to cover the entire fastener. The exceptions included a noted site where the debond occurred on the downwind side of the fastener. That site is among those I selected for material removal. These are sites that can be expected to have higher heat flux during the ascent part of the flight. Based on USBI data subsequent to the PFA inspection, the frustrum sees its highest heat-loads during ascent, whereas the aft skirt sees its highest heat loads during reentry. All cracks are associated with debonds.

In all cases where I removed material containing a debond with a crack, the debond affected a larger region than the size of the crack - the physical appearance supports the hypothesis that the crack comes after the debond. I saw no exceptions to change this hypothesis. Further, and much more critically, the removed material at the debonds indicated quite clearly

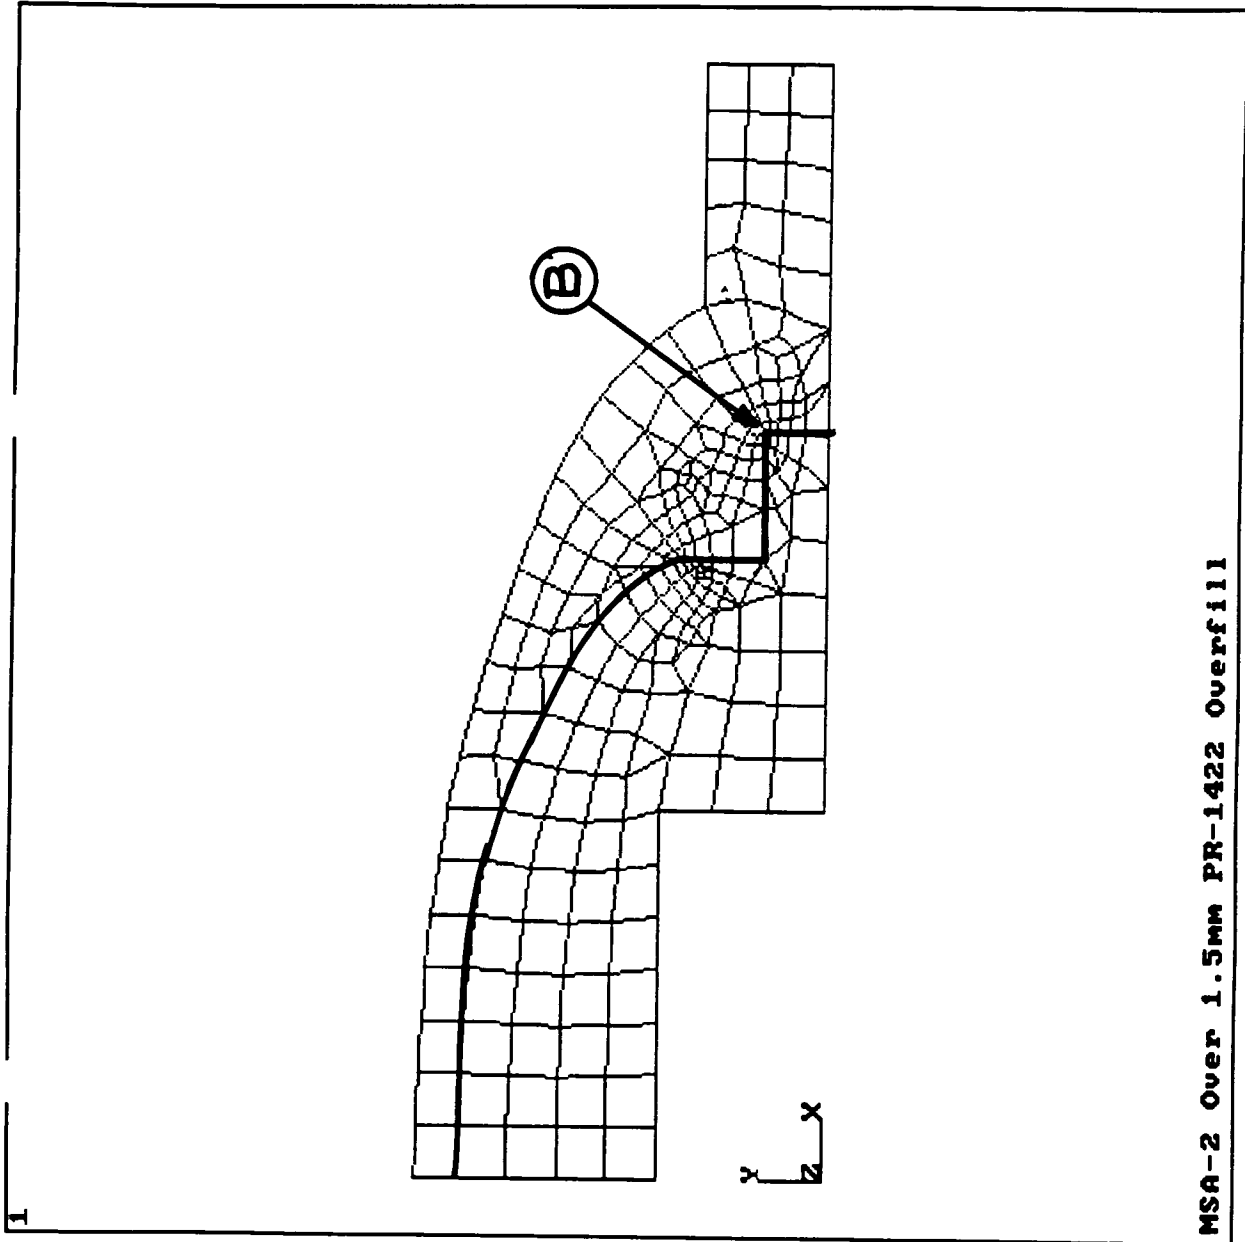
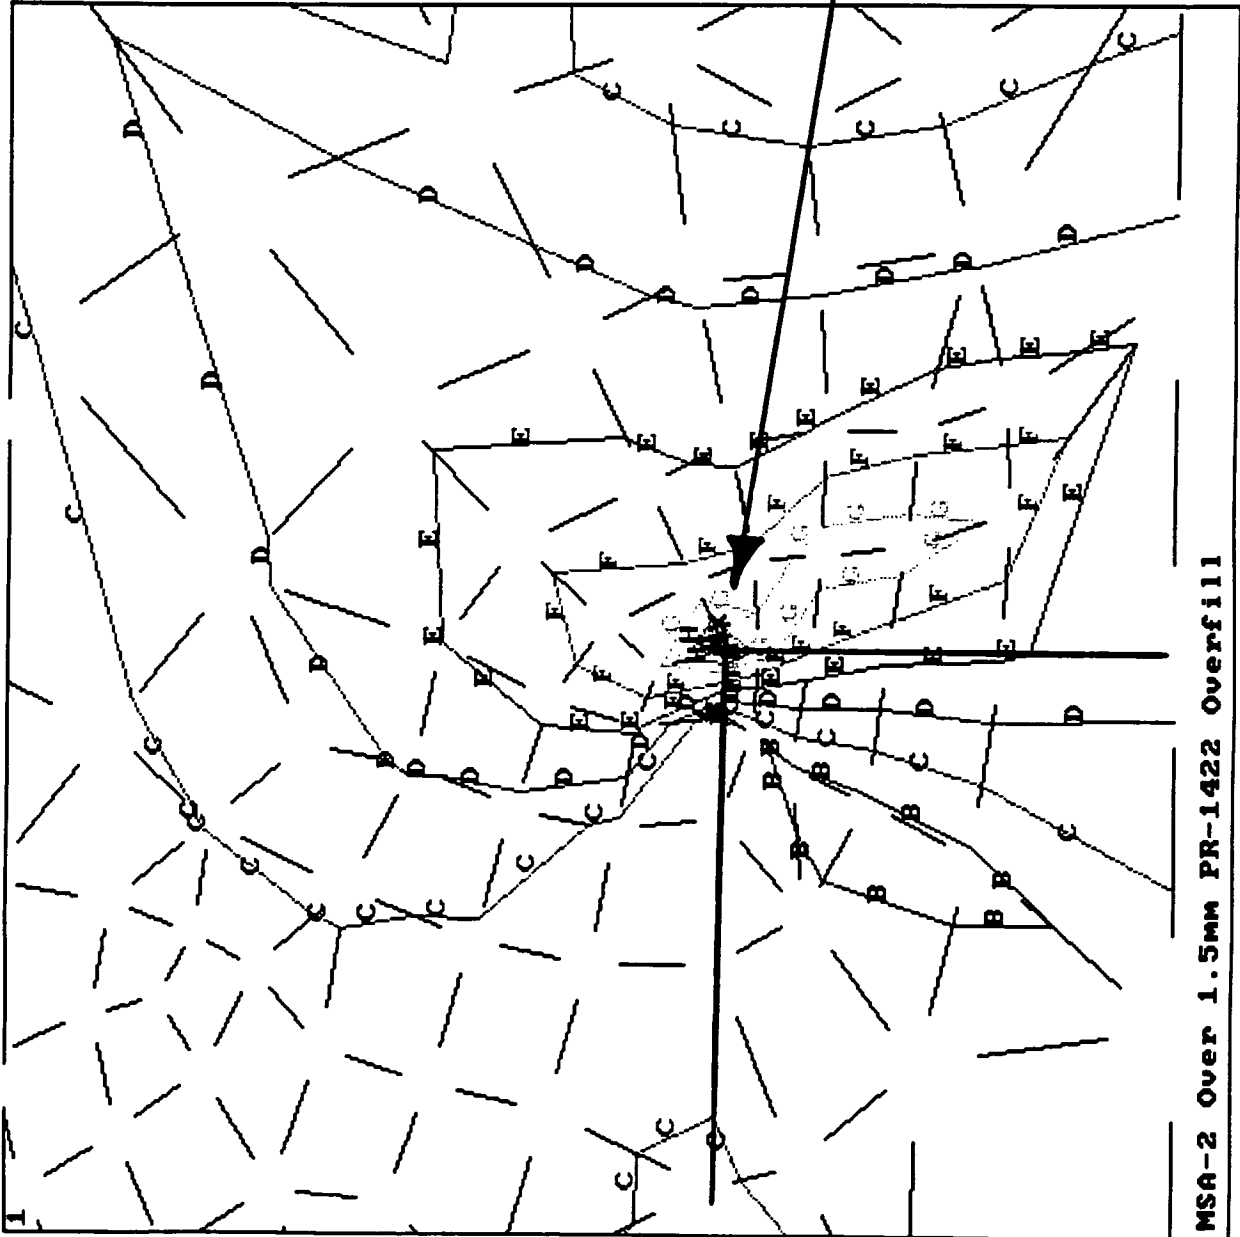
CASE 5

MSA-2 Over 1.5mm PR-1422 Overf111

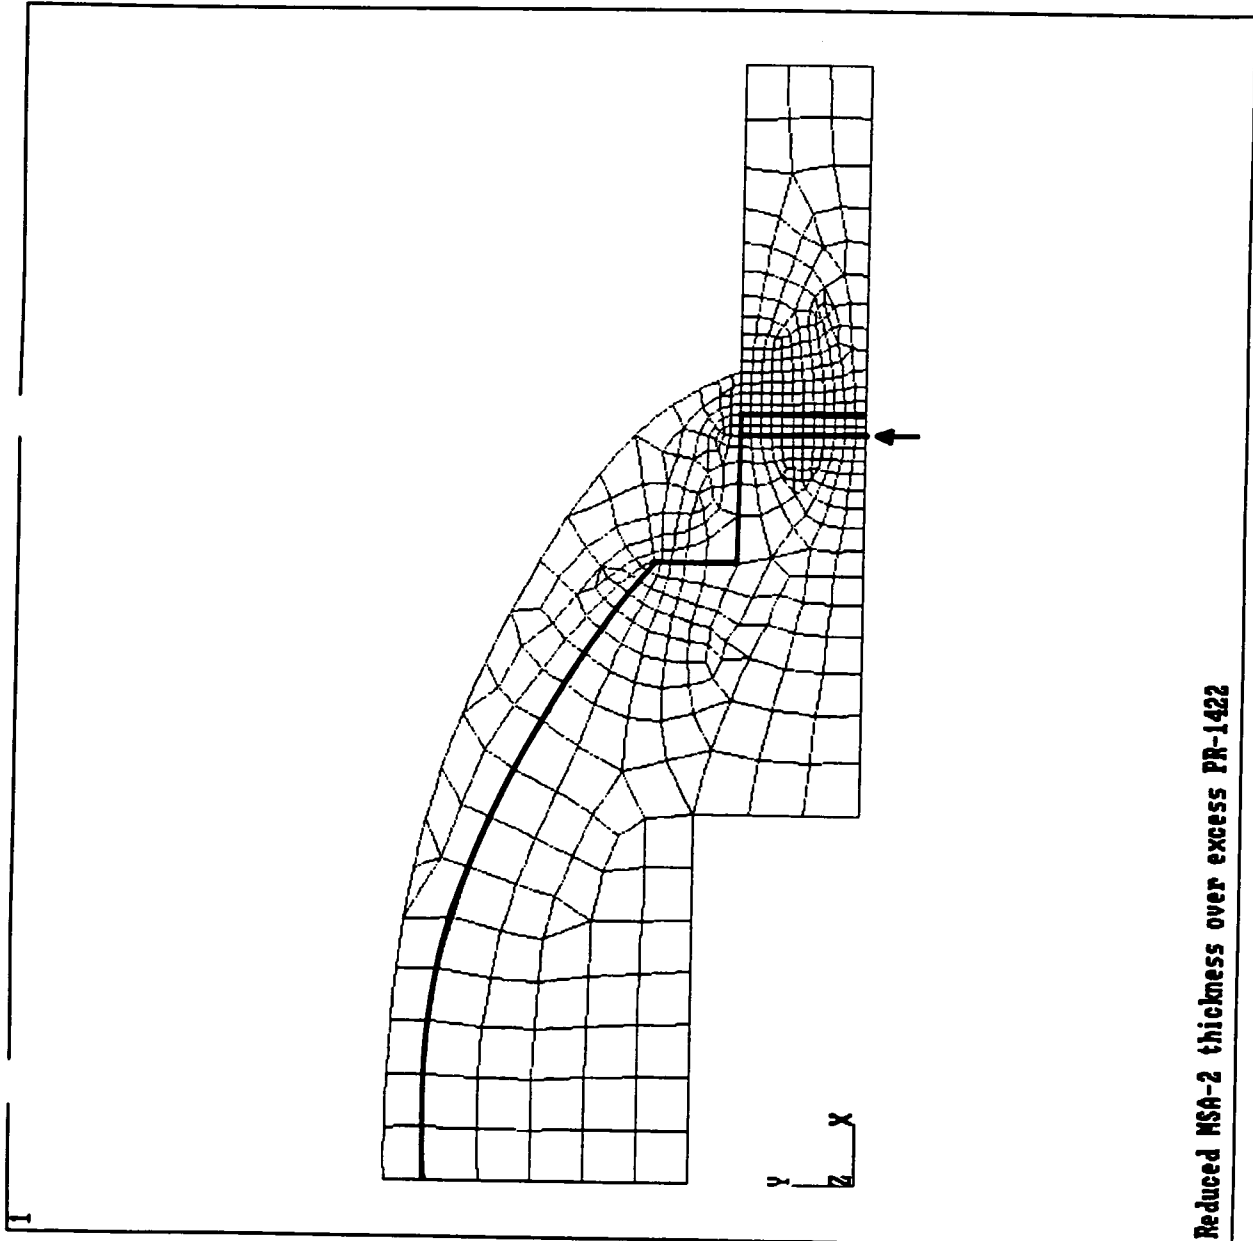
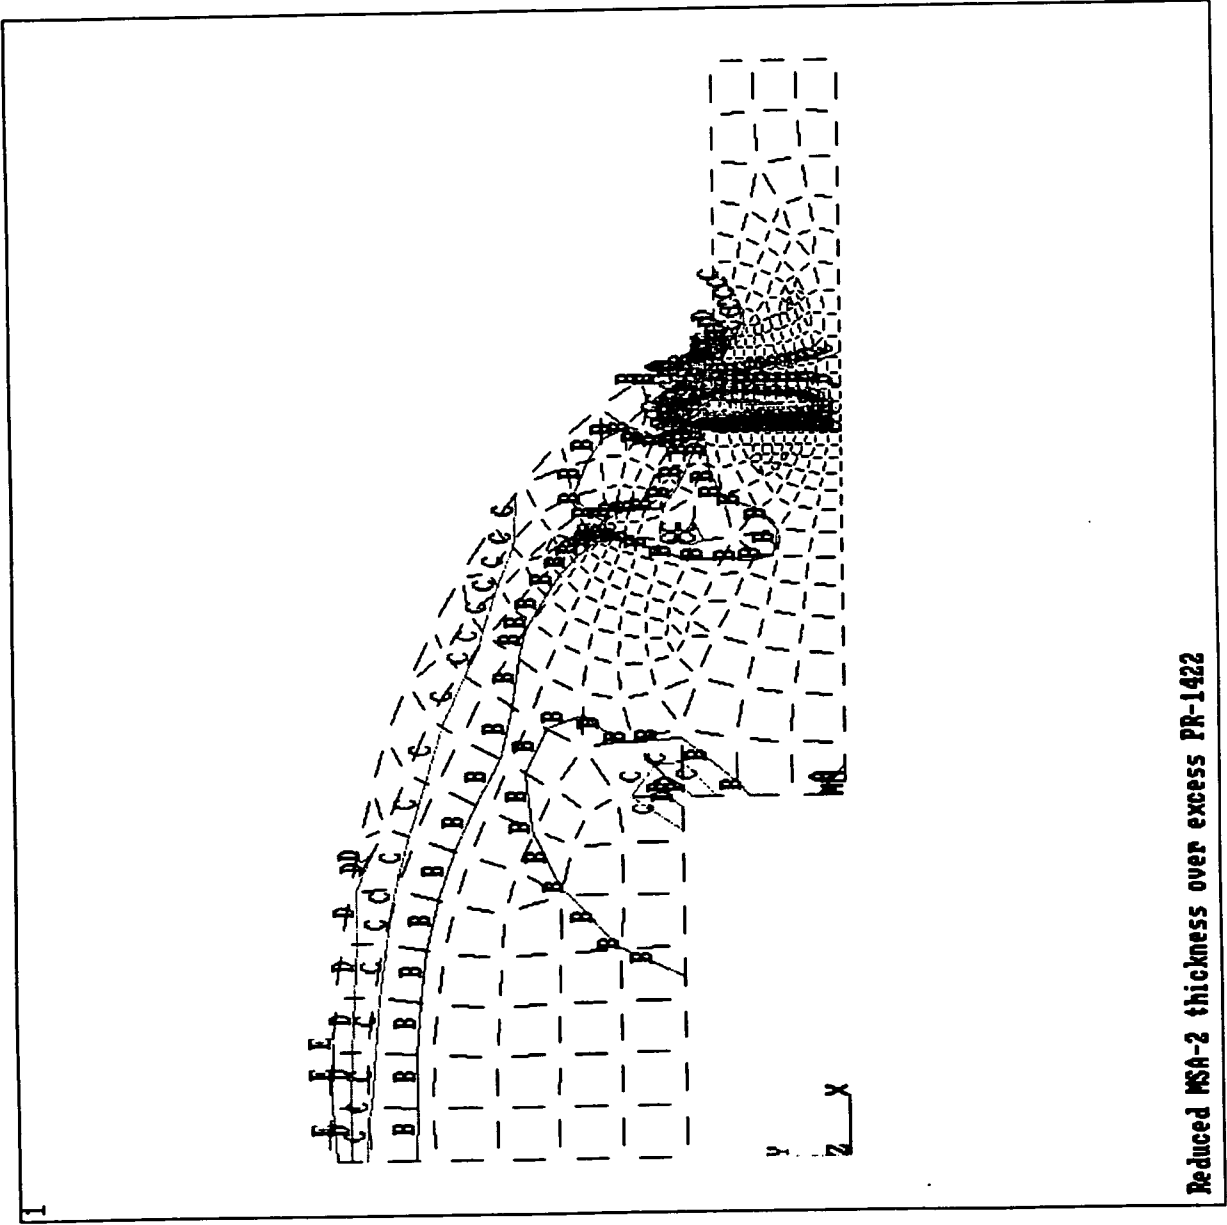
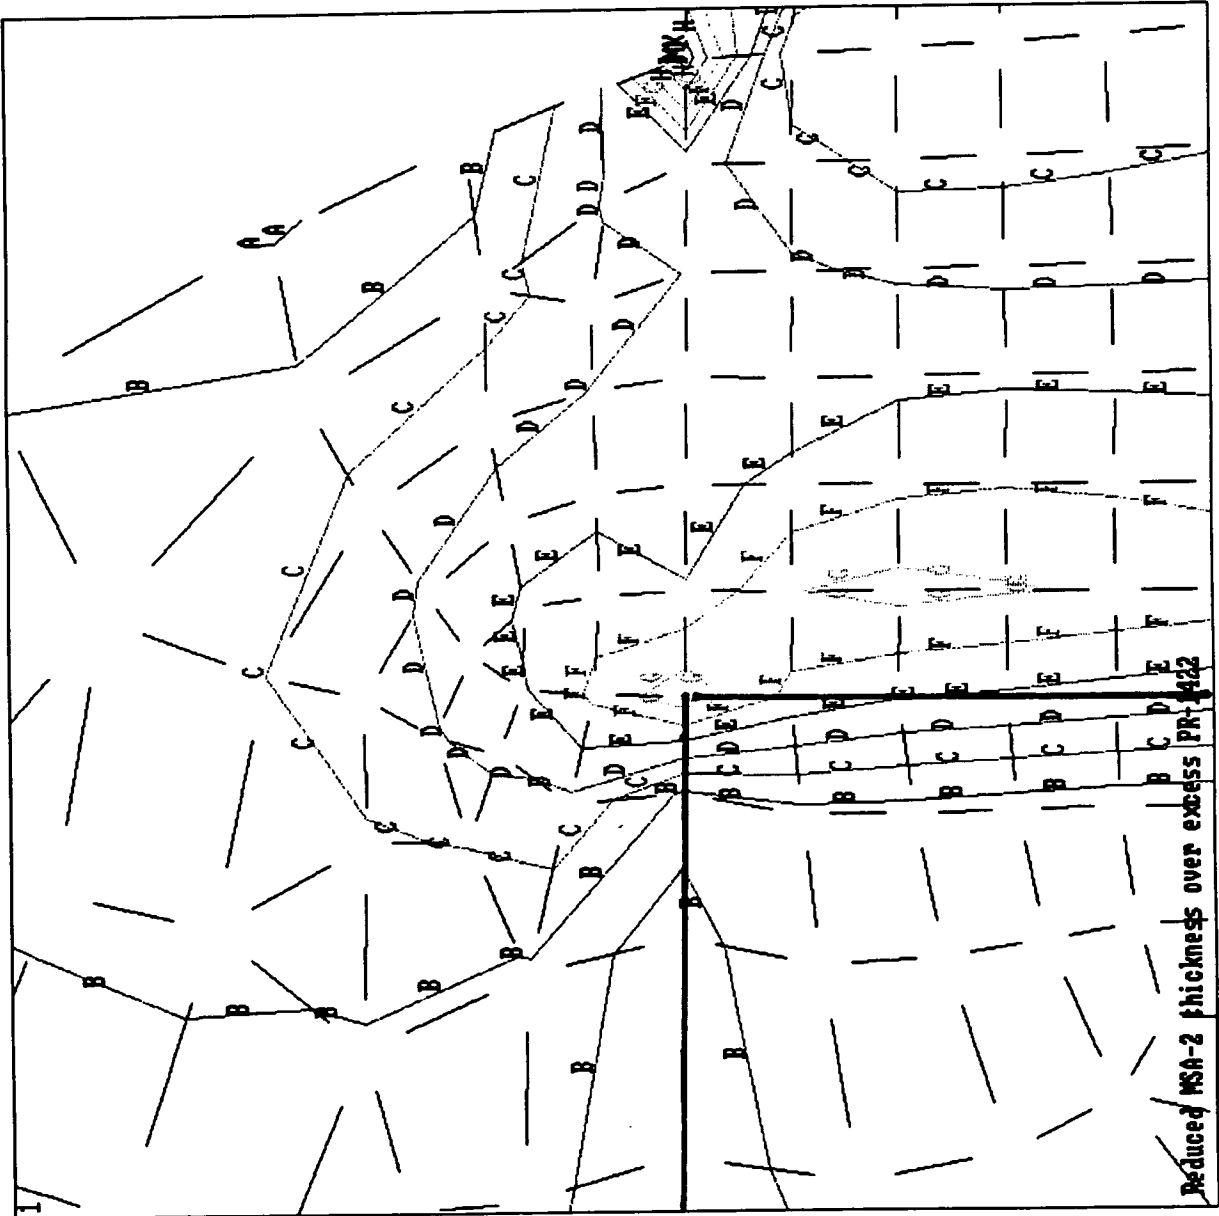
CASE-Y

Reduced MSA-2 thickness over excess PR-1422

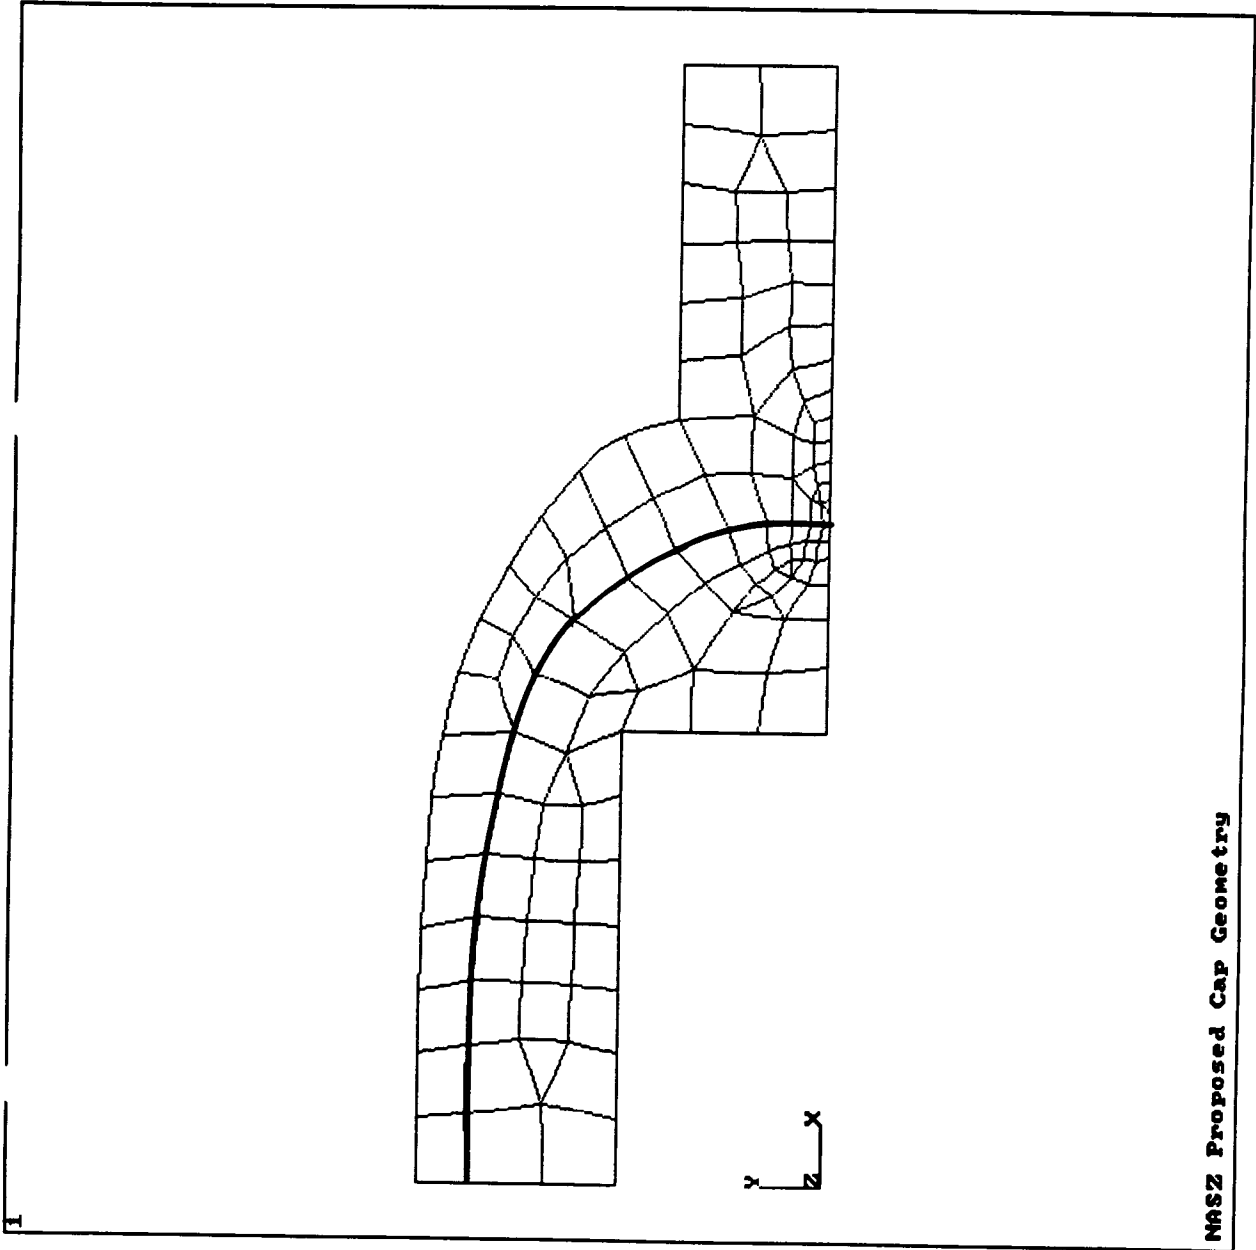
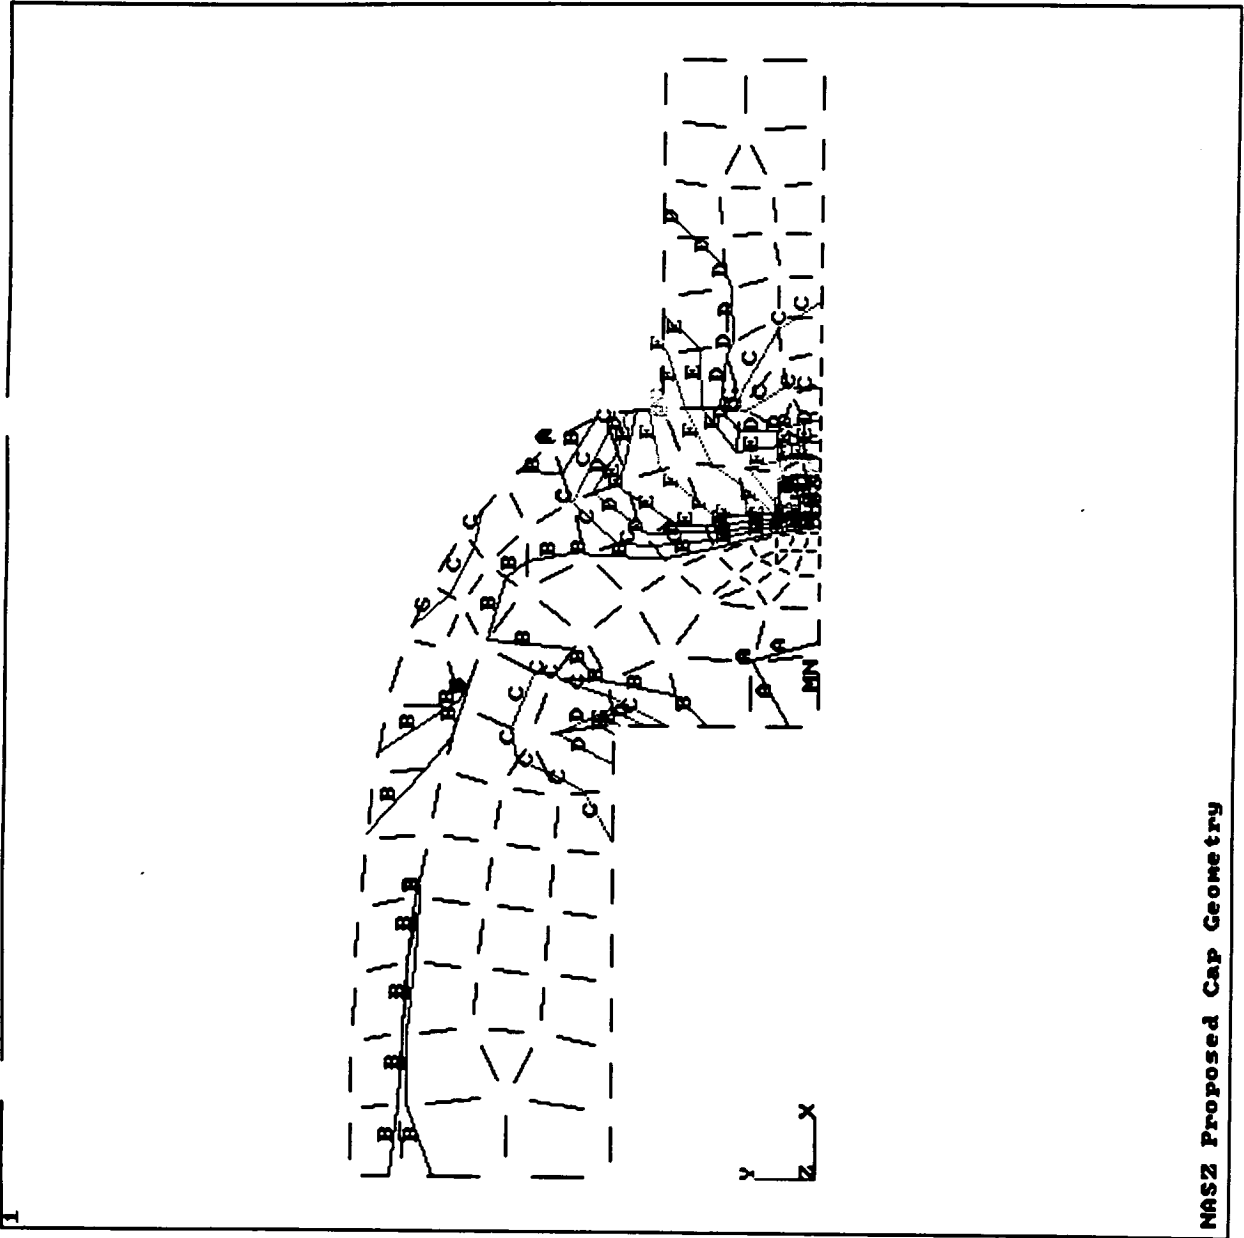
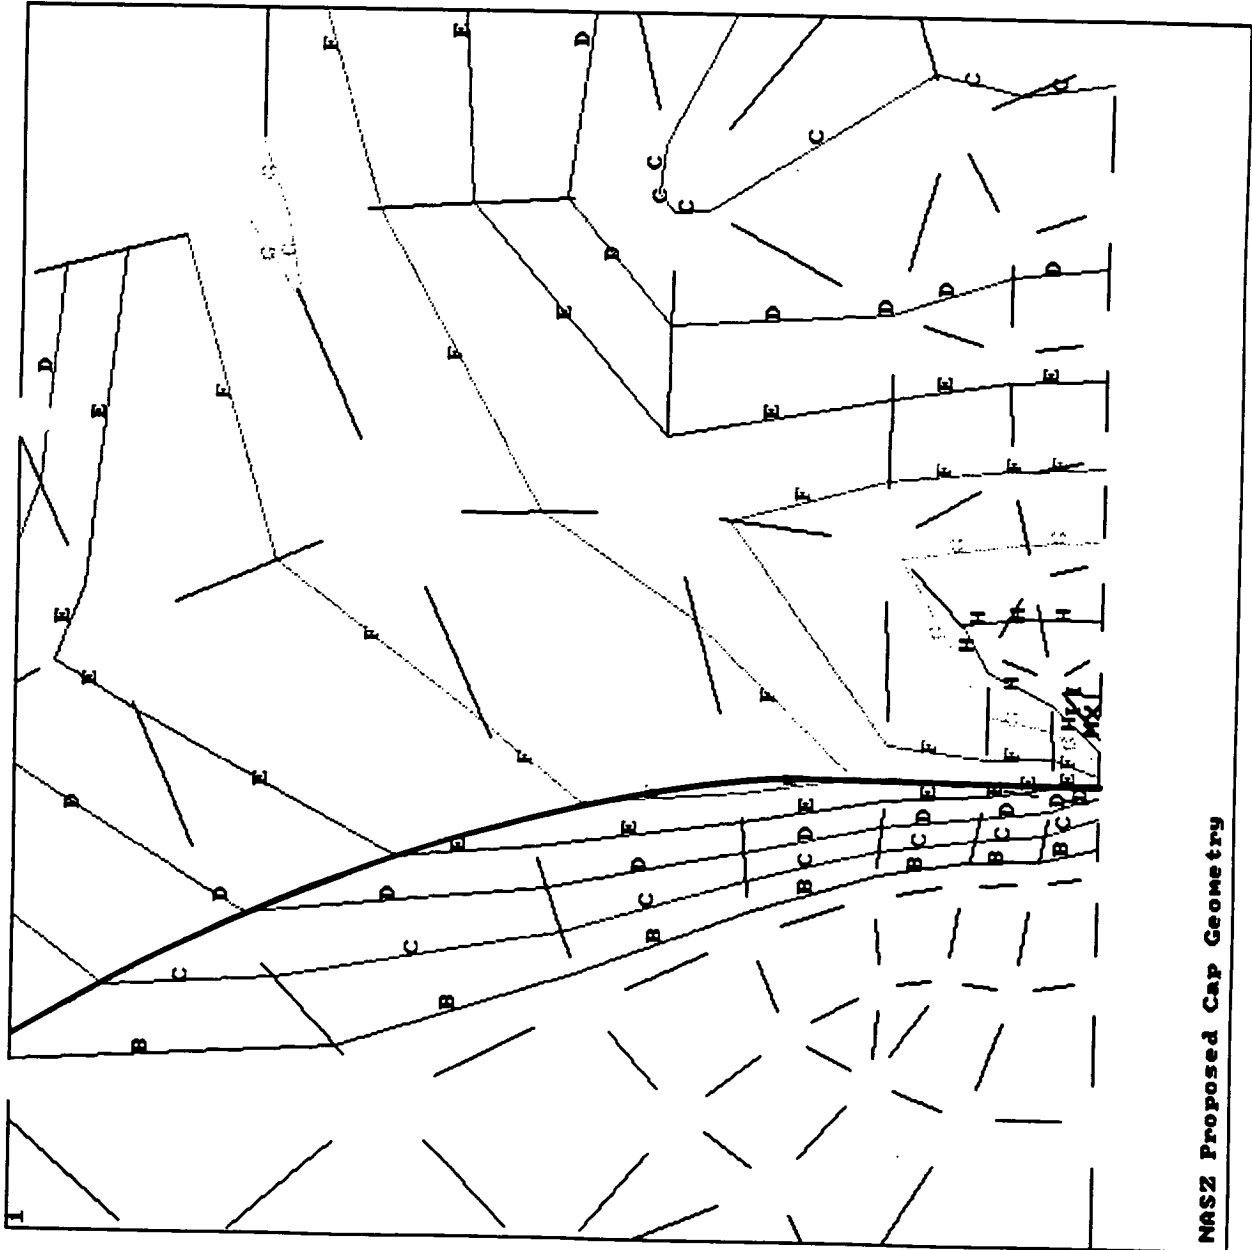
CASE - 2

NASZ Proposed Cap Geometry
