NASA Technical Memorandum 105864

Brush Seal Bristle Flexure and Hard-Rub Characteristics

Robert C. Hendricks, Julie A. Carlile,
and Anita D. Liang
Lewis Research Center
Cleveland, Ohio

Prepared for the
Seals Workshop
sponsored by the NASA Lewis Research Center
Cleveland, Ohio, August 5–6, 1992

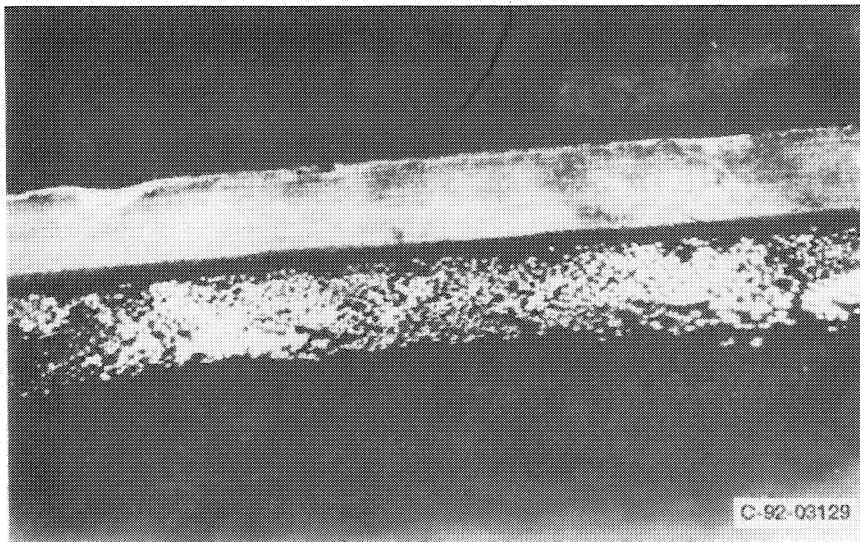
The 38.1-mm (1.5-in.) diameter brush seal (fig. 4) was damaged in a previous series of tests related to reference 2. The damaged section, although quite small and having a "chewed" appearance, increased seal leakage. The seal could no longer be used for leakage tests but was adequate for the tests herein.

Figure 4.—Brush seal prior to tests (270° mark).

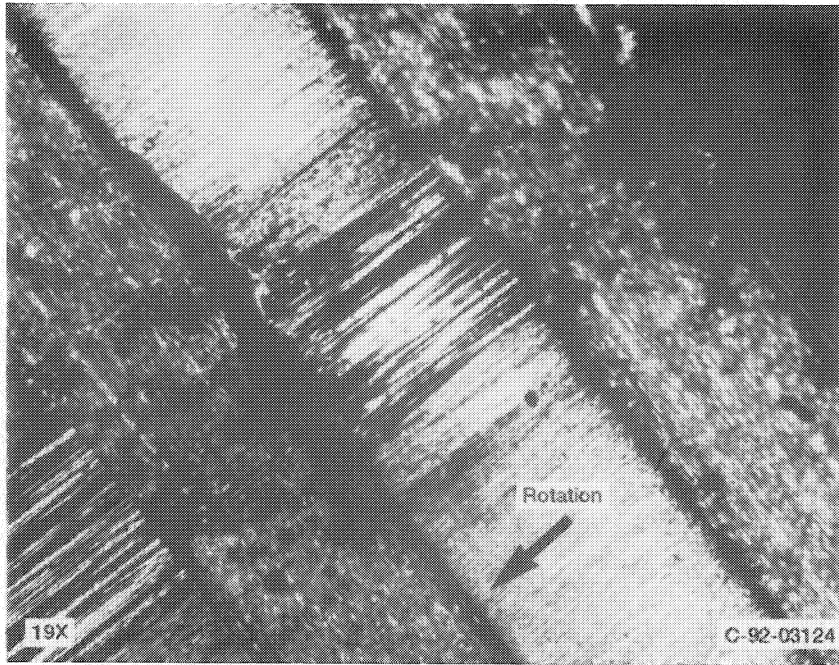
Optical inspection of the grooves cut by the brush into the stainless steel rotor (test 1) showed that the cut converged from the leading edge to the trailing edge of the land as the wires (bristles) crossed the rotor (fig. 5). Wire grooves were clear cut and debris was evident, as is better shown in the enlargement (fig. 6).

Figure 5.—Rotor surface after test 1. (Arrow shows direction of rotation.)

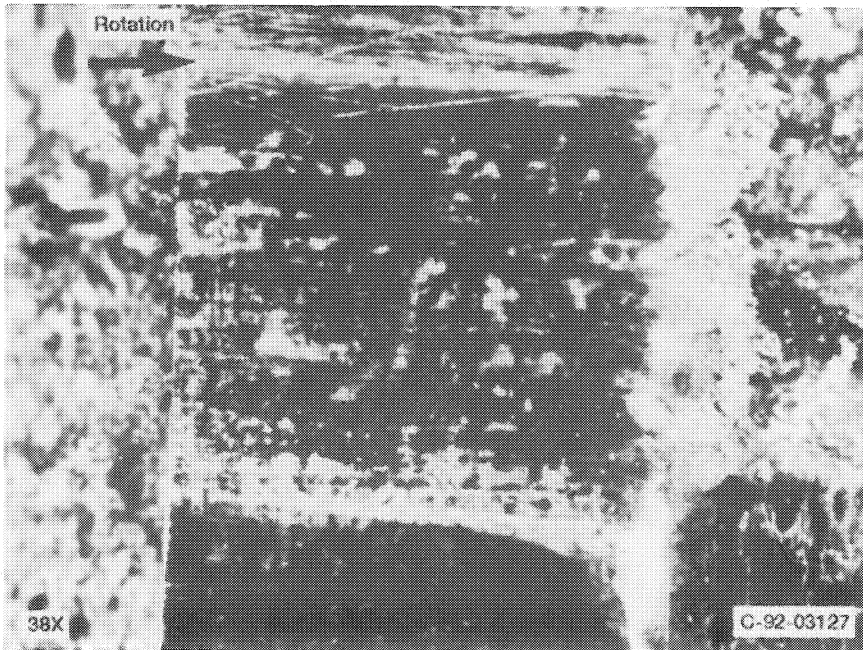
Figure 6.—Rotor land and groove after test 1.

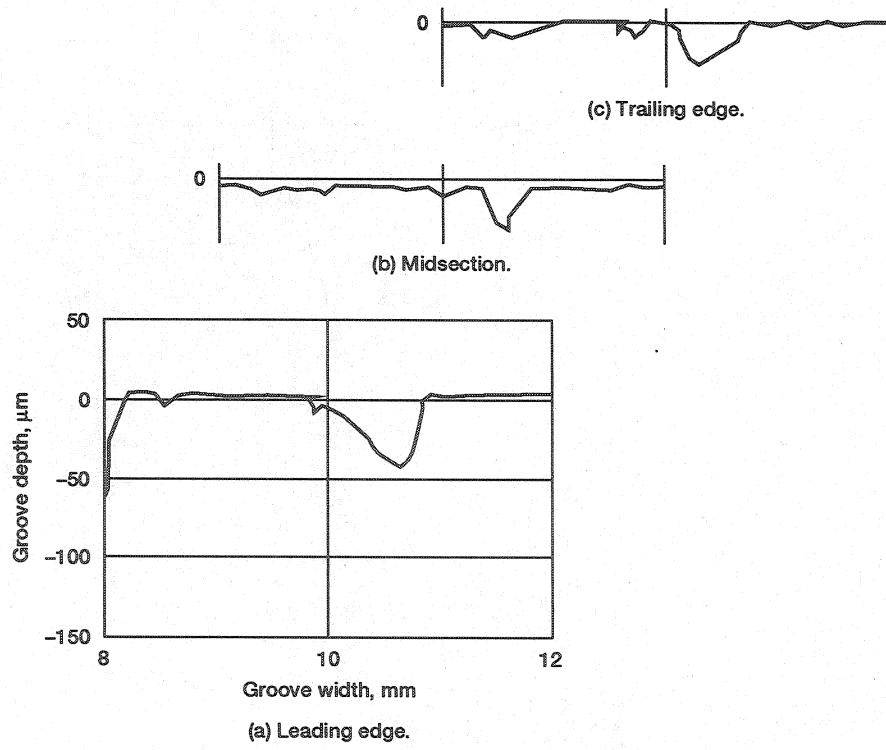
The first profile, labeled "leading edge," was taken within 0.10 mm (0.004 in.) of the leading edge and shows a broad damage region with deep grooving for test 2 (fig. 8(a)) and test 3 (fig. 9(a)) but a minor amount of material damage for test 1 (fig. 7(a)). The material buildup adjacent to the groove of test 3 probably occurred during rotor-fence rub. The second profile, labeled "mid section," was taken midway between the tooth leading and trailing edges. The damage of test 2 (fig. 8(b)) and test 3 (fig. 9(b)) was severe, and a twofold cut has developed in the rotor during test 2. Again moderate damaged was noted for test 1 (fig. 7(b)). The third profile, labeled "trailing edge," was taken within 5 percent of the trailing edge. The grooving seen in the midsection profile carried through with perhaps some sharpness of the features near the trailing edge (figs. 7(c), 8(c), and 9(c) for tests 1, 2, and 3, respectively).

Figure 7.—Profilometer traces for 40-tooth rotor (test 1).

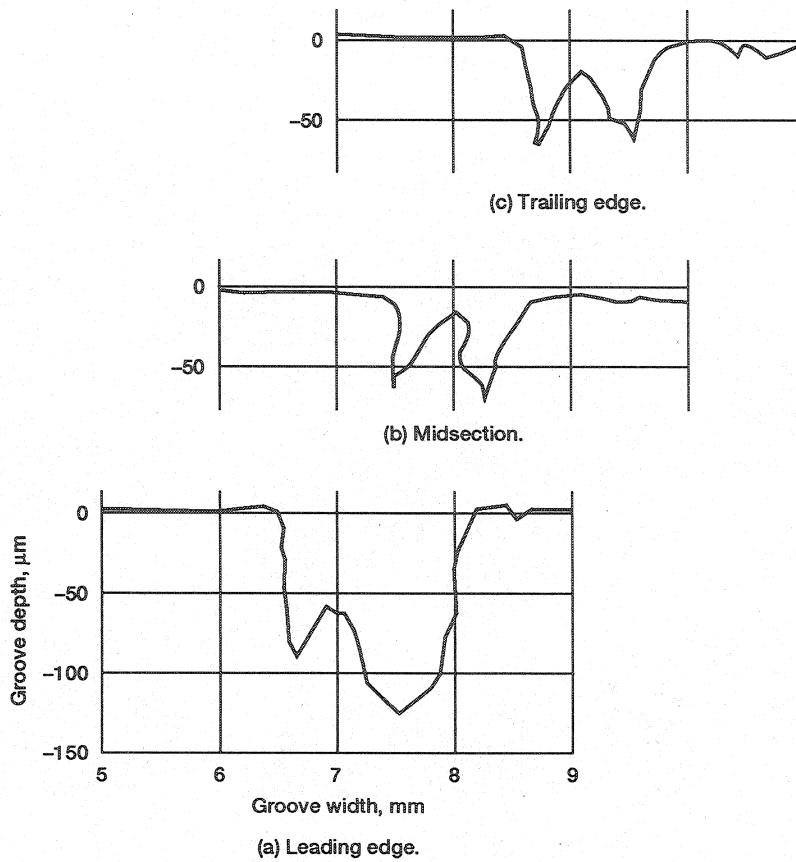
Figure 8.—Profilometer traces for 40-tooth rotor (test 2).

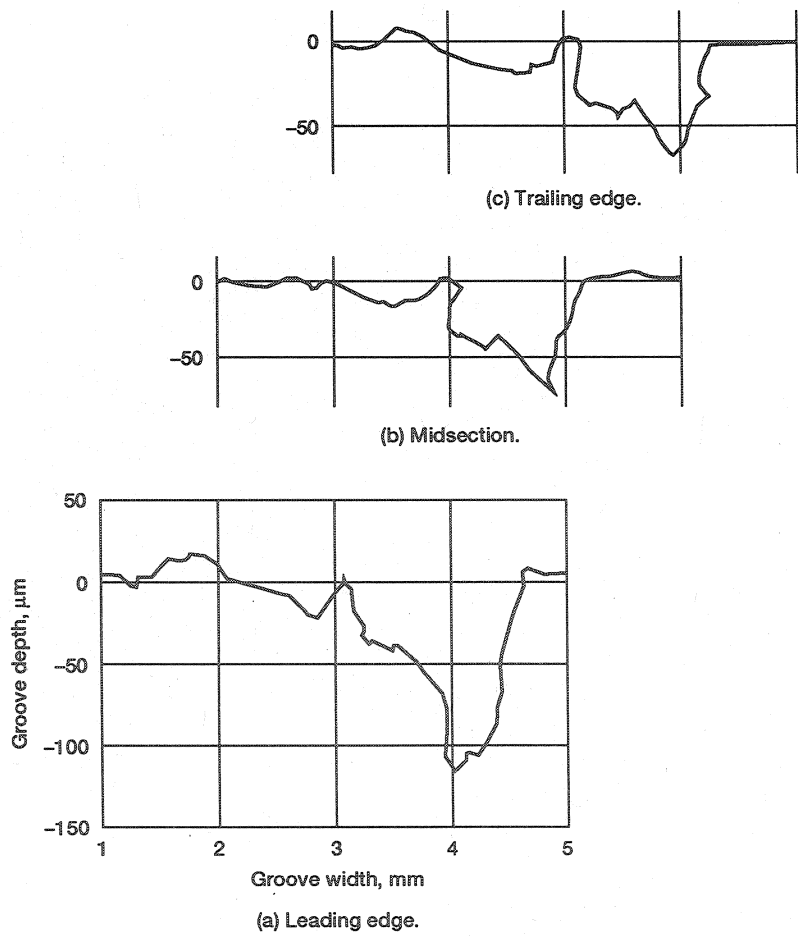
Figure 9.—Profilometer traces for 40-tooth rotor (test 3).

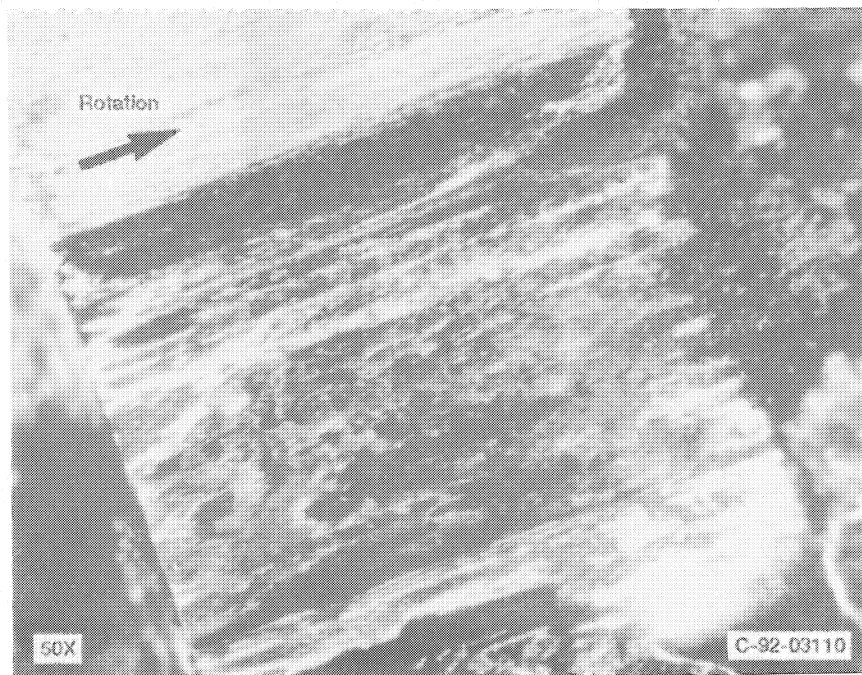
The brush bristle impact at the leading edge left material deposits that were magnetic (i.e., from the rotor) and rust color (probably Fe_3O_4) with a spongelike (or cauliflower) appearance (fig. 10); these deposits are readily seen at higher magnification (80X) in figure 11. Debris was generated by surface machining grooves, "whipping" of the leading edge, burnishing, and sharp trailing edges. The deposited materials were fine, porous, "greasy" to the fingers, and readily removed from the rotor; removal from the bristles was not straightforward. Standard degreasing cleaned but not thoroughly, and ultrasonic cleaning was not attempted. The reasoning was to see if these deposits would inhibit the responsive character of the bristles. The debris can affect both the response and the leakage, but neither effect was observed in these tests. Further work here is warranted.

Figure 10.—Rotor land with debris and rub scars (test 2).

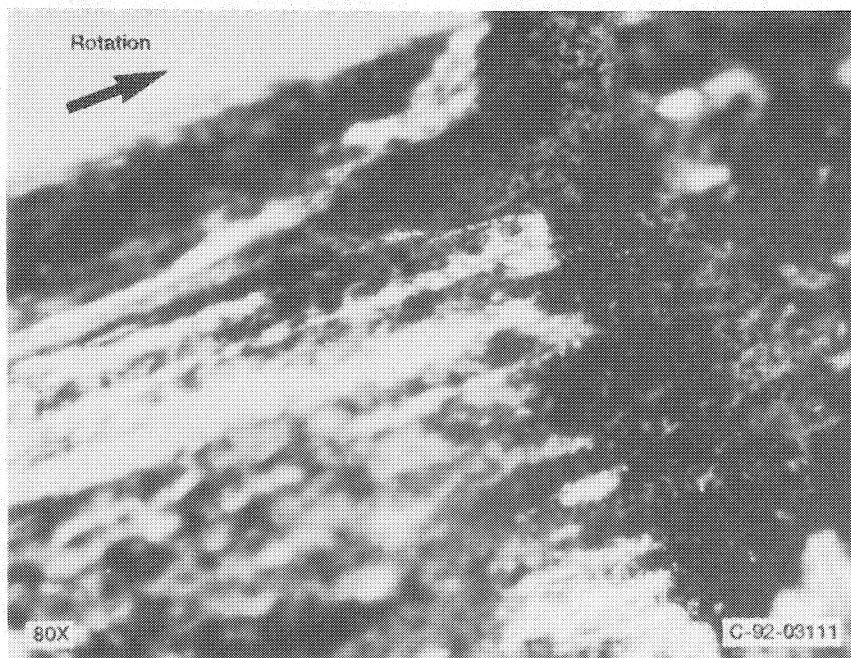
These deposits also indicate rapid wear-in with a long oxidation period for the "machined out" material. The materials deposited on the groove wall at the land leading edge (fig. 11) and on the groove wall at the land trailing edge (fig. 12) had little or no structure; the defraction spectra were peakless.

Figure 11.—Rotor leading-edge debris formation (test 2).

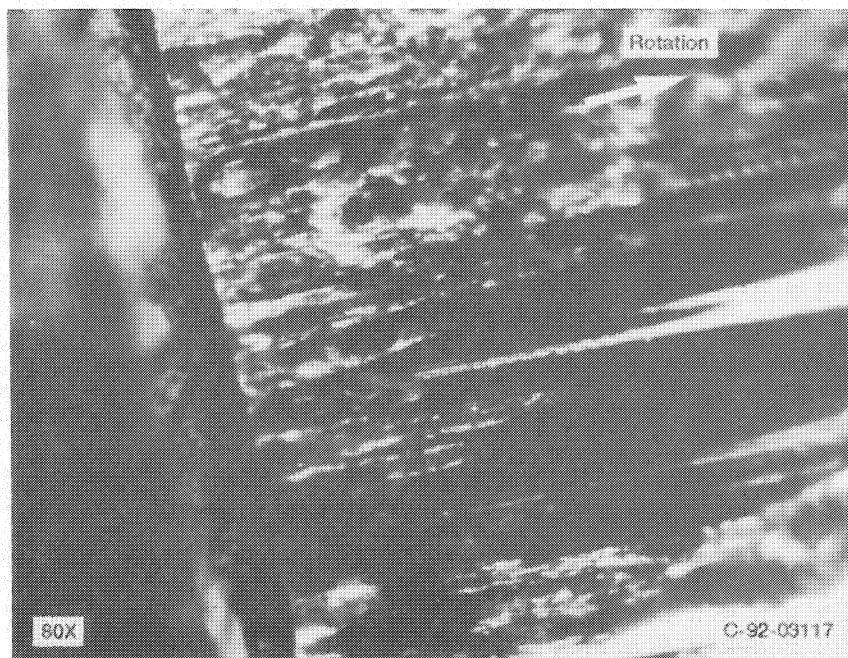
Figure 12.—Rotor trailing-edge surface grooving and debris (test 3).

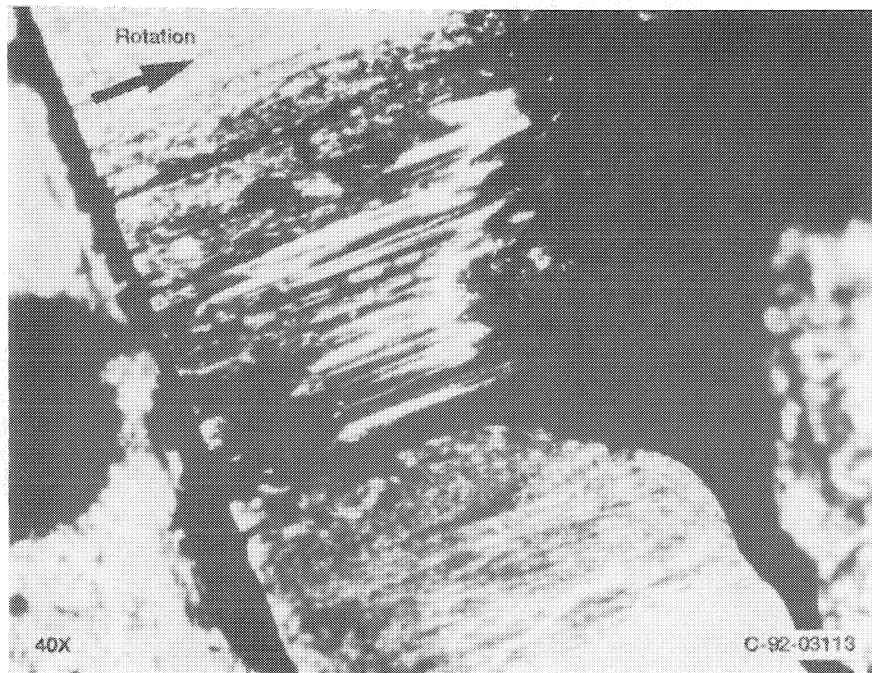
Stainless steel work hardens so that the cut grooves were probably harder than the parent stainless steel and would wear the annealed Haynes 25 bristles. The smooth grooves, the hot spots, and the hot streaking may indicate that a thin layer of stainless steel flowed plastically as it was machined out (figs. 13 and 14). Because of the incursive impact of the toothed rotor and the heated interface, the

Figure 13.—Rotor leading edge, surface machining, and hot spots (test 3).

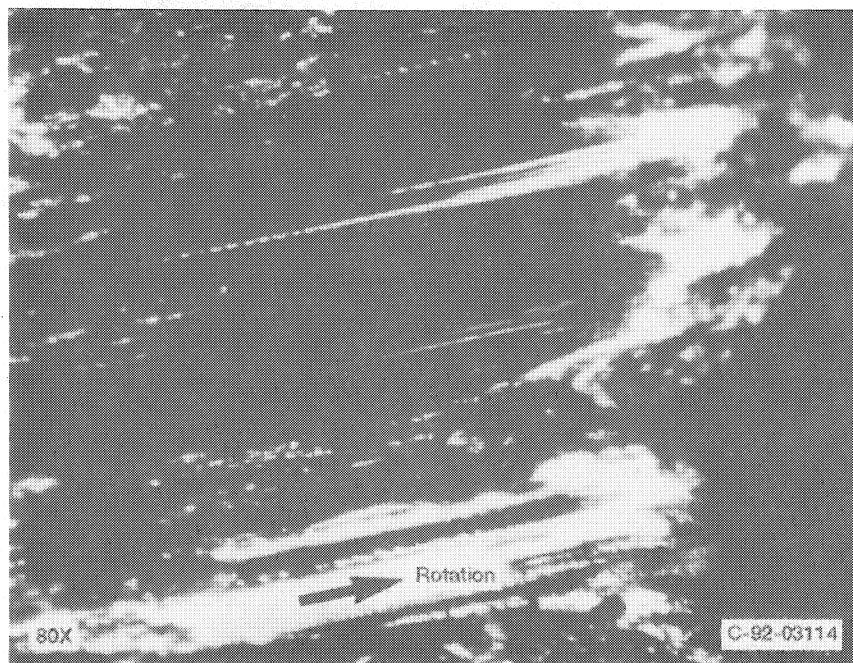
Figure 14.—Rotor land hot streaks, hot spots, and surface machining (test 3).

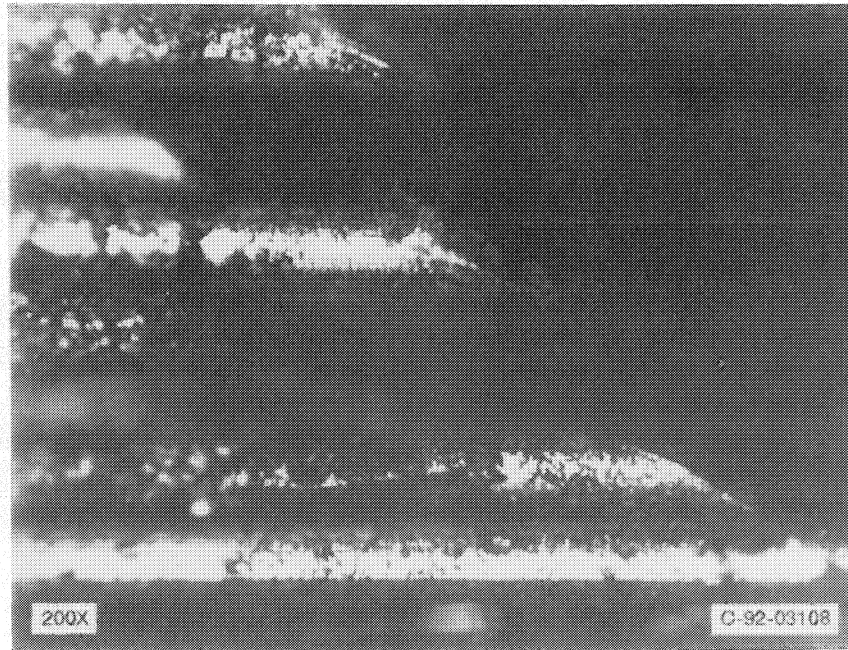
Figure 15.—Brush bristle tips with debris (test 1).

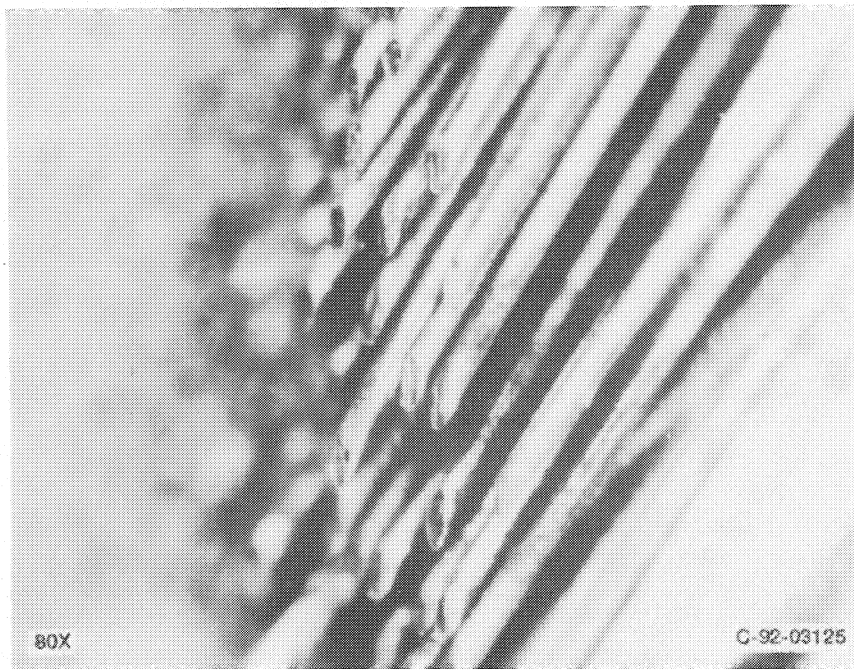
Figure 16.—Brush bristle tip wear patterns (test 2).

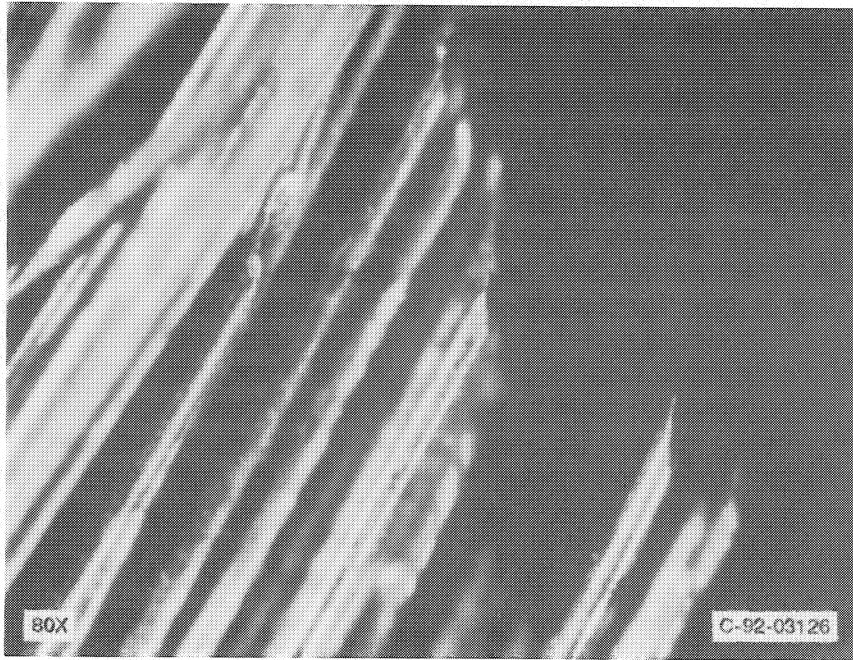
Haynes 25 bristles could lose strength, erode, fracture, or pull out as massive debris. But no pullouts or massive debris was found after any of the three tests. At higher magnification (200X) the tips still appear intact without fracture, but wear is evident and oxidation debris appears to be well adhered to the surface (fig. 15). As further evidence of the bristle wear an examination of the bristle tip surface revealed tip grooving (fig. 16), and the severe impacting on the bristles is shown by erratic wear notches on the bristle surface (fig. 17).

Figure 17.—Brush bristle tips and damage (test 1).

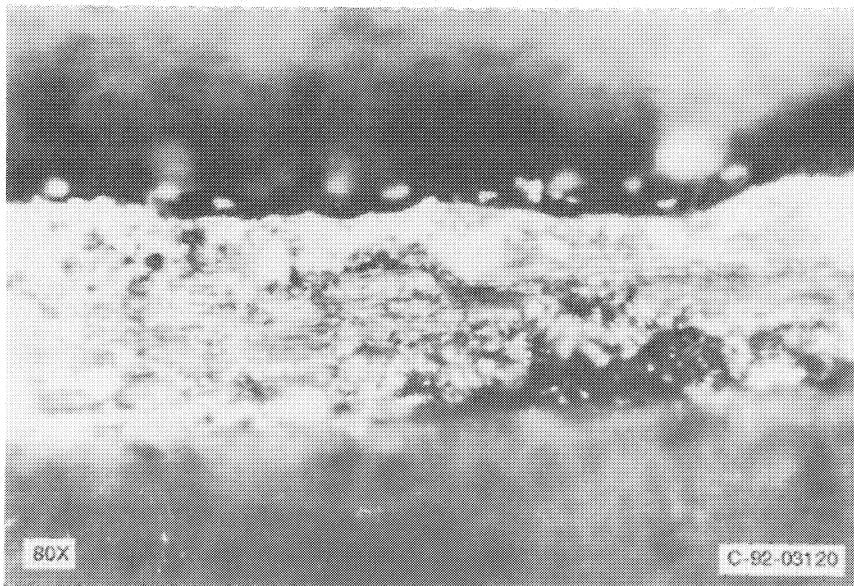
The trailing edge of the land was "cut" clean by the brush in all three tests (fig. 18) in stark contrast to the erratic leading-edge surface, which was whipped by the bristles (fig. 19). Of interest is the contrast between the land surface cuts. Test 1 surface cuts were a simple wear scar; those of tests 2 and 3 were multiple grooves with complex surfaces and burnishing (fig. 20). The most rotor damage appeared from test 2 and the most brush damage from test 3, where the rotor was set eccentric.

Figure 18.—Rotor trailing edge (test 3).

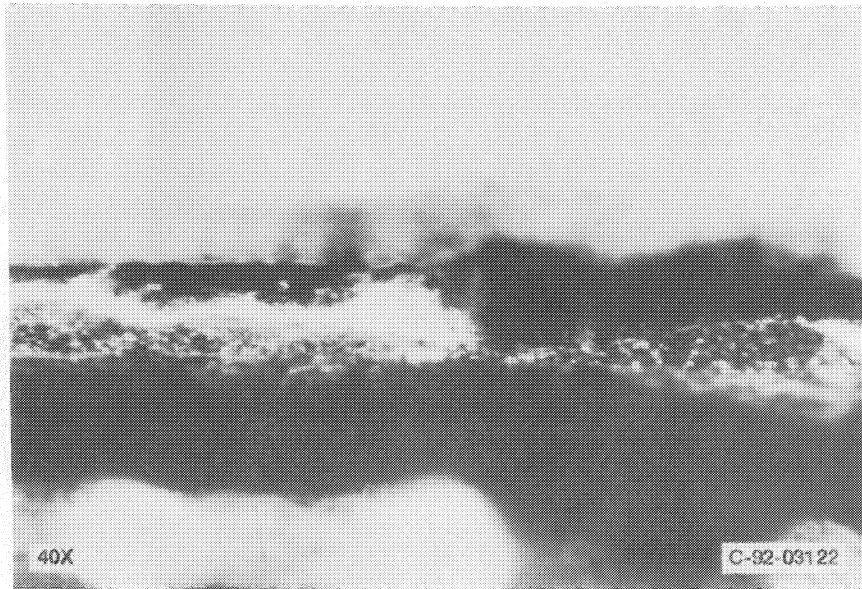
Figure 19.—Rotor leading edge (test 2).

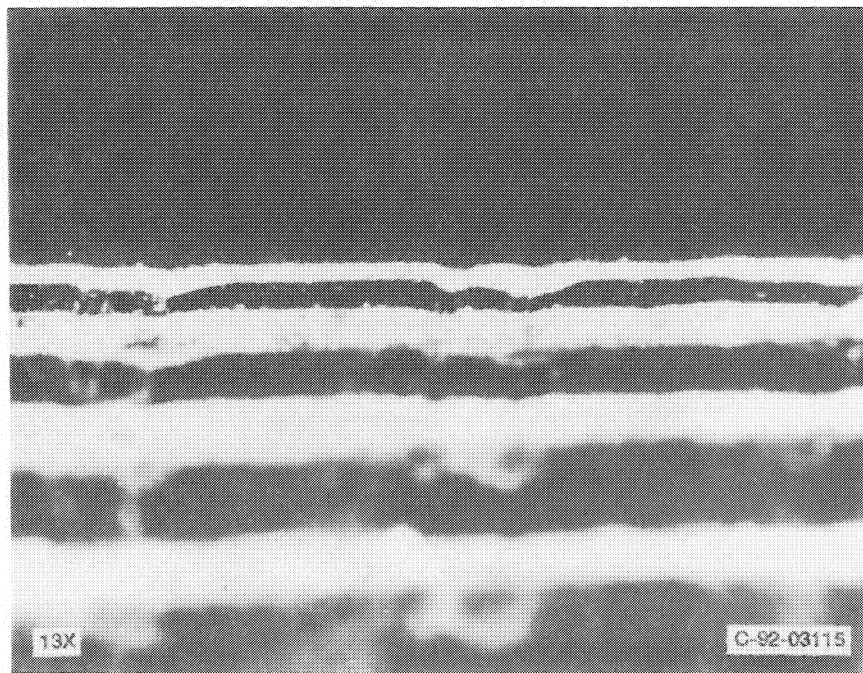
Figure 20.—Rotor trailing edge (tests 1, 2, and 3).

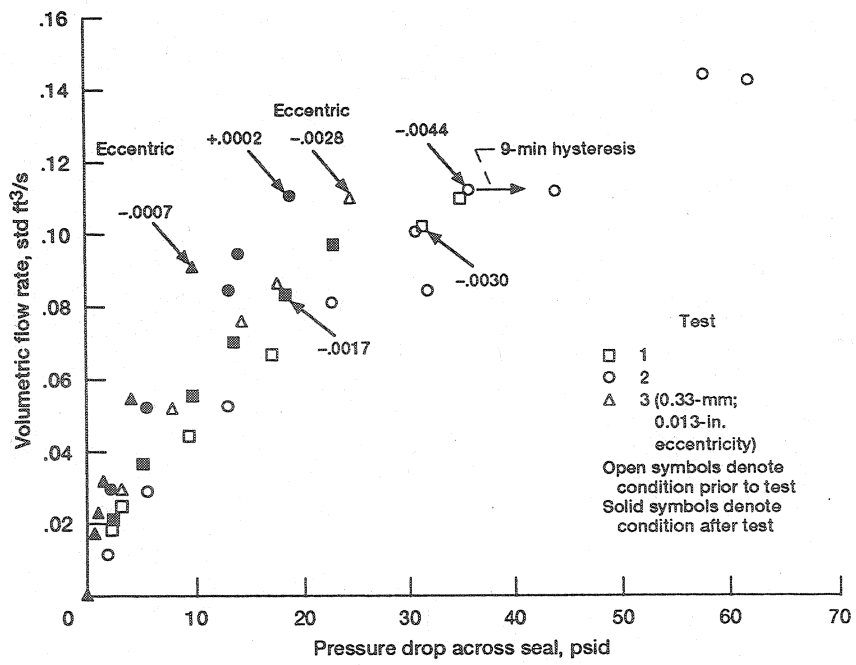
Leakage is characterized in figure 21 in terms of volumetric flow rate as a function of pressure drop across the brush seal before and after each of the three tests. Both pretest and post-test results are provided in the same figure. Because this brush seal was damaged (see APPARATUS section), absolute leakage measurements would require weighing, but the relative leakage should be accurate. The interference fits for the brush seal leakage data for pretests 1 and 2 were nearly the same, resulting in corresponding leakages. While taking data it was found that the brush would stiffen and the pressure drops would increase. Data points illustrating hysteresis (typical in brush seals) are shown. After correcting the post-test 2 data for clearance, these test results agreed with those of post-test 1.

Figure 21.—Pre- and posttest leakage results for smooth rotor.

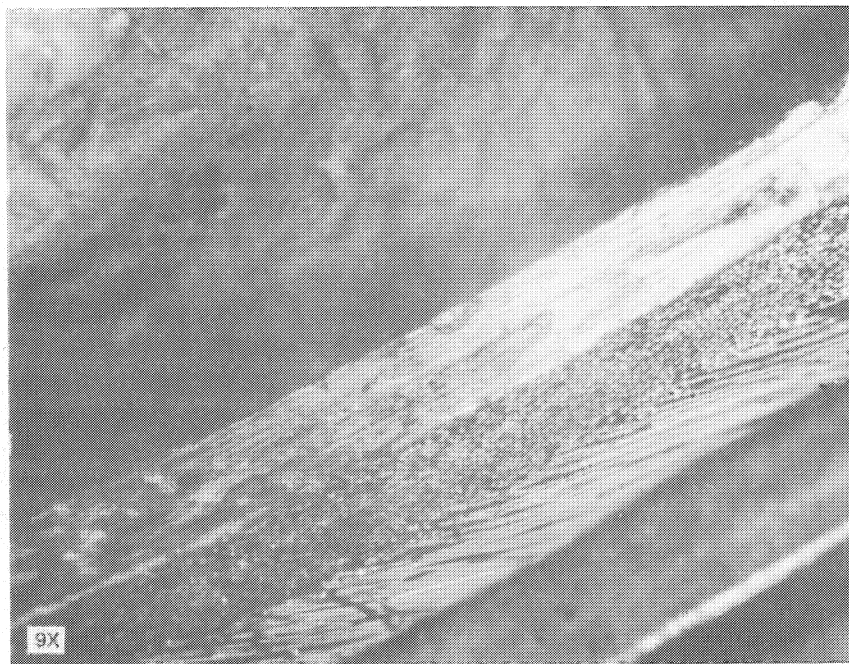
Setting the rotor eccentric in test 3 proved a major problem in cross correlating the leakage results. The estimated initial static eccentricity for the smooth rotor was less than 0.15 mm (0.006 in.), and the smooth rotor and the 40-tooth rotor were assumed to be interchangeable at the same spindle loading. However, the rotor rubbed the fence (backing washer) slightly, requiring an initial static eccentricity of 0.36 mm (0.014 in.) and implying a difference in spindle loading. The rotor was reset to an estimated eccentricity of less than 0.025 mm (0.010 in.). Post-test photographs indicated that the dynamic eccentricity was <0.10 mm (<0.004 in.) and clearly illustrated the fence rub (fig. 22).

Figure 22.—Fence damage sustained during test 3.
