CLEANING OF A THERMAL VACUUM CHAMBER**WITH SHROUDS IN PLACE**

William R. Bond
NSI Technology Services Corporation

ABSTRACT

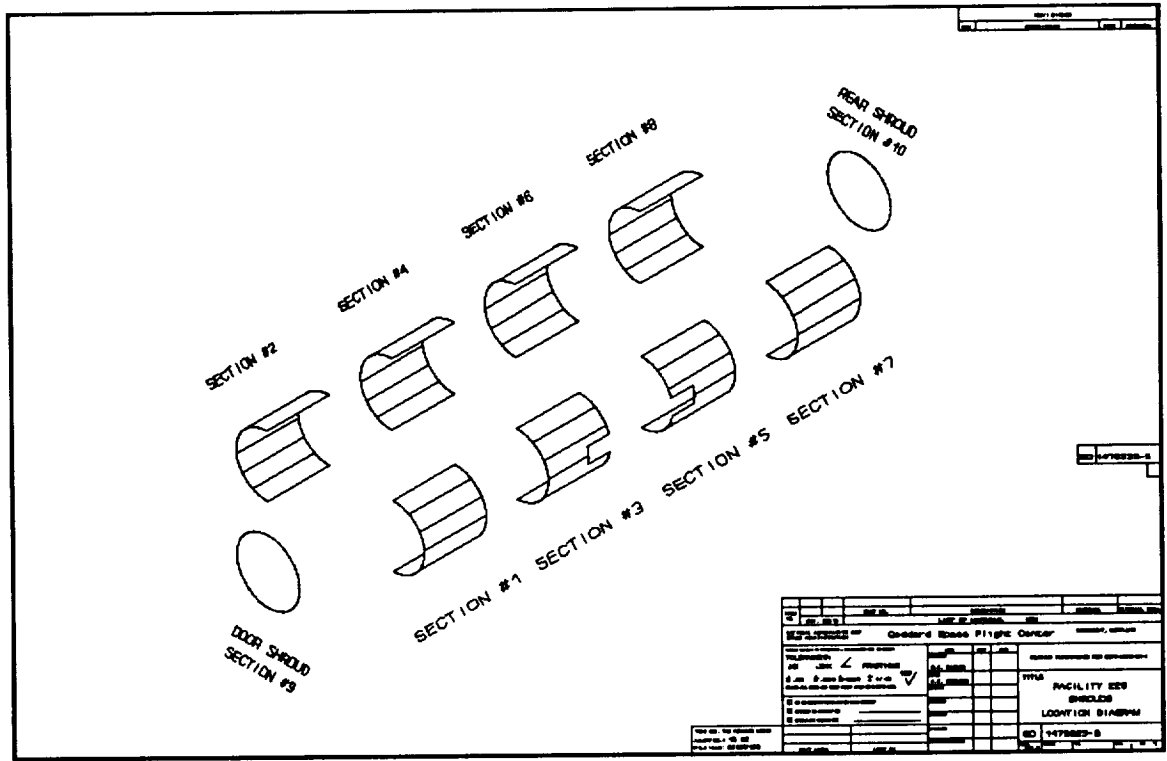
Figure 1 - Facility 225 Shroud Arrangement

major vacuum components were also substantially unchanged. The rotary piston pump and rotary lobe booster pump did not come with the chamber but were of similar age to the originals. Inside the chamber the thermal system consisted of front and rear shrouds and four pairs of side shrouds. (Figure 1) Shrouds 3 and 5 have cutouts to allow an opening for the old solar simulator source.

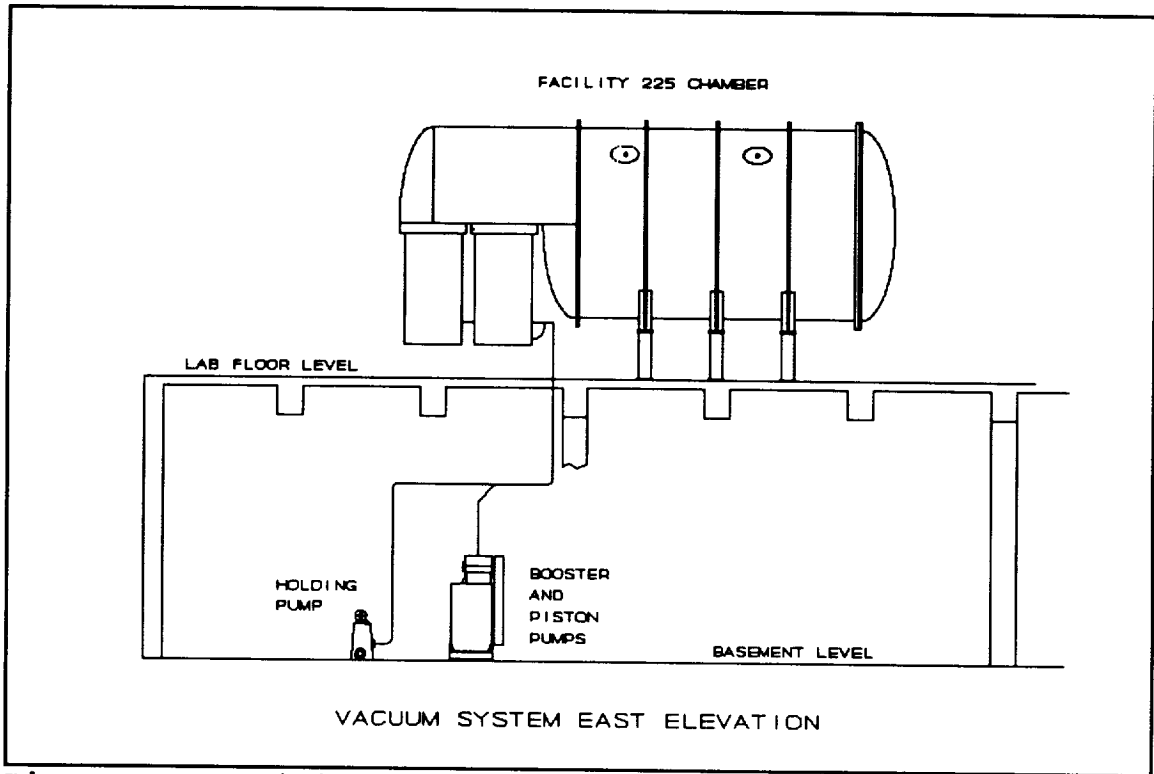
Figure 2 - Facility 225 Vacuum Pump Locations

Besides the previously mentioned piston and booster pumps, the vacuum system consists of three diffusion pumps and a small rotary piston pump. All of the mechanical pumps are located in a machine room in the basement. (Figure 2) The three diffusion pumps are located at the back of the chamber behind the rear shroud. No valves exist between the diffusion pumps and the chamber. The diffusion pumps use an oil described as 100% mixed isomers of pentaphenyl ether. Based upon the MSDS provided with the oil, the boiling point is 476°C and the flash point is 288°C.
