**NASA
Technical
Paper
3222**

Hot Fire Test Results of Subscale Tubular Combustion Chambers

John M. Kazaroff,
Robert S. Jankovsky,
and Albert J. Pavli

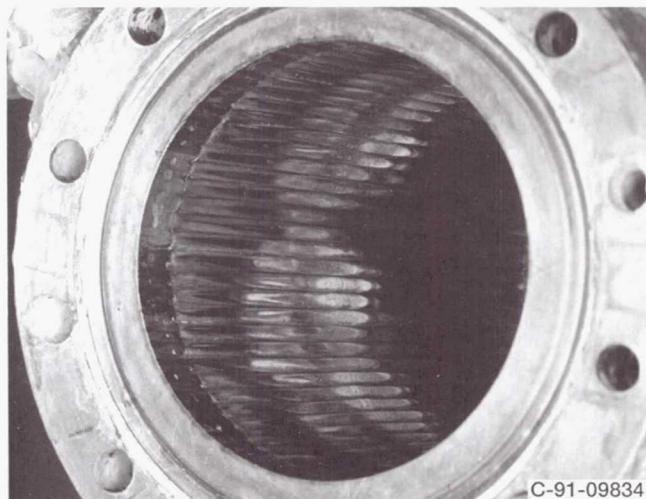
Figure 7 shows the inside surface of the second chamber after the 637 firing cycles. Surface roughness measurements were made on the tube centerlines at the throat prior to testing and, again, after 637 cycles. The roughness before testing was measured as 32 μin., or less. After testing, the average surface roughness in the throat region was 300 μin., with a range from 152 to 534 μin. This roughening, termed "blanching," is caused by cyclically repeated oxidation and reduction reactions between the combustion gases and the copper wall. A thorough examination of this process is reported in reference 7, which includes data of surface roughness as a function of the hot-gas-side wall temperature. For the wall roughness measured on the second chamber (300 μin.), reference 7 predicts a temperature of 830 °C (1525 °F) for the hot-gas-side wall temperature. Although the crown temperature at throat plane at the start of testing was estimated to be 570 °C (1060 °F), the surface deterioration caused by blanching raised the temperature to an estimated 830 °C (1525 °F) before the testing was suspended. Continued cyclic testing would have lead to a chamber failure. Furthermore, the failure would not be a conventional fatigue failure caused by

Figure 7.—Second tube chamber after 637 firing cycles.

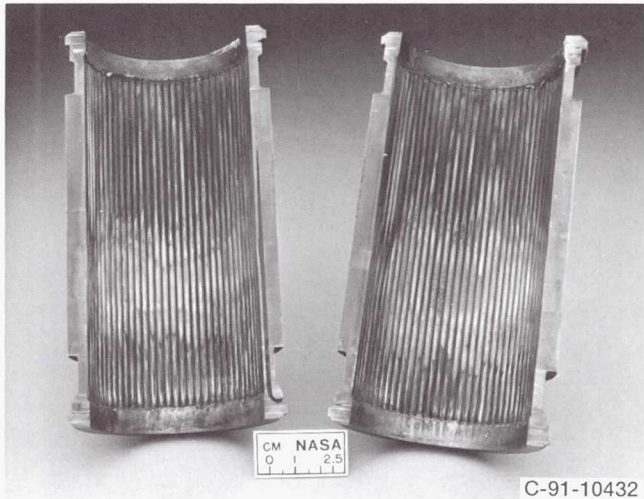
C-91-10432

Figure 8.—Third chamber after firing showing failure and throat area roughness.

To reduce the cost of running many cycles, a set of more severe test conditions was selected for the third chamber. These conditions were a combustion-chamber pressure of 4137 kN/m^2 (600 psia), a mixture ratio of 6.0, and a coolant flow of 0.807 kg/sec (1.78 lb/sec). Figure 6 shows that the coolant flow of 0.807 kg/sec (1.78 lb/sec) was expected to produce a crown temperature of $671 \text{ }^\circ\text{C}$ ($1240 \text{ }^\circ\text{F}$). The expected life at this temperature for the 72 milled-channel chamber configuration would be 118 cycles (ref. 5). The actual life obtained from the third chamber before it failed was 256 cycles. Figure 8 shows the inside of failed chamber number three. The distress in the throat location can be easily seen. Surface roughness measurements made on the tube centerlines in the throat region ranged from 178 to $573 \text{ } \mu\text{in.}$, with the average at $360 \text{ } \mu\text{in.}$ Referring to reference 7, this roughness corresponds to a wall temperature of $849.2 \text{ }^\circ\text{C}$ ($1560 \text{ }^\circ\text{F}$).

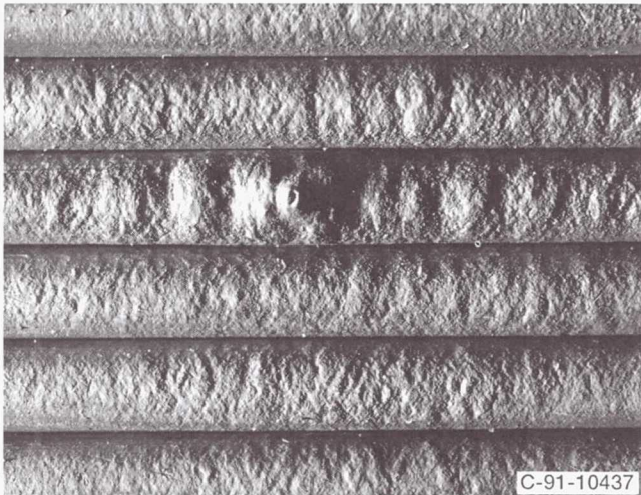
C-91-10437

Figure 9.—Failure site.

Figure 9 shows the failure site with lighting located close to the surface to provide good contrast of the surface texture. The failure appears as a protrusion in the surface shaped like a volcano, clearly indicating that the failure was a pressure rupture. Figure 10, taken just downstream of the location shown in the previous figure, shows the downstream end of the blanch zone of the throat. Visible on the smoother and cooler surfaces are a series of round globules, indicating the attachment of molten copper from the throat region. This molten copper is also apparent on tubes that are adjacent to the failure, indicating that even the unfailed tubes had surface melting and that the surface temperature was higher than the roughness correlation of reference 7 would predict; that is, $1083 \text{ }^\circ\text{C}$ ($1981 \text{ }^\circ\text{F}$) instead of $849.2 \text{ }^\circ\text{C}$ ($1560 \text{ }^\circ\text{F}$).

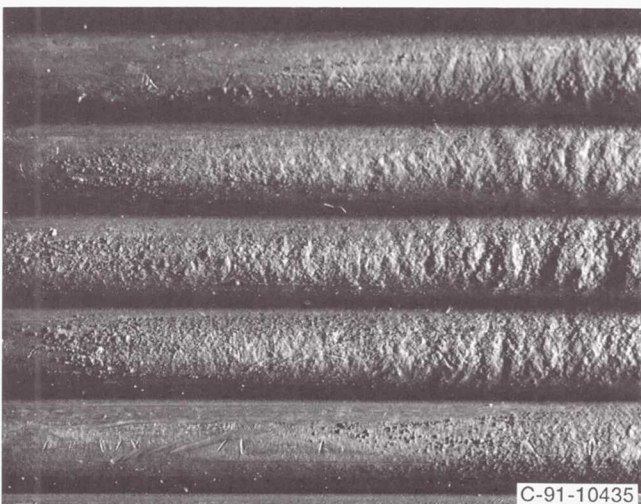
C-91-10435

Figure 10.—Surface downstream of failure site.

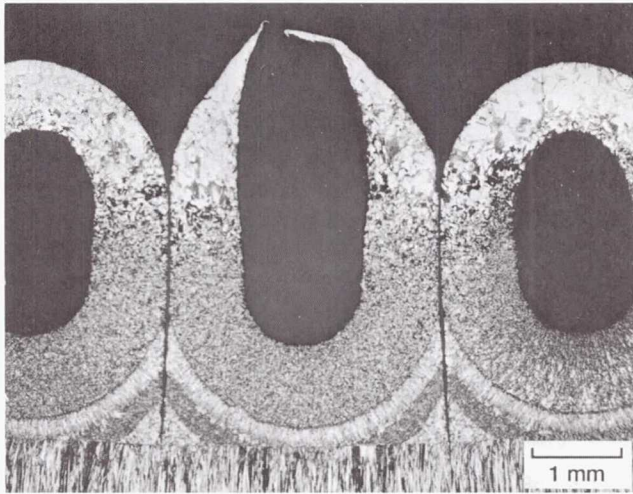
The chamber was sectioned in the region of the failure and in other areas for purposes of comparison. Each specimen was polished and etched to show the metallurgical grain structure and photographed to illustrate the findings. Figure 11 shows the failure site and the distress in the two adjacent tubes. The nature of the stress rupture failure is shown; there is no evidence of thermal ratcheting, only tensile yield. There is evidence of thinning of the wall thickness at the top of the adjacent tubes, which would indicate tensile yield of the material because of insufficient strength at the elevated temperature. The height of the coolant passage is increased due to this yielding as well. The grain structure shows a wide variation of grain size from top to bottom. The grains at the bottom are the original fine grain structure of the OFHC copper tubes. Farther up the sides of the tubes, where the temperature was higher, the grains are larger, and at the top, where the tubes were hottest, they are largest. This grain

Figure 11.—Cross section at failure site.

growth is a result of exposure to the annealing environment of the excessive temperatures present on the tubes.

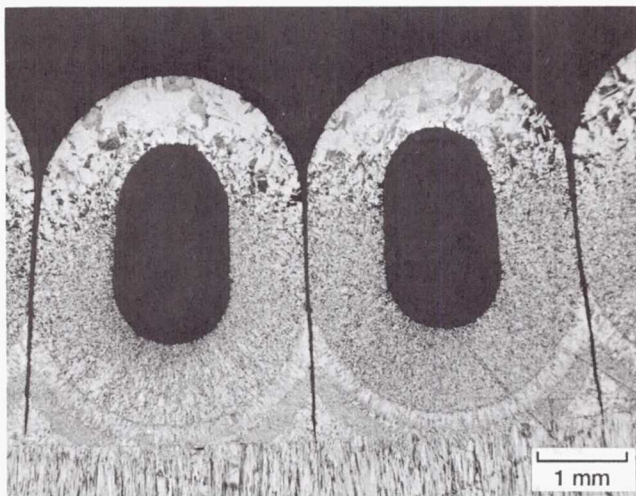
Figure 12 shows a region of the specimen 0.42 cm (0.16 in.) downstream from the throat in a lower temperature zone. The tensile yielding is still evident in the appearance of thinned wall thickness at the top of the tubes along with an increased height dimension of the coolant passage. The grain growth appears as severe as at the throat location, indicating exposure to excessive temperature. In addition, it can be seen that the “as-fabricated” expansion joint experienced some compressive yielding on heat-up that caused an expansion gap to form between the tubes. The width of this gap is the exact width required to fully close during the hot-fire duration of the cycle. This is exactly the kind of gap formed in the compliant chamber work of reference 8, where it was shown that a natural strain-relieving gap is formed on the first hot-fire test cycle. The absence of this expansion gap in figure 11

Figure 12.—Cross section 0.42 cm downstream of the throat.

may be due to the pressure rupture failure that, when it burst, caused the wall to move and close the gap. In either case the natural expansion joint of the stacked tubes did not show any crack propagation beyond the original expansion joint dimension.

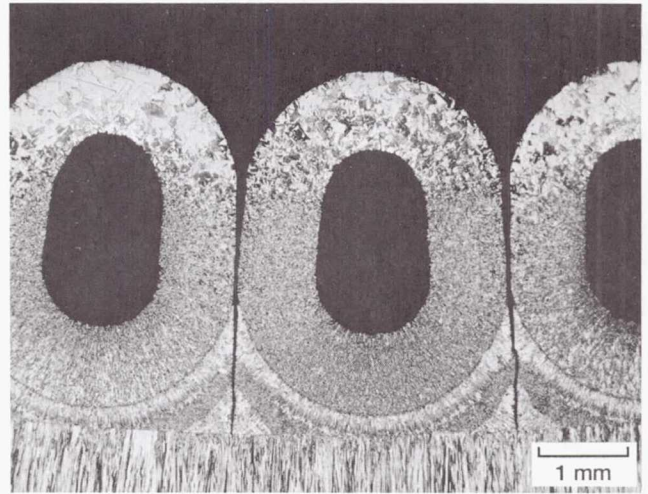
Figure 13.—Cross section 0.84 cm downstream of the throat.

Figure 13 is a photograph of the specimen taken at a location 0.84 cm (0.33 in.) downstream of the throat. The temperature at this location is low enough to result in less distress of the cooling tubes. The thinning at the top of the tubes and the increase of coolant-passage height is less severe, indicating less tensile yielding due to the coolant pressure forces. The grain growth is also less severe as the fine grain on the bottom continues farther up the sides of the tubes; the grain size at the top of the tubes is somewhat smaller than the grains of the previous specimen. Also, this figure illustrates the forming of the expansion gap in the same manner as the previous two figures. It is obvious that the feature of structural compliance performed as expected. The expansion joint between the tubes shows no crack propagation beyond the initial dimension.

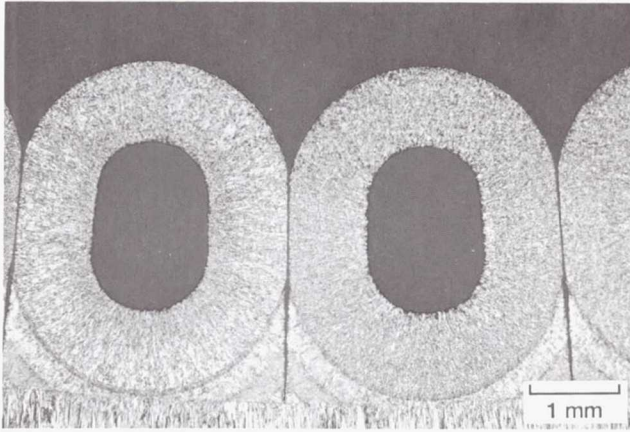
The next specimen was obtained farther downstream at a location 1.27 cm (0.5 in.) downstream from the throat. Figure 14 is a photograph of this specimen, and it shows no distress at all. The grain structure is uniform from top to bottom of the tube indicating no annealing and grain growth. Furthermore, there is no evidence of yielding or coolant-passage distortion. The expansion joints appear as fabricated with no evidence of plastic deformation on the first cycle and with the bond line between tubes as originally fabricated.

Figure 14.—Cross section 1.27 cm downstream of the throat.

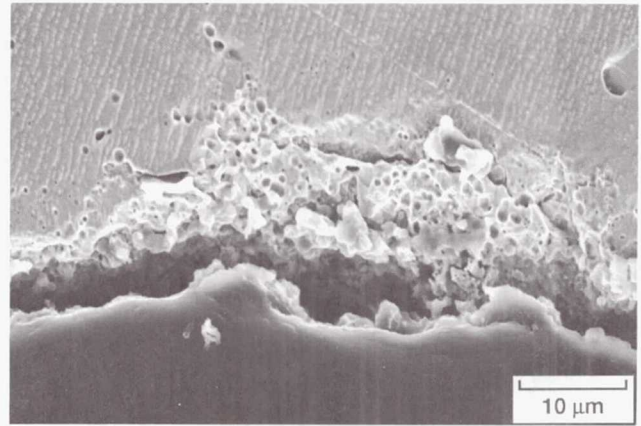
Figure 17.—SEM showing porosity and recast copper in tube away from its failure site.

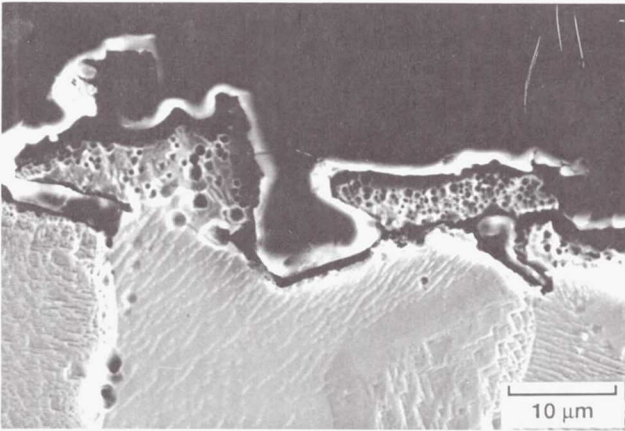
In addition to metallography, several of the chamber specimens were analyzed using the scanning electron microscope (SEM). The SEM photographs (figs. 15 to 17) showed that the hot-gas-side surfaces had considerable porosity and some recast copper. The porosity and recast copper indicate that a temperature above 1083 °C (1981 °F), the melting point of copper, was obtained. These findings are similar to those

Figure 15.—SEM showing porosity and recast copper downstream of failure site.

reported in reference 7. This is further evidence that severe blanching of the tubes occurred.

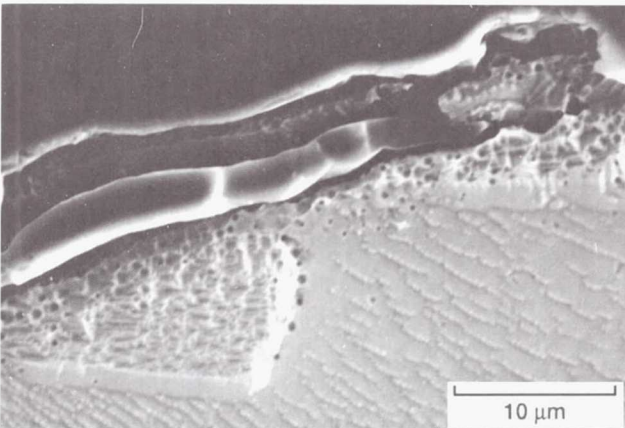
Figure 16.—SEM of area downstream of failure site.

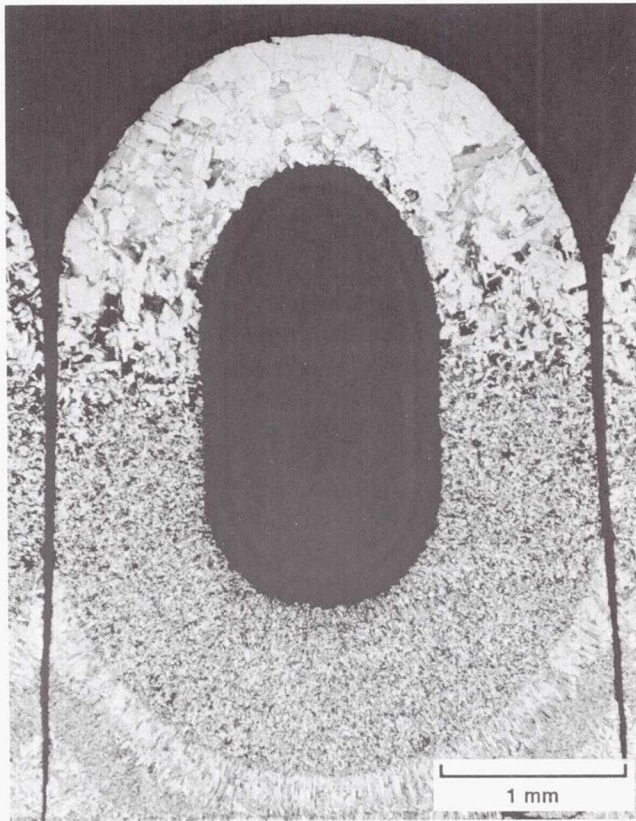
Figure 19.—Cross-section of fired tube sample taken from 0.42 cm downstream of the throat showing grain structure.

the wall material of a fired chamber (also photographed at 25×) is shown in figure 19. The grain sizes are equivalent, indicating that they had been exposed to the same temperature. However, the tube sample of figure 19 was taken from a location of 0.42 cm (0.16 in.) downstream of the throat area.

Figure 20 shows the grain size resulting from exposure to 538.1 °C (1000 °F). Grains of this size are also seen in figure 19, which shows an area just below the crevice region. This indicates that the temperature in the crevice region was slightly higher than 538.1 °C (1000 °F). This accounts for a crown to crevice difference of just under 204.4 °C (400 °F), which agrees reasonably well with the analytical prediction of 171.4 °C (340 °F) for this difference.
