NASA Technical Memorandum 105807

Nondestructive Evaluation of Ceramic and Metal Matrix Composites for NASA's HITEMP and Enabling Propulsion Materials Programs

Edward R. Generazio
Lewis Research Center
Cleveland, Ohio

August 1992

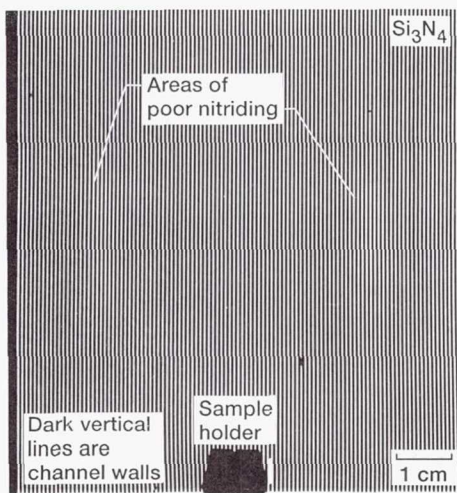
We begin our study with the development of a Si_3N_4 /SCS-6 (ref. 15) panel that contains coolant channels (fig. 1). The actively cooled panel is made up of a monolithic, 10.0 by 10.0 cm, Si_3N_4 slab that is laminated to a cross-ply composite panel Si_3N_4 /SCS-6 [0-90]. The laminated panel is 0.335 cm thick. The monolithic panel has 0.05 cm wide and 0.05 cm high coolant channels. The channel walls are 0.05 cm thick. During the development of this panel the interlaminar bonding procedure is evaluated by bonding two similar but monolithic plates. The bond between planar layers may be evaluated with radiographic and through transmission, focused 10 MHz, ultrasonic c-scan analysis; the results are shown in figures 2 and 3, respectively. A low x-ray intensity, i.e., high x-ray attenuation, corresponds to dark region in the x-ray film positive. The dark vertical bands in the radiograph correspond to the walls of the coolant channels. The channels are uniform in shape and there are no chips, cracks or occlusions present. There are two lighter vertical bands at areas where poor reaction of the bonding material produced low densities. (A subsequent modification of the manufacturing process eliminated these poorly reacted areas.)

Figure 2.—Radiograph of monolithic Si_3N_4 , actively cooled panel.

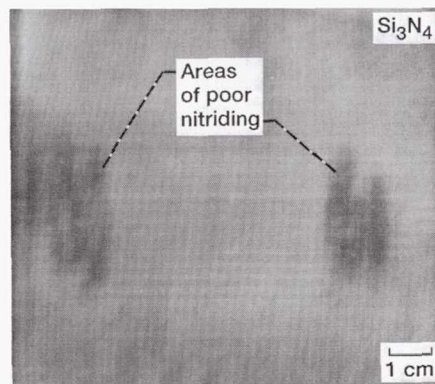
The ultrasonic c-scan shows these poorly reacted regions more clearly and to be somewhat larger than that observed in the radiograph. The condition of the channels can not be determined from the ultrasonic information.

Figure 3.—Ultrasonic, 10 MHz, through transmission c-scan of monolithic Si_3N_4 , actively cooled panel.

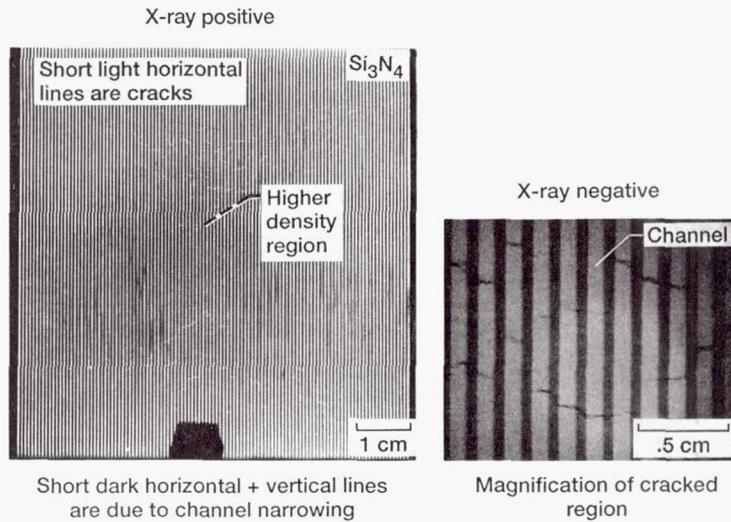
Figures 4 and 5 show the radiographic and focused 10 MHz, ultrasonic c-scan results for a $\text{Si}_3\text{N}_4/\text{SCS-6 } [0^\circ]$ panel. Severe microcracking is observed in the radiograph as short light horizontal lines. The microcracks are most visible at the walls of the coolant channels. Note that in the enlarged region of the radiograph the crack lengths are not limited to the channel wall thickness but actually are several channels wide. The short dark vertical lines scattered throughout the image each have a short horizontal dark line at their central regions. These short dark vertical regions are regions where the channel has decreased in width. The dark horizontal line at the center of each of these regions, when examined at high magnifications, has been found to be an optical illusion that occurs where the channel walls have the closest approach to each other. At the region of closest approach some channels are partially blocked by this narrowing of the channel. Several channels had adjacent walls that were of sufficient thickness that the walls were touching and apparently completely blocking the channel. The ultrasonic image reveals a considerable amount of disordered mottling in the structure. The radiograph does exhibit density variations. There is no correlation between the mottling structure in the ultrasonic c-scan image and the crack structure observed in the radiograph. This mottling is due to porosity and bond variations between the laminated layers (refs. 16 to 22).

Figure 4.—Radiographs of $\text{Si}_3\text{N}_4/\text{SCS-6}$ [0 degree] actively cooled panel.

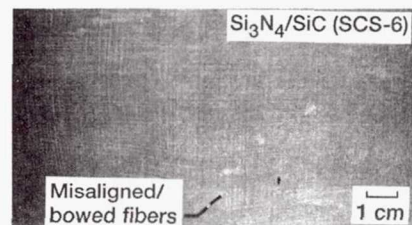
In the previous example the fiber orientation is not easily determined. Figures 6 and 7 show the radiographic and focused 10 MHz, ultrasonic, c-scan images of a $\text{Si}_3\text{N}_4/\text{SCS-6 } [0/90^\circ]$ composite panel that does not have coolant channels. The radiograph reveals a bowed fiber system. These bowed patterns are not actual individual bowed fibers but are x-ray "shadows" of a collection of fibers that are bowed. The shadows forming the bowed pattern are due to fiber volume density variations through the thickness and perpendicular to the x-ray film plane. This is manifestation of the Moiré effect (refs. 18 and 23) found in composite systems. The density of the system is uniform as indicated by the uniform gray level or shading in the radiograph. The dark areas in the ultrasonic image also yielded reflected ultrasonic signals that corresponded to reflections from the laminated boundary, these dark areas are regions having poor or no bond between laminated layers.

Figure 6.—Radiograph of $\text{Si}_3\text{N}_4/\text{SiC}$ SCS-6 [0-90 degree] panel.

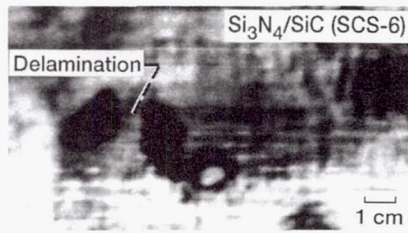
Figure 7.—Ultrasonic, 10 MHz, through transmission c-scan of $\text{Si}_3\text{N}_4/\text{SiC}$ SCS-6 [0-90 degree] panel.

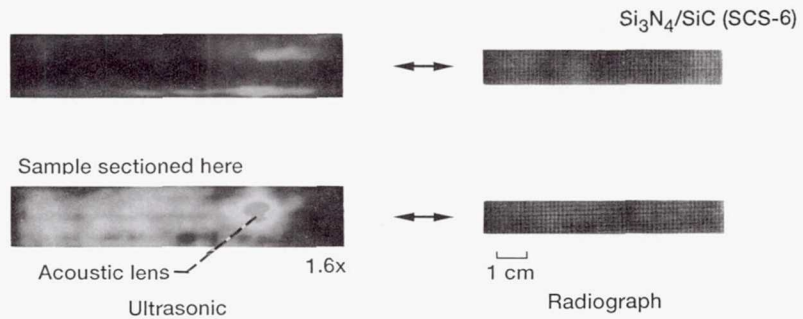
Fibers need only be well ordered and spaced uniformly in the plane of a $\text{Si}_3\text{N}_4/\text{SCS-6 } [0/90]$ plate in order to yield relatively uniform radiographic and ultrasonic images (fig. 8). However, if there are any systematic variations, such as, ordered through the thickness buckling (due to processing) of the fibers (fig. 9), then the ultrasonic image will reveal this systematic fiber spacing variations. The fiber buckling can be readily observed in the photomicrograph (fig. 9) by comparing the spacing between the bottom two rows of fibers that are perpendicular to the cross section. Note that this spacing varies dramatically from center to the right edge of the sample. In this case, the fibers are forming a crude diffractive/refractive acoustic lens (fig. 9) that is observed as a bright spot in the ultrasonic image. No indication of this fiber buckling is seen in the radiograph.

Figure 8.—Ultrasonic, 10 MHz, through transmission c-scan and radiographs of similarly produced $\text{Si}_3\text{N}_4/\text{SiC}$ SCS-6 [0-90 degree], test bars.

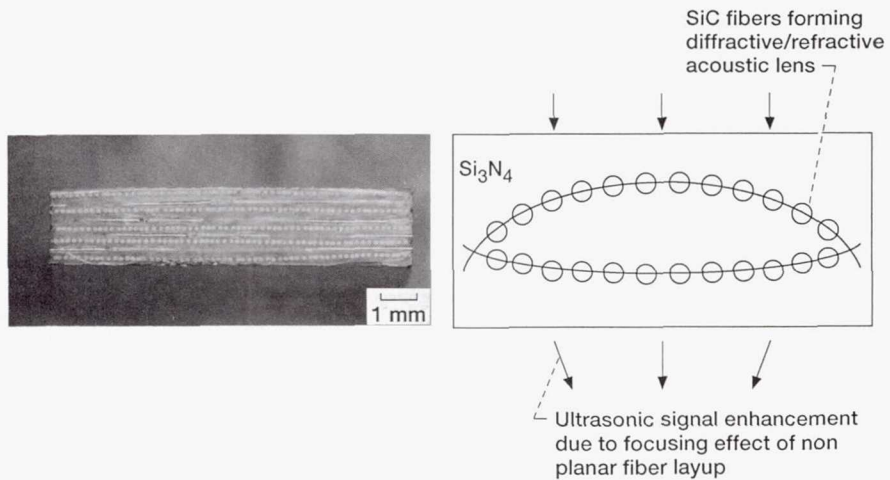
Figure 9.—Cross-section of $\text{Si}_3\text{N}_4/\text{SiC}$ SCS-6 [0-90 degree] test bar at region showing large ultrasonic transmission.

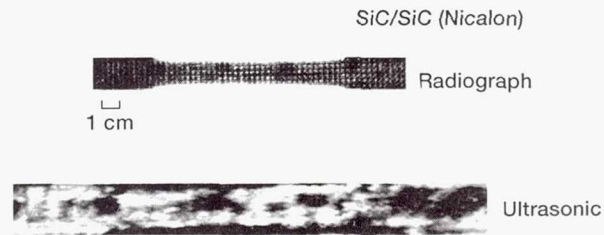
A SiC/SiC (Nicalon fiber) laminated, two-dimensional, woven composite yield very complicated radiographic and focused 10 MHz, ultrasonic c-scan (fig. 10) images. The radiograph reveals a cross hatch pattern that varies in density. This variation may be due to density variations in the matrix material or registration variations between the woven layers. The dark circular regions that are uniformly spaced are due to local density variations that have been produced during processing. These circular density variations are also visible in the ultrasonic image. The distorted or blurry appearance of

the ultrasonic images is due to refractive and diffractive scattering (ref. 17) occurring at the rough surfaces and woven fibers. There is little additional information obtained from the 10 MHz, ultrasonic c-scan.

Figure 10.—Ultrasonic, 10 MHz through transmission c-scan and radiograph of SiC/SiC (Nicalon) woven laminated composite.

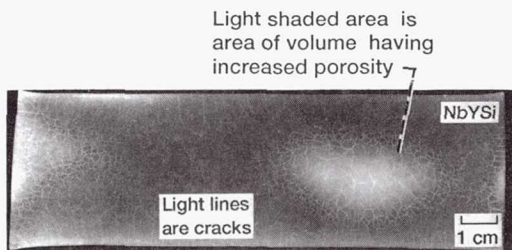
During the development of potential metal matrices the processing procedures are optimized by a combination of methods. One technique developed for consolidating metallic glass powders requires the use of a molybdenum or niobium encapsulating can for hot isostatic pressing (HIP). Radiographic (fig. 11) and ultrasonic (fig. 12) imaging can be performed while the consolidated material, NbYSi is still encapsulated. The radiograph reveals an extensive amount of cracking throughout the consolidated material. Regions of increased porosity can be readily identified as light cloud-like areas in the radiograph and dark areas in the ultrasonic image. The crack density increases with an increase in porosity.

Figure 11.—Radiograph of encapsulated NbYSi matrix material.

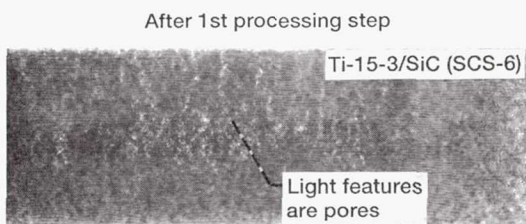
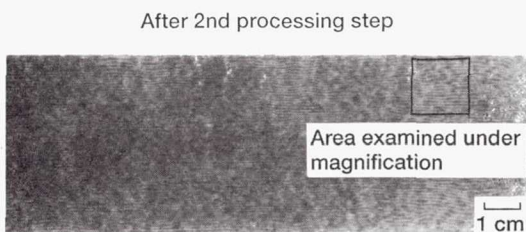
The degree of consolidation was monitored in Ti-15-3/SiC (SCS-6) fiber composites with radiographic (fig. 13) and ultrasonic imaging (fig. 14). This panel was HIPped in two steps. The second processing step has removed much of the porosity (fig. 13). A close examination of the radiograph reveals fine fiber fractures (fig. 15). The intensity of the x-rays at the fracture sites is low. This low intensity or high x-ray attenuation at the fracture sites is an indication that the matrix material has infiltrated into these fracture sites as shown in figure 15. An increase in the x-ray intensity at the fracture sites would indicate that these fracture sites contained voids. The fractures occurred during the ductile part of the HIP stage and are not due to the mismatch between the coefficients of thermal expansion of the fiber and matrix materials. The initial infiltration of the matrix into the fiber fracture sites was radiographically observed after the first HIP stage.

Figure 13.—Radiographs of Ti-15-3/SiC (SCS-6) composites after first and second processing steps.

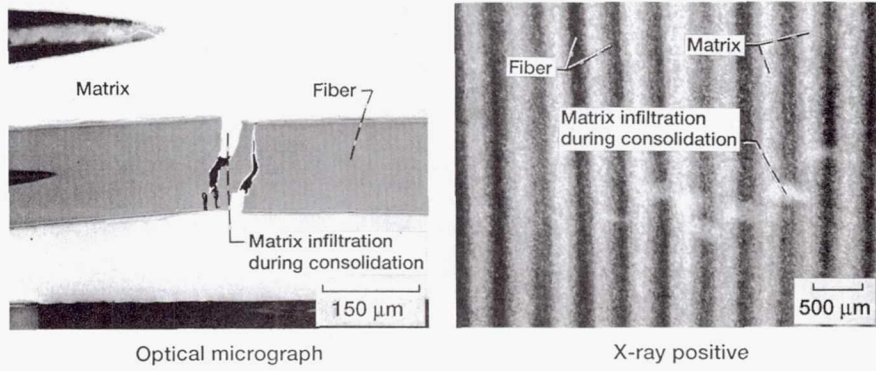
Figure 15.—Metallograph and enlarged x-ray positive of region highlighted in figure 13.

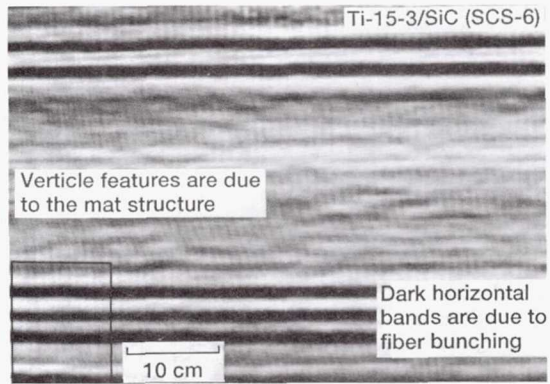
Composites with three phases yield complex radiographic and ultrasonic data. A Ti-15-3 plate containing unidirectional SiC (SCS-6) fibers and a molybdenum wire mat represents a simple three phase composite system. Groups of molybdenum wires can be identified in the focused 10 MHz, ultrasonic c-scan image (fig. 16) as faint uniformly spaced vertical lines. Here each group of mat wires act as an ultrasonic line scatterer. Dark horizontal bands in the upper and lower parts of the ultrasonic image are due to the slight bunching of the horizontal SiC fibers, i.e., areas having high fiber volume density. The central region of the ultrasonic image also exhibits some horizontally oriented mottling. This mottling is due to similar fiber volume density variations except that these fiber volume density variations are not as ordered as those near the upper and lower edges of the plate. The radiograph shows both the orientation and structure of the horizontal SiC fibers and the vertical molybdenum wires that make up the mat (fig. 17). Broken, twisted, and bent molybdenum wires are easily identifiable and occur throughout the system. Fiber rich banded zones can also be identified, but not easily, in the radiograph.

Figure 16.—Ultrasonic, 10 MHz, through transmission c-scan of Ti-15-3/SiC (SCS-6) composite.

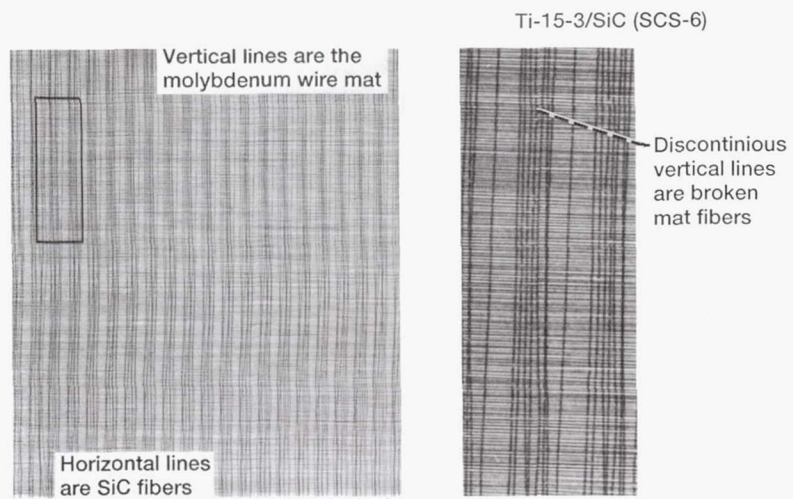
Figure 17.—Radiograph of highlighted region in figure 16.

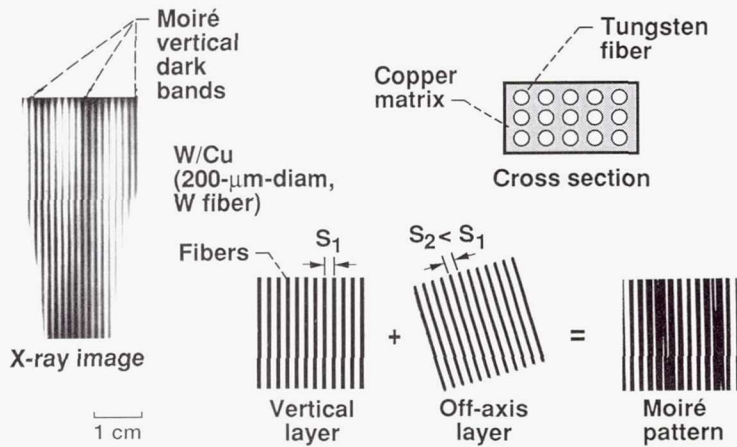
Ordered or systematic changes in the fiber volume density or orientation can produce artifacts or Moiré (refs. 17 and 23) patterns in the radiographs. For example, if in one layer, the fiber spacing, S1, is slightly different from the fiber spacing, S2, in another layer, then a Moiré pattern will be observed in the radiograph. The radiograph of a copper matrix system containing tungsten wires (fig. 18) reveals broad vertical dark Moiré bands. (This is not an advanced high temperature composite material for the HITEMP or EPM programs, but it does dramatically show an artifact that occurs in all continuous fiber composites to some degree.) In addition, if the fiber layers are also off-axis from each other then the Moiré bands will also be off-axis.

Figure 18.—Radiograph and illustrations showing Moiré effect in W/Cu composite.

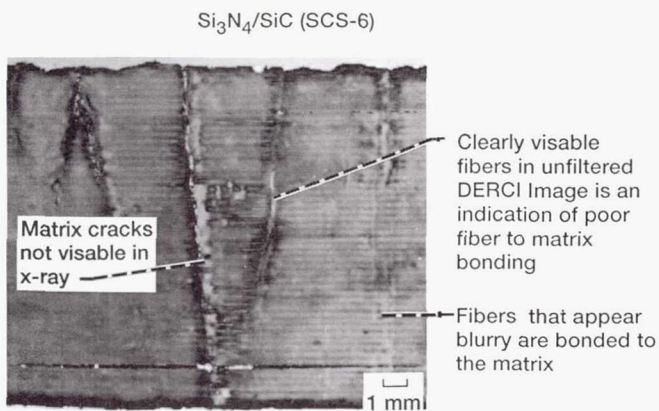
A $\text{Si}_3\text{N}_4/\text{SiC}$ [0] (SCS-6 fiber) composite was tested in tension until matrix cracking was visually observed. The specimen was then unloaded and a NDE was performed. A region of the specimen was identified that did not visually exhibit matrix cracking. A radiograph of this area reveals a uniform structure (fig. 19). A microscopic evaluation of the radiograph does not reveal the presence of any microcracks. However, a 50 MHz, ultrasonic DERICI image (fig. 20) reveals a detailed subsurface structure. The individual subsurface fibers of the first ply can be identified as horizontal features across the image. The vertical and near vertical features are cracks in the matrix material. Note that along and near the matrix cracks there are areas in the image where the fibers appear to be clear or less blurry. The fibers in these areas have decoupled from the matrix material and in doing so have formed nearly perfect cylindrical ultrasonic scattering boundary. This rather clean boundary prohibits any secondary or blur induced scattering of the wave that would have occurred if the ultrasound travelled into the SiC fiber (fig. 21). A fluorescent dye penetrant makes these matrix cracks visible under an ultraviolet light (fig. 22).

Figure 20.—Ultrasonic DERC I unfiltered image at 50 MHz of section of $\text{Si}_3\text{N}_4/\text{SiC}$ SCS-6 [0] RBSN tensile test bar.

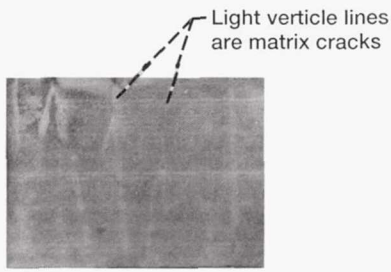
Figure 22.—Fluorescent penetrant image of section of $\text{Si}_3\text{N}_4/\text{SiC}$ SCS-6 [0] RBSN tensile test bar.

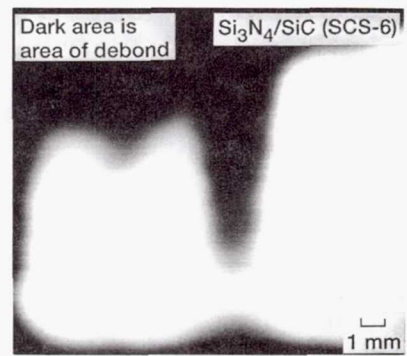
An extensive amount of ultrasonic scattering is observed in a 10 MHz, ultrasonic c-scan (fig. 25). The dark areas in the ultrasonic image correspond to the areas where cracks are observed in the DERICI image.

Figure 25.—Ultrasonic, 10 MHz, through transmission c-scan of section of $\text{Si}_3\text{N}_4/\text{SiC}$ SCS-6 [0] RBSN tensile test bar.

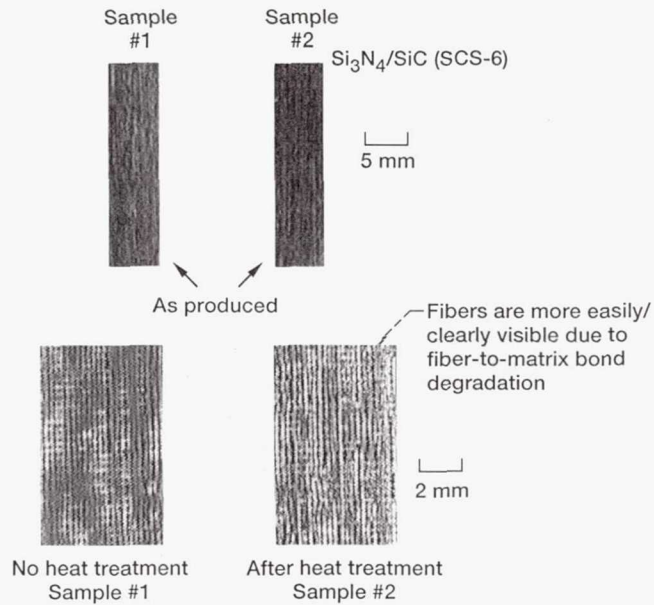
Two identically produced specimens of $\text{Si}_3\text{N}_4/\text{SiC}$ (SCS-6) [0] were ultrasonically evaluated using the DERICI technique. The DERICI images are spatially filtered with a two-dimensional high pass filter before further evaluation. This filter extracts the important spatial high frequency components (i.e., reflections from the fiber-to-matrix interface) from the reflections from porosity which are generally observed as mottling in ceramics (refs. 16 to 22 and figs. 5 and 7). The DERICI results reveal similar features in both samples before heat treatment (fig. 26). The vertical features in these images are due to reflections at the subsurface fiber-to-matrix interfaces. One sample was heat treated at 600 °C for 100 hr in flowing oxygen to degrade the fiber-to-matrix interface (via oxidation) (ref. 24). This heat treatment decreased the interfacial shear strength from 18 ± 4 MPa to 0.8 ± 0.4 MPa (ref. 24). After heat treatment there is a marked change in the DERICI image. After heat treatment the reflections from the interface are more intense so that the fibers become more visible. This change in the DERICI results before and after heat treatment can be quantified. The histogram maximum of the gray scale of each of the images may be used to quantify the DERICI results (fig. 27). A low value for the histogram maximum indicates that there is considerable amount of scattering at the fiber-to-matrix interfaces per unit area. A high maximum value indicates that the fibers are difficult to observe and that the image is rather bland or smooth. Ideally, if the fibers were perfectly bonded, and therefore essentially unobservable (except for the small variation in the acoustic impedance between the fiber and matrix) then the DERICI images would contain predominantly one shade, 128, in the gray scale. The gray scale maximums for the untreated and heat treated specimens are 1.9 and 3.3 (arbitrary units), respectively. This corresponds to about a 75 percent change in histogram amplitudes. These values can be correlated with the respective interfacial

Figure 26.—DERCI images of $\text{Si}_3\text{N}_4/\text{SiC}$ SCS-6 [0] RBSN at 50 MHz before and after heat treatment.

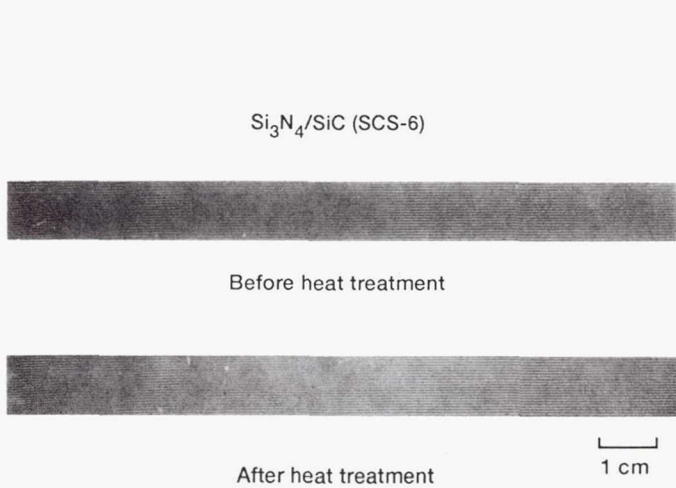
shear strengths. If the interfacial shear strength is strongly dependent on the contact area between the fiber and matrix, then the DERICI results, which are also sensitive to changes in this contact area, are images of variations in interfacial shear strength. Since the fiber and matrix acoustic impedances are not identical, then the interrelationship between the DERICI results and the interfacial shear strength, which to first approximation is assumed to be a linear relationship, will contain a calibration or scale factor. The radiographs before and after the heat treatment (fig. 28) show essentially similar results.

Figure 28.—Radiographs of $\text{Si}_3\text{N}_4/\text{SiC}$ SCS-6 [0] RBSN sample #2 before and after heat treatment.

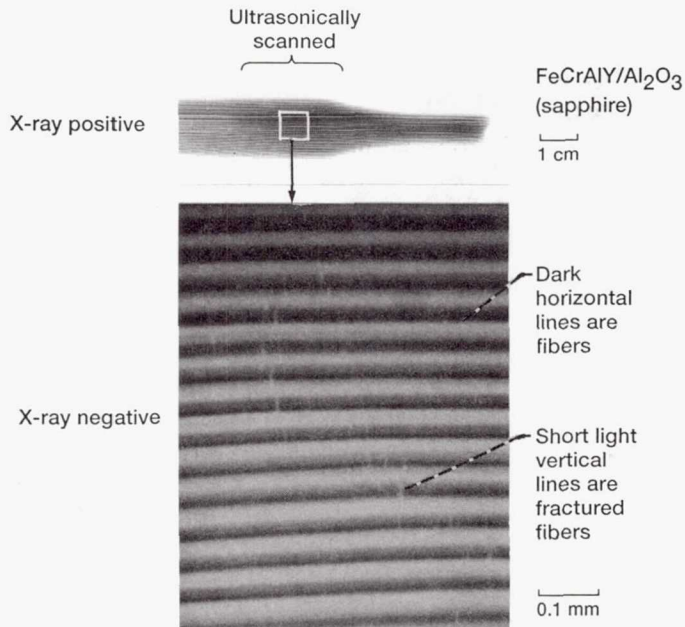
A FeCrAlY/Al₂O₃ [0] (single crystal sapphire fiber) composite bar was tested in tension at 300 K until failure. Fine cracks in the fibers are barely visible under magnification of the radiograph shown in figure 31. The fibers fractured far away from the test area where the sample ultimately fractured. The horizontal dark and light bands are due to changes in the fiber volume density through the thickness of the sample. This banding, even though it is not cyclic, is produced in an identical way as the Moiré patterns discussed previously. Similar bands have been found in untested samples. A 50 MHz, ultrasonic surface wave examination of the region having cracked fibers also reveals the extent and location of these cracked fibers (fig. 32). A focused 30 MHz, ultrasonic back echo c-scan reveals a mottled matrix material (fig. 32). This mottling is related to the original surface condition (i.e., before the grinding the surface smooth) of the sample. The mottling is most likely due to porosity variations that are dependant on the manufacturing process that creates the "as produced" rough surface. Figure 33 optically shows the "as produced" and "as ground" surface structures. All samples have "as ground" surfaces before being mechanically tested. The radiograph (fig. 31) does exhibit some mottling in the matrix. However, these variations are just barely visible.

Figure 31.—Radiograph and radiographic enlargement of FeCrAlY/Al₂O₃ (sapphire fiber) composite.
