## ADDITIONAL RESULTS ON SPACE ENVIRONMENTAL EFFECTS ON POLYMER MATRIX COMPOSITES — EXPERIMENT AO180

R. C. Tennyson  
University of Toronto Institute for Aerospace Studies  
Toronto, Ontario, Canada  
M3H 5T6

### ABSTRACT

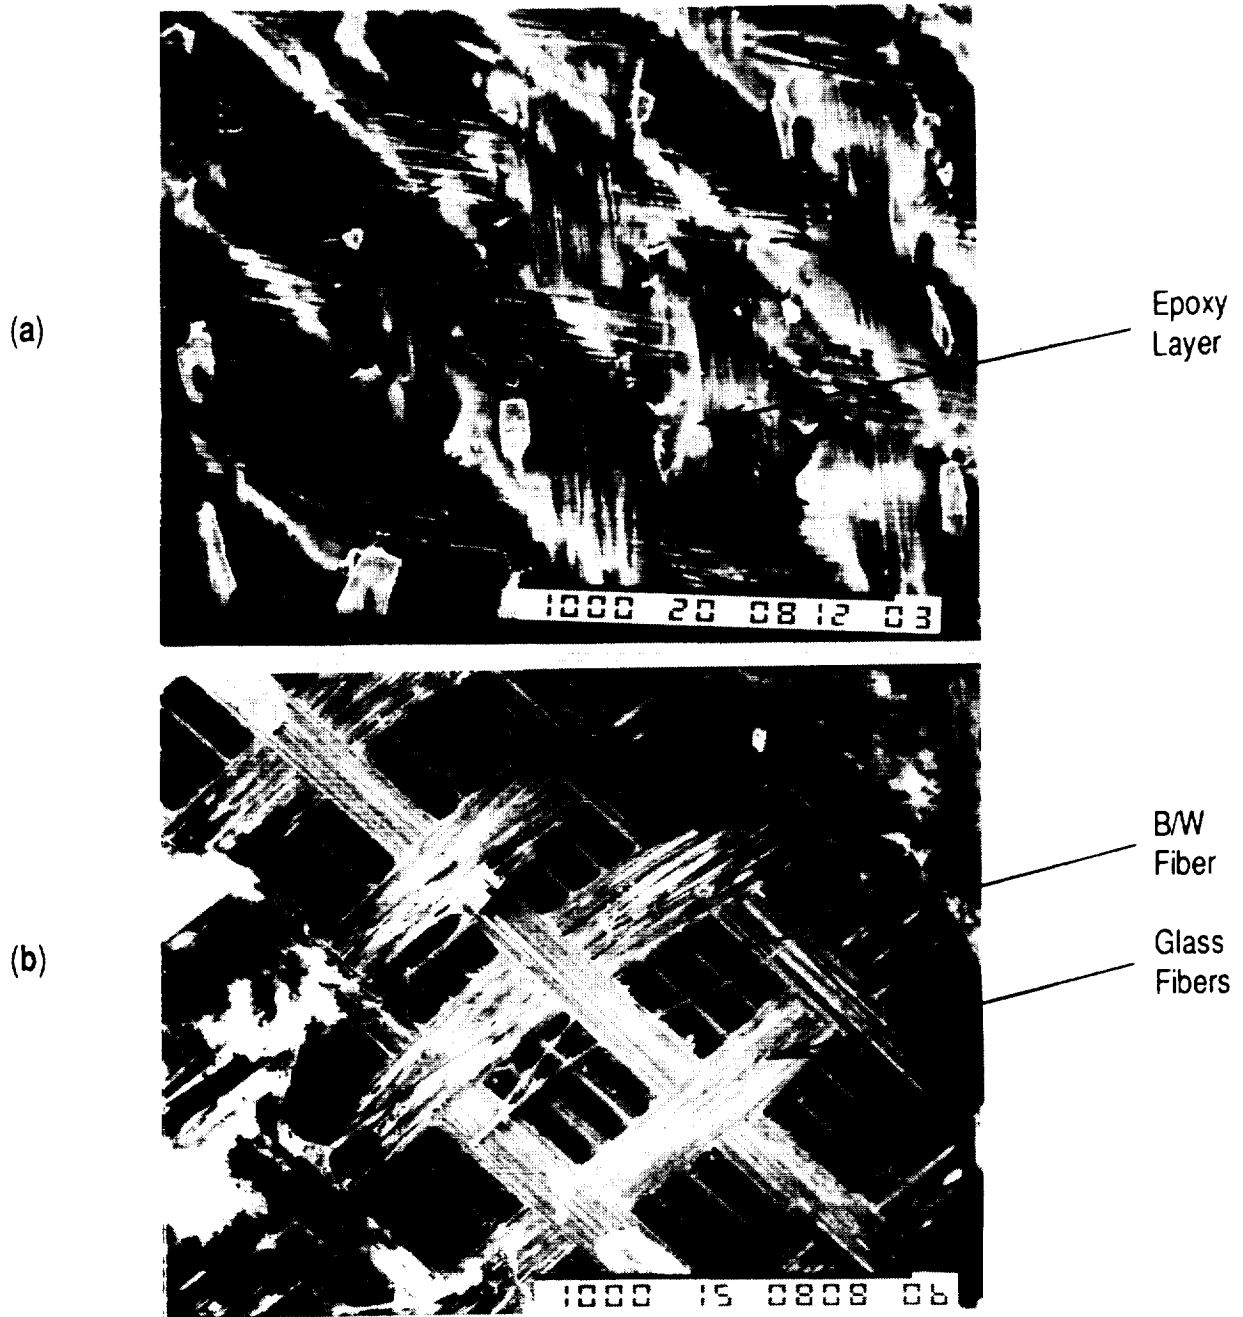
The erosion of boron/epoxy laminates was restricted to the outer epoxy layer. Figure 1 shows a comparison of the unexposed (a) and exposed (b) areas, where it is evident that loss of the outer epoxy layer reveals the woven glass fiber cloth (used as a binder material) and the unidirectional boron (coating over tungsten) fibers. Cross-sectional views (Figure 2) show the outer resin layer, glass fibers and composition of the reinforcing 'boron' fiber with its tungsten core. Figure 3 presents a similar view including the AO erosion profiles of the epoxy layer. For a tube structure, the erosion angle varies with circumferential position around the tube, as demonstrated by the results plotted in Figure 4. Finally, close-up examination of the boron fibers exposed to AO reveals a grain structure (Figure 5) that has formed in the boron coating, although no loss of boron material due to erosion was observed. The combination of boron reinforcing fibers overlaid with glass fiber scrim cloth yields a laminate that is significantly less sensitive to AO erosion than graphite and Kevlar® reinforcements.

Fig. 1 SEM Photographs of Boron/Epoxy Tube Surface [SP-290,  $(\pm 45^\circ)_4S$ ] (a) Unexposed (x50), (b) Exposed to Atomic Oxygen (x50)

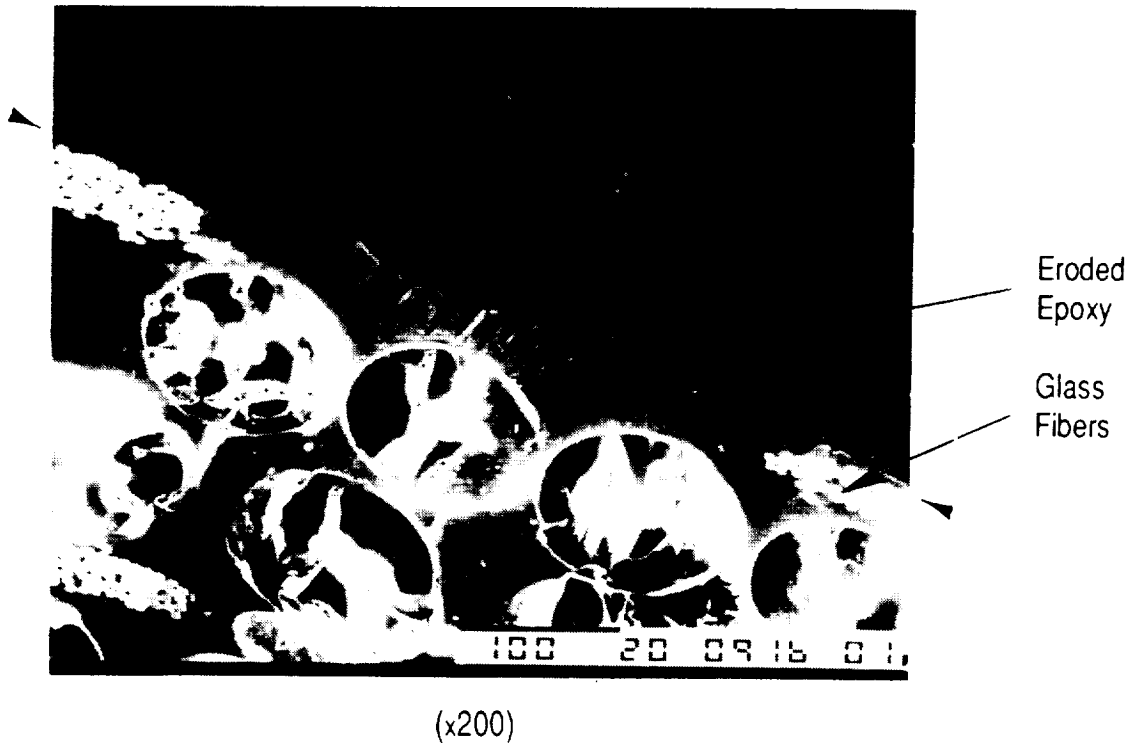
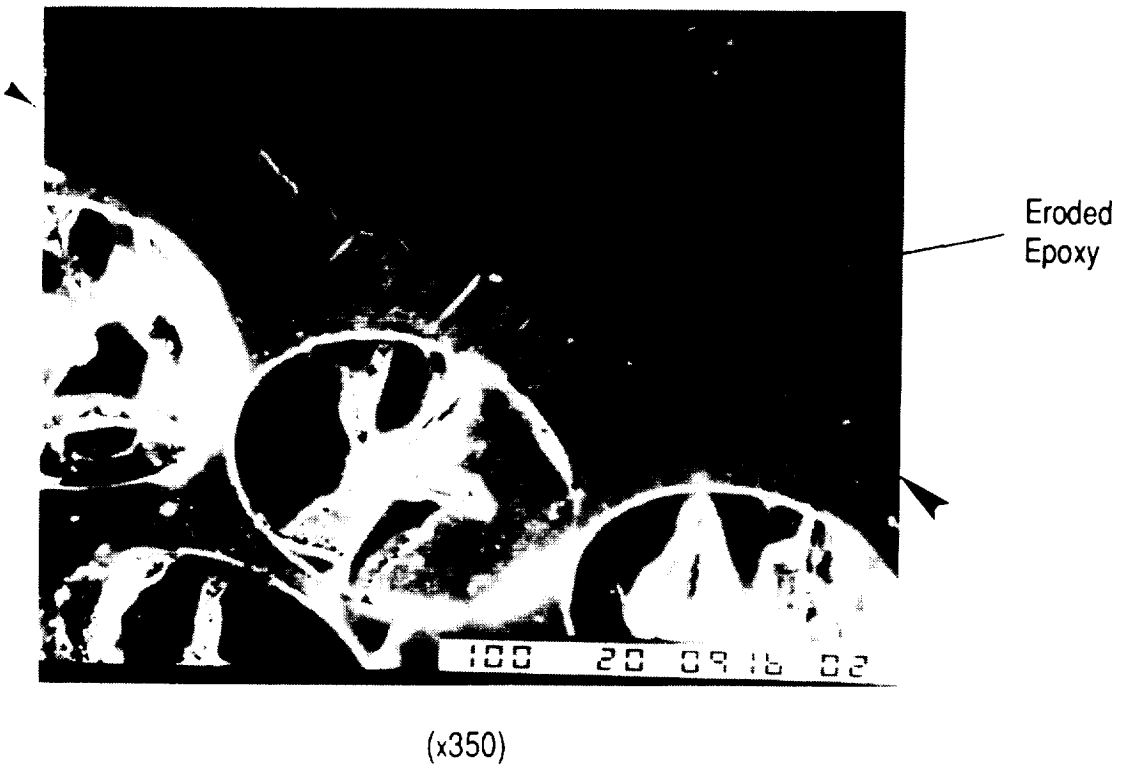
Fig. 3 SEM Photographs of Eroded Cross-Section of Boron/Epoxy Tube [SP-290, ( $\pm 45^\circ$ )<sub>4S</sub>] Exposed to Atomic Oxygen. (Arrows delineate boundary between outer epoxy layer and potting compound)

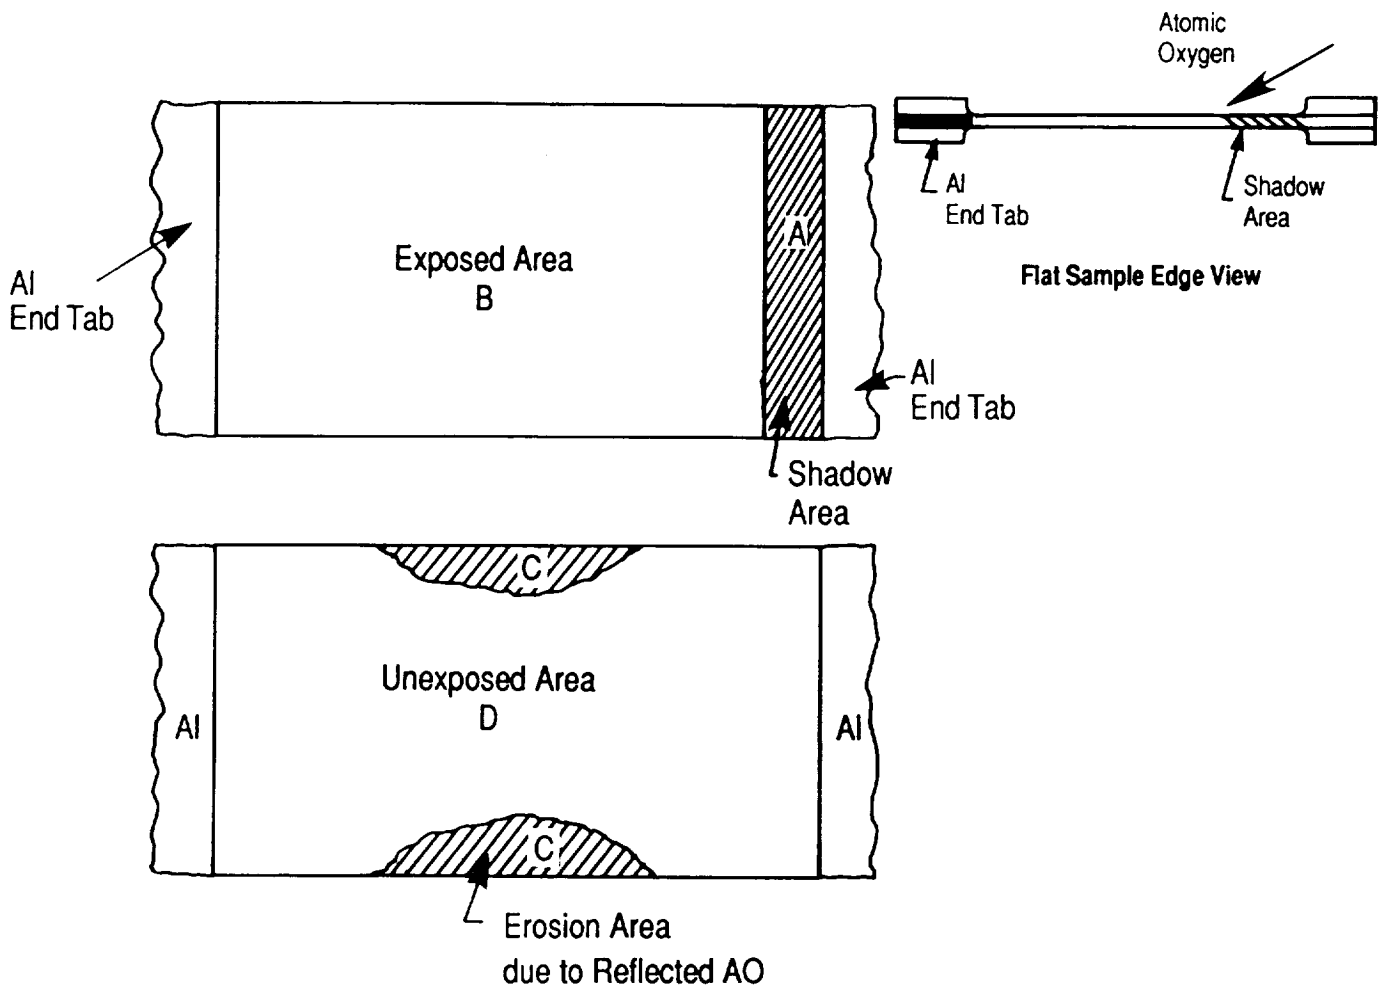
Kevlar®/epoxy flat plate laminates were mounted on the exterior of the UTIAS LDEF experiment. The schematic shown in Figure 6 illustrates a shadow region (A) adjacent to an aluminum (Al) end tab, the outer exposed face (B) and erosion areas (C) on the bottom face (D) which resulted from AO reflection off cylindrical aluminum end fixtures mounted on adjacent tube specimens. Figure 7 presents SEM photographs of two unexposed regions, A and D. These can be compared to the AO erosion surface morphologies found in the exposed areas, B and C. The fibrous nature of the eroded Kevlar® is clearly evident in B, with C more typical of non-directional AO attack on the outer resin layer. Note the difference in texture of the Kevlar® fibers between B and C. In photograph B, the outer epoxy layer is gone and only the partially eroded Kevlar® fibers in the first layer remain.

Fig. 6 Kevlar®/Epoxy (SP-328) Flat Plate Laminate

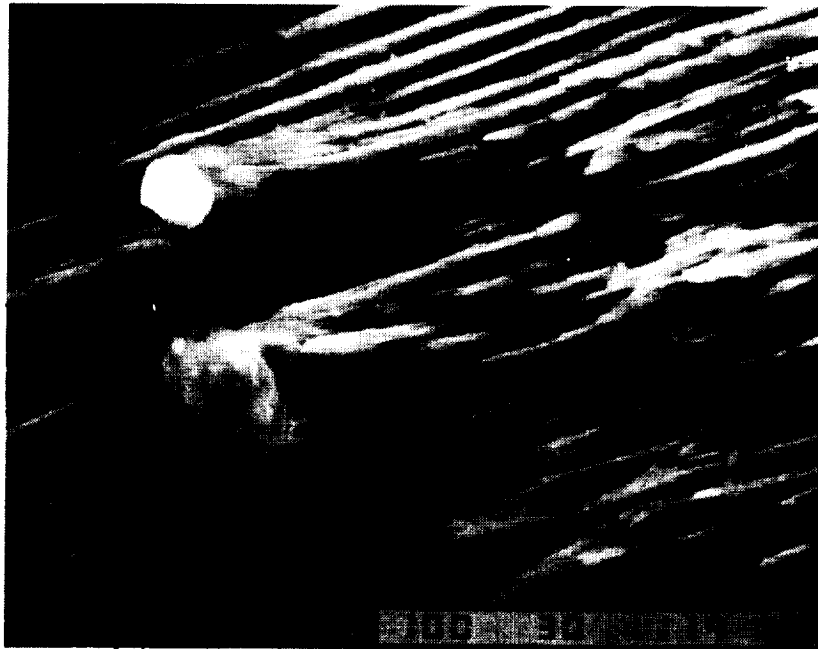
The surface erosion morphology observed on graphite/epoxy laminates due to AO is shown in Figure 8 for a 90°, 4 ply tube (934/T300). When viewing the cross-section of a laminate, one finds that the AO fluence at station D-12 was sufficient to erode the outer epoxy layer and a portion of the reinforcing graphite fibers. Figure 9 presents SEM photographs of unexposed and exposed regions for a ( $\pm 43^\circ$ )<sub>4s</sub> tube (SP288/T300). Erosion of the graphite fibers is clearly evident.

Fig. 8 SEM Photograph of Surface Morphology on Exposed Graphite/Epoxy Tube [934/T300, (90°)<sub>4S</sub>]

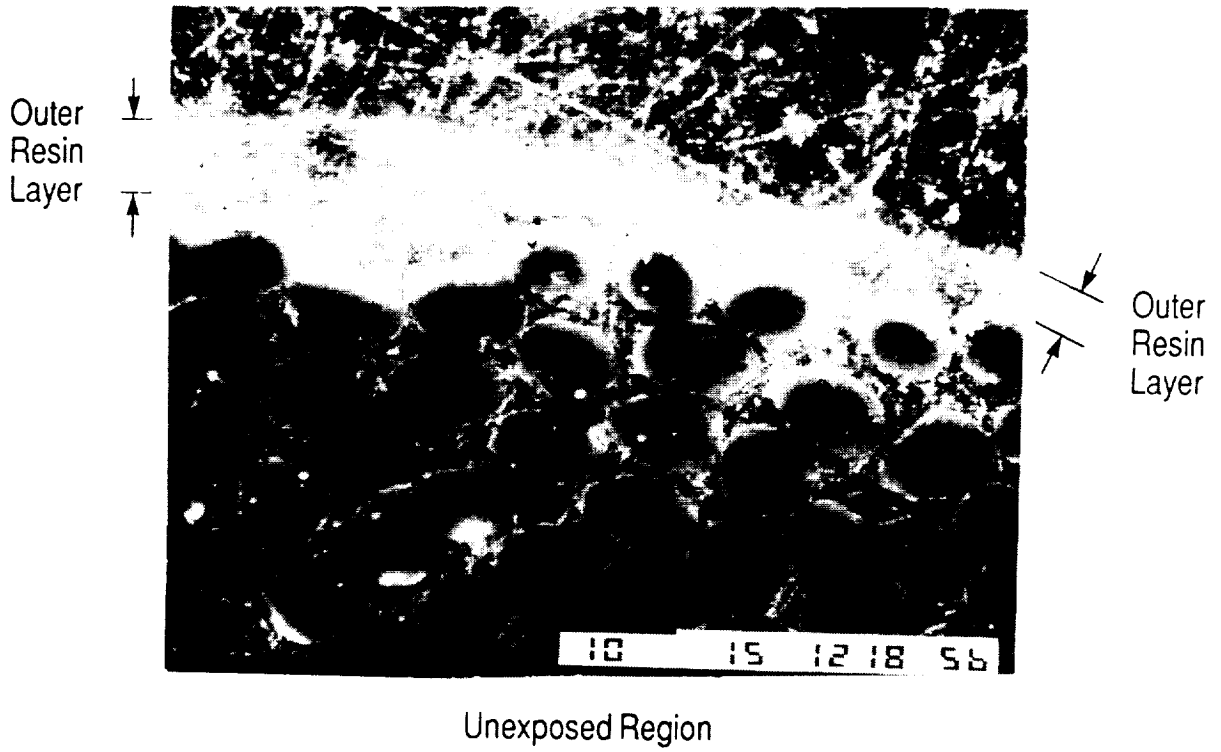
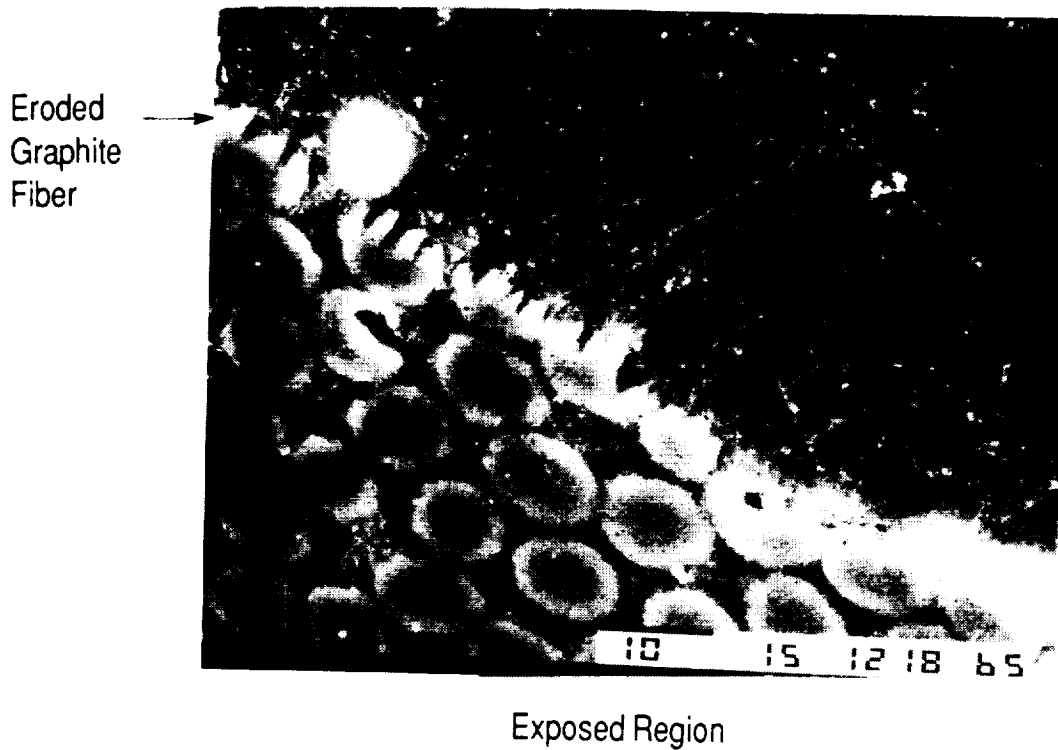
Fig. 9 SEM Cross-Sectional Photographs of Graphite/Epoxy Tube Subjected to AO Erosion [SP-288/T300, ( $\pm 43^\circ$ )<sub>4S</sub>]

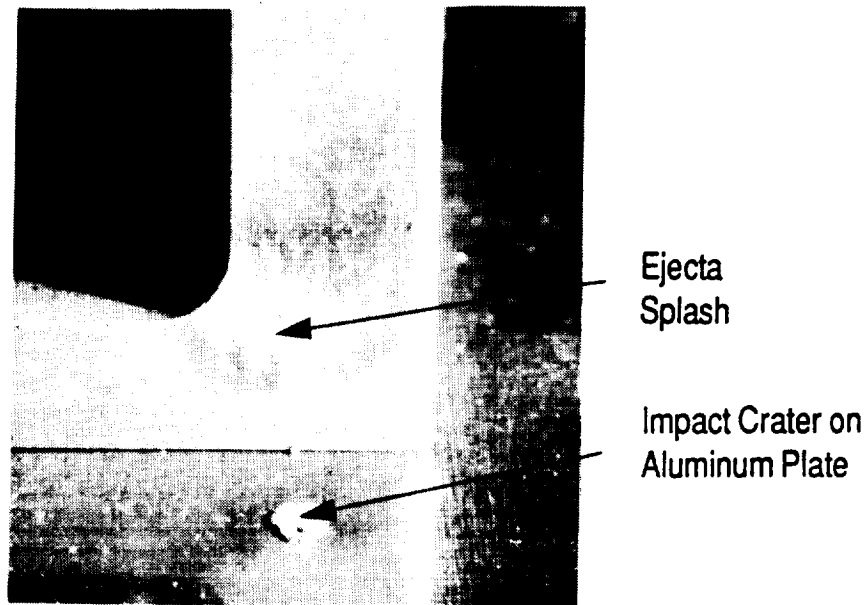
The largest impact found on experiment AO180 occurred on an aluminum base plate, with an ejecta splash observed on an adjacent flange structure (Figure 10). A view of the 1 mm diameter crater is shown in Figure 11. EDS spectra of the crater rim material composition (Figure 12) exhibits a strong Fe peak along with the Al substrate. Based on this evidence it is assumed that the crater resulted from a micrometeoroid impact. Figure 13 contains a SEM photograph of the surface ejecta splash pattern on the flange structure. Details of the different splash patterns in this region are shown in Figure 14. An aluminum ejecta particle, visible in Figure 14, is enlarged in Figure 15 and Figure 16 (lower photograph). Figure 16 presents two different forms of aluminum ejecta particles and their associated splash patterns. The lower photograph shows the remnants of a molten particle while the upper photograph shows the full spherical form of an aluminum particle.

Fig. 10 View of Micrometeoroid Impact Crater and Ejecta Splash Pattern on Adjacent Vertical Flange Structure

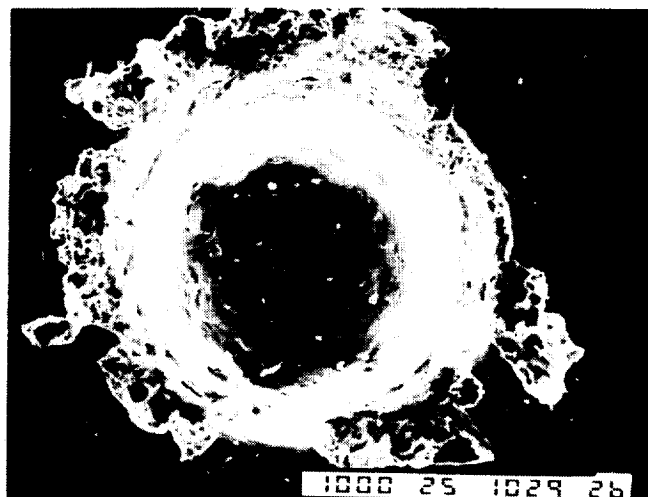
Fig. 11 View of Micrometeoroid Crater on Aluminum Base Plate

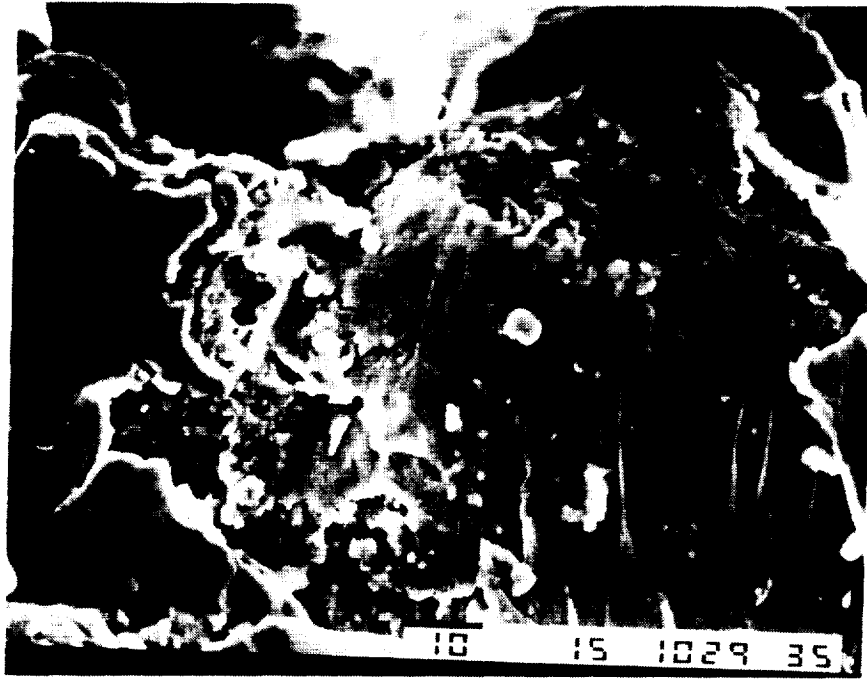
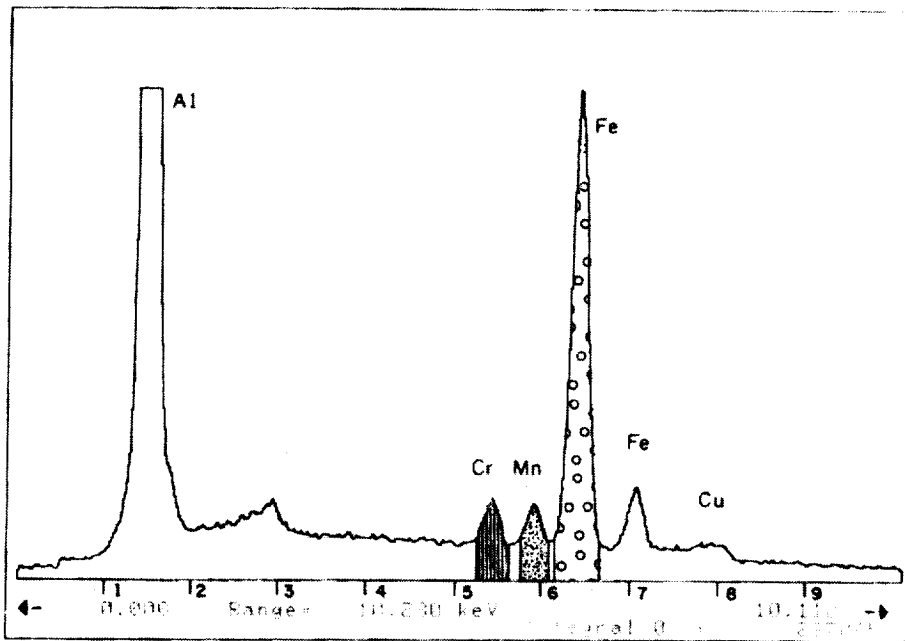
Fig. 12 Crater Ejecta and Elemental Composition (EDS Spectra)

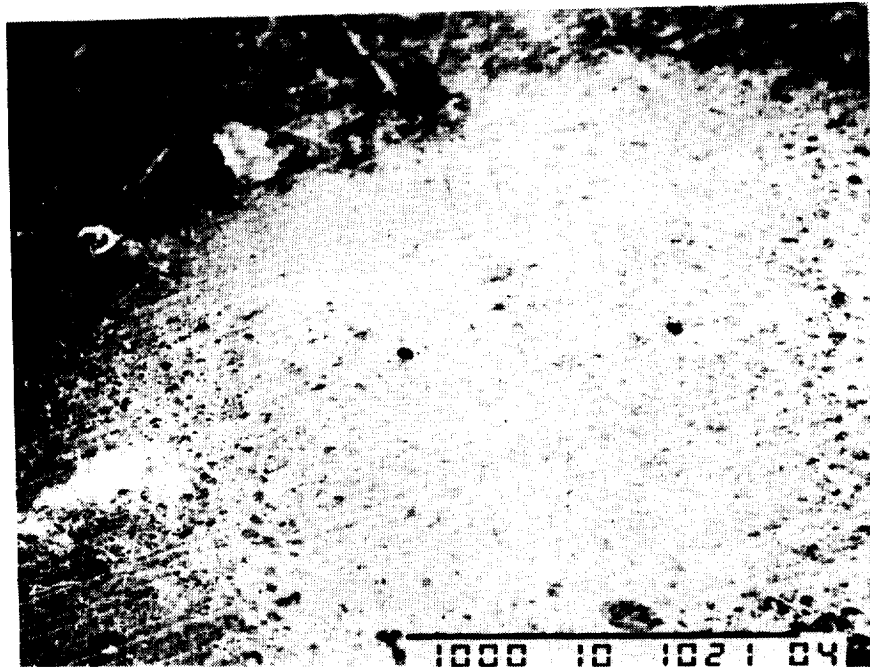
Fig. 13 Ejecta Splash Pattern on Vertical Flange Structure Adjacent to Crater

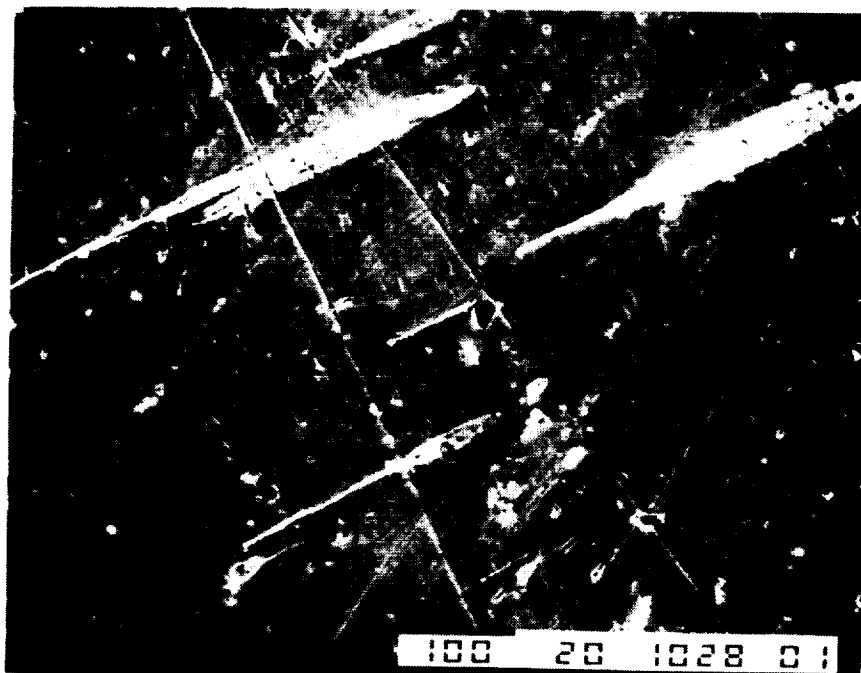
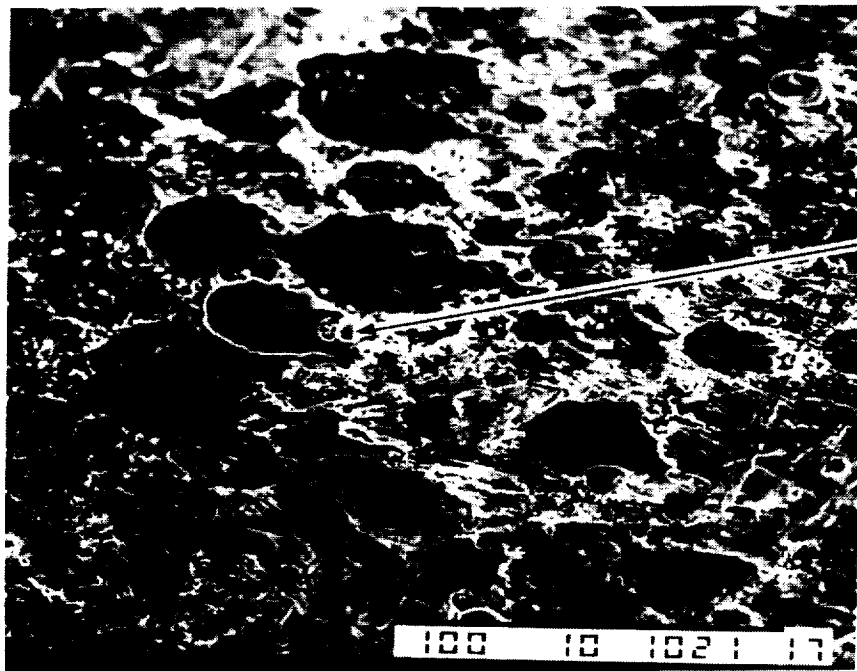
Fig. 14 Different Splash Patterns formed by Ejecta from Micrometeoroid Impact

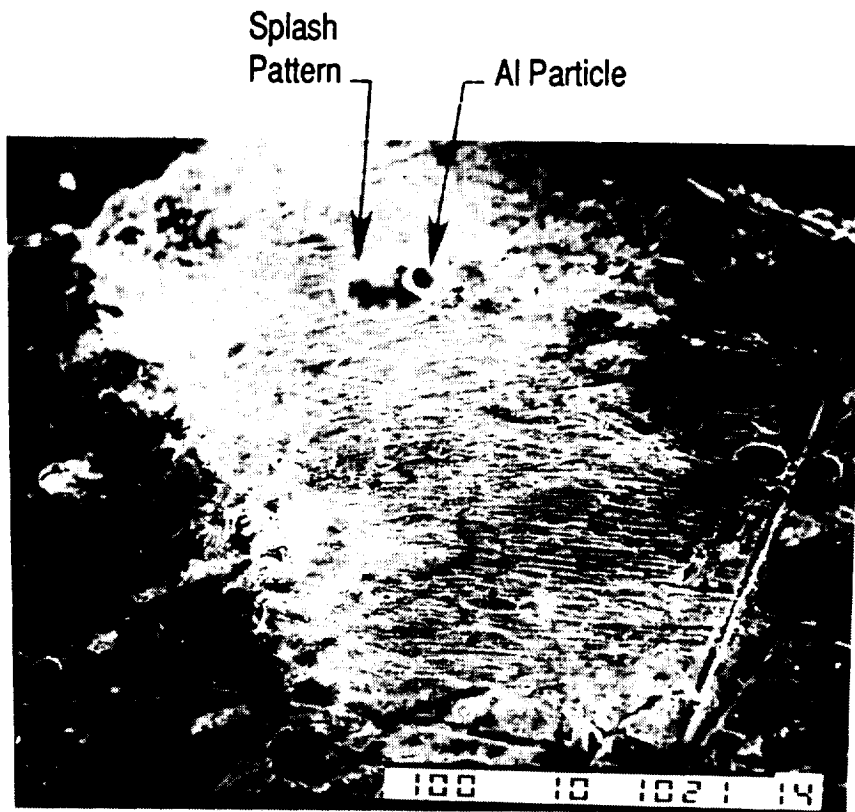
Fig. 15 Superposition of Aluminum Ejecta Particle on Splash Pattern

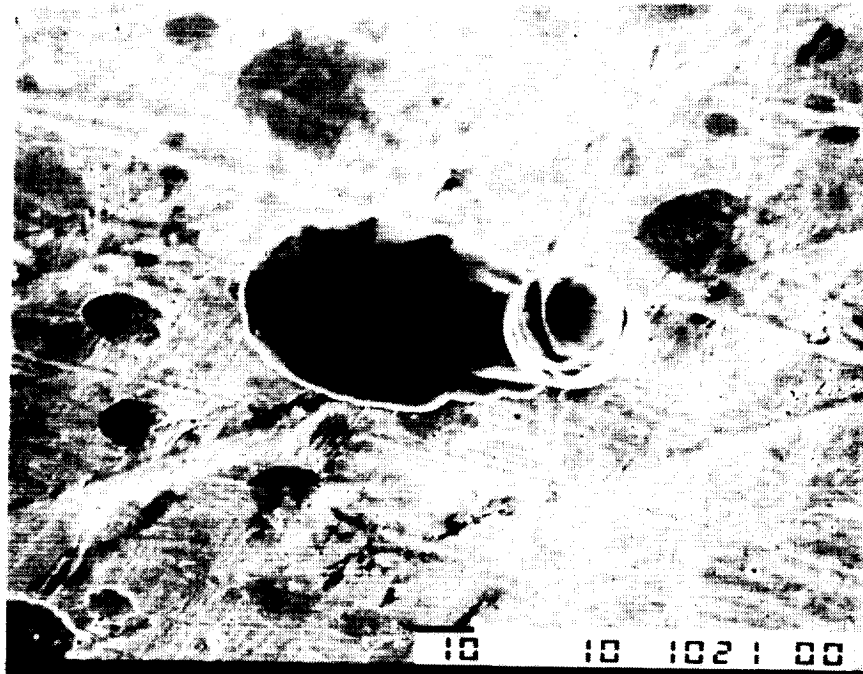
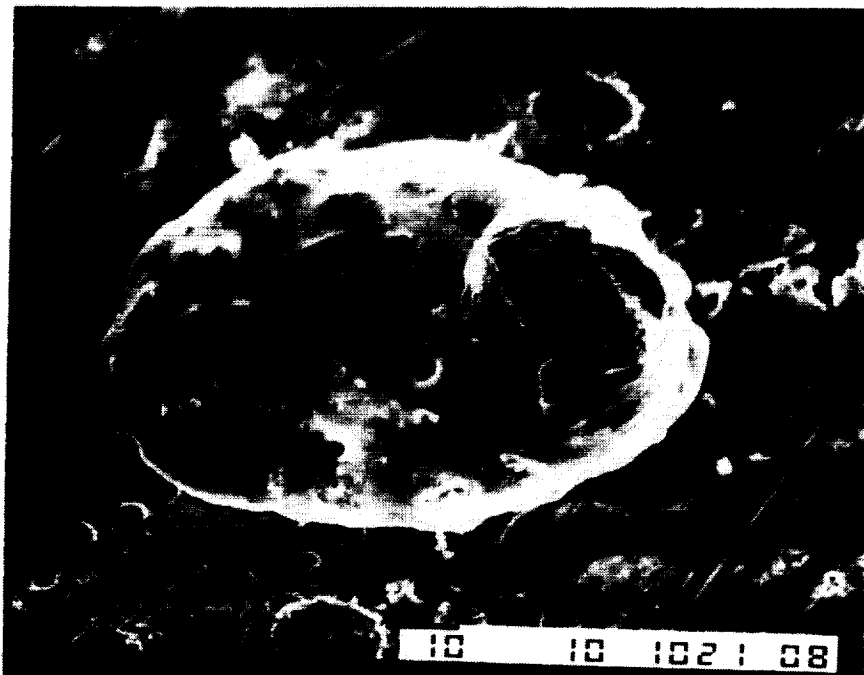
Fig. 16 Aluminum Ejecta Particles with Associated Splash Patterns

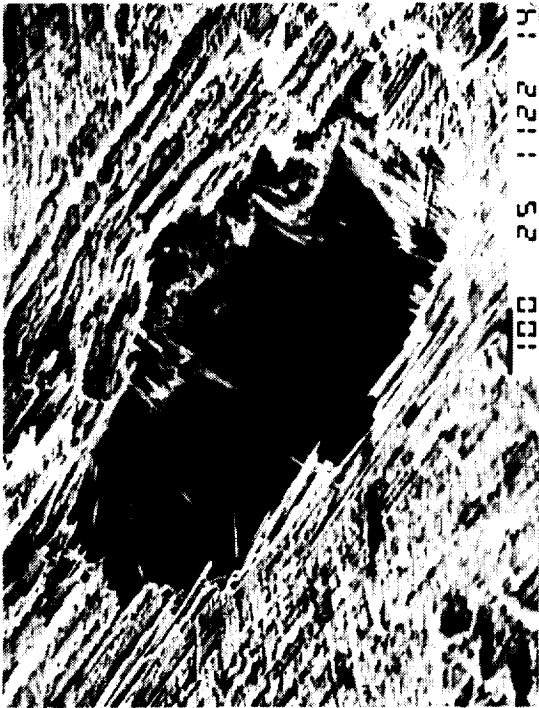
Impact Hole - Exposed Surface  
(x100)

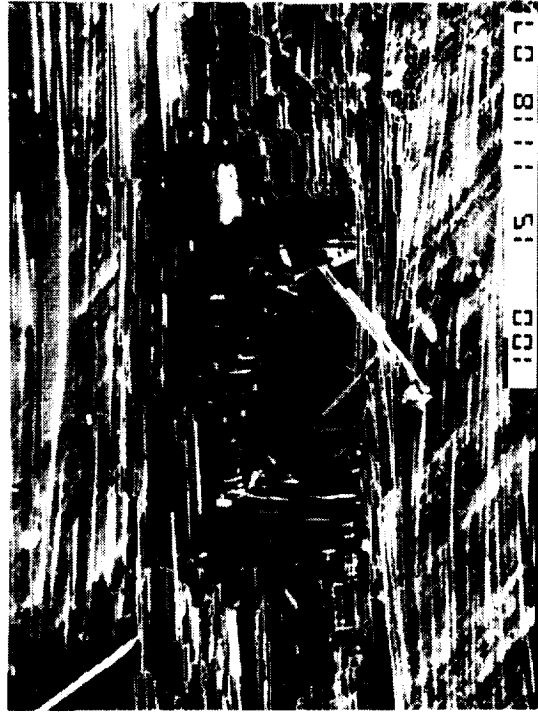
Exit Hole on  
Inside Tube Wall  
(x75)

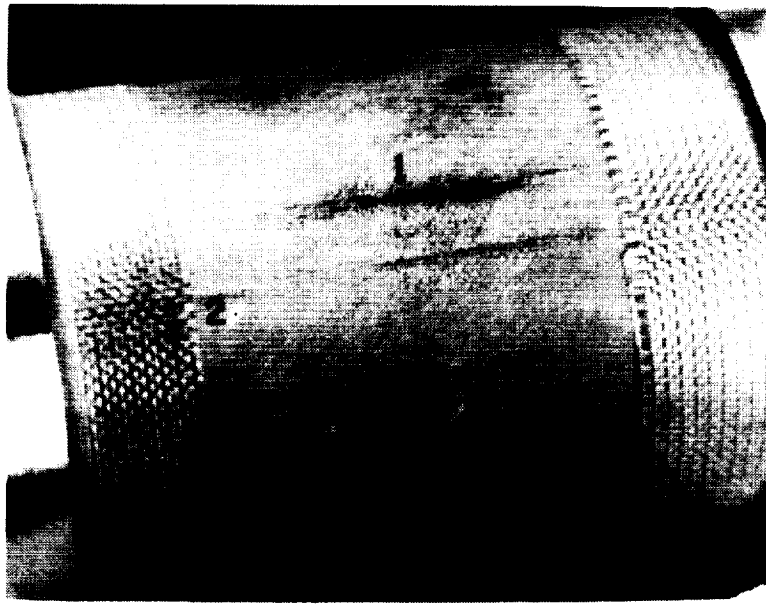
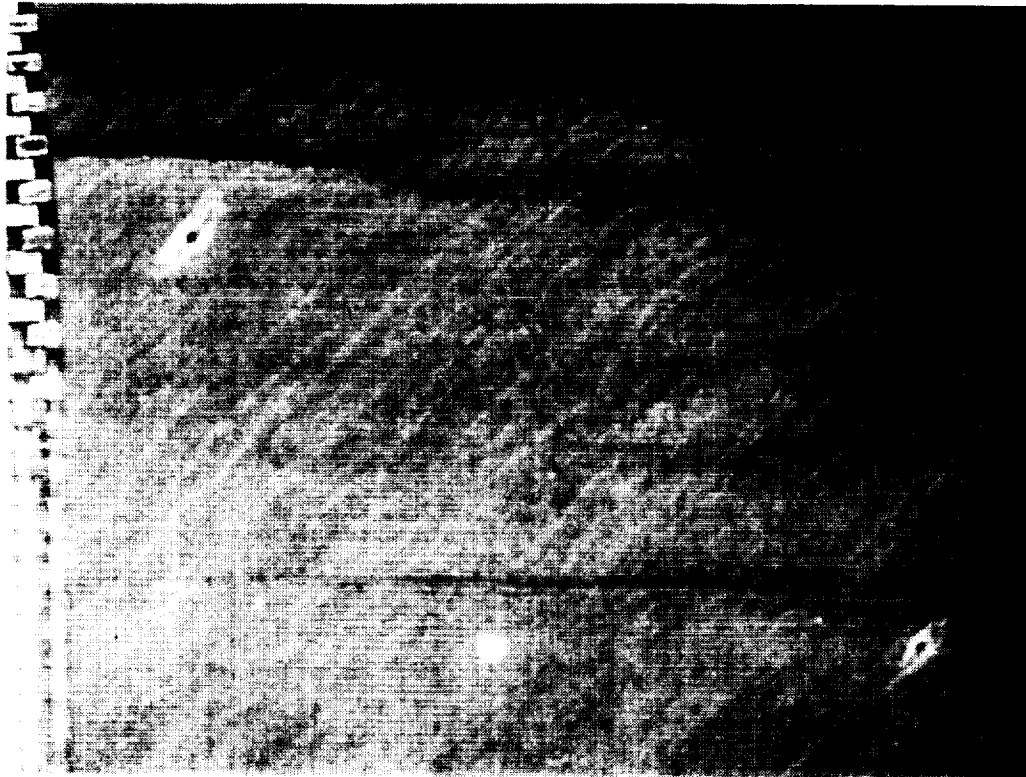
Fig. 18 Micrometeoroid/Debris Impacts on Kevlar®/Epoxy Tube [SP-328, ( $\pm 45^\circ$ )<sub>4S</sub>]

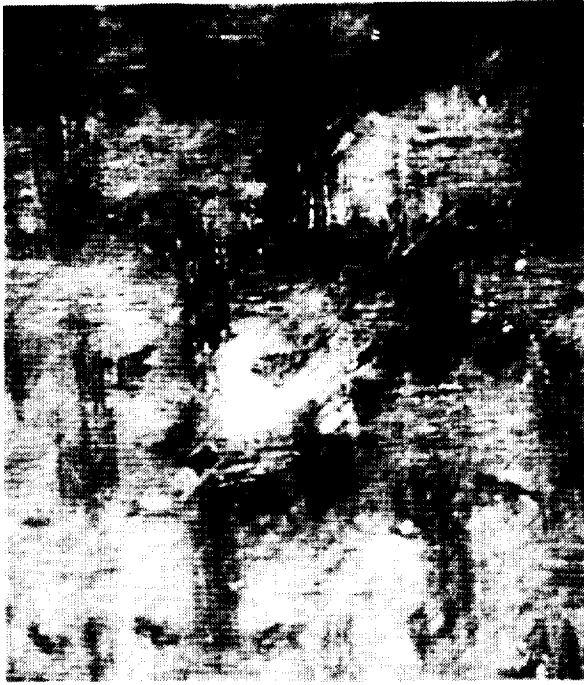
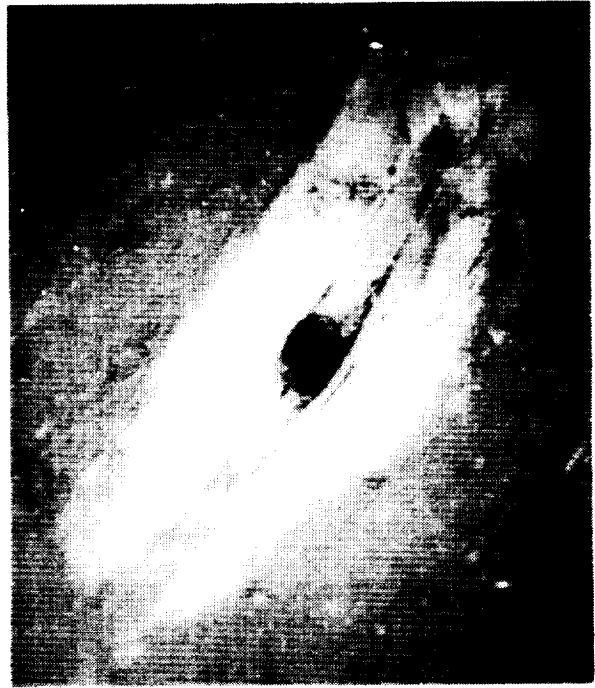
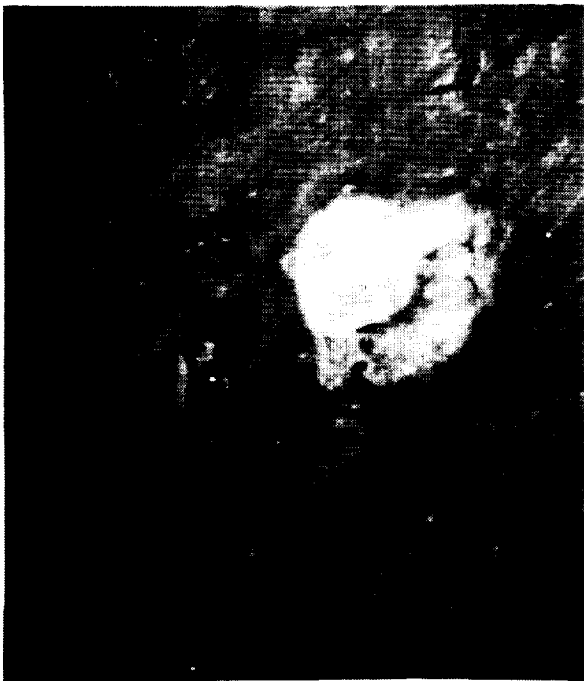
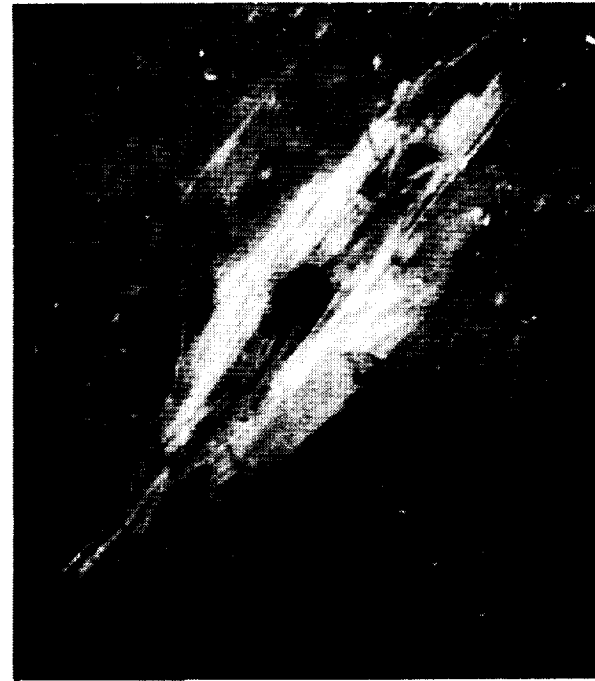
Fig. 19 Micrometeoroid/Debris Impact Damage (x100) on Kevlar®/Epoxy Tube [SP-328,  $(\pm 45^\circ)_{4S}$ ]

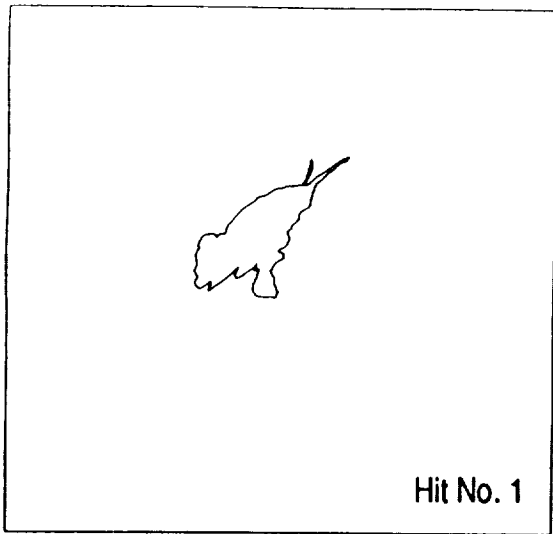
Hit No. 1

Surface Damage Area = 0.223 mm<sup>2</sup>  
 Extent of Penetration = 1 - 2 plies

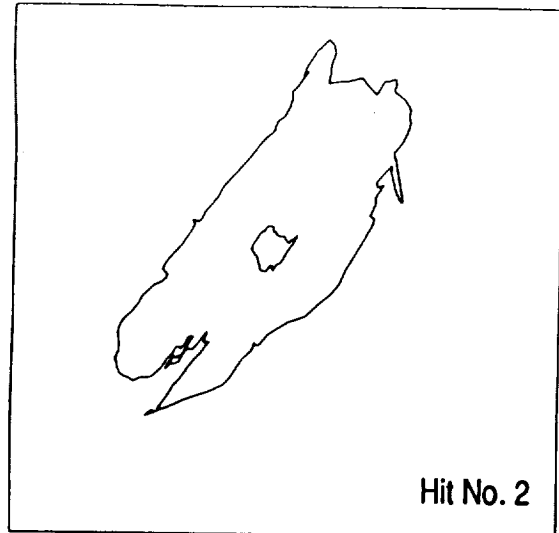
Hit No. 2

Surface Damage Area = 1.445 mm<sup>2</sup>  
 Crater Area = 0.033 mm<sup>2</sup>  
 Crater Diameter = 0.204 mm  
 Extent of Penetration = 2 - 3 plies

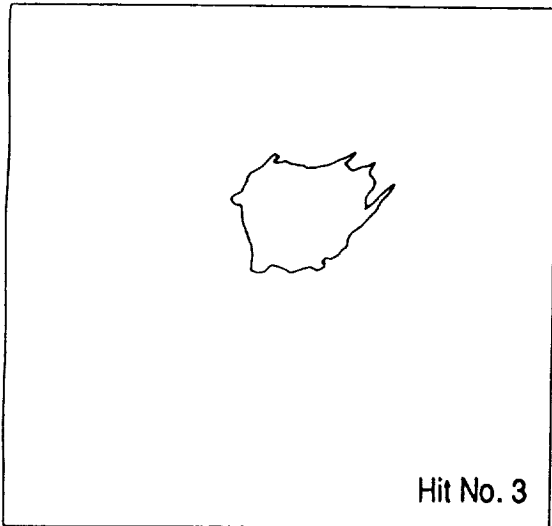
Hit No. 3

Surface Damage Area = 0.370 mm<sup>2</sup>  
 Extent of Penetration = 0 - 1 plies

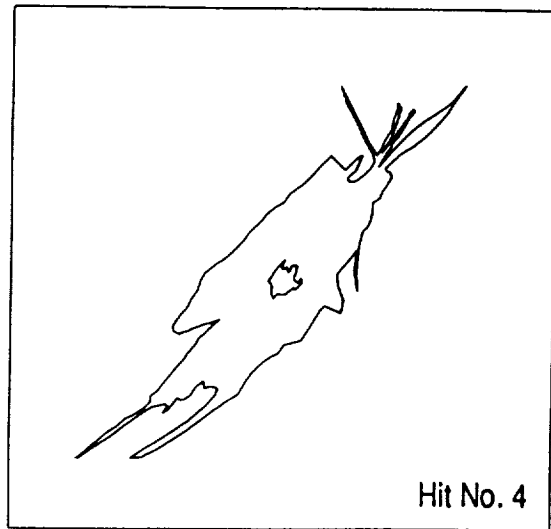
Hit No. 4

Surface Damage Area = 0.881 mm<sup>2</sup>  
 Crater Area = 0.020 mm<sup>2</sup>  
 Crater Diameter = 0.159 mm  
 Extent of Penetration = 2 - 3 plies
