NASA Technical Memorandum 4214

Cyclic Hot Firing of  
Tungsten-Wire-Reinforced,  
Copper-Lined Thrust Chambers

John M. Kazaroff and Robert S. Jankovsky

SEPTEMBER 1990

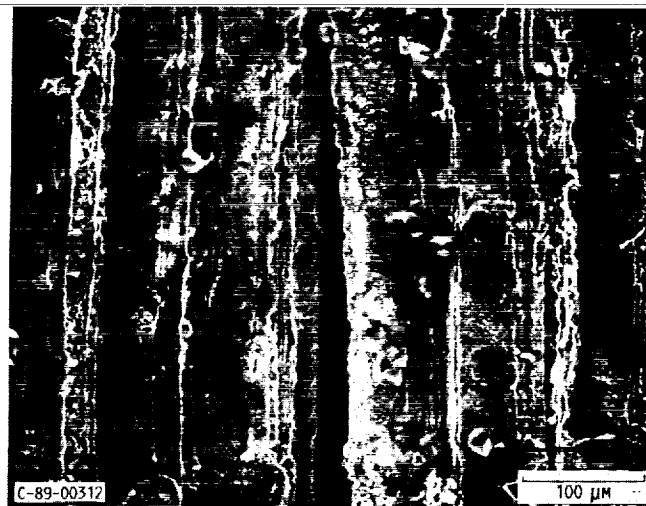
The results for each chamber, although similar, are discussed separately. Chamber 1, which was the first to be fabricated and tested, had the greatest number of thermocouples installed for a complete thermal mapping of the chamber hot-gas-side wall (eight evenly spaced thermocouples located in the throat plane, four located 1.49 cm (0.586 in.) upstream, and four located 1.27 cm (0.50 in.) downstream of the throat). The single failure in the chamber was located in the upstream thermocouple plane exactly between two thermocouples. This through-the-wall crack is shown in figure 8 from the inside chamber wall view.

Figure 8.—Inside chamber wall view of through-the-wall crack in chamber 1.

Also visible in figure 8 are the grooves caused by the final machining of the inside surface of the chamber. Both chambers had identical surface finishes. Figure 9 is an unetched cross-sectional view of these machining grooves. Although they are not considered a major factor, these grooves contributed to the early failures by acting as crack initiators.

1. Repeat testing should be at the same operating test conditions, with careful attention paid to controlling these conditions for the necessary life comparisons.
2. In order to help control conditions, the channels should be made identical, and the cover, or closeout, structure should be uniformly applied so that channel height does not vary.
3. Thermocouple holes should either not be used or be moved back away from the liner material to eliminate them as possible early failure sites.
4. The tungsten reinforcing wires should be cleaned and precoated in order to enhance bonding with the copper alloy. Coatings such as plated silver or copper could be used to protect the surface of the tungsten wire during processing and would readily diffuse when HIPed.
5. Before testing, the liner should be polished to remove all machining marks.

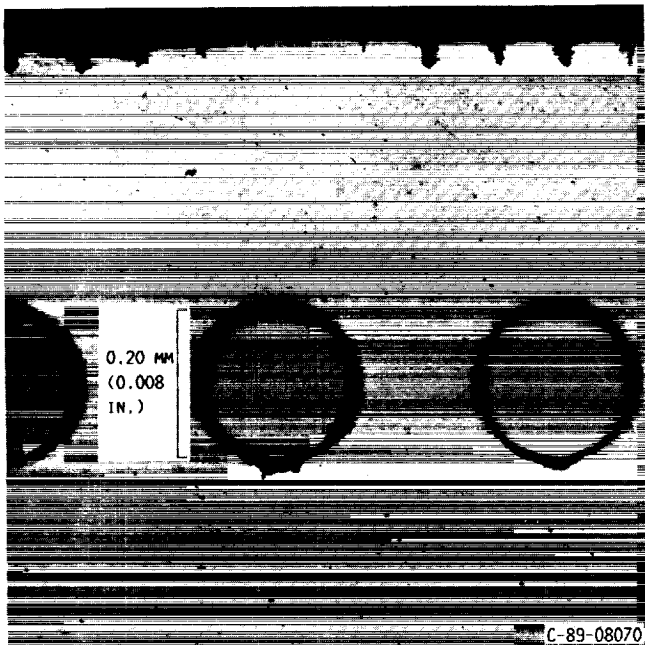
Figure 9.—Unetched cross-sectional view of machining grooves.

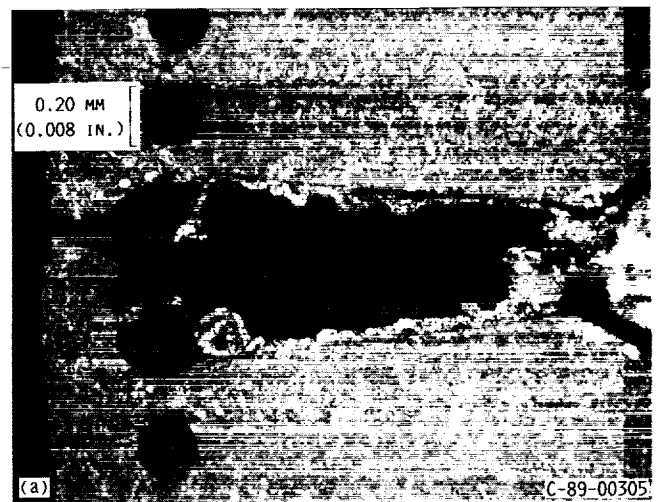
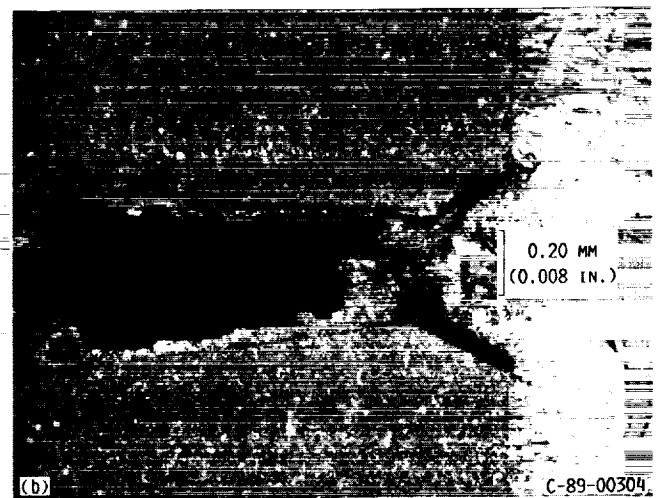
Figure 10(a), which shows the through-the-wall crack, also reveals that the tungsten wires were distorted and damaged at this location and that a large void was exposed above the damaged region. When the specimen was etched to reveal the grain structure and reexamined, electroplated material was found in the void area (figs. 10(a) and (b)). Since the void was so large and the wires were damaged, the drawings and the fabrication process were reviewed. It was discovered that a thermocouple hole was inadvertently drilled in the wrong location. Figure 10 shows that copper was deposited in the exposed hole and sealed up during final electroform closeout. When the thermocouple hole was drilled, the depth was beyond the 0.889-mm (0.035-in.) limit from the hot-gas-side wall, and the drill penetrated into the liner and the reinforcing wires, causing distortion and damage to the wires and leaving a wall thickness of only 0.381 mm (0.015 in.) instead of the 0.889 mm (0.035 in.) required. This damaged, thinner section was determined to be the crack initiation site. With each test cycle, the crack continued to spread in both directions, following a circumferential machining groove until it reached a channel where it fractured and caused hydrogen to leak into the chamber. This explains the early failure of this chamber, especially in a cooler region than the throat area, where failure was not expected. Once this was discovered the failure analysis of chamber 2 was begun.

(a) Showing wire damage and large void.  
(b) Showing copper deposited in thermocouple hole.  
Figure 10.—Cross-sectional views of crack in chamber 1.

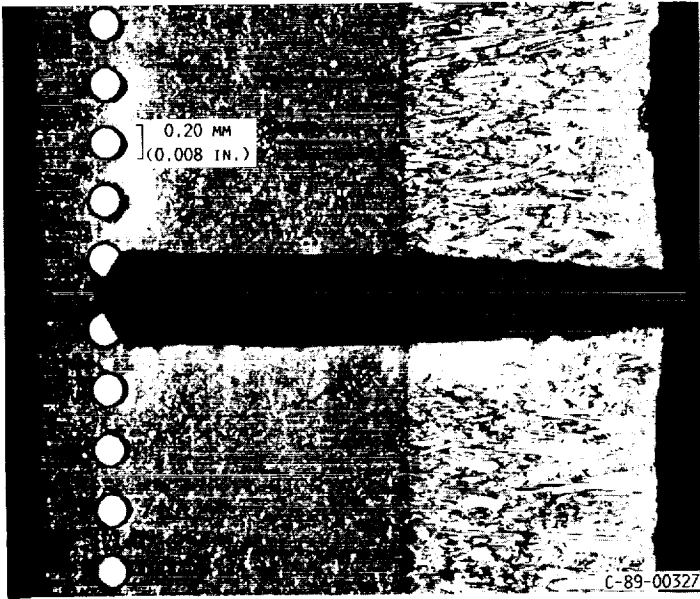
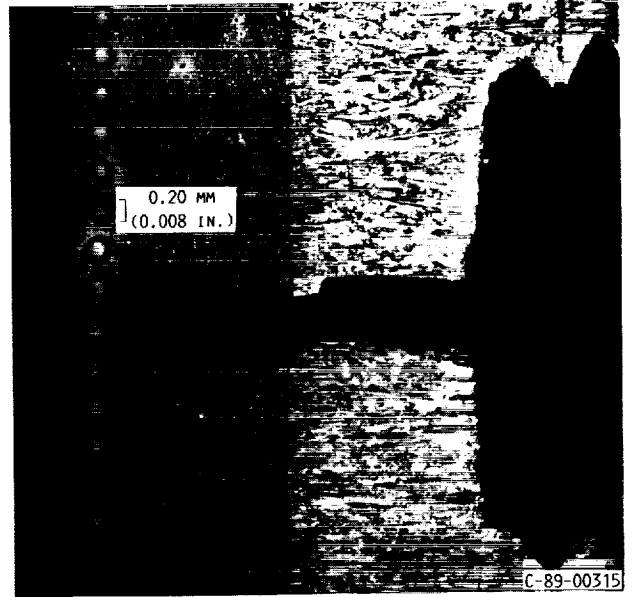
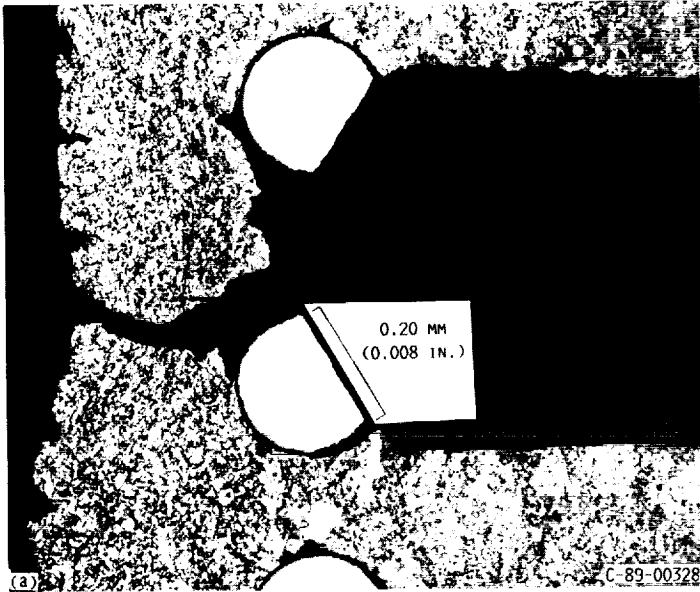
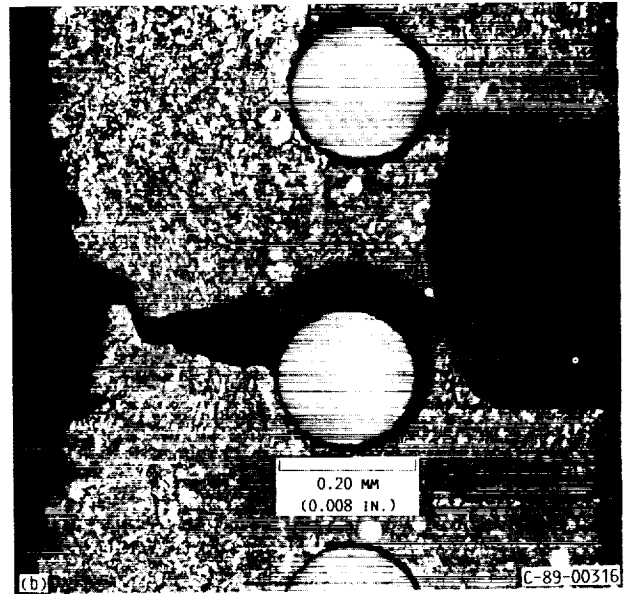
There were three crack locations on chamber 2, all in the throat plane. These cracks, designated here as cracks A, B, and C, are shown in figure 11. Sectioning and polishing revealed that all three crack sites were associated with a thermocouple hole. In all cases the holes were drilled to a depth greater than required and were the cause of early failure. Figure 12 shows cross-sectional views of cracks A and B. The views shown for crack C in figures 13 and 14 are different because this specimen was polished from the back side toward the wires rather than cross sectionally. Figure 13 shows the thermocouple hole and the crack leading from it in an area above the reinforcing wires, and figure 14 shows the damaged area after it had been polished further to expose the wires. There is no question that the cause of these failures was thermocouple hole penetration into the composite liner material.

Figure 12.—Cross-sectional views of cracks A and B.

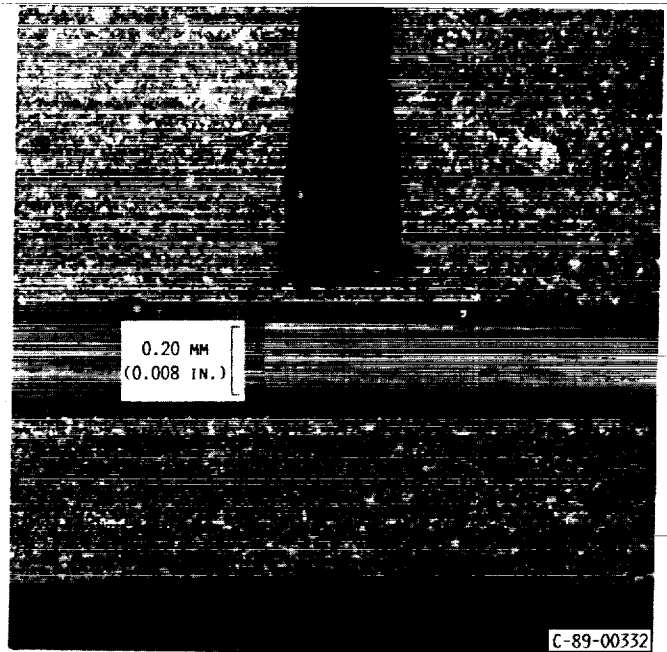
Figure 15.—Chamber 1 specimen from nonfailed thermocouple location.

Since a number of specimens were available, a sample from chamber 1 was prepared at a nonfailed thermocouple location (fig. 15). Here again the thermocouple hole was deeper than required, but since this location was not in the hotter throat plane, there was less thermal strain. Figure 15 also shows that

the copper was not bonded to the tungsten wire, possibly indicating a limited amount of load sharing. This lack of bonding can be seen again in figure 16, cross-sectional views of a series of wires. The specimen shown in figure 16 was also taken from chamber 1 in a region remote from the throat area.

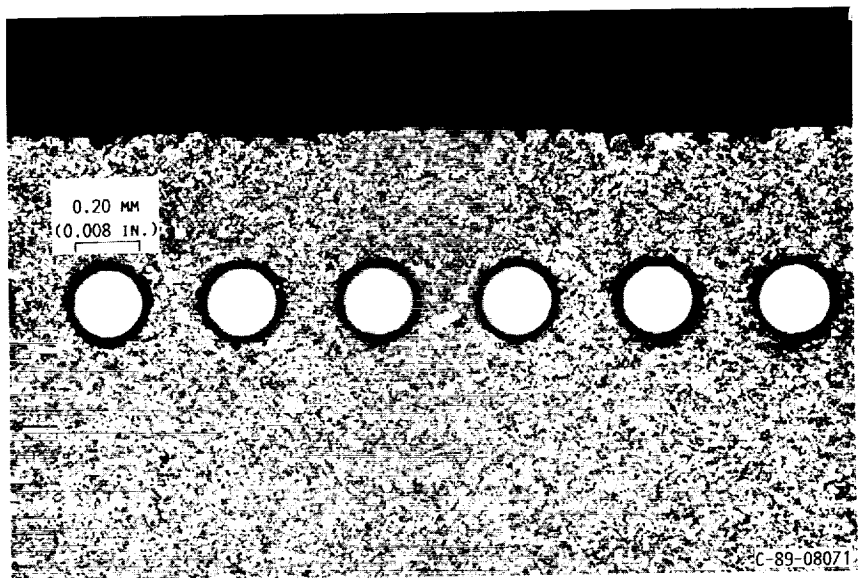
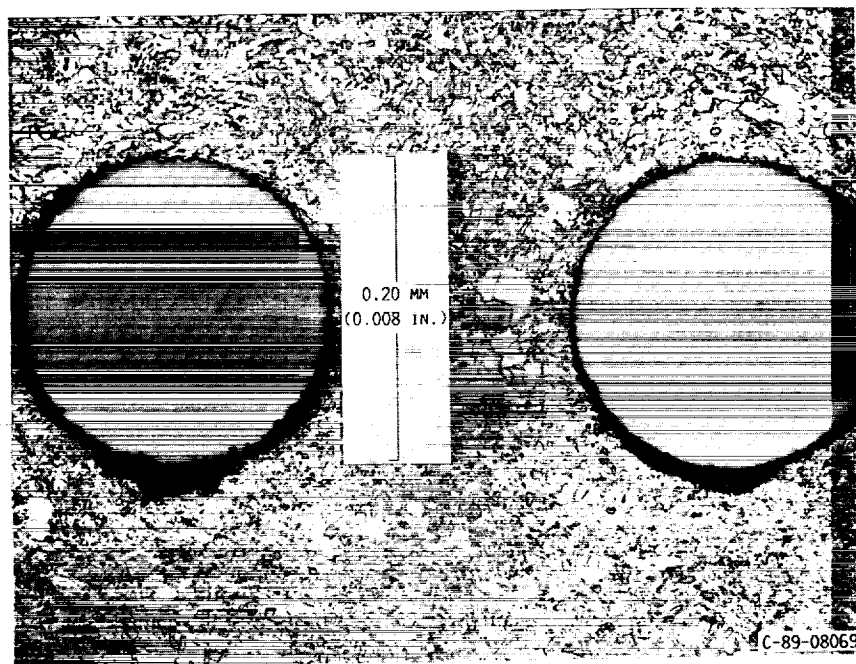
Figure 16.—Cross-sectional views of chamber 1 showing lack of bonding between tungsten wires and copper alloy.
