MOLECULAR FILMS ASSOCIATED WITH LDEF*

E. R. Crutcher and K. J. Warner
Boeing Defense and Space Group
Seattle, WA 98124-2499
Phone: 206/773-7002, Fax: 206/773-1473

SUMMARY

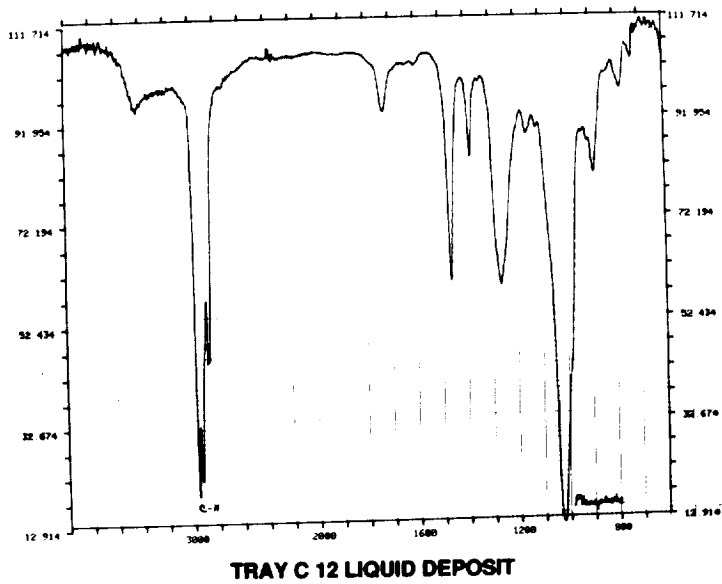
Tray C-12 was a special case. When LDEF was first rotated in SAEF-2 a liquid began running from this tray. The spectrum of the liquid (Figure 7) essentially matched that of the triocyl phosphate used as a fire retardant material in the plastic insulation around the fiber optic bundles on that tray (Figure 6). The brown film around tray C-12 contained very little silicones as is indicated by the absence of the peak near 800 wave numbers in this spectrum (Figure 8).

Figure 7: Tray C-12, liquid collected on glass fiber paper during deintegration.

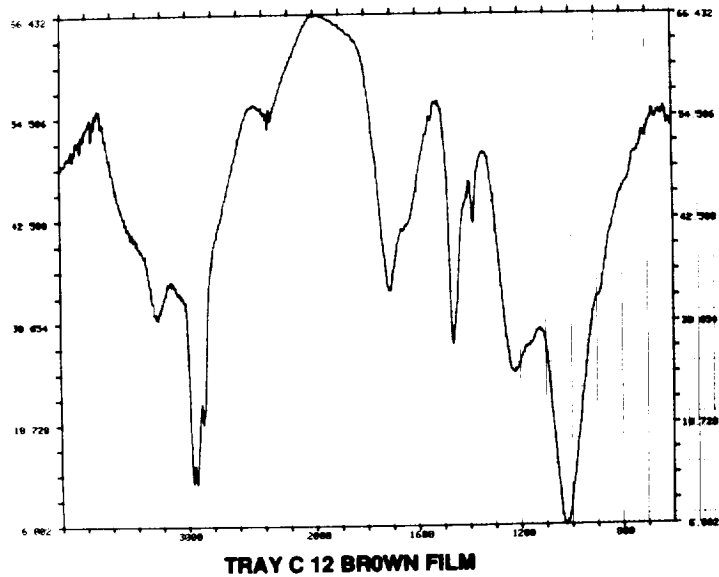
Figure 8: Tray C-12, brown film from corner vent.

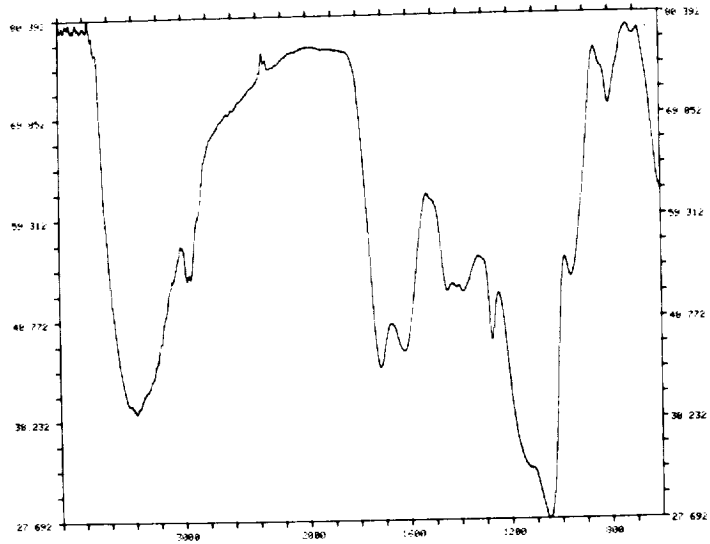
TRAY E 06 CORNER VENT FACING RAM DIRECTION

The thickest brown films always formed on vents from the interior on the side facing into the ram direction. Figure 15 is an example from tray F-06. Notice that this spectrum is very similar to that in Figures 1 and 2. A yellow deposit on the front of tray E-02, clamp 6 had a pattern that was quite different than the typical brown film (Figure 16). No precursor of this deposit has been found at this time.

Figure 15: Tray F-06, corner vent deposit facing ram exposure.

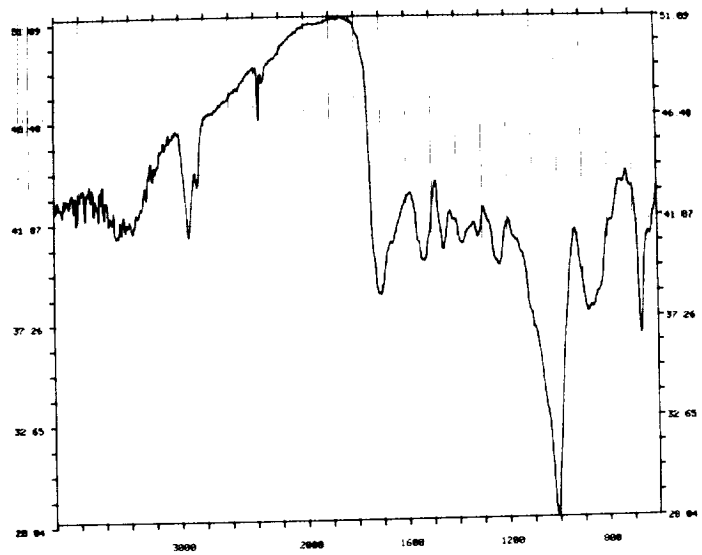
TRAY CLAMP E 02 6 YELLOW DEPOSIT ON FRONT SURFACE

Figure 16: Tray E-02, clamp 3, yellow deposit.

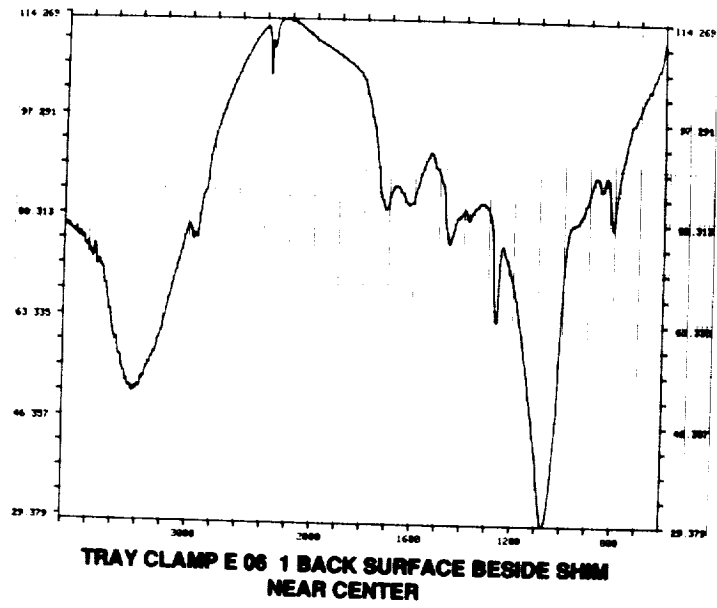
The backs of the tray clamps and shims were examined to evaluate the types of molecular film contaminants that were launched with LDEF. The material on the back surface of tray E-06, clamp 1 had a large silicone component (Figure 17). Closer to the edge of the clamp the hydrocarbon component increased (Figure 18) until at the edge of the clamp the pattern had become very similar to the typical brown film pattern (Figure 19).

Figure 17: Tray E-06, clamp 1, deposit between clamp and shim at center.

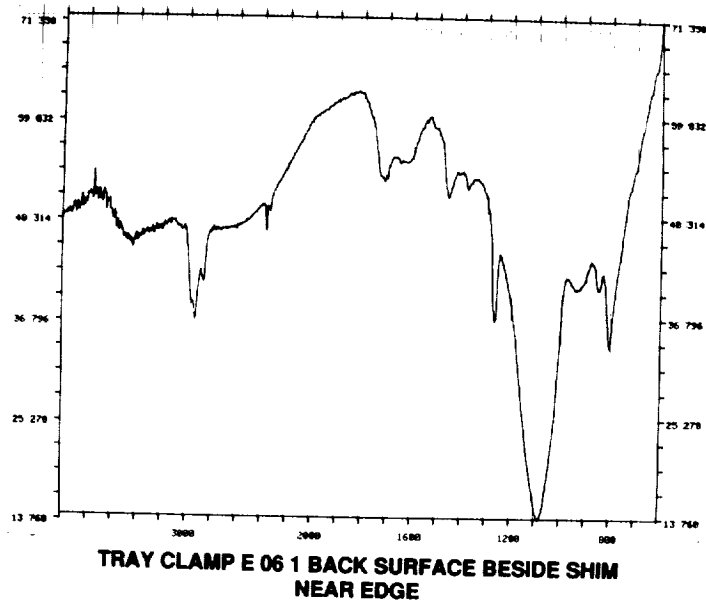
Figure 18: Tray E-06, clamp 1, deposit between clamp and shim near edge of clamp.

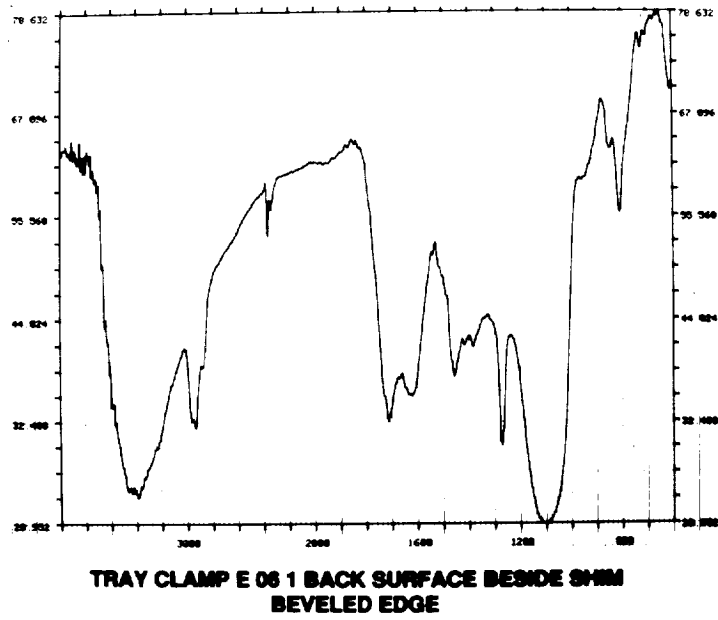
Figure 19: Tray E-06, clamp 1, deposit on beveled edge of clamp.

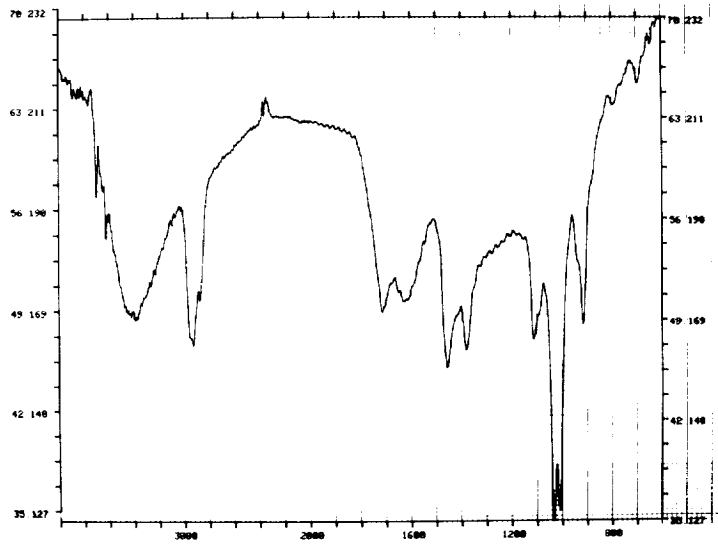
Another interesting spectrum was shown by brown spots found on a number of surfaces (Figure 20). These brown spots were often associated with a variety of particulate matter, paint spheres, wear metals, fibers, and other debris (Photograph 5) and a significant concentration of sodium chloride, potassium chloride, and other water soluble salts. These materials were also found on leading edge trays indicating they were not present during the nearly six years LDEF was in orbit. These may be the residue of waste dumps made after the retrieval of LDEF by the shuttle.

Figure 20: Tray F-09, clamp 8, brown spot.

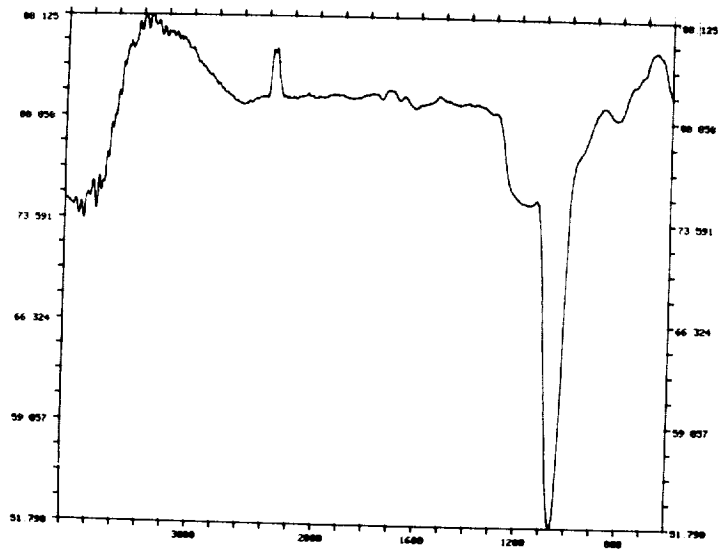
On the leading edge trays there was often little evidence of deposition by discoloration. Elemental analysis of the surface in many areas did indicate silicate films, presumably the remnant of the hydrocarbon/silicone film after reacting with atomic oxygen. Figure 21 is the infrared spectrum of one of these films on clamp 4 of tray F-09. Figure 22 shows the elemental mapping of this "shadow" seen next to bolt A of clamp 4 on tray F-09. The aluminum map shows the bare aluminum exposed under the washer and the aluminum in the anodized surface of the clamp. The oxygen map illustrates the distribution of oxides. In the area of the weaker aluminum signal the silicon map illustrates a concentration of silicon. This is a silicon dioxide film over the anodized aluminum. Photograph 8 shows the LDEF structure with the trays removed and a slight discoloration in the exposed area of the structure associated with the presence of the silica film compared to the areas covered by the tray edges and tray clamps. This is in contrast to the obvious dark film seen on the trailing structure clearly delineating the position of the tray edges and clamps (Photograph 9).

Figure 21: Tray F-09, clamp 4, surface with change in interference color.

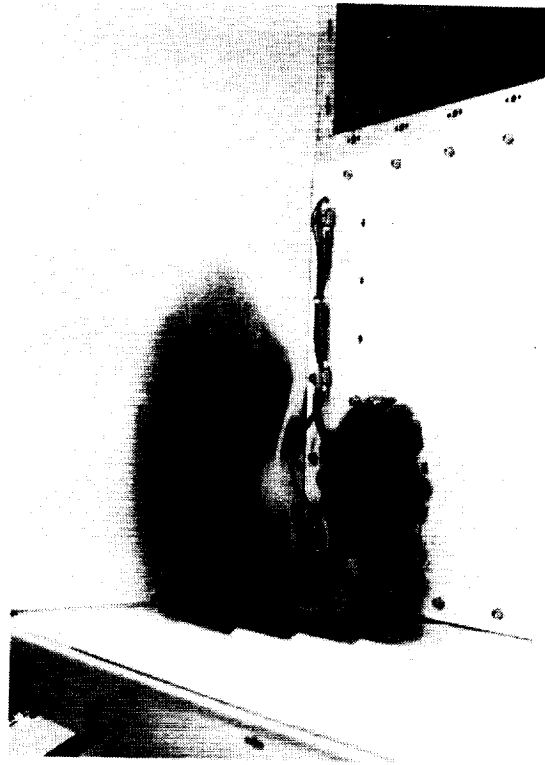
Photograph 1: Tray H-06, brown deposit in AO exposed corner.
(See color photograph, p.599.)

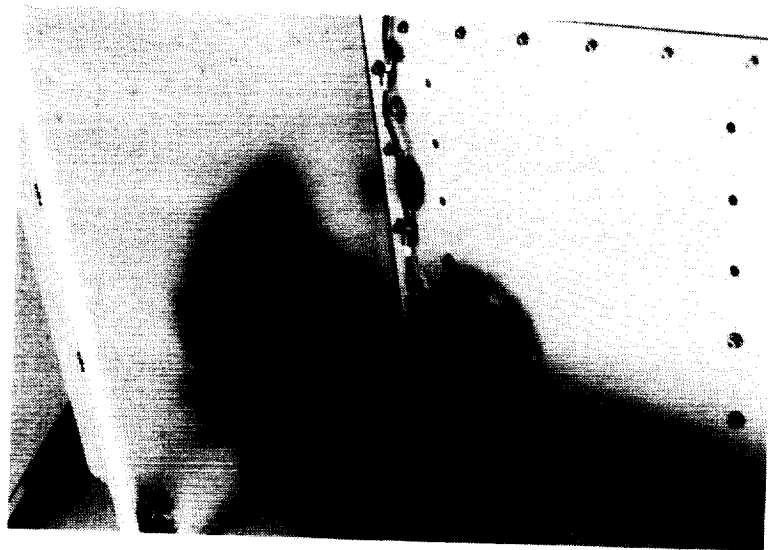
Photograph 2: Tray H-06, brown deposit and tie wrap deposit in other corner.
(See color photograph, p. 599.)

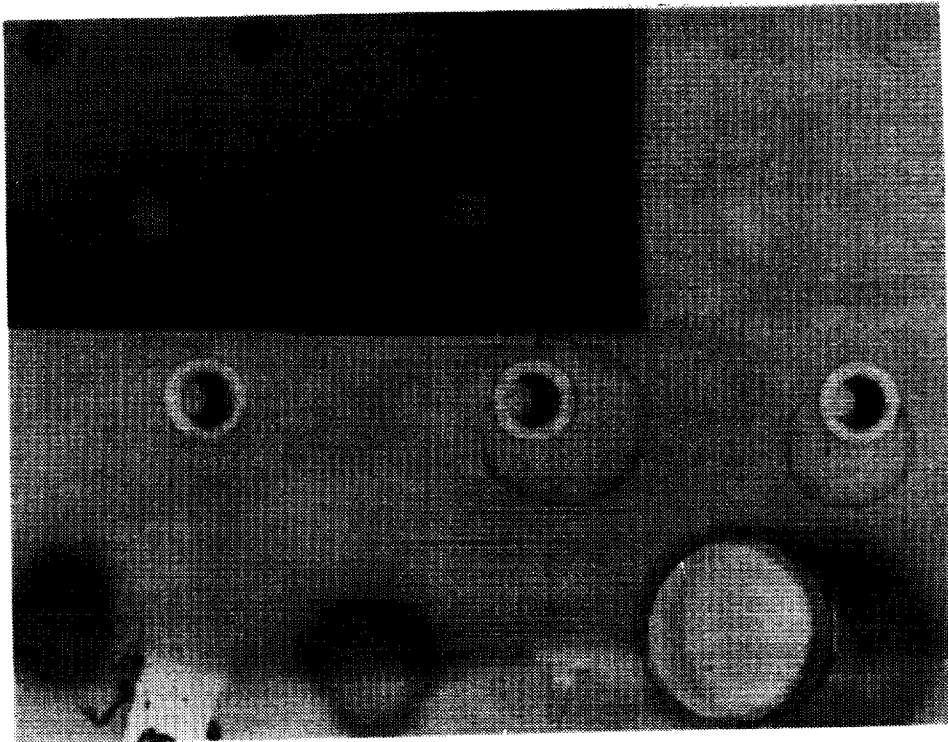
Photograph 3: Tray H-06, visible and UV illumination view of the tie wrap deposit.

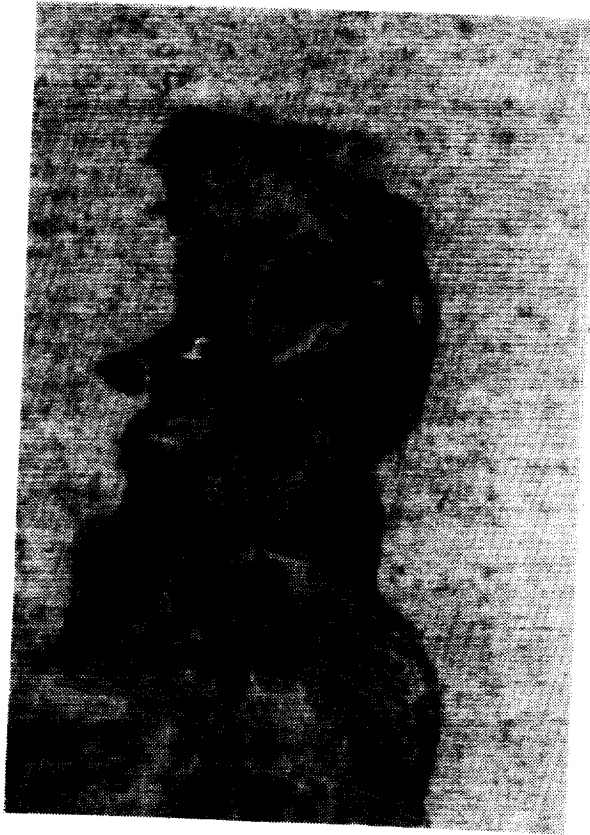
Photograph 5: Tray F-02, clamp 6, brown droplet deposit.

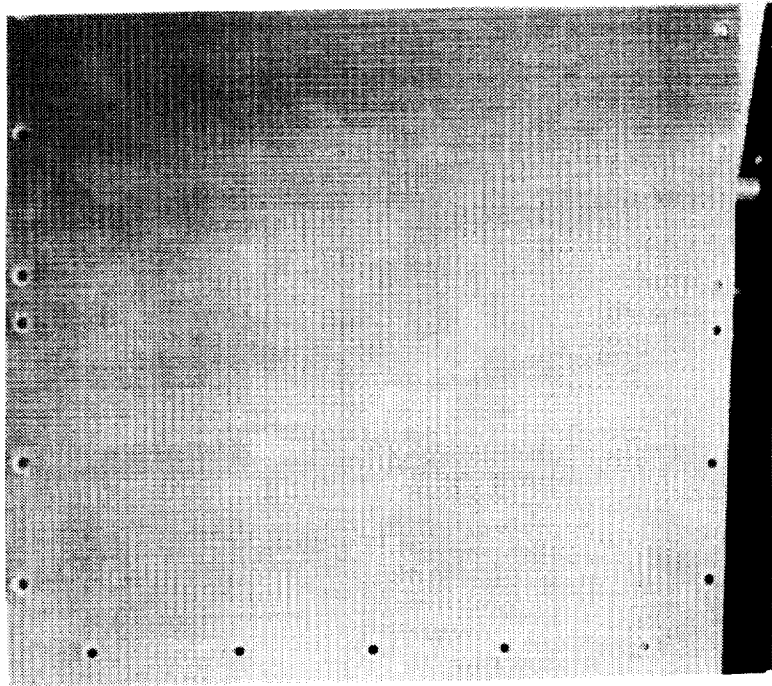
Photograph 6 shows a handprint in the bottom of tray F-06. The handprint is lighter than the surrounding area indicating the print acted as an ultraviolet light filter or as a sacrificial surface layer reducing the effect on the paint vehicle underneath or it represented an area of positive pressure preventing the deposition of brown molecular film. Fingerprints in other areas were seen to become dark brown or black but this was always on metal surfaces rather than paint. Similar "lightening" effects were seen on other trays such as the pre-flight scuff patterns seen in the brown deposits in Photographs 1 and 2.

Photograph 6: Tray F-06, handprint on bottom panel.

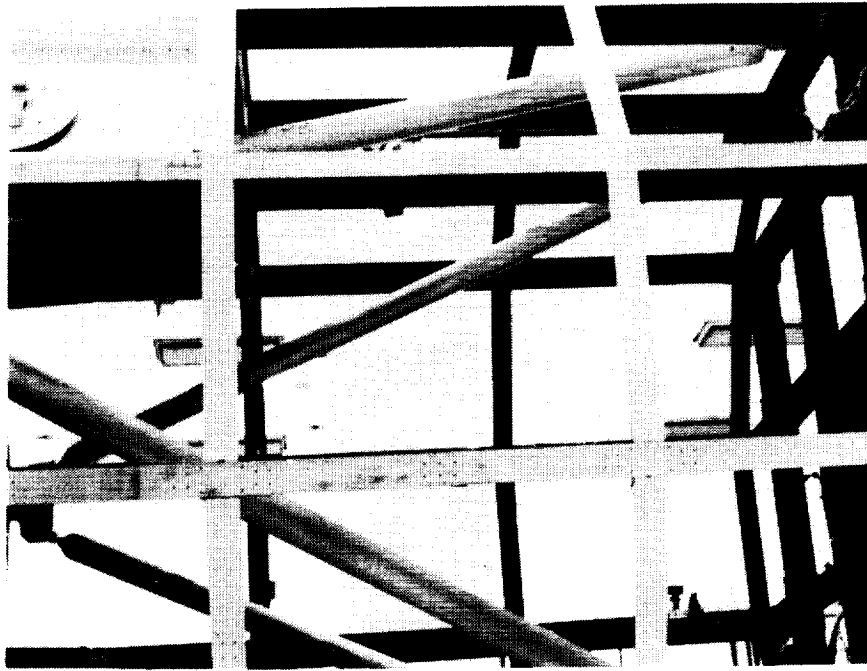
LDEF Leading edge (ram direction)

Photograph 8: Leading edge view of LDEF structure.

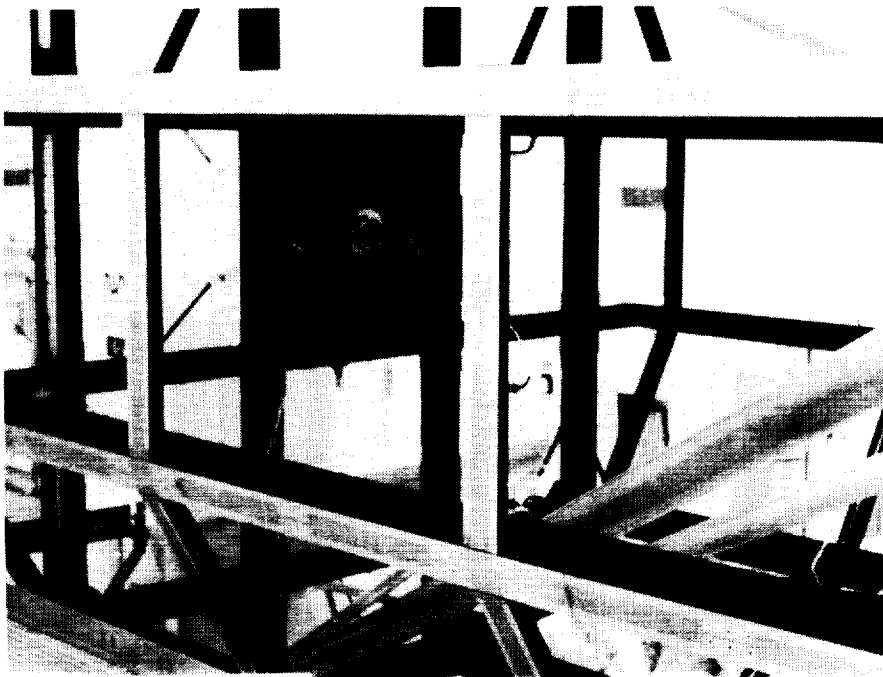
NVR stain LDEF trailing edge Earth end

Photograph 9: Trailing edge view of LDEF structure.
