TWR-17548 Volume II

FLIGHT SET 360L009 (STS-36)  
 CASE AND SEALS COMPONENT FINAL REPORT

NOVEMBER 1990

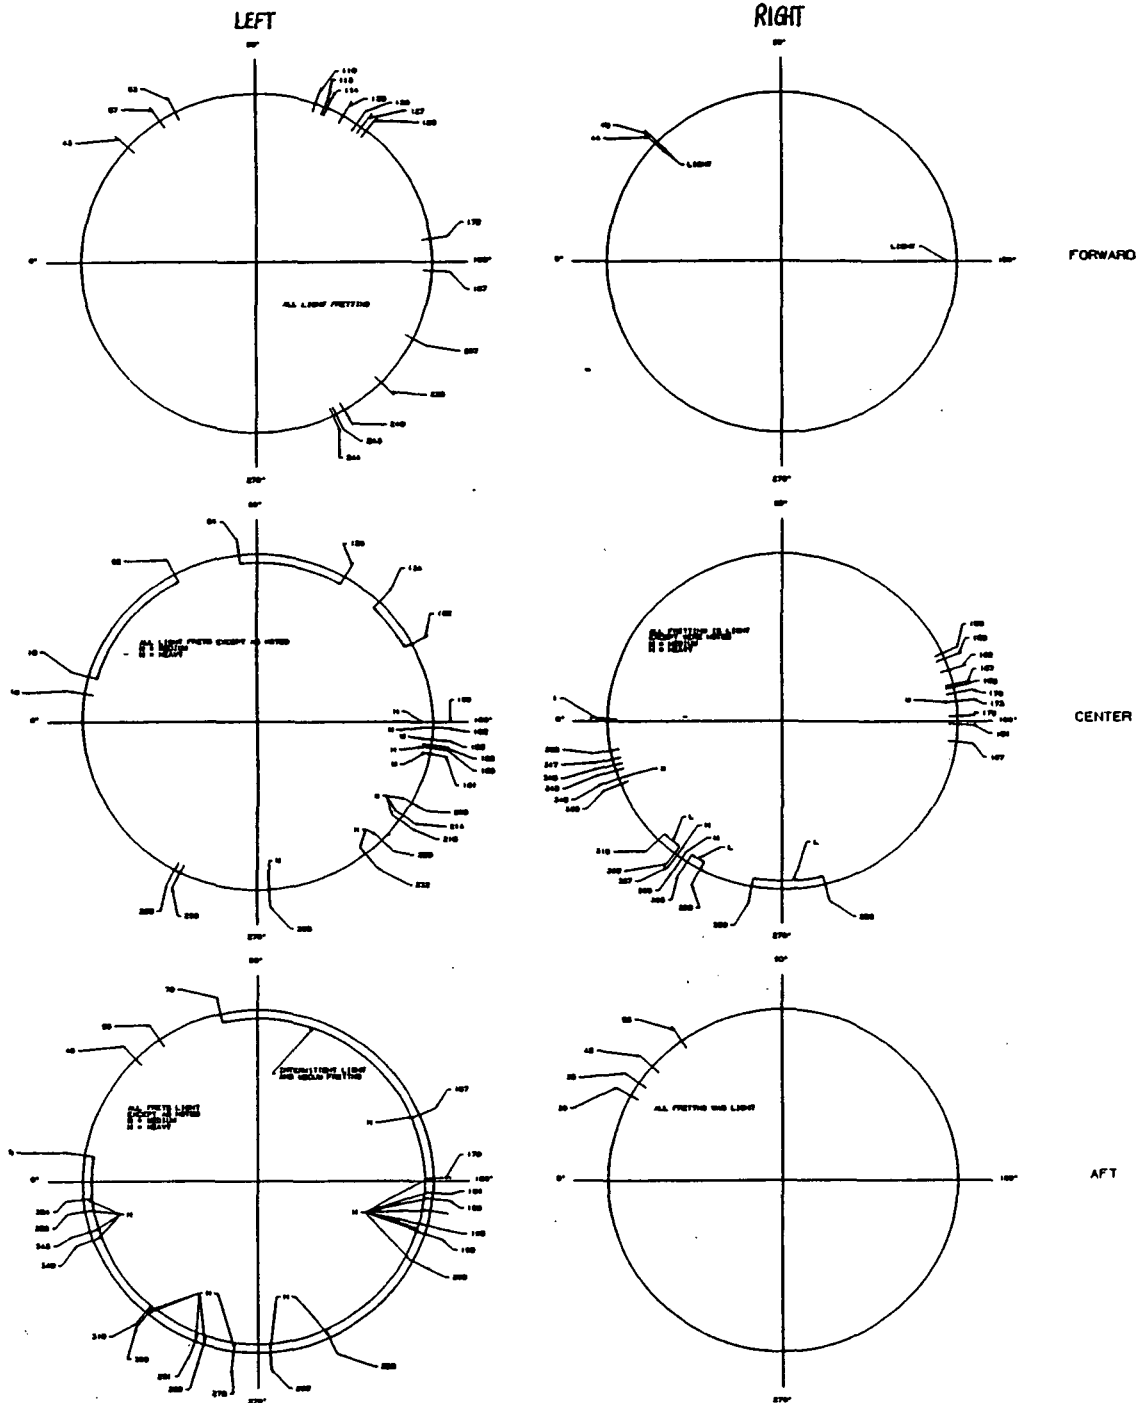
Figure 5 Field Joint Fretting Summary

- LH/CTR Intermittent light fretting around most of the joint with concentrations of moderate (0.003 to 0.005 inch deep) and heavy (>0.005 inch deep) fretting between 180 and 300 degrees. A 0.008 inch deep fret was found at 225 degrees.
- LH/AFT Intermittent light fretting around most of the joint with concentrations of moderate (0.003 to 0.005 inch deep) and heavy (>0.005 inch deep) fretting from 135 through 0 to 9 degrees. Two 0.009 inch deep frets were found at 195, and 350 degrees and a 0.011 inch deep fret at 278 degrees.
- RH/FWD Light frets at 44 and 45 degrees and a 0.004 inch deep fret at 180 degrees.
- RH/CTR Light fretting from 156 to 187, 256 to 280, 298 to 315, and 338 through 0 to 1 degrees. Moderate (0.003 to 0.005 inch deep) fretting at 118, 305, and 340 degrees. A 0.009 inch deep fret was found at 350 degrees.
- RH/AFT Light fretting at 30, 35, 42, and 55 degrees.

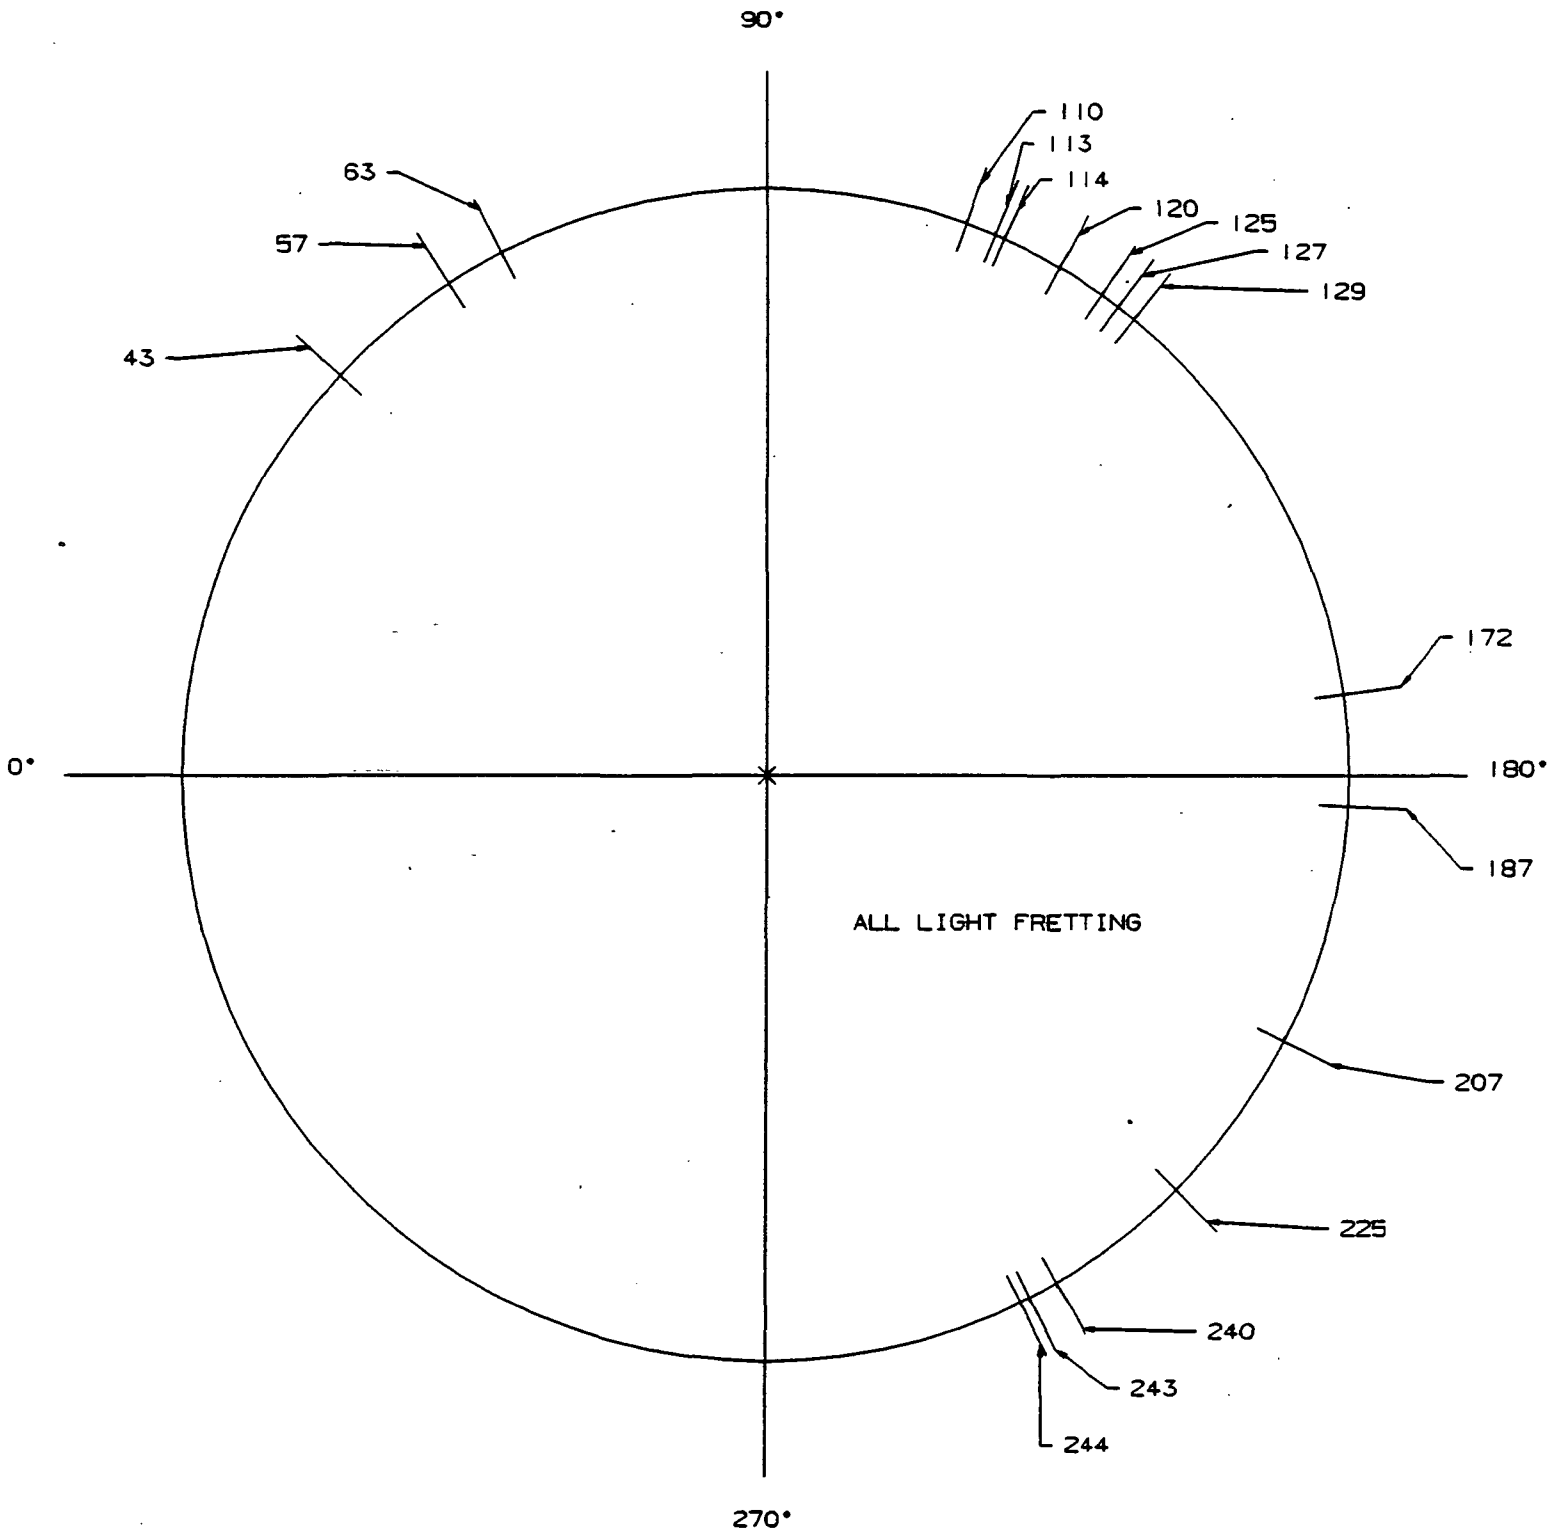
Figure 7 LH Forward Field Joint Fretting

Assessment of the metal components found light fretting at 43, 57, 62, 110 to 129, 172, 187, 207, 243, and 244 degrees. No medium

or heavy fretting was found. Figure 7 gives a detailed view of the fretting.

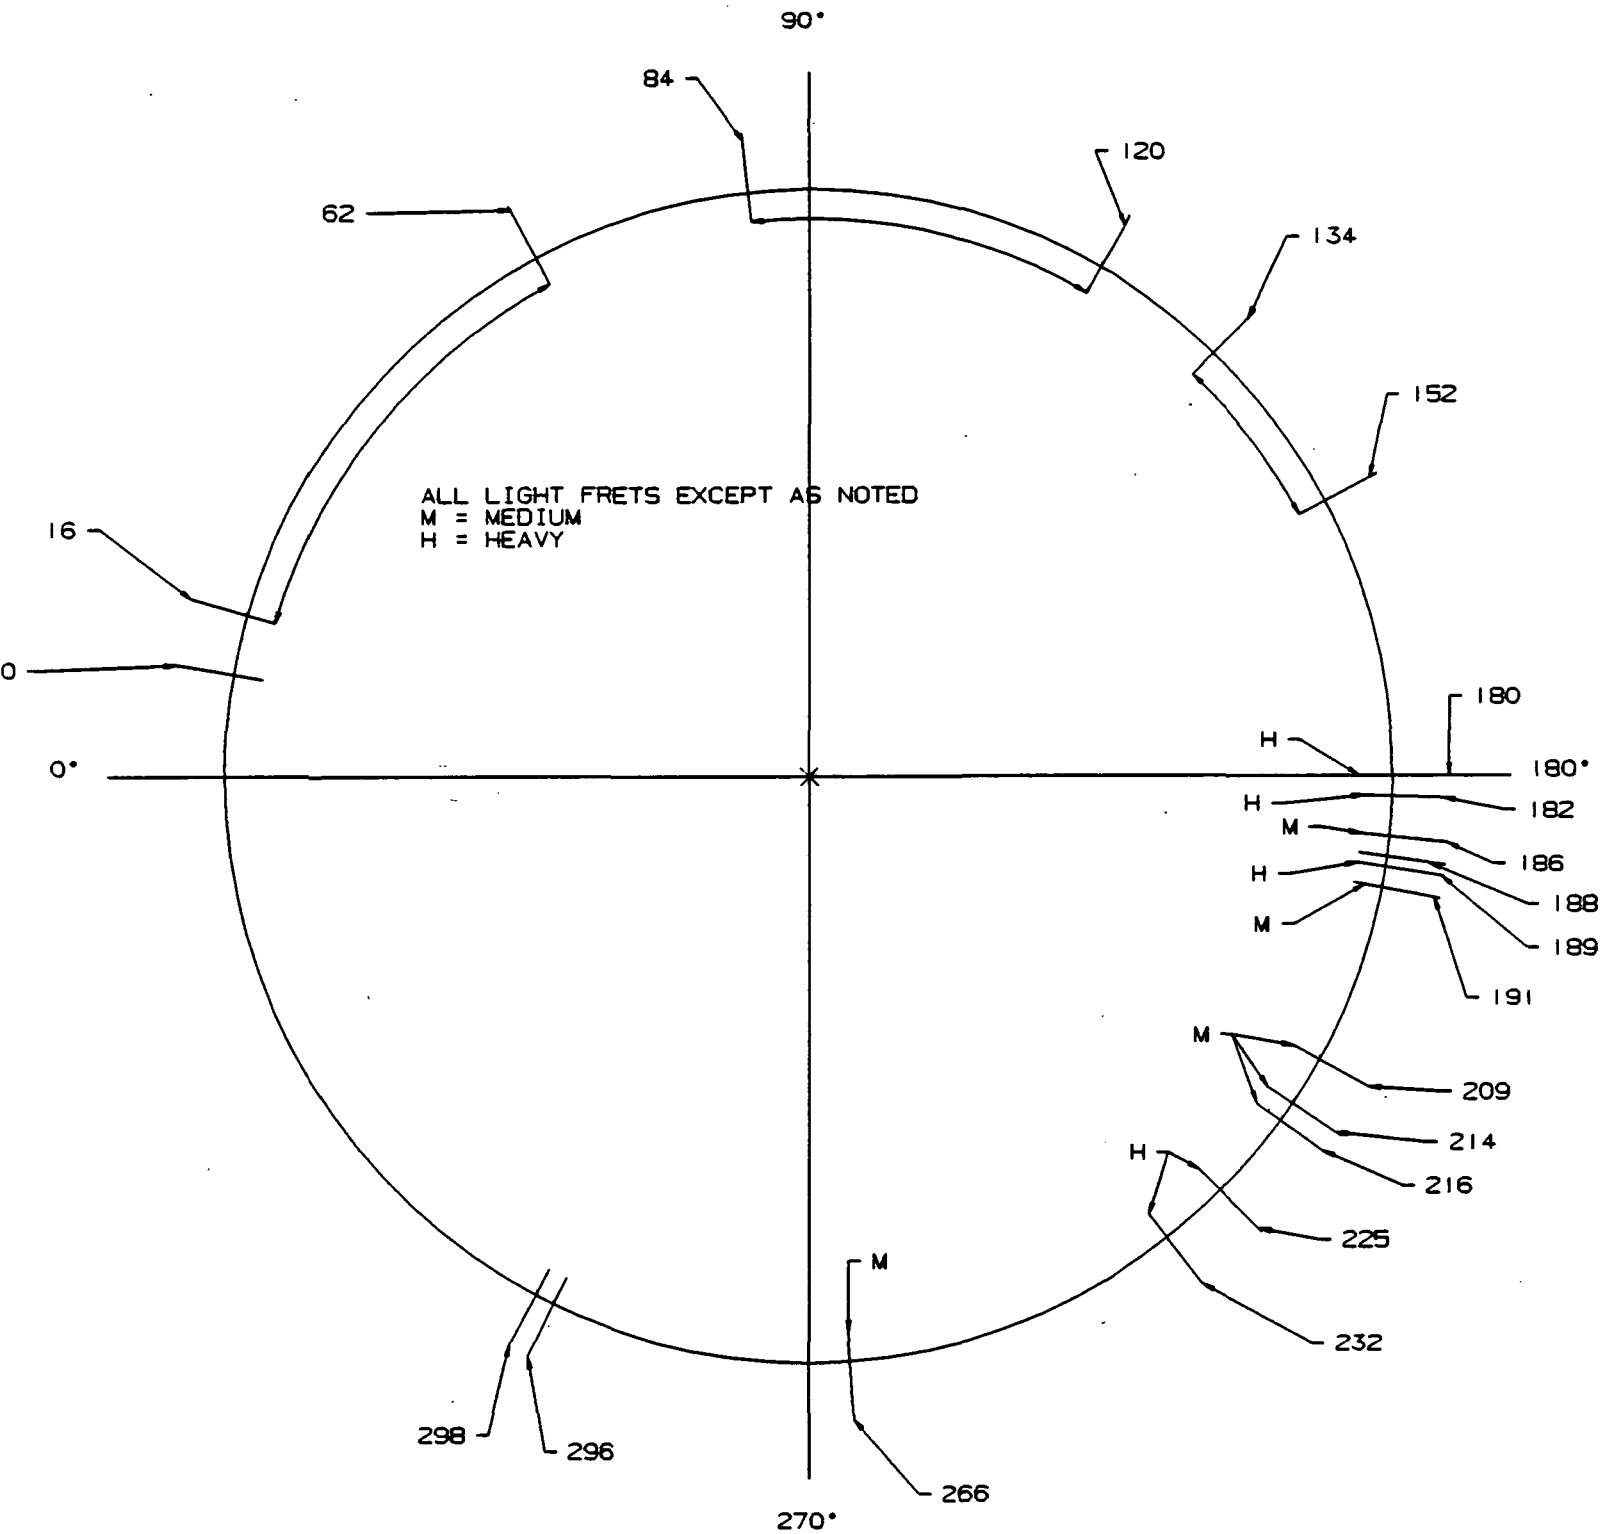
Figure 8 LH Center Field Joint Fretting

Assessment of the metal components found intermittent light fretting from 10 to 300 degrees. Concentrations of medium and heavy fretting were found from 180 to 300 degrees. One 0.008 inch deep fret was located at 225 degrees. Figure 8 gives a detailed view of the fretting.

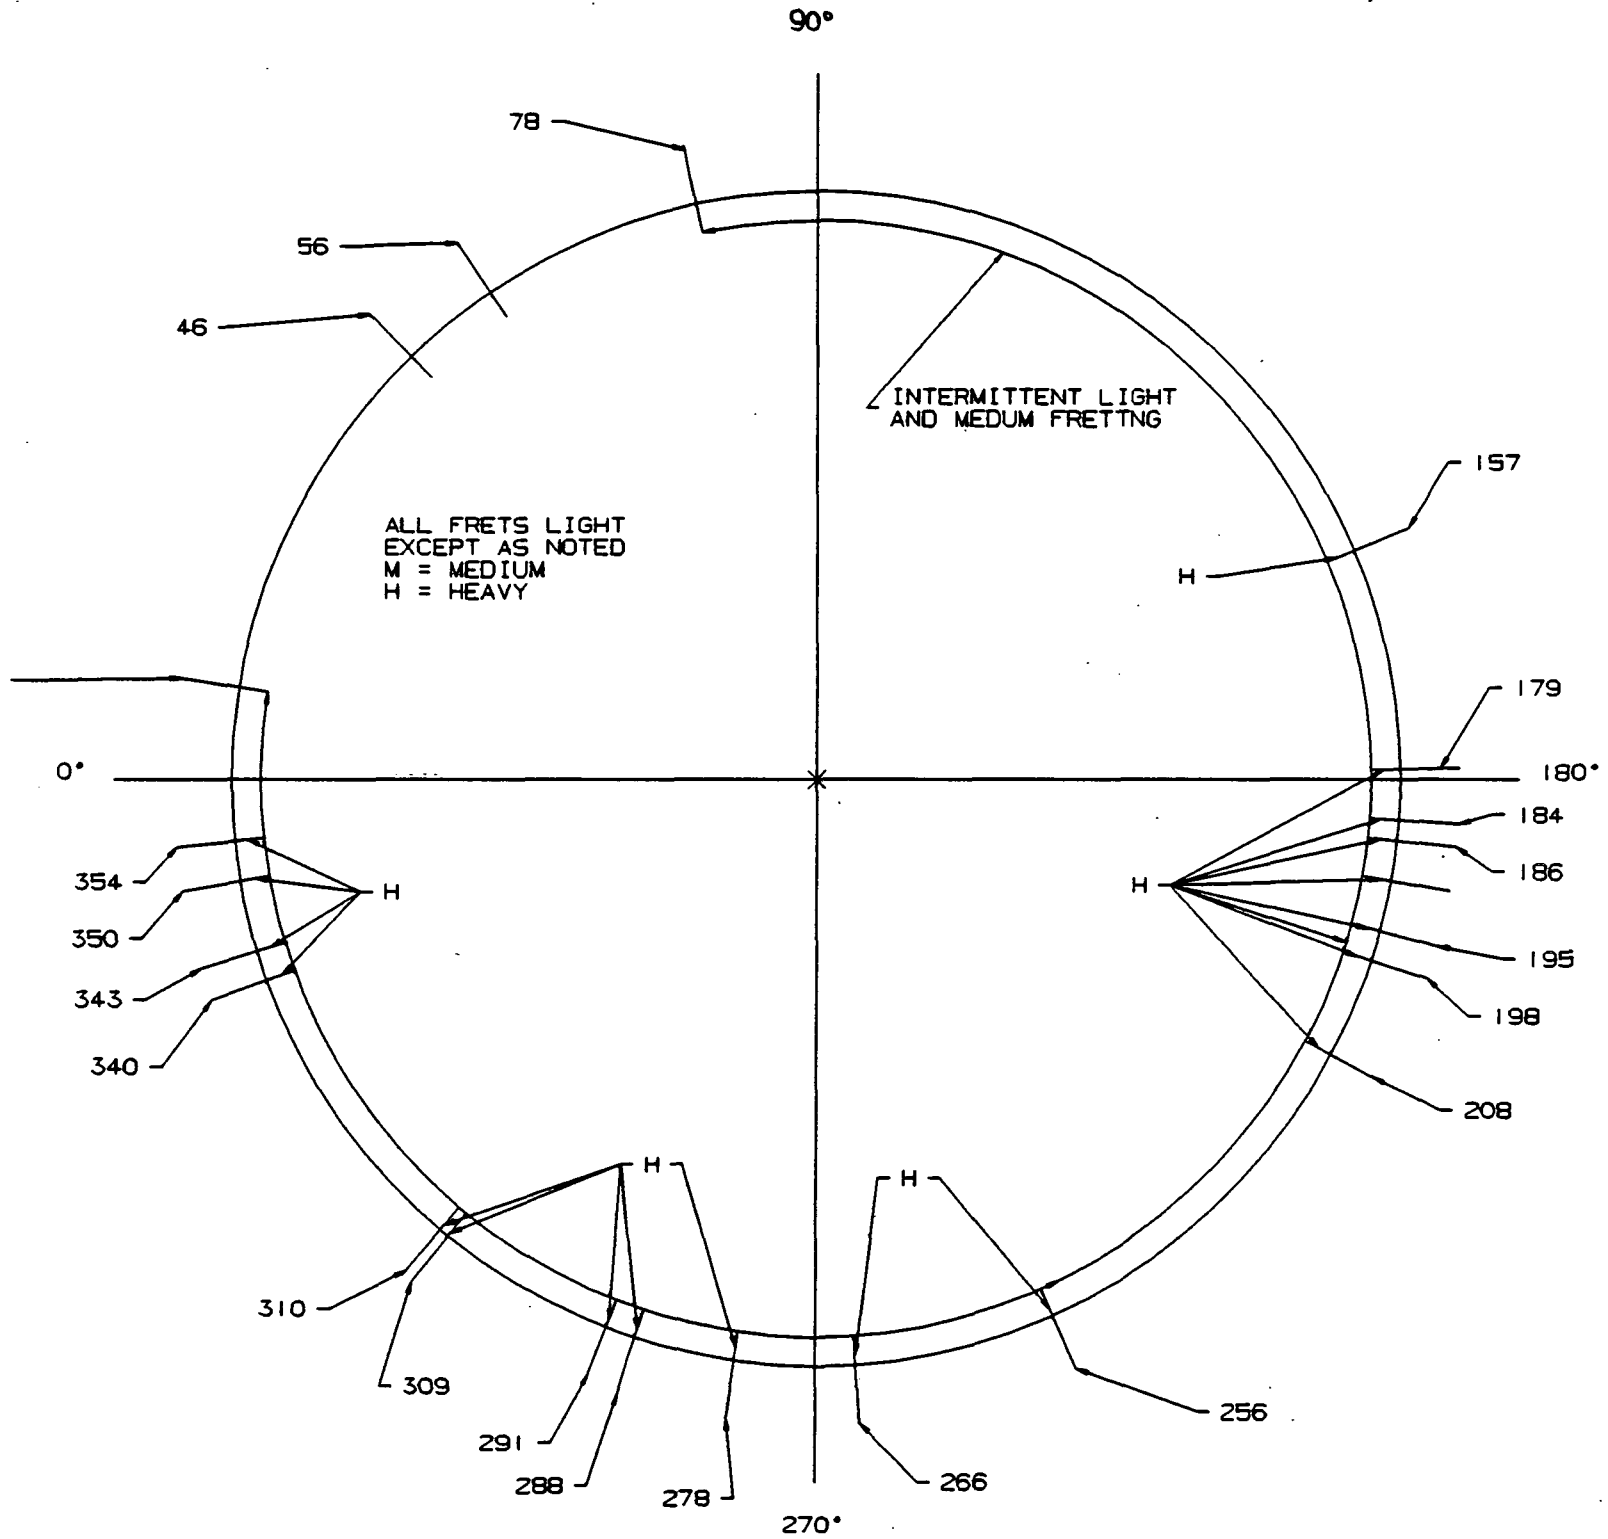
Figure 9 LH Aft Field Joint Fretting

Assessment of the metal components found light fretting around the entire circumference except between 9 to 46, and 56 to 116 degrees. Medium and heavy fretting was present from 135 through zero to nine degrees. Two heavy frets of 0.009 inch deep fret are located at 195 and 350 degrees. Also, a 0.011 inch deep fret was found at 278 degrees. Figure 9 gives a detailed view of the fretting. This joint, both clevis and tang had flown on RSRM-2 (STS-27), had been previously fretted and repaired. Fretting was found at the edges of repaired areas but not in any areas where metal was removed.

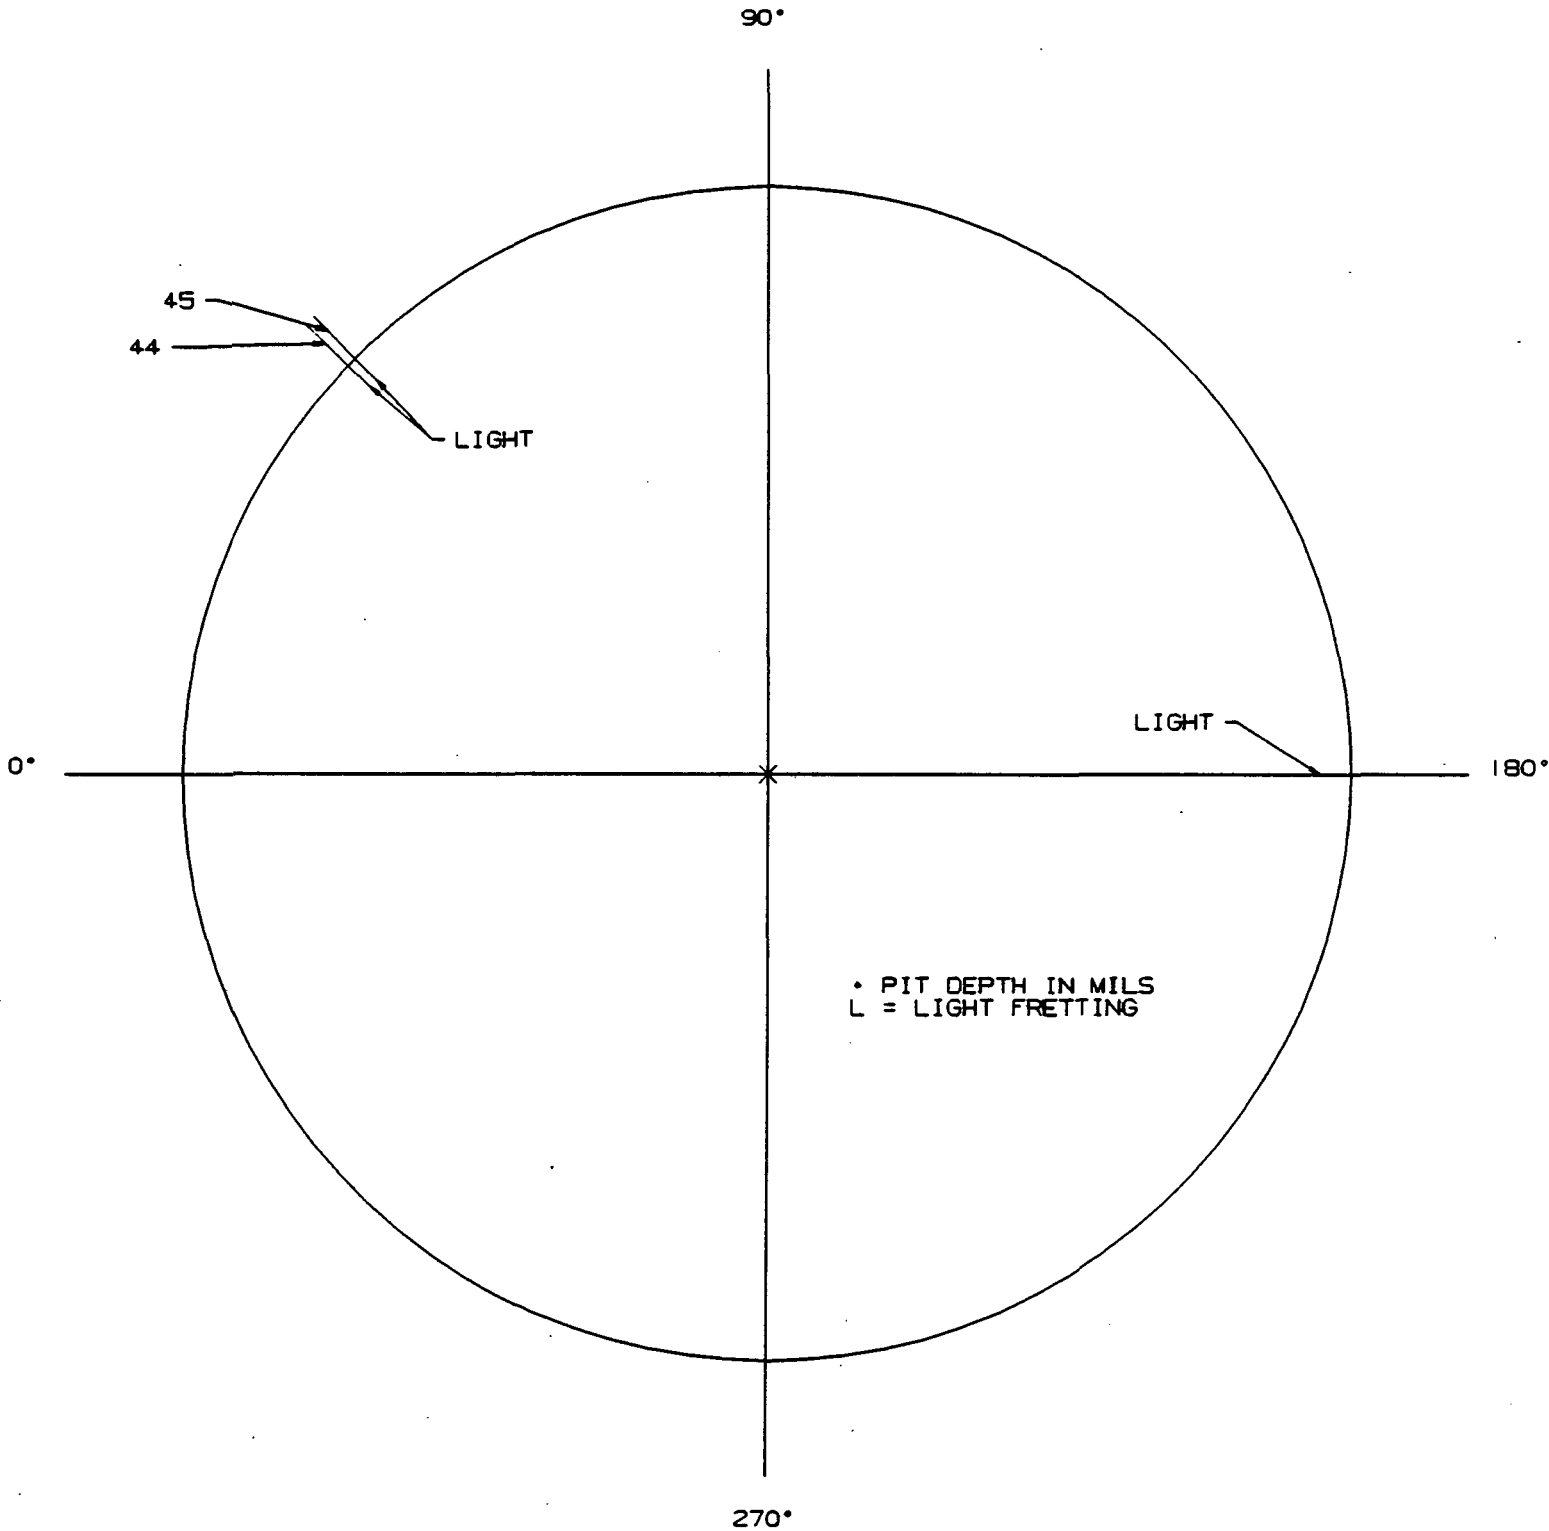
Figure 10 RH Forward Field Joint Fretting

Assessment of the metal components found light fretting at 44 and 45 degrees and a 0.004 inch deep fret at 180 degrees. Figure 10 gives a detailed view of the fretting.

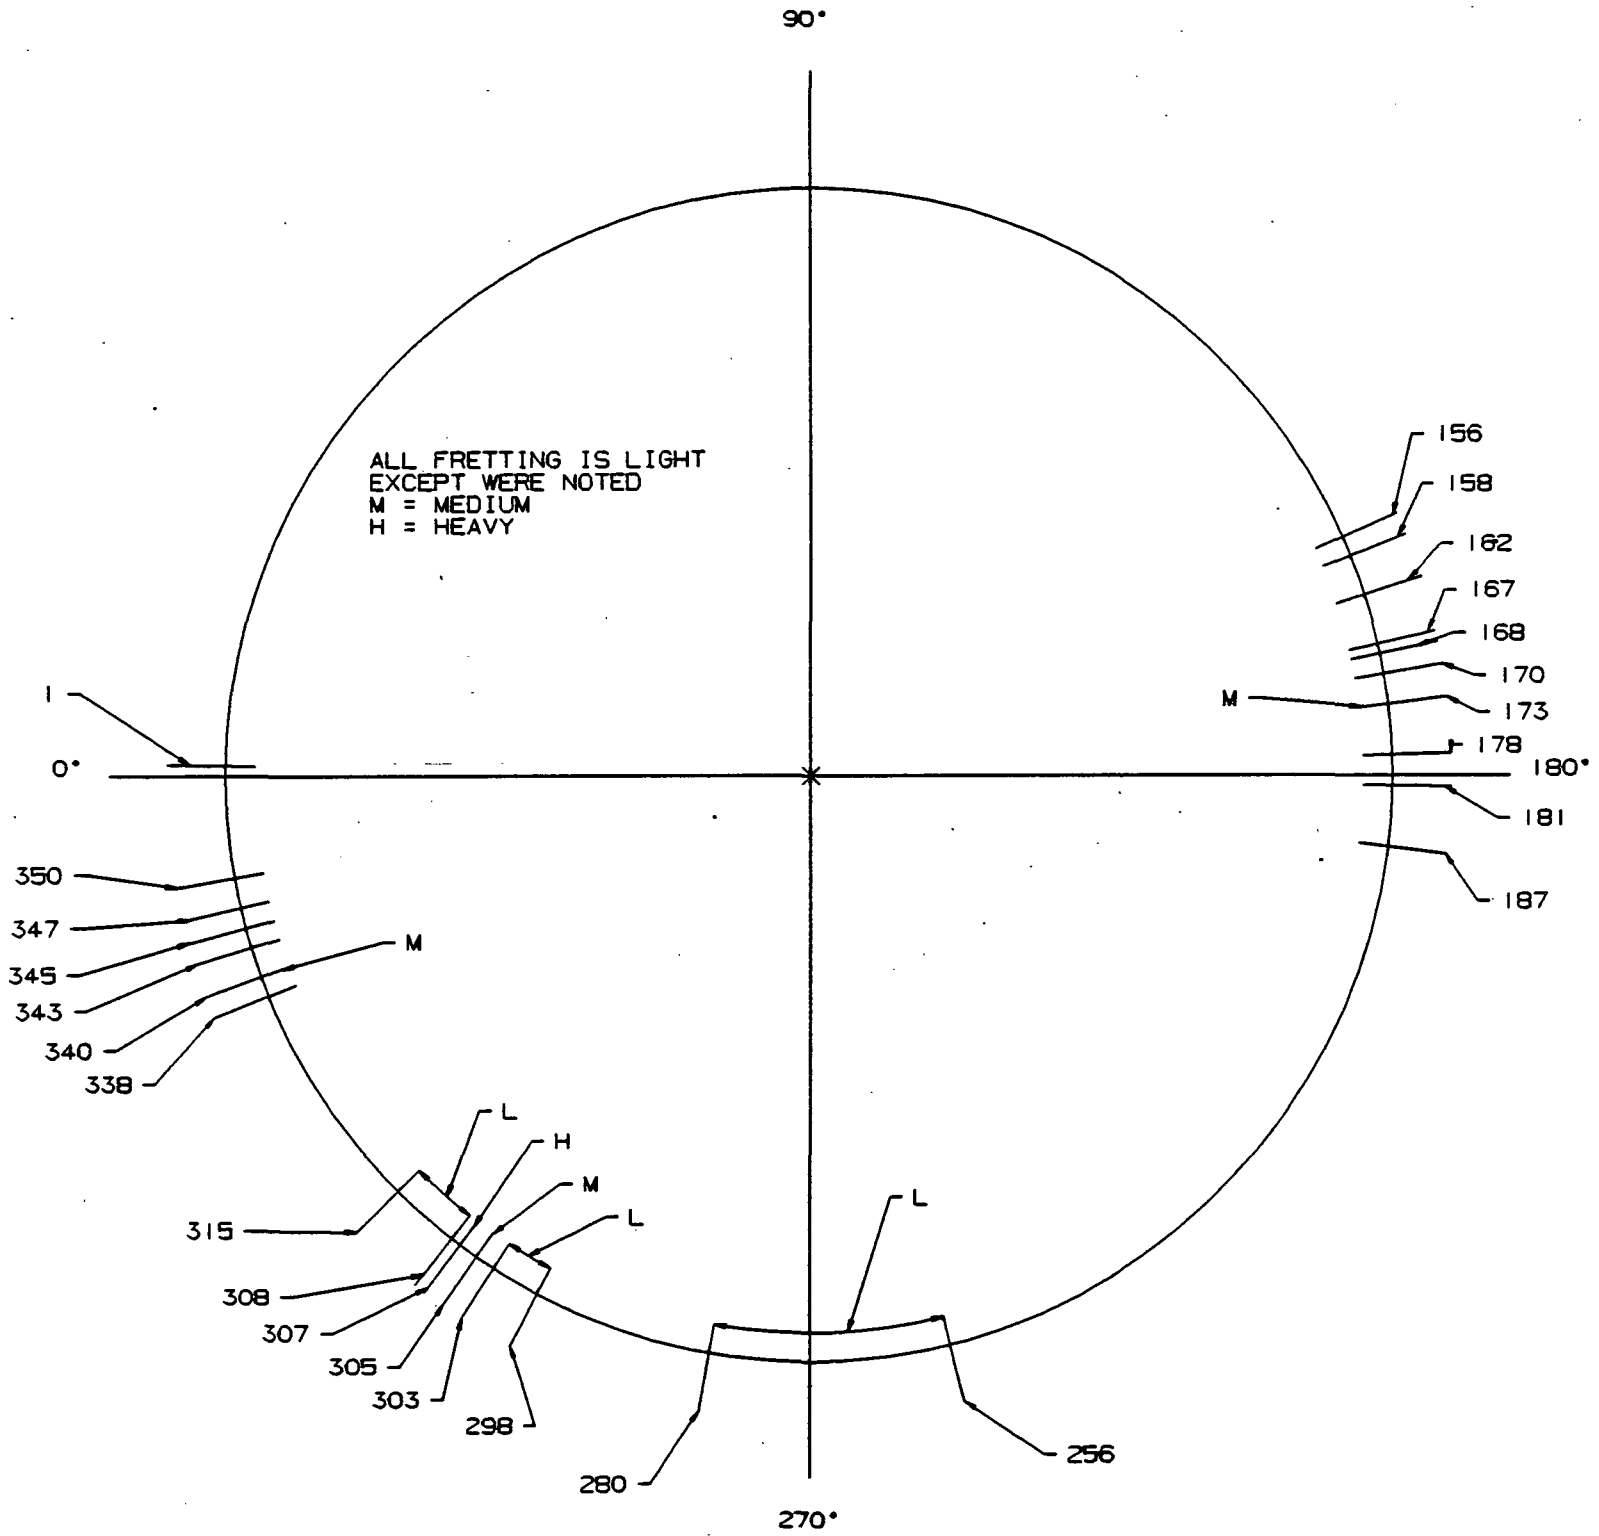
Figure 11 RH Center Field Joint Fretting

Assessment of the metal components found light fretting from 156 to 187, 256 to 280, 298 to 315, and 338 through 0 to 1 degrees. Moderate (0.003 to 0.005 inch deep) fretting at 118, 305, and 340 degrees. A 0.009 inch fret was found at 350 degrees. Figure 11 gives a detailed view of the fretting. Also, medium corrosion was present on the O.D. of the clevis from 86 to 92 degrees.

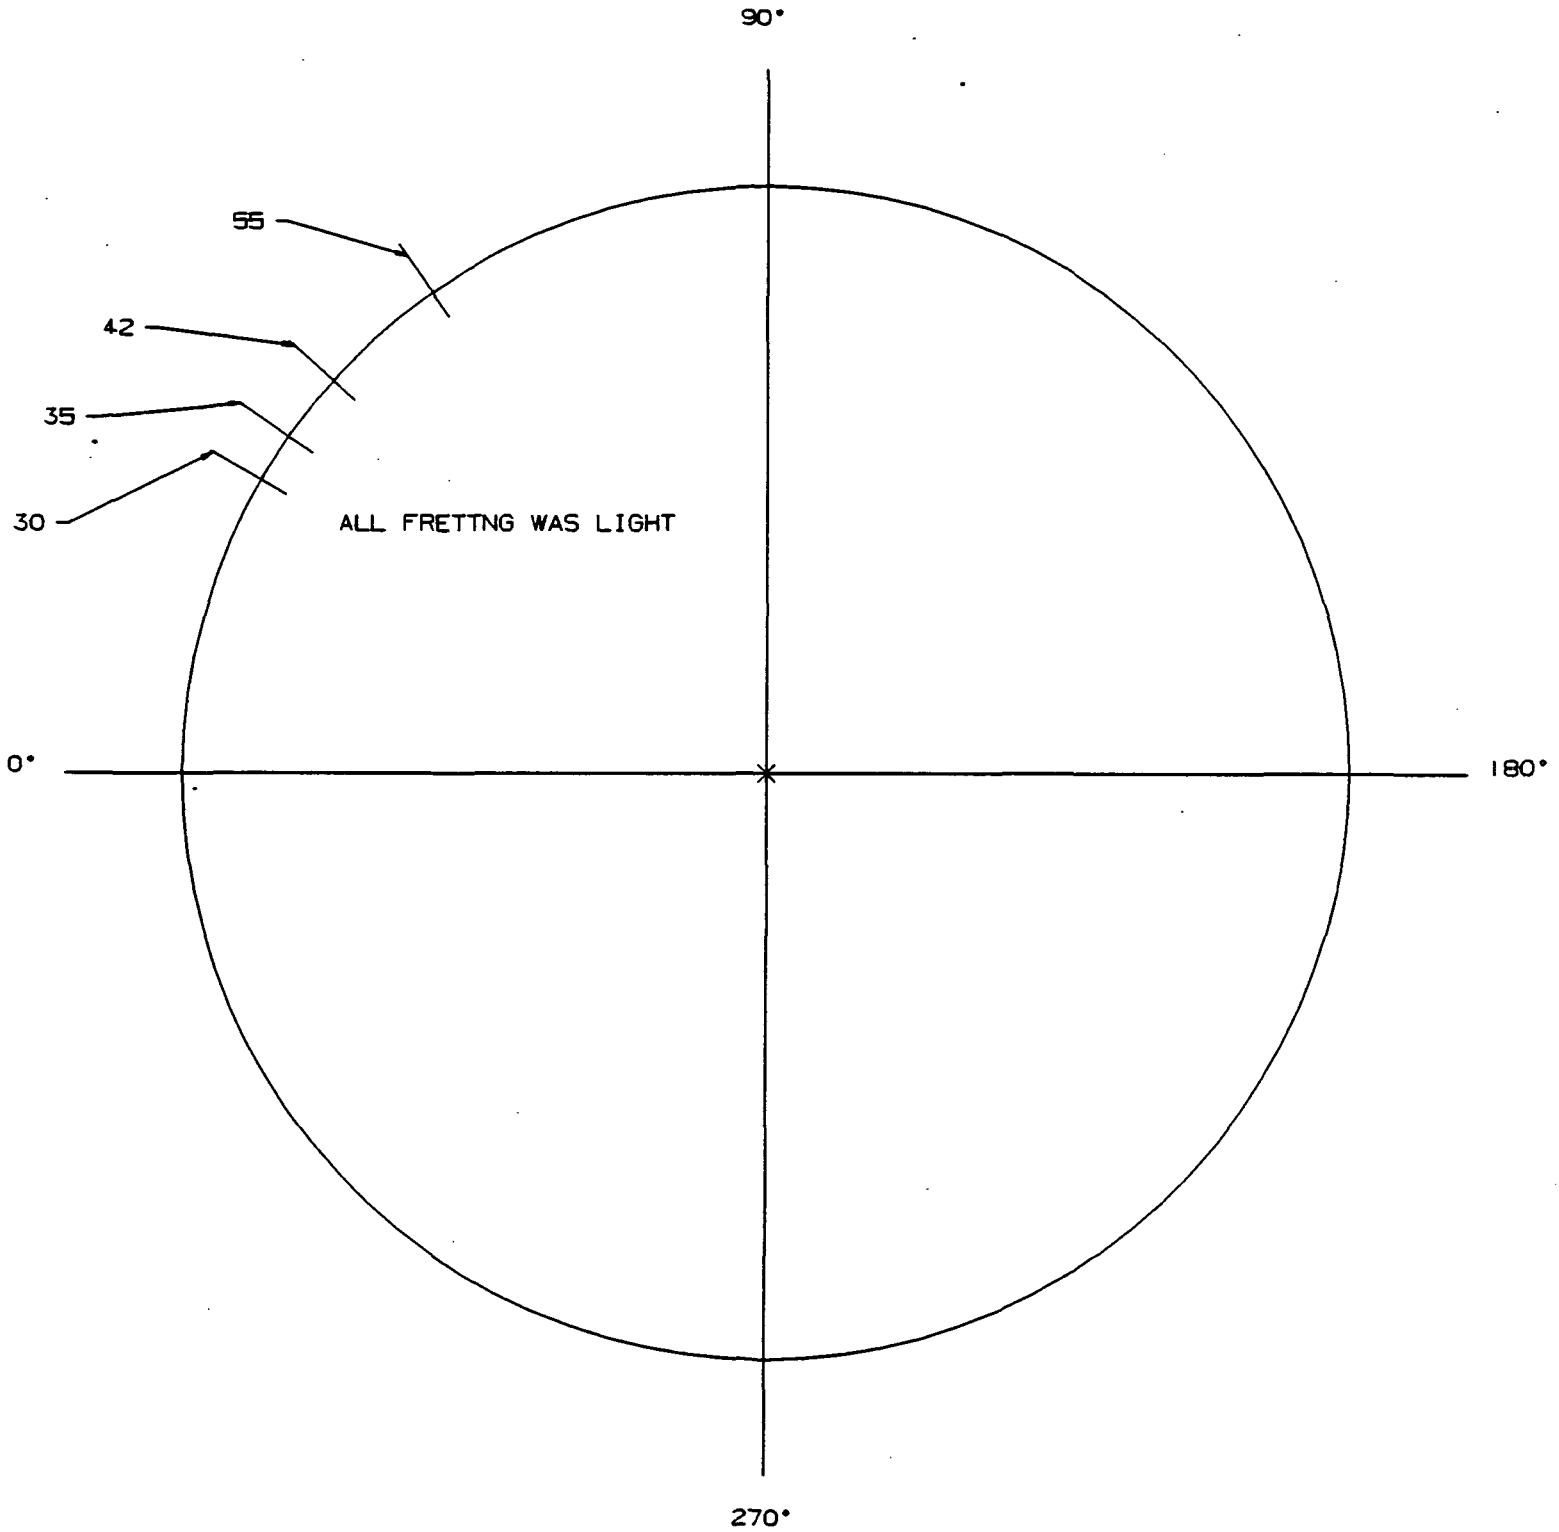
Figure 12 RH Aft Field Joint Fretting

Assessment of the metal components found light fretting at 30, 35, 42, and 55 degrees. Figure 12 gives a detailed view of the fretting.

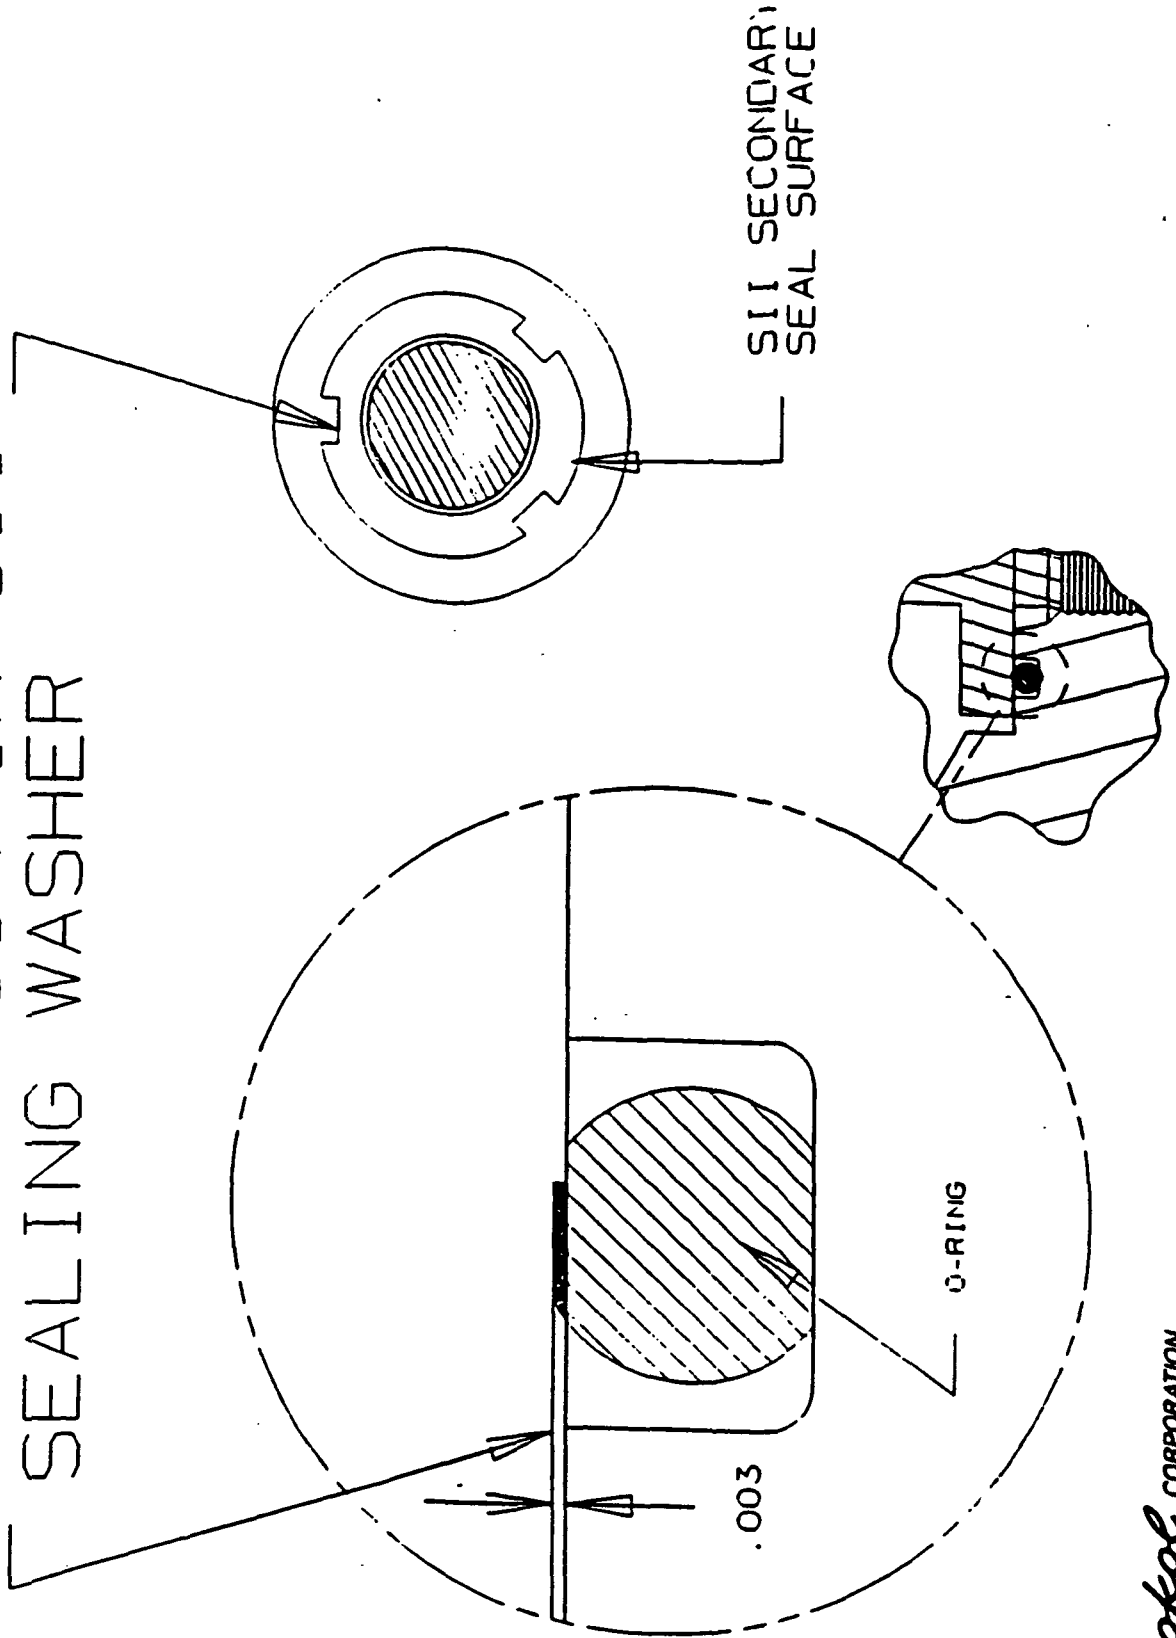
Assessment of the safe and arm device found deformations of the sealing washer of the 18 degree SII. A radial scratch across seal washer of the 18 degree SII was also found. Raised metal was present on the primary seal surface and the lead-in thread of the 198 degree SII port. Circumferential galling was found on the land between the primary and secondary seal surfaces of both SII ports. A closed radial flow line was found on the I.D. of the B-B leak test port plug O-ring. Circumferential galling was found on the seal surface of the Barrier Booster (B-B) and S&A leak check port plugs. Also, three deformations were present on the underside of the S&A leak check port plug, the largest deformation extended into the O-ring footprint.

DEFORMATION IN SII  
SEALING WASHER
