NASA Technical Memorandum 103875

# Tiltrotor Research Aircraft Composite Blade Repairs— Lessons Learned

Paul S. Espinosa and David R. Groepler

December 1991

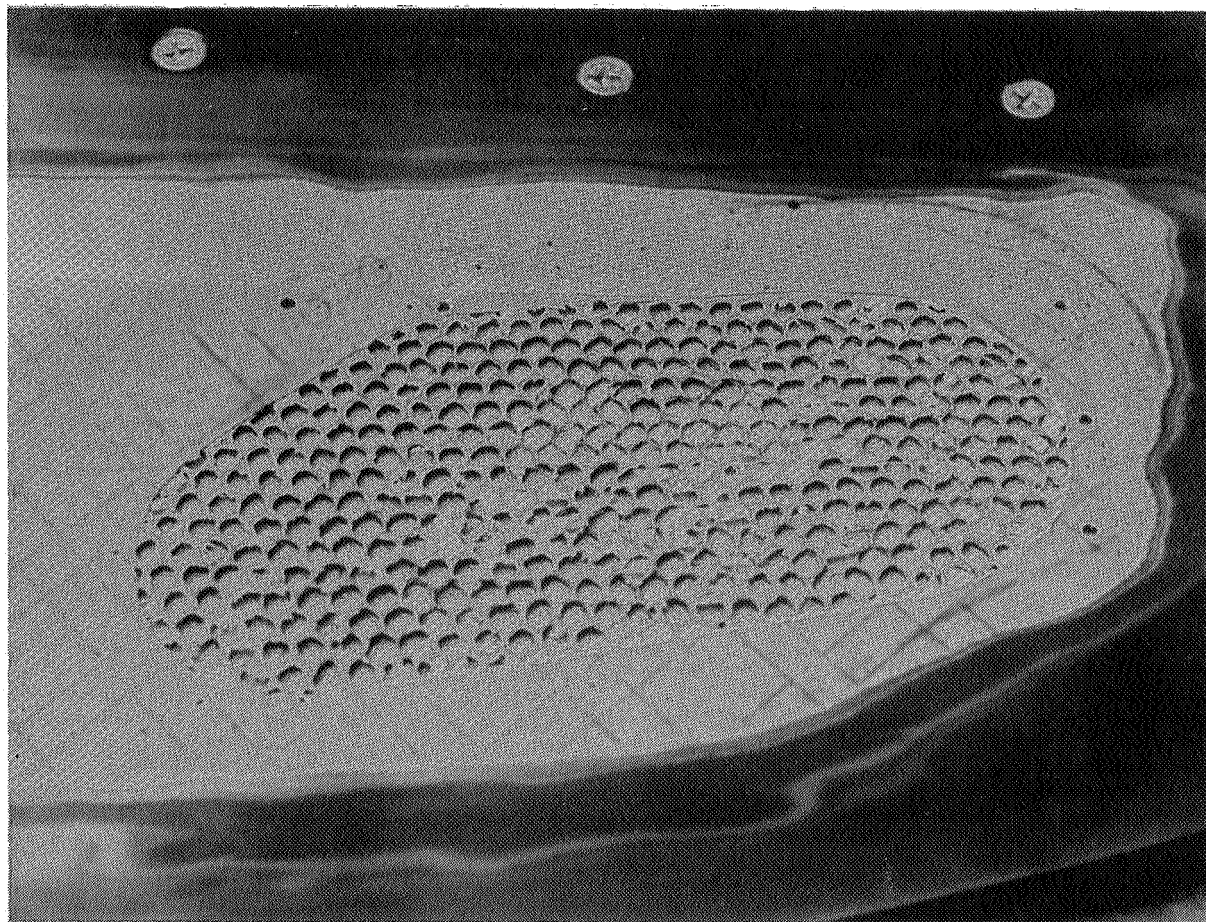
**2.2.1 Description of the problem**— After about 20 hr of operational testing, approximately 12 in.<sup>2</sup> (77.42 cm<sup>2</sup>) of the core of one blade tip was found to have failed, primarily by shearing of the honeycomb through its center (fig. 9). The cause of the failure in the honeycomb core is unknown. The thin shell is highly susceptible to damage from relatively light impact and pressure, but no other failures of the honeycomb core were found in either the baseline or the alternate tips or in any other section of the blade.

**2.2.4 Level of severity and monitoring of critical problems**— The failure of the honeycomb core was considered to be a critical problem because it reduced the strength of the tip. The same size criteria of 2.5 in. (6.35 cm) described in section 2.1.4 for debonding between the fiberglass skin and honeycomb core was also applied to failure of the honeycomb core. Monitoring was performed by tapping any suspected areas between each flight and documenting the results.

FIGURE 9. Failure of honeycomb core (skin removed)

**2.2.3 Repairs performed**— The honeycomb core was repaired by replacing the damaged core. The upper skin of the damaged area was removed by carefully grinding the skin away until the core was exposed. The damaged honeycomb was then removed and the inner surface of the lower skin was prepared by sanding and cleaning it (for bonding with the replacement core). A honeycomb plug was shaped to fit the contour of the cavity extending above the surface of the skin 0.25 in. (0.635 cm). The core was bonded to the lower skin and to the existing honeycomb core interface with Hysol EA9309.1 adhesive. After the adhesive cured, the plug was trimmed and sanded to match the upper-skin-surface contour, plus 0.020 + 0.010/–0.005 in. (0.05 + 0.025/–0.013 cm) to allow for crushing of the honeycomb when the skin is applied in accordance with the procedure recommended by the manufacturer, shown in figures 4–10 of reference 4. A skin patch was prepared with a 1-in. (2.54-cm) overlap of the repaired

area and applied to the honeycomb plug with EA9309.1 adhesive; it was clamped during curing. After curing, the clamp was removed and the patch was faired to the existing skin and refinished.

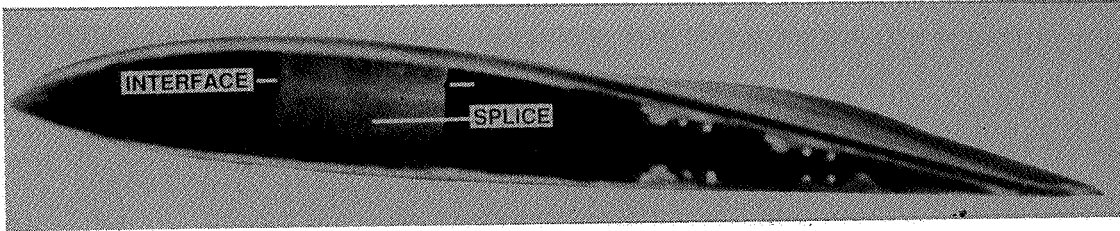
**2.3.1 Description of the problem**— After 20.1 operational hours several baseline blade tips were found to have failures in the shear splice (a good shear splice is shown in fig. 10). At 25.8 operational hours, two more splices were found to have failed. These debonds, which appeared as cracks, were found at the interface of the splice (one laminate of fiberglass-cured cloth) and the two tangs on the top and bottom of the inner surface of the tip shell (see fig. 11). Two factors contributed to the failures. First, the adhesive at the splice contained voids or did not adequately cover the mating surfaces, or second, the splice was too small and did not provide enough surface area at the interface for a proper bond. Failure in the shear web only occurred in the baseline tips because the alternate tips did not contain shear splices. Once the shear splices were properly repaired no further failures were found.

**2.3.4 Level of severity and monitoring of critical problems**– The shear splice in the XV-15 ATB baseline blade tip is not primary flight structure. It is a secondary structure web used to prevent damage to the tip cover during handling and when the tip is removed or installed. All failures of the tip splice had a bond area less than 0.25 in. (0.635 cm) in width. A 0.25-in. (0.635-cm) crack is allowed in the chordwise direction, for the small voids in the adhesive which may form during assembly or repair of the splice. Because the loads during flight are carried by the fasteners into the spar, it is not expected that a crack will grow during flight. If a crack or debond in the web is less than 0.25 in. (0.635 cm) long in the chordwise direction, it is monitored and repaired during the next convenient maintenance period. All the noncritical cracks and debonds are recorded and visually inspected for growth each time the tip cover is removed.

FIGURE 10. Location of shear splice in baseline tip cover

**2.3.3 Repairs performed**— Repairs were performed by replacing the existing fiberglass splice or by injecting adhesive into the failed section of the interface. Since most of the original fiberglass splices did not provide enough overlap for a good bond, the original splice was removed and a new one was fabricated to provide a 0.25-in. (0.635-cm) overlap. The original adhesive was cleaned from the web tangs, and the new splice was bonded into place with EA9309.1 adhesive; a specially

made clamp was used to hold the splice in place while it cured. In some cases where a sufficient overlap already existed the debonded area was cleaned, and either EA9309.1 or Hysol 956 adhesive was injected with a hypodermic needle into the debonded area. The new splice was then clamped and allowed to cure.

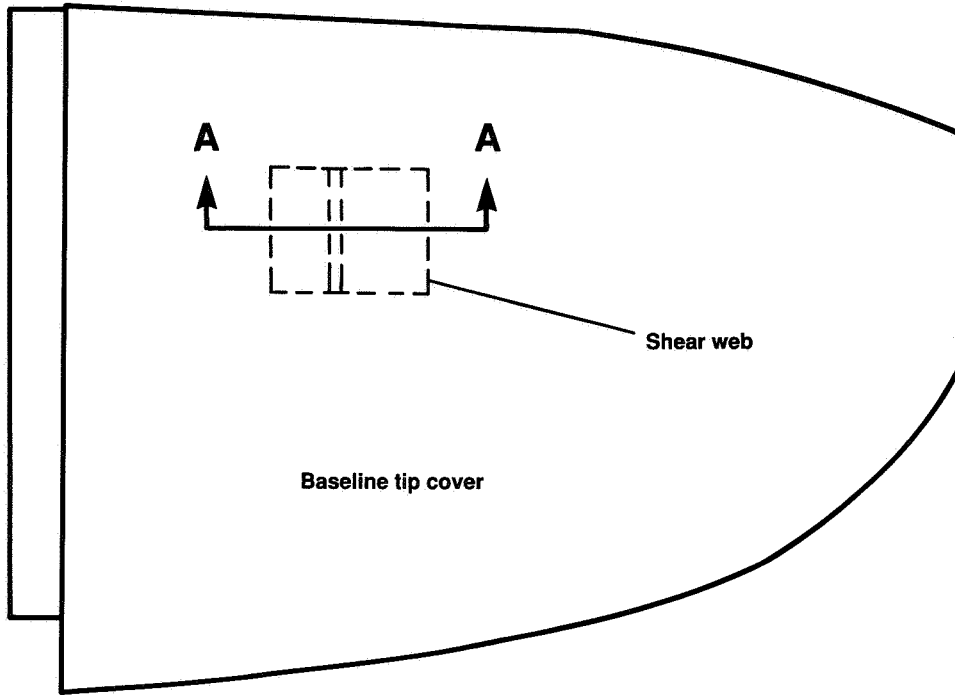
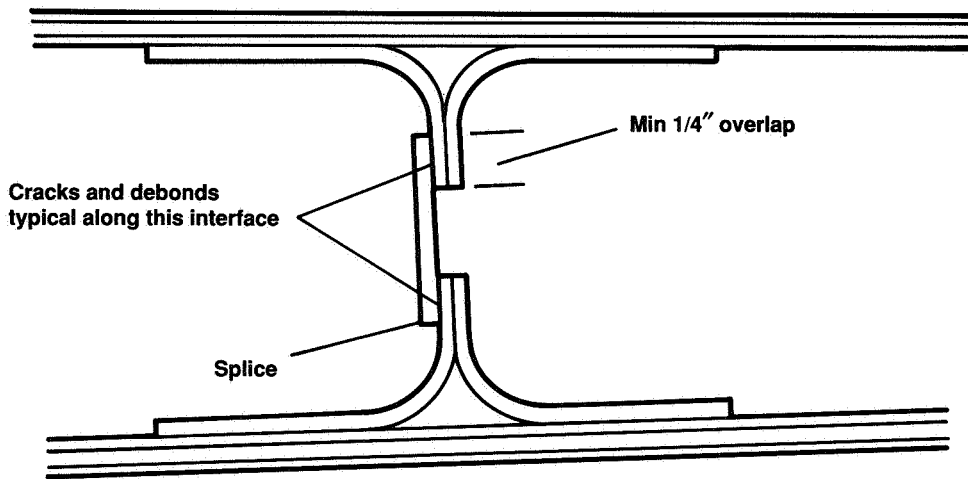
A-A

FIGURE 11. Detail of shear splice in baseline tip cover

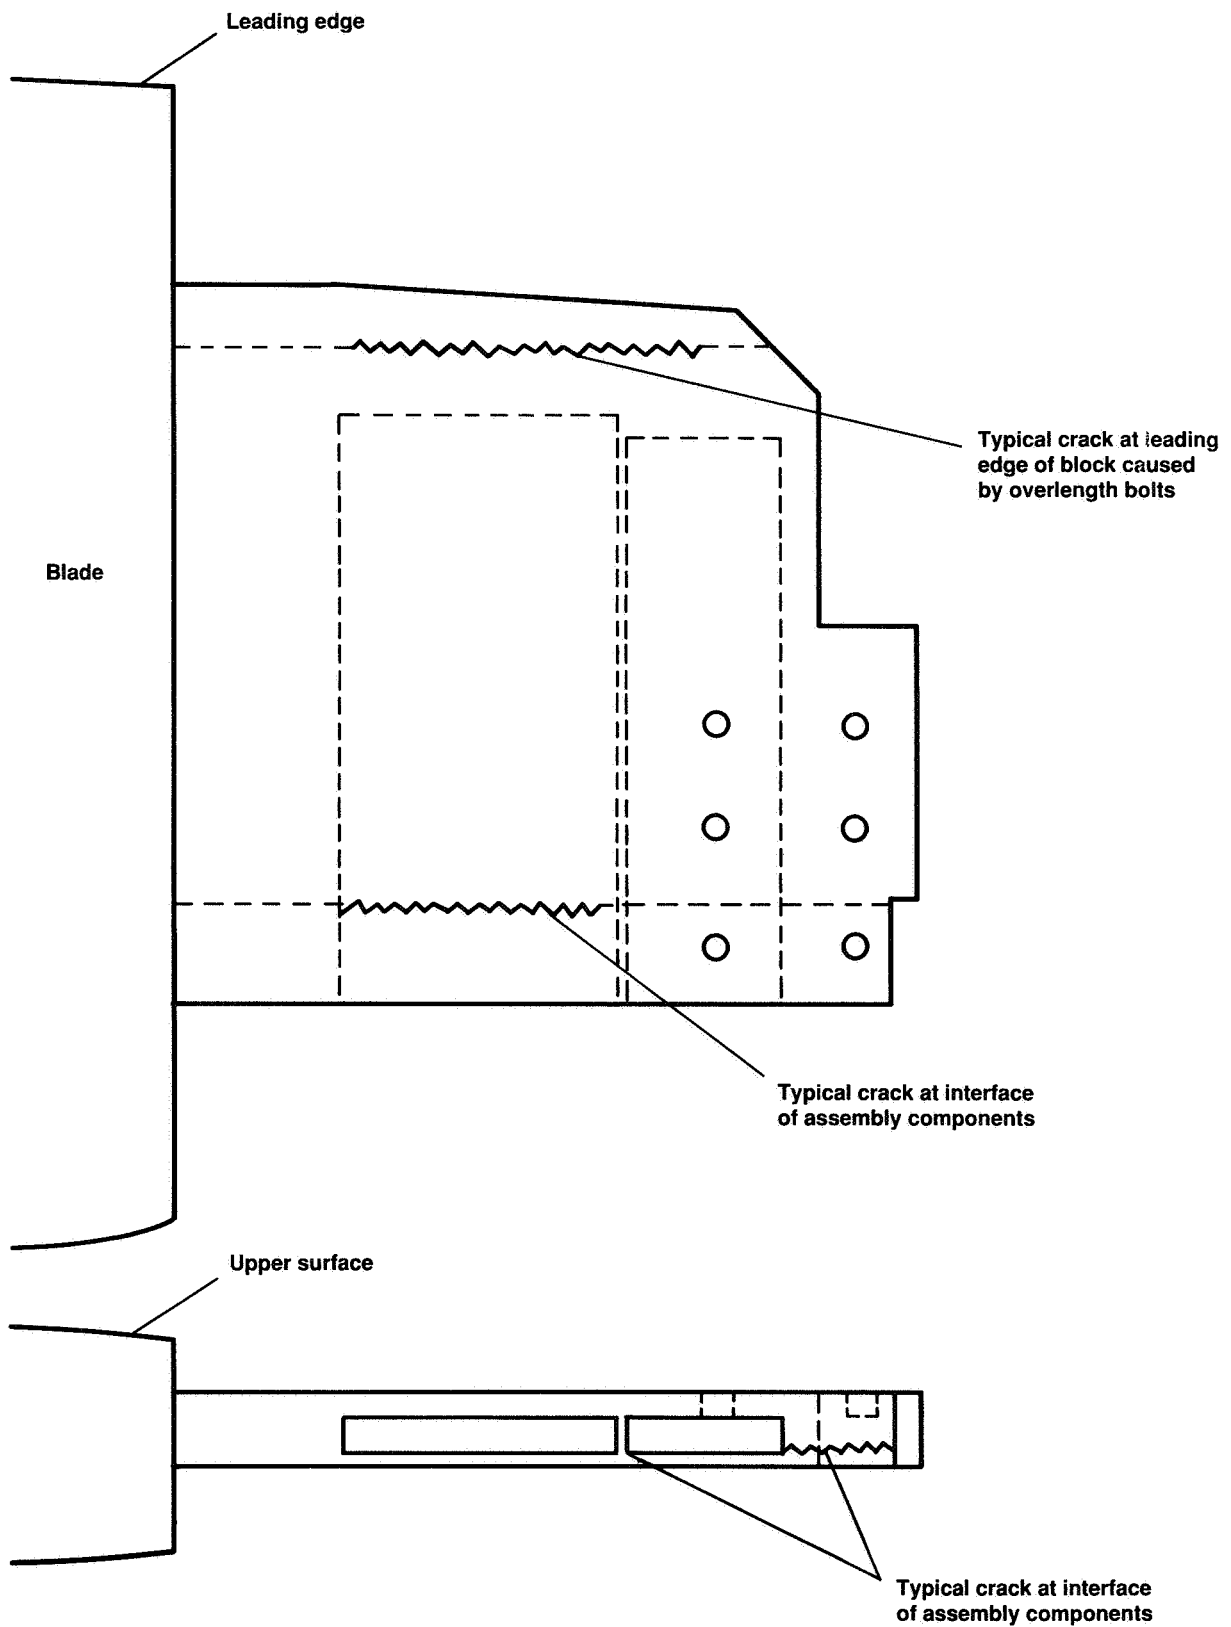
**2.4.1 Description of the problem**– Before the first flight on the aircraft, many cracks were found in the fiberglass blocks at the interface between the molded weight blocks of each tip-weight-fitting assembly where they are bonded together (fig. 12). Throughout the flight-test activity, the blocks continued to be plagued by cracks at various bond-line locations. Various types of adhesives and repair methods were tried. Since the weight blocks are secondary structure (the weight blocks are held together by fiberglass wraps from the main spar), this problem was not a safety issue. Some of the cracks were caused by the inadvertent use of over-length fasteners, which pushed against a mating block and caused the blocks to separate. Most cracks were formed when the adhesive between the blocks failed during flight or upon assembly. The adhesive at the block interfaces may have squeezed out during curing, causing inadequate bonding of the blocks. Another possibility is that the adhesive did not cure properly or was under-strength during assembly, resulting in lower strength of the interface. A repair procedure was established in which a high-strength adhesive with a long cure time was used, coupled with a procedure to prevent the crack from fully closing during the cure cycle, which ensured that the thickness of the adhesive would be adequate for maximum strength. None of the repaired blocks had further failures.

**2.4.4 Level of severity and monitoring of critical problems**– Cracks in the fiberglass blocks were not considered to be a critical problem because these blocks were not primary structure (primary retention is provided by the spar extension wraps). The area was therefore inspected for cracks only when the tip caps were removed for maintenance. Any cracks found were repaired before the next flight.

FIGURE 12. Typical cracks in tip-weight-fitting assembly

**2.4.3 Repairs performed**– All the cracks were at the interface of assembly components, and were repaired by bonding the components. The cracks were opened slightly with a small wedge, and Hysol EA954 adhesive was injected into the crack. The wedge was left in place during curing to prevent the adhesive from being squeezed out. The wedge was then removed, and the tip was replaced.

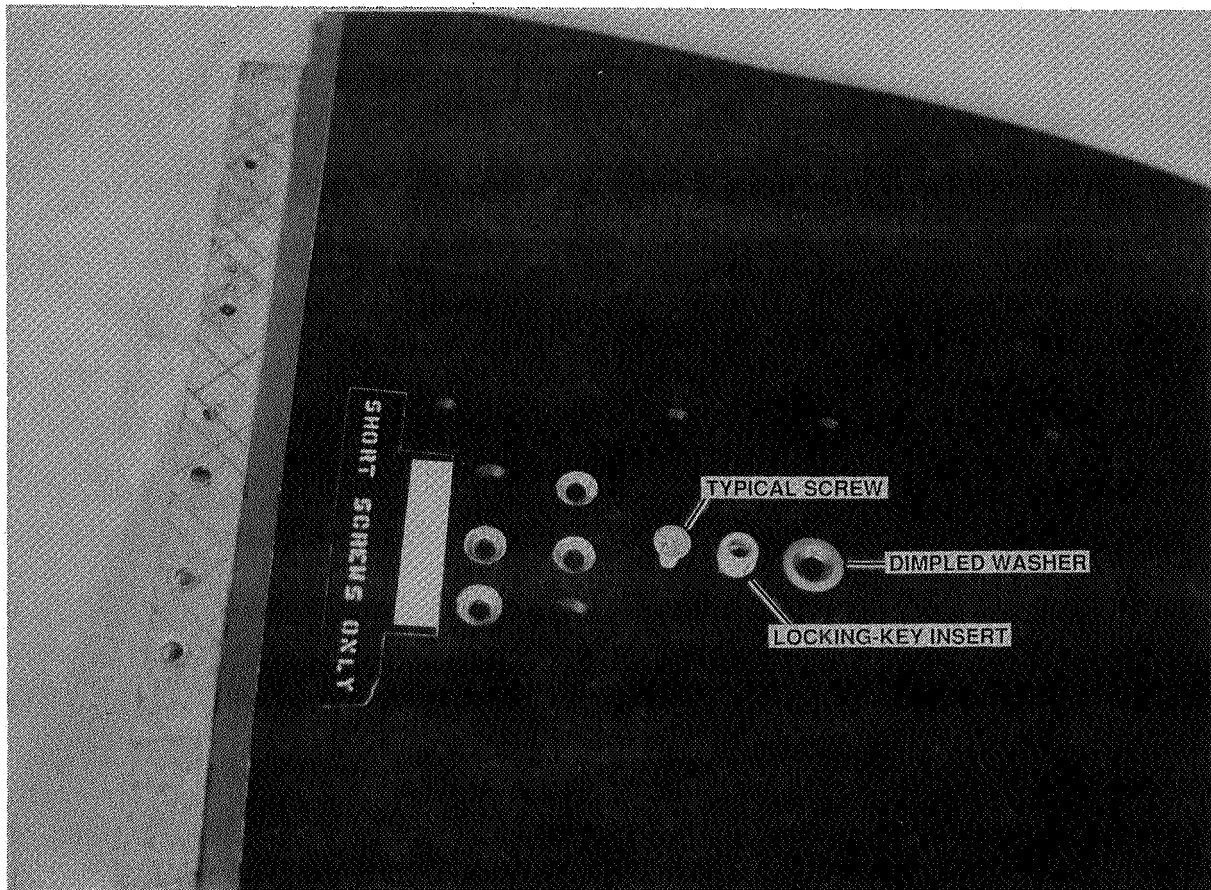
**2.6.1 Description of the problem**— There were three major types of problems associated with the metal fasteners in the fiberglass on the ATB blades. These problems involved the locking-key inserts, the use of helicoils, and the dimpled washers. Figure 14 shows a typical fastener, locking-key insert, and dimpled washer.

The most common fastener problem was associated with the locking-key inserts located at the outboard end of the main body of the blade in the spar and in the tip weight fitting. Problems included: (1) damage to the fiberglass threads in which the insert is seated; (2) failure of the adhesive, or lack of adhesive, at the interface of the insert and fiberglass; and (3) failure of the fiberglass in the vicinity of the insert. After 25.8 hr of flight time, an insert was found to have pulled loose from the fiberglass nose block. The failure of the insert in a fiberglass block was discovered during a post-flight inspection; it was manifested as a bulge in the skin, about 0.0625 in. (0.159 cm) high, at one of the outboard fastener locations. When the insert was removed it was found to have been fastened with adhesive into a hole in the fiberglass. Apparently the original threaded hole had been too large, so it was drilled out and the insert was glued in place. The glue alone does not provide the retention strength that threads in the fiberglass do. Further inspection showed no other inserts with this deviation; however, a torque test identified a number of inserts that were also loose. Loads and vibration caused the threads in the fiberglass to deform slightly, which loosened the inserts. The inserts were removed and reinstalled with adhesive so that they were securely bonded to the fiberglass threads.

FIGURE 14. Metal fasteners currently used in ATB blade and tip-cover structure

**2.6.3 Repairs performed**— All the failed metal fasteners were replaced as soon as they were detected. The loose inserts were replaced by removing the insert from its cavity either by pulling it directly out of its hole if the fiberglass threads were badly damaged, or, if the threads were not badly damaged, by knocking the insert's "keys" down into the cavity below the insert so that the insert was free to be twisted out. A new insert was then glued in place with EA9309.1 adhesive. If there was damage to the threads in the fiberglass structure, they were sanded out and the hole was drilled oversize and cleaned. The hole was then coated with adhesive and lined with three layers of fiberglass cloth saturated with the same adhesive, with the first and third layers at 0/90 deg and the second layer at  $\pm 45$  deg. Pressure was applied to the fiberglass using a tapered plastic dowel inserted into the hole. After the adhesive cured, the hole was drilled and tapped using a guide to ensure perpendicularity to the surface of the tip. A new locking-key insert was installed with adhesive.

The unbonded dimpled washers were removed and the dimple in the fiberglass skin was cleaned and sanded. The depression in the fiberglass was built up with a mixture of chopped fiberglass cloth and EA9309.1 adhesive. The bonding surfaces of the washers were etched, primed, and coated with adhesive, and the washers were bonded to the blade.

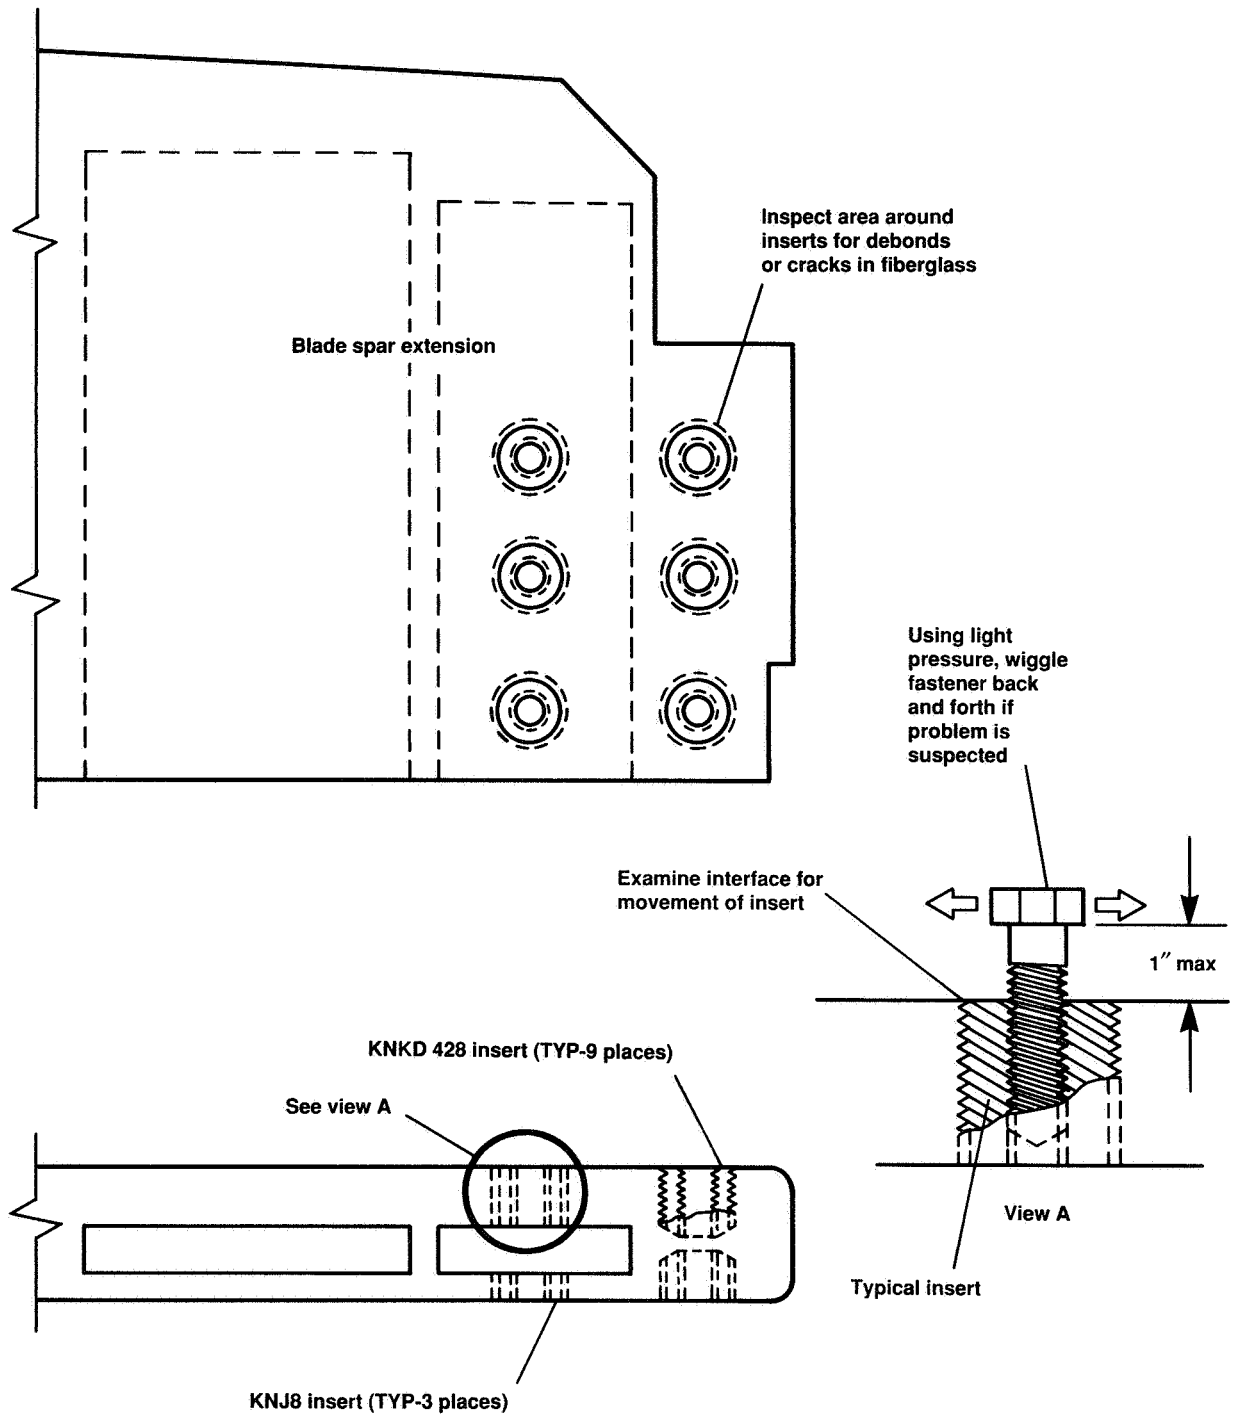
**2.6.2 Inspection procedures**— A visual inspection was performed on all the metal fasteners visible on the surface of the blade after every flight. The metal fasteners located in the tip weight fitting or under the tip cap were visually inspected when the tips were removed for changing the tip weights or for maintenance. If it was suspected that an insert was loose, a torque test was performed and/or a short fastener with the same threads as the insert was inserted (fig. 15) and, using light pressure (pushing on the fastener too hard could damage the fiberglass threads), the fastener was wiggled laterally by hand while a visual examination was made of the interface of the insert and the fiberglass for unusual movement, debonds, or cracks in the fiberglass. The insert was then replaced, if necessary.

FIGURE 15. Inspection of inserts in spar extension and end of blade
