NASA Technical Memorandum TM 103826

Debris/Ice/TPS Assessment And Photographic Analysis For Shuttle Mission STS-48

November 1991

Gregory N. Katnik
NASA/Kennedy Space Center

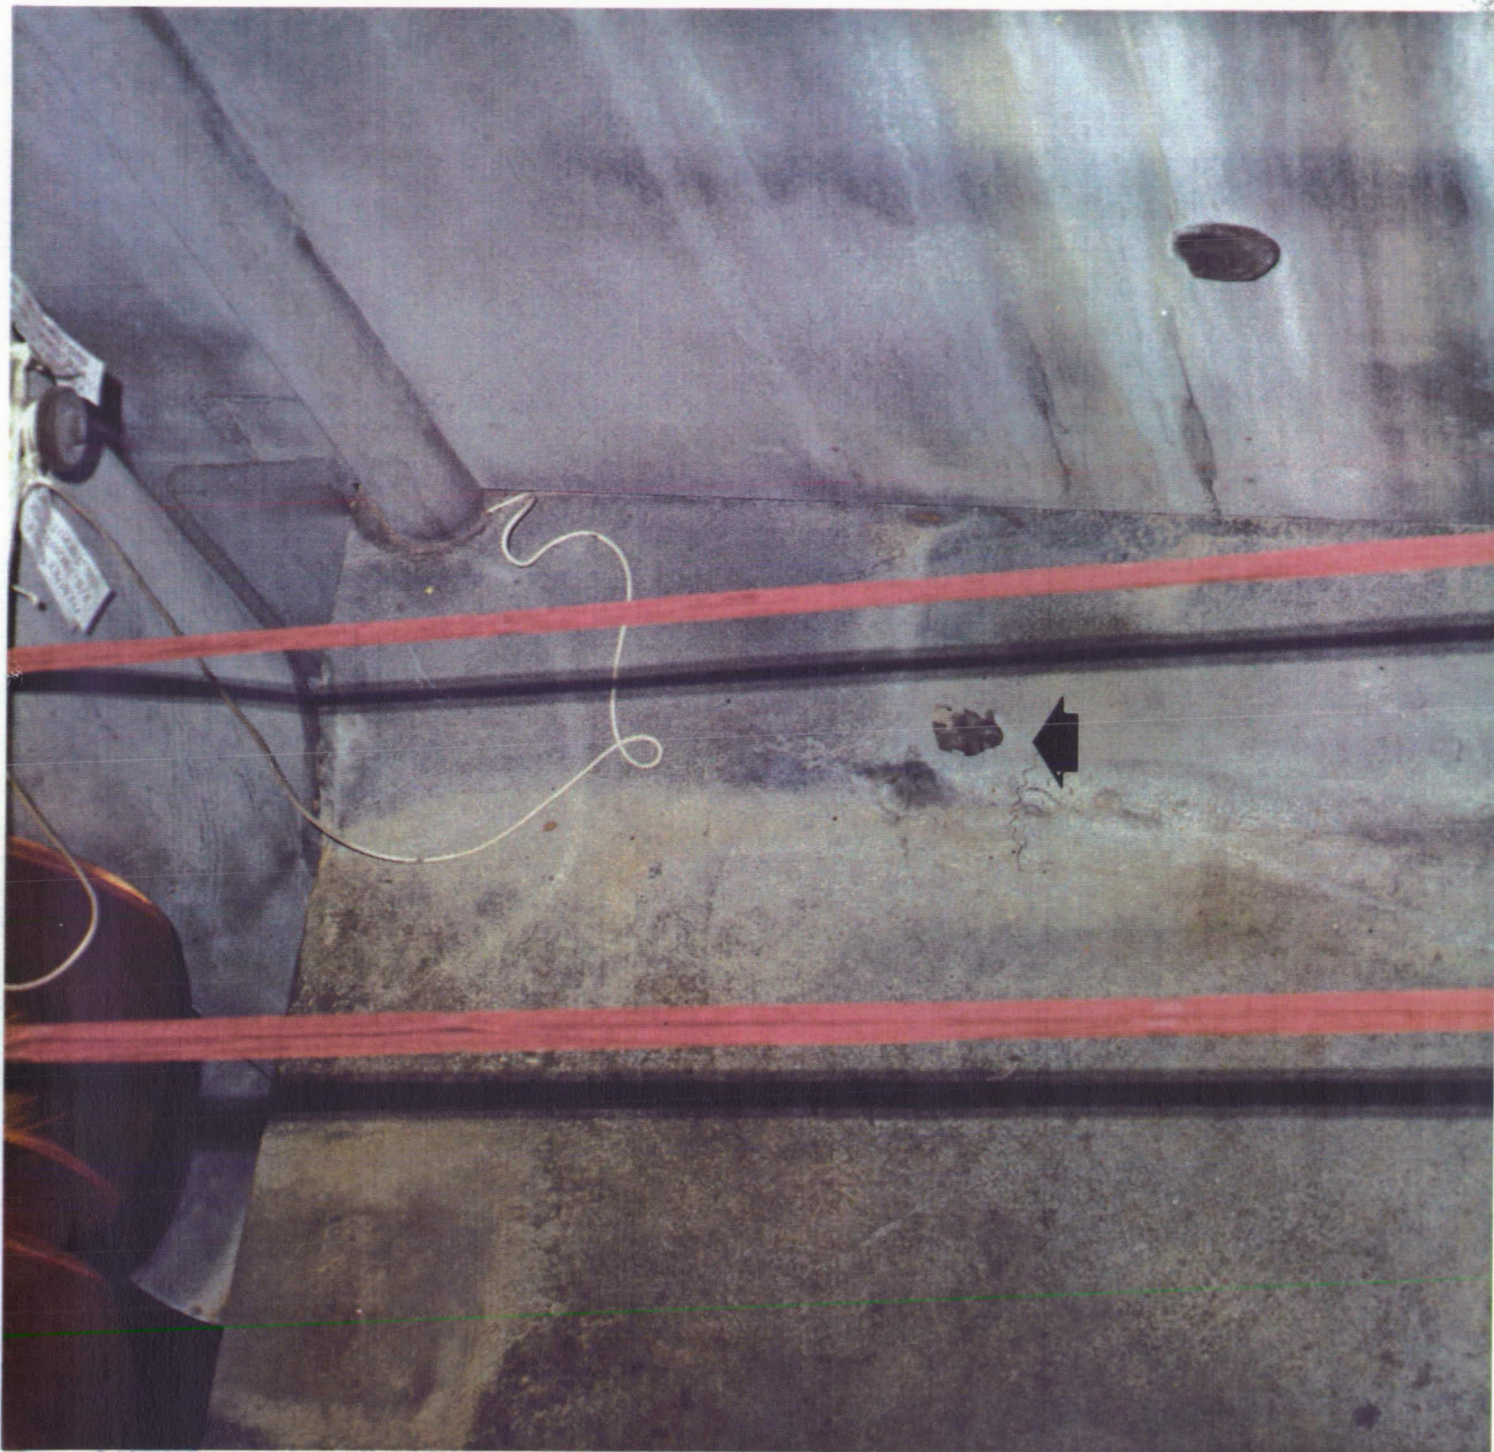
Universal metal clamp lay on the holddown post haunch near the
base of HDP #5

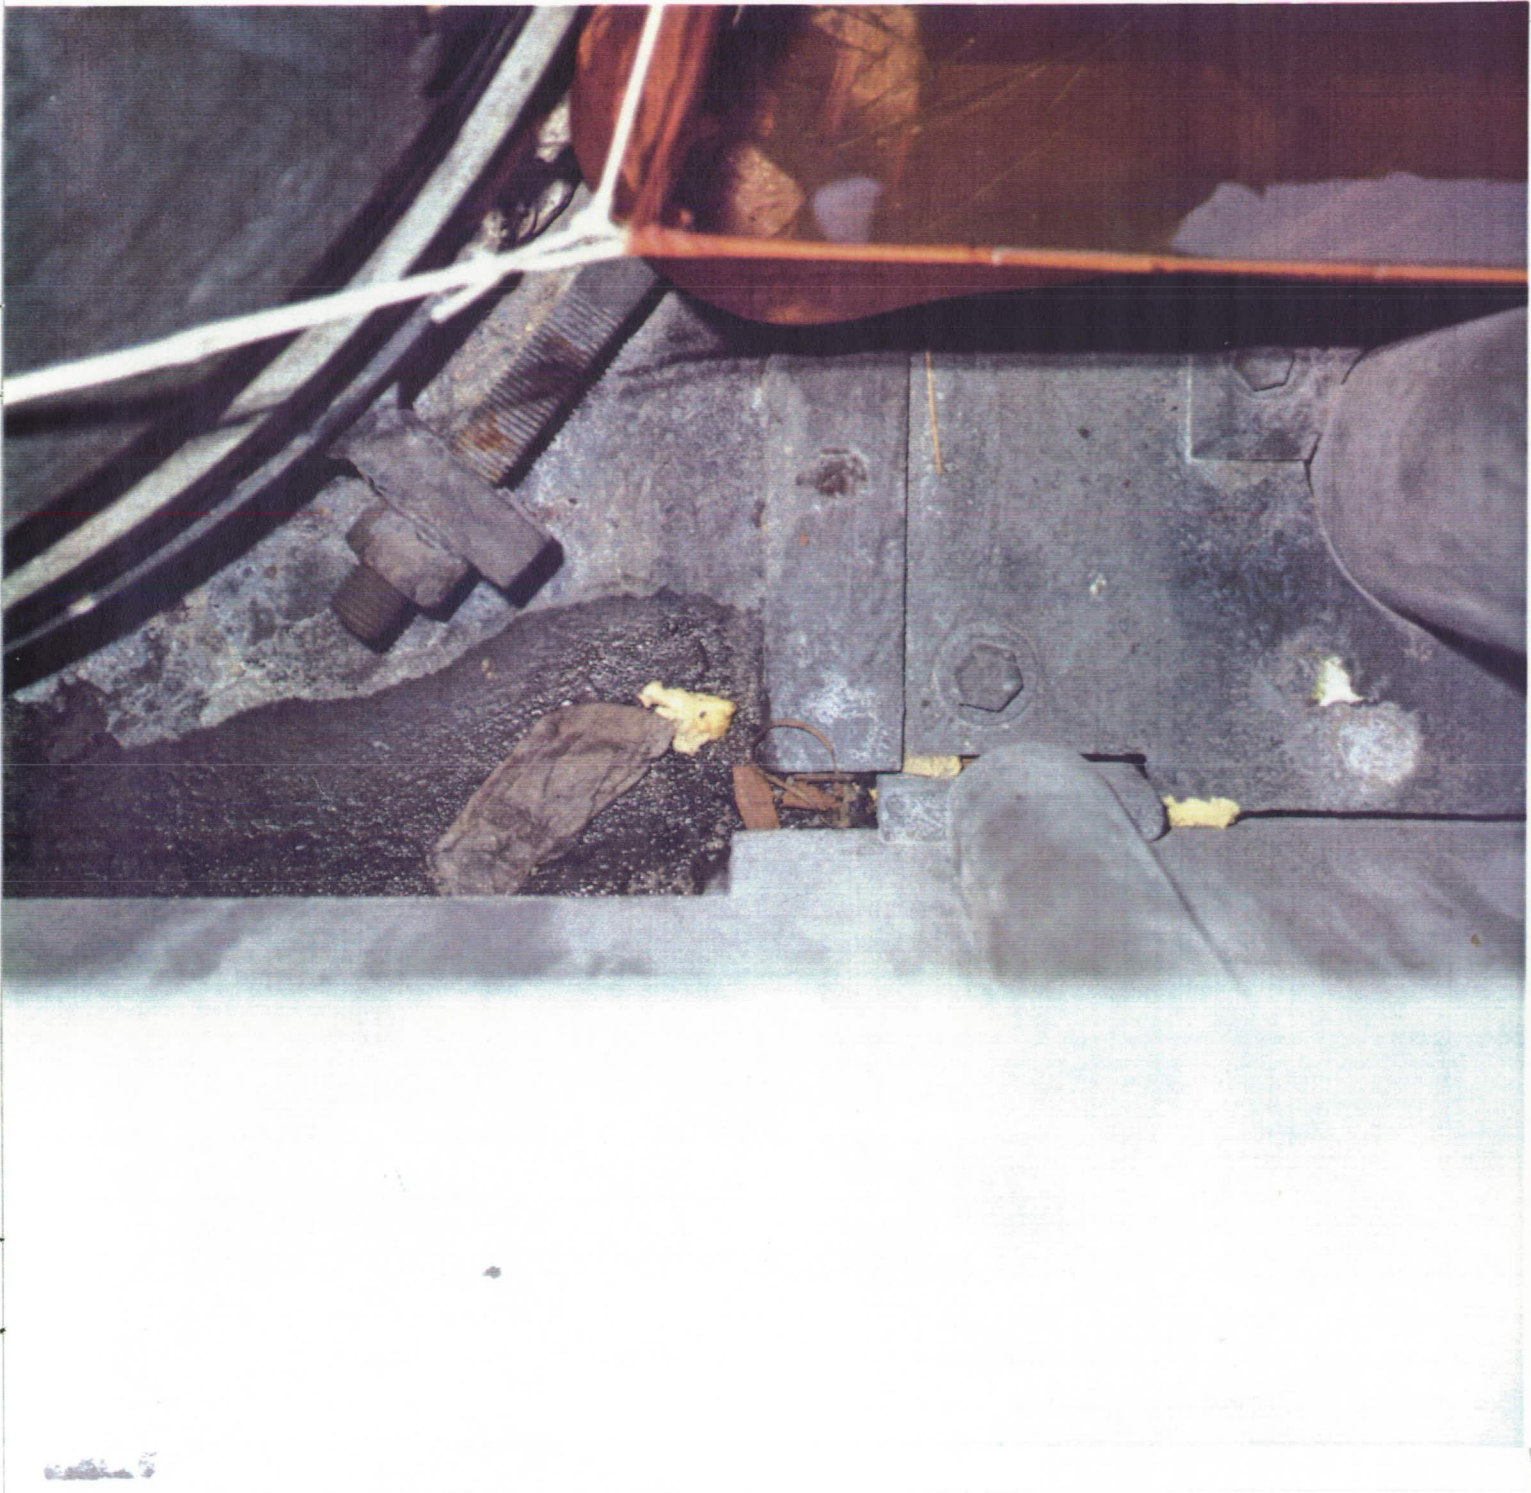
K5NA and instafoam trimmings, tie wrap pieces, and other debris were present around the bases of the south holddown posts and in the haunch areas

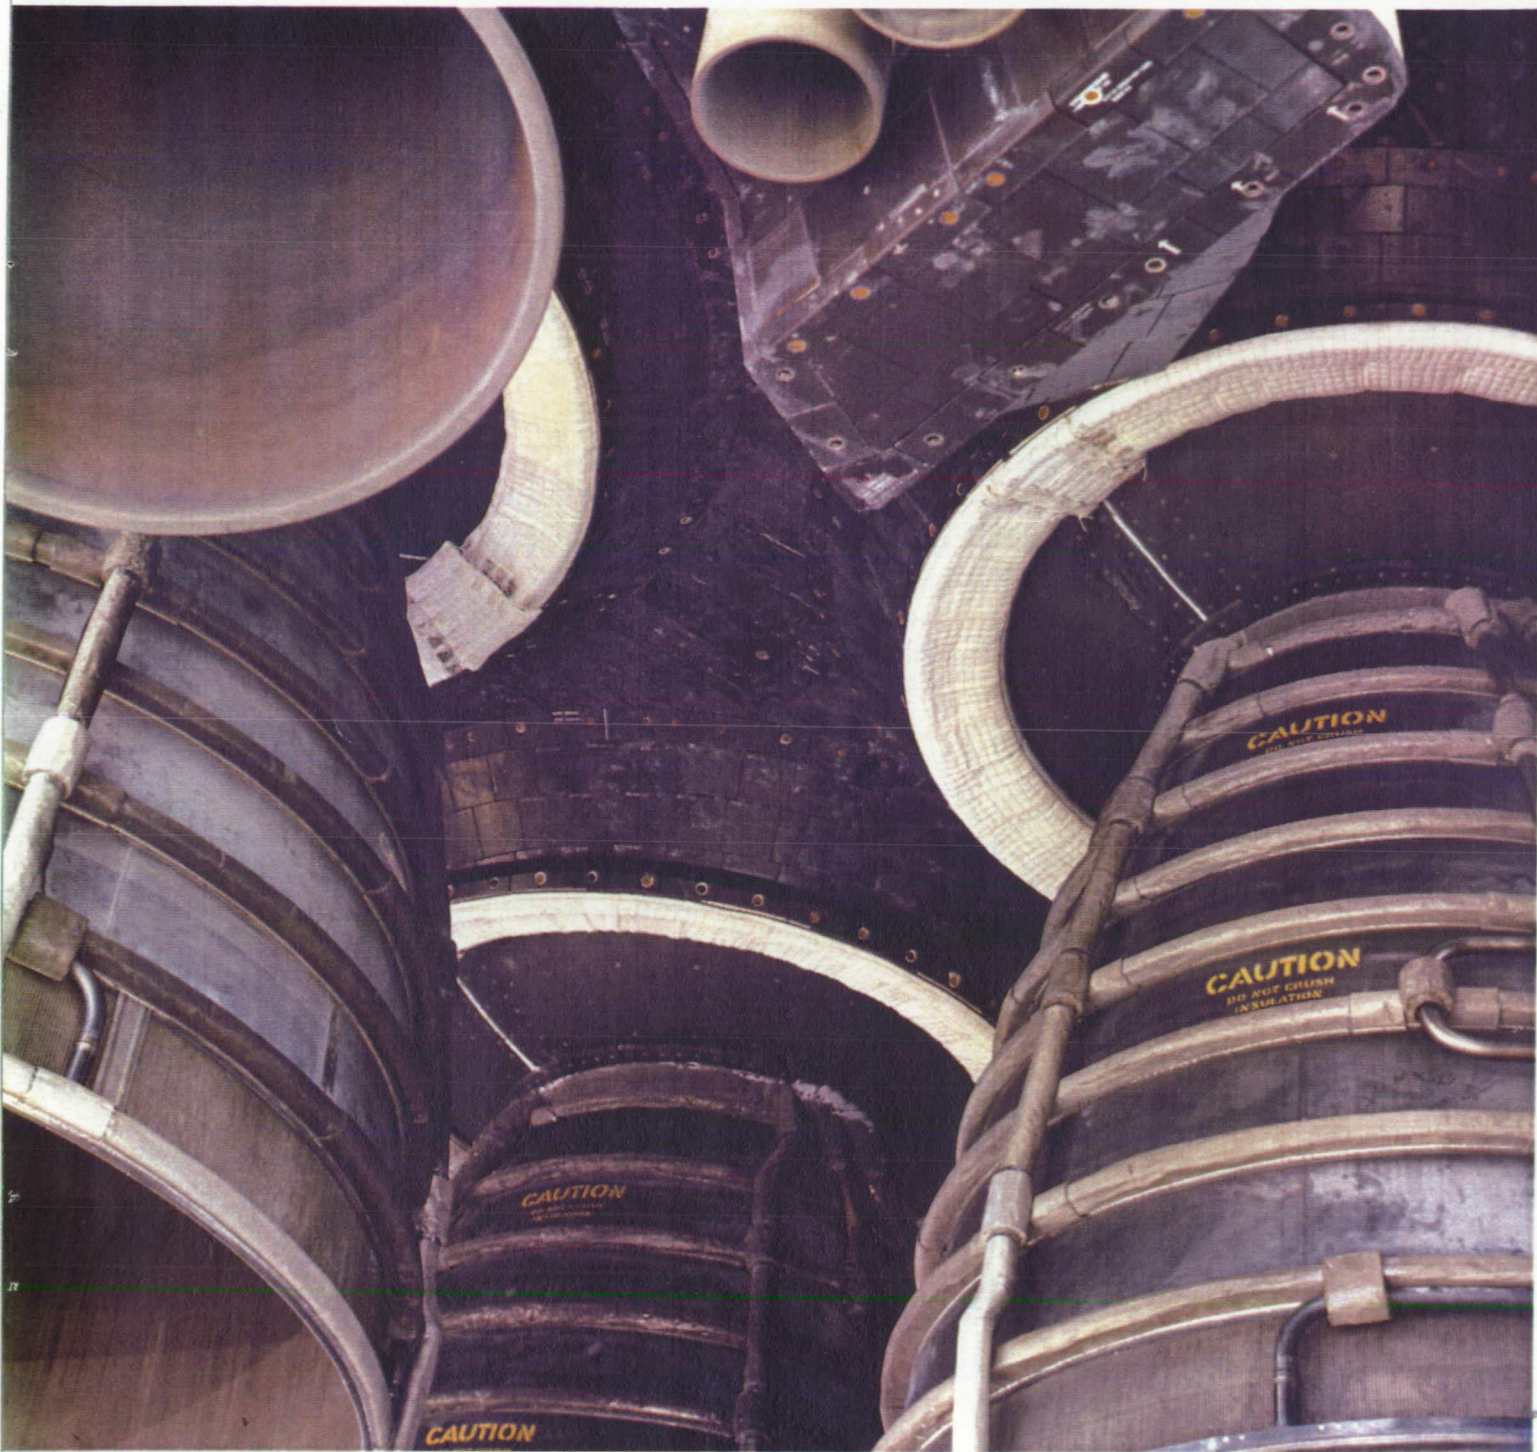
Overall view of SSME cluster. Some ice/frost had formed at the SSME #2 heat shield-to-nozzle interface.

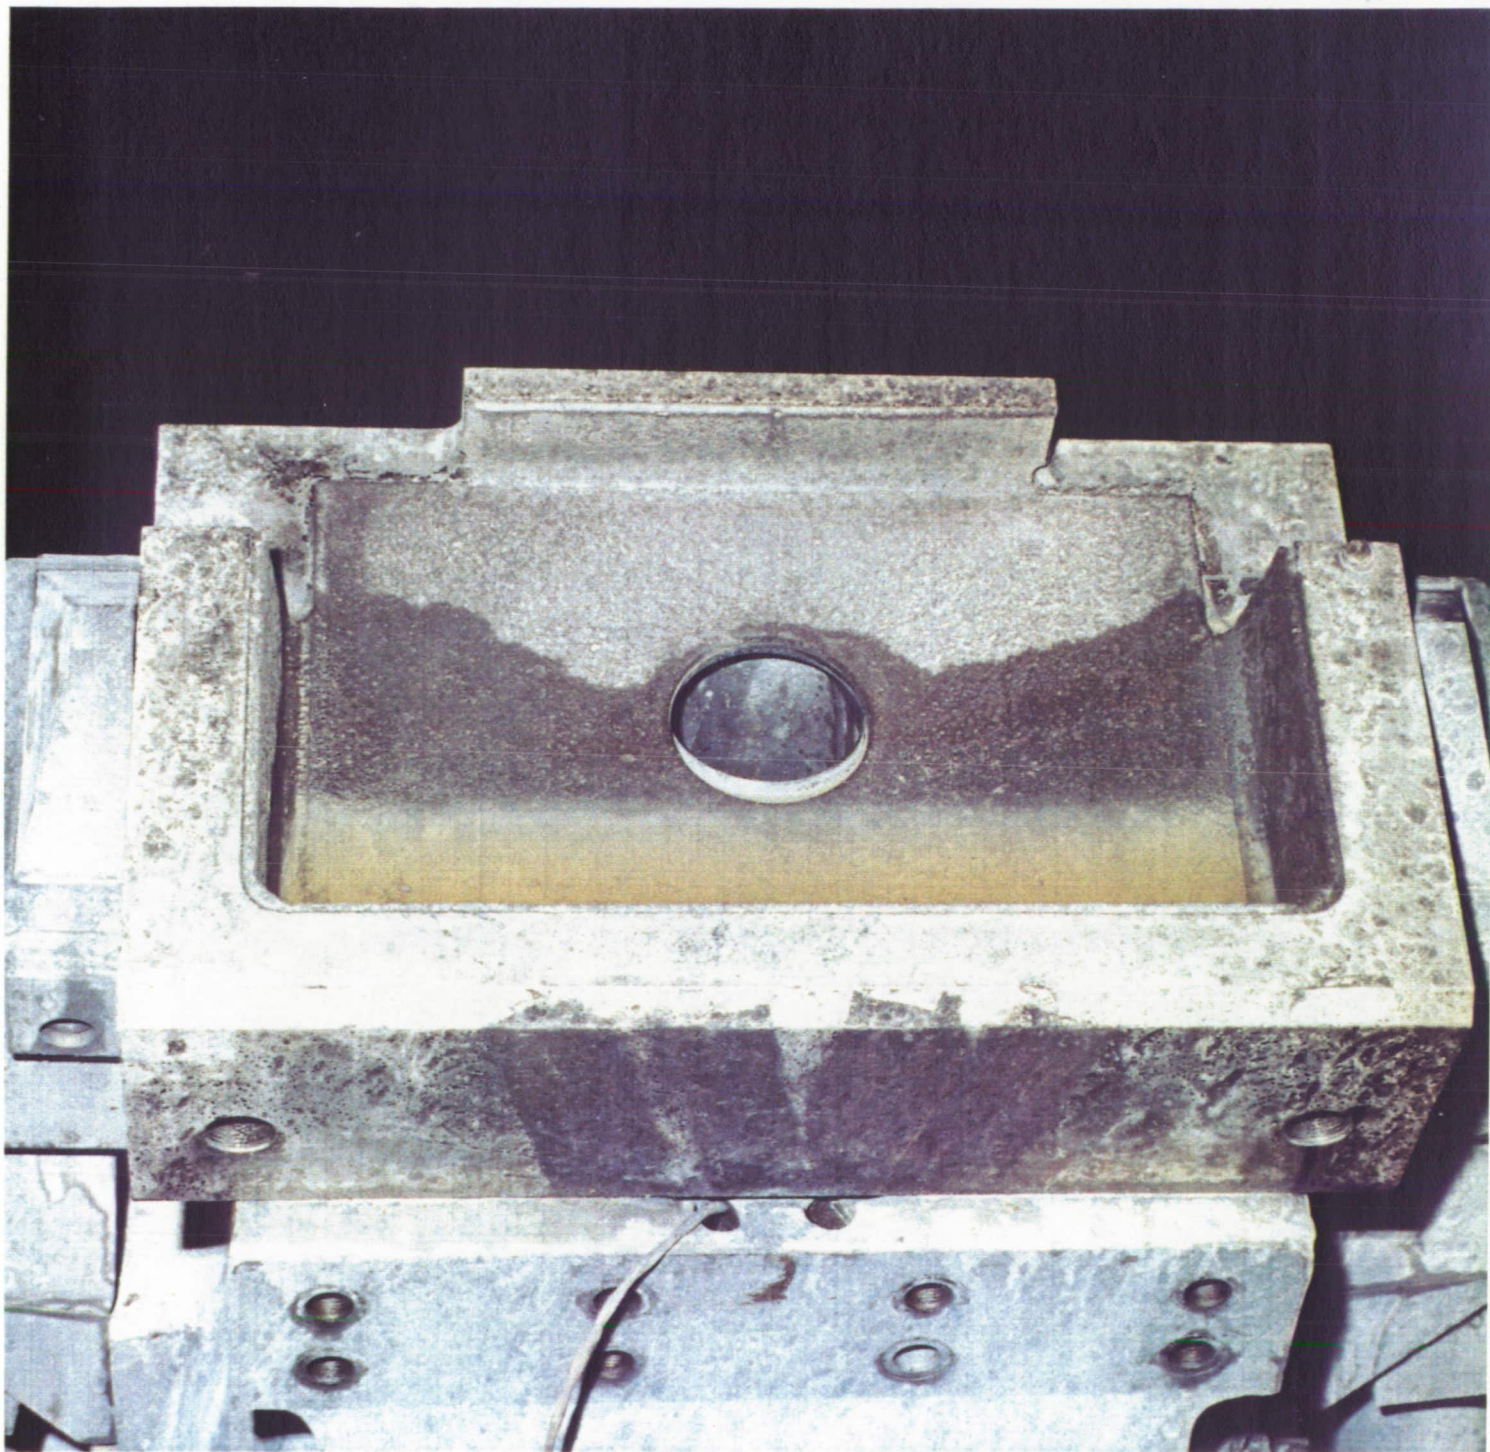
Plume erosion of the south SRB holddown posts was typical. All EPON shim sidewall material and shim bottom plate material was intact and bonded to the shoes. There was no visual indication of a stud hang-up on any of the south holddown posts.

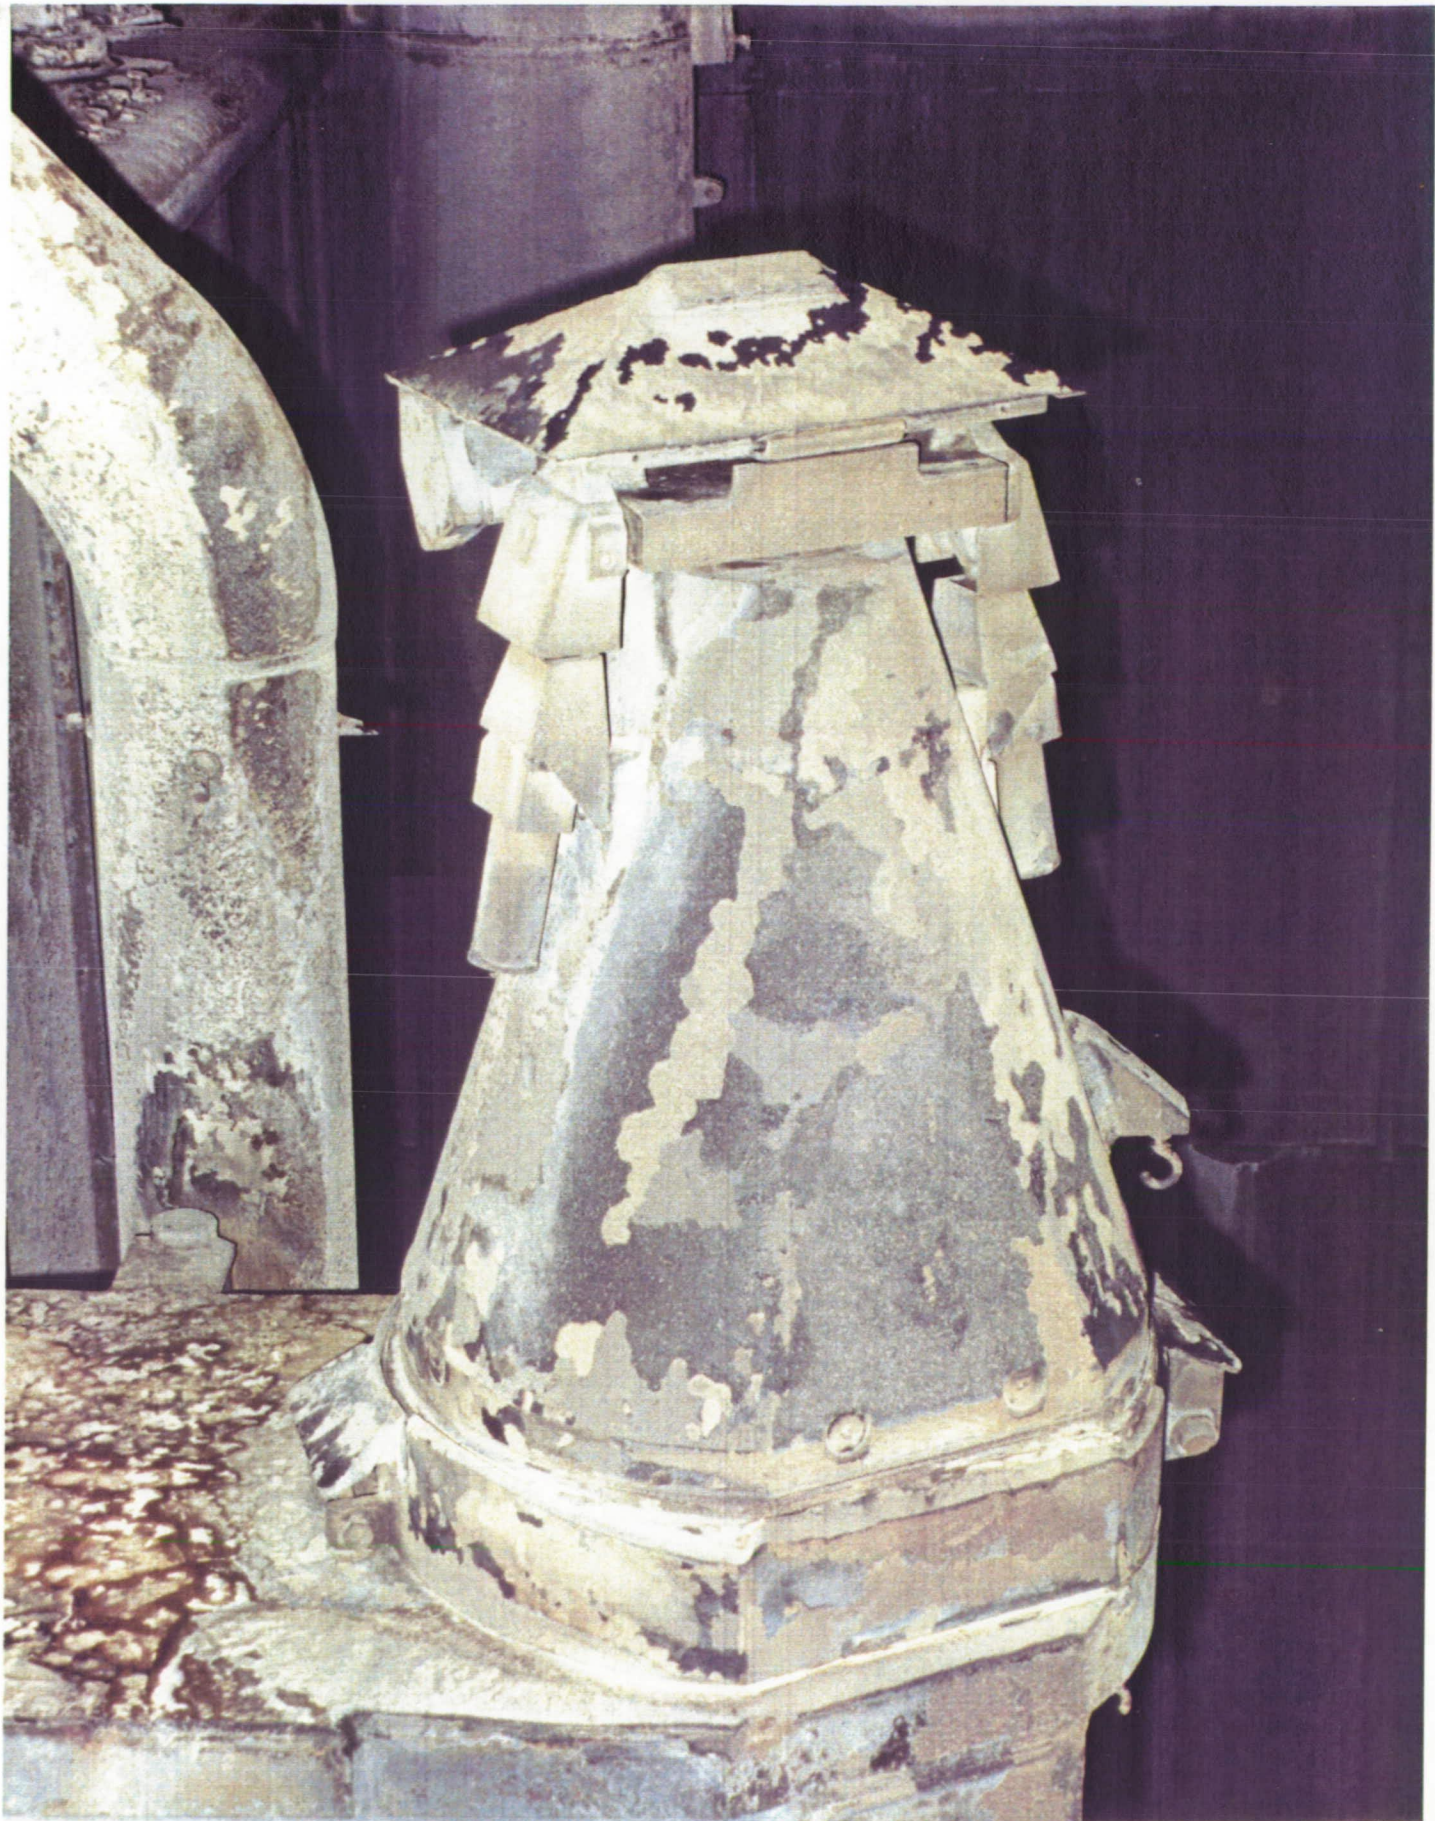
North HDP blast covers were in the closed position and exhibited typical SRB plume erosion effects

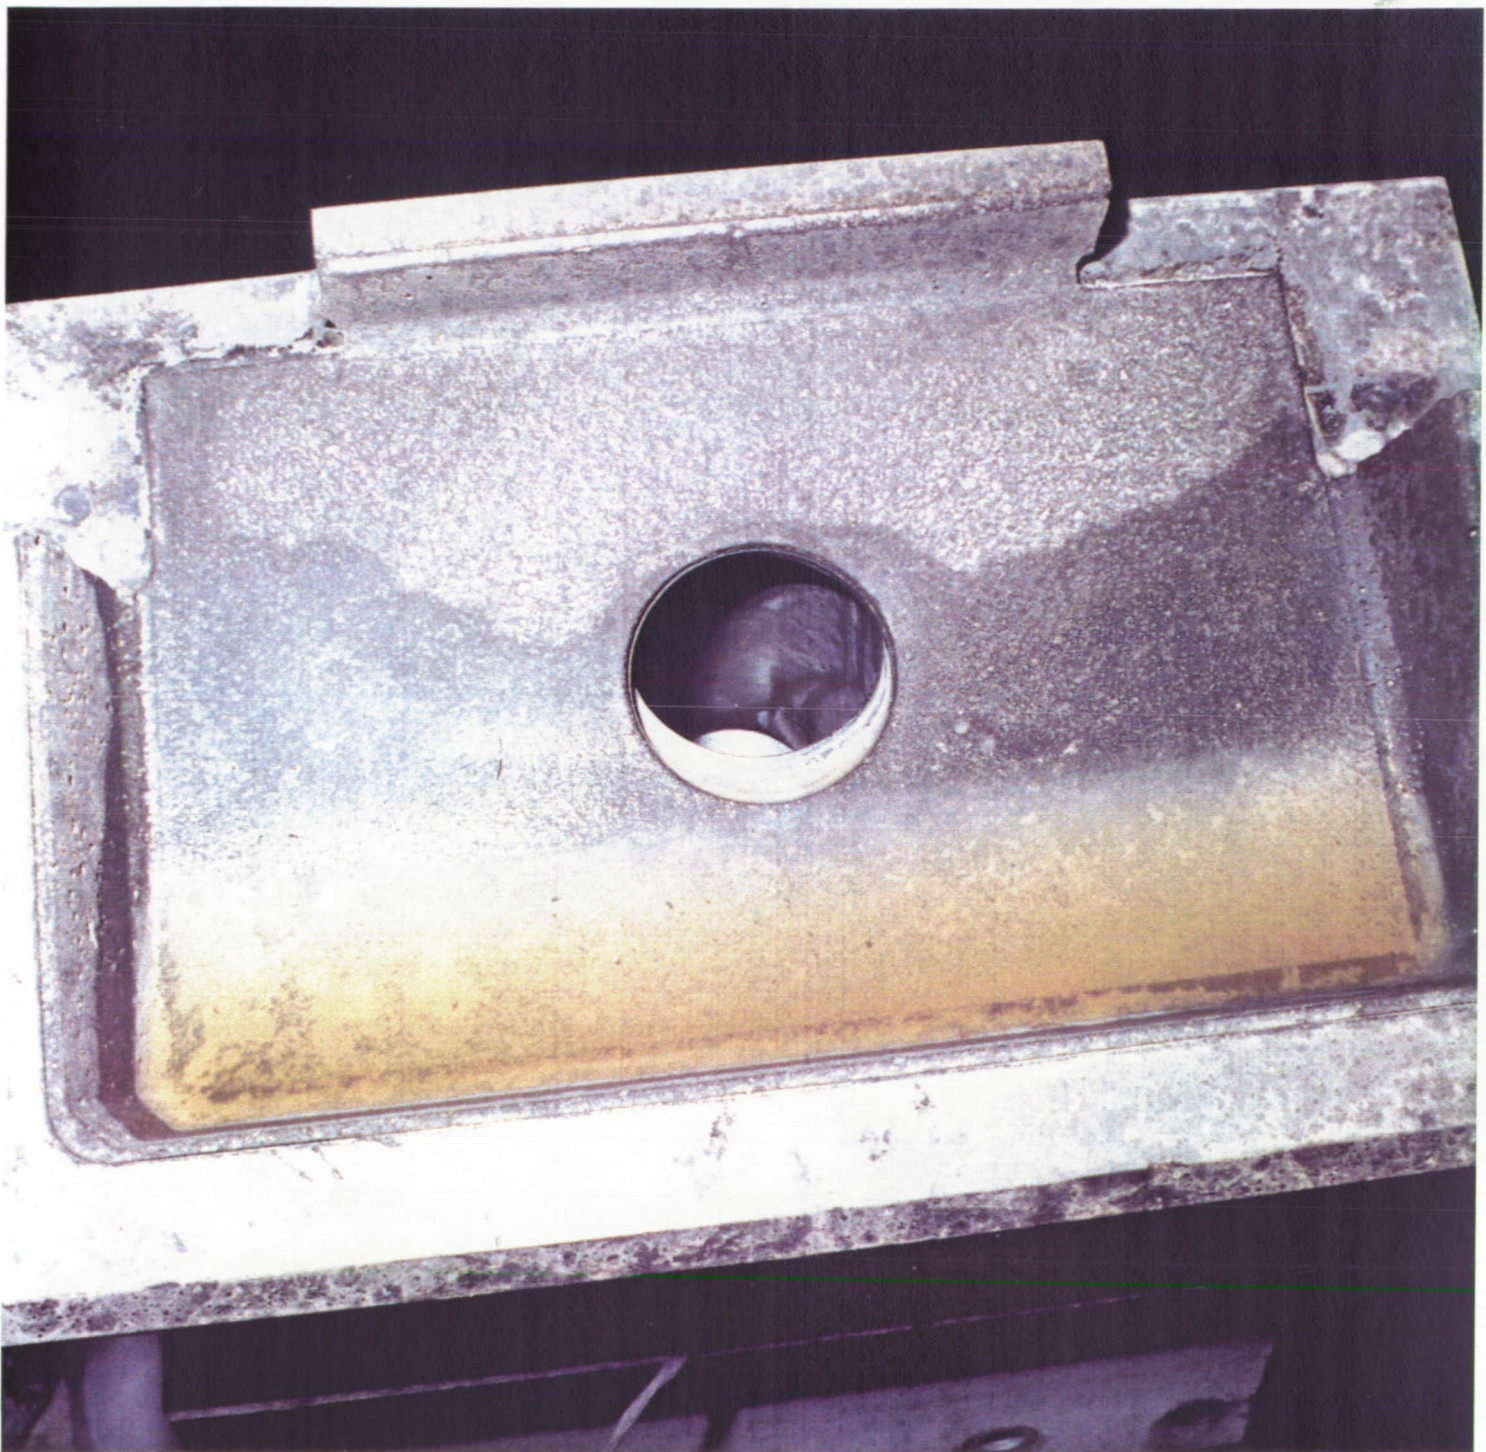
Frangible nut/ordnance fragments lay on the stud in HDP #5. These fragments had not been retained by the Debris Containment System (DCS) and fell from the aft skirt stud hole shortly after liftoff.

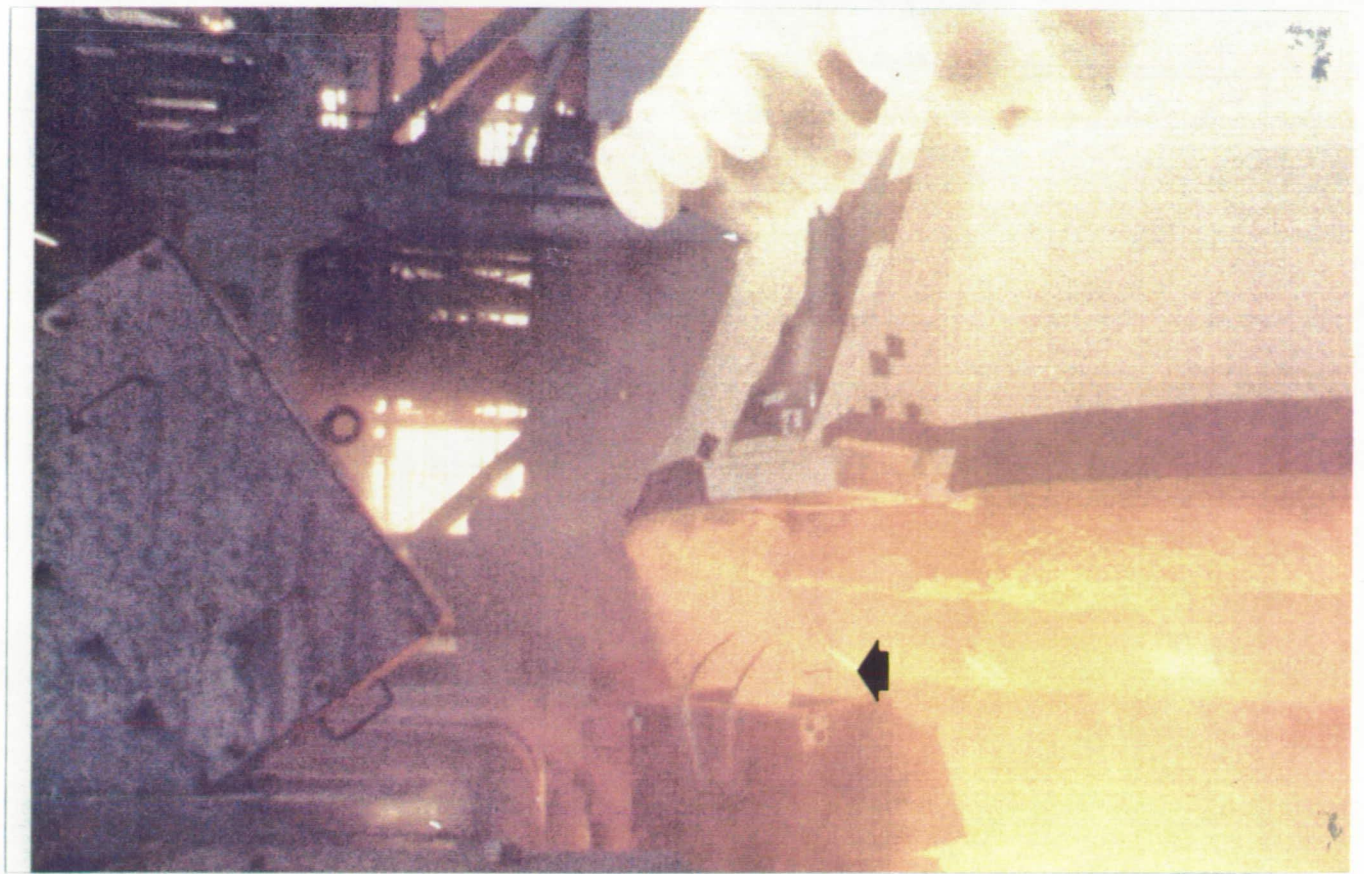
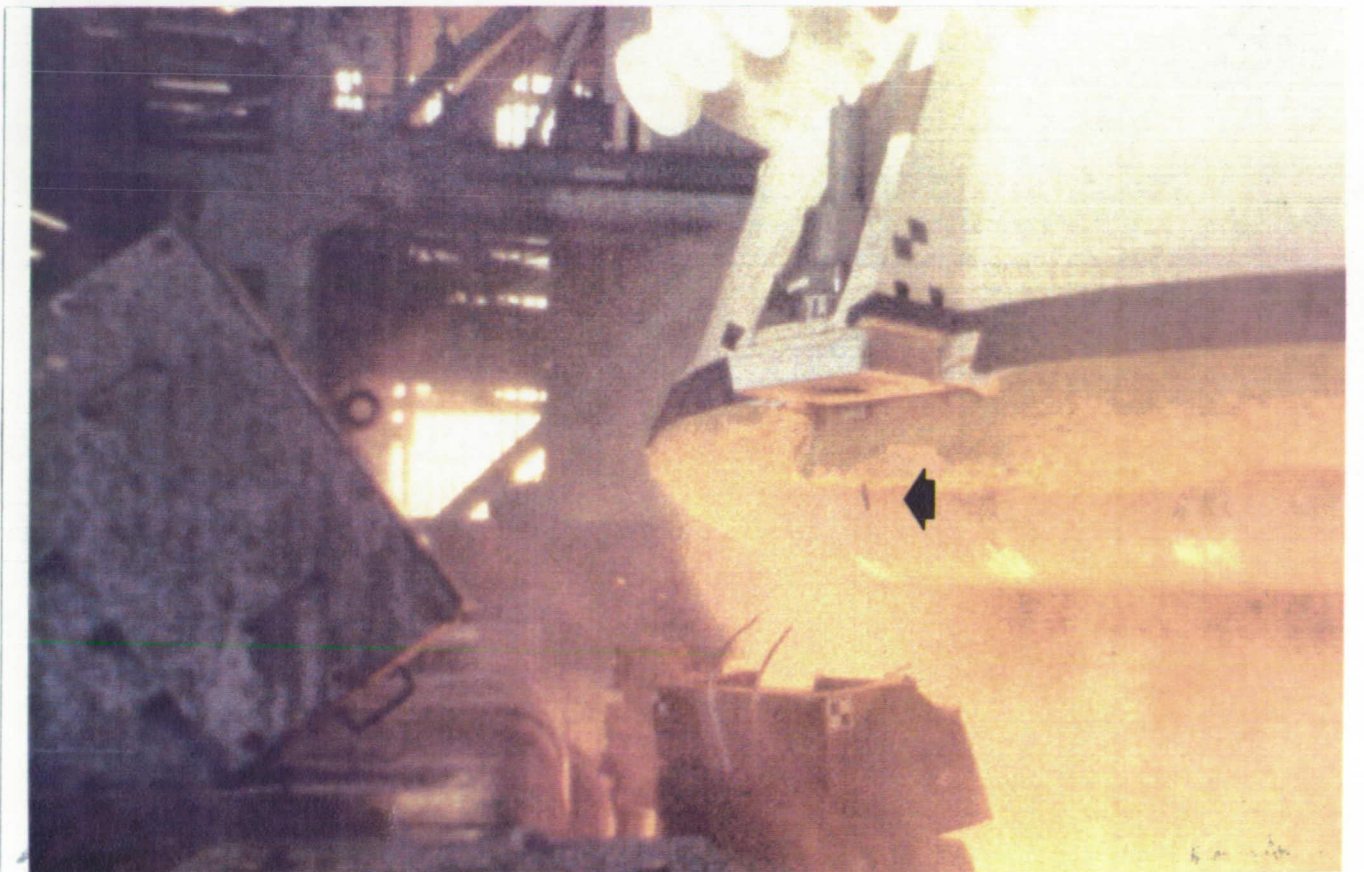
Shortly after liftoff, five ordnance fragments including two NSI booster pieces or frangible nut webs (3 inches in length), fell from the HDP #5 DCS/stud hole.

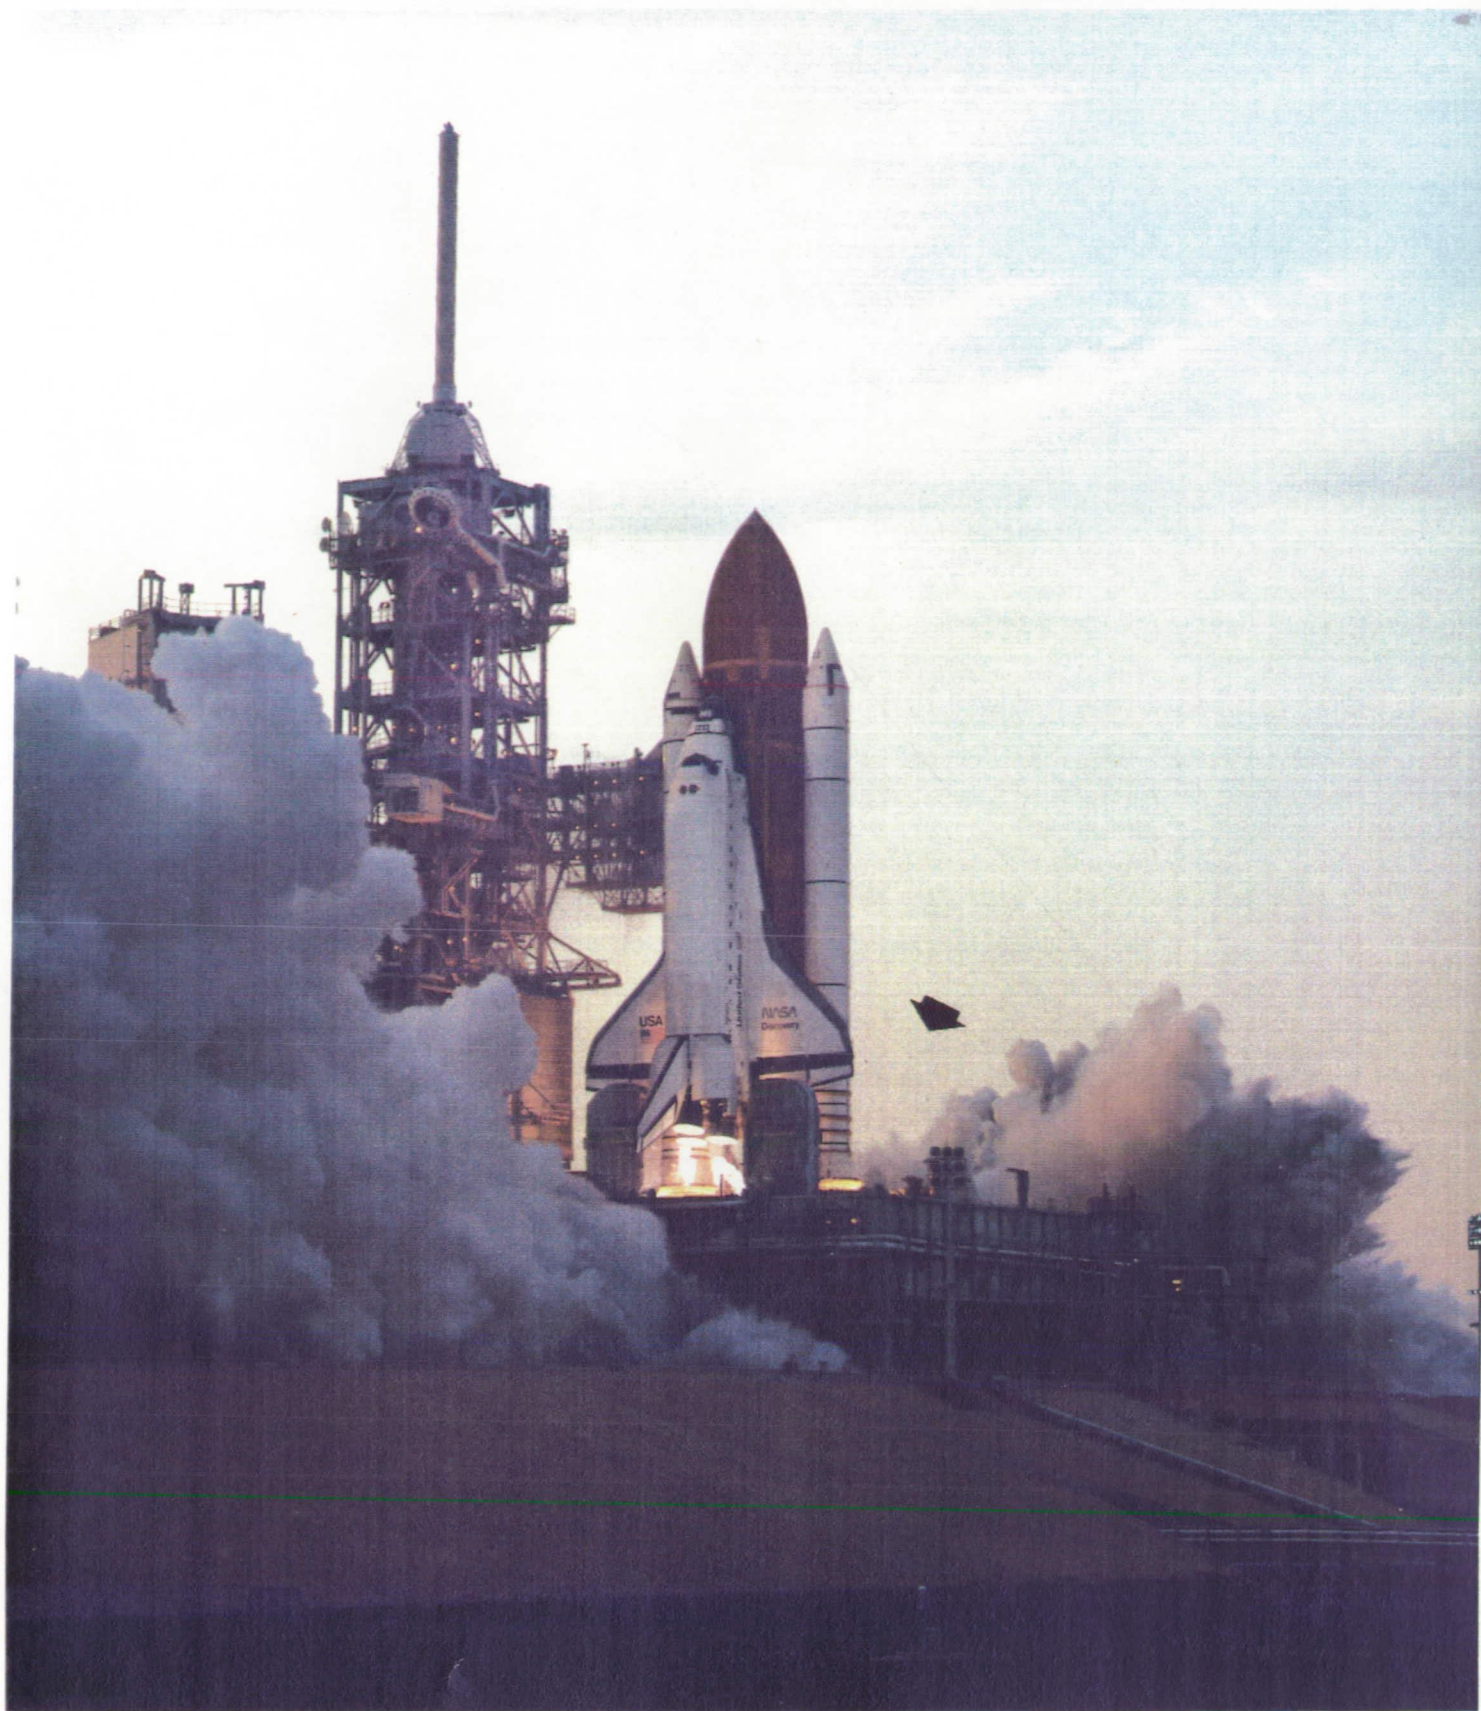
Numerous pieces of SRB throat plug material were ejected out of the SRB flame trench north of the vehicle. More SRB throat plug material was ejected upward out of the SRB exhaust holes. This is a common occurrence and none of the material was a threat to the vehicle.

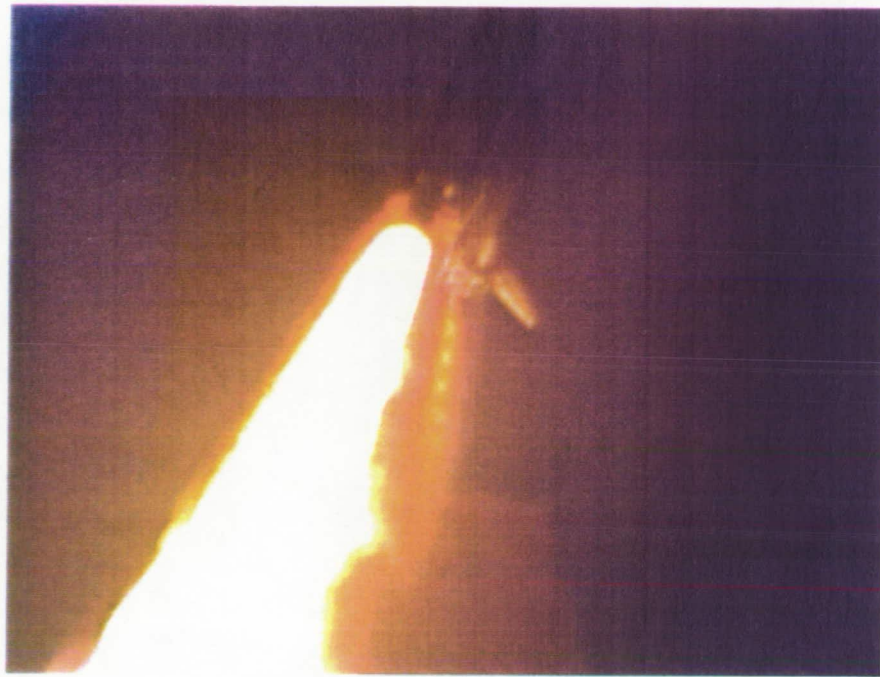
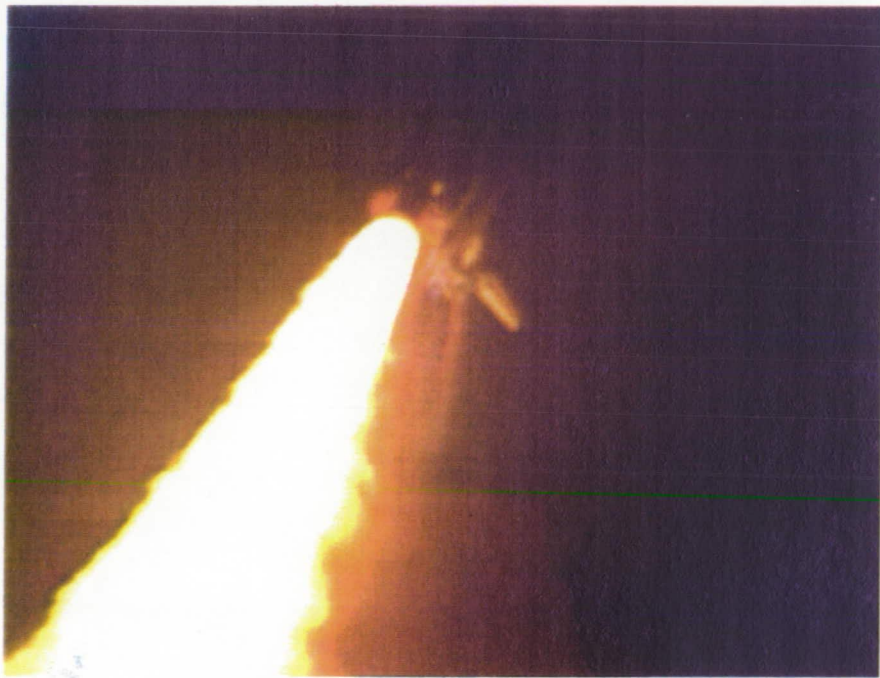
Two large orange flashes occurred in the SSME plume during ascent at T+29 seconds MET from SSME #2 and at T+31 seconds MET from SSME #1.

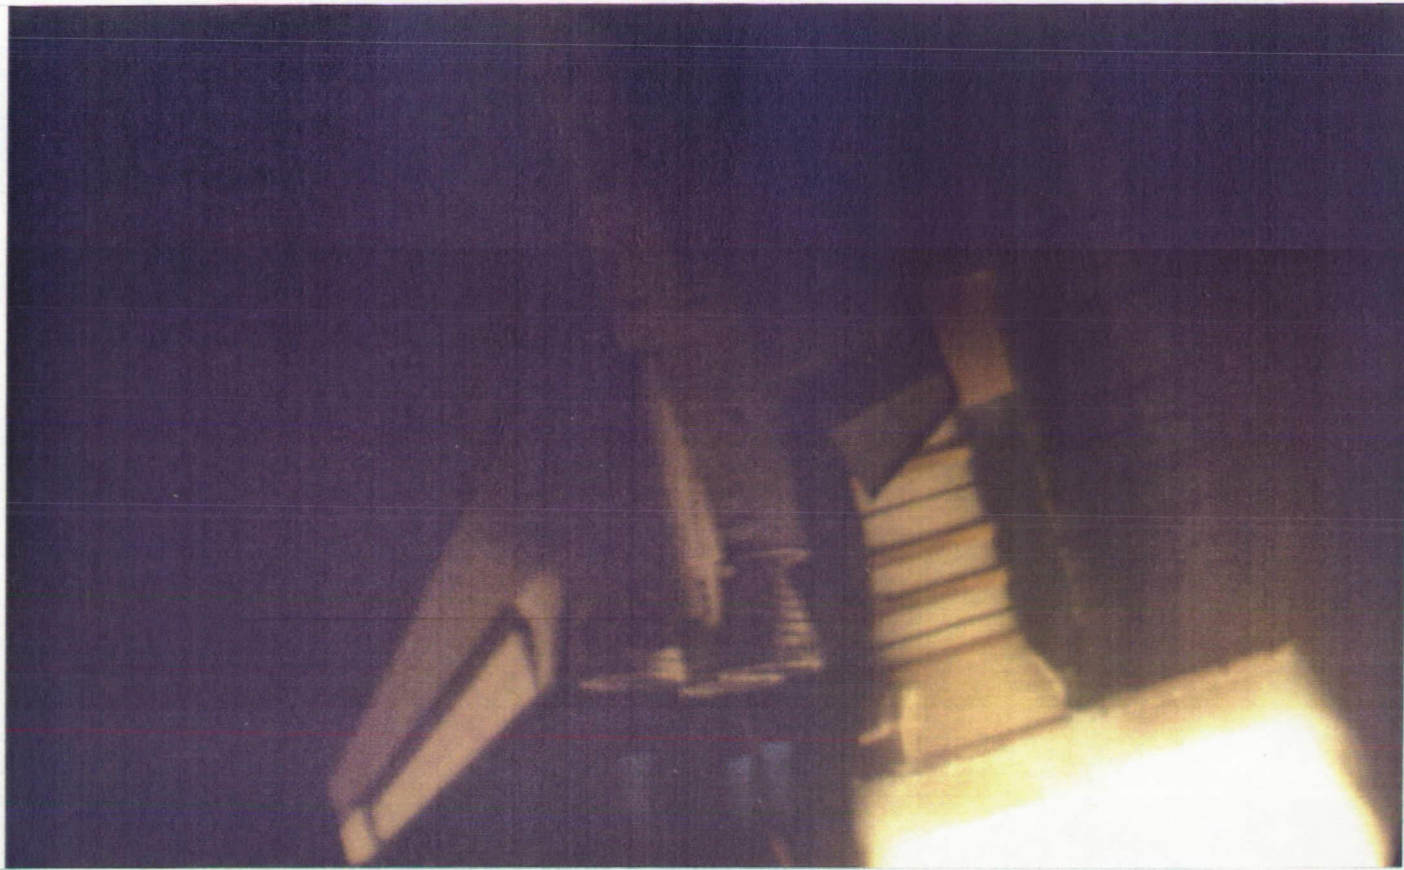
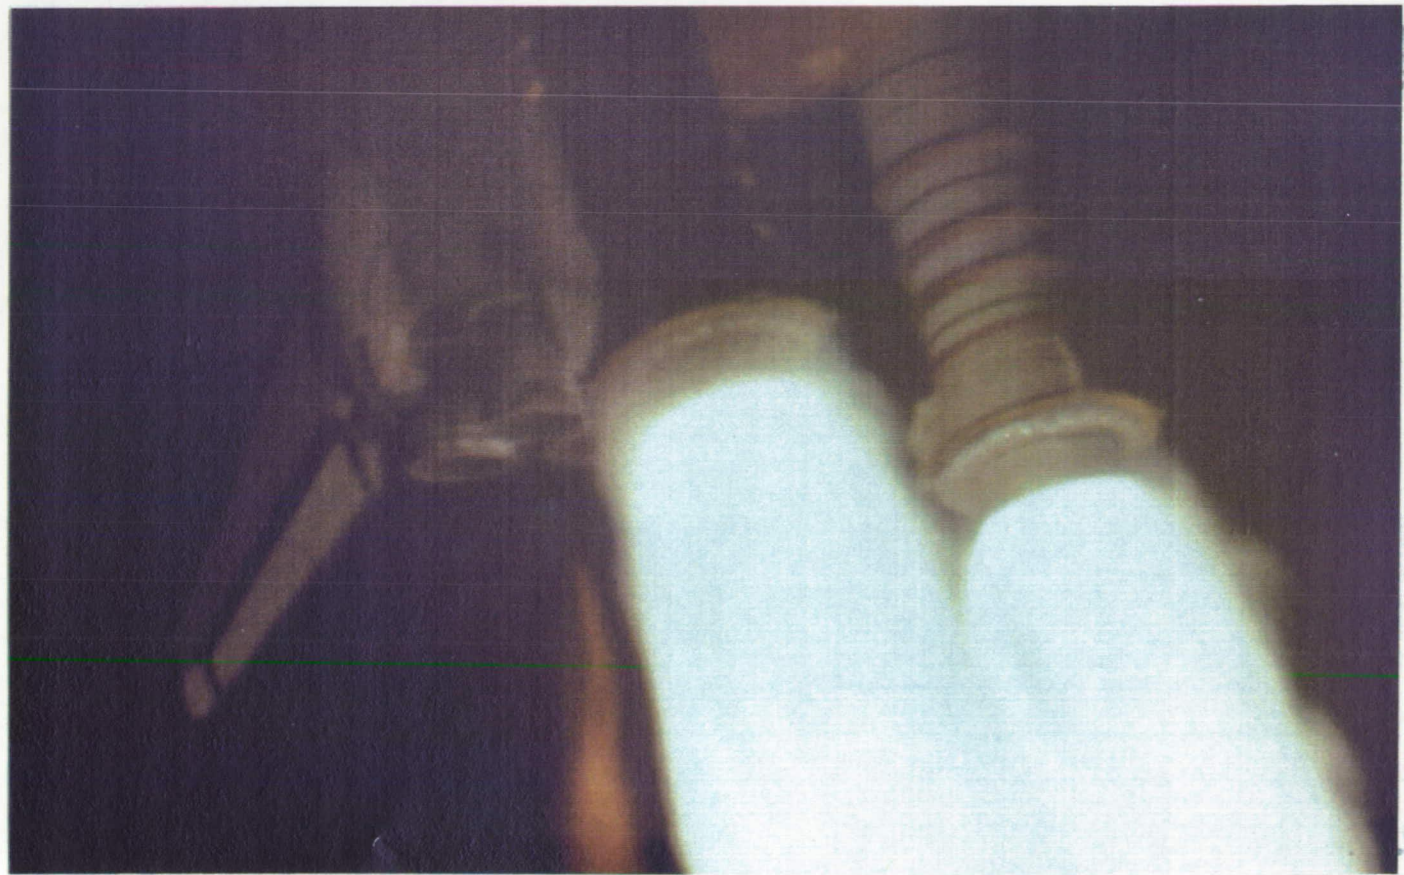
Pieces of paper covers from the LH FWD RCS fell past the aft end of the Orbiter (top photo). Orange streaks in the SSME plume are typically caused by debris particles, such as the RCS paper covers, entering the plume (bottom photo).
