NASA Technical Memorandum TM 103826

Debris/Ice/TPS Assessment And Photographic Analysis For Shuttle Mission STS-48

November 1991

Gregory N. Katnik
NASA/Kennedy Space Center

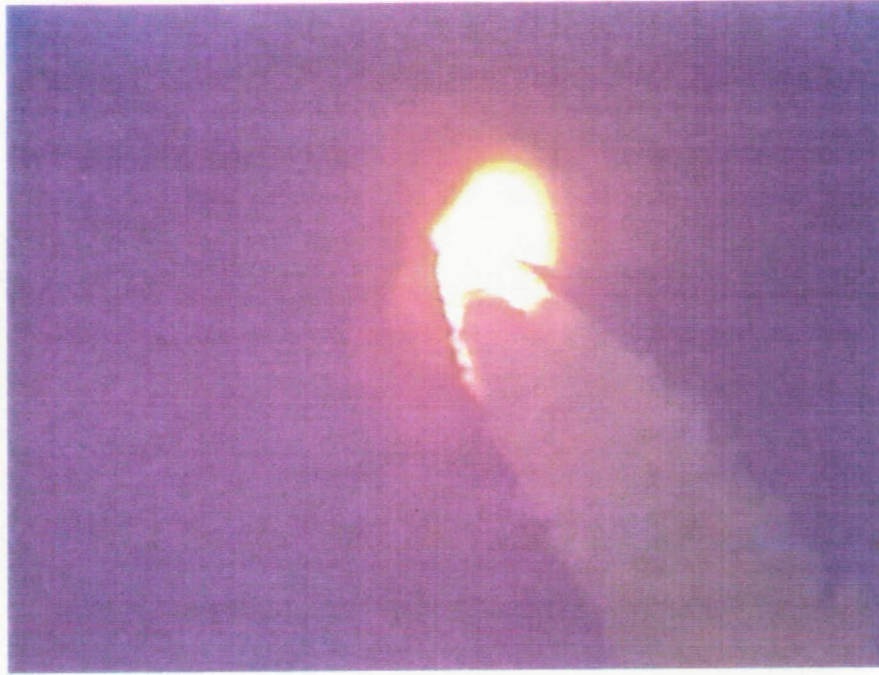
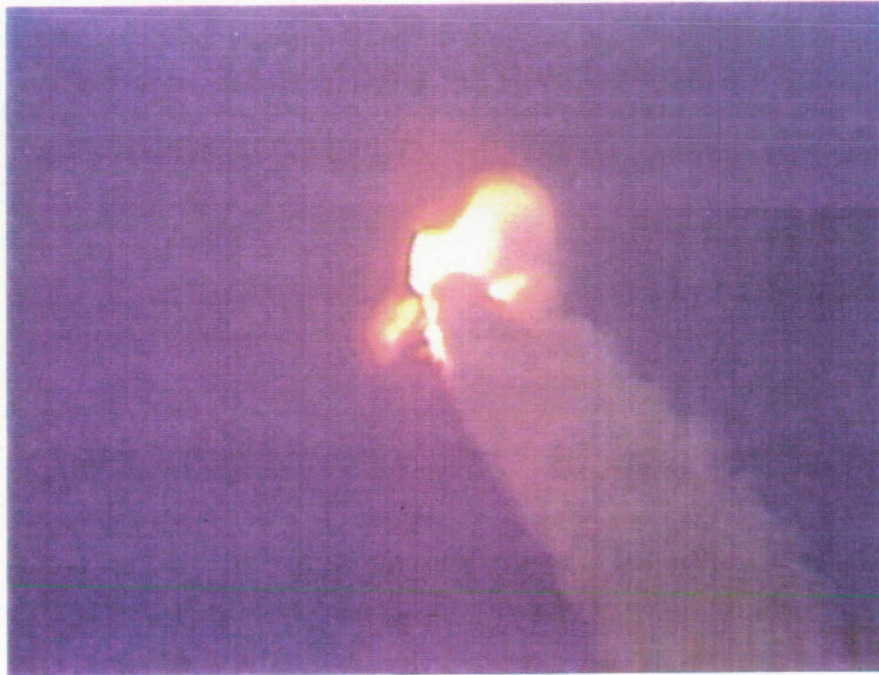
At T+58 seconds MET, the vehicle passed through a layer of cirrus clouds containing moisture or ice particles and a bright cloud of condensation/reflection surrounded the vehicle. The event was caused by atmospheric effects and was not a vehicle problem.

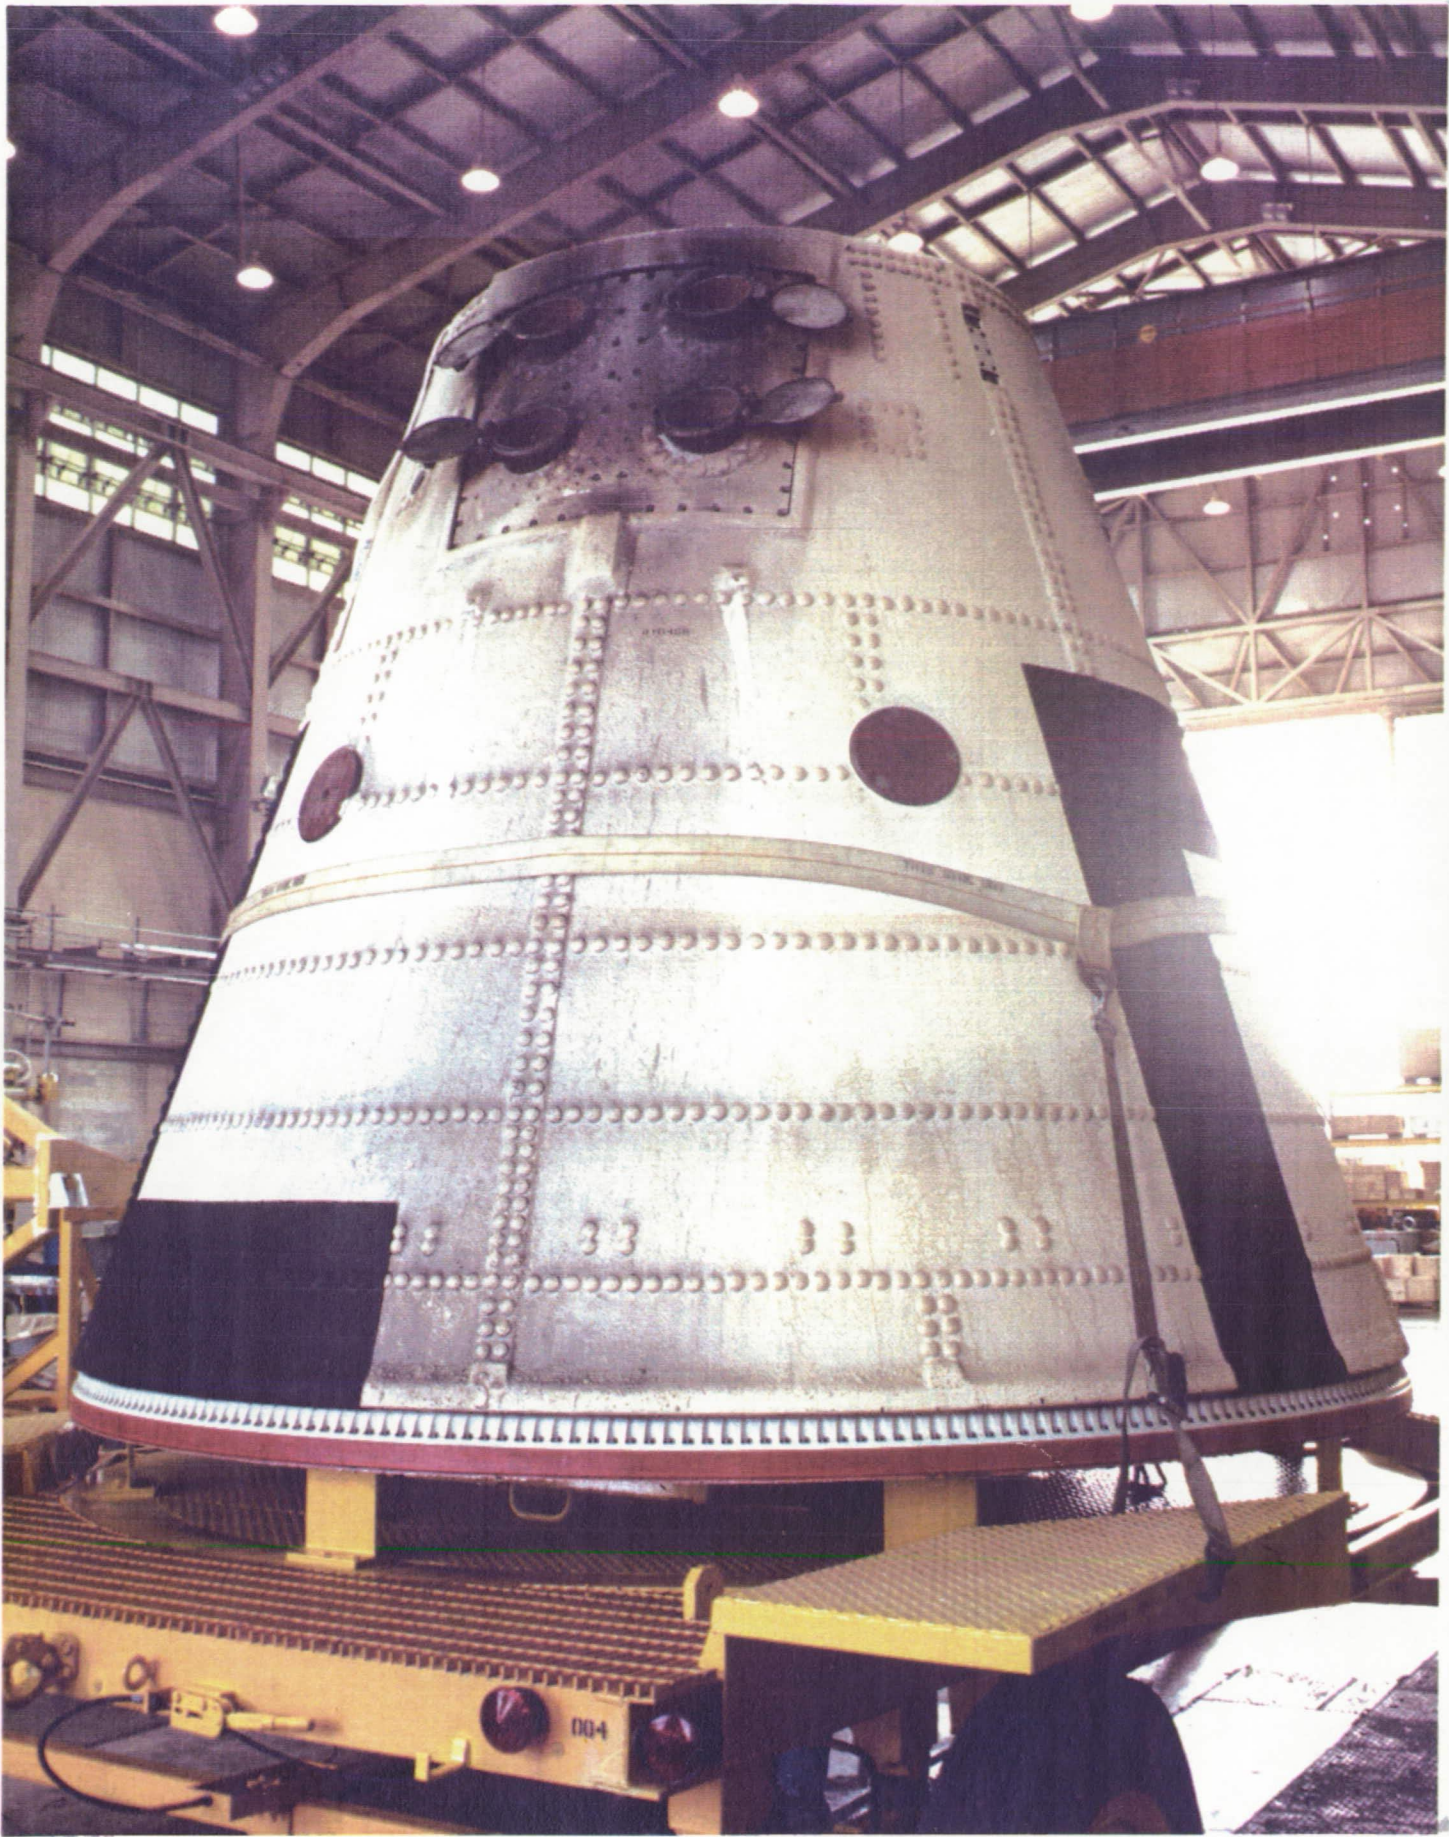
The RH frustum was missing no TPS but had 26 MSA-2 debonds over fasteners.

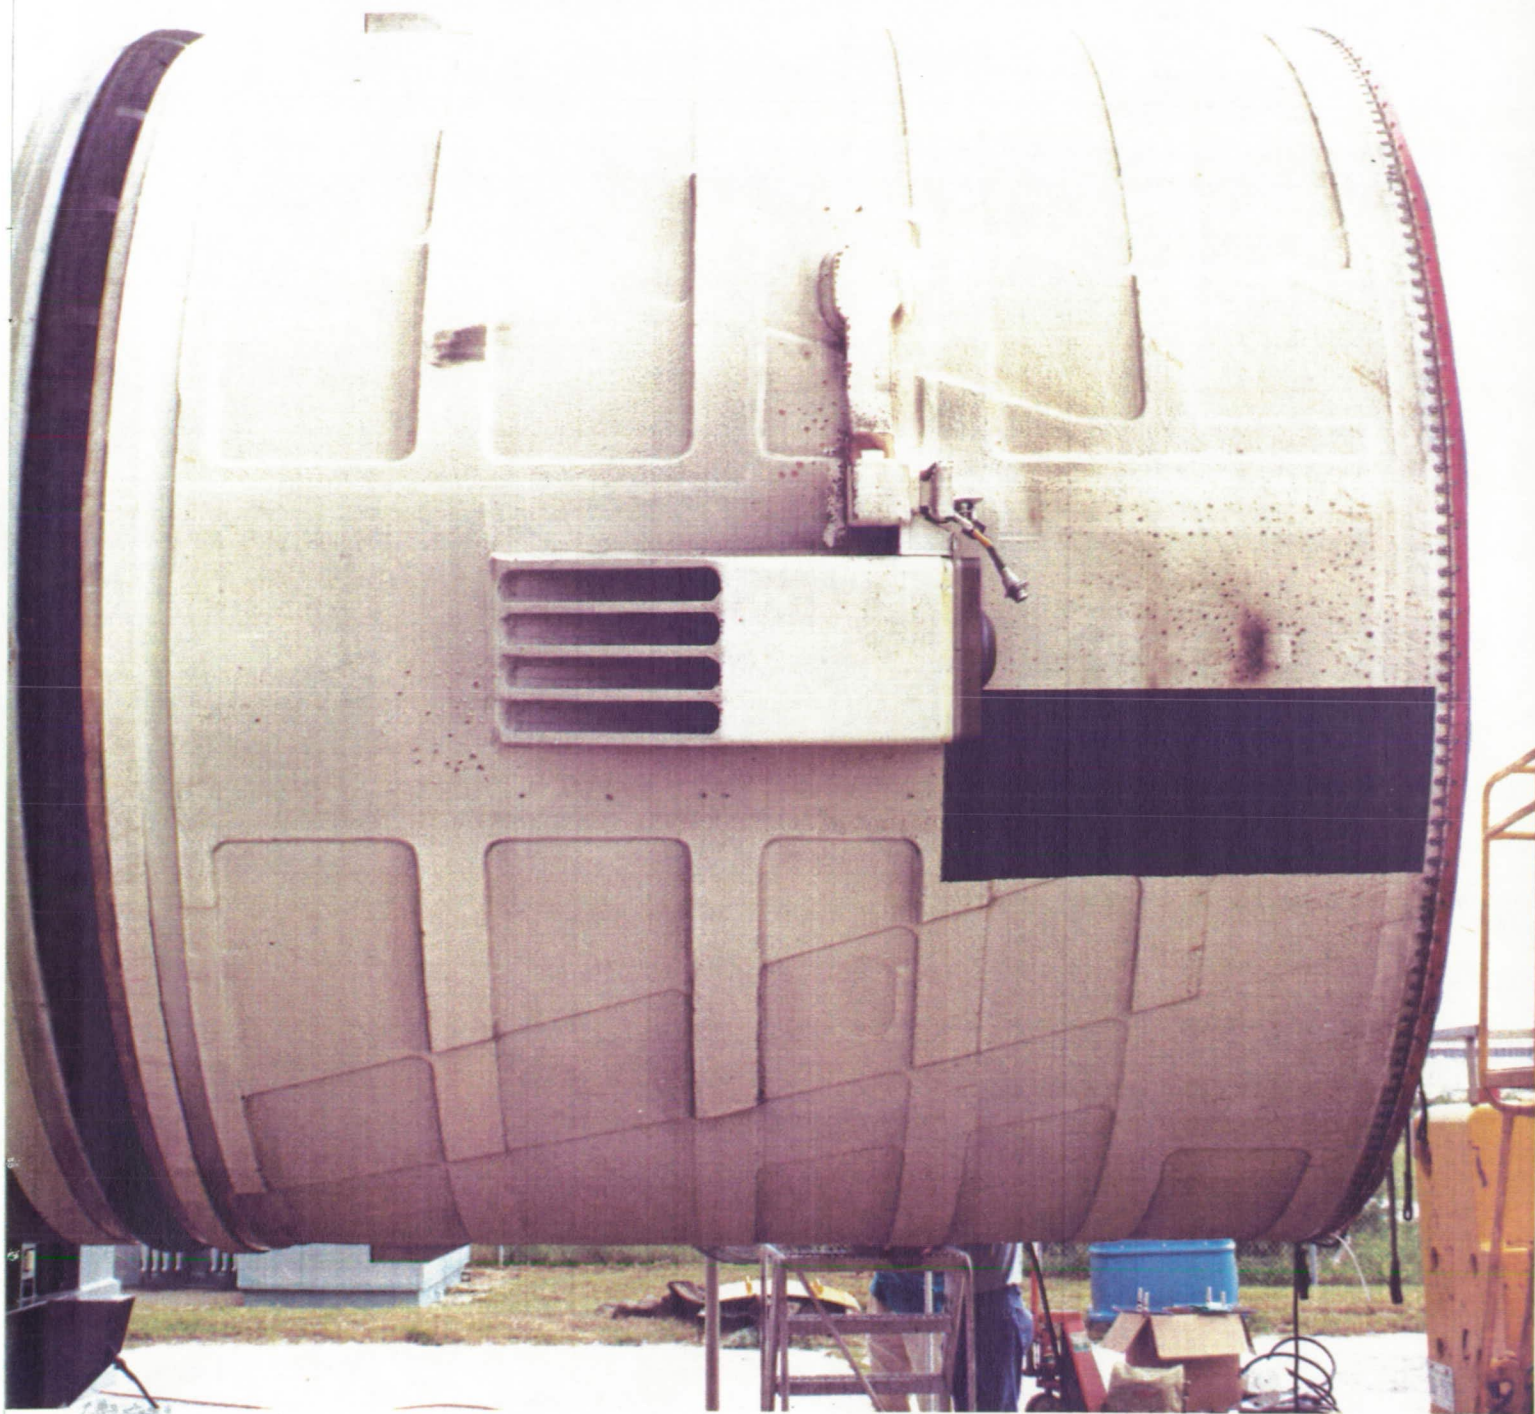
The RH forward skirt exhibited no debonds or missing TPS. Both RSS antenna phenolic plates were intact. Minor blistering of the Hypalon paint occurred forward of the ET/SRB attach point.

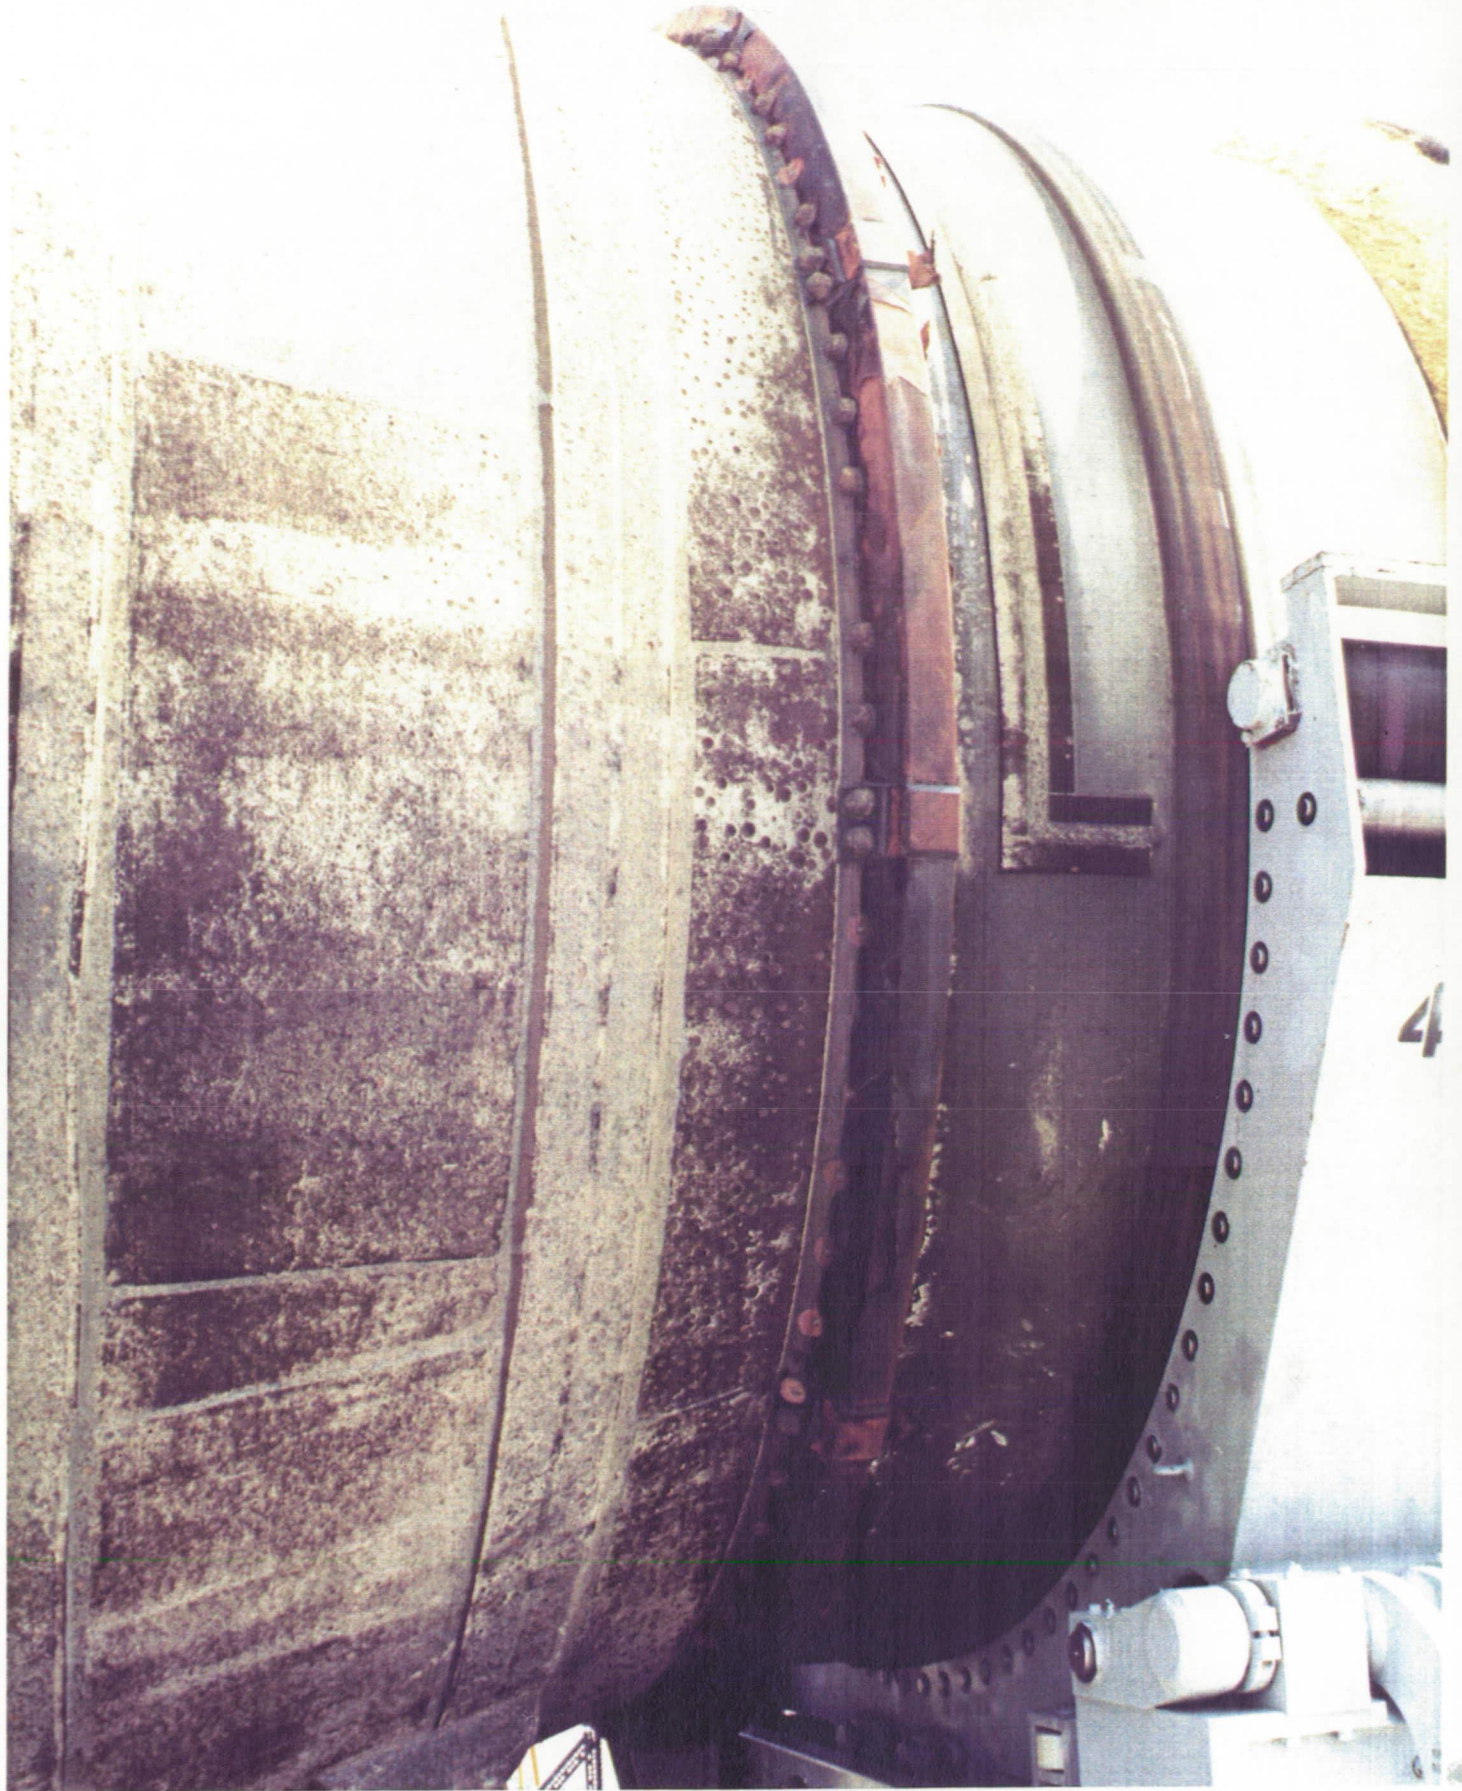
K5NA protective domes were lost from bolt heads on the aft side of the phenolic kick ring prior to water impact and exhibited a sooted substrate.

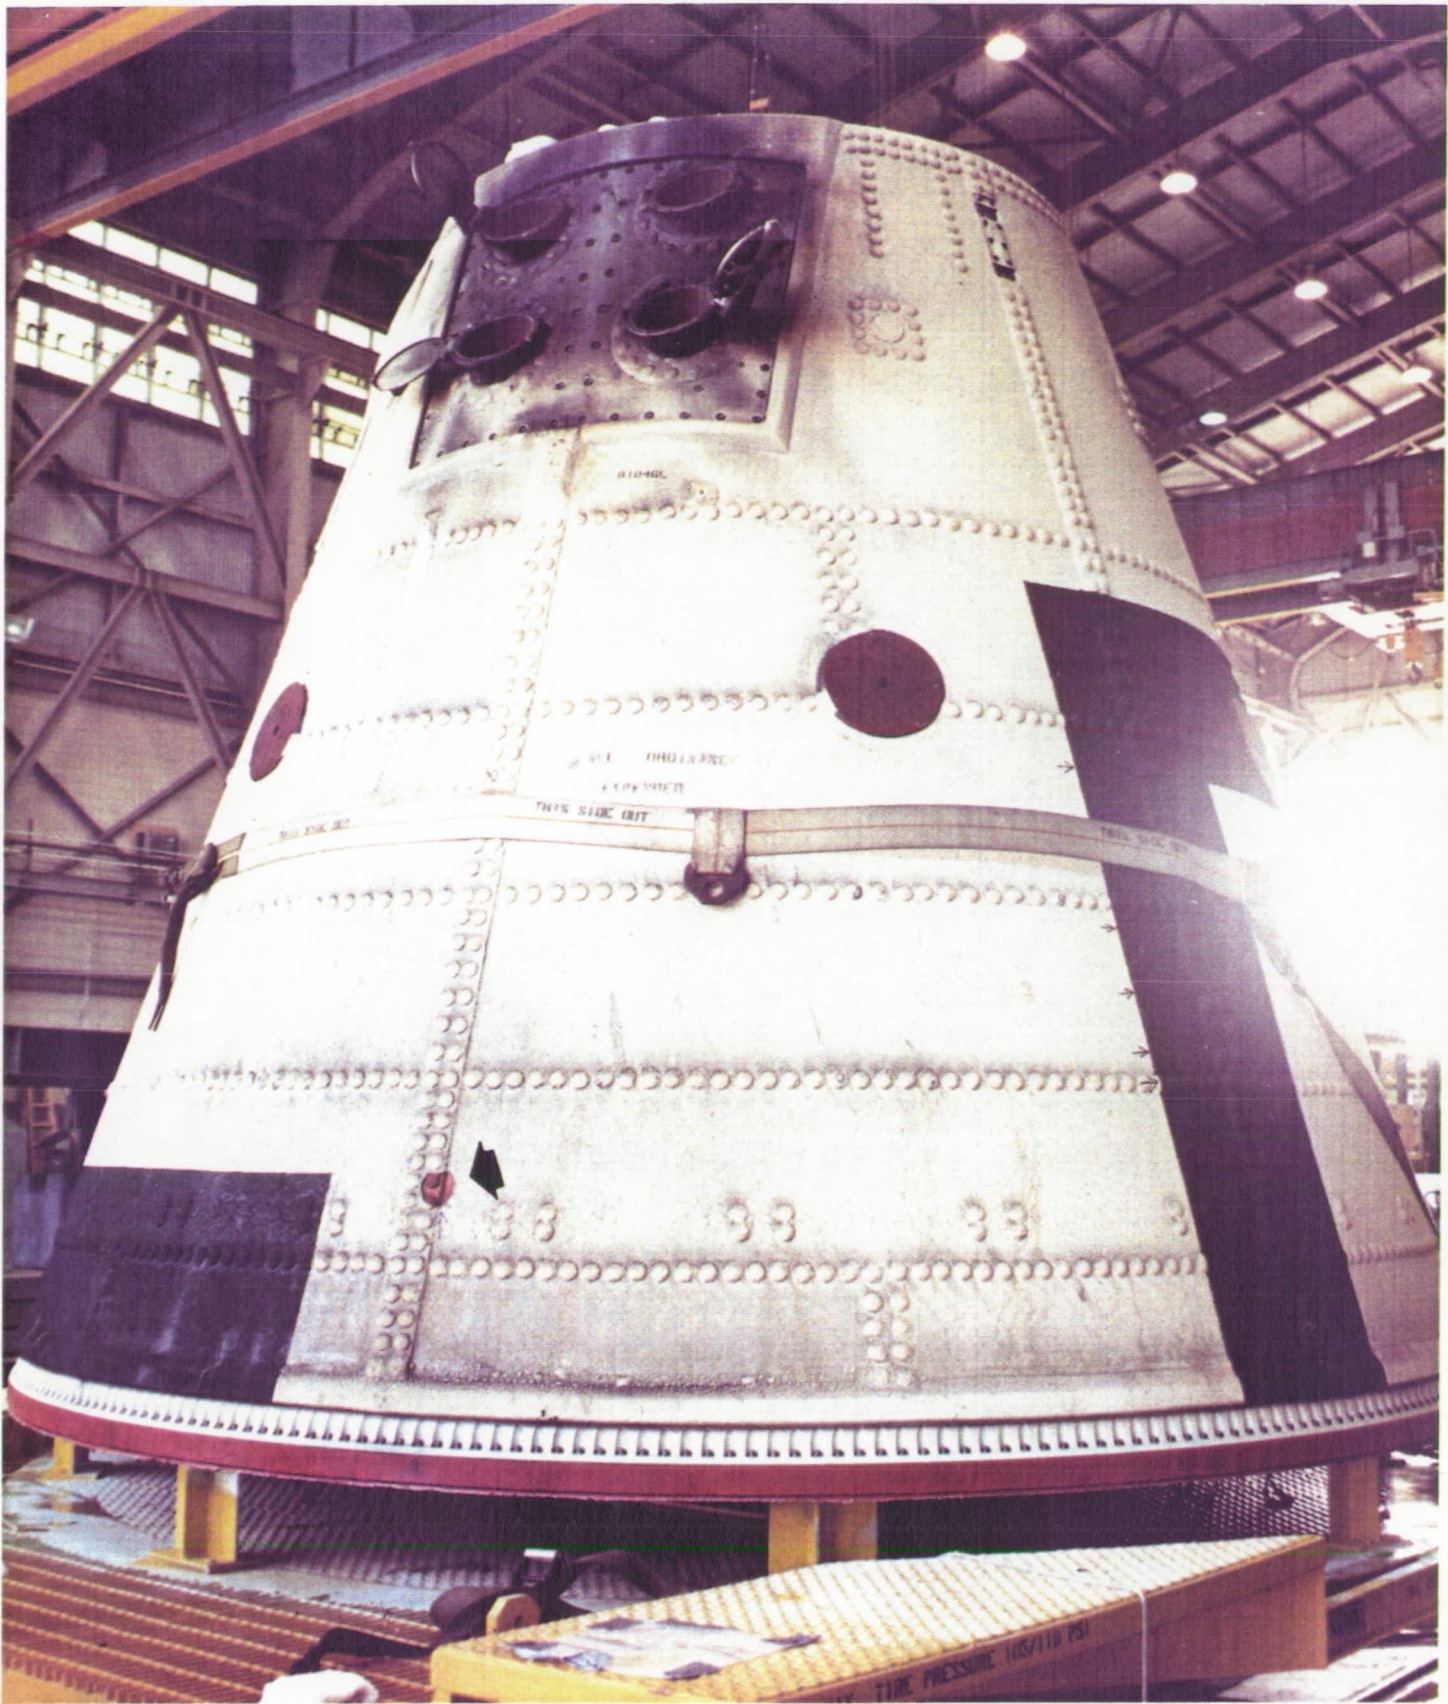
The LH frustum had 51 MSA-2 debonds over fasteners. Damage occurred to the forward BSM aero heatshield covers/attach rings and a piece of MSA-2 was missing near the 381 ring. BSM residue and sooting were typical. There was no evidence that unusual aerodynamic loading had occurred on the frustum.

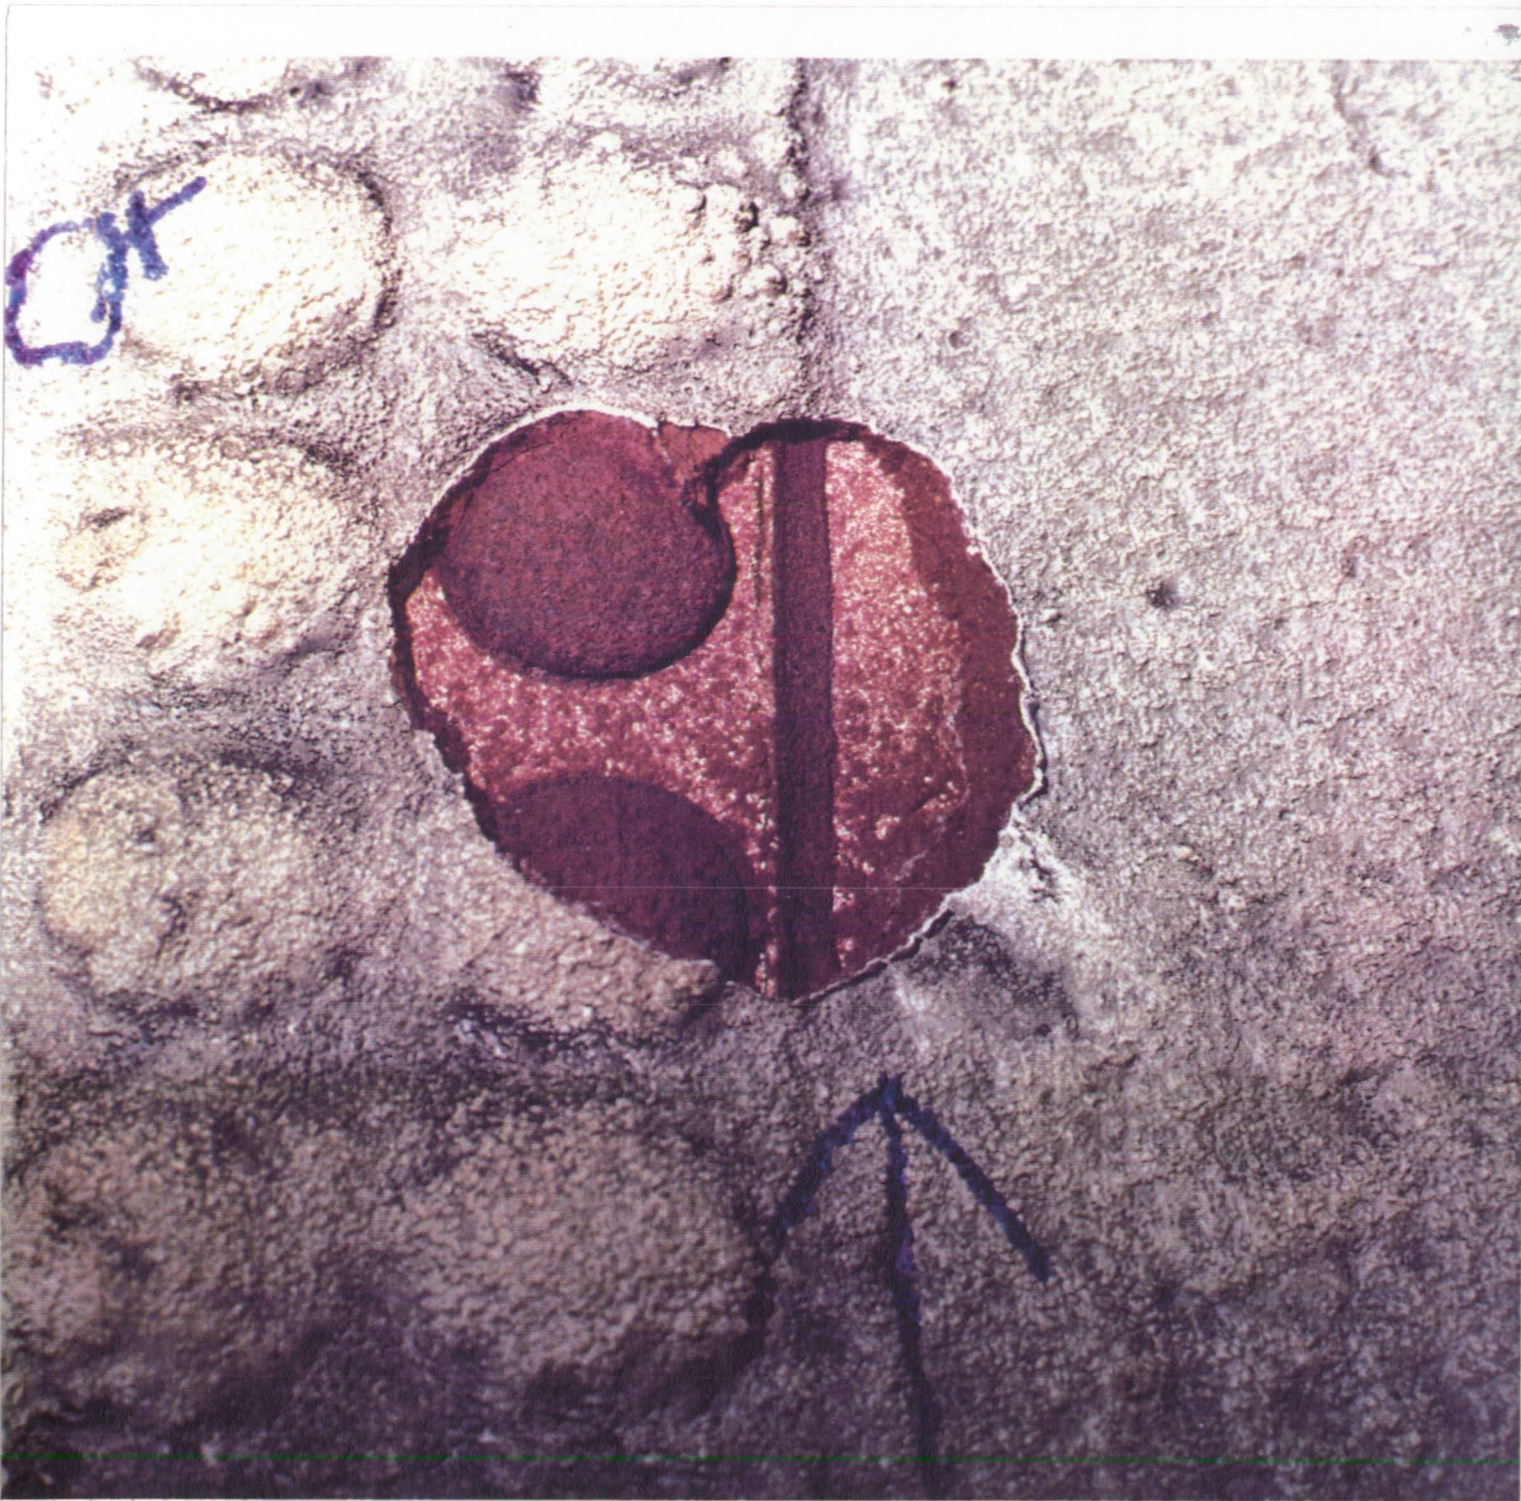
A 2.9" x 2.75" area of MSA-2 was missing from the LH frustum on the stiffener below the BSM's near the 381 ring. A laboratory analysis was performed at MSFC on the MSA-2 divot area. Examination of the surrounding material showed that the exposed surfaces were clean and free of sooting/charring/ heat effects in an aero-thermal environment. Hypalon peelback occurred laterally and was not in the direction of the nosecone (forward flight). The report concluded the MSA-2 was lost either during the late stages of descent, at water impact, or during retrieval operations.

A 2.9" x 2.75" area of MSA-2 was missing near the 381 ring. The MSA-2 had separated completely from the substrate. The exposed surfaces of the surrounding material were clean and free of sooting/charring/heat effects. Hypalon peelback occurred laterally and was not in the direction of the nosecone. The MSA-2 was lost during the later stages of descent, at water impact, or during retrieval operations.

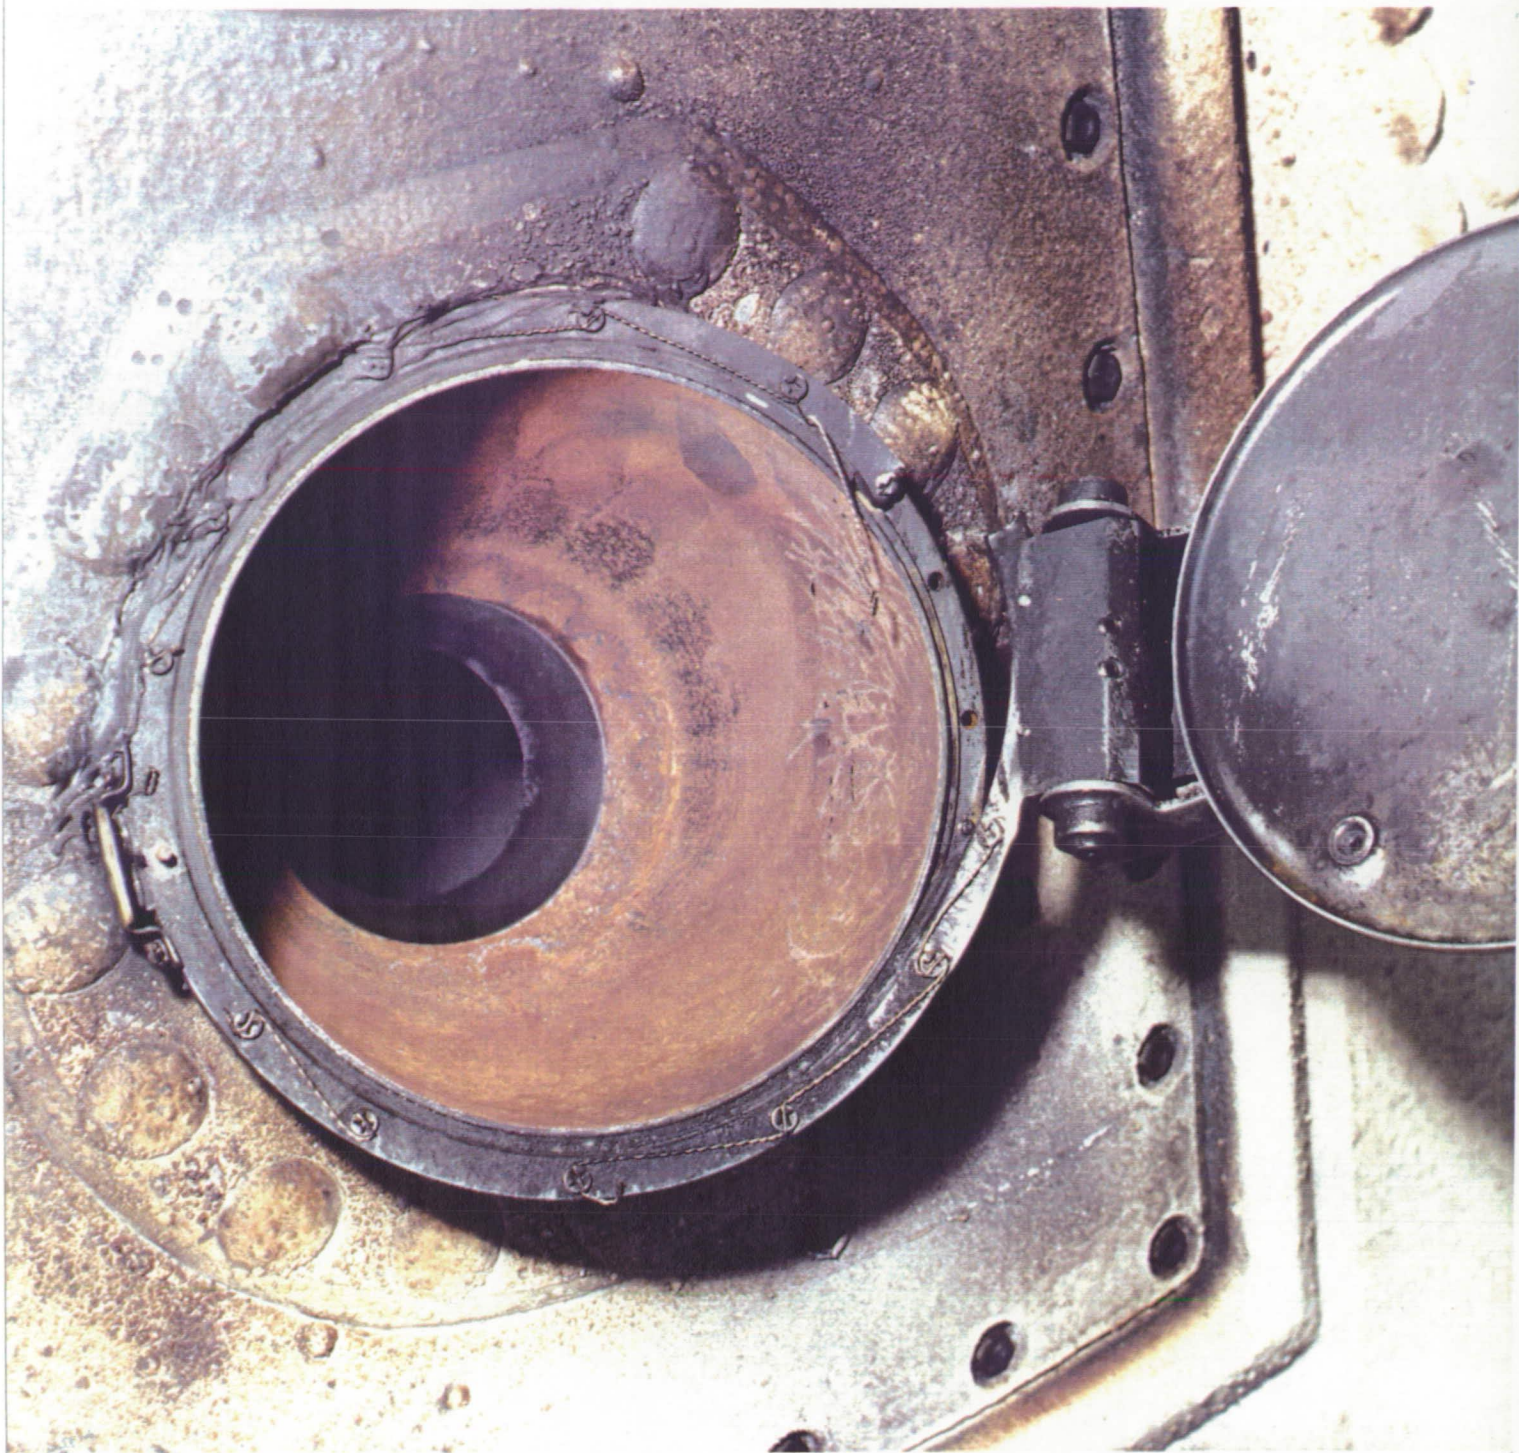
The lower right BSM aero heatshield cover attach ring/hinge had been deformed some time after being locked in the fully opened position. The attach ring was fractured at one location.

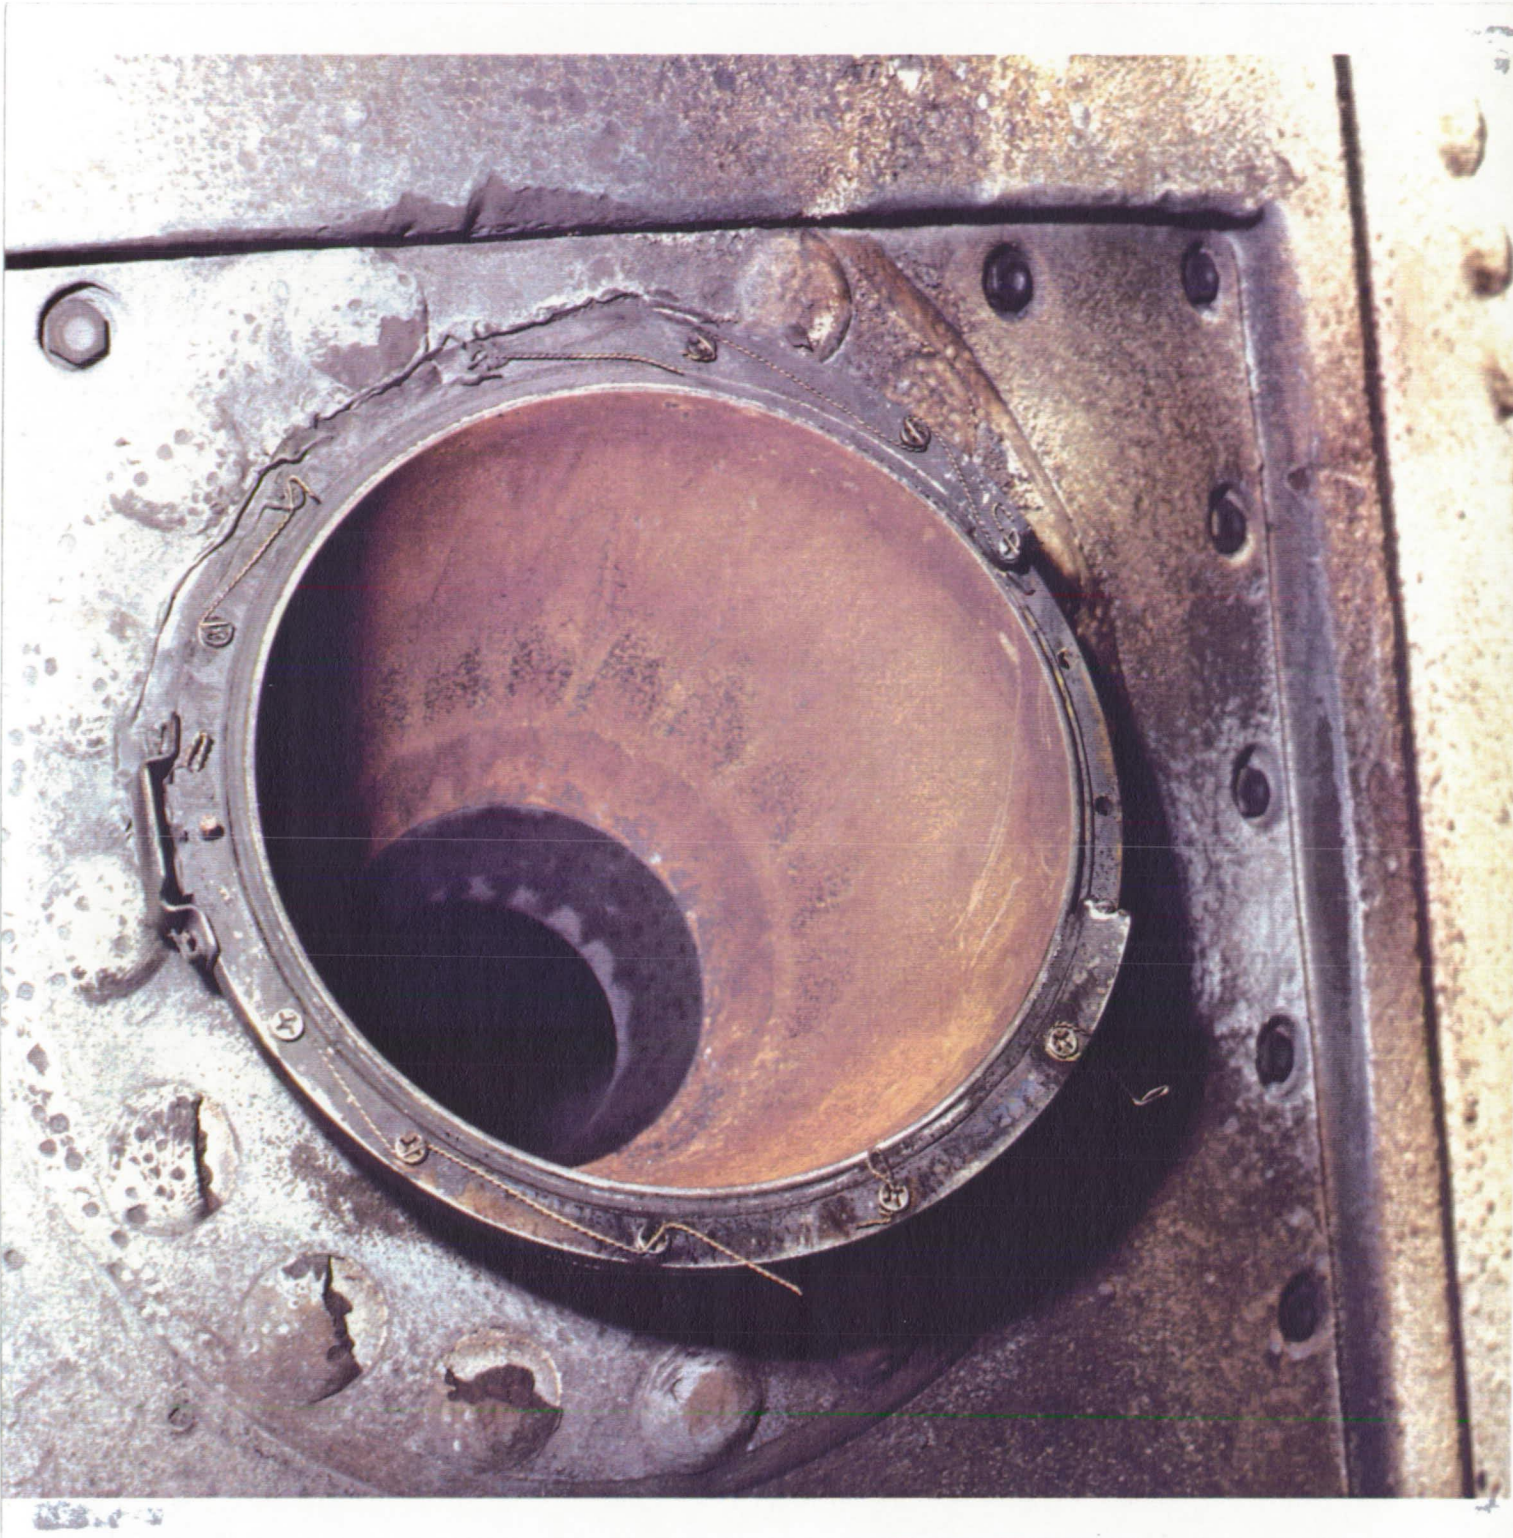
The substrate at the fracture planes, including the threads of the exposed screws, were sooted. MSFC laboratory analysis of the attach ring concluded the failure did not occur prior to or during BSM firing. There were no unusual aerodynamic loads during ascent or descent that could have caused the failure. SRB Max Q occurs during re-entry.

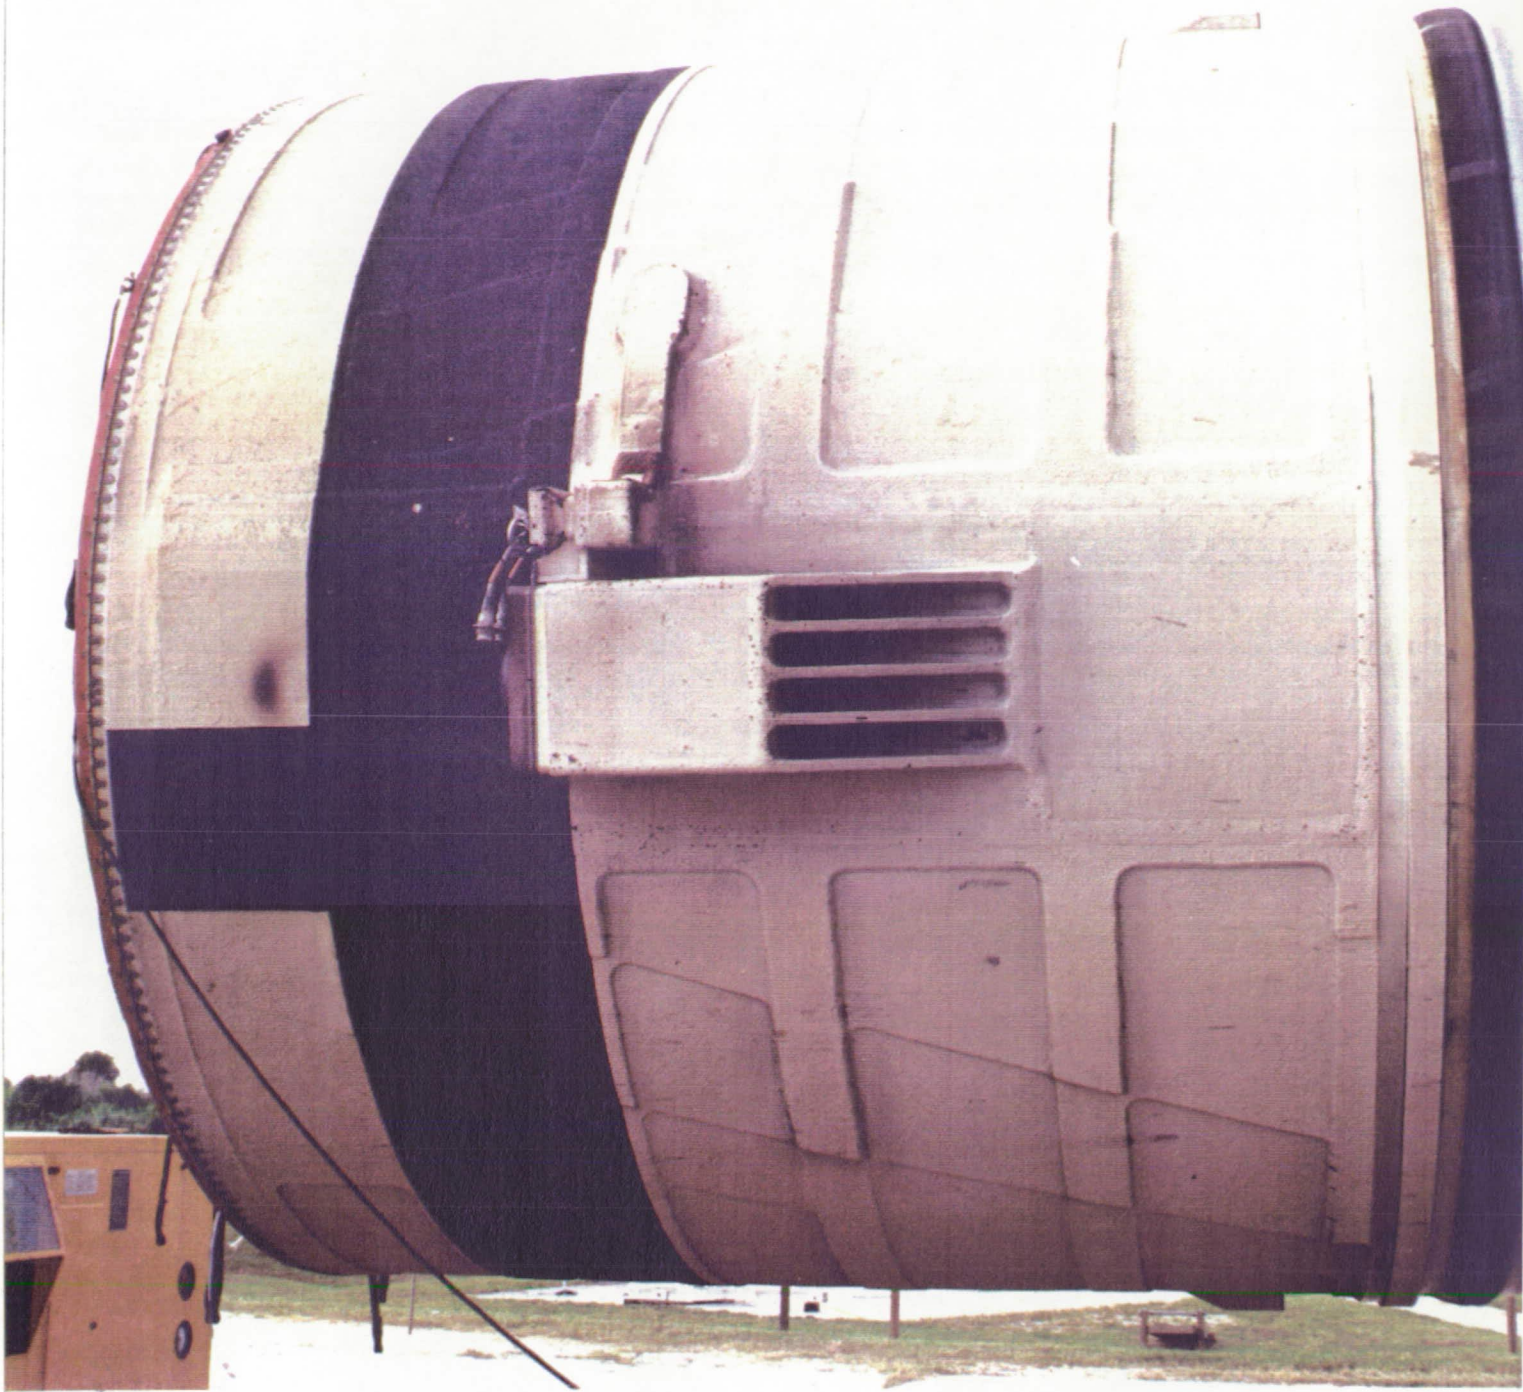
The left forward skirt exhibited no MSA-2 debonds. Minor blistering of Hypalon paint occurred forward of the ET/SRB attach point. The RSS antenna phenolic plates were intact.
