NASA Technical Memorandum TM 103826

Debris/Ice/TPS Assessment And Photographic Analysis For Shuttle Mission STS-48

November 1991

Gregory N. Katnik
NASA/Kennedy Space Center

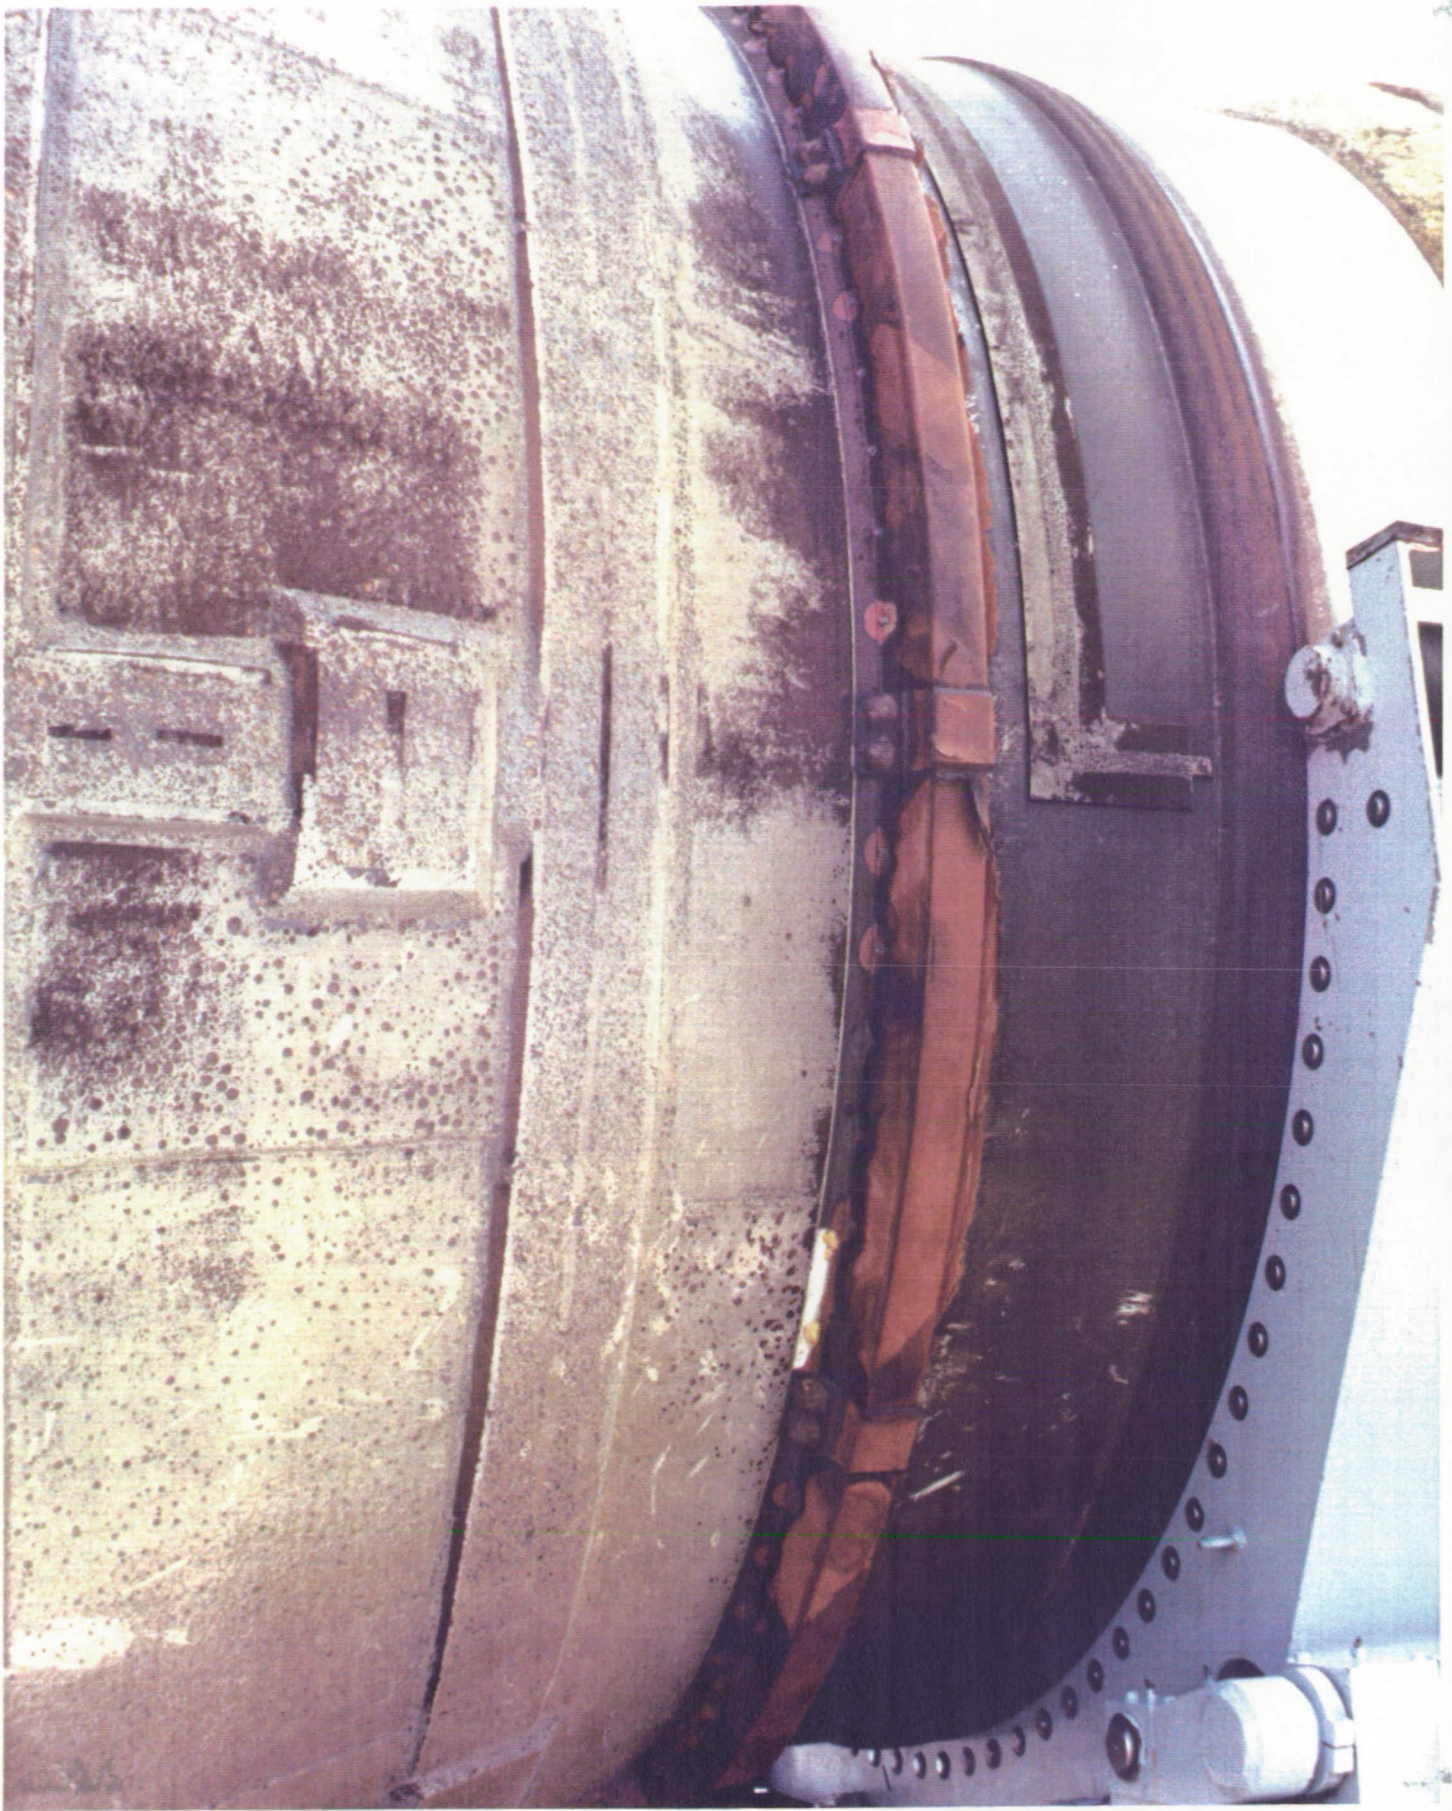
K5NA protective domes were missing from bolt heads on the phenolic kick ring prior to water impact. The substrate under the missing domes was sooted.

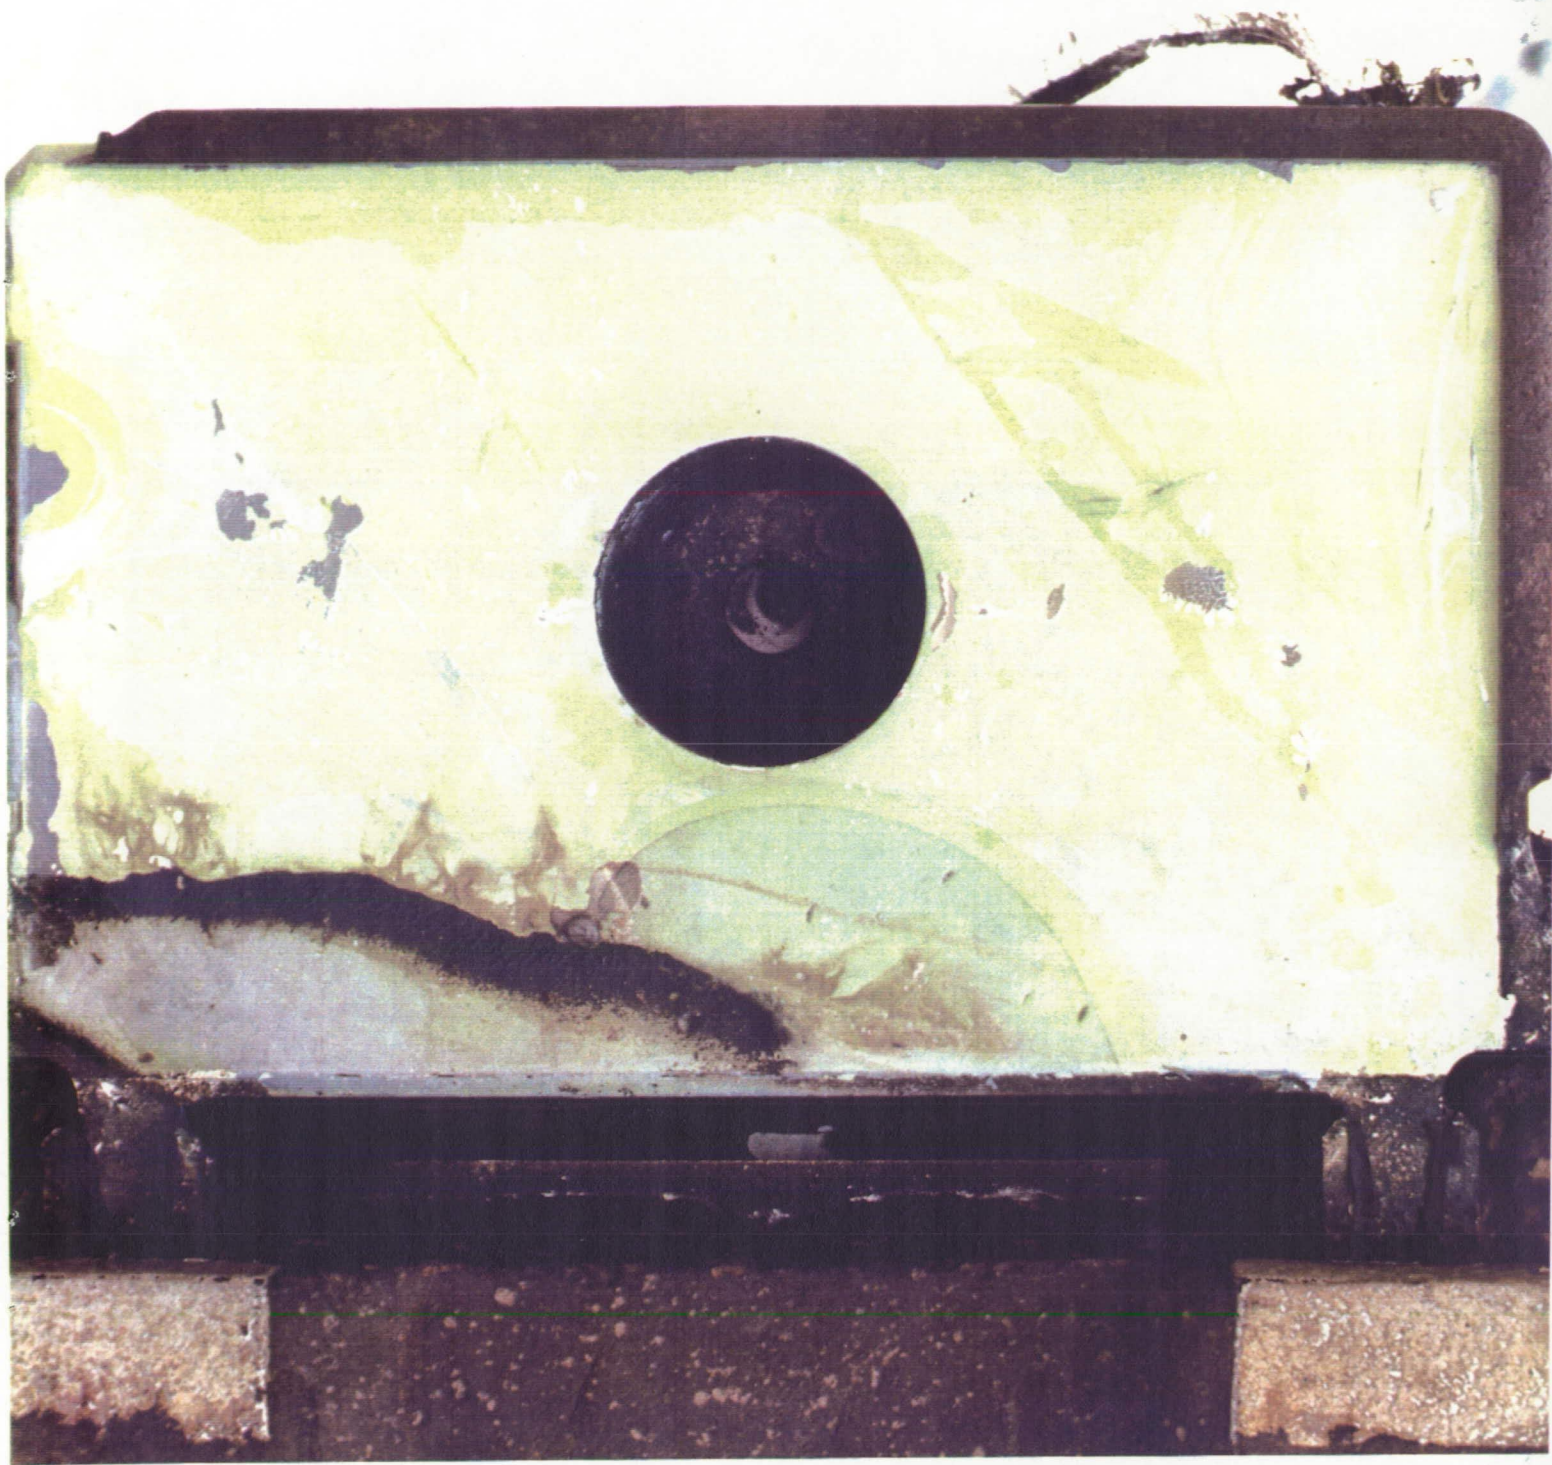
Aft skirt foot (sooted substrate) reveals part of the EPON shim material was missing prior to water impact.

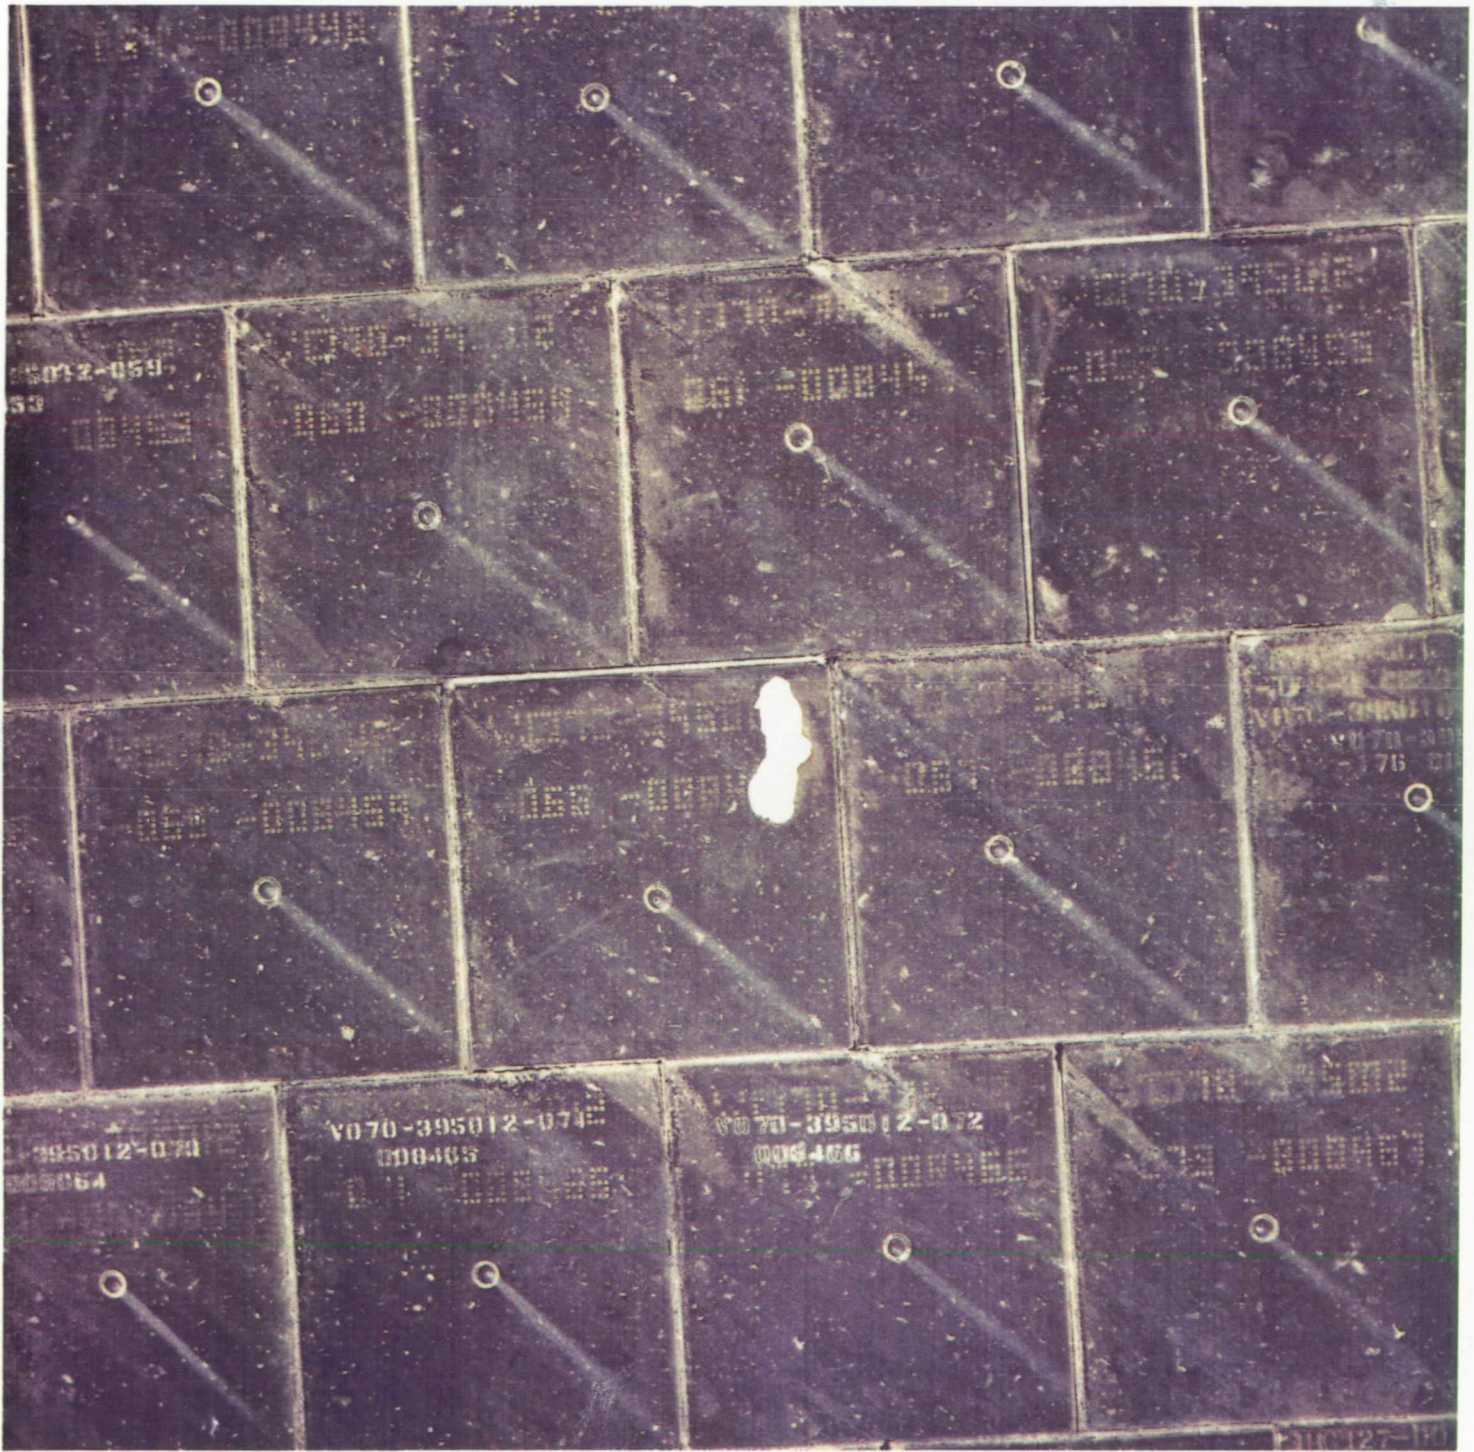
Typical tile damage on the Orbiter lower surface

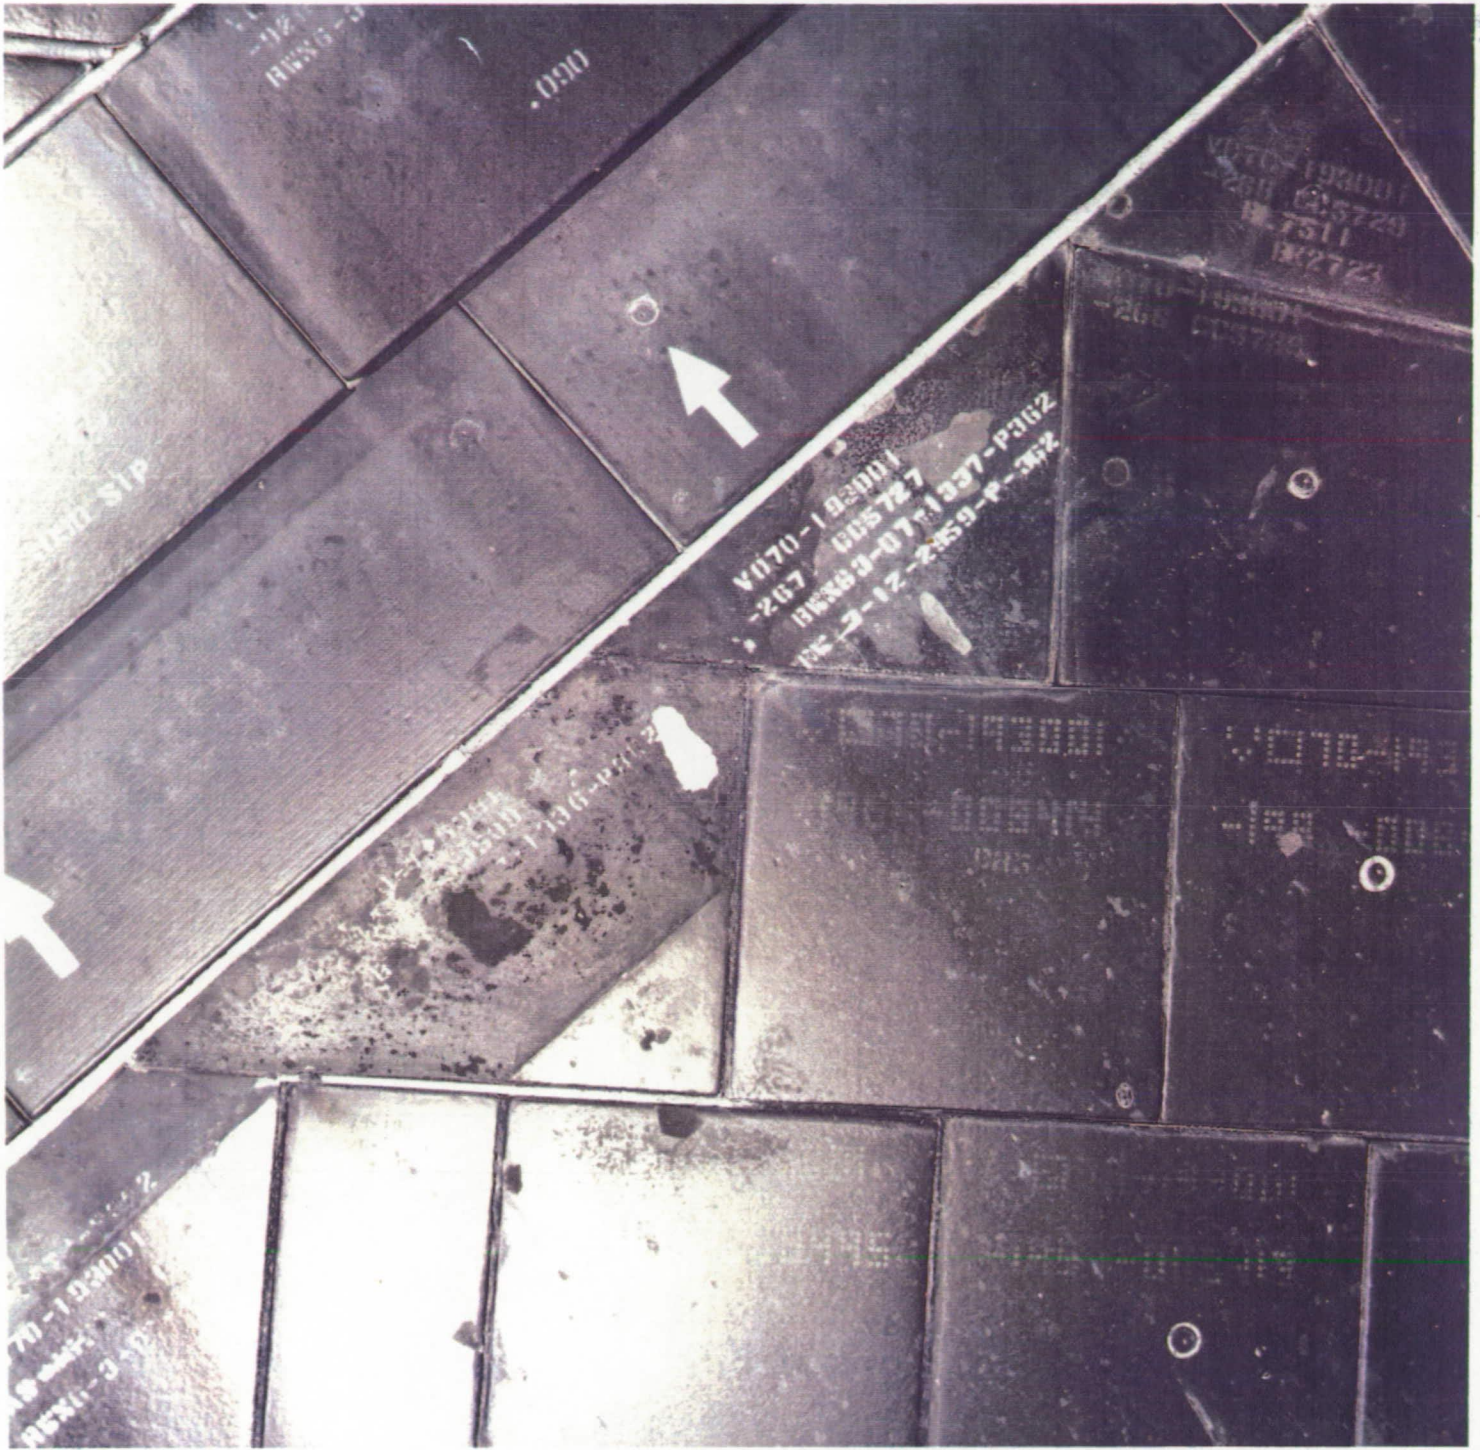
Typical tile damage on the Orbiter lower surface

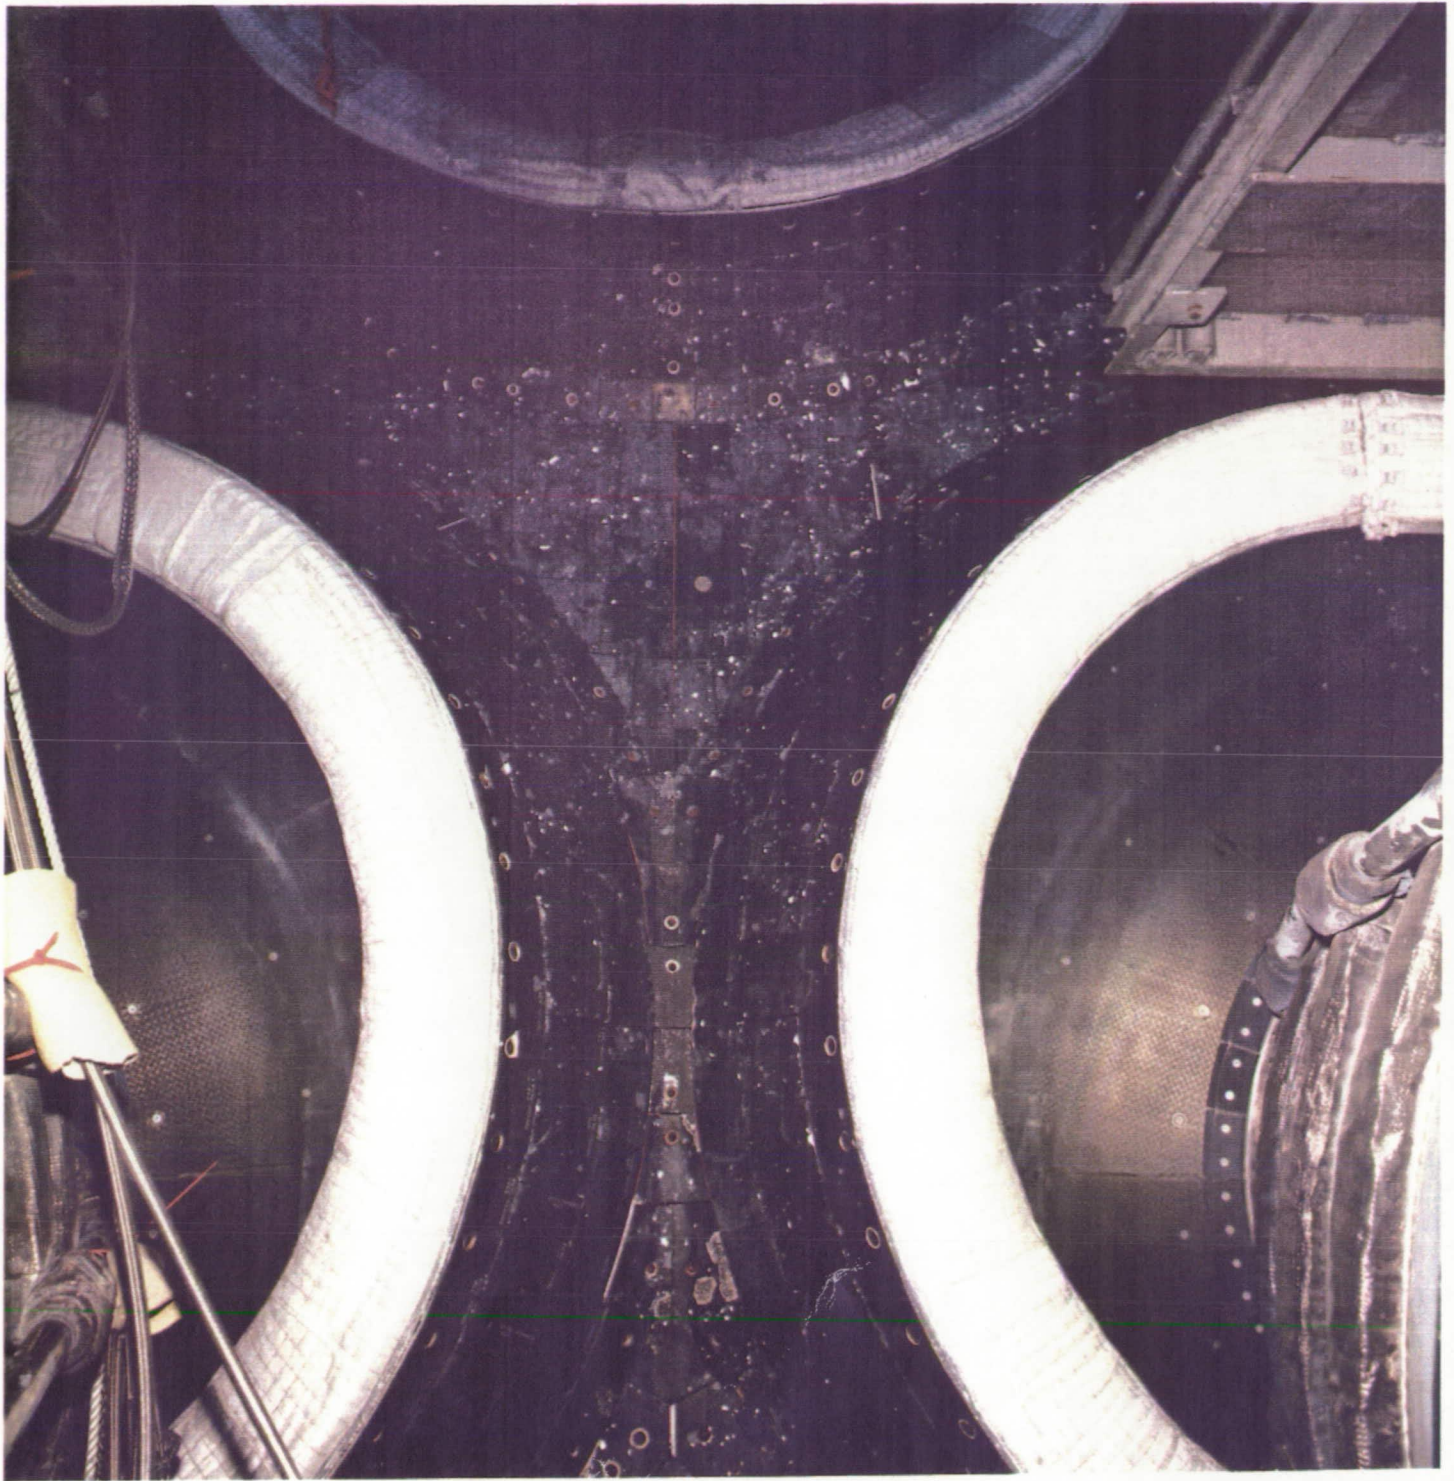
Damage to the base heat shield tiles was less than average. The main engine closeout blankets were in excellent condition with only minor fraying damage on the SSME #1 blanket.

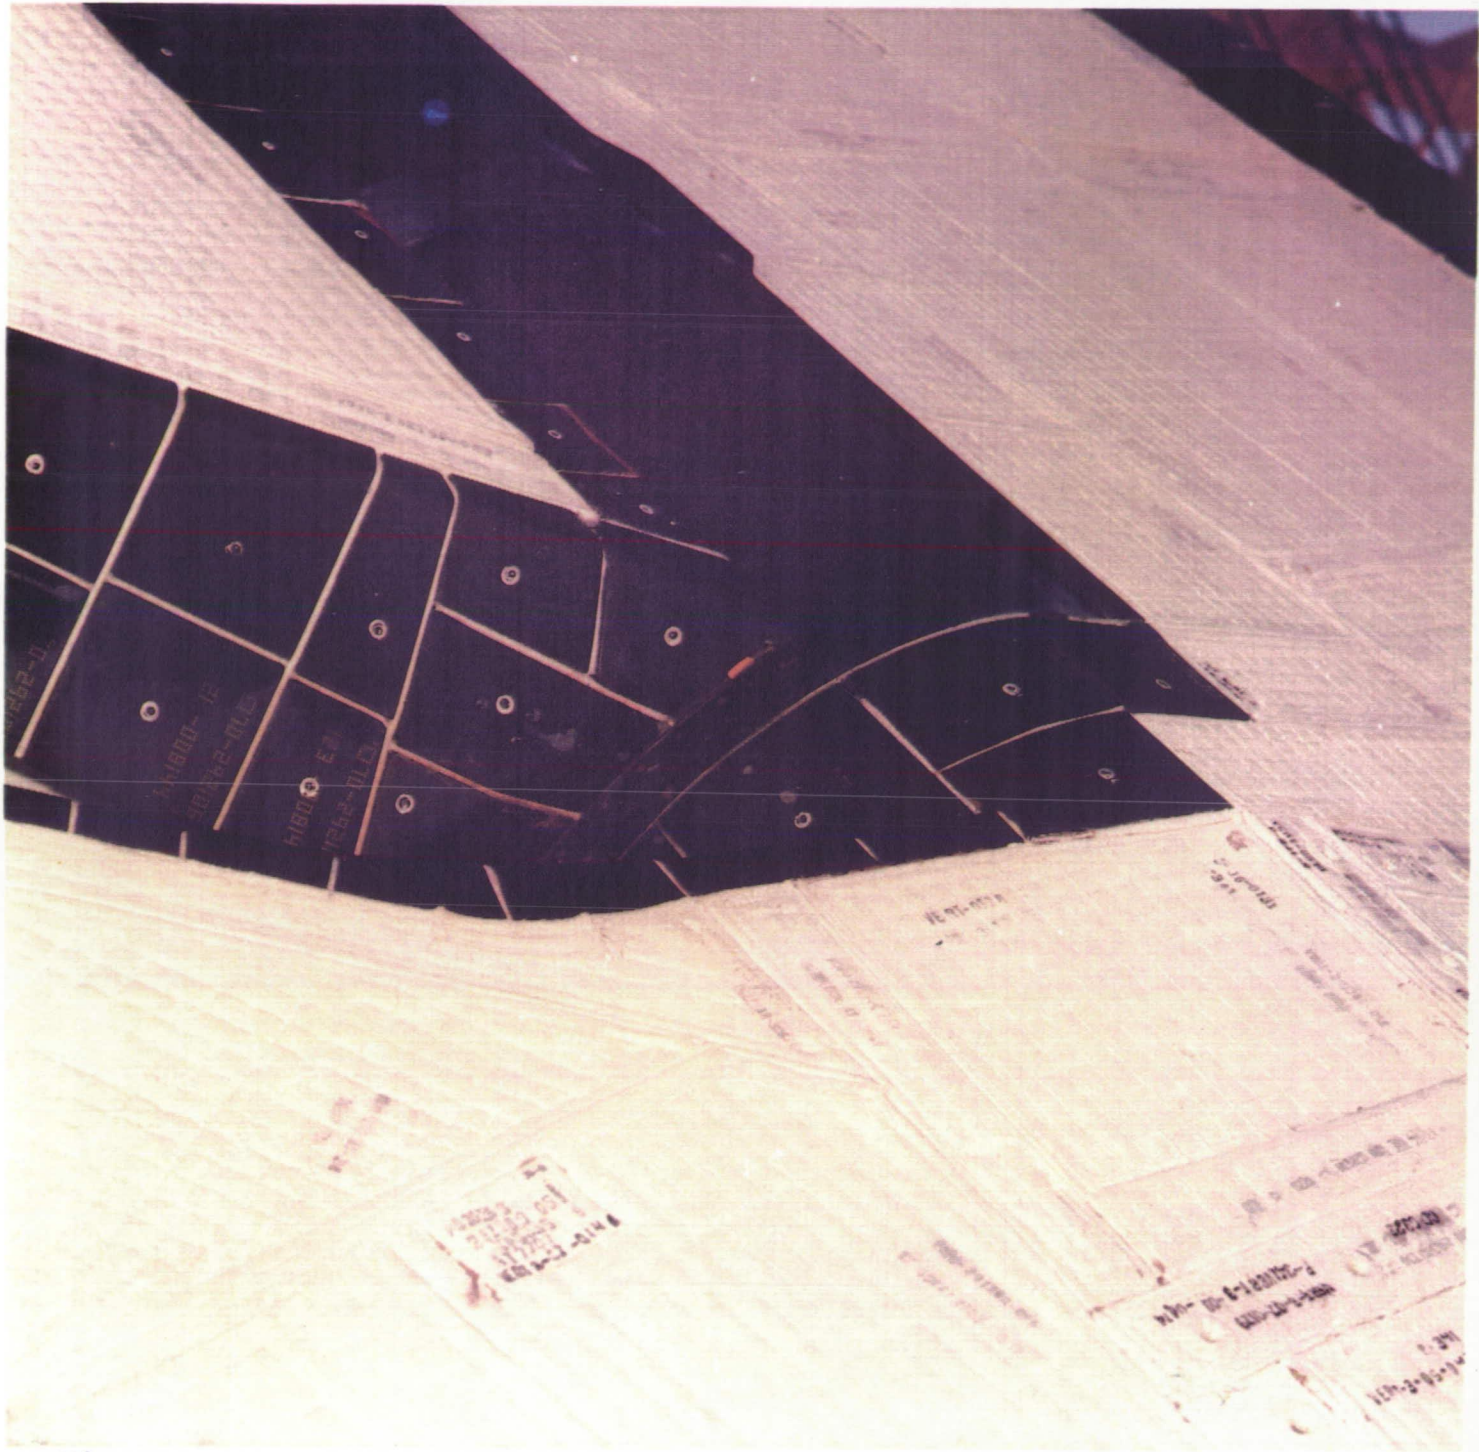
A thin orange GSE tile shim, approximately 1 inch by 1 inch in size, protruded from tiles at the bottom of the RH rudder speed brake near the hinge. GSE tile shim should not remain on the Orbiter for flight.

A thin, orange GSE tile shim, approximately 1 inch by 1 inch in size, protruded from tiles at the bottom of the RH rudder speed brake near the hinge.

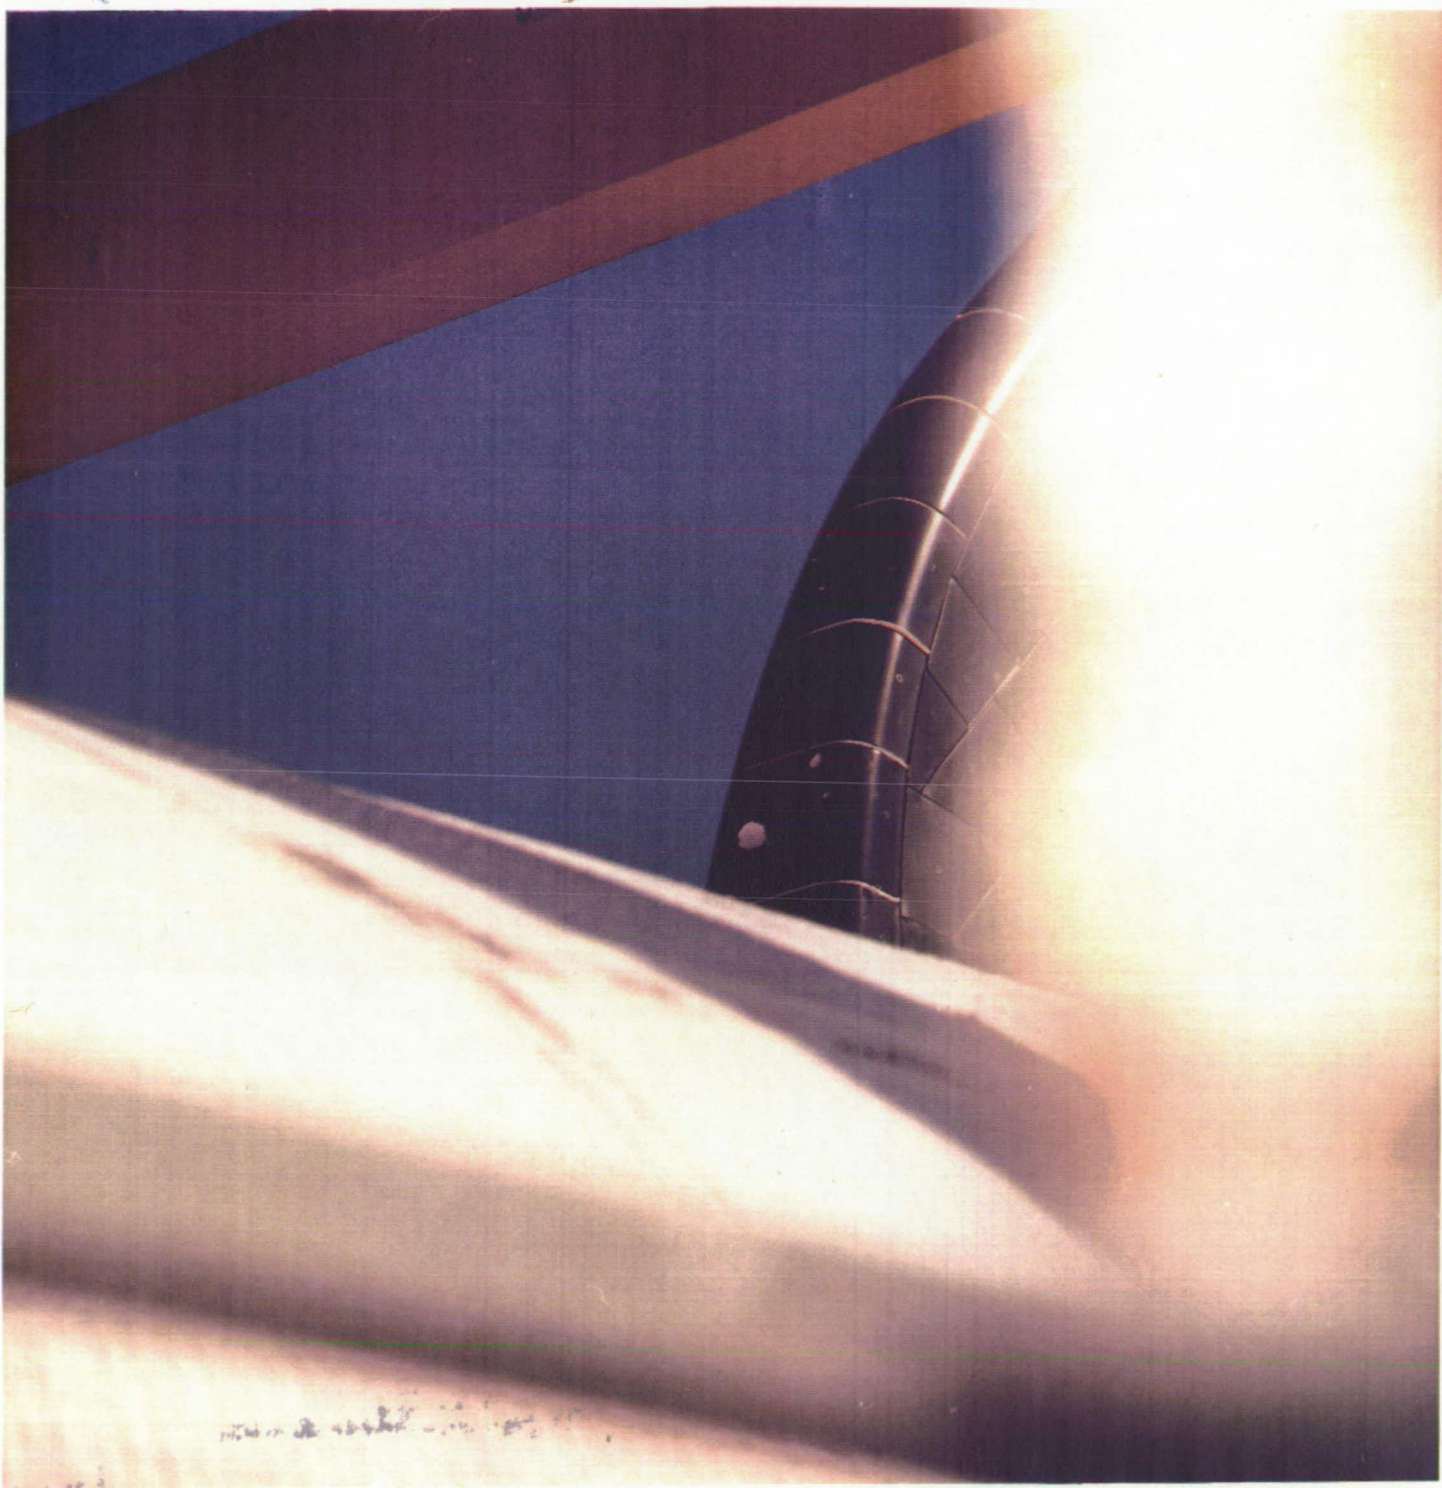
A cluster of 7 hits with one larger than one inch (3"x2"x1") was present on the leading edge of the vertical stabilizer near the root. Tile damage in this area is uncommon and may possibly be related to tile damage around the forward facing windows.

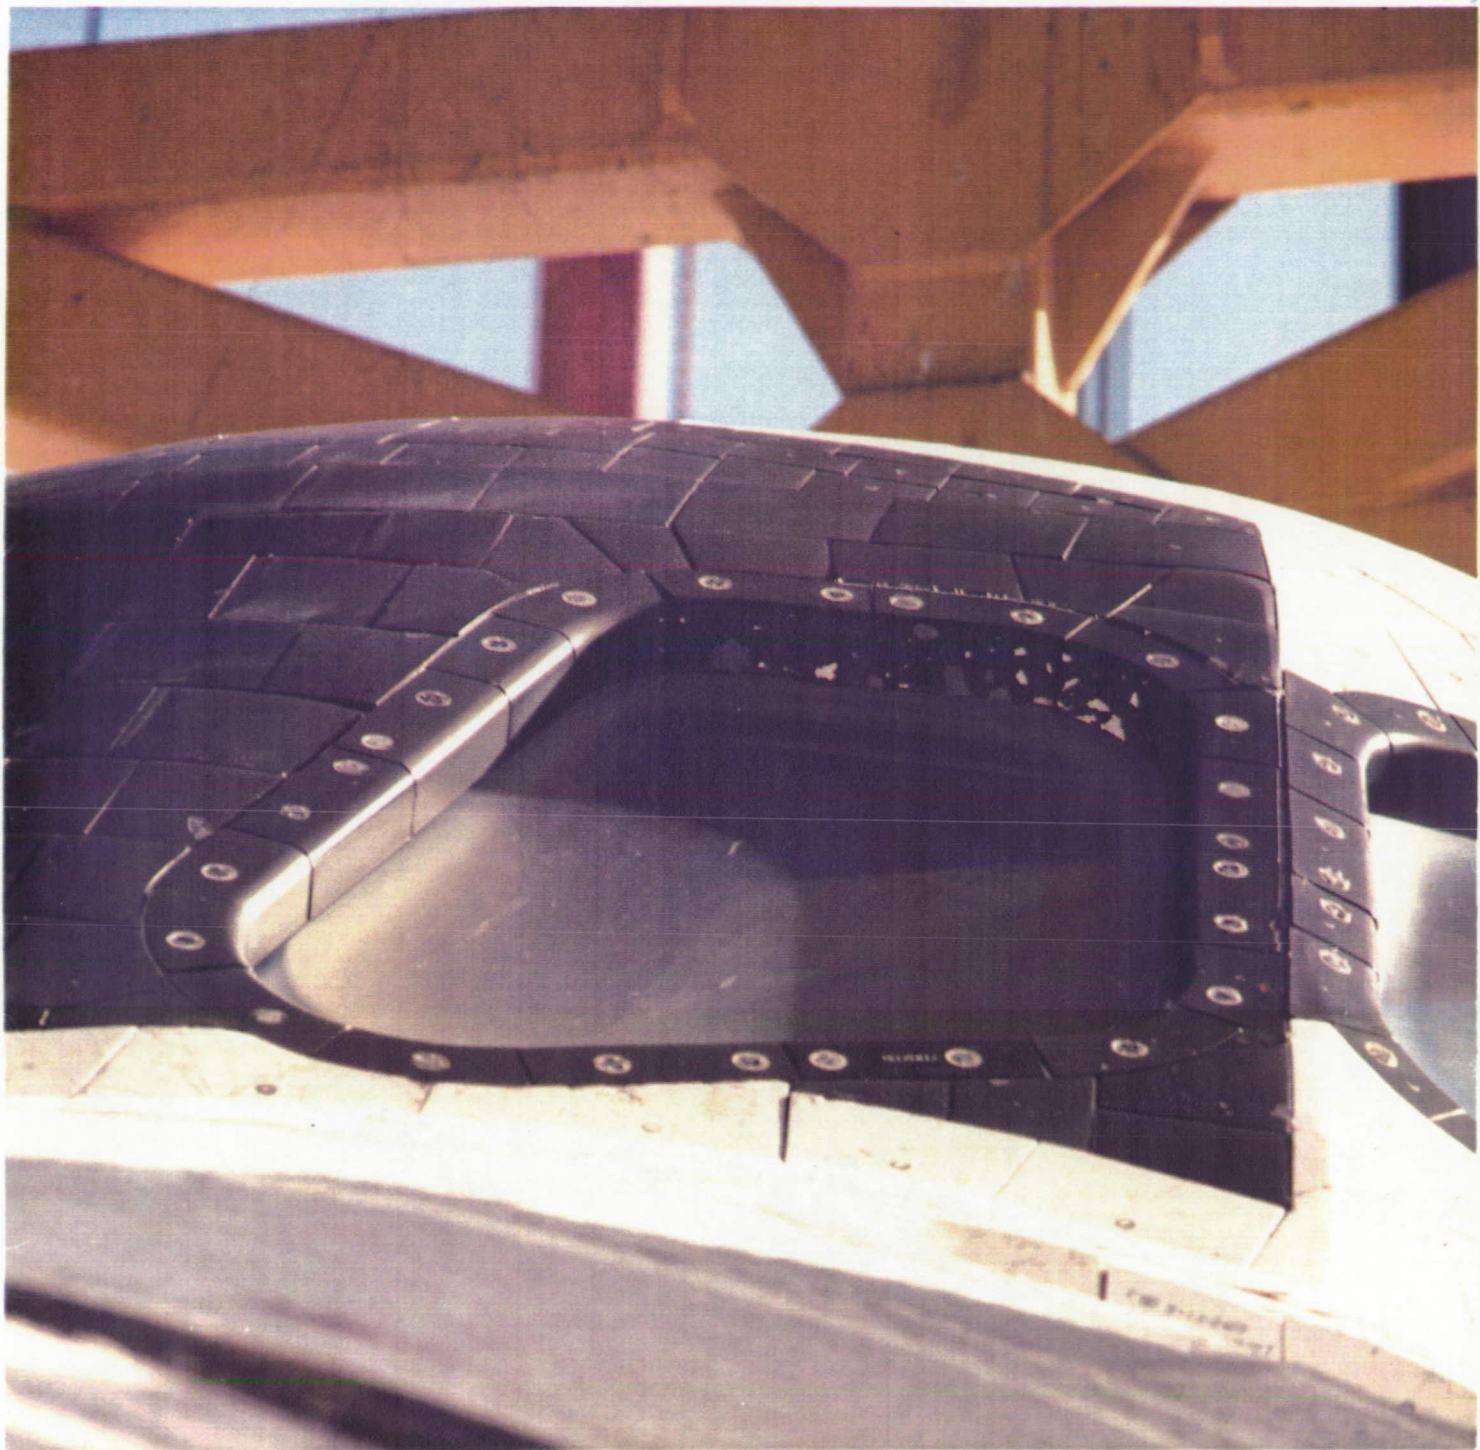
Orbiter windows #1 and #2 were lightly hazed. Window #3 exhibited moderate to heavy hazing and had numerous streaks. A greater than previously observed number of damage sites occurred on the perimeter tiles of windows #1-#6. Most of the impact sites did not exceed a depth of 1/16th inch. This damage may have been caused by the RTV used to bond paper covers to the FRCS nozzles.

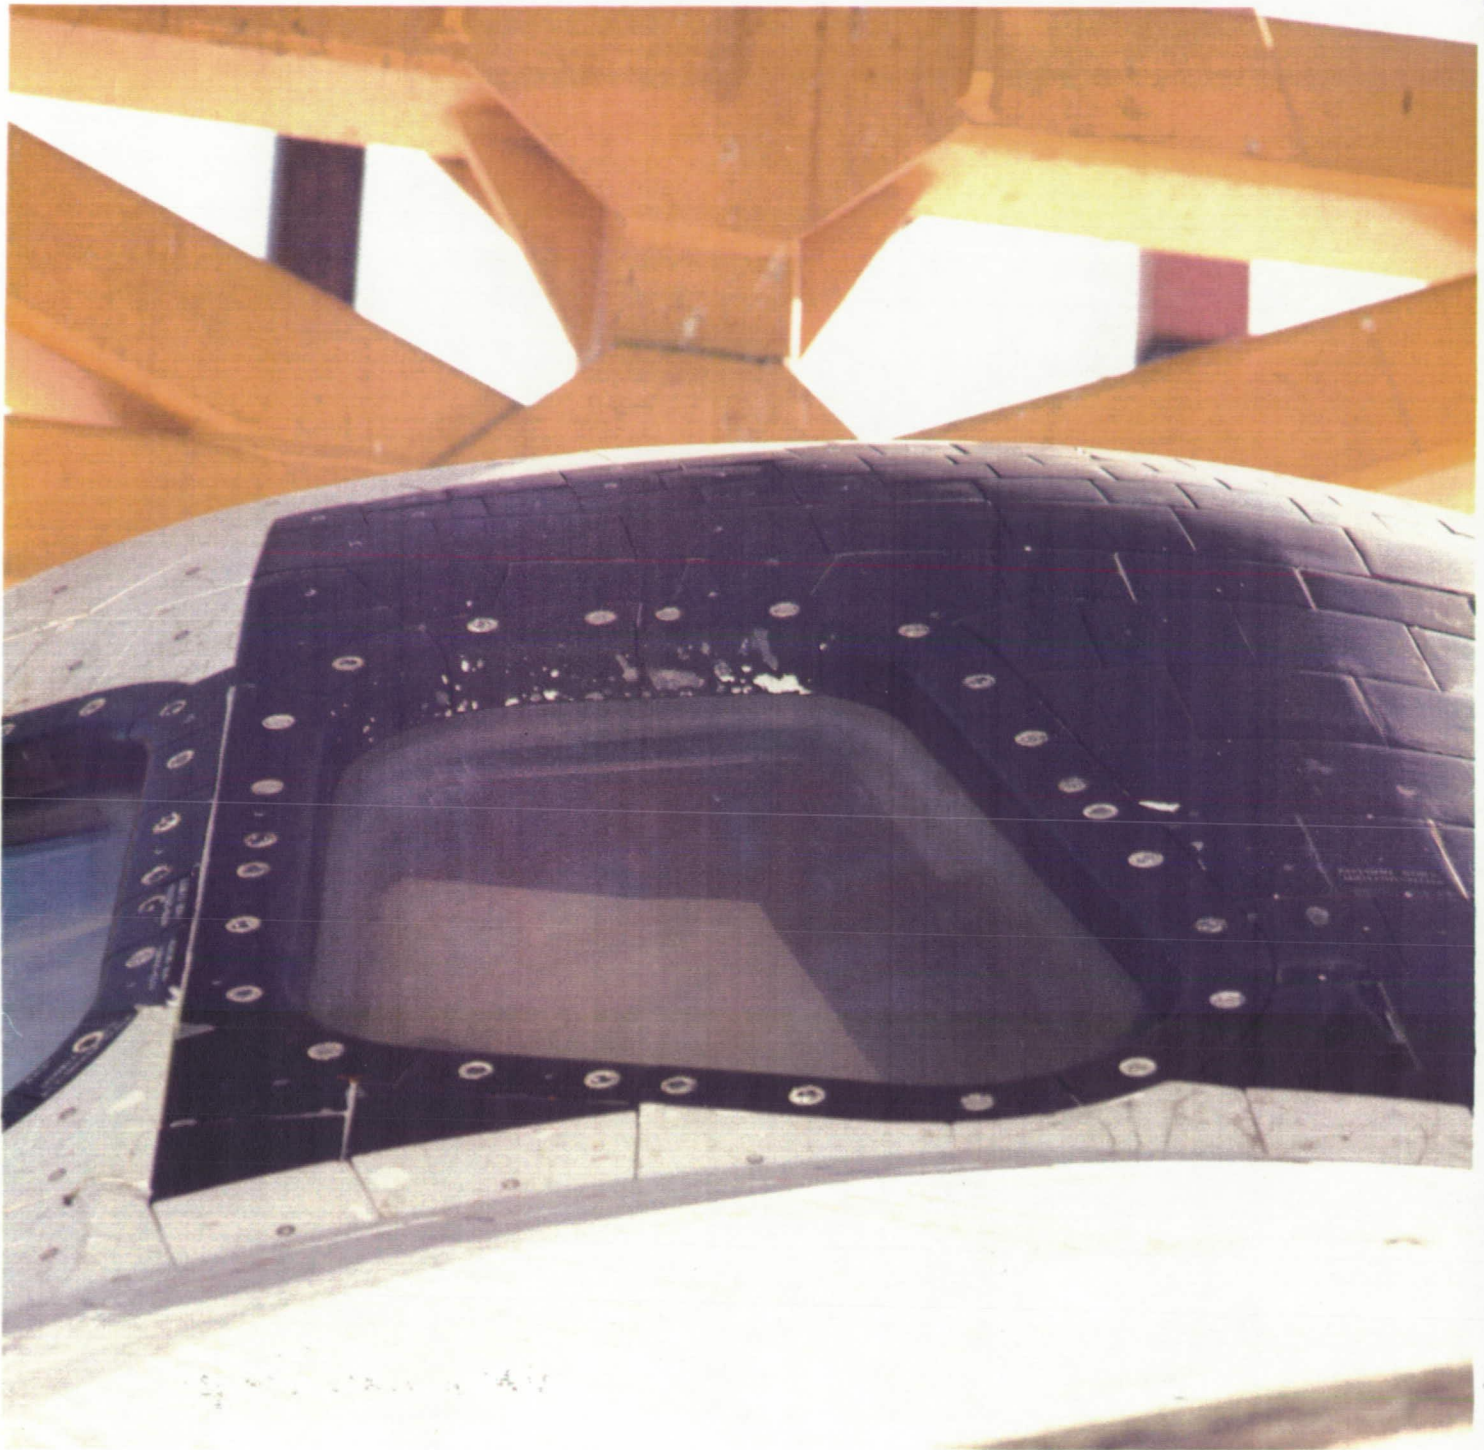
Orbiter windows #5 and #6 were lightly hazed. Window #4 exhibited moderate to heavy hazing and had numerous streaks. A greater than previously observed number of damage sites occurred on the perimeter tiles of windows #1-#6. Most of the impact sites did not exceed a depth of 1/16th inch. This damage may have been caused by the RTV used to bond paper covers to the FRCS nozzles.

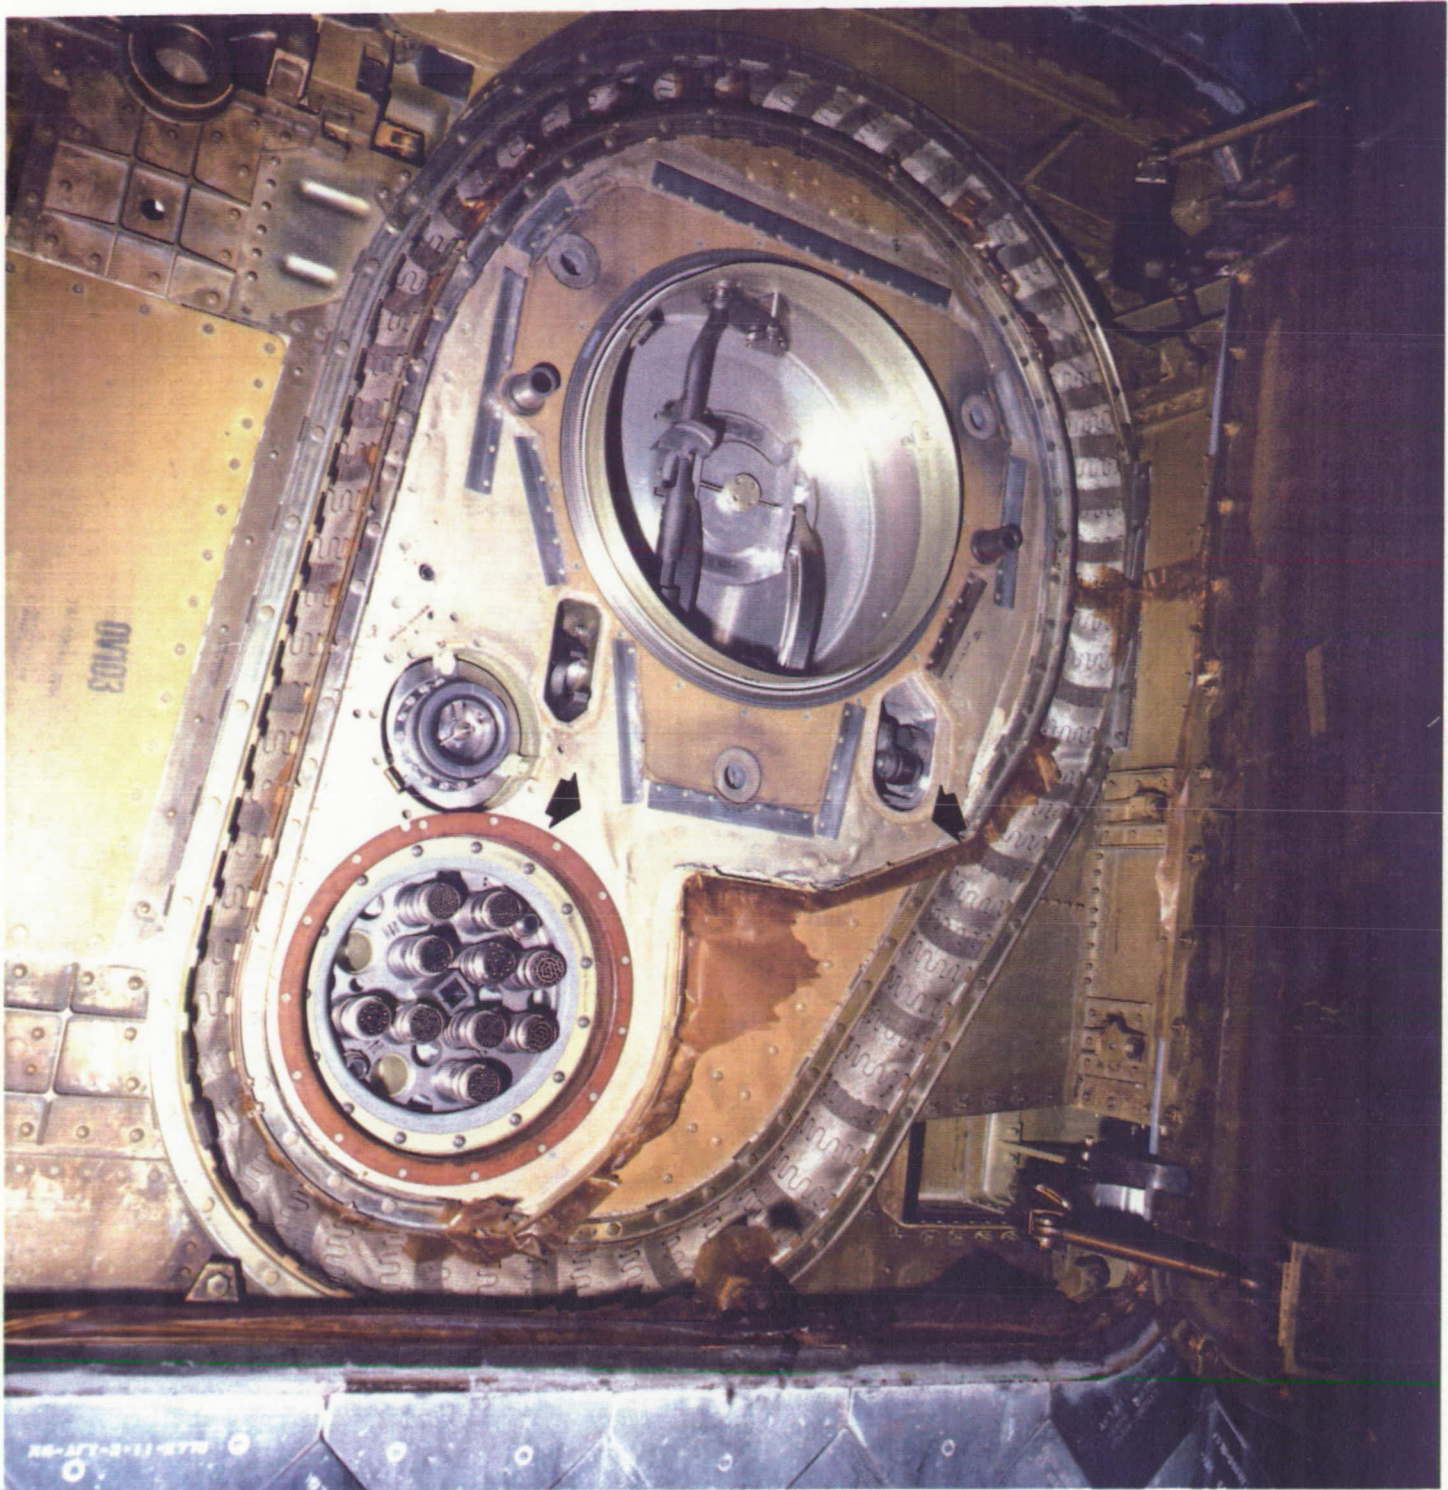
Overall view of the L02 ET/ORB umbilical. The separation ordnance device debris plunger in EO-3 was seated and appeared to have functioned properly. Wrinkling of the umbilical face plate (arrow) was probably caused by material shrinkage during cryo load and was not considered to be an anomaly.
