TWR-17546
Volume II

Flight Set 360L007 (STS-33R)
Case and Seal Final Report
Volume II

February 1991

***Thiokol* CORPORATION
SPACE OPERATIONS**

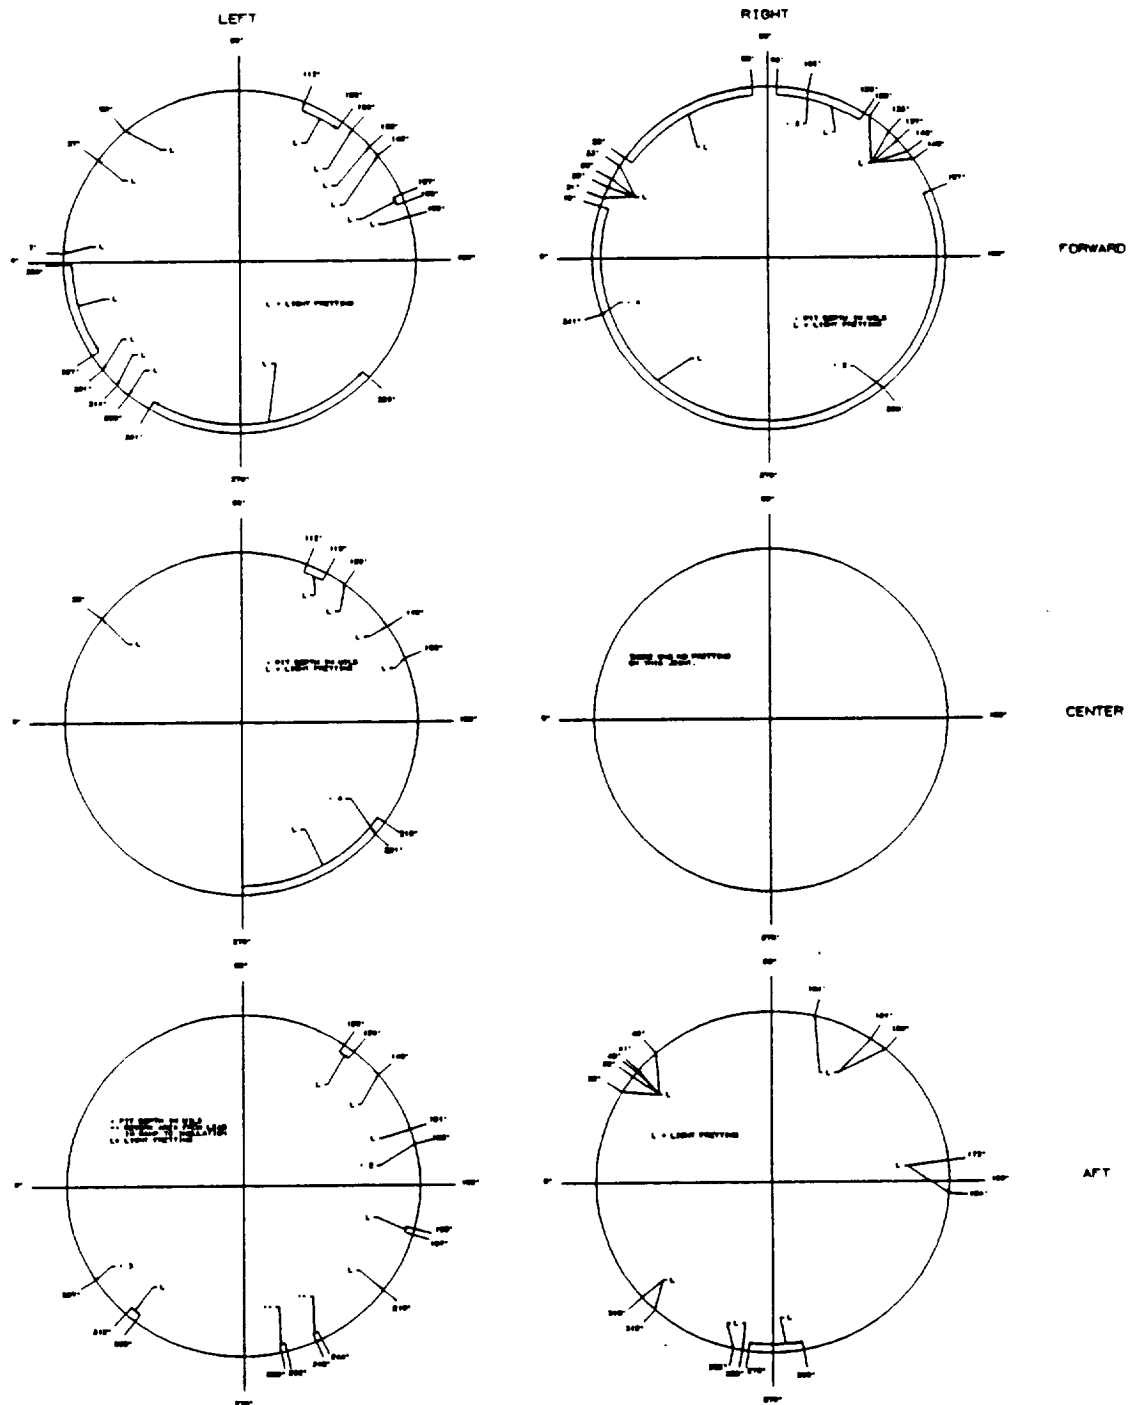
Figure 5. Field Joint Fretting Summary

The post-flight assessment of both motors showed the case segments to be in good condition. Field joint fretting indications on this flight set ranged from none on one joint through light (<0.003 inch deep) on most of the joints to locally medium (>0.003 , <0.005 inch deep) on two joints. Figure 5 visually summarizes the fretting on all the field joints. No new fretting was found in old fretting locations. All fretting was mapped from the inner clevis leg. The capture feature fretting was not mapped due

to the difficulty of measuring the fretting in the capture feature region, but it is assumed that the capture feature had similar damage as the inner clevis leg. Listed below is a summary of fretting for each joint:

- LH/FWD Light fretting (0.000 to 0.003 inch deep) at 37, 50 degrees. Intermittently light from 112 to 142, 157 through 165, and from 223 through 0 through 3 degrees.
- LH/CTR Light fretting at 38, 112 through 119, 126, 146, and 158 degrees. Intermittent light fretting from 216 through 270 degrees. A moderate fret of 0.004 inch deep was observed at 221 degrees.
- LH/AFT Light fretting at 125 through 129, 140, 161, 166, 195 through 197, 218, 244 through 246, 256 through 258, 308 through 312, and 327 degrees. This joint had fretting from a previous flight from 185 through 220 degrees.
- RH/FWD Intermittent light fretting around entire circumference of joint. A moderate fret at 341 degrees, and no heavy frets.
- RH/CTR No light, moderate, or heavy frets.
- RH/AFT Light fretting at 32 through 41, 49, 104, 124, 130, 173, 184, 260 to 283, 312 to 318 degrees. No moderate or heavy frets.

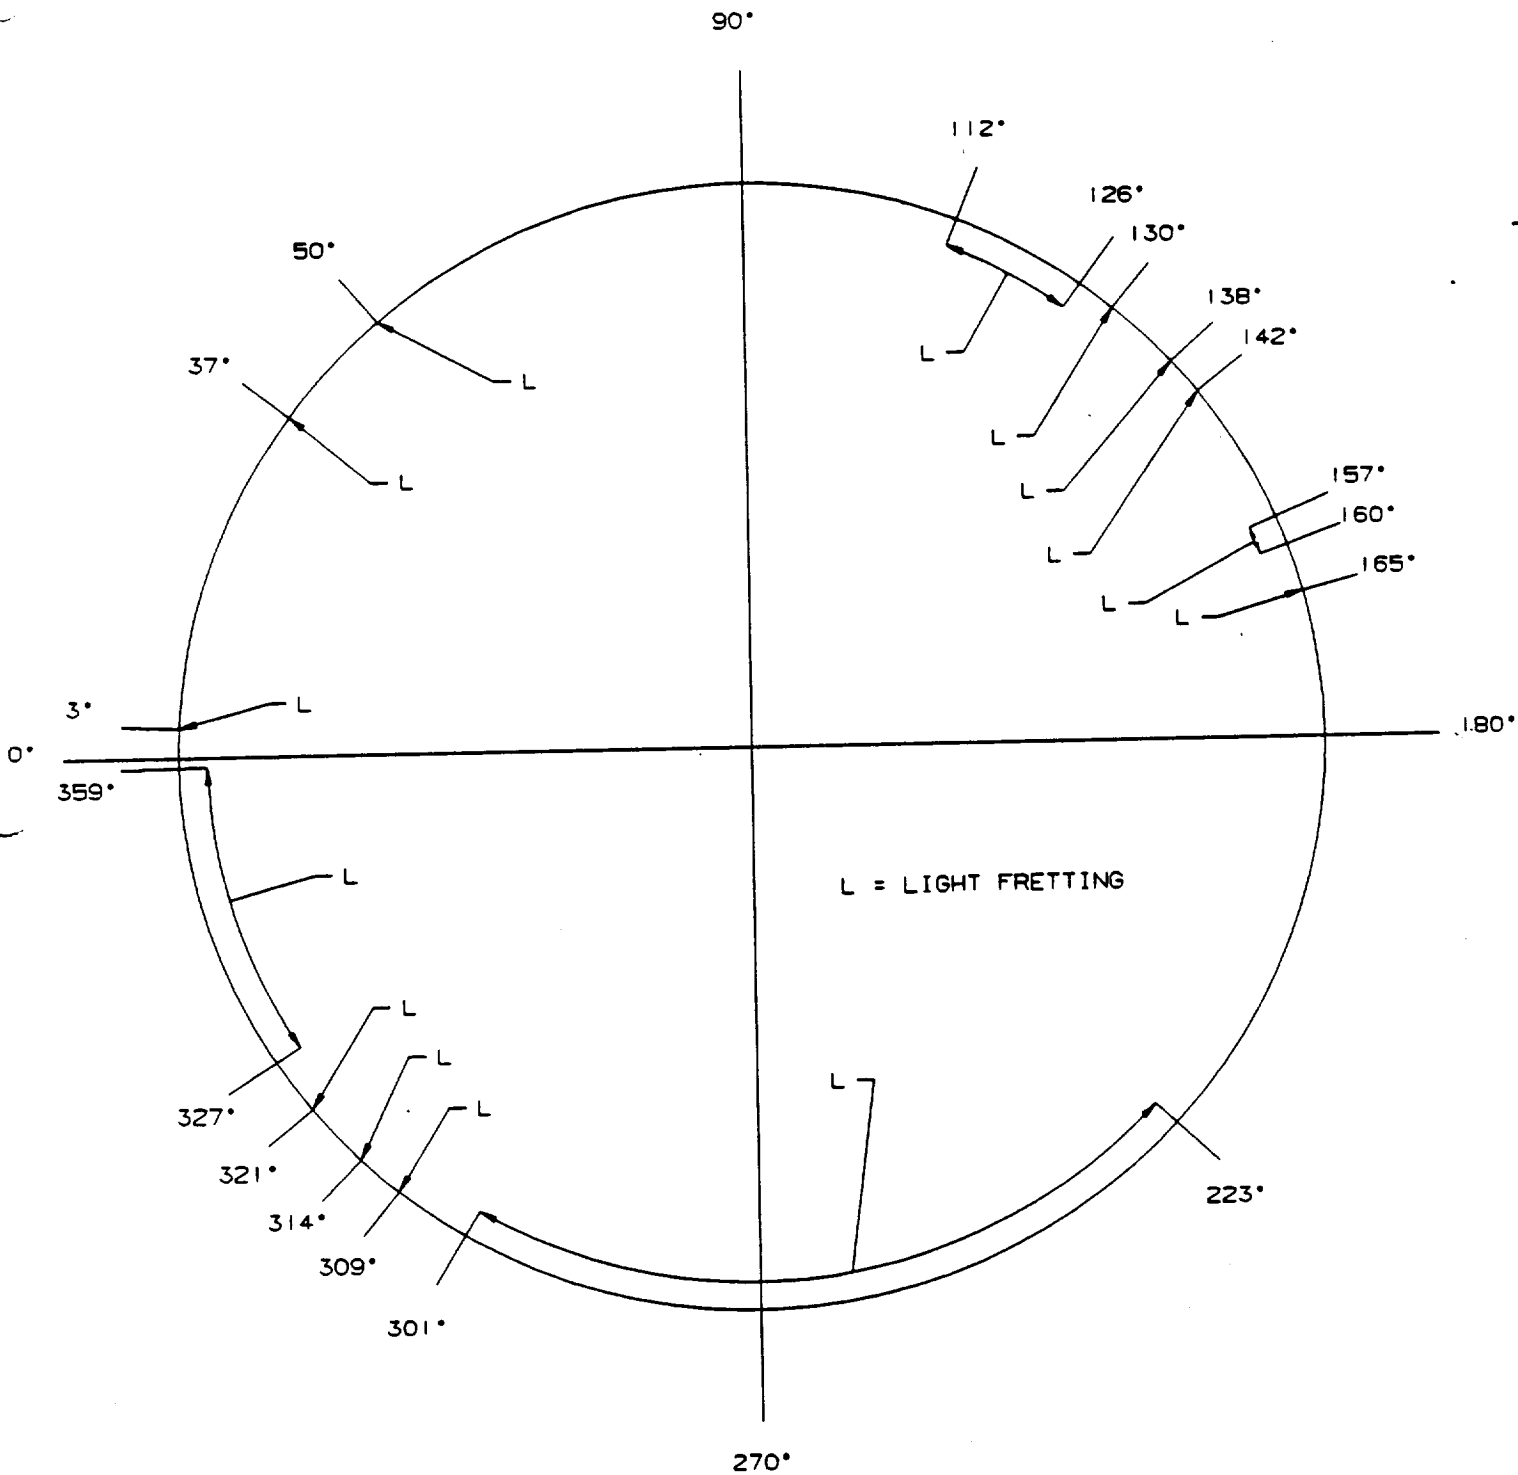
Figure 6. LH Forward Field Joint Fretting

Assessment of the metal components found light fretting at 37, 50, 112 intermittently through 142, 157 though 165, and 223 intermittently through 0 though 3 degrees. Figure 6 gives a detailed view of the fretting.

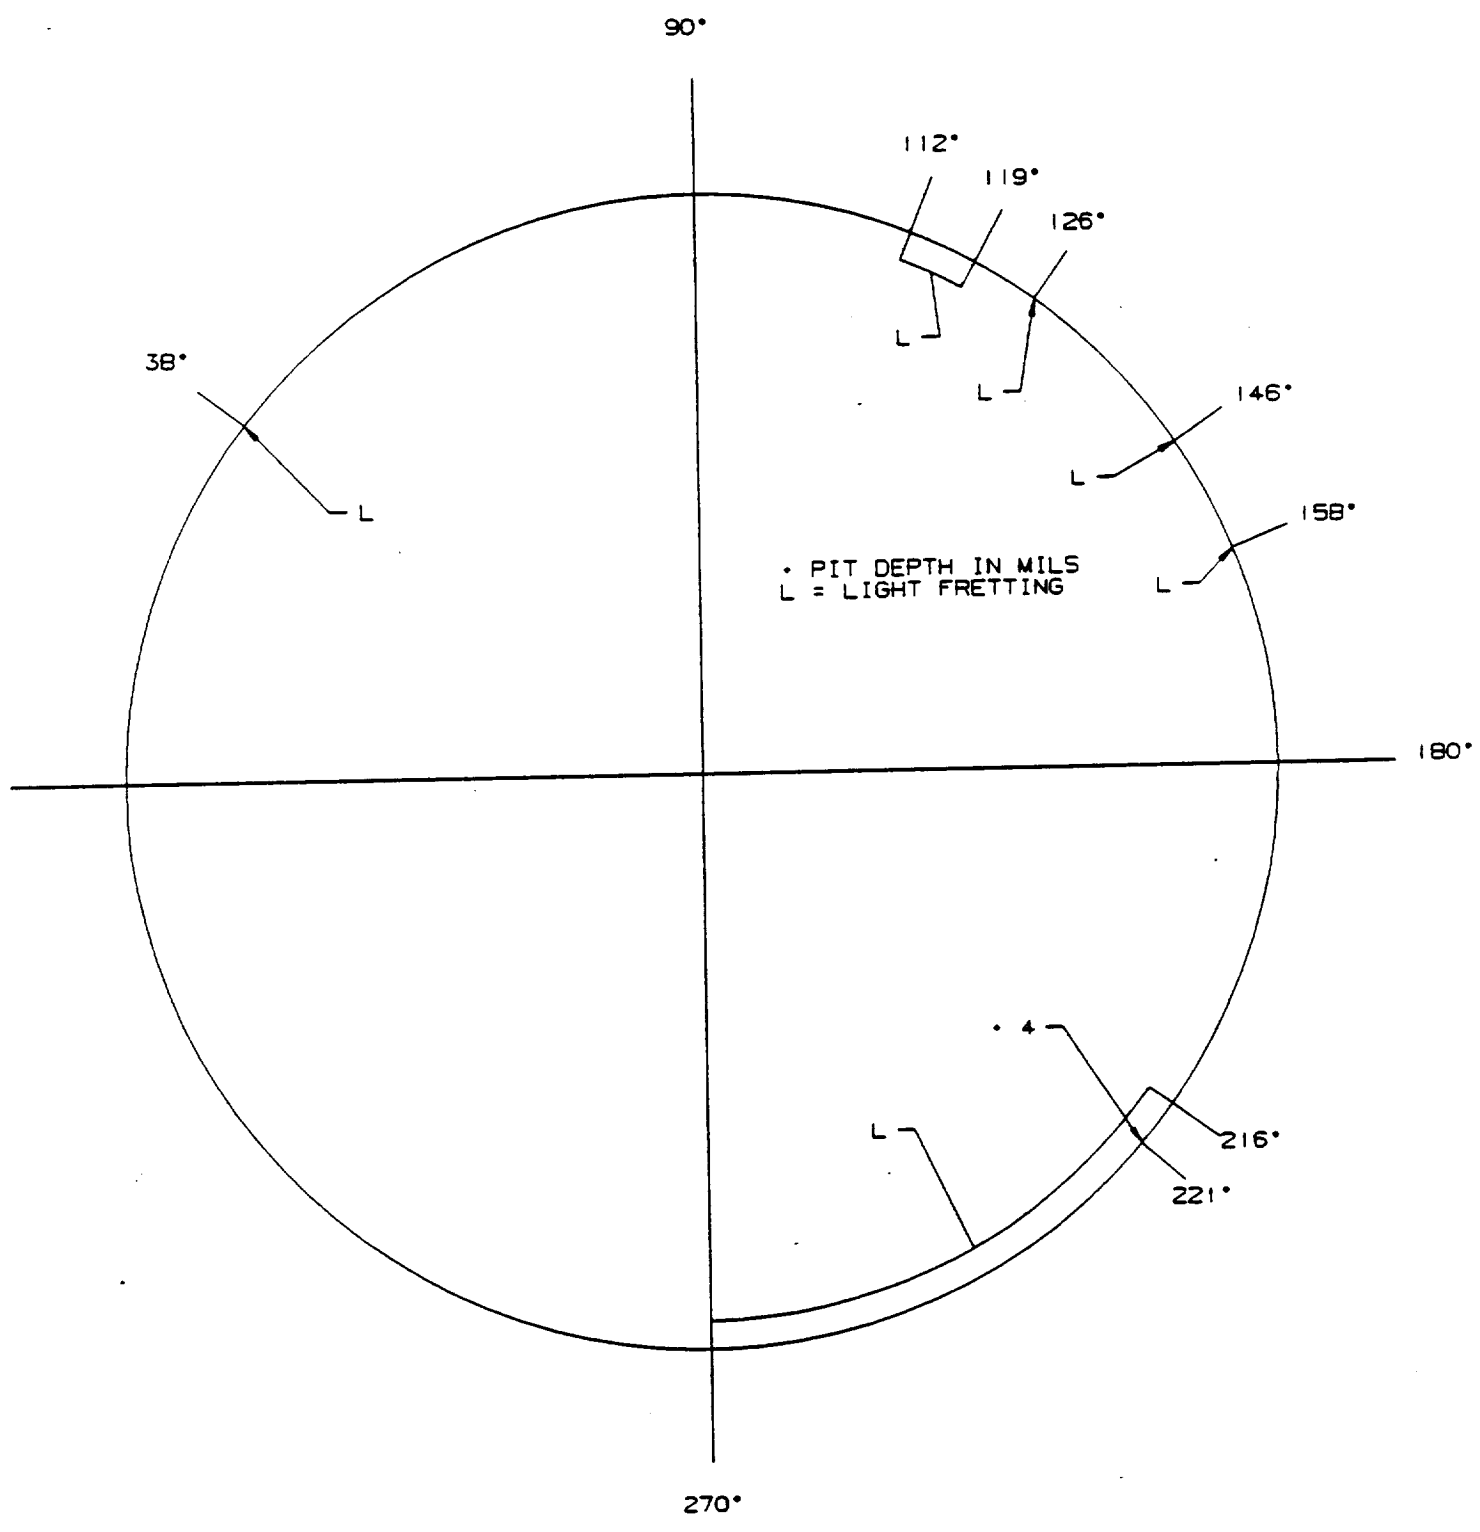
Figure 7. LH Center Field Joint Fretting

Assessment of the metal components found light fretting at 38, 112 through 119, 126, 146, 158, and intermittently from 216 through 270 degrees. A moderate fret of 0.004 inch deep was observed at 221 degrees. Figure 7 gives a detailed view of the fretting.

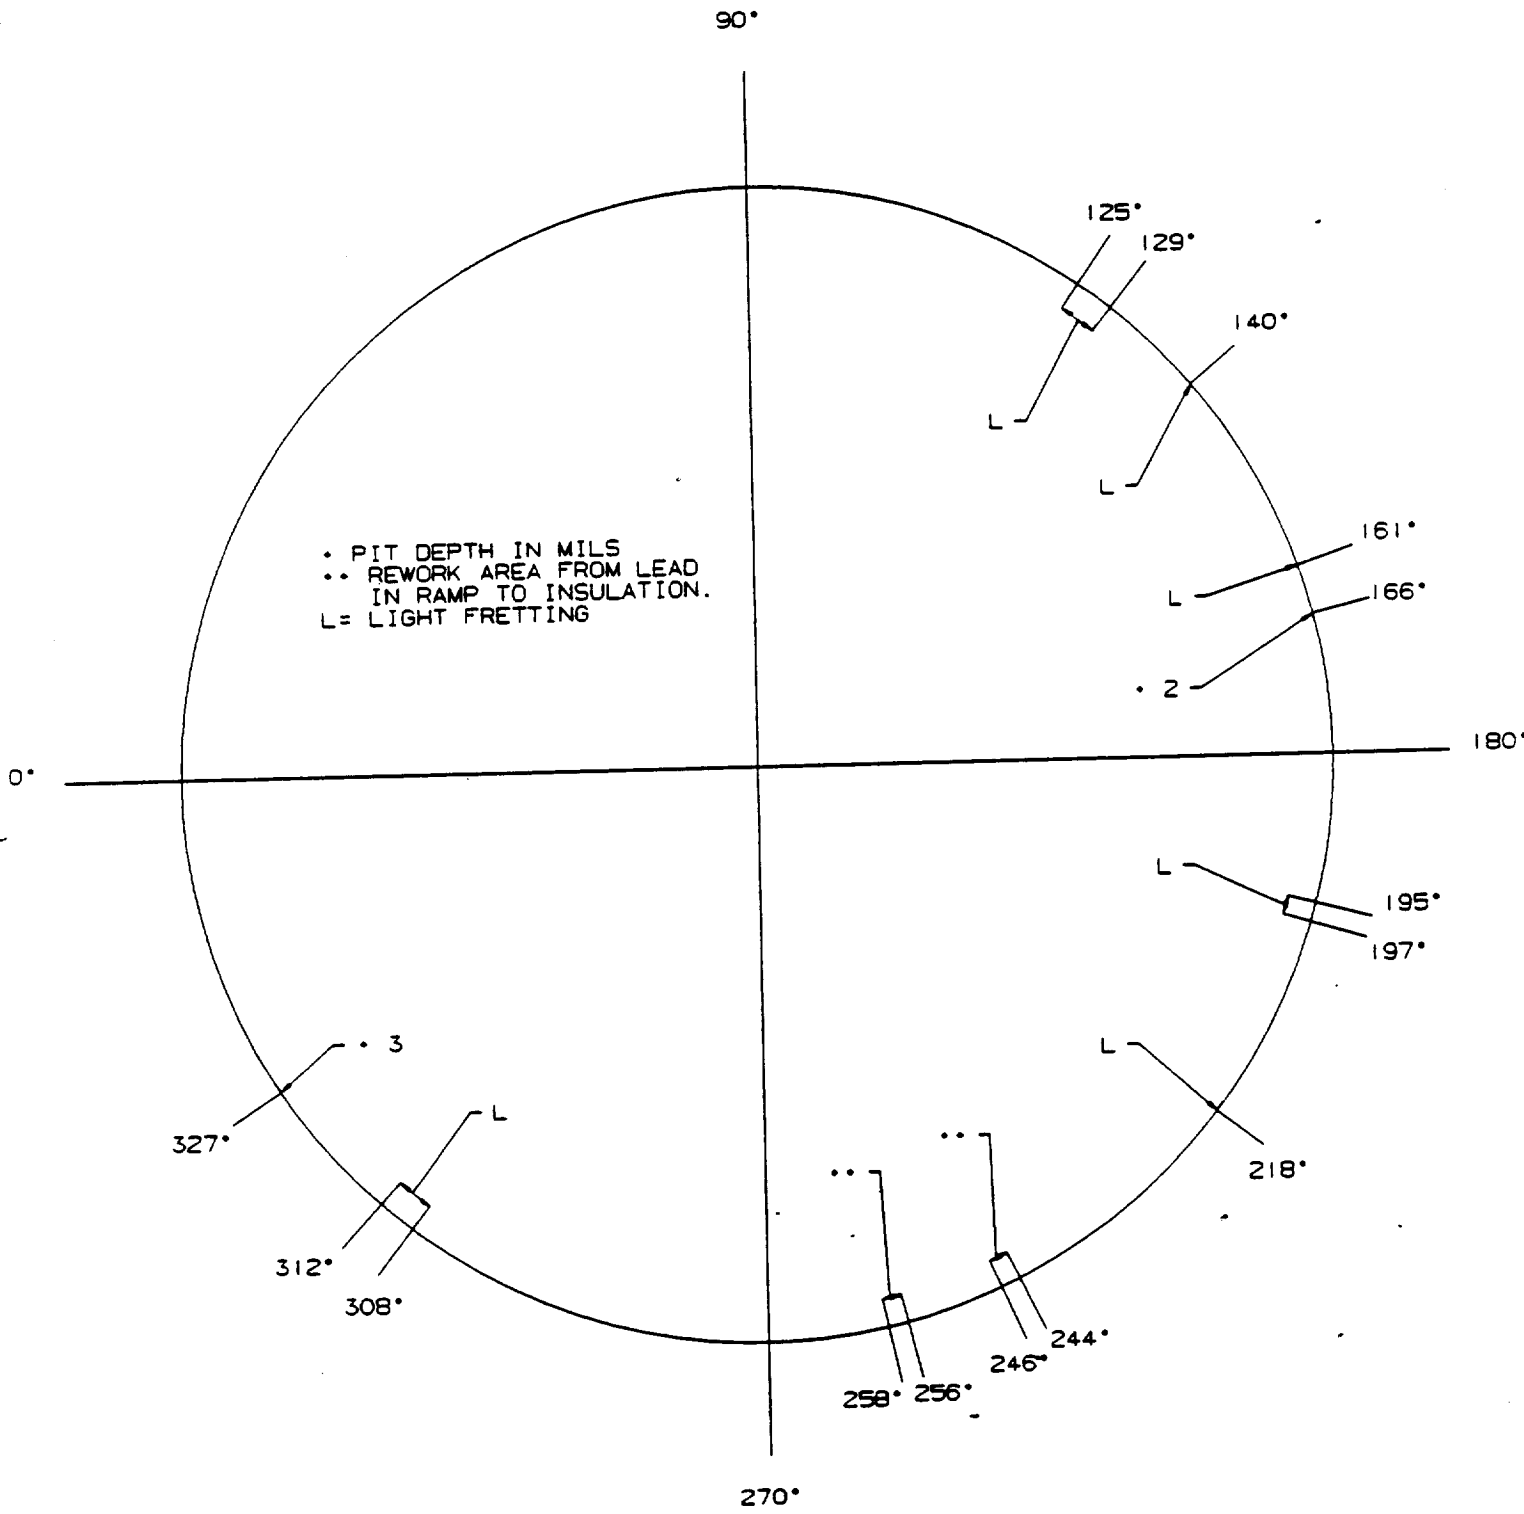
Figure 8. LH Aft Field Joint Fretting

Assessment of the metal components found light fretting at 125 through 129, 140, 161, 166, 195 through 197, 218, 244 through 246, 256 through 258, 308 through 312, and 327 degrees. This joint had fretting from a previous flight from 185 through 220 degrees. Figure 8 gives a detailed view of the fretting. All fretting was mapped on the clevis and it is assumed that the tang has similar damage to it.

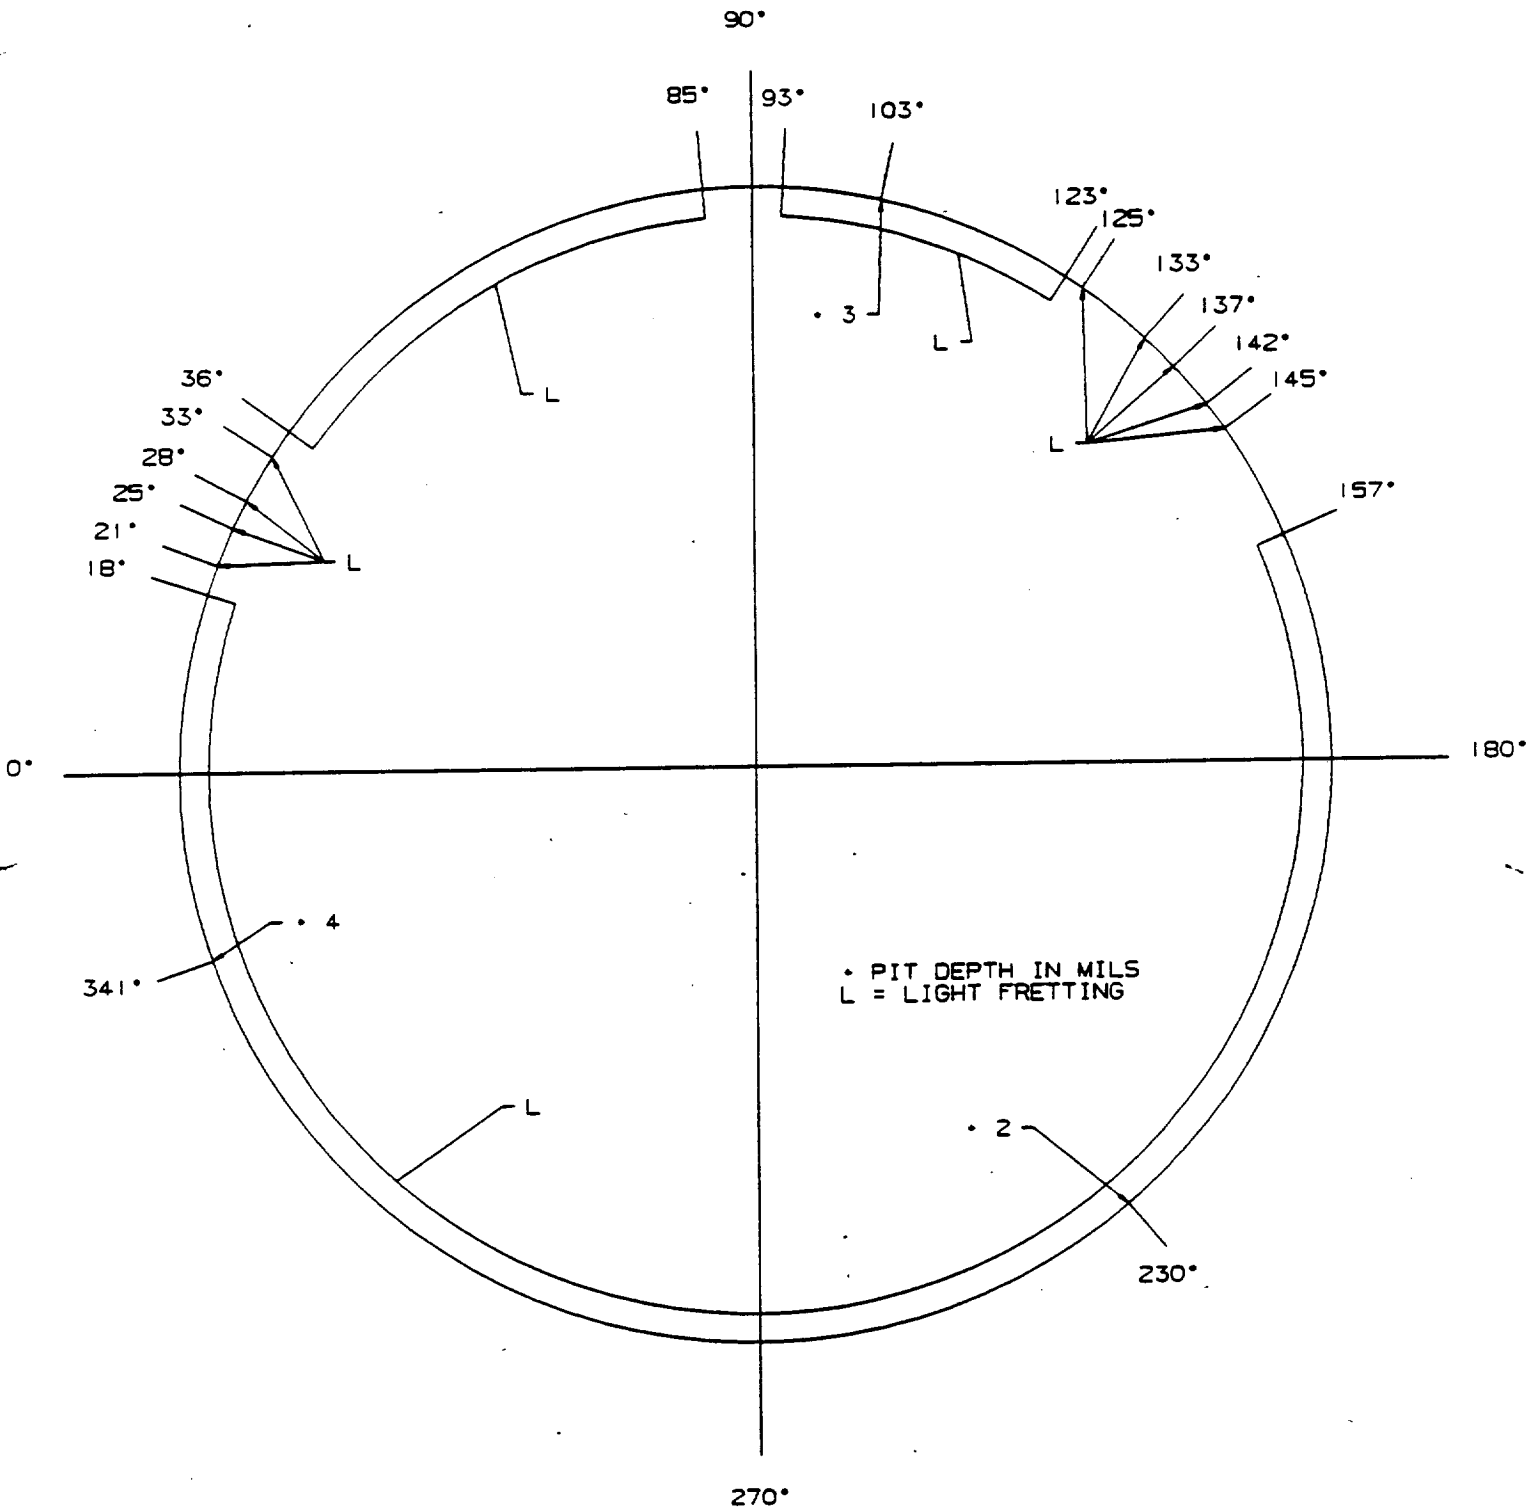
Figure 9. RH Forward Field Joint Fretting

Assessment of the metal components found light fretting intermittently the entire circumference of the joint. Figure 9 gives a detailed view of the fretting, all fretting was mapped on the clevis and it is assumed that the tang has similar damage to it.

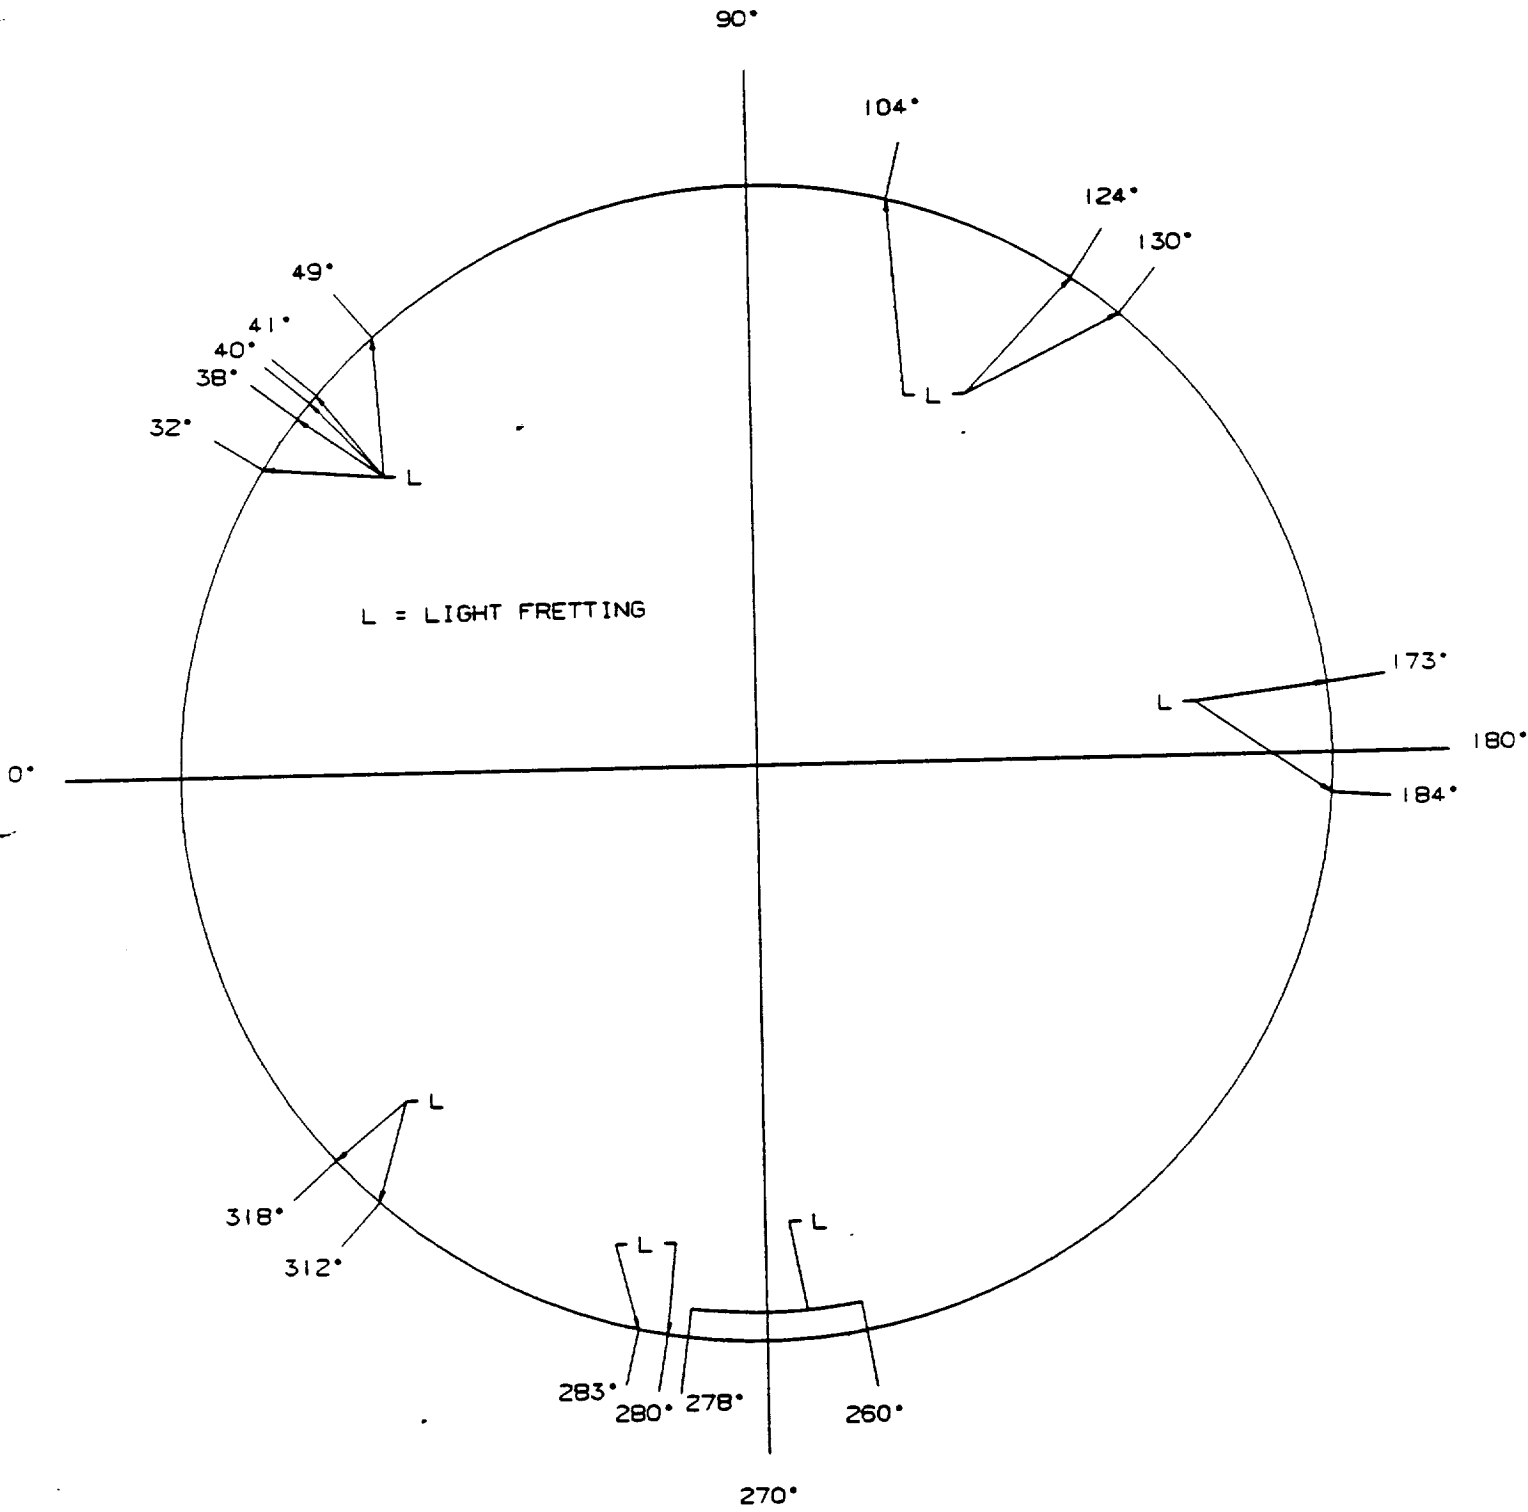
Figure 10. RH Aft Field Joint Fretting

Assessment of the metal components found light fretting at 32 to 41, 49, 104, 124, 130, 173, 184, 260 to 283, and 312 to 318 degrees. Figure 10 gives a detailed view of the fretting.
