NASA Technical Memorandum 104532
AIAA-91-2123

Microanalysis of Extended-Test Xenon Hollow Cathodes

MICROANALYSES OF EXTENDED-TEST XENON HOLLOW CATHODES

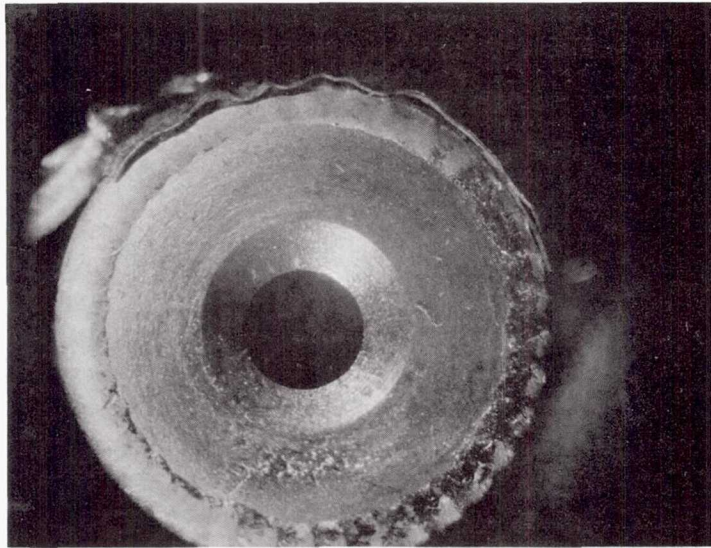
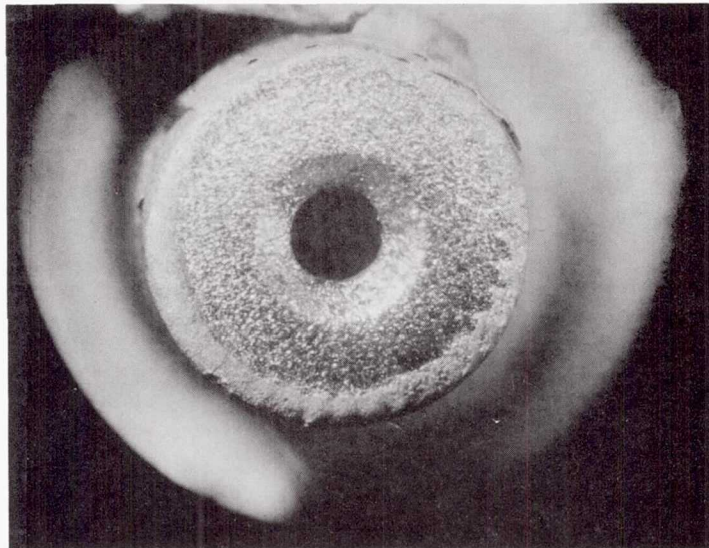
Figure 11. External surface of cathode WT-I orifice plate.

The external surface conditions of the cathodes were examined prior to and after all the tests. For the first wear-test, cathode WT-I had not previously been used. The orifice plate showed machining marks and the electron-beam weld was clearly visible, as shown in the photograph in Figure 11(a). In addition, the edges of the chamfer were well-defined and the chamfer had the same smoothness as the plate surface. After the wear-test, the orifice plate was substantially roughened over its entire area, including the chamfer (Fig. 11(b)). The Ta foil thermocouple cover junction appeared severely eroded and heat-treated. Also, the downstream end of the cathode body tube had the appearance of being eroded up to the point of coverage by the swaged heater.

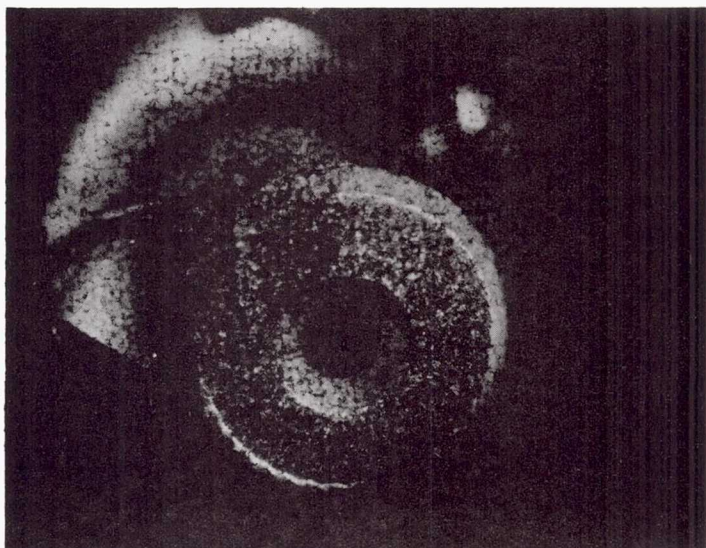
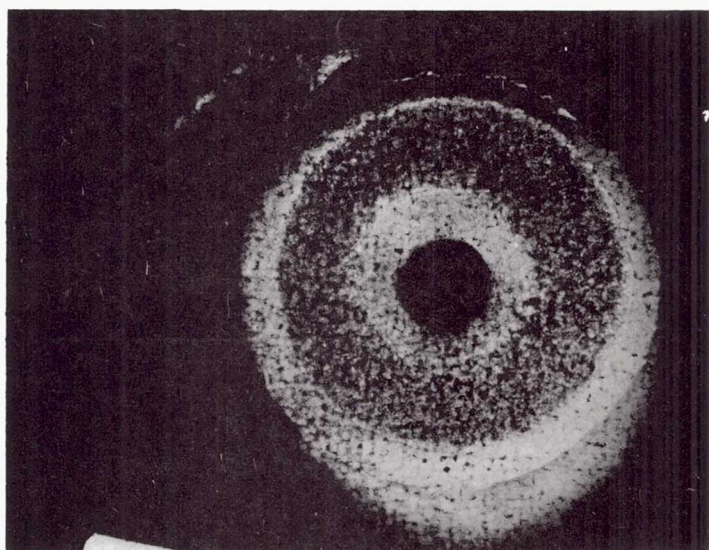
Figure 12. External surface of cathode WT-II orifice plate.

The initial condition of cathode WT-II shows in Fig. 12(a) the effects of 41 hours of discharge operation prior to the wear-test. The orifice plate was already eroded and exhibited the

roughened appearance on plate, chamfer, and e-beam weld surfaces. However, the orifice geometry had not been altered; the chamfer was straight and the orifice had the specified size and shape. The Ta foil cover over the thermocouple junction was undamaged. Post-test examination of the condition of the orifice plate showed no discernible change (see Fig. 12(b)). The cathode tube exhibited the same surface erosion observed on cathode WT-I and the Ta foil was sufficiently embrittled to flake off when a slight force was applied.

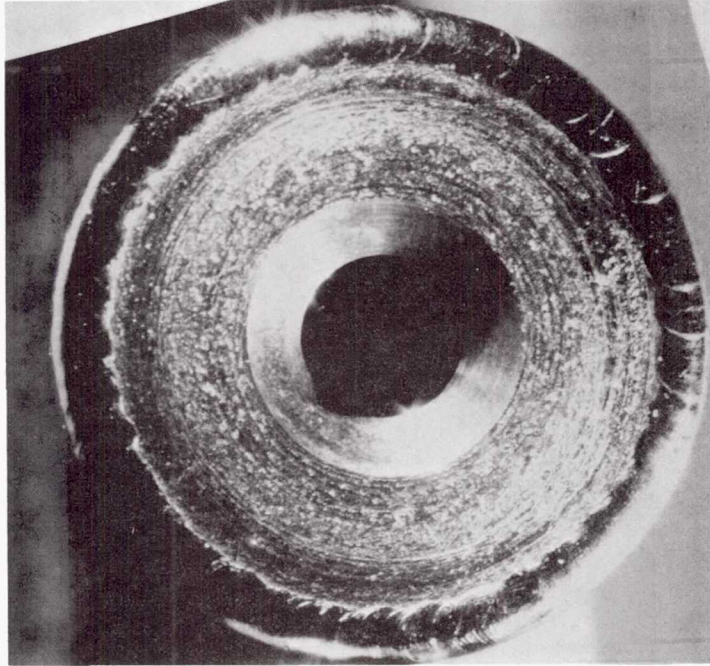
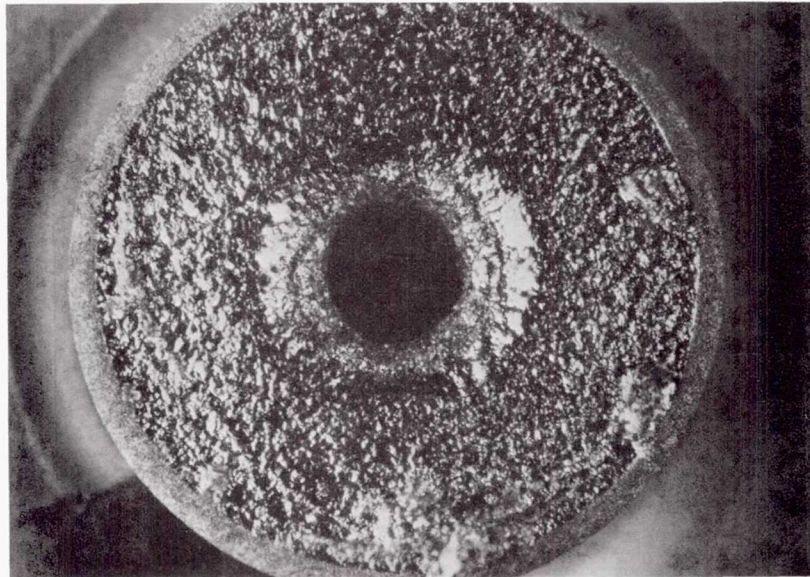
Figure 13. External surface of cathode TL-I orifice plate.

Prior to the life-test and the initial check-out period, both cathodes TL-I and TL-II were in pristine condition, as shown in Fig. 13(a) and 14(a). Post-test examination showed several changes which are shown in Fig. 13(b) and Fig. 14(b). Cathode TL-I experienced severe ion bombardment of the orifice and orifice plate. The surface had been roughened to the point of removing all pre-test features including the electron-beam weld structure. The chamfer on the orifice appeared to no longer be a smooth 45°, but very irregular and filled-in. In addition, the orifice, while not changing significantly in diameter, had an irregular geometry with one edge being opened up, possibly by erosion. There also appeared to be irregular metallic deposits on the orifice plate.

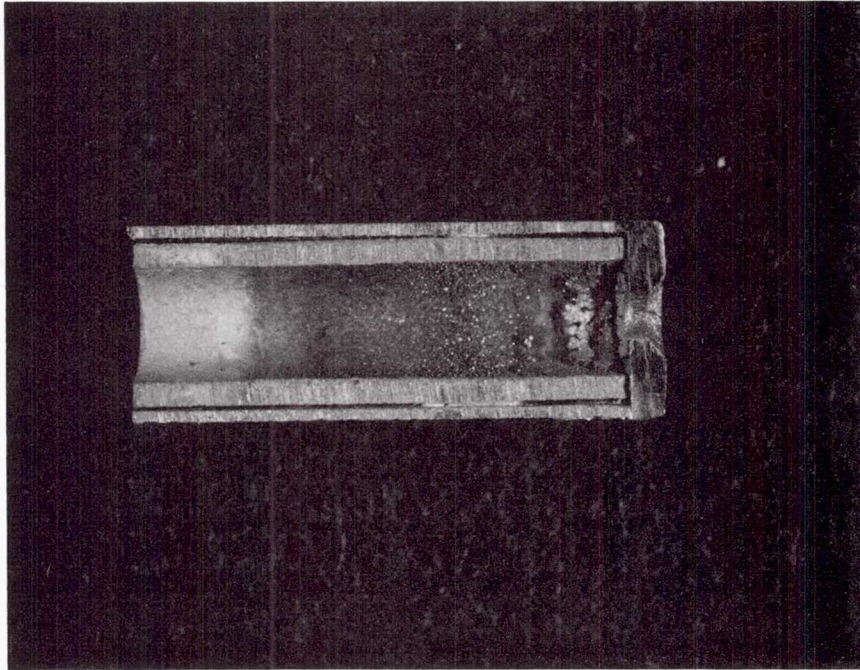
(a) WT-I Cathode

Inside cathode WT-I, the shape of the orifice chamfer and channel appeared intact. However, a large deposit of material was found at the downstream end of the insert and on the orifice plate, as shown in Fig. 15(a). The rest of the insert surface was divided up into three regions with decreasing degrees of roughness and different colors. The insert surface was slightly irregular, indicating material removal. There was also material visible between the insert outer wall and cathode body tube. This material may have been responsible for affixing the insert to the cathode body.

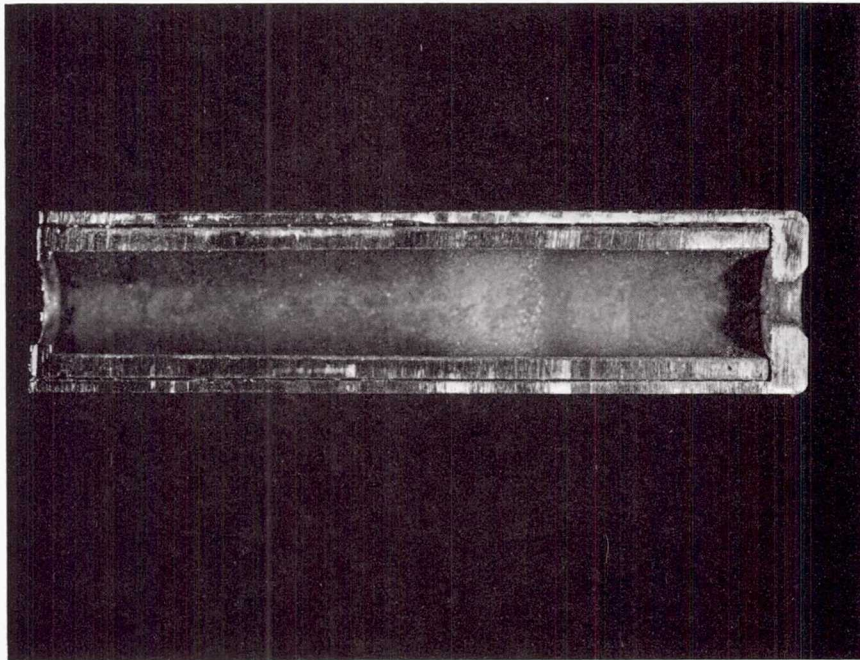
(b) WT-II Cathode

and at the downstream end of the insert. The remainder of the insert surface was separated into different colored regions, all with approximately the same degree of roughness. The insert surface has one distinct boundary at approximately 0.85 cm from the orifice plate and another, less distinct, boundary at 1.6 cm. The insert wall thickness was uniform and the surface was smooth. The orifice chamfer and channel appeared to be in near original condition with no deposition visible.

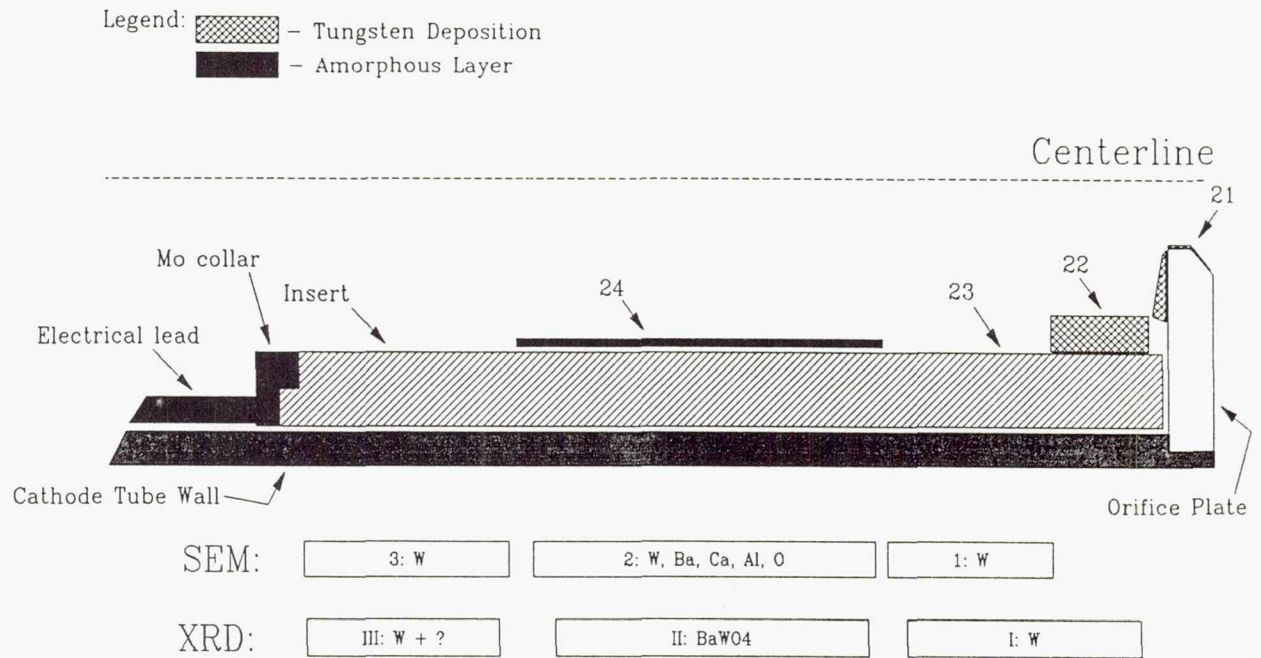
Figure 17. Schematic of cathode WT-I cross-section with the observed phenomena summarized. Numbers locate the SEM photographs by figure number and the SEM and XRD bars list the elemental and molecular composition in respective regions.

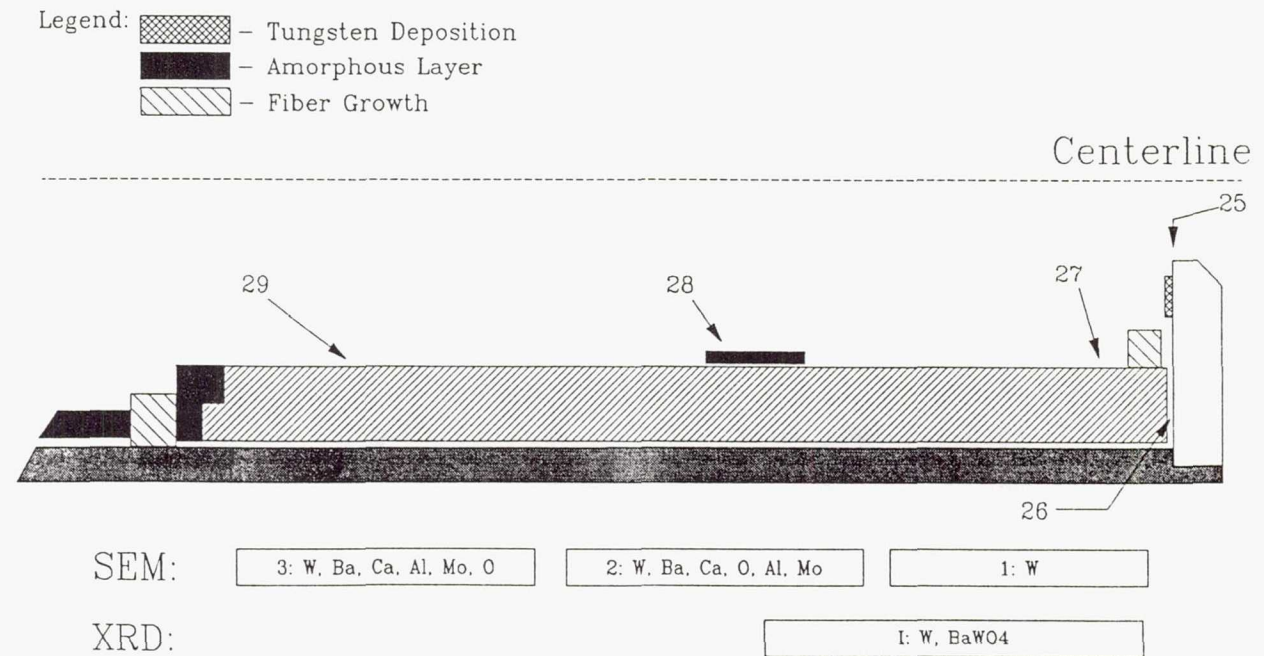
For cathode WT-II, the orifice plate and insert surfaces were observed to be in relatively good condition. The orifice appeared to be surrounded by a rough ring of deposited material, but it was difficult to distinguish the amount. Outside of this ring, some material had collected over the rest of the orifice plate in grain-like structures. The downstream end of the insert had a ring of crystal growths that stuck fiber-like out from the surface, as indicated in Fig. 18. These fibers appeared to be deposited metal and have very reflective surfaces. The ring was very narrow and had a distinct boundary with a region of very fine structure. This next region appeared to be uniformly covered with fibrous crystals, possibly of similar composition as the larger growths observed at the insert edge. Upstream of the fibrous growth, the remainder of the insert surface appeared uniform and without any distinct features, though different color striations were apparent. The molybdenum collar at the upstream insert end appeared clear of material deposition. Crystal growth was apparent in the gap between insert wall and cathode tube wall with some material extending further upstream of the moly collar. Later boroscope examination did not find this material as it was lost when the insert was found to be removable.

Figure 18. Schematic of cathode WT-II cross-section with the observed phenomena summarized.

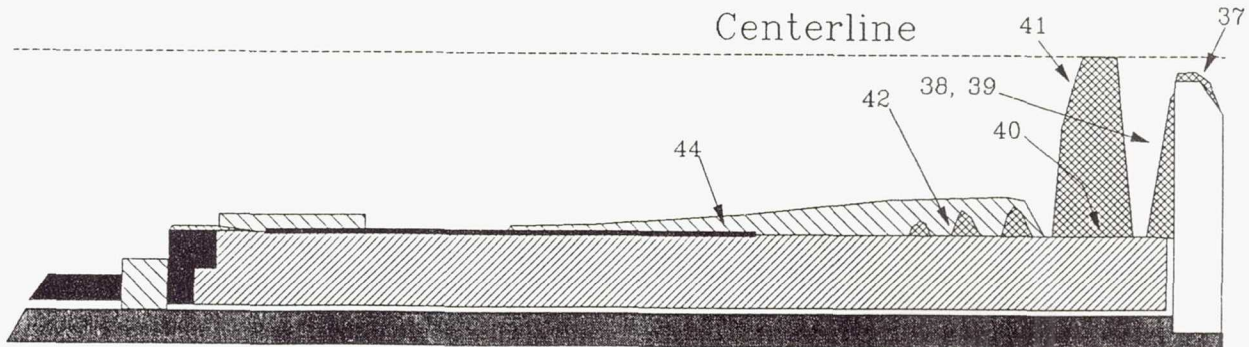
The interior of cathode TL-II is represented in Fig. 20 and had many of the same characteristics as cathode TL-I. The orifice was found to be blocked (visually) by a large metallic deposit. The material of this plug extended into the insert cavity as well as covered a substantial area of the orifice plate. However, the degree of physical blockage was unknown. The downstream insert surface area possessed several ridge-like features which were relatively symmetric. The entire length of the insert surface seemed to be covered with fibrous crystal growth which covered the surface very densely and extended into the insert cavity. The farther the distance upstream from the orifice, the less apparent the growth appeared, until the insert surface had a smooth appearance. However, at the upstream end of insert, the crystal formations increased in density symmetrically over the surface. Material was deposited on the surface of molybdenum collar parallel to the tube wall. There was a extensive

Figure 20. Schematic of cathode TL-II cross-section with the observed phenomena summarized.

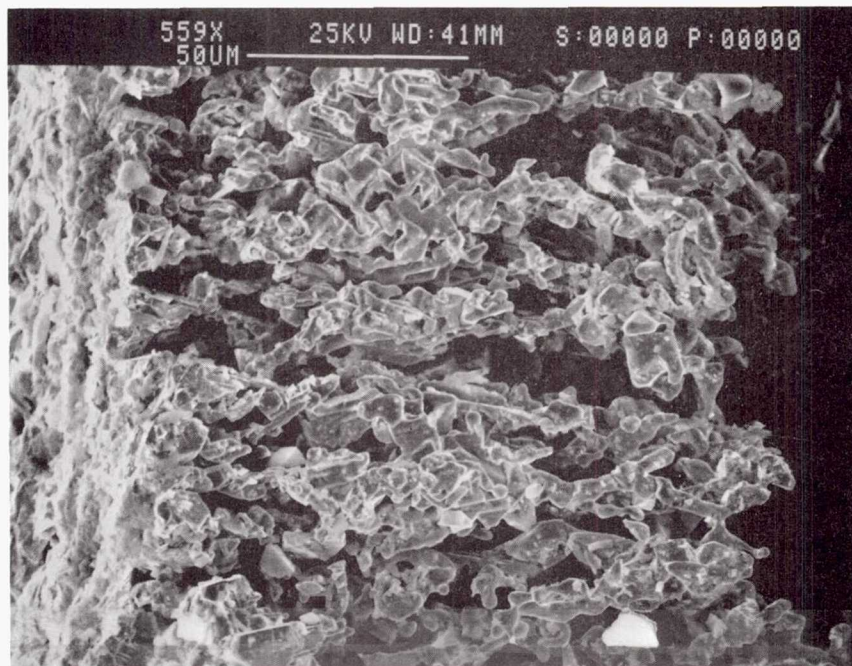
Figure 22. SE image of the tungsten deposition on the downstream end of cathode WT-I. The top of the deposition surface is at the left of the photograph.

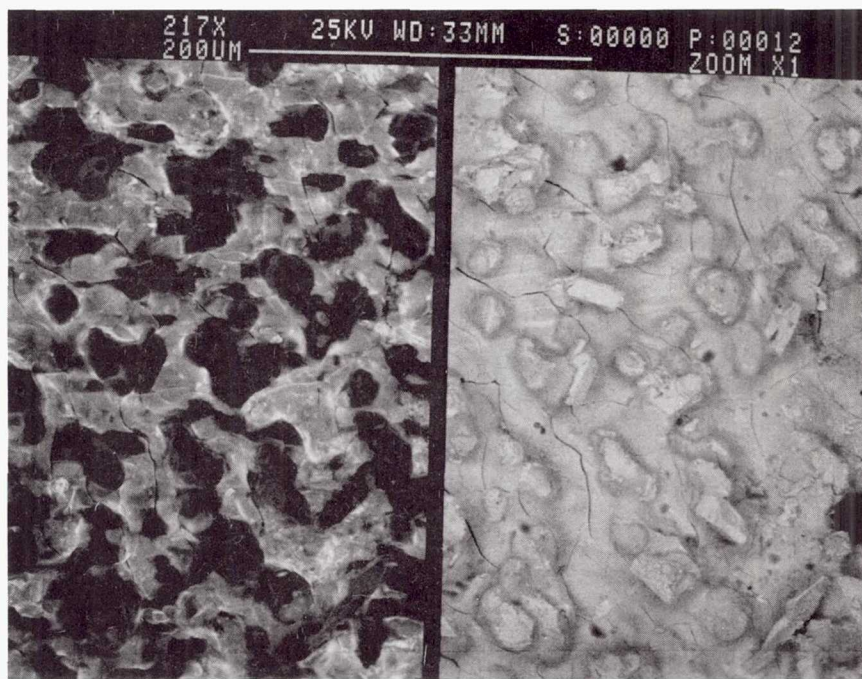
Figure 24. Nonconductive material on the surface of the third section of cathode WT-I insert, SE image on the left and BSE image on the right.

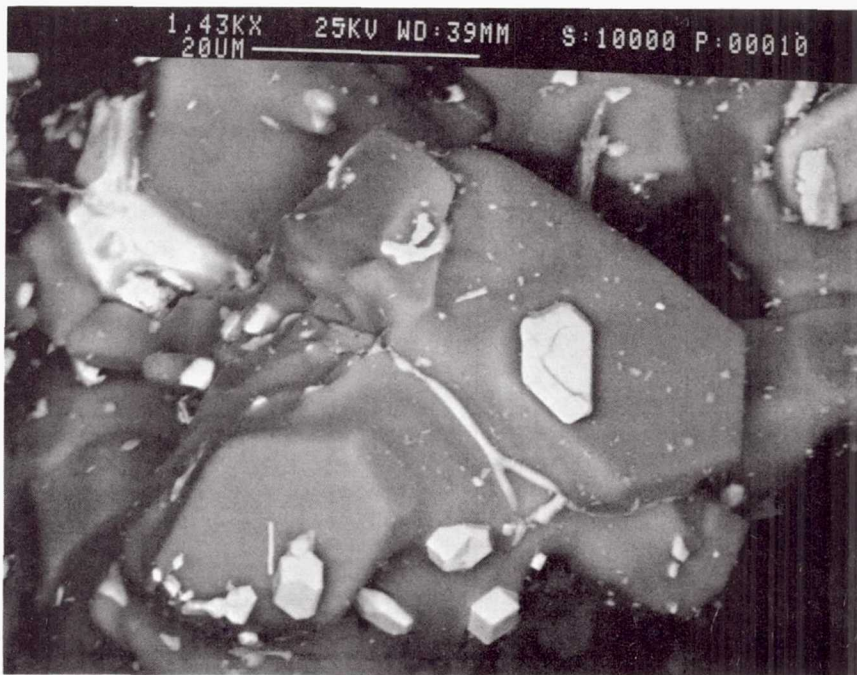
Figure 32. BSE image of coating composed of barium, aluminum, tungsten, and oxygen on the orifice plate in cathode TL-I.

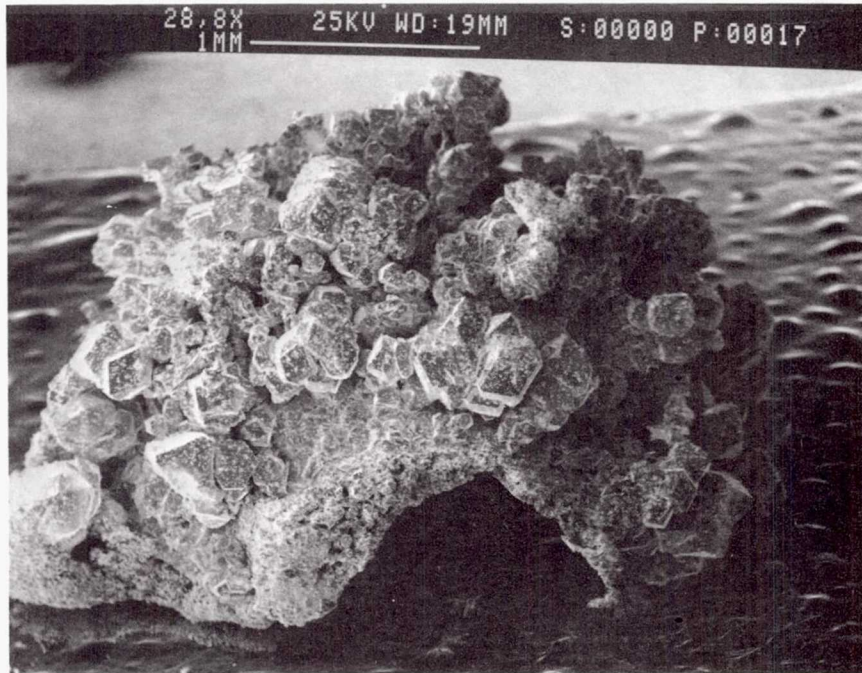
Figure 41. SE image of tungsten plug from cathode TL-II.

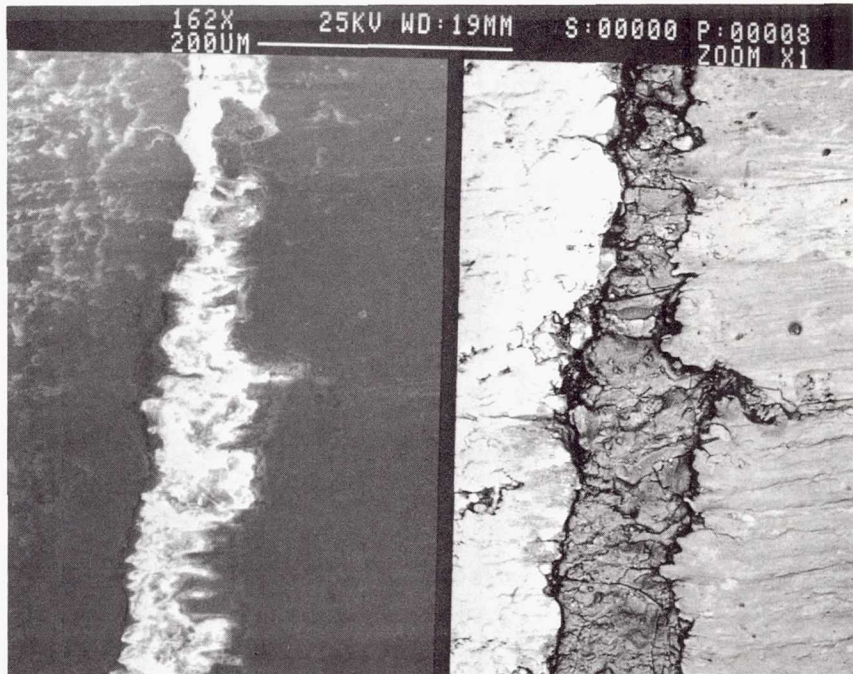
Figure 43. Gap material found between insert and cathode body tube walls in cathode TL-II.
