NASA Technical Memorandum 103620

Tensile Deformation Damage in SiC Reinforced Ti-15V-3Cr-3Al-3Sn

Bradley A. Lerch and James F. Saltsman
Lewis Research Center
Cleveland, Ohio

April 1991

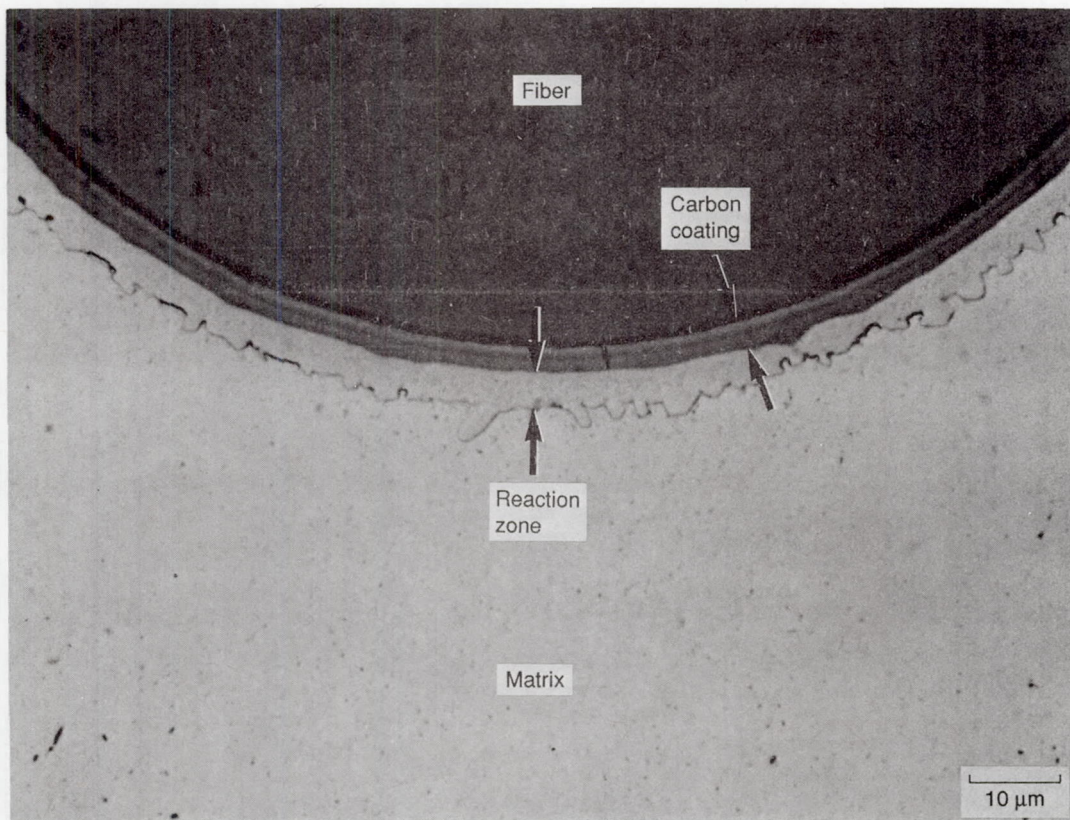
fibers in this specimen was 3 μm thick (fig. 5) rather than the 0.3 μm observed in the other specimens (ref. 1). Although the cause of this large reaction zone is unknown, with all other factors equal, we conclude that the interface can significantly affect the elastic modulus of the composite.

Figure 5.—Anomalously large reaction zone in specimen 5.

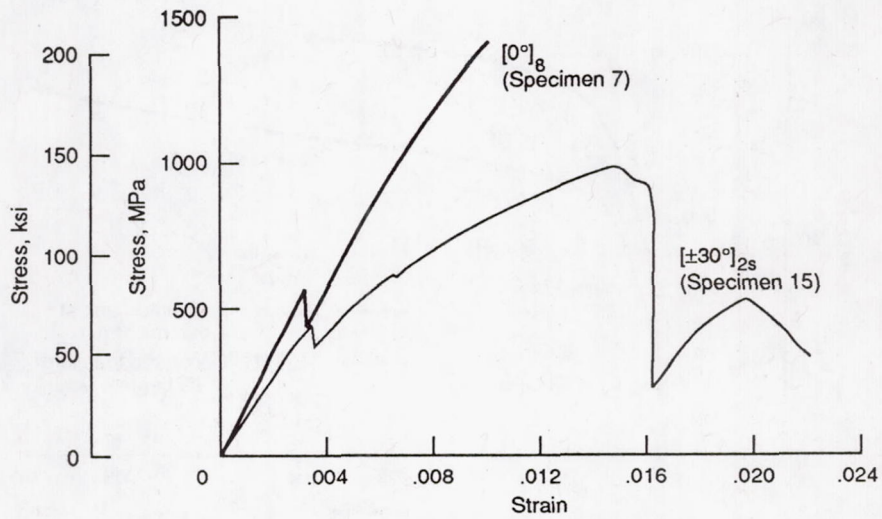
During testing of some specimens, discontinuous stress-strain behavior was observed (fig. 8). At the lower strains, the sudden load drop was accompanied by an audible click. This behavior was observed primarily at room temperature for some of the $[0^\circ]_8$ and $[\pm 30^\circ]_{2s}$ layups that were tested as 10.2-cm (4-in.) long samples. We do not know why the shorter specimen length was more prone to this behavior. Metallographic examination of these specimens from tests which were continued to failure, and of specimens from tests interrupted after the load drop failed to reveal the cause for this behavior.

Other discontinuities in the tensile curves were occasionally observed near final fracture (fig. 8, $[\pm 30^\circ]_{2s}$ curve). This behavior was only observed in room temperature tests for the $[\pm 30^\circ]_{2s}$ specimens. Its cause is unknown but is believed to be due to the propagation and arrest of cracks.

Another disadvantage of the 10.2-cm-long specimens is that they are prone to sudden load drops (fig. 8). It is possible that these load drops, and the audible click associated with them, were caused by partial debonding of the tab from the specimen. This debonding may have been induced by the stress concentration in the tab region.

Figure 8.—Room temperature tensile curves showing discontinuities.

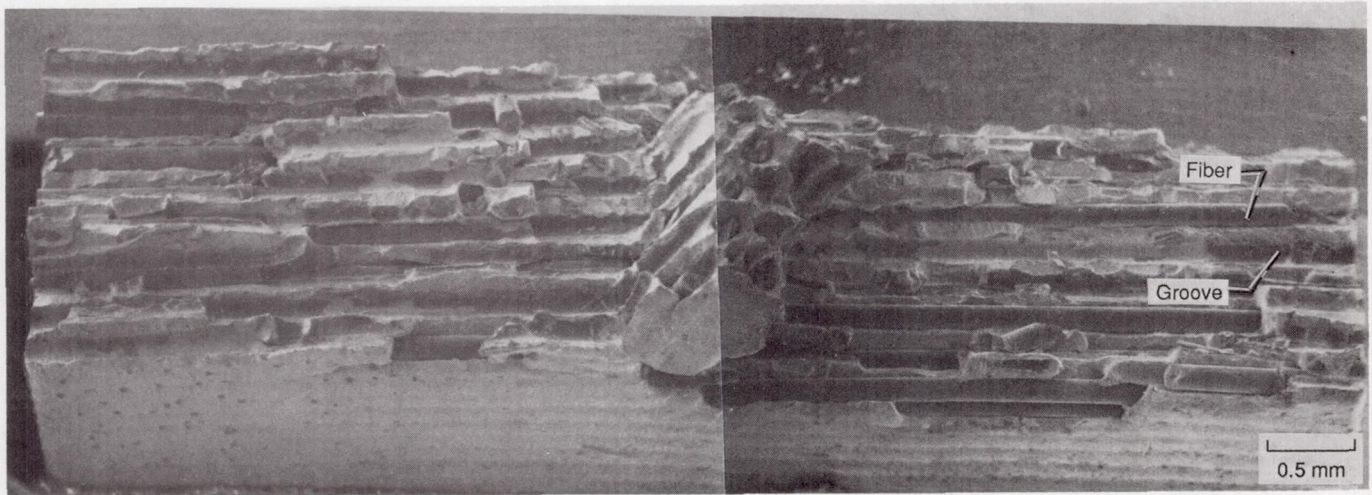
$[90^\circ]_8$ Layups. - Cracking in this fiber layup occurred parallel to the fibers, forming a flat fracture surface (fig. 16). Occasionally, sections of matrix and/or composite were ripped off in chunks. The fibers were either intact or completely missing, and no fiber splitting was observed. If fibers were missing, a groove remained where the fiber once was. The matrix failed similarly to that in the $[0^\circ]_8$ specimens in that shear lips formed next to the fibers and microvoid coalescence occurred elsewhere (fig. 17(a)). At 427°C cleavage was an important matrix cracking mechanism as depicted in figure 17(b). More necking of the matrix surrounding the fibers was also observed at 427°C .

Figure 16.—Fracture surface of $[90]_g$ specimen tested at 427 °C.

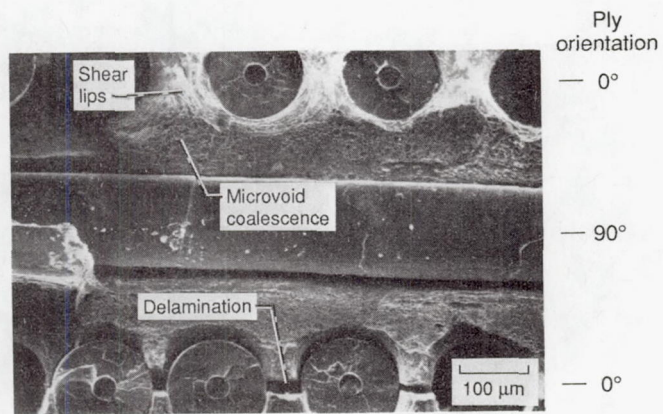
$[0^\circ/90^\circ]_{2s}$ and $[90^\circ/0^\circ]_{2s}$ Layups. - The $[0^\circ/90^\circ]_{2s}$ and $[90^\circ/0^\circ]_{2s}$ specimens behaved similarly and will therefore be discussed together. These specimens' fracture surfaces were identical to the $[0^\circ]_8$ or $[90^\circ]_8$ specimen fractures for those plies oriented at 0° or 90° , respectively, to the load axis. The overall fracture surfaces showed evidence of fiber pullout (fig. 18) in the 0° -plies, and missing fibers or fiber-matrix separation in the 90° -plies. The matrix failed through tensile overload as evidenced by microvoid coalescence and shear lips next to the fibers (fig. 19). Some delamination was observed in the 0° plies.

Figure 19.—Fractographs of $[90^\circ/0^\circ]_{2s}$ specimens tested at room temperature.

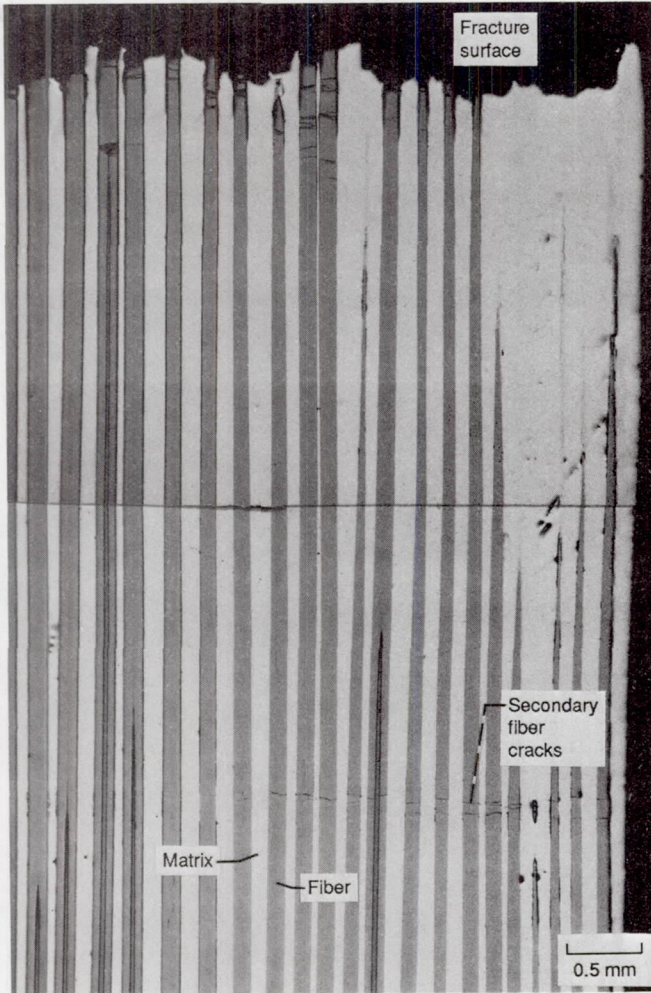
$[0^\circ]_8$ Layups. - Specimens tested to failure at room temperature exhibited extensive fiber cracking and debonding near the fracture surface (fig. 21). These cracks were generally perpendicular to the fiber axis. Away from the fracture surface, few cracks, if any, were observed. Figure 21 also shows a group of secondary fiber cracks in the second ply, ≈ 5 mm below the fracture surface. These cracks occurred in the area of a titanium wire and are better observed in the etched specimen of figure 22(a). This row of fiber cracks was not observed in the first ply, since the titanium wire did not appear there.

Figure 21.—Face section of second ply of $[0^\circ]_8$ specimen showing fiber cracks. Specimen tested at room temperature.

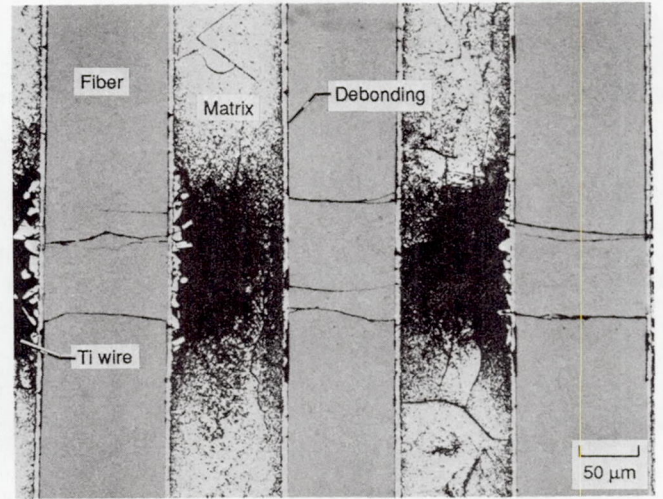
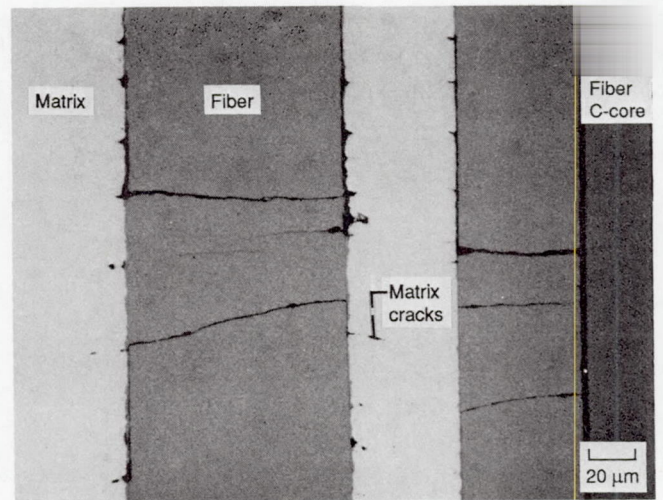
Other than the primary crack (which led to failure), no other matrix cracks were observed. The exceptions were those cracks which sometimes occurred in the matrix in the area of a titanium wire. An example of this is shown in figure 22(b), which is from the same general area of the sample in figure 22(a), but, here, the sample is unetched to permit viewing of the matrix cracks. These cracks were small and rarely propagated to the next fiber.

Figure 22.—Micrograph of $[0^\circ]_8$ specimen showing fiber cracks near titanium wire weave. Specimen tested at room temperature.

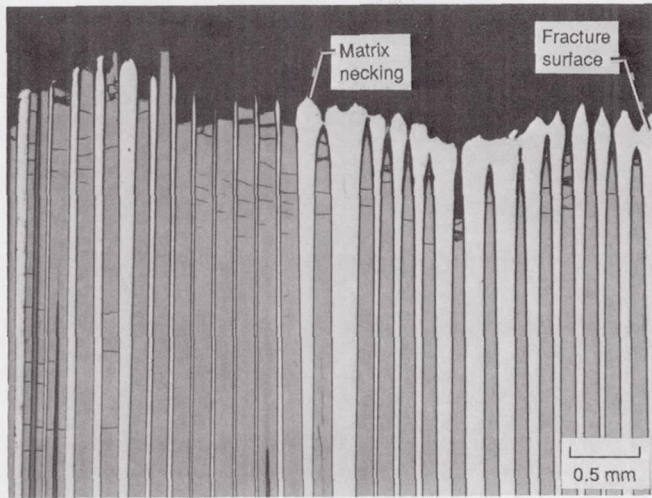
Examination of specimens tested at 427°C showed an increase in matrix ductility at this temperature as evidenced by matrix necking on the fracture surface (fig. 23). This behavior was not observed in specimens tested at room temperature (compare with figs. 21 and 23). The specimens tested at 427°C also showed extensive fiber cracking and debonding near the fracture surface and little or no matrix cracking. More fiber cracks were observed away from the fracture surface but these cracks could have been due to specimen to specimen variations and not necessarily to test temperature. One unique observation from the 427°C test is shown in figure 24. In the through-the-thickness section shown the specimen has necked at the fracture surface. As a result fibers cracked extensively, and the fibers in the outer most plies bent toward the center of the specimen. This necking was not observed in the width nor in any orientation tested at room temperature.

Figure 23.—Face section of $[0^\circ]_B$ specimen tested at 427 °C.

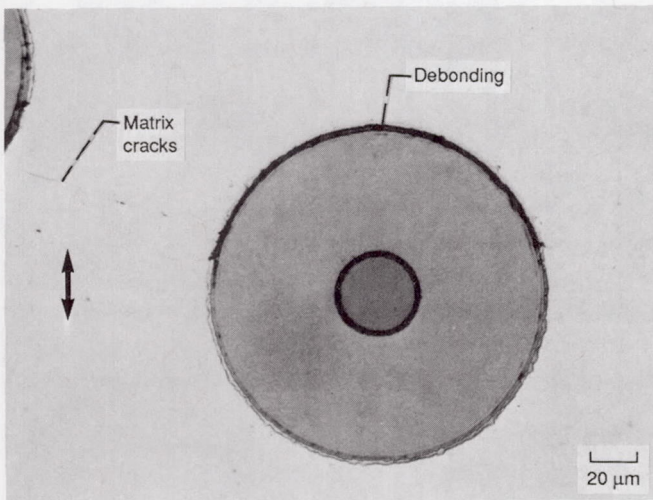
$[90^\circ]_8$ Layups. - Examination of the fracture surfaces showed no difference between those specimens tested at room temperature and those at 427 °C. Other than the primary crack, few matrix cracks, if any, were observed. Figure 25 is a through-the-thickness section showing matrix cracks emanating radially from a debonded fiber. Most fibers were debonded in these specimens. Examination of the first fiber row (fig. 26) shows extensive fiber cracking and splitting only near the fracture surface, which suggests that there was some bending moment, perhaps due to the final fracture.

Figure 25.—Through-the-thickness section of $[90^\circ]_B$ specimen showing matrix radial cracks and debonding. Specimen tested at 427 °C. Double pointed arrow indicates loading direction.

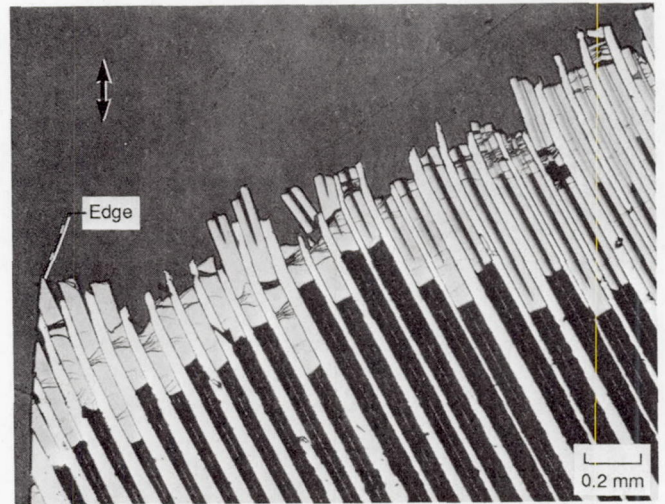
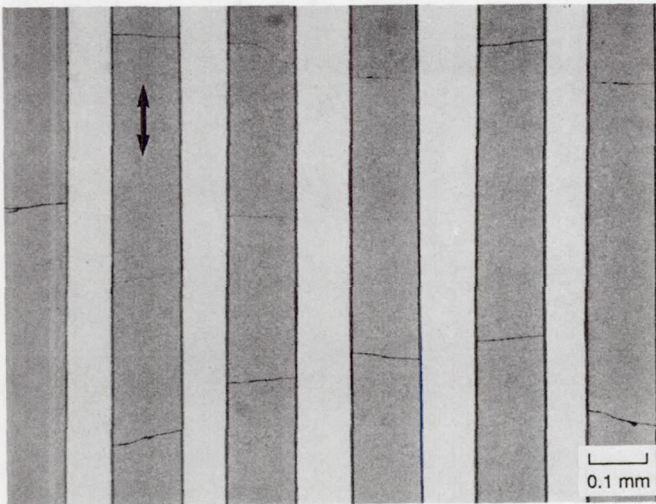
Figure 27.—Face section of third ply of $[0^\circ/90^\circ]_{2s}$ specimen showing fiber cracks far from fracture surface. Specimen tested at room temperature. Double pointed arrow indicates loading direction.

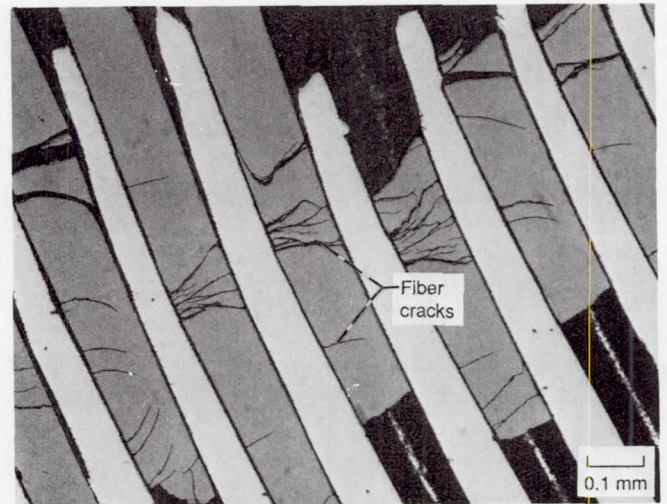
$[\pm 30^\circ]_{2s}$ Layups. - The fracture profile in the first ply is shown in figure 28(a). The fibers, as well as the matrix slivers between the fibers, have rotated as if to align themselves with the load axis. Extensive fiber cracking occurred near the fracture surface, with less occurring away from it. Fiber cracks initiated on one side of the fiber (fig. 28(b)). Some of these cracks did not propagate completely across the fiber diameter. Debonding was also observed along most fibers. Matrix cracks were rarely observed, except when associated with a leach pit, as depicted in figure 29. These pits were observed frequently on the crossplied material and reportedly result from the manufacturing process. The hot isostatic press (HIP) can after consolidation is removed using an acid solution. If not done correctly, the solution can etch the composite matrix leaving a pit (fig. 29). In this study these pits usually acted as crack initiators, regardless of fiber orientation. Since there is no way to assess their effect on the mechanical behavior, although it probably degrades properties, they will not be further discussed. It is interesting to note however, that cracks initiating at the tip of a leach pit were always arrested at the first fiber row.

Figure 28.—Face section of $[\pm 30^\circ]_{2s}$ specimen tested at room temperature. Fiber rotation is accommodated by fiber cracking. Double pointed arrow indicates loading direction.

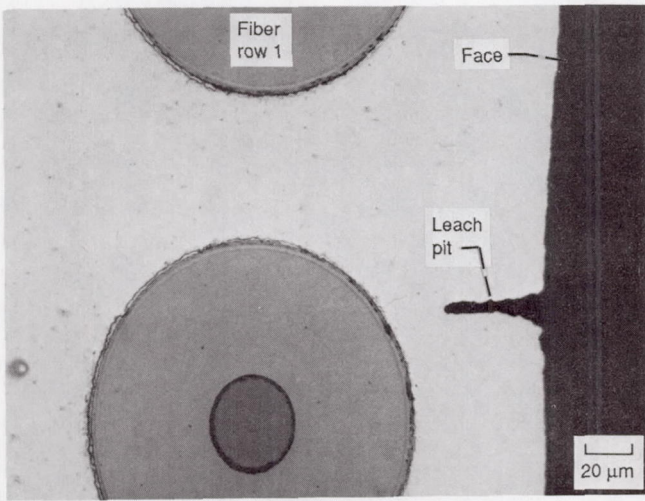
Some matrix cracks were observed, but these were limited to the outer matrix sheet and were always associated with the leach pits (fig. 29). There was also one isolated area in which cracks (a total of five cracks) were found in four fibers. This area was on the edge of the specimen and in the second ply. No other fiber cracks were observed.

Figure 29.—Through-the-thickness section of $[\pm 30^\circ]_{2s}$ specimen showing leach pit created during manufacturing process.

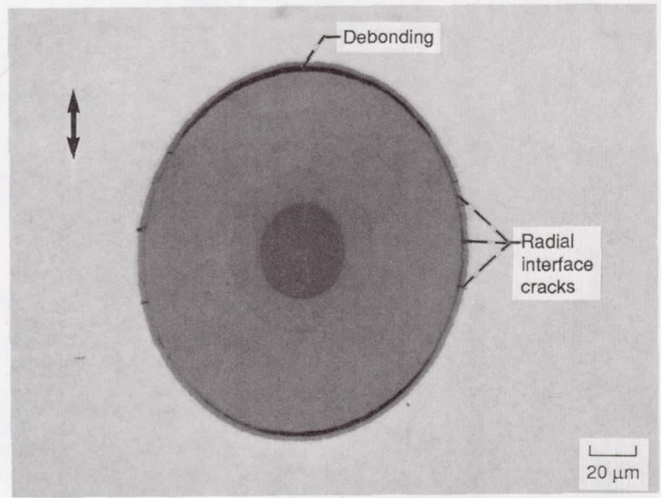
$[\pm 60^\circ]_{2s}$ Layups. - Optical microscopy investigations revealed no differences between specimens tested at room temperature and at 427 °C. The primary fracture followed one set of fibers, and in these plies the damage was similar to that seen in unidirectional, $[90^\circ]_8$ specimens. Few, if any, matrix cracks were observed. Some fiber cracks perpendicular to the fiber axis were observed, but no longitudinal splitting at the specimen edges was seen, as was the case in the unidirectional, $[90^\circ]_8$ specimens. Debonding was observed along nearly every fiber. Figure 30 shows a through-the-thickness section showing a debonded fiber. The gap between the interface and the fiber is largest on the ends that are nearly parallel to the thickness of the specimen. The other sides of the fiber, that is those that are parallel to the length of the specimen, contain radial coating cracks, some of which extend into the reaction zone.

Figure 30.—Through-the-thickness section of $[\pm 60^\circ]_{2s}$ specimen showing interface debonding on upper and lower surfaces and radial interface cracks on left and right surfaces. Double pointed arrow indicates loading direction.

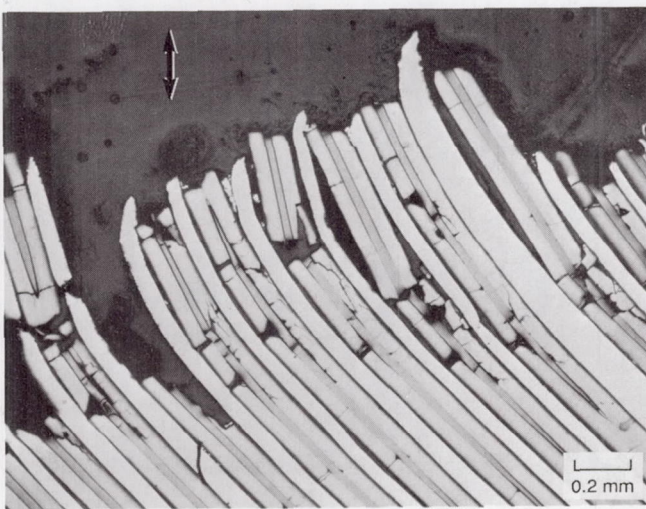
Although the fracture followed one set of fibers, the other set (i.e., the crossplies) were fractured in a manner similar to that of the $[\pm 30^\circ]_{2s}$ specimens. Figure 31 shows extensive

bending of the fibers and matrix toward the loading axis. Fiber cracks occurred throughout the specimen, and propagated perpendicular to the fiber axis. Near the fracture surface, fiber damage is extensive. Again, nearly every fiber was debonded.

Figure 31.—Face section of $[\pm 60^\circ]_{2s}$ specimen showing fracture surface. Specimen tested at room temperature. Double pointed arrow indicates loading direction.

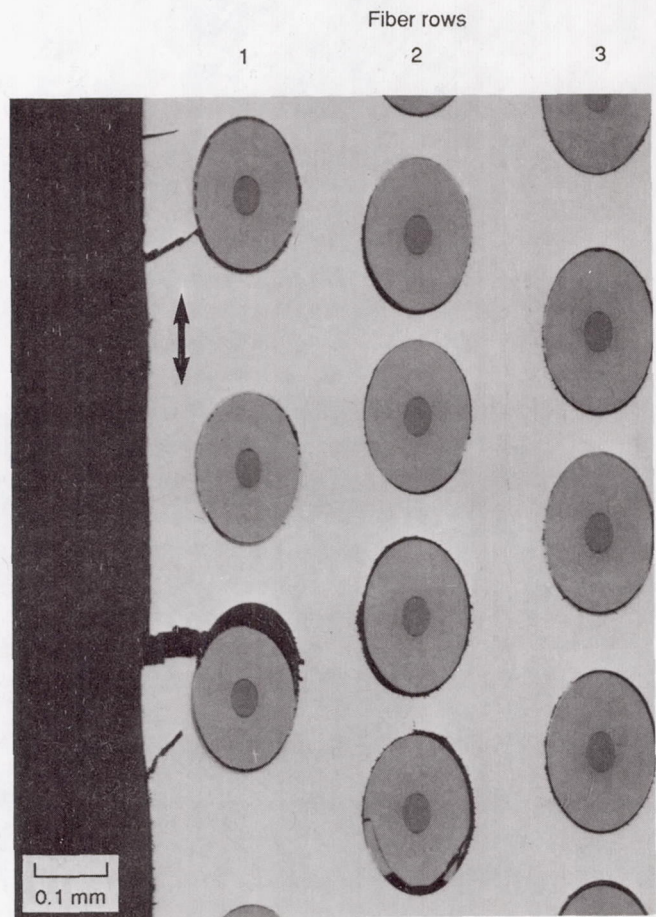
$[\pm 45^\circ]_{2s}$ Layups. - This orientation contained unique damage modes. Testing of the room temperature specimen was stopped at 4 percent strain. Extensive fiber cracking and debonding had occurred. The fiber cracks were perpendicular to the fiber axis. Some matrix cracking was observed in through-the-thickness sections (fig. 32), and these cracks appeared to initiate on the face. No matrix cracks were observed beyond the first fiber row.

Figure 32.—Through-the-thickness section of $[\pm 45^\circ]_{2s}$ specimen. Room temperature test interrupted after 4 percent strain. Double pointed arrow indicates loading direction.

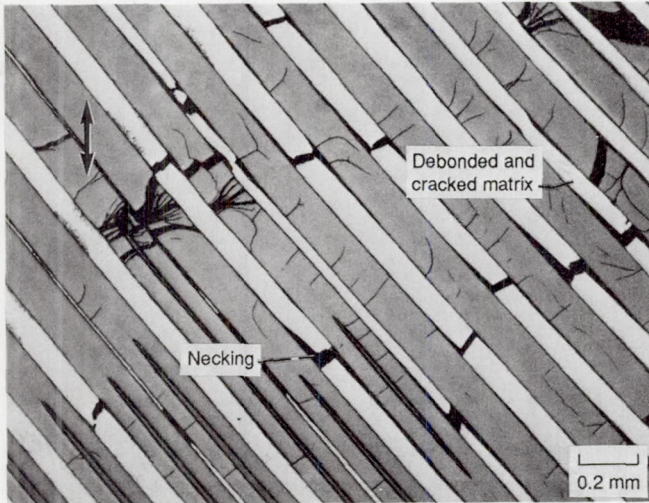
The specimens tested at 427 °C sustained a large amount of damage. Fibers were extensively cracked, even in areas far removed from the fracture surface (fig. 33). The fiber cracks were not always perpendicular to the fiber axis but were bent, approaching a longitudinal direction. Large gaps associated with debonding were also seen. Extensive matrix cracking is also observed in figure 33. The matrix in several areas has necked down and resulted, in some areas, in a 43-percent reduction in area. Figure 34 shows the edge of the specimen at which the matrix has been stretched past the plane of the fiber ends by approximately one fiber diameter. This figure also shows a waviness in the fibers and matrix slivers between fibers which is due to the large amounts of damage.

Figure 33.—Face section of $[\pm 45^\circ]_{2s}$ specimen pulled to failure at 427 °C. Double pointed arrow indicates loading direction.

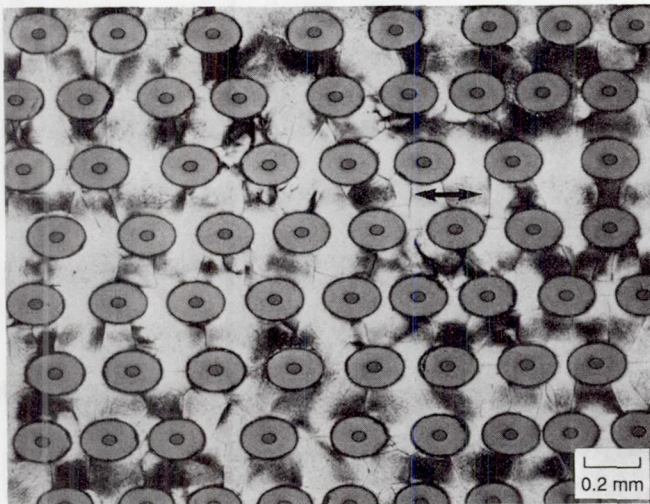
Testing at a slower strain rate of 10^{-5} sec^{-1} at 427 °C resulted in observable slip bands in the matrix (fig. 35). Slip could not be resolved in any of the other tested specimens. It is believed that the appearance of these bands is a dynamic strain aging effect caused by the slower straining rates. Thus, the waviness in the stress-strain curve observed in figure 13 is believed to be a consequence of dynamic strain aging.

Figure 35.—Sections of $[\pm 45^\circ]_{2s}$ specimen showing slip bands. Test temperature, 427 °C; strain rate, 10^{-5} ; etched. Double pointed arrows indicate loading direction.

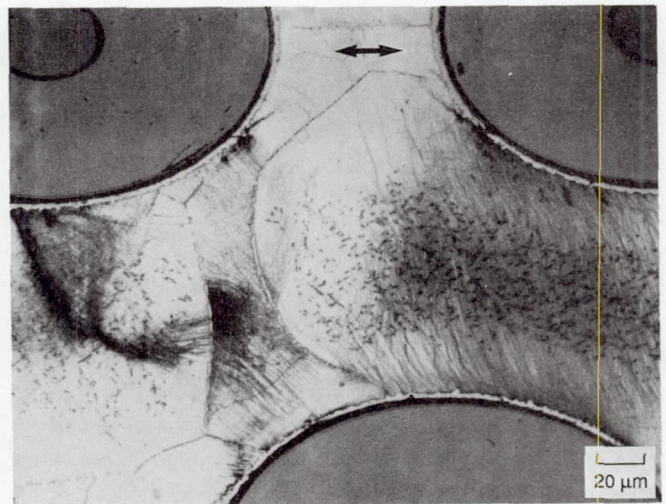
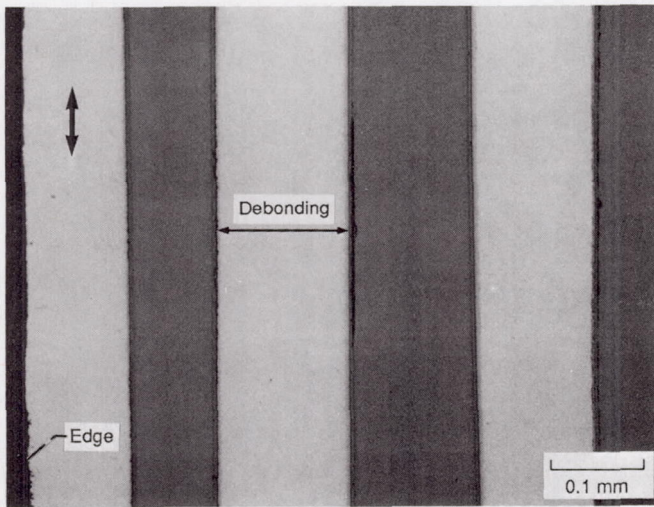
$[0^\circ]_8$ Layups. - A specimen was interrupted at a longitudinal strain of 0.5 percent which represents the first signs of nonlinearity (point A in fig. 7(a)). No damage was observed in the composite. A second specimen was strained just short of failure (point B in fig. 7(a)) to a longitudinal strain of 0.85 percent. This strain is 94 percent of the average failure strain of 0.90 percent for the $[0^\circ]_8$ orientation. No matrix or fiber cracks were observed, nor was there any evidence of delamination. However, some debonding was evident (fig. 36).

Figure 36.—Face section of $[0^\circ]_B$ specimen tested to a strain of 0.85 percent at room temperature. Double pointed arrow indicates loading direction.

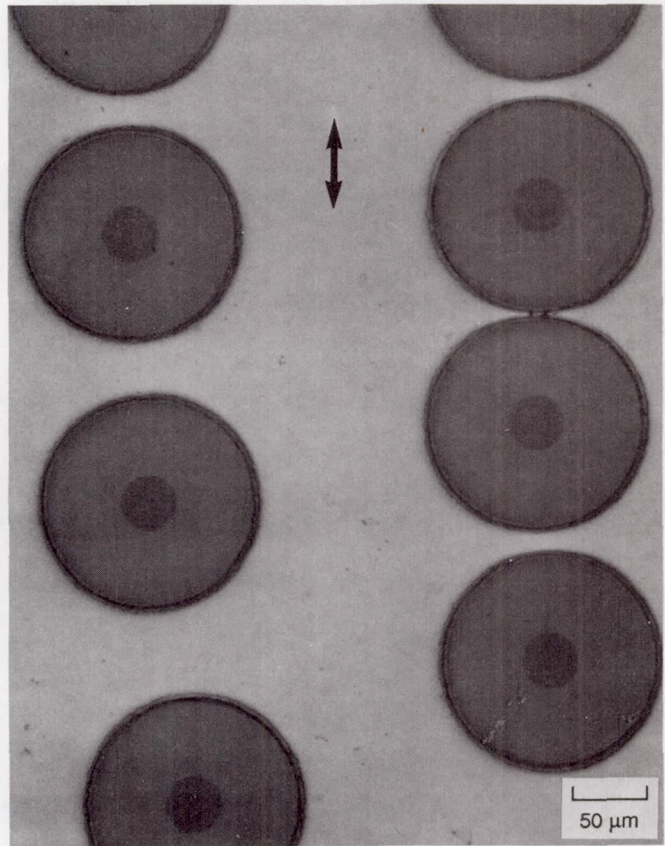
$[90^\circ]_8$ Layups. - One specimen was tested to a strain of 0.6 percent (point A in fig. 7(b)) which is in the nonlinear portion of the stress-strain curve. The only damage observed was some limited debonding of the fibers. A specimen tested to a higher strain of 1.0 percent (point B in fig. 7(b)), suffered extensive debonding, as indicated by the larger interfacial gaps and the increase in the number of fibers debonded (fig. 37). No fiber or matrix cracking was observed.

Figure 37.—Through-the-thickness section of $[90^\circ]_B$ specimen showing interface debonding. Specimen tested to strain of 1.0 percent at room temperature. Double pointed arrow indicates loading direction.
