NASA Technical Memorandum TM 103820

Debris/Ice/TPS Assessment And Photographic Analysis For Shuttle Mission STS-39

April 28, 1991

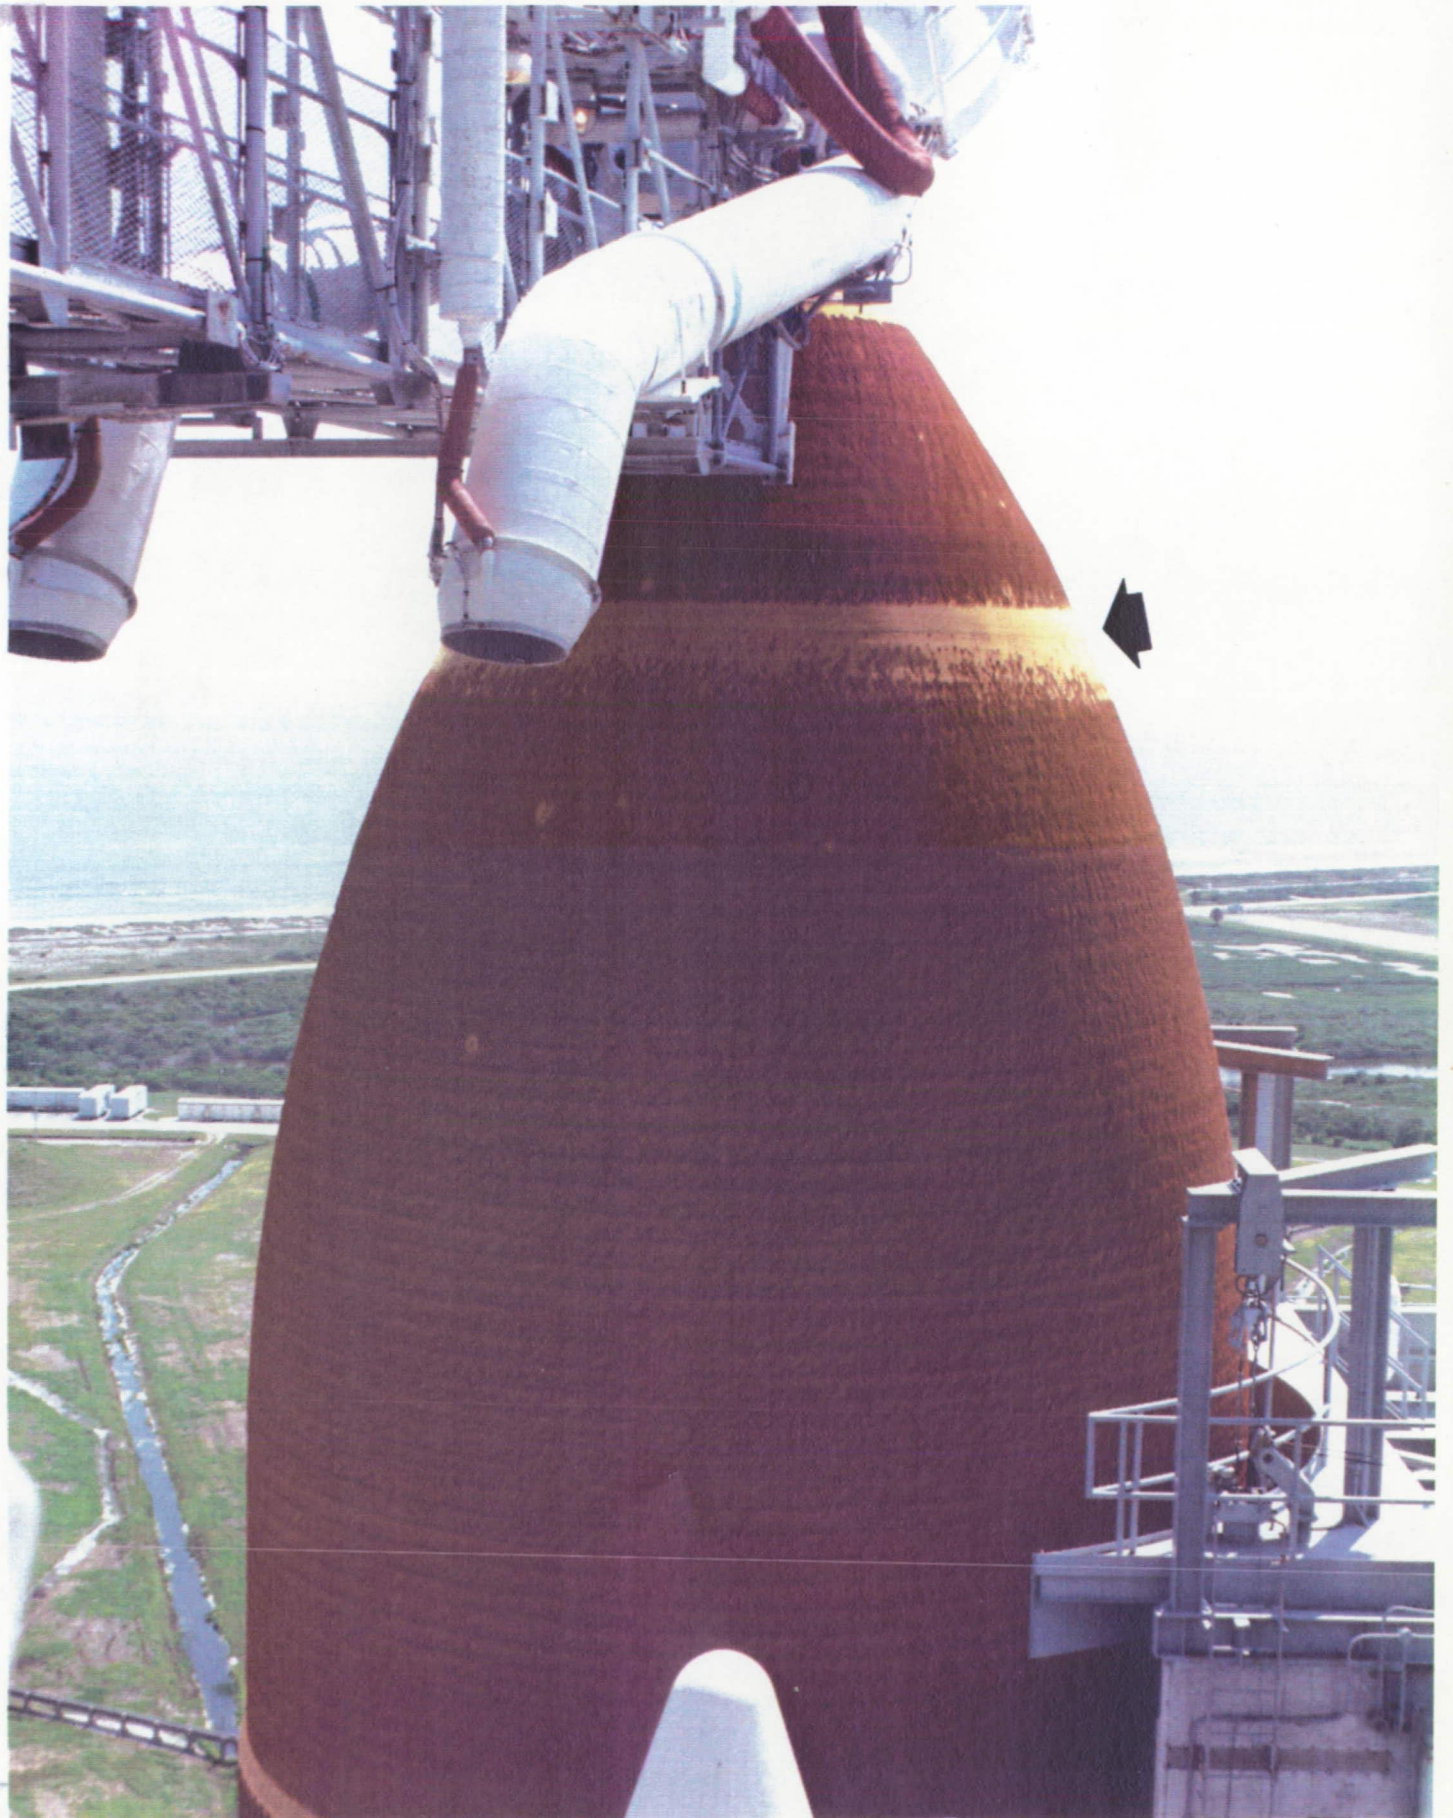
Overall view of ET-46 (LWT 39) L2 tank. Note SOFI spray interrupt/sanded area on ogive section.

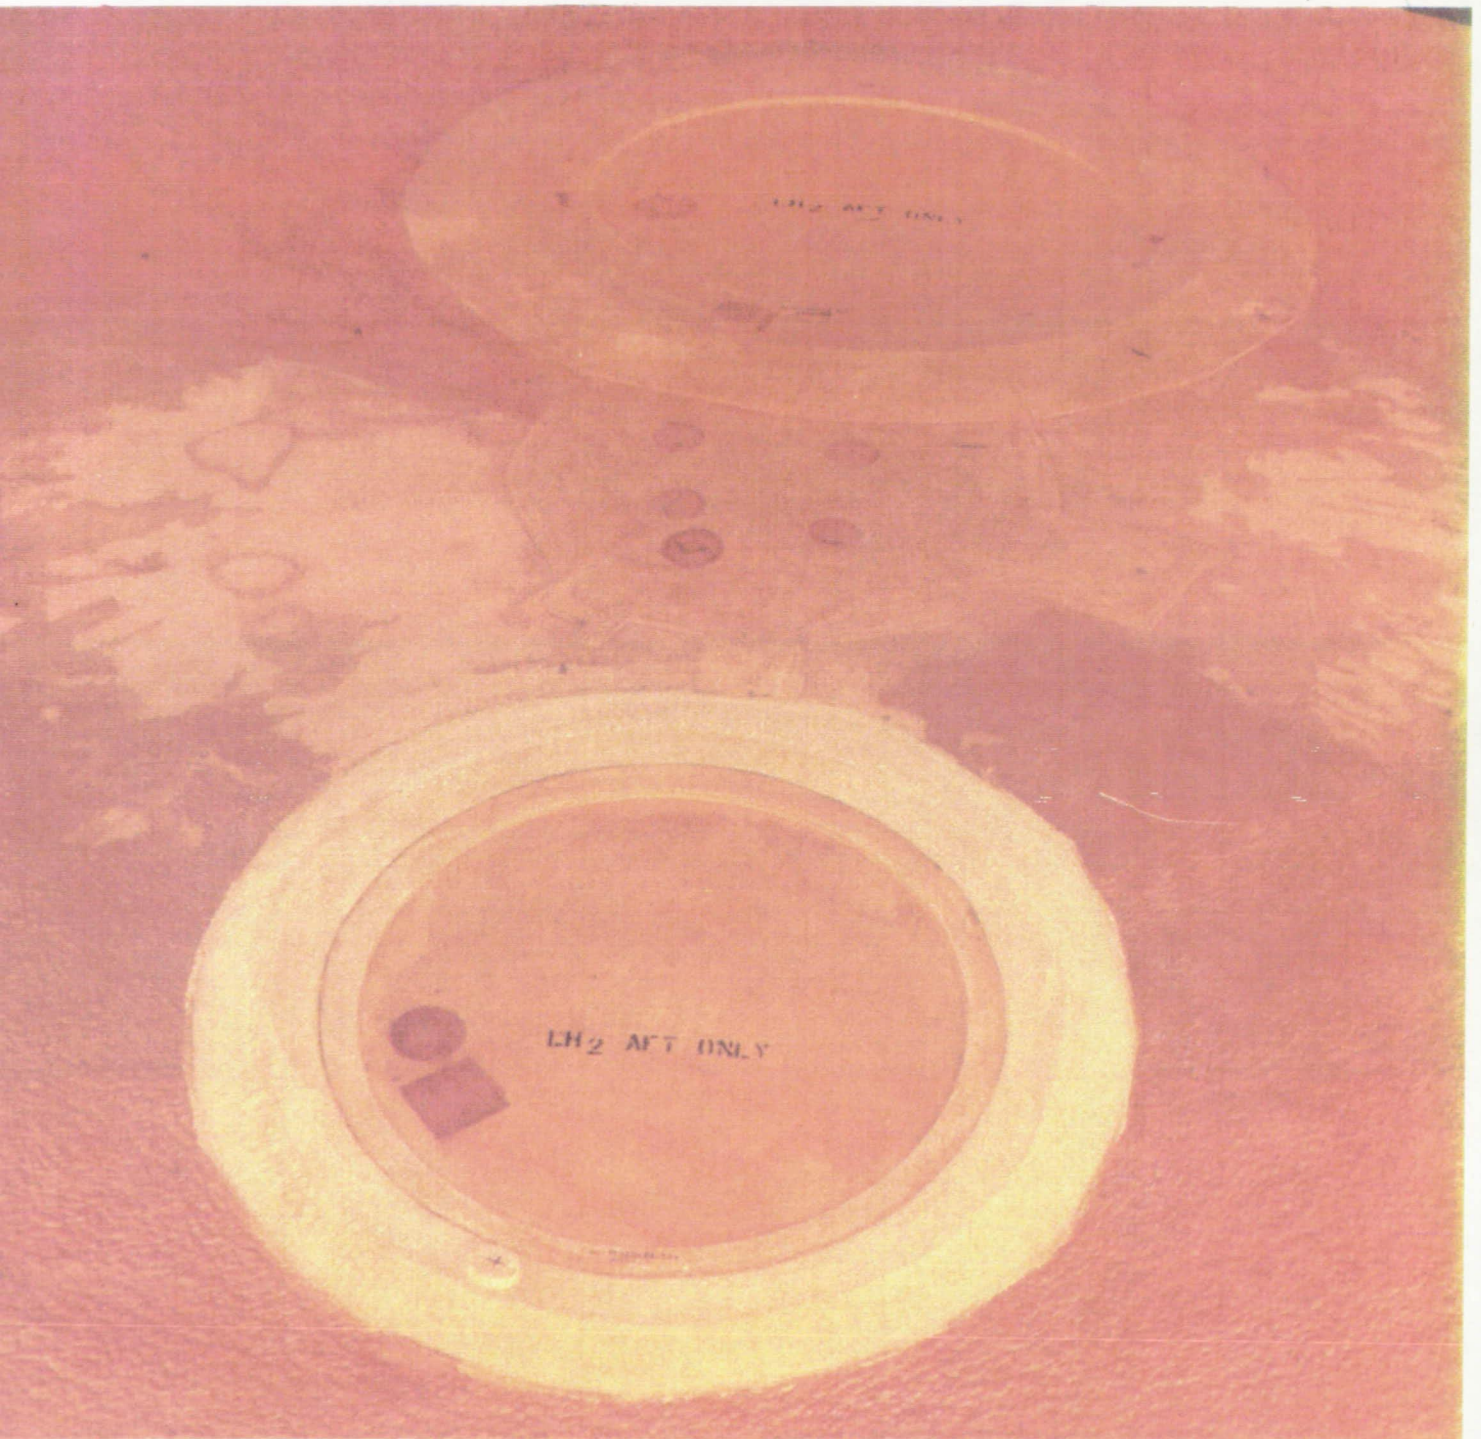
Vapors vented from the LH2 tank aft dome +Z manhole cover TPS closeout (+Y side) at the outer closeout perimeter during cryoload and drain. No TPS anomaly was visible.

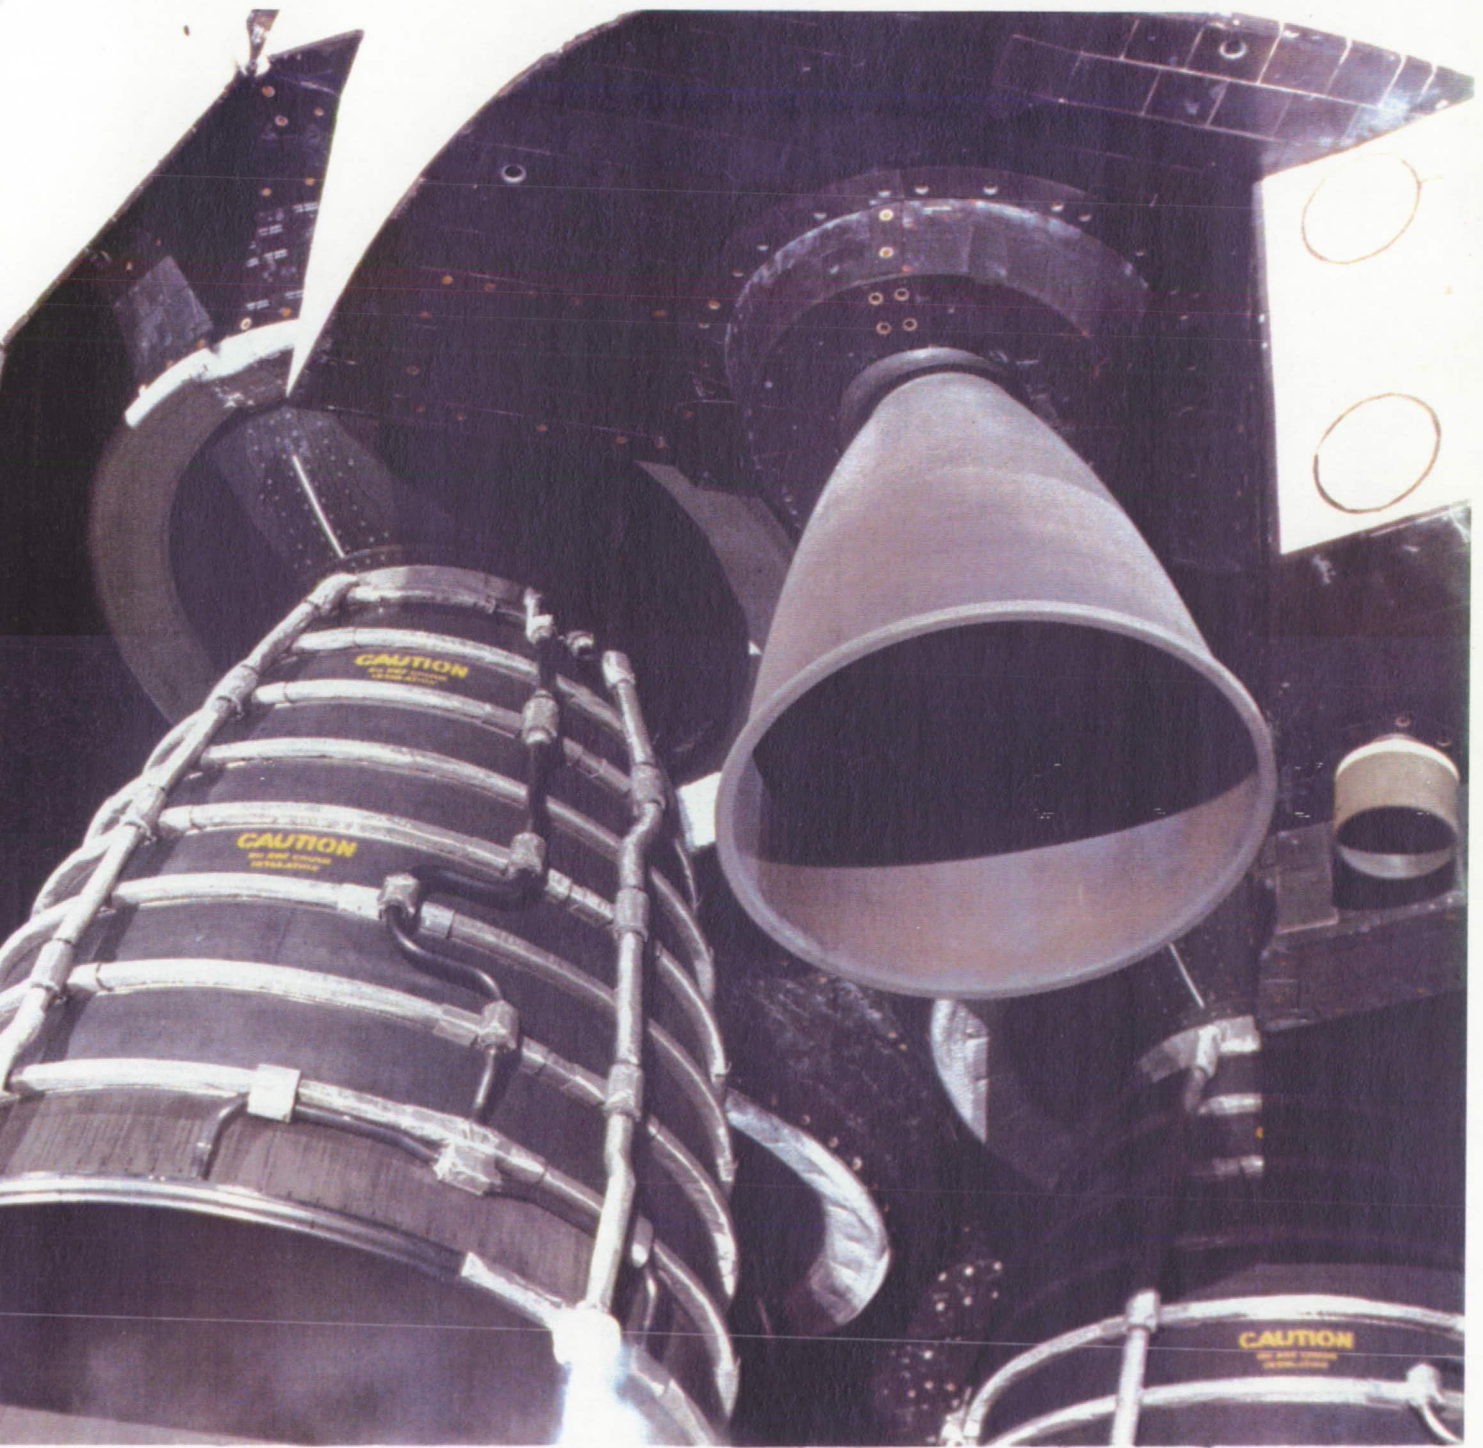
Overall view of OV-103 SSME's. Less than usual ice/frost had formed at the engine heat shield-to-nozzle interface. Some condensate was present on the SSME heatshields.

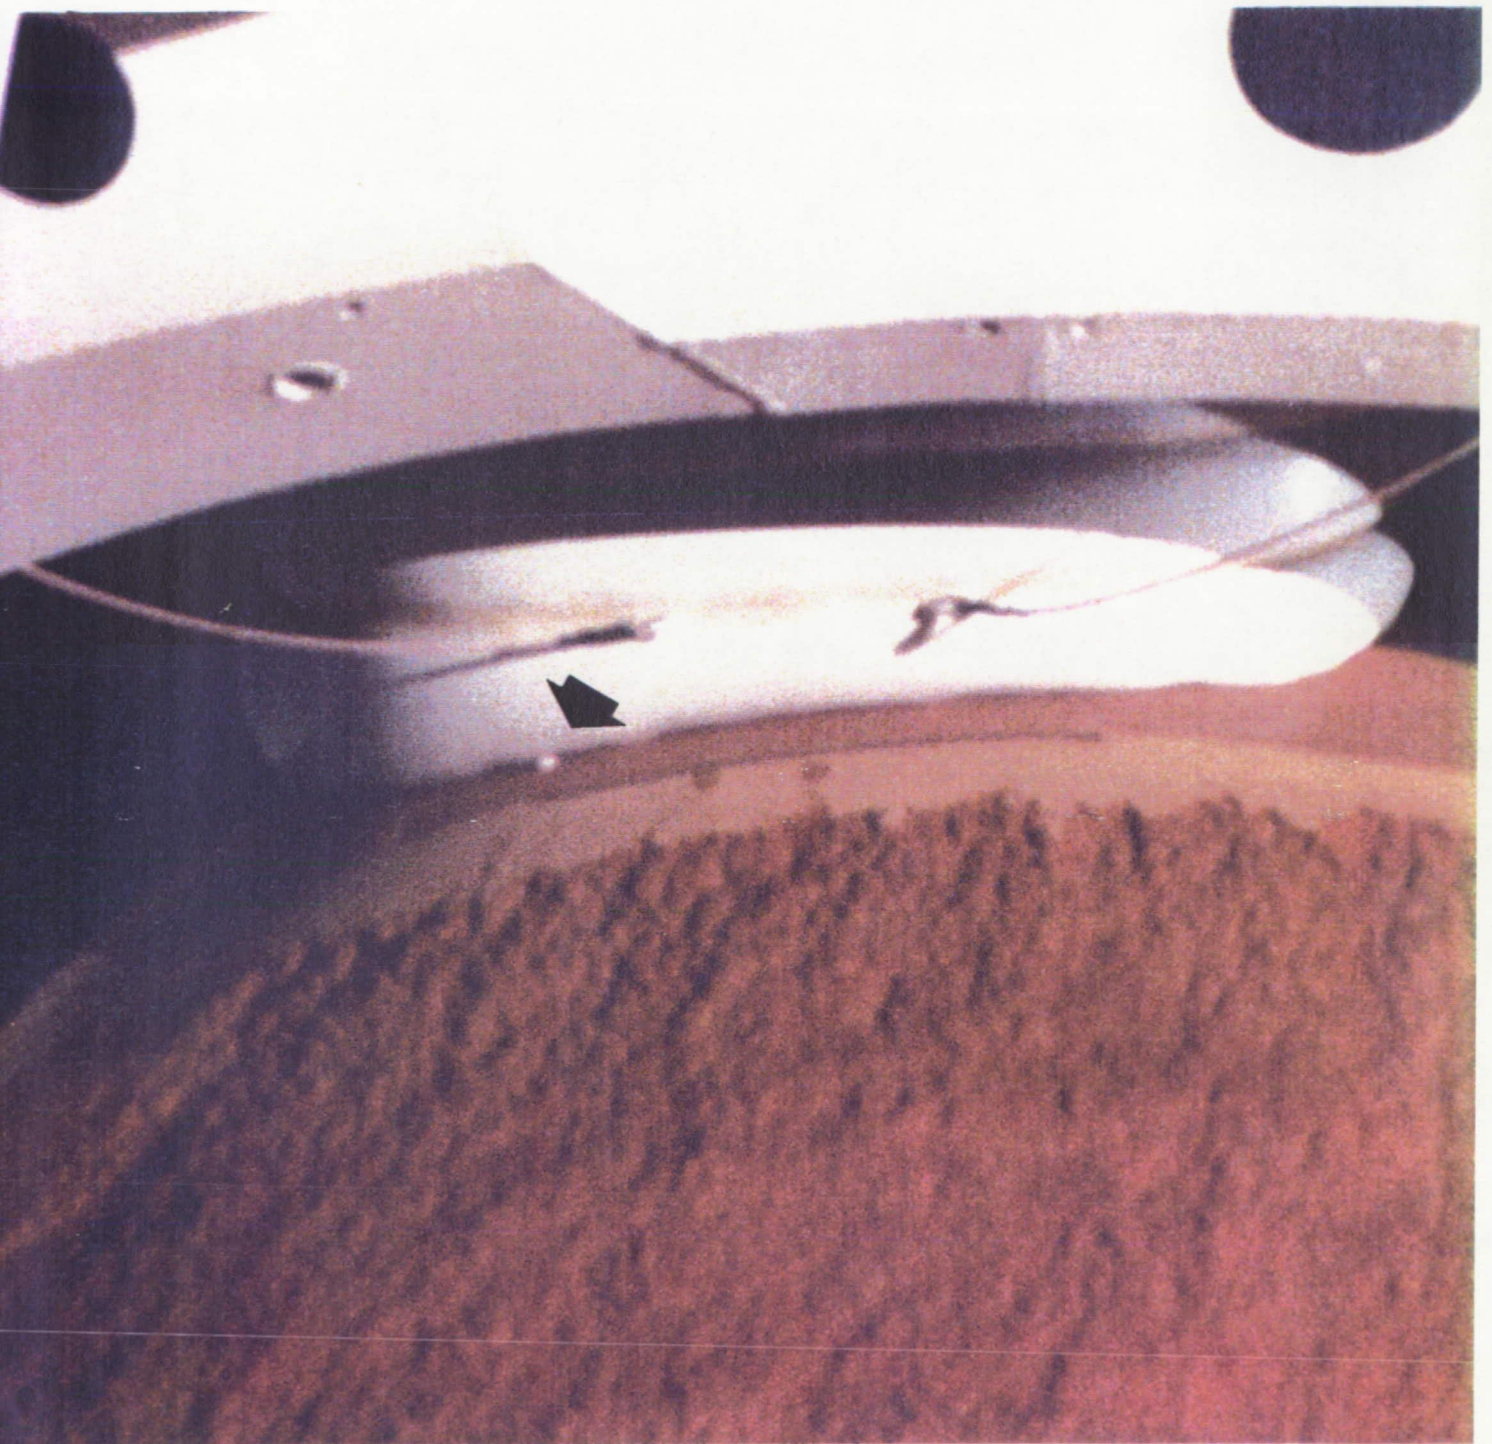
Small white debris particle or ice ball 1/2-inch in diameter was visible between the southwest (-Y) GOX seal and the ET TPS/footprint. GOX vent hood retraction prior to launch revealed no TPS damage or ice/frost accumulation.

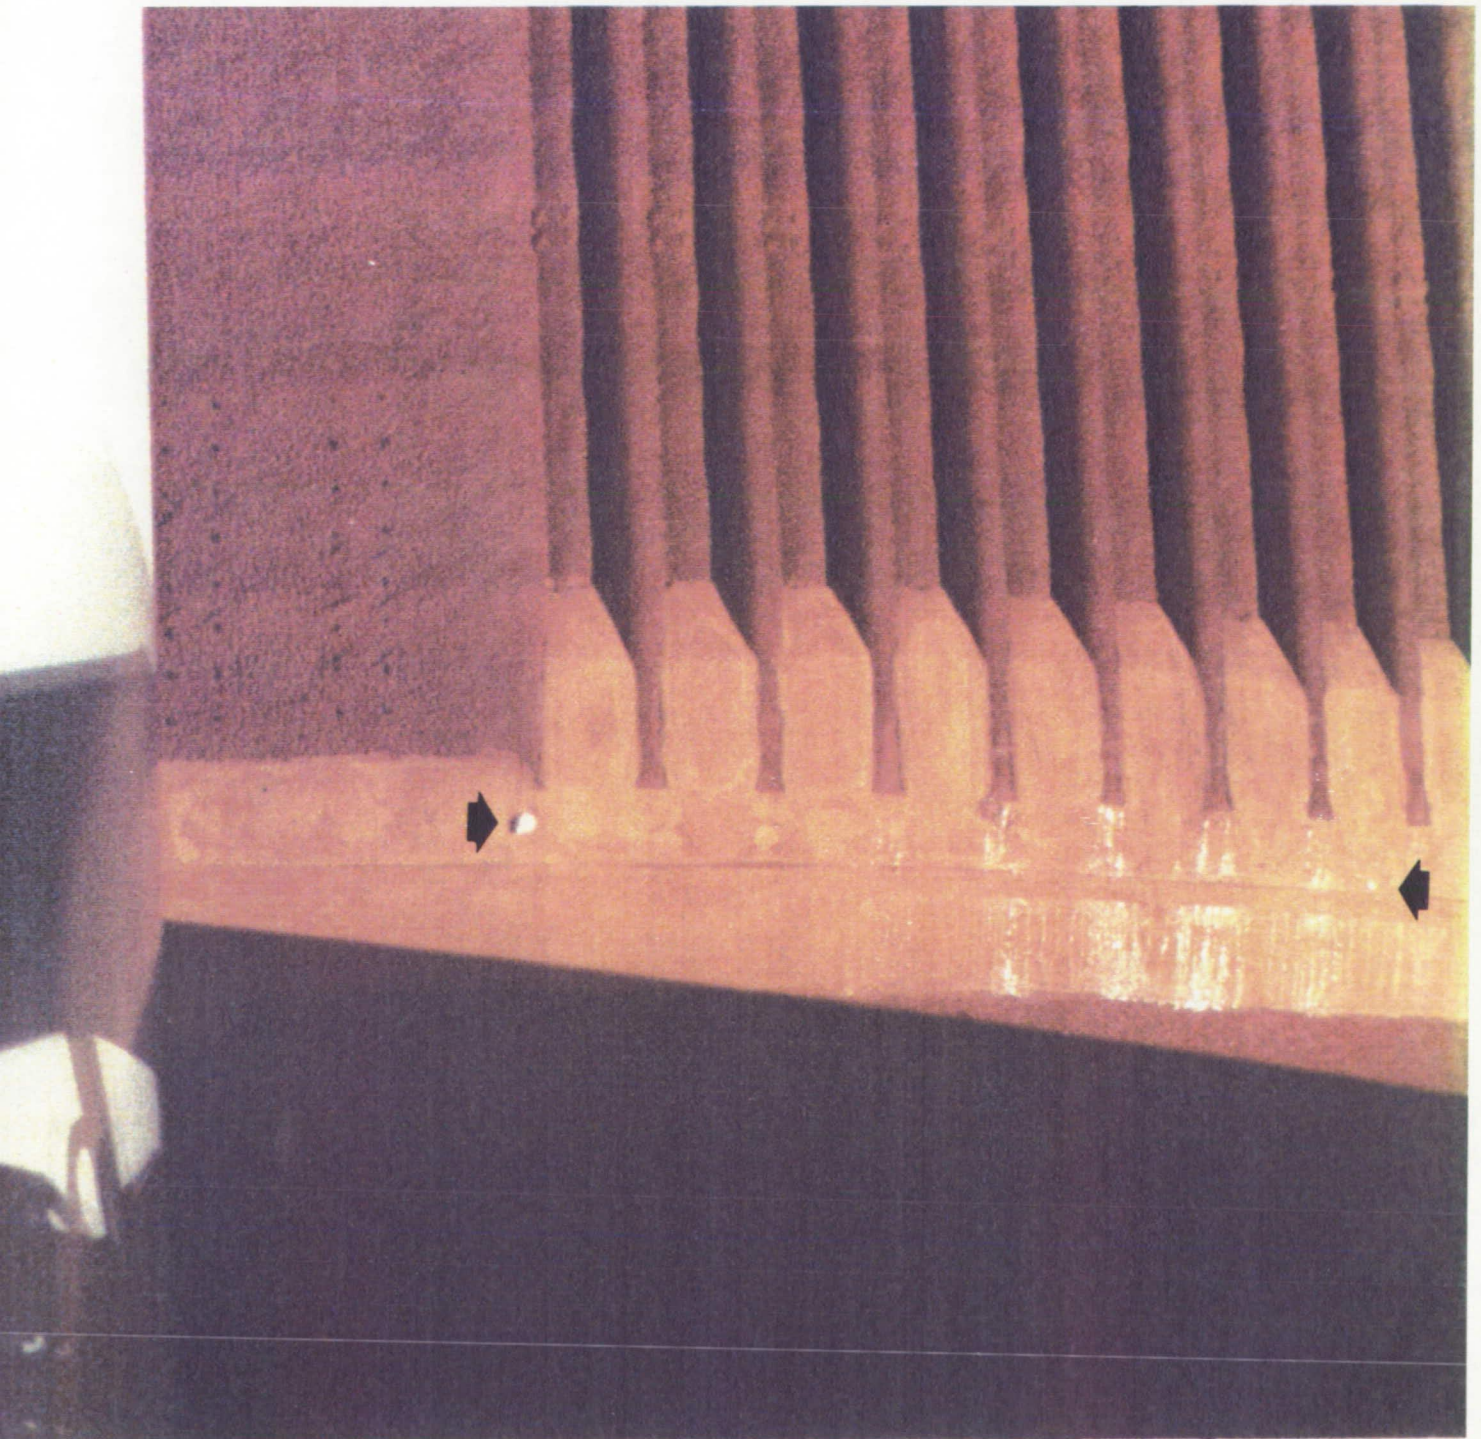
Ice/frost ball, 1-2 inches in diameter, formed on a small void in the LH2 tank-to-intertank flange TPS closeout. Some venting of vapor occurred while the ice/frost accumulated. Engineering evaluation determined this ice/frost condition was acceptable for launch. Two other frost spots also occurred on the flange closeout.

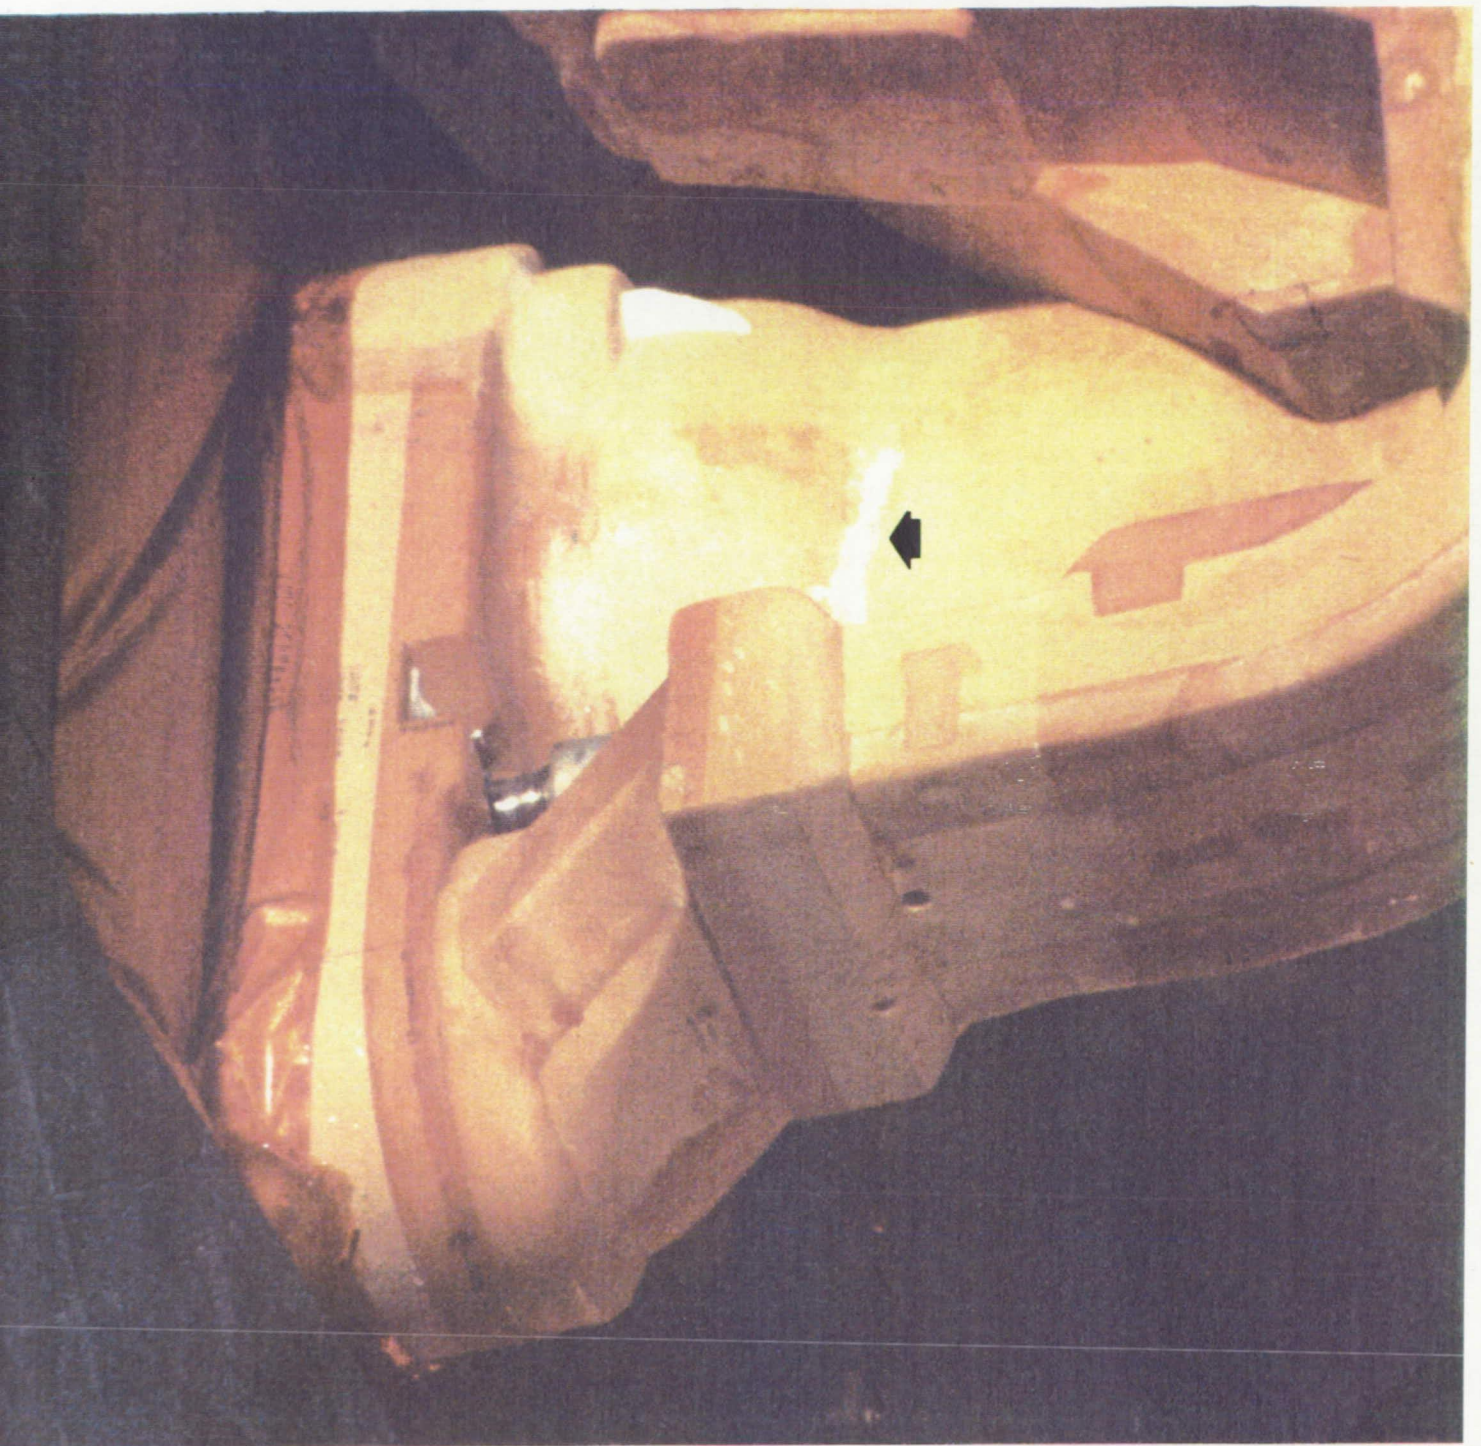
Overall view of L02 ET/ORB umbilical. Ice/frost finger on forward outboard pyrotechnic canister purge vent was typical. No TPS anomalies were visible. White line at L02 feedline-to-umbilical interface was spackling material, not ice or frost.

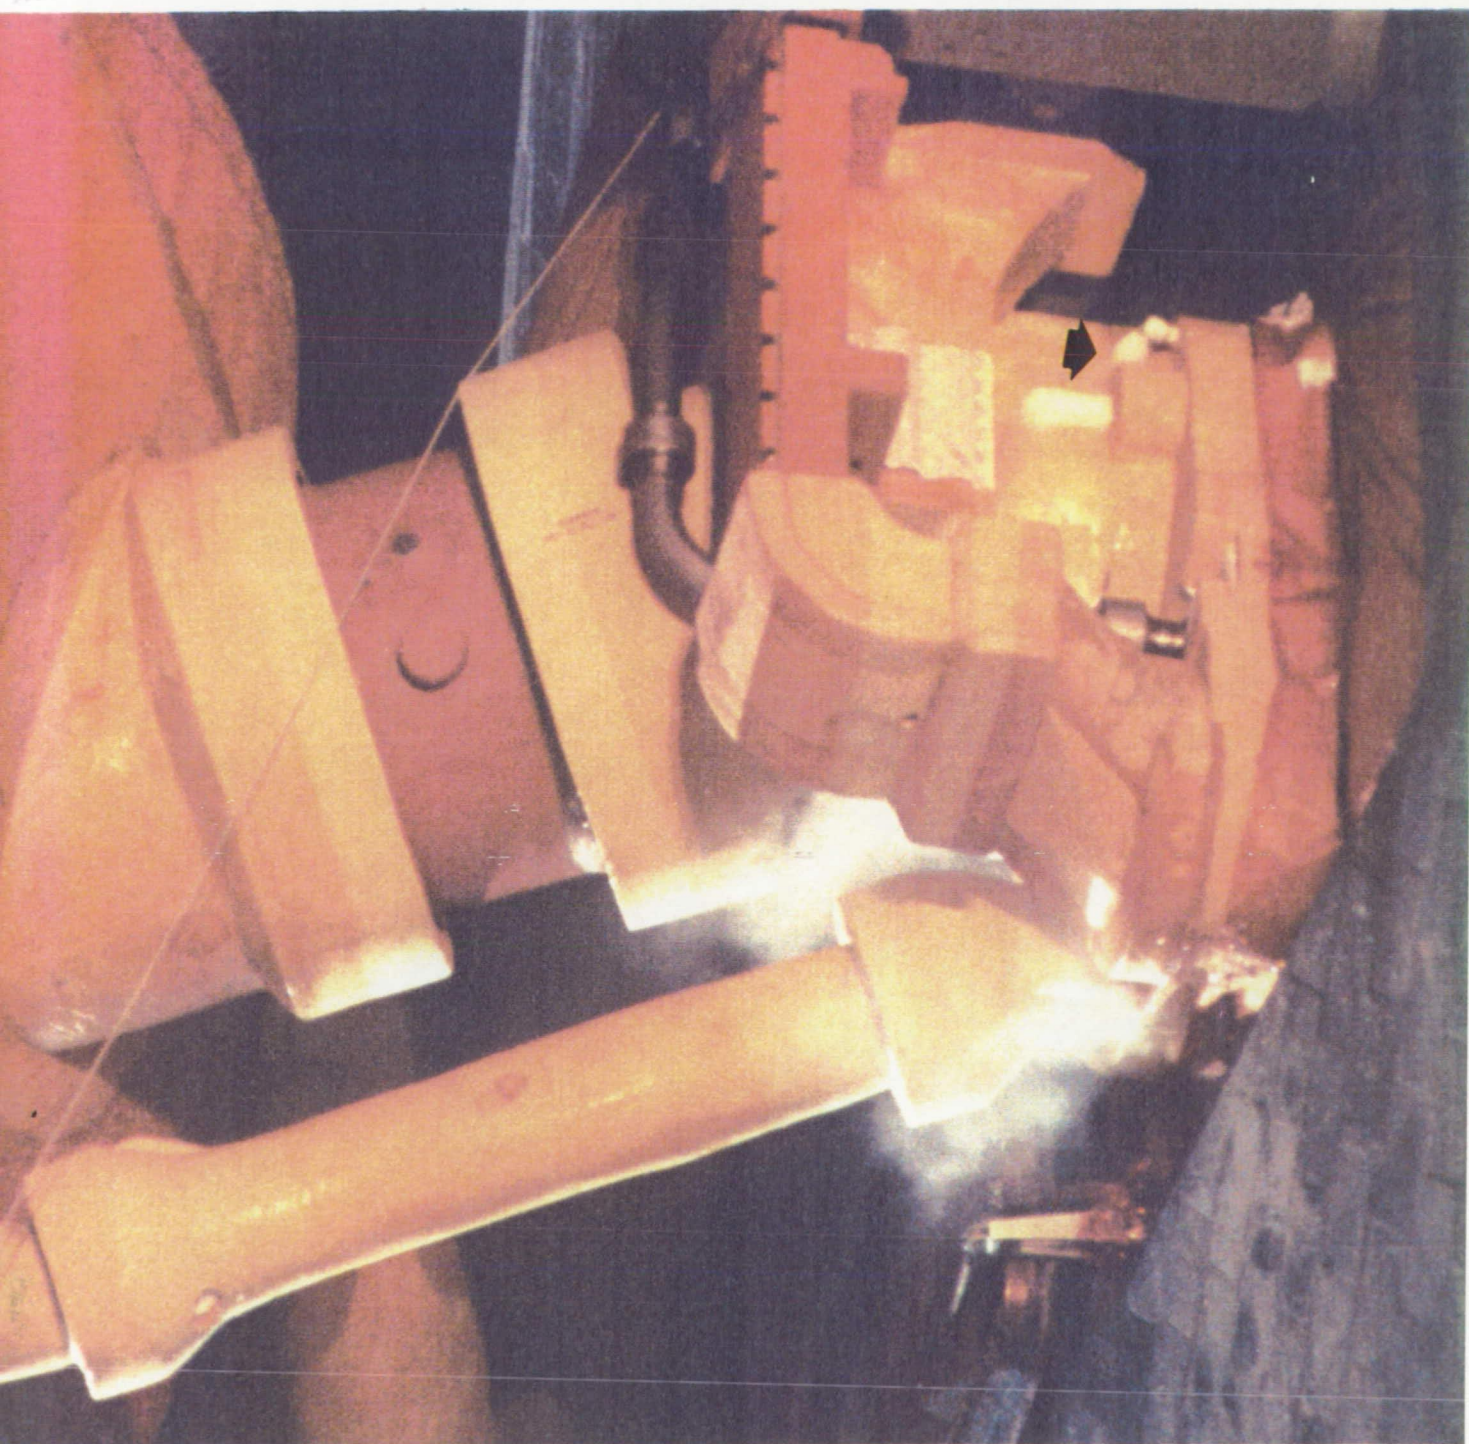
Overall view of LH2 ET/ORB umbilical. Ice/frost finger formation on plate gap and pyrotechnic canister purge vents was typical. Small ice/frost ball formed on forward outboard pyro canister TPS closeout bondline (arrow). Venting of vapors was typical and no cryogenic drops were present. Less than usual ice/frost accumulated on the purge barrier baggie material.

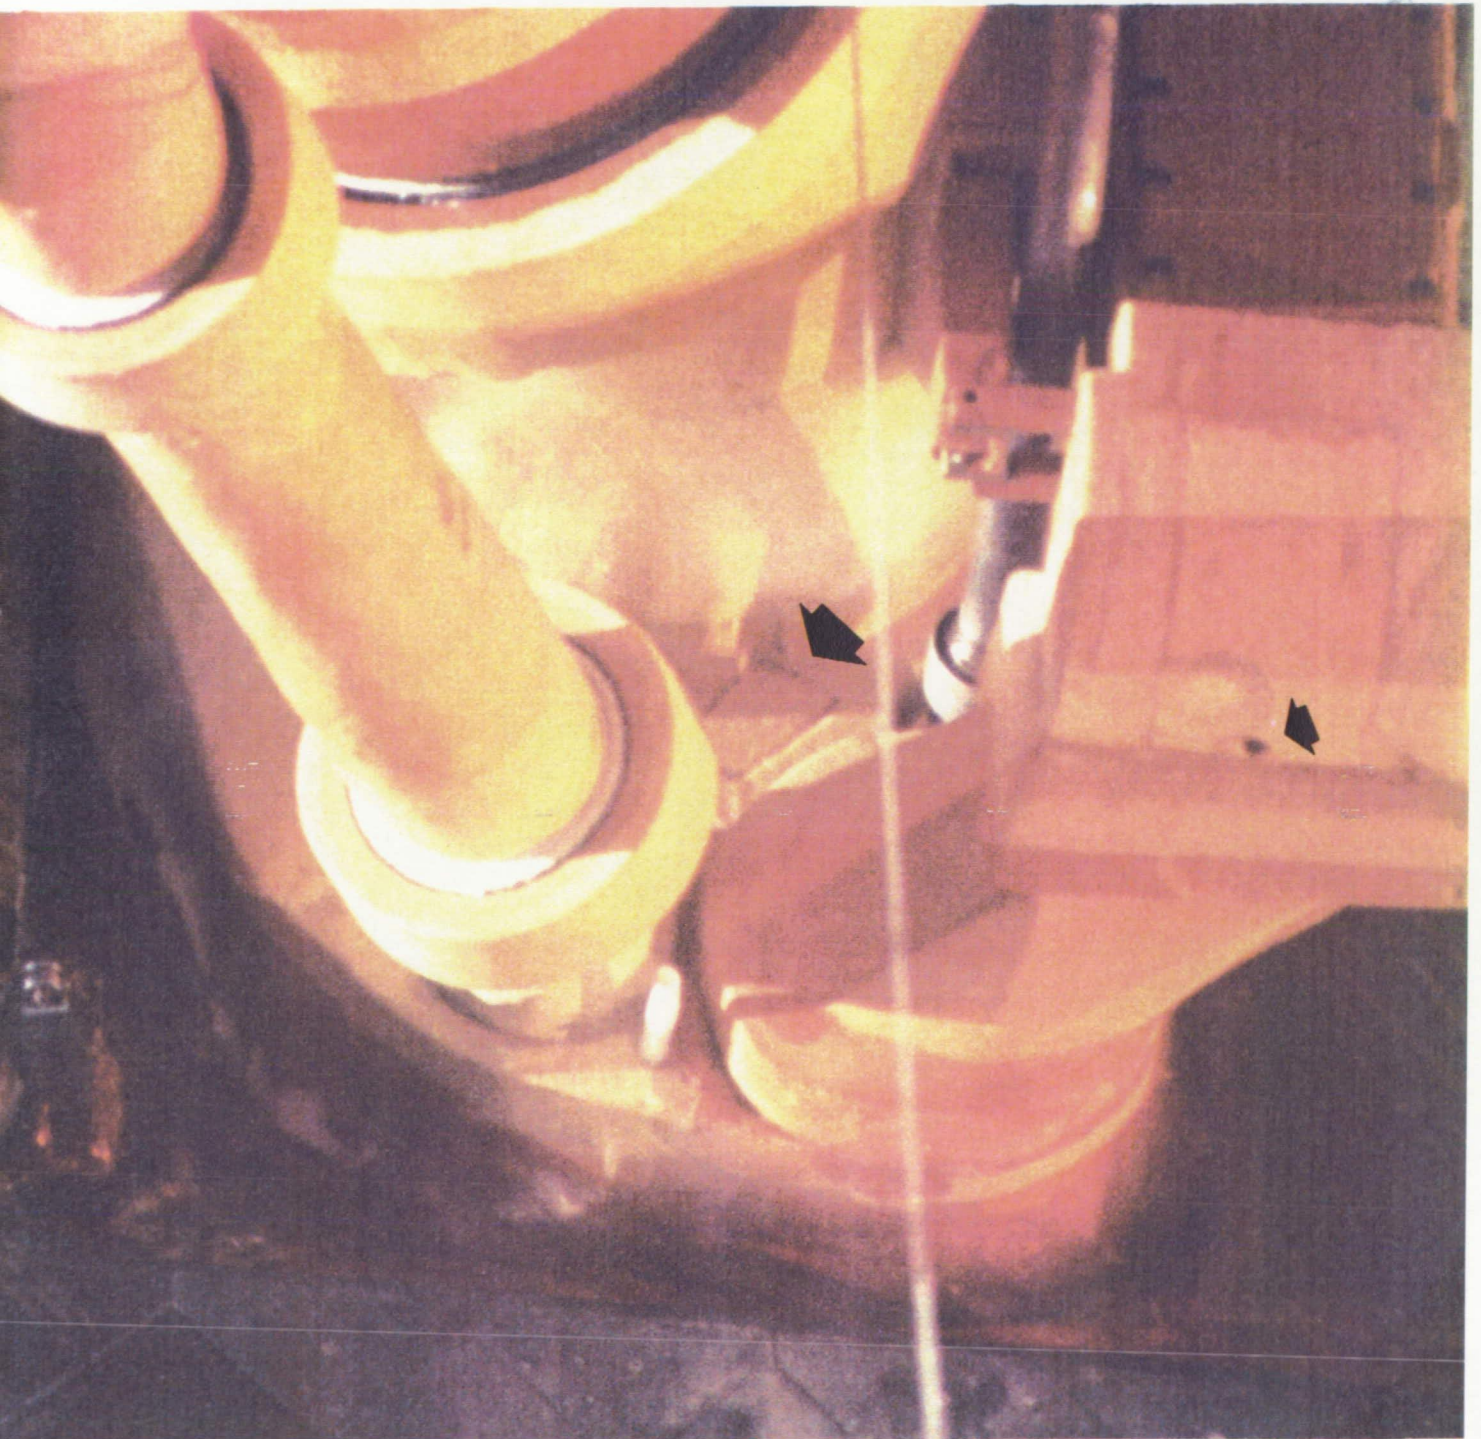
Aft view of LH2 ET/ORB umbilical. Ice/frost finger on the aft plate gap purge vent was typical. No ice/frost was present on the cable tray vent hole or the 17-inch flapper valve actuator tool access port foam plug closeout. Typical amounts of ice/frost accumulated in the LH2 recirculation line bellows.

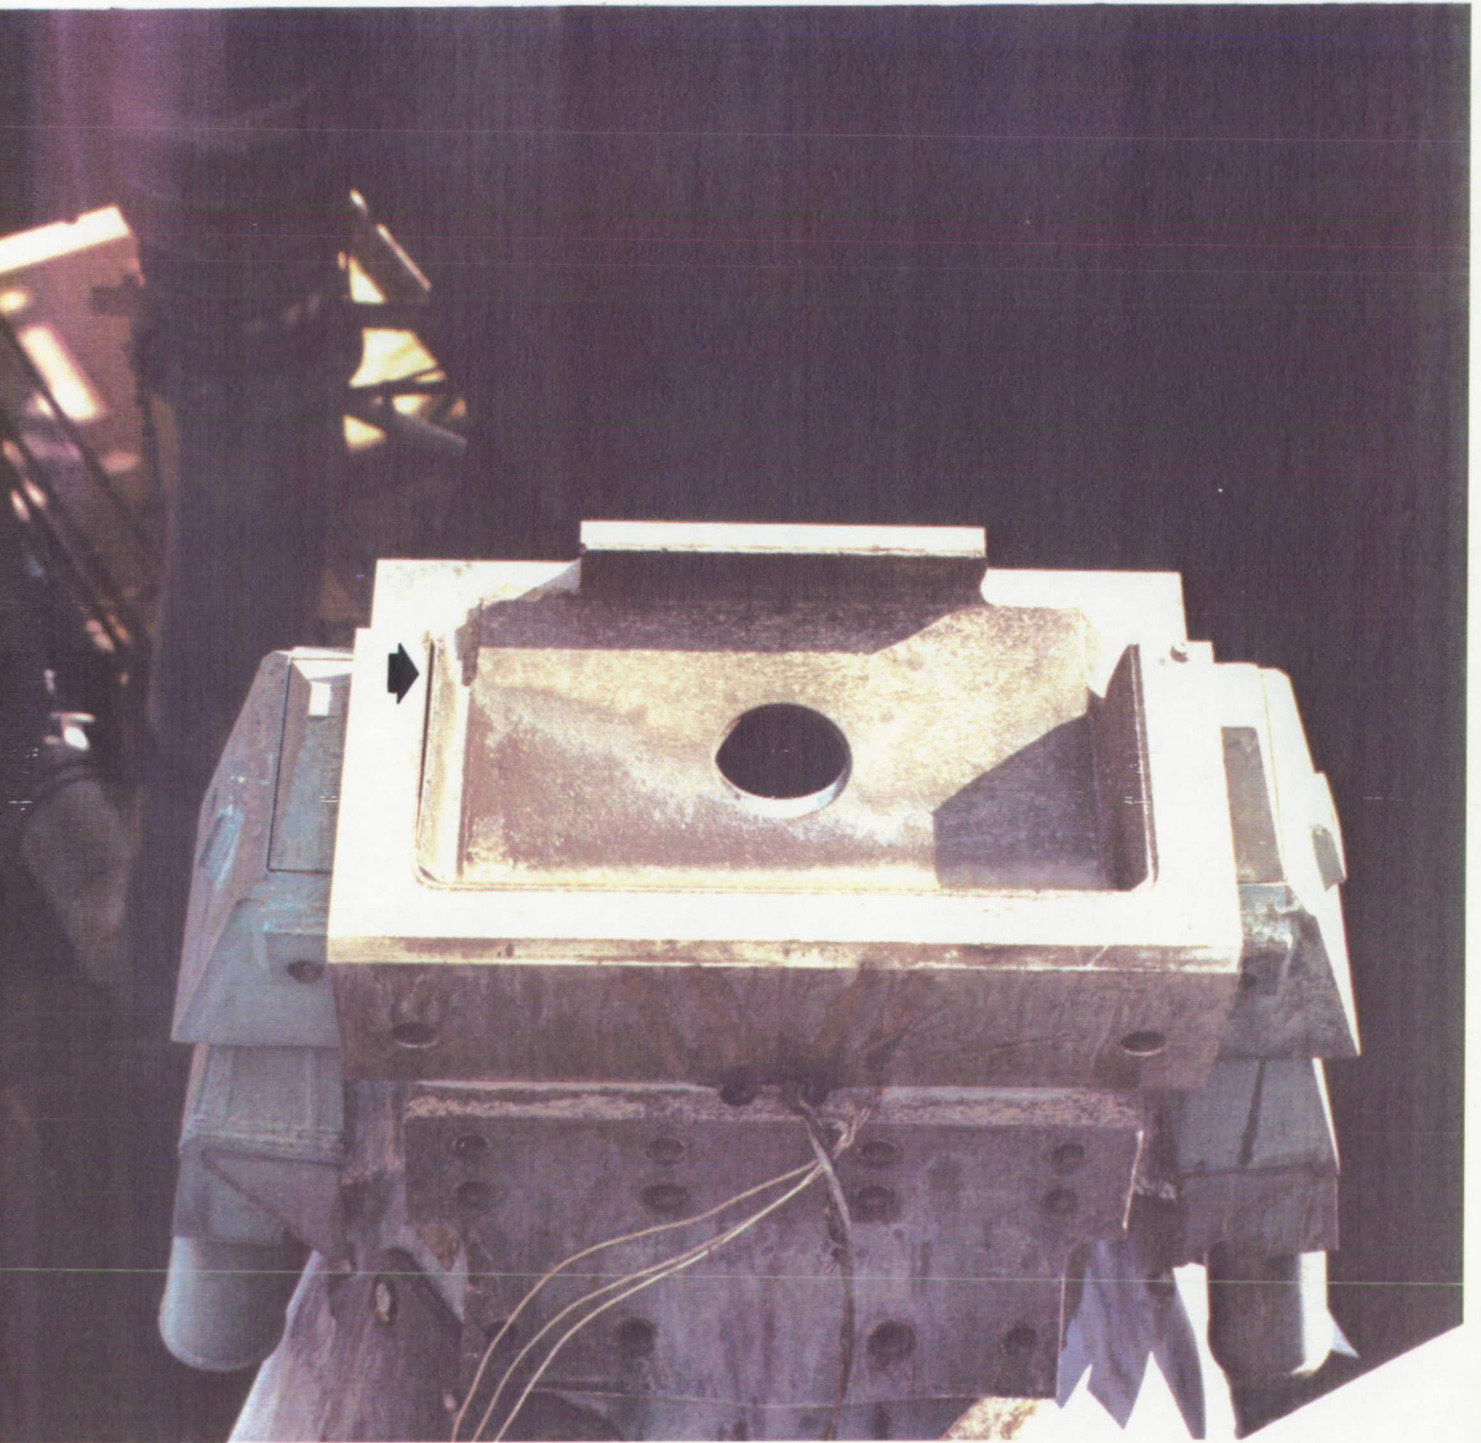
EPON shim material on the south holddown posts was intact but debonded along the sidewalls to various degrees

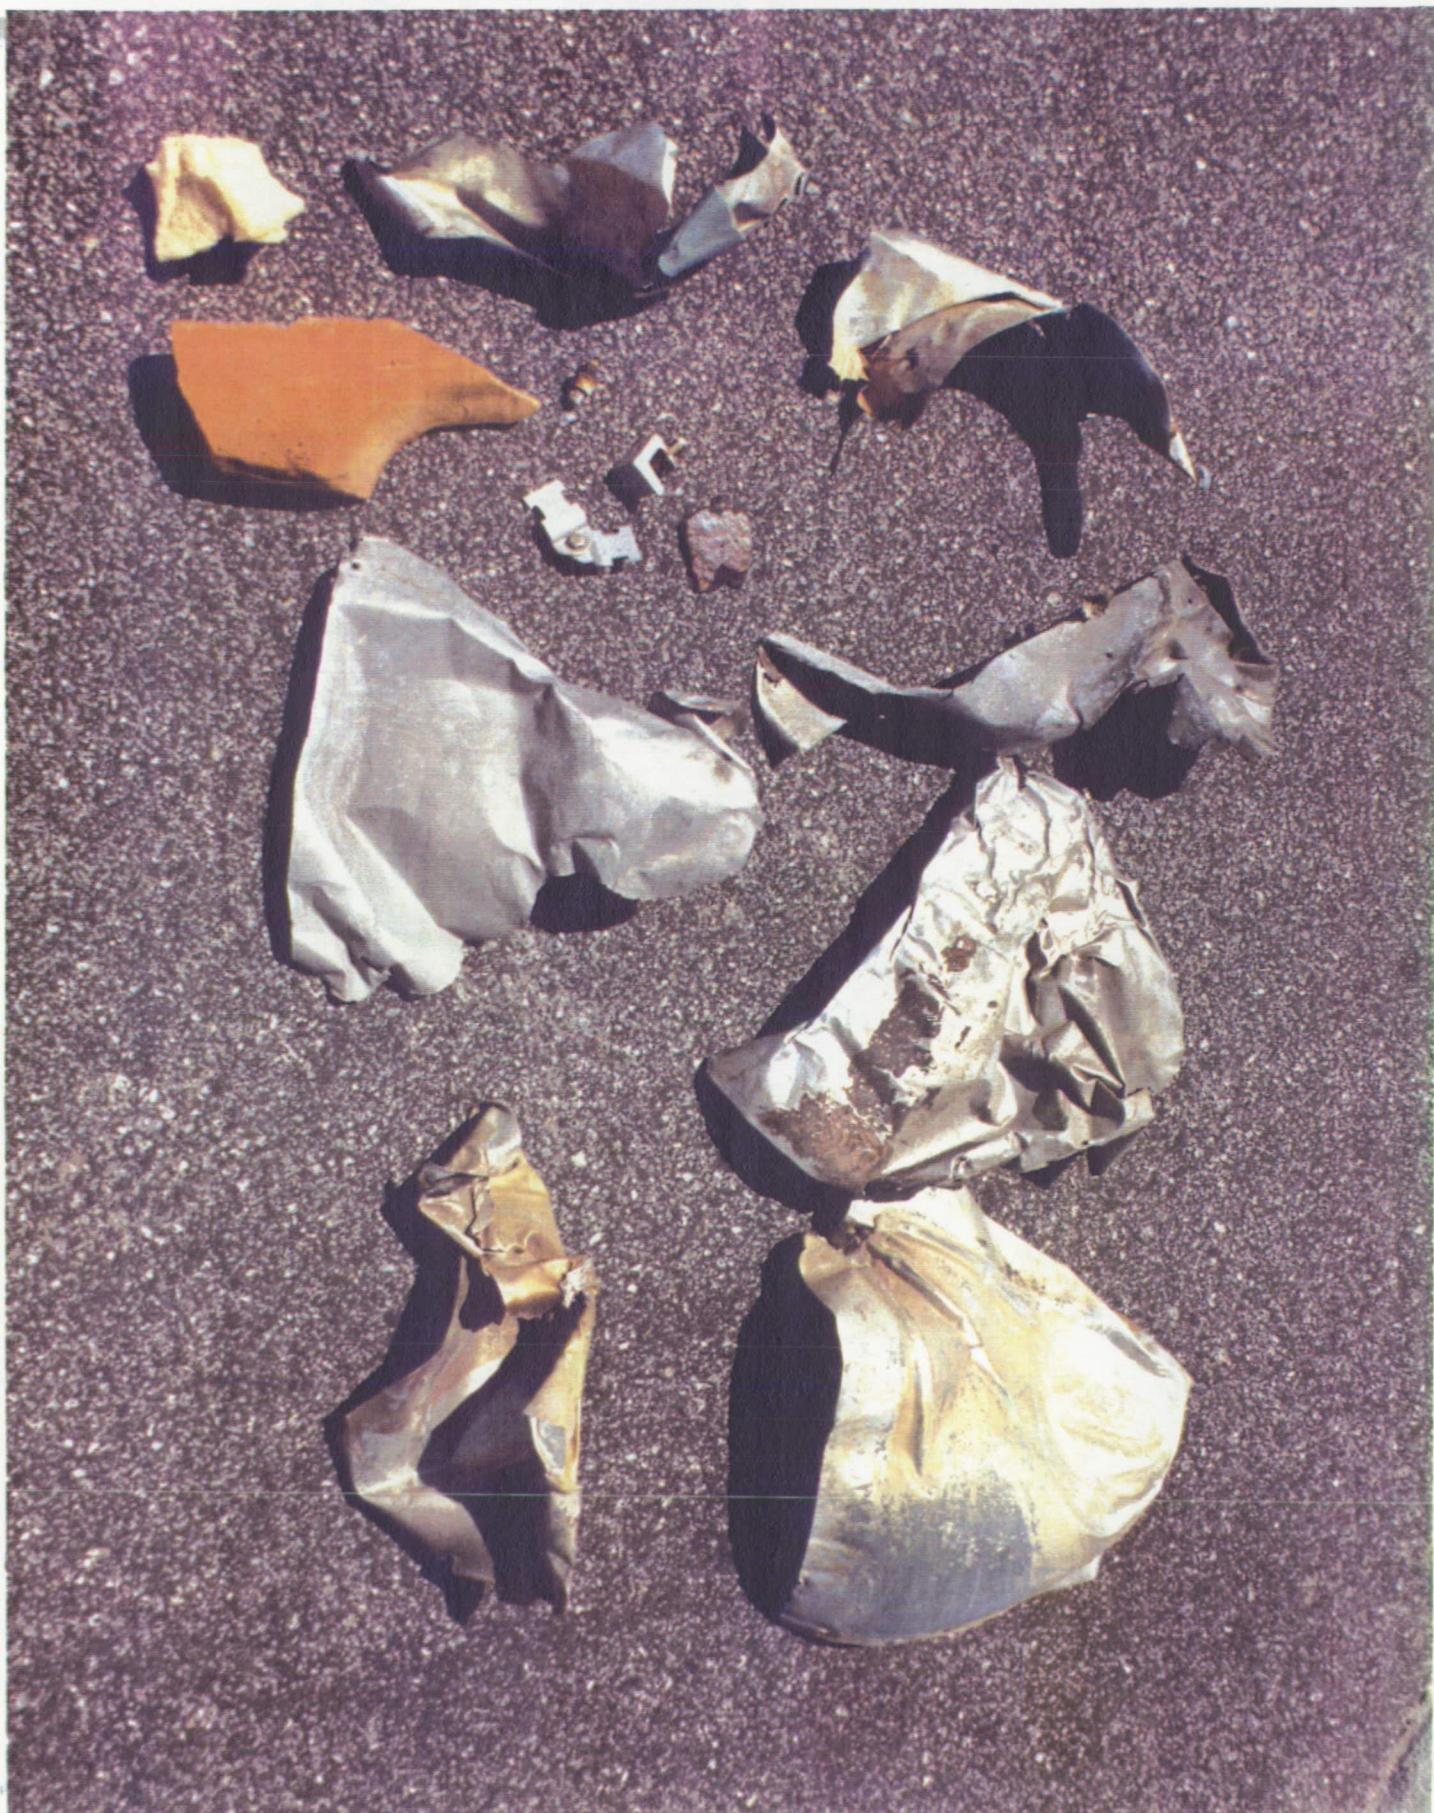
Post launch debris included pieces of thin sheet metal from a chilled water pipe on the FSS/RSS 107 foot level crossover. No flight hardware was found.
