NASA Technical Memorandum TM 103820

Debris/Ice/TPS Assessment And Photographic Analysis For Shuttle Mission STS-39

April 28, 1991

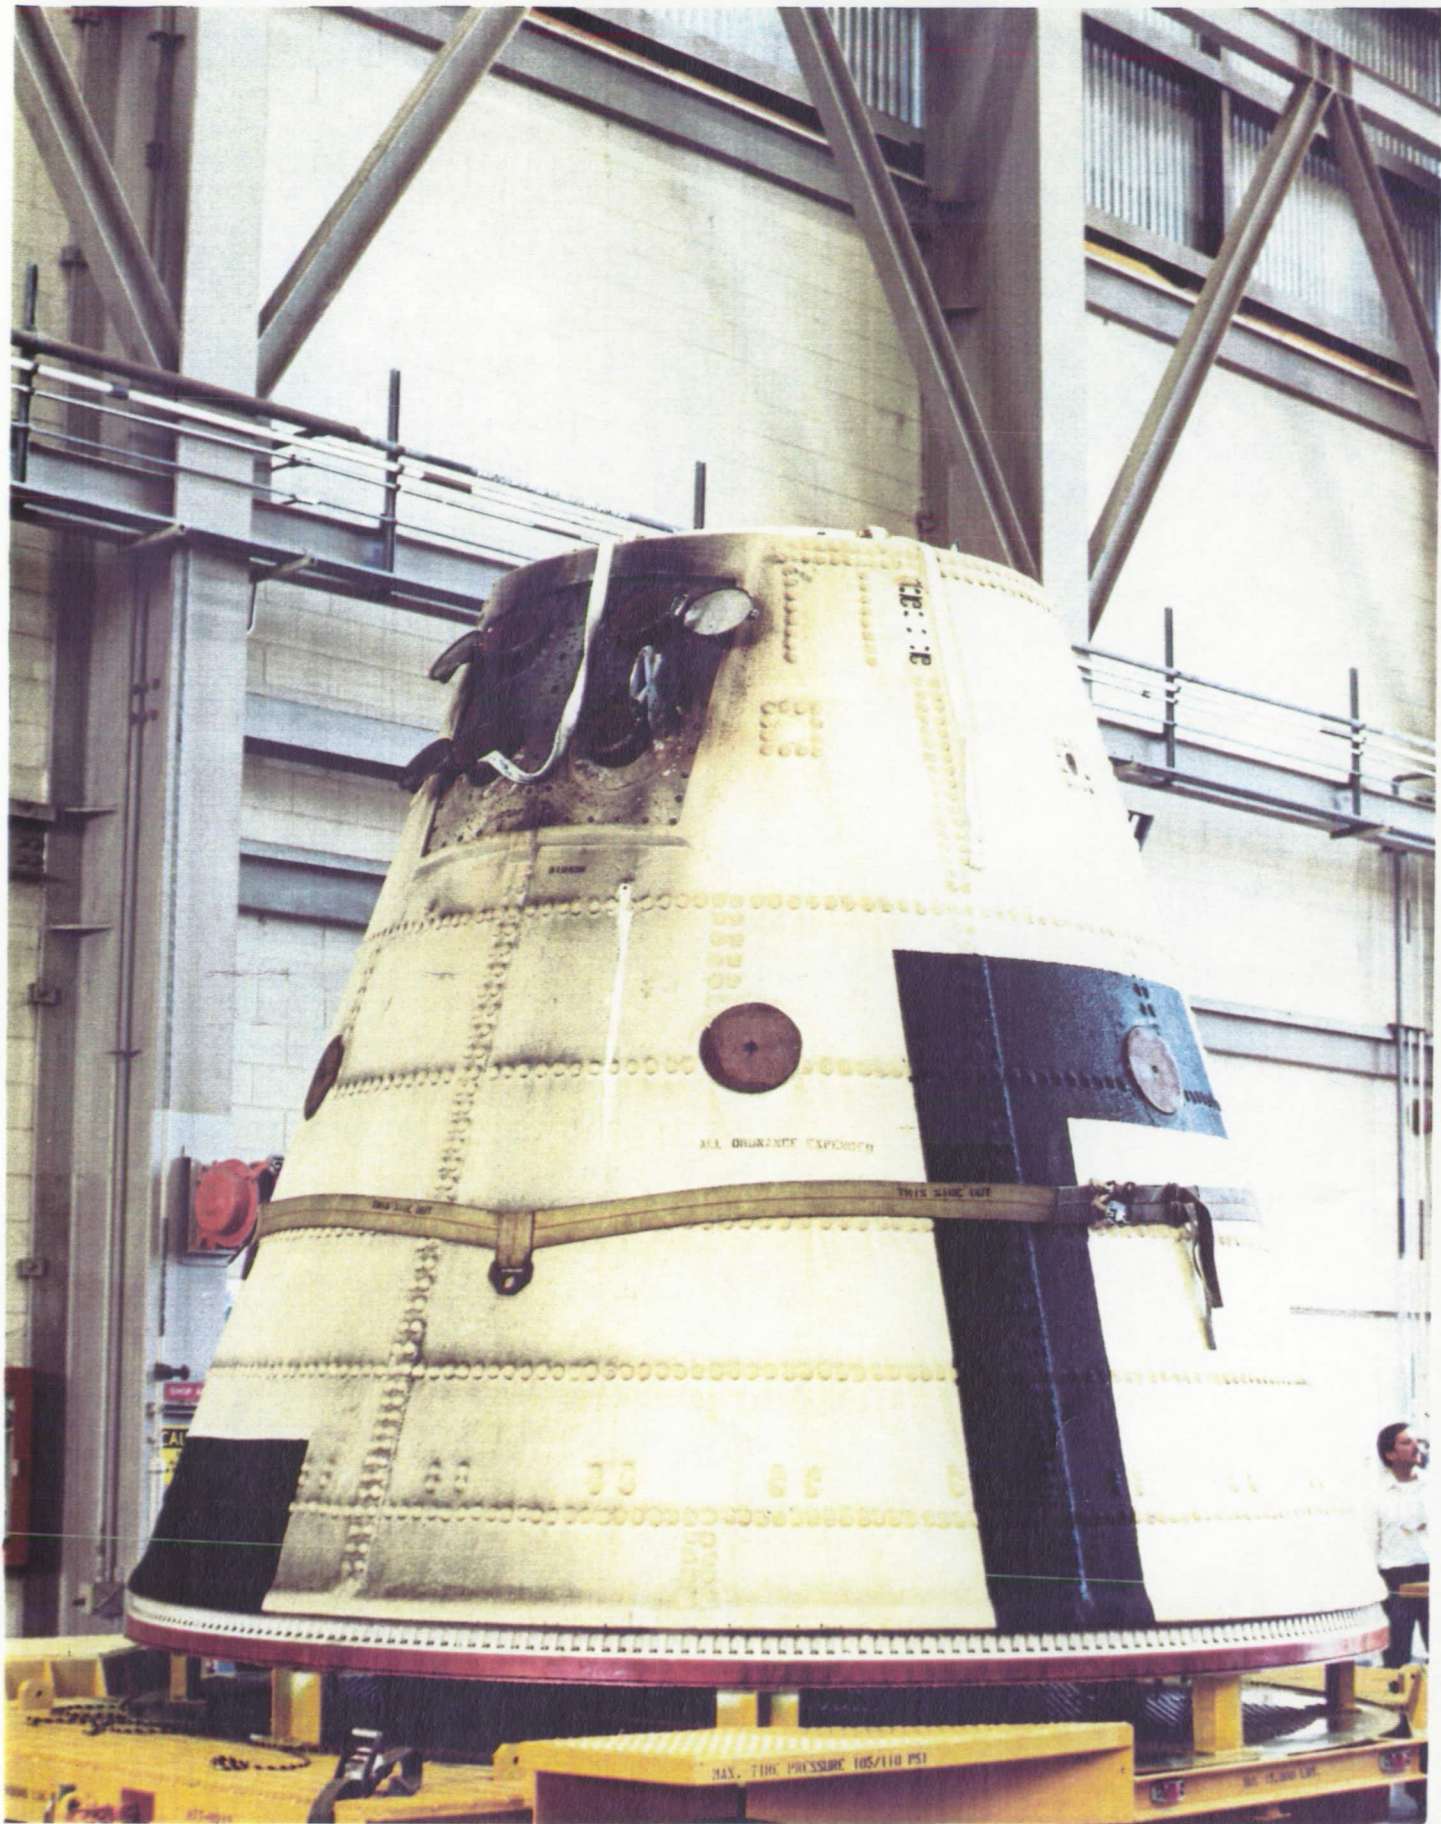
Post flight condition of the RH frustum. There were 52 MSA-2 debonds over fasteners, but no areas of missing TPS.

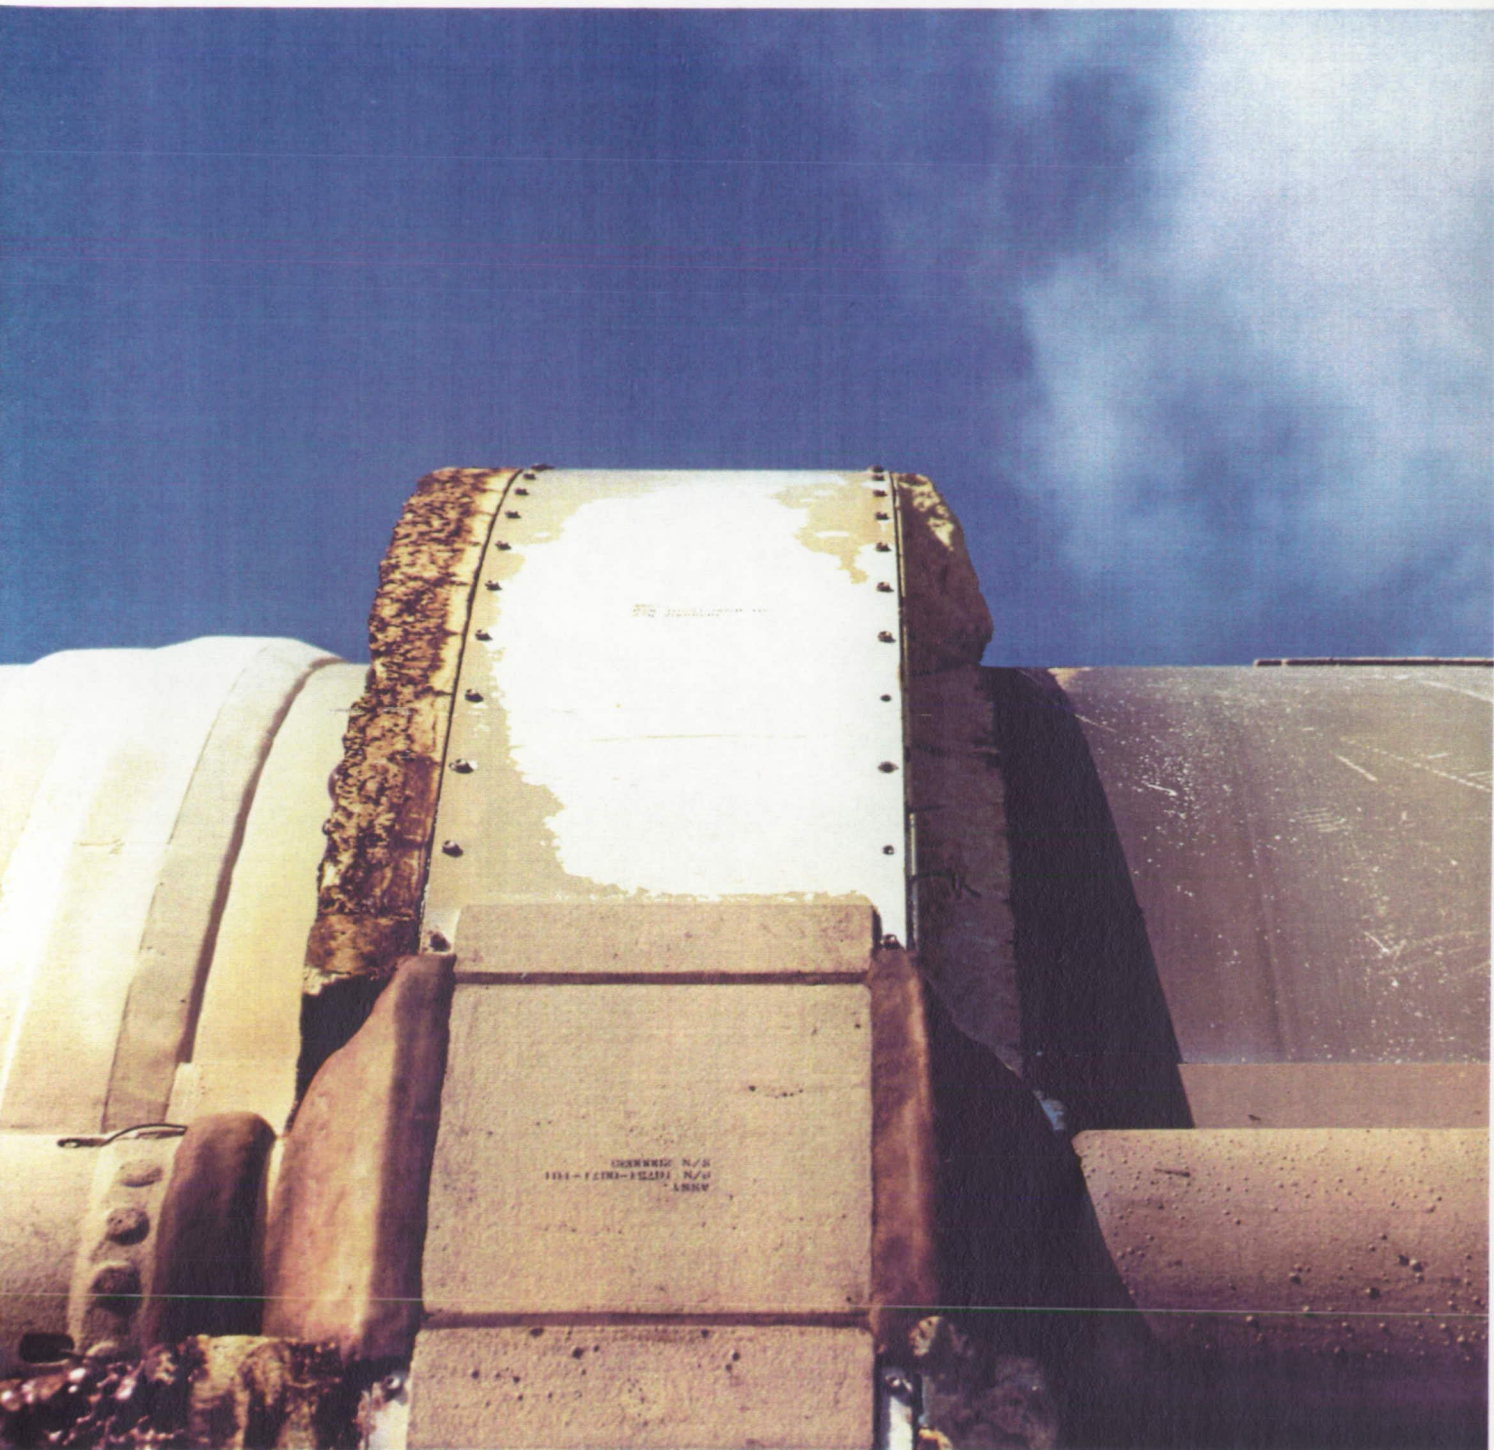
Three bolt heads were missing from ETA ring cover fasteners

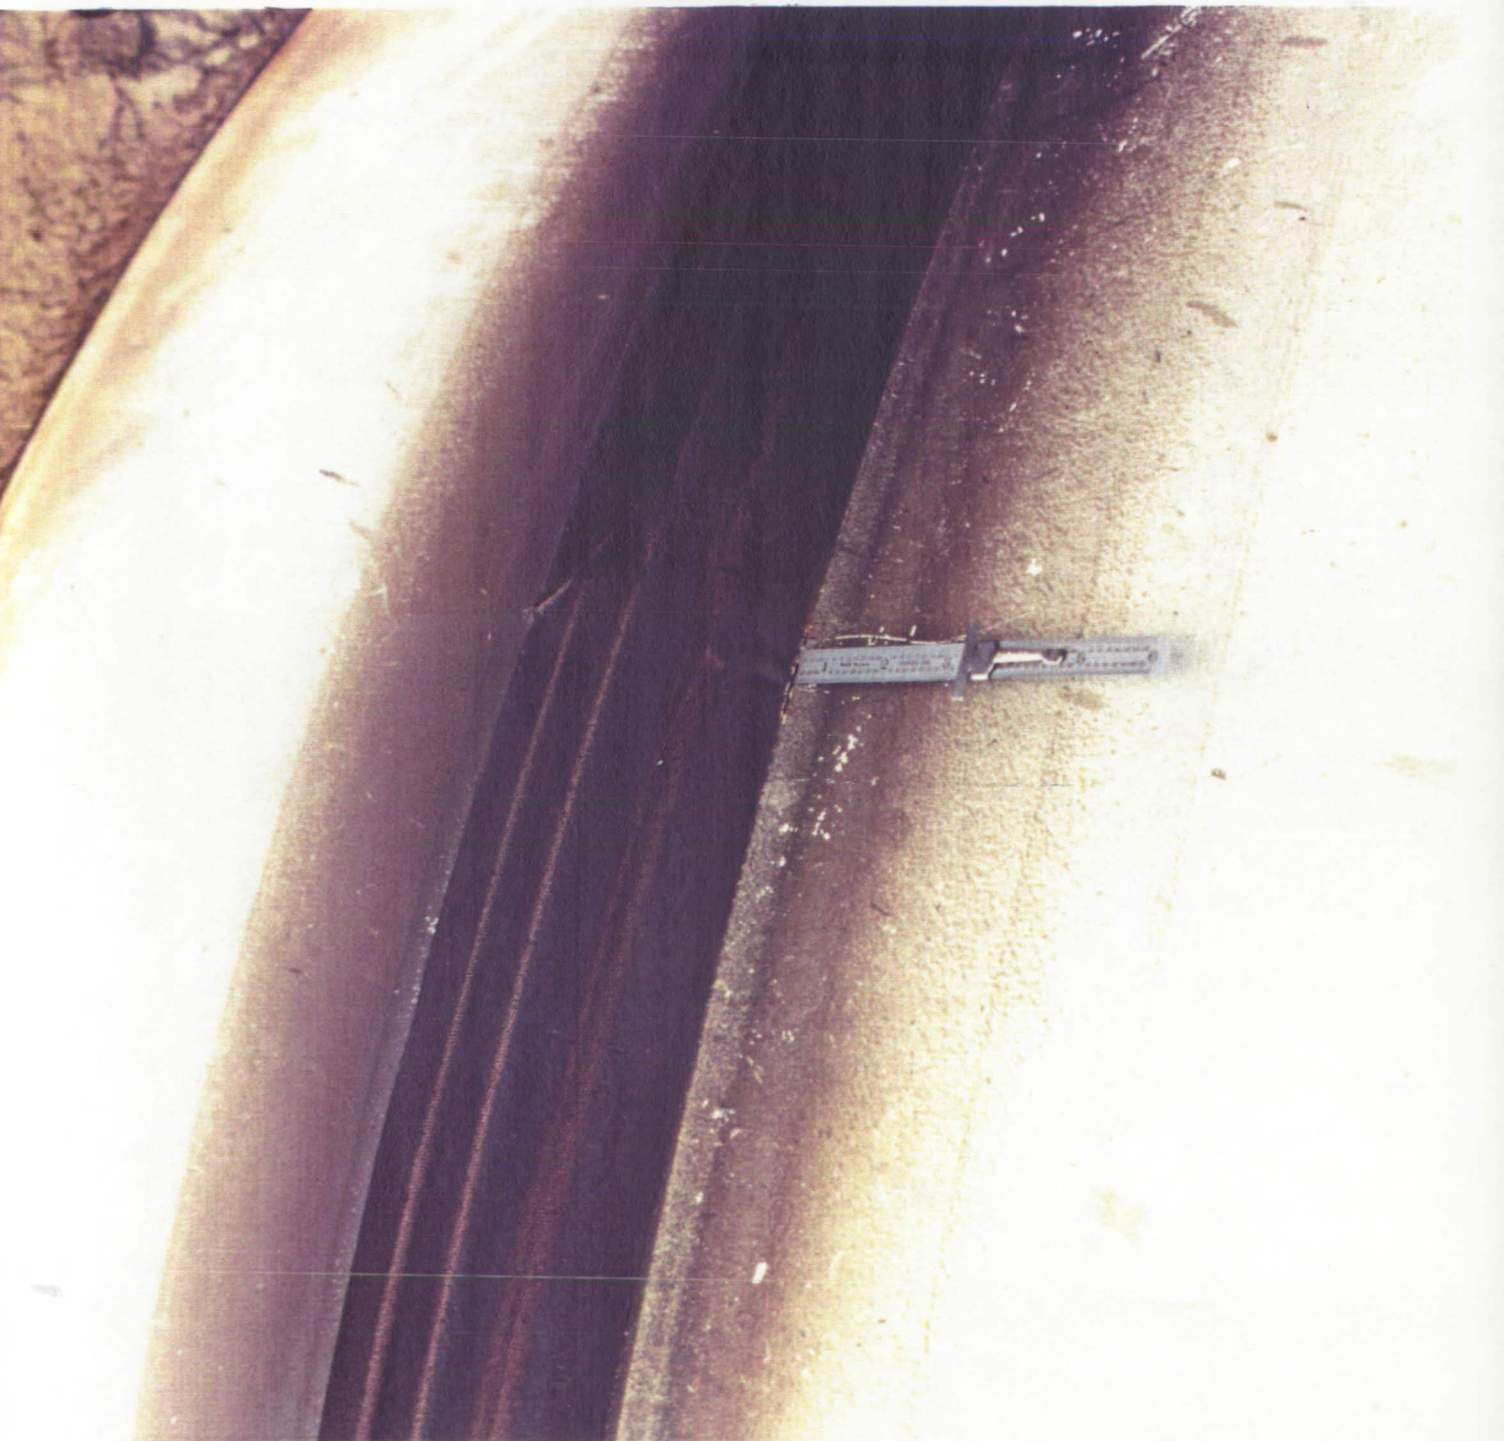
EPDM weather seals on the RH aft booster factory joint closeouts had 5 debonds, the largest of which measured 2"x0.25"

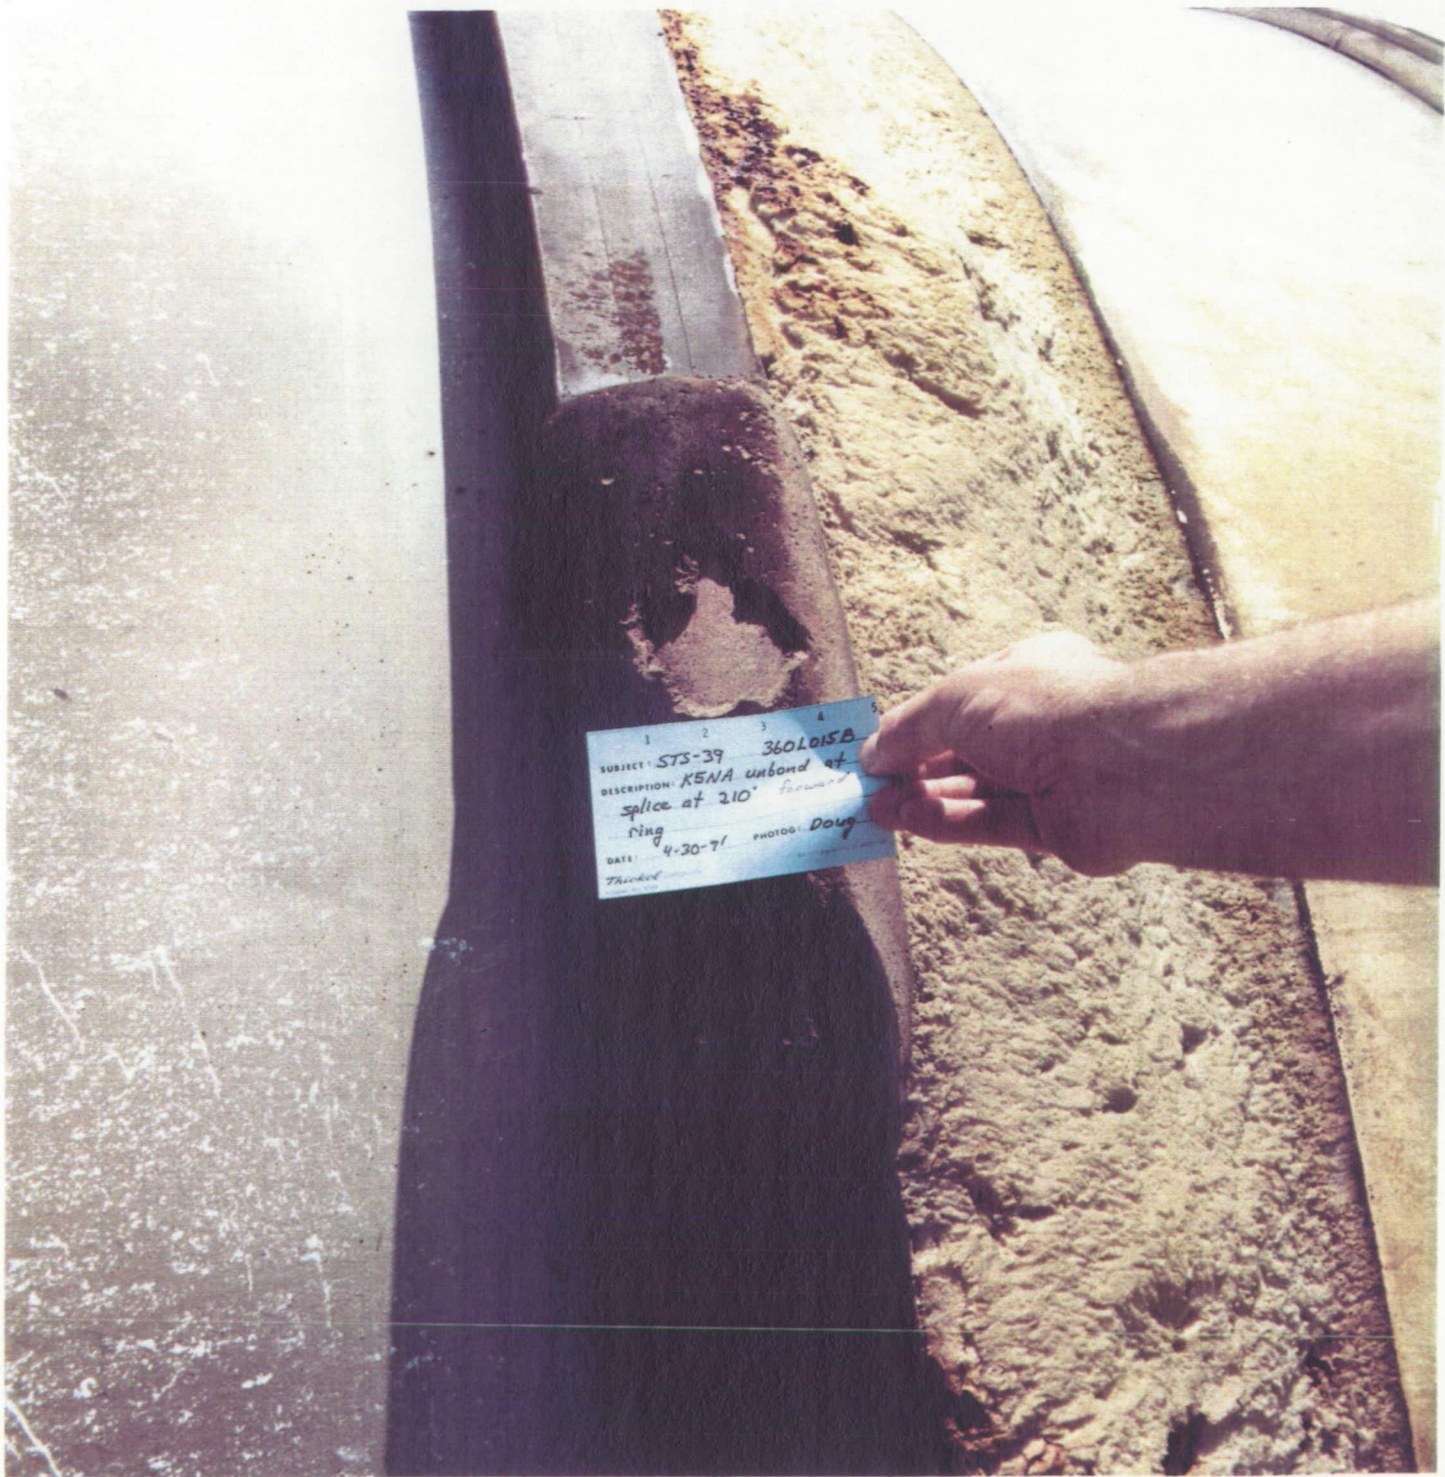
K5NA was missing from the RH aft booster stiffener ring splice plates (aft ring at 330 degrees, forward ring at 210 degrees). The substrate was not charred and loss of the material occurred at water impact.

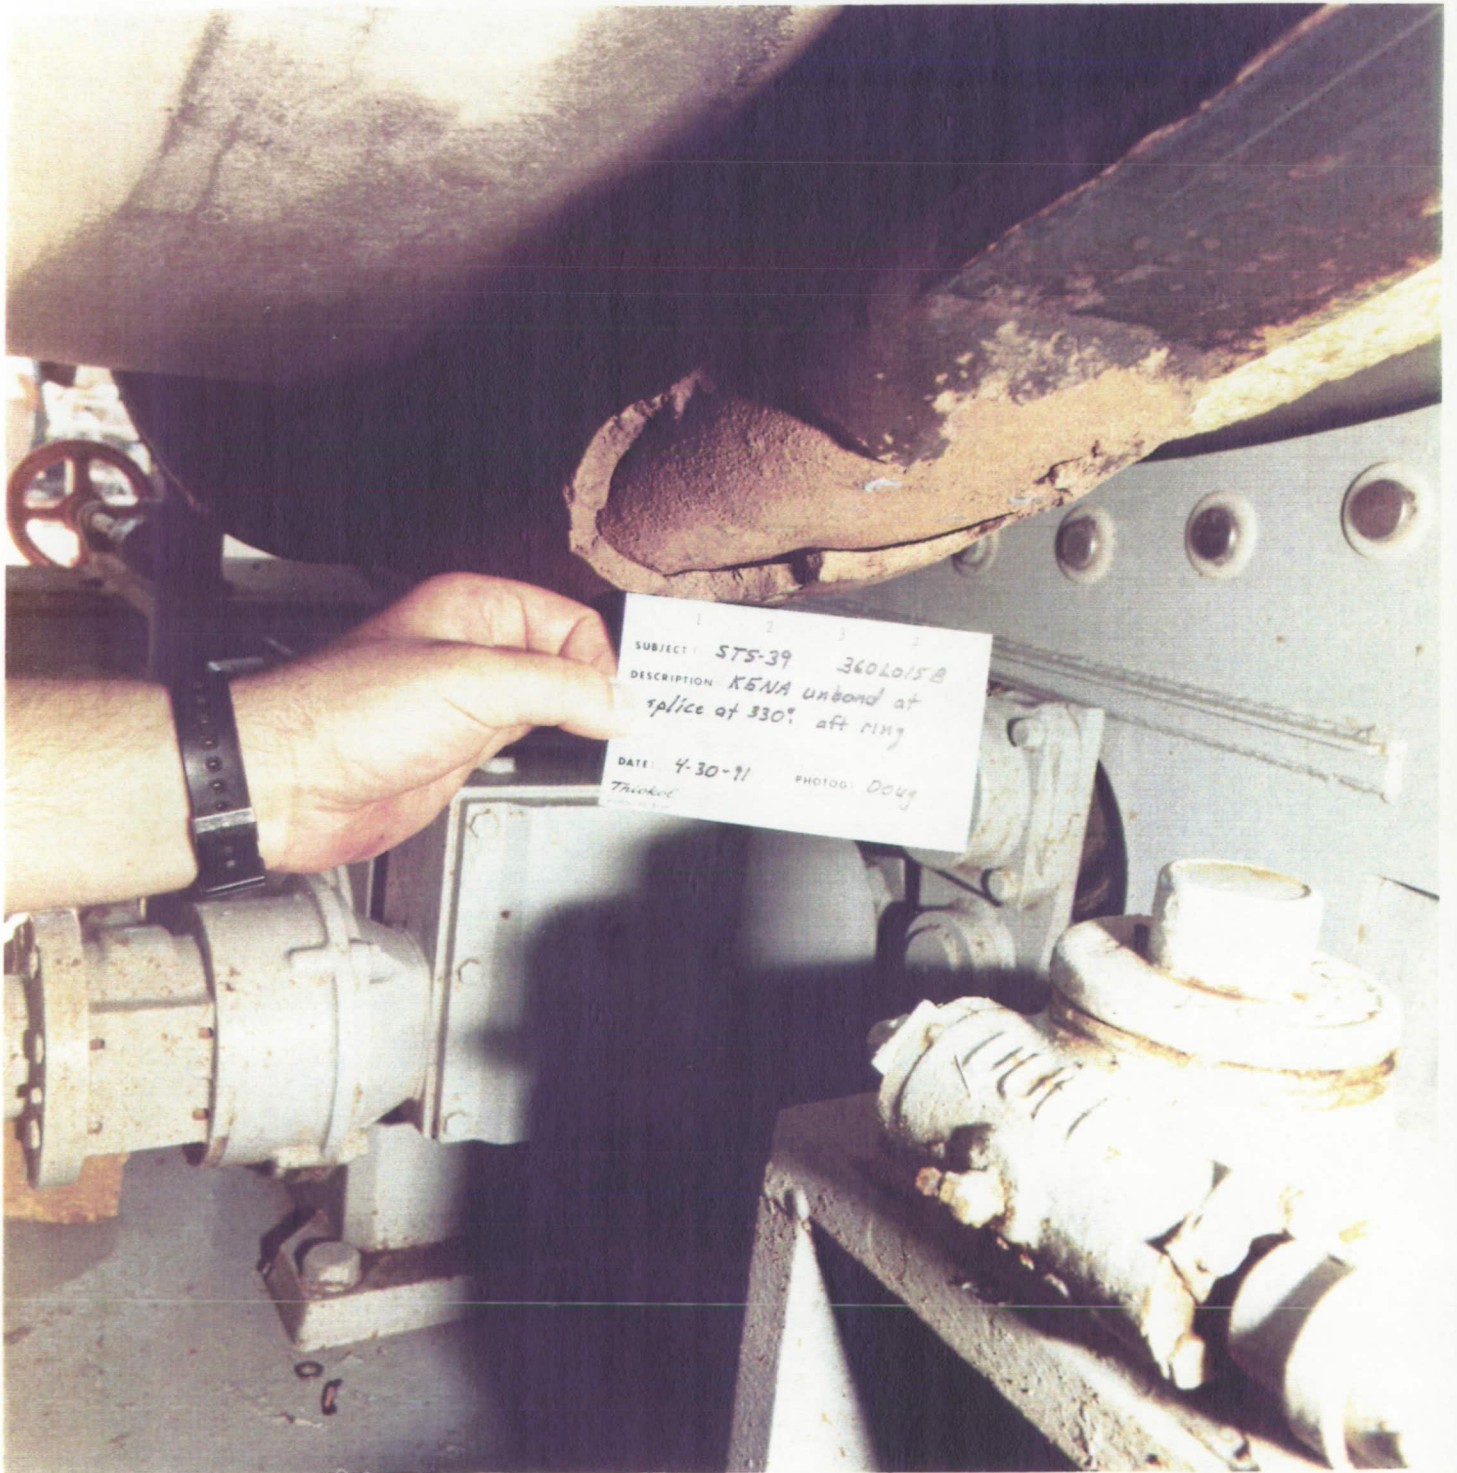
K5NA was missing from the RH SRB aft booster stiffener ring splice plates (aft ring at 330 degrees, forward ring at 210 degrees). The remaining material was not charred and loss of the K5NA occurred at water impact. Post flight assessment showed failure of the K5NA was caused by an unbond between the first and second layers and may be indicative of improper K5NA application (use of the "pancake" method instead of a homogeneous hand-pack). A suspect PR was taken against similar K5NA closeouts on STS-40, 43, and 48. A potential debris hazard exists if the K5NA is lost at liftoff or during ascent.

Post flight assessment showed failure of the K5NA was caused by an unbond at the substrate. Loss of this closeout at T-0 or during ascent could be a potential debris hazard.

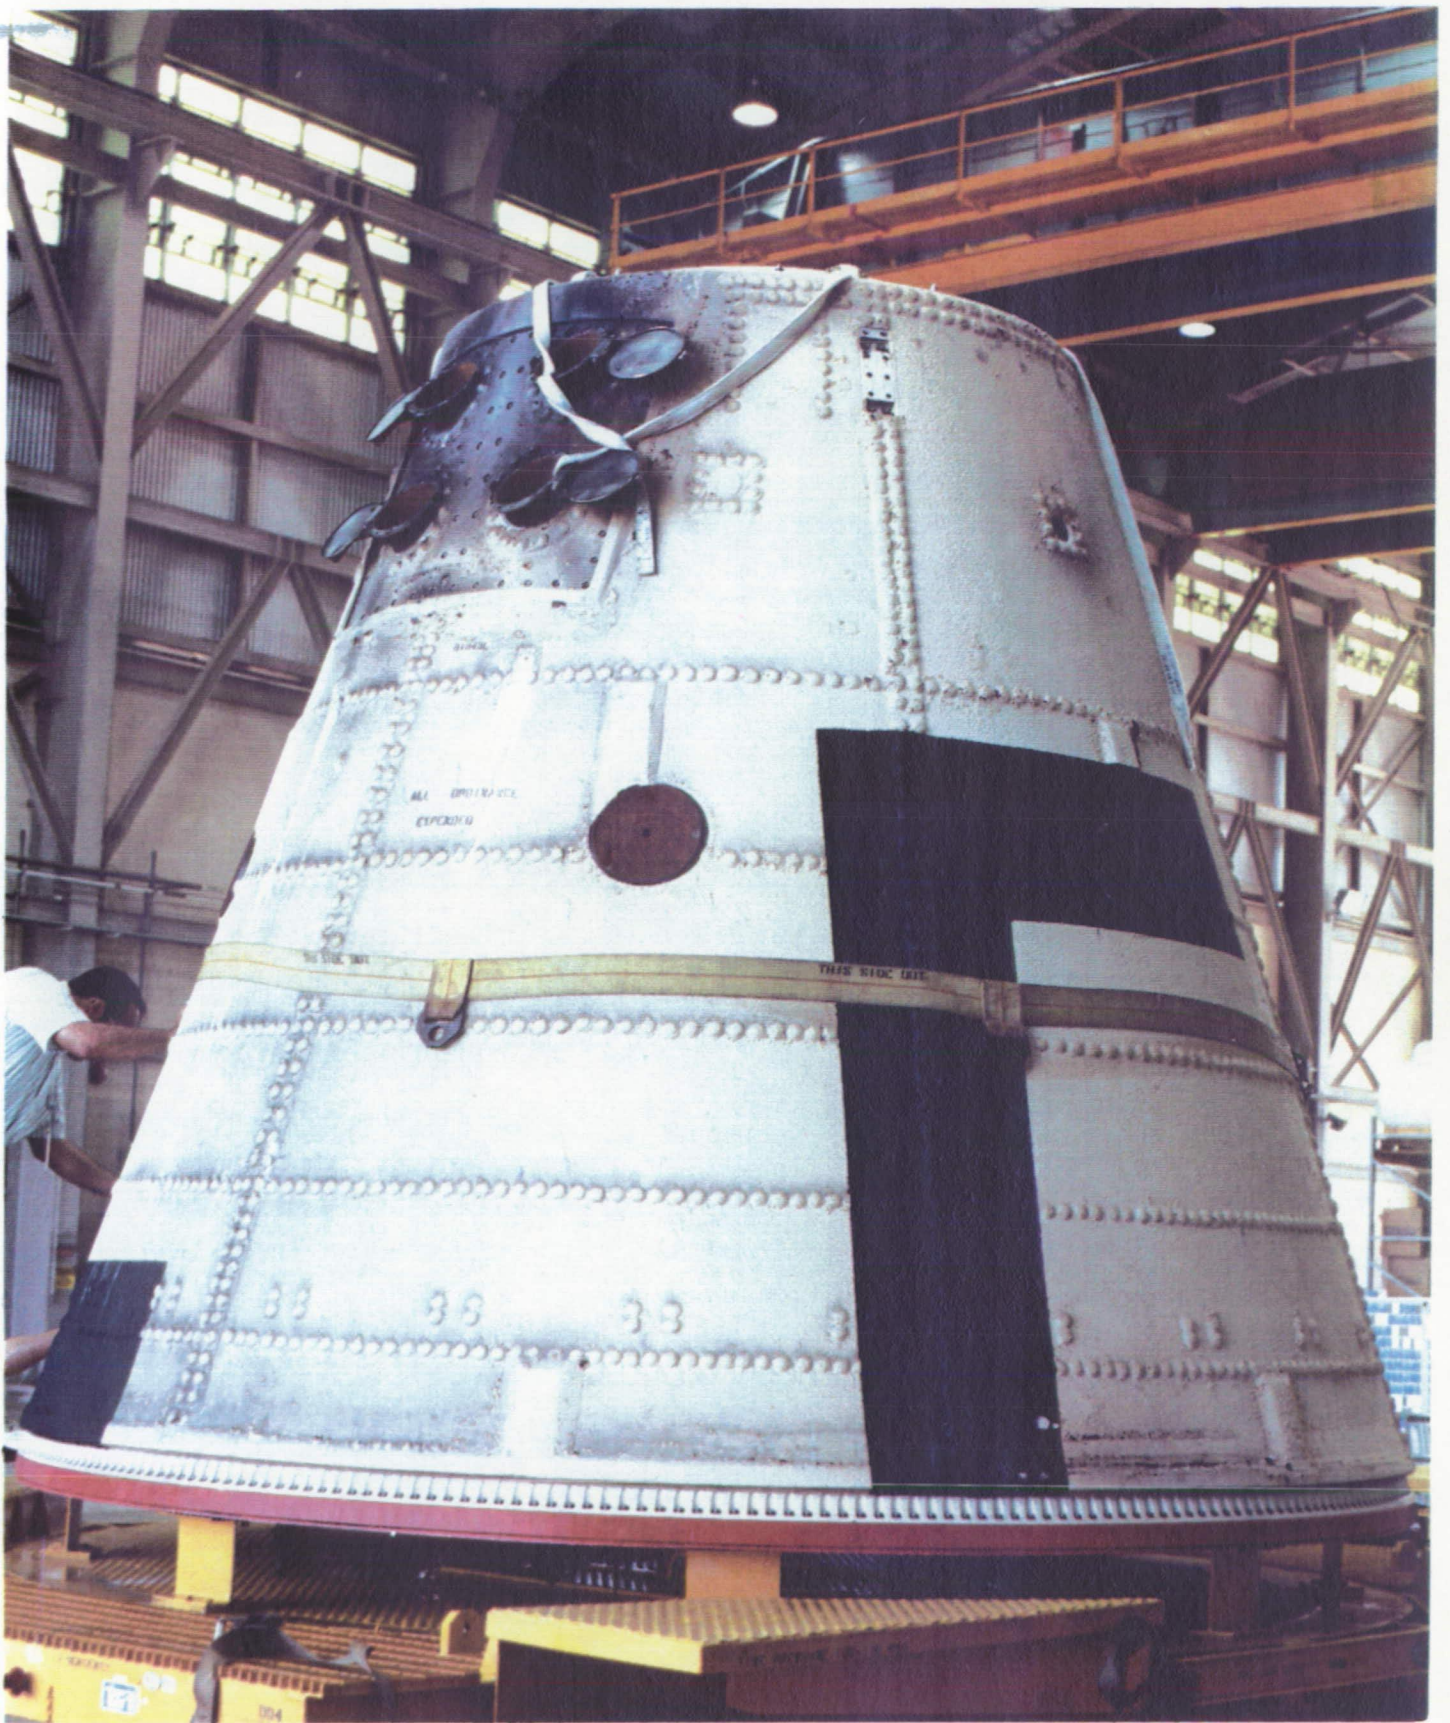
Post flight condition of the LH frustum. There were 22 MSA-2 debonds over fasteners, but no missing TPS.

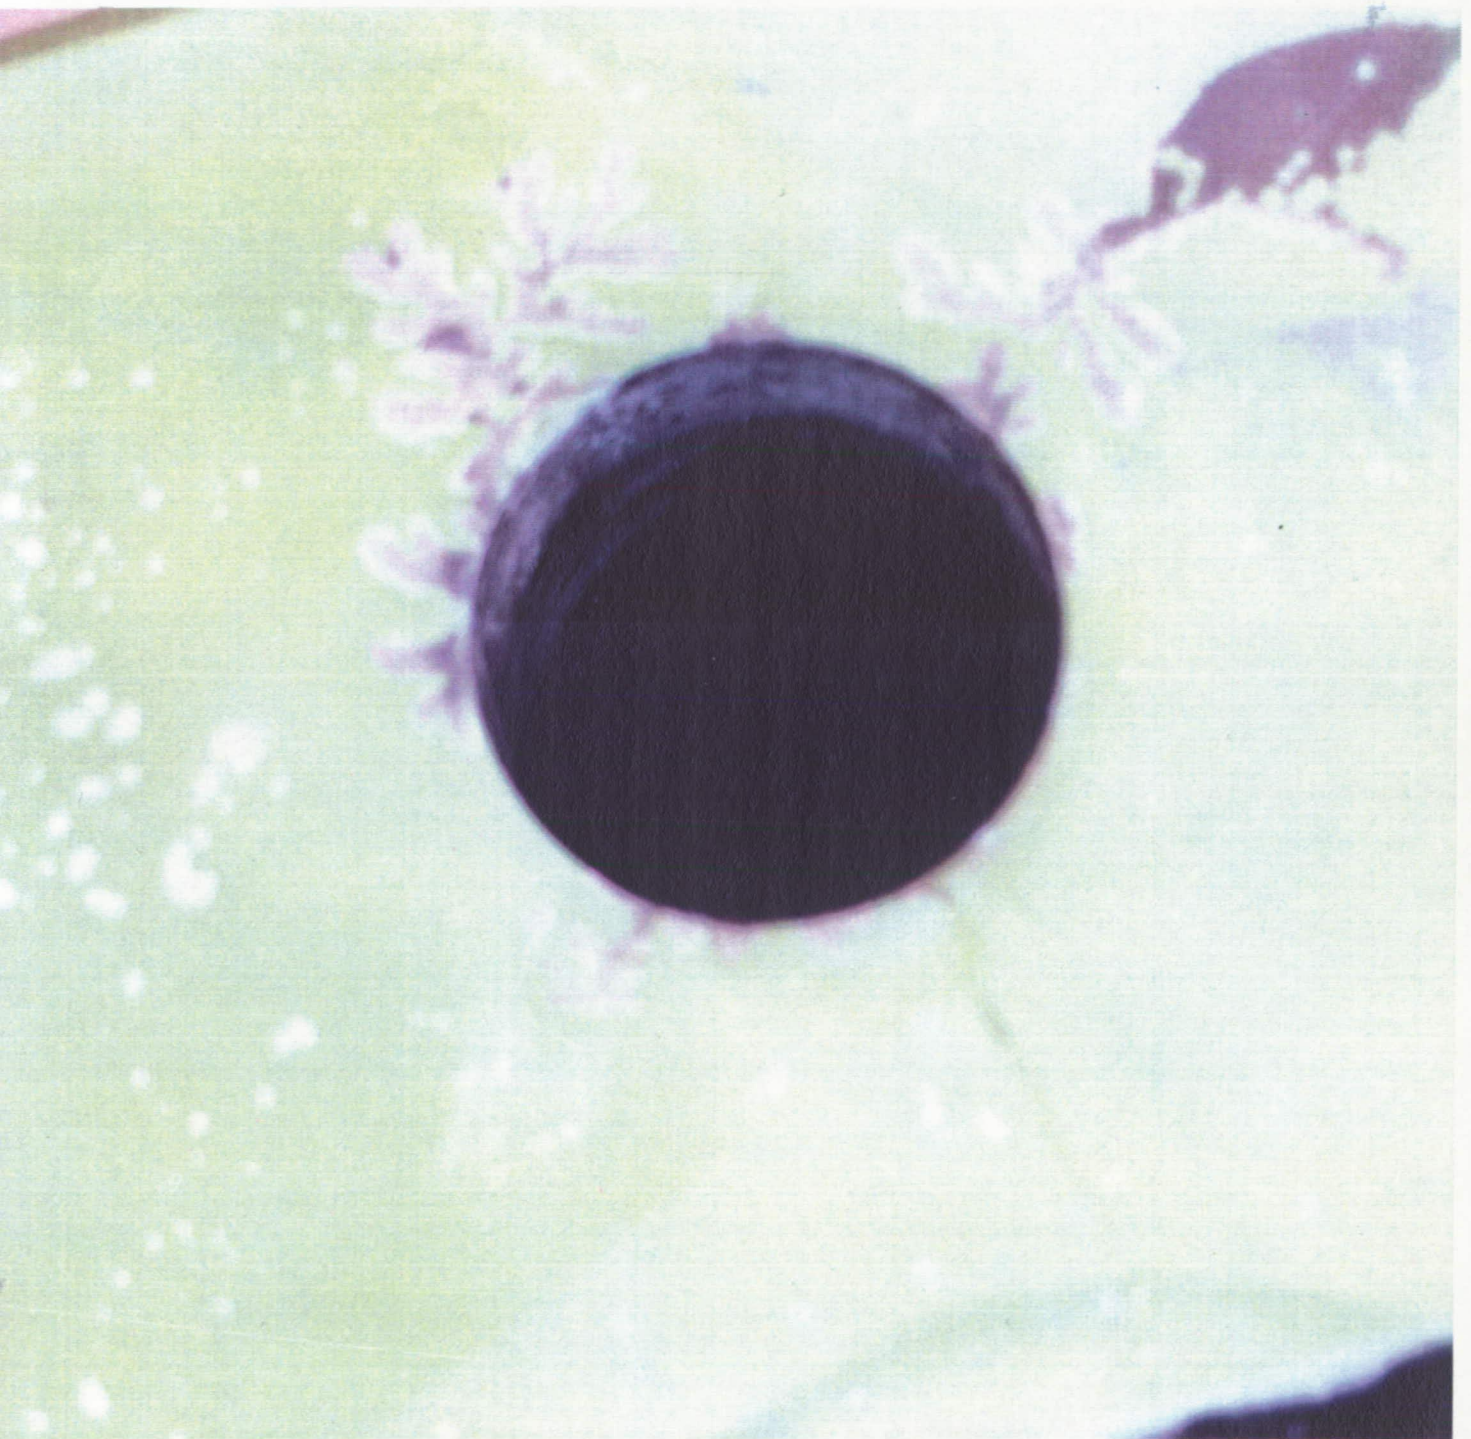
Debris Containment System (DCS) plungers were properly seated except for HDP #7, which was obstructed by frangible nut halves. None of the EPON shim material on the LH aft skirt was missing prior to water impact.

Holddown post #7 Debris Containment System (DCS) plunger was obstructed by frangible nut halves. Five ordnance fragments had fallen from the DCS/stud hole shortly after liftoff.

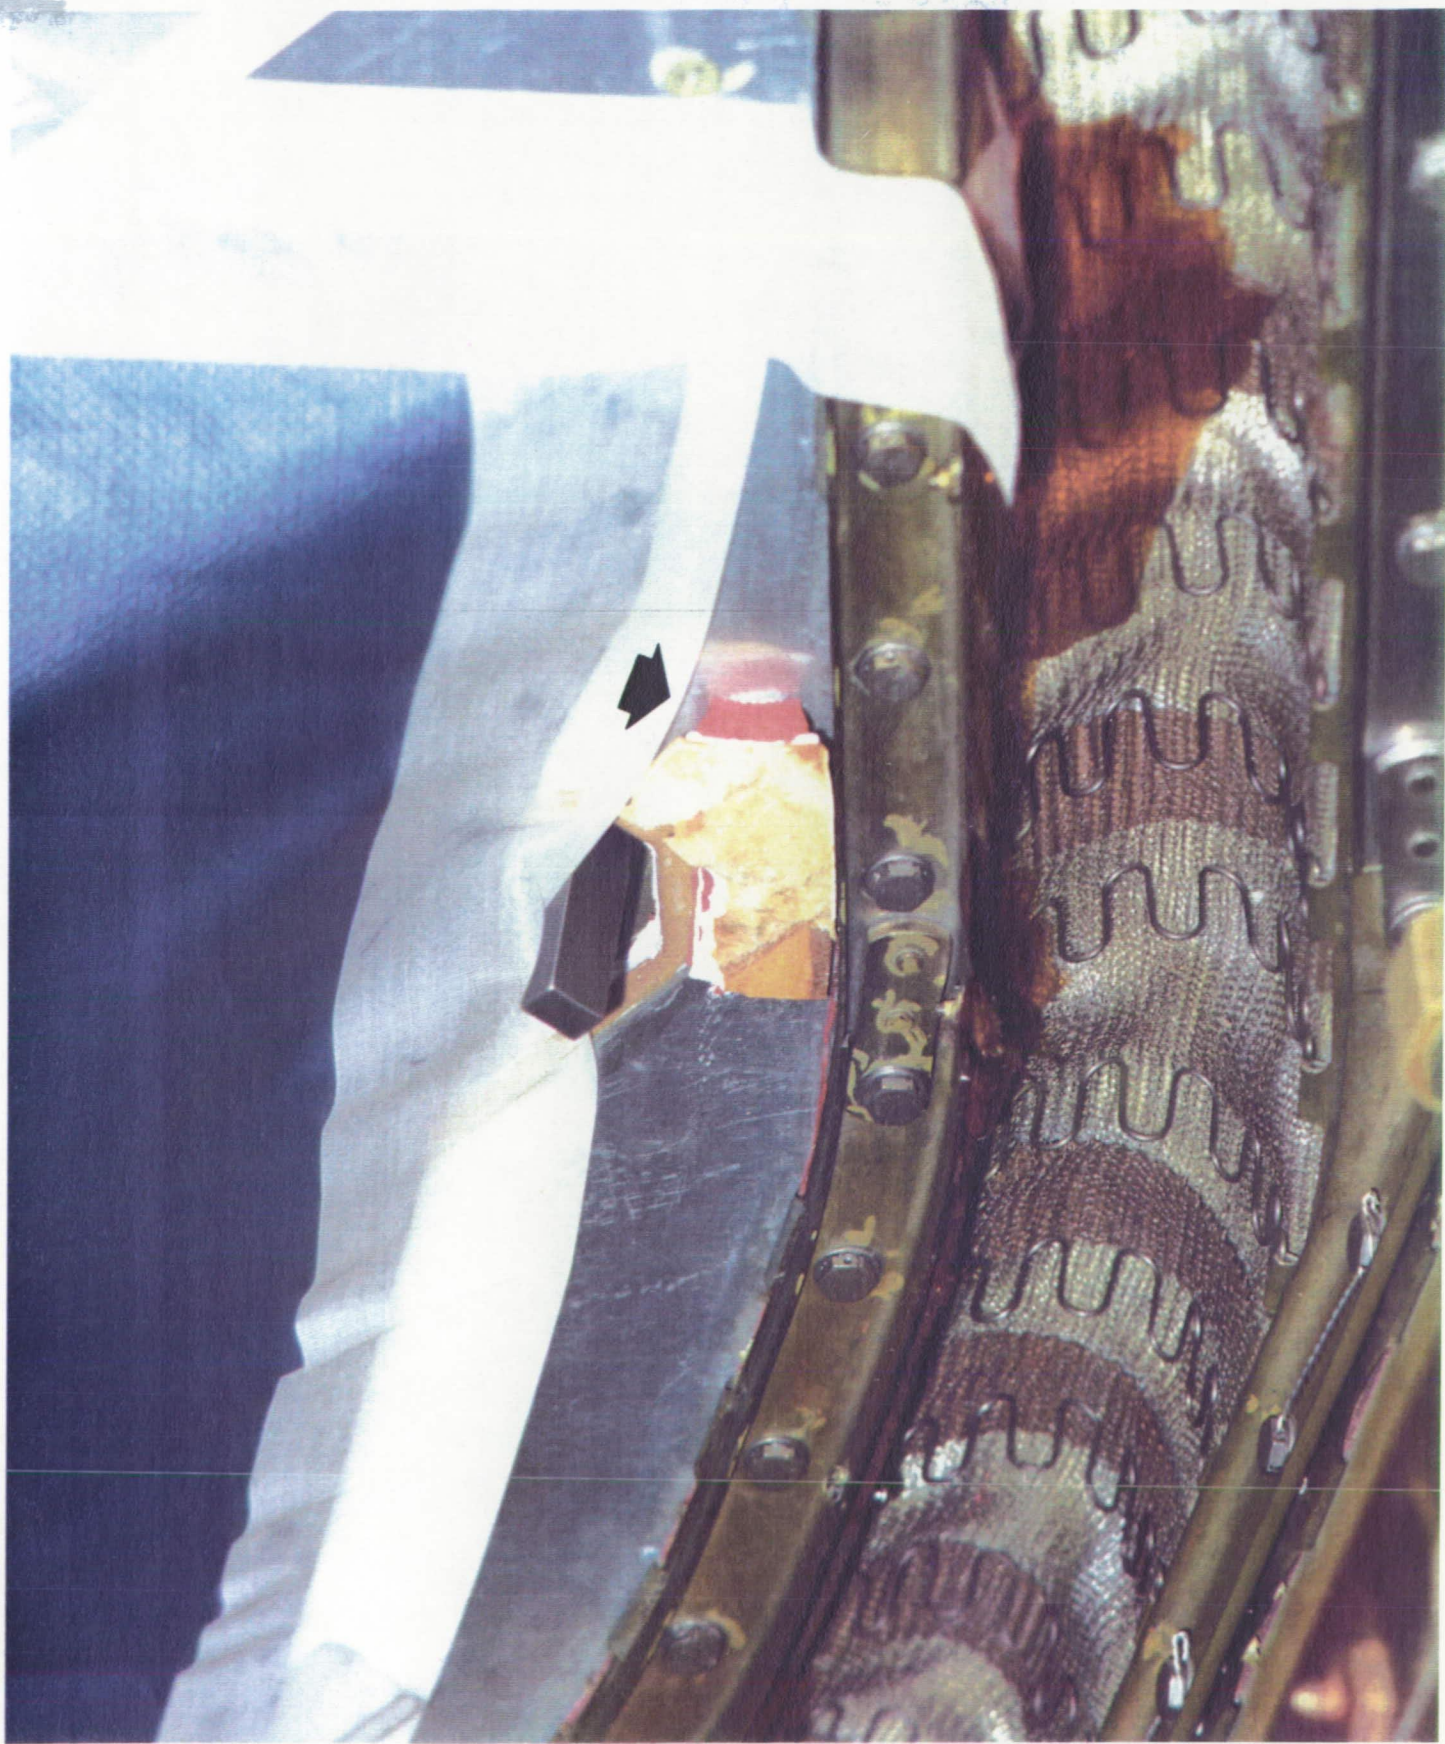
2-inch piece of umbilical purge seal, which should have remained attached to the External Tank, adhered to the Orbiter side of the LH2 ET/ORB umbilical plate

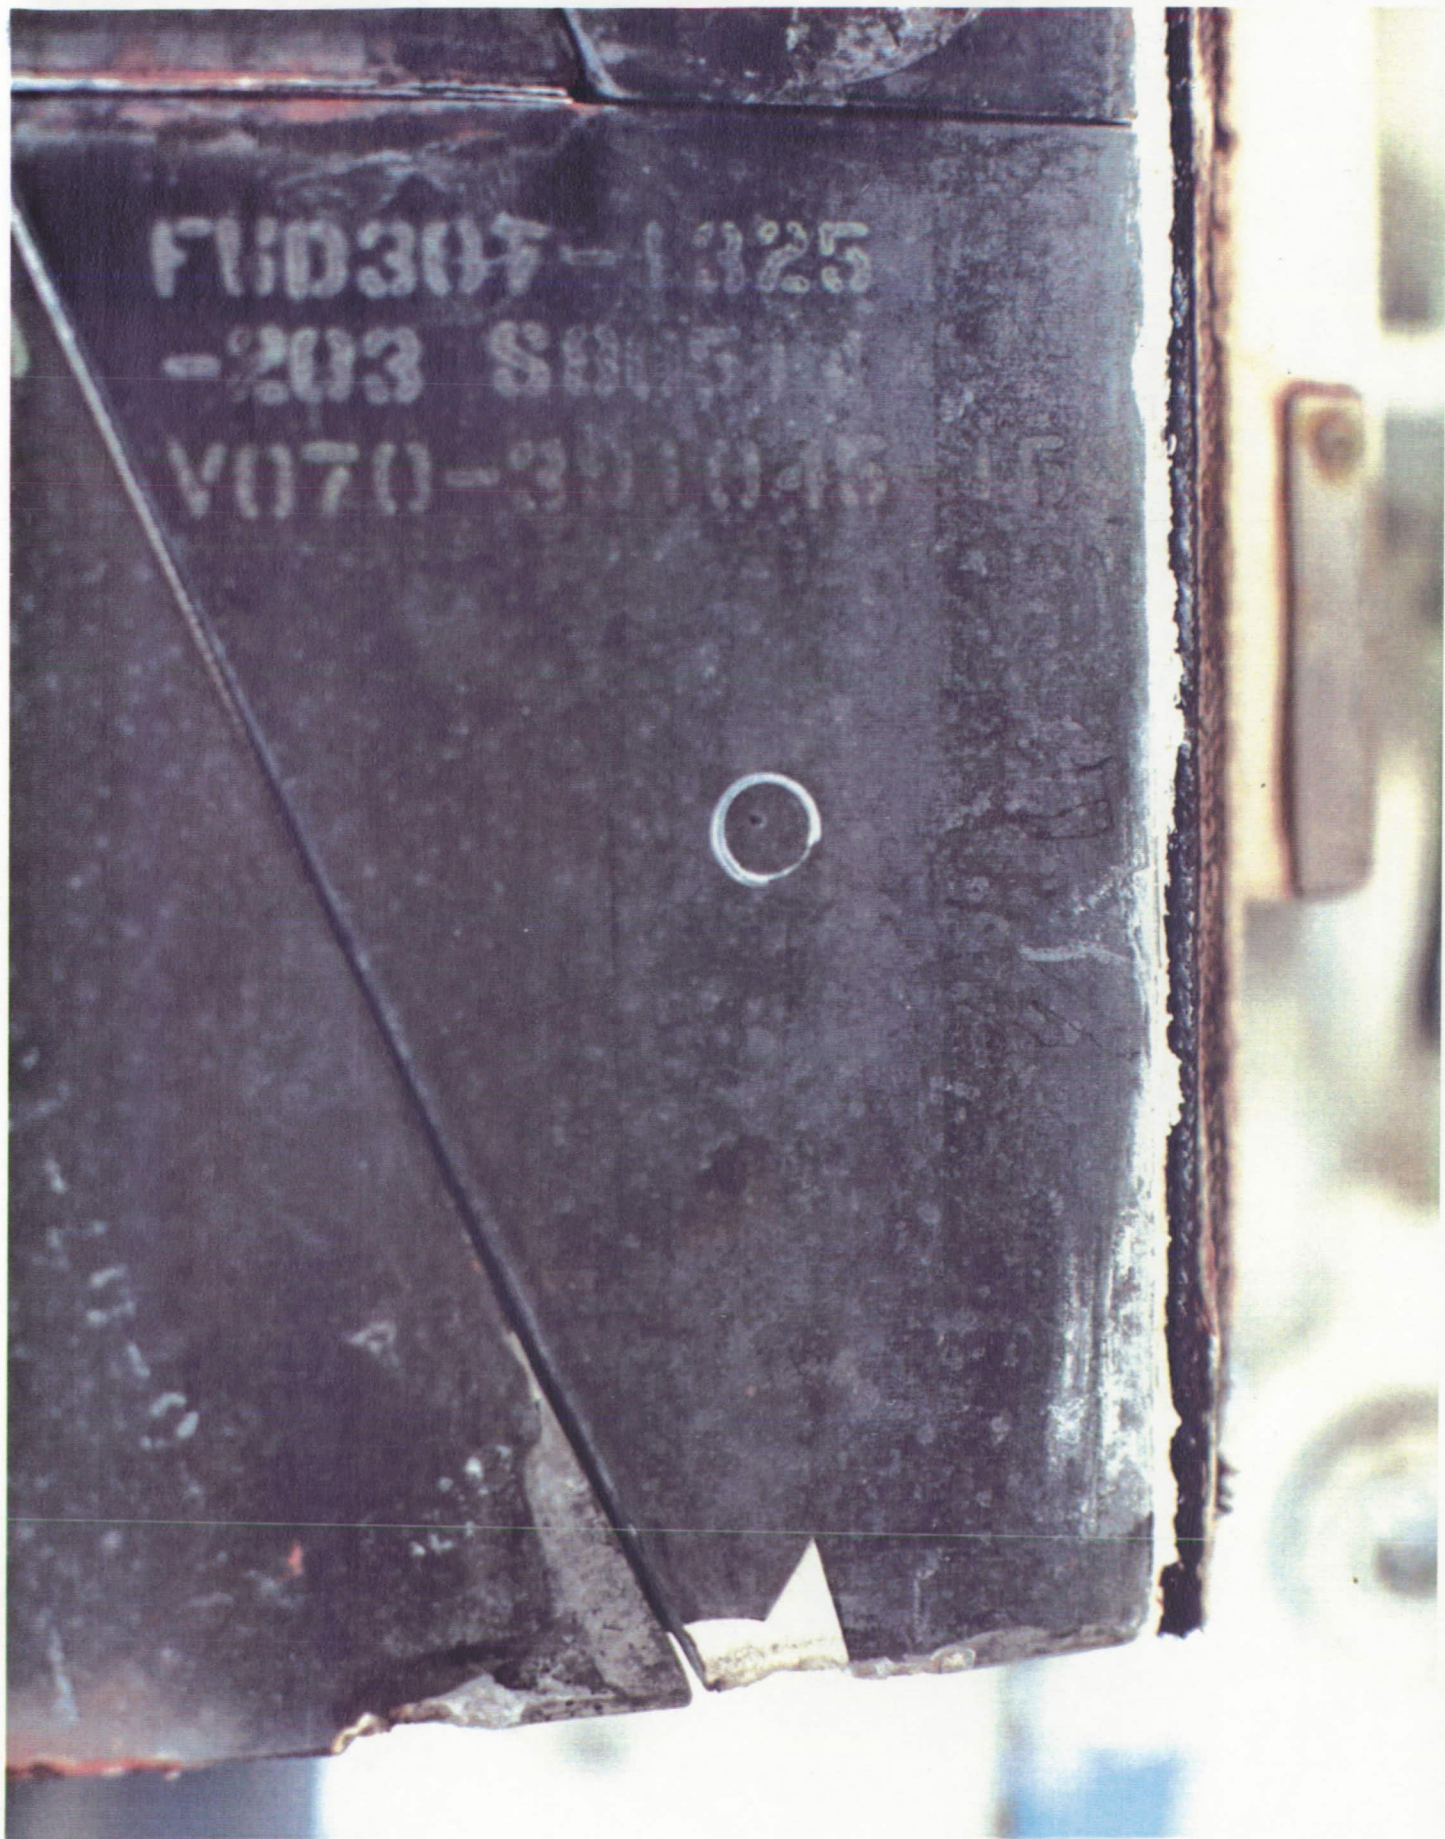
Tile damage on trailing edge of RH nose landing gear door
