NASA Technical Memorandum TM 103820

Debris/Ice/TPS Assessment And Photographic Analysis For Shuttle Mission STS-39

April 28, 1991

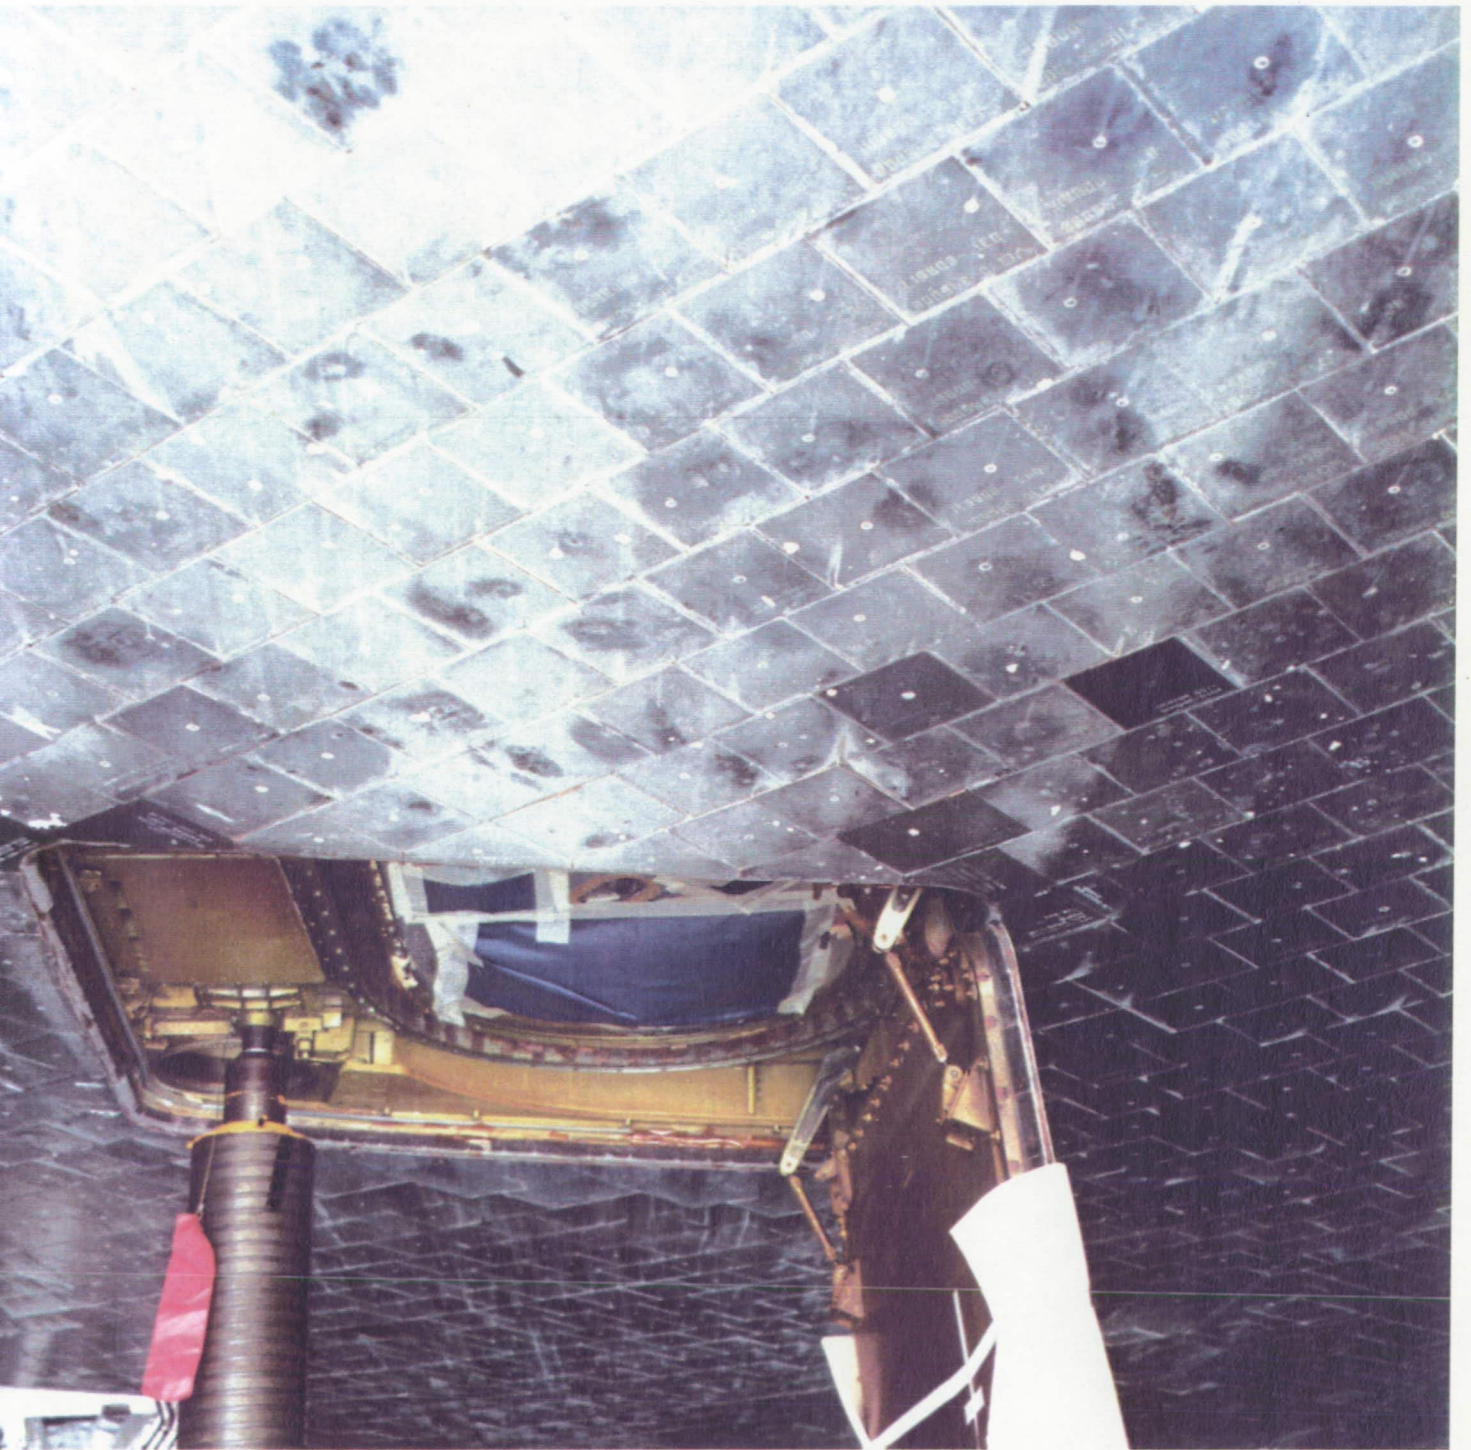
Cluster of hits on the tiles aft of the LH2 ET/ORB umbilical is typically caused by ice impacts during ascent and separation

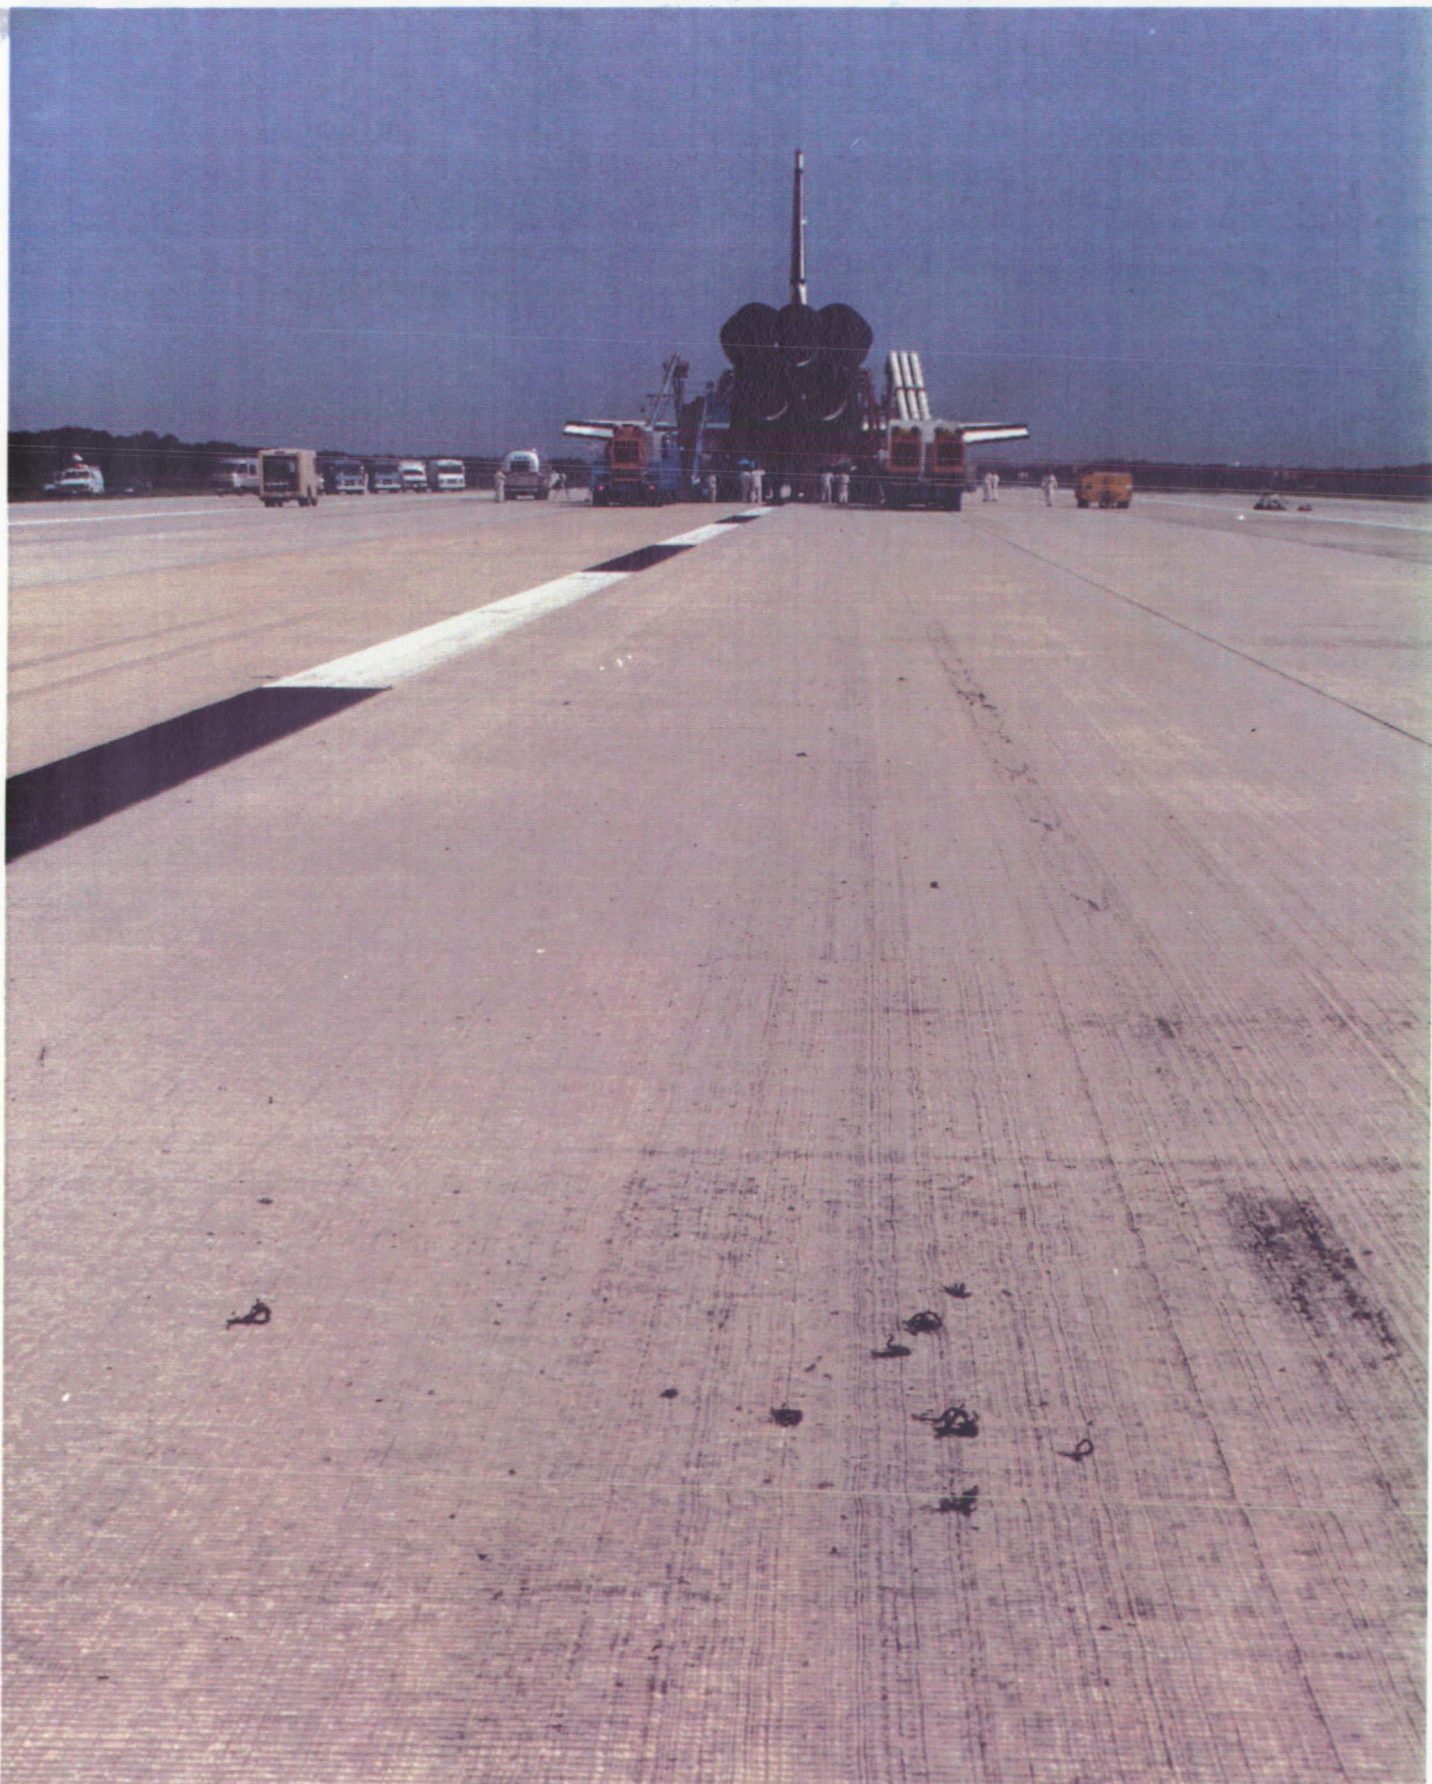
Material from the RH main landing gear tires lay on the runway within 1000 feet of the Orbiter stop point. There was no tire material at the touchdown point.

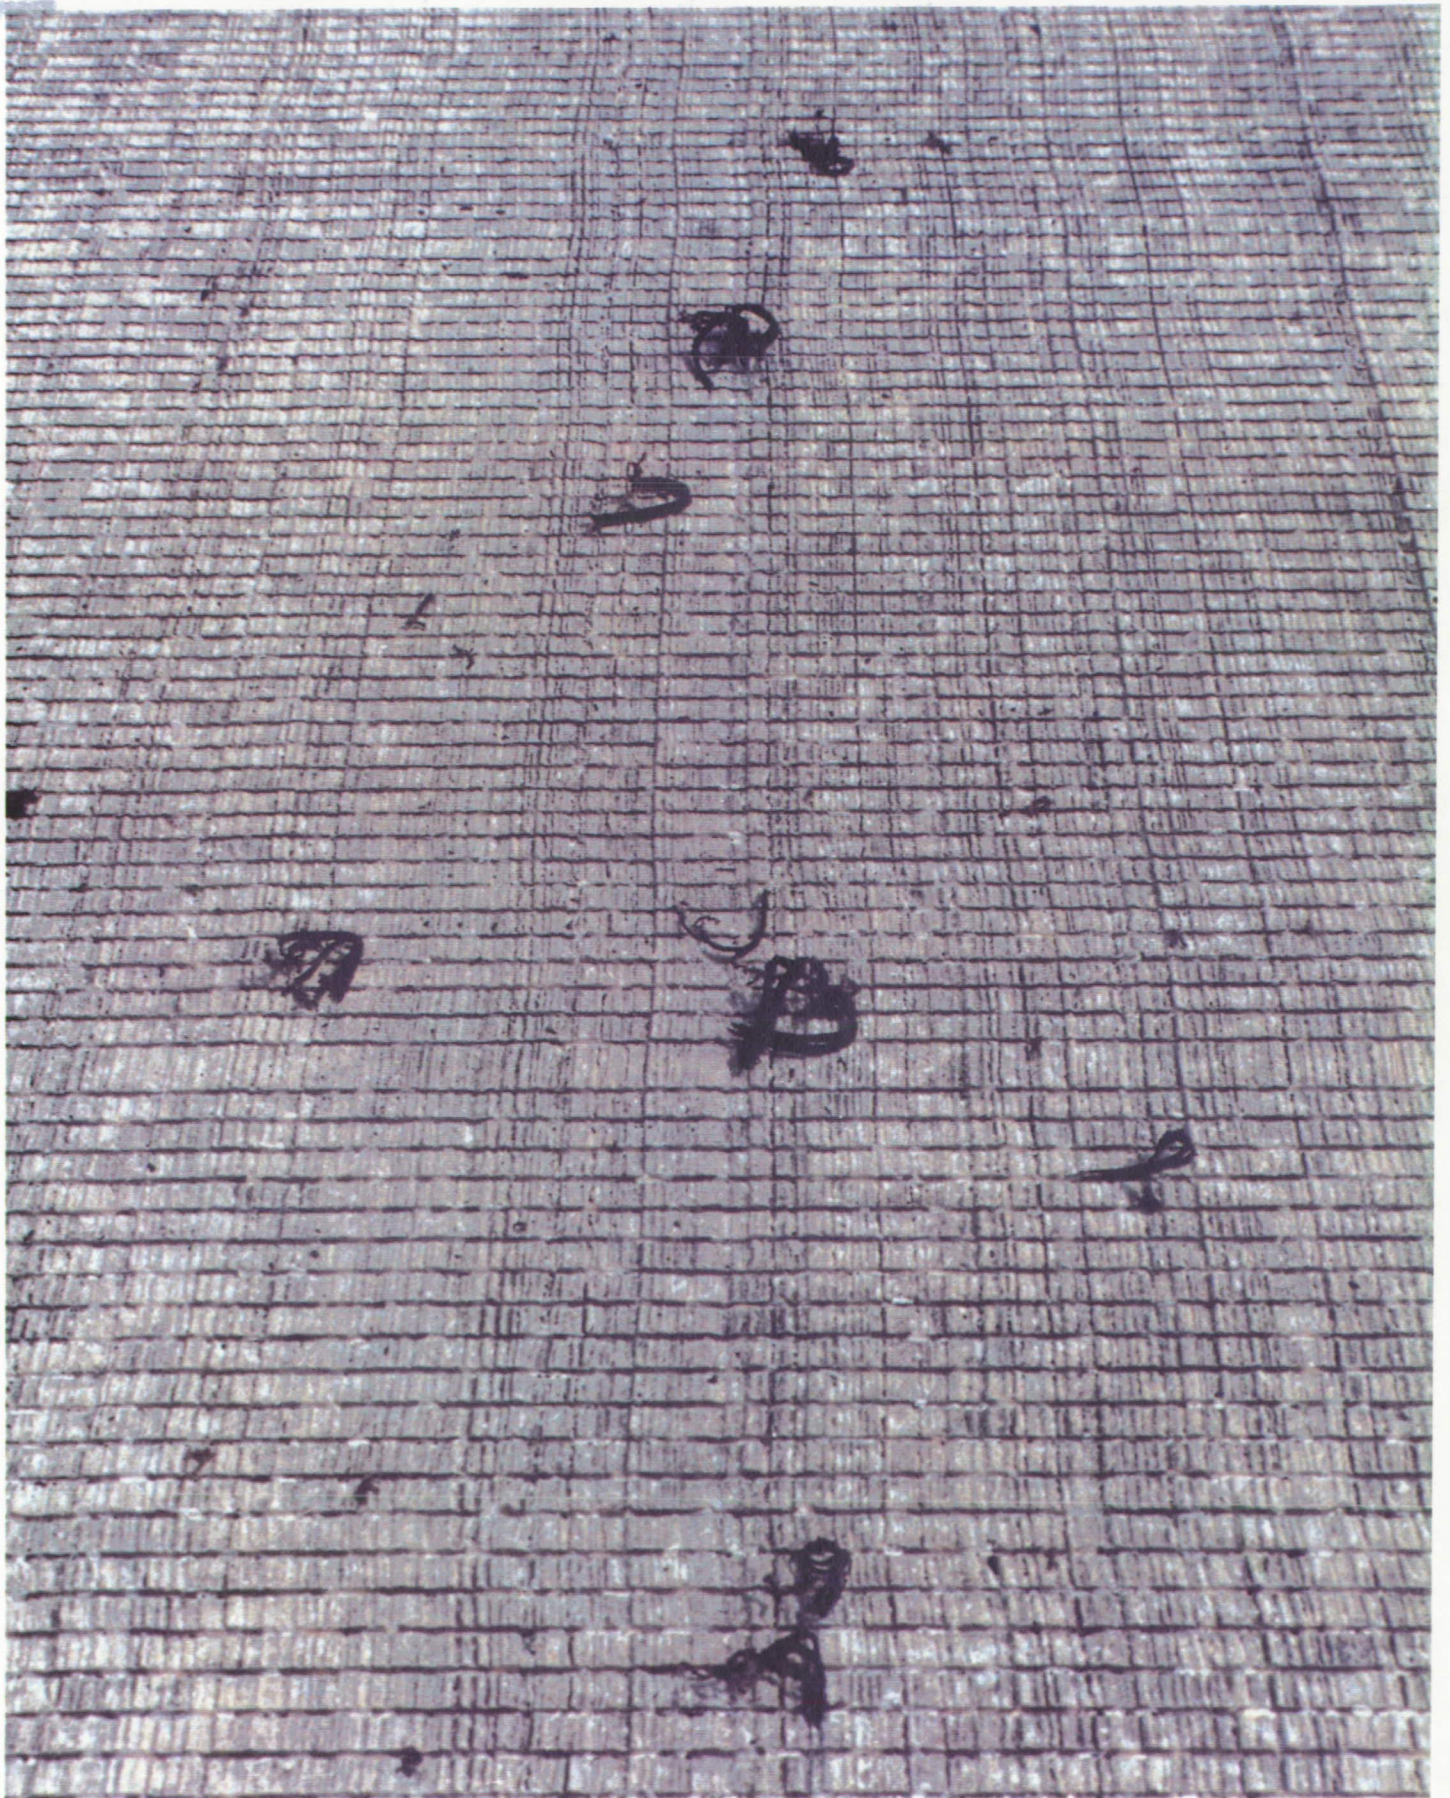
Three plies of material were lost from the RH outboard tire
and 1 ply was lost from the RH inboard tire
