TWR-17592 VOL. VII

Space Shuttle Production Verification Motor 1 (PV-1)  
Field Joint Protection System  
Final Report  
Volume VII

10 December 1990

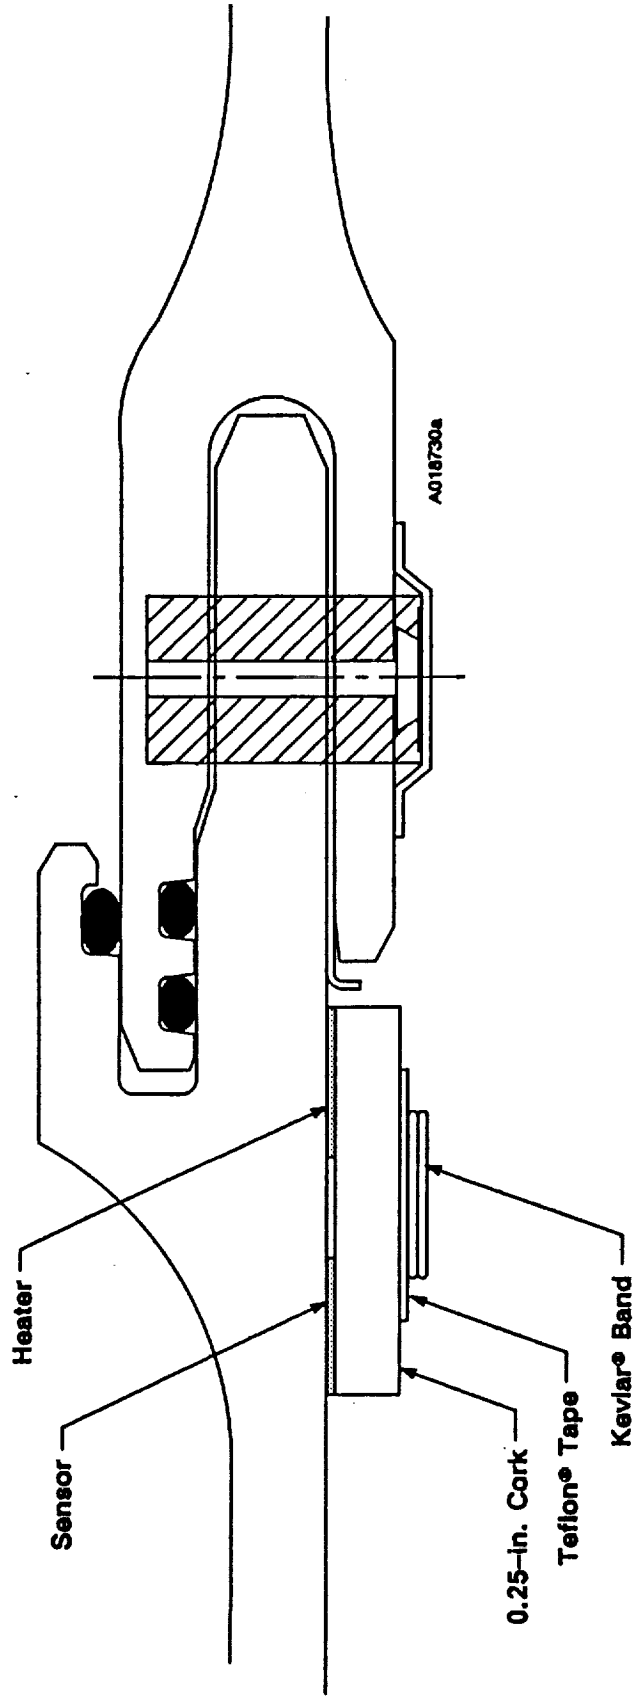
Figure 1. Simplified Field Joint Protection System

Field joint seal temperatures were maintained using a simplified field joint protection system (FJPS), shown in figure 1, consisting of heaters and sensors only. The heaters consisted of primary and redundant chemically etched foil circuits which were superimposed upon one another and laminated in Kapton and fluoroethylene polymer Teflon. Adjacent to the heaters were two temperature sensor assemblies, each containing two resistive temperature devices (RTD). These were covered by a 0.25-in thick strip of cork held in place by a single Kevlar strap.

The simplified FJPS was in excellent condition with no signs of abnormal heat effects on the cork strip or Kevlar band. No anomalies were observed on the FJPS.
