NASA Technical Memorandum TM 103815

Debris/Ice/TPS Assessment And Photographic Analysis For Shuttle Mission STS-38

November 15, 1990

Shuttle mission STS-38 was launched at 6:48 p.m. EST 11/15/90

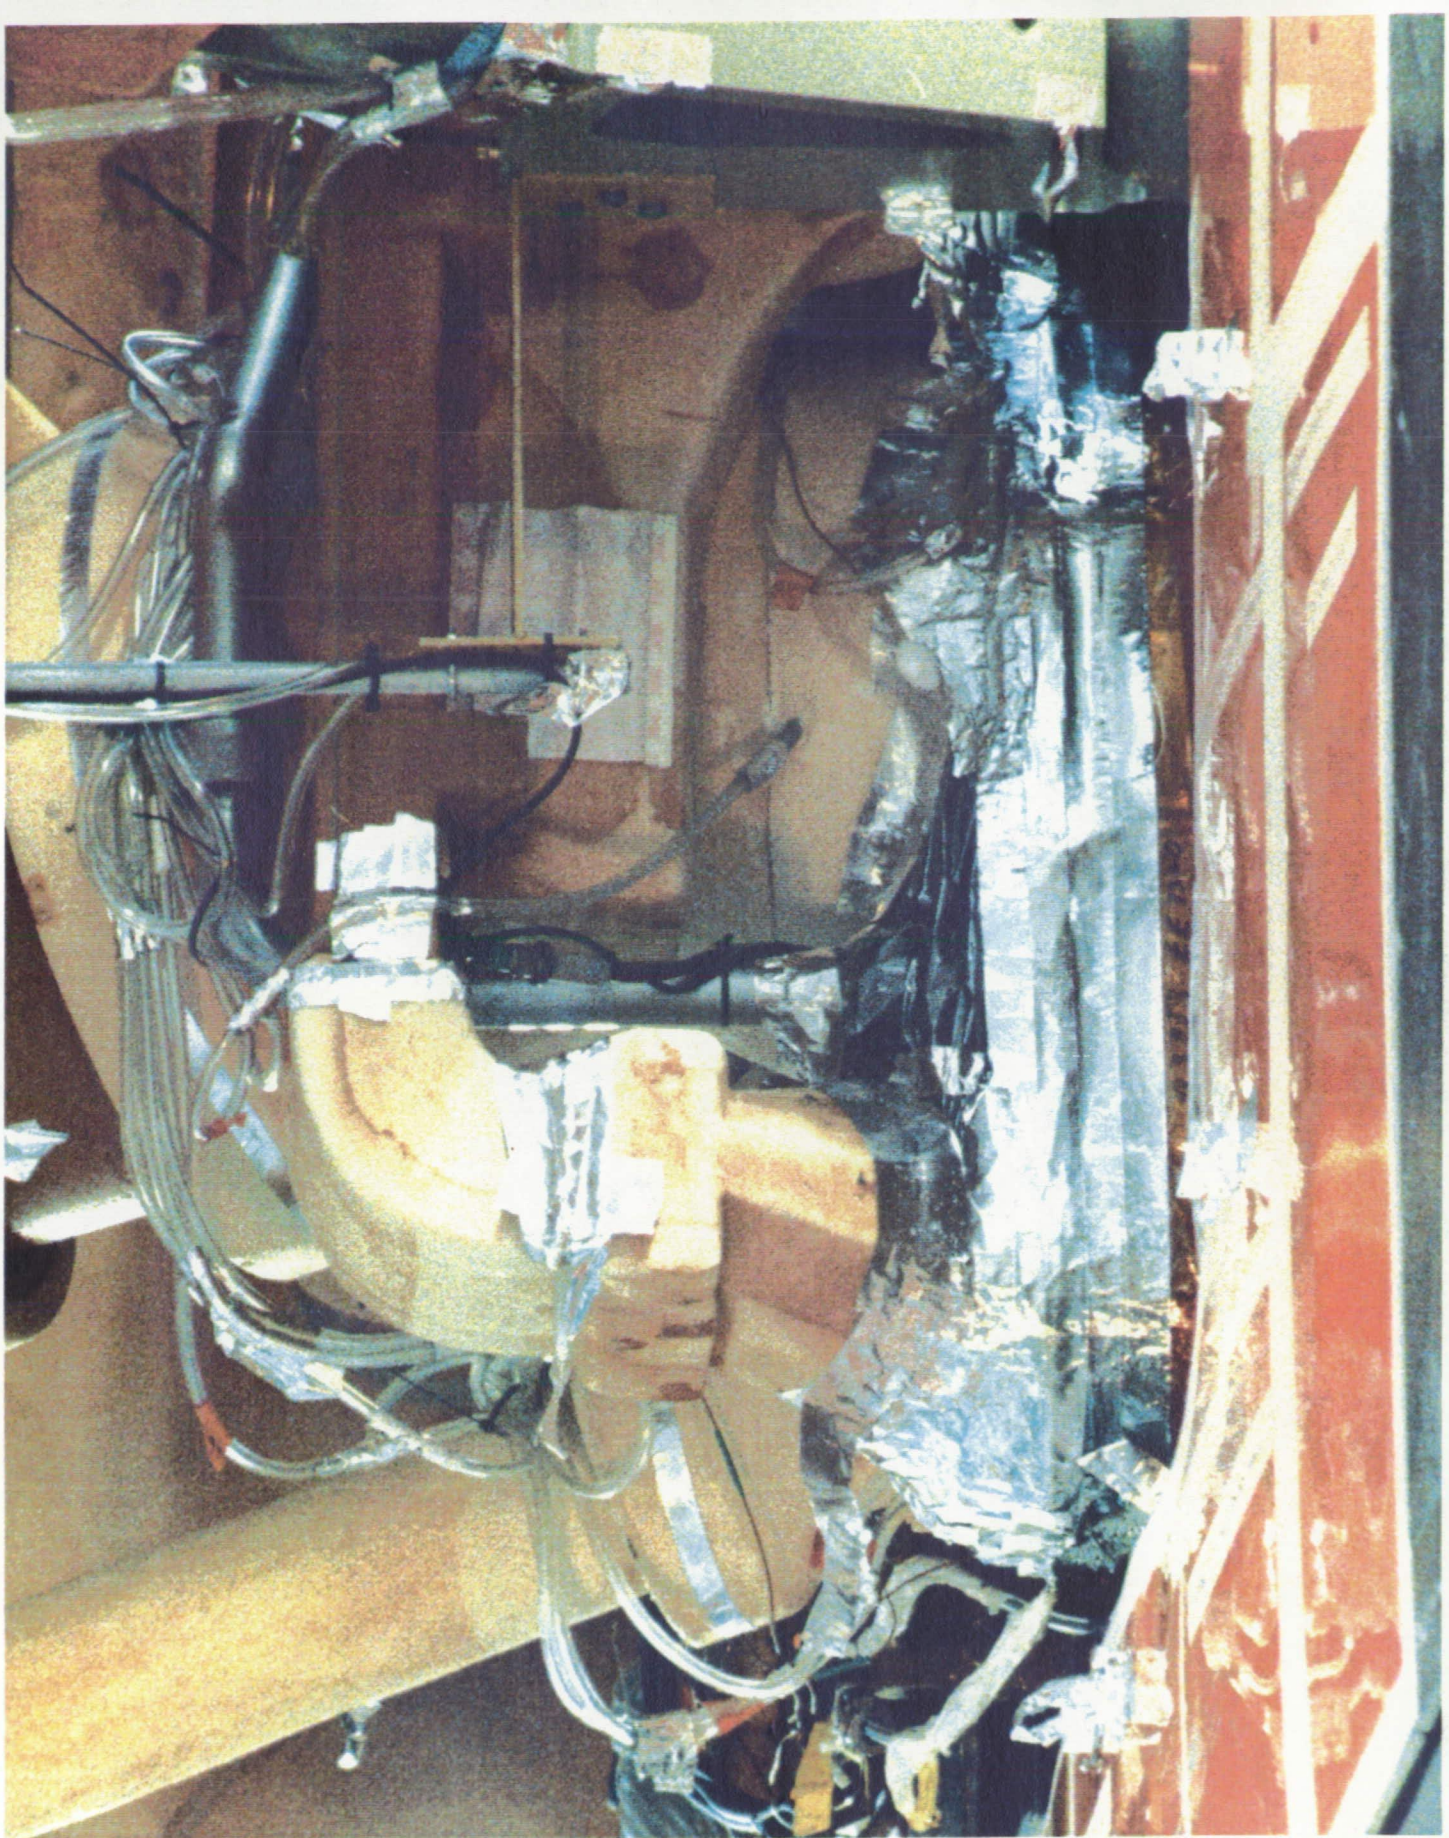
Post drain condition of the LH2 umbilical after Tanking Test 2.
Aluminum tape covers/seals in the area where the LH2 feedline
flange had been enclosed by a baggie to contain hydrogen leaks.

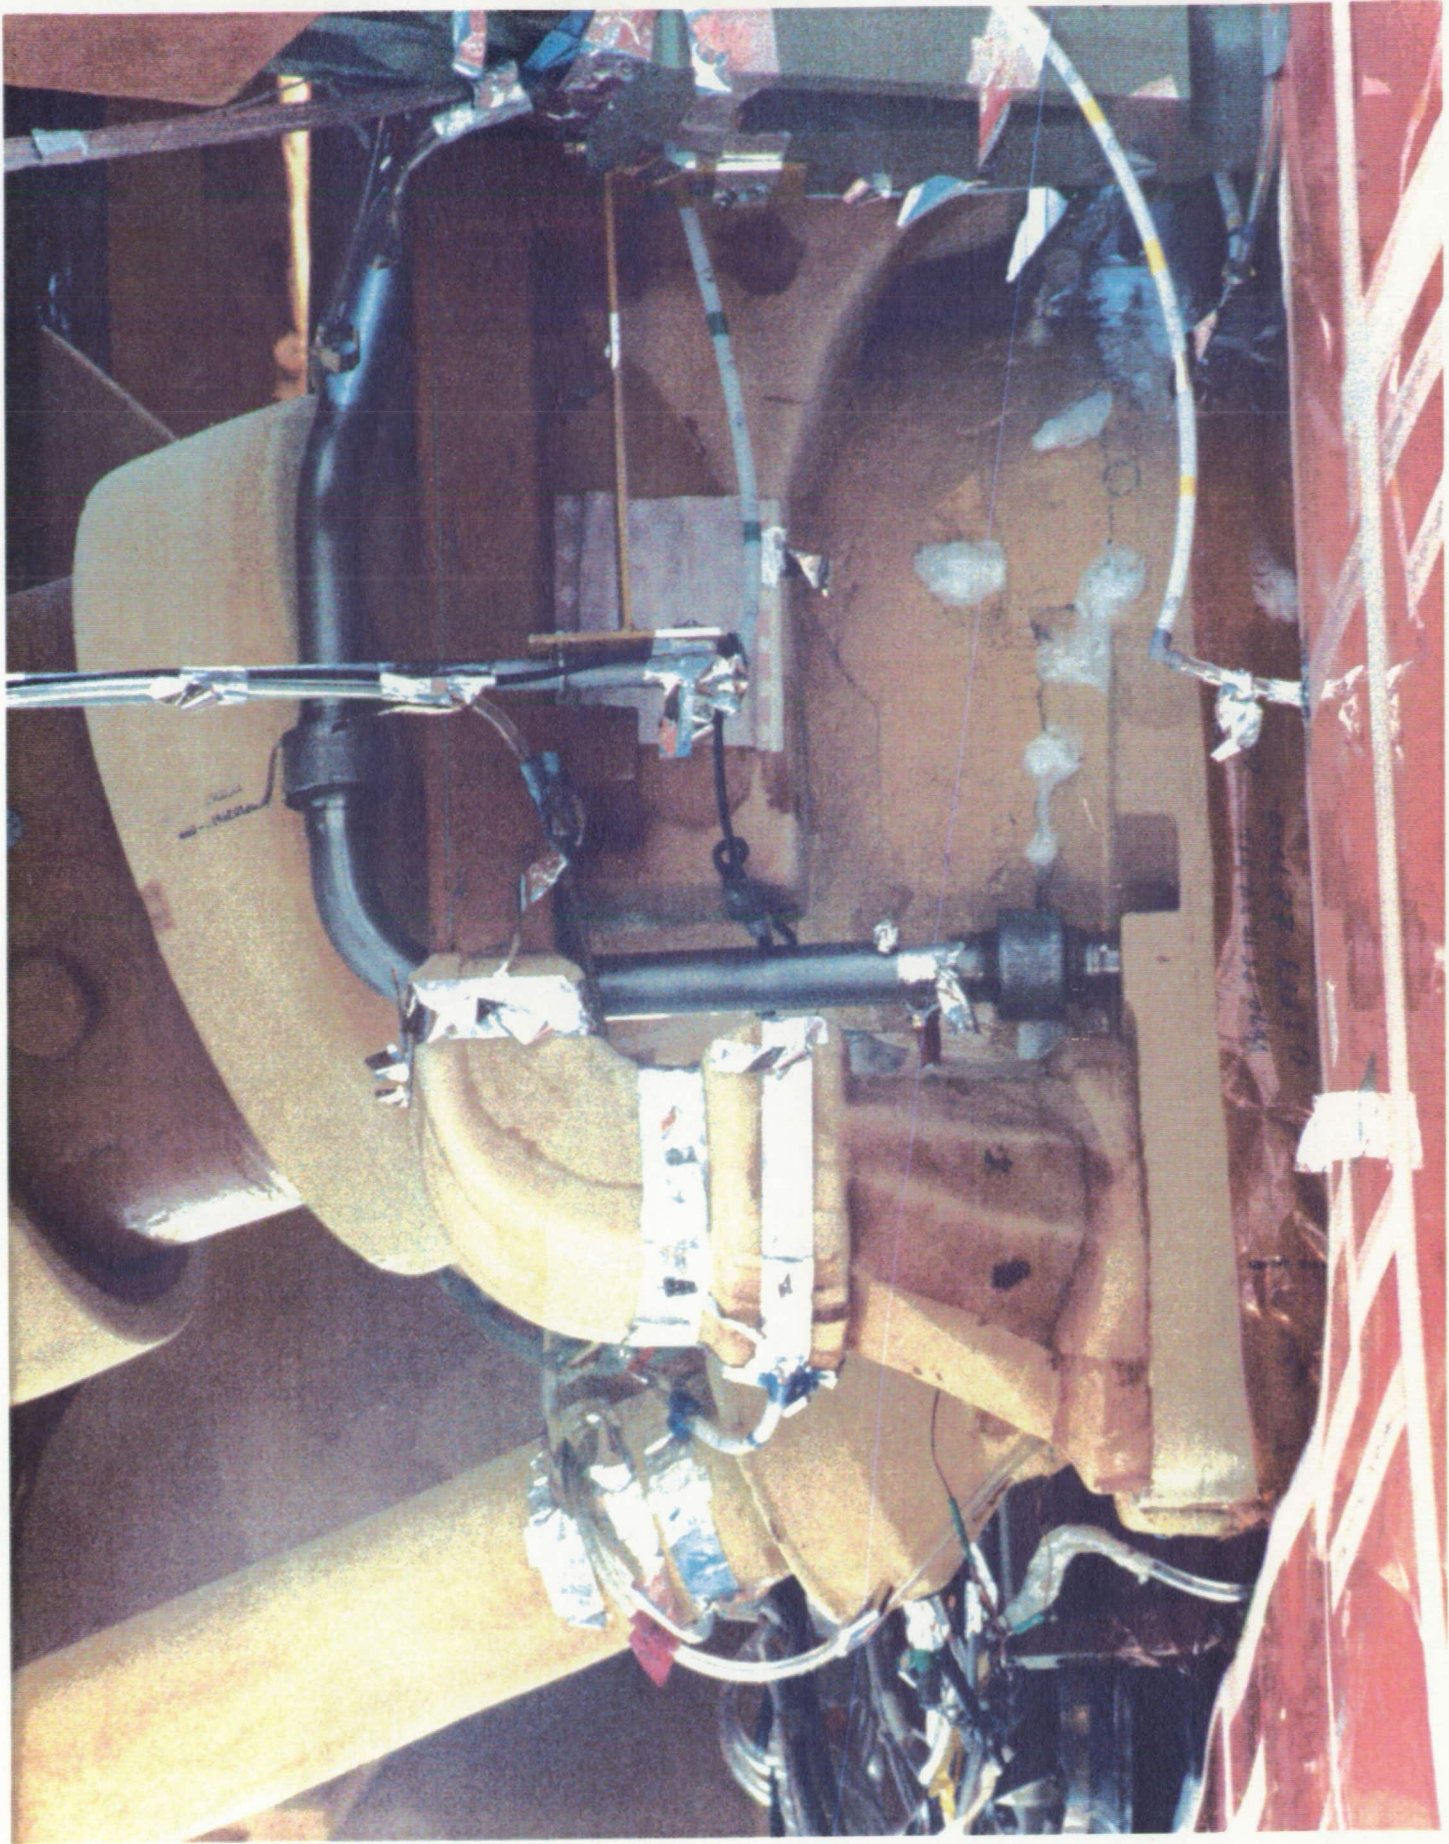
Post drain condition of the LH2 umbilical after Tanking Test 3. Special leak detection instrumentation, including tygon tube rakes, had been installed to map hydrogen leak flow fields.

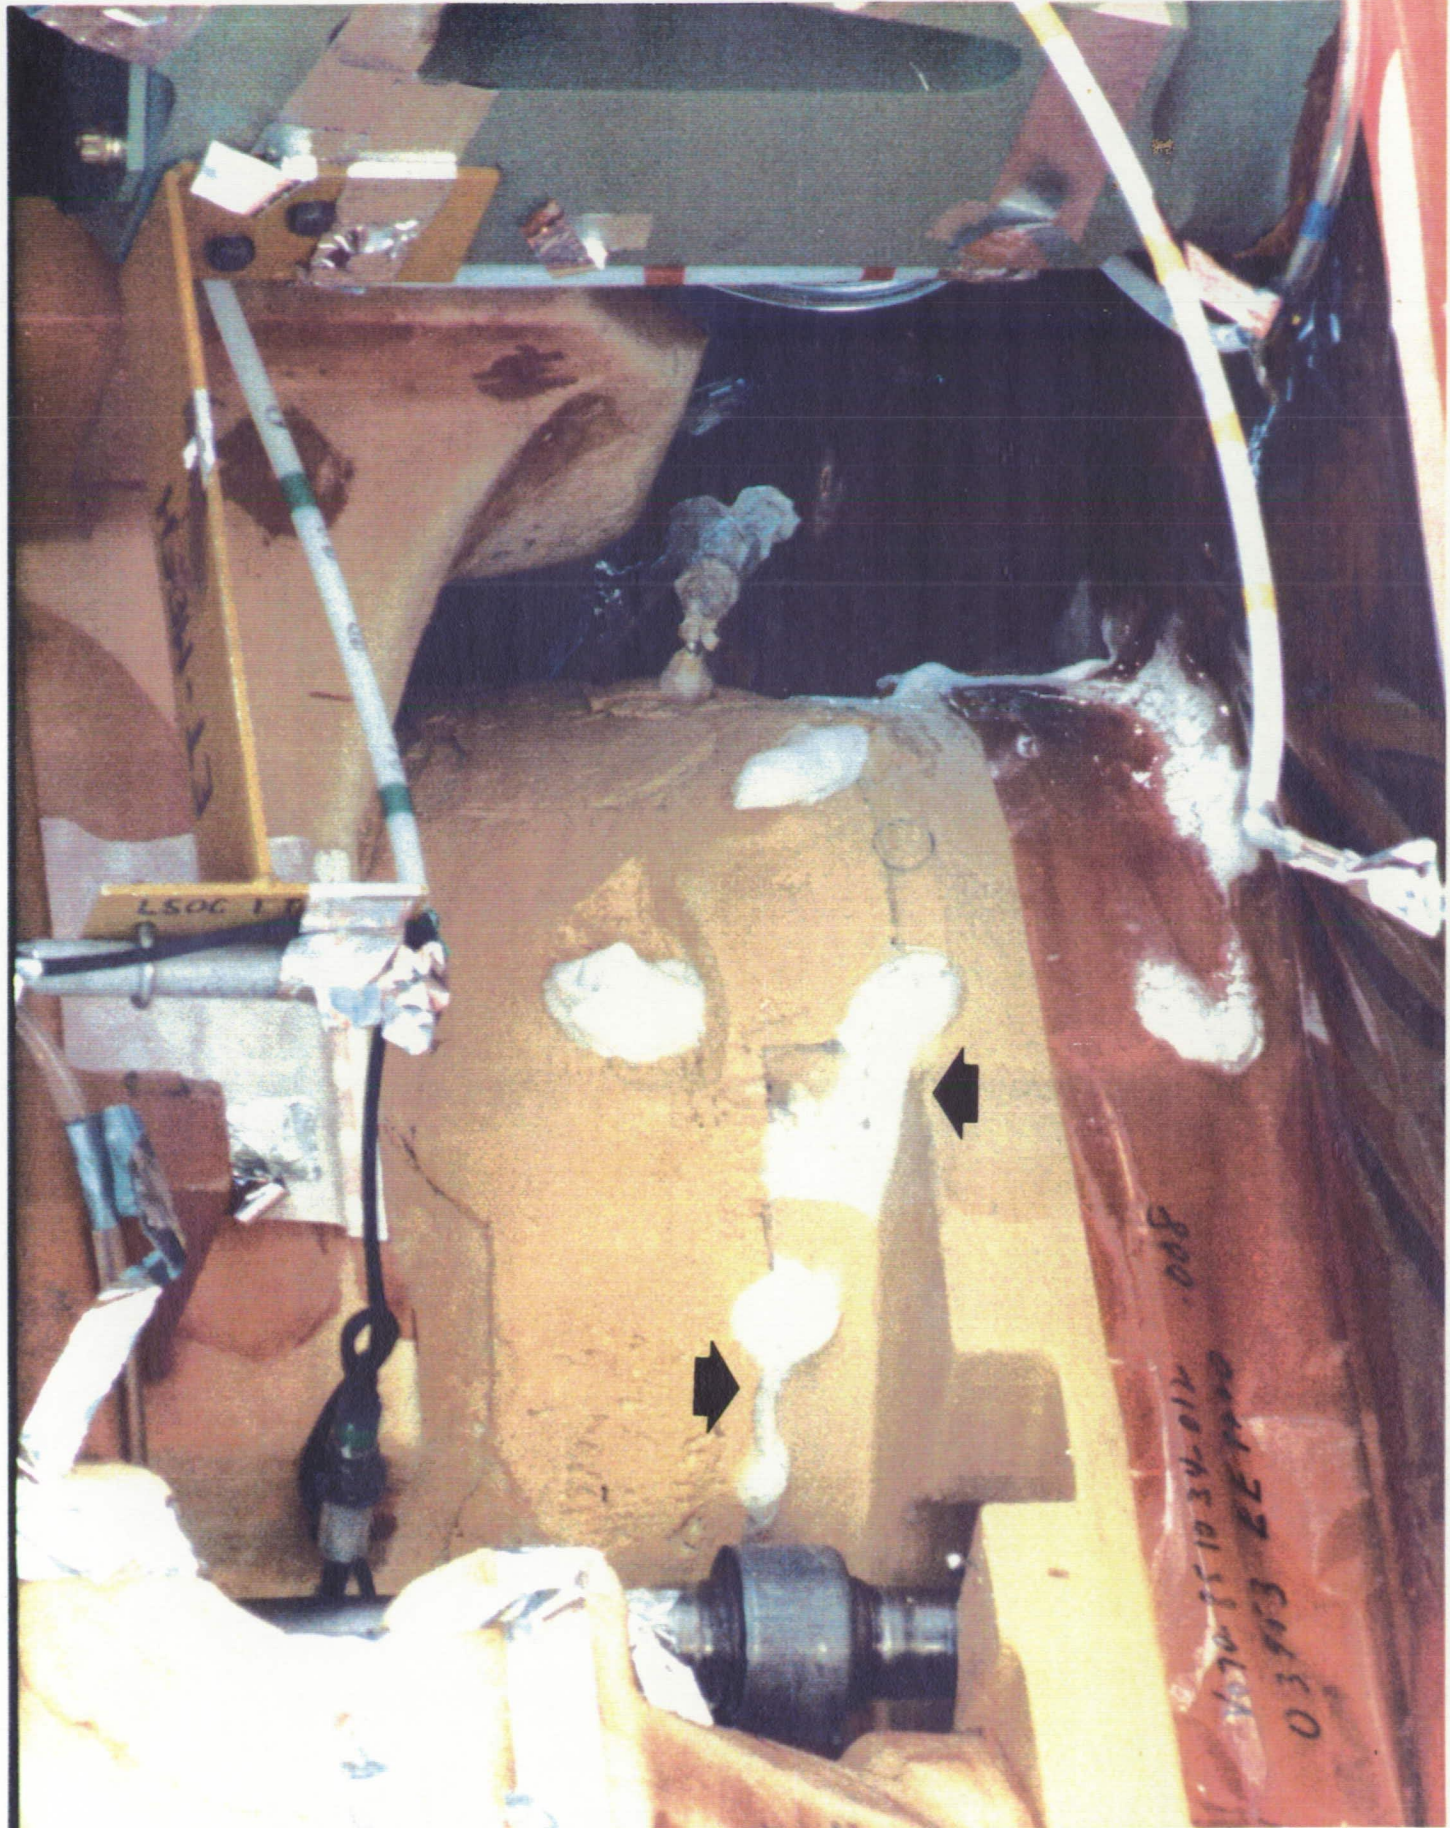
Due to the changing test configurations, numerous TPS cracks and isochem bondline thermal shorts were revealed by the appearance of ice/frost formations.

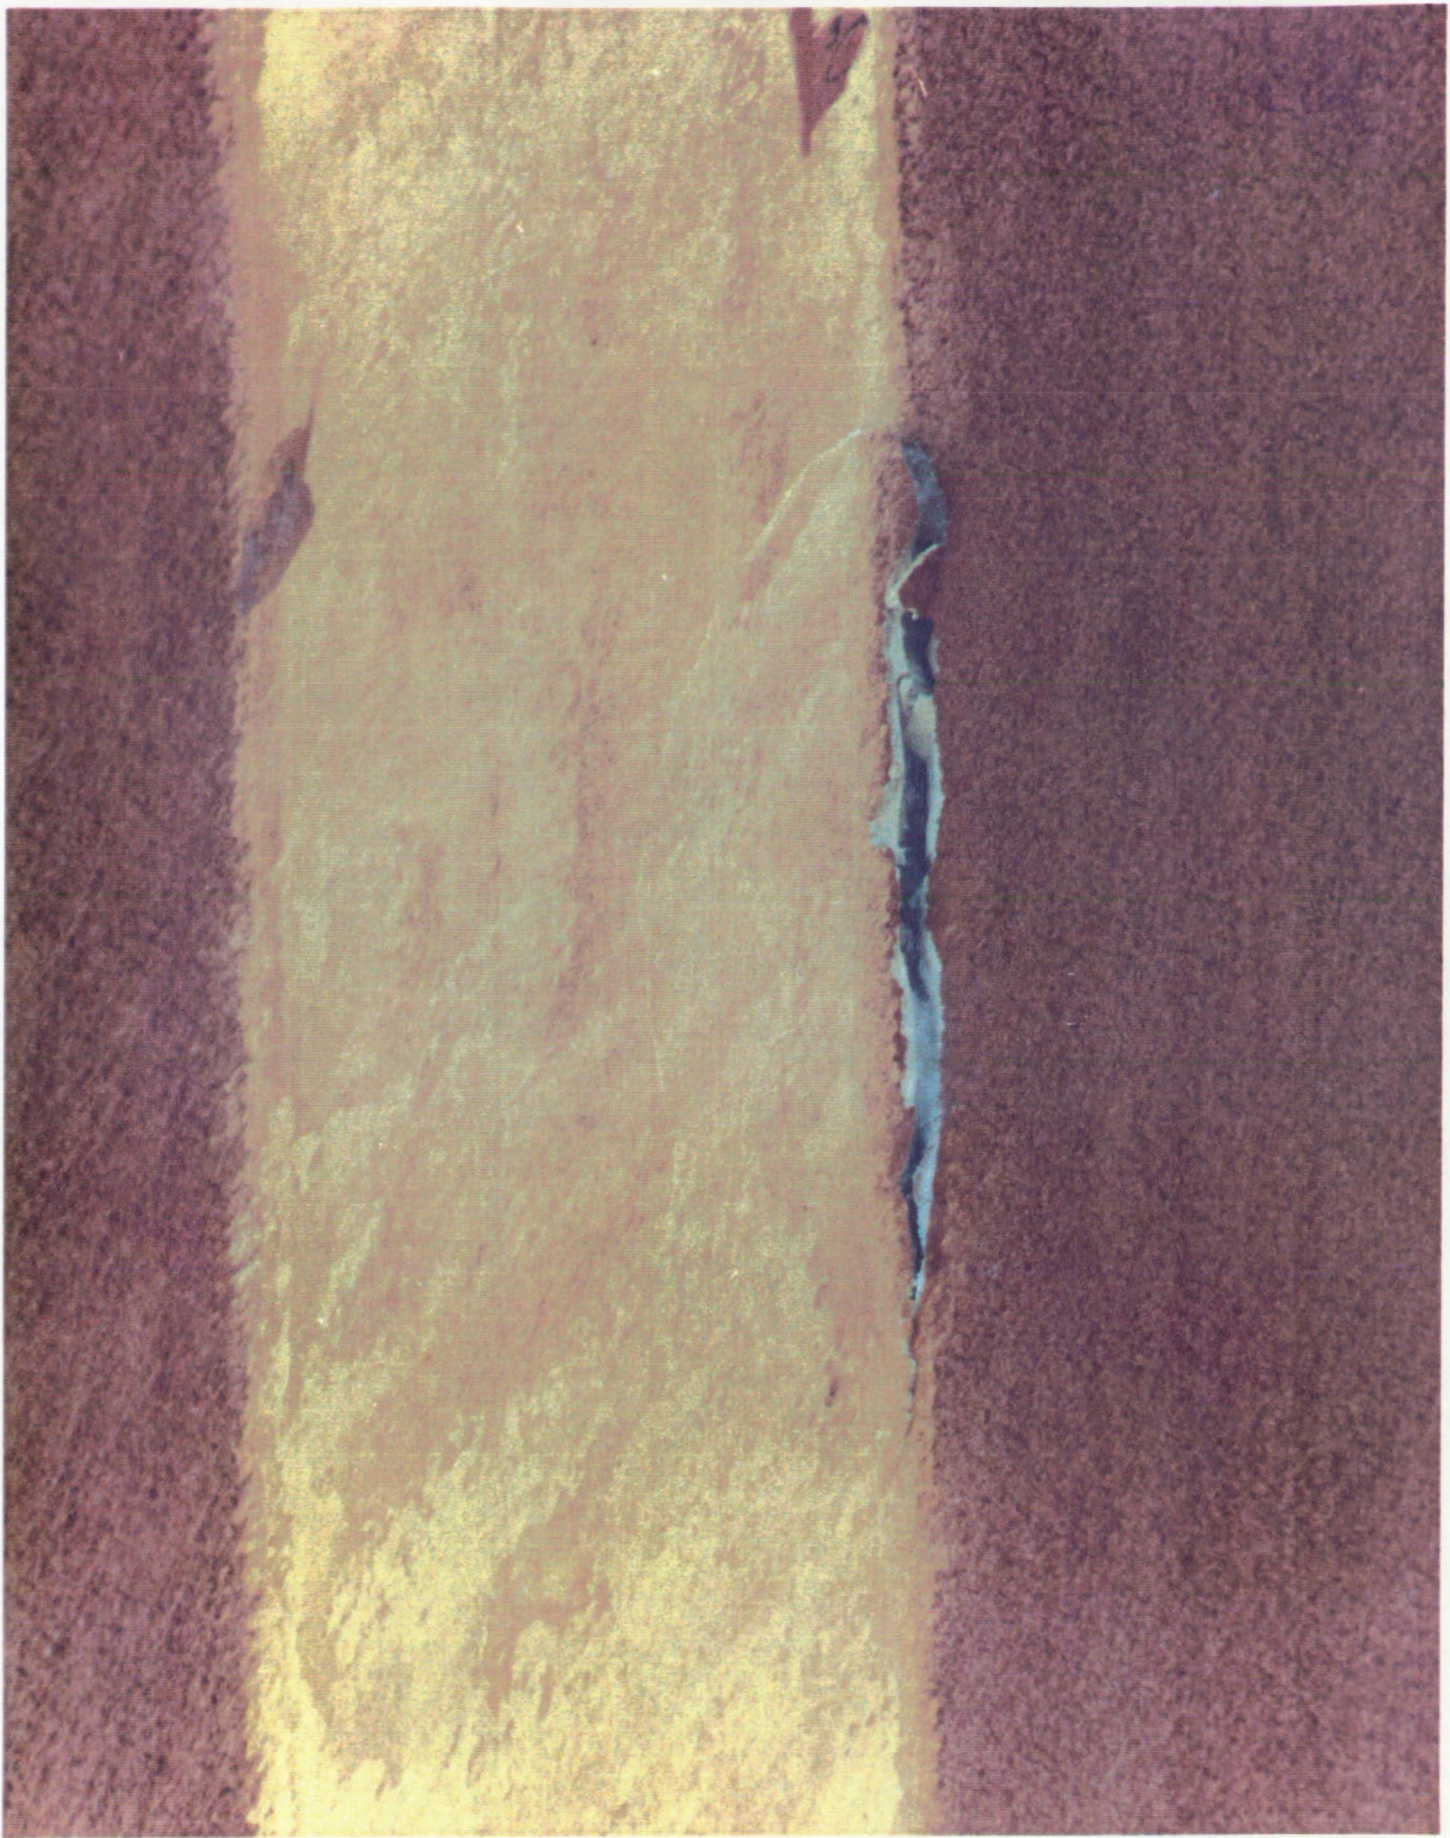
Tanking Test #3 post drain inspection revealed an 18-inch long crack 3/8-inch wide with offset on the aft hardpoint closeout.

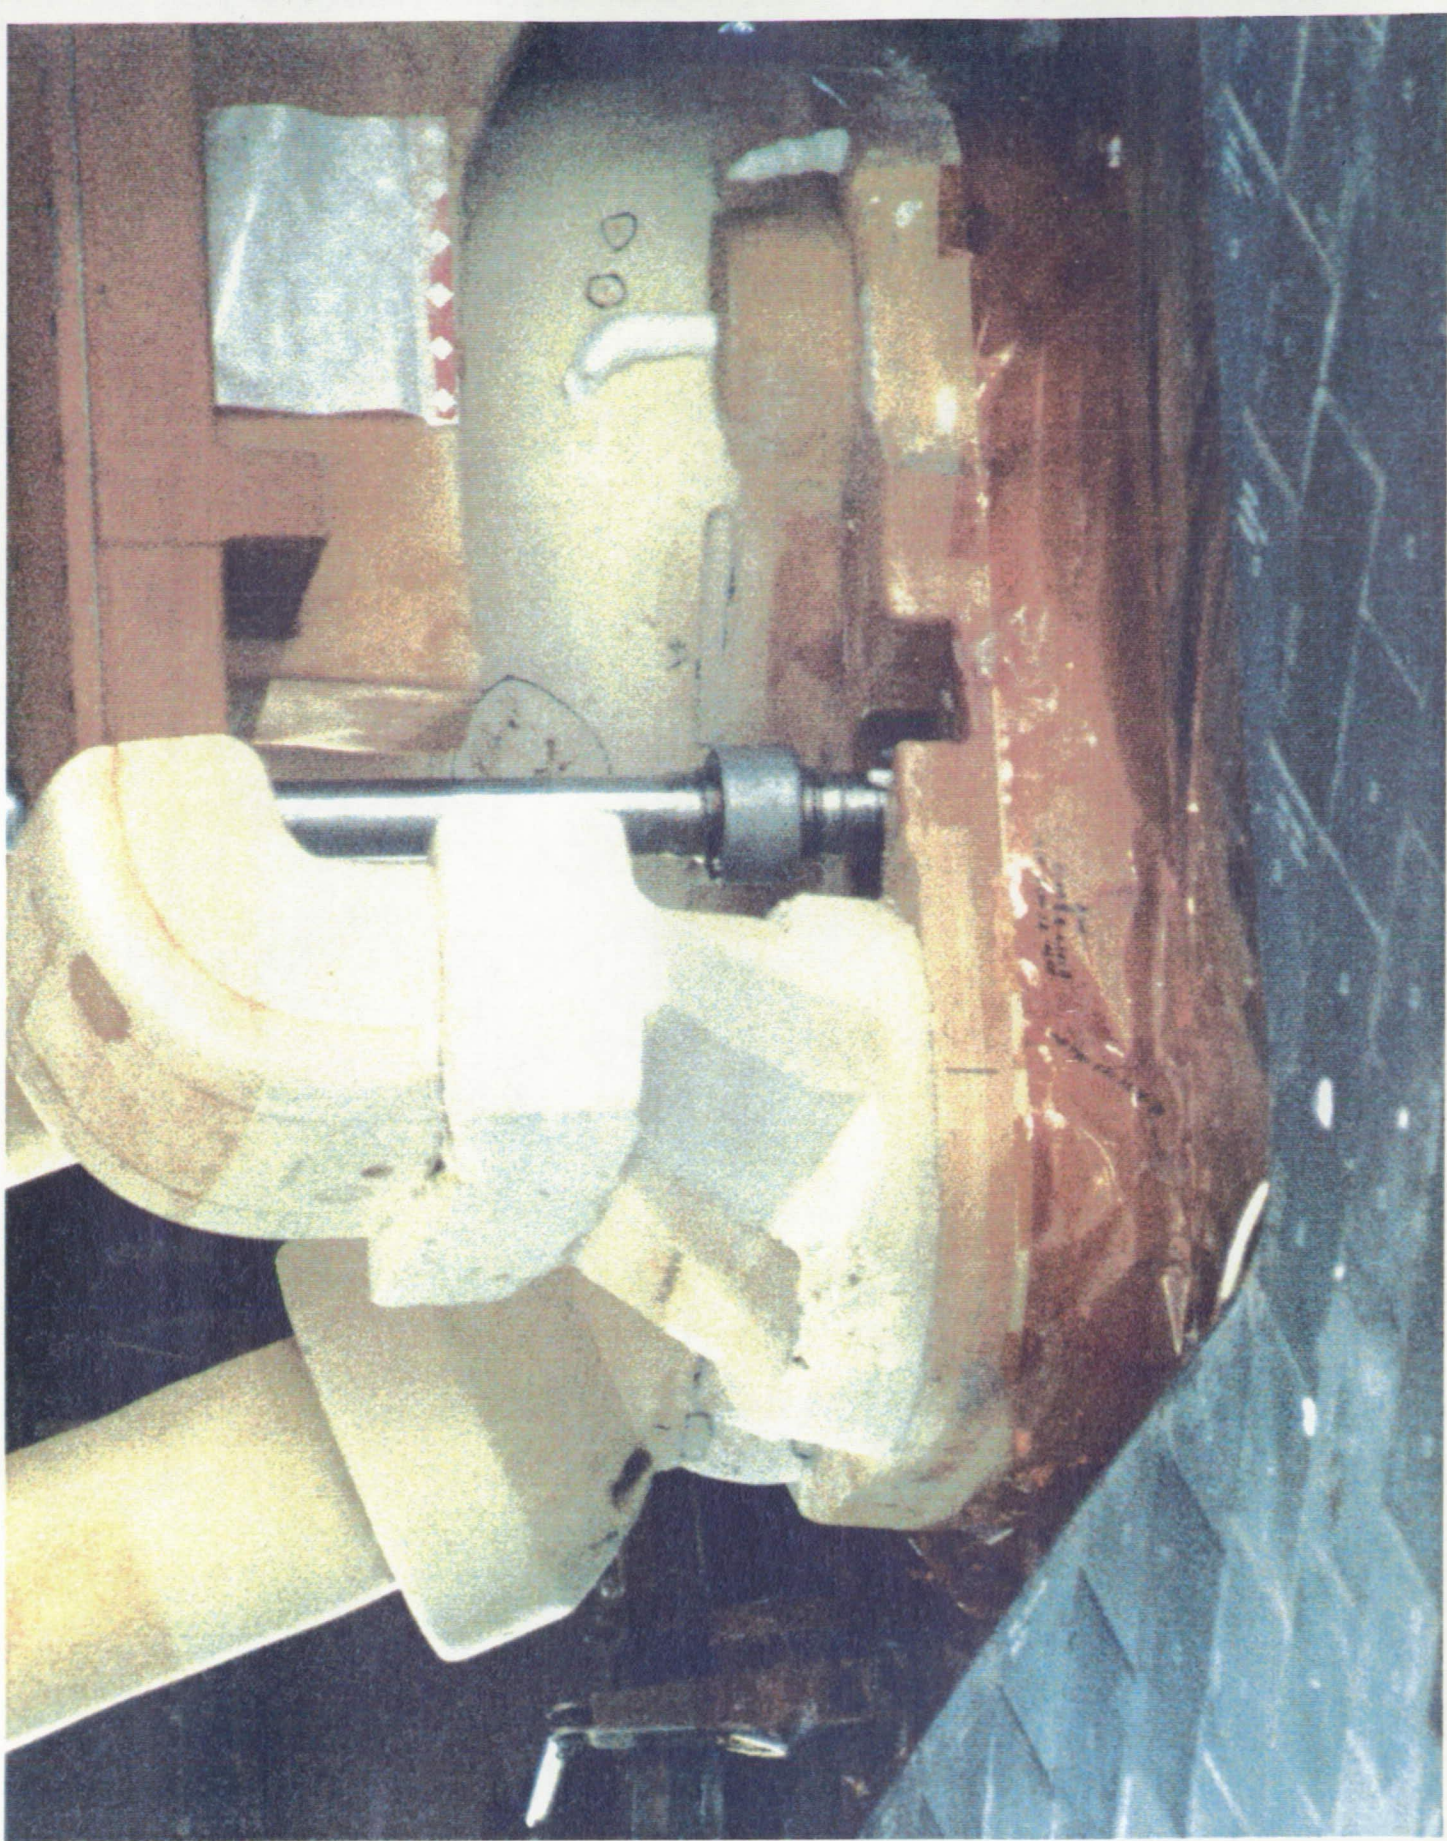
Post drain condition of the LH2 umbilical after Tanking Test 4.
Ice/frost formations on the plate gap and pyrotechnic canister
purge vents were normal.

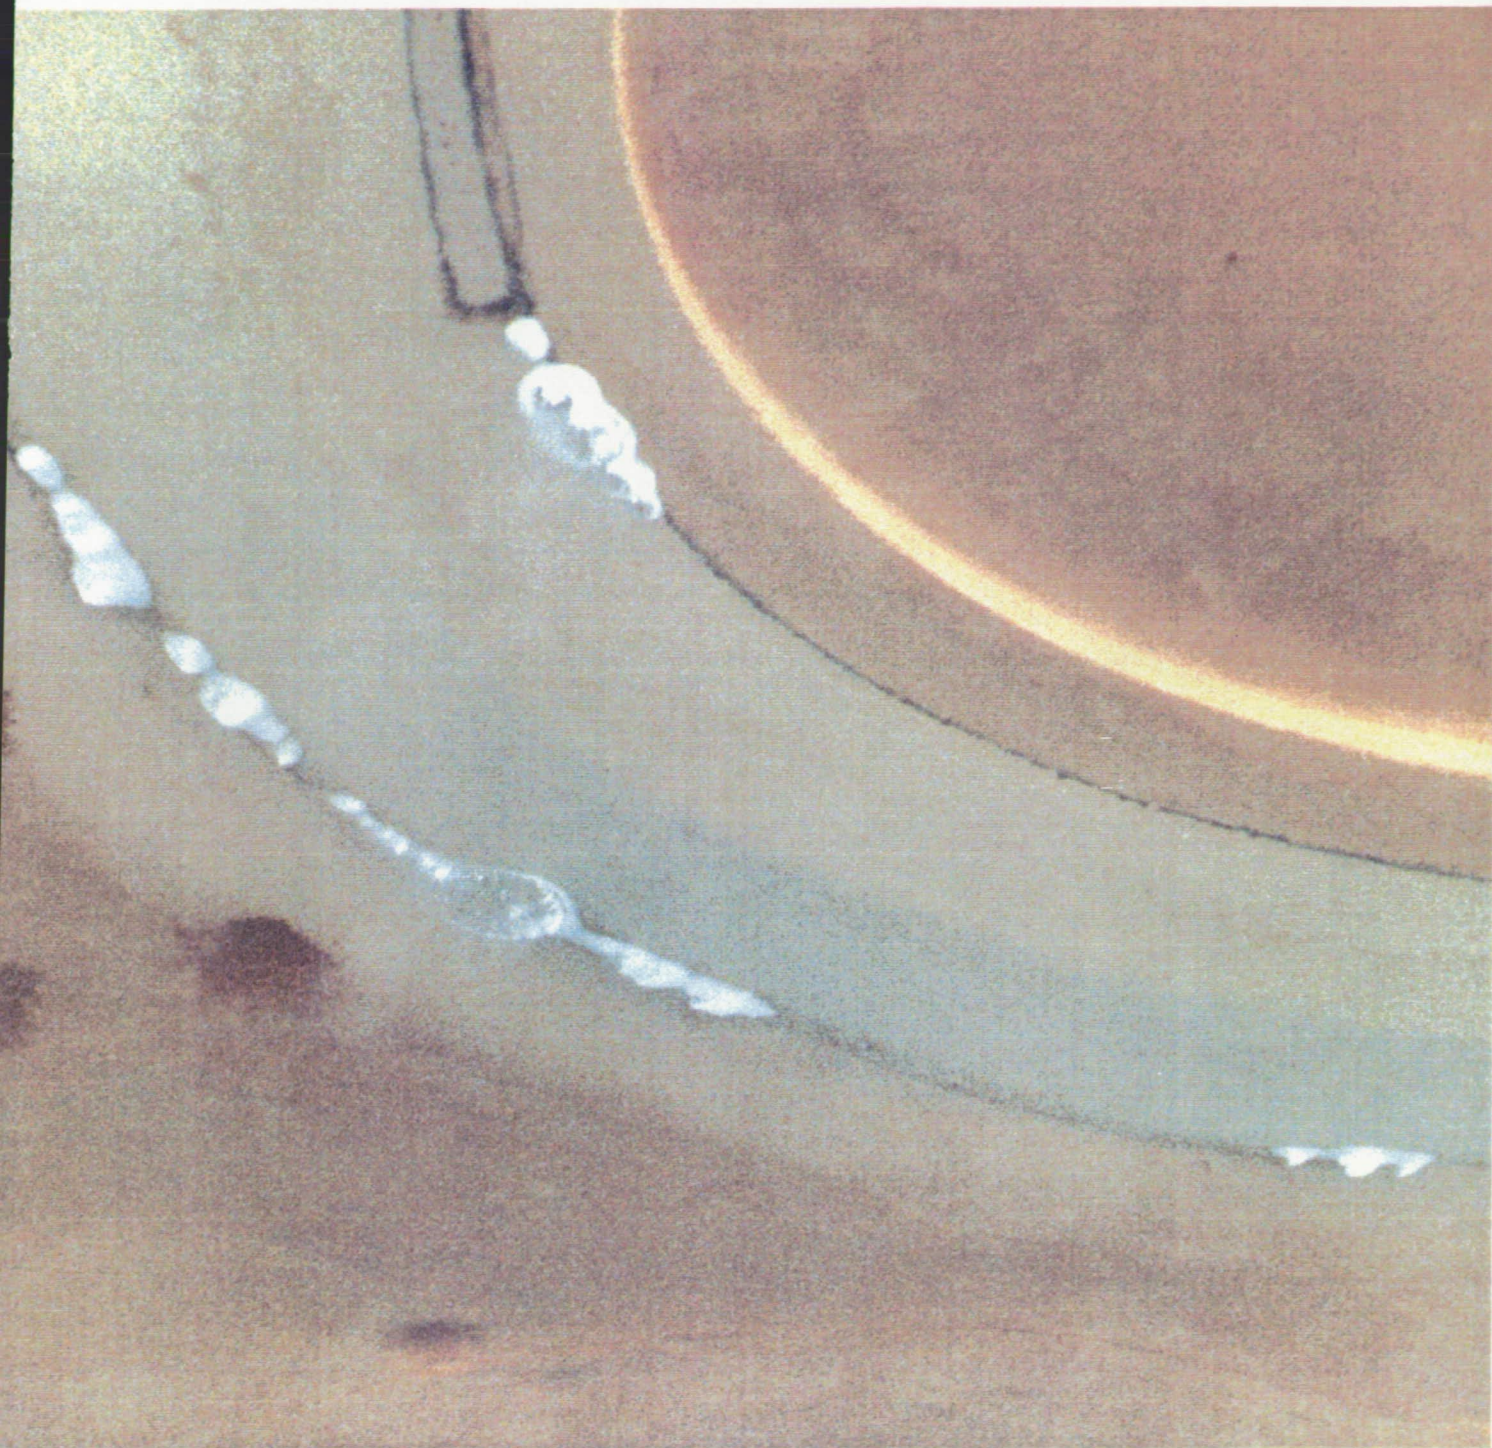
Ice/frost appeared on the outside bondline of the LH2 tank aft dome siphon manhole cover - approximately 40 percent of the circumference.

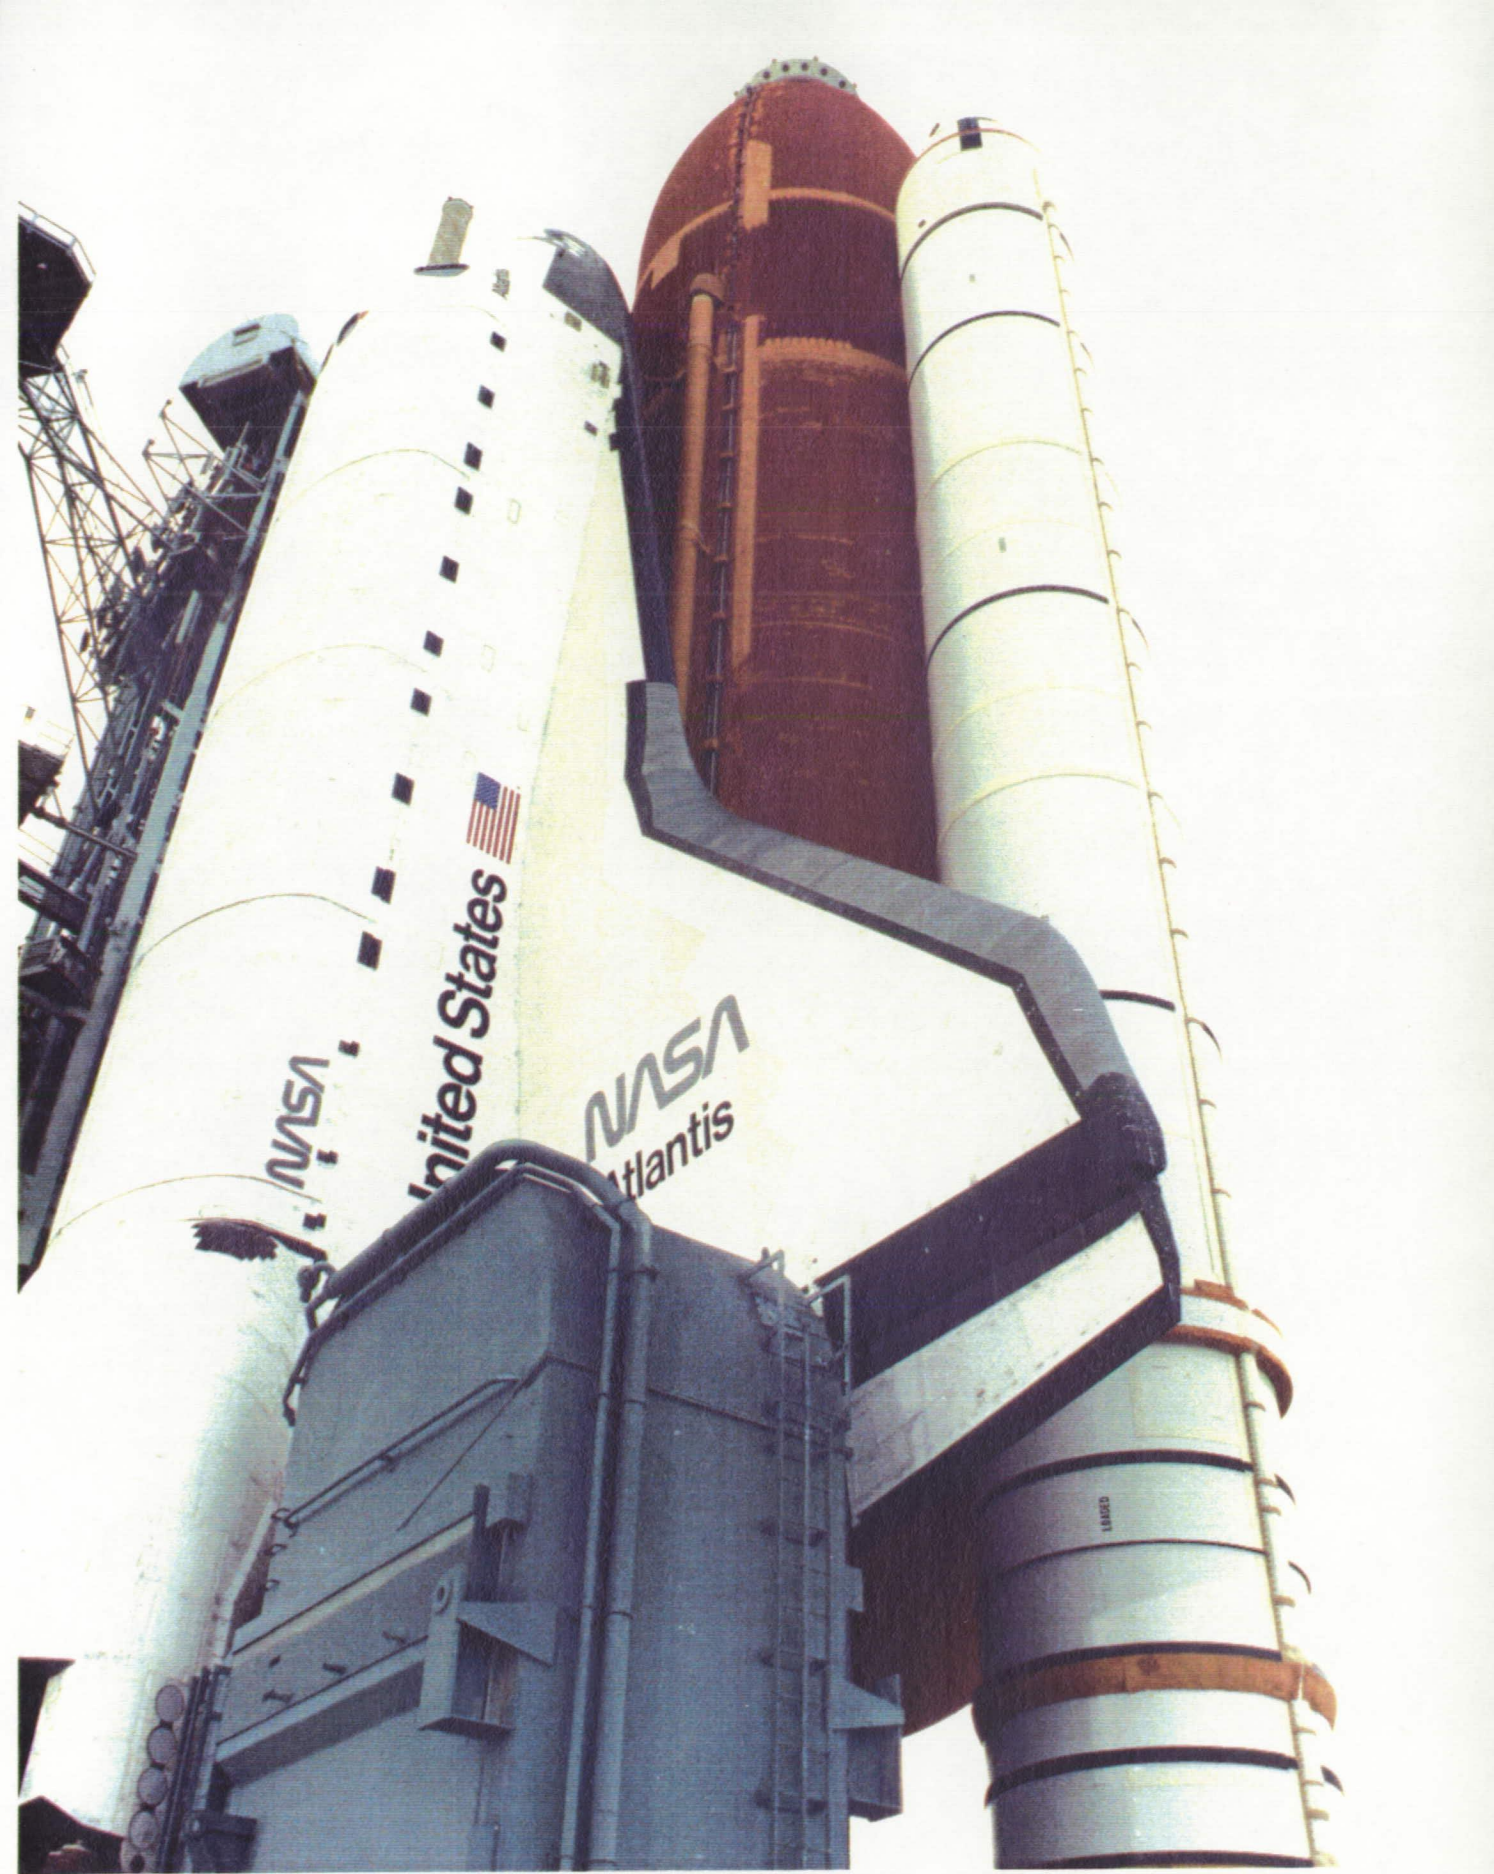
Overall view of OV-104, ET-40, and RH SRB B1039. No ice/frost had formed on the External Tank TPS acreage.

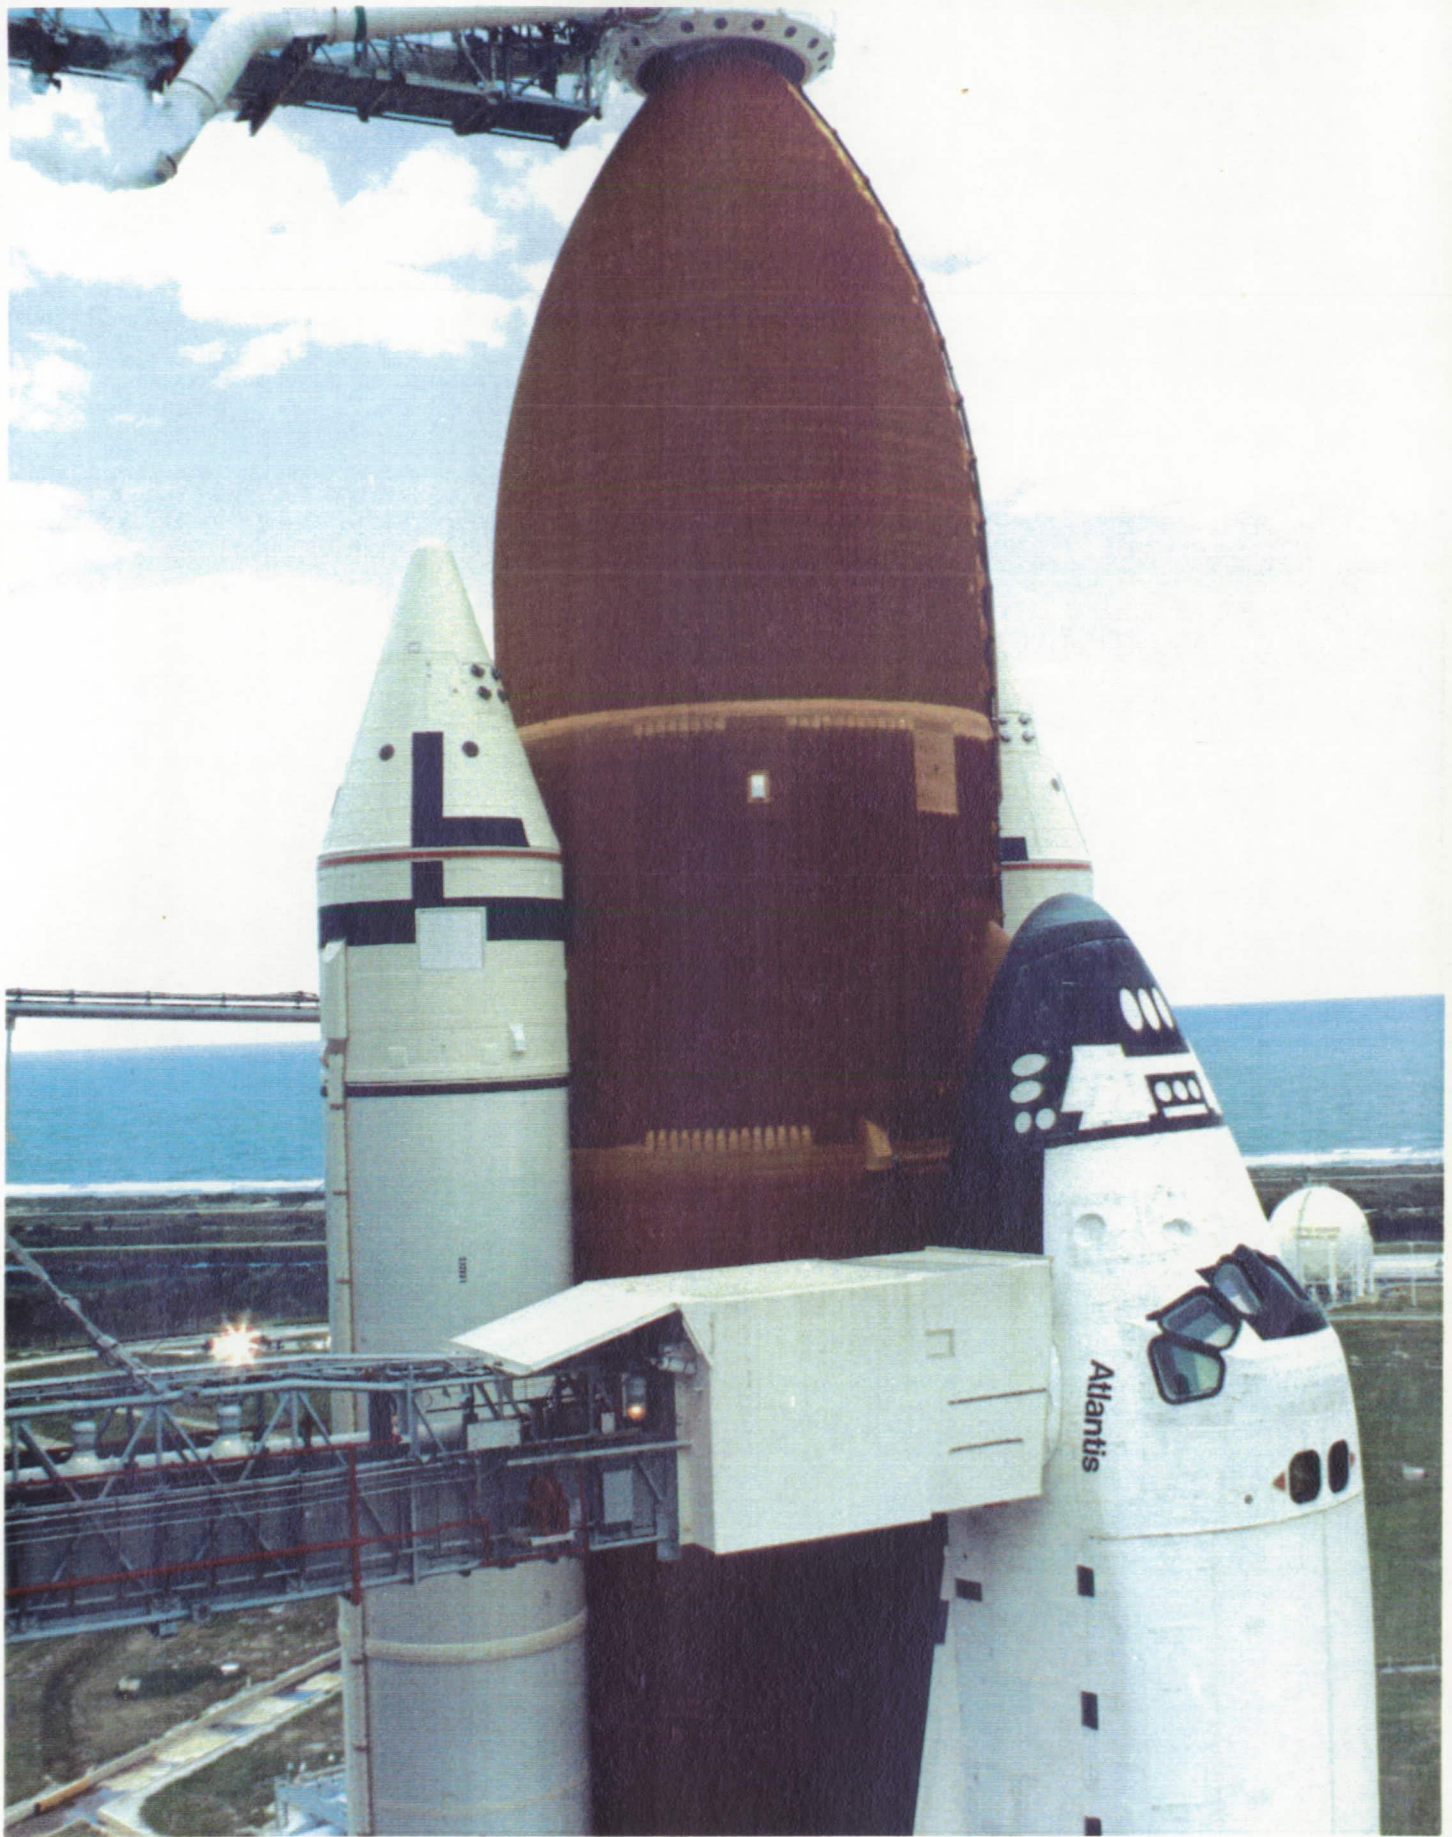
Overall view of ET-40 L02 tank and upper LH2 tank -Y+Z side. No ice/frost had formed on the ET TPS acreage.
