NASA Technical Memorandum TM 103815

Debris/Ice/TPS Assessment And Photographic Analysis For Shuttle Mission STS-38

November 15, 1990

Shuttle mission STS-38 was launched at 6:48 p.m. EST 11/15/90

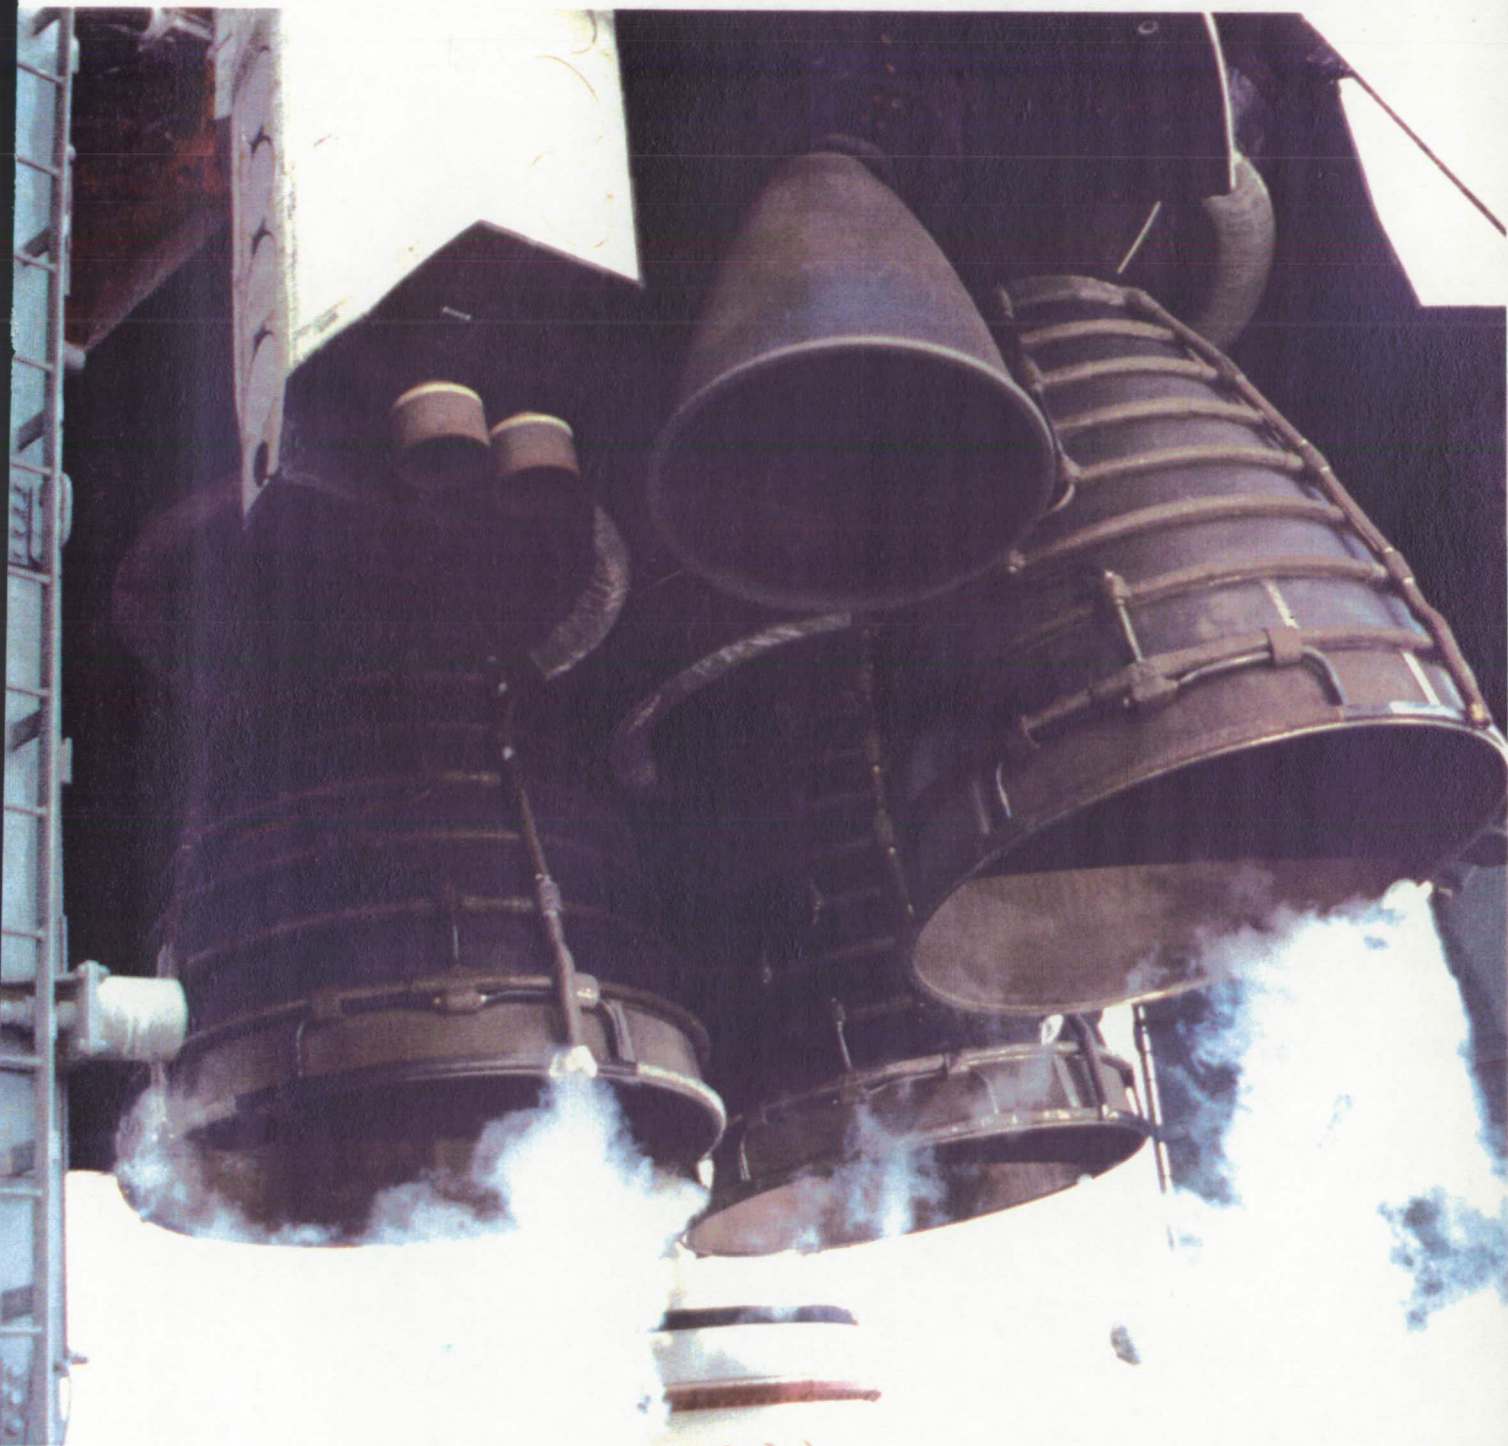
Overall view of SSME's. A small amount of ice/frost had formed on the SSME #1 and #2 engine mounted heat shield interfaces.

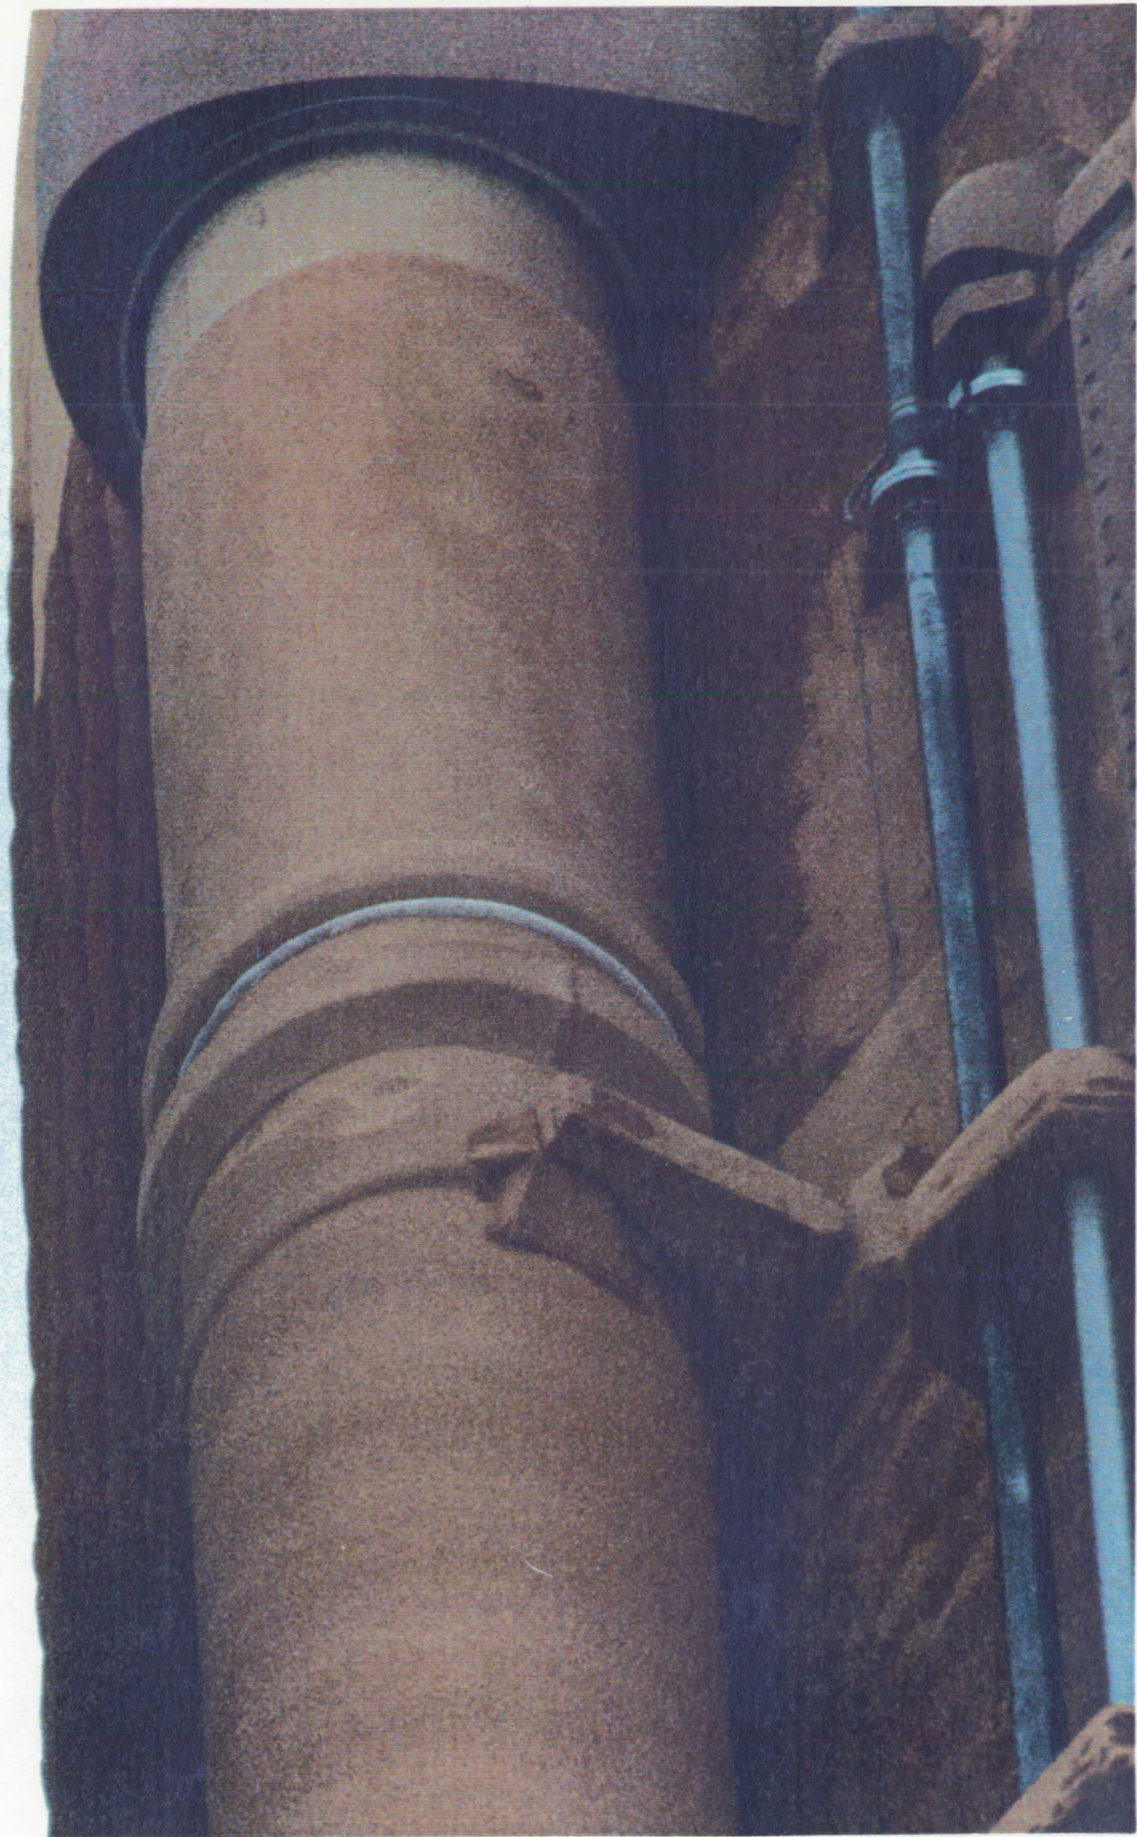
Typical ice/frost accumulation in the L02 feedline upper bellows and less-than-usual ice/frost in the support bracket

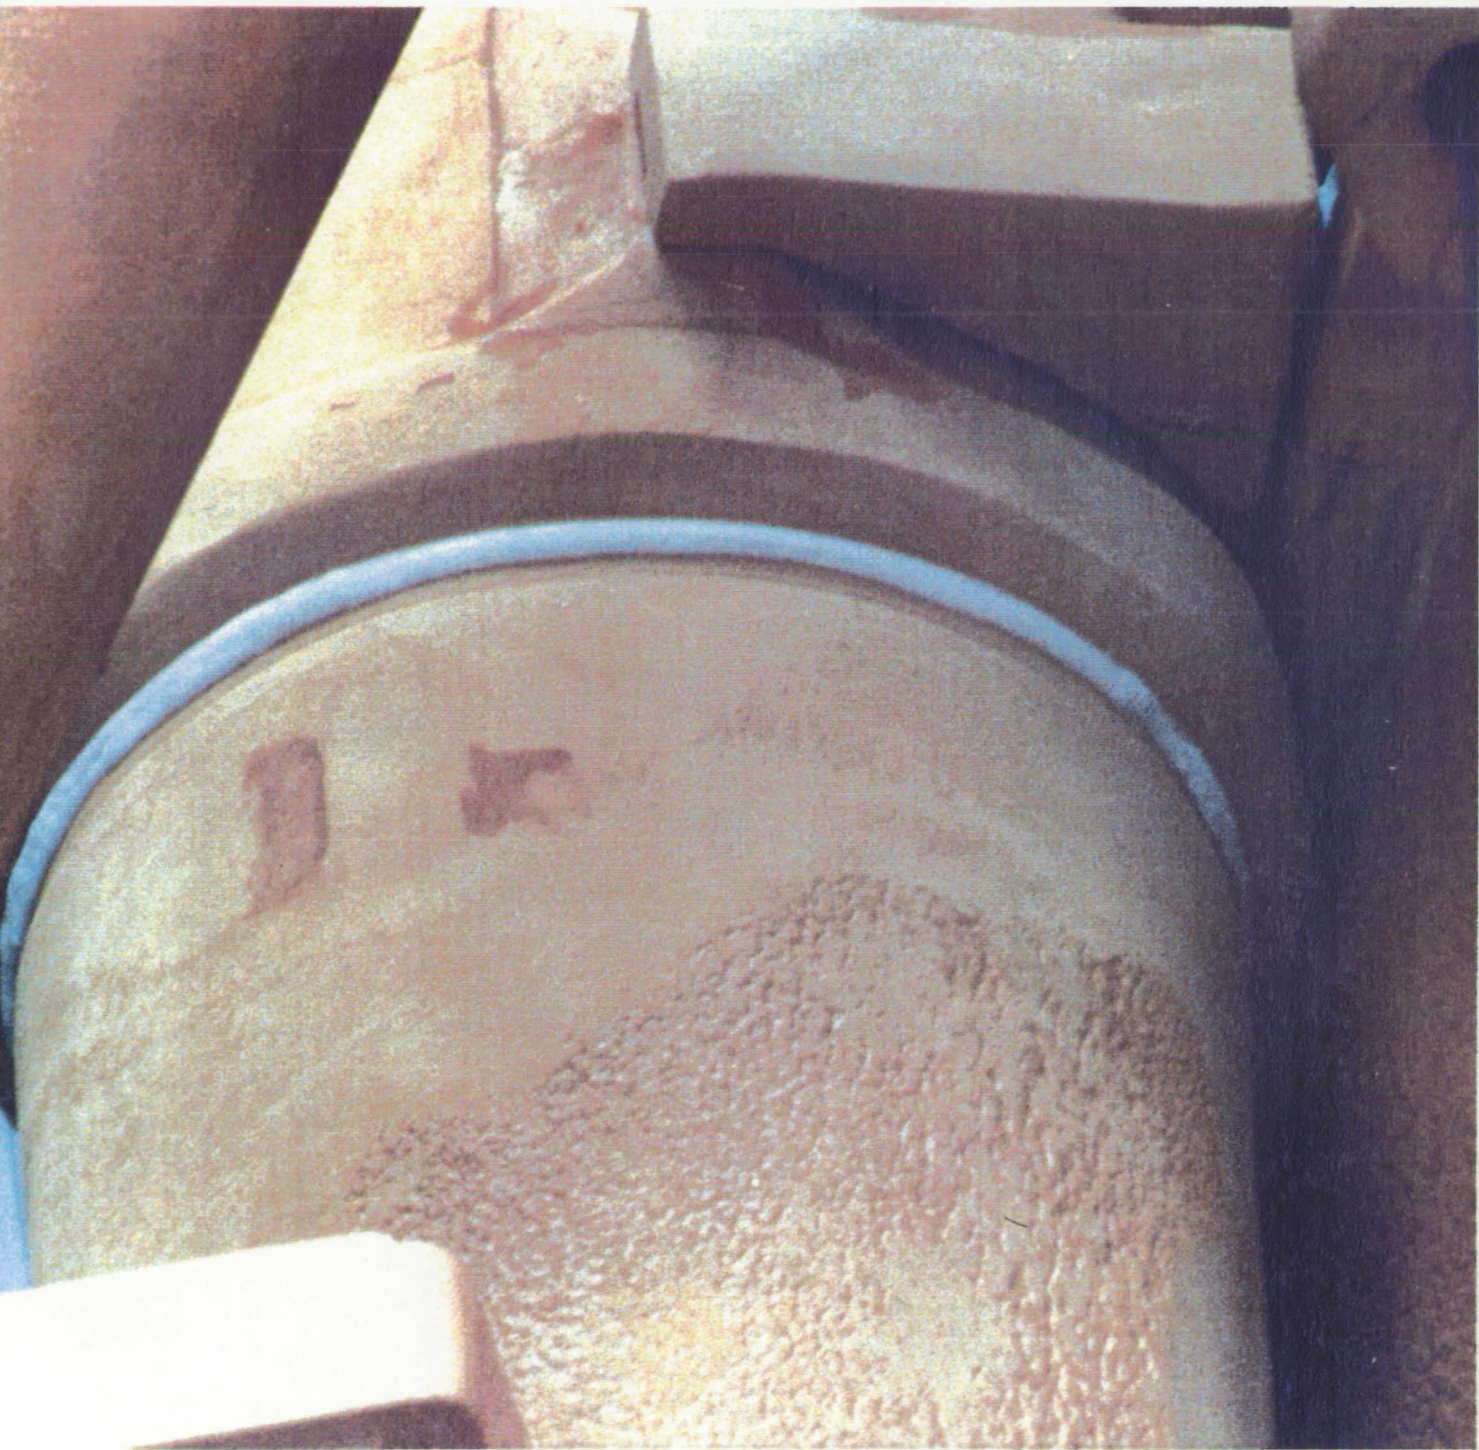
Typical ice/frost accumulation in the L02 feedline lower bellows and less-than-usual ice/frost in the support brackets

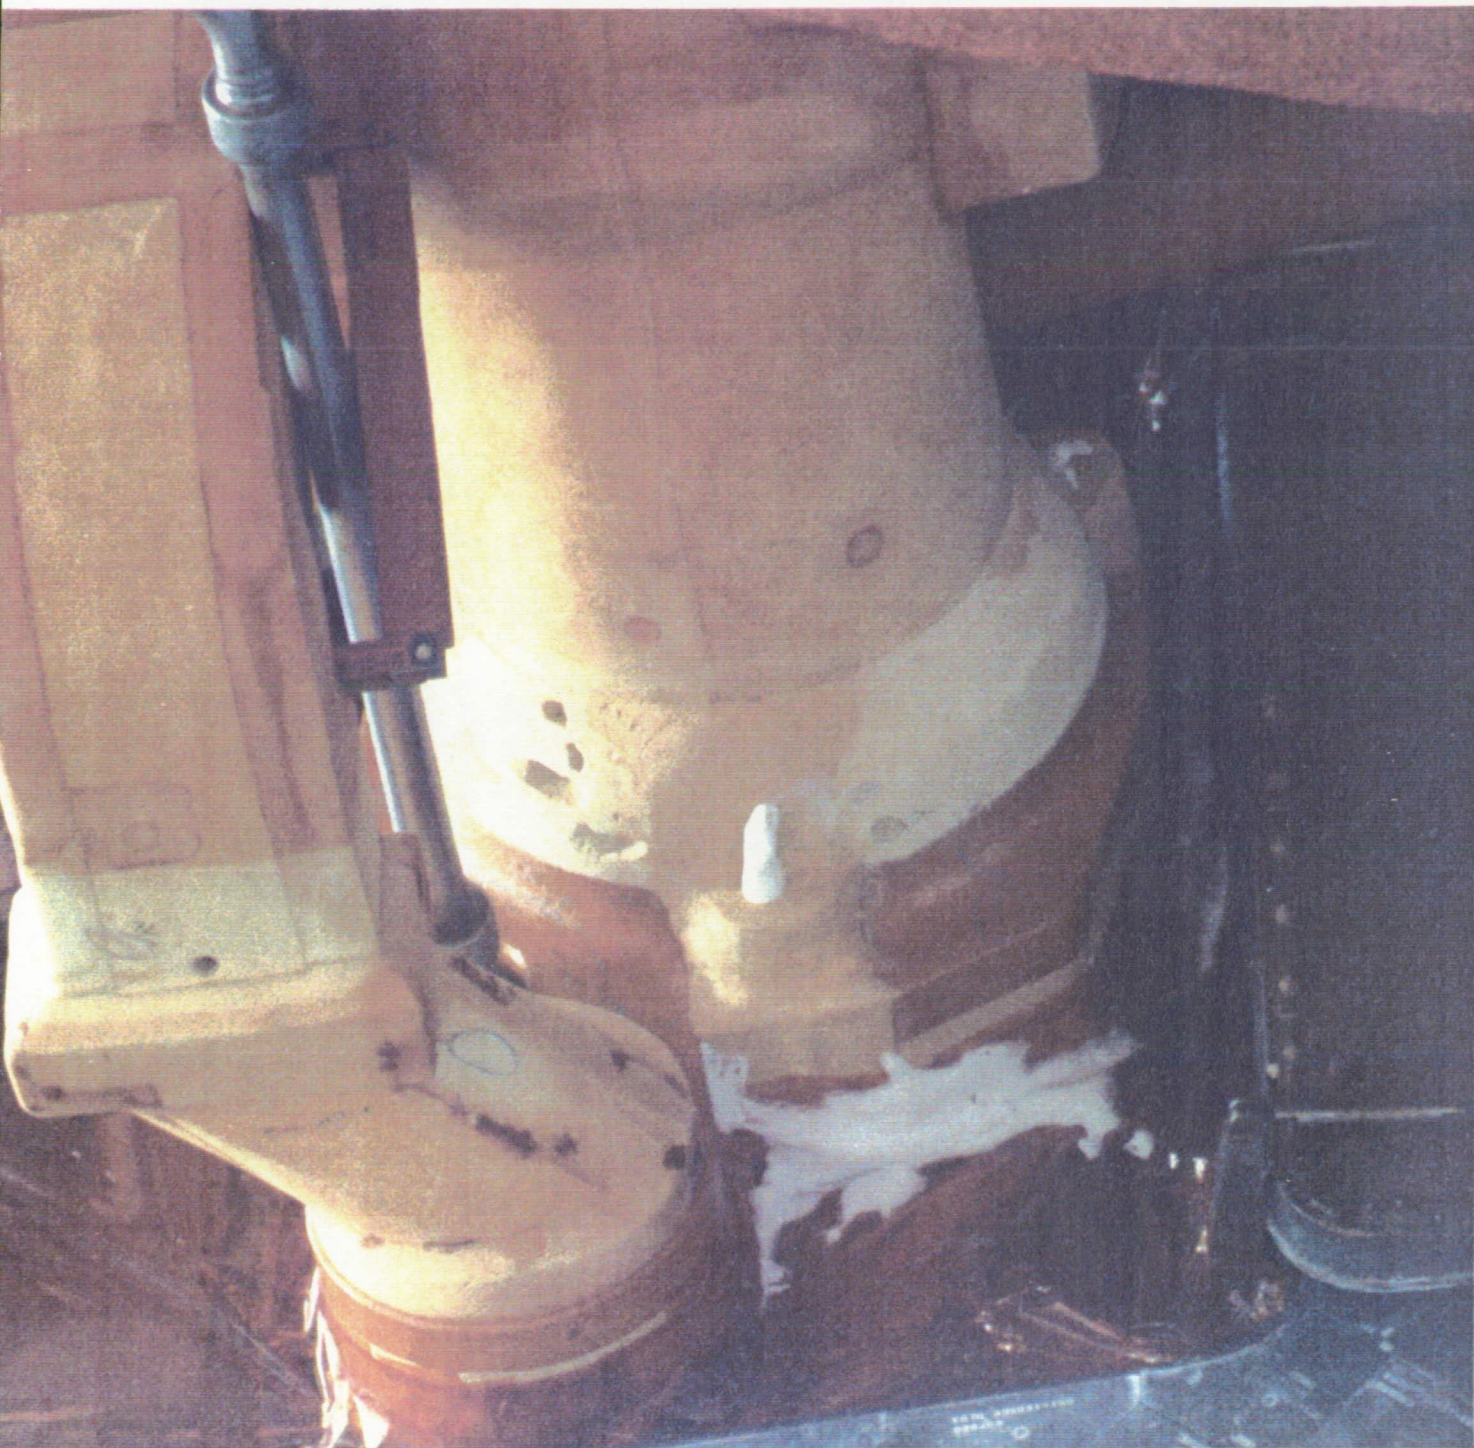
Typical ice/frost formations on the ET/ORB L02 umbilical purge barrier and pyro canister purge vents. Venting of nitrogen purge gas through the purge vents was normal.

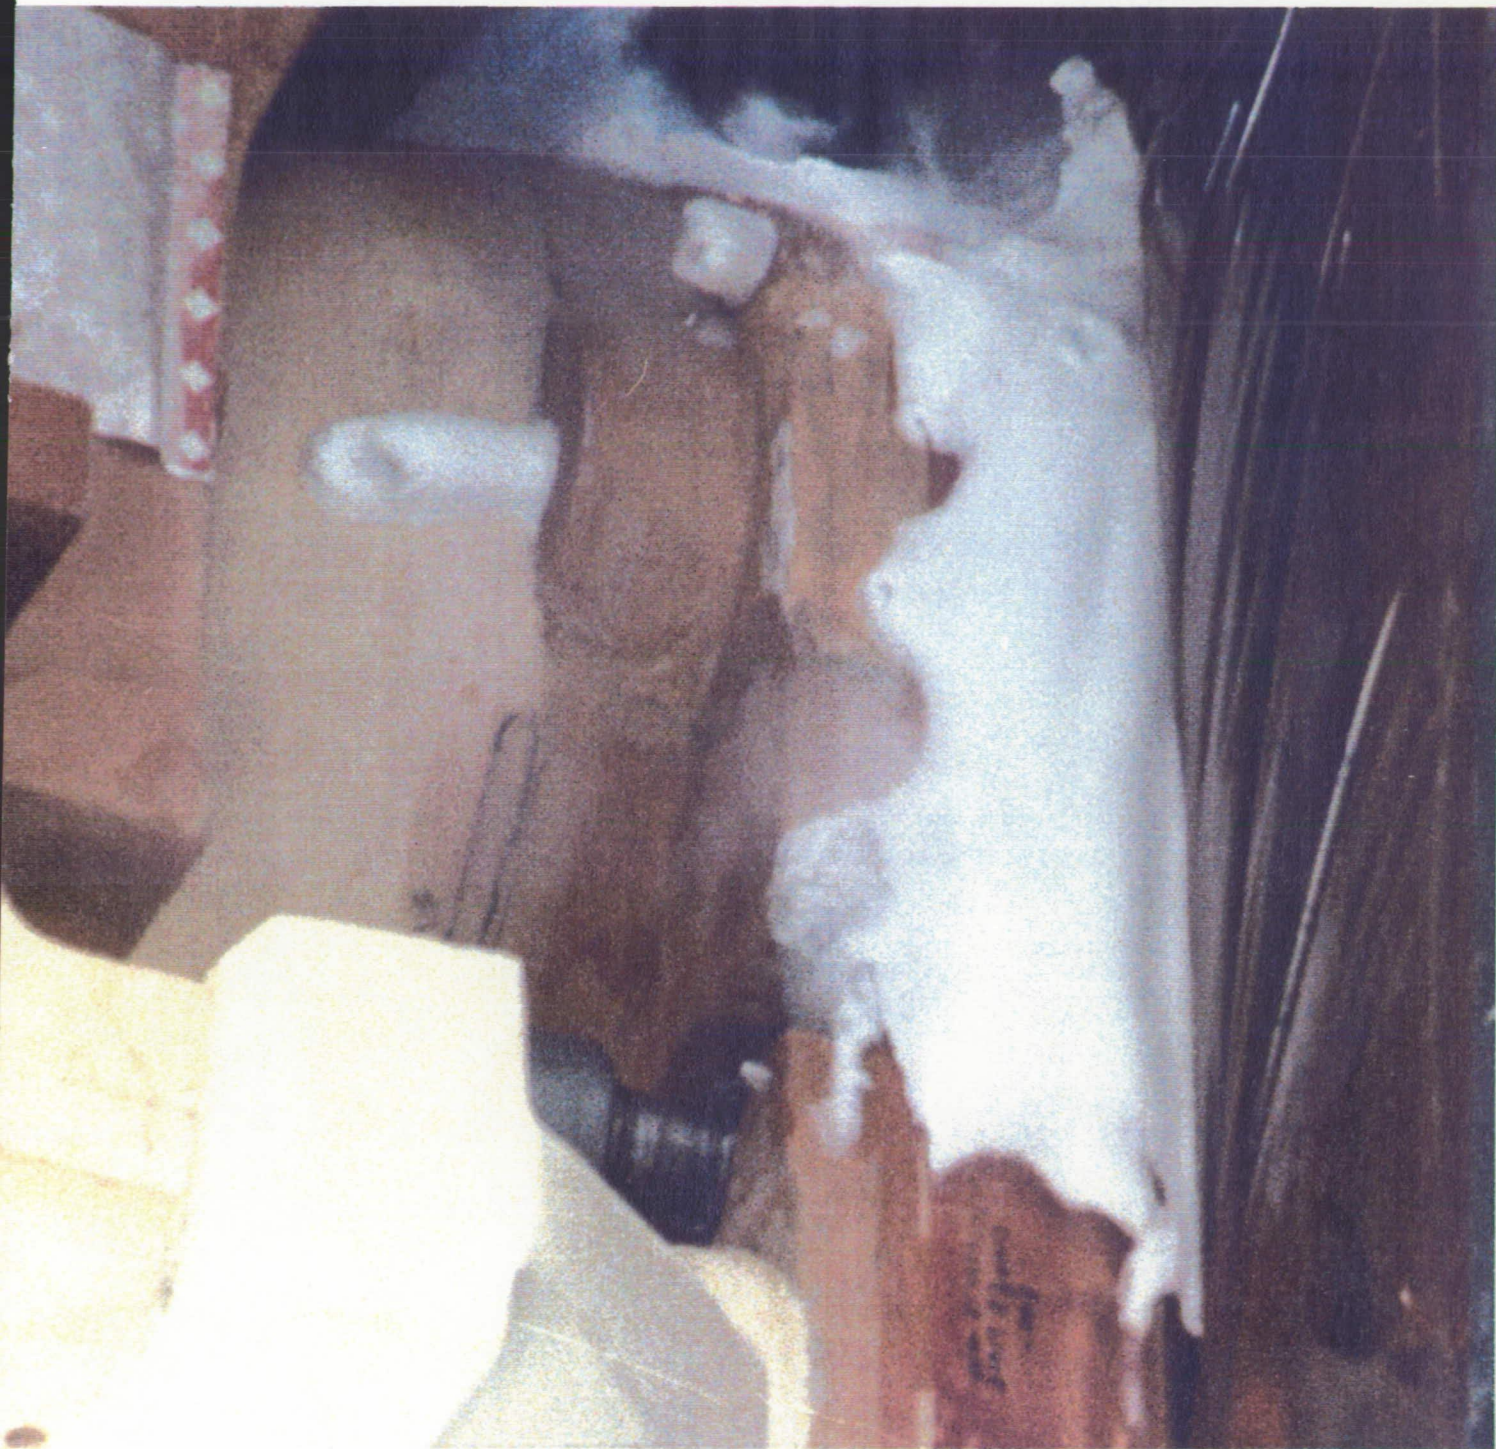
Typical ice/frost formations on the ET/ORB LH2 umbilical purge barrier top and outboard sides, the upper plate gap purge vent, and the forward outboard pyrotechnic canister purge vent.

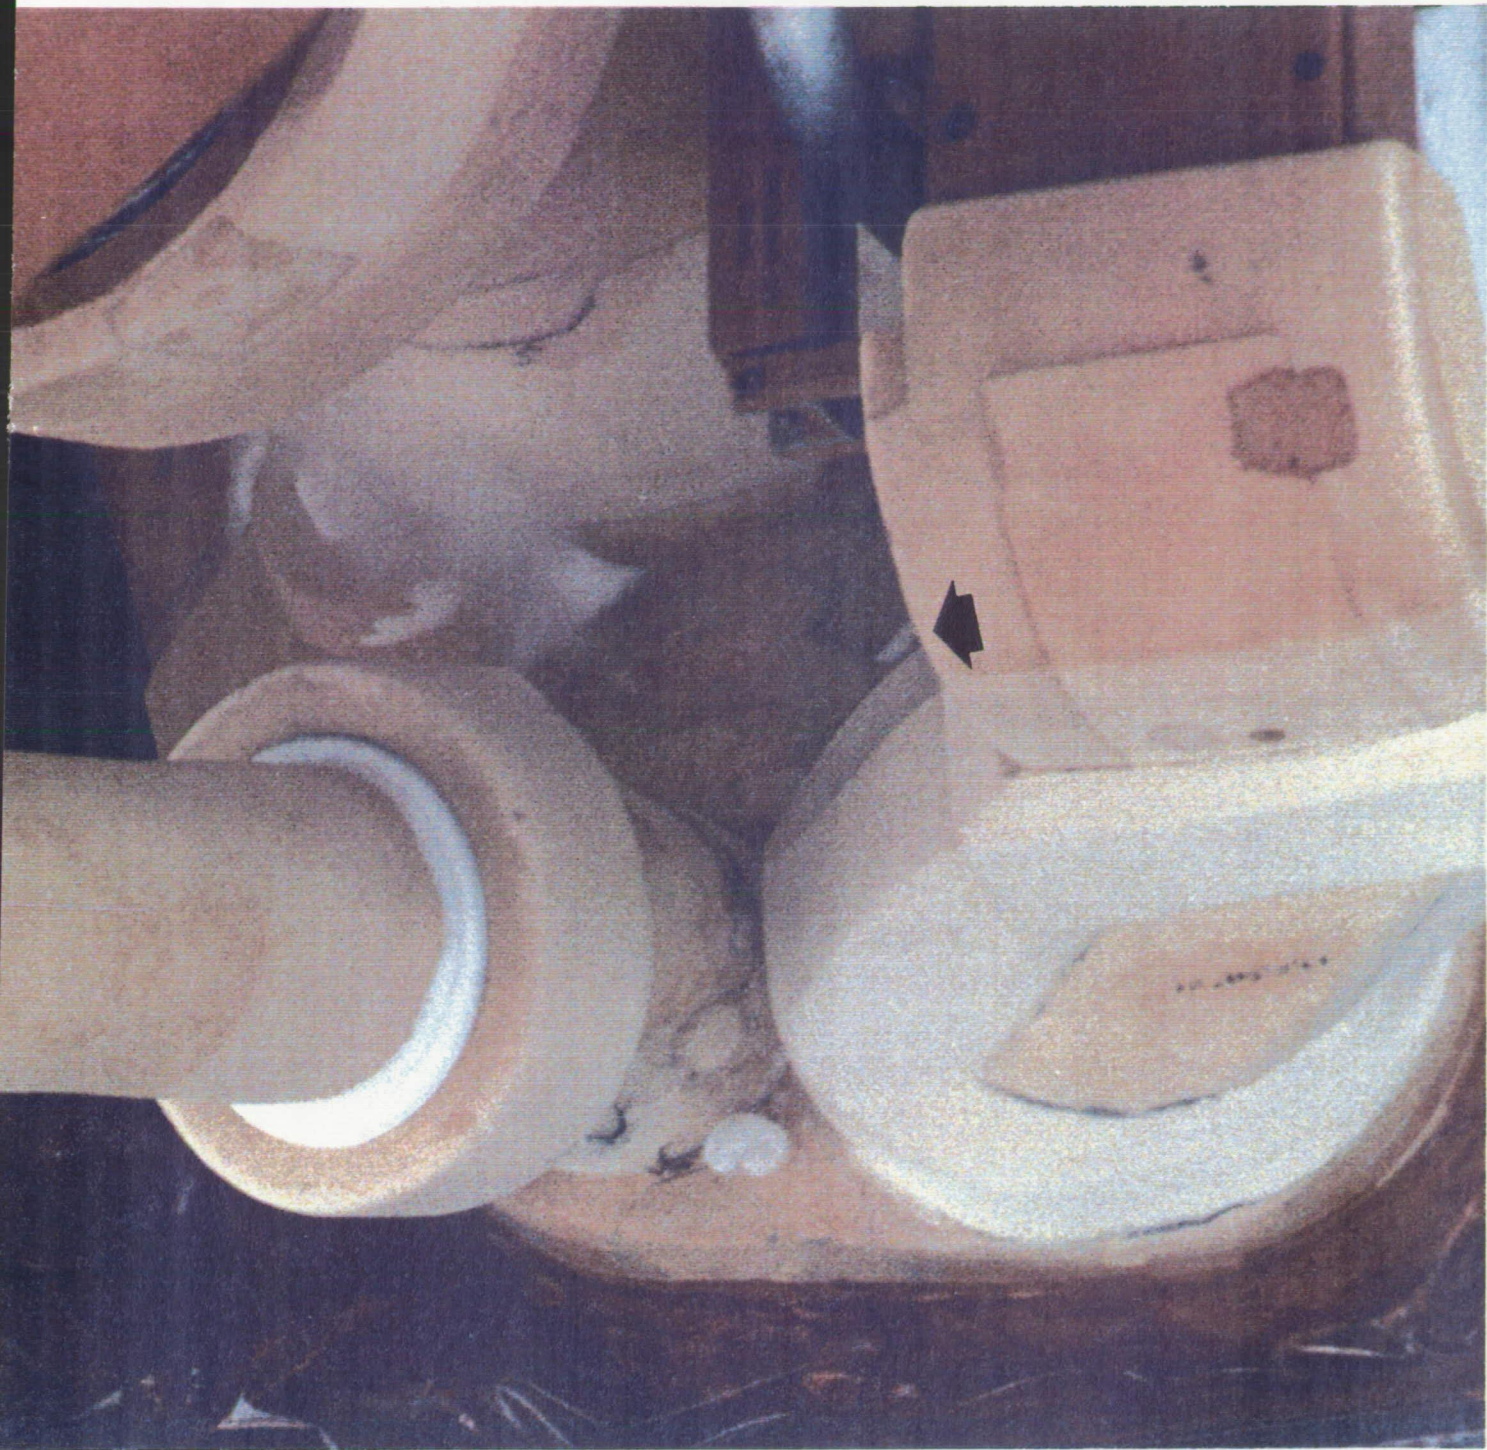
Typical ice/frost formations on the ET/ORB LH2 umbilical lower plate gap purge vent, lower pyro canister purge vent, and LH2 recirculation line upper bellows. Venting of cold helium purge gas from the pyro canister purge vent was normal. Note small frost spot on 17-inch flapper valve tool access port foam plug closeout bondline. Small frost spots also formed on lower pyro can TPS bondlines due to thermal shorts.

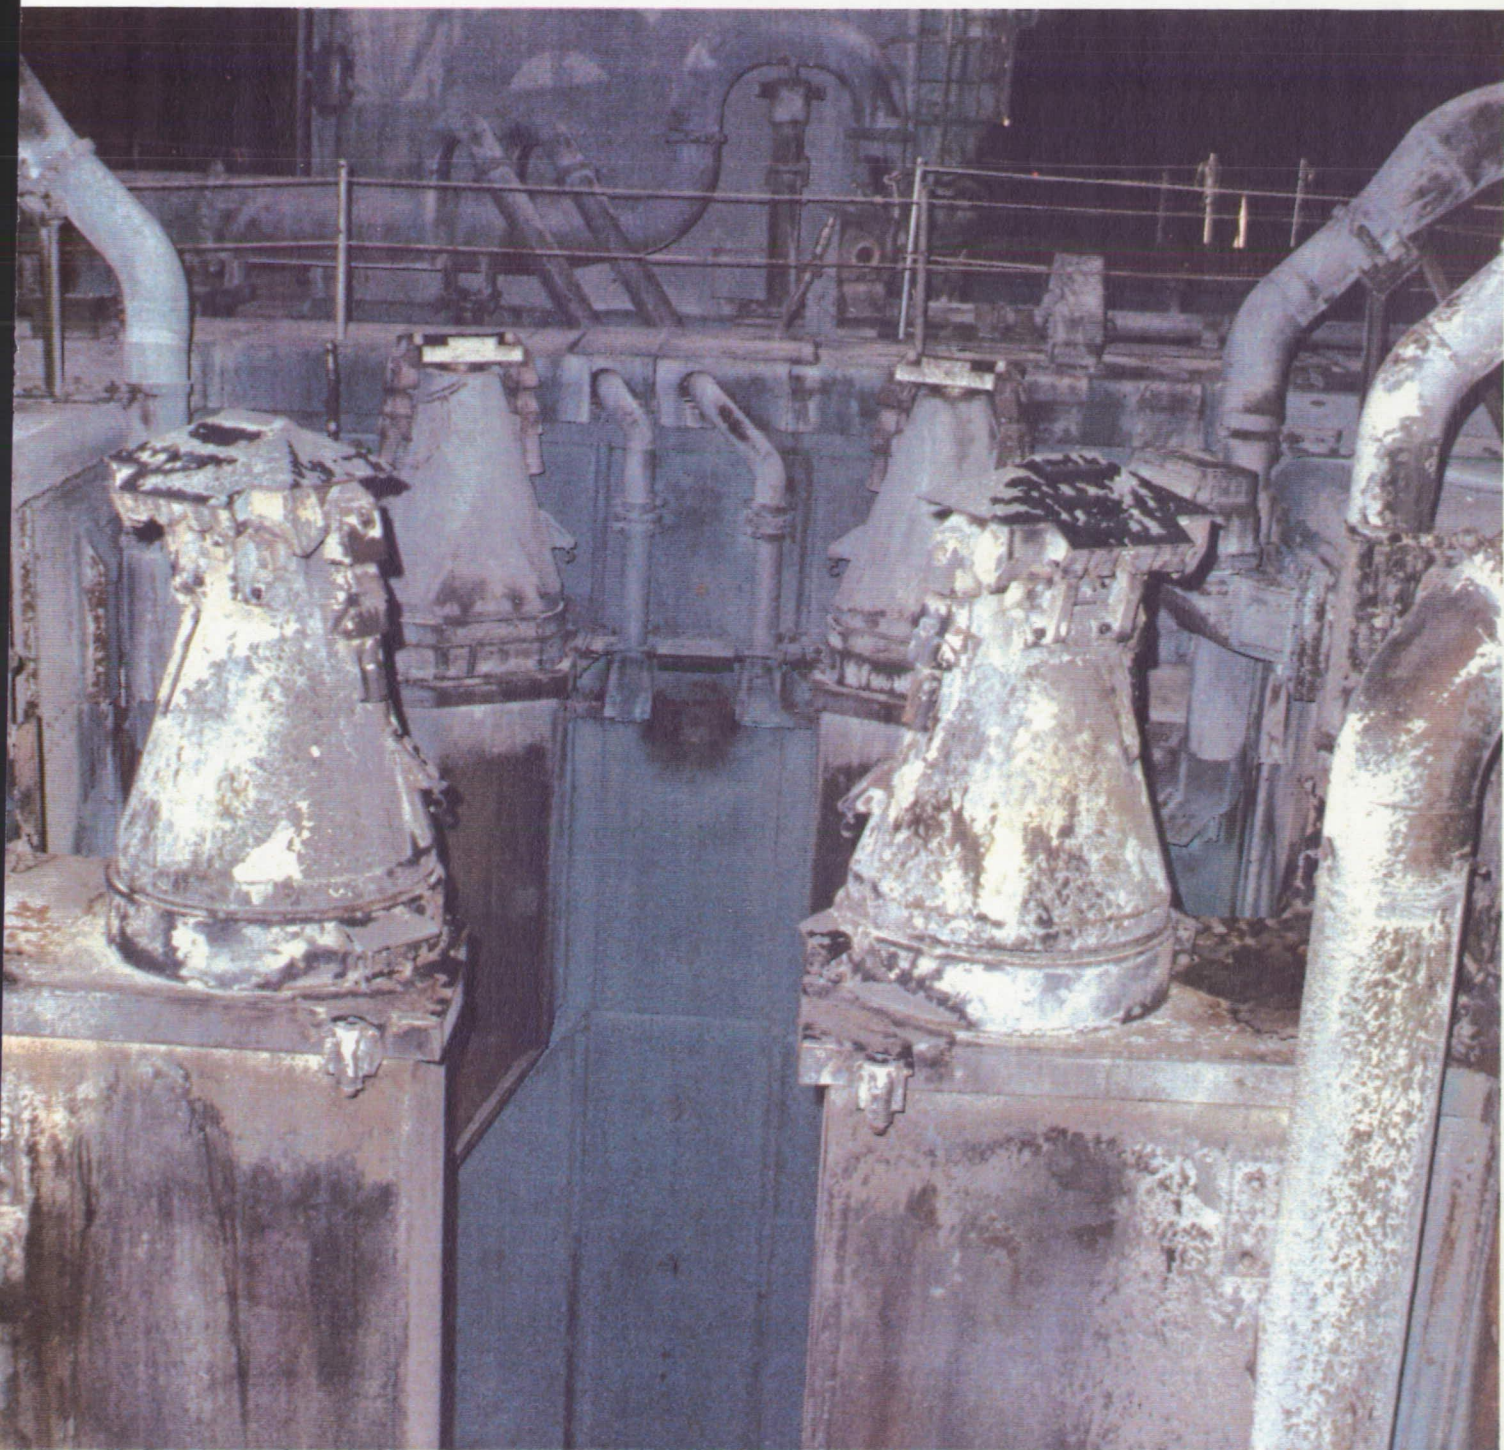
Post launch condition of RH SRB holddown posts. Note SRB plume effects on north posts compared to little effect on south posts

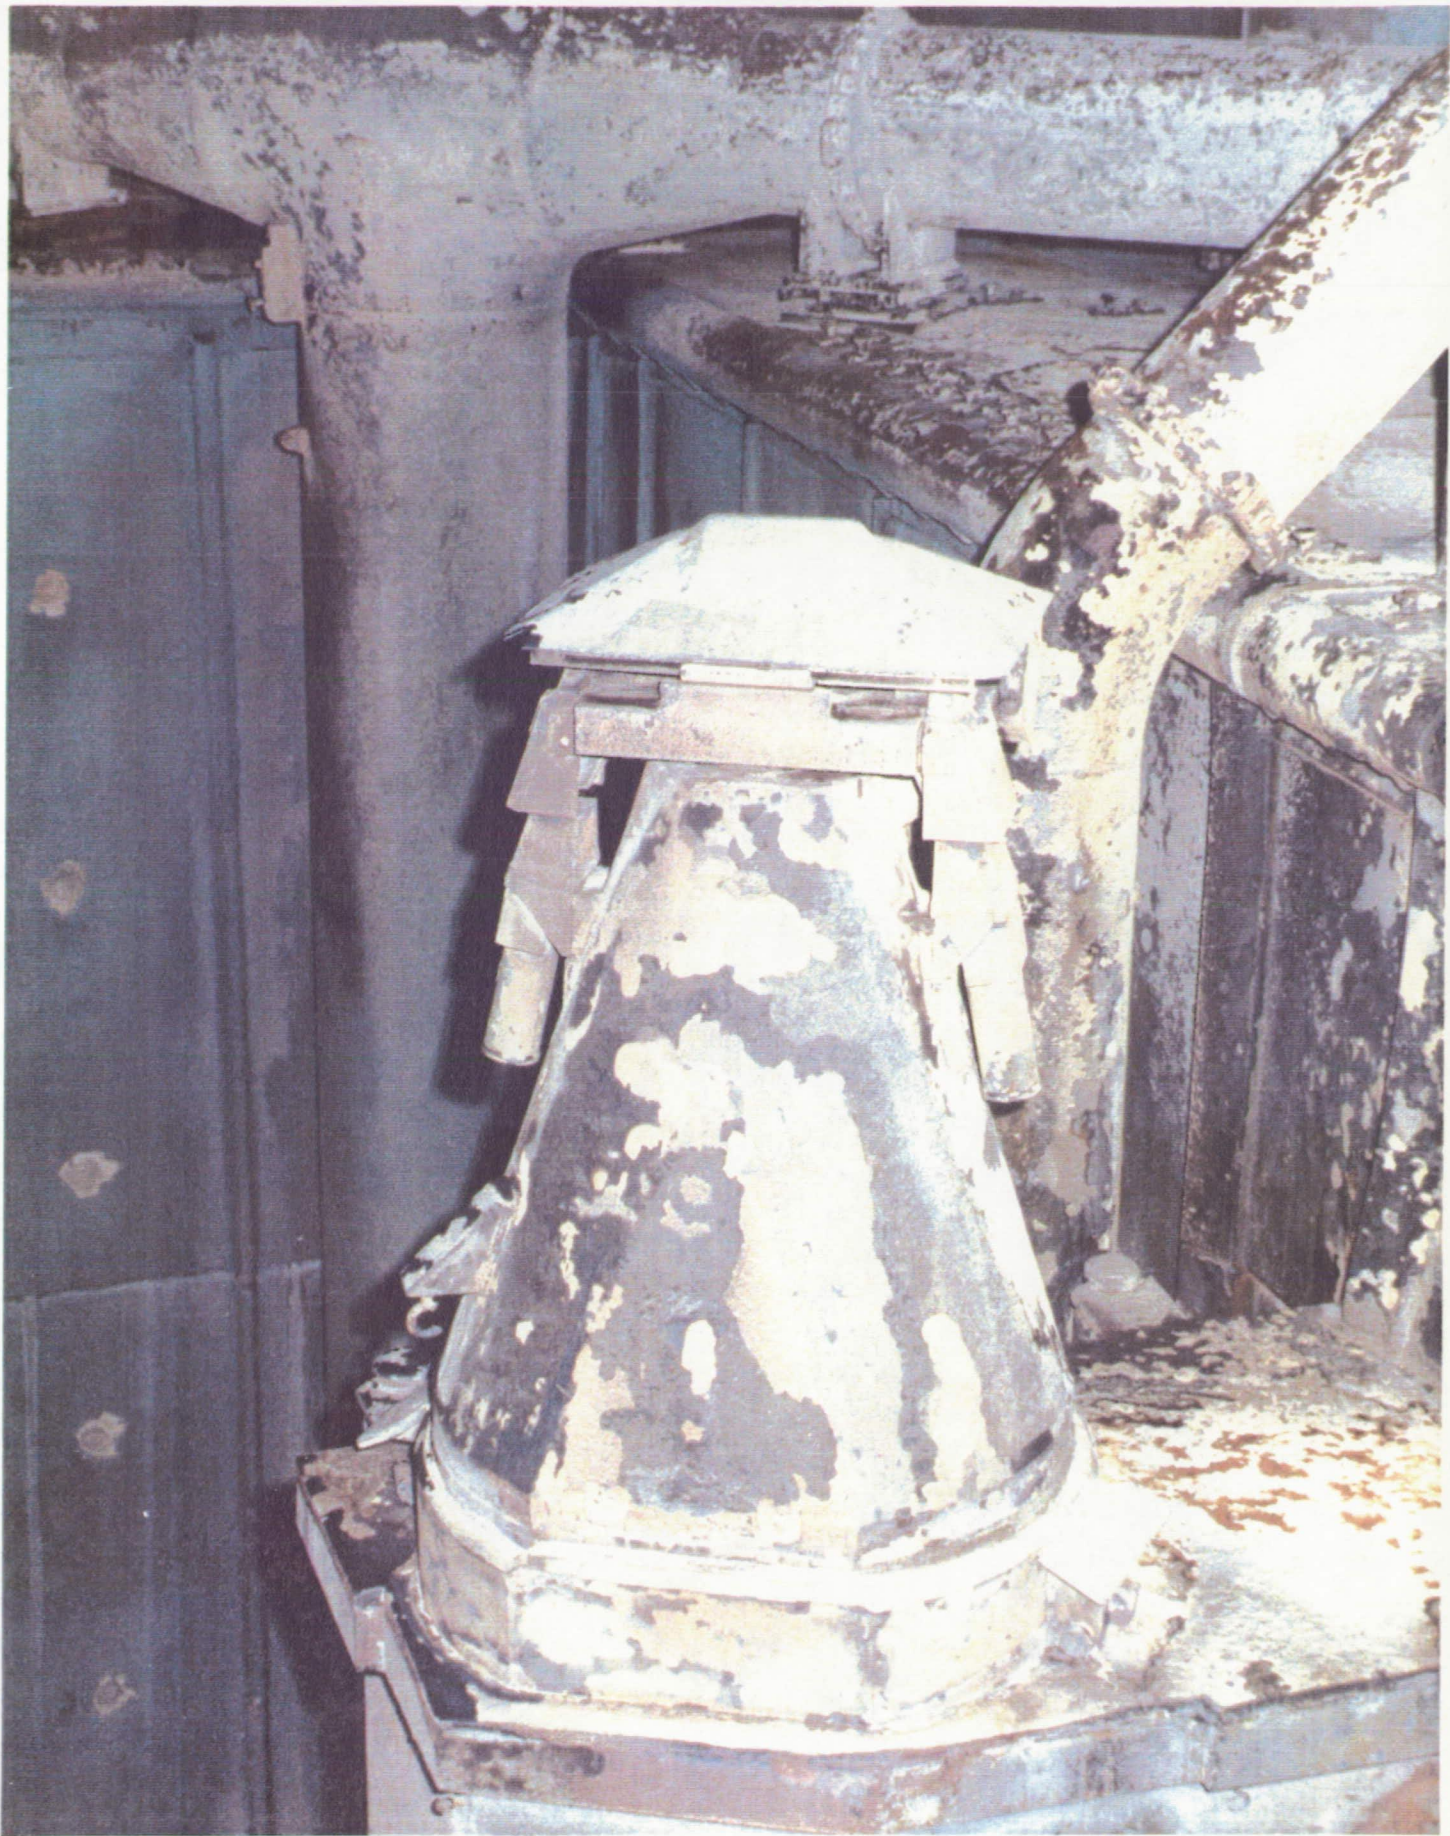
Typical SRB plume erosion on north holddown posts. All doghouse
blast covers had closed properly.

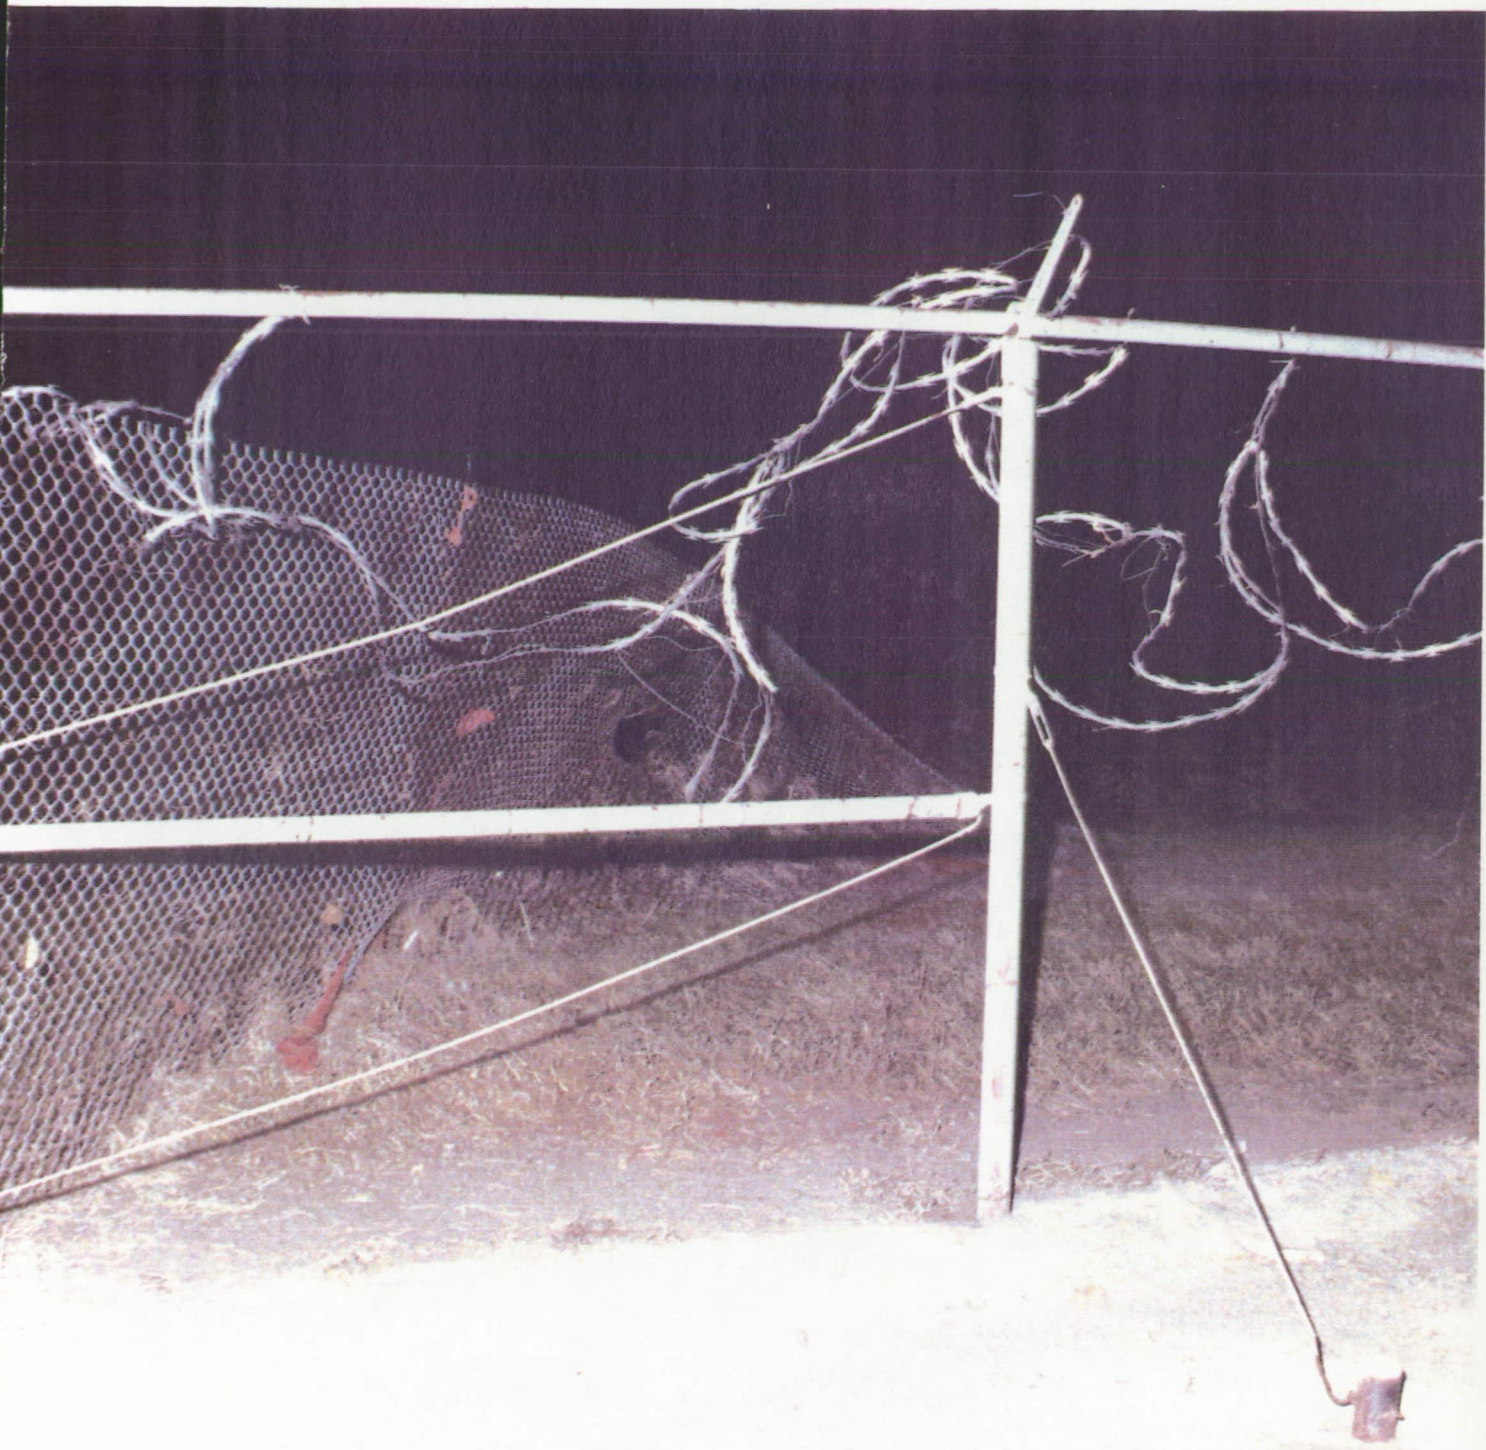
SRB exhaust plume from the pad flame trench caused damage to
the north pad perimeter fence

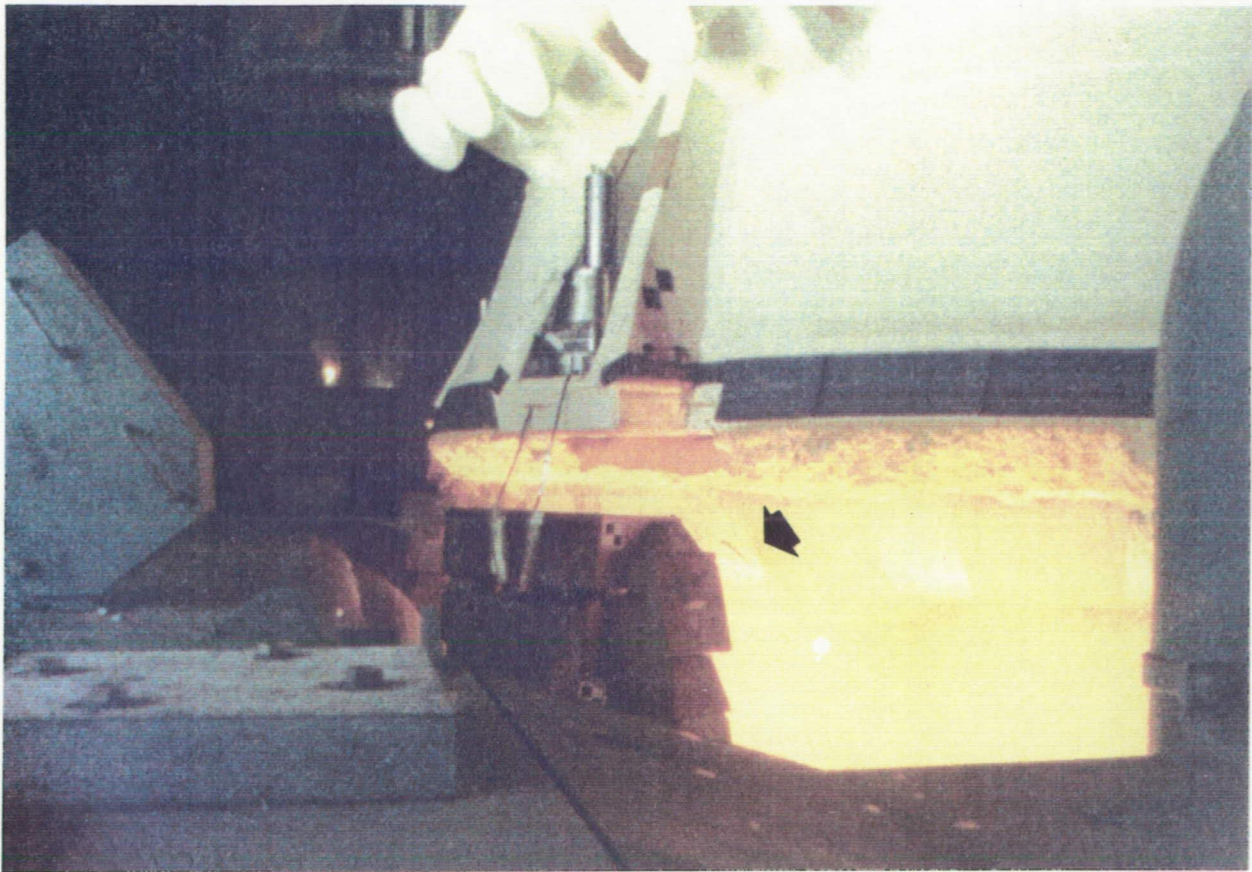
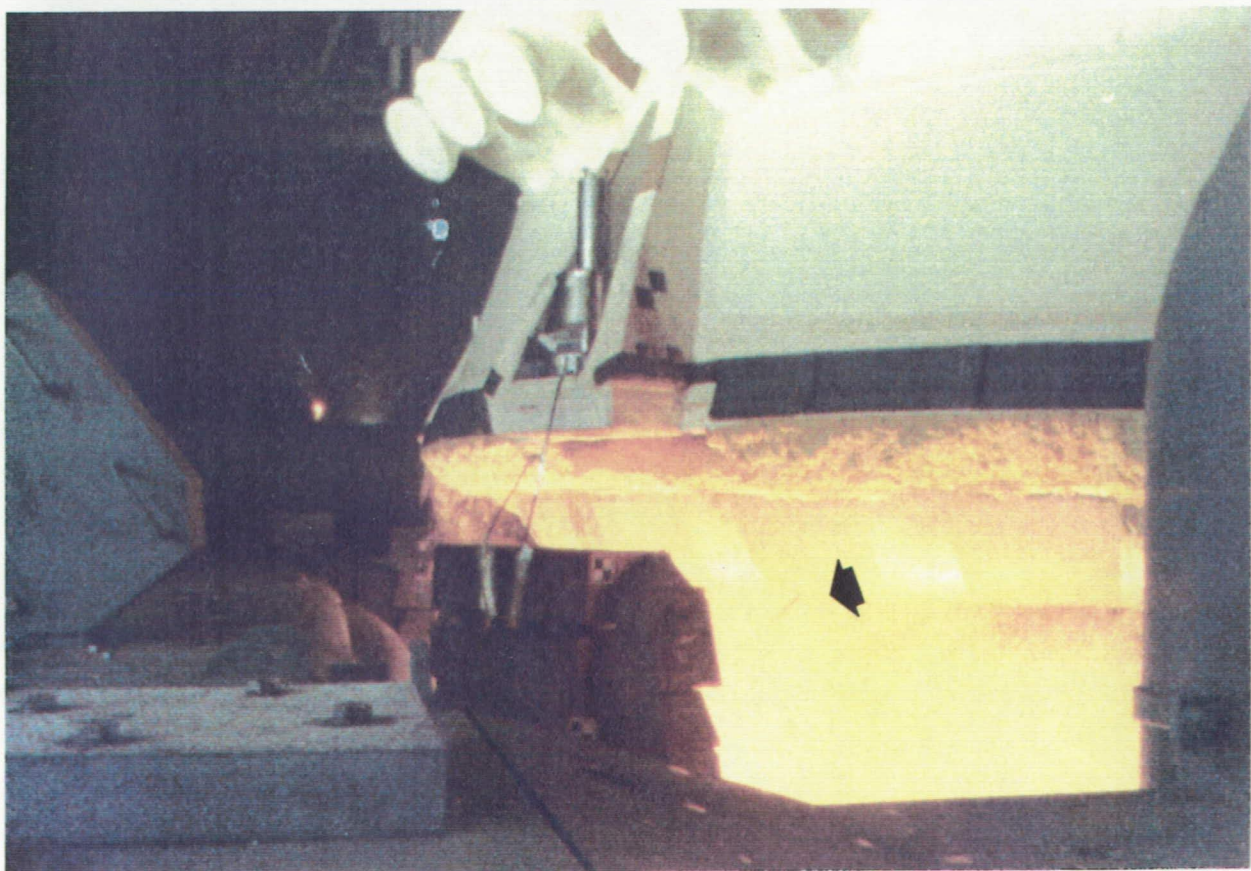
Small pieces of aft skirt instafoam and a sliver of HDP shim material/putty were pulled loose from the HDP #5 area at T-0
